Your Ref: SFE 83M
Our Ref : CI/TP21011944/D

22 November 2021

AUTOMOBILE INSPECTION REPORT OF MOTOR CAR SFE 83M

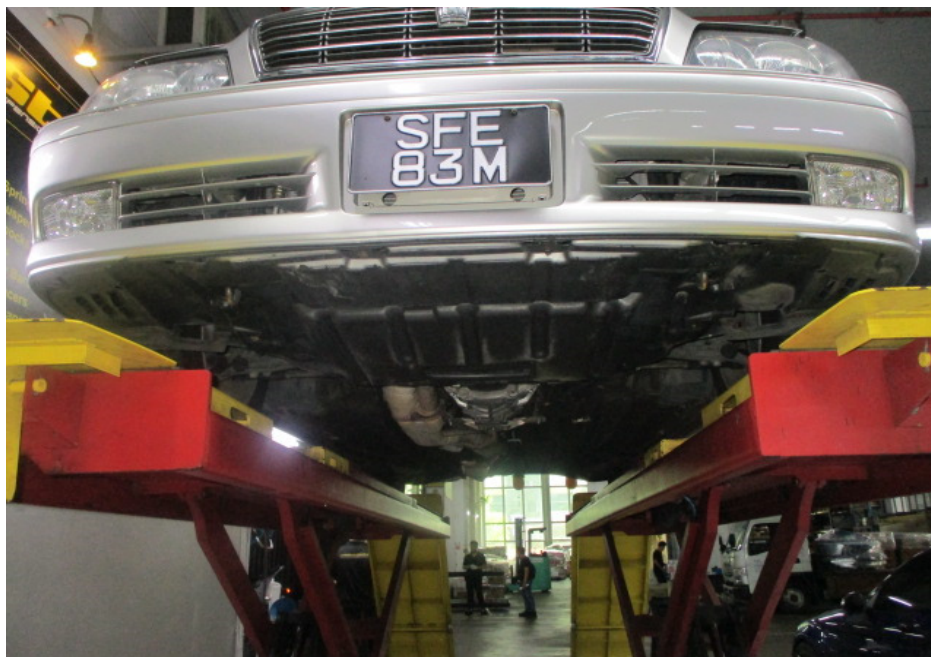
Photo 1 shows the Motor Car hoisted for checks on its undercarriage, in particular to the transmission.

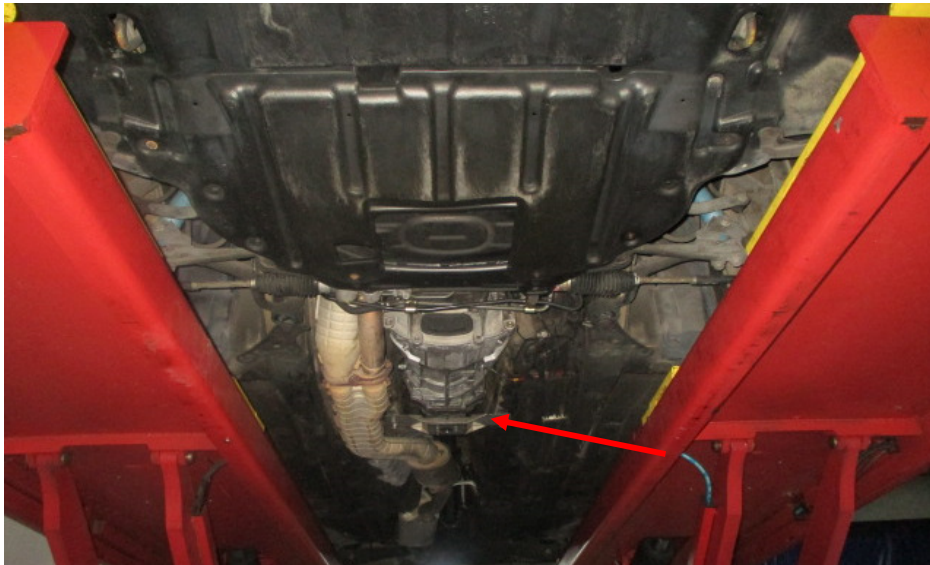
6. The Motor Car was fitted with a 5-speed manual transmission system, consisting of 2 main housings. The input side of the transmission, which houses the main shaft and various gear sets is bolted to the crankshaft side of the engine block. The gear set in the input side of the transmission connects to the transfer case, which is the second of the 2 main housings. The transfer case is also the output (rear) side of the Motor Car's transmission. The transfer case connects to the propeller shaft, which leads to the rear differential of the Motor Car. There was no crack and/or hole observed on both housings.

Photo 2 shows a general view of the transmission (arrowed) that was fitted on the Motor Car. The front (input) side of the transmission is bolted to the crankshaft side of the engine block. The gear set in the input side of the transmission connects to the transfer case, which is the output (rear) side of the Motor Car's transmission. The transfer case connects to the propeller shaft, which leads to the rear differential of the Motor Car.

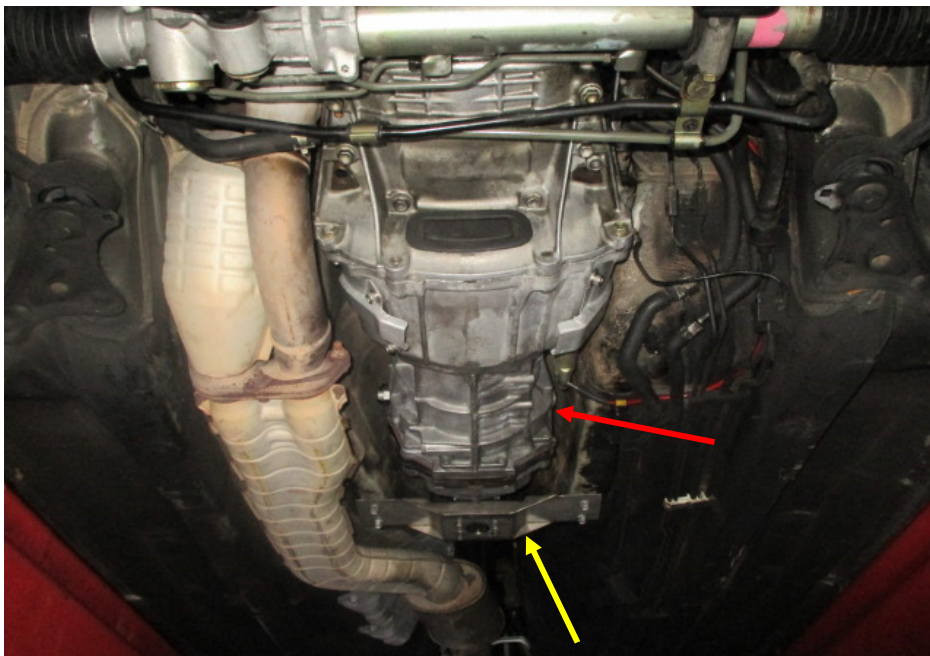
Photo 3 shows a closer view of the transmission (red arrow) that was fitted on the Motor Car. The front (input) side of the transmission is bolted to the crankshaft side of the engine block while the rear (output) side of the transmission is connected to the propeller shaft, which leads to the rear differential of the Motor Car. A bracket (yellow arrow) was mounted to the underside of the floorboard of the Motor Car, via bolts and nuts. This bracket supports the rear (output) side of the transmission.

11. In general, the transmission of the Motor Car was found to be secured properly. It was not mounted onto the chassis body or any integral body part of the Motor Car. The structural integrity of the Motor Car is not compromised by the fitment of this particular transmission. Overall, the operating condition of the Motor Car's transmission system was satisfactory throughout the Motor Car's test drive.

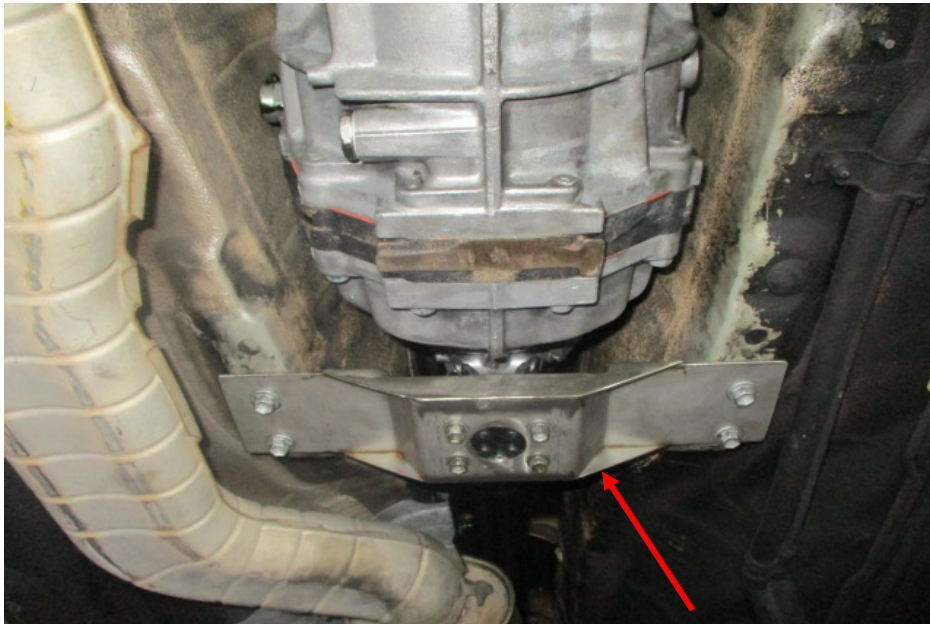
7. A bracket mounted to the underside of the floorboard of the Motor Car, via bolts and nuts, supports the output (rear) side of the transmission. Rubber bushing, sitting between the transmission and this bracket, absorbs any vibrations arising from the rotation of the transmission gears, minimising any stress to the bracket and correspondingly also minimise any stress at the mounting points of this bracket.

Photo 4 shows a closer view of the bracket (arrowed) mounted to the underside of the Motor Car's floorboard via bolts and nuts. The bracket supports the rear (output) side of the transmission. Rubber bushing absorbs any vibrations arising from the rotation of the transmission gears, minimising any stress to the bracket and correspondingly also minimise any stress at the mounting points of this bracket.

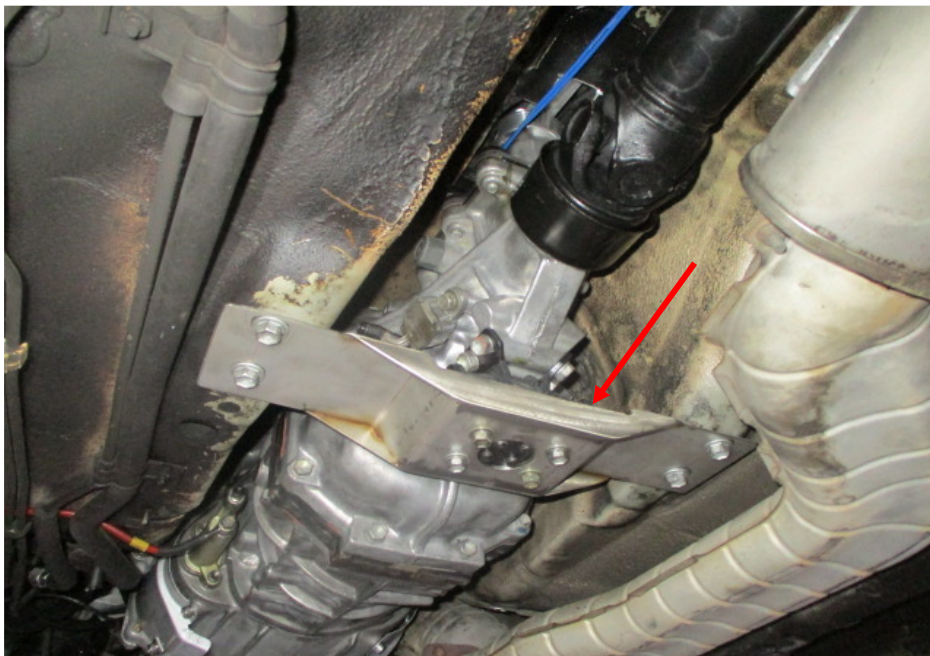
Photo 5 shows another view of the bracket (arrowed) that supports the transmission of the Motor Car, as viewed from the rear to front. This bracket at the rear of the transmission was with rubber bushing, which absorbs any vibrations arising from the rotation of the transmission gears, minimising any stress to the bracket and correspondingly also minimise any stress at the mounting points of this bracket.

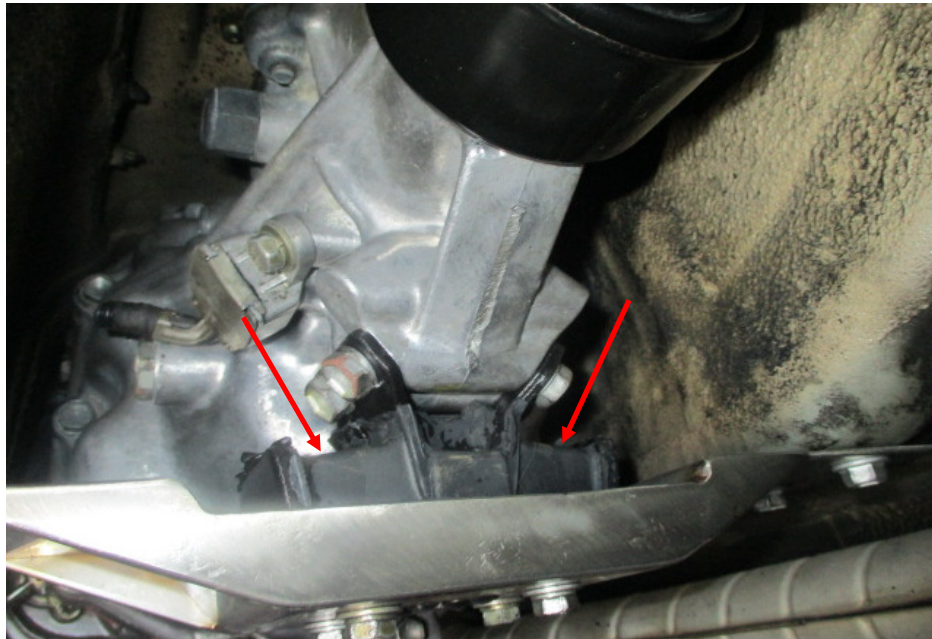
Photo 6 shows the rubber bushing (arrowed), sitting between the transmission and the bracket. The rubber bushing absorbs any vibrations arising from the rotation of the transmission gears, minimising any stress to the bracket and correspondingly also minimise any stress at the mounting points of this bracket.

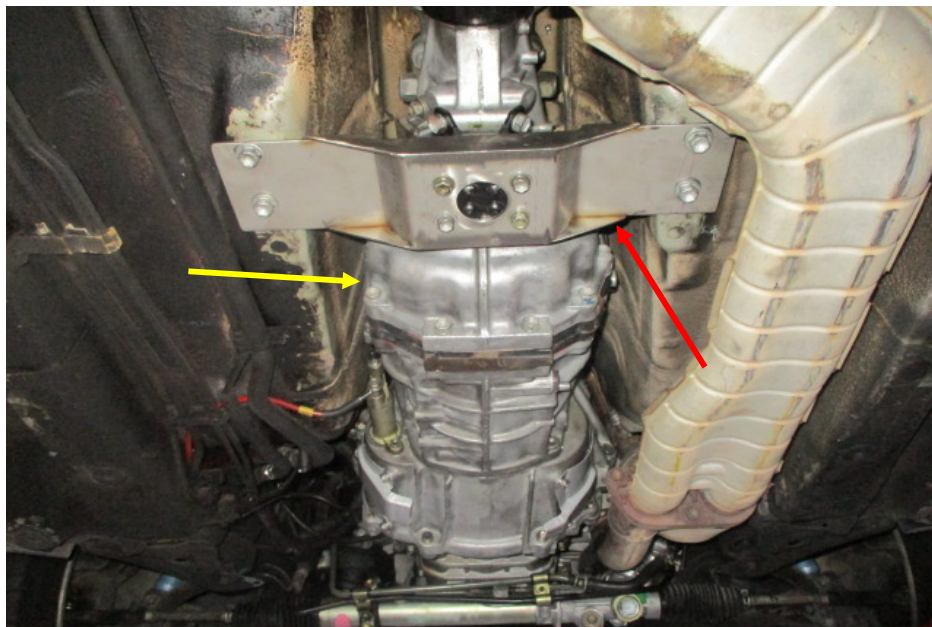
Photo 7 shows the transmission that was fitted on the Motor Car, as viewed from the rear to front. The front (input) side of the transmission is bolted to the crankshaft side of the engine block while the rear (output) side of the transmission, which is also referred to as transfer case (yellow arrow), is connected to the propeller shaft, which leads to the rear differential of the Motor Car. A bracket (red arrow) was mounted to the underside of the floorboard of the Motor Car, via bolts and nuts. This bracket supports the rear (output) side of the transmission.

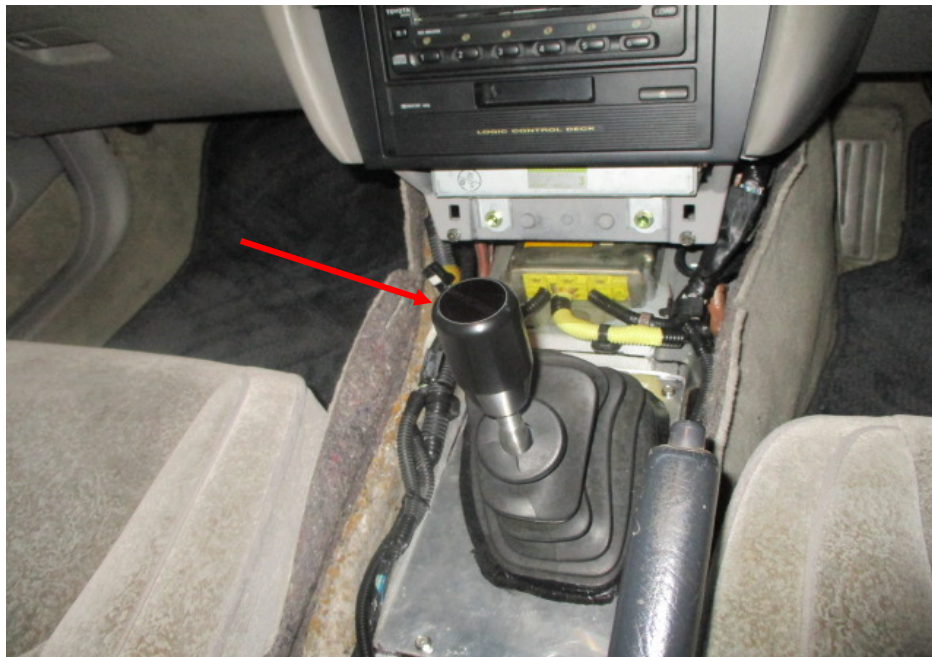
Photo 8 shows the manual gear shifter (arrowed) that was fitted on the Motor Car, for manually selecting the transmission gear to be engaged.

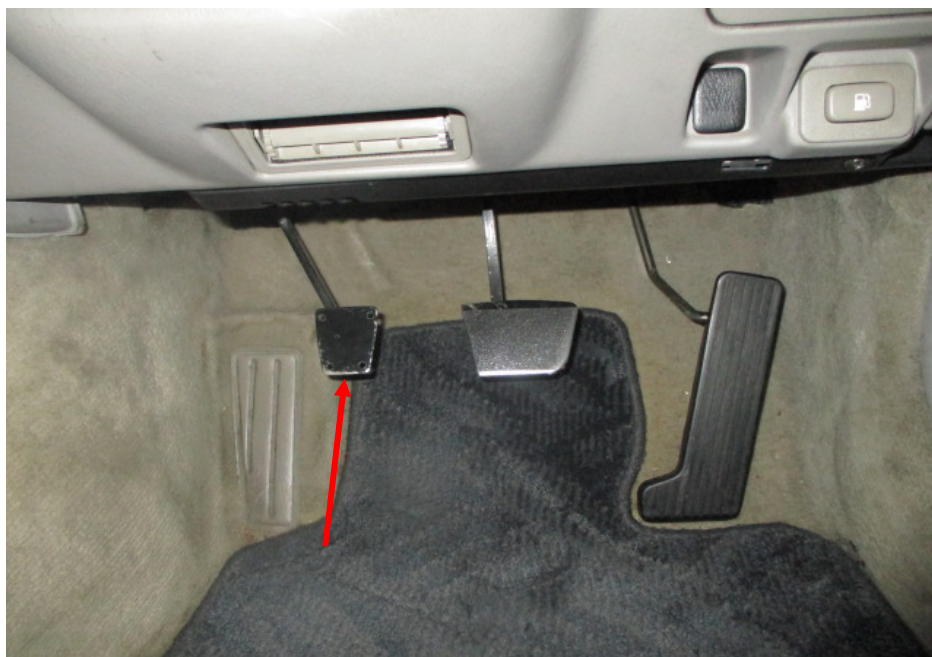
Photo 9 shows the clutch pedal (arrowed) of the Motor Car, for engaging and disengaging the transmission gears.
