**ACCIDENT DAMAGED VEHICLE INSPECTION REPORT**

Date : 28 December 2021
Our Ref : TP/GAS/GBA1411L/8603

Registration No : GBA 1411 L
Make : Toyota
Model : Hiace Manual
Year : 2007 (COE Expiry 31 Dec 2026)

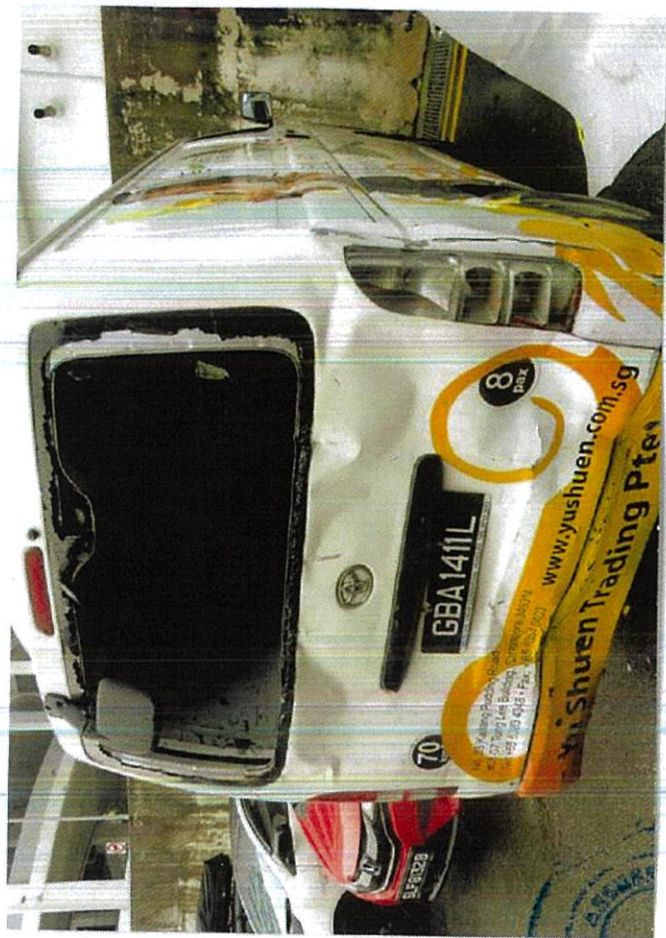
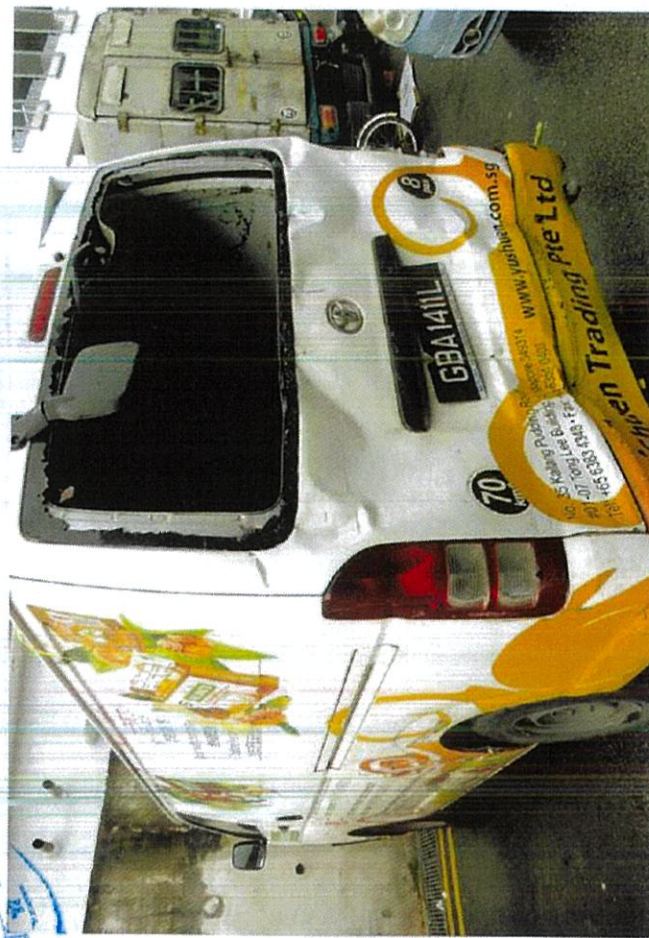
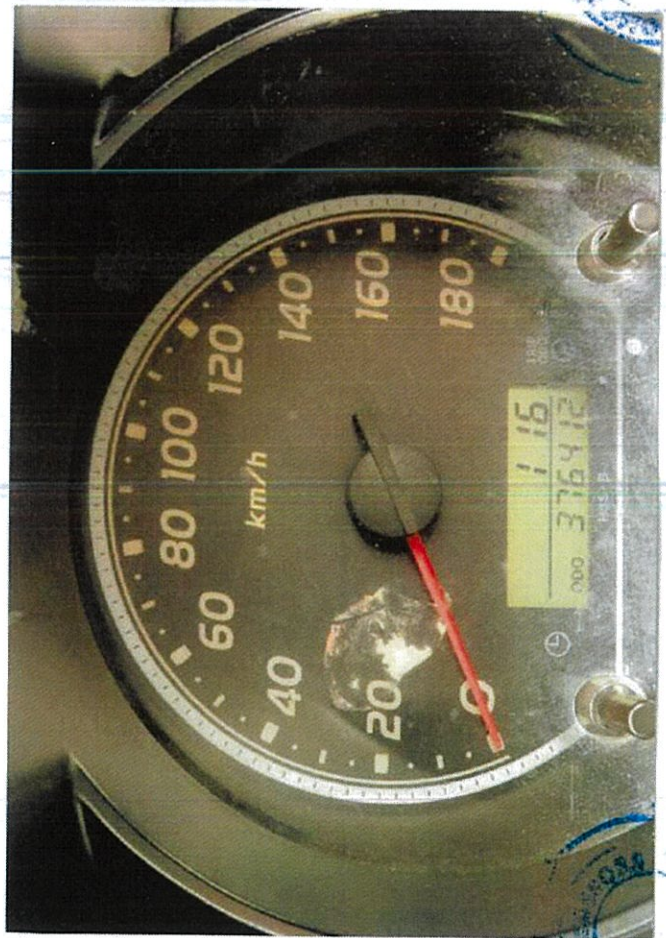
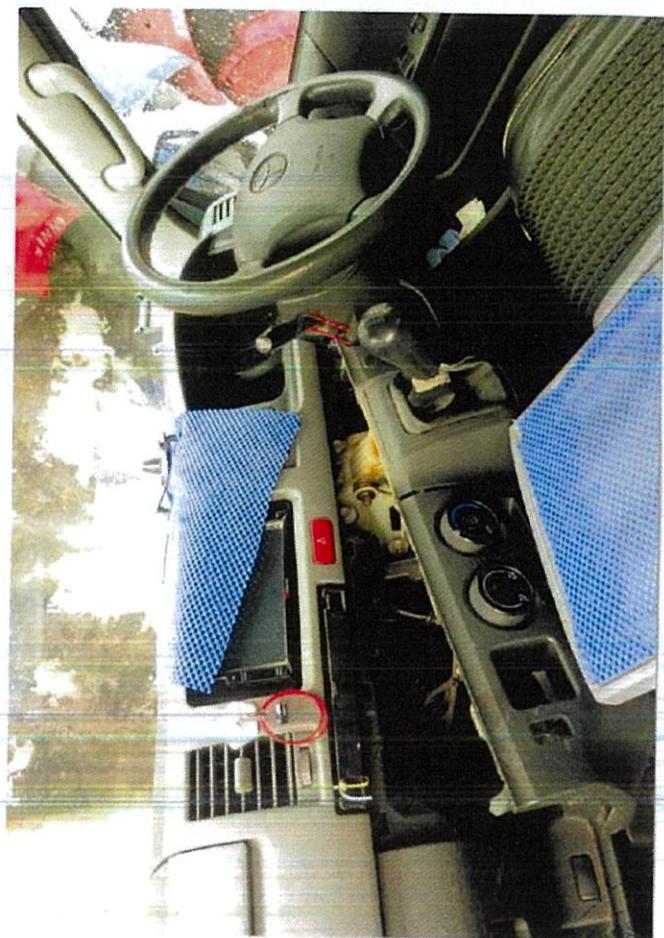
CHASSIS NO JTFHT02P30-0002823
 U.W. 1820KG
 M.L.W. 2800KG
 PASS.CAP 02
 TYRE SIZE F195R15C/8PR
 R195R15C/8PR (S)
