## VEHICLE DAMAGE INSPECTION REPORT

Our Ref: 18/TP/2021

Date of loss: 12/1/2021  
Claimant: Michael Tan

| Reg No: | SKU3968Y | Make & | Honda |

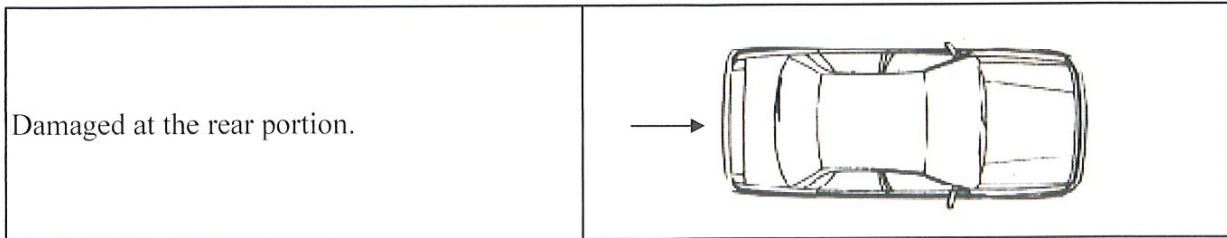
### POINT OF IMPACT

Our visual inspection of the vehicle revealed that the damages noted are at the rear portion.
