Your Ref: BMW X3  
(chassis number WBAUZ36010N007491)  
Our Ref : CI/TP21012039/D

**INSPECTION REPORT OF AN UNREGISTERED BMW X3 MOTOR CAR WITH  
CHASSIS NUMBER WBAUZ36010N007491**

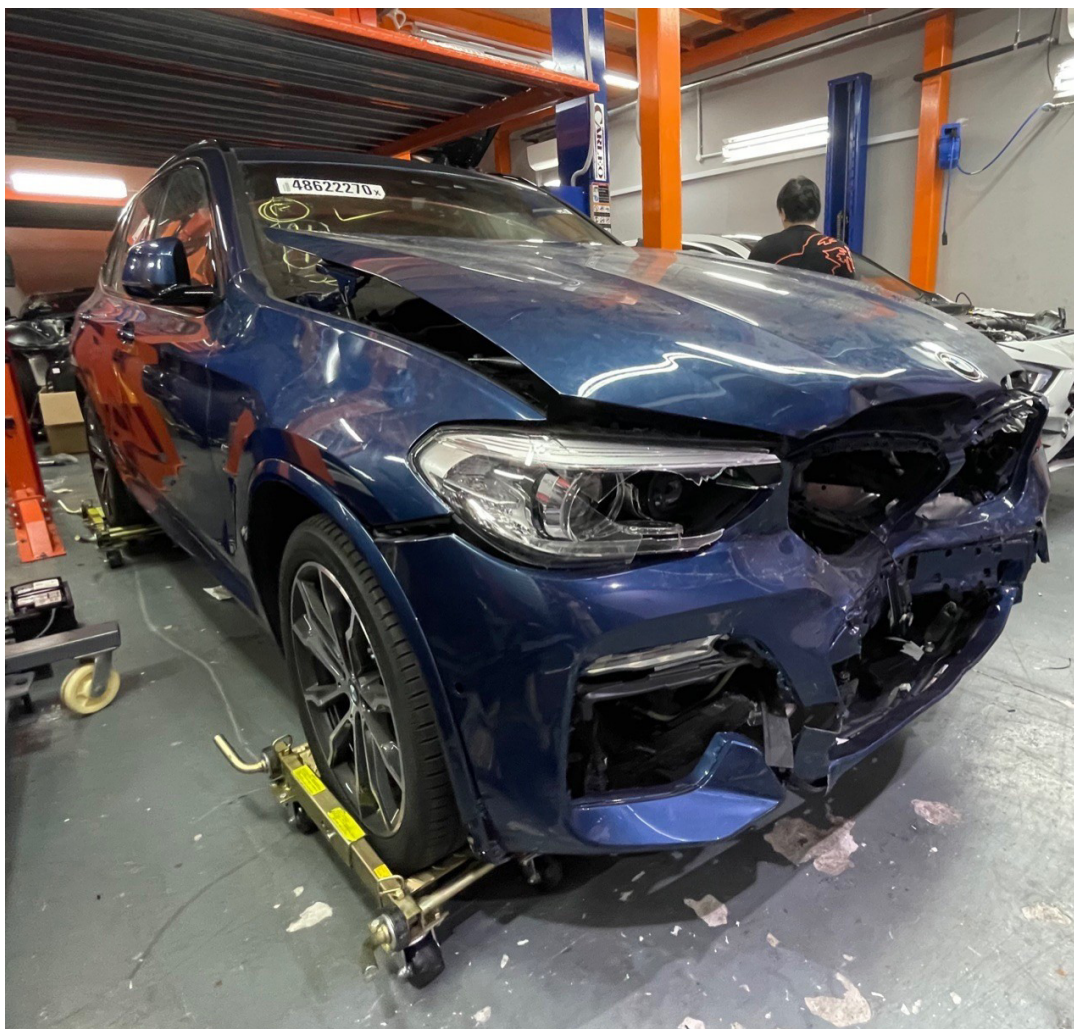
**Photo 1** shows the front right body of the Motor Car (photograph provided to me). The Motor Car was observed to have sustained damage at its frontal portion. The front bumper, front bumper reinforcement, front bumper centre lower grille, front bumper right lower grille, radiator grilles, front bonnet, front bonnet right hinge, front right day light, front right headlamp and front right fender wheel arc garnish were amongst the body parts that were observed to have been damaged. The extent of damage to the frontal portion of the Motor Car would suggest to me that either the driver airbag and/or the front left passenger airbag was possibly deployed.

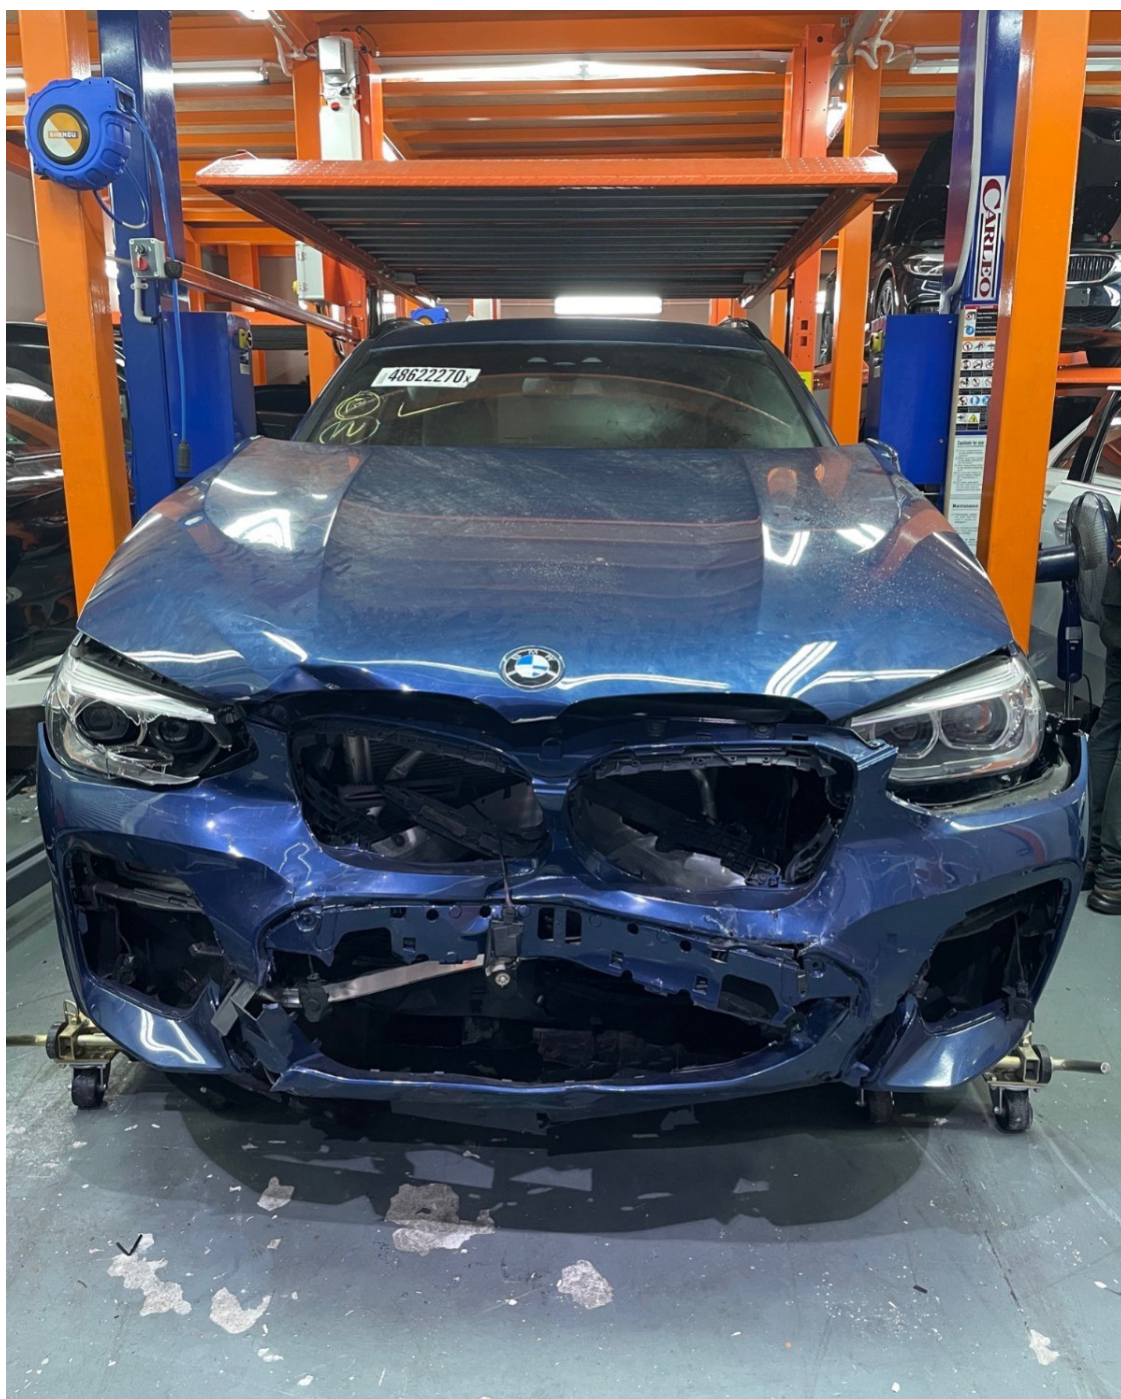
**Photo 2** shows the frontal body of the Motor Car (photograph provided to me). The Motor Car was observed to have sustained damage at its frontal portion. The front bumper, front bumper centre garnish, front bumper lower grille, front bumper sponge, front bumper reinforcement, front bumper right lower grille, front bumper left lower grille, front bumper sensors, radiator grilles, front bonnet, front right day light, front left day light, front right headlamp, front left headlamp, aircon condenser and radiator were amongst the body parts that were observed to have been damaged. The extent of damage to the frontal portion of the Motor Car would suggest to me that either the driver airbag and/or the front left passenger airbag was possibly deployed.

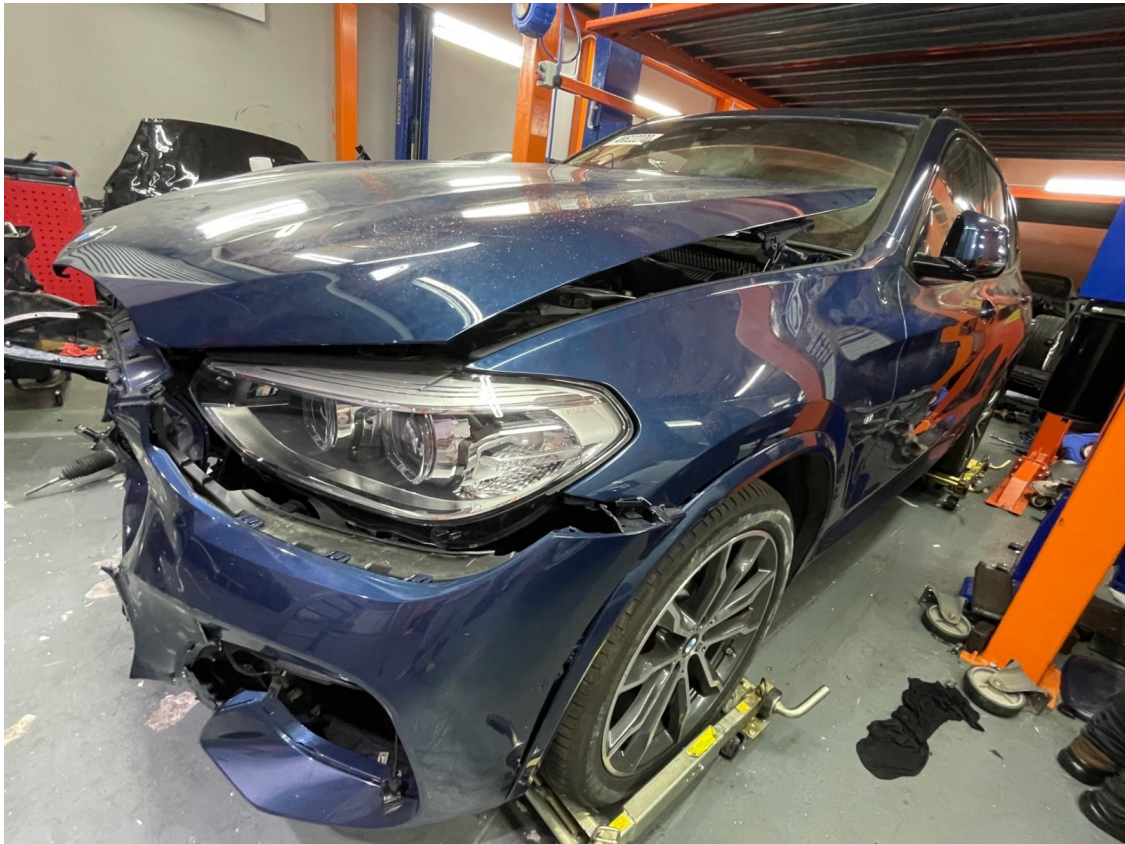
**Photo 3** shows the front left body of the Motor Car (photograph provided to me). The Motor Car was observed to have sustained damage at its frontal portion. The front bumper, front bumper left lower grille, front bonnet, front bonnet left hinge, front left day light, front left headlamp and front left fender wheel arc garnish were amongst the body parts that were observed to have been damaged. The extent of damage to the frontal portion of the Motor Car would suggest to me that either the driver airbag and/or the front left passenger airbag was possibly deployed.

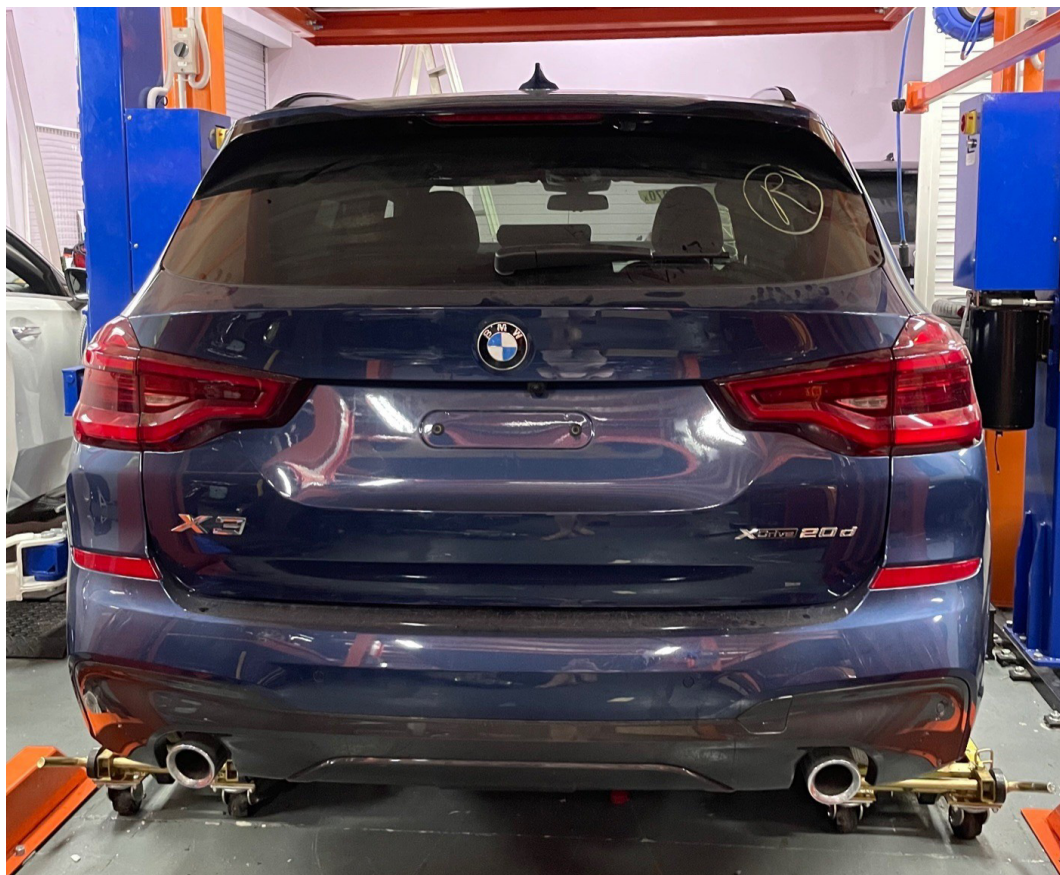
**Photo 4** shows the rear body of the Motor Car (photograph provided to me). Apart for the frontal portion, there was no physical damage seen to other areas of the Motor Car.

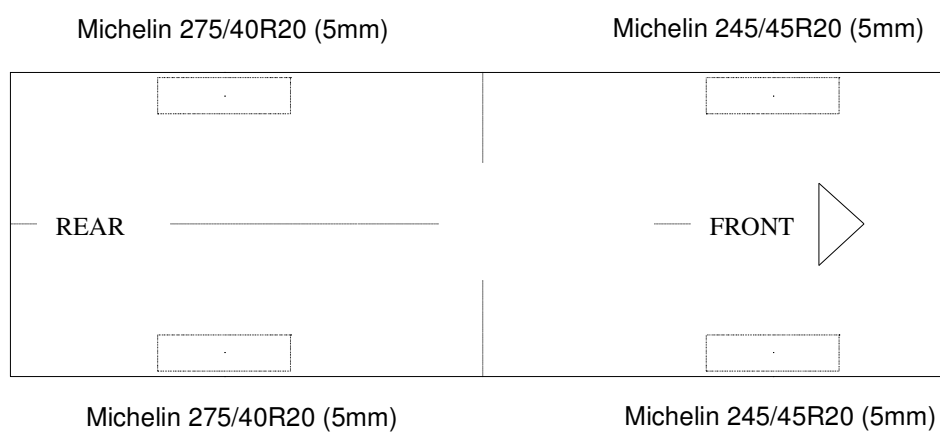
9. It was fitted with 20inch sport wheel rims that were wrapped with tyres that were observed to be of serviceable condition. The tyres were also sufficiently inflated for vehicular operation. The tyre brand, tyre size and approximate remaining tread depth of the 4 tyres of the Motor Car were recorded as follows: -

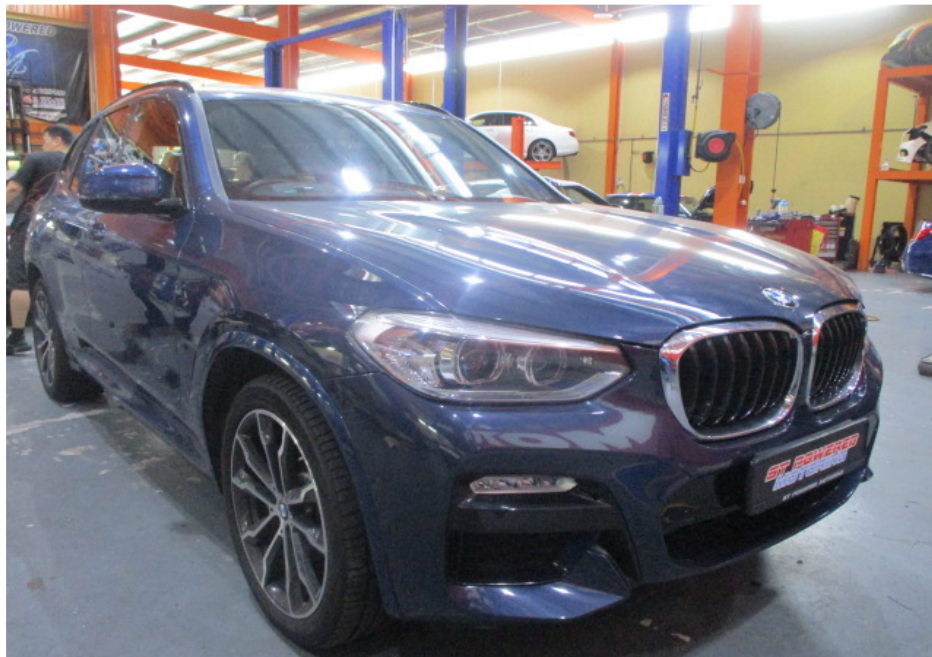
**Photo 5** shows a general view of the front right body of the Motor Car at the time of my inspection. The Motor Car was observed to be in a relatively good general condition with no loose exterior fittings observed. The body parts at the frontal portion of the Motor Car were visually examined and it was observed that the repair/restoration works carried out to the damaged area of the Motor Car (refer to photograph 1 – 3 above) were reasonably adequate and in order.

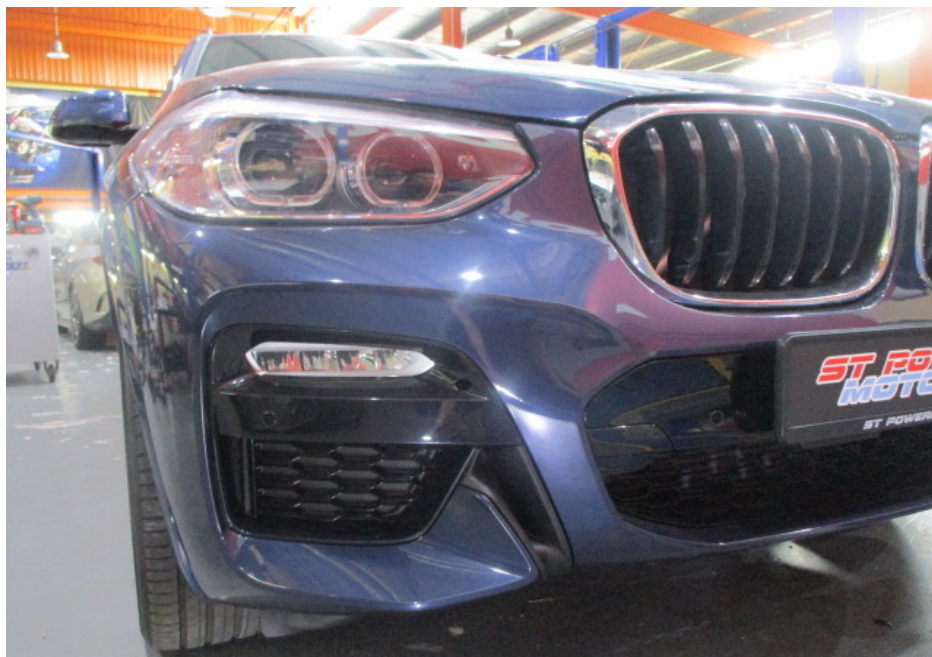
**Photo 6** shows a closer view of the Motor Car's front bumper, front bumper right lower grille, front right headlamp and front right day light. The body parts at the frontal portion of the Motor Car were visually examined and it was observed that the repair/restoration works carried out to the damaged area of the Motor Car (refer to photograph 1 – 3 above) were reasonably adequate and in order.

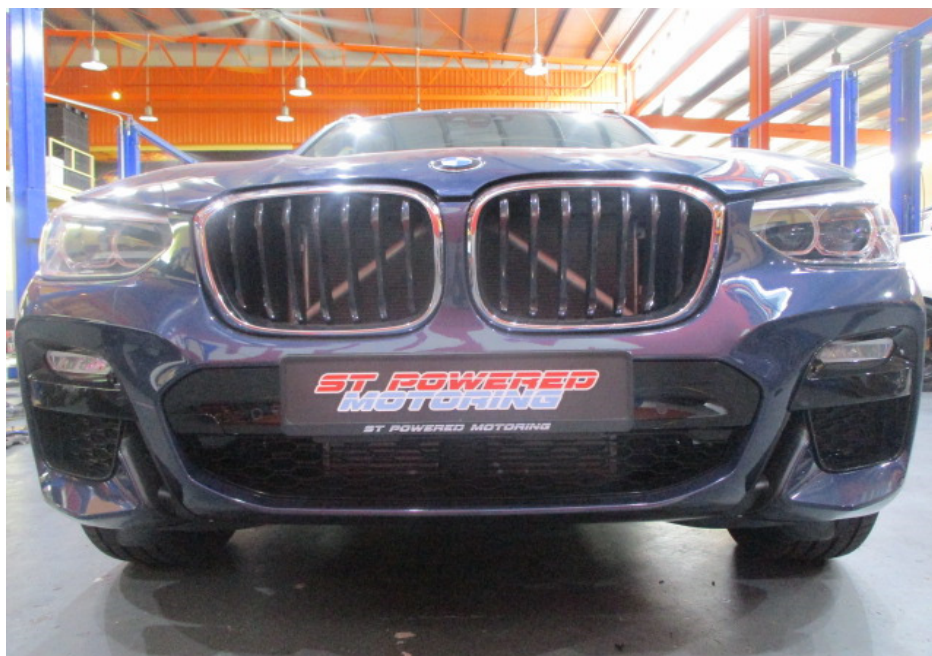
**Photo 7** shows a closer view of the Motor Car's front bumper, front bumper centre lower grille, front bonnet, radiator grilles, front day lights and front headlamps. The body parts at the frontal portion of the Motor Car were visually examined and it was observed that the repair/restoration works carried out to the damaged area of the Motor Car (refer to photograph 1 – 3 above) were reasonably adequate and in order.

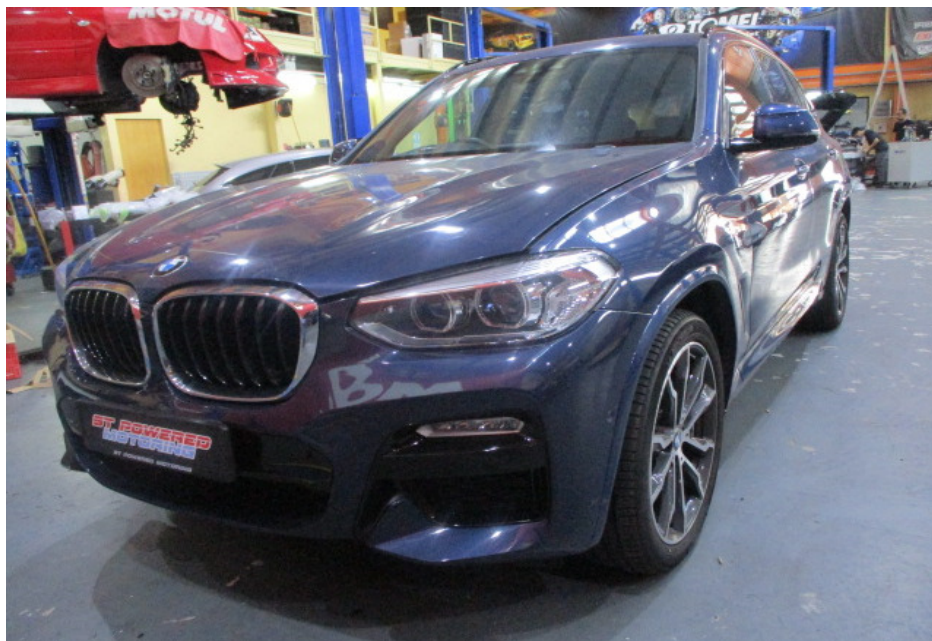
**Photo 8** shows a general view of the front left body of the Motor Car at the time of my inspection. The Motor Car was observed to be in a relatively good general condition with no loose exterior fittings observed. The body parts at the frontal portion of the Motor Car were visually examined and it was observed that the repair/restoration works carried out to the damaged area of the Motor Car (refer to photograph 1 – 3 above) were reasonably adequate and in order.

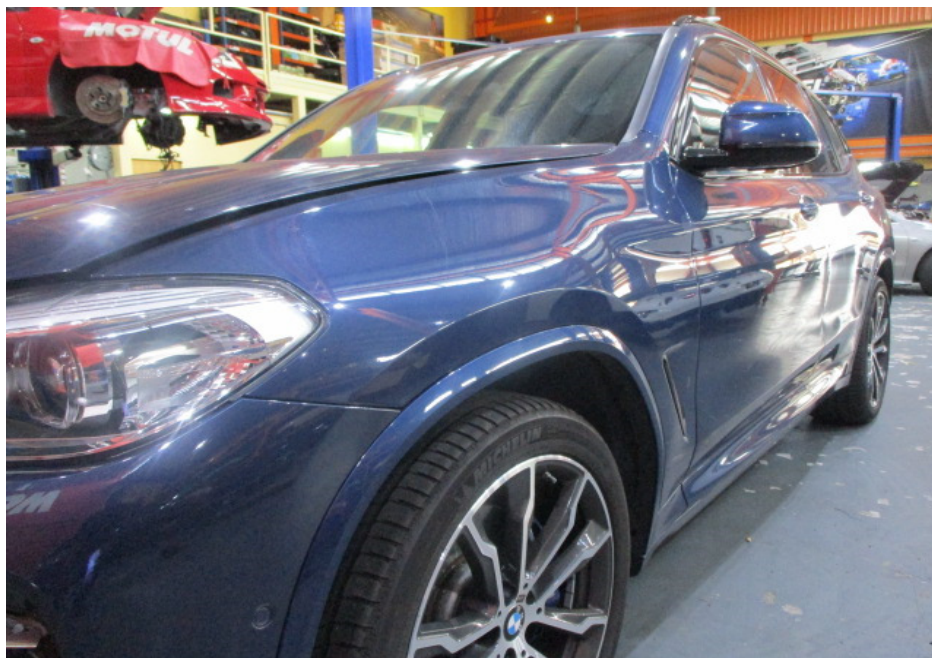
**Photo 9** shows a closer view of the Motor Car's front left fender, front left fender wheel arc garnish and front left headlamp. The body parts at the frontal portion of the Motor Car were visually examined and it was observed that the repair/restoration works carried out to the damaged area of the Motor Car (refer to photograph 1 – 3 above) were reasonably adequate and in order.

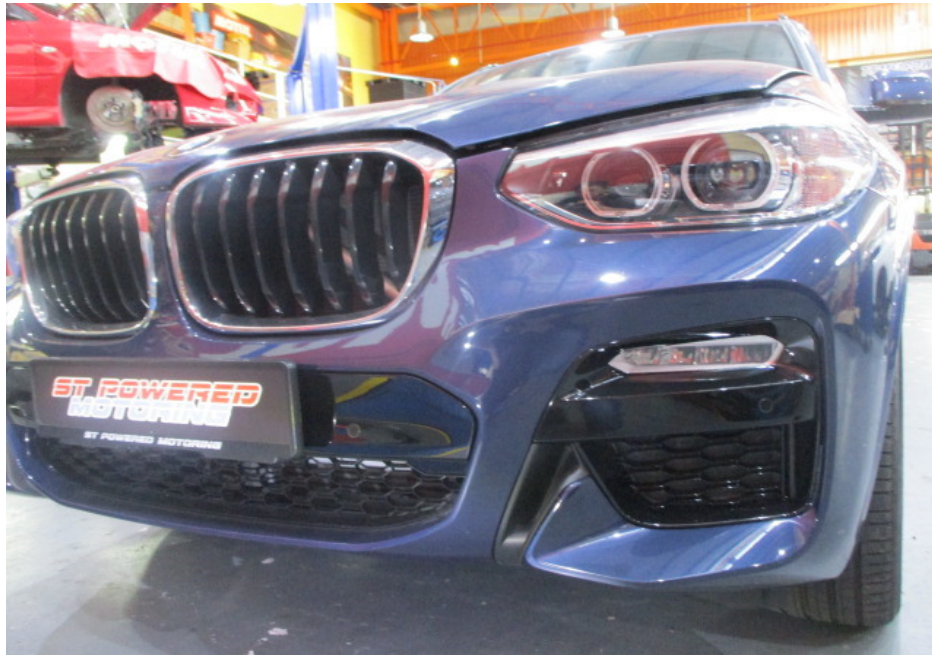
**Photo 10** shows a closer view of the Motor Car's front bumper, front bumper centre garnish, front bumper centre lower grille, front bumper left lower grille, front left day light and front left headlamp. The body parts at the frontal portion of the Motor Car were visually examined and it was observed that the repair/restoration works carried out to the damaged area of the Motor Car (refer to photograph 1 – 3 above) were reasonably adequate and in order.

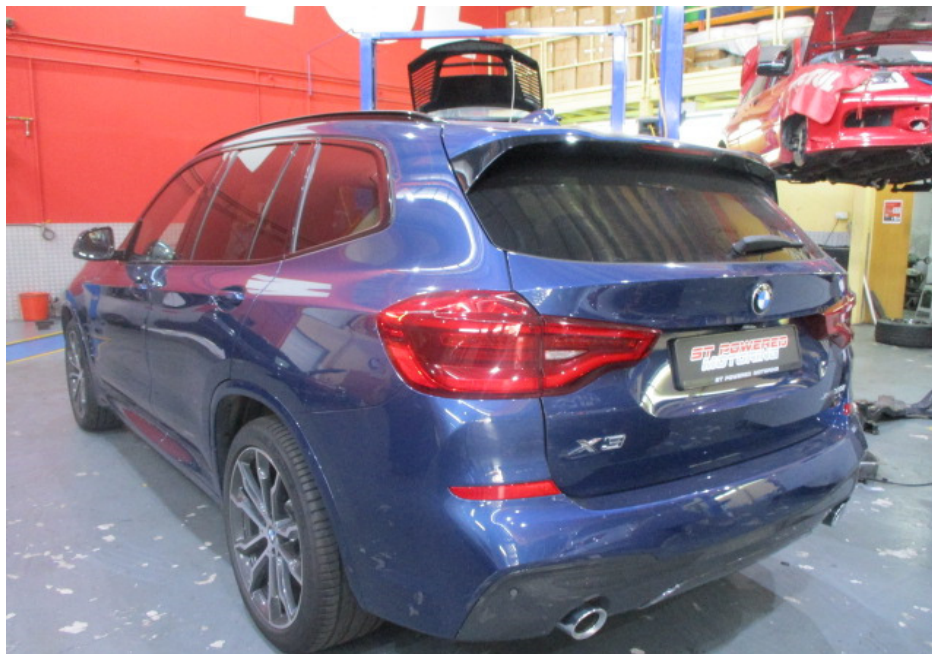
**Photo 11** shows a general view of the rear left body of the Motor Car at the time of my inspection. The Motor Car was observed to be in a relatively good general condition with no loose exterior fittings observed. The mileage of the Motor Car recorded at the time of my inspection was 8,234km.

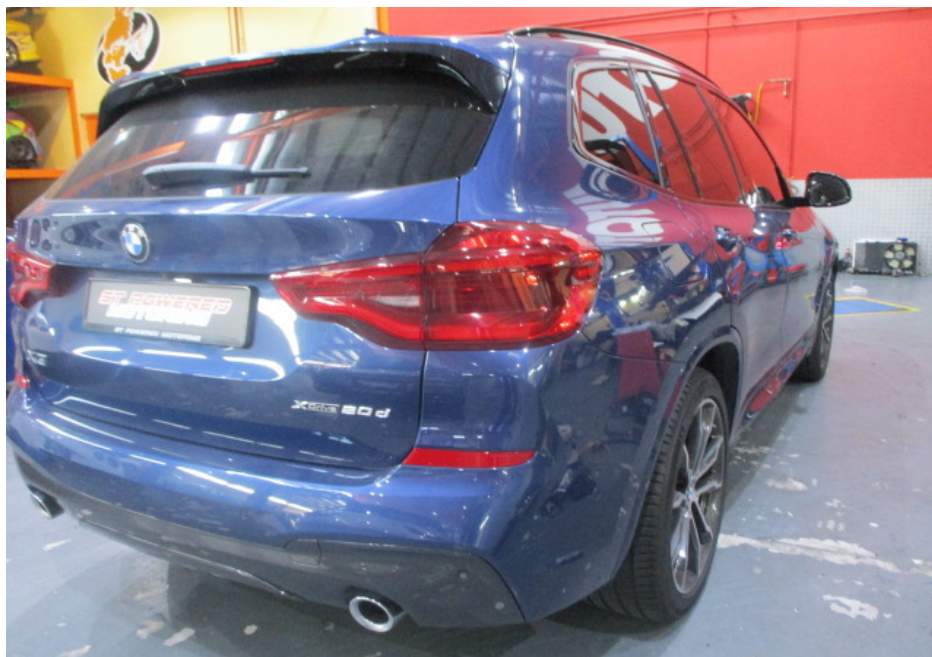
**Photo 12** shows a general view of the rear right body of the Motor Car at the time of my inspection. The Motor Car was observed to be in a relatively good general condition with no loose exterior fittings observed. The mileage of the Motor Car recorded at the time of my inspection was 8,234km.

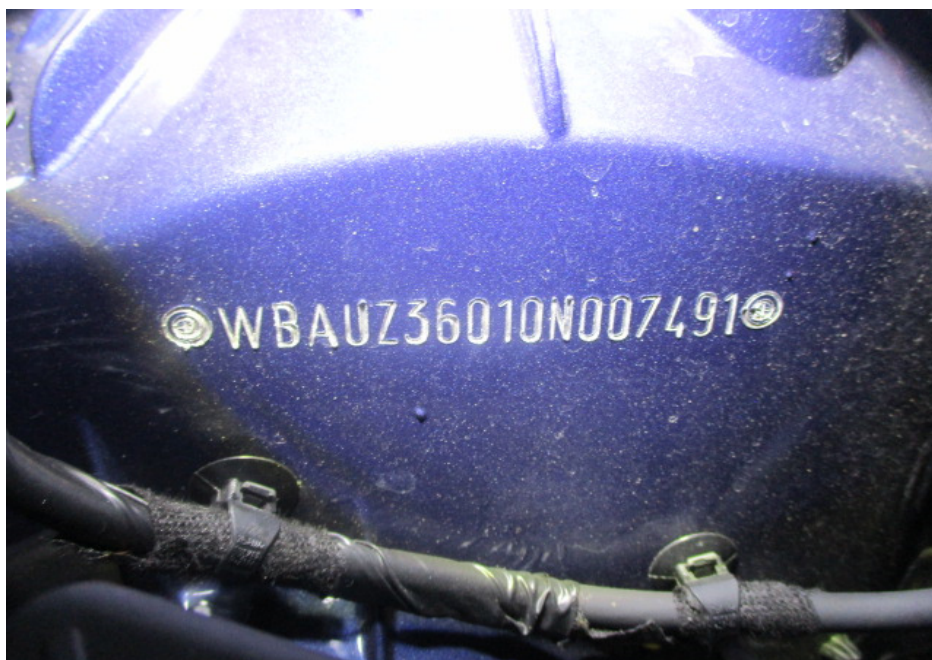
**Photo 13** shows the chassis number of the Motor Car. The chassis number recorded was WBAUZ36010N007491.

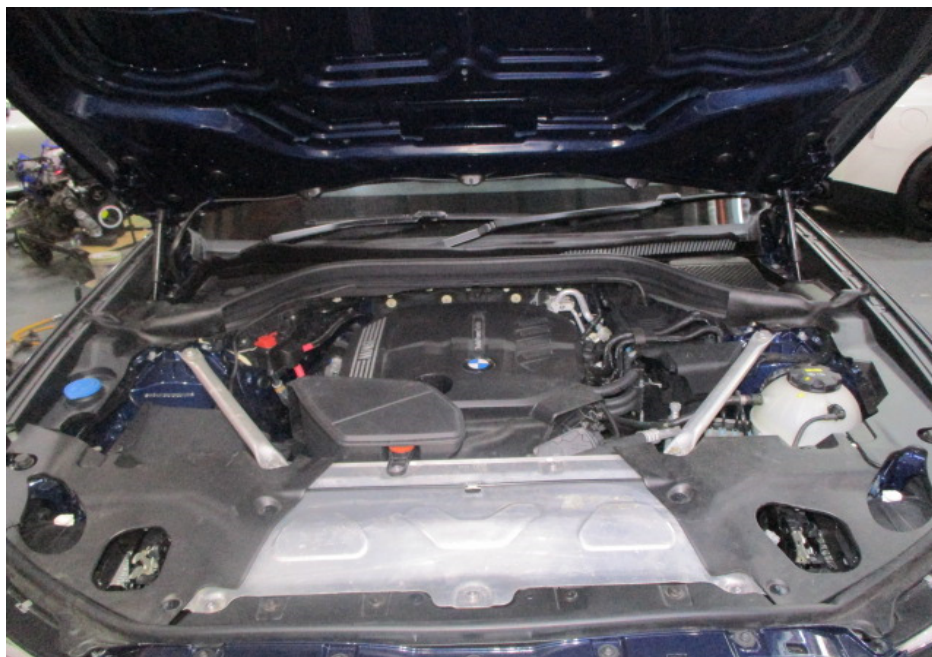
**Photo 14** shows a general view of the engine compartment of the Motor Car at the time of my inspection. The various parts and components inside the engine compartment were all observed to be intact and properly fitted. There was also no sign(s) or indication(s) of fluid leak and/or fluid stain found inside the engine compartment. The repair/restoration works carried out to the various parts within the engine compartment like the front bonnet locks, front support panel, front support panel top centre garnish, aircon condenser, radiator and oil cooler amongst others, were reasonably adequate and in order.

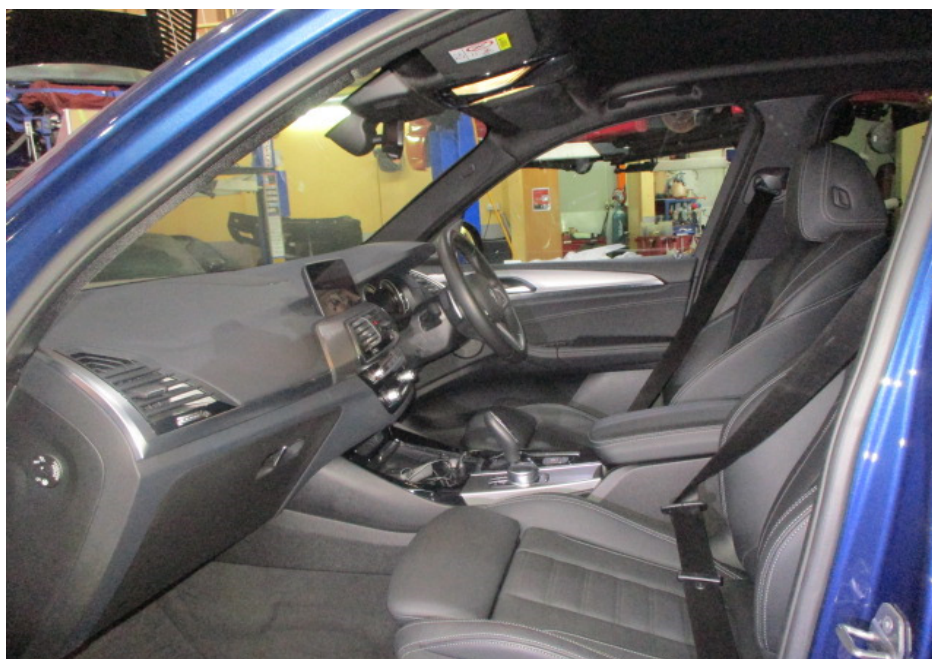
**Photo 15** shows the interior compartment of the Motor Car. The front dashboard, steering wheel, seats, upholstery and trims etc were all observed to be intact and properly fitted.

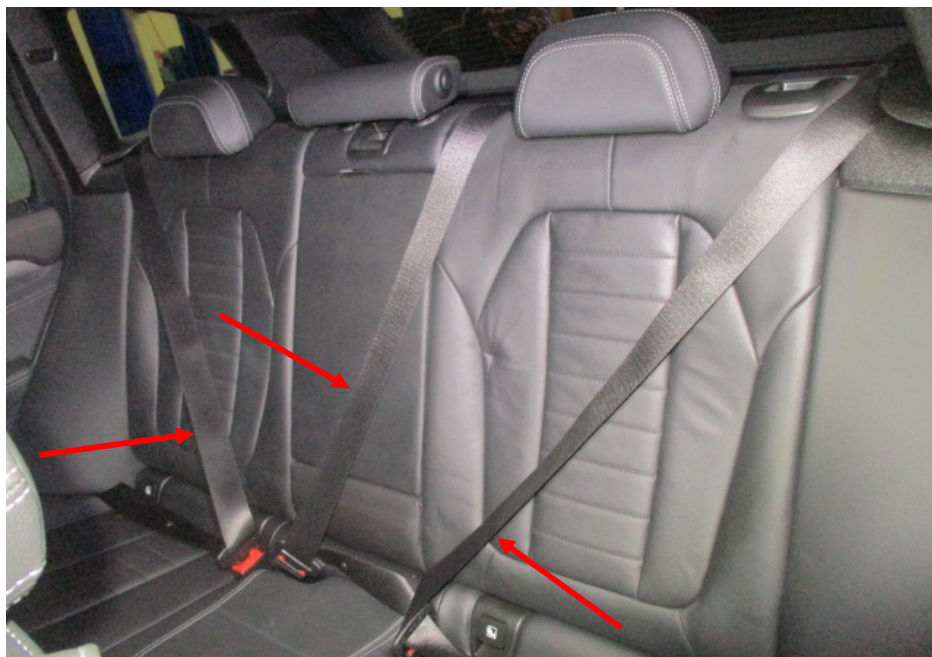
**Photo 16** shows the rear seats of the Motor Car. All the seats of the Motor Car were secured via seat rails to the floorboard. They were also fitted with a retractable seat belt reel and a pre-tensioner. The seat belts (arrowed) were tested and were able to be fastened into the respective pre-tensions that were fitted on the side of each individual seat.

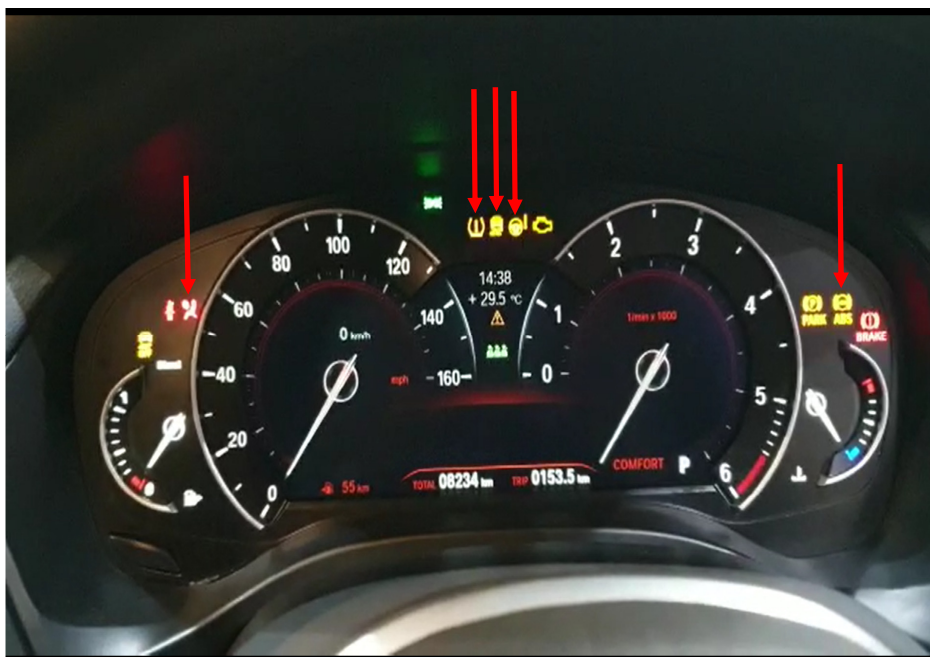
**Photo 17** shows the warning lights for the various electronic safety features appearing on the instrument panel of the Motor Car during its self-test when the engine is cranked, in particular the ABS, SRS, IAS, TPM and DSC lights (arrowed).

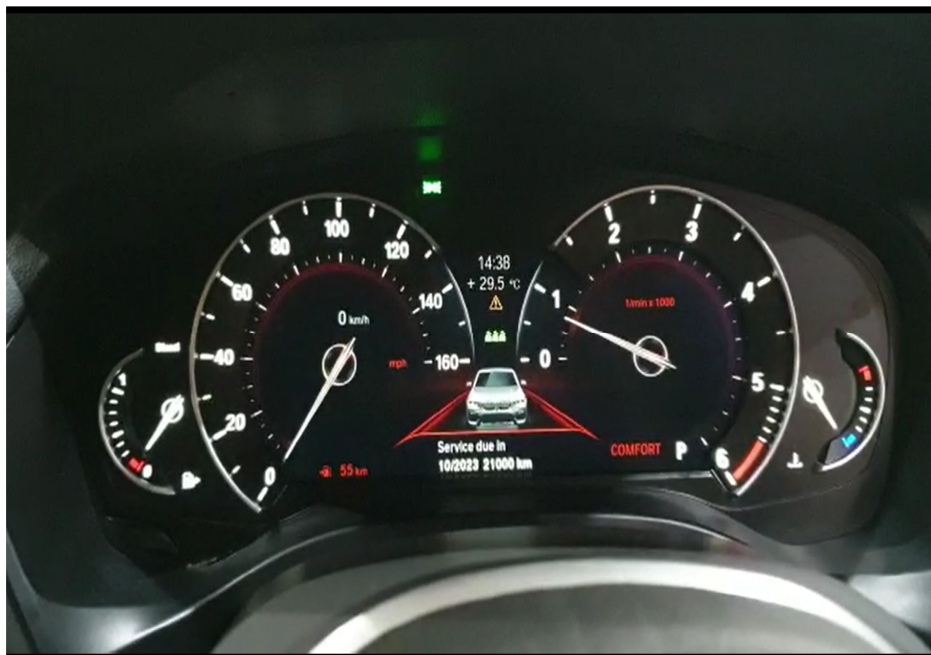
**Photo 18** shows the respective warning lights no longer illuminated, indicating that there is no fault detected to the ABS, SRS, IAS, TPM and DSC systems of the Motor Car during the self-test. These electronic systems were hence in working condition at the time of my inspection.

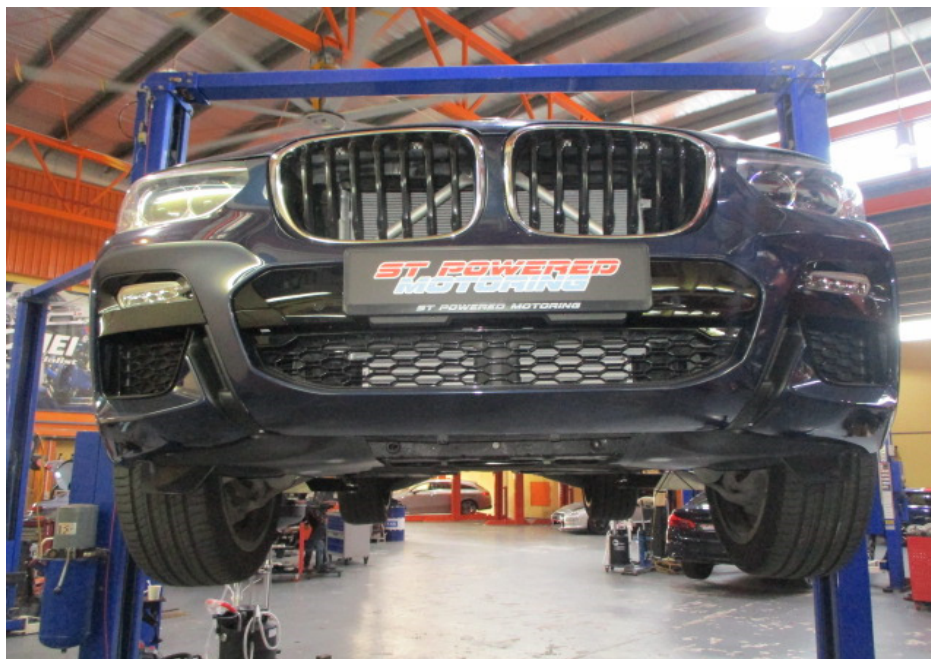
**Photo 19** shows the Motor Car hoisted up for checks on its undercarriage. There was no sign(s) or indication(s) of fluid leakage and/or fluid stain(s) on the underside of the Motor Car. The undercarriage components of the Motor Car were also all observed to be intact and secured in an appropriate manner.

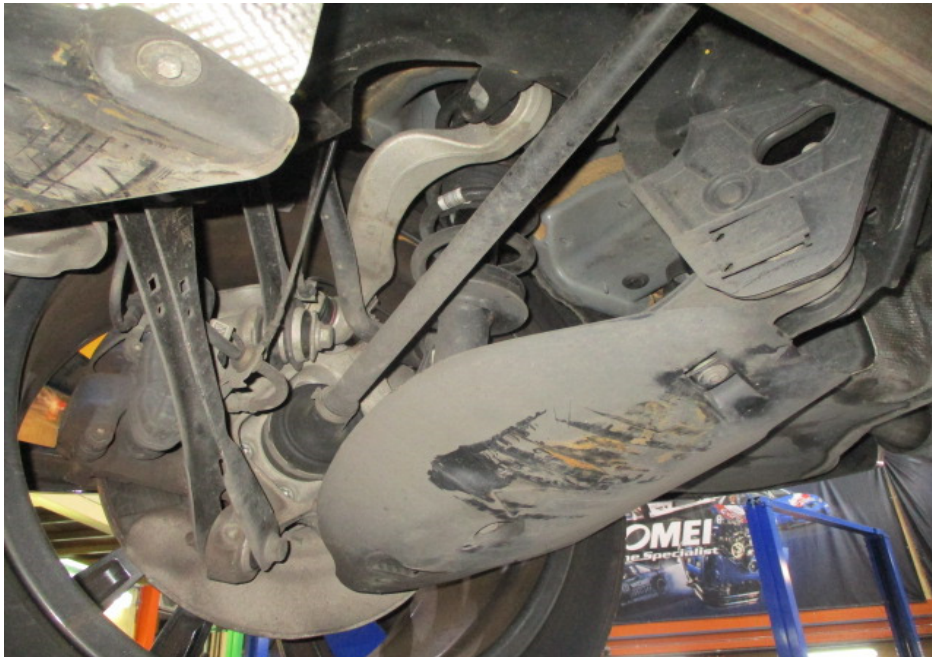
**Photo 20** shows a general view of the control arms and linkages at the rear right wheel of the Motor Car. I did not observe any fluid leak and/or fluid stain on the underside of the Motor Car. All of the Motor Car's undercarriage components were observed to be intact and secured in an appropriate manner.

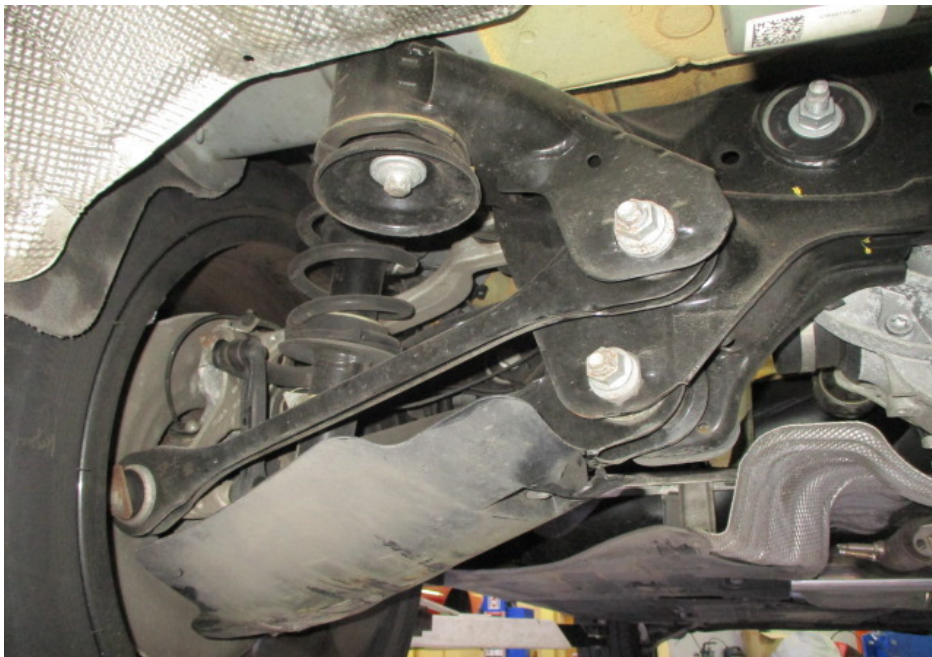
**Photo 21** shows a general view of the control arms and linkages at the rear left wheel of the Motor Car. I did not observe any fluid leak and/or fluid stain on the underside of the Motor Car. All of the Motor Car's undercarriage components were observed to be intact and secured in an appropriate manner.

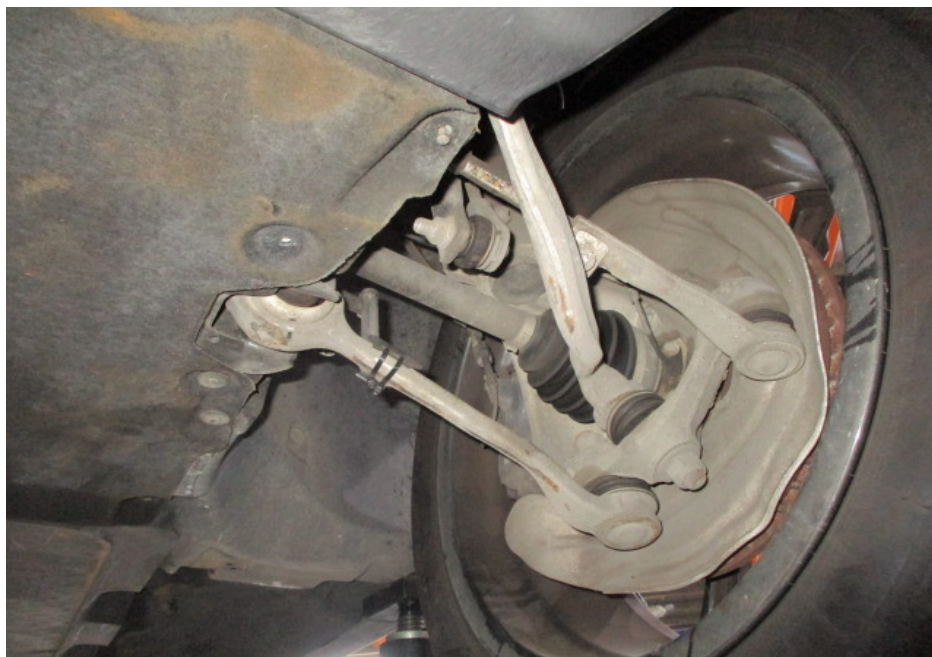
**Photo 22** shows the various undercarriage components at the front left wheel of the Motor Car. The mechanical components, control arms and linkages were all found to be intact and secured in an appropriate manner.

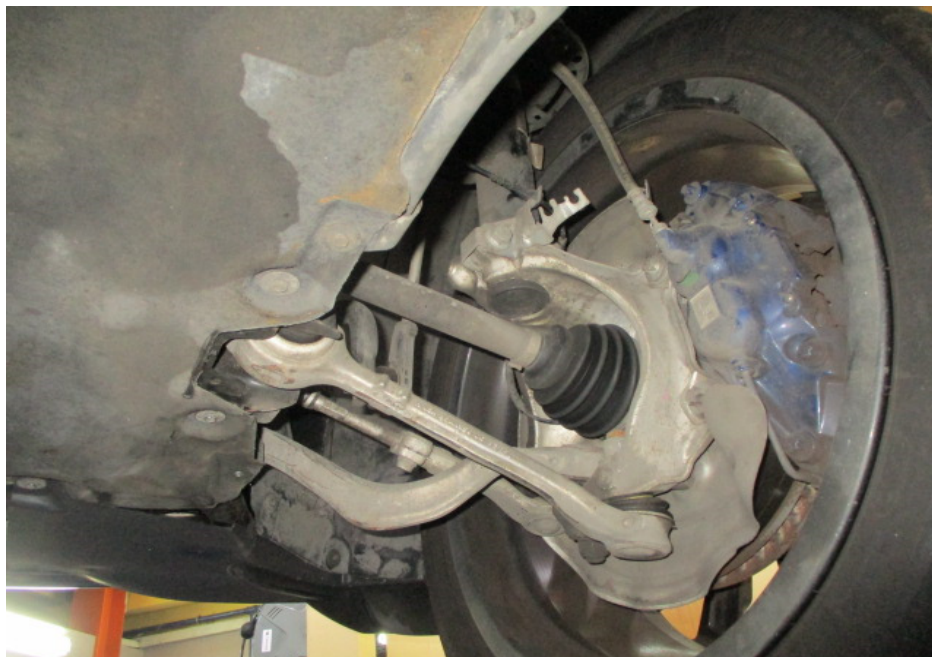
**Photo 23** shows the various undercarriage components at the front right wheel of the Motor Car. The mechanical components, control arms and linkages were all found to be intact and secured in an appropriate manner. I also did not observe any fluid leak and/or fluid stain on the underside of the Motor Car.

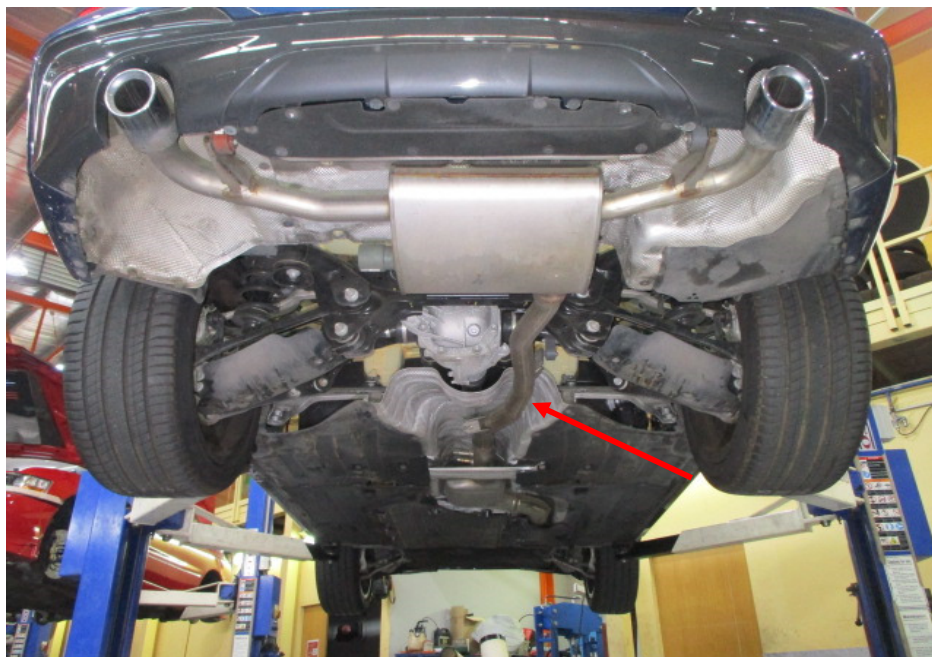
**Photo 24** shows the rear section of the Motor Car's exhaust system. My examination of the Motor Car's exhaust system revealed no sign(s) or indication(s) of any cut or weld marks along its exhaust pipes (arrowed), on its rear muffler, on its centre resonator box and on its catalytic converter.

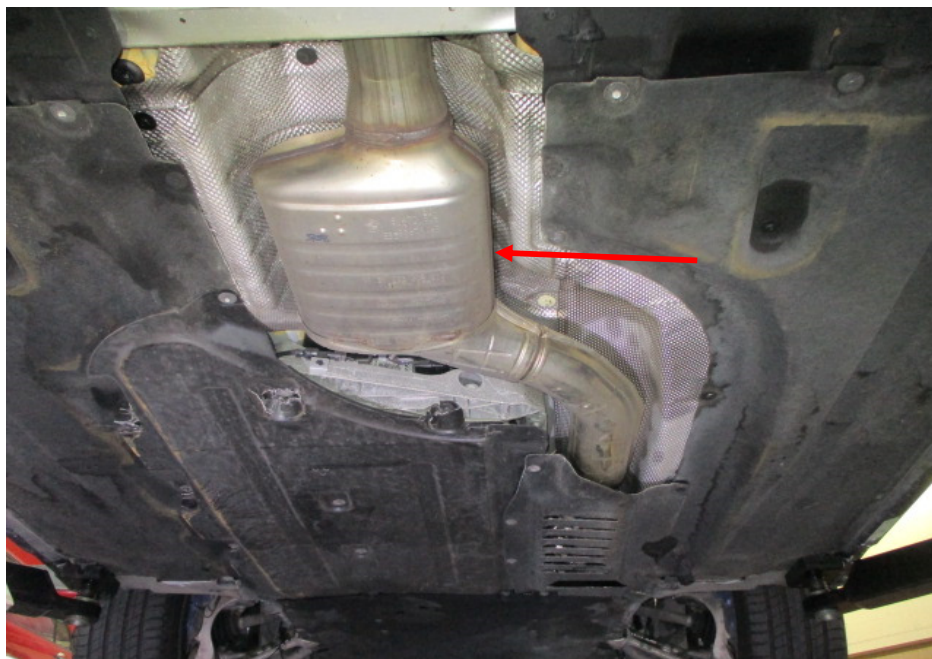
**Photo 25** shows the front section of the Motor Car's exhaust system. My examination of the Motor Car's exhaust system revealed no sign(s) or indication(s) of any cut or weld marks along its exhaust pipes, on its rear muffler, on its centre resonator box (arrowed) and on its catalytic converter.

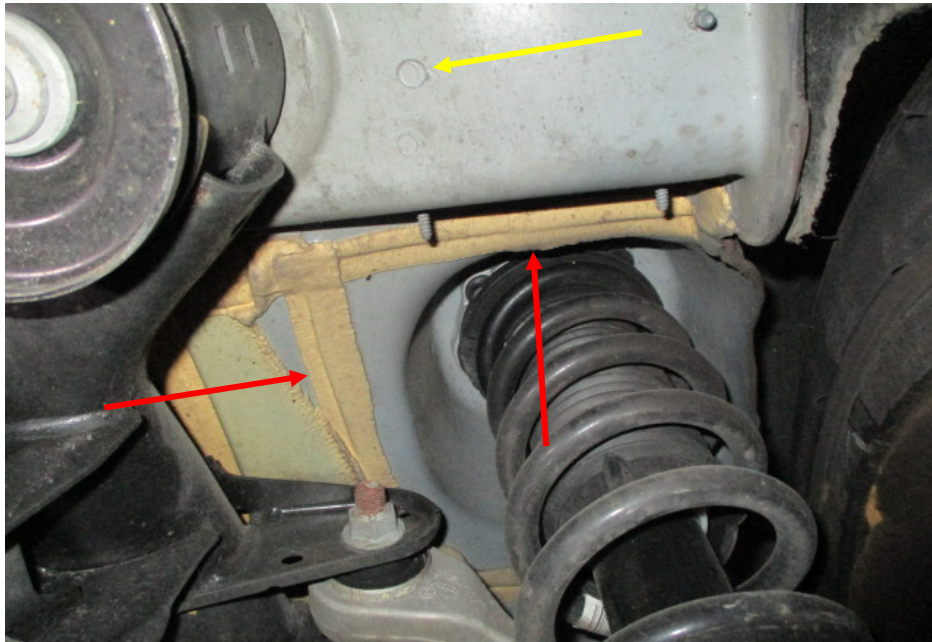
**Photo 26** shows the chassis/structural body at the underside rear right of the Motor Car. I did not find any weld marks other than original spot weld marks (yellow arrow) on the chassis/structural body of the Motor Car. The original factory sealant (red arrow) at the joints along the chassis/structural body was also untouched, indicating no work was done on the chassis/structural body of the Motor Car and that the chassis/structural body was originally fitted.

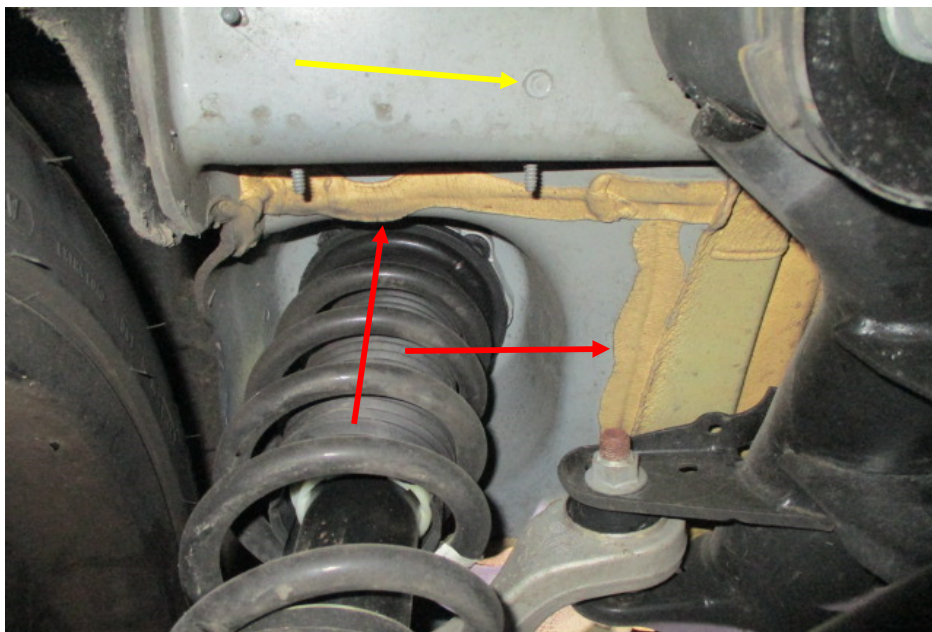
**Photo 27** shows the chassis/structural body at the underside rear left of the Motor Car. I did not find any weld marks other than original spot weld marks (yellow arrow) on the chassis/structural body of the Motor Car. The original factory sealant (red arrow) at the joints along the chassis/structural body was also untouched, indicating no work was done on the chassis/structural body of the Motor Car and that the chassis/structural body was originally fitted.

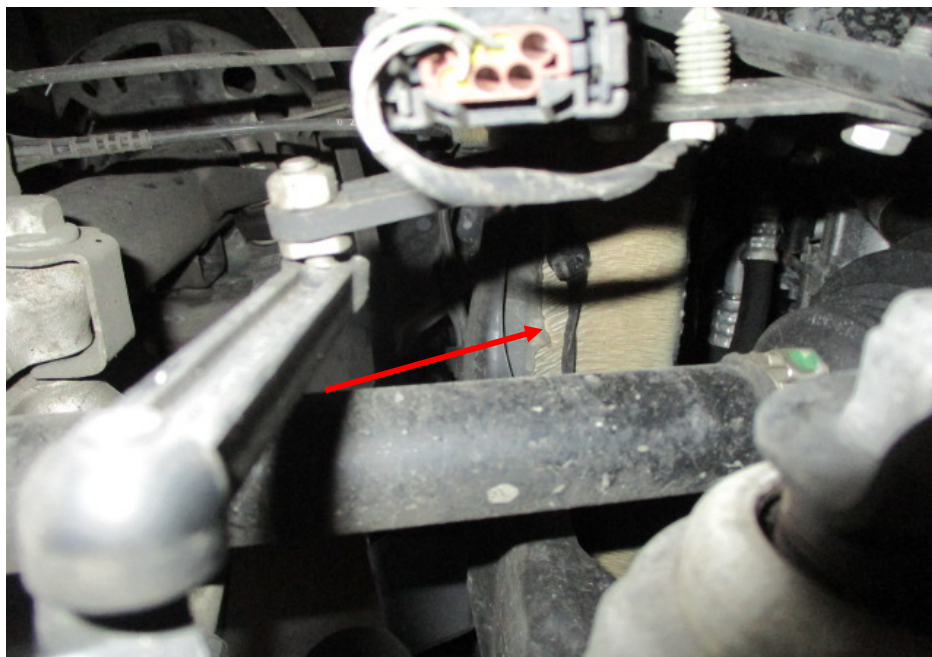
**Photo 28** shows the chassis/structural body at the underside front left of the Motor Car. The original factory sealant (arrowed) at the joints along the chassis/structural body was observed to be untouched. In general, I had found no work was carried out on the chassis/structural body of the Motor Car. The chassis/structural body of the Motor Car was originally fitted.
