Your Ref: BMW X3  
(chassis number WBAUZ36010N007491)  
Our Ref : CI/TP21012039/D

**INSPECTION REPORT OF AN UNREGISTERED BMW X3 MOTOR CAR WITH  
CHASSIS NUMBER WBAUZ36010N007491**

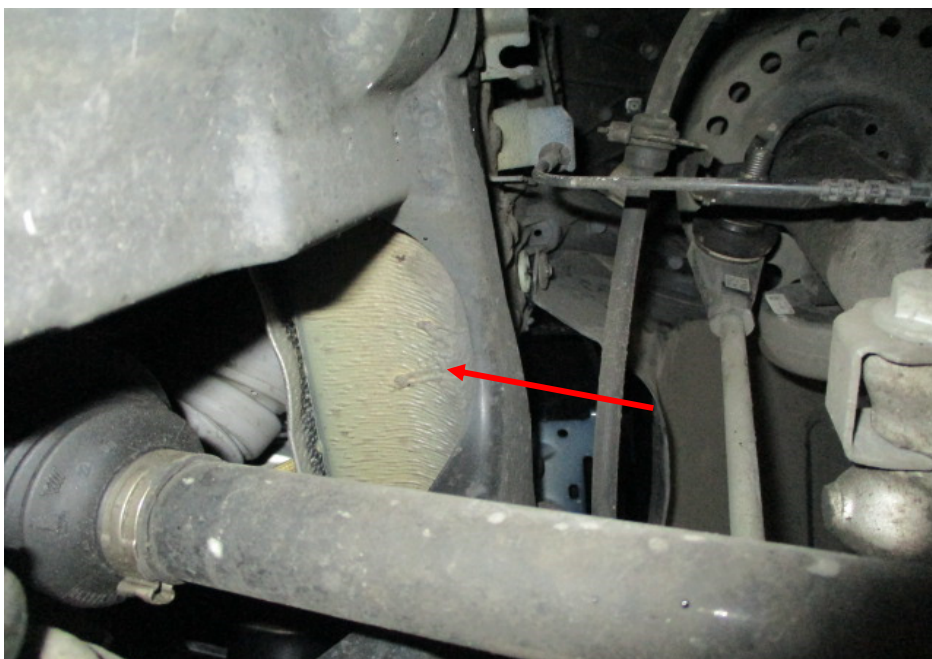
**Photo 29** shows the chassis/structural body at the underside front right of the Motor Car. The original factory sealant (arrowed) at the joints along the chassis/structural body was observed to be untouched. In general, I had found no work was carried out on the chassis/structural body of the Motor Car. The chassis/structural body of the Motor Car was originally fitted.

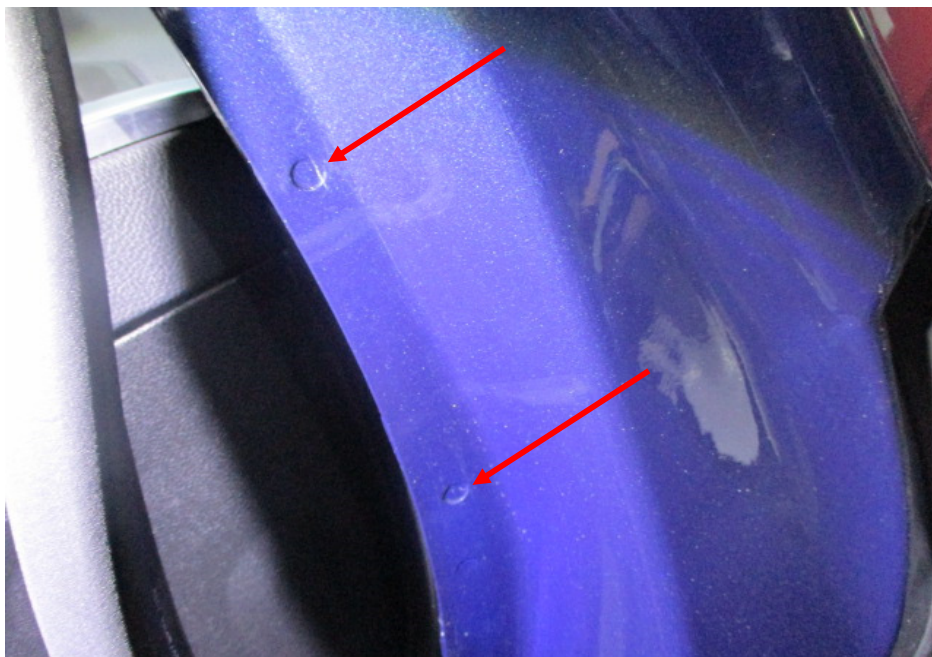
**Photo 30** shows the right side “A” pillar of the Motor Car. I did not find any weld marks other than original spot weld marks (arrowed) on the right side “A” pillar of the Motor Car which, indicates that there was no re-welding works carried out. In general, I had found all the non-detachable body panels of the Motor Car to be originally fitted at the time of my inspection.

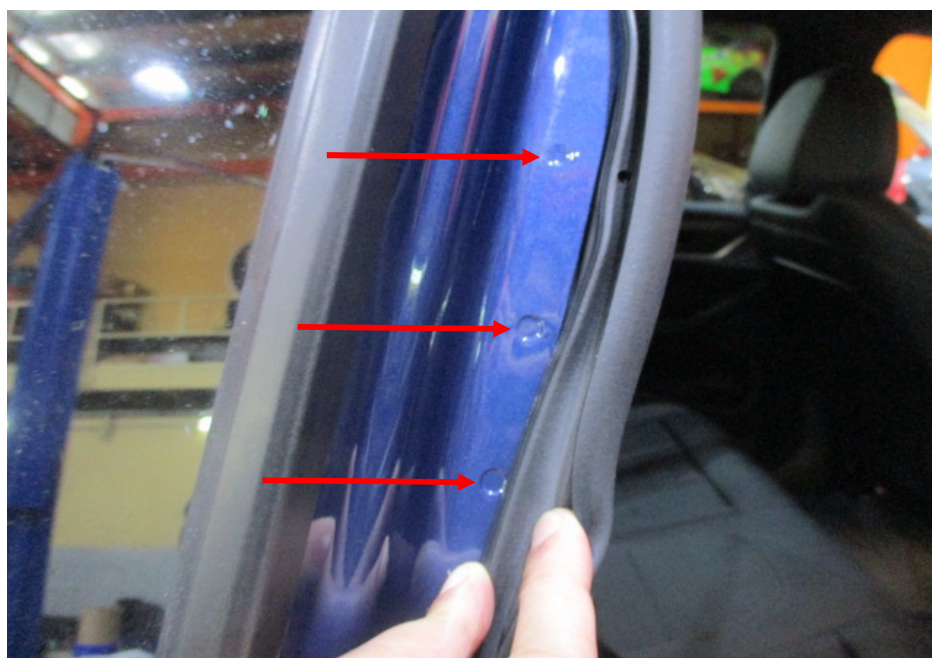
**Photo 31** shows the right side “C” pillar of the Motor Car. I did not find any weld marks other than original spot weld marks (arrowed) on the right side “C” pillar of the Motor Car which, indicates that there was no re-welding works carried out. In general, I had found all the non-detachable body panels of the Motor Car to be originally fitted at the time of my inspection.

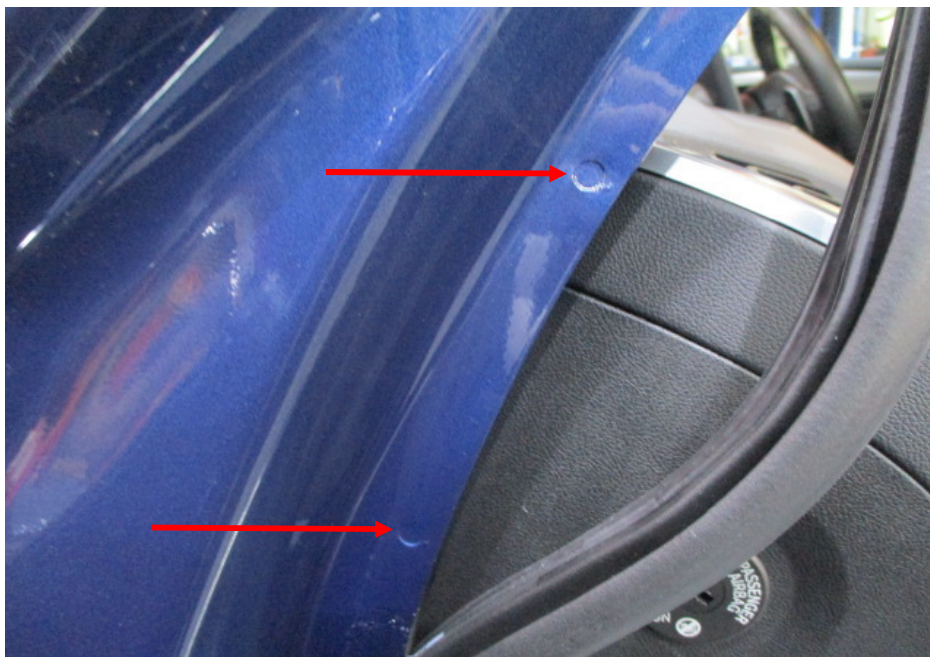
**Photo 32** shows the left side "A" pillar of the Motor Car. I did not find any weld marks other than original spot weld marks (arrowed) on the left side "A" pillar of the Motor Car which, indicates that there was no re-welding works carried out. In general, I had found all the non-detachable body panels of the Motor Car to be originally fitted at the time of my inspection.
