Your Ref: BMW 540i
(chassis number WBAJB52030WW16830)
Our Ref : CI/TP21012040/D

24 November 2021

**INSPECTION REPORT OF AN UNREGISTERED BMW 540i MOTOR CAR
WITH CHASSIS NUMBER WBAJB52030WW16830**

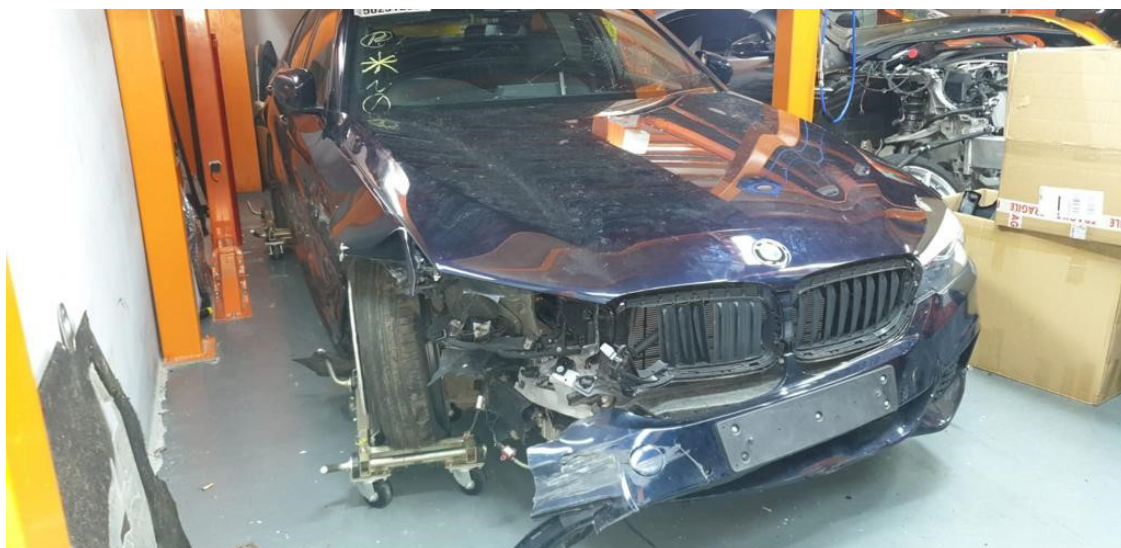
3. The photographs provided to me had showed damage to the Motor Car's front right portion. Body parts damaged include the front bumper, front bumper centre lower grille, front bumper sponge, front bumper reinforcement, front bumper right lower grille, radiator grilles, front bonnet, front bonnet right side lock, front right day light, front right headlamp, front right fender, front right fender inner shield, front support panel, front support panel top centre garnish and front right headlamp top garnish amongst others. The front left passenger airbag and left curtain airbag were deployed.
4. The orientation of the Motor Car's front right wheel indicates damage to its front right undercarriage parts. Undercarriage parts that may possible be damaged include the front right lower arm, front right shock absorber and front right steering tie rod amongst others.

Photo 1 shows the front right body of the Motor Car (photograph provided to me). The Motor Car was observed to have sustained damage at its front right portion. The front bumper, front bumper centre lower grille, front bumper sponge, front bumper reinforcement, front bumper right lower grille, radiator grilles, front bonnet, front right day light, front right headlamp, front right fender and front right fender inner shield were amongst the body parts that were observed to have been damaged. The orientation of the Motor Car's front right wheel indicates damage to its front right undercarriage parts.

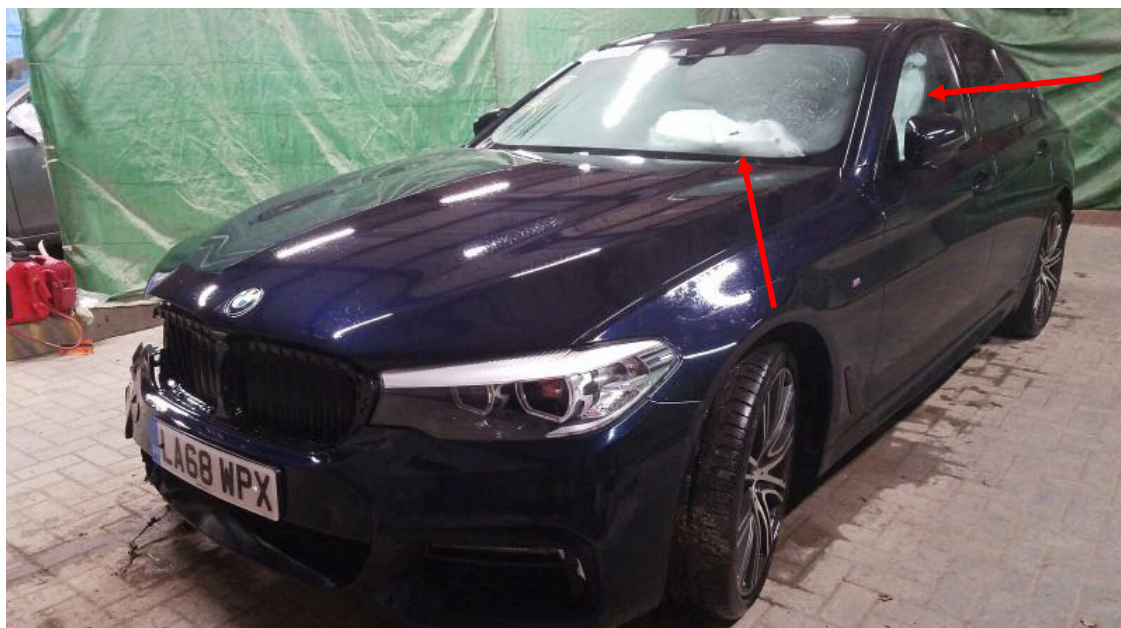
Photo 2 shows the front left body of the Motor Car (photograph provided to me). The front left passenger airbag and left curtain airbag were deployed (arrowed).

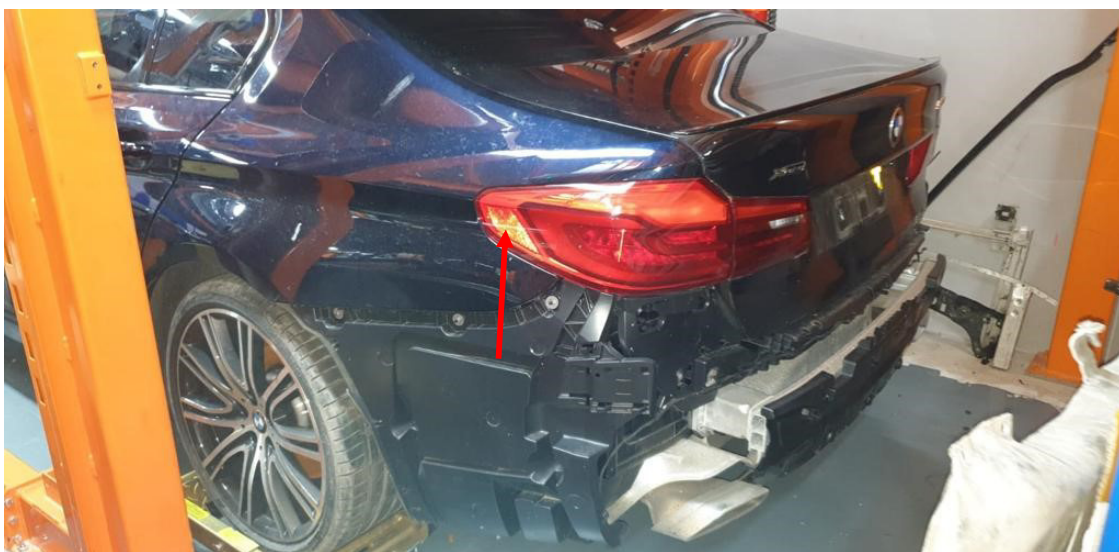
5. The Motor Car's rear bumper and all its related parts and attachments were also observed to be missing/dislodged/damaged. Relatively minor damage to the rear left taillamp and rear left fender were further seen from the photograph that was provided. See photo 1 – 3 below.

Photo 3 shows the rear left body of the Motor Car (photograph provided to me). The Motor Car's rear bumper and all its related parts and attachments were missing/dislodged/damaged. Relatively minor damage was also seen to the rear left taillamp (arrowed) and rear left fender of the Motor Car.

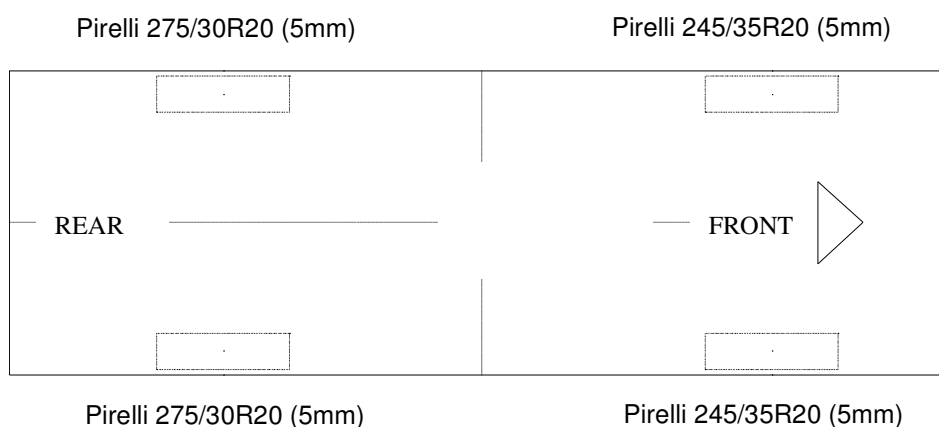
9. It was fitted with 20inch sport wheel rims that were wrapped with tyres that were observed to be of serviceable condition. The tyres were also sufficiently inflated for vehicular operation. The tyre brand, tyre size and approximate remaining tread depth of the 4 tyres of the Motor Car were recorded as follows: -

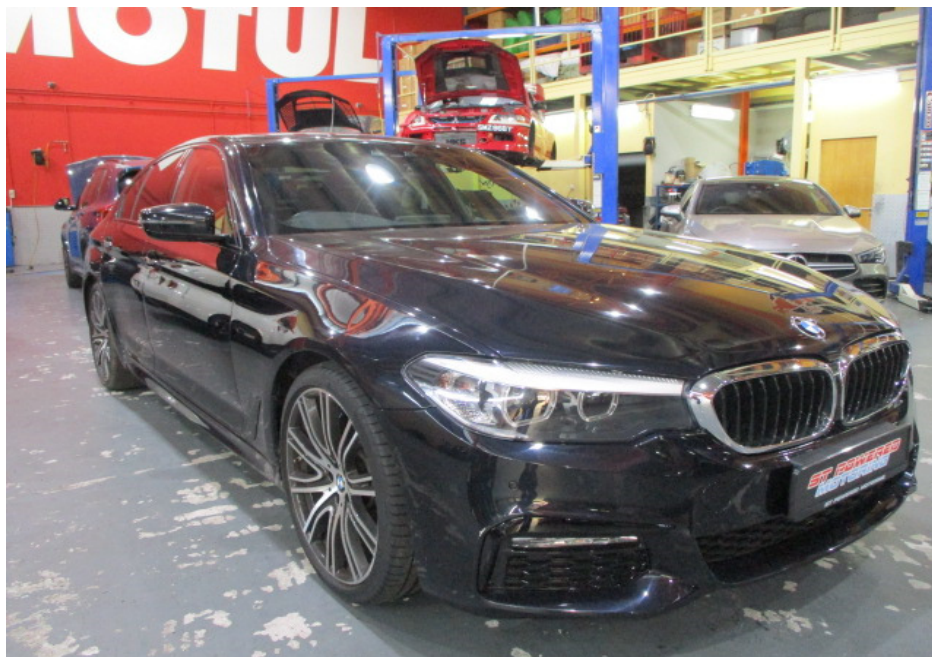
Photo 4 shows a general view of the front right body of the Motor Car at the time of my inspection. The Motor Car was observed to be in a relatively good general condition with no loose exterior fittings observed. The body parts at the front right portion of the Motor Car were visually examined and it was observed that the repair/restoration works carried out to the damaged area of the Motor Car (refer to photograph 1 above) were reasonably adequate and in order.

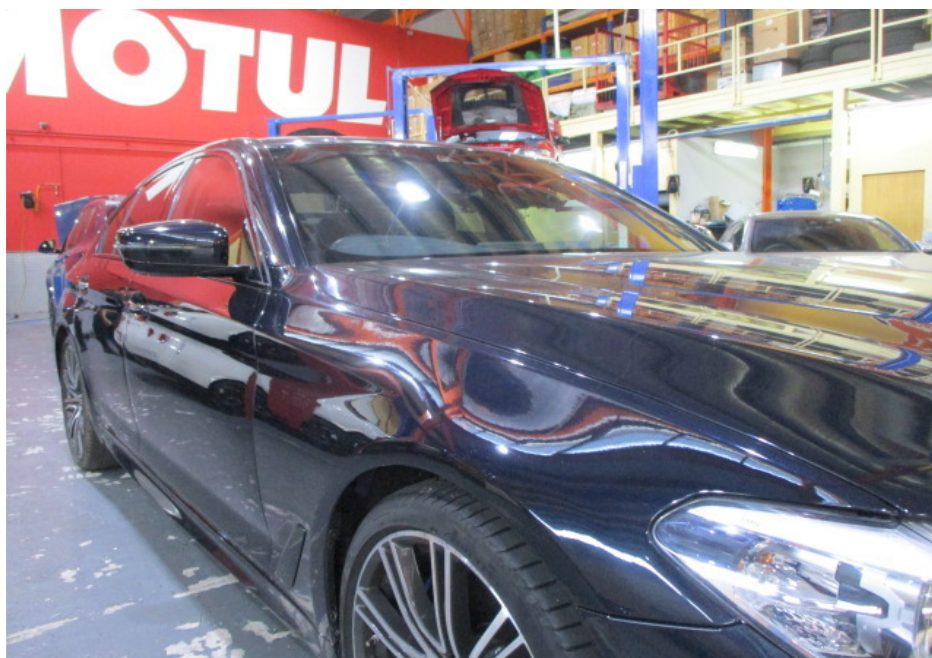
Photo 5 shows a closer view of the Motor Car's front right headlamp, front right fender and front bonnet. The body parts at the front right portion of the Motor Car were visually examined and it was observed that the repair/restoration works carried out to the damaged area of the Motor Car (refer to photograph 1 above) were reasonably adequate and in order.

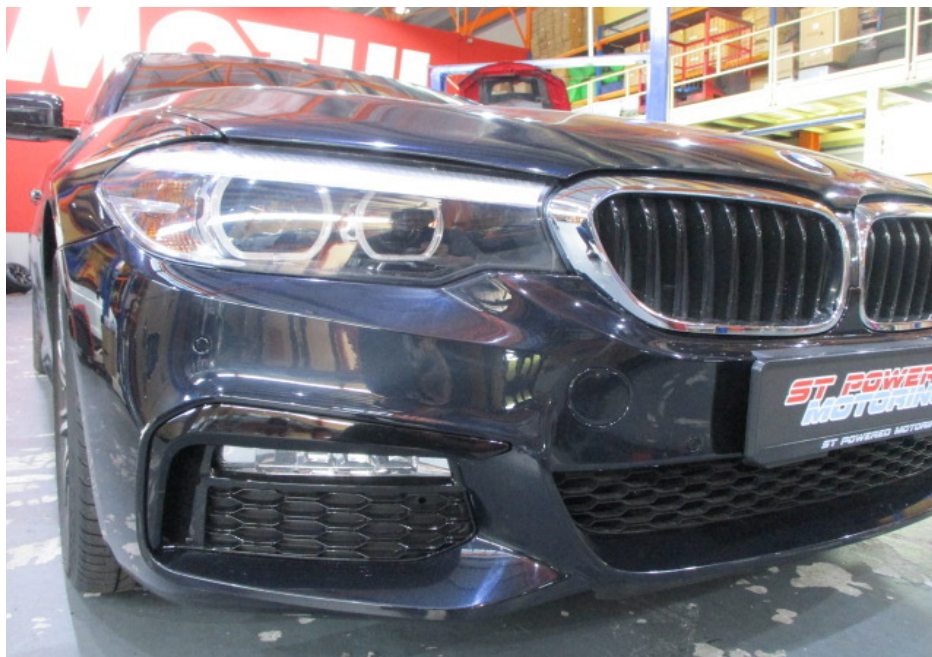
Photo 6 shows a closer view of the Motor Car's front bumper, front bumper right lower grille, front bumper centre lower grille, front bonnet, front right headlamp and front right day light. The body parts at the front right portion of the Motor Car were visually examined and it was observed that the repair/restoration works carried out to the damaged area of the Motor Car (refer to photograph 1 above) were reasonably adequate and in order.

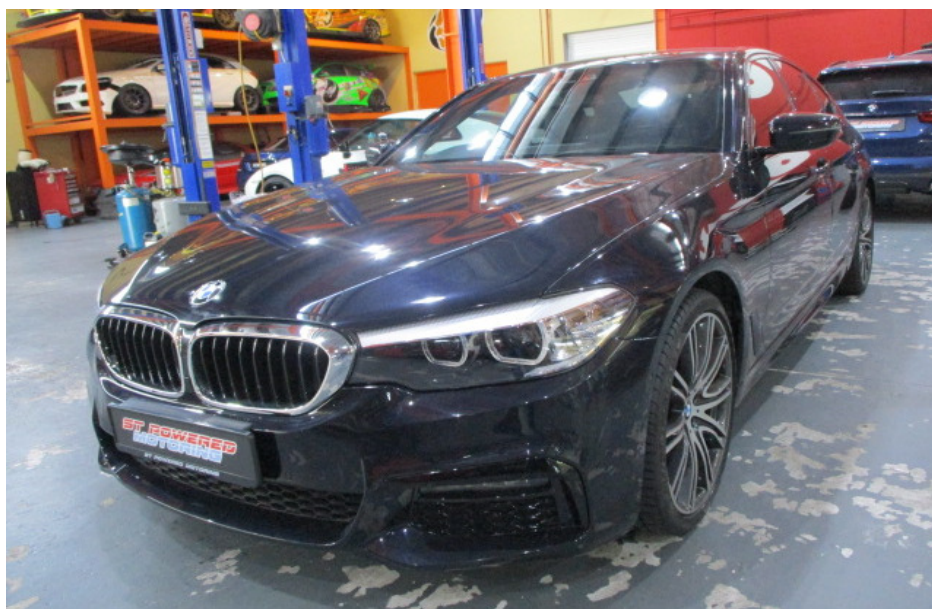
Photo 7 shows a general view of the front left body of the Motor Car at the time of my inspection. The Motor Car was observed to be in a relatively good general condition with no loose exterior fittings observed. The body parts at the front right portion of the Motor Car were visually examined and it was observed that the repair/restoration works carried out to the damaged area of the Motor Car (refer to photograph 1 above) were reasonably adequate and in order.

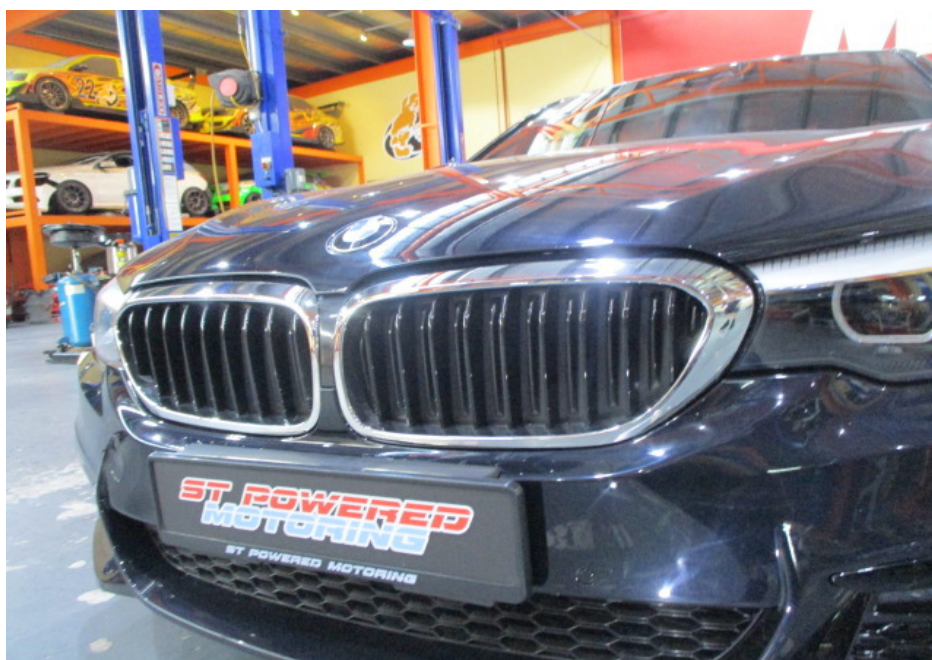
Photo 8 shows a closer view of the Motor Car's front bumper, front bumper centre lower grille, radiator grilles and front bonnet. The body parts at the front right portion of the Motor Car were visually examined and it was observed that the repair/restoration works carried out to the damaged area of the Motor Car (refer to photograph 1 above) were reasonably adequate and in order.

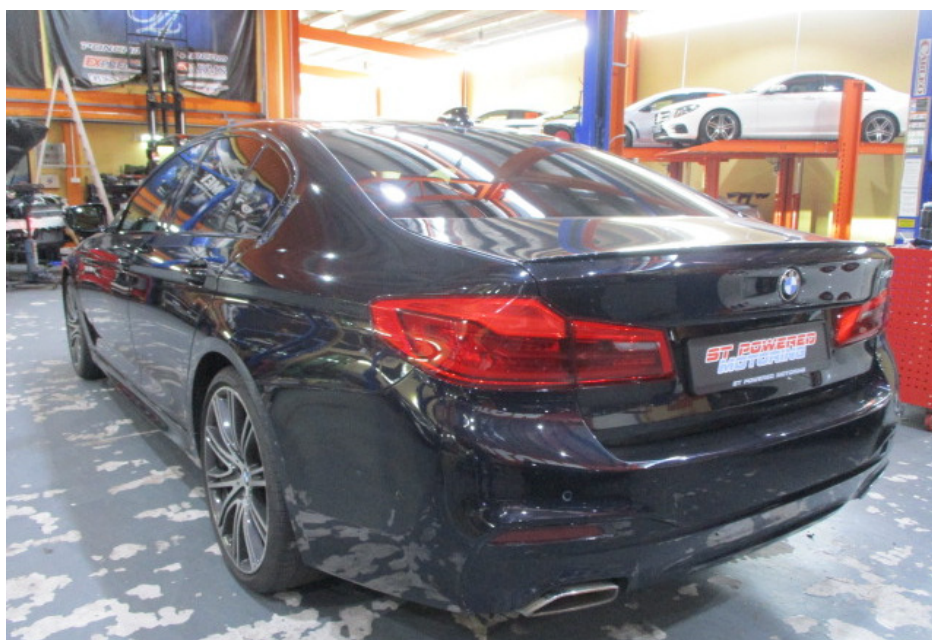
Photo 9 shows a general view of the rear left body of the Motor Car at the time of my inspection. The Motor Car was observed to be in a relatively good general condition with no loose exterior fittings observed. The rear left taillamp, rear left fender, rear bumper and all its related parts and attachments were check and it was observed that the repair/restoration works carried out (refer to photograph 3 above) were reasonably adequate and in order.

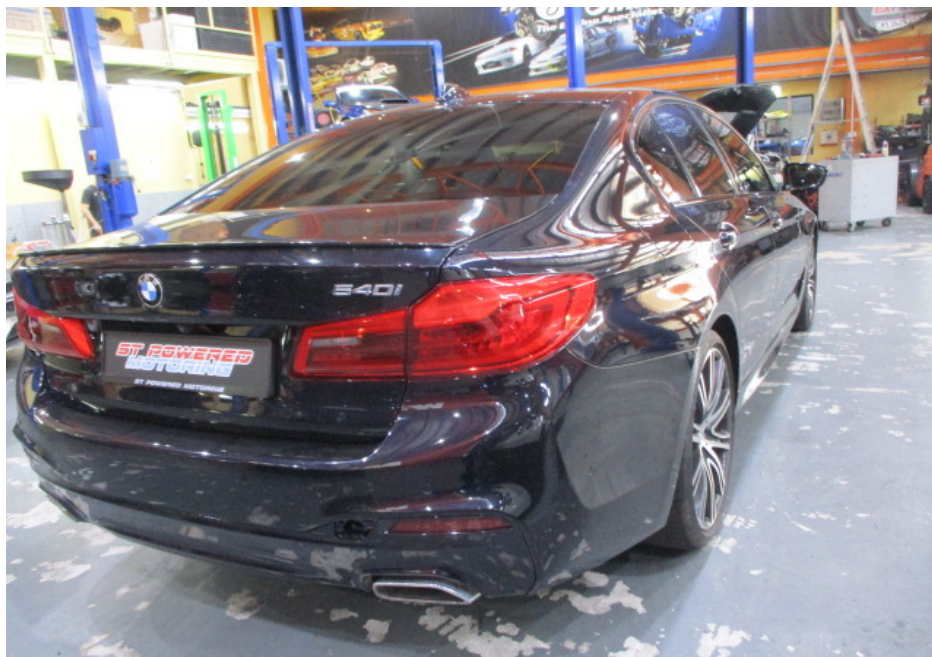
Photo 10 shows a general view of the rear right body of the Motor Car at the time of my inspection. The Motor Car was observed to be in a relatively good general condition with no loose exterior fittings observed. The mileage of the Motor Car recorded at the time of my inspection was 30,442km.

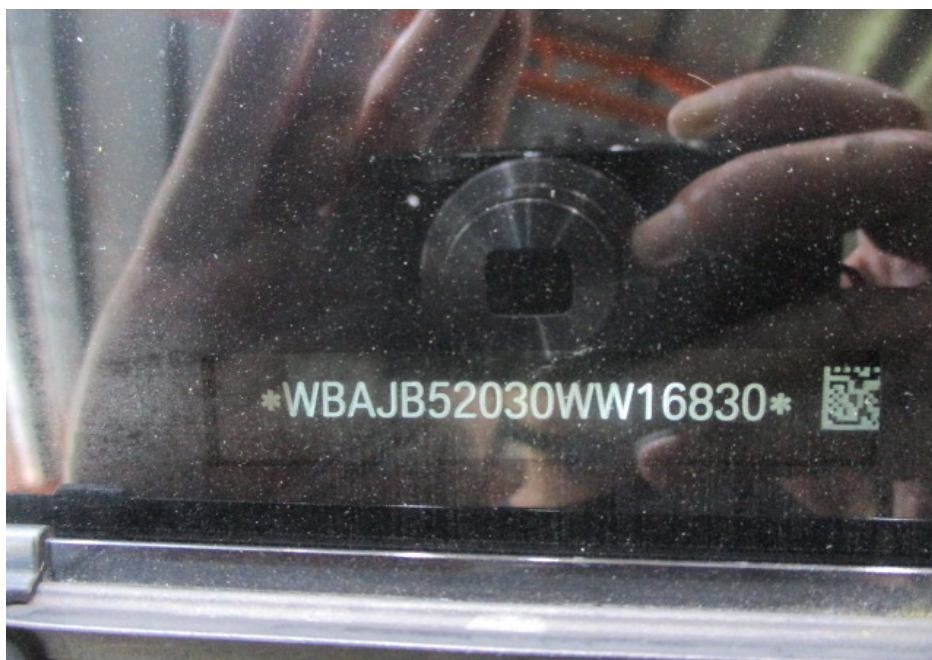
Photo 11 shows the chassis number of the Motor Car. The chassis number recorded was WBAJB52030WW16830.

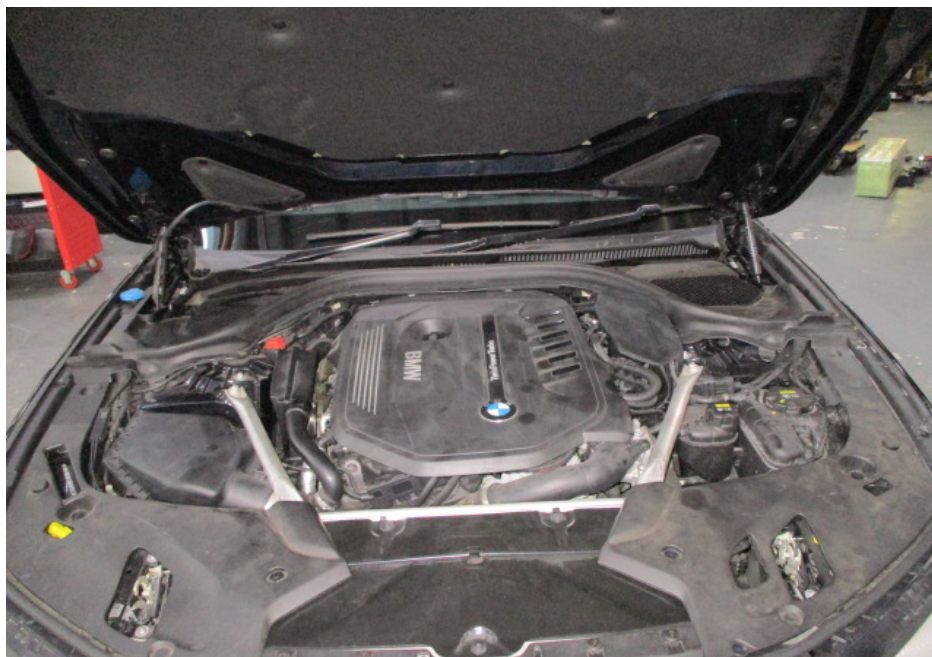
Photo 12 shows a general view of the engine compartment of the Motor Car at the time of my inspection. The various parts and components inside the engine compartment were all observed to be intact and properly fitted. There was also no sign(s) or indication(s) of fluid leak and/or fluid stain found inside the engine compartment. The repair/restoration works carried out to the various parts within the engine compartment like the front bonnet right side lock, front support panel, front support panel top centre garnish and front right headlamp top garnish amongst others, were reasonably adequate and in order.

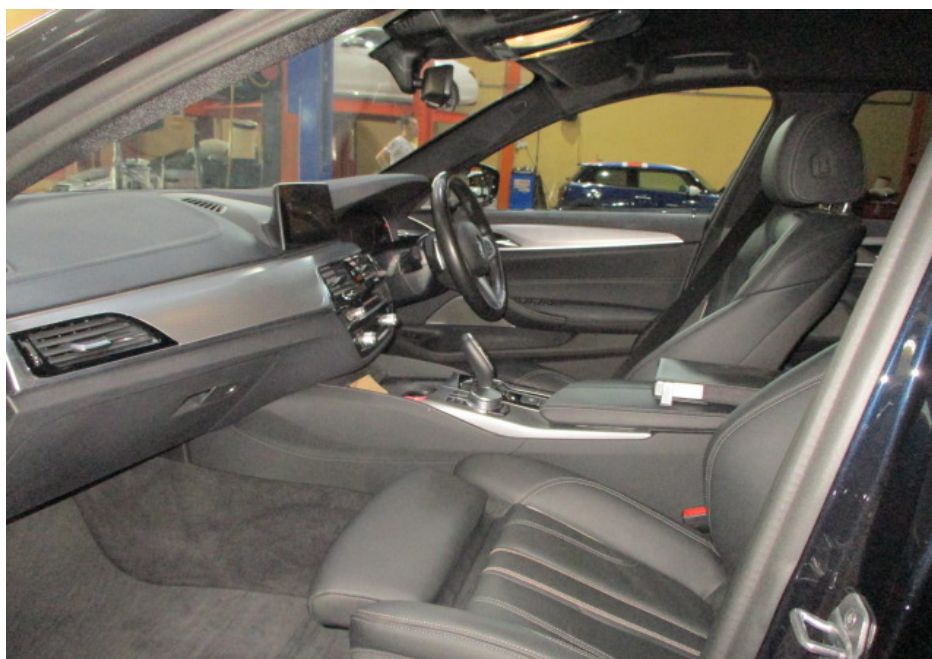
Photo 13 shows the interior compartment of the Motor Car. The front dashboard, steering wheel, seats, upholstery and trims etc were all observed to be intact and properly fitted.

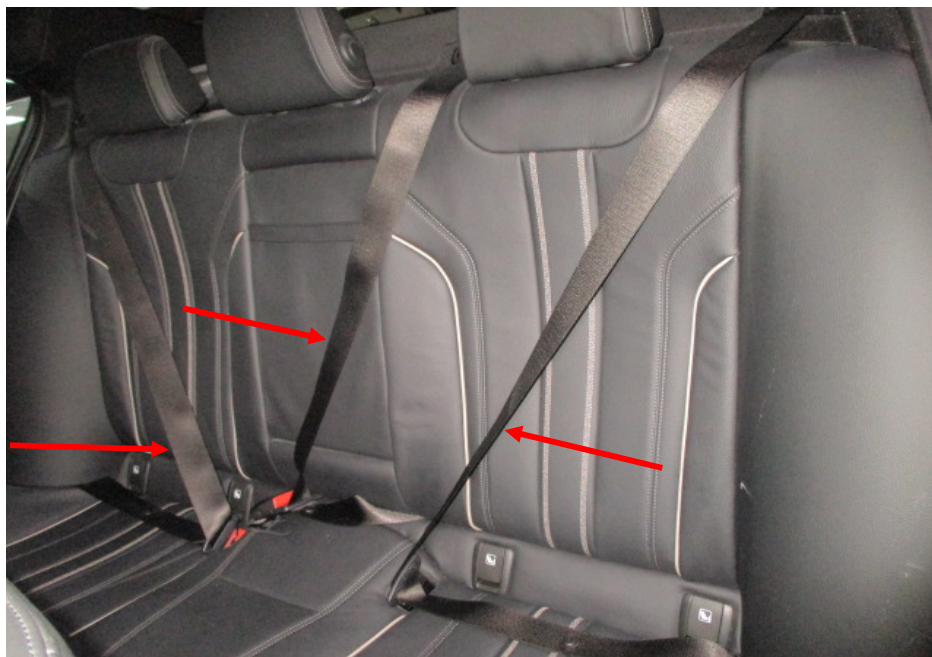
Photo 14 shows the rear seats of the Motor Car. All the seats of the Motor Car were secured via seat rails to the floorboard. They were also fitted with a retractable seat belt reel and a pre-tensioner. The seat belts (arrowed) were tested and were able to be fastened into the respective pre-tensions that were fitted on the side of each individual seat.

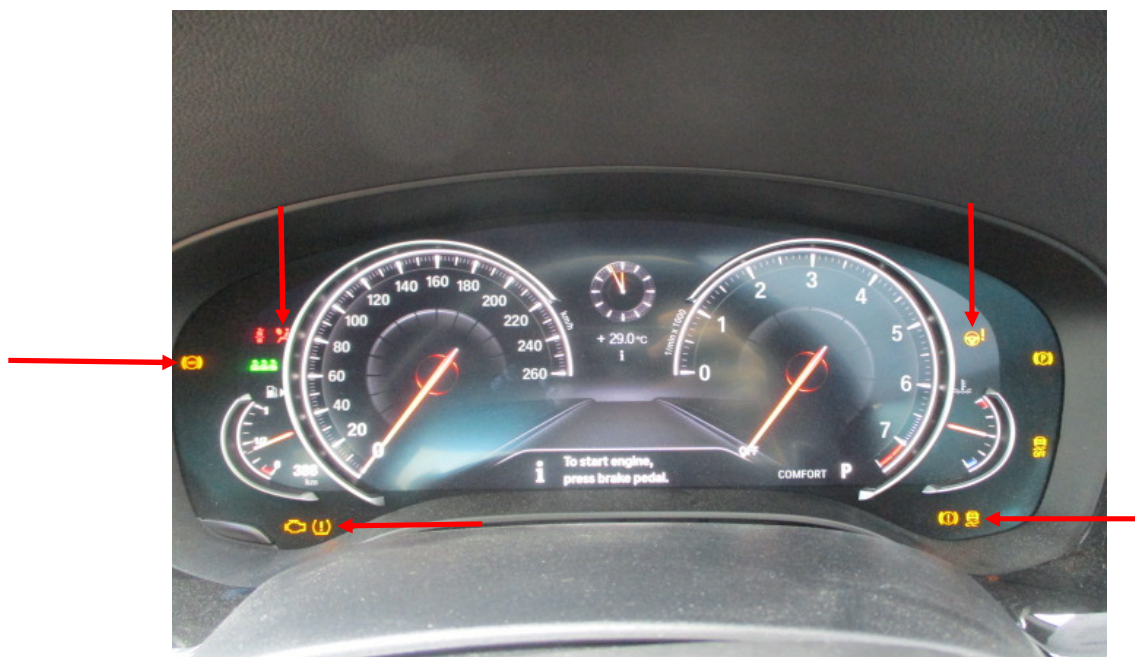
Photo 15 shows the warning lights for the various electronic safety features appearing on the instrument panel of the Motor Car during its self-test when the engine is cranked, in particular the ABS, SRS, IAS, TPM and DSC lights (arrowed).

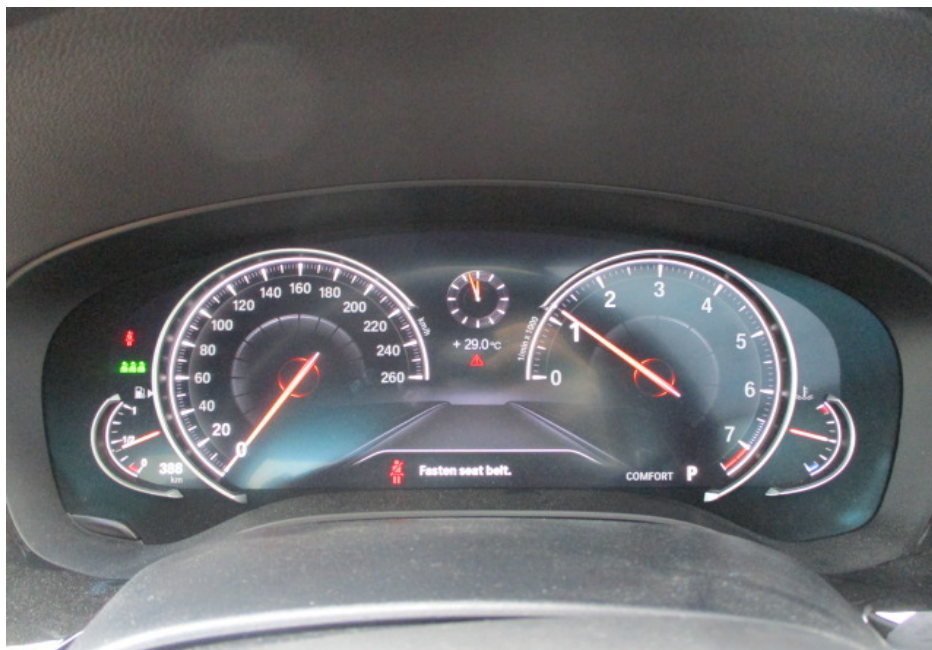
Photo 16 shows the respective warning lights no longer illuminated, indicating that there is no fault detected to the ABS, SRS, IAS, TPM and DSC systems of the Motor Car during the self-test. These electronic systems were hence in working condition at the time of my inspection.

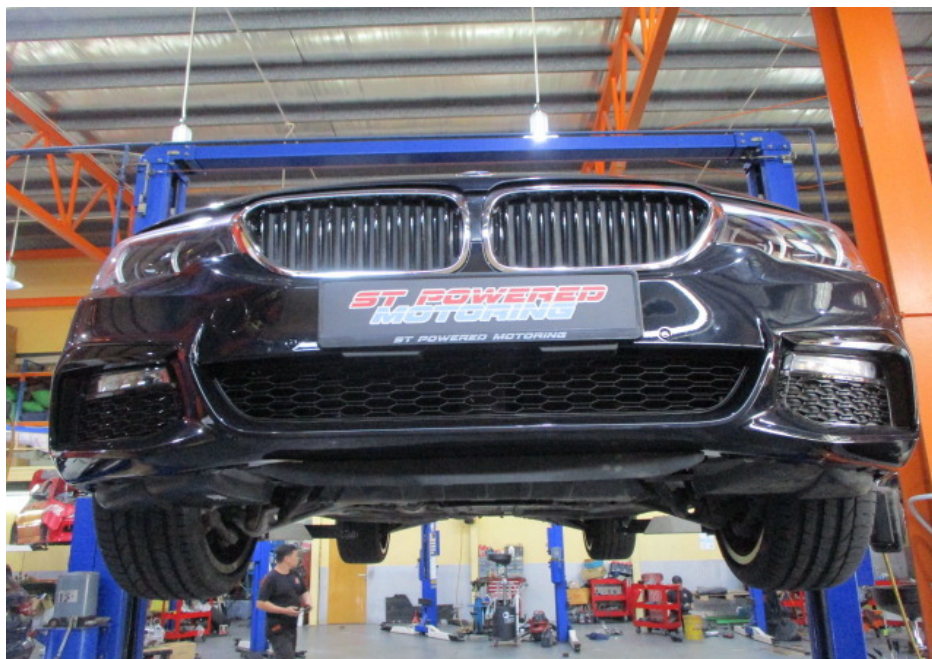
Photo 17 shows the Motor Car hoisted up for checks on its undercarriage. There was no sign(s) or indication(s) of fluid leakage and/or fluid stain(s) on the underside of the Motor Car. The undercarriage components of the Motor Car were also all observed to be intact and secured in an appropriate manner.

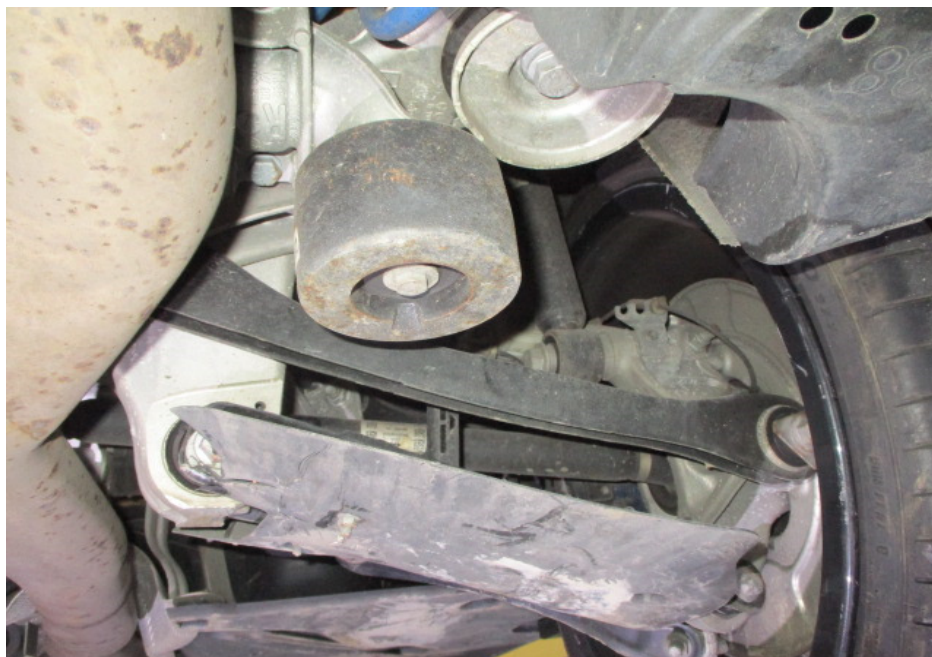
Photo 18 shows a general view of the control arms and linkages at the rear right wheel of the Motor Car. I did not observe any fluid leak and/or fluid stain on the underside of the Motor Car. All of the Motor Car's undercarriage components were observed to be intact and secured in an appropriate manner.

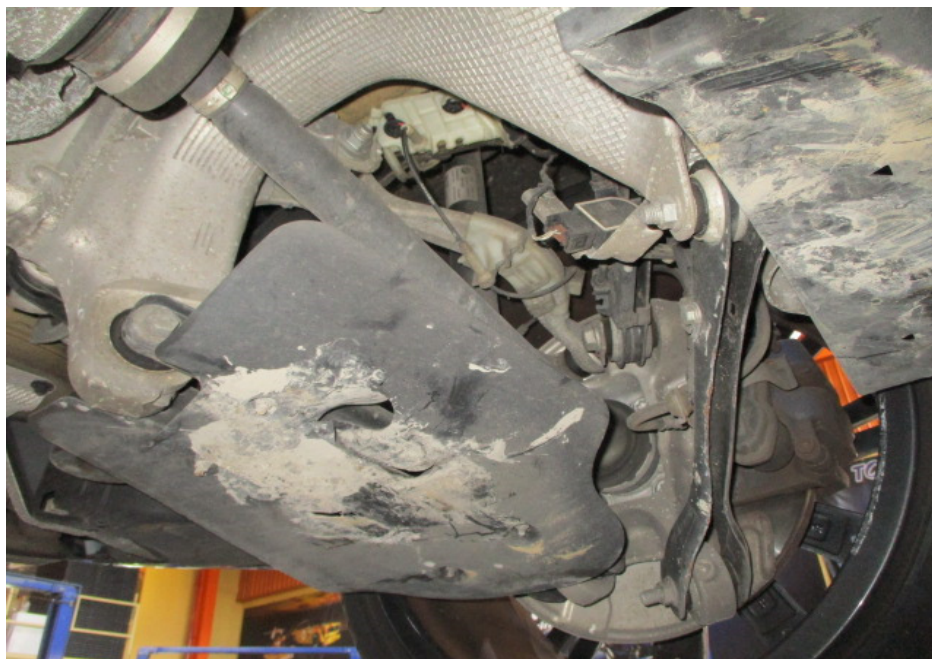
Photo 19 shows a general view of the control arms and linkages at the rear left wheel of the Motor Car. I did not observe any fluid leak and/or fluid stain on the underside of the Motor Car. All of the Motor Car's undercarriage components were observed to be intact and secured in an appropriate manner.

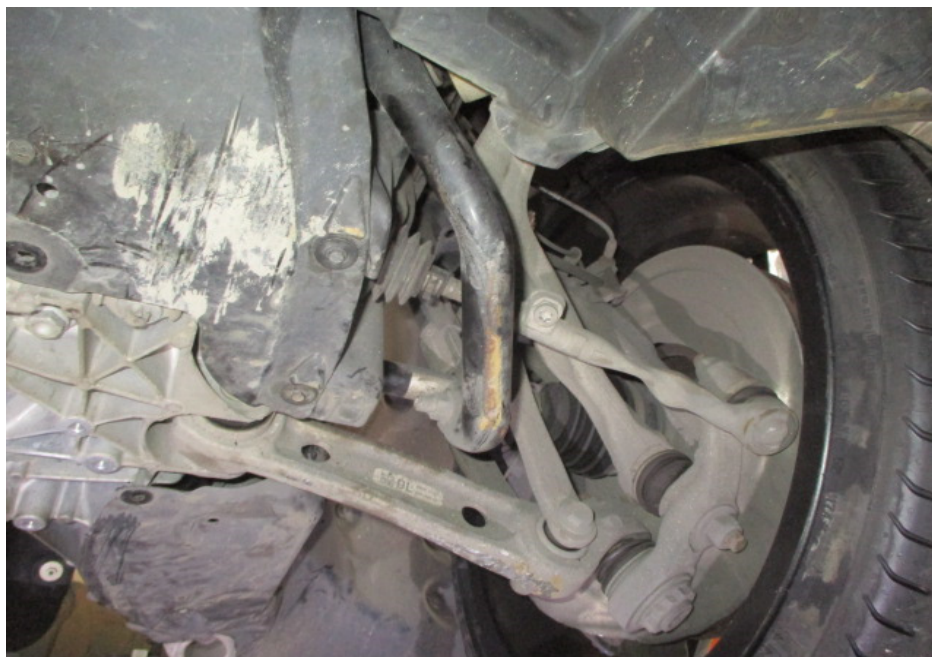
Photo 20 shows the various undercarriage components at the front left wheel of the Motor Car. The mechanical components, control arms and linkages were all found to be intact and secured in an appropriate manner.

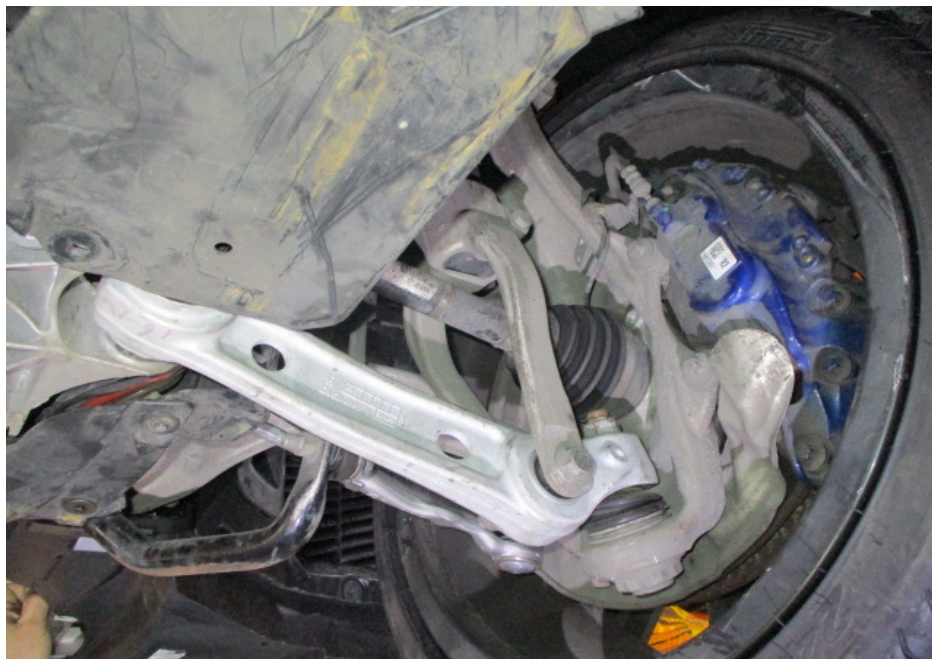
Photo 21 shows the various undercarriage components at the front right wheel of the Motor Car. The mechanical components, control arms and linkages were all found to be intact and secured in an appropriate manner. I also did not observe any fluid leak and/or fluid stain on the underside of the Motor Car.

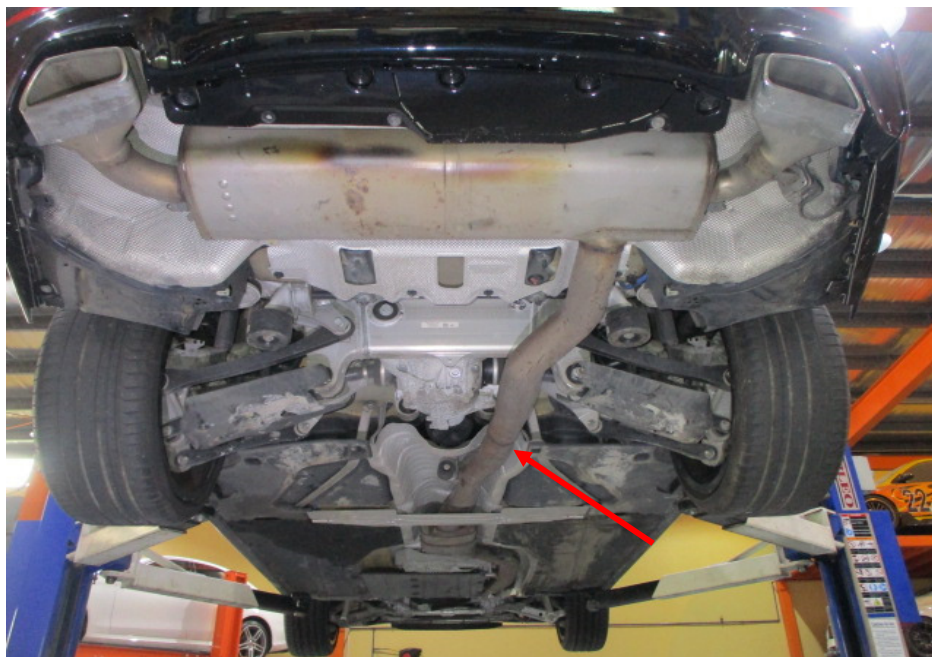
Photo 22 shows the rear section of the Motor Car's exhaust system. My examination of the Motor Car's exhaust system revealed no sign(s) or indication(s) of any cut or weld marks along its exhaust pipes (arrowed), on its rear muffler, on its centre resonator box and on its catalytic converter.

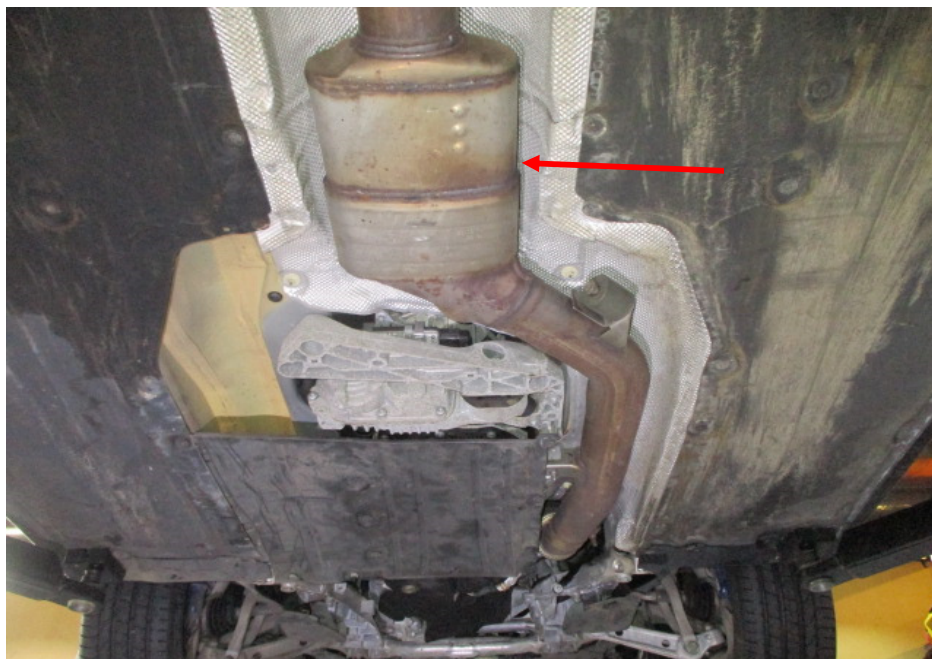
Photo 23 shows the front section of the Motor Car's exhaust system. My examination of the Motor Car's exhaust system revealed no sign(s) or indication(s) of any cut or weld marks along its exhaust pipes, on its rear muffler, on its centre resonator box (arrowed) and on its catalytic converter.

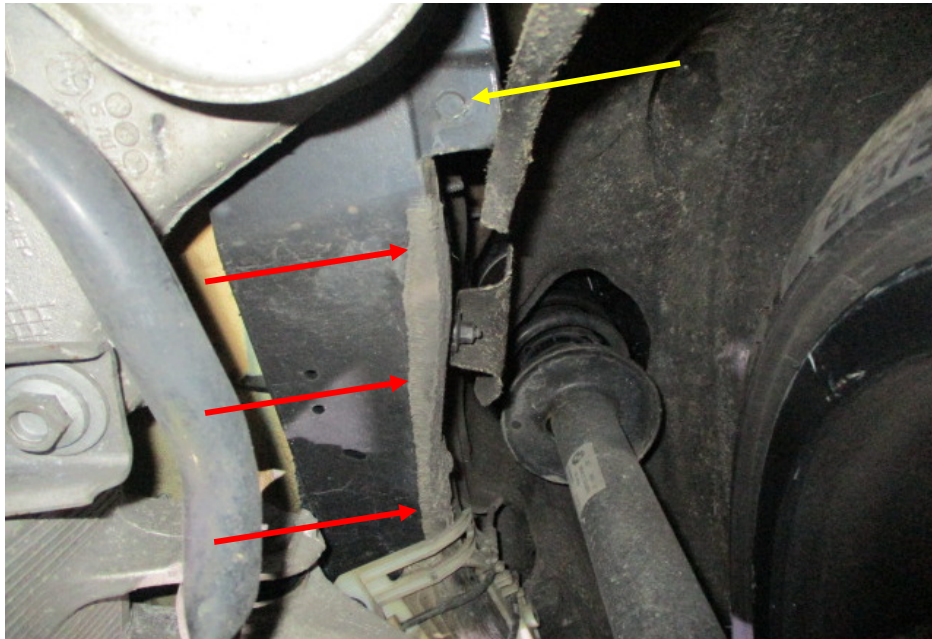
Photo 24 shows the chassis/structural body at the underside rear right of the Motor Car. I did not find any weld marks other than original spot weld marks (yellow arrow) on the chassis/structural body of the Motor Car. The original factory sealant (red arrow) at the joints along the chassis/structural body was also untouched, indicating no work was done on the chassis/structural body of the Motor Car and that the chassis/structural body was originally fitted.

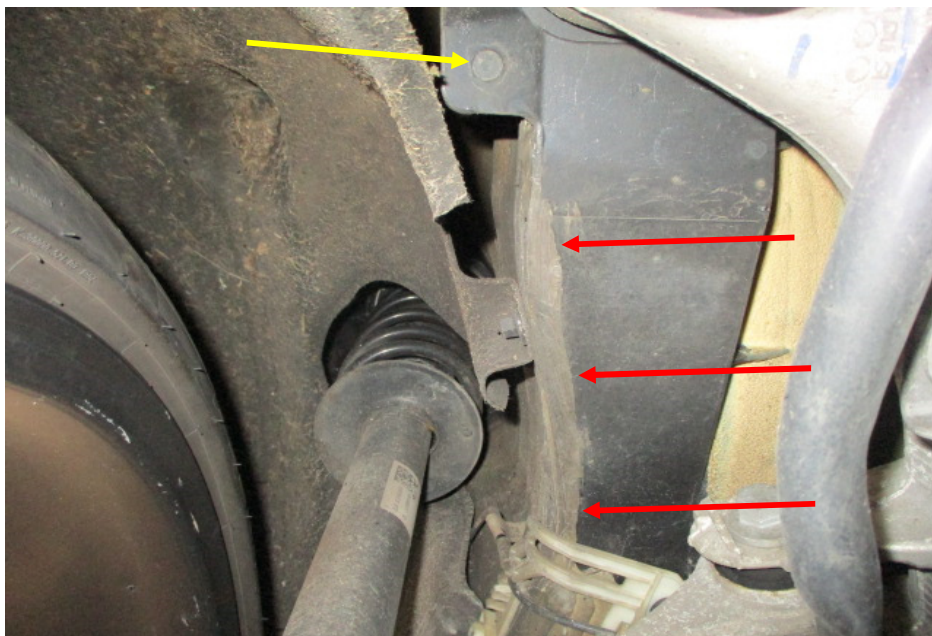
Photo 25 shows the chassis/structural body at the underside rear left of the Motor Car. I did not find any weld marks other than original spot weld marks (yellow arrow) on the chassis/structural body of the Motor Car. The original factory sealant (red arrow) at the joints along the chassis/structural body was also untouched, indicating no work was done on the chassis/structural body of the Motor Car and that the chassis/structural body was originally fitted.

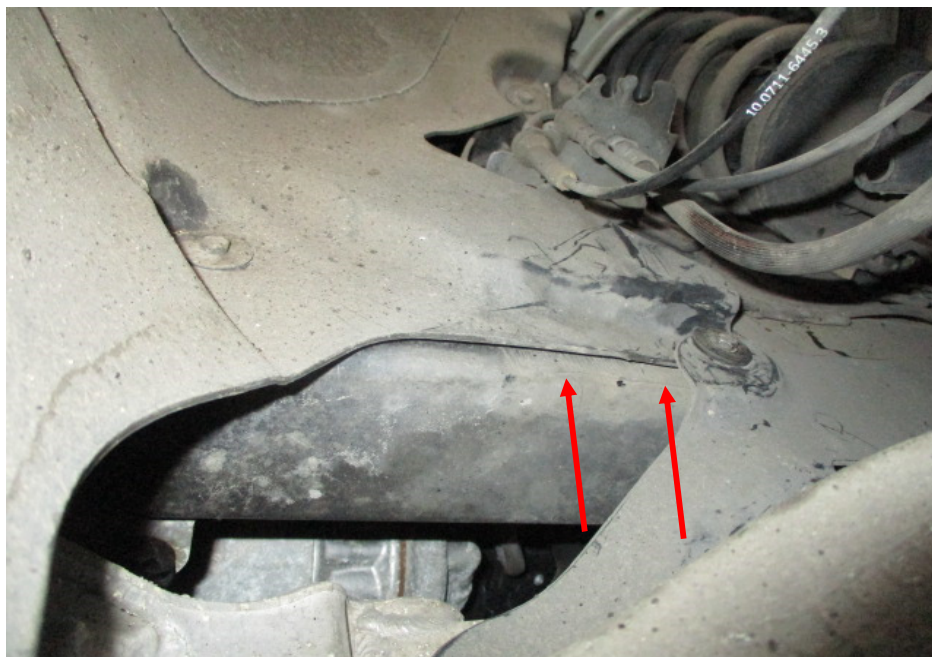
Photo 26 shows the chassis/structural body at the underside front left of the Motor Car. The original factory sealant (arrowed) at the joints along the chassis/structural body was observed to be untouched. In general, I had found no work was carried out on the chassis/structural body of the Motor Car. The chassis/structural body of the Motor Car was originally fitted.

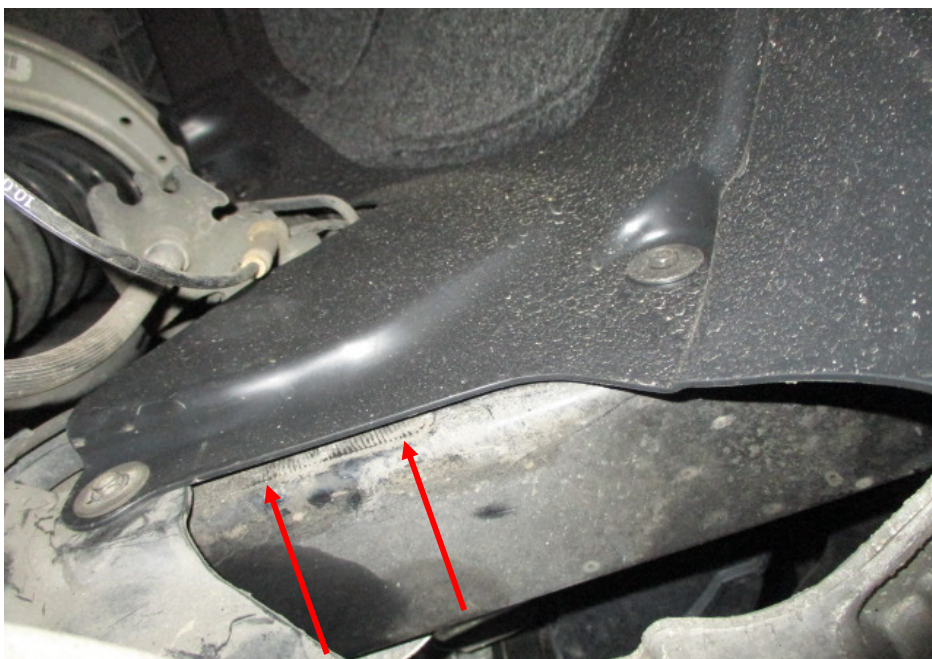
Photo 27 shows the chassis/structural body at the underside front right of the Motor Car. The original factory sealant (arrowed) at the joints along the chassis/structural body was observed to be untouched. In general, I had found no work was carried out on the chassis/structural body of the Motor Car. The chassis/structural body of the Motor Car was originally fitted.

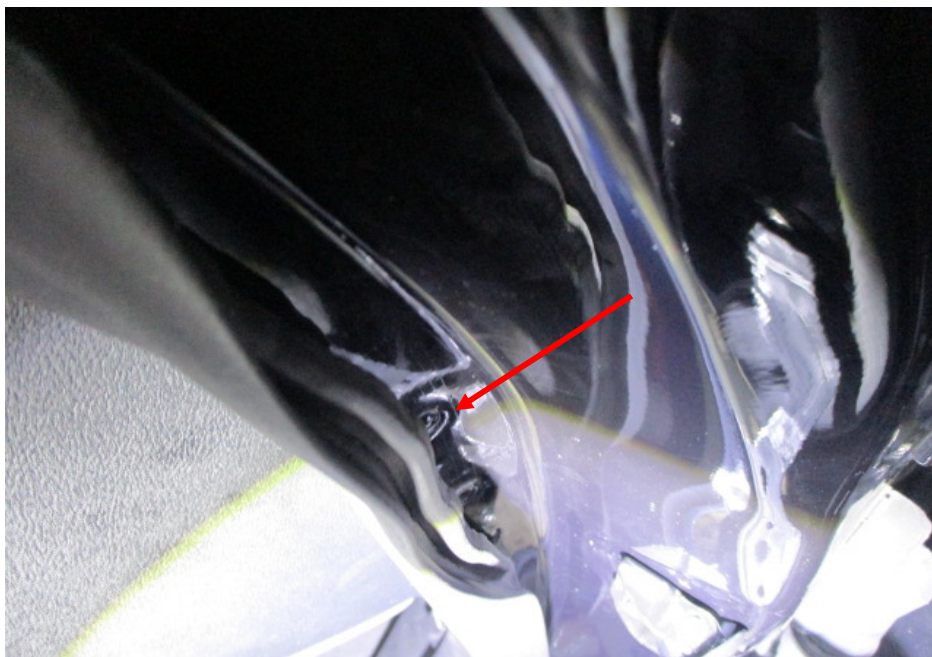
Photo 28 shows the right side "A" pillar of the Motor Car. I did not find any weld marks other than original spot weld marks (arrowed) on the right side "A" pillar of the Motor Car which, indicates that there was no re-welding works carried out. In general, I had found all the non-detachable body panels of the Motor Car to be originally fitted at the time of my inspection.

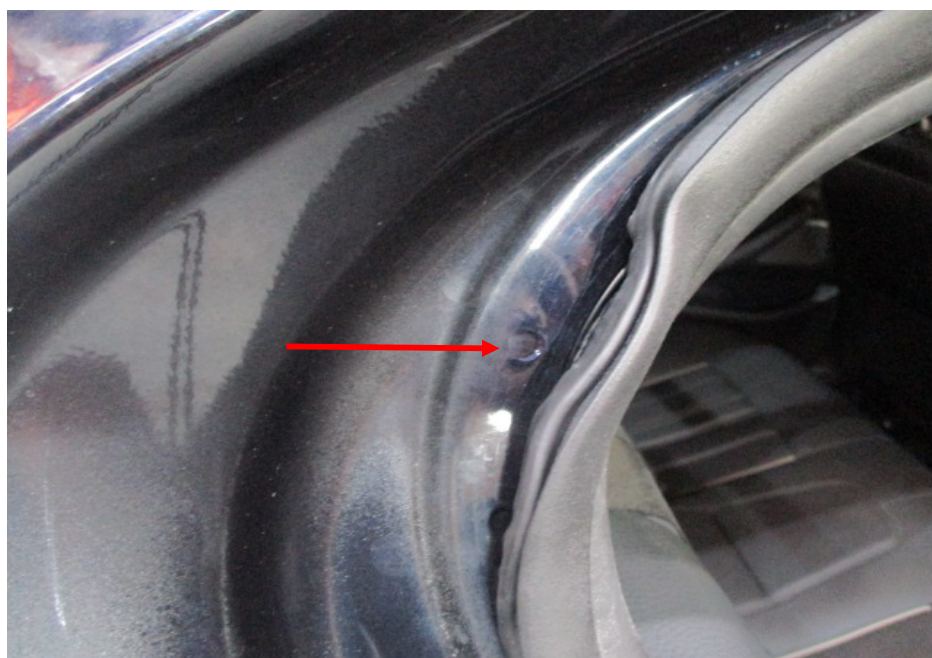
Photo 29 shows the right side "C" pillar of the Motor Car. I did not find any weld marks other than original spot weld marks (arrowed) on the right side "C" pillar of the Motor Car which, indicates that there was no re-welding works carried out. In general, I had found all the non-detachable body panels of the Motor Car to be originally fitted at the time of my inspection.

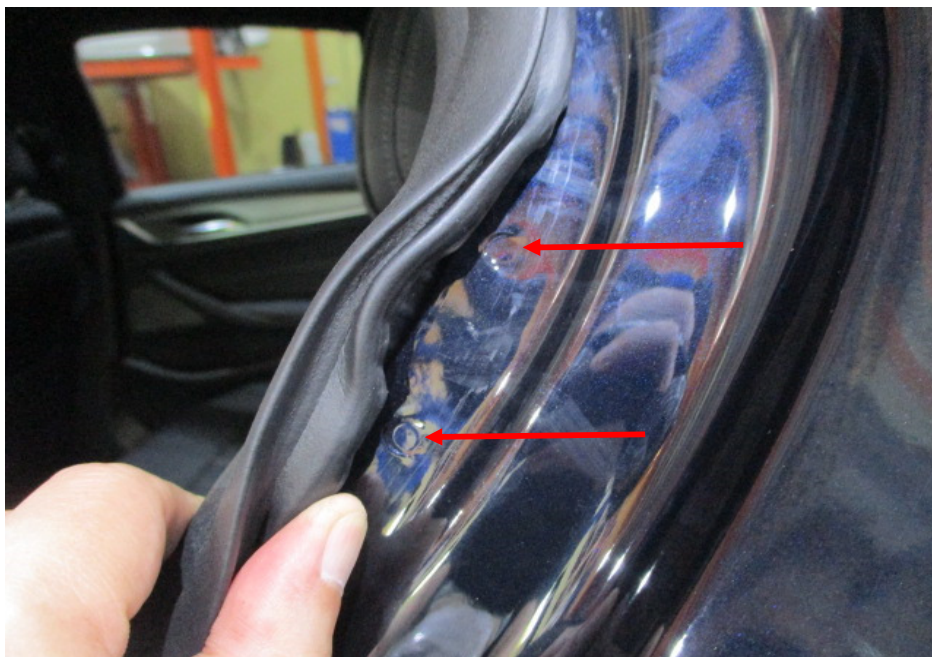
Photo 30 shows the left side "C" pillar of the Motor Car. I did not find any weld marks other than original spot weld marks (arrowed) on the left side "C" pillar of the Motor Car which, indicates that there was no re-welding works carried out. In general, I had found all the non-detachable body panels of the Motor Car to be originally fitted at the time of my inspection.
