Your Ref: Mercedes Benz CLA 35 Wagon  
(chassis number W1K1186512N128479)

26 November 2021

Our Ref : CI/TP21012041/D

**INSPECTION REPORT OF AN UNREGISTERED MERCEDES BENZ CLA 35  
WAGON MOTOR CAR WITH CHASSIS NUMBER W1K1186512N128479**

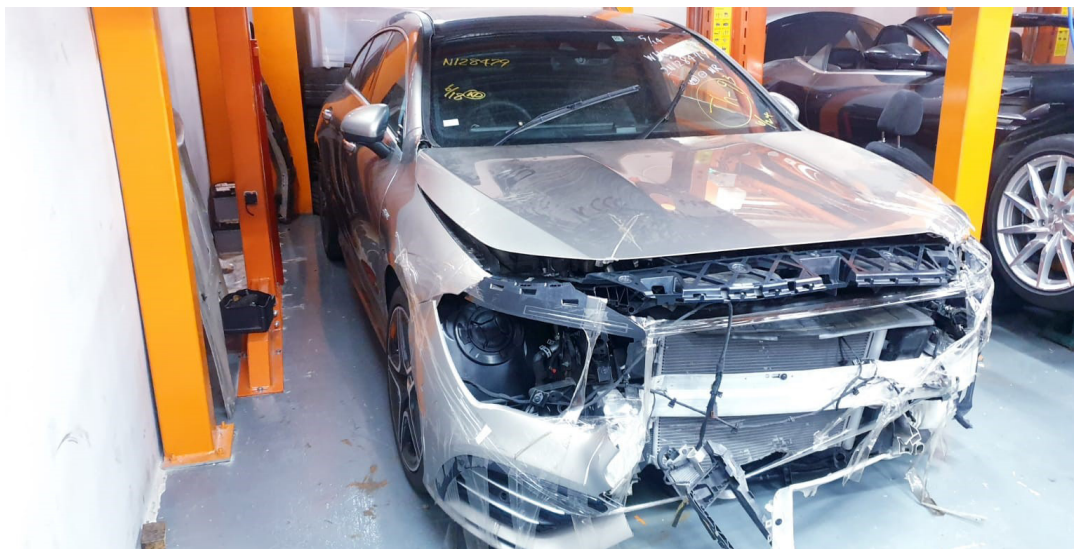
3. The photographs provided to me had showed damage to the Motor Car's frontal portion. Body parts damaged include the front bumper, front bumper lower lip, front bumper centre lower grille, front bumper sponge, front bumper reinforcement, front bumper right lower grille, front bumper left lower grille, front bumper sensors, radiator grille, front emblem, front bonnet, front bonnet lock, front right headlamp, front left headlamp, front right fender, front left fender, front support panel, front right headlamp top panel, front left headlamp top panel, aircon condenser and radiator amongst others.

4. The photographs provided did not clearly show whether any airbag was deployed, however the extent of damage to the frontal portion of the Motor Car would suggest to me that either the driver airbag and/or the front left passenger airbag was possibly deployed.

**Photo 1** shows the front right body of the Motor Car (photograph provided to me). The Motor Car was observed to have sustained damage at its frontal portion. The front bumper, front bumper lower lip, front bumper reinforcement, front bumper centre lower grille, front bumper right lower grille, radiator grille, front emblem, front bonnet, front right headlamp, front right fender, front support panel and front right headlamp top panel were amongst the body parts that were observed to have been damaged. The extent of damage to the frontal portion of the Motor Car would suggest to me that either the driver airbag and/or the front left passenger airbag was possibly deployed.

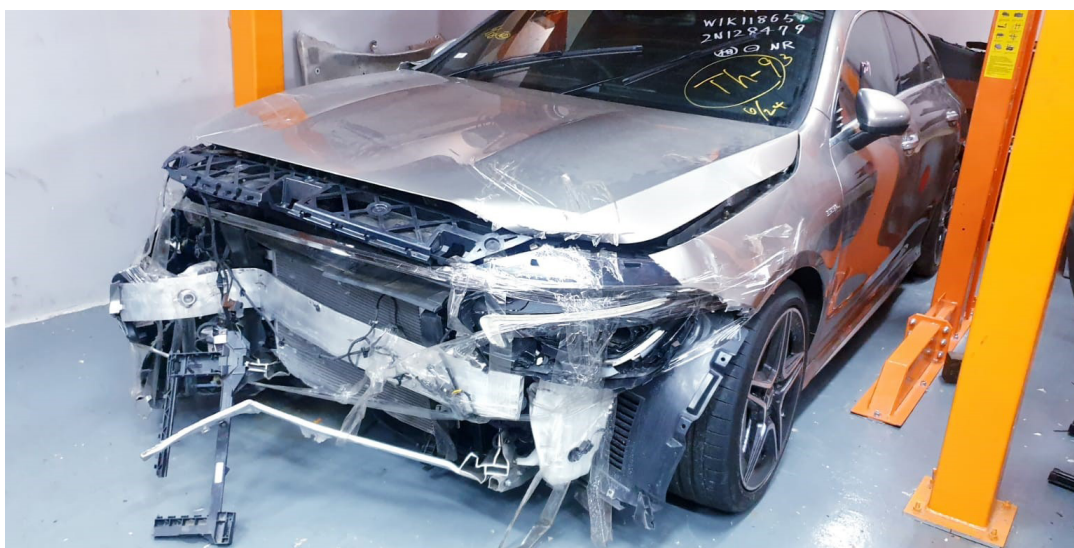
**Photo 2** shows the front left body of the Motor Car (photograph provided to me). The Motor Car was observed to have sustained damage at its frontal portion. The front bumper, front bumper reinforcement, front bumper sponge, front bumper lower reinforcement, front bumper left lower grille, front bonnet, front left headlamp, front left fender, front left fender inner shield, front support panel, aircon condenser and radiator were amongst the body parts that were observed to have been damaged. The extent of damage to the frontal portion of the Motor Car would suggest to me that either the driver airbag and/or the front left passenger airbag was possibly deployed.

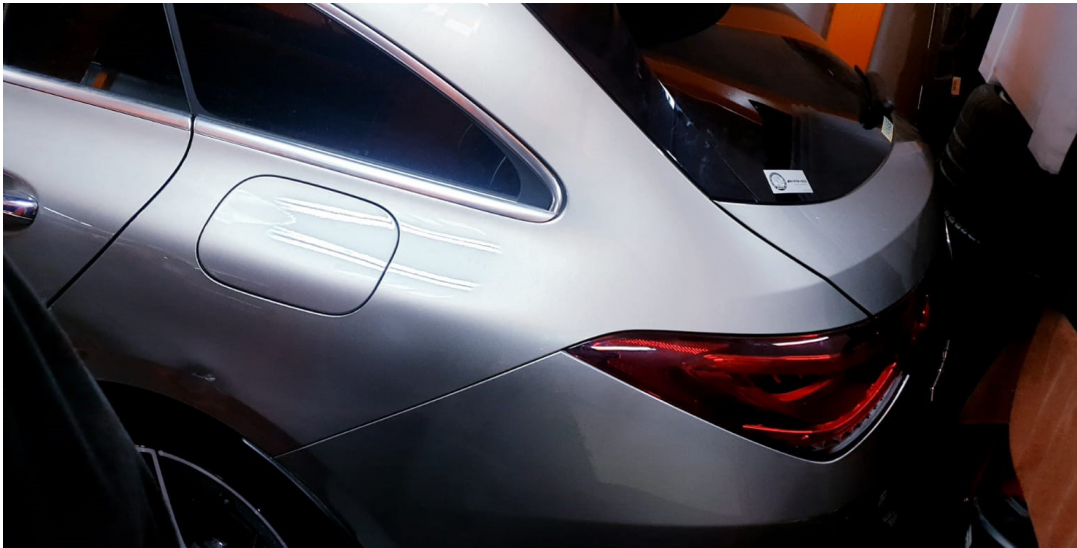
**Photo 3** shows the rear left body of the Motor Car (photograph provided to me). Apart for the frontal portion, there was no physical damage seen to other areas of the Motor Car

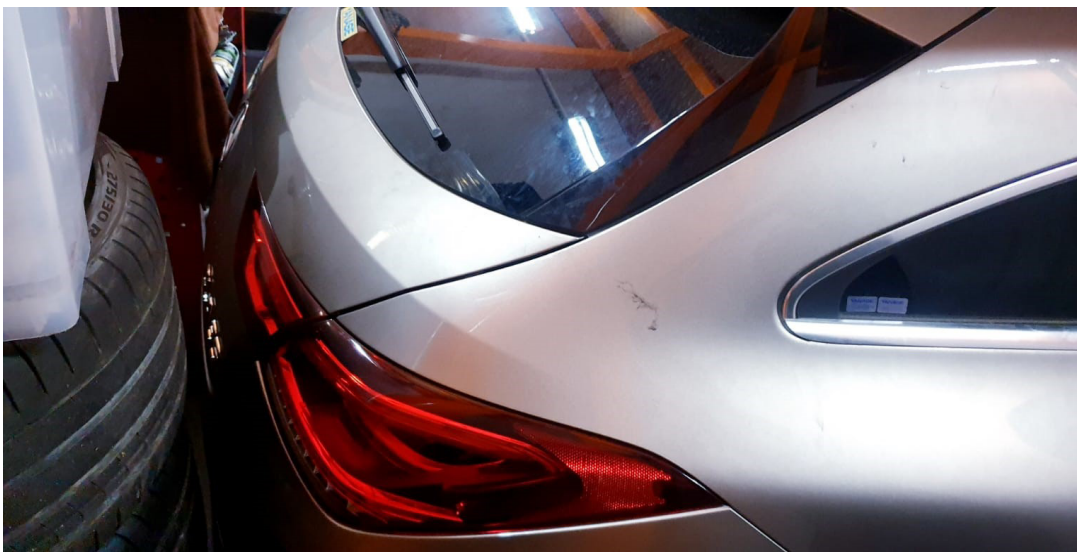
**Photo 4** shows the rear right body of the Motor Car (photograph provided to me). Apart for the frontal portion, there was no physical damage seen to other areas of the Motor Car.

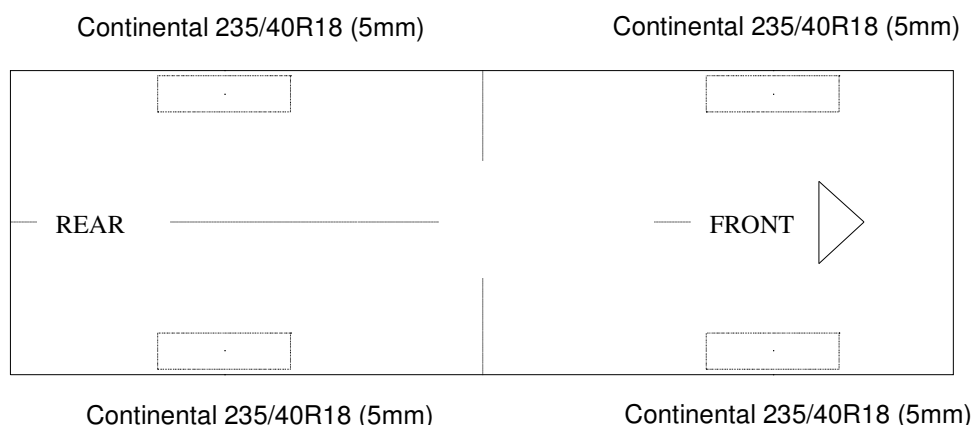
9. It was fitted with 18inch sport wheel rims that were wrapped with tyres that were observed to be of serviceable condition. The tyres were also sufficiently inflated for vehicular operation. The tyre brand, tyre size and approximate remaining tread depth of the 4 tyres of the Motor Car were recorded as follows: -

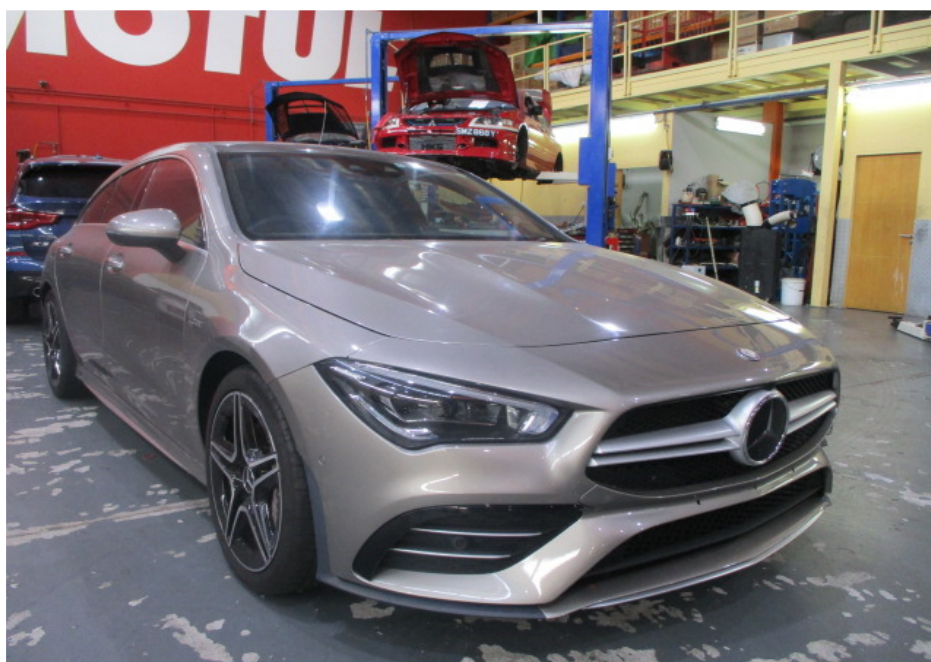
**Photo 5** shows a general view of the front right body of the Motor Car at the time of my inspection. The Motor Car was observed to be in a relatively good general condition with no loose exterior fittings observed. The body parts at the frontal portion of the Motor Car were visually examined and it was observed that the repair/restoration works carried out to the damaged area of the Motor Car (refer to photograph 1 & 2 above) were reasonably adequate and in order.

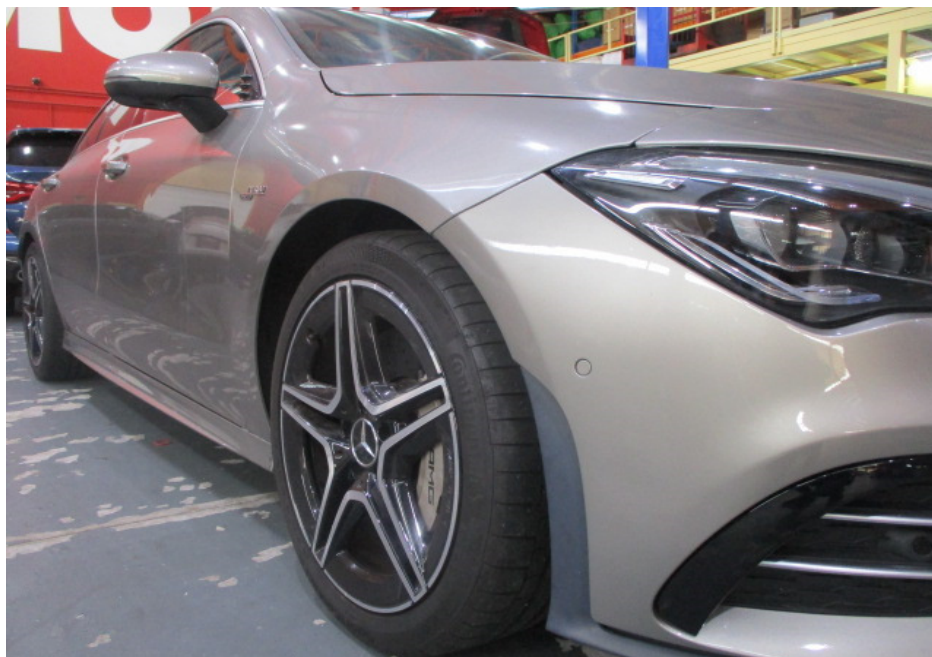
**Photo 6** shows a closer view of the Motor Car's front bumper, front bumper right corner garnish, front right headlamp and front right fender. The body parts at the frontal portion of the Motor Car were visually examined and it was observed that the repair/restoration works carried out to the damaged area of the Motor Car (refer to photograph 1 & 2 above) were reasonably adequate and in order.

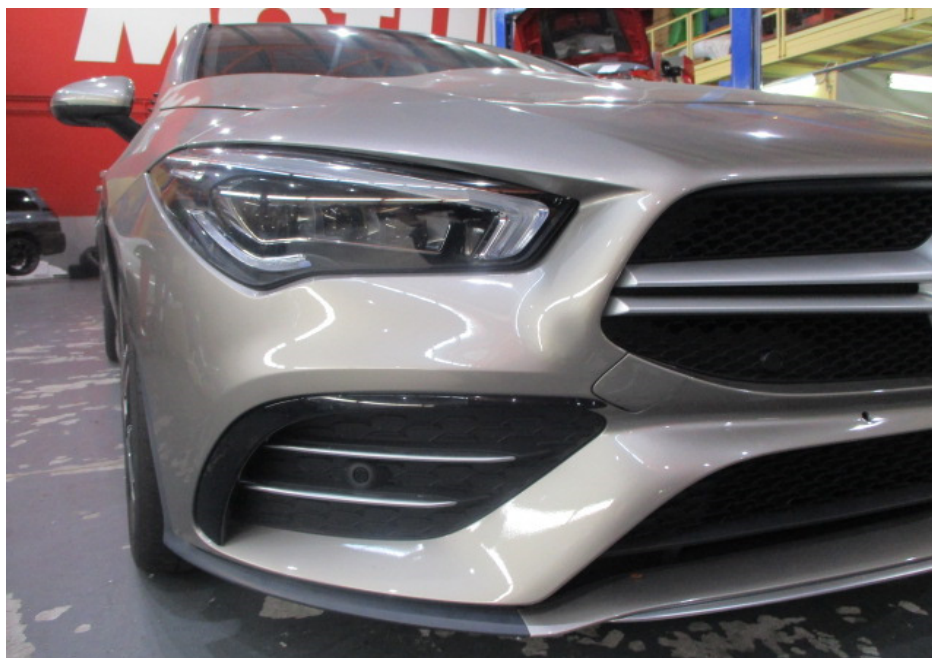
**Photo 7** shows a closer view of the Motor Car's front bumper, front bumper right lower grille, front bumper lower lip, front right headlamp and front bonnet. The body parts at the frontal portion of the Motor Car were visually examined and it was observed that the repair/restoration works carried out to the damaged area of the Motor Car (refer to photograph 1 & 2 above) were reasonably adequate and in order.

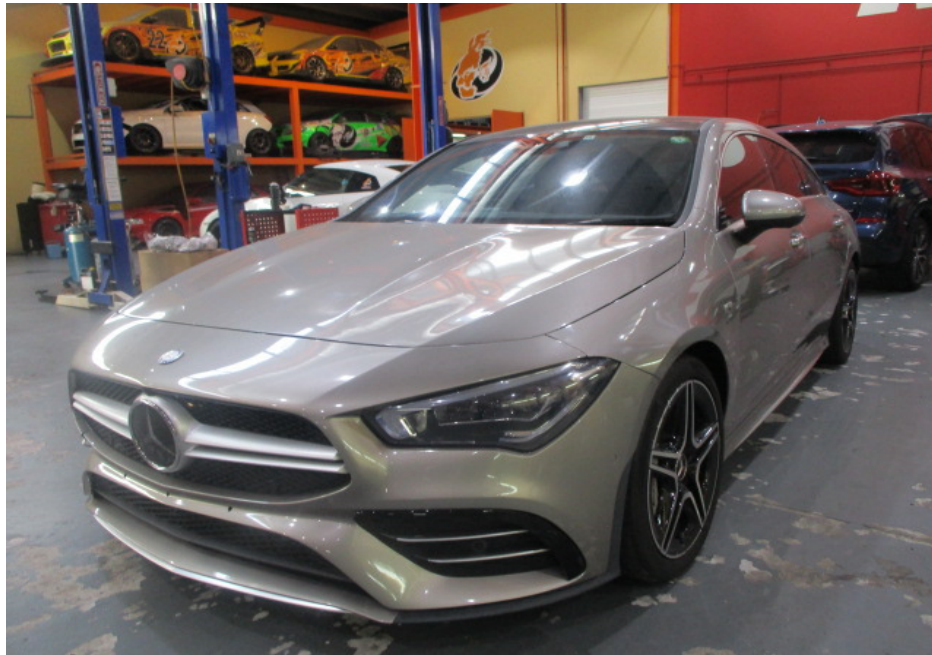
**Photo 8** shows a general view of the front left body of the Motor Car at the time of my inspection. The Motor Car was observed to be in a relatively good general condition with no loose exterior fittings observed. The body parts at the frontal portion of the Motor Car were visually examined and it was observed that the repair/restoration works carried out to the damaged area of the Motor Car (refer to photograph 1 & 2 above) were reasonably adequate and in order.

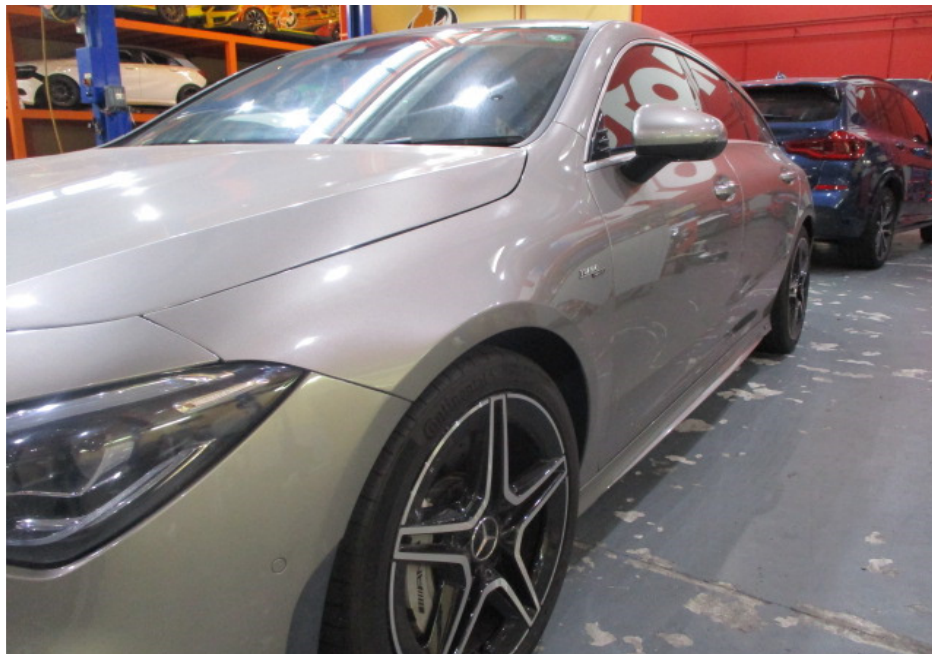
**Photo 9** shows a closer view of the Motor Car's front bumper, front left headlamp and front left fender. The body parts at the frontal portion of the Motor Car were visually examined and it was observed that the repair/restoration works carried out to the damaged area of the Motor Car (refer to photograph 1 & 2 above) were reasonably adequate and in order.

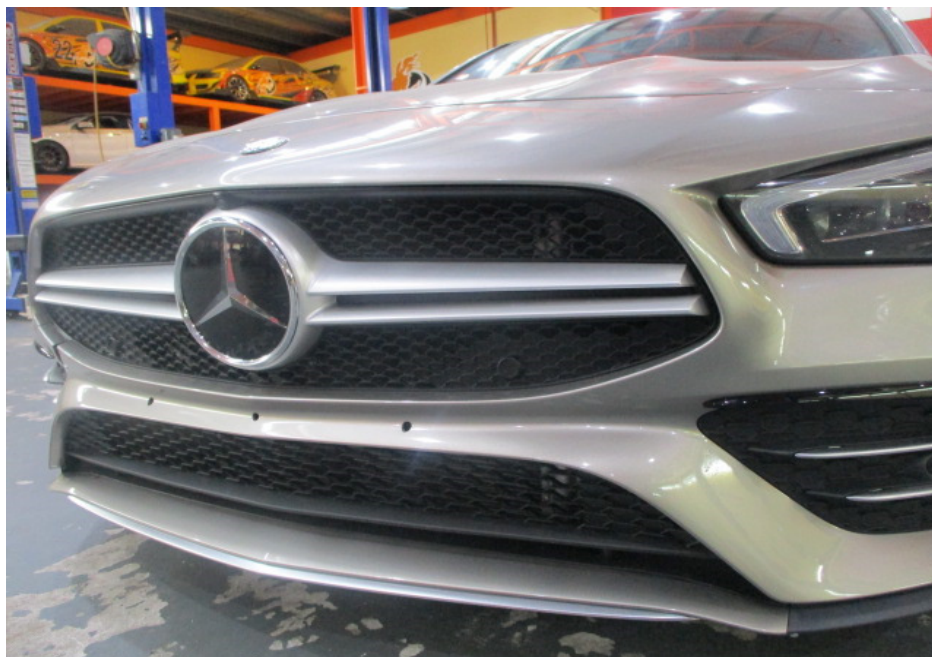
**Photo 10** shows a closer view of the Motor Car's front bumper, front bumper left lower grille, front bumper centre lower grille, front bumper lower lip, radiator grille, front emblem and front bonnet. The body parts at the frontal portion of the Motor Car were visually examined and it was observed that the repair/restoration works carried out to the damaged area of the Motor Car (refer to photograph 1 & 2 above) were reasonably adequate and in order.

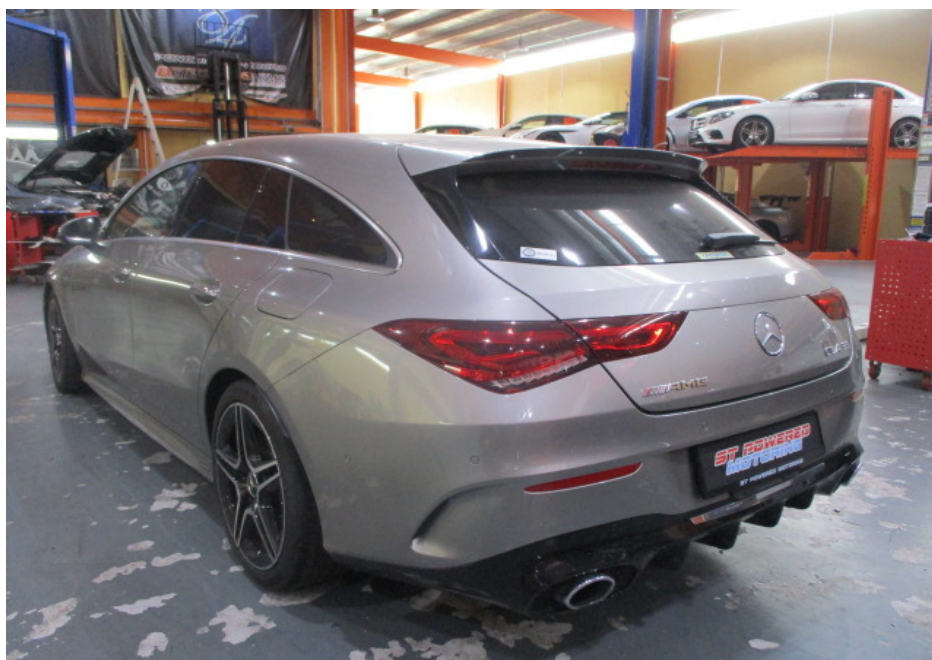
**Photo 11** shows a general view of the rear left body of the Motor Car at the time of my inspection. The Motor Car was observed to be in a relatively good general condition with no loose exterior fittings observed. The mileage of the Motor Car recorded at the time of my inspection was 9,045km.

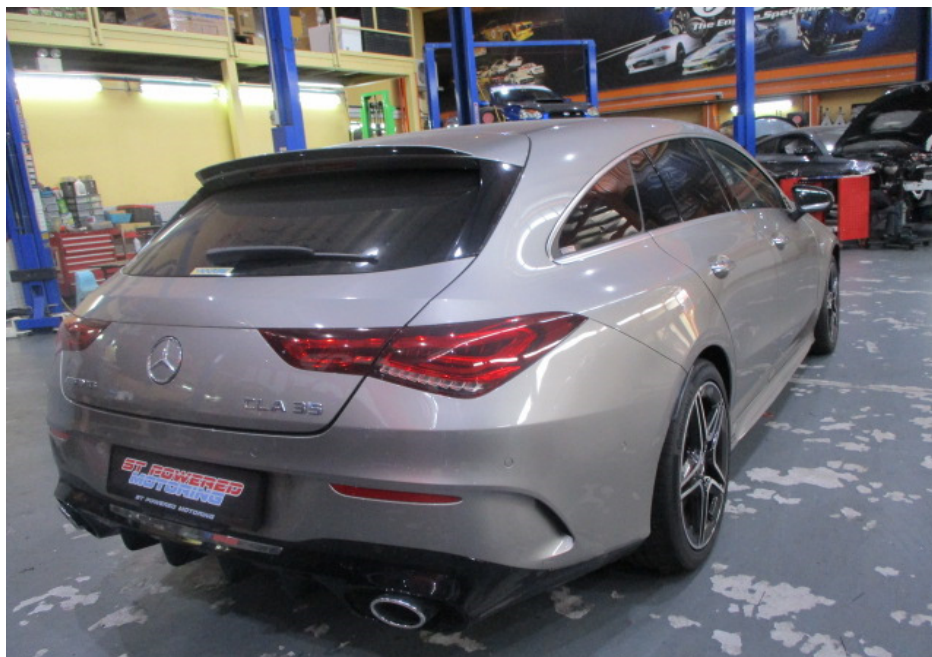
**Photo 12** shows a general view of the rear right body of the Motor Car at the time of my inspection. The Motor Car was observed to be in a relatively good general condition with no loose exterior fittings observed. The mileage of the Motor Car recorded at the time of my inspection was 9,045km.

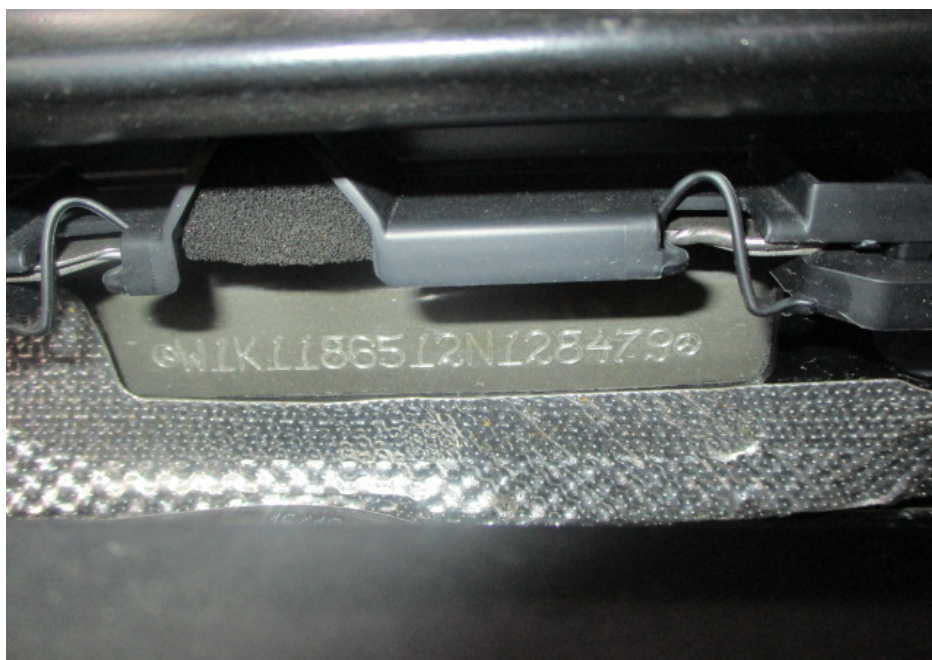
**Photo 13** shows the chassis number of the Motor Car. The chassis number recorded was W1K1186512N128479.

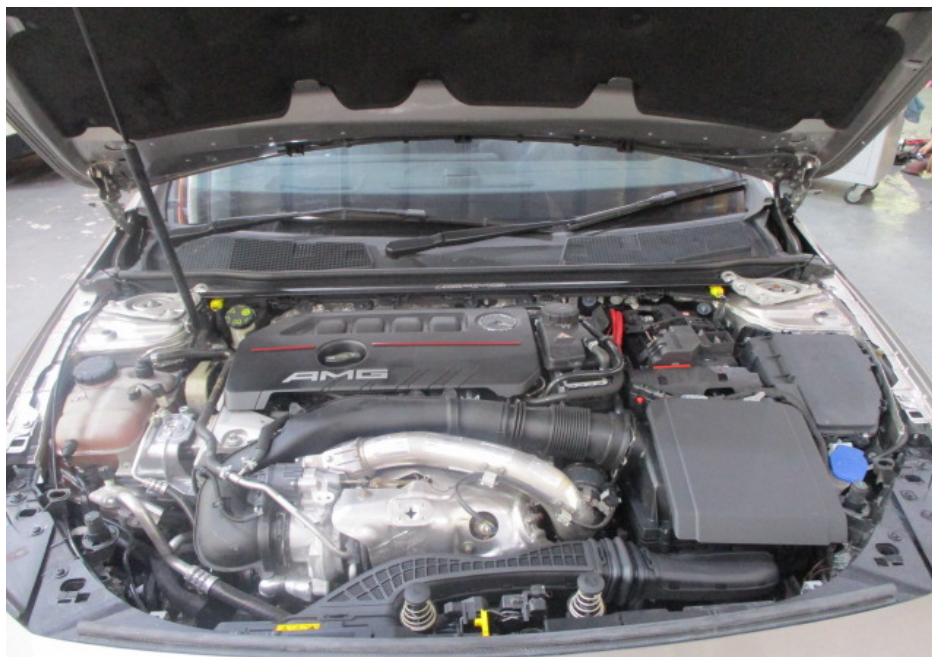
**Photo 14** shows a general view of the engine compartment of the Motor Car at the time of my inspection. The various parts and components inside the engine compartment were all observed to be intact and properly fitted. There was also no sign(s) or indication(s) of fluid leak and/or fluid stain found inside the engine compartment. The repair/restoration works carried out to the various parts within the engine compartment like the front bonnet lock, front support panel, aircon condenser and radiator amongst others, were reasonably adequate and in order.

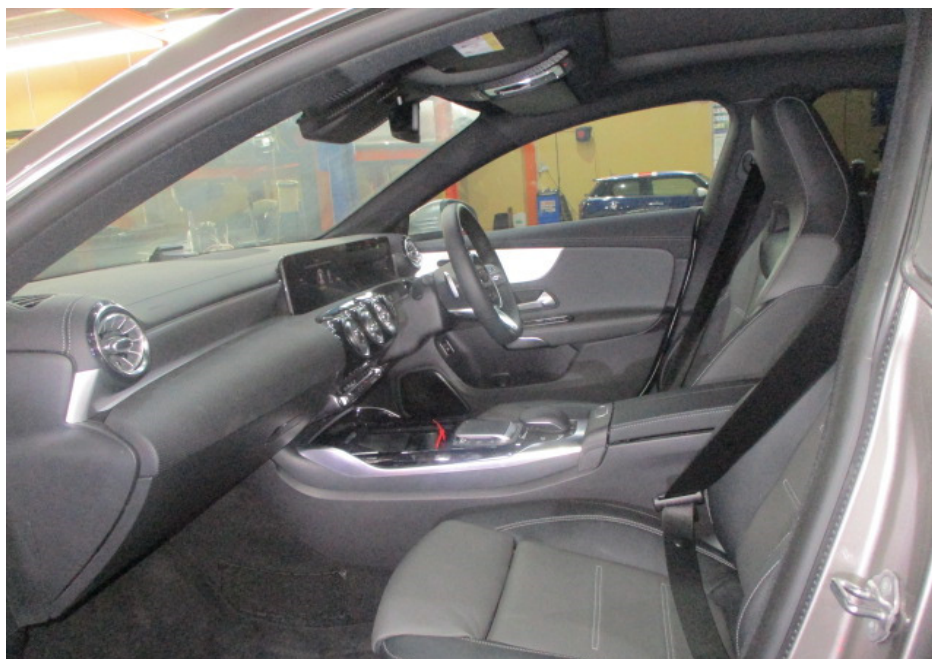
**Photo 15** shows the interior compartment of the Motor Car. The front dashboard, steering wheel, seats, upholstery and trims etc were all observed to be intact and properly fitted.

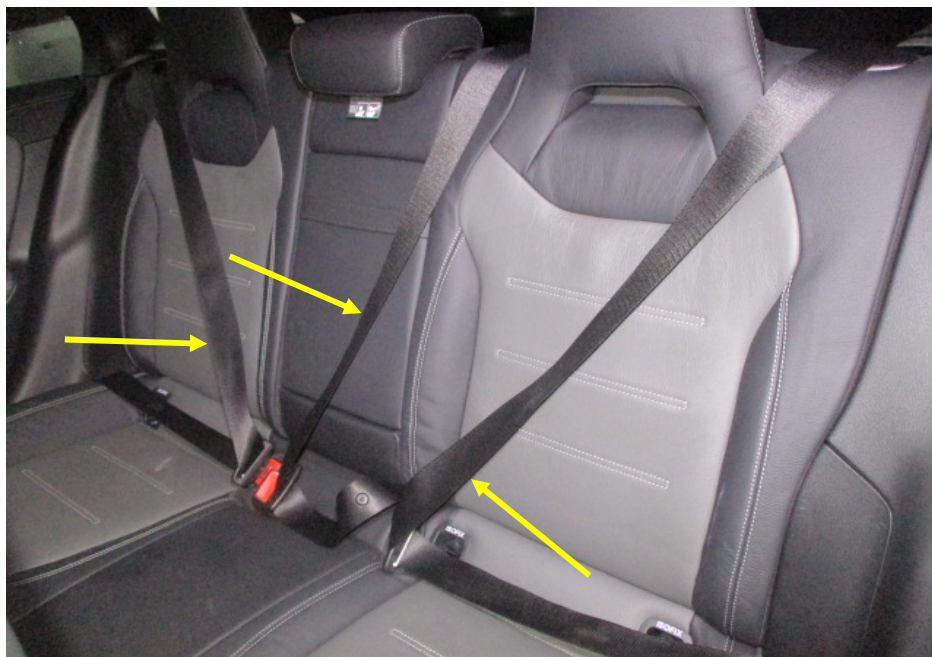
**Photo 16** shows the rear seats of the Motor Car. All the seats of the Motor Car were secured via seat rails to the floorboard. They were also fitted with a retractable seat belt reel and a pre-tensioner. The seat belts (arrowed) were tested and were able to be fastened into the respective pre-tensions that were fitted on the side of each individual seat.

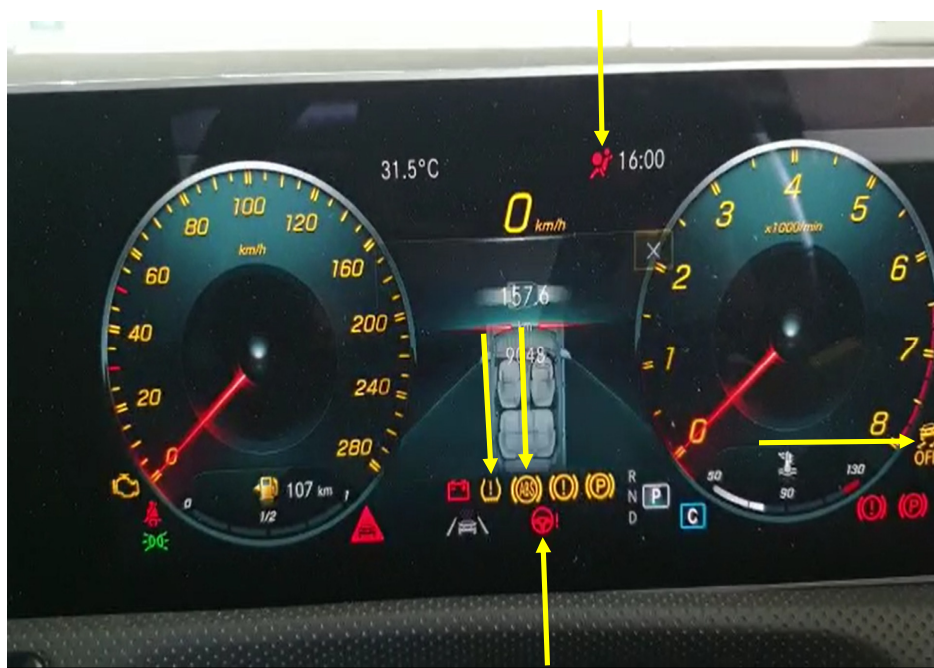
**Photo 17** shows the warning lights for the various electronic safety features appearing on the instrument panel of the Motor Car during its self-test when the engine is cranked, in particular the ABS, SRS, EPS, TPM and TCS lights (arrowed).

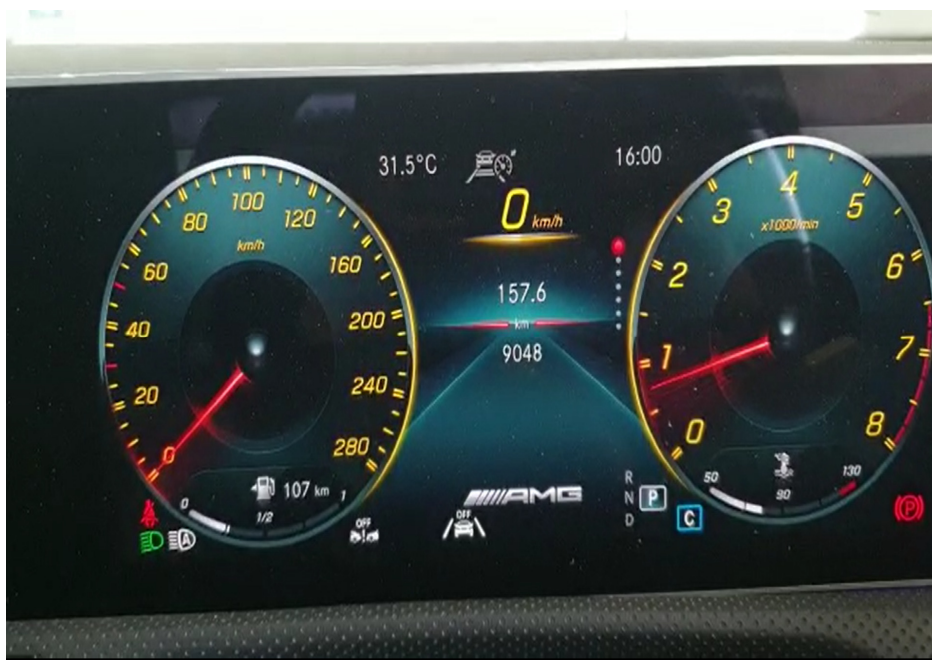
**Photo 18** shows the respective warning lights no longer illuminated, indicating that there is no fault detected to the ABS, SRS, EPS, TPM and TCS systems of the Motor Car during the self-test. These electronic systems were hence in working condition at the time of my inspection.

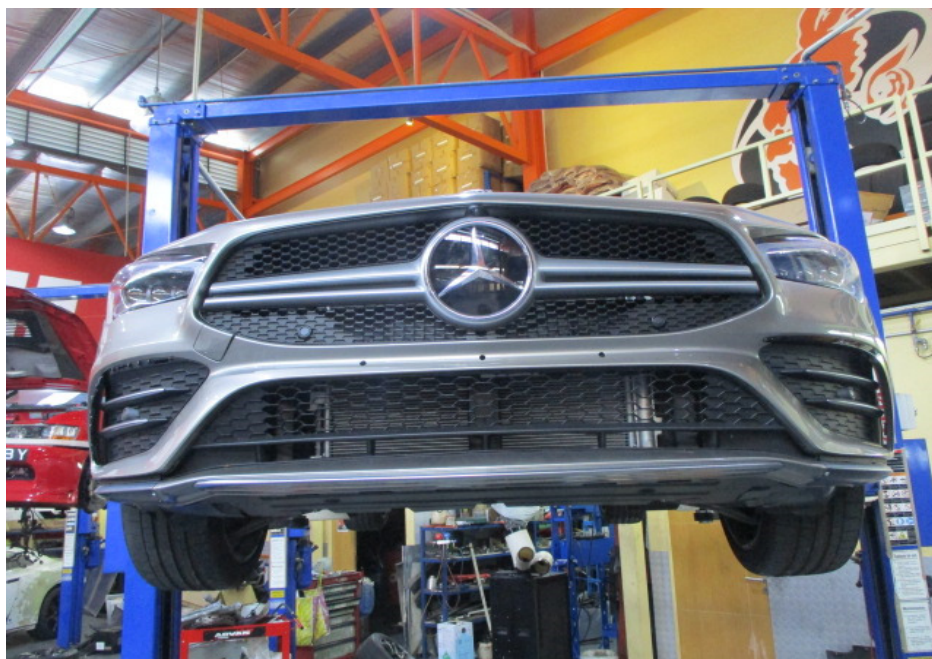
**Photo 19** shows the Motor Car hoisted up for checks on its undercarriage. There was no sign(s) or indication(s) of fluid leakage and/or fluid stain(s) on the underside of the Motor Car. The undercarriage components of the Motor Car were also all observed to be intact and secured in an appropriate manner.

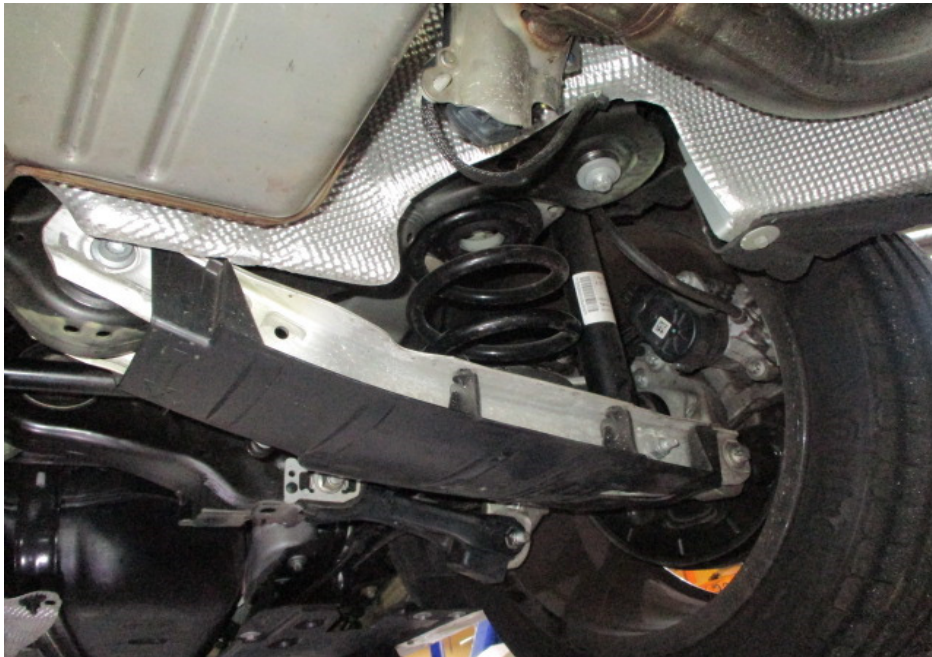
**Photo 20** shows a general view of the control arms and linkages at the rear right wheel of the Motor Car. I did not observe any fluid leak and/or fluid stain on the underside of the Motor Car. All of the Motor Car's undercarriage components were observed to be intact and secured in an appropriate manner.

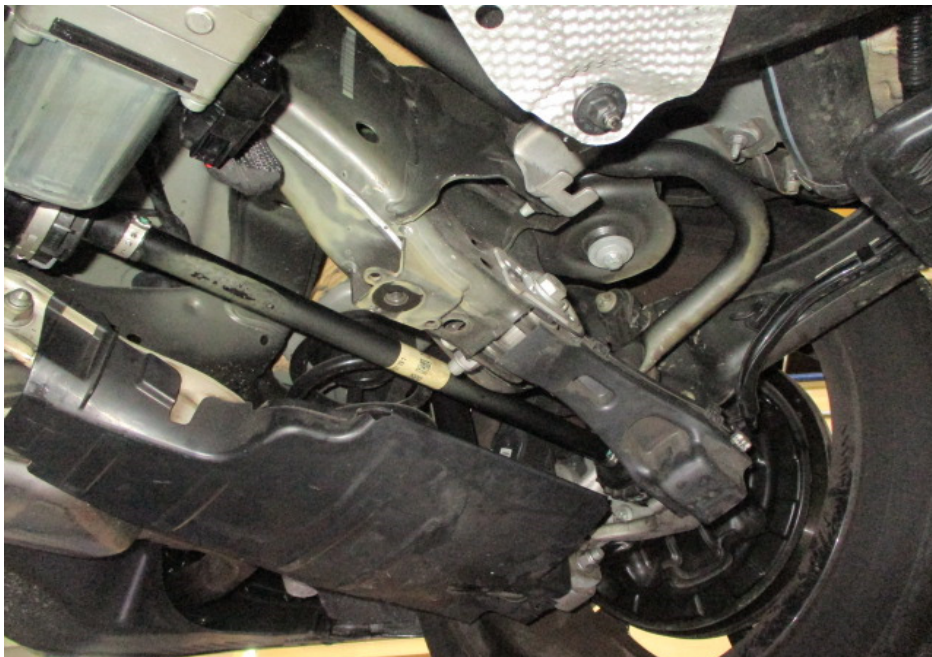
**Photo 21** shows a general view of the control arms and linkages at the rear left wheel of the Motor Car. I did not observe any fluid leak and/or fluid stain on the underside of the Motor Car. All of the Motor Car's undercarriage components were observed to be intact and secured in an appropriate manner.

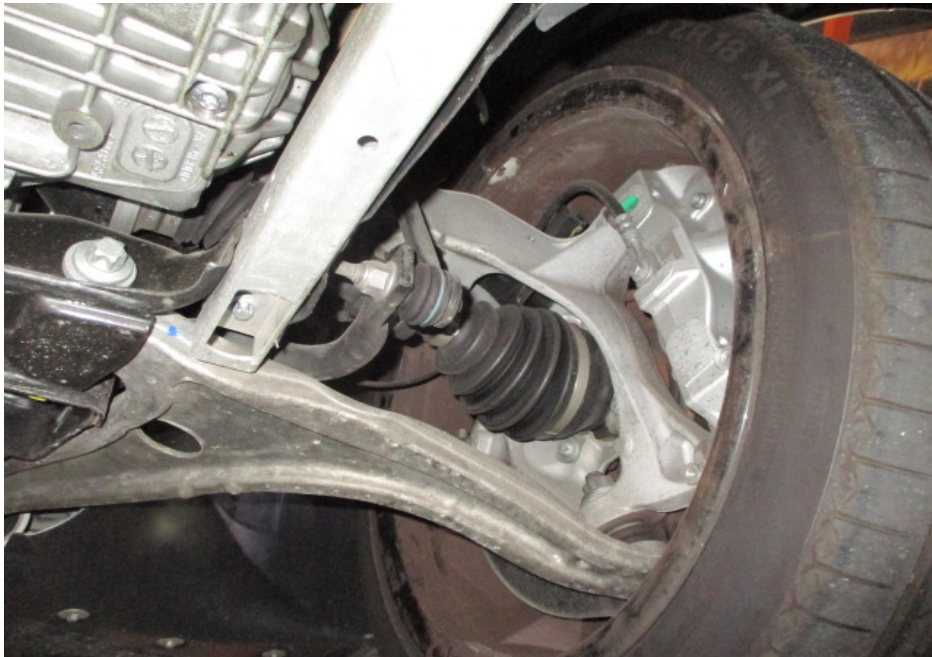
**Photo 22** shows the various undercarriage components at the front left wheel of the Motor Car. The mechanical components, control arms and linkages were all found to be intact and secured in an appropriate manner.

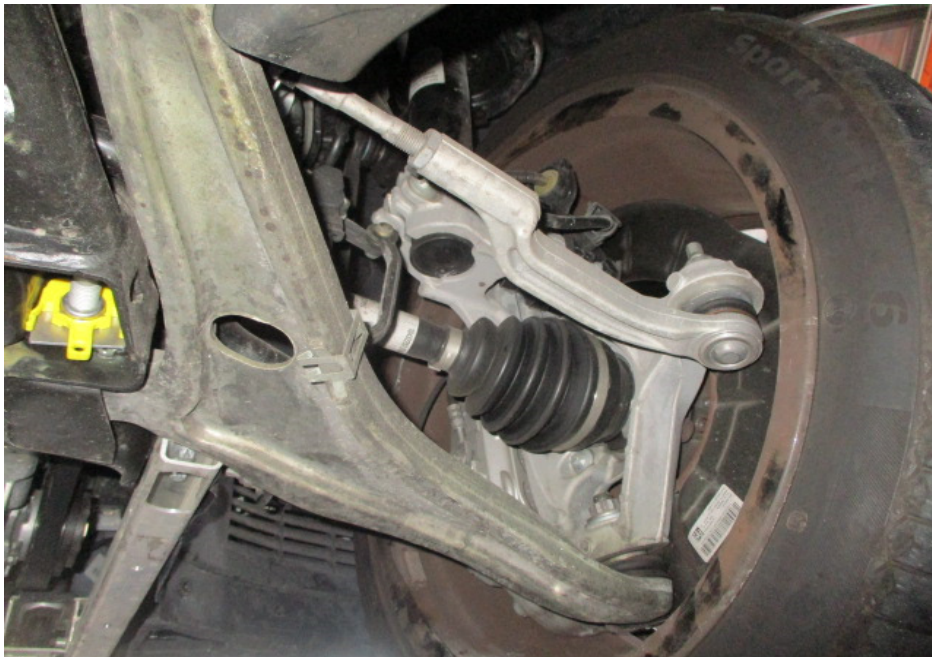
**Photo 23** shows the various undercarriage components at the front right wheel of the Motor Car. The mechanical components, control arms and linkages were all found to be intact and secured in an appropriate manner. I also did not observe any fluid leak and/or fluid stain on the underside of the Motor Car.

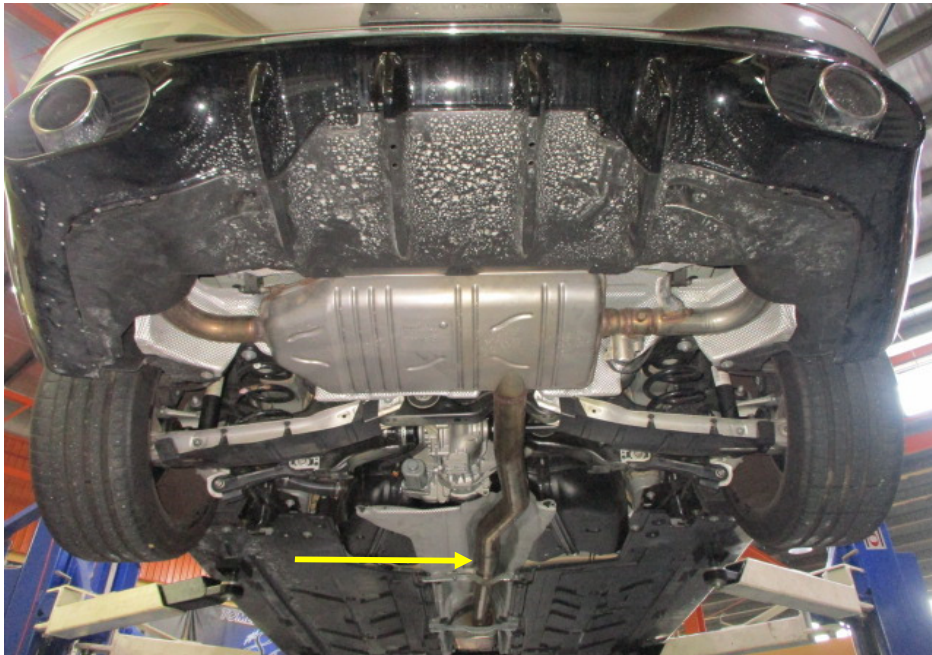
**Photo 24** shows the rear section of the Motor Car's exhaust system. My examination of the Motor Car's exhaust system revealed no sign(s) or indication(s) of any cut or weld marks along its exhaust pipes (arrowed), on its rear muffler, on its centre resonator box and on its catalytic converter.

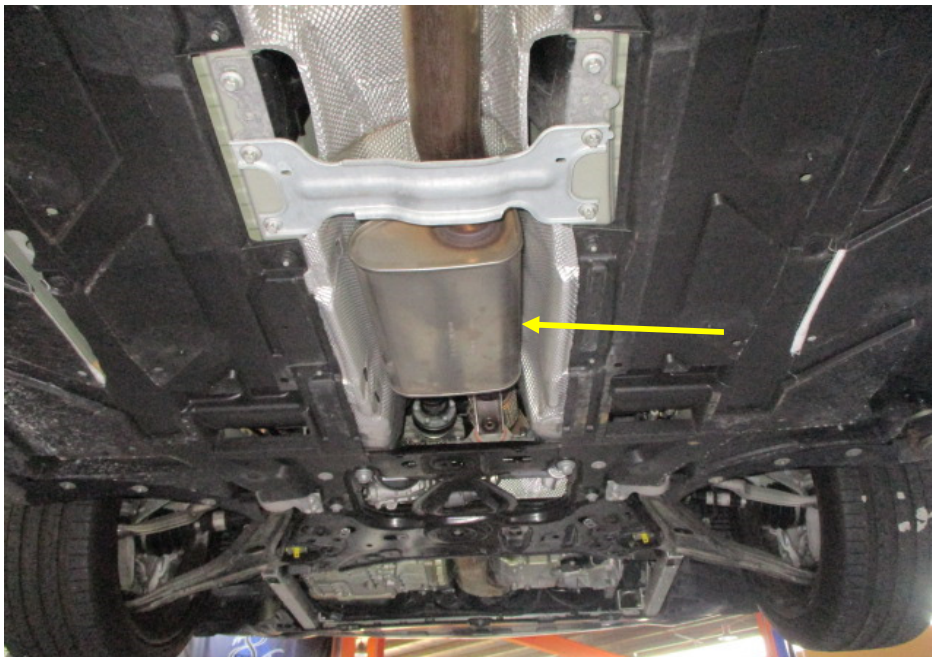
**Photo 25** shows the front section of the Motor Car's exhaust system. My examination of the Motor Car's exhaust system revealed no sign(s) or indication(s) of any cut or weld marks along its exhaust pipes, on its rear muffler, on its centre resonator box (arrowed) and on its catalytic converter.

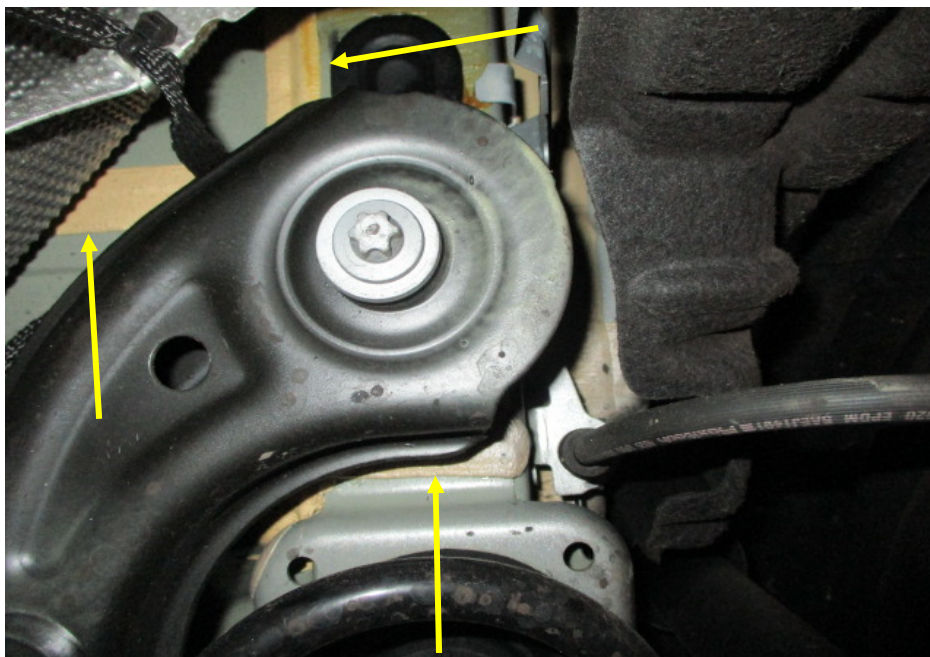
**Photo 26** shows the chassis/structural body at the underside rear right of the Motor Car. I did not find any weld marks other than original spot weld marks on the chassis/structural body of the Motor Car. The original factory sealant (arrowed) at the joints along the chassis/structural body was also untouched, indicating no work was done on the chassis/structural body of the Motor Car and that the chassis/structural body was originally fitted.

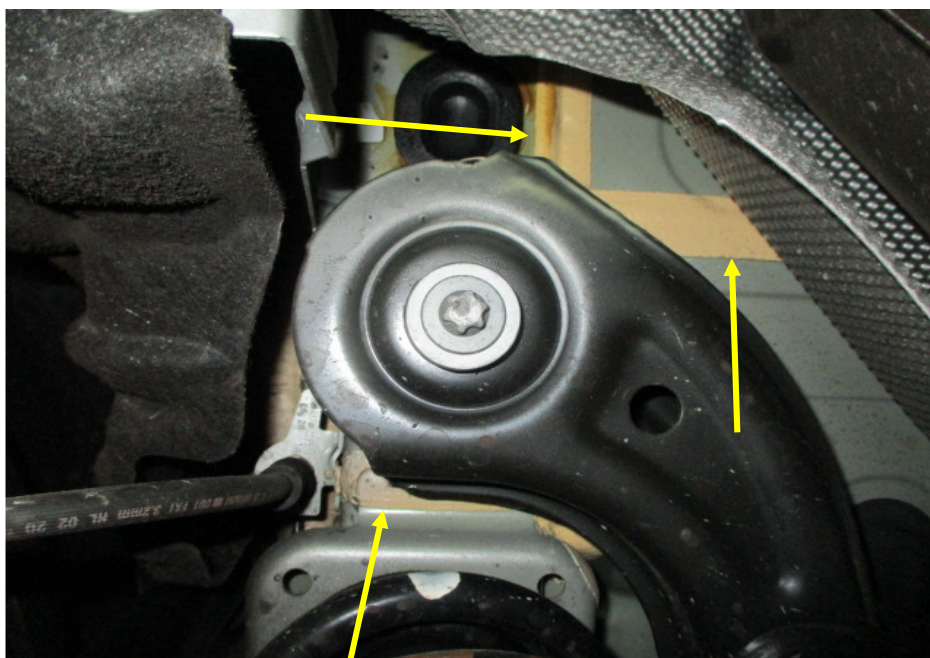
**Photo 27** shows the chassis/structural body at the underside rear left of the Motor Car. The original factory sealant (arrowed) at the joints along the chassis/structural body was observed to be untouched. In general, I had found no work was carried out on the chassis/structural body of the Motor Car. The chassis/structural body of the Motor Car was originally fitted.

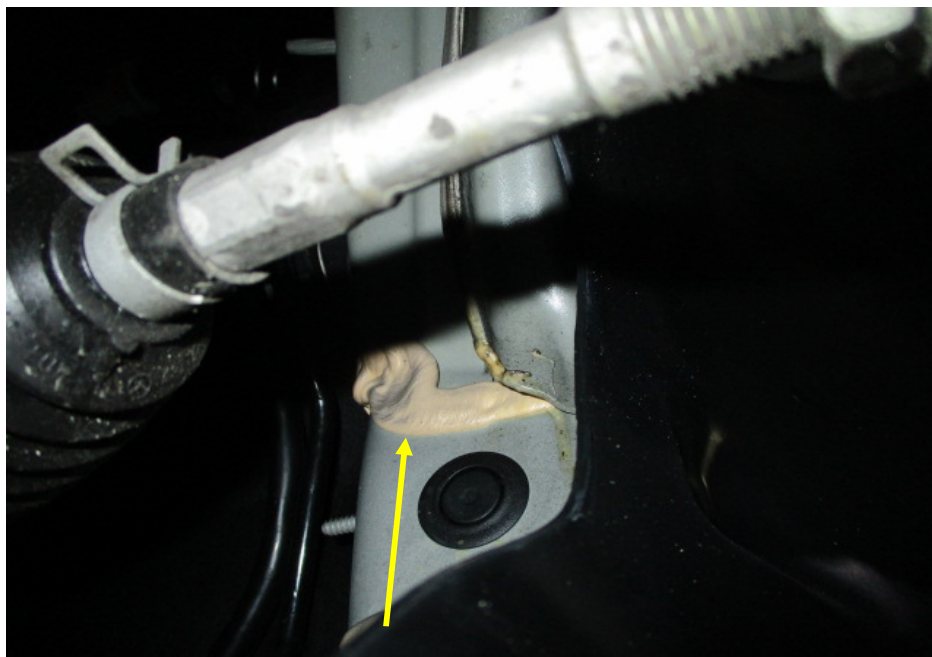
**Photo 28** shows the chassis/structural body at the underside front left of the Motor Car. The original factory sealant (arrowed) at the joints along the chassis/structural body was observed to be untouched. In general, I had found no work was carried out on the chassis/structural body of the Motor Car. The chassis/structural body of the Motor Car was originally fitted.

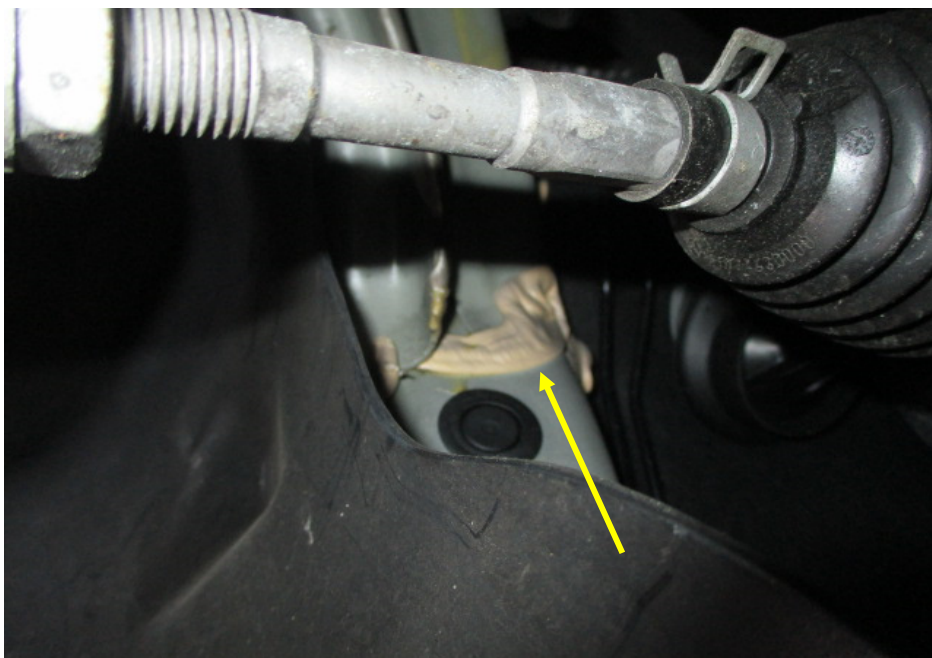
**Photo 29** shows the chassis/structural body at the underside front right of the Motor Car. I did not find any weld marks other than original spot weld marks on the chassis/structural body of the Motor Car. The original factory sealant (arrowed) at the joints along the chassis/structural body was also untouched, indicating no work was done on the chassis/structural body of the Motor Car and that the chassis/structural body was originally fitted.

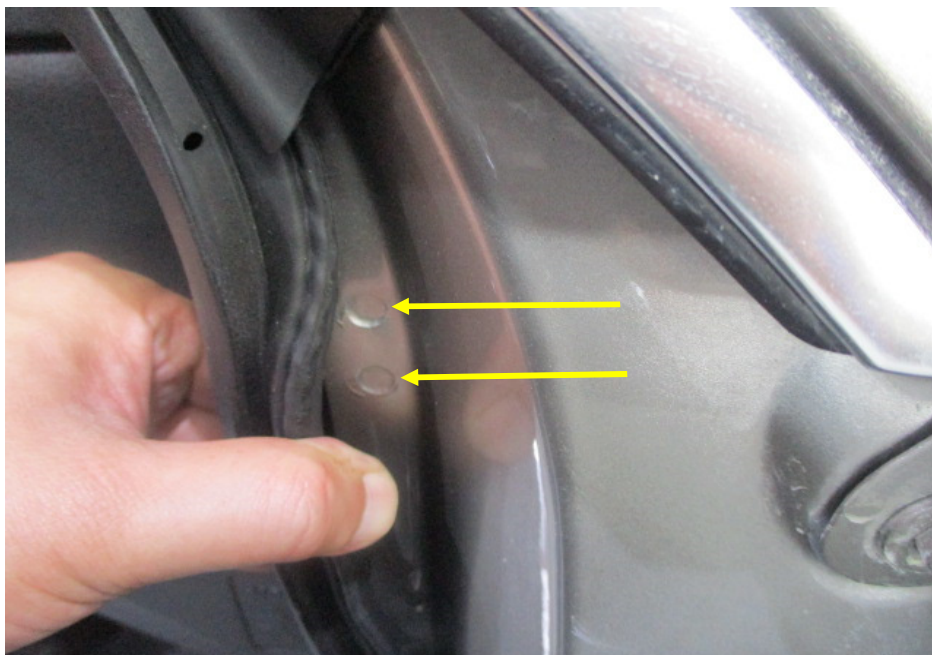
**Photo 30** shows the right side "A" pillar of the Motor Car. I did not find any weld marks other than original spot weld marks (arrowed) on the right side "A" pillar of the Motor Car which, indicates that there was no re-welding works carried out. In general, I had found all the non-detachable body panels of the Motor Car to be originally fitted at the time of my inspection.

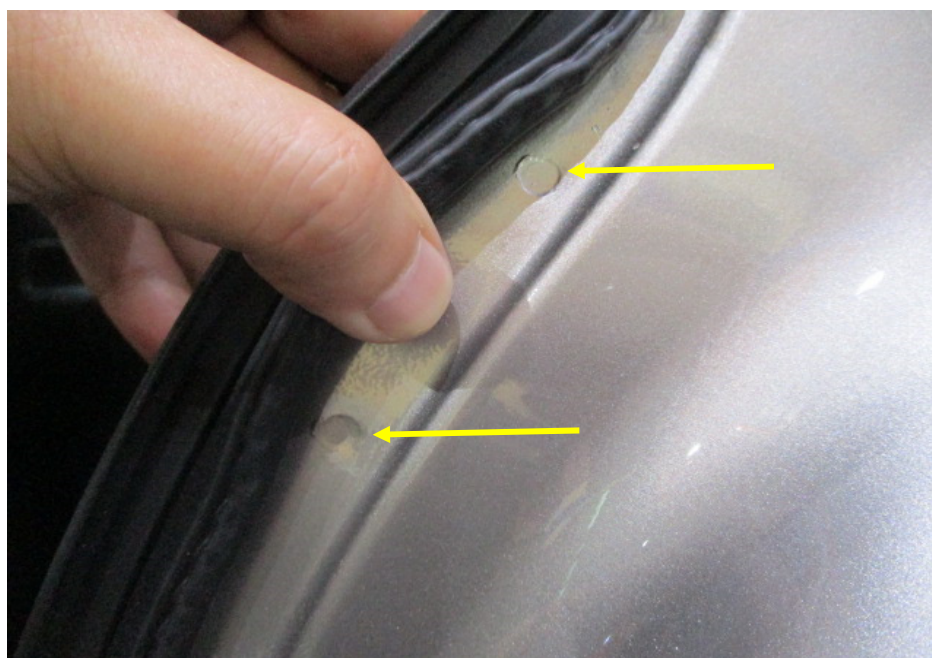
**Photo 31** shows the left side "C" pillar of the Motor Car. I did not find any weld marks other than original spot weld marks (arrowed) on the left side "C" pillar of the Motor Car which, indicates that there was no re-welding works carried out. In general, I had found all the non-detachable body panels of the Motor Car to be originally fitted at the time of my inspection.
