Your Ref: Mercedes Benz CLA 35 Wagon  
(chassis number W1K1186512N128479)

26 November 2021

Our Ref : CI/TP21012041/D

**INSPECTION REPORT OF AN UNREGISTERED MERCEDES BENZ CLA 35  
WAGON MOTOR CAR WITH CHASSIS NUMBER W1K1186512N128479**

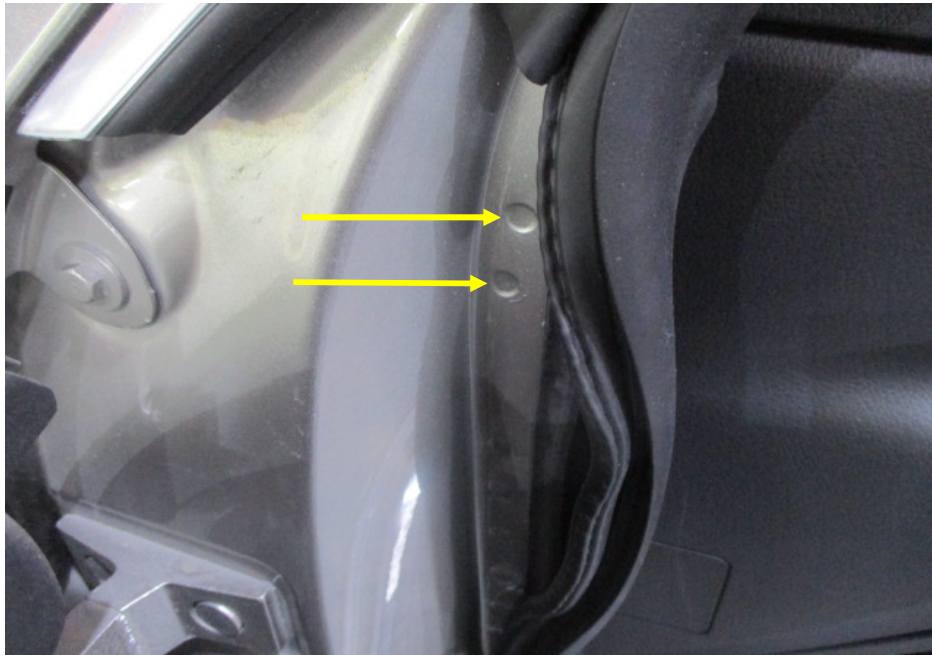
**Photo 32** shows the left side "A" pillar of the Motor Car. I did not find any weld marks other than original spot weld marks (arrowed) on the left side "A" pillar of the Motor Car which, indicates that there was no re-welding works carried out. In general, I had found all the non-detachable body panels of the Motor Car to be originally fitted at the time of my inspection.
