Your Ref : 639105
Our Ref : CS4/MSG21012112/D

07 April 2022

**AUTOMOBILE TECHNICAL INVESTIGATION REPORT OF INCIDENT
INVOLVING SNA 9130C AND SKP 5353J ON 29 NOVEMBER 2021**

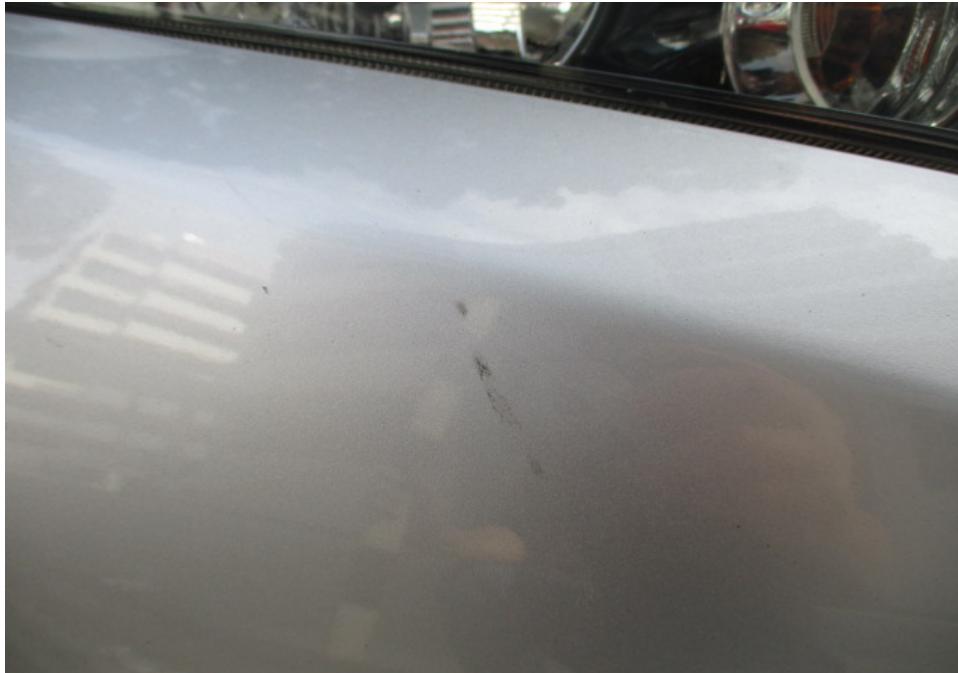
Photo 10 shows a close up view of the relatively faint grazed mark that I had observed on the Insured Vehicle's front bumper, at the area below the front right headlamp.

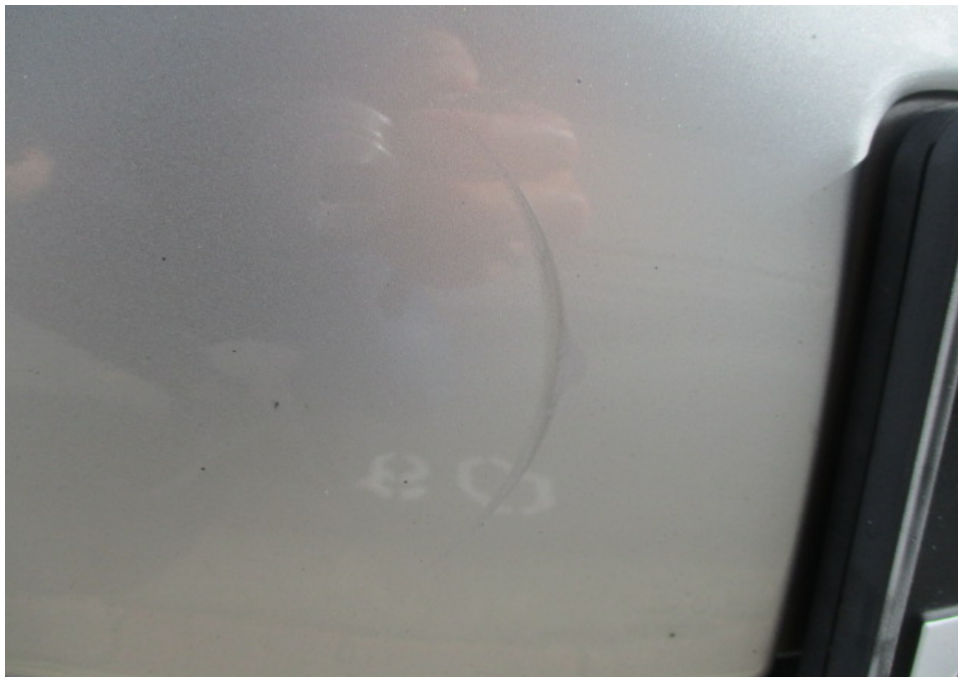
Photo 11 shows a close up view of the semi-circular imprint mark that was found on the front bumper of the Insured Vehicle, at the area towards the right side of the front number plate.

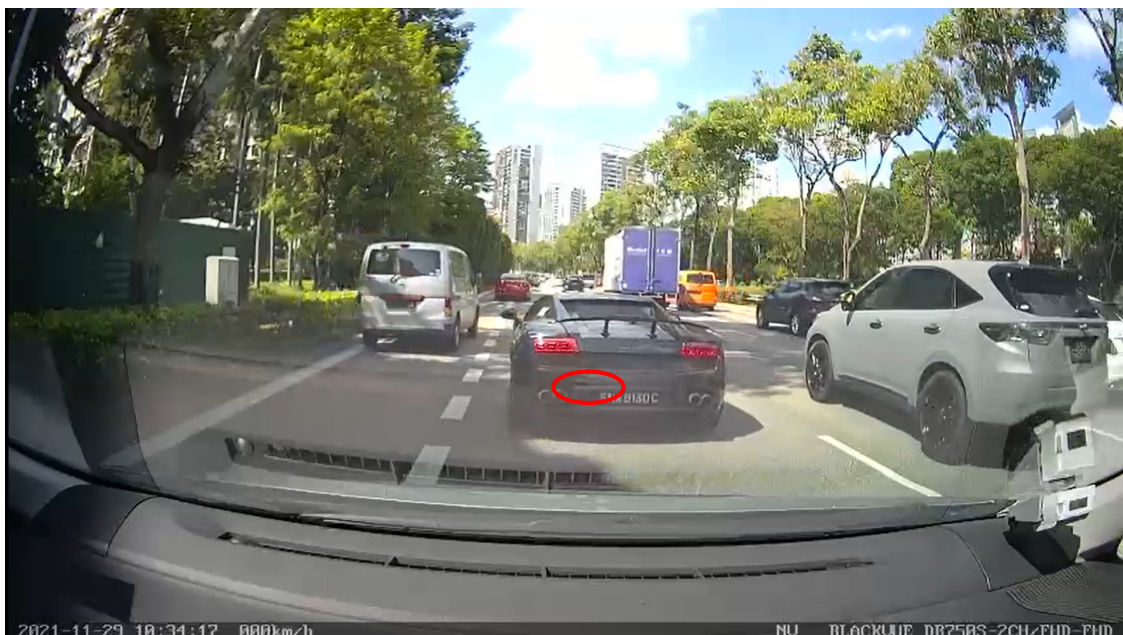
Photo 19 shows screenshot extracted from the video footage taken from the recording device that was mounted on the front windscreen of the Insured Vehicle. This was at the 10:34:17 time stamp mark, when the Third Party Vehicle was driving off after the incident. The damage that was seen on the rear left lower portion of the Third Party Vehicle, shown in photograph 2 above, was similarly seen on the same area of the Third Party Vehicle (circled) in the images captured by the recording device after the incident. This damage was not seen on the Third Party Vehicle before the contact (refer to photograph 20 to 22 below).

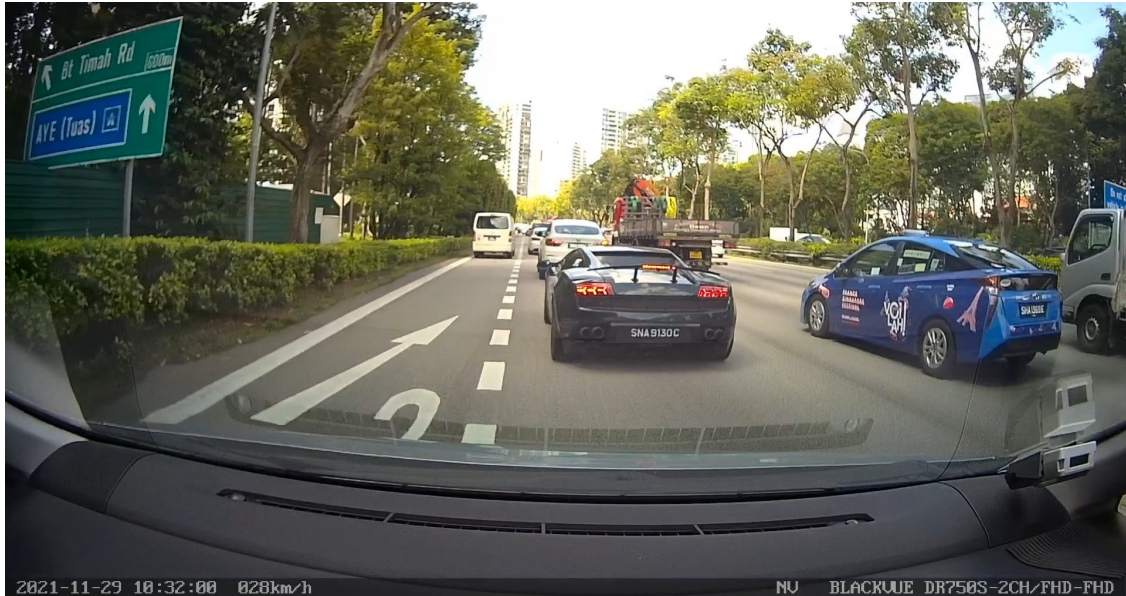
Photo 21 shows screenshot extracted from the video footage taken from the recording device that was mounted on the front windscreen of the Insured Vehicle. This was at the 10:32:00 time stamp mark, before the occurrence of contact. The Insured Vehicle was seen maneuvering into the extreme left lane of CTE behind the Third Party Vehicle. At this point of the video footage, the brake lights of the Third Party Vehicle illuminated. Note that the brake lights of the white BMW make motor car that was in front of the Third Party Vehicle was not illuminated. The distance between the Third Party Vehicle and the BMW make motor car was also not close to suggest that the Third Party Vehicle was tailgating the BMW make motor car.

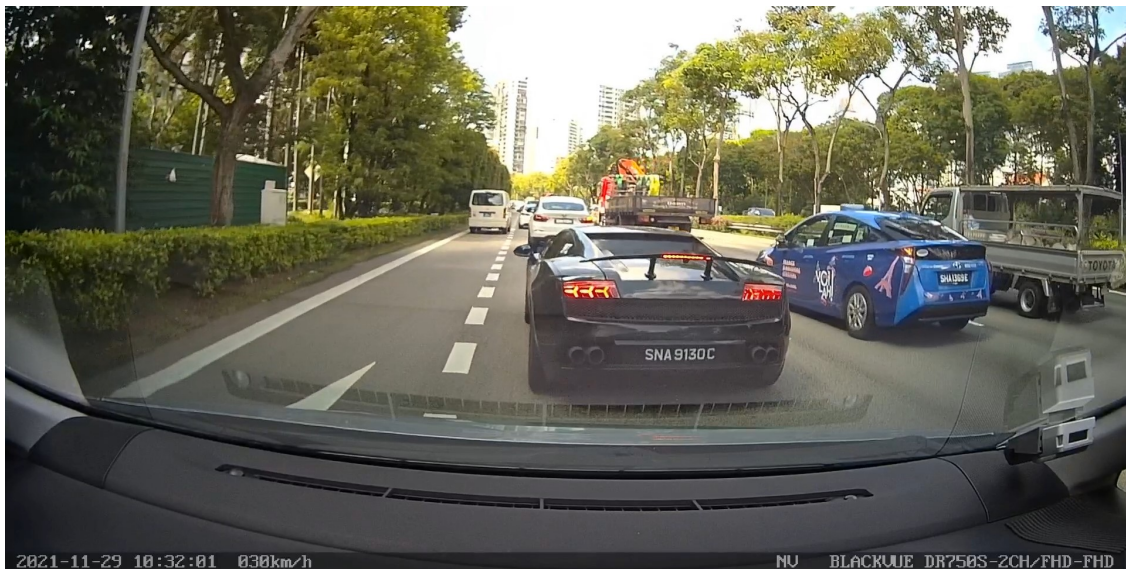
Photo 22 shows screenshot extracted from the video footage taken from the recording device that was mounted on the front windscreen of the Insured Vehicle. This was at the 10:32:01 time stamp mark, before the occurrence of contact. At this point, the Third Party Vehicle came to a complete stop with the insured Vehicle closing in on the Third Party Vehicle. Note that the brake lights of the white BMW make motor car that was in front of the Third Party Vehicle was still not illuminated and the distance between the Third Party Vehicle and the BMW make motor car was also not close. There appears to be no reasonable cause for the Third Party Vehicle to brake to a complete stop.
