# LKK Auto Consultants Pte Ltd

Affiliated to Federation Internationale Des Experts En Automobile				
CHINA TAIPING INSURANCE (S) PTE LTD 3 ANSON ROAD #16-00 SPRINGLEAF TOWERSINGAPORE 079909			Ref: CC6/CTI21012113/Kea3q2	
			Date: 13/06/2022	
			Code: CTI	
<b>1. Policy Particulars :- THIRD PARTY CLAIM</b>				
Insured Veh.	SMK 8910J	Veh. Inspected	SMG 5692D	
Policy No.	DMPCSNW00152992100	Coverage (\$)	0.00	
Claim No.	SNM21D206887/C02	Excess (\$)	0.00	
Assign From		Assign Date	01/12/2021	
<b>2. Vehicle Particulars &amp; Condition</b>				
Make & Model	TOYOTA PRIUS	c.c	1797	
Engine No.	HIDDEN	Year of Reg.	2018	
Chassis No.	ZVW506050829	Colour	METALLIC GREY	
Odometer	262737 KM	Steering	IN ORDER	
Brakes	IN ORDER	Modification	STANDARD ALLOY RIM	
General	GOOD			
<b>3. Conditions of Tyres</b>				
	Size	Make	Balance	
R/H Front Tyre	195/65 R15	SAILUN	8 mm	
L/H Front Tyre	195/65 R15	SAILUN	8 mm	
R/H Rear Tyre	195/65 R15	APLUS	6 mm	
L/H Rear Tyre	195/65 R15	APLUS	6 mm

## ADJUSTMENT ON REPAIR COST FOR VEHICLE NO. SMG 5692D

### PHOTOGRAPHS FOR VEHICLE NO. SMG 5692D

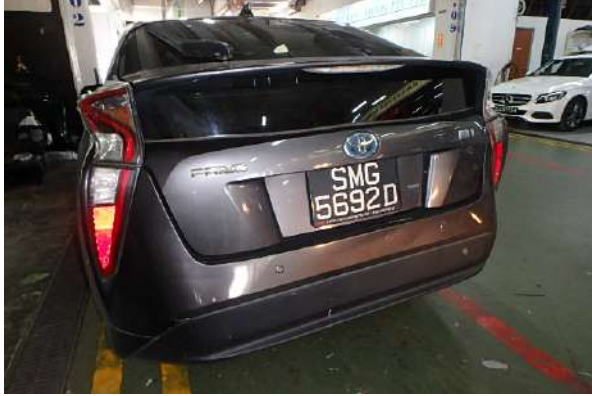
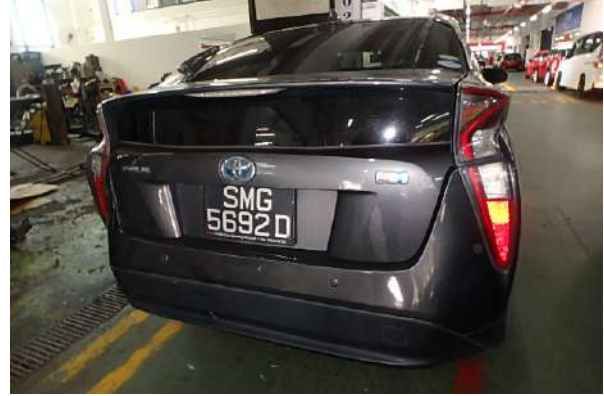
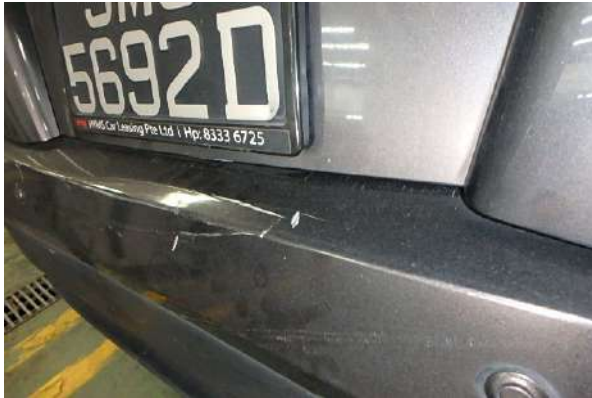
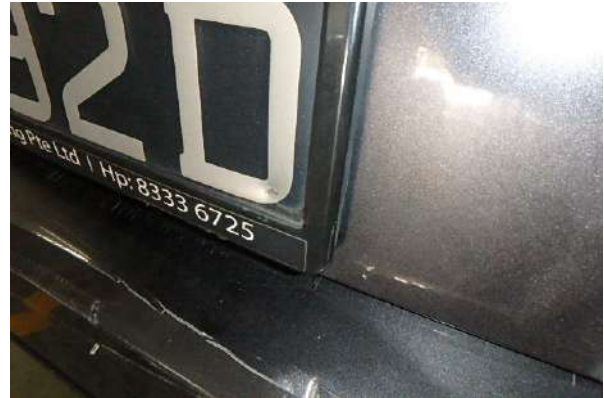
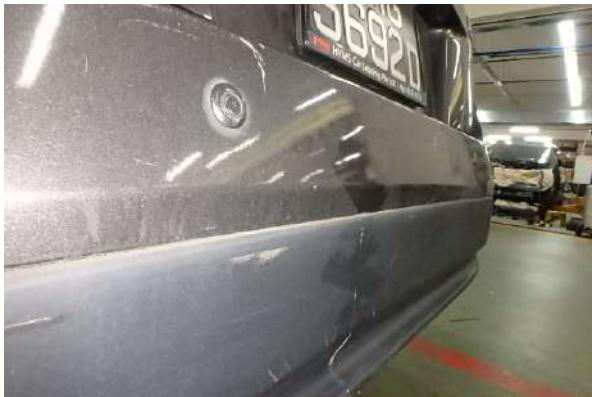
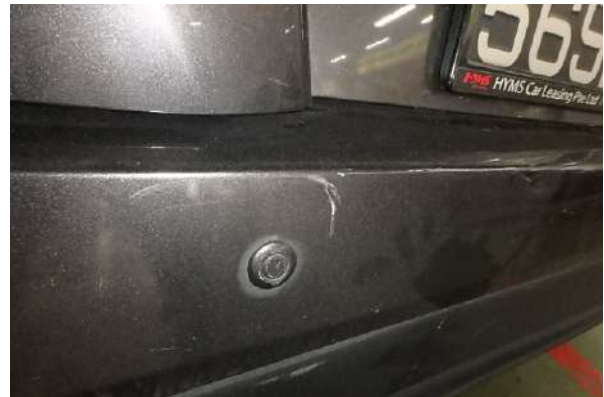
### INSPECTION

<b>4. Description of Damages</b>				
THE VEHICLE SUSTAINED DAMAGES AT THE REAR PORTION.  DAMAGES SEE DETAILS.				
<b>5. General Information</b>				
Accident Date	26/11/2021	Inspection Date	01/12/2021	
Survey held at	HUI YANG MOTOR PTE LTD BLOCK 176 SIN MING DRIVE #04-02 SIN MING AUTOCARE SINGAPORE 575721			
<b>5a. Remarks</b>				
A)THE INSPECTION WAS CONDUCTED ON A"WITHOUT PREJUDICE" BASIS. B)IN ACCORDANCE TO YOUR INSTRUCTIONS, WE HAVE NOT AUTHORISED REPAIRS.				
<b>5b. Estimate Days of Repair</b>				
ESTIMATED NORMAL PERIOD FOR REPAIR:			<b>4 Working Days</b>
