VEHICLE INSPECTION REPORT

Date : 16 August 2017
Our ref : AA/08/1701/TP

Registration No : SKS 7309 J
Make / Model : Nissan GT-R
Chassis No : R35004341
Engine No : VR38006051A

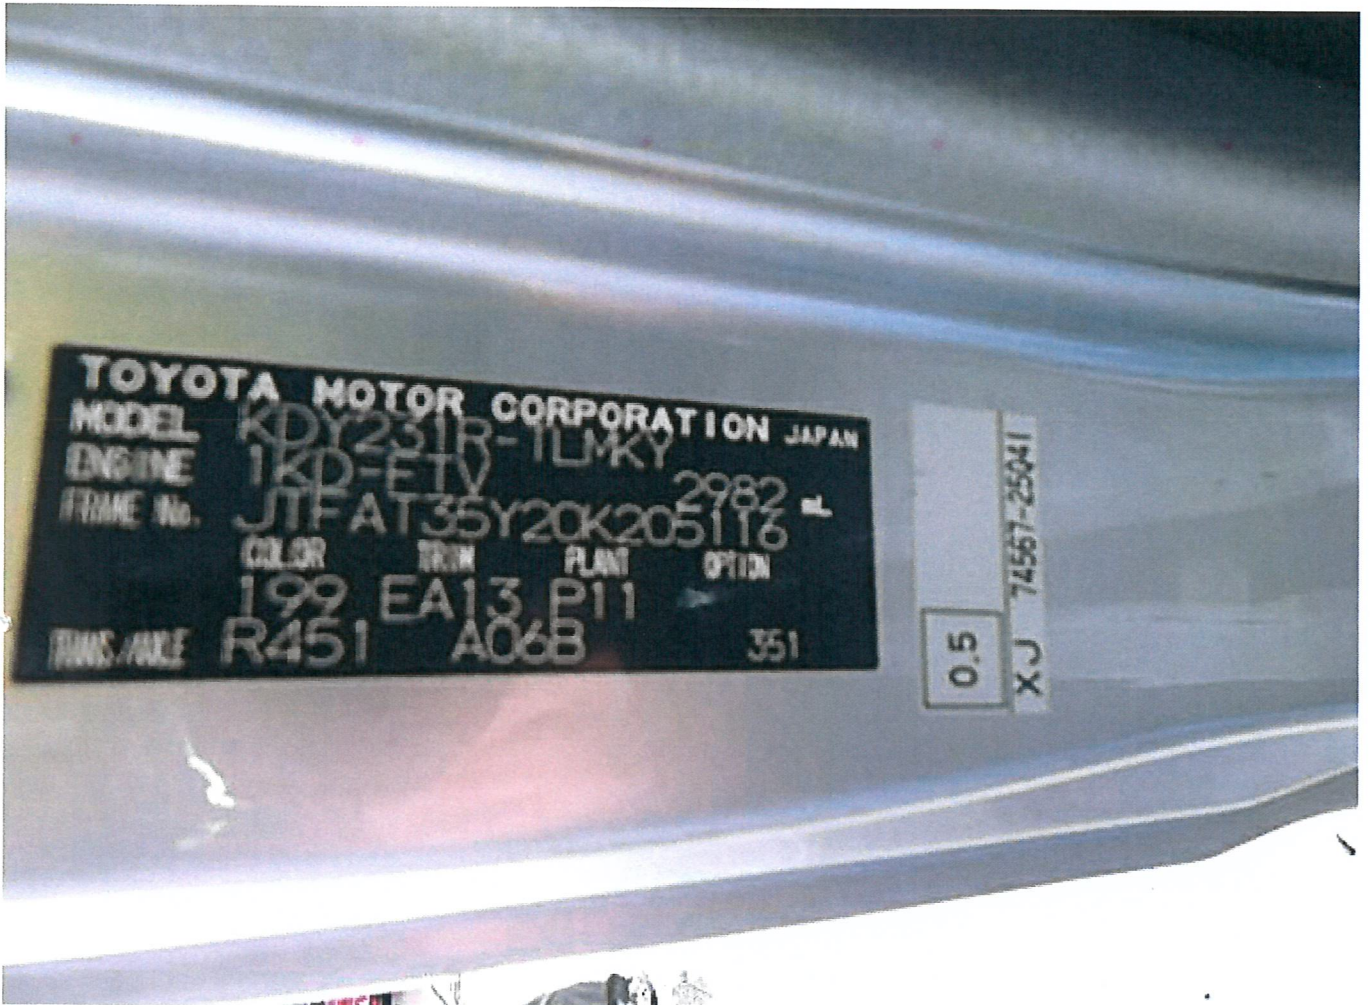
Accident Photo

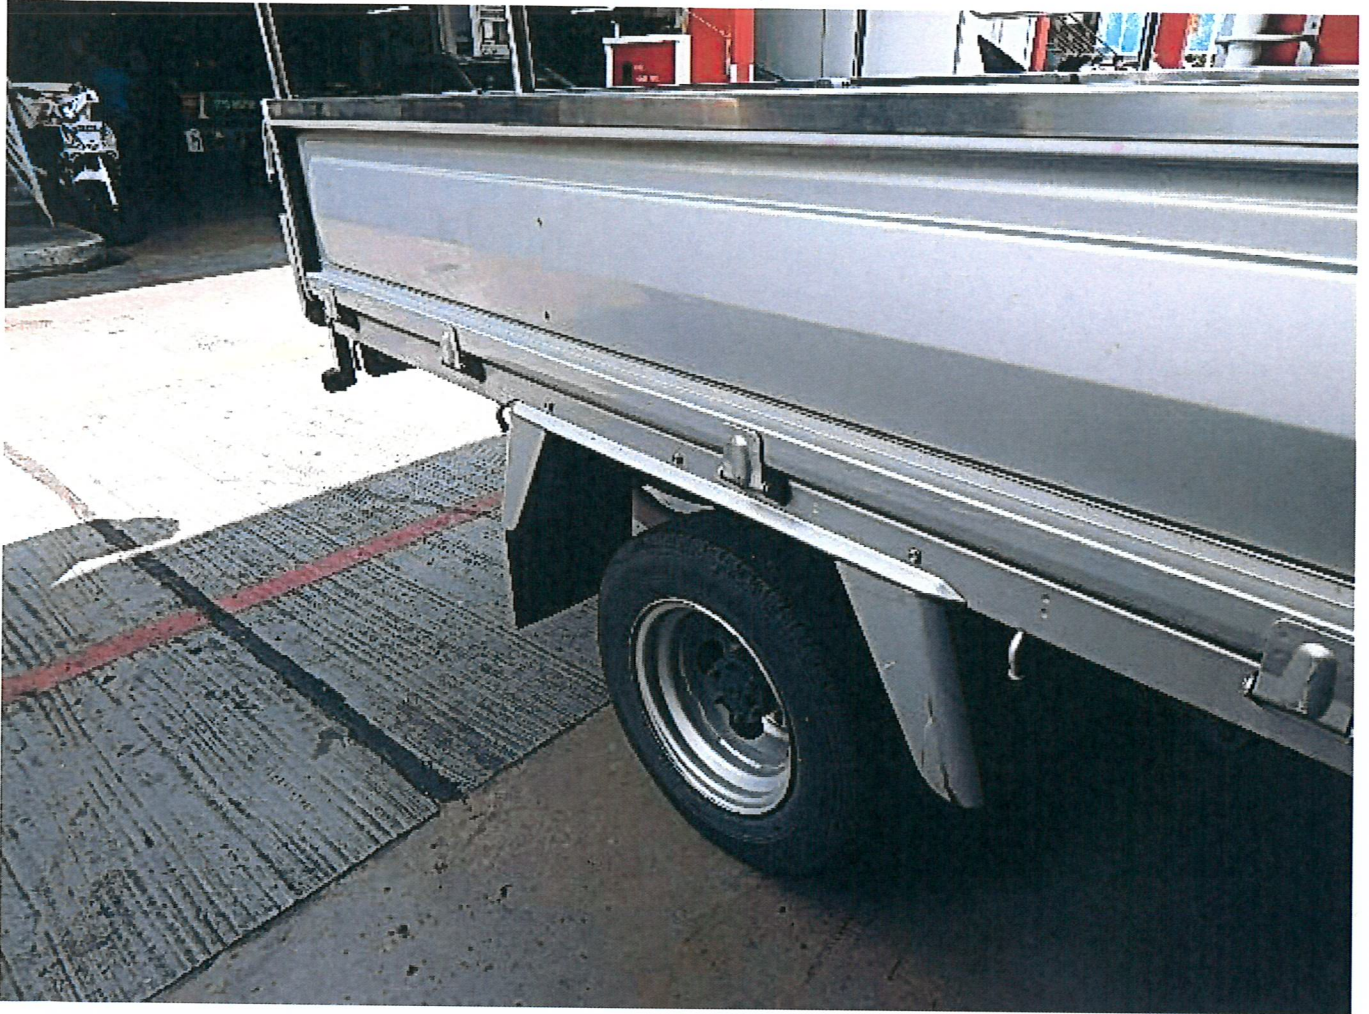
Accident Photo

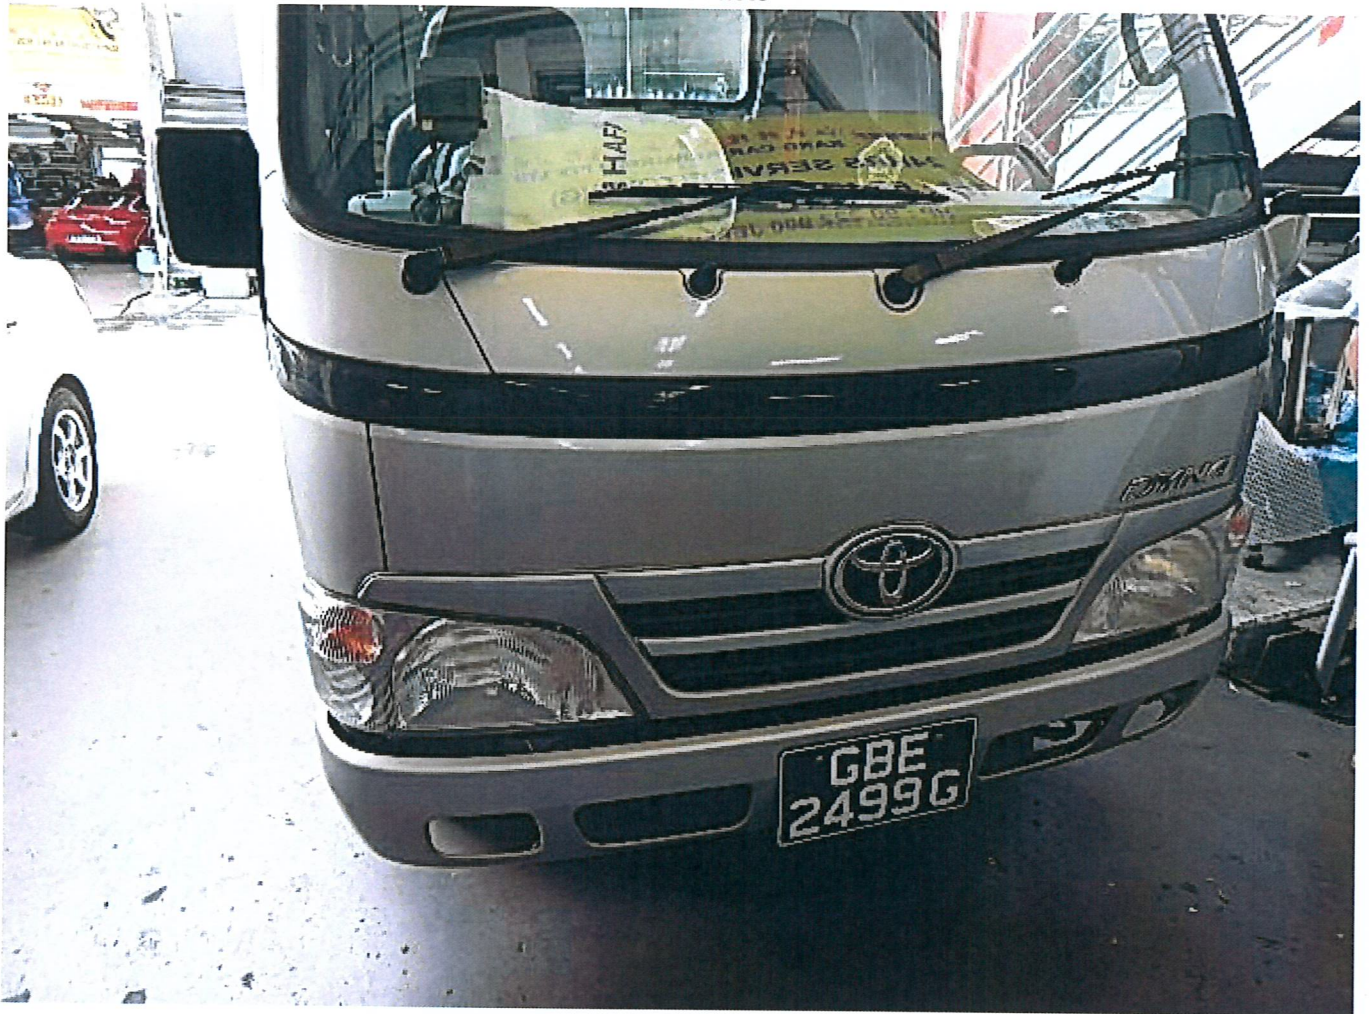
Accident Photo
