Your Ref: Mercedes Benz GLC 63s  
(chassis number WDC2539892F626934)

02 December 2021

Our Ref : CI/TP21012235/D

**INSPECTION REPORT OF AN UNREGISTERED MERCEDES BENZ GLC 63s MOTOR CAR WITH CHASSIS NUMBER WDC2539892F626934**

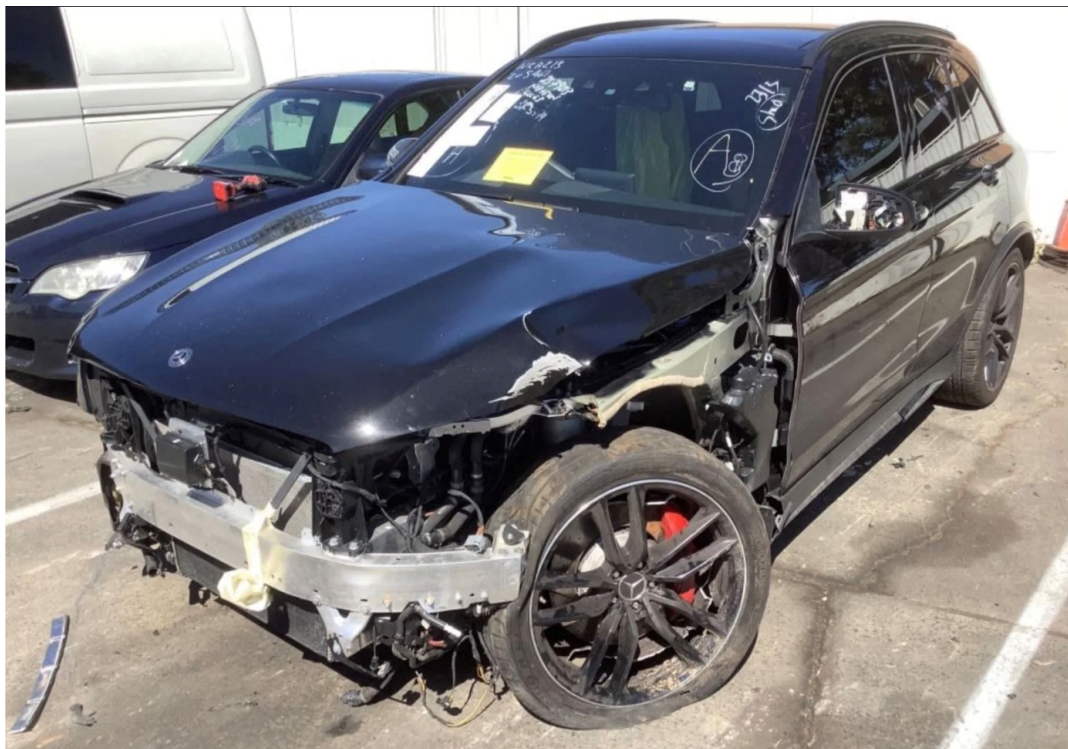
3. The photographs provided to me had showed damage to the Motor Car's front left portion and rear right portion. Body parts damaged at the front left portion include the front bumper reinforcement, front bonnet, front left wheel rim, front left tyre, left rocker panel garnish and left wing mirror amongst others. The radiator grille, front emblem, front left headlamp, front left fender wheel arc garnish, front left fender inner shield, front bumper and all its related parts and attachments like the front bumper left lower grille, front bumper right lower grille, front bumper centre lower grille and front sensors etc, were dislodged/missing/damaged.

4. The orientation of the Motor Car's front left wheel indicates damage to its front left undercarriage parts. Undercarriage parts that may possible be damaged include the front left lower arm, front left shock absorber, front left knuckle arm and front left steering tie rod amongst others.

**Photo 1** shows the front left body of the Motor Car (photograph provided to me). The photographs provided to me had showed damage to the front left portion of the Motor Car. Body parts damaged include the front bumper reinforcement, front bonnet, front left wheel rim, front left tyre, left rocker panel garnish and left wing mirror amongst others. The radiator grille, front emblem, front left headlamp, front left fender wheel arc garnish, front left fender inner shield, front bumper and all its related parts and attachments like the front sensors, front bumper left lower grille and front bumper centre lower grille amongst others, were dislodged/missing/damaged. The orientation of the front left wheel and front right wheel (refer to photograph 2 below) indicates damage to the front left undercarriage parts of the Motor Car.

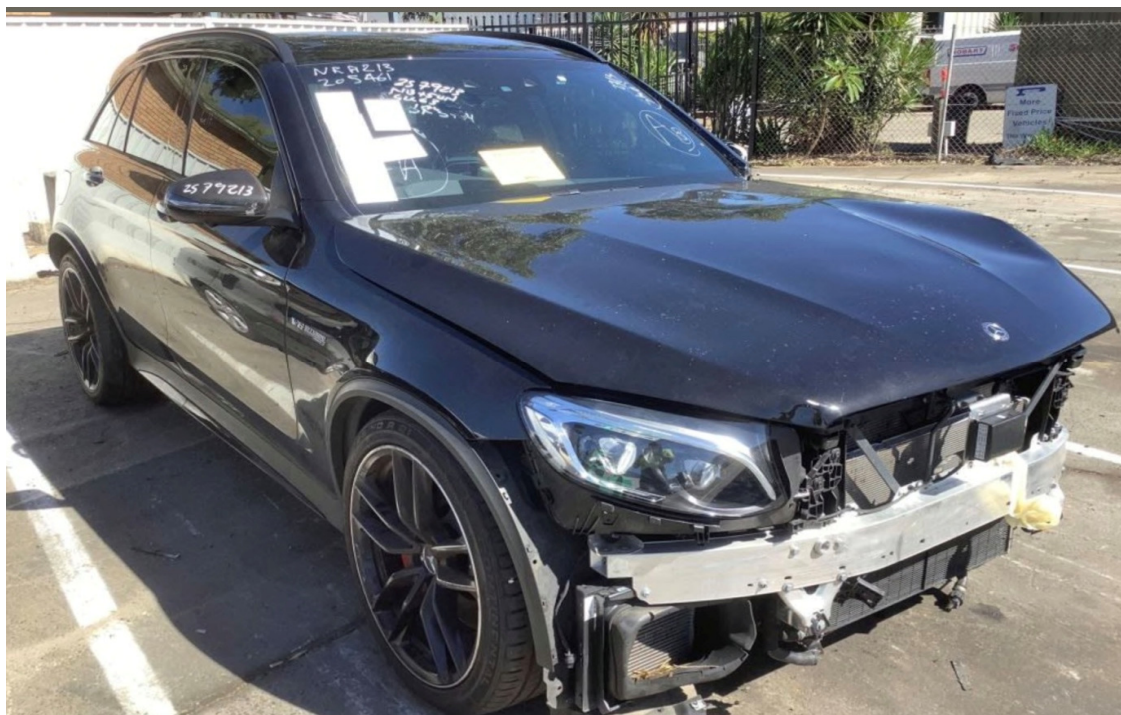
**Photo 2** shows the front right body of the Motor Car (photograph provided to me). The radiator grille, front emblem, front bumper and all its related parts and attachments like the front bumper centre lower grille, front bumper right lower grille and front sensors amongst others, were dislodged/missing/damaged.

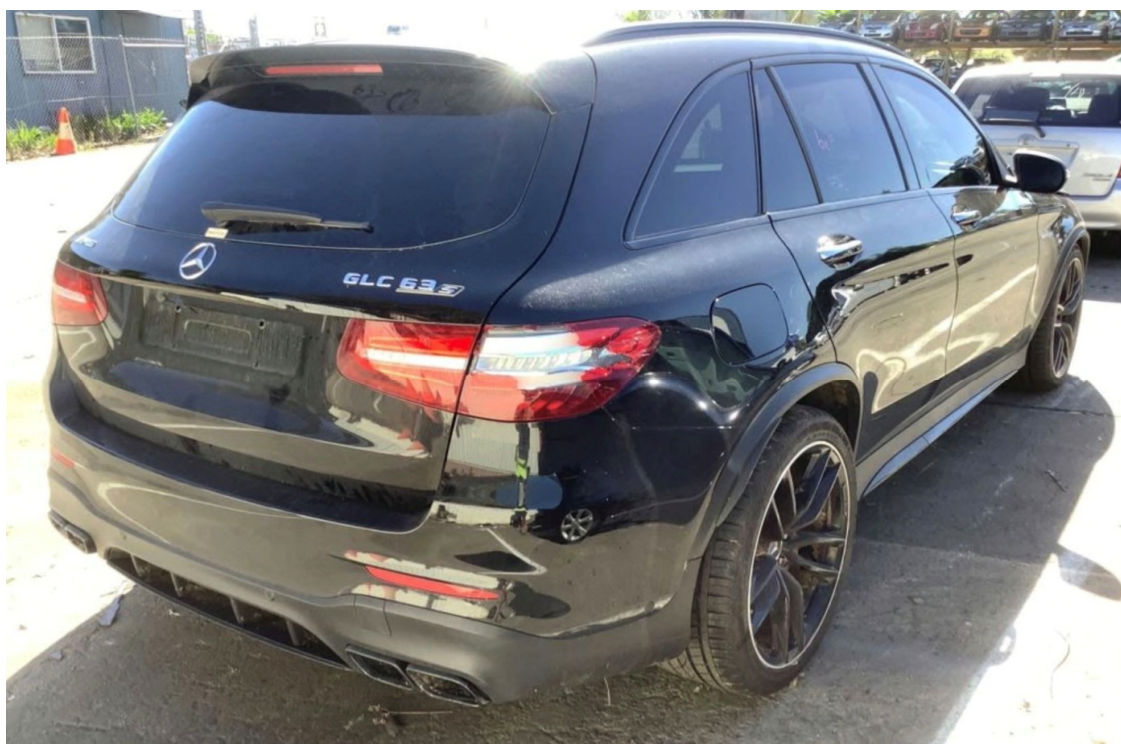
5. As for the rear right portion, I had observed that the rear right taillamp was broken. The Motor Car's airbag(s) was not deployed as seen from the photographs that were provided. See photo 1 – 5 below.

**Photo 3** shows the rear right body of the Motor Car (photograph provided to me). Apart for the front left portion, I had also observed that the rear right taillamp of the Motor Car was broken.

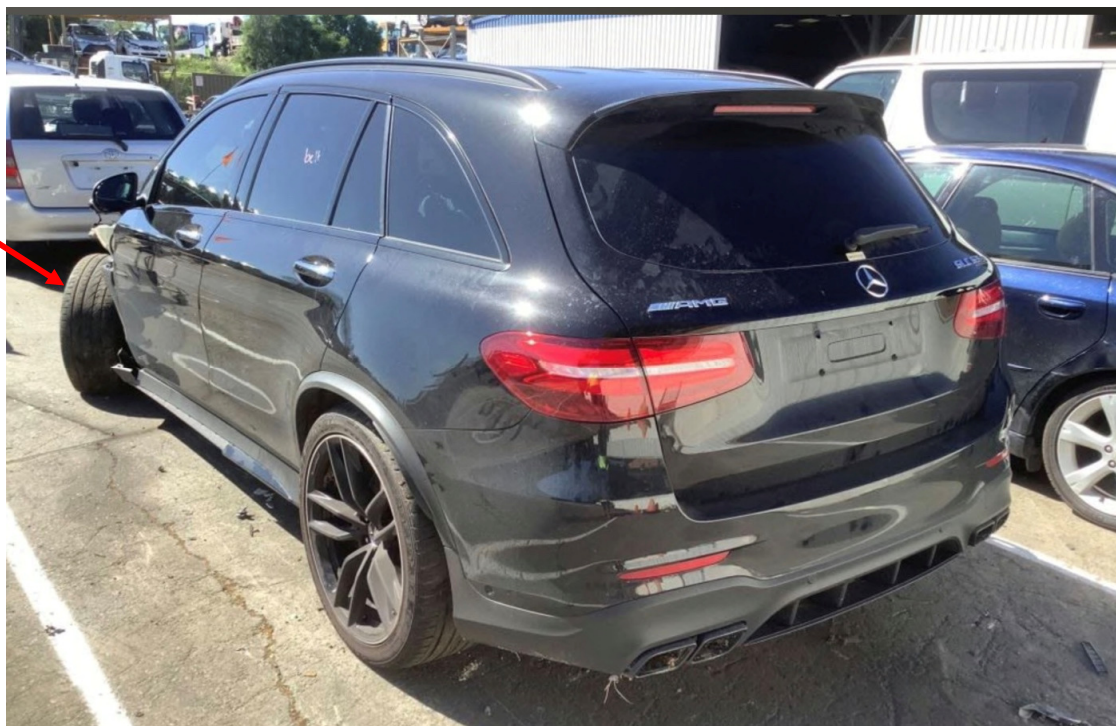
**Photo 4** shows the rear left body of the Motor Car (photograph provided to me). No physical damage was observed to the rear left portion of the Motor Car. The orientation of the front left wheel (arrowed) and front right wheel (refer to photograph 3 above) indicates damage to the front left undercarriage parts of the Motor Car.

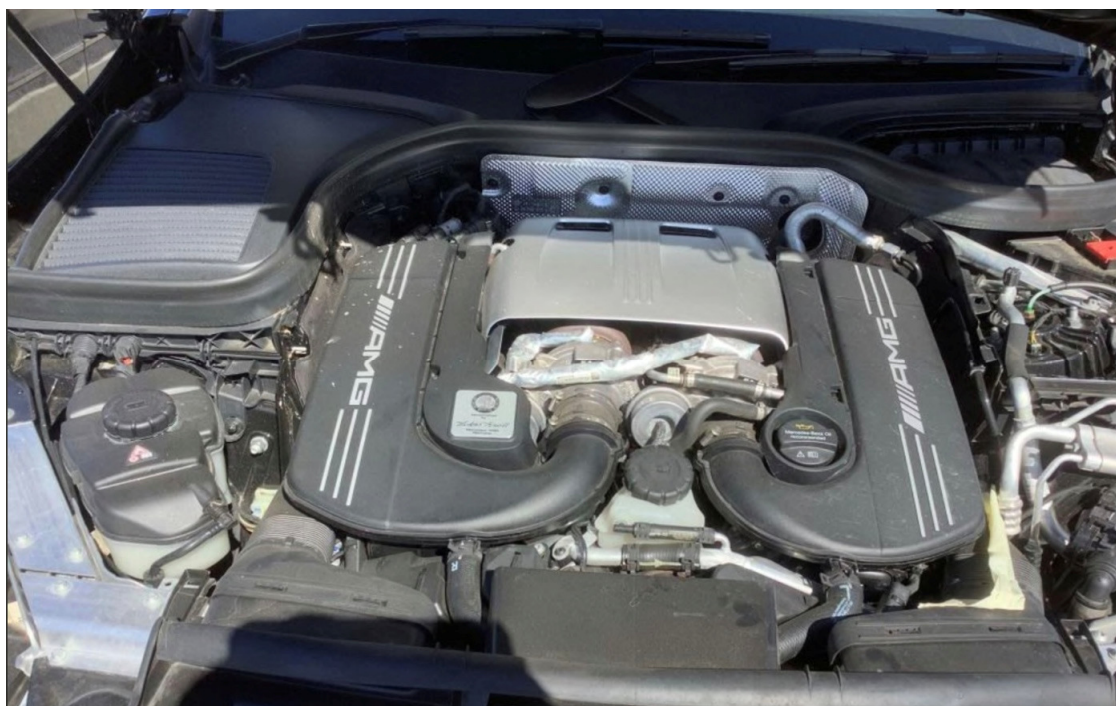
**Photo 5** shows the engine compartment of the Motor Car (photograph provided to me). The various parts and components within the engine compartment were observed to be intact and unaffected.

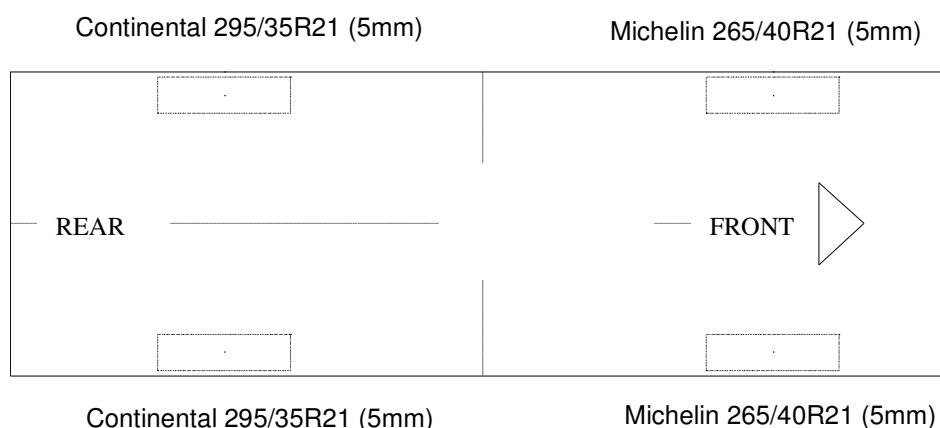
9. It was fitted with 21inch sport wheel rims that were wrapped with tyres that were observed to be of serviceable condition. The tyres were also sufficiently inflated for vehicular operation. The tyre brand, tyre size and approximate remaining tread depth of the 4 tyres of the Motor Car were recorded as follows: -

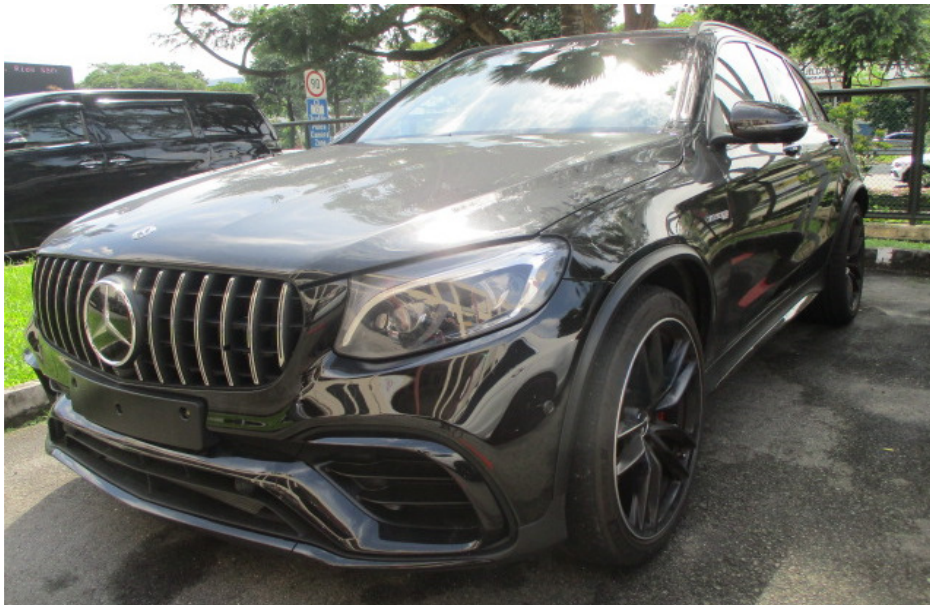
**Photo 6** shows a general view of the front left body of the Motor Car at the time of my inspection. The Motor Car was observed to be in a relatively good general condition with no loose exterior fittings observed. The body parts at the front left portion of the Motor Car were visually examined and it was observed that the repair/restoration works carried out to the damaged area of the Motor Car (refer to photograph 1 above) were reasonably adequate and in order.

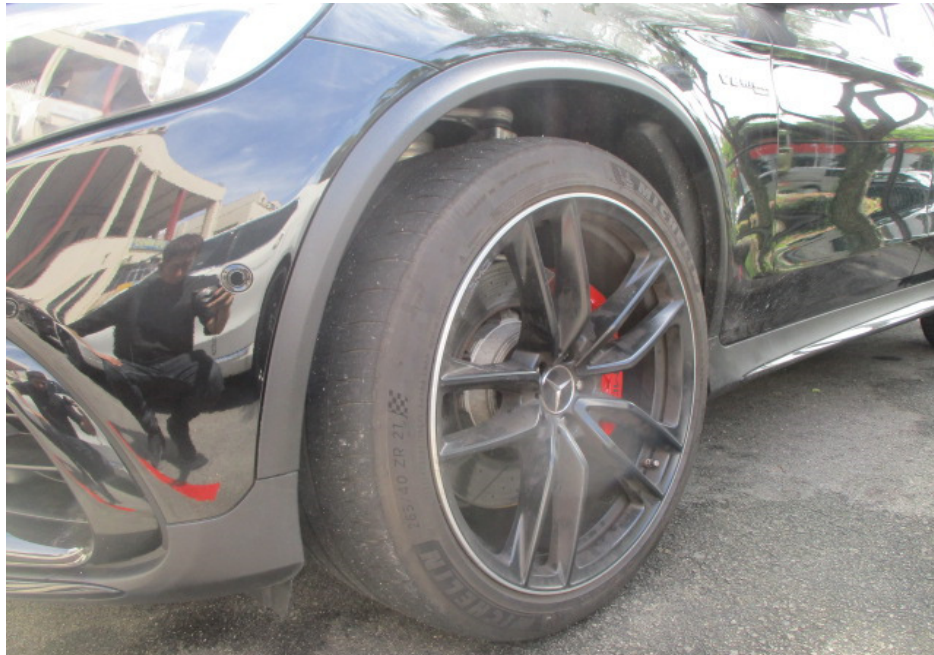
**Photo 7** shows a closer view of the Motor Car's front bumper, front left fender wheel arc garnish, front left wheel rim and front left tyre at the time of my inspection. The body parts at the front left portion of the Motor Car were visually examined and it was observed that the repair/restoration works carried out to the damaged area of the Motor Car (refer to photograph 1 above) were reasonably adequate and in order.

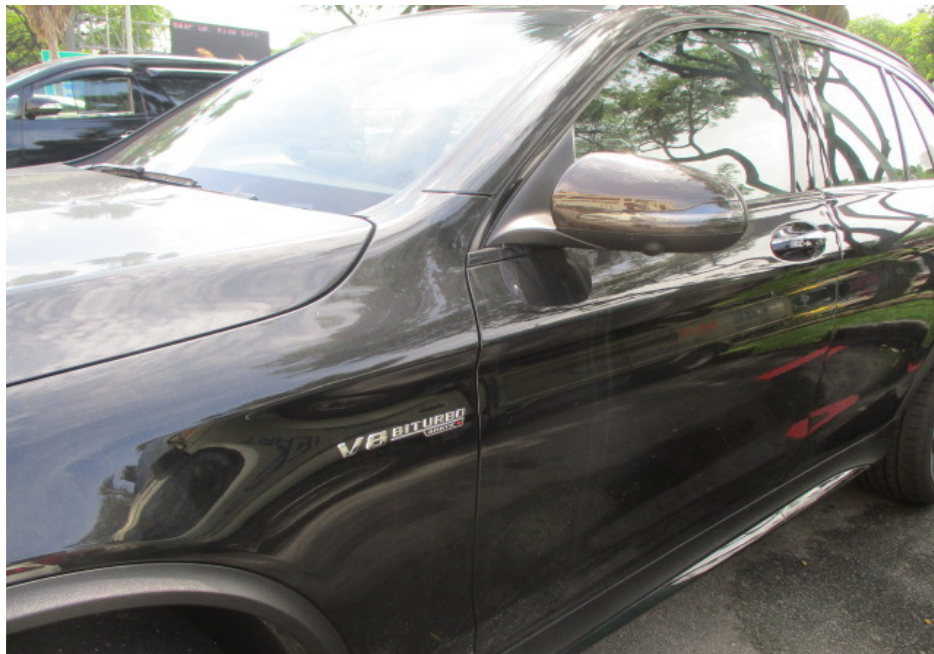
**Photo 8** shows a closer view of the Motor Car's front left fender, front left door and left wing mirror at the time of my inspection. The body parts at the front left portion of the Motor Car were visually examined and it was observed that the repair/restoration works carried out to the damaged area of the Motor Car (refer to photograph 1 above) were reasonably adequate and in order.

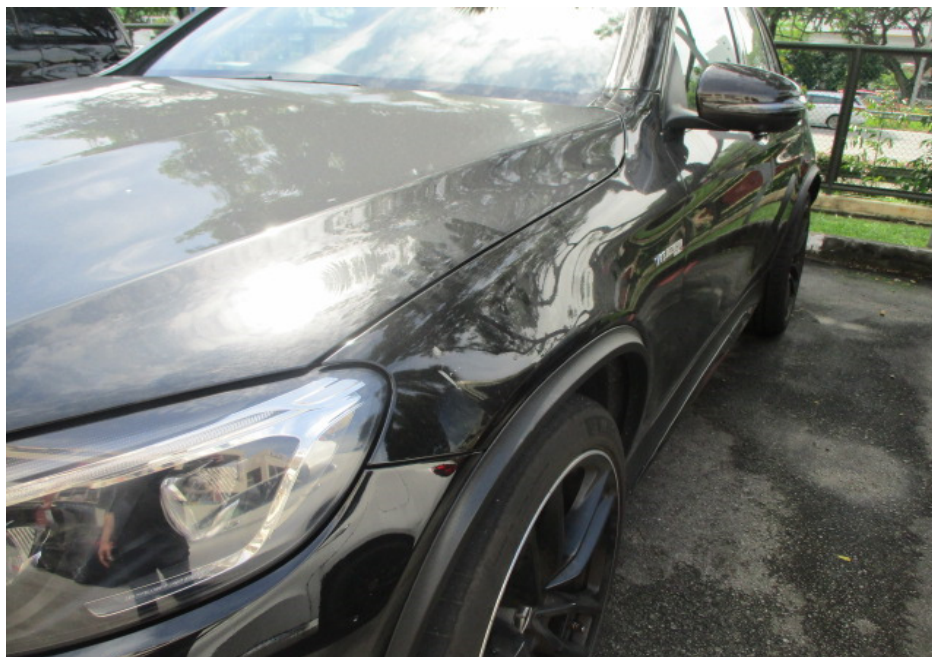
**Photo 9** shows a closer view of the Motor Car's front bonnet, front left headlamp, front left fender and front left fender wheel arc garnish. The body parts at the front left portion of the Motor Car were visually examined and it was observed that the repair/restoration works carried out to the damaged area of the Motor Car (refer to photograph 1 above) were reasonably adequate and in order.

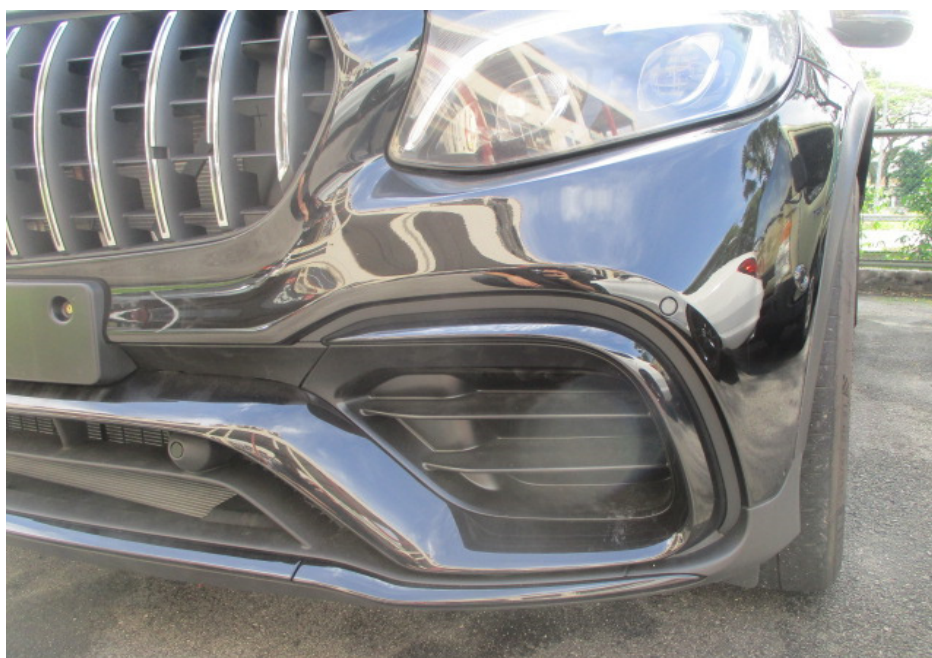
**Photo 10** shows a closer view of the Motor Car's front bumper, front bumper left lower grille, front bumper centre lower grille and radiator grille. The body parts at the front left portion of the Motor Car were visually examined and it was observed that the repair/restoration works carried out to the damaged area of the Motor Car (refer to photograph 1 above) were reasonably adequate and in order.

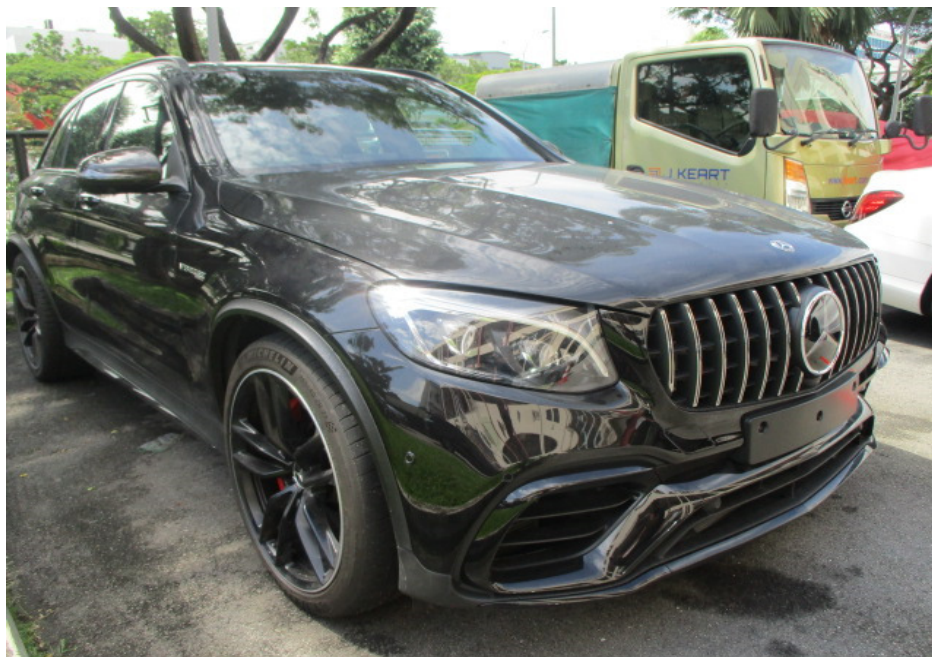
**Photo 11** shows a general view of the front right body of the Motor Car at the time of my inspection. The Motor Car was observed to be in a relatively good general condition with no loose exterior fittings observed. The mileage of the Motor Car recorded at the time of my inspection was 37,093km.

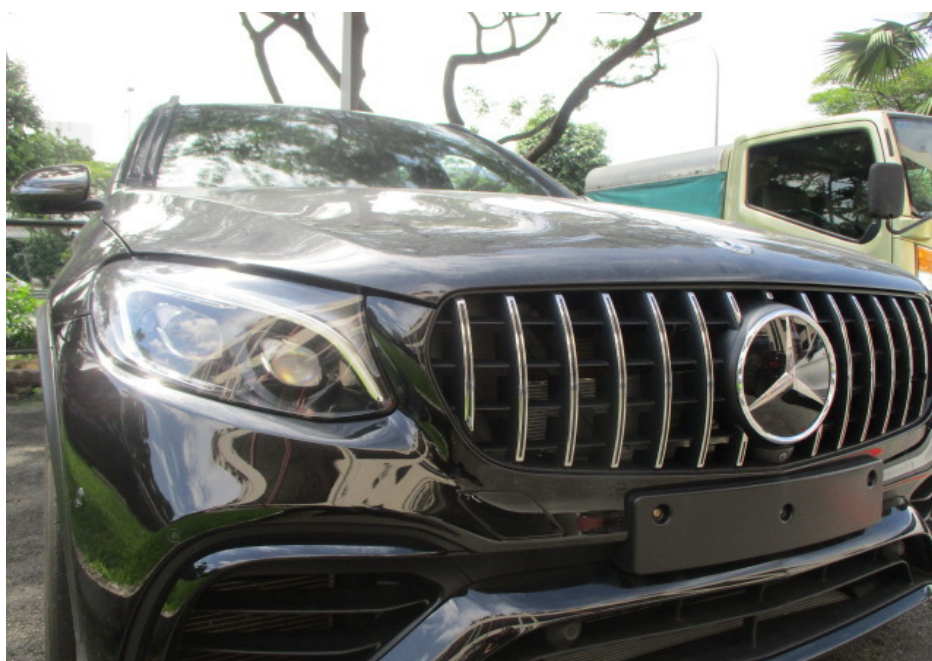
**Photo 12** shows a closer view of the Motor Car's front bumper, front bumper right lower grille, front right headlamp and radiator grille. The body parts at the frontal portion of the Motor Car were visually examined and it was observed that the repair/restoration works carried out to the damaged area of the Motor Car (refer to photograph 2 above) were reasonably adequate and in order.

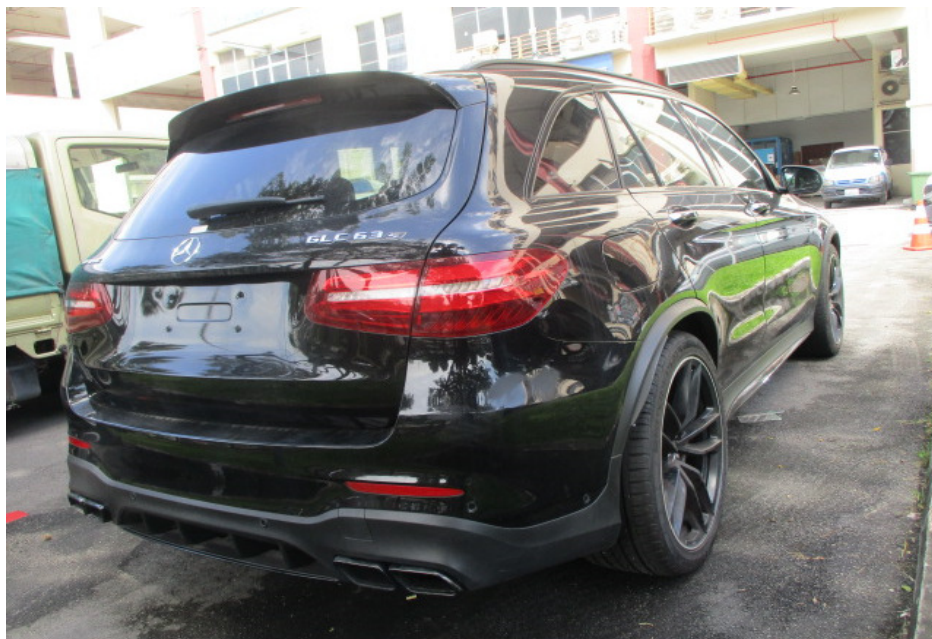
**Photo 13** shows a general view of the rear right body of the Motor Car at the time of my inspection. The Motor Car was observed to be in a relatively good general condition with no loose exterior fittings observed. The body parts at the rear right portion of the Motor Car were visually examined and it was observed that the repair/restoration works carried out to the damaged area of the Motor Car (refer to photograph 3 above) were reasonably adequate and in order.

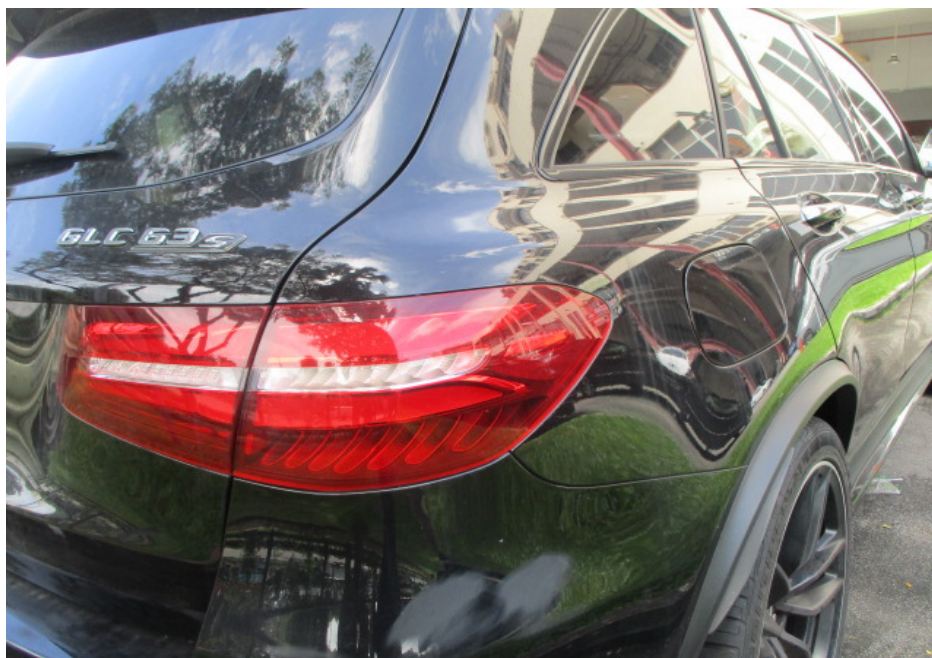
**Photo 14** shows a closer view of the Motor Car's rear bumper, rear bootlid, rear right bootlid lamp, rear right taillamp and rear right fender. The body parts at the rear right portion of the Motor Car were visually examined and it was observed that the repair/restoration works carried out to the damaged area of the Motor Car (refer to photograph 3 above) were reasonably adequate and in order.

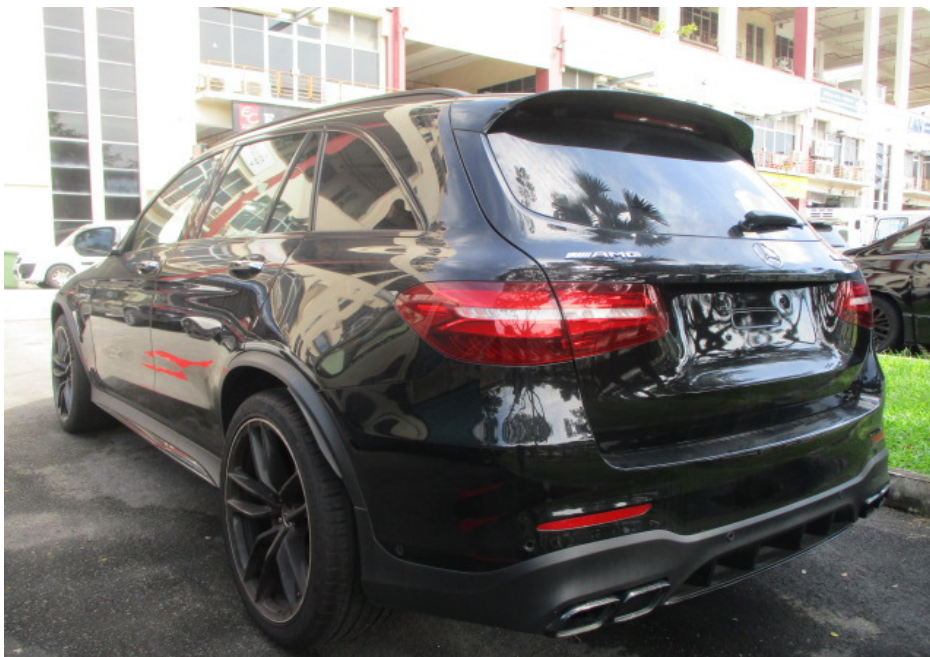
**Photo 15** shows a general view of the rear left body of the Motor Car at the time of my inspection. The Motor Car was observed to be in a relatively good general condition with no loose exterior fittings observed. The mileage of the Motor Car recorded at the time of my inspection was 37,093km.

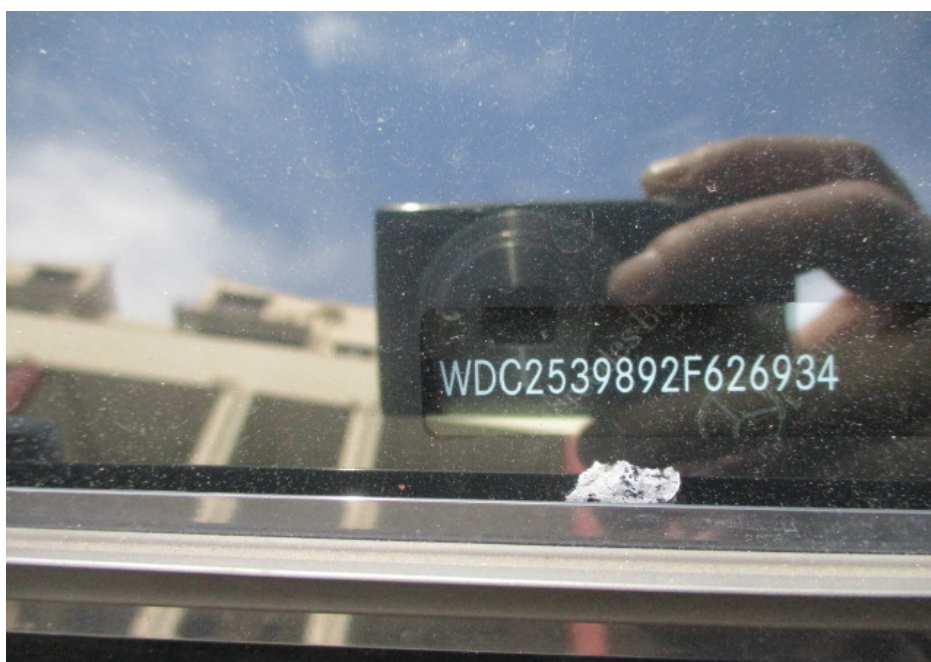
**Photo 16** shows the chassis number of the Motor Car. The chassis number recorded was WDC2539892F626934.

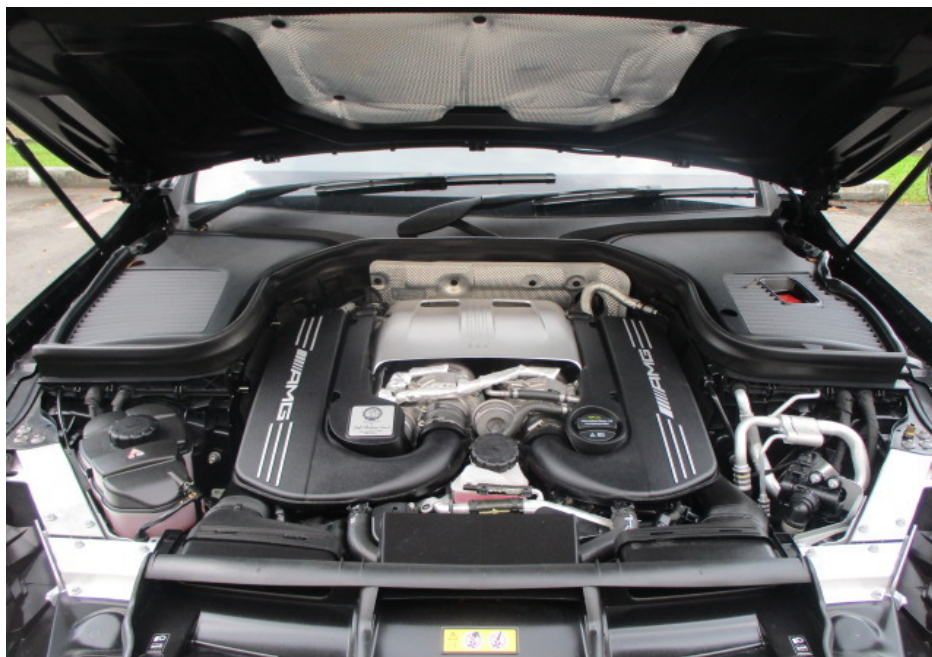
**Photo 17** shows a general view of the engine compartment of the Motor Car at the time of my inspection. The various parts and components inside the engine compartment were all observed to be intact and properly fitted. There was also no sign(s) or indication(s) of fluid leak and/or fluid stain found inside the engine compartment.

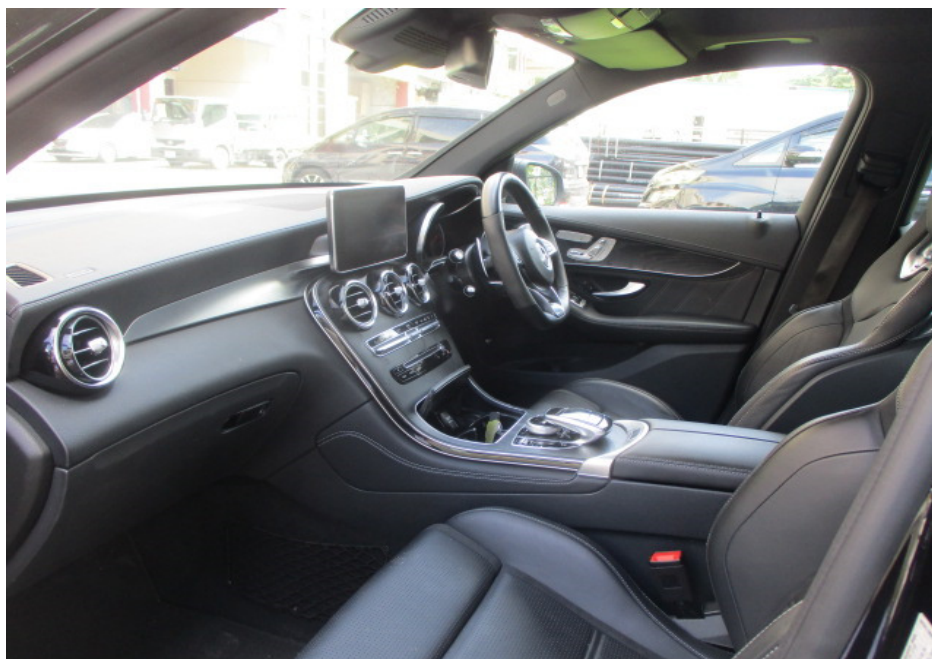
**Photo 18** shows the interior compartment of the Motor Car at the time of my inspection. The various parts and components, trims, carpet, and upholstery inside the interior compartment were all observed to be intact and properly fitted.

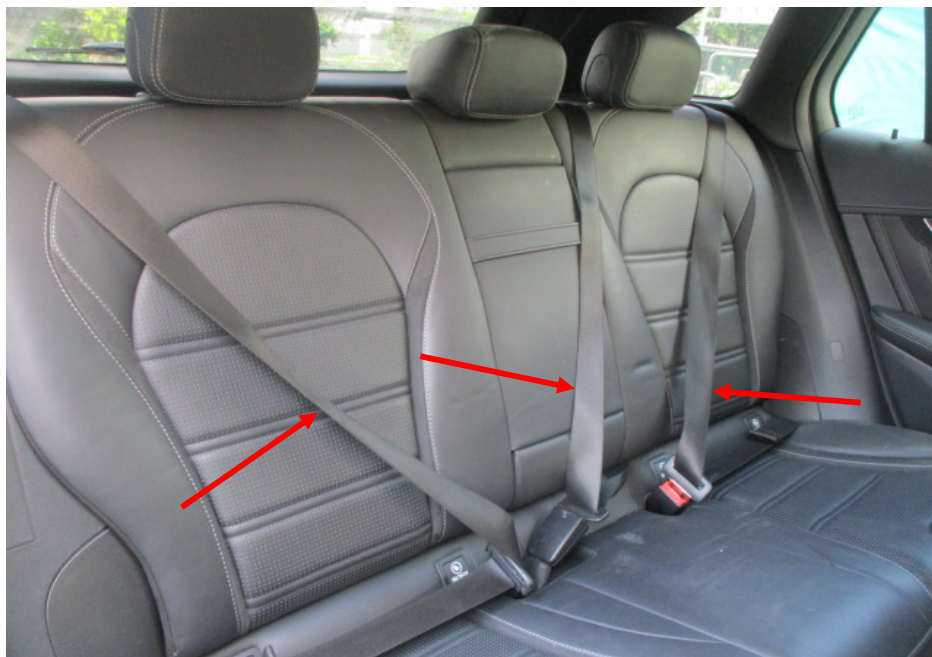
**Photo 19** shows the rear seats of the Motor Car. All the seats of the Motor Car were secured via seat rails to the floorboard. They were also fitted with a retractable seat belt reel and a pre-tensioner. The seat belts (arrowed) were tested and were able to be fastened into the respective pre-tensions that were fitted on the side of each individual seat.

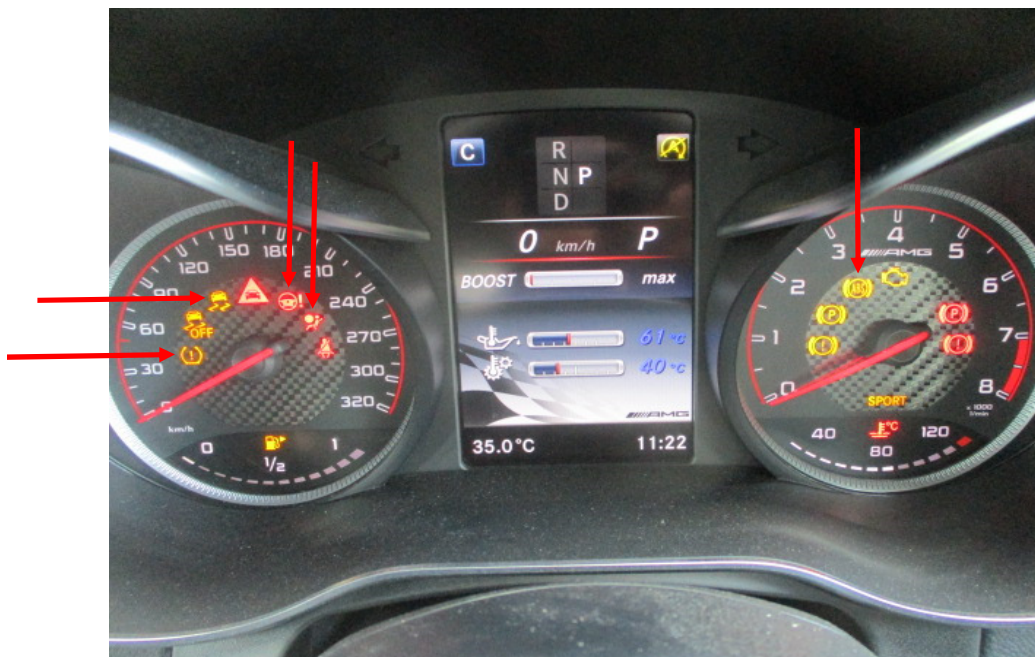
**Photo 20** shows the warning lights for the various electronic safety features appearing on the instrument panel of the Motor Car during its self-test when the engine is cranked, in particular the ABS, SRS, EPS, TPM and TCS lights (arrowed).

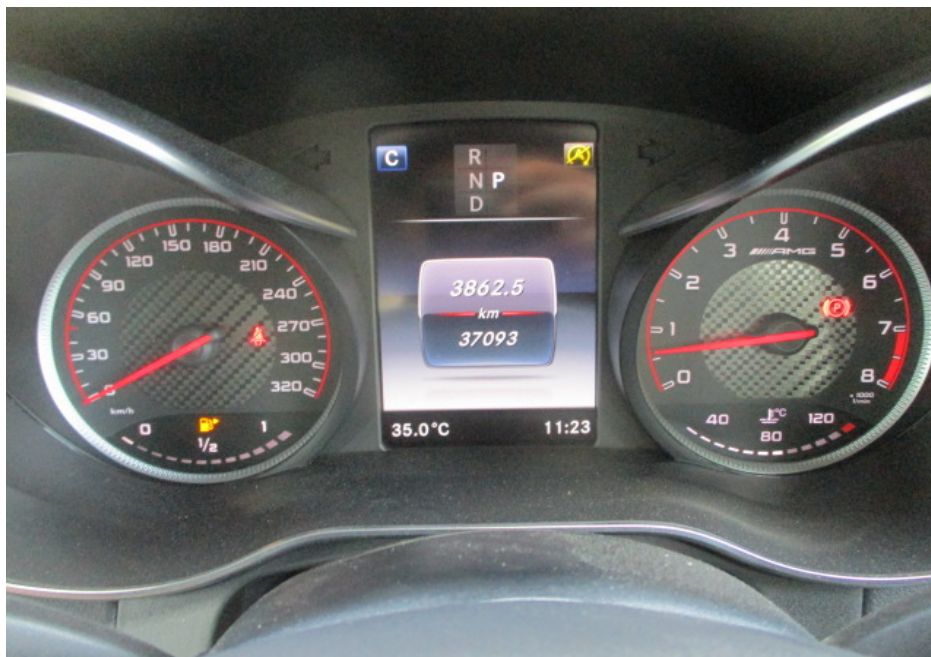
**Photo 21** shows the respective warning lights no longer illuminated, indicating that there is no fault detected to the ABS, SRS, EPS, TPM and TCS systems of the Motor Car during the self-test. These electronic systems were hence in working condition at the time of my inspection.

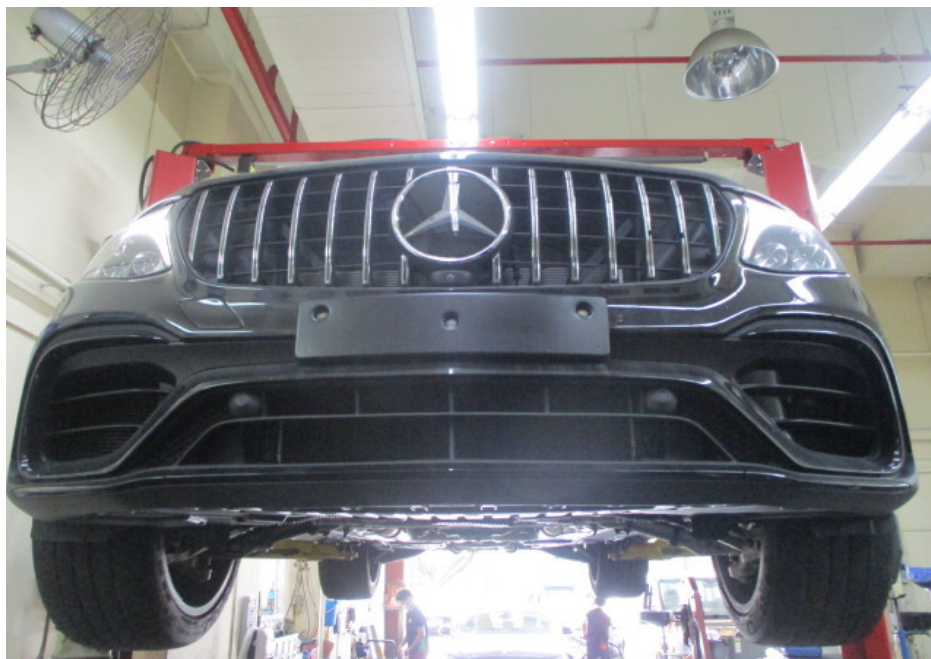
**Photo 22** shows the Motor Car hoisted up for checks on its undercarriage. There was no sign(s) or indication(s) of fluid leakage and/or fluid stain(s) on the underside of the Motor Car. The undercarriage components of the Motor Car were also all observed to be intact and secured in an appropriate manner.

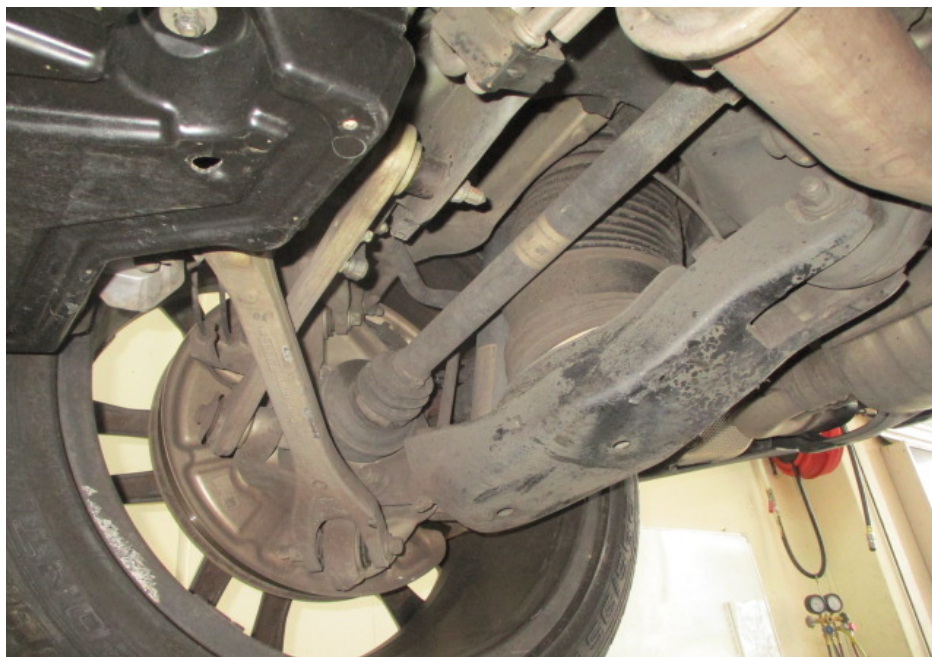
**Photo 23** shows a general view of the control arms and linkages at the rear right wheel of the Motor Car. I did not observe any fluid leak and/or fluid stain on the underside of the Motor Car. All of the Motor Car's undercarriage components were observed to be intact and secured in an appropriate manner.

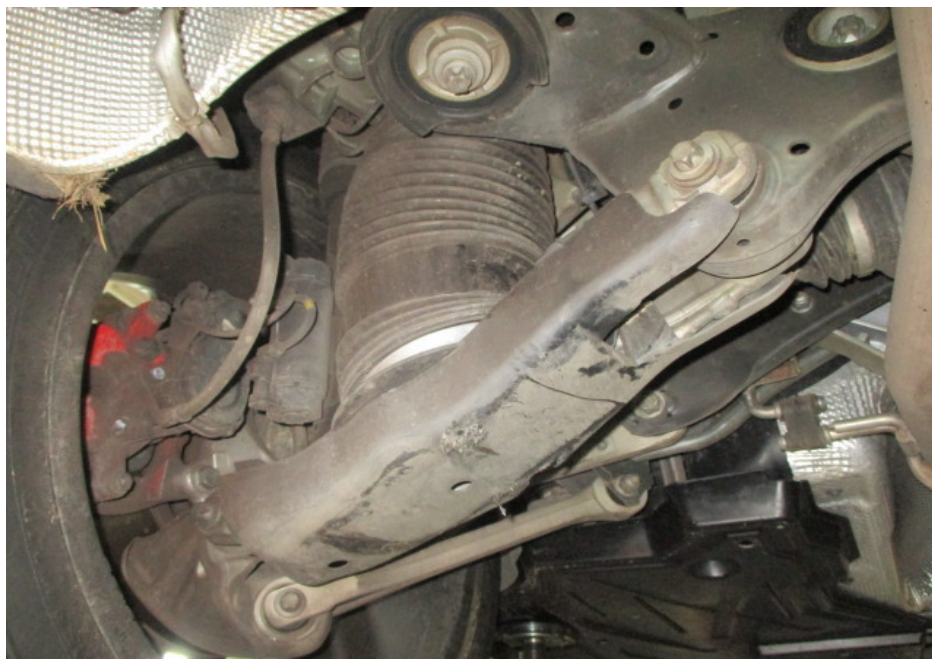
**Photo 24** shows a general view of the control arms and linkages at the rear left wheel of the Motor Car. I did not observe any fluid leak and/or fluid stain on the underside of the Motor Car. All of the Motor Car's undercarriage components were observed to be intact and secured in an appropriate manner.

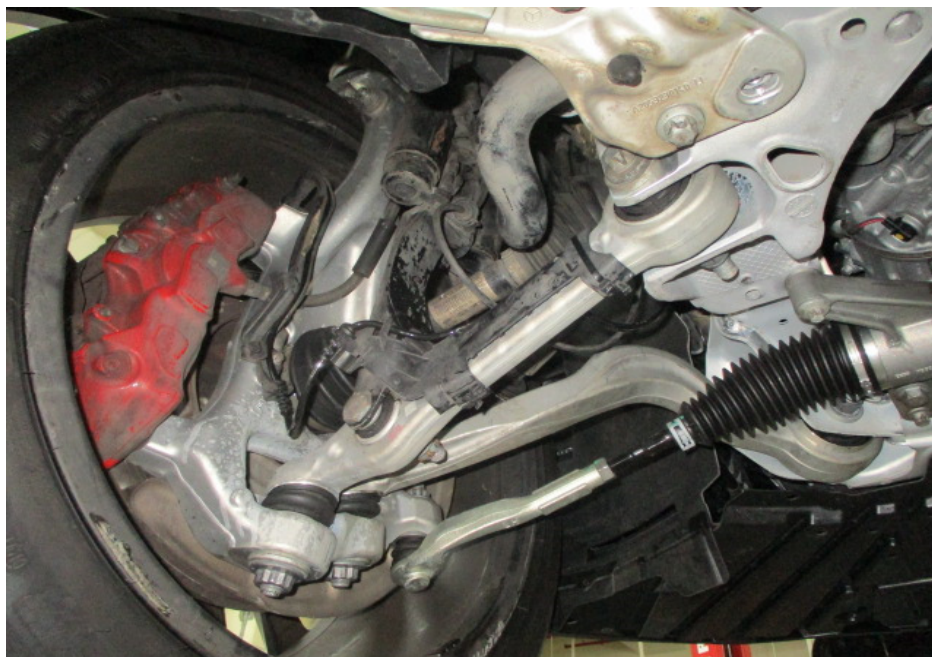
**Photo 25** shows the various undercarriage components at the front left wheel of the Motor Car. The mechanical components, control arms and linkages were all found to be intact and secured in an appropriate manner.

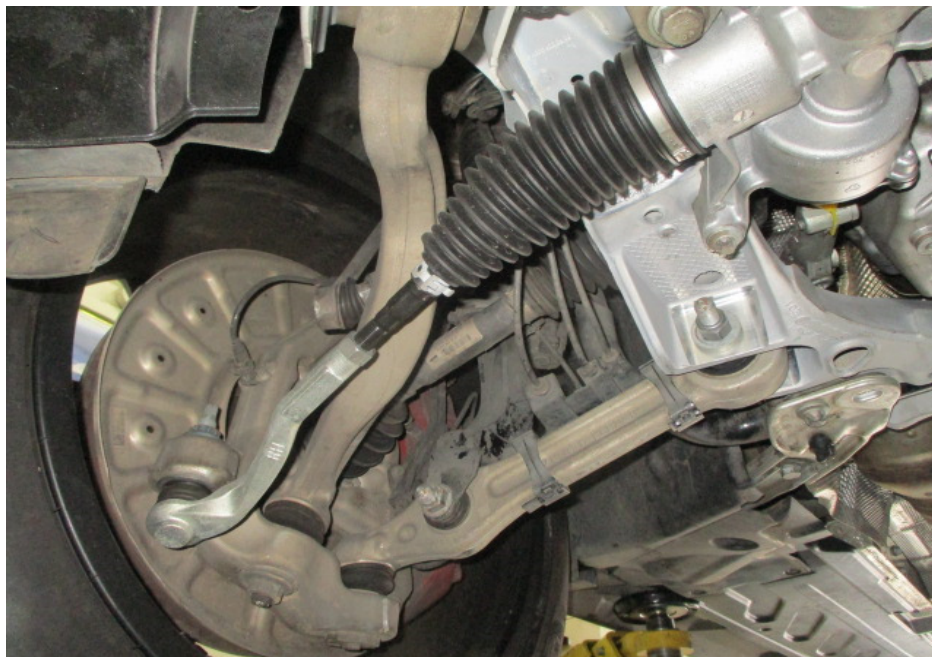
**Photo 26** shows the various undercarriage components at the front right wheel of the Motor Car. The mechanical components, control arms and linkages were all found to be intact and secured in an appropriate manner. I also did not observe any fluid leak and/or fluid stain on the underside of the Motor Car.

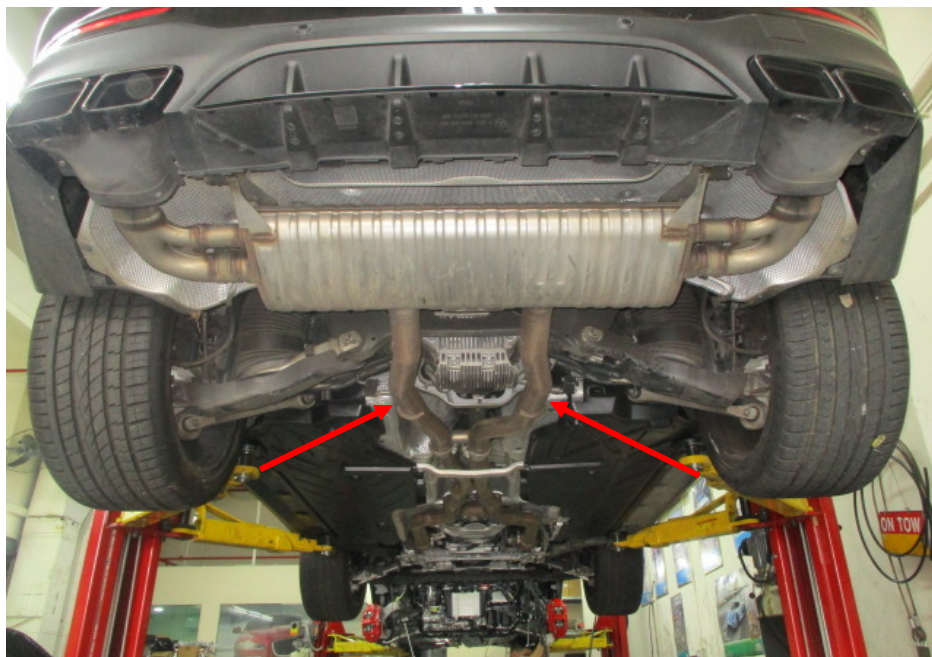
**Photo 27** shows the rear section of the Motor Car's exhaust system. My examination of the Motor Car's exhaust system revealed no sign(s) or indication(s) of any cut or weld marks along its exhaust pipes (arrowed), on its rear muffler and on its catalytic converters.

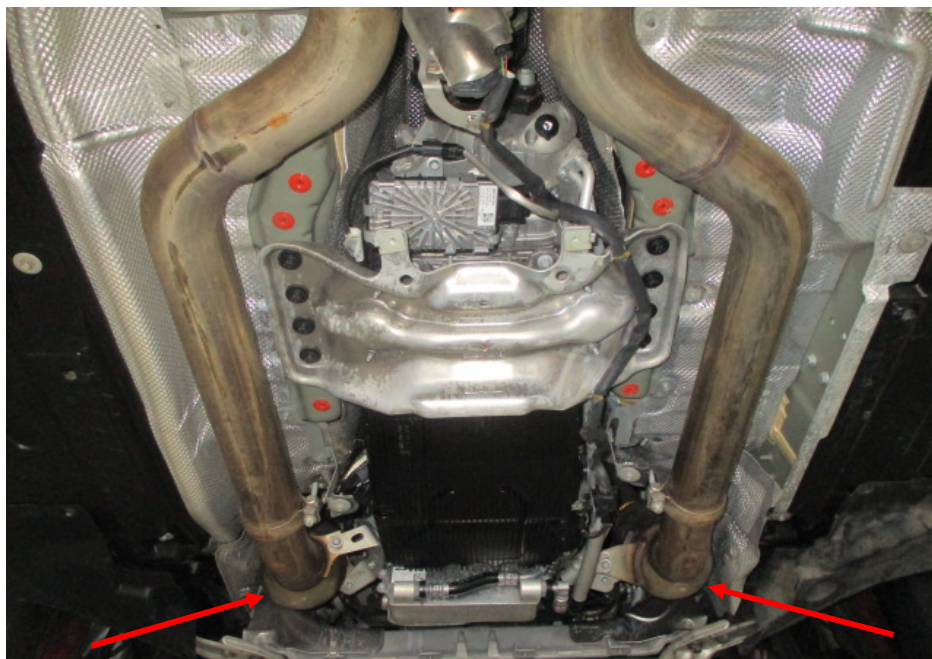
**Photo 28** shows the front section of the Motor Car's exhaust system. My examination of the Motor Car's exhaust system revealed no sign(s) or indication(s) of any cut or weld marks along its exhaust pipes, on its rear muffler, and on its catalytic converters (arrowed).

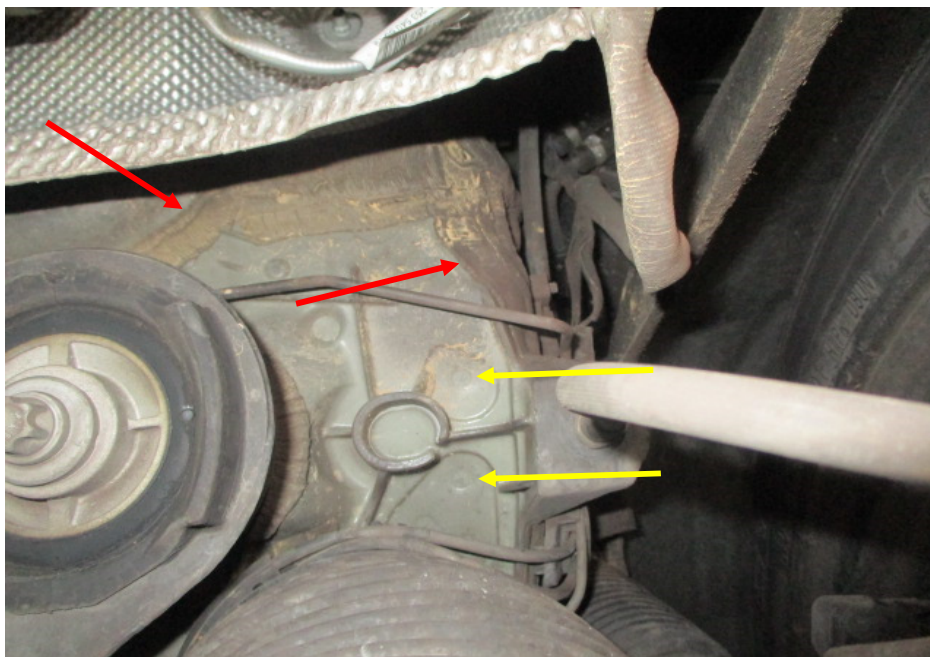
**Photo 29** shows the chassis/structural body at the underside rear right of the Motor Car. I did not find any weld marks other than original spot weld marks (yellow arrow) on the chassis/structural body of the Motor Car. The original factory sealant (red arrow) at the joints along the chassis/structural body was untouched, indicating no work was done on the chassis/structural body of the Motor Car and that the chassis/structural body was originally fitted.

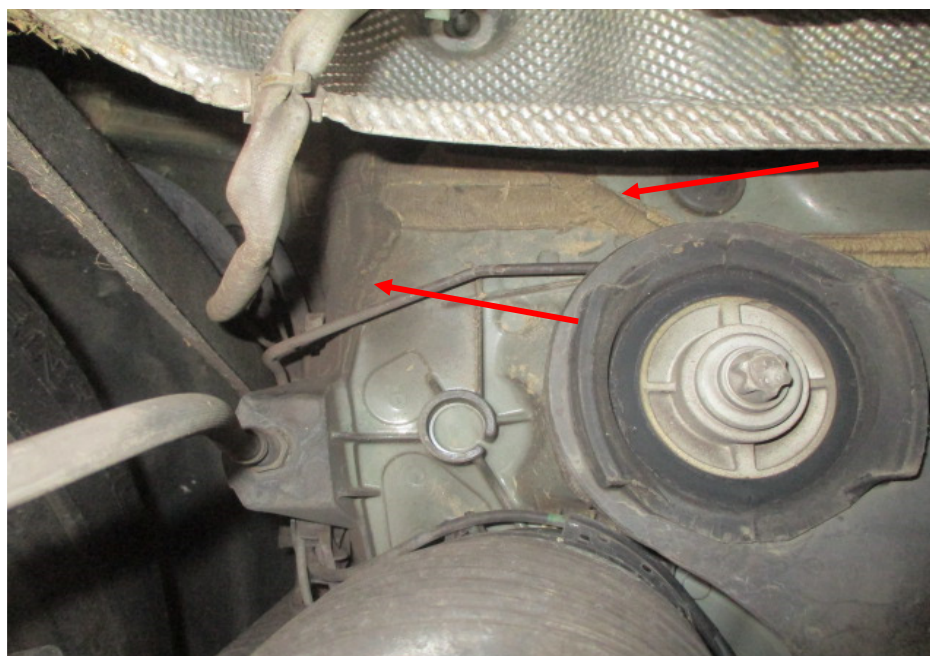
**Photo 30** shows the chassis/structural body at the underside rear left of the Motor Car. The original factory sealant (arrowed) at the joints along the chassis/structural body was observed to be untouched. In general, I had found no work was carried out on the chassis/structural body of the Motor Car. The chassis/structural body of the Motor Car was originally fitted.
