Your Ref: Mercedes Benz GLC 63s  
(chassis number WDC2539892F626934)

02 December 2021

Our Ref : CI/TP21012235/D

**INSPECTION REPORT OF AN UNREGISTERED MERCEDES BENZ GLC 63s MOTOR CAR WITH CHASSIS NUMBER WDC2539892F626934**

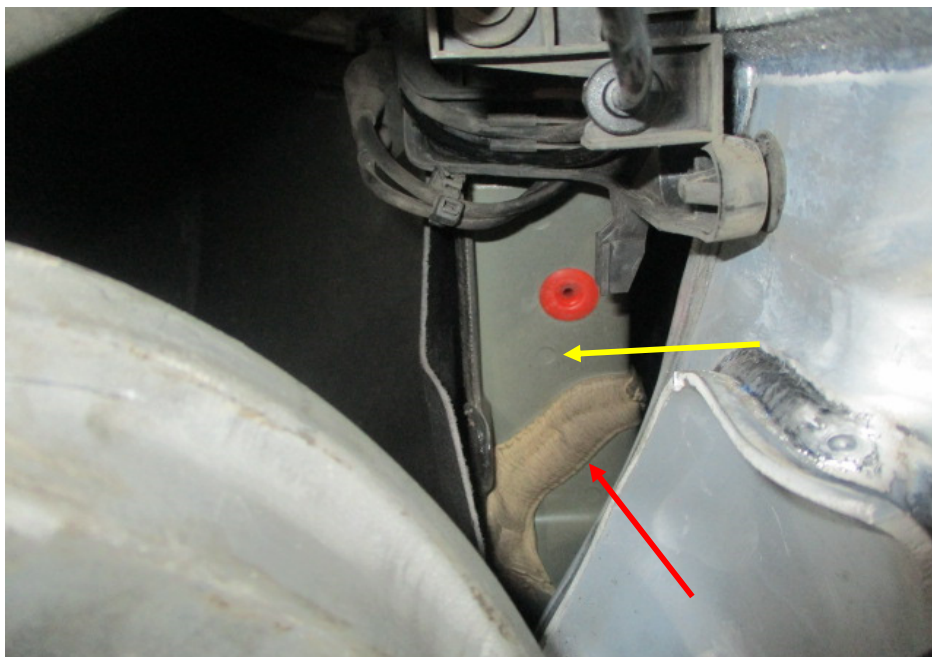
**Photo 31** shows the chassis/structural body at the underside front left of the Motor Car. I did not find any weld marks other than original spot weld marks (yellow arrow) on the chassis/structural body of the Motor Car. The original factory sealant (red arrow) at the joints along the chassis/structural body was untouched, indicating no work was done on the chassis/structural body of the Motor Car and that the chassis/structural body was originally fitted.

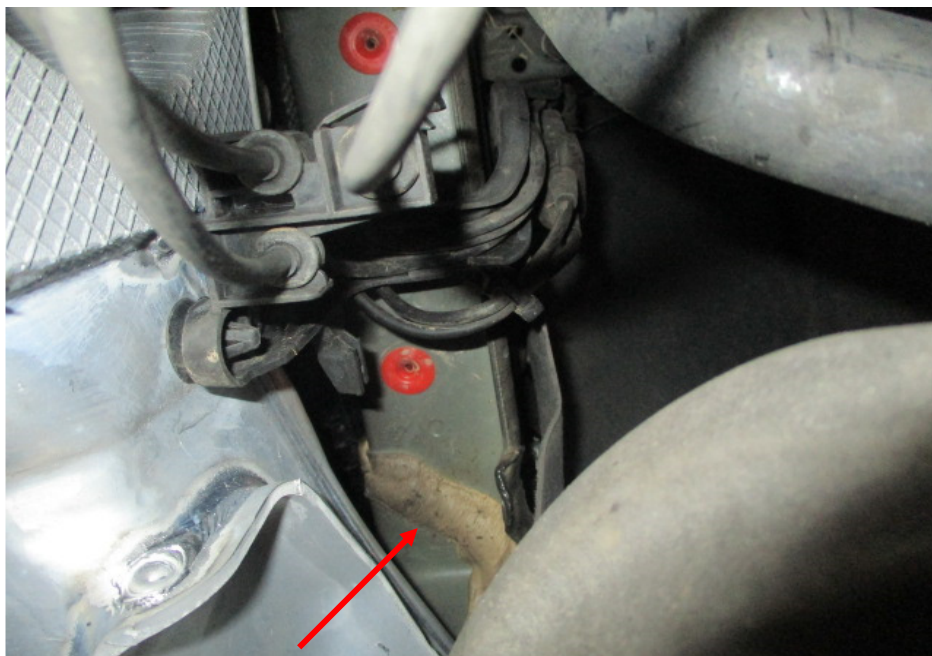
**Photo 32** shows the chassis/structural body at the underside front right of the Motor Car. The original factory sealant (arrowed) at the joints along the chassis/structural body was observed to be untouched. In general, I had found no work was carried out on the chassis/structural body of the Motor Car. The chassis/structural body of the Motor Car was originally fitted.

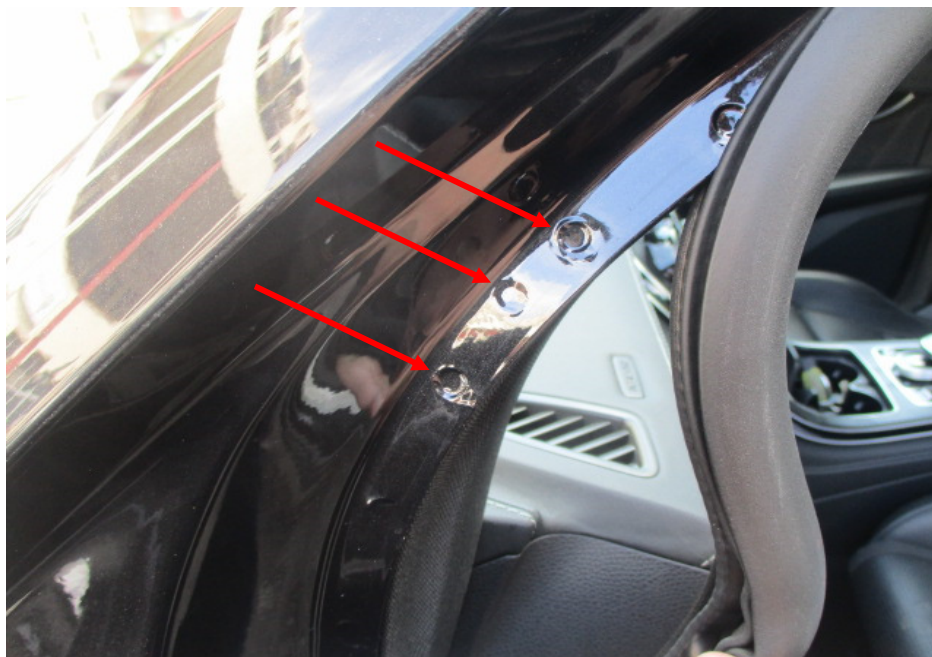
**Photo 33** shows the left side "A" pillar of the Motor Car. I did not find any weld marks other than original spot weld marks (arrowed) on the left side "A" pillar of the Motor Car which, indicates that there was no re-welding works carried out. In general, I had found all the non-detachable body panels of the Motor Car to be originally fitted at the time of my inspection.

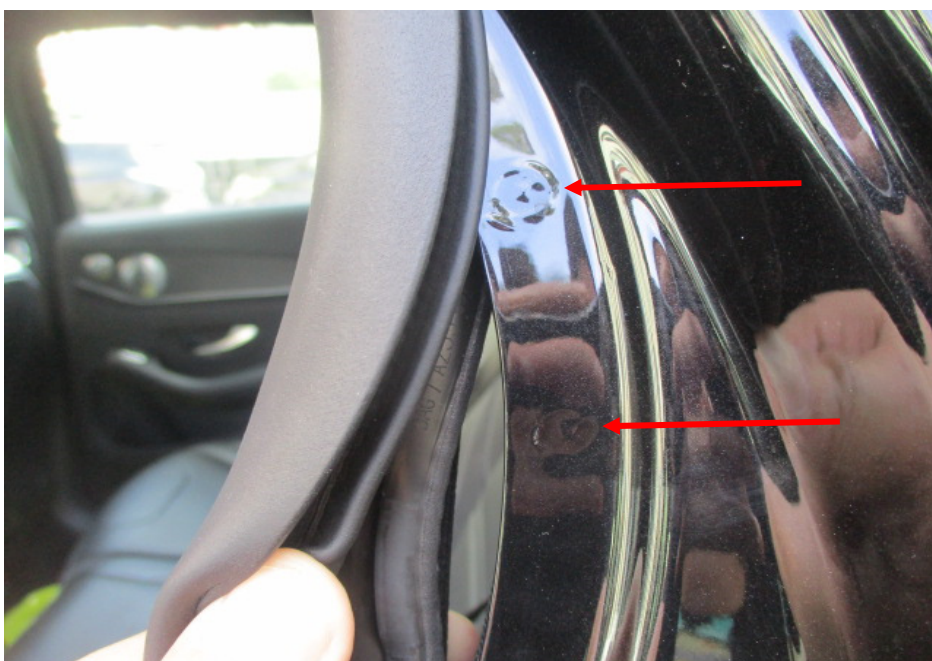
**Photo 34** shows the left side "C" pillar of the Motor Car. I did not find any weld marks other than original spot weld marks (arrowed) on the left side "C" pillar of the Motor Car which, indicates that there was no re-welding works carried out. In general, I had found all the non-detachable body panels of the Motor Car to be originally fitted at the time of my inspection.

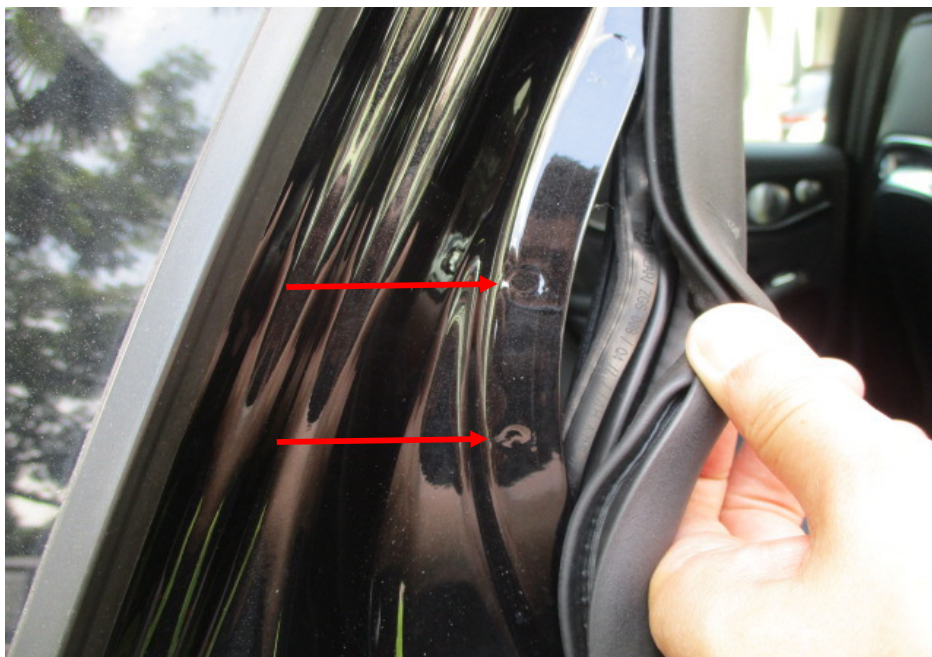
**Photo 35** shows the right side "C" pillar of the Motor Car. I did not find any weld marks other than original spot weld marks (arrowed) on the right side "C" pillar of the Motor Car which, indicates that there was no re-welding works carried out. In general, I had found all the non-detachable body panels of the Motor Car to be originally fitted at the time of my inspection.
