Your Ref: Mercedes Benz E200  
(chassis number W1K2130802A866466)  
Our Ref : CI/TP21012236/D

01 December 2021

**INSPECTION REPORT OF AN UNREGISTERED MERCEDES BENZ E200  
MOTOR CAR WITH CHASSIS NUMBER W1K2130802A866466**

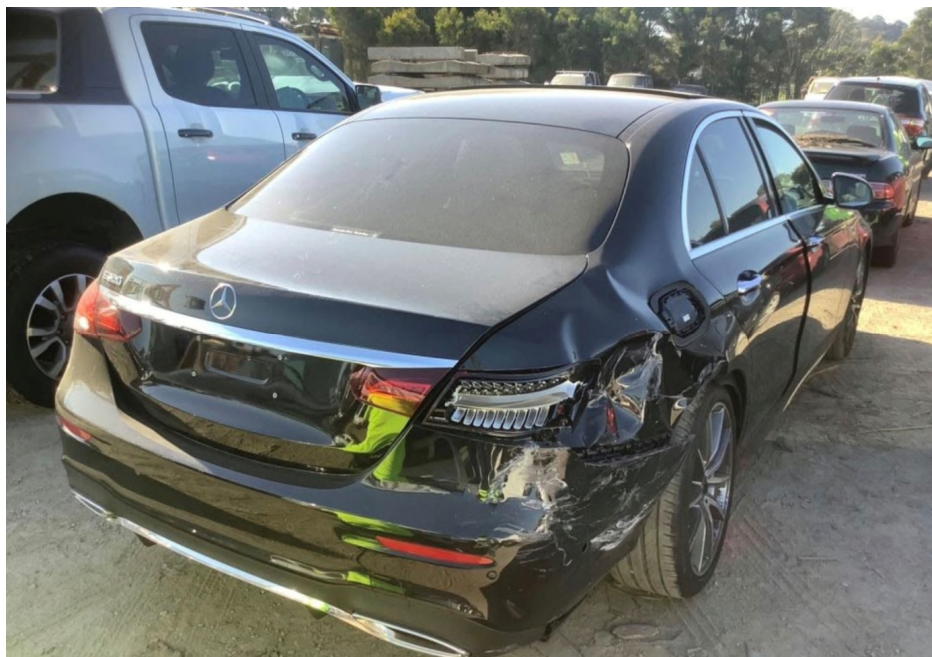
3. The photographs provided to me had showed damage to the right rear portion of the Motor Car. Body parts observed to be damaged include the rear bumper, rear bumper right reflector, rear bumper sensor, rear bootlid, rear right taillamp, rear right fender, rear right fender inner shield and petrol inlet outer cover amongst others.
4. No physical damage was observed to other areas of the Motor Car. The airbags were not deployed as seen from the photographs that were provided to me. See photo 1 – 6 below.

**Photo 1** shows the rear right body of the Motor Car (photograph provided to me). The photographs provided to me had showed damage to the right rear portion of the Motor Car. Body parts damaged include the rear bumper, rear bumper right reflector, rear bumper sensor, rear bootlid, rear right taillamp, rear right fender, rear right fender inner shield and petrol inlet outer cover amongst others.

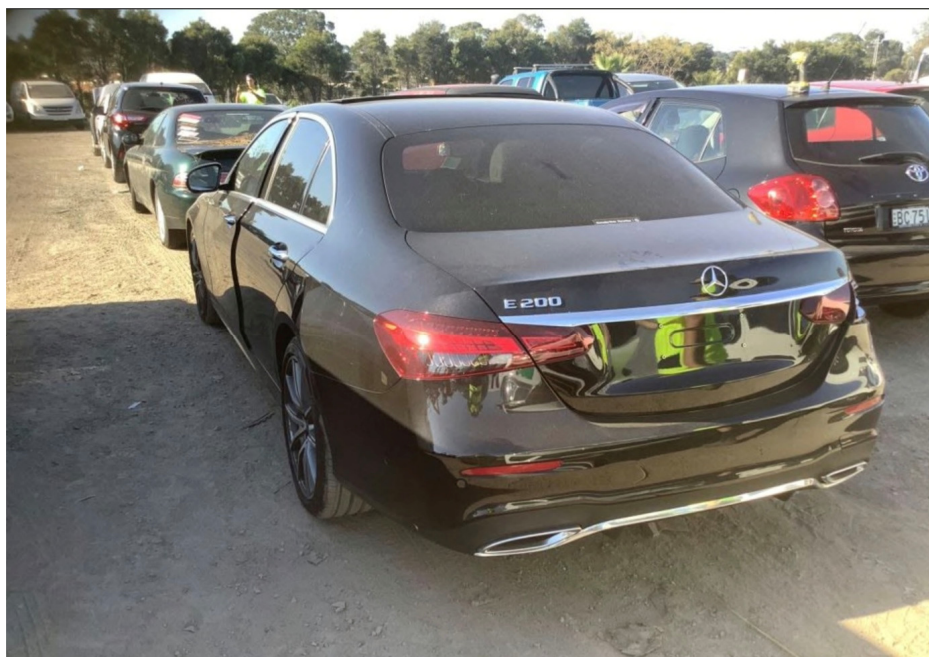
**Photo 2** shows the rear left body of the Motor Car (photograph provided to me). Apart for the right rear portion, there was no physical damage observed to other areas of the Motor Car. The airbags were also not deployed as seen from the photographs that were provided to me.

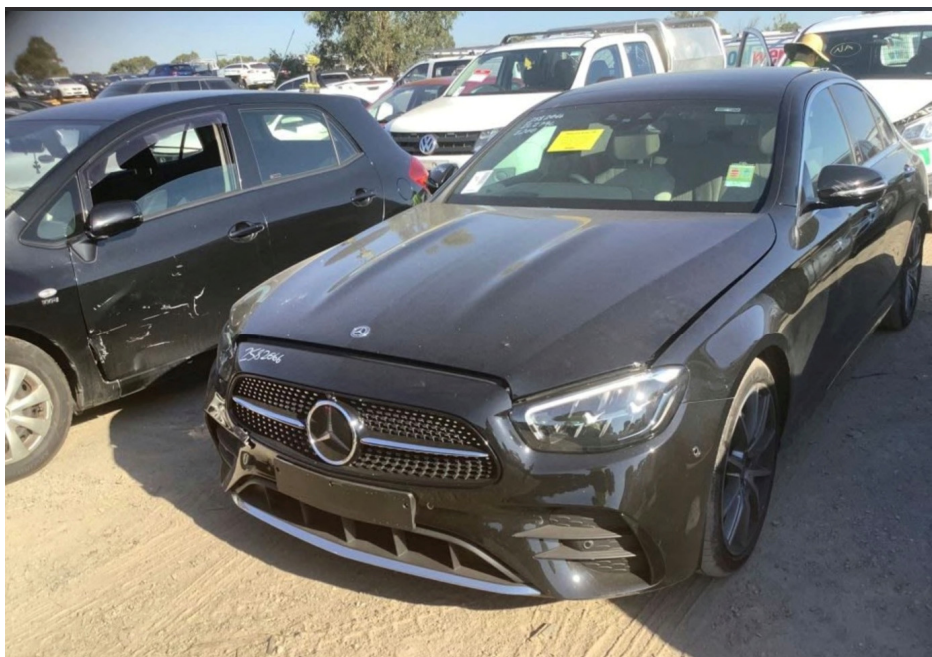
**Photo 3** shows the front left body of the Motor Car (photograph provided to me). Apart for the right rear portion, there was no physical damage observed to other areas of the Motor Car. The airbags were also not deployed as seen from the photographs that were provided to me.

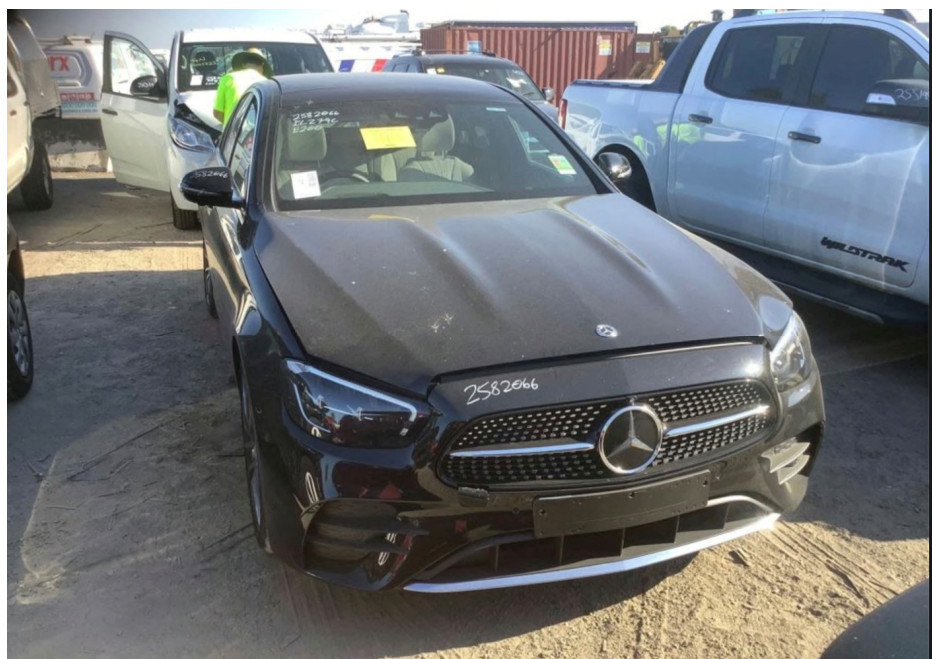
**Photo 4** shows the front right body of the Motor Car (photograph provided to me). Apart for the right rear portion, there was no physical damage observed to other areas of the Motor Car. The airbags were also not deployed as seen from the photographs that were provided to me.

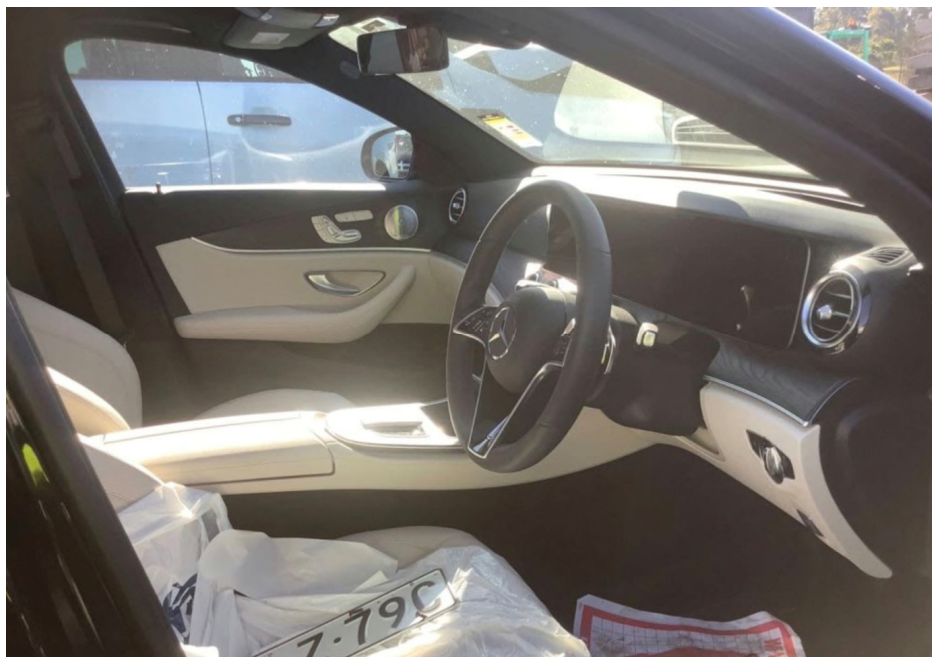
**Photo 5** shows the front interior compartment of the Motor Car (photograph provided to me). Parts and components within the interior compartment were observed to be unaffected. The airbags of the Motor Car were also not deployed as seen from the photographs that were provided to me.

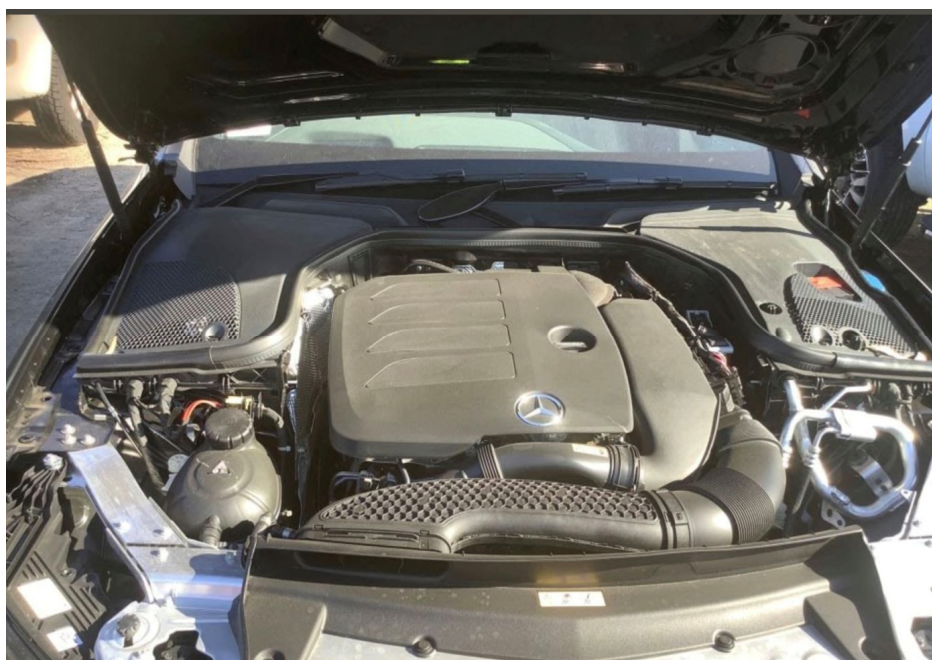
**Photo 6** shows the engine compartment of the Motor Car (photograph provided to me). Parts and components within the engine compartment were observed to be intact and unaffected.

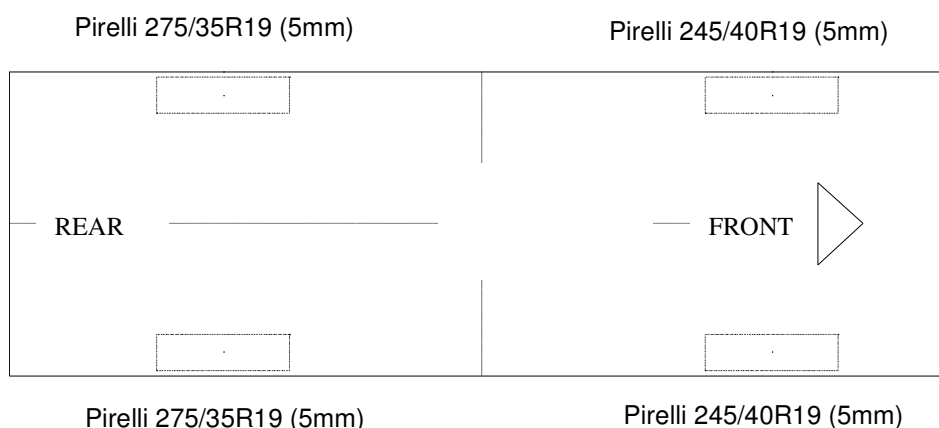
8. It was fitted with 19inch sport wheel rims that were wrapped with tyres that were observed to be of serviceable condition. The tyres were also sufficiently inflated for vehicular operation. The tyre brand, tyre size and approximate remaining tread depth of the 4 tyres of the Motor Car were recorded as follows: -

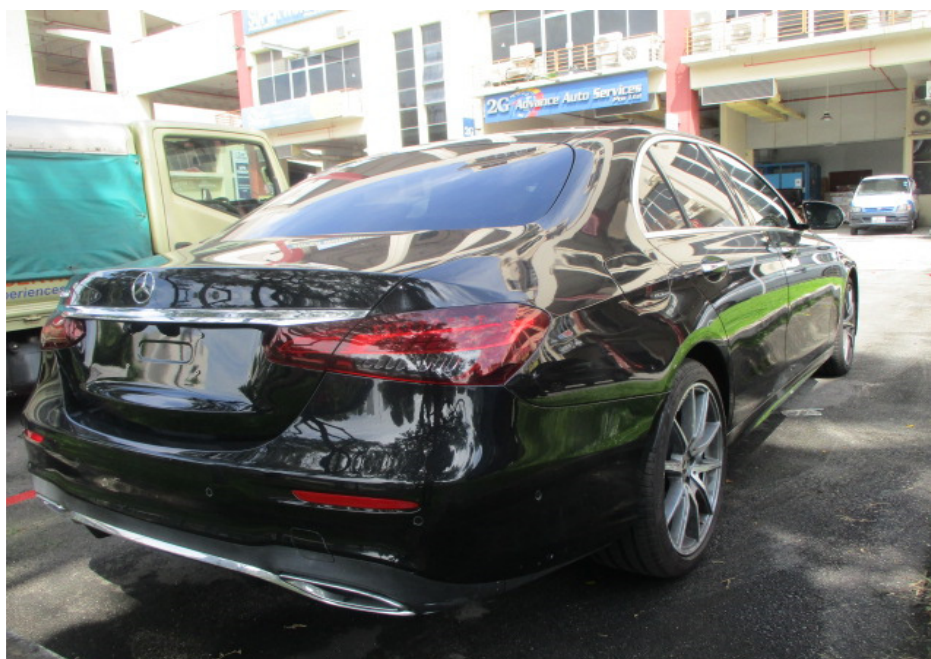
22. The body parts at the right rear portion of the Motor Car were visually examined and it was noted that the repair/restoration works carried out to the damaged area of the Motor Car (refer to photograph 1 above) were reasonably adequate and in order.

**Photo 7** shows a general view of the rear right body of the Motor Car at the time of my inspection. The Motor Car was observed to be in a relatively good general condition with no loose exterior fittings observed. The body parts at the right rear portion of the Motor Car were visually examined and it was observed that the repair/restoration works carried out to the damaged area of the Motor Car (refer to photograph 1 above) were reasonably adequate and in order.

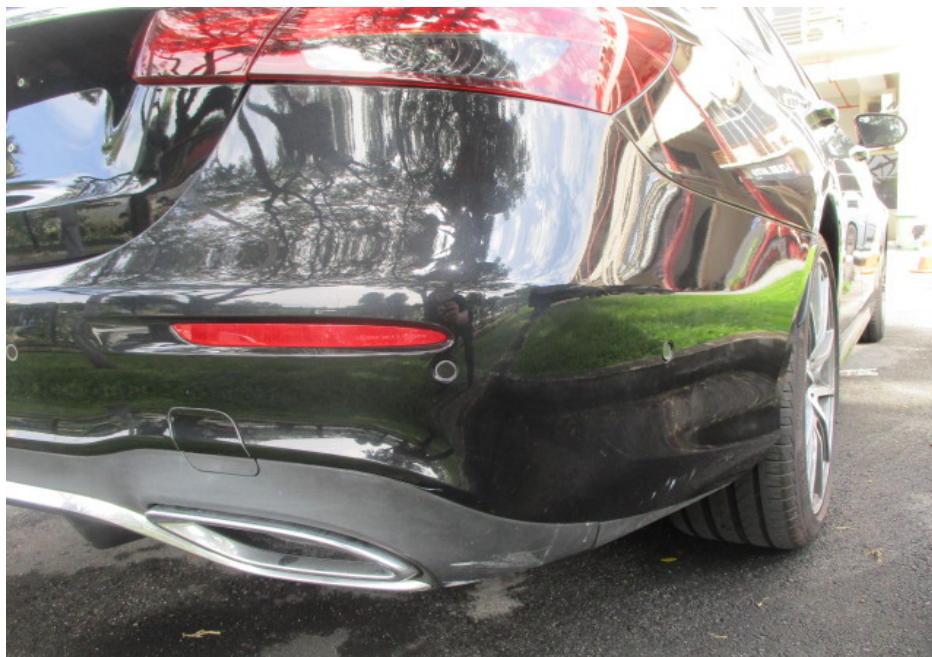
**Photo 8** shows a closer view of the Motor Car's rear bumper, rear bumper lower cover, rear bumper right reflector and rear bumper sensors at the time of my inspection. The body parts at the right rear portion of the Motor Car were visually examined and it was observed that the repair/restoration works carried out to the damaged area of the Motor Car (refer to photograph 1 above) were reasonably adequate and in order.

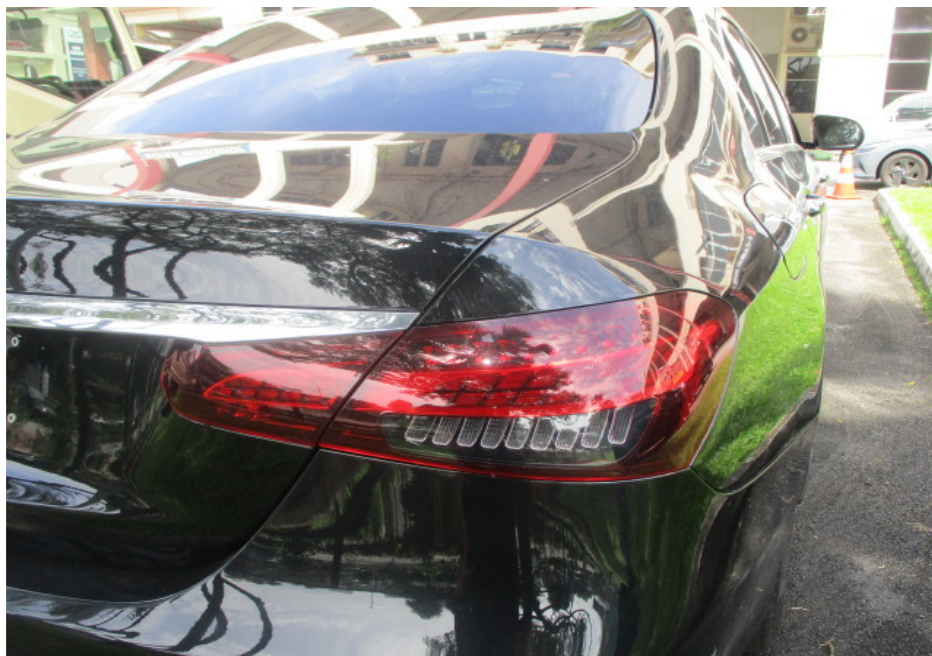
**Photo 9** shows a closer view of the Motor Car's rear bootlid, rear right bootlid lamp and rear right taillamp at the time of my inspection. The body parts at the right rear portion of the Motor Car were visually examined and it was observed that the repair/restoration works carried out to the damaged area of the Motor Car (refer to photograph 1 above) were reasonably adequate and in order.

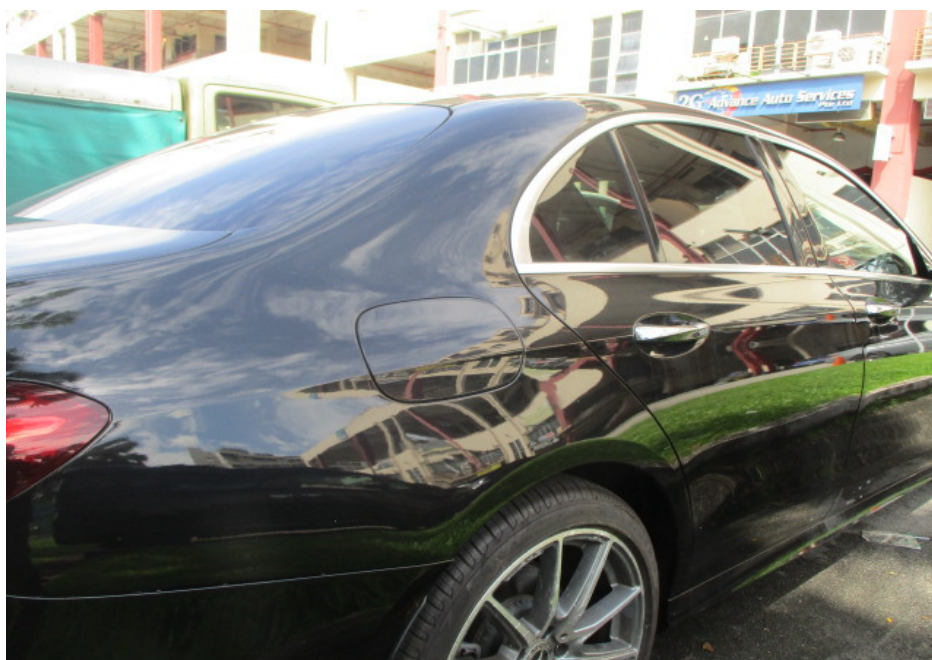
**Photo 10** shows a closer view of the Motor Car's rear right fender and petrol inlet outer cover at the time of my inspection. The body parts at the right rear portion of the Motor Car were visually examined and it was observed that the repair/restoration works carried out to the damaged area of the Motor Car (refer to photograph 1 above) were reasonably adequate and in order.

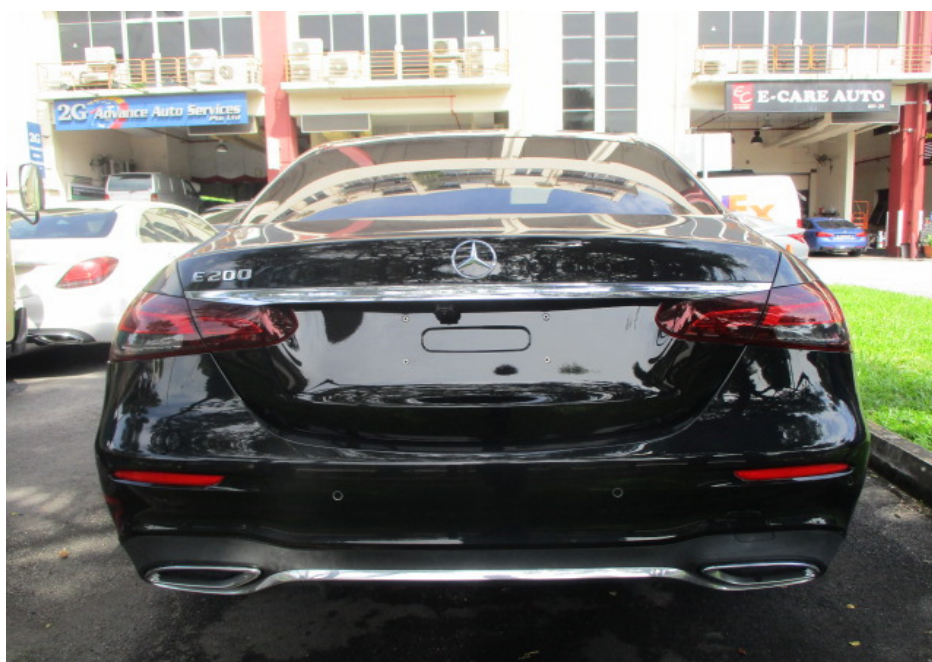
**Photo 11** shows a general view of the rear body of the Motor Car at the time of my inspection. The Motor Car was observed to be in a relatively good general condition with no loose exterior fittings observed. The mileage of the Motor Car recorded at the time of my inspection was 2,624km.

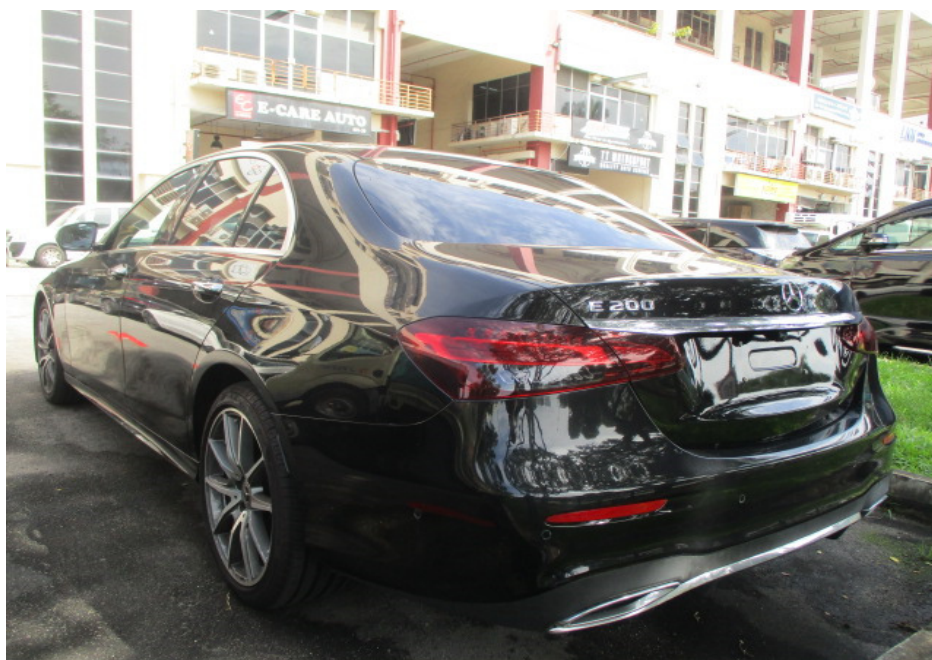
**Photo 12** shows a general view of the rear left body of the Motor Car at the time of my inspection. The Motor Car was observed to be in a relatively good general condition with no loose exterior fittings observed. The mileage of the Motor Car recorded at the time of my inspection was 2,624km.

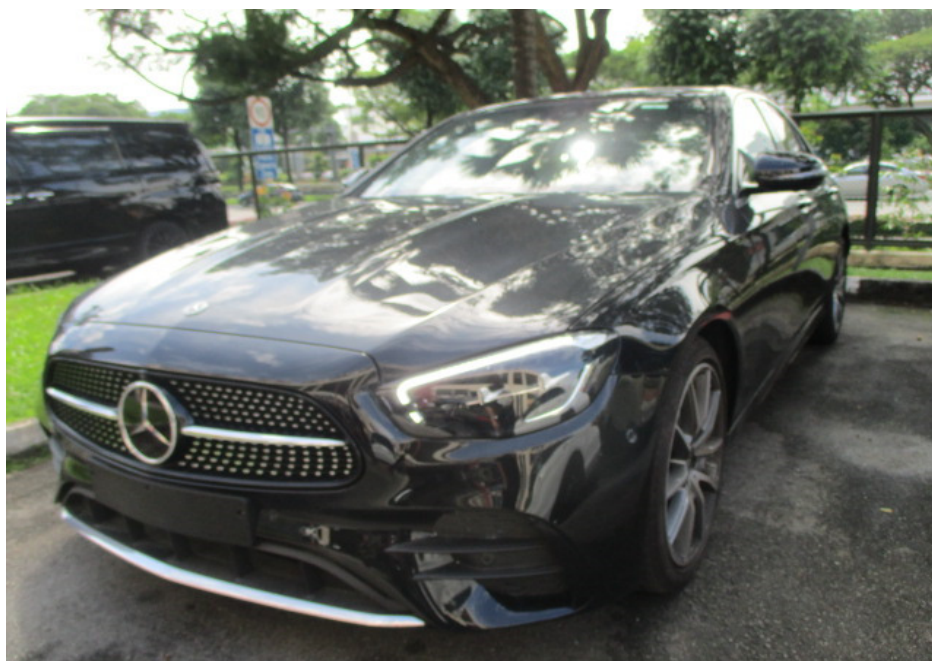
**Photo 13** shows a general view of the front left body of the Motor Car at the time of my inspection. The Motor Car was observed to be in a relatively good general condition with no loose exterior fittings observed. The mileage of the Motor Car recorded at the time of my inspection was 2,624km.

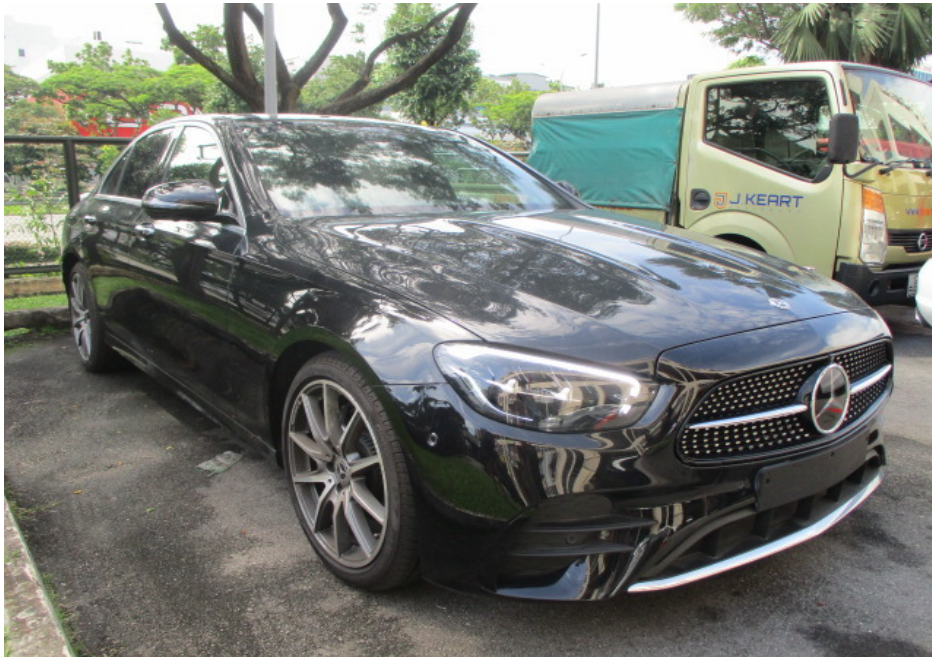
**Photo 14** shows a general view of the front right body of the Motor Car at the time of my inspection. The Motor Car was observed to be in a relatively good general condition with no loose exterior fittings observed. The mileage of the Motor Car recorded at the time of my inspection was 2,624km.

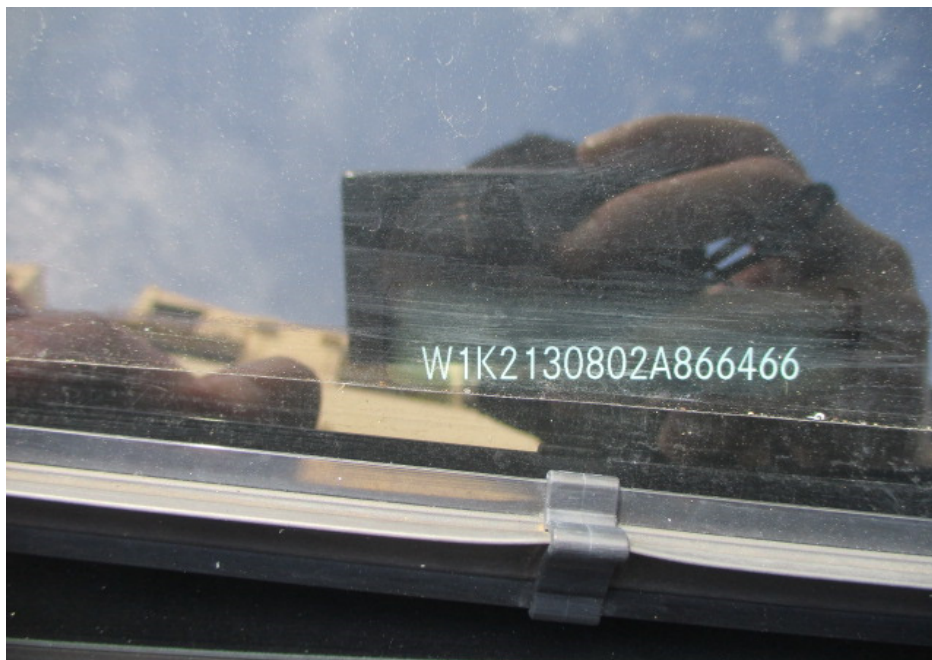
**Photo 15** shows the chassis number of the Motor Car. The chassis number recorded was W1K2130802A866466.

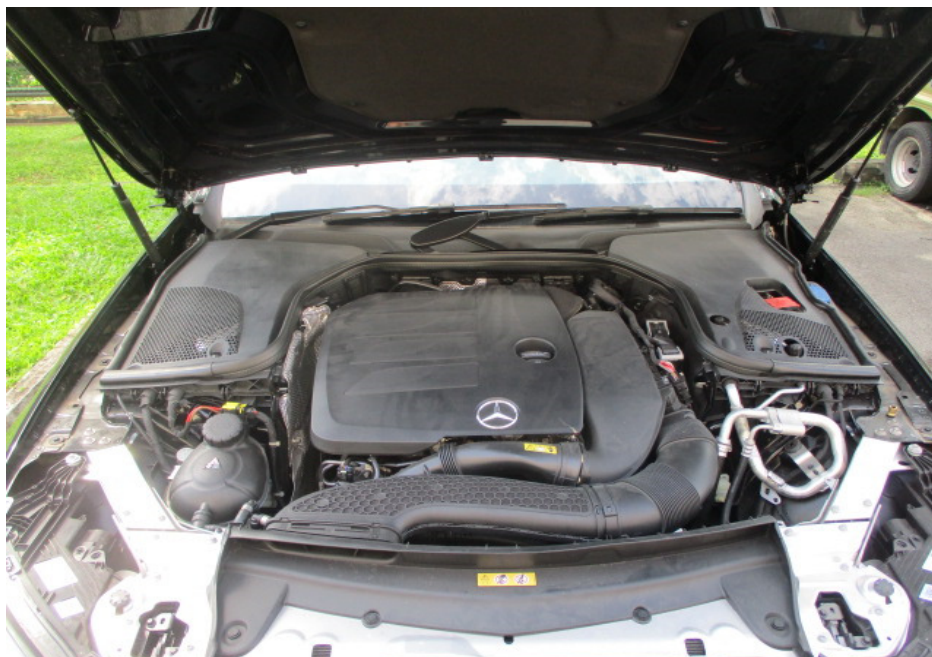
**Photo 16** shows a general view of the engine compartment of the Motor Car at the time of my inspection. The various parts and components inside the engine compartment were all observed to be intact and properly fitted. There was also no sign(s) or indication(s) of fluid leak and/or fluid stain found inside the engine compartment.

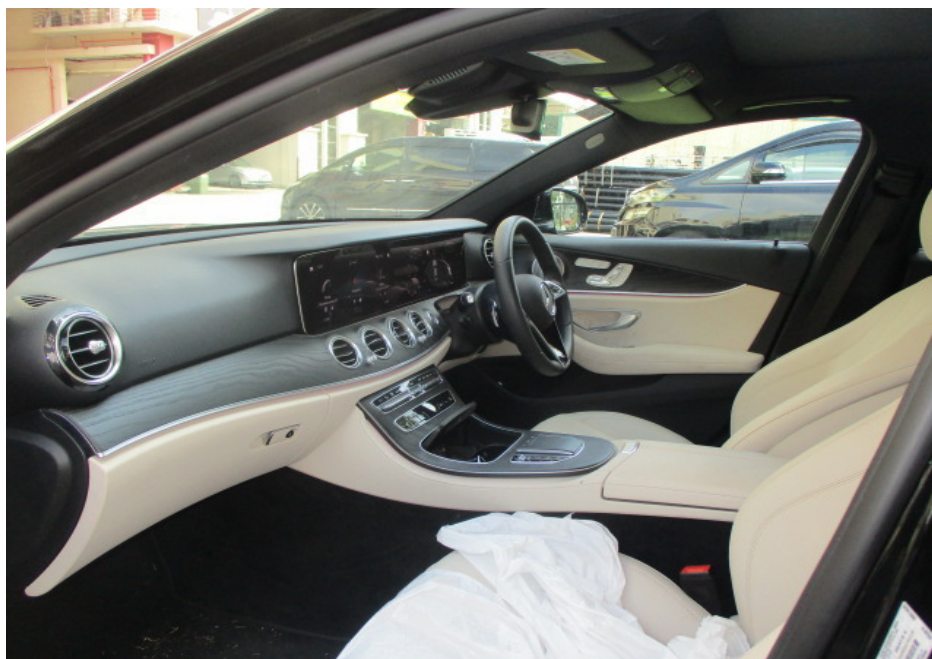
**Photo 17** shows the interior compartment of the Motor Car at the time of my inspection. The various parts and components, trims, carpet, and upholstery inside the interior compartment were all observed to be intact and properly fitted.

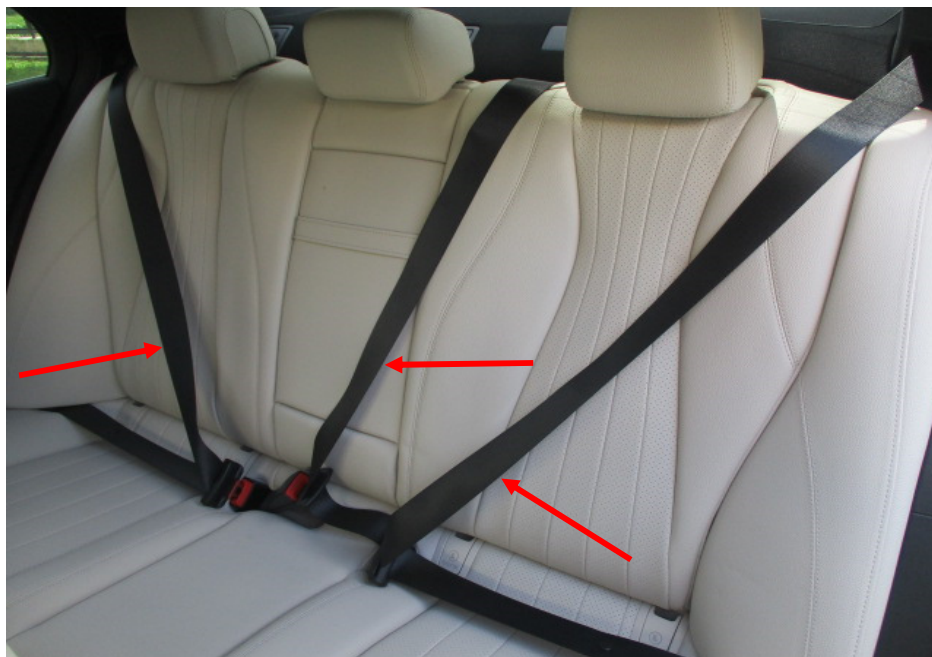
**Photo 18** shows the rear seats of the Motor Car. All the seats of the Motor Car were secured via seat rails to the floorboard. They were also fitted with a retractable seat belt reel and a pre-tensioner. The seat belts (arrowed) were tested and were able to be fastened into the respective pre-tensions that were fitted on the side of each individual seat.

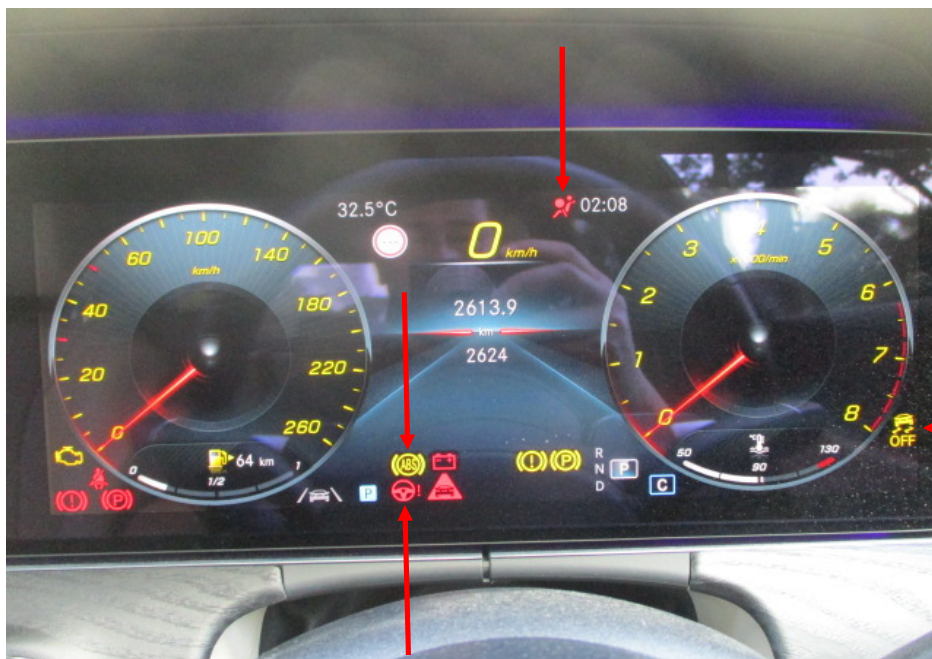
**Photo 19** shows the warning lights for the various electronic safety features appearing on the instrument panel of the Motor Car during its self-test when the engine is cranked, in particular the ABS, SRS, EPS and TCS lights (arrowed).

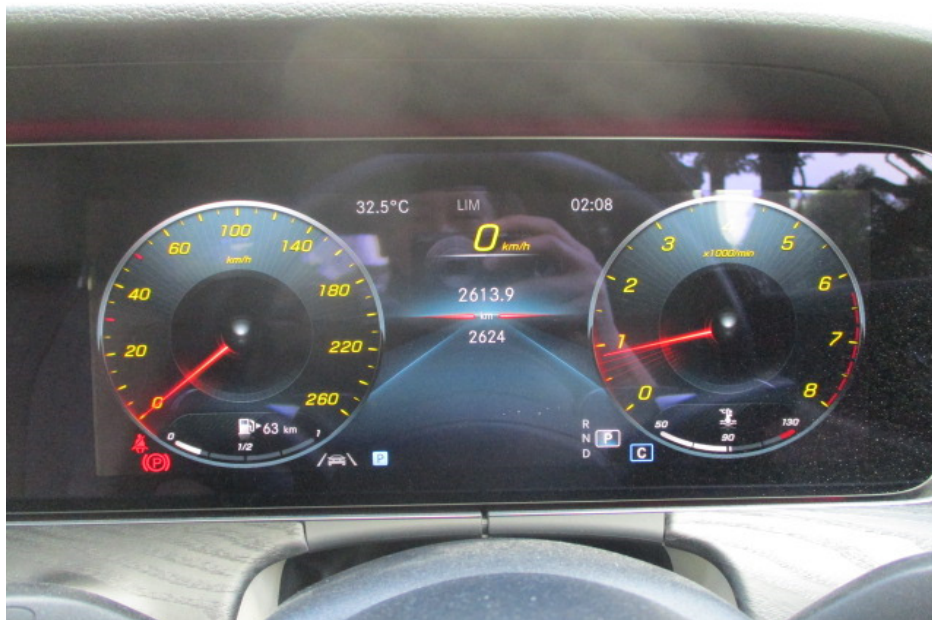
**Photo 20** shows the respective warning lights no longer illuminated, indicating that there is no fault detected to the ABS, SRS, EPS and TCS systems of the Motor Car during the self-test. These electronic systems were hence in working condition at the time of my inspection.

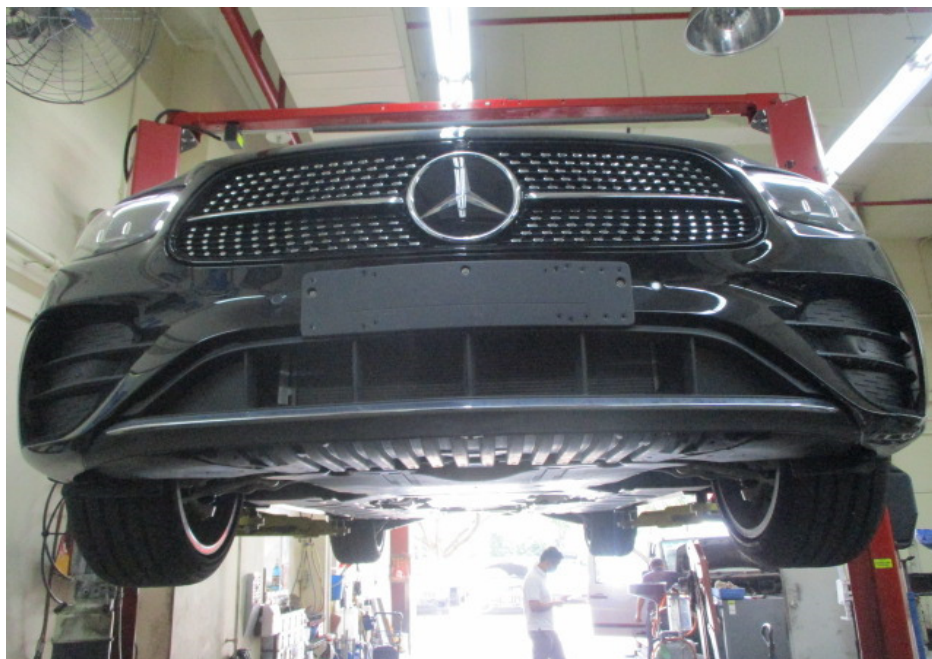
**Photo 21** shows the Motor Car hoisted up for checks on its undercarriage. There was no sign(s) or indication(s) of fluid leakage and/or fluid stain(s) on the underside of the Motor Car. The undercarriage components of the Motor Car were also all observed to be intact and secured in an appropriate manner.

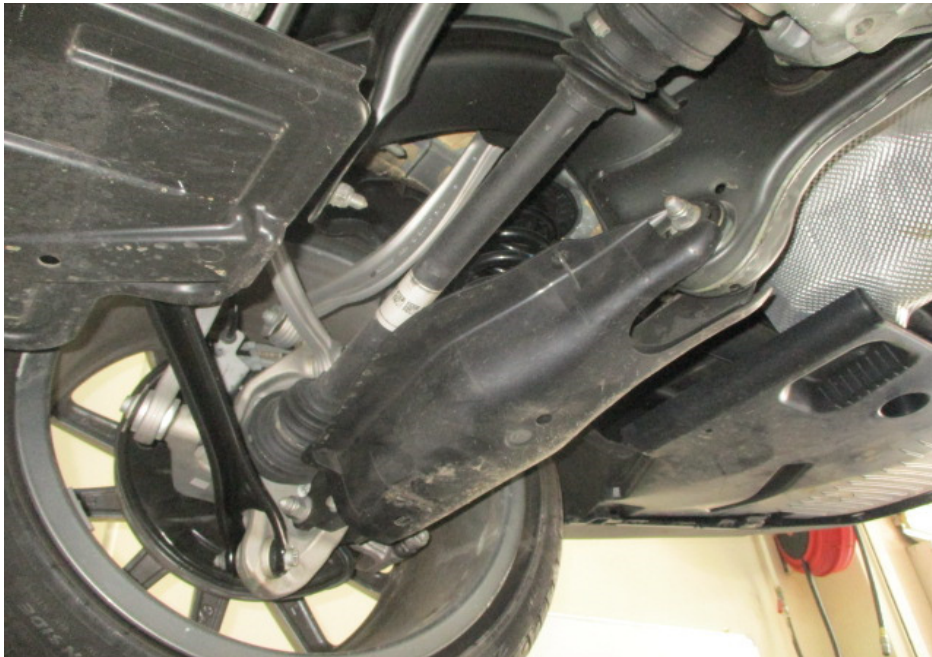
**Photo 22** shows a general view of the control arms and linkages at the rear right wheel of the Motor Car. I did not observe any fluid leak and/or fluid stain on the underside of the Motor Car. All of the Motor Car's undercarriage components were observed to be intact and secured in an appropriate manner.

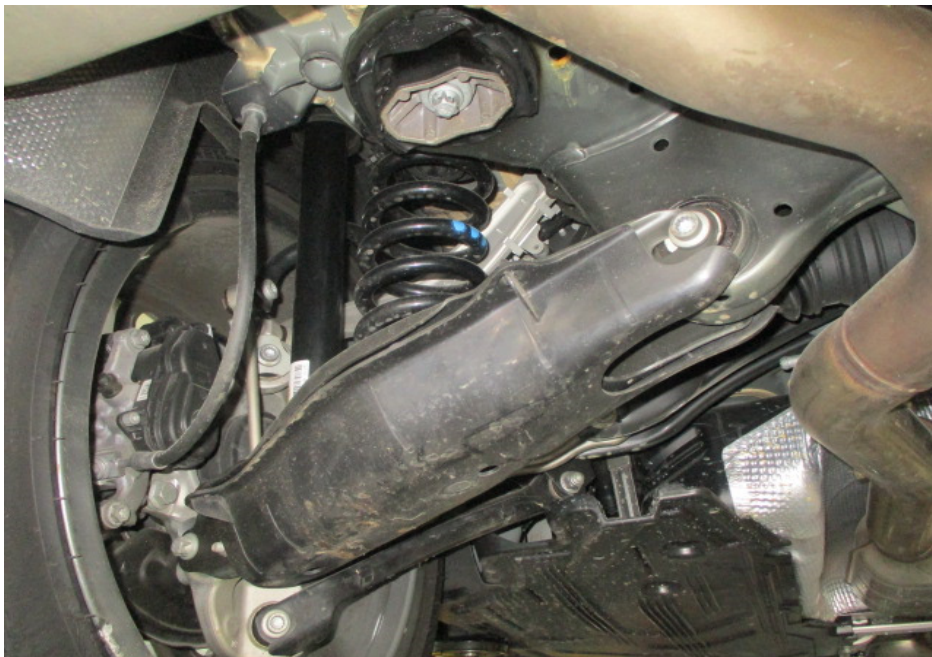
**Photo 23** shows a general view of the control arms and linkages at the rear left wheel of the Motor Car. I did not observe any fluid leak and/or fluid stain on the underside of the Motor Car. All of the Motor Car's undercarriage components were observed to be intact and secured in an appropriate manner.

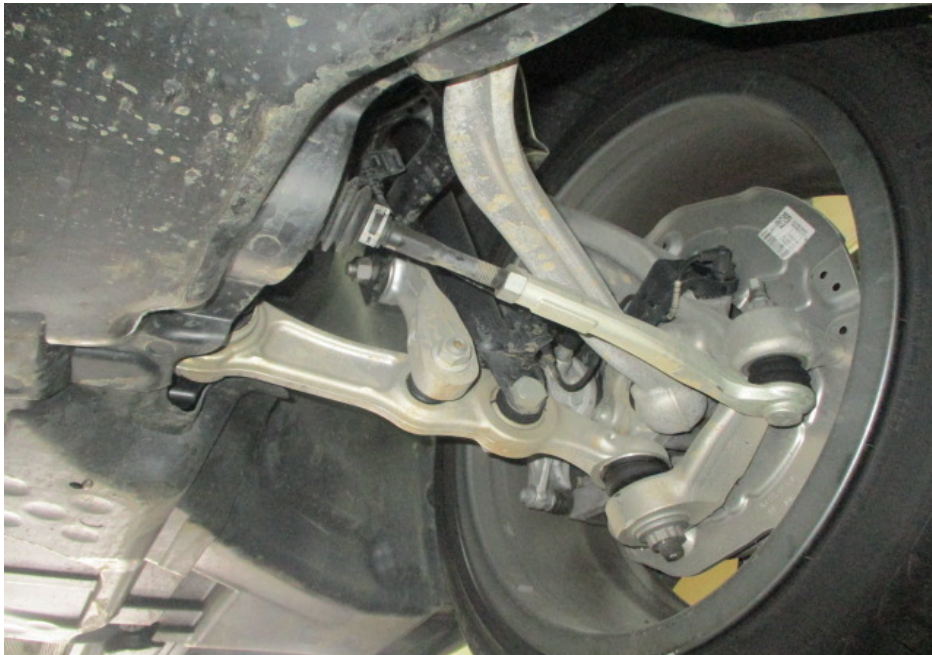
**Photo 24** shows the various undercarriage components at the front left wheel of the Motor Car. The mechanical components, control arms and linkages were all found to be intact and secured in an appropriate manner.

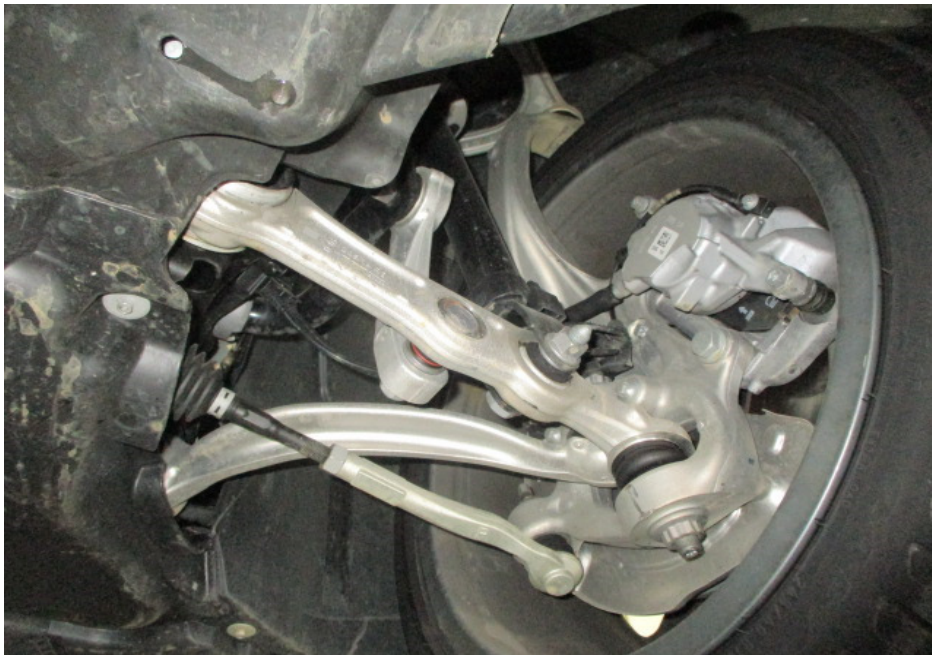
**Photo 25** shows the various undercarriage components at the front right wheel of the Motor Car. The mechanical components, control arms and linkages were all found to be intact and secured in an appropriate manner. I also did not observe any fluid leak and/or fluid stain on the underside of the Motor Car.

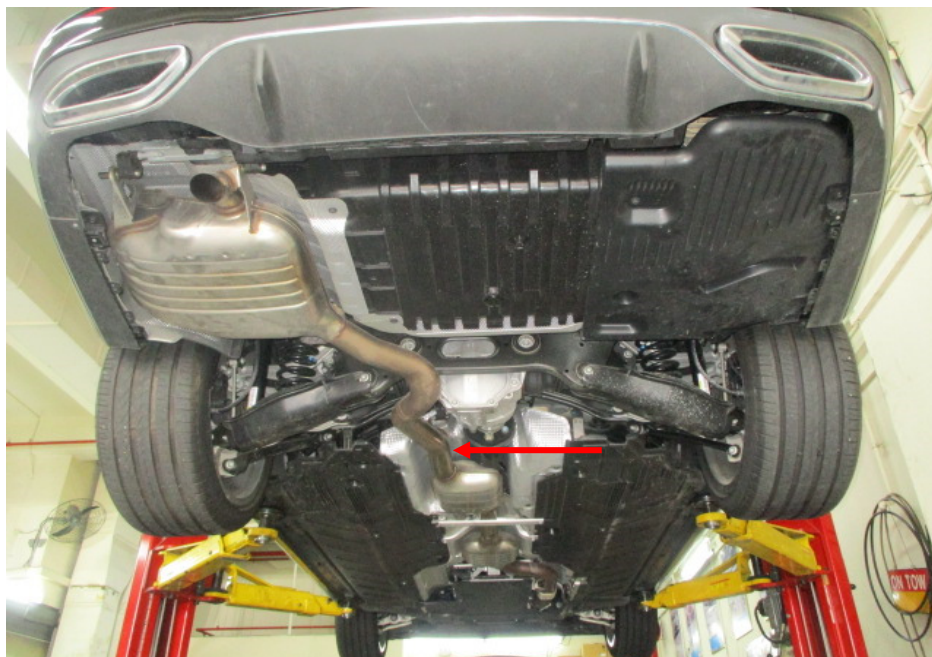
**Photo 26** shows the rear section of the Motor Car's exhaust system. My examination of the Motor Car's exhaust system revealed no sign(s) or indication(s) of any cut or weld marks along its exhaust pipes (arrowed), on its rear muffler, on its centre resonator boxes and on its catalytic converter.

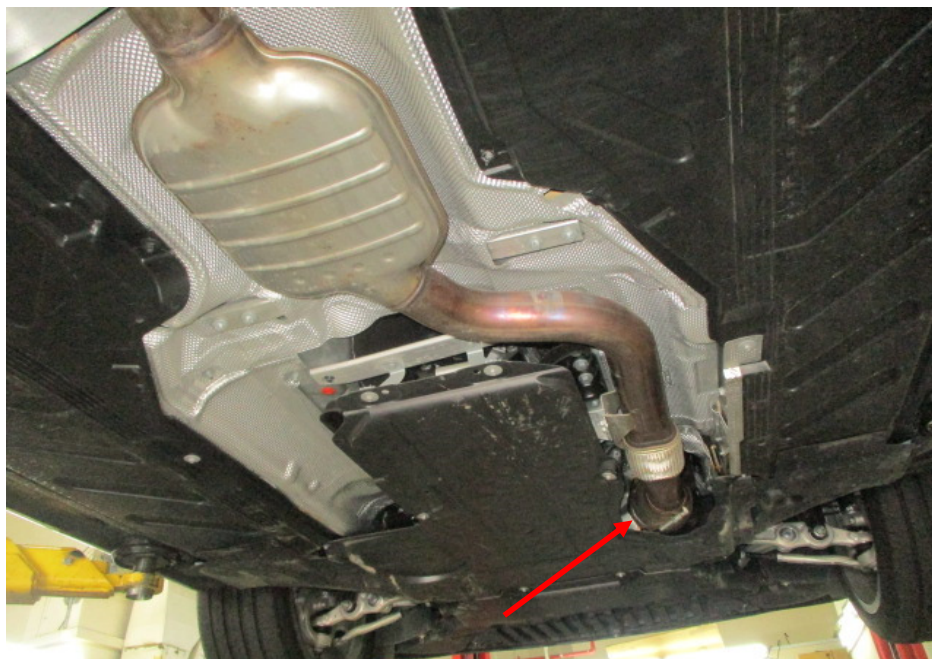
**Photo 27** shows the front section of the Motor Car's exhaust system. My examination of the Motor Car's exhaust system revealed no sign(s) or indication(s) of any cut or weld marks along its exhaust pipes, on its rear mufflers, on its centre resonator boxes and on its catalytic converter (arrowed).

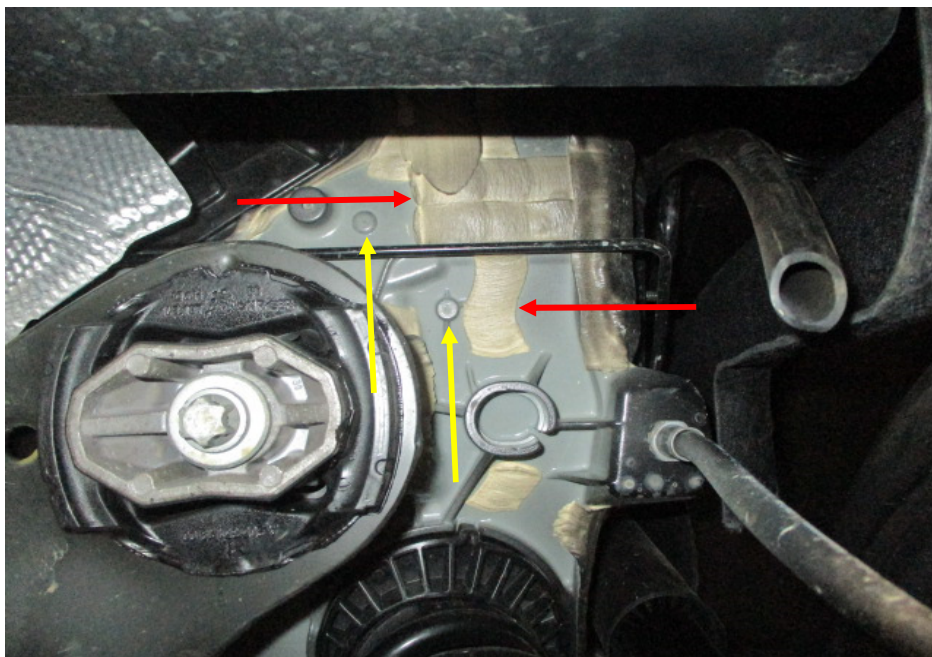
**Photo 28** shows the chassis/structural body at the underside rear right of the Motor Car. I did not find any weld marks other than original spot weld marks (yellow arrow) on the chassis/structural body of the Motor Car. The original factory sealant (red arrow) at the joints along the chassis/structural body was untouched, indicating no work was done on the chassis/structural body of the Motor Car and that the chassis/structural body was originally fitted.

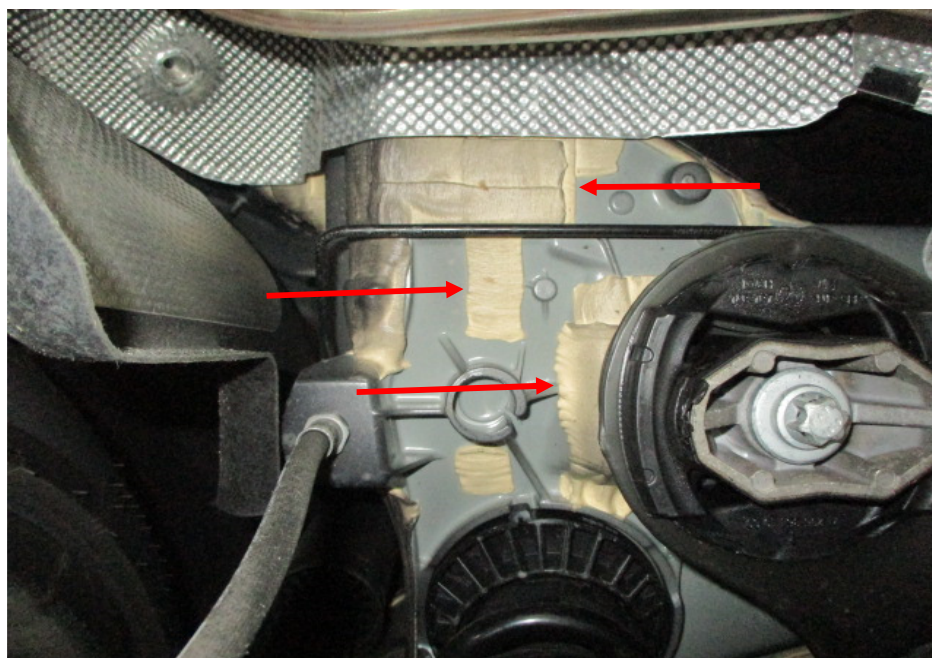
**Photo 29** shows the chassis/structural body at the underside rear left of the Motor Car. The original factory sealant (arrowed) at the joints along the chassis/structural body was observed to be untouched. In general, I had found no work was carried out on the chassis/structural body of the Motor Car. The chassis/structural body of the Motor Car was originally fitted.

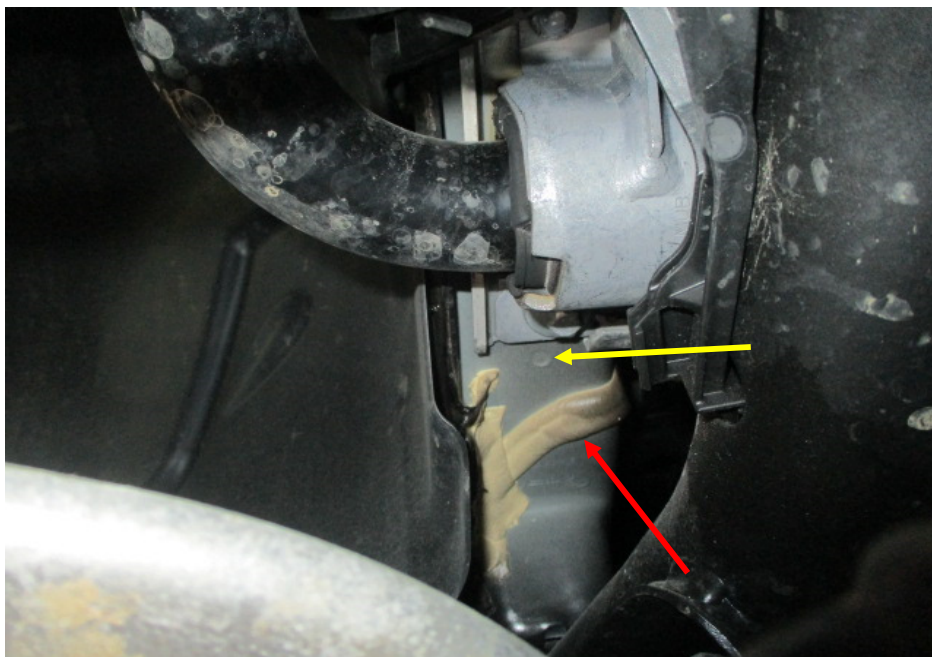
**Photo 30** shows the chassis/structural body at the underside front left of the Motor Car. I did not find any weld marks other than original spot weld marks (yellow arrow) on the chassis/structural body of the Motor Car. The original factory sealant (red arrow) at the joints along the chassis/structural body was untouched, indicating no work was done on the chassis/structural body of the Motor Car and that the chassis/structural body was originally fitted.

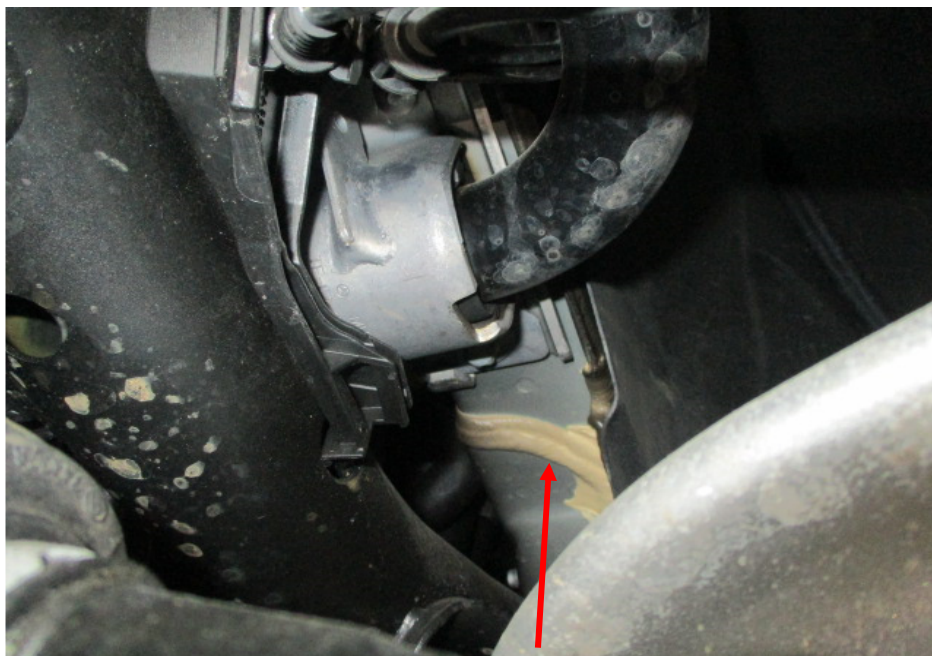
**Photo 31** shows the chassis/structural body at the underside front right of the Motor Car. The original factory sealant (arrowed) at the joints along the chassis/structural body was observed to be untouched. In general, I had found no work was carried out on the chassis/structural body of the Motor Car. The chassis/structural body of the Motor Car was originally fitted.
