Your Ref: Mercedes Benz E200  
(chassis number W1K2130802A866466)  
Our Ref : CI/TP21012236/D

01 December 2021

**INSPECTION REPORT OF AN UNREGISTERED MERCEDES BENZ E200  
MOTOR CAR WITH CHASSIS NUMBER W1K2130802A866466**

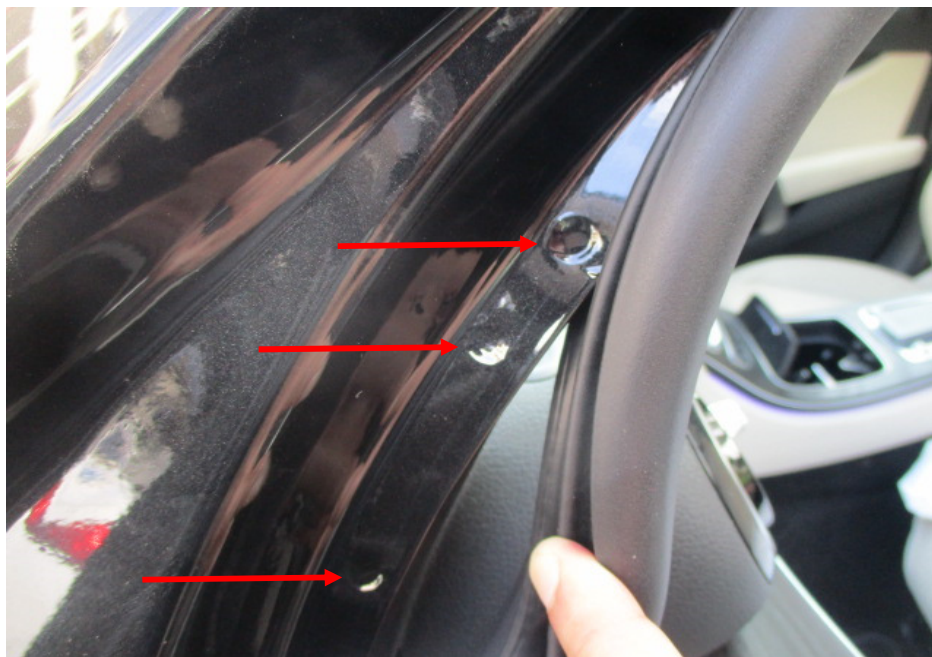
**Photo 32** shows the left side "A" pillar of the Motor Car. I did not find any weld marks other than original spot weld marks (arrowed) on the left side "A" pillar of the Motor Car which, indicates that there was no re-welding works carried out. In general, I had found all the non-detachable body panels of the Motor Car to be originally fitted at the time of my inspection.

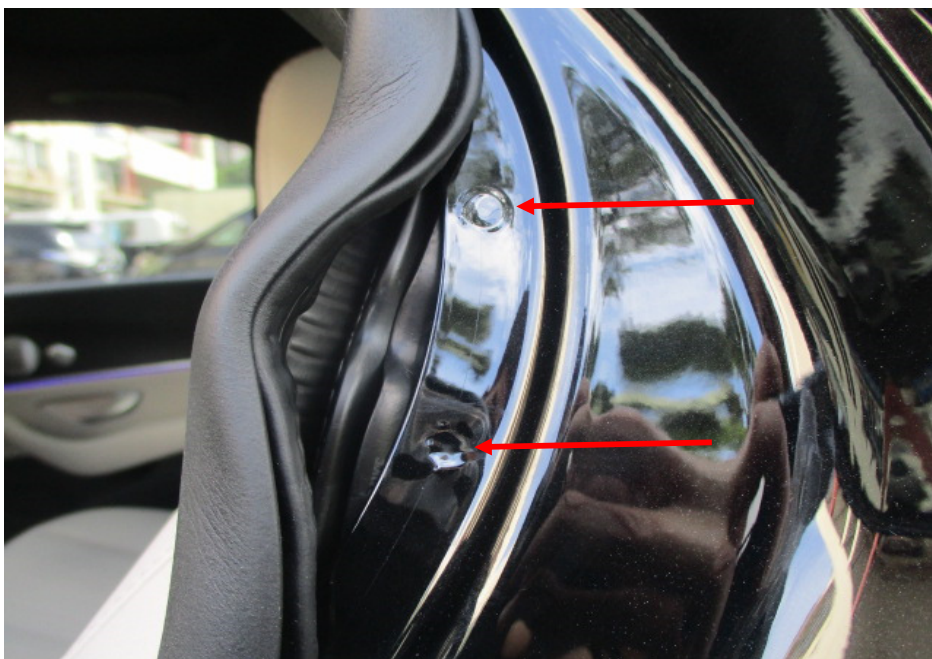
**Photo 33** shows the left side "C" pillar of the Motor Car. I did not find any weld marks other than original spot weld marks (arrowed) on the left side "C" pillar of the Motor Car which, indicates that there was no re-welding works carried out. In general, I had found all the non-detachable body panels of the Motor Car to be originally fitted at the time of my inspection.

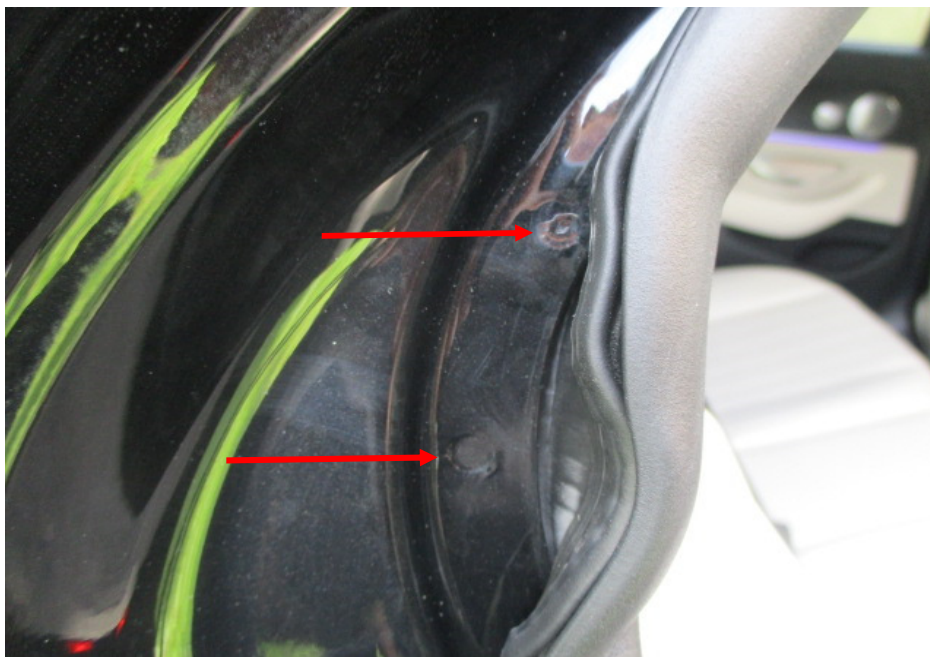
**Photo 34** shows the right side “C” pillar of the Motor Car. I did not find any weld marks other than original spot weld marks (arrowed) on the right side “C” pillar of the Motor Car which, indicates that there was no re-welding works carried out. In general, I had found all the non-detachable body panels of the Motor Car to be originally fitted at the time of my inspection.
