LKK Auto Consultants Pte Ltd

ADJUSTMENT ON REPAIR COST FOR VEHICLE NO. SHD 5965S

PHOTOGRAPHS FOR VEHICLE NO. SHD 5965S

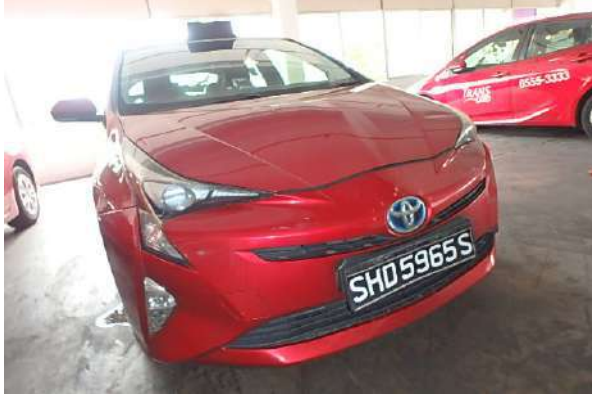
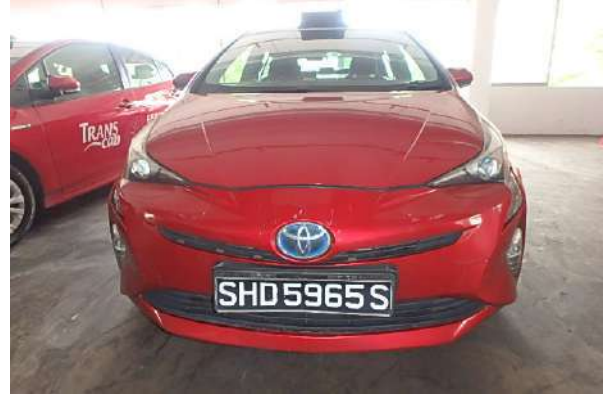
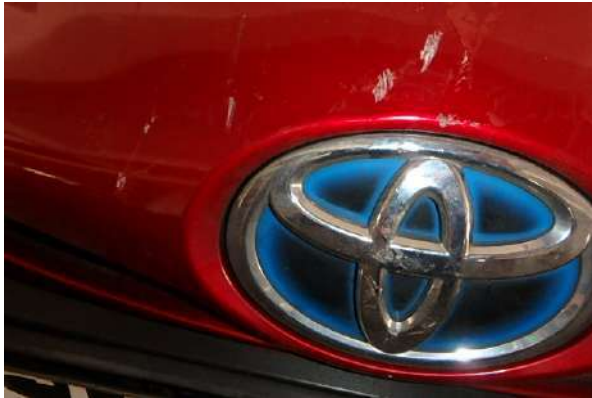
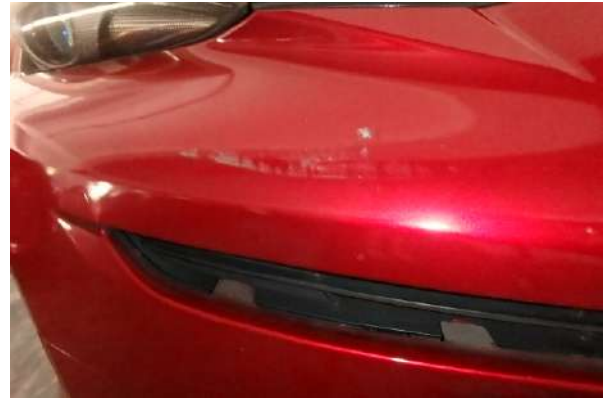
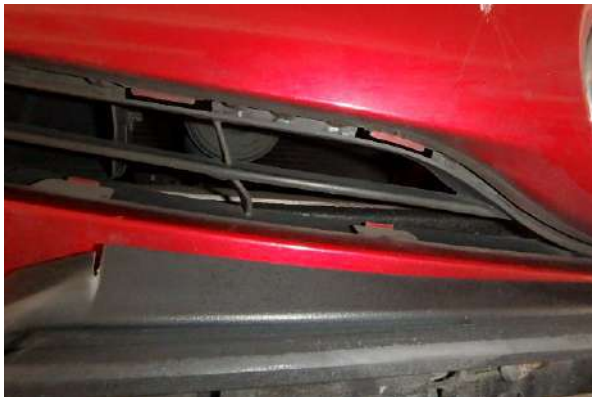
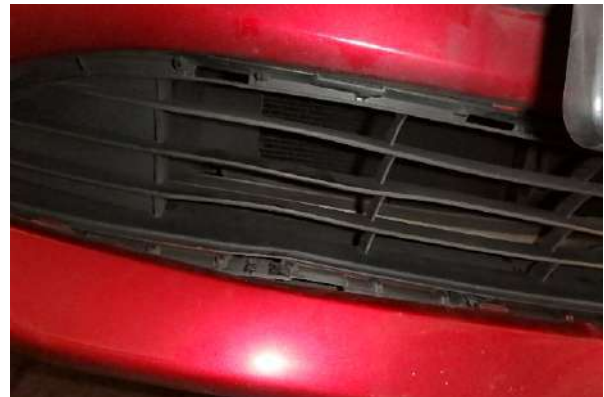
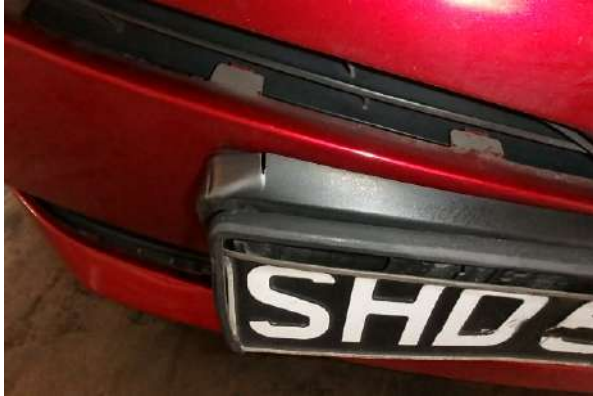
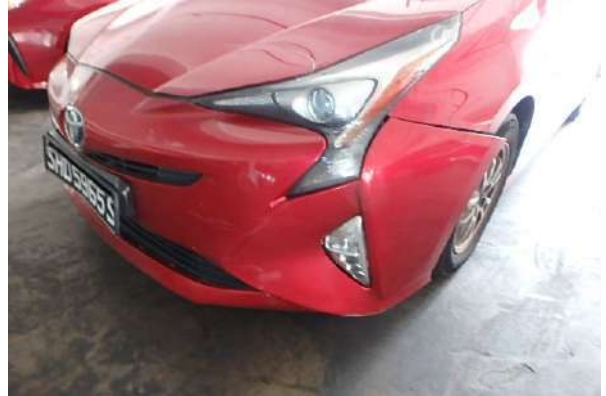
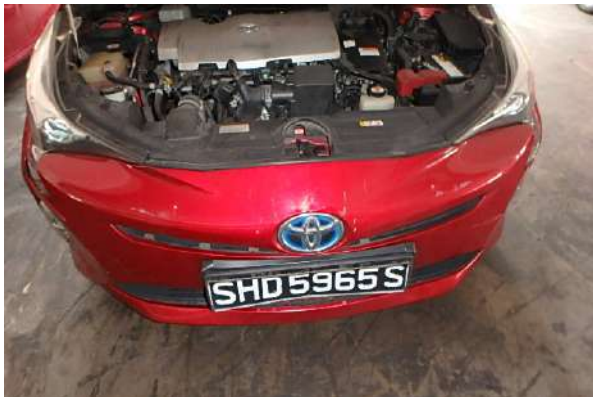
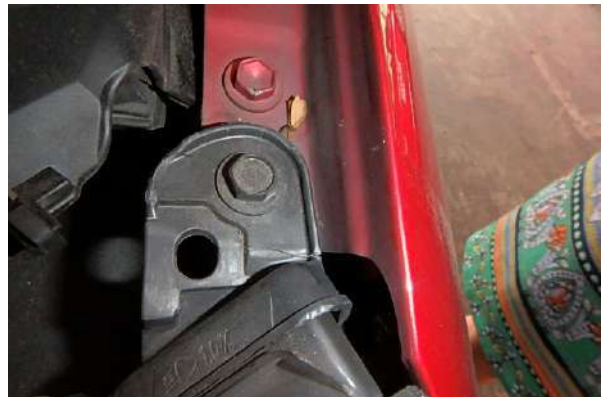
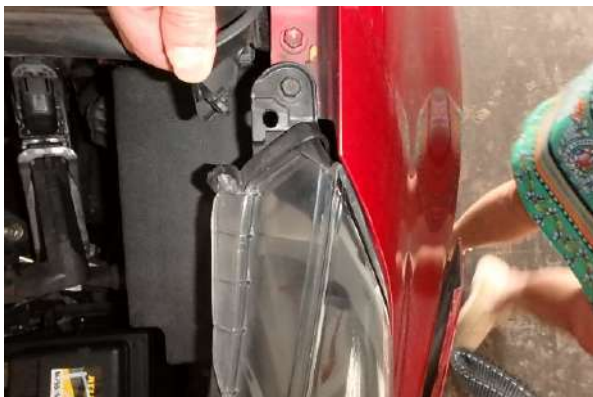
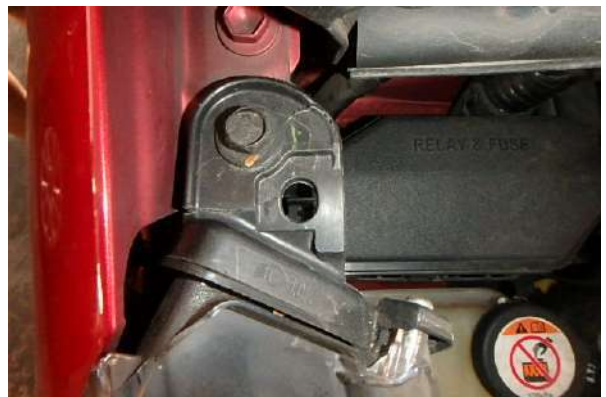
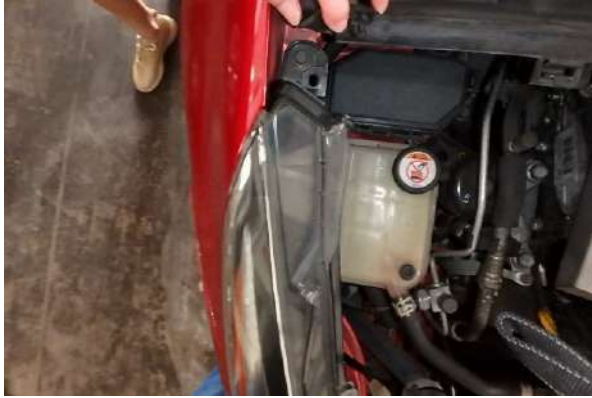
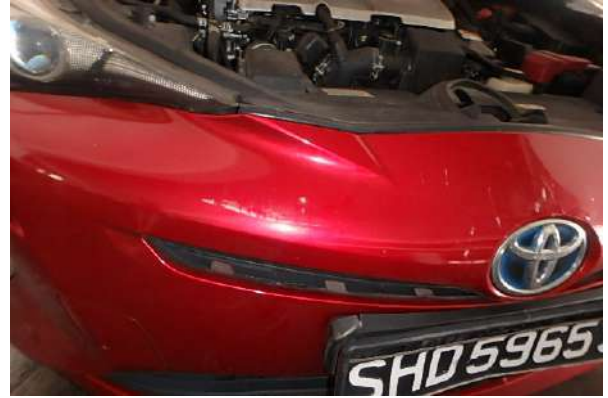
4. Description of Damages				
THE VEHICLE SUSTAINED DAMAGES AT THE FRONT PORTION. DAMAGES SEE DETAILS.				
5. General Information				
Accident Date	20/11/2021	Inspection Date	06/12/2021	
Survey held at	TRANS-CAB AUTO SERVICES PTE LTD NO.2 ANG MO KIO ST 63 SINGAPORE 569111			
5a. Remarks				
A)THE INSPECTION WAS CONDUCTED ON A"WITHOUT PREJUDICE" BASIS. B)IN ACCORDANCE TO YOUR INSTRUCTIONS, WE HAVE NOT AUTHORISED REPAIRS.				
5b. Estimate Days of Repair				
ESTIMATED NORMAL PERIOD FOR REPAIR:			2 Working Days
