Your Ref: Porsche Cayenne  
(chassis number WP1ZZZ9YZLDA79335)  
Our Ref : CI/TP21012424/D

08 December 2021

**INSPECTION REPORT OF AN UNREGISTERED PORSCHE CAYENNE  
MOTOR CAR WITH CHASSIS NUMBER WP1ZZZ9YZLDA79335**

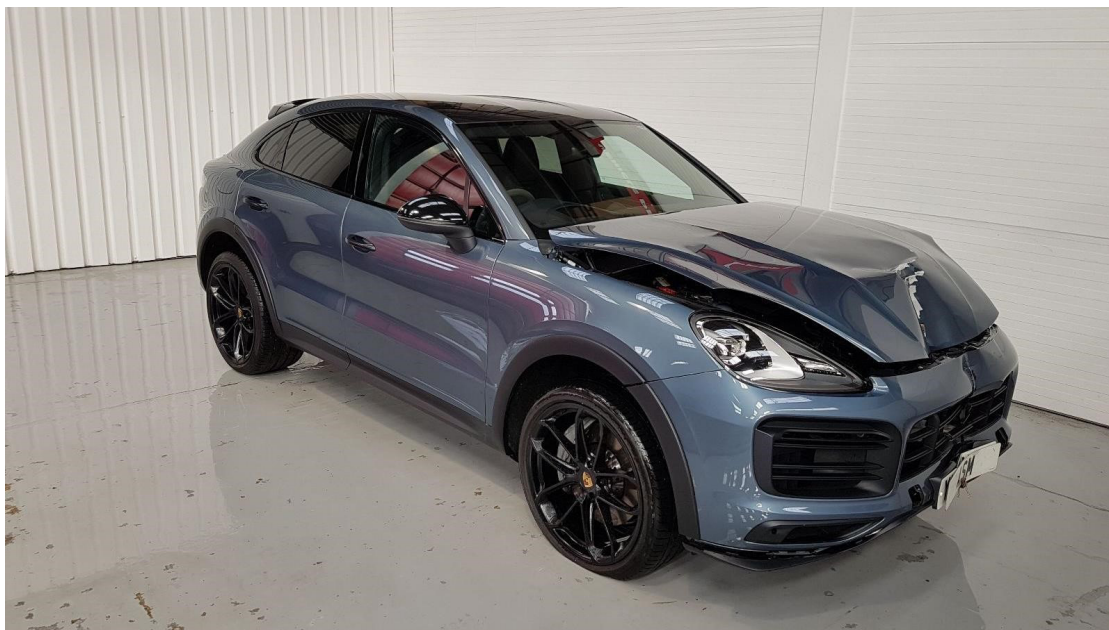
**Photo 1** shows the front right body of the Motor Car (photograph provided to me). The photographs provided to me had showed damage to the frontal portion of the Motor Car. Body parts damaged include the front bumper, front bonnet, front bonnet lock and radiator grille amongst others. The airbags were not deployed as seen from the photographs that were provided to me.

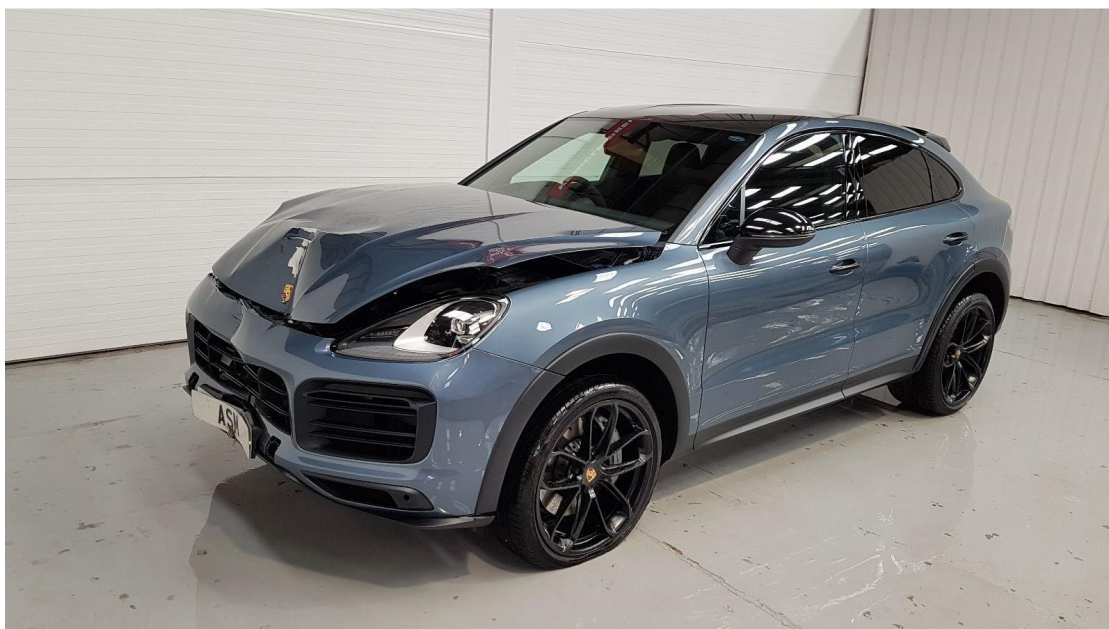
**Photo 2** shows the front left body of the Motor Car (photograph provided to me). The photographs provided to me had showed damage to the frontal portion of the Motor Car. Body parts damaged include the front bumper, front bonnet, front bonnet lock and radiator grille amongst others. The airbags were not deployed as seen from the photographs that were provided to me.

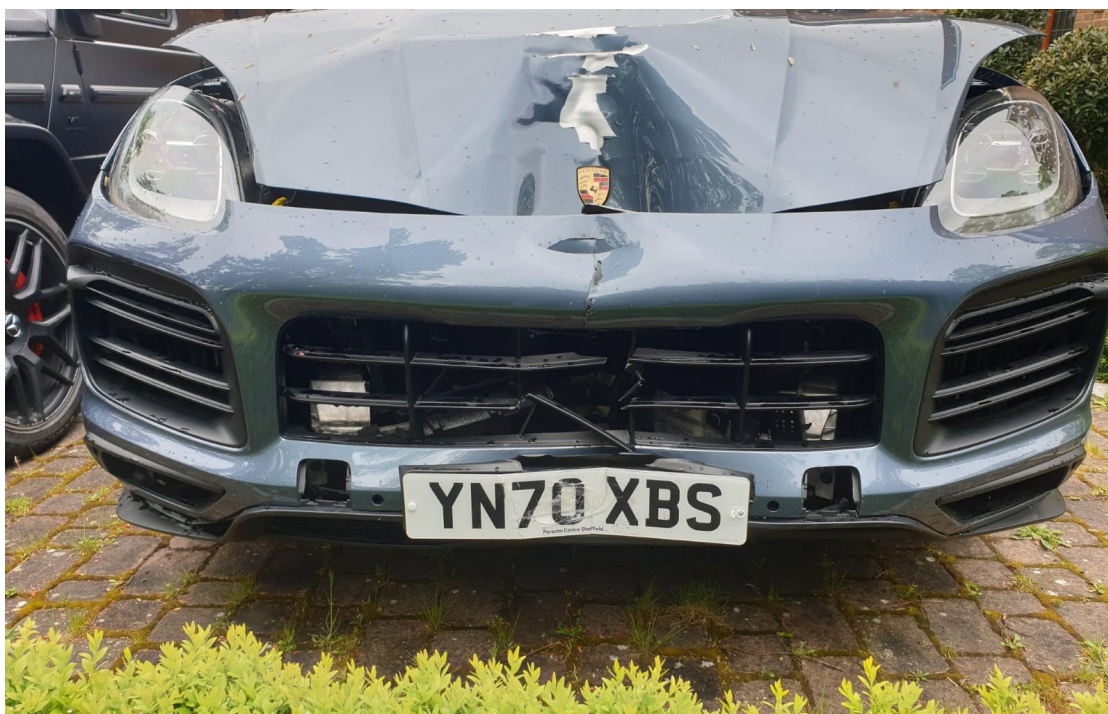
**Photo 3** shows the frontal body of the Motor Car (photograph provided to me). The photographs provided to me had showed damage to the frontal portion of the Motor Car. Body parts damaged include the front bumper, front bumper reinforcement, front bumper centre lower grille, front bumper tow hook covers, front sensor, radiator grille, front bonnet and front bonnet lock amongst others.

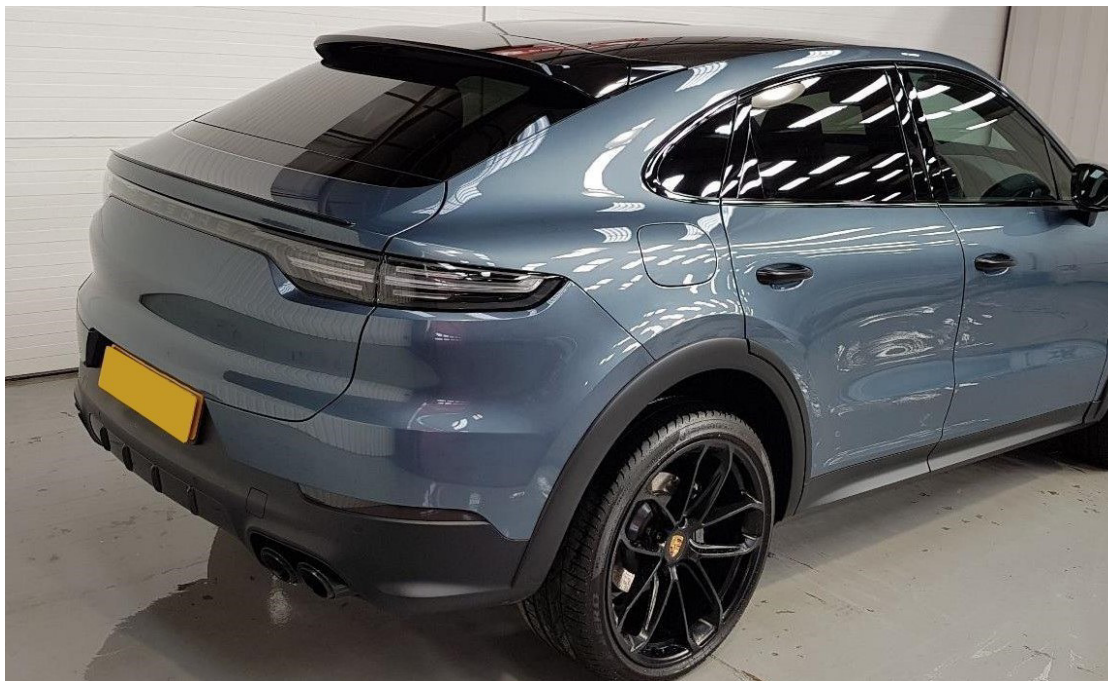
**Photo 4** shows the rear right body of the Motor Car (photograph provided to me). Apart for the frontal portion, there was no physical damage observed to other areas of the Motor Car. The airbags were also not deployed as seen from the photographs that were provided to me.

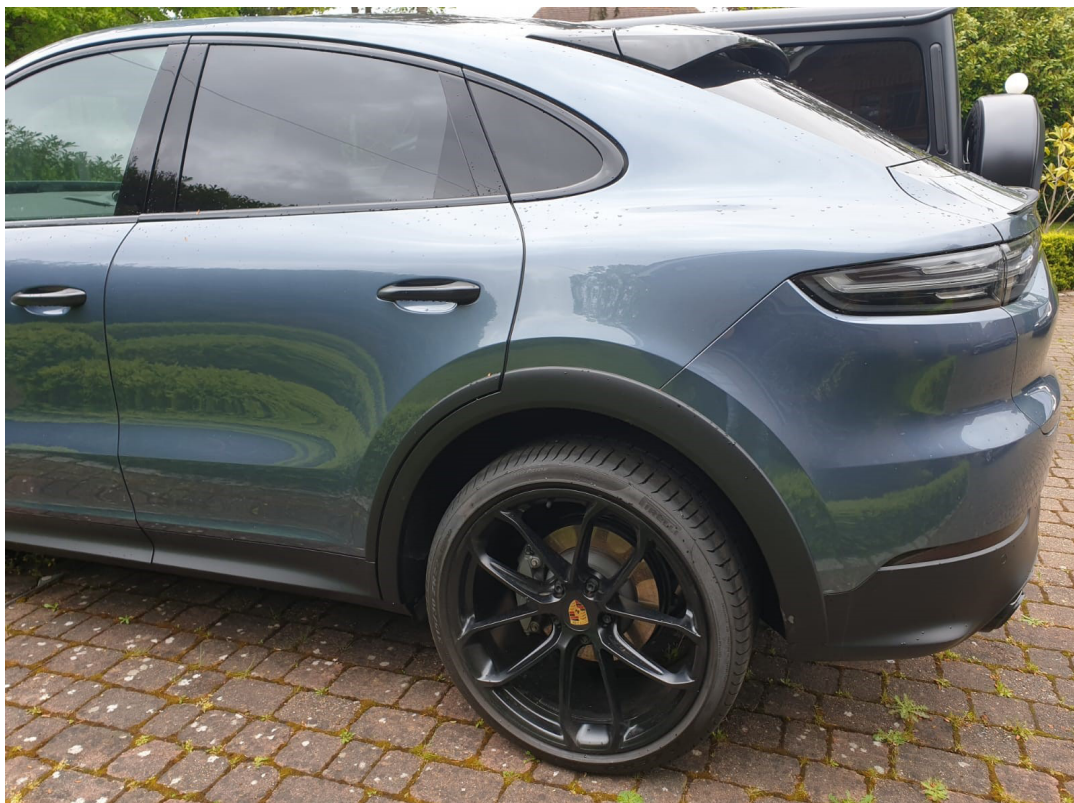
**Photo 5** shows the rear left body of the Motor Car (photograph provided to me). Apart for the frontal portion, there was no physical damage observed to other areas of the Motor Car.

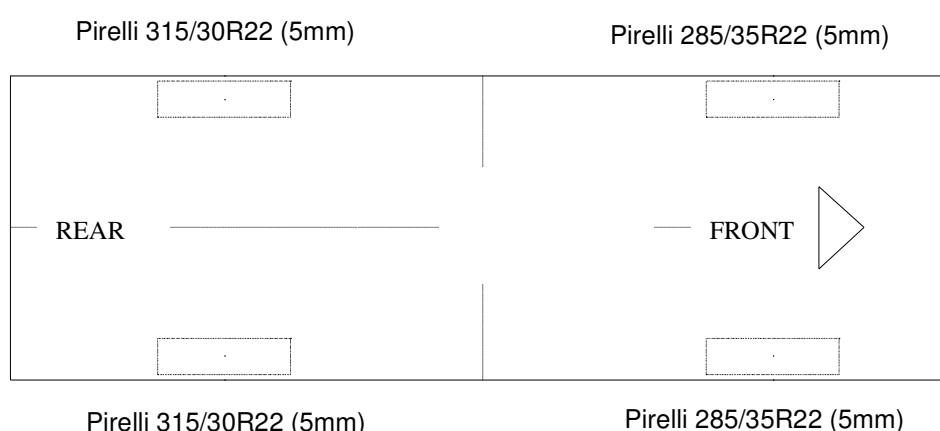
8. It was fitted with 22inch sport wheel rims that were wrapped with tyres that were observed to be of serviceable condition. The tyres were also sufficiently inflated for vehicular operation. The tyre brand, tyre size and approximate remaining tread depth of the 4 tyres of the Motor Car were recorded as follows: -

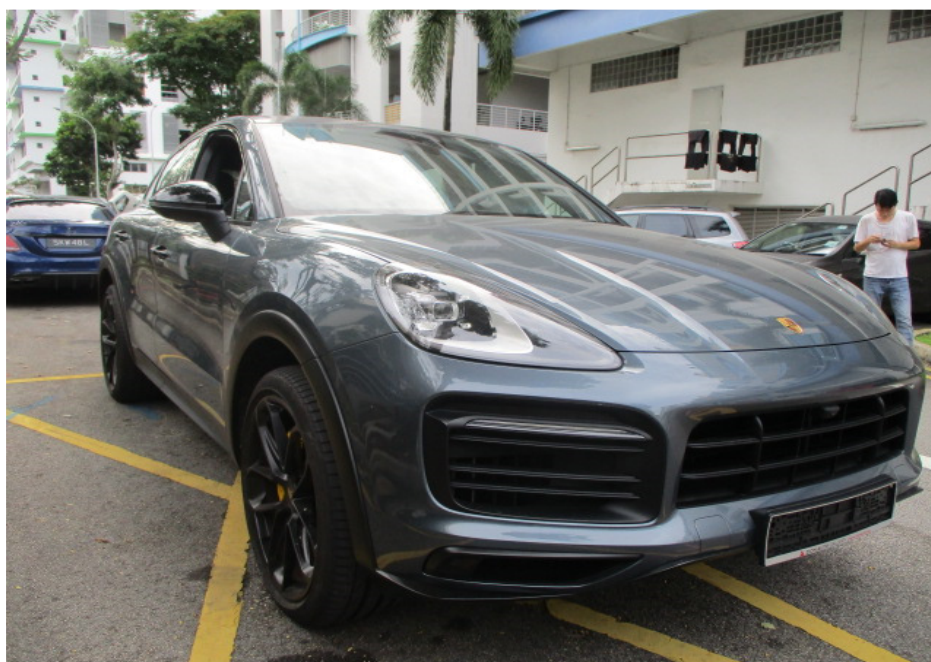
**Photo 6** shows a general view of the front right body of the Motor Car at the time of my inspection. The Motor Car was observed to be in a relatively good general condition with no loose exterior fittings observed. The body parts at the frontal portion of the Motor Car were visually examined and it was observed that the repair/restoration works carried out to the damaged area of the Motor Car (refer to photograph 1 - 3 above) were reasonably adequate and in order.

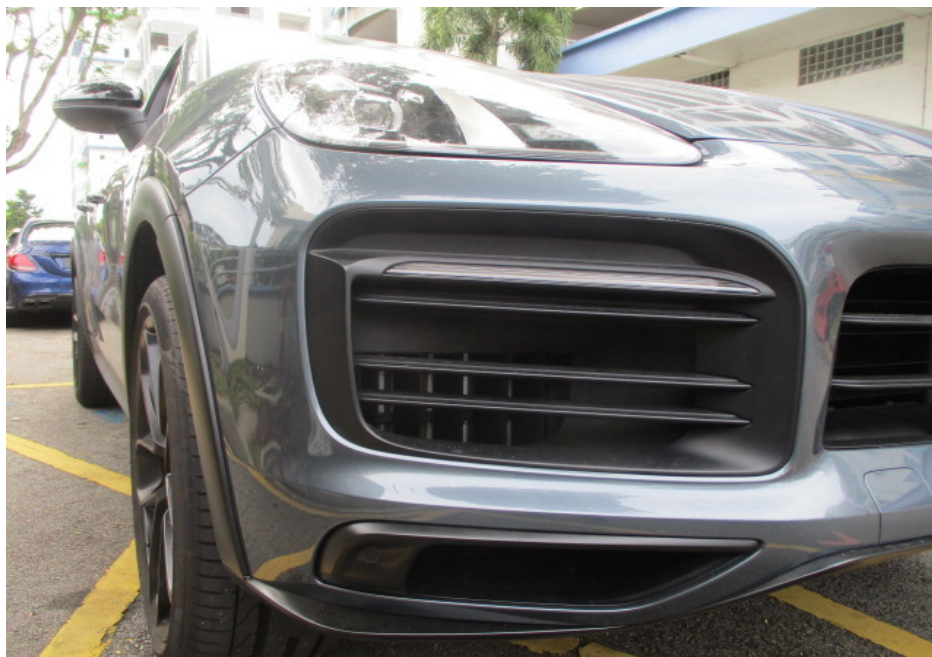
**Photo 7** shows a closer view of the Motor Car's front bumper, front bumper right grille, front bumper right lower grille, front right day light and front right headlamp at the time of my inspection. The body parts at the frontal portion of the Motor Car were visually examined and it was observed that the repair/restoration works carried out to the damaged area of the Motor Car (refer to photograph 1 - 3 above) were reasonably adequate and in order.

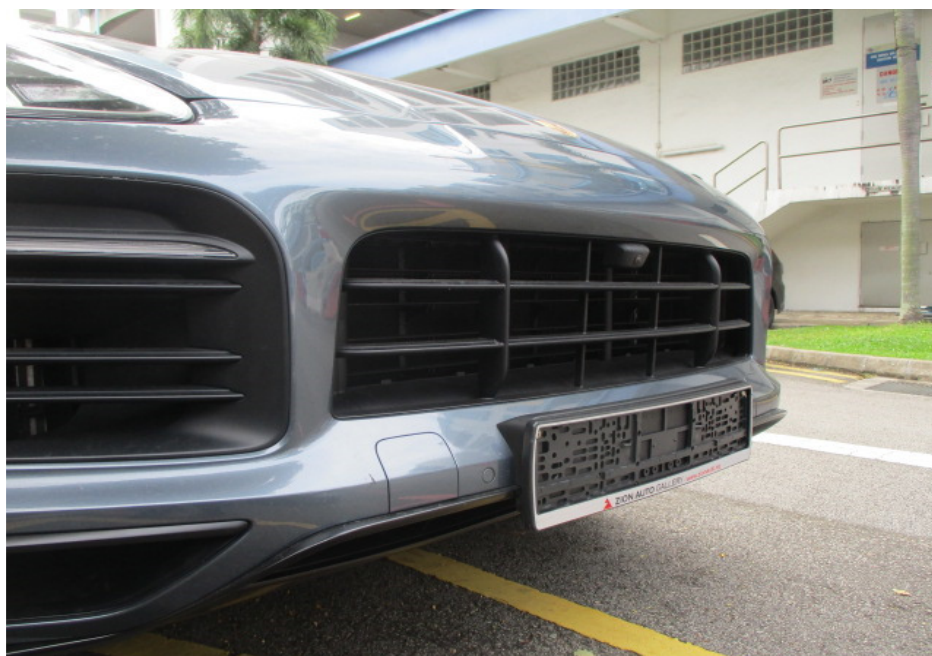
**Photo 8** shows a closer view of the Motor Car's front bumper, front bumper tow hook cover, front bumper centre lower grille and radiator grille. The body parts at the frontal portion of the Motor Car were visually examined and it was observed that the repair/restoration works carried out to the damaged area of the Motor Car (refer to photograph 1 - 3 above) were reasonably adequate and in order.

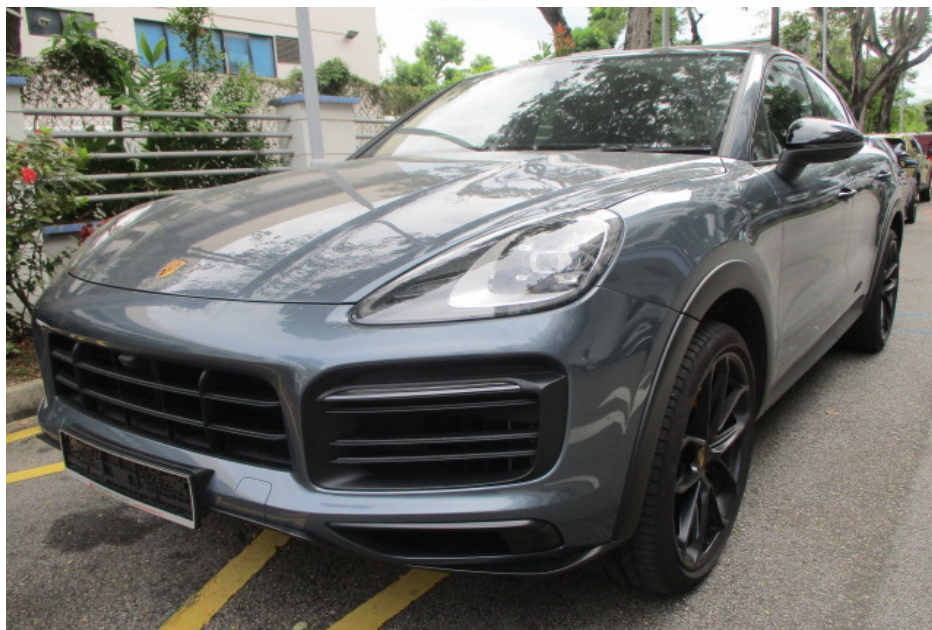
**Photo 9** shows a general view of the front left body of the Motor Car at the time of my inspection. The Motor Car was observed to be in a relatively good general condition with no loose exterior fittings observed. The body parts at the frontal portion of the Motor Car were visually examined and it was observed that the repair/restoration works carried out to the damaged area of the Motor Car (refer to photograph 1 - 3 above) were reasonably adequate and in order.

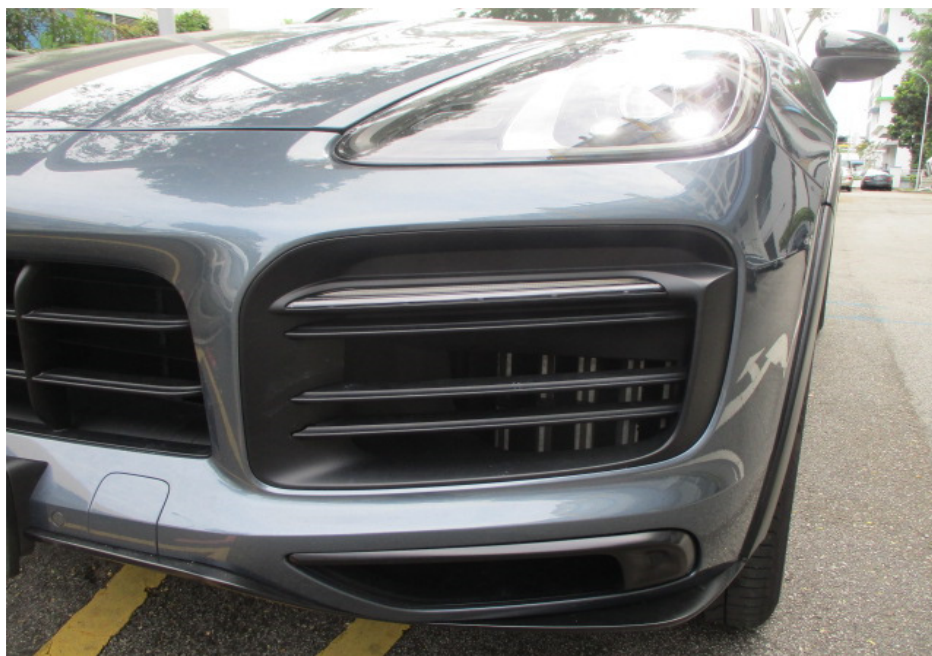
**Photo 10** shows a closer view of the Motor Car's front bumper left grille, front bumper left lower grille, front left day light and front left headlamp. The body parts at the frontal portion of the Motor Car were visually examined and it was observed that the repair/restoration works carried out to the damaged area of the Motor Car (refer to photograph 1 - 3 above) were reasonably adequate and in order.

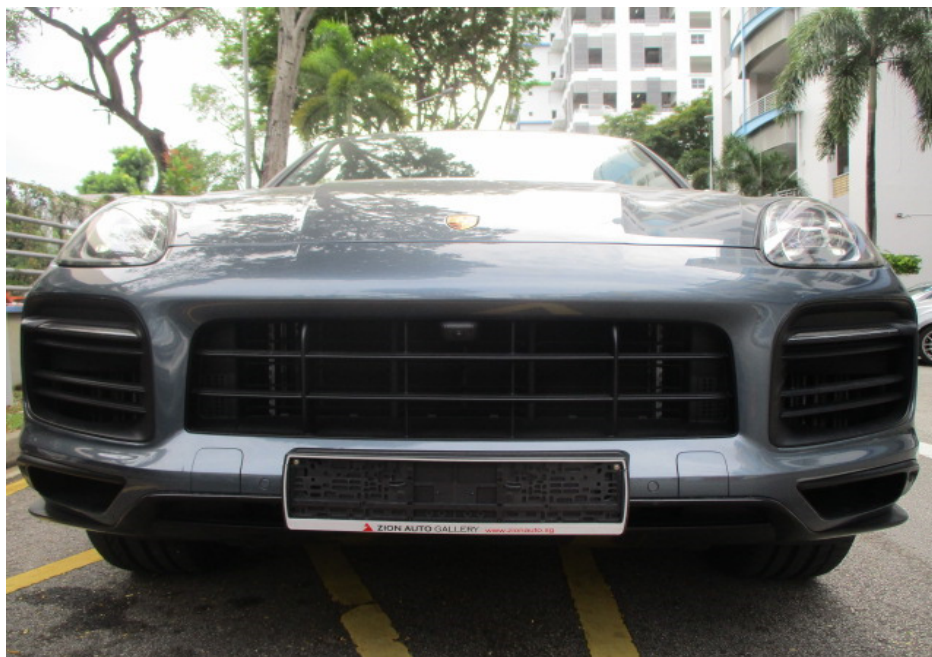
**Photo 11** shows a closer view of the Motor Car's front bumper, front bumper tow hook covers, front sensor, radiator grille and front bonnet at the time of my inspection. The body parts at the frontal portion of the Motor Car were visually examined and it was observed that the repair/restoration works carried out to the damaged area of the Motor Car (refer to photograph 1 - 3 above) were reasonably adequate and in order.

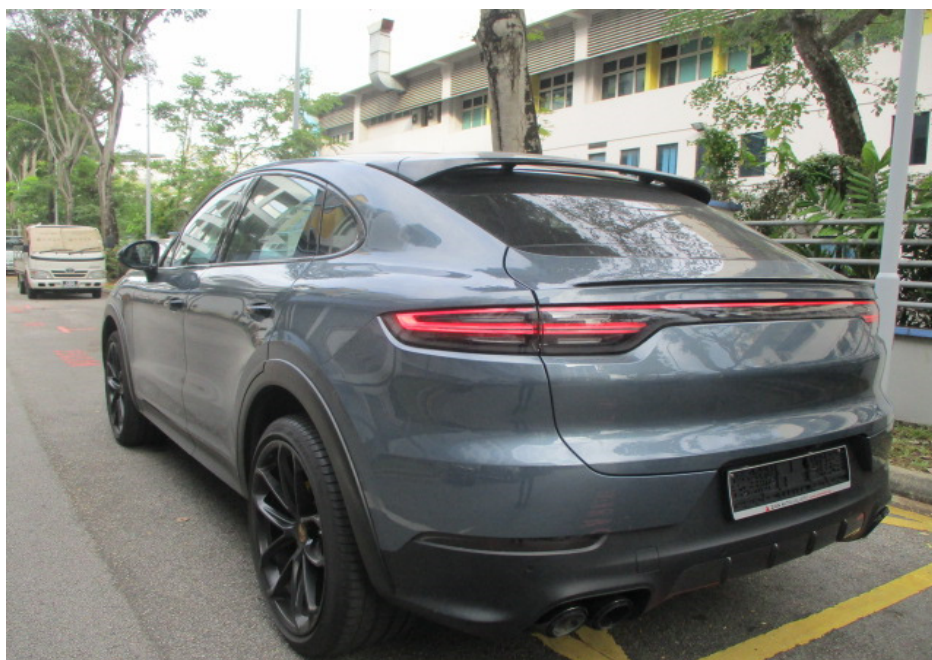
**Photo 12** shows a general view of the rear left body of the Motor Car at the time of my inspection. The Motor Car was observed to be in a relatively good general condition with no loose exterior fittings observed. The mileage of the Motor Car recorded at the time of my inspection was 7,040km.

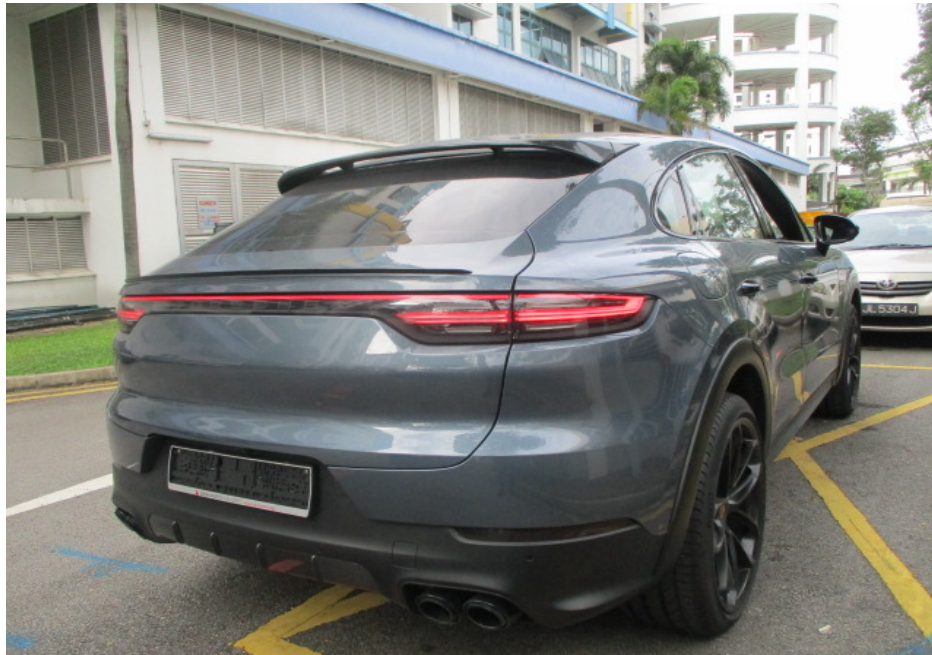
**Photo 13** shows a general view of the rear right body of the Motor Car at the time of my inspection. The Motor Car was observed to be in a relatively good general condition with no loose exterior fittings observed. The mileage of the Motor Car recorded at the time of my inspection was 7,040km.

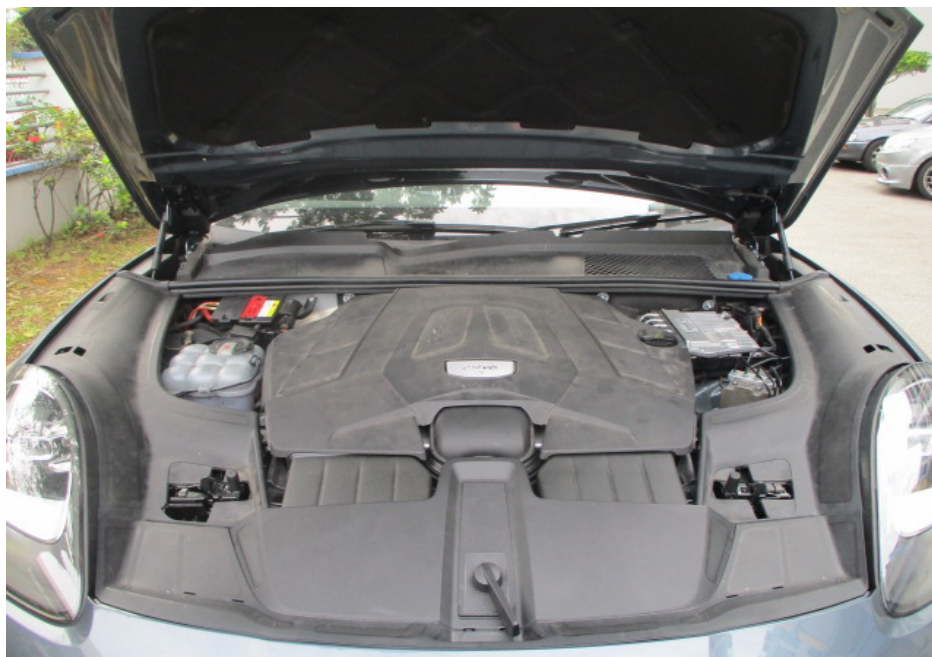
**Photo 15** shows a general view of the engine compartment of the Motor Car at the time of my inspection. The various parts and components inside the engine compartment were all observed to be intact and properly fitted. There was also no sign(s) or indication(s) of fluid leak and/or fluid stain found inside the engine compartment.

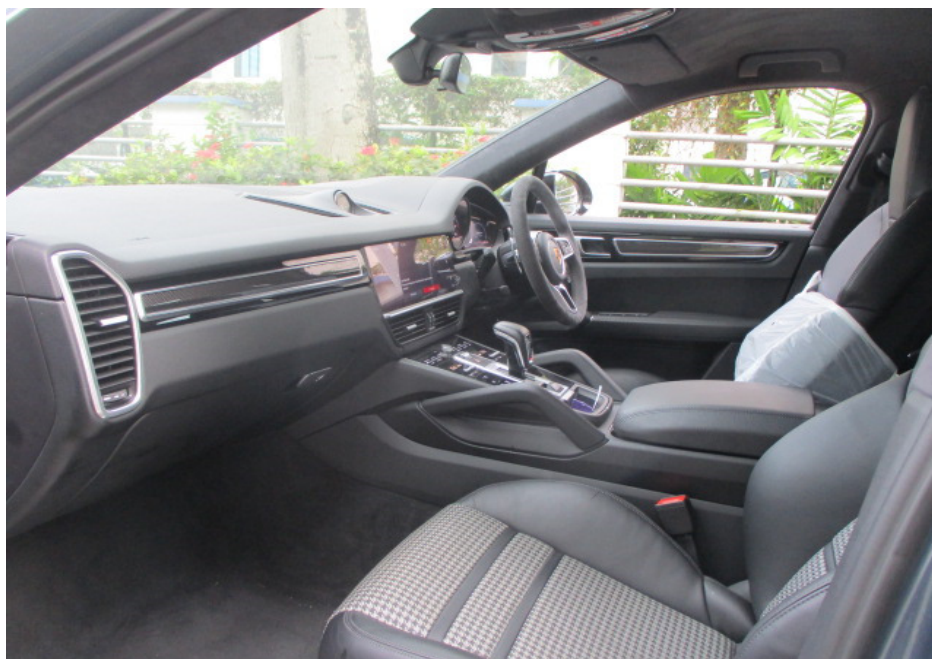
**Photo 16** shows the interior compartment of the Motor Car at the time of my inspection. The various parts and components, seats, trims, carpet, and upholstery inside the interior compartment were all observed to be intact and properly fitted.

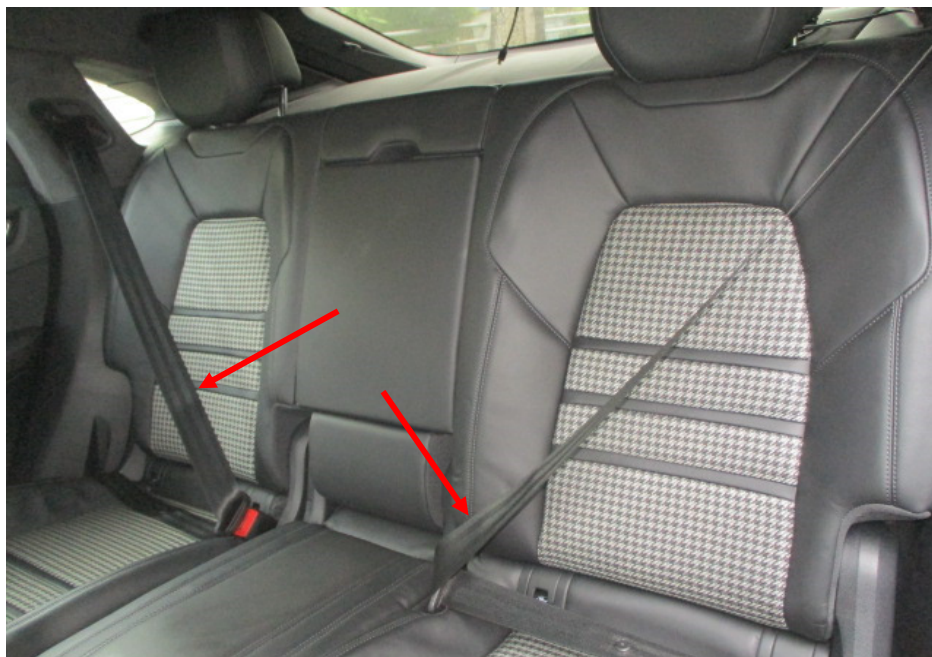
**Photo 17** shows the rear seats of the Motor Car. All the seats of the Motor Car were secured via seat rails to the floorboard. They were also fitted with a retractable seat belt reel and a pre-tensioner. The seat belts (arrowed) were tested and were able to be fastened into the respective pre-tensions that were fitted on the side of each individual seat.

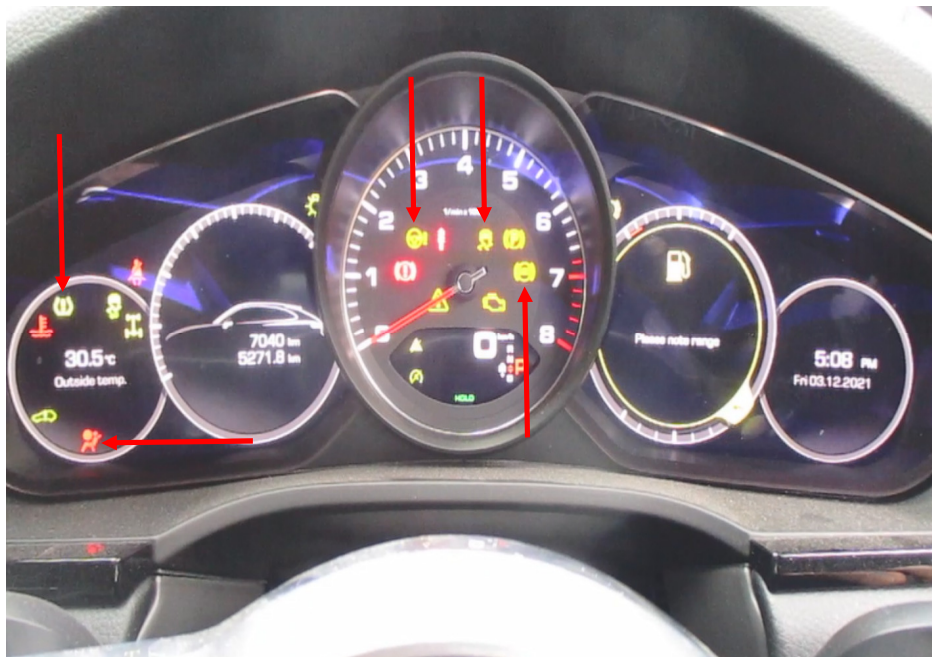
**Photo 18** shows the warning lights for the various electronic safety features appearing on the instrument panel of the Motor Car during its self-test when the engine is cranked, in particular the ABS, SRS, EPS, TPM and TCS lights (arrowed).

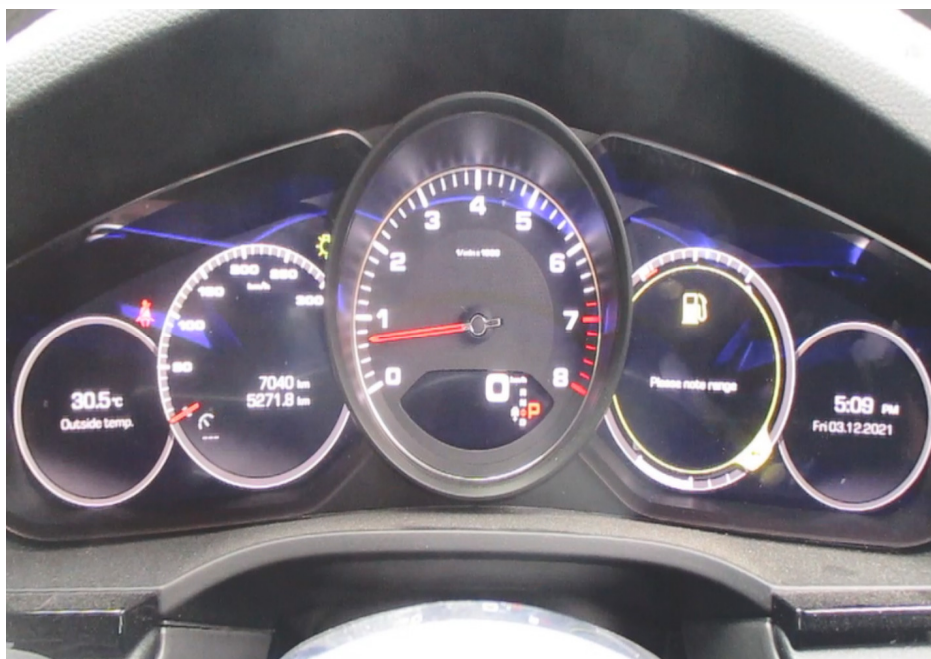
**Photo 19** shows the respective warning lights no longer illuminated, indicating that there is no fault detected to the ABS, SRS, EPS, TPM and TCS systems of the Motor Car during the self-test. These electronic systems were hence in working condition at the time of my inspection.

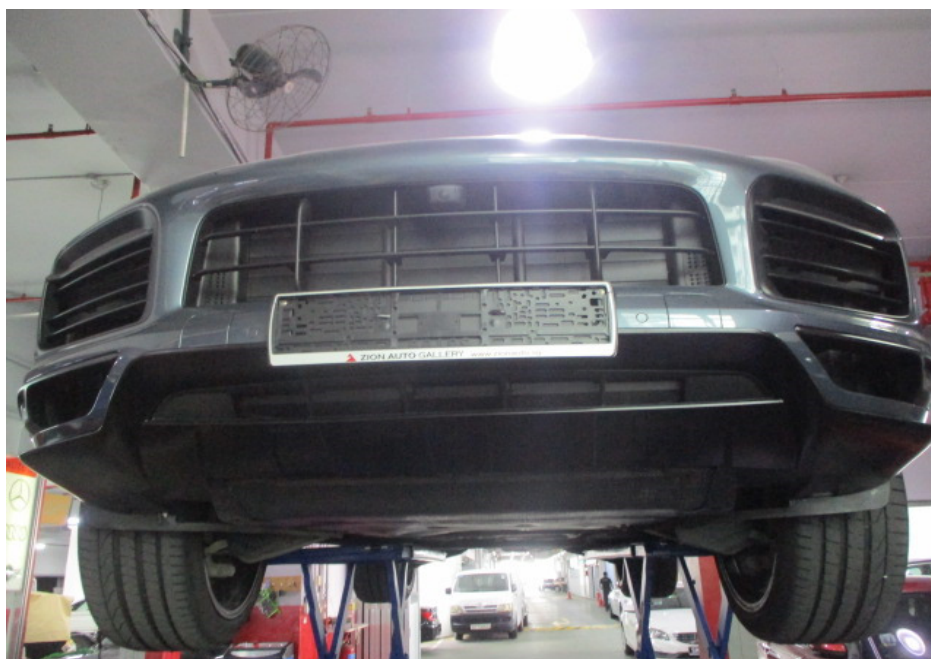
**Photo 20** shows the Motor Car hoisted up for checks on its undercarriage. There was no sign(s) or indication(s) of fluid leakage and/or fluid stain(s) on the underside of the Motor Car. The undercarriage components of the Motor Car were also all observed to be intact and secured in an appropriate manner.

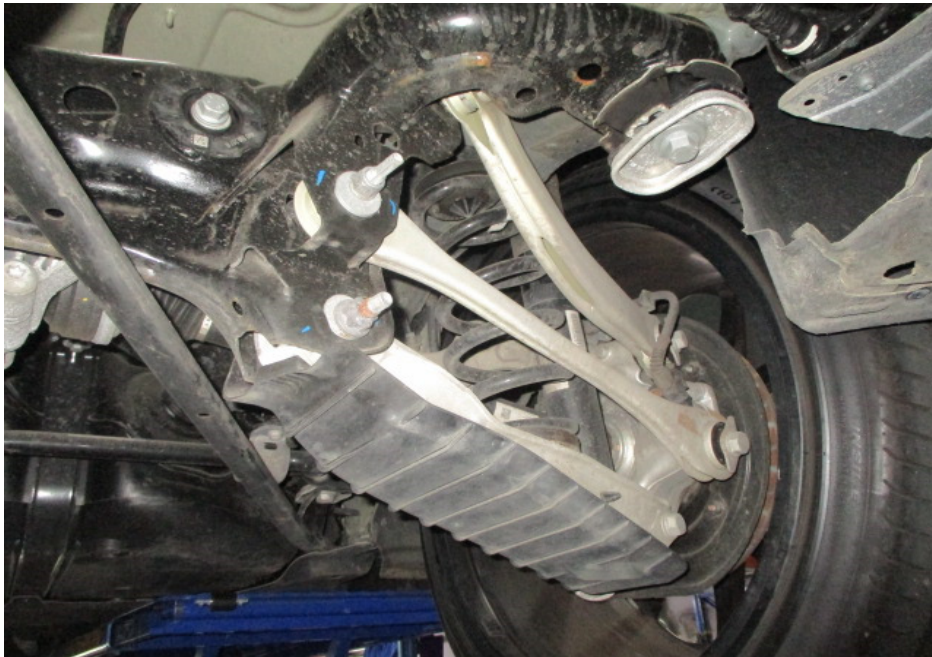
**Photo 21** shows a general view of the control arms and linkages at the rear right wheel of the Motor Car. I did not observe any fluid leak and/or fluid stain on the underside of the Motor Car. All of the Motor Car's undercarriage components were observed to be intact and secured in an appropriate manner.

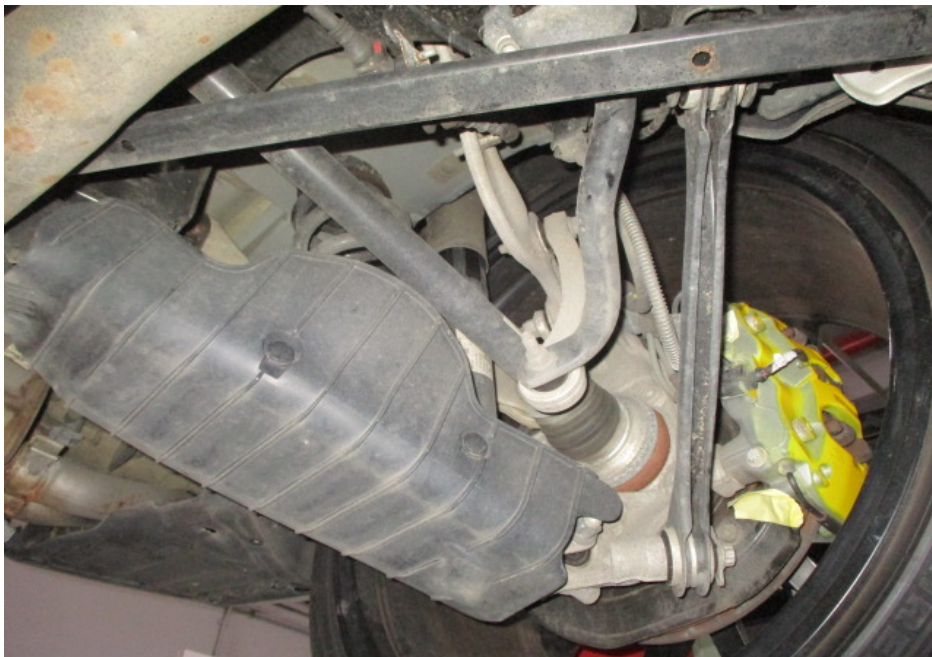
**Photo 22** shows a general view of the control arms and linkages at the rear left wheel of the Motor Car. I did not observe any fluid leak and/or fluid stain on the underside of the Motor Car. All of the Motor Car's undercarriage components were observed to be intact and secured in an appropriate manner.

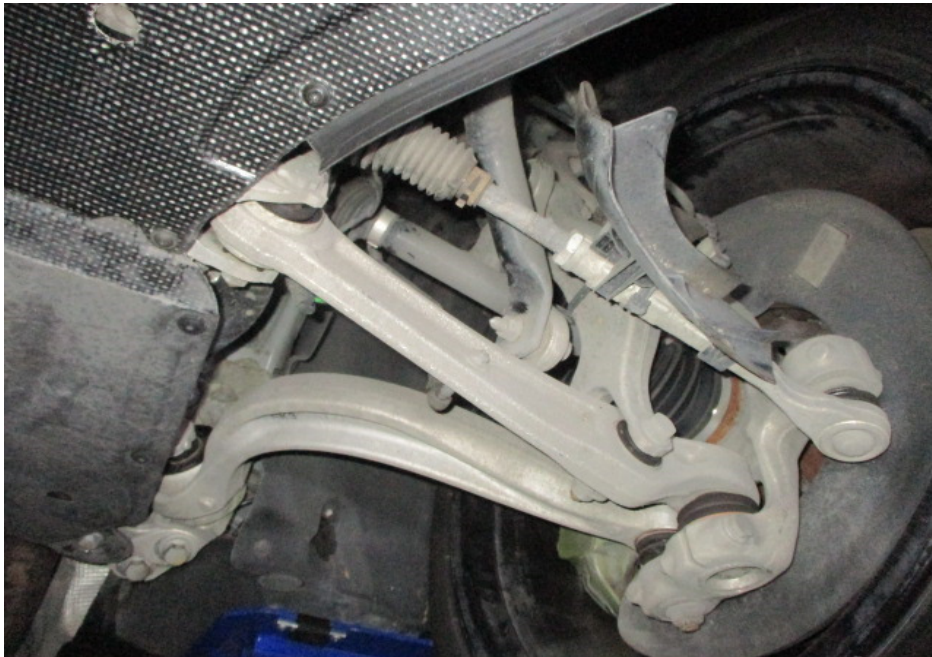
**Photo 23** shows the various undercarriage components at the front left wheel of the Motor Car. The mechanical components, control arms and linkages were all found to be intact and secured in an appropriate manner.

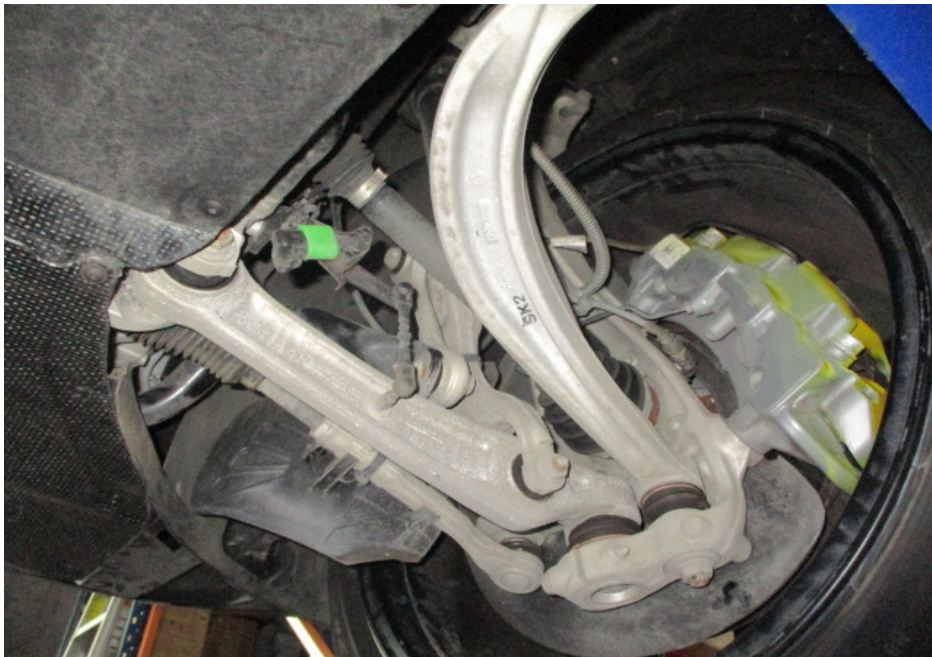
**Photo 24** shows the various undercarriage components at the front right wheel of the Motor Car. The mechanical components, control arms and linkages were all found to be intact and secured in an appropriate manner. I also did not observe any fluid leak and/or fluid stain on the underside of the Motor Car.

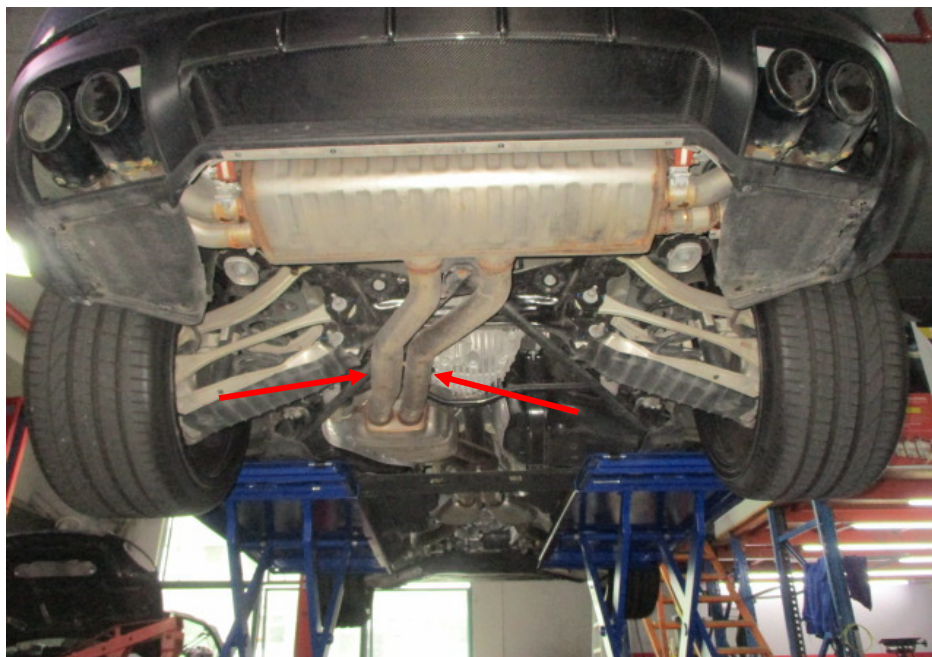
**Photo 25** shows the rear section of the Motor Car's exhaust system. My examination of the Motor Car's exhaust system revealed no sign(s) or indication(s) of any cut or weld marks along its exhaust pipes (arrowed), on its rear muffler, on its centre resonator boxes and on its catalytic converters.

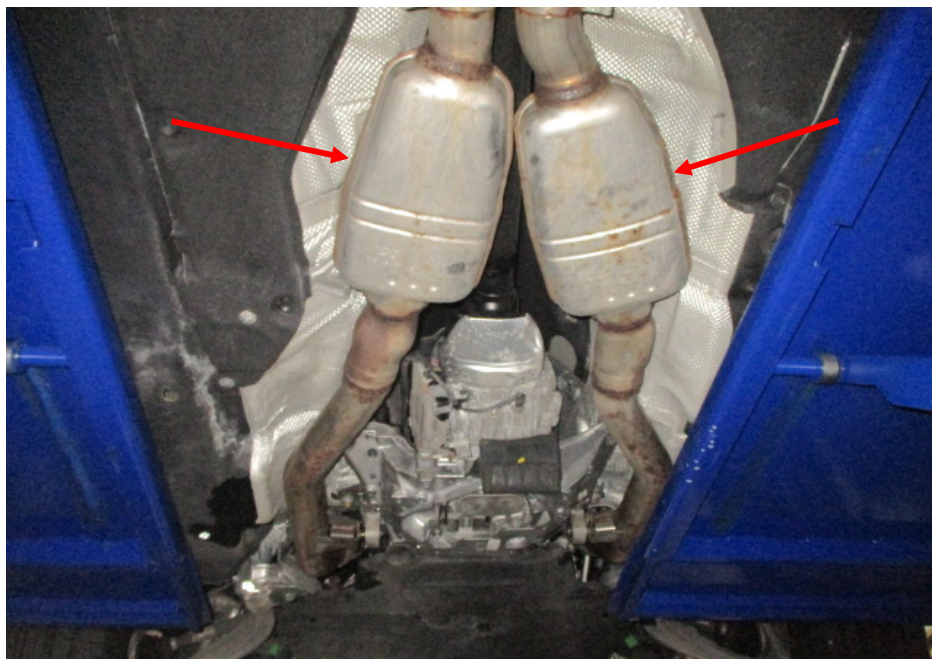
**Photo 26** shows the front section of the Motor Car's exhaust system. My examination of the Motor Car's exhaust system revealed no sign(s) or indication(s) of any cut or weld marks along its exhaust pipes, on its rear muffler, on its centre resonator boxes (arrowed) and on its catalytic converters.

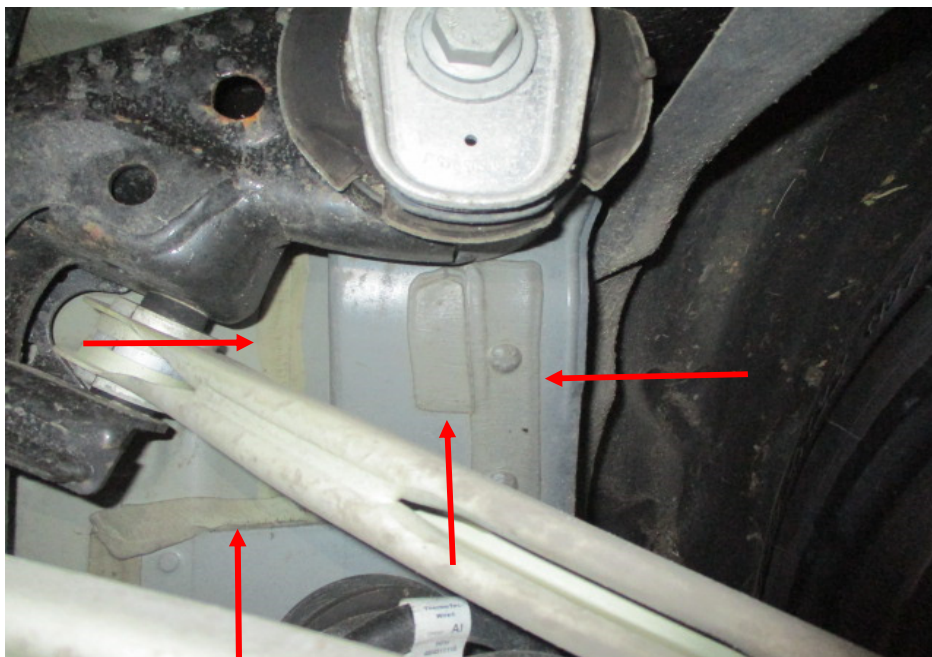
**Photo 27** shows the chassis/structural body at the underside rear right of the Motor Car. I did not find any weld marks other than original spot weld marks on the chassis/structural body of the Motor Car. The original factory sealant (arrowed) at the joints along the chassis/structural body was untouched, indicating no work was done on the chassis/structural body of the Motor Car and that the chassis/structural body was originally fitted.

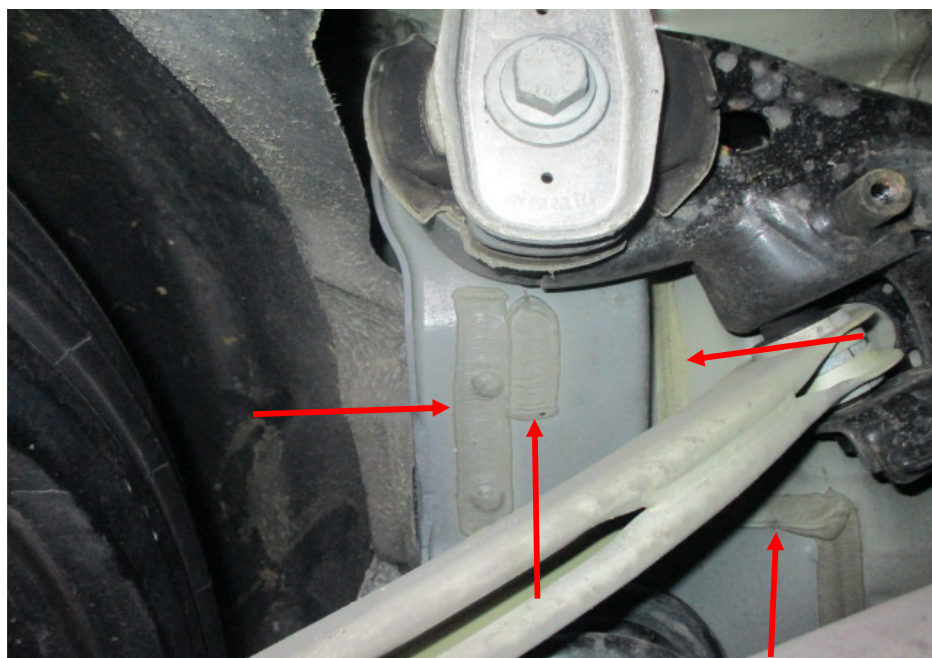
**Photo 28** shows the chassis/structural body at the underside rear left of the Motor Car. The original factory sealant (arrowed) at the joints along the chassis/structural body was observed to be untouched. In general, I had found no work was carried out on the chassis/structural body of the Motor Car. The chassis/structural body of the Motor Car was originally fitted.

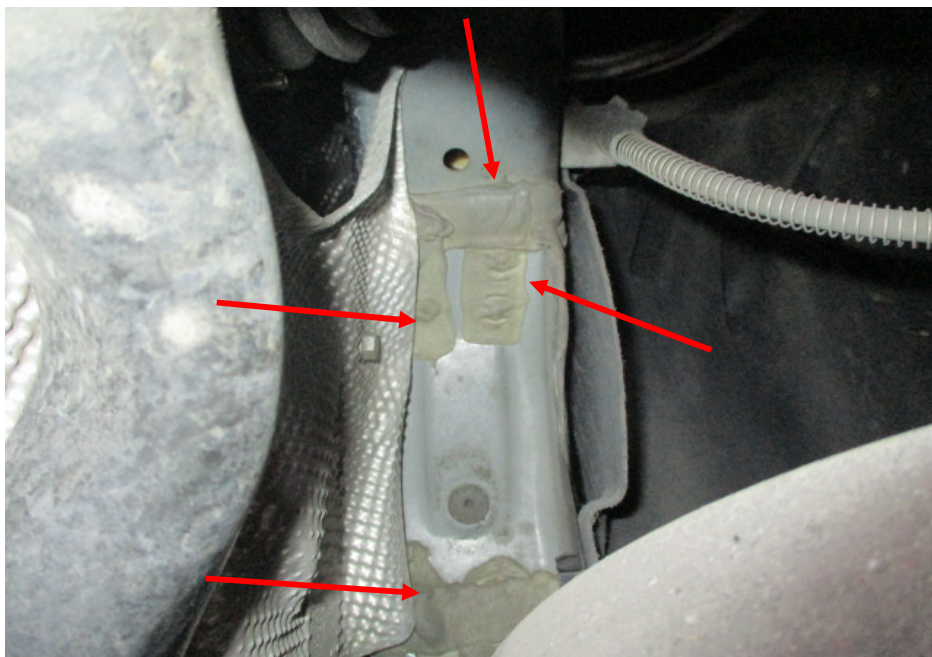
**Photo 29** shows the chassis/structural body at the underside front left of the Motor Car. I did not find any weld marks other than original spot weld marks on the chassis/structural body of the Motor Car. The original factory sealant (arrowed) at the joints along the chassis/structural body was untouched, indicating no work was done on the chassis/structural body of the Motor Car and that the chassis/structural body was originally fitted.

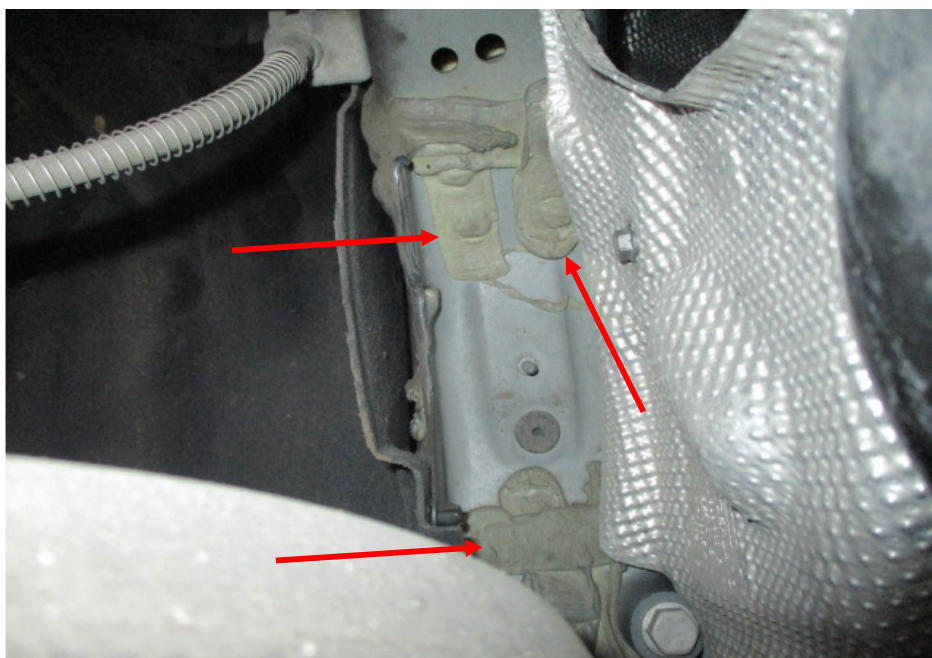
**Photo 30** shows the chassis/structural body at the underside front right of the Motor Car. The original factory sealant (arrowed) at the joints along the chassis/structural body was observed to be untouched. In general, I had found no work was carried out on the chassis/structural body of the Motor Car. The chassis/structural body of the Motor Car was originally fitted.

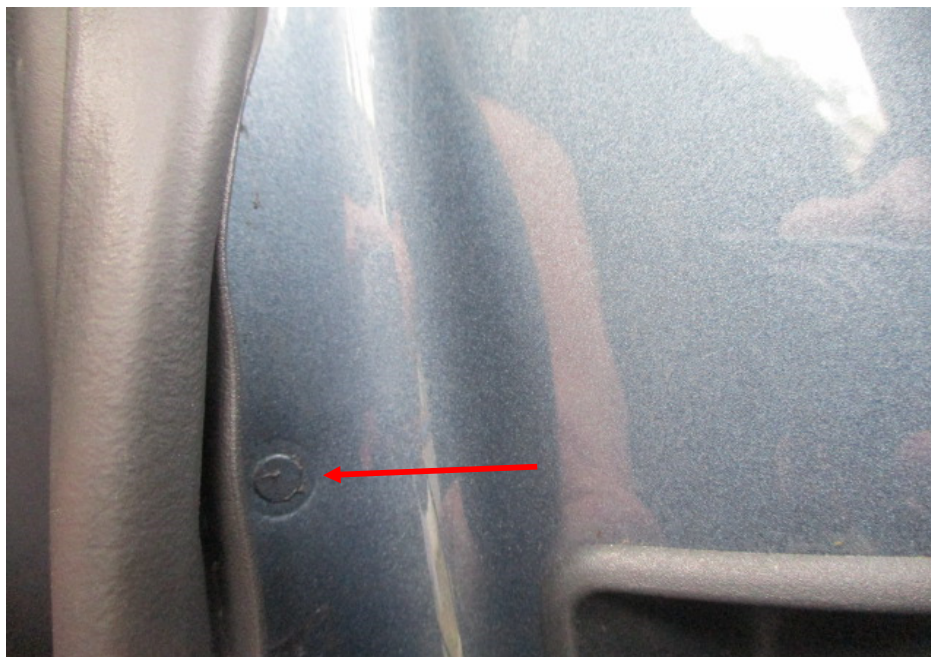
**Photo 31** shows the right side "A" pillar of the Motor Car. I did not find any weld marks other than original spot weld marks (arrowed) on the right side "A" pillar of the Motor Car which, indicates that there was no re-welding works carried out. In general, I had found all the non-detachable body panels of the Motor Car to be originally fitted at the time of my inspection.
