Our Ref : CI/TP21012425/D

Armstrong Auto Pte Ltd

INSPECTION REPORT OF AN UNREGISTERED PORSCHE 718 BOXSTER GTS MOTOR CAR WITH CHASSIS NUMBER WP0ZZZ98ZKS220446

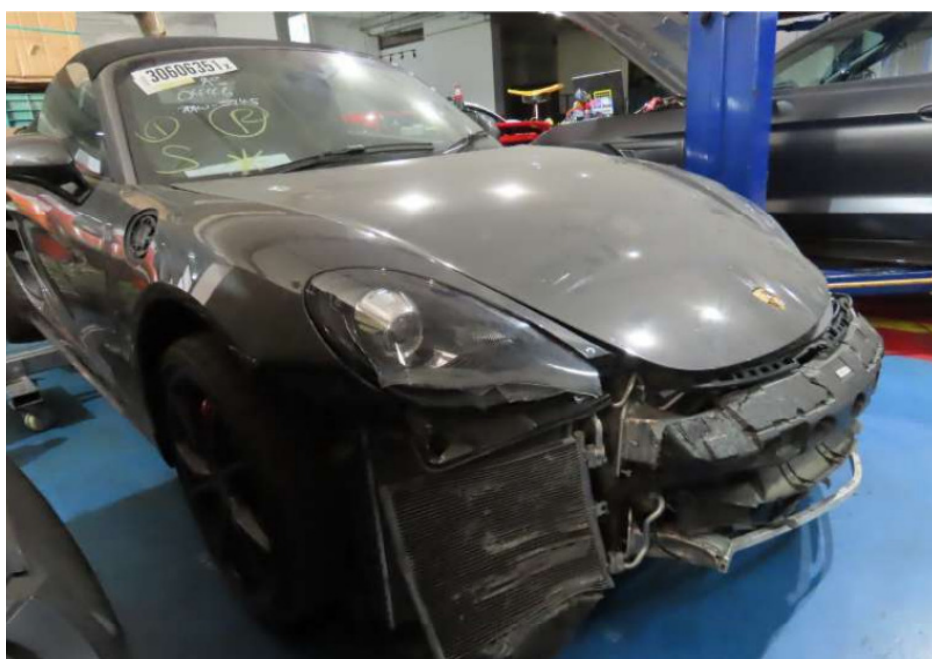
Photo 1 shows the front right body of the Motor Car (photograph provided to me). The Motor Car was observed to have sustained damages at its front right portion. The front bumper, front bumper lower grille, front bumper sponge, front bumper reinforcement, front bumper lower reinforcement, front centre air guide, front right day light, front right headlamp, front right aircon condenser and front right radiator were amongst the body parts that were observed to have been damaged.

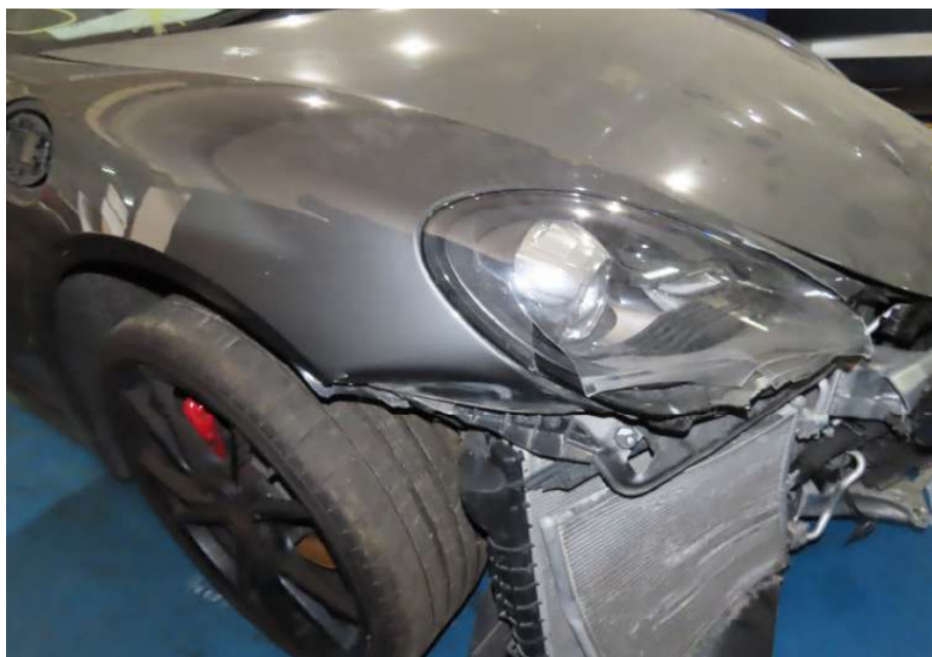
Photo 2 shows a closer view of the damaged front right fender, front right headlamp, front right aircon condenser and front right radiator of the Motor Car (photograph provided to me).

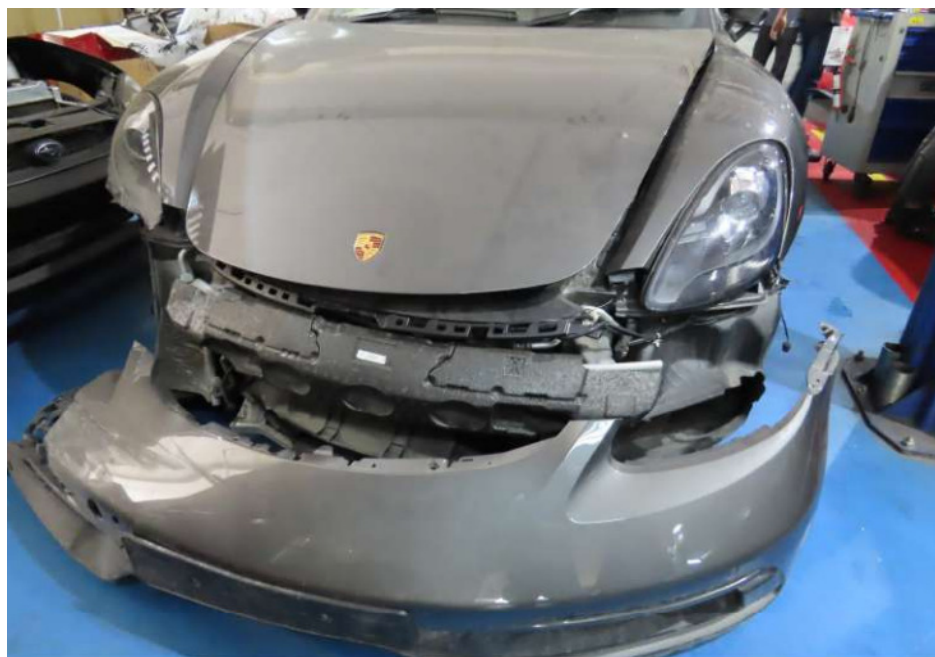
Photo 3 shows the frontal body of the Motor Car (photograph provided to me). The front bumper, front bumper sponge, front bumper reinforcement and front bonnet were amongst the body parts that were observed to have been damaged.

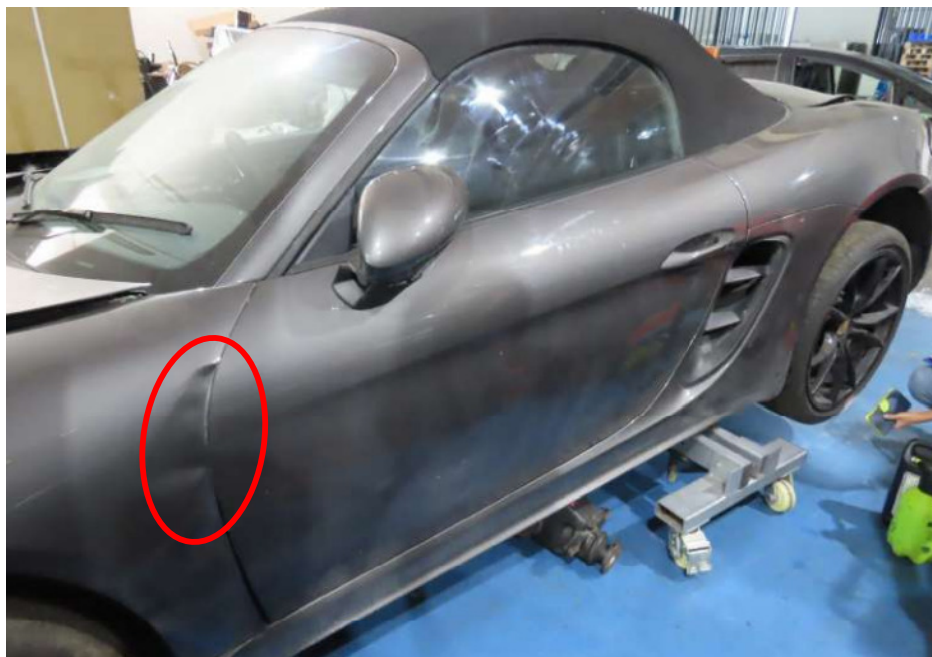
Photo 4 shows the left side body of the Motor Car (photograph provided to me). The Motor Car's front left fender was observed to be damaged (circled).

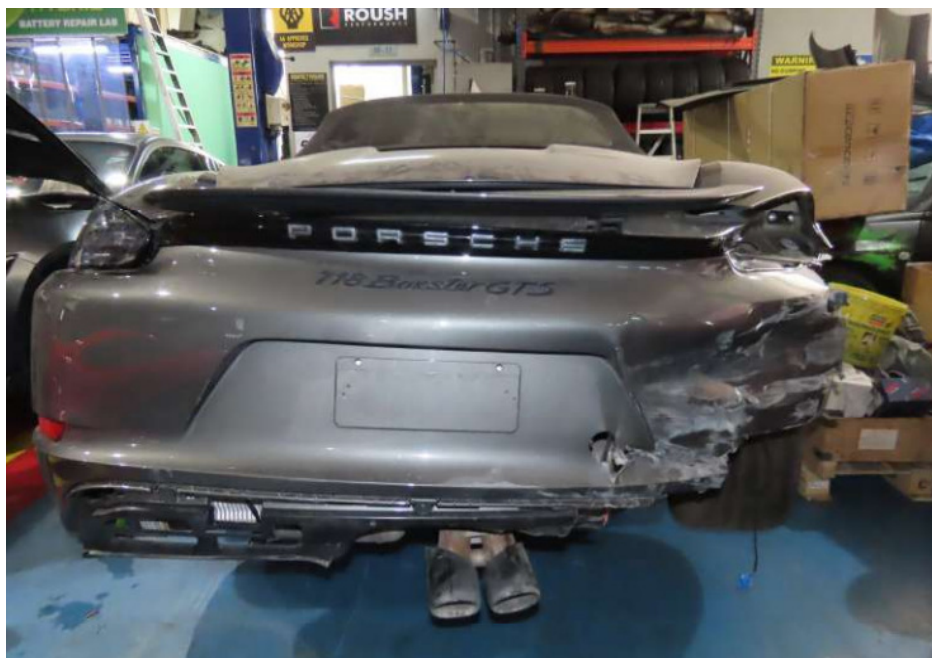
Photo 5 shows the rear body of the Motor Car (photograph provided to me). Apart for the front right portion and left front portion, the Motor Car had also sustained damages at its rear right portion. Body parts damaged include the rear bumper, rear bumper lower cover, rear bumper tow hook cover, rear bumper right reflector, rear exhaust, rear bootlid and rear right taillamp amongst others.

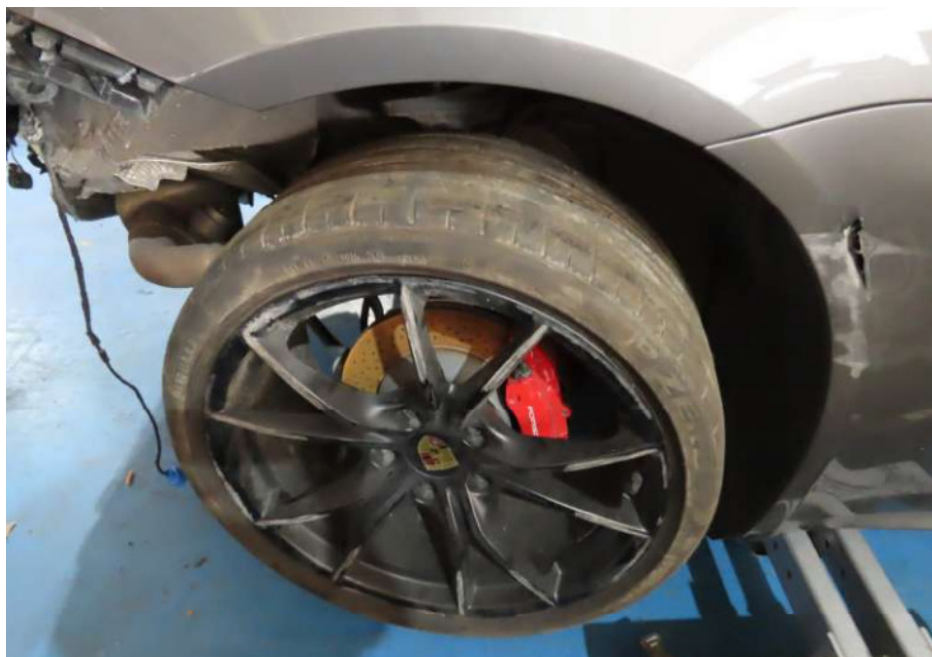
Photo 6 shows the damage to the rear right wheel rim and right side rocker panel garnish of the Motor Car (photograph provided to me). The orientation of the Motor Car's rear right wheel indicates damage to its rear right undercarriage parts. Undercarriage parts that may possibly be damaged include the rear right lower arm, rear right upper arm, rear right shock absorber and rear right knuckle arm amongst others.

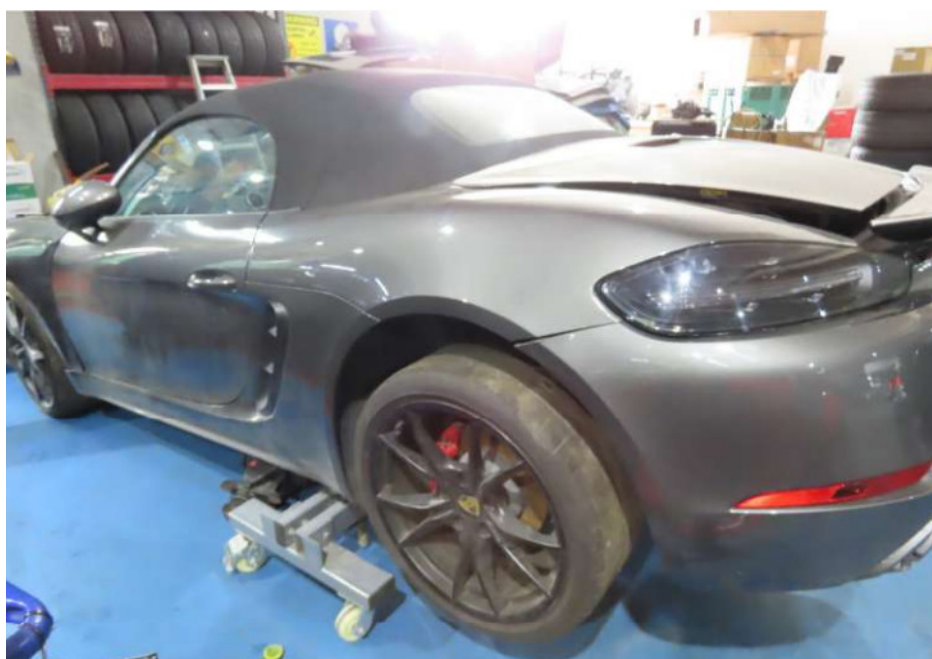
Photo 7 shows the rear left body of the Motor Car (photograph provided to me). No physical damage was observed to the rear left portion of the Motor Car.

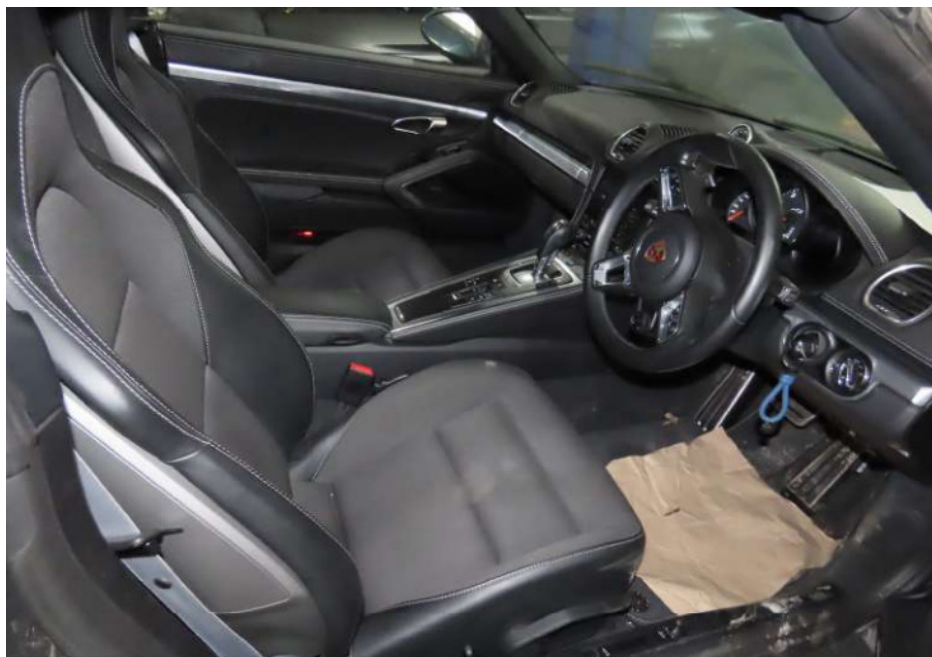
Photo 8 shows the interior compartment of the Motor Car (photograph provided to me). Parts and components within the interior compartment were observed to be unaffected. The airbags of the Motor Car were also not deployed as seen from the photographs that were provided to me.

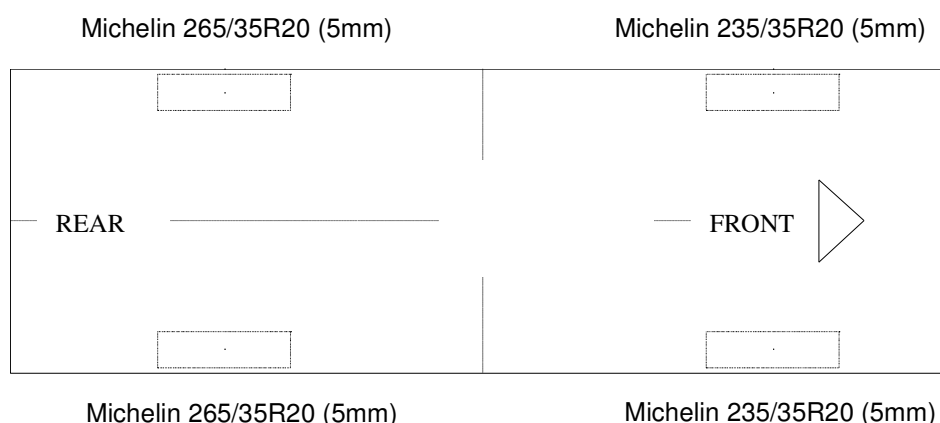
12. It was fitted with 20inch sport wheel rims that were wrapped with tyres that were observed to be of serviceable condition. The tyres were also sufficiently inflated for vehicular operation. The tyre brand, tyre size and approximate remaining tread depth of the 4 tyres of the Motor Car were recorded as follows: -

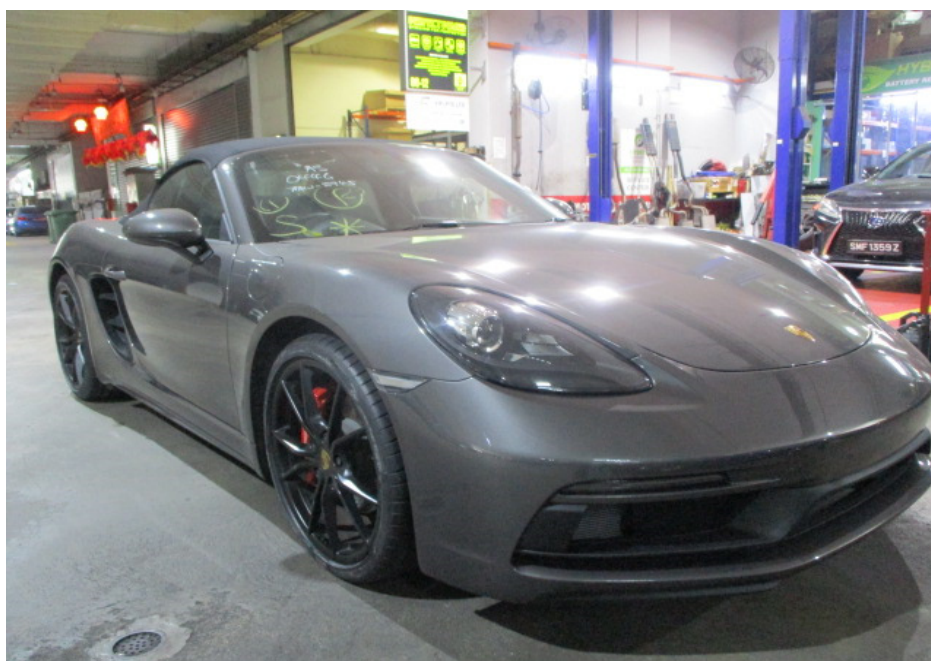
Photo 9 shows a general view of the front right body of the Motor Car at the time of my inspection. The Motor Car was observed to be in a relatively good general condition with no loose exterior fittings observed. The body parts at the front right portion of the Motor Car were visually examined and it was observed that the repair/restoration works carried out to the damaged area of the Motor Car (refer to photograph 1 - 3 above) were reasonably adequate and in order.

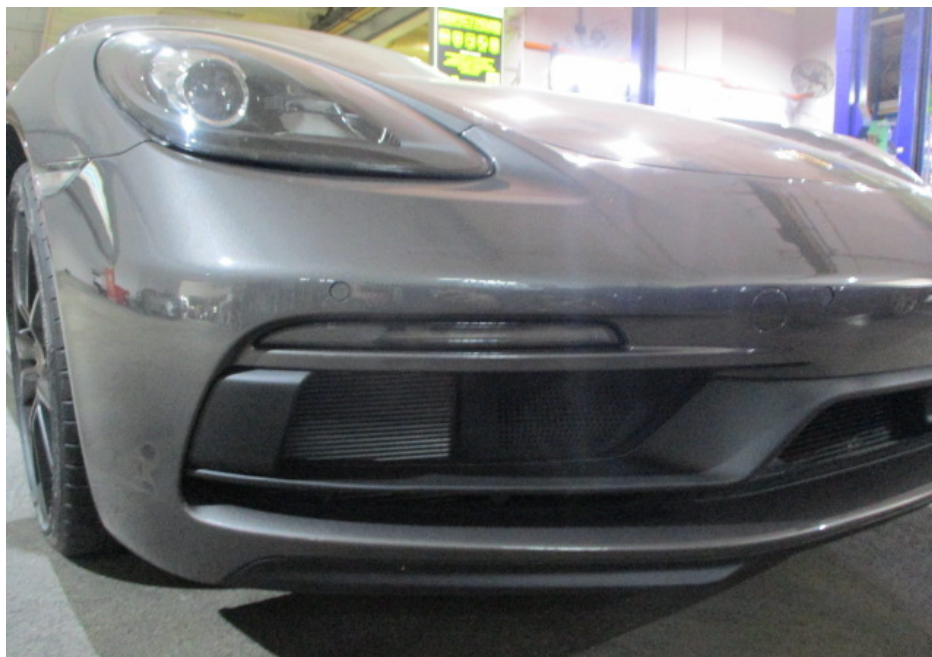
Photo 10 shows a closer view of the Motor Car's front bumper, front bumper lower grille, front right day light, front right headlamp and front right aircon condenser. The body parts at the front right portion of the Motor Car were visually examined and it was observed that the repair/restoration works carried out to the damaged area of the Motor Car (refer to photograph 1 & 2 above) were reasonably adequate and in order.

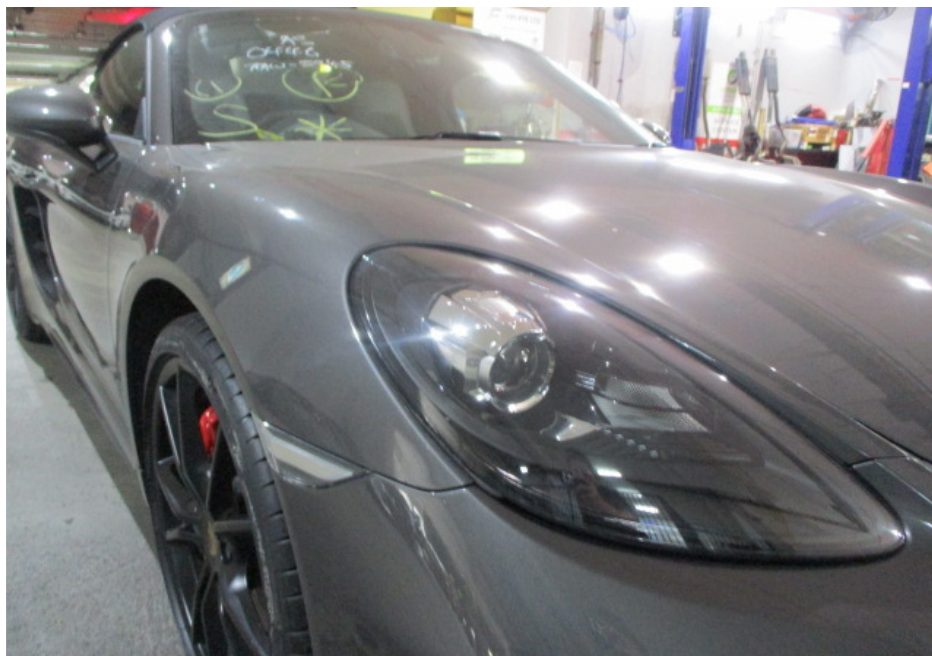
Photo 11 shows a closer view of the Motor Car's front bonnet, front right headlamp, front right fender and front right signal lamp. The body parts at the front right portion of the Motor Car were visually examined and it was observed that the repair/restoration works carried out to the damaged area of the Motor Car (refer to photograph 1 & 2 above) were reasonably adequate and in order.

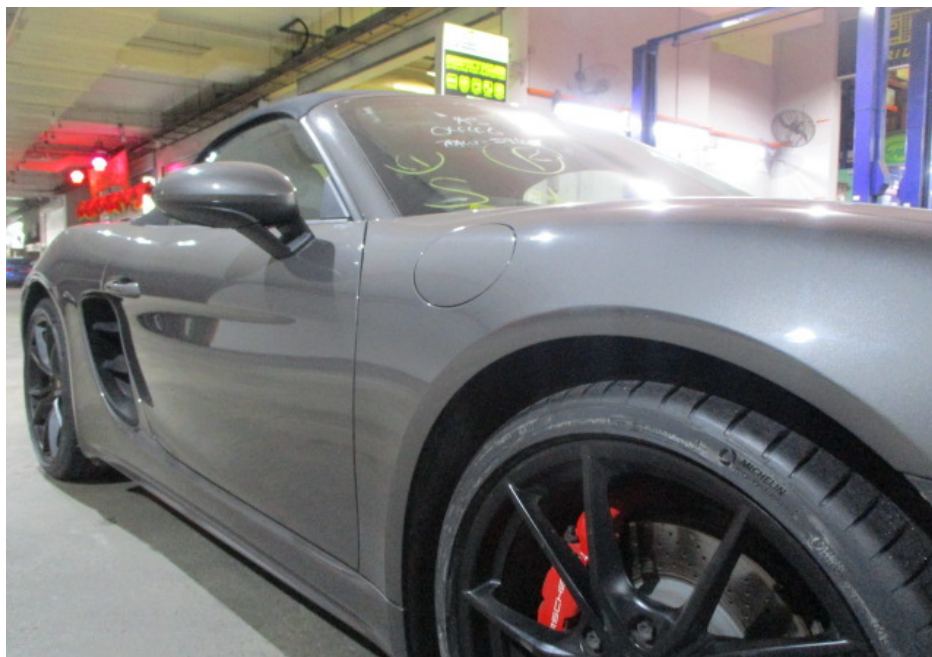
Photo 12 shows a closer view of the Motor Car's front right fender, petrol filler outer cover and front right door. The body parts at the front right portion of the Motor Car were visually examined and it was observed that the repair/restoration works carried out to the damaged area of the Motor Car (refer to photograph 1 & 2 above) were reasonably adequate and in order.

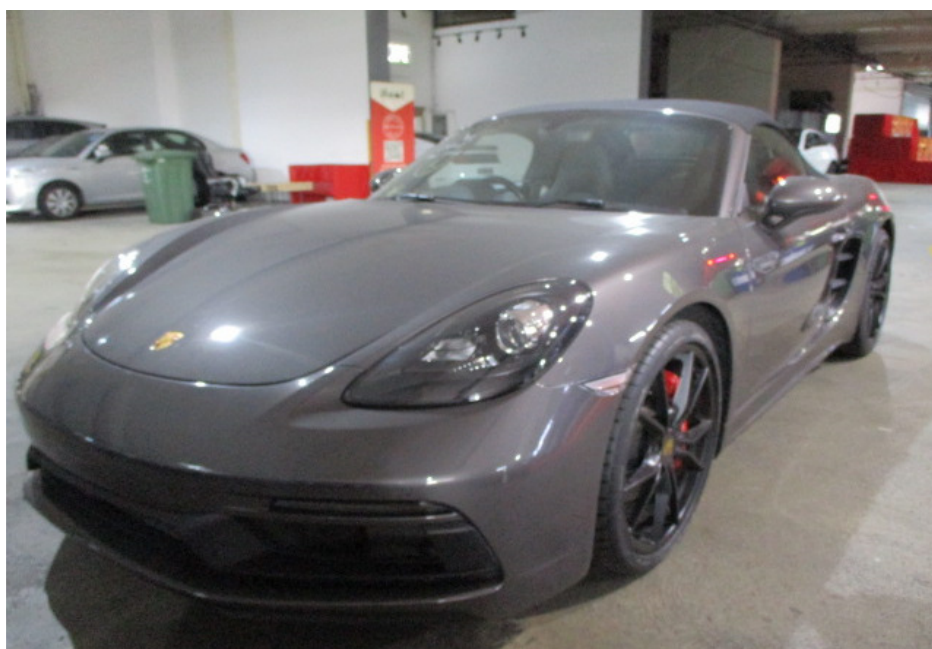
Photo 13 shows a general view of the front left body of the Motor Car at the time of my inspection. The Motor Car was observed to be in a relatively good general condition with no loose exterior fittings observed. The body parts at the front left portion of the Motor Car were visually examined and it was observed that the repair/restoration works carried out to the damaged area of the Motor Car (refer to photograph 3 & 4 above) were reasonably adequate and in order.

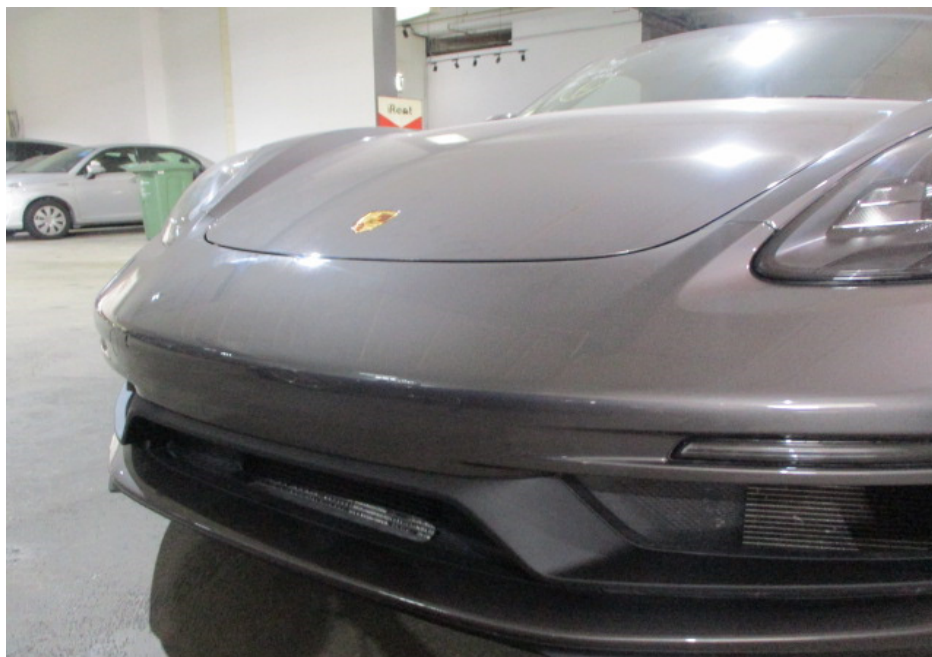
Photo 14 shows a closer view of the Motor Car's front bumper, front bumper lower grille, front left day light and front bonnet. The body parts at the front left portion of the Motor Car were visually examined and it was observed that the repair/restoration works carried out to the damaged area of the Motor Car (refer to photograph 3 above) were reasonably adequate and in order.

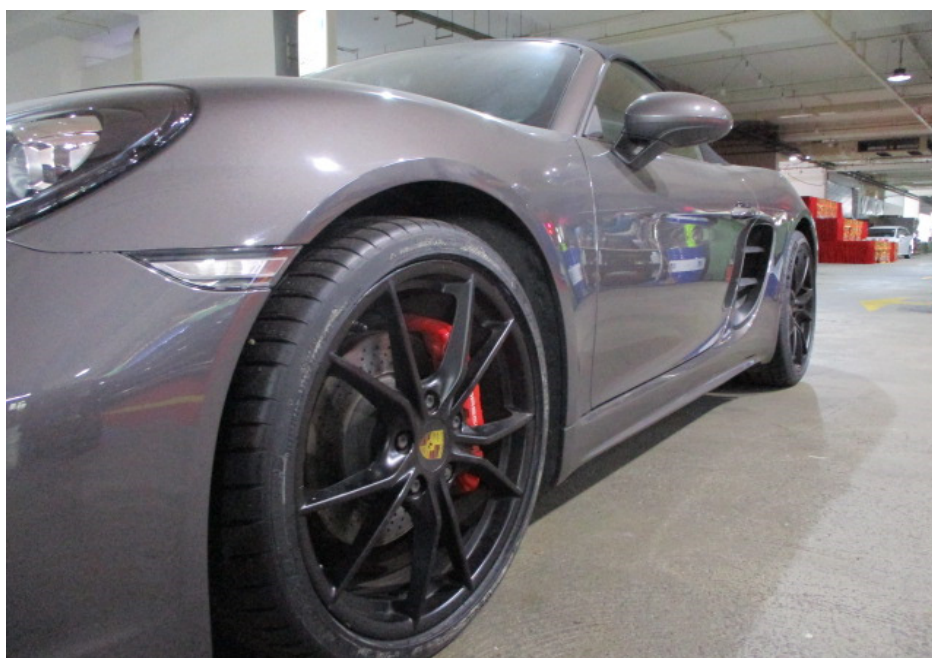
Photo 15 shows a closer view of the Motor Car's front bumper, front left signal lamp, front left fender and front left wheel rim. The body parts at the front left portion of the Motor Car were visually examined and it was observed that the repair/restoration works carried out to the damaged area of the Motor Car (refer to photograph 3 & 4 above) were reasonably adequate and in order.

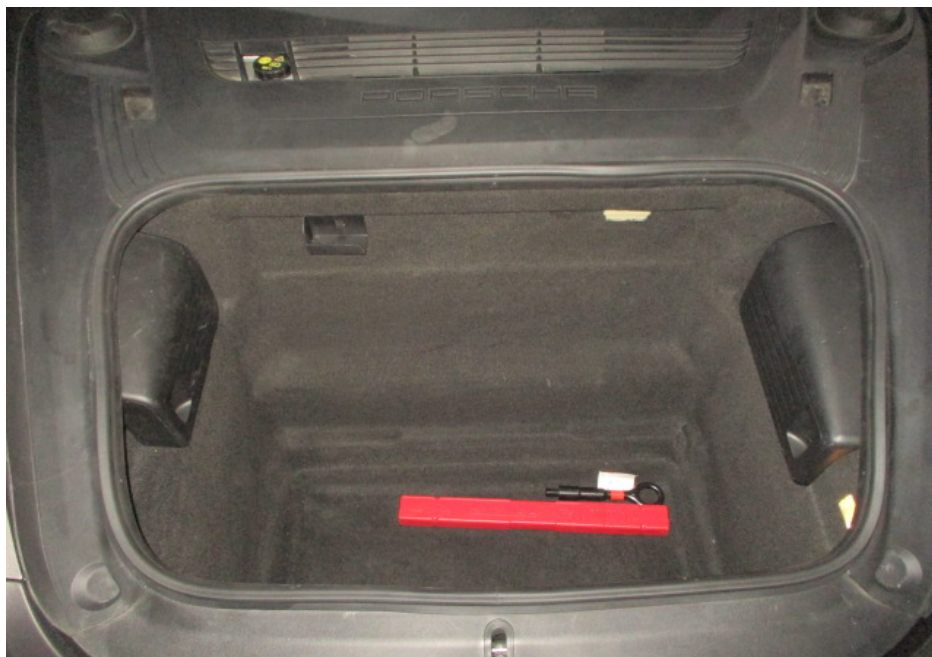
Photo 16 shows a general view of the Motor Car's front bonnet compartment at the time of my inspection. All inner trims, garnishes and upholstery etc were observed to be properly fitted.

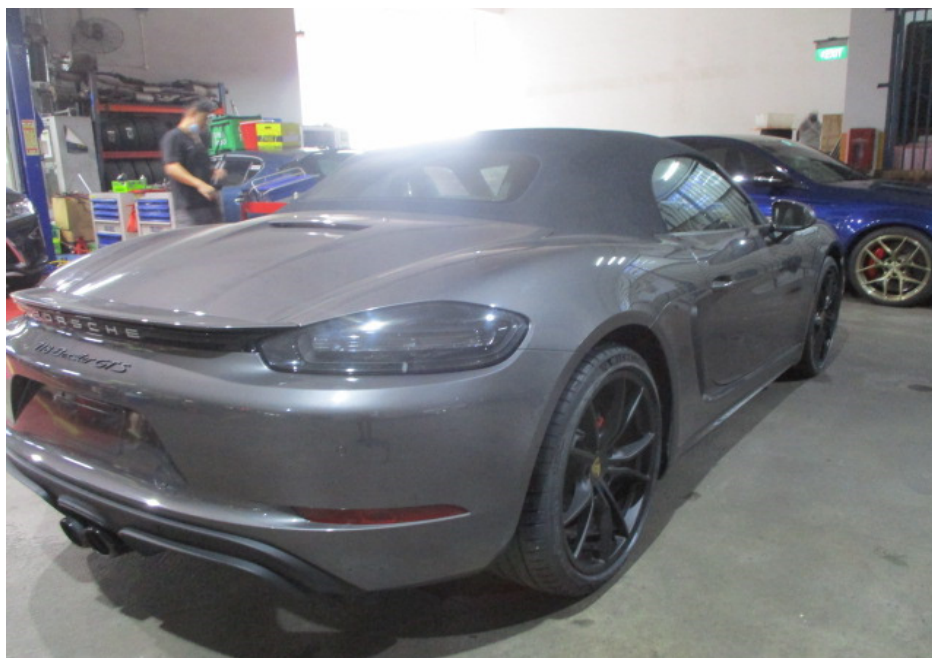
Photo 17 shows a general view of the rear right body of the Motor Car at the time of my inspection. The Motor Car was observed to be in a relatively good general condition with no loose exterior fittings observed. The body parts at the rear right portion of the Motor Car were visually examined and it was observed that the repair/restoration works carried out to the damaged area of the Motor Car (refer to photograph 5 & 6 above) were reasonably adequate and in order.

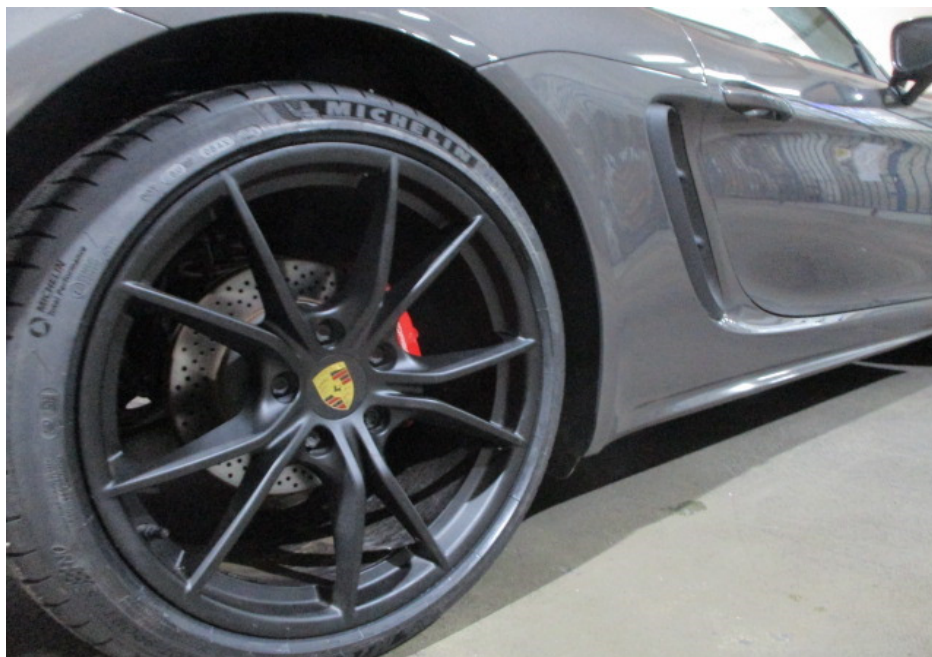
Photo 18 shows a closer view of the Motor Car's rear right wheel rim, rear right tyre and right side rocker panel garnish. The body parts at the rear right portion of the Motor Car were visually examined and it was observed that the repair/restoration works carried out to the damaged area of the Motor Car (refer to photograph 6 above) were reasonably adequate and in order.

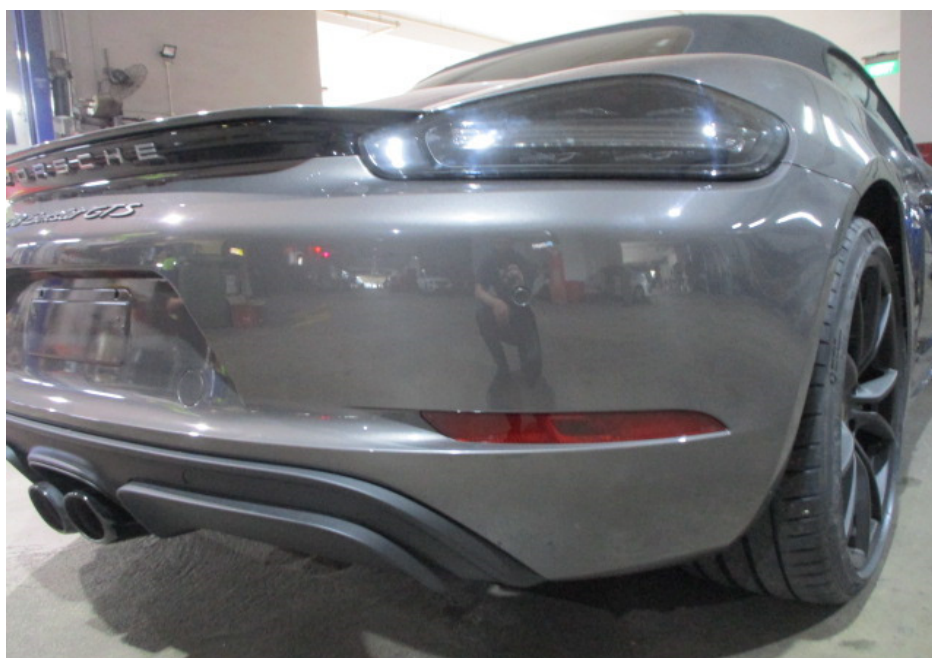
Photo 19 shows a closer view of the Motor Car's rear bumper, rear bumper right reflector, rear bumper lower cover and rear right taillamp. The body parts at the rear right portion of the Motor Car were visually examined and it was observed that the repair/restoration works carried out to the damaged area of the Motor Car (refer to photograph 5 above) were reasonably adequate and in order.

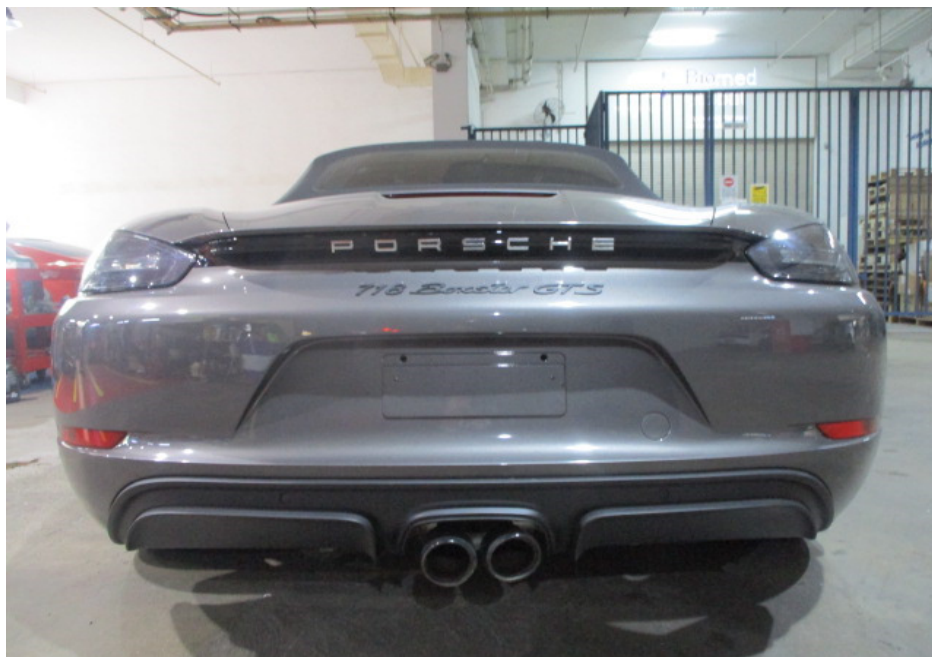
Photo 20 shows a closer view of the Motor Car's rear bumper, rear bumper reflectors, rear bumper lower cover and rear exhaust. The body parts at the rear right portion of the Motor Car were visually examined and it was observed that the repair/restoration works carried out to the damaged area of the Motor Car (refer to photograph 5 above) were reasonably adequate and in order.

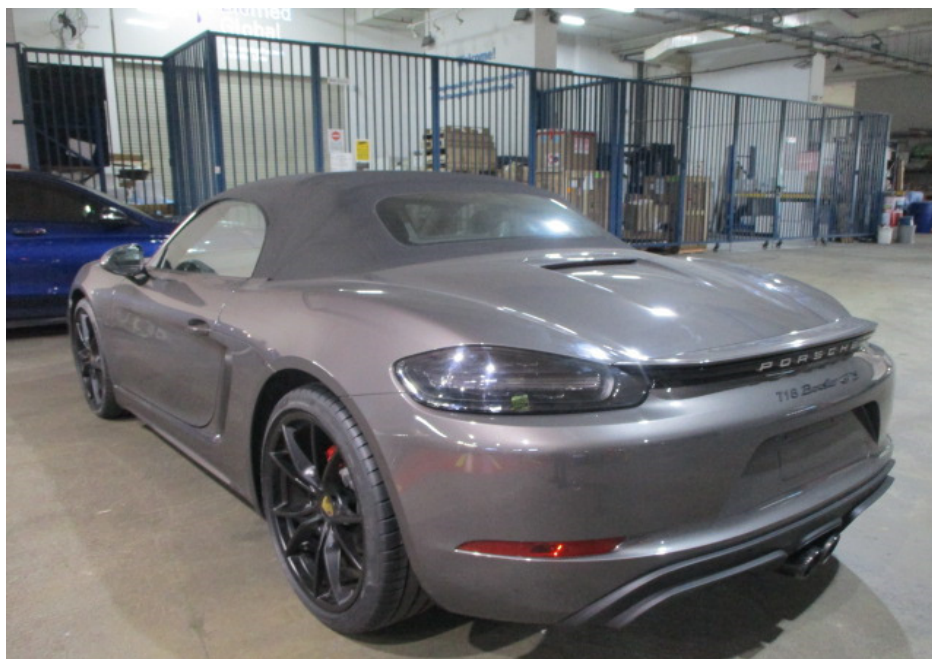
Photo 21 shows a general view of the rear left body of the Motor Car at the time of my inspection. The Motor Car was observed to be in a relatively good general condition with no loose exterior fittings observed. The mileage of the Motor Car recorded at the time of my inspection was 17,710 miles.

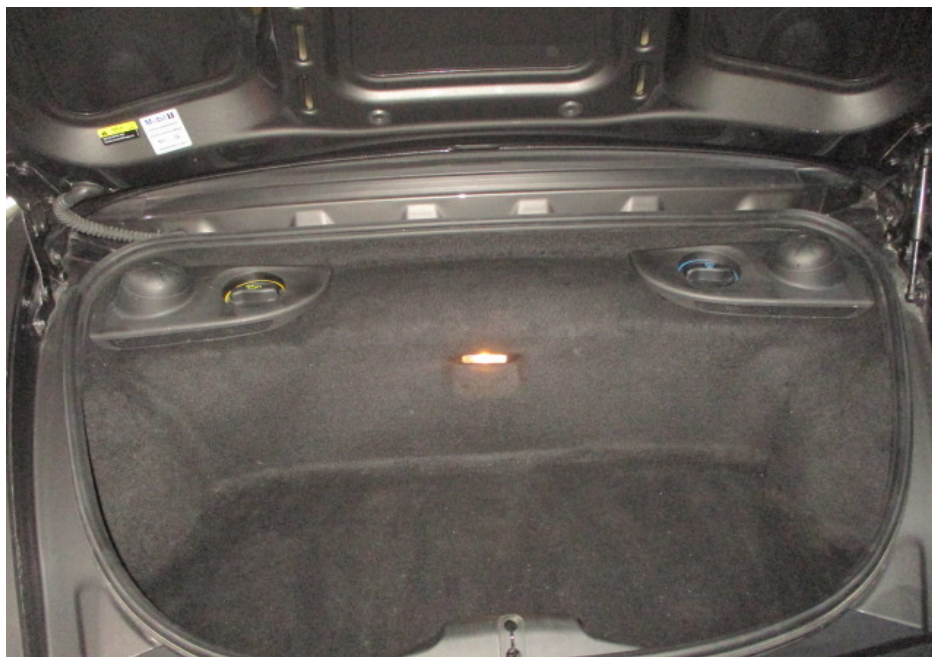
Photo 22 shows a general of the Motor Car's rear boot compartment at the time of my inspection. All inner trims, garnishes and upholstery etc were observed to be properly fitted.

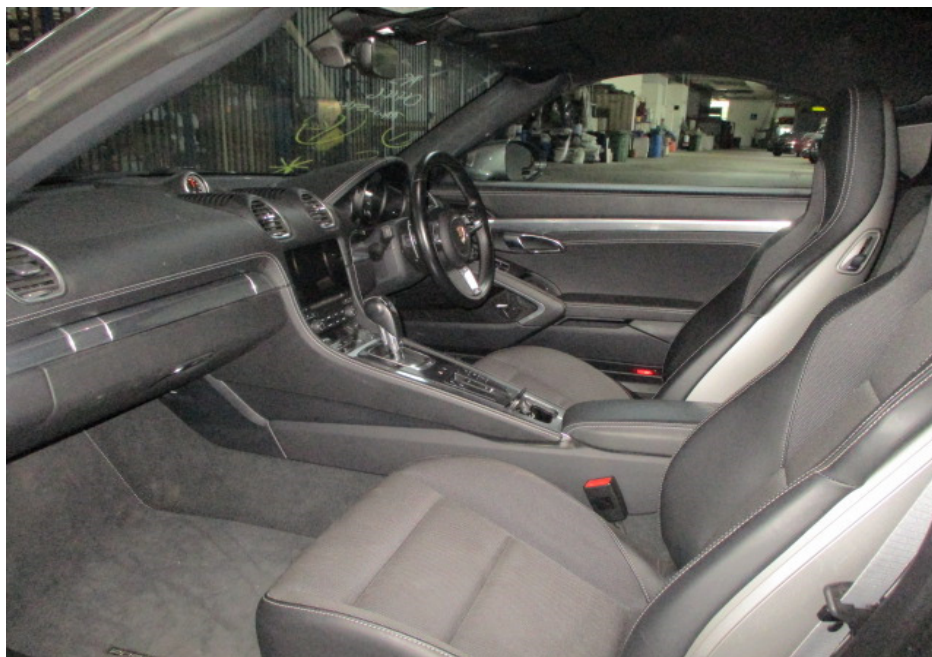
Photo 24 shows the interior compartment of the Motor Car at the time of my inspection. The various parts and components, seats, trims, carpet and upholstery inside the interior compartment were all observed to be intact and properly fitted

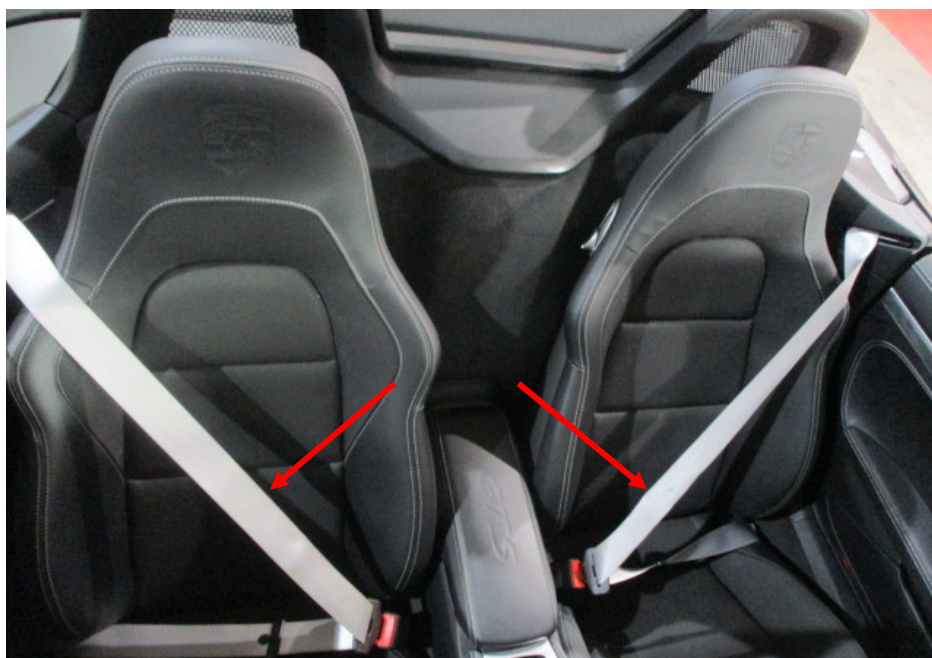
Photo 25 shows the seats of the Motor Car. All the seats of the Motor Car were secured via seat rails to the floorboard. They were also fitted with a retractable seat belt reel and a pre-tensioner. The seat belts (arrowed) were tested and were able to be fastened into the respective pre-tensions that were fitted on the side of each individual seat.

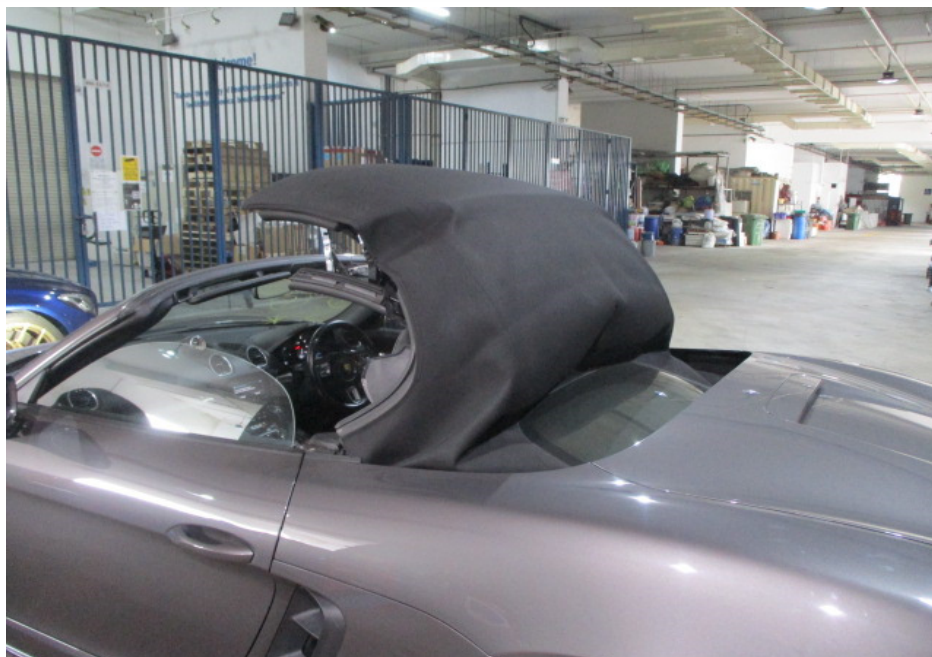
Photo 26 shows the Motor Car's soft top roof being tested. It was observed that as a safety feature, the soft top roof could only open and close when the Motor Car was in a stationary position. When in an open position, the soft top roof is completely folded into its rear compartment with no parts protruding out of the Motor Car's body. The soft top roof was also found adequately secured to the "A" pillar after closing.

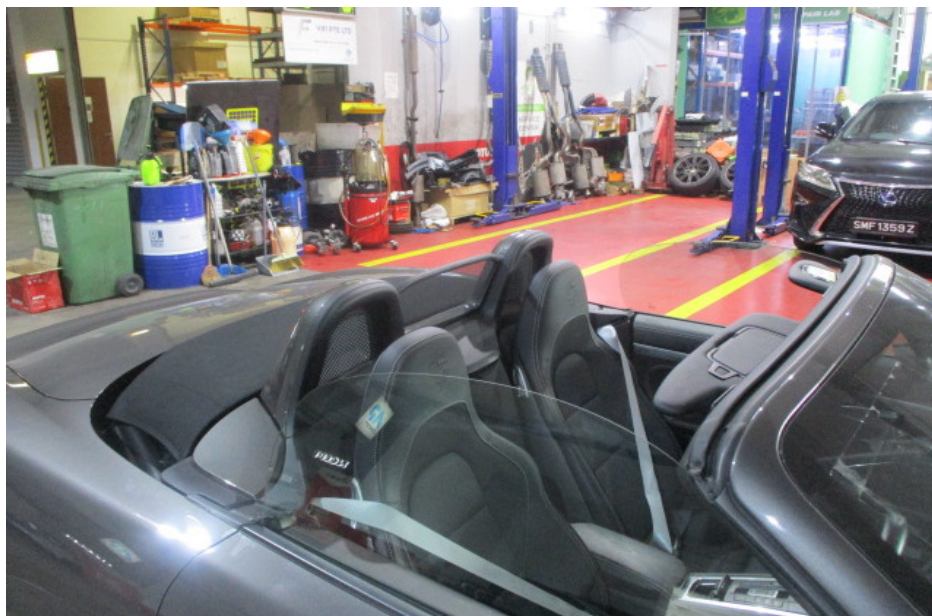
Photo 27 shows the Motor Car with its soft top roof in an open position. It was observed that as a safety feature, the soft top roof could only open and close when the Motor Car was in a stationary position. When in an open position, the soft top roof is completely folded into its rear compartment with no parts protruding out of the Motor Car's body. The soft top roof was also found adequately secured to the "A" pillar after closing.

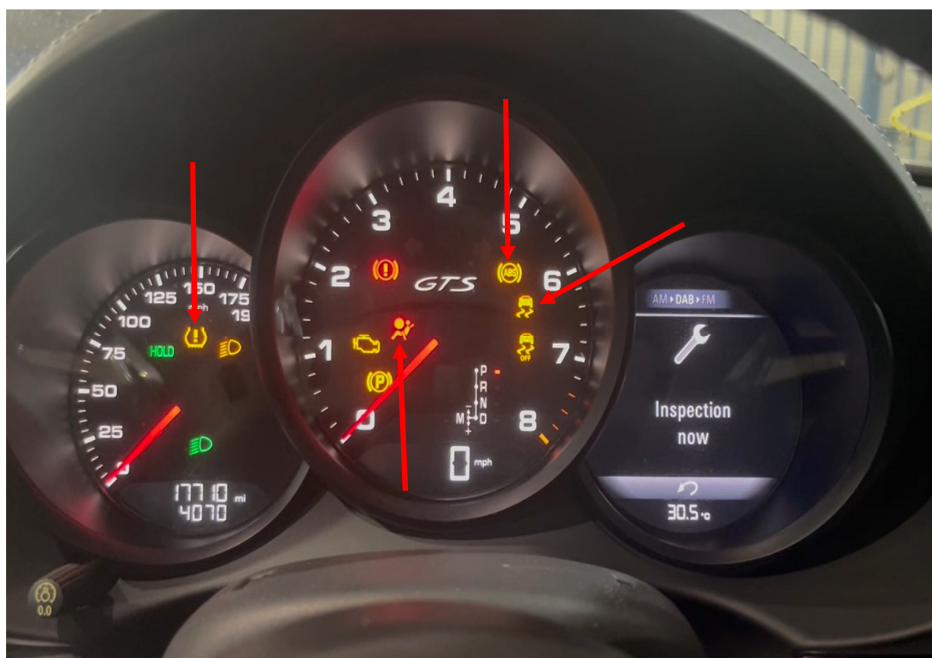
Photo 28 shows the warning lights for the various electronic safety features appearing on the instrument panel of the Motor Car during its self-test when the engine is cranked, in particular the ABS, SRS, TPM and TCS lights (arrowed).

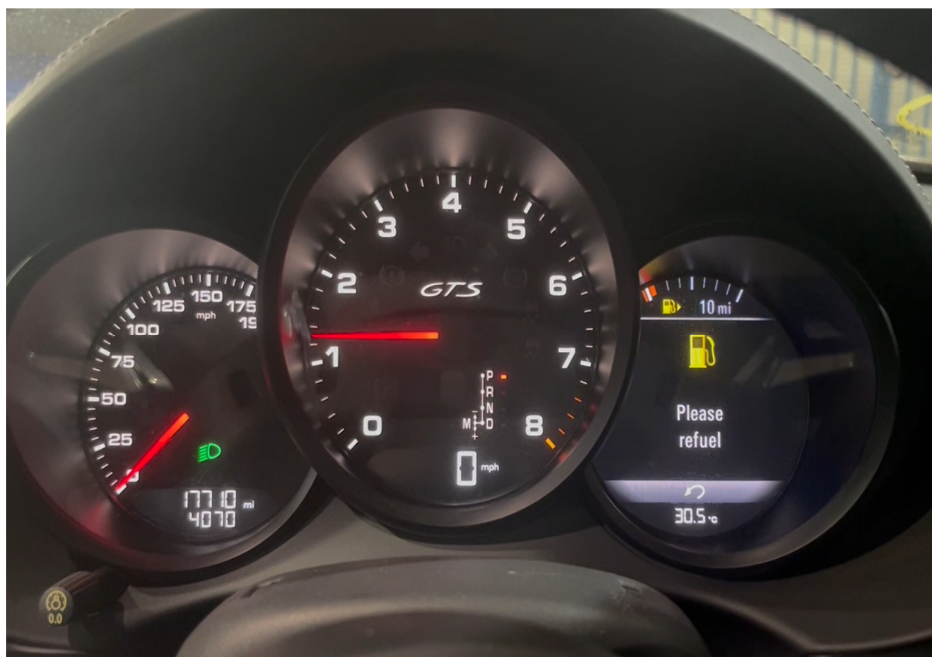
Photo 29 shows the respective warning lights no longer illuminated, indicating that there is no fault detected to the ABS, SRS, TPM and TCS systems of the Motor Car during the self-test. These electronic systems were hence in working condition at the time of my inspection.

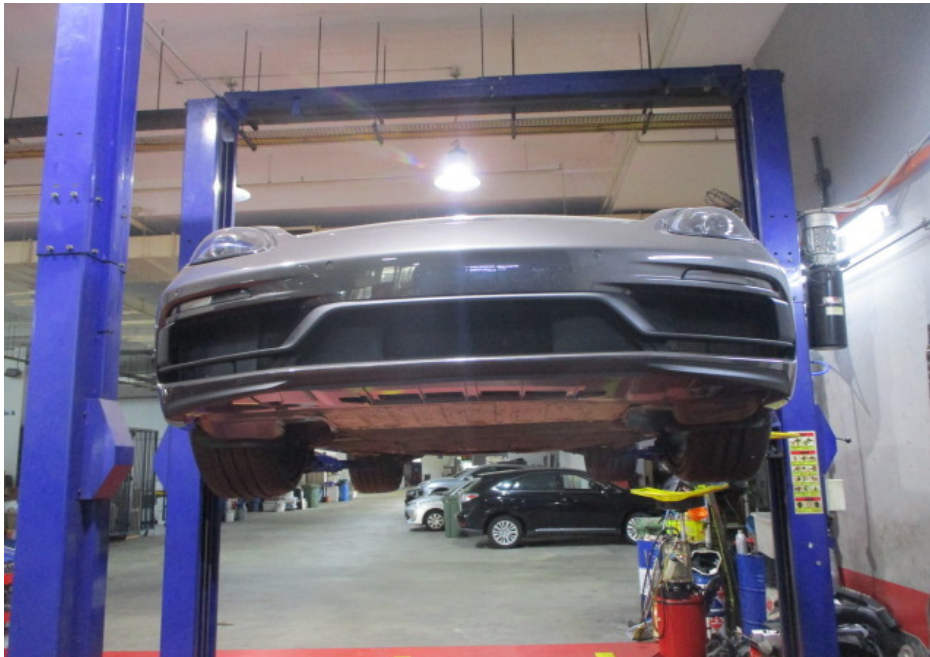
Photo 30 shows the Motor Car hoisted up for checks on its undercarriage. There was no sign(s) or indication(s) of fluid leakage and/or fluid stain(s) on the underside of the Motor Car. The undercarriage components of the Motor Car were also all observed to be intact and secured in an appropriate manner.

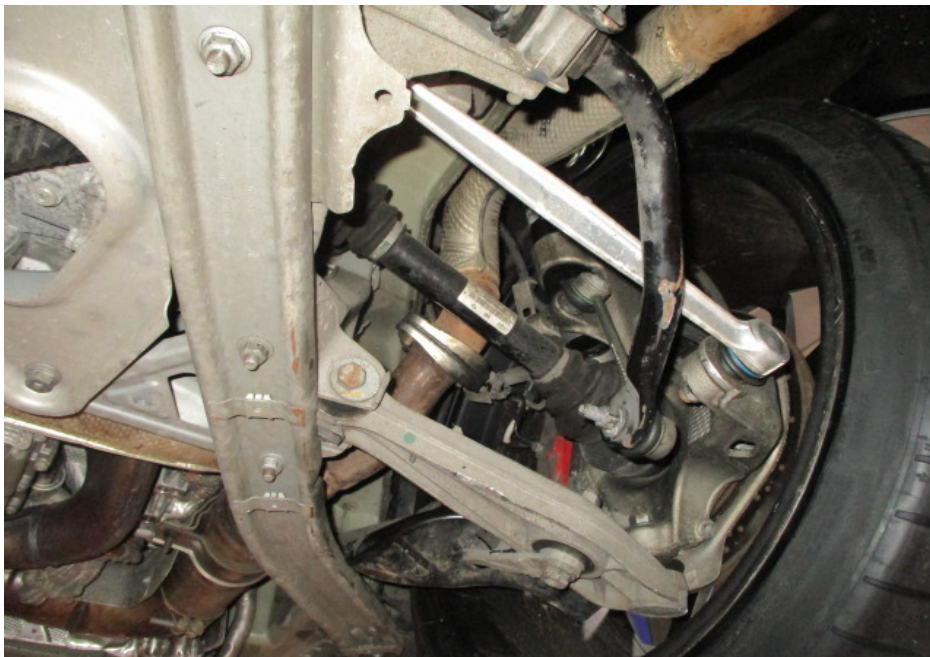
Photo 31 shows a general view of the control arms and linkages at the rear right wheel of the Motor Car. I did not observe any fluid leak and/or fluid stain on the underside of the Motor Car. All of the Motor Car's undercarriage components were observed to be intact and secured in an appropriate manner.

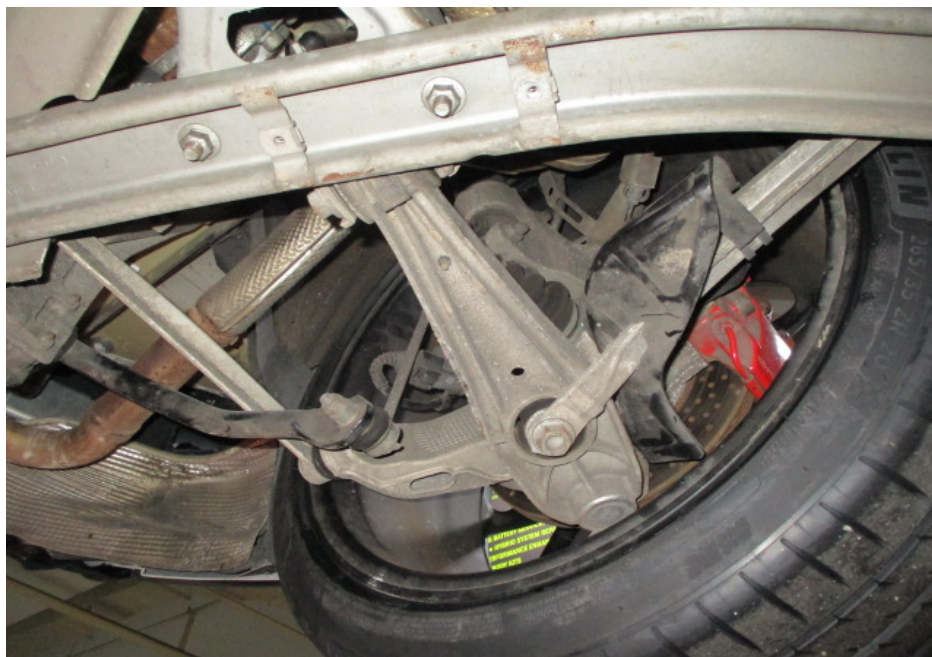
Photo 32 shows a general view of the control arms and linkages at the rear left wheel of the Motor Car. I did not observe any fluid leak and/or fluid stain on the underside of the Motor Car. All of the Motor Car's undercarriage components were observed to be intact and secured in an appropriate manner.

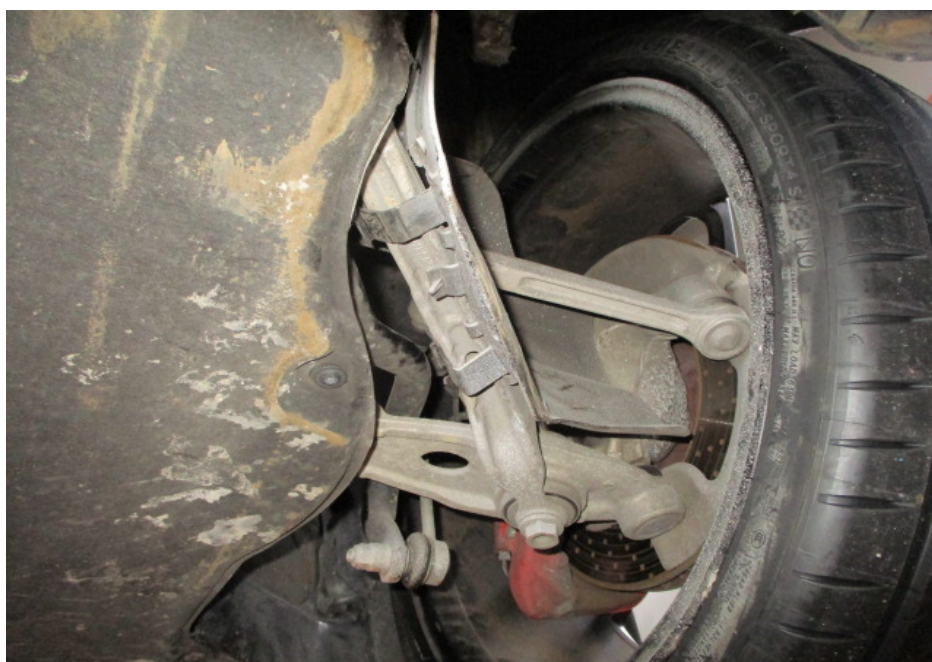
Photo 33 shows the various undercarriage components at the front left wheel of the Motor Car. The mechanical components, control arms and linkages were all found to be intact and secured in an appropriate manner.
