Our Ref : CI/TP21012425/D

Armstrong Auto Pte Ltd

INSPECTION REPORT OF AN UNREGISTERED PORSCHE 718 BOXSTER GTS MOTOR CAR WITH CHASSIS NUMBER WP0ZZZ98ZKS220446

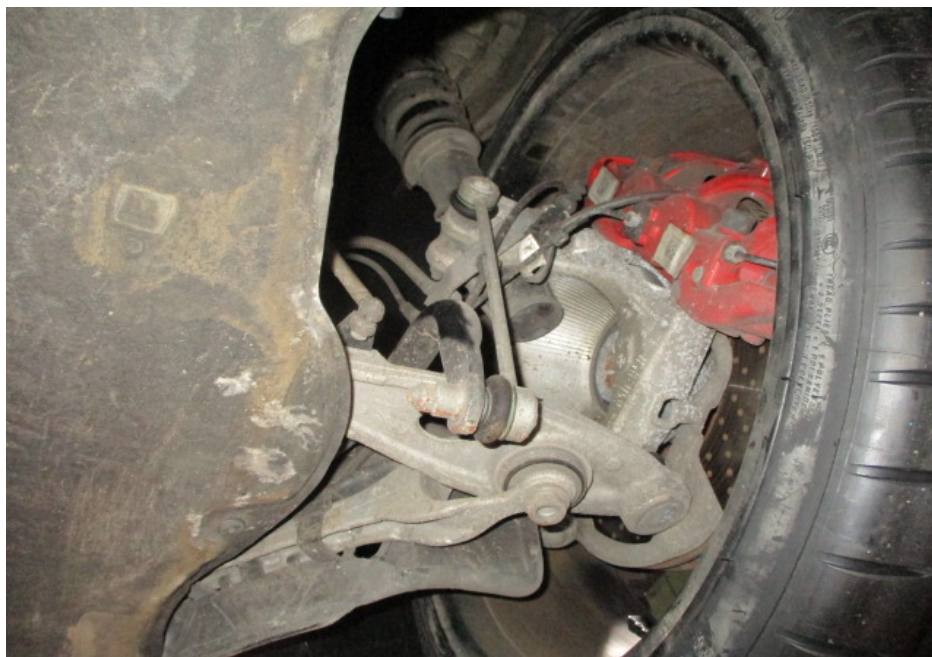
Photo 34 shows the various undercarriage components at the front right wheel of the Motor Car. The mechanical components, control arms and linkages were all found to be intact and secured in an appropriate manner. I also did not observe any fluid leak and/or fluid stain on the underside of the Motor Car.

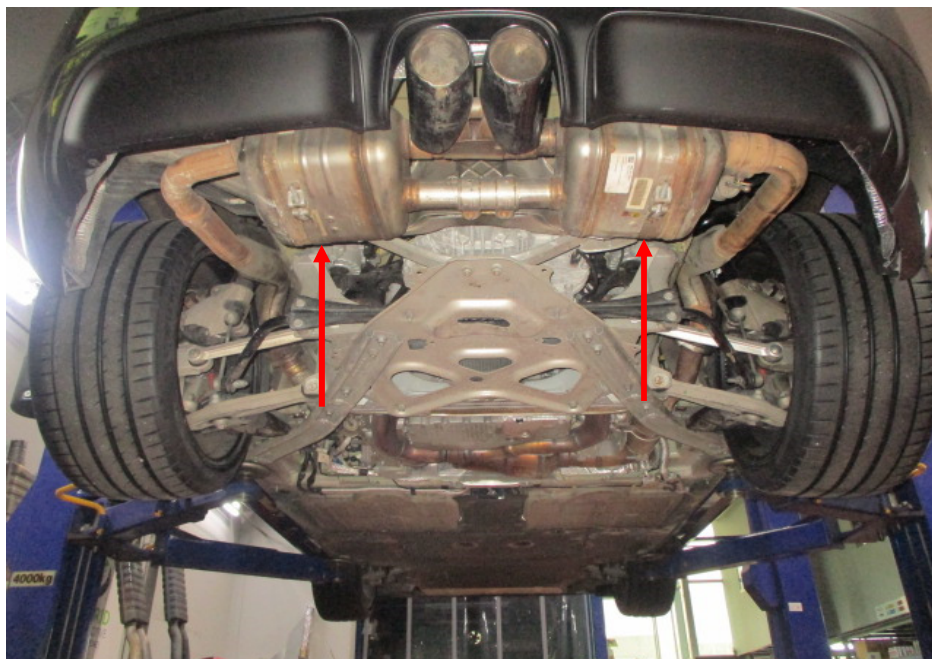
Photo 35 shows the Motor Car's rear mufflers (arrowed). My examination of the Motor Car's exhaust system revealed no sign(s) or indication(s) of any cut or weld marks along its exhaust pipes, on its catalytic converters and on its rear mufflers.

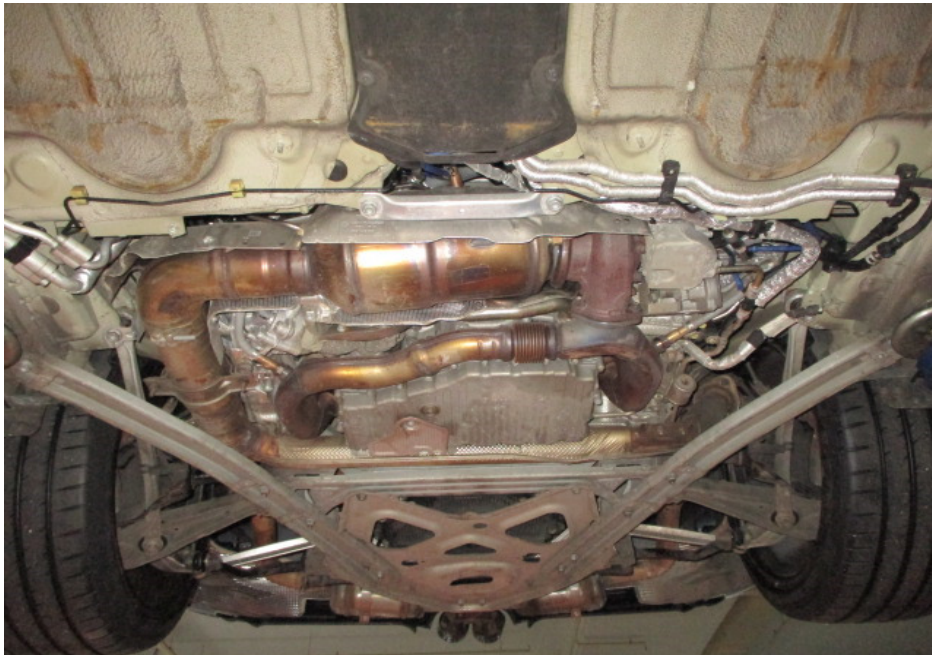
Photo 36 shows the Motor Car's catalytic converters. My examination of the Motor Car's exhaust system revealed no sign(s) or indication(s) of any cut or weld marks along its exhaust pipes, on its catalytic converters and on its rear mufflers.

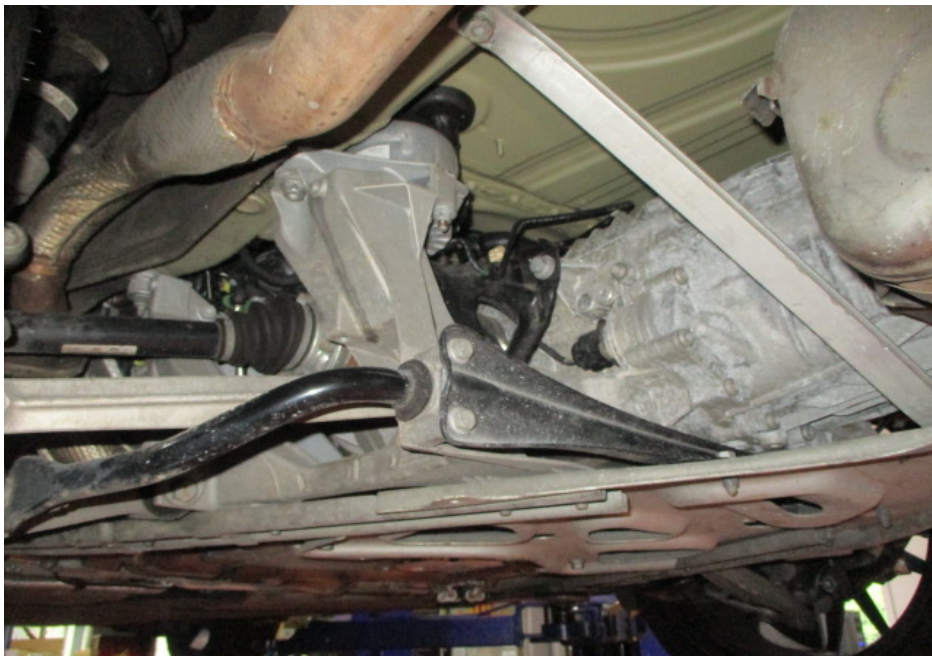
Photo 37 shows a general view of the Motor Car's engine compartment. The engine compartment was at the rear underside of the Motor Car. The various parts and components inside the engine compartment were all observed to be intact and properly fitted. There was also no sign(s) or indication(s) of fluid leak and/or fluid stain found inside the engine compartment.

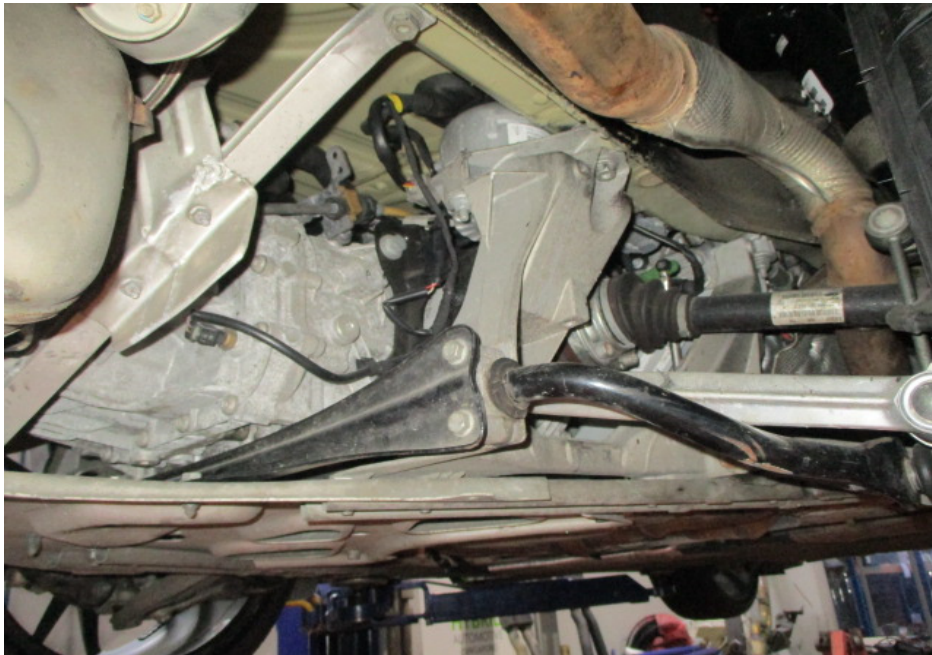
Photo 38 shows another view of the Motor Car's engine compartment. The engine compartment was at the rear underside of the Motor Car. The various parts and components inside the engine compartment were all observed to be intact and properly fitted. There was also no sign(s) or indication(s) of fluid leak and/or fluid stain found inside the engine compartment.

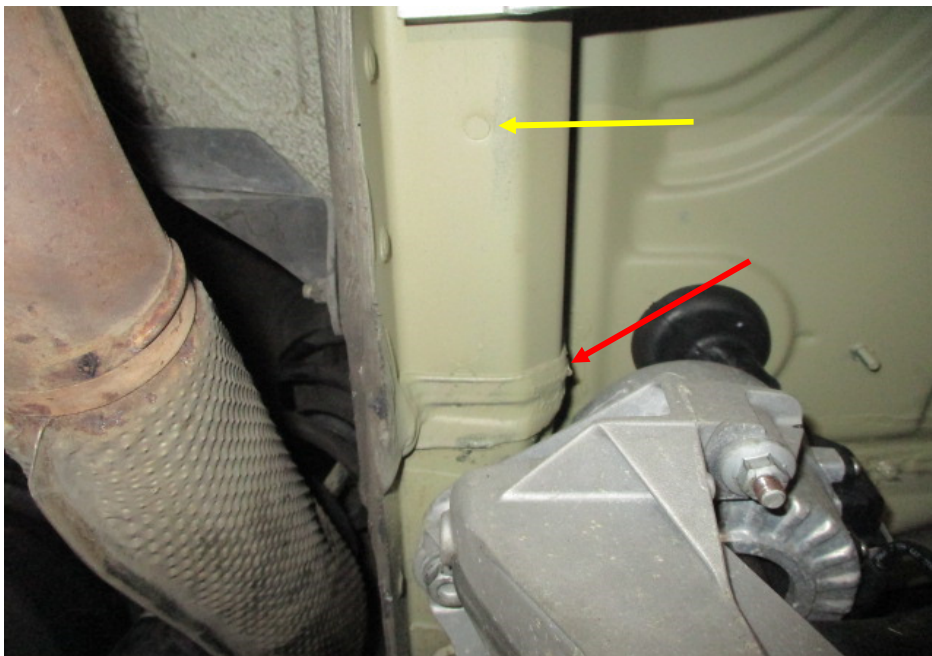
Photo 39 shows the chassis/structural body at the underside rear left of the Motor Car. I did not find any weld marks other than original spot weld marks (yellow arrow) on the chassis/structural body of the Motor Car. The original factory sealant (red arrow) at the joints along the chassis/structural body was also untouched. In general, the Motor Car's chassis/structural body was found to be originally fitted.

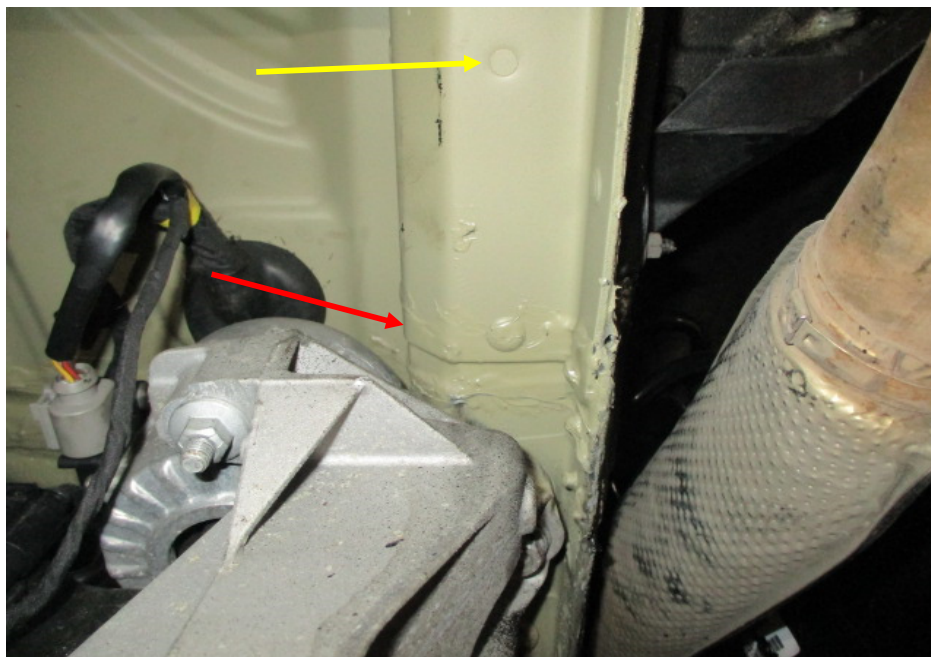
15. Visually, I did not find any weld marks, other than the original spot weld marks, on the chassis/structural body of the Motor Car. The original factory sealant at the joints along the chassis/structural body was also untouched, indicating that no replacement of the chassis/structural body was carried out; and that the chassis/structural body was originally fitted. I did however find signs of repair work carried out to the end section of the Motor Car's rear right chassis (refer to photograph 40 below).

27. I had found signs of repair work carried out to the end section of the Motor Car's rear right chassis. The repairs carried out were in order as the repairs did not involve any cutting and/or re-welding of the Motor Car's original chassis/structural body. Furthermore, lower body chassis alignment measurements carried out by STA Inspection Pte Ltd on 29 November 2021 also showed the chassis/structural measurements of the Motor Car to be without any major deviation (refer to Appendix 1 at page 29 of this report).

Photo 40 shows the chassis/structural body at the underside rear right of the Motor Car. The end section of the chassis/structural body at the underside rear right was found with signs of repair. However, the rear right chassis of the Motor Car was still observed to be an originally fitted part given that original factory sealant (red arrow) and original spot weld mark (yellow arrow) were seen on the rear right chassis.

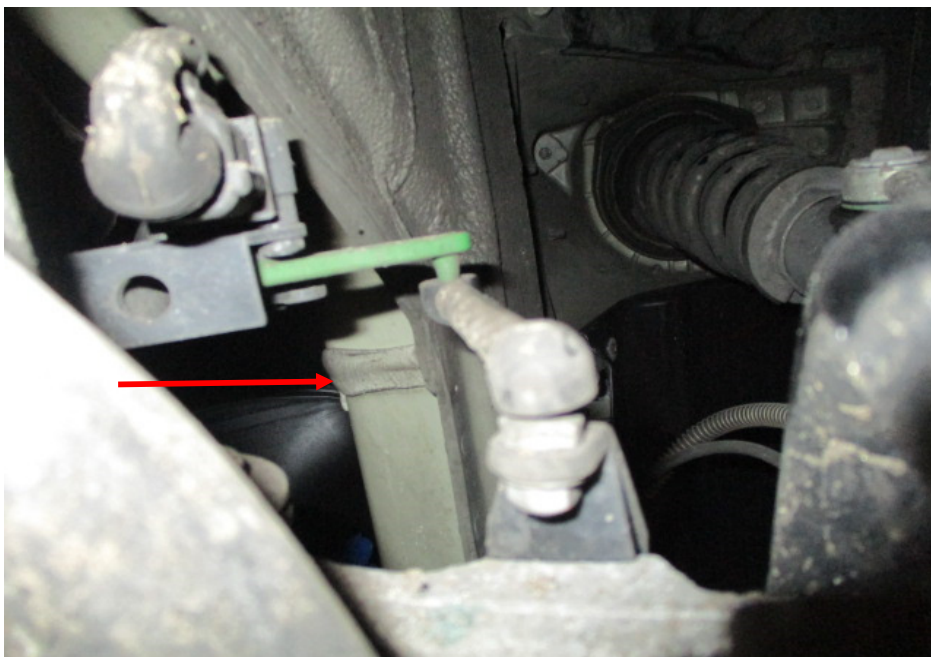
Photo 41 shows the chassis/structural body at the underside front right of the Motor Car. The original factory sealant (arrowed) at the joints along the chassis/structural body was observed to be untouched. In general, I had found the chassis/structural body of the Motor Car to be originally fitted.

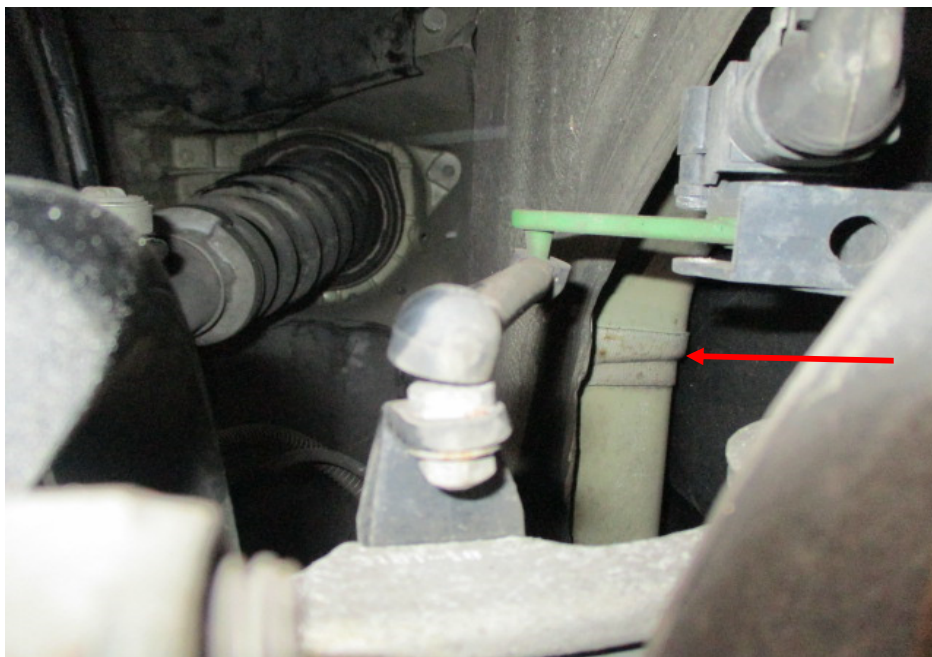
Photo 42 shows the chassis/structural body at the underside front left of the Motor Car. The original factory sealant (arrowed) at the joints along the chassis/structural body was observed to be untouched. In general, I had found the chassis/structural body of the Motor Car to be originally fitted.

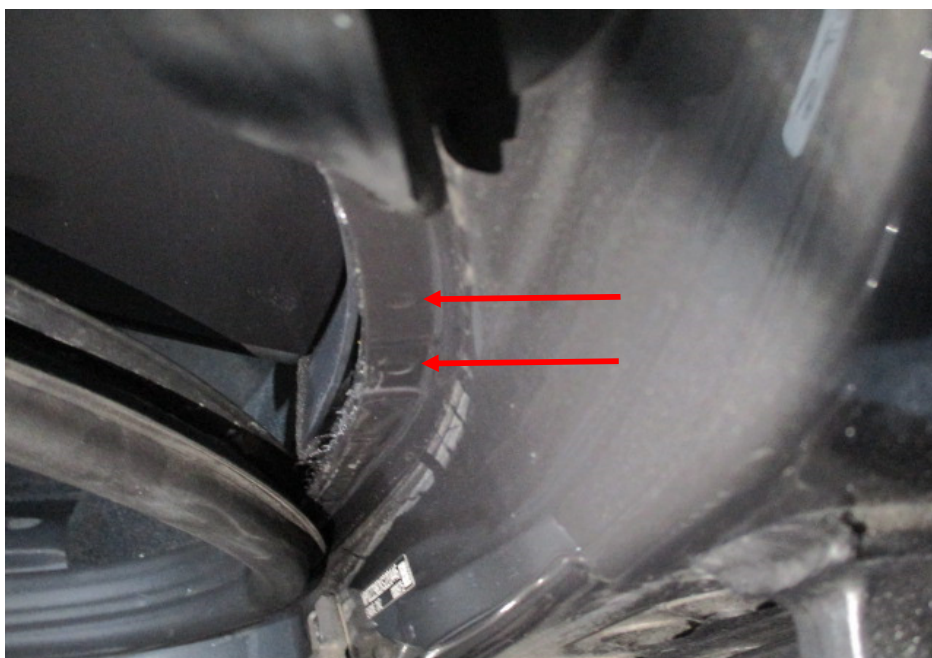
Photo 43 shows the right side "A" pillar of the Motor Car. I did not find any weld marks other than original spot weld marks (arrowed) on the right side "A" pillar of the Motor Car, which indicates that there was no re-welding works carried out. In general, I had found all the non-detachable body panels of the Motor Car to be originally fitted at the time of my inspection.

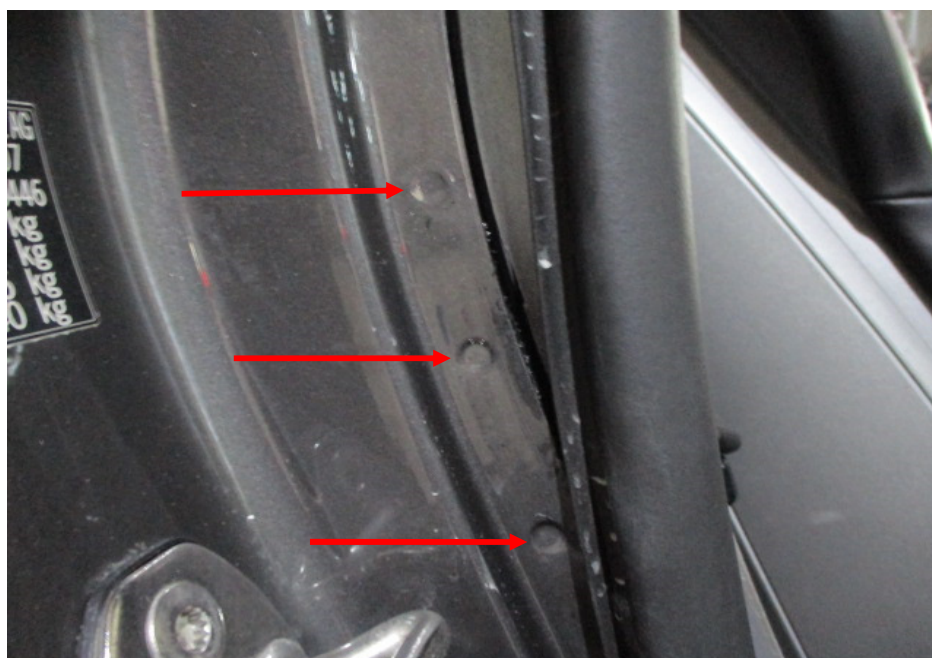
Photo 44 shows the rear right body panel of the Motor Car. I did not find any weld marks other than original spot weld marks (arrowed) on the rear right body panel of the Motor Car, which indicates that there was no re-welding works carried out. In general, I had found all the non-detachable body panels of the Motor Car to be originally fitted at the time of my inspection.

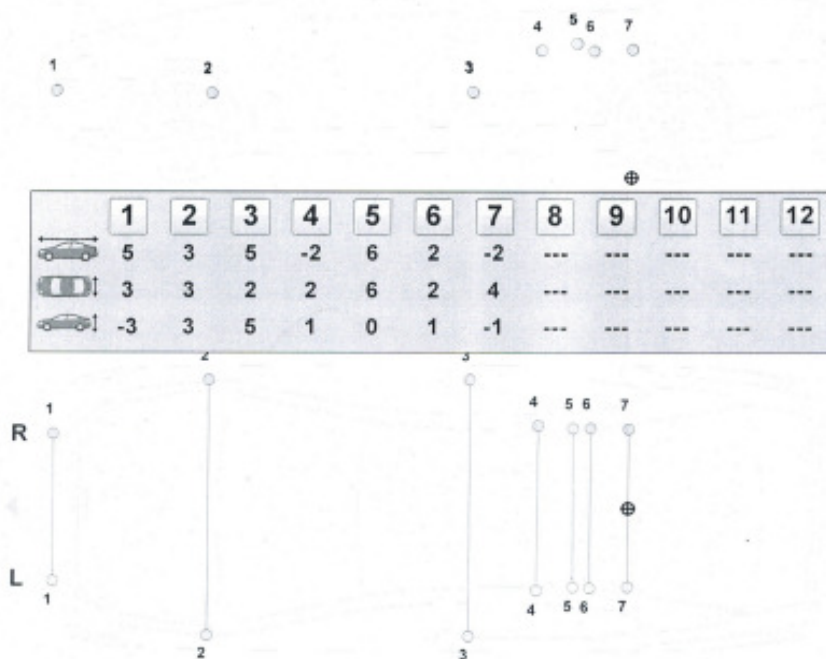
BodyShop	Notes
Company STA Evaluation	NO MAJOR DEVIATION ←
Address 302 Sin Ming Road	+/-10mm THE MACHINE GIVEN
City SINGAPORE	PANEL REPAIRED (FRONT & REAR)
State	
E-mail baydennis@stegg.com	
Zip 575627	
Phone +65 6453 0200

Appendix 1 shows the lower body chassis measurements of the Motor Car (yellow arrow) that was carried out by STA Inspection Pte Ltd on 29 November 2021 (circled). I note that the chassis/structural measurements of the Motor Car were without major deviation (red arrow).
