ACCIDENT DAMAGED VEHICLE INSPECTION REPORT

Date : 29 June 2021
Our Ref : WG/TP/2021-109

Registration No : SLZ8974H
Make : HYUNDAI
Model : ACCENT (RB) 1.4 CVT
Year : 2018

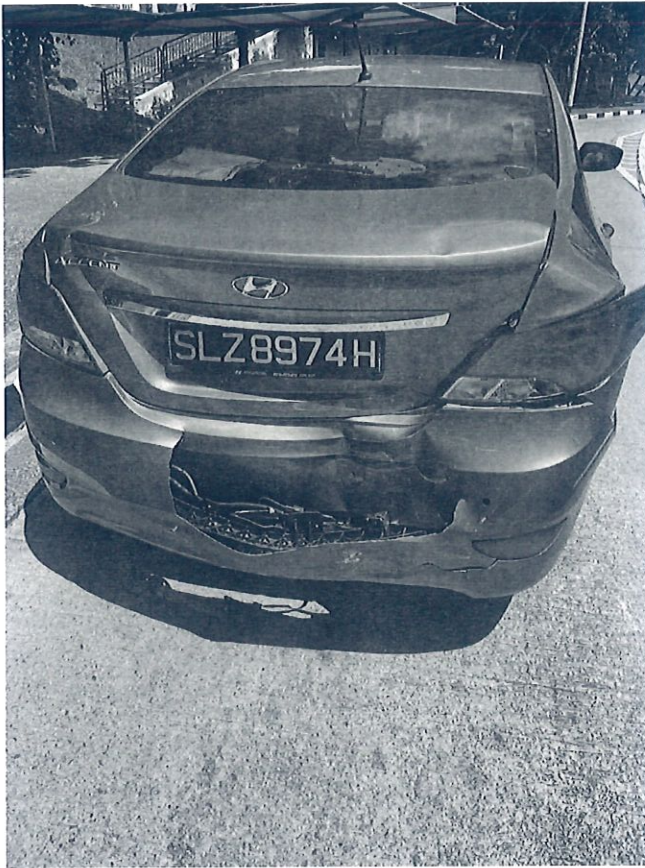
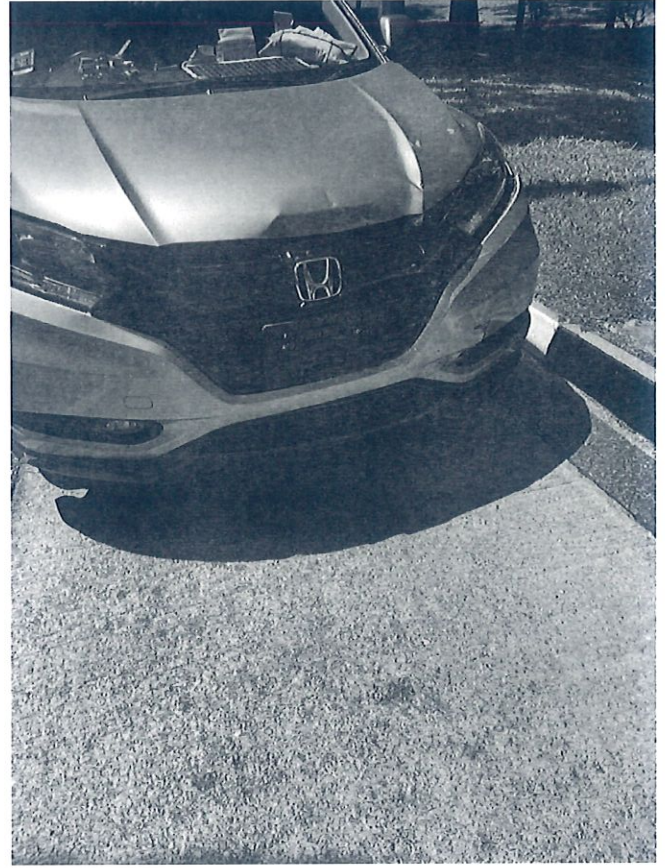
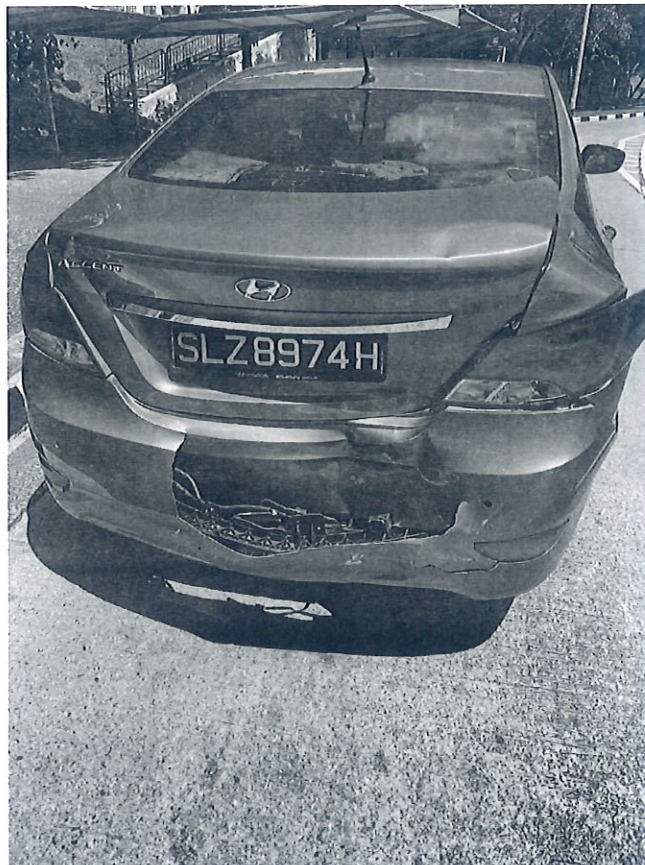
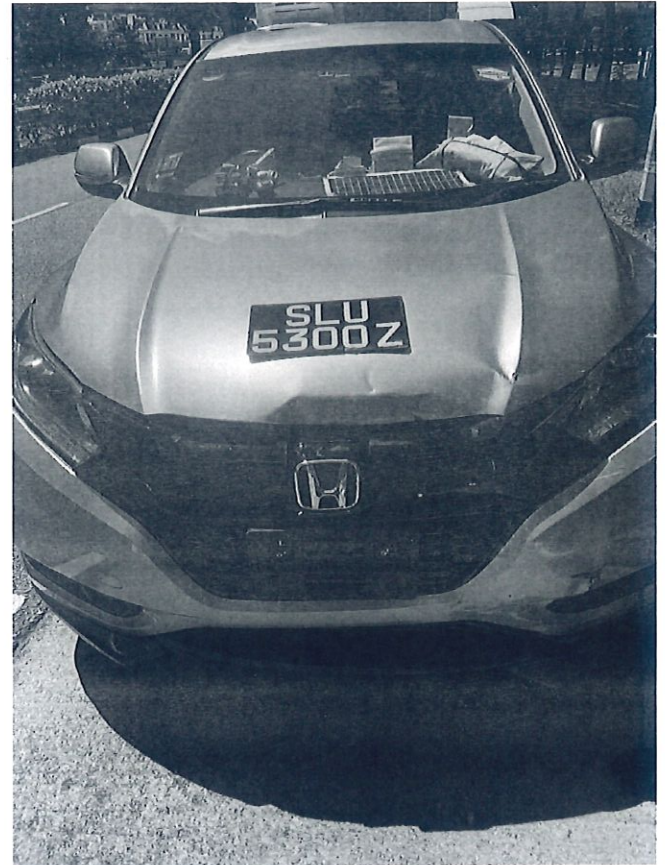
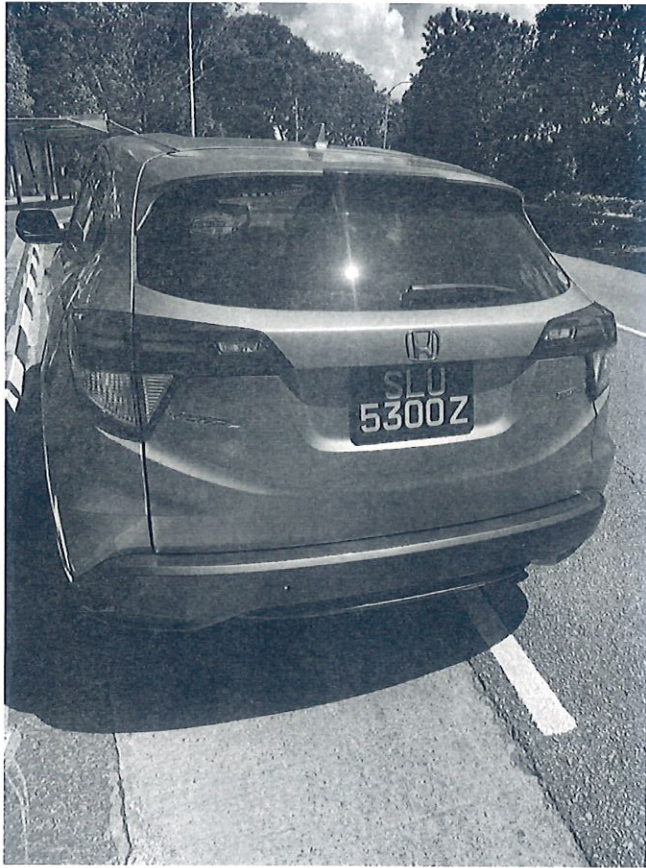
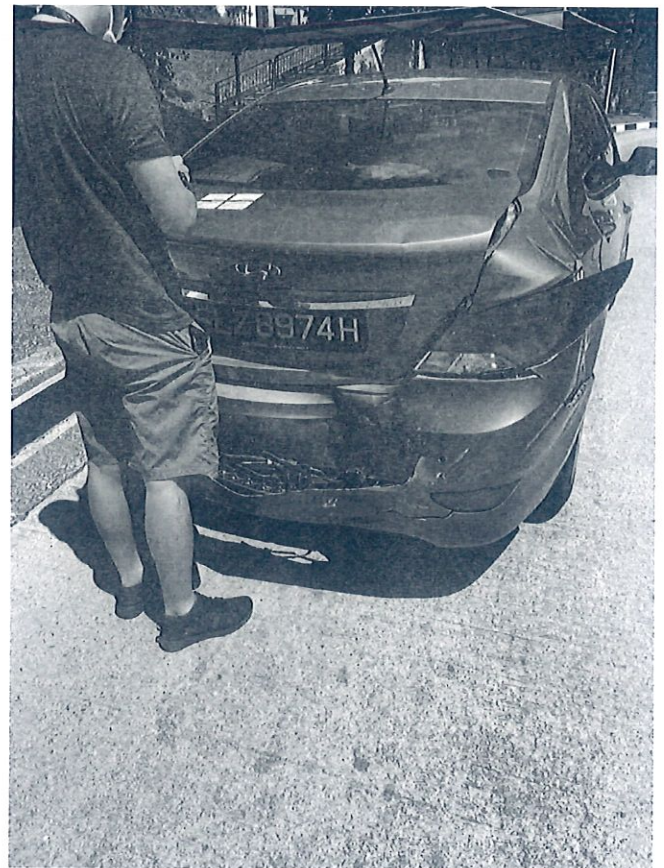
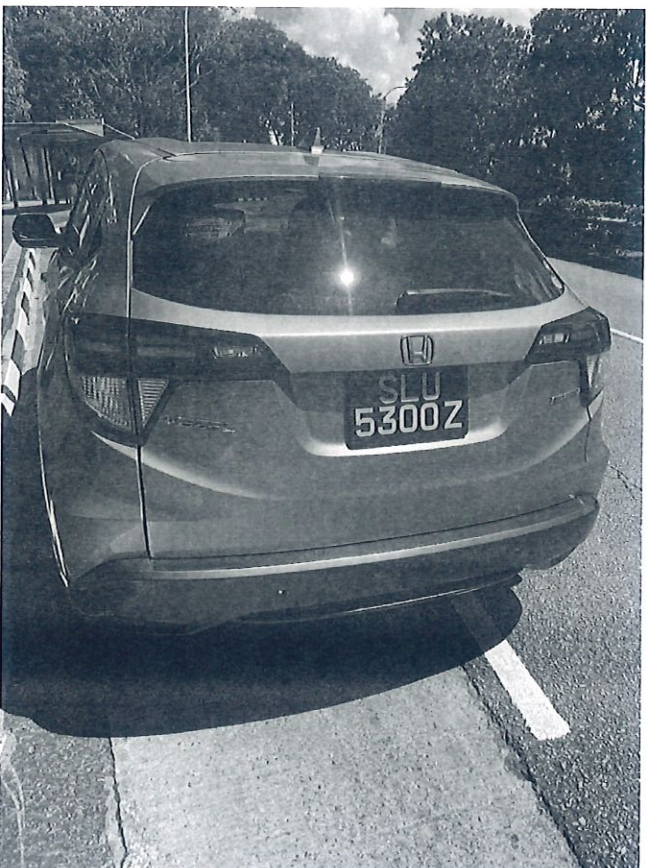
The vehicle sustained damage at the rear portions..
For details, refer to assessment for repairs and photographs attached.

The impact was confined to the rear portion of the vehicle.
The damages appeared to be consistent as per the accident report statement.
Please refer the attached schedule and photographs for details.
