Your Ref : 2095512292SG
Our Ref : CC3/AIG21012429/N

12 January 2022

**AUTOMOBILE TECHNICAL INVESTIGATION REPORT OF ACCIDENT
INVOLVING SHC 5812E AND SMJ 192Y ON 4 DECEMBER 2021**

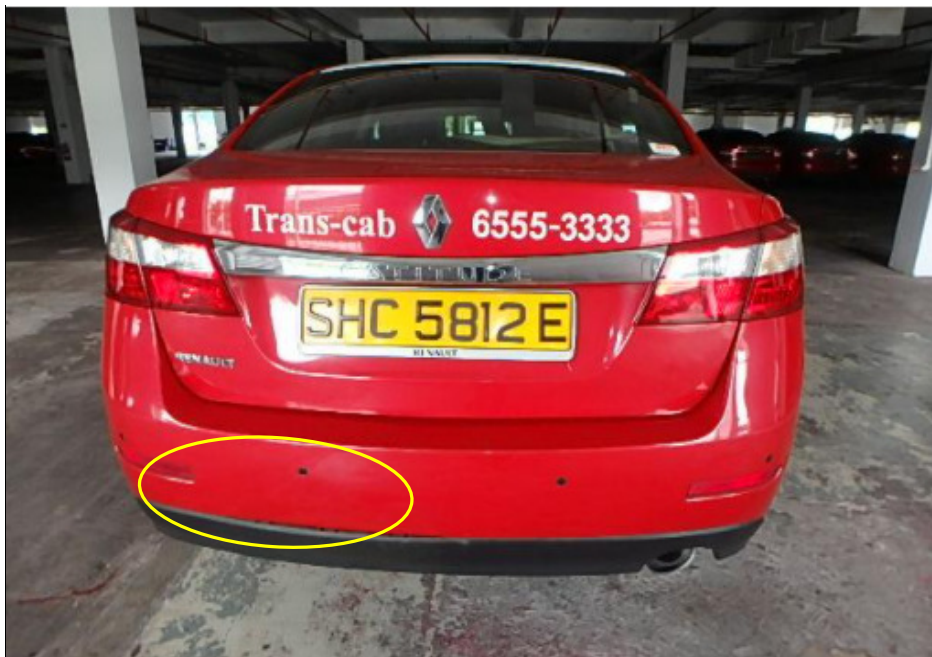
8. From our examination of the photographs taken during the Pre- Repair Survey conducted by LKK Auto Consultants Pte. Ltd. about 3 days after the accident, the damage to the Taxi was observed to be confined to its rear left portion. We observed a slight dislodgement of the lower rear bumper cover as well as paint graze marks at the left portion. Upon examination of the photographs of the Taxi taken at the time of reporting, we also noted the rear bumper was dislodged at the left corner edge. See photos 1 - 5 below.

Photo 1 shows the general view of the rear portion of the Taxi at the time of the Pre-Repair Survey conducted by LKK Auto Consultants Pte. Ltd. taken 3 days after the accident. The damage to the Taxi was observed to be confined to its rear left portion (circled).

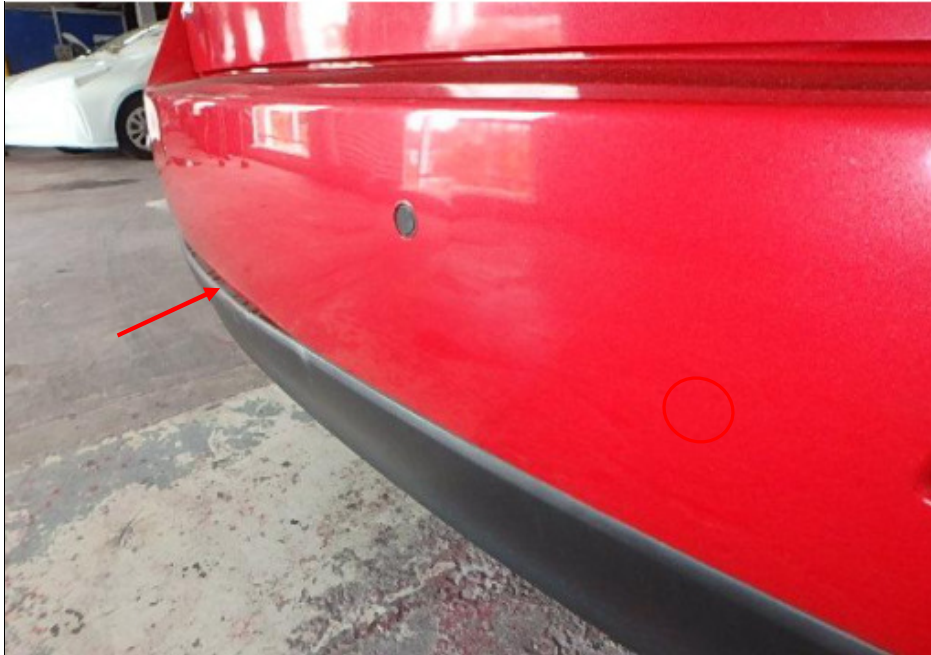
Photo 2 shows upon closer examination of the lower portion of the rear bumper, we observed a slight dislodgement of the lower rear bumper cover (arrowed) of the Taxi.

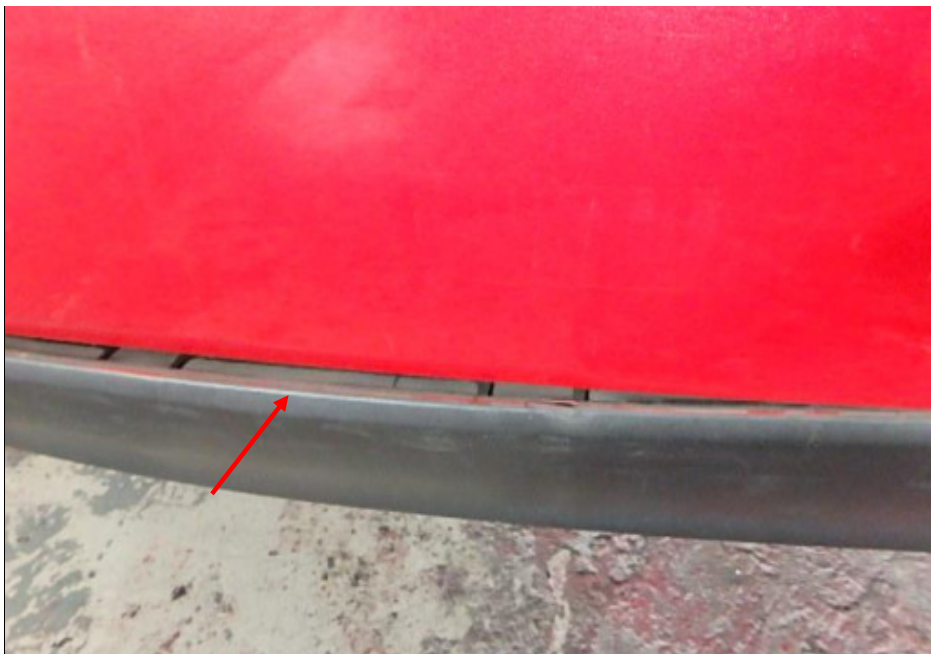
Photo 3 shows a close up view of the slight dislodgement of the lower rear bumper cover (arrowed) of the Taxi.

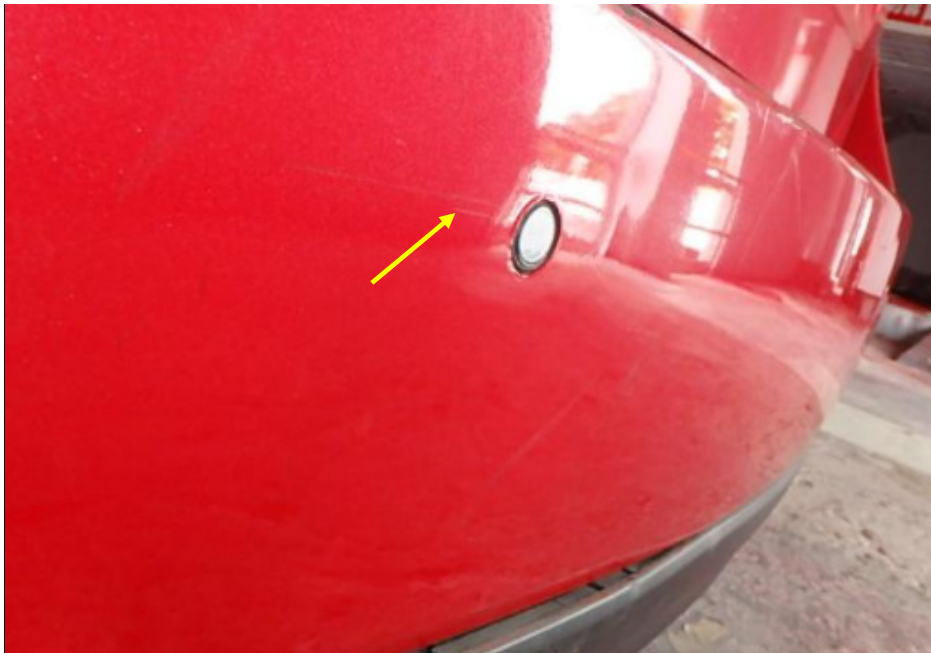
Photo 4 shows a close up view of the paint graze marks (arrowed) at the left portion of the Taxi's rear bumper.

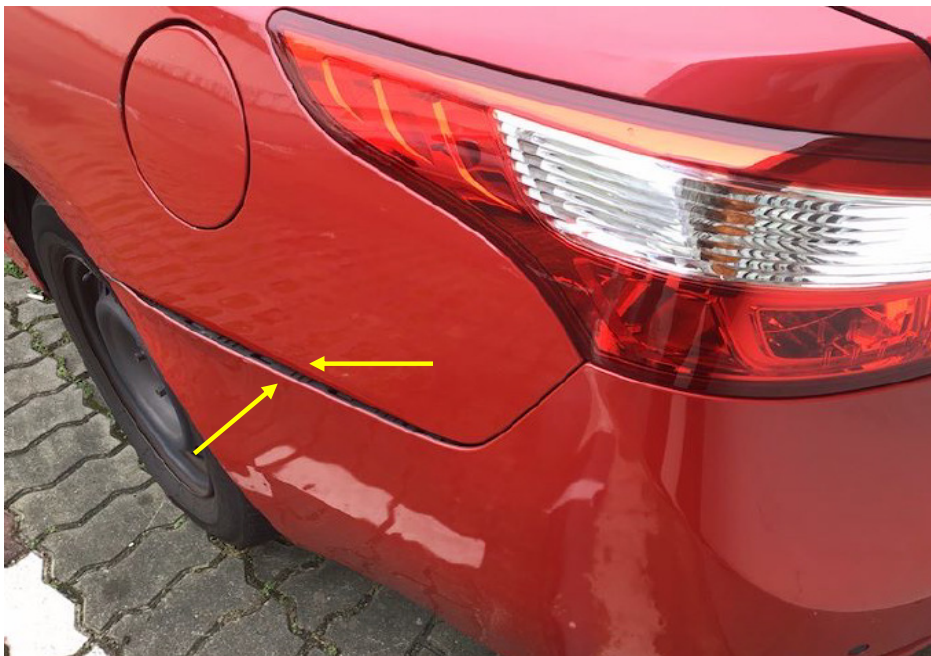
Photo 5 shows the left corner edge of the rear bumper of the Taxi which was taken at the time of reporting. We observed that the rear bumper was slightly dislodged at the left corner edge (arrowed).

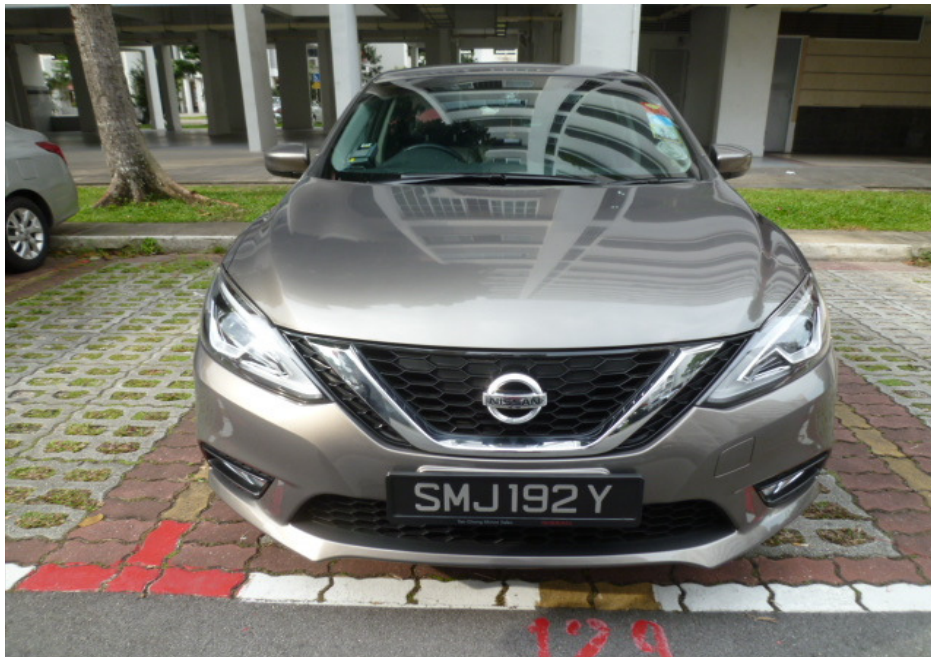
Photo 6 shows the general view of the frontal portion of the Nissan at the time of our inspection. The physical inspection carried out had primarily focused on the frontal portion of the Nissan, in particular its front bumper as the accident was reported to be of a head to rear nature where the Nissan was in front of the Taxi at the material time. The mileage recorded was 55, 540 km.

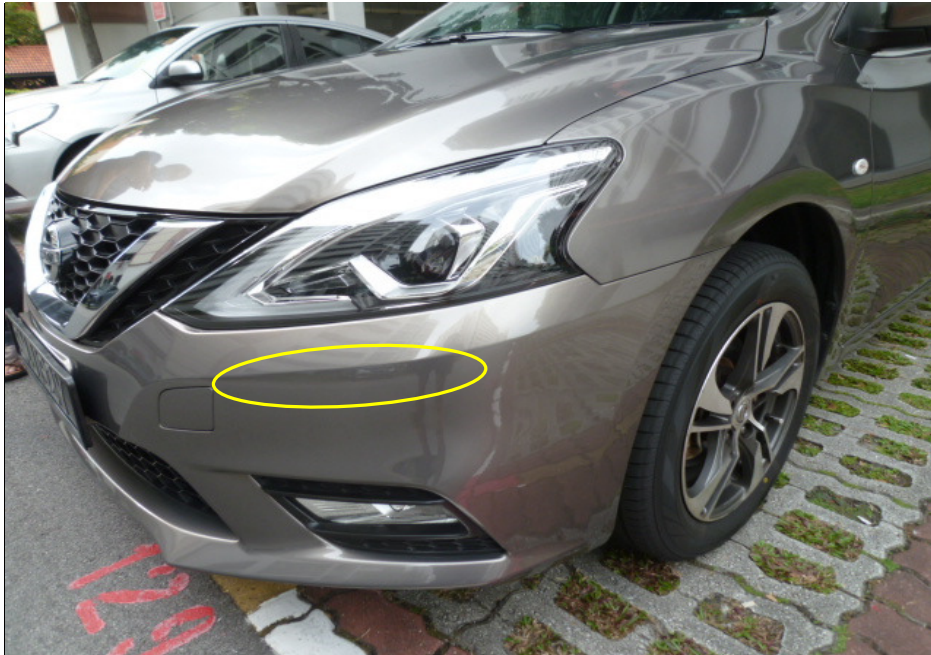
Photo 7 shows upon closer visual examination, we observed paint graze marks on the left portion of the Nissan's front bumper (circled).

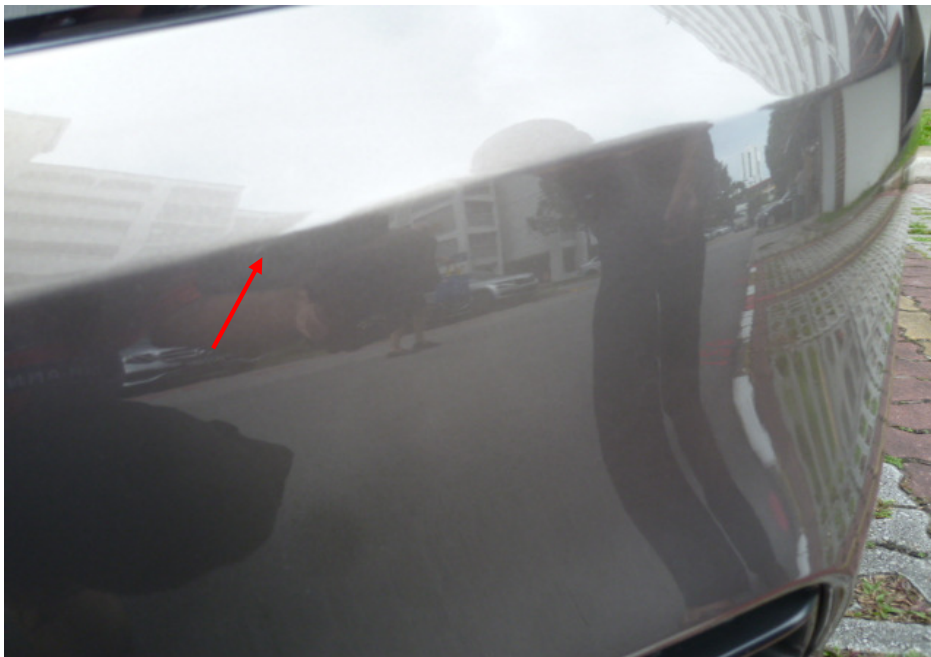
Photo 8 shows a closer view of the paint graze marks on the left portion of the Nissan's front bumper (arrowed).

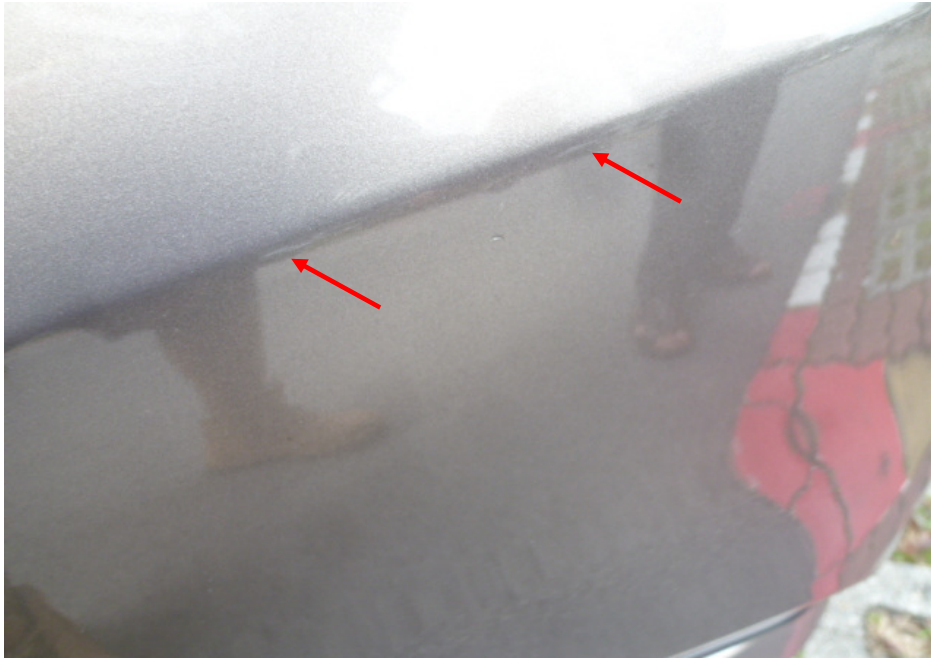
Photo 9 shows a close up view of the paint graze marks on the left portion of the Nissan's front bumper (arrowed). Mr Wong informed us that the paint graze marks were pre- existing damages.

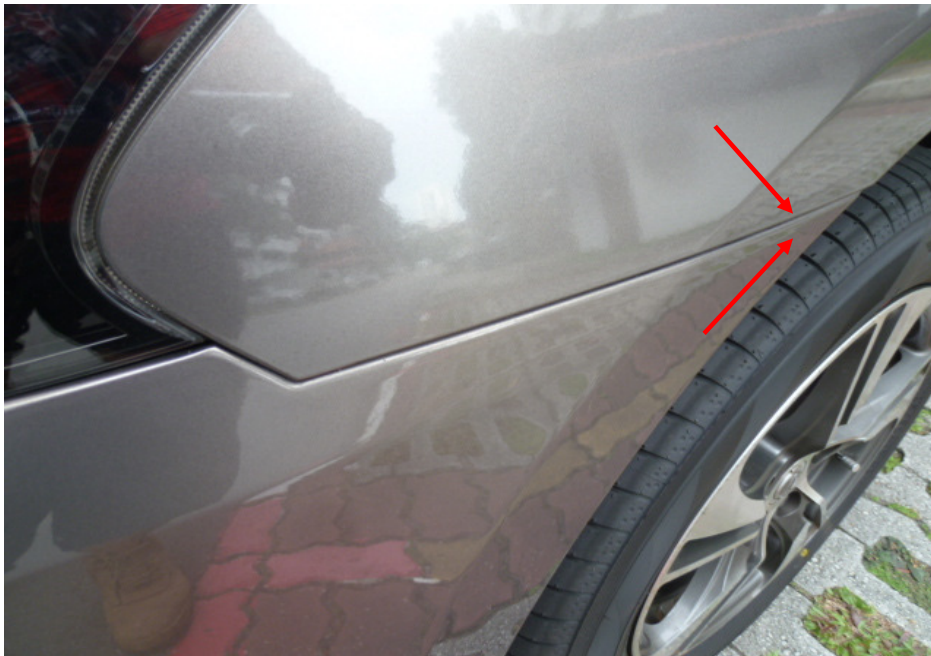
Photo 10 shows a closer view of the left corner edge of the front bumper of the Nissan. We observed no misalignment at the corner edges (red arrows).

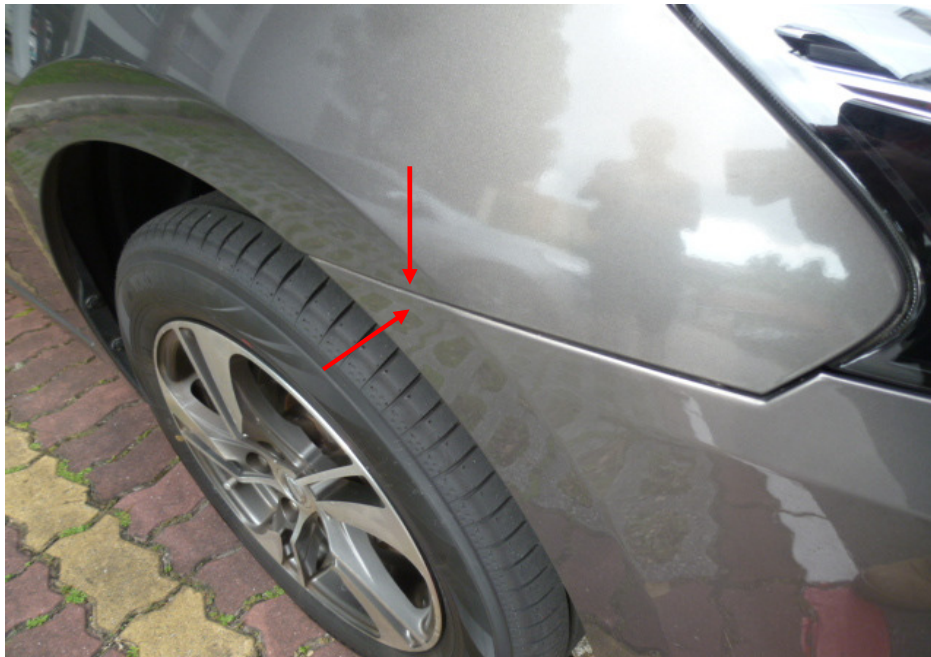
Photo 11 shows a closer view of the right corner edge of the front bumper of the Nissan. We observed no misalignment at the corner edges (red arrows).

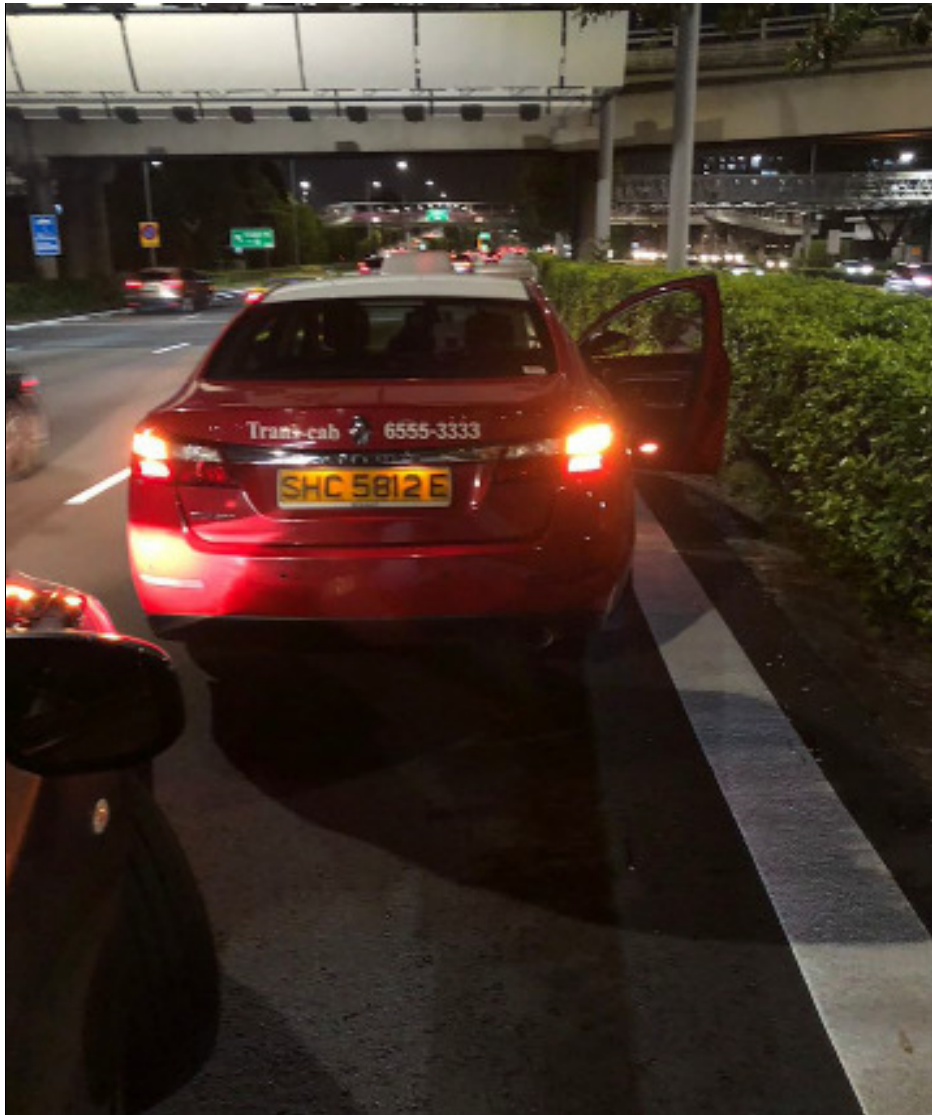
Photo 12 shows the position of the Involved Motor Vehicles at the accident location provided by Mr Wong. The position of the Nissan appeared to be slightly towards the left from the rear of the Taxi.

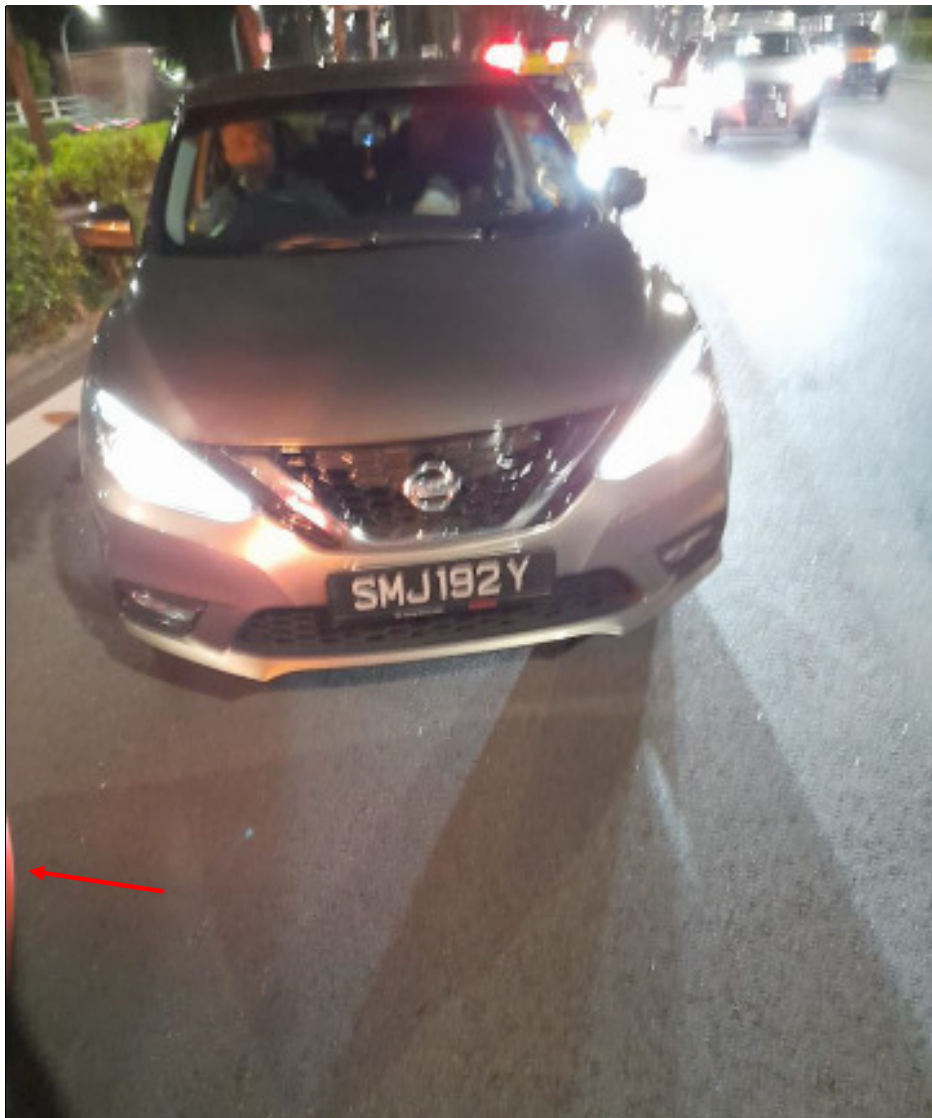
Photo 13 shows the frontal view of the Nissan at the accident location provided by Mr Teo. The position of the Nissan appeared to be slightly towards the left from the rear of the Taxi (arrowed).

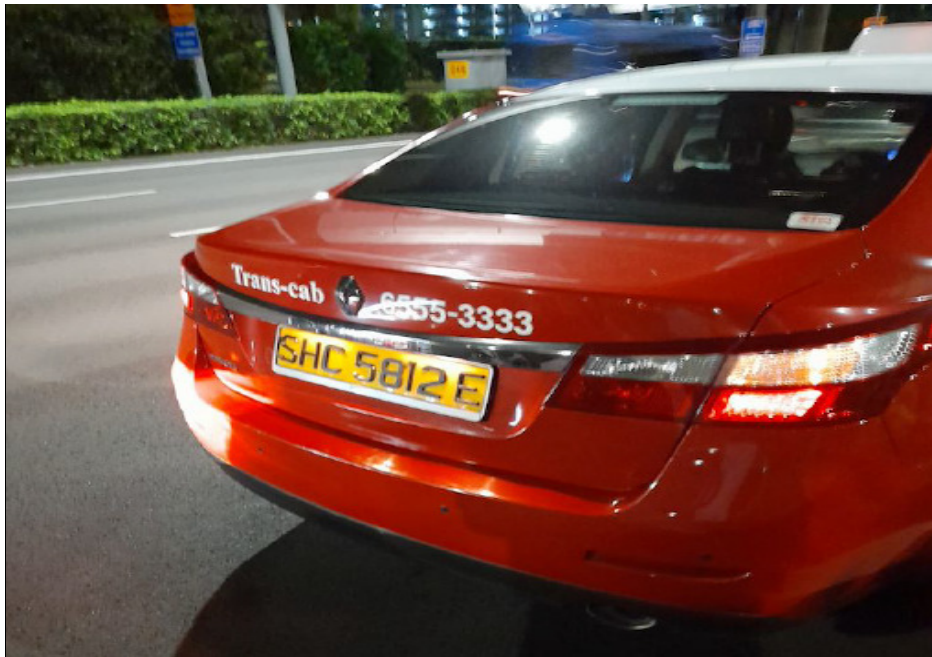
Photo 14 shows the rear portion of the Taxi at the accident location provided by Mr Teo. Apart from the fact that the Involved Motor Vehicles were at the accident location, no other information could be obtained from the photographs.

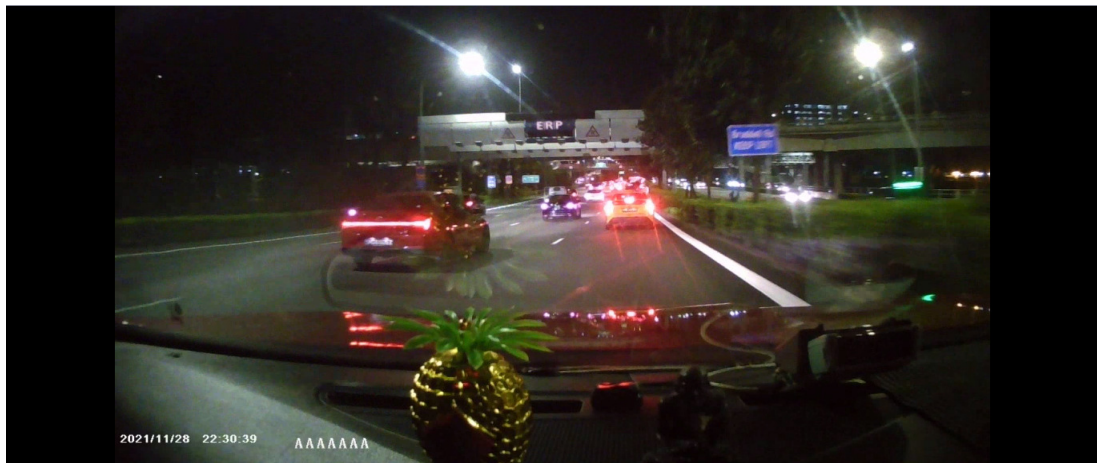
Screenshot 1 shows the start of the video recording. The Taxi could be seen travelling along the 1st lane of the expressway.

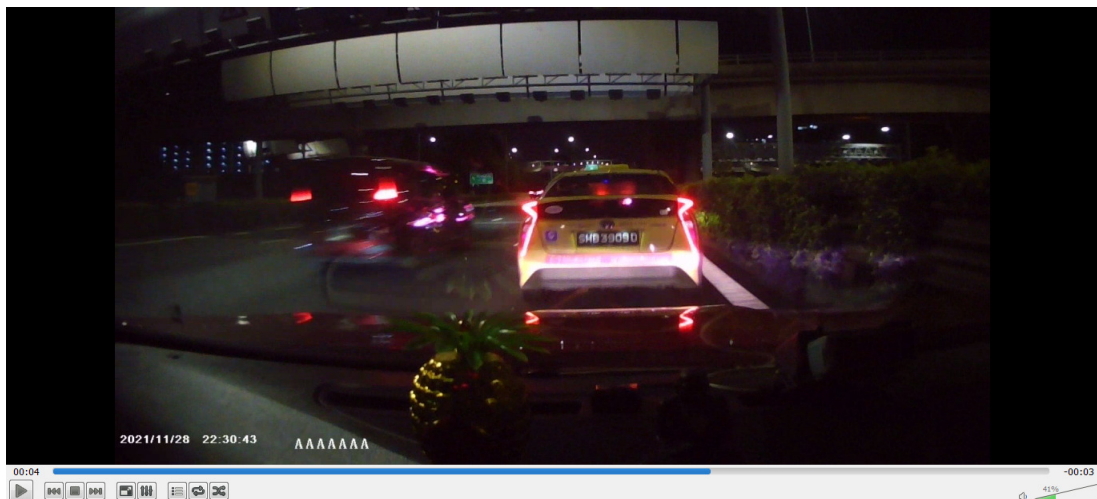
Screenshot 2 shows the 4 second mark of the video recording. Between the 1st and 4th second mark of the video recording, the Taxi could be seen coming to a stop at the 1st lane of the expressway. Apart from the Taxi coming to a stop, there is no indication of contact (jerky or shaky image seen) between the rear portion of the Taxi and the frontal portion of the Nissan.

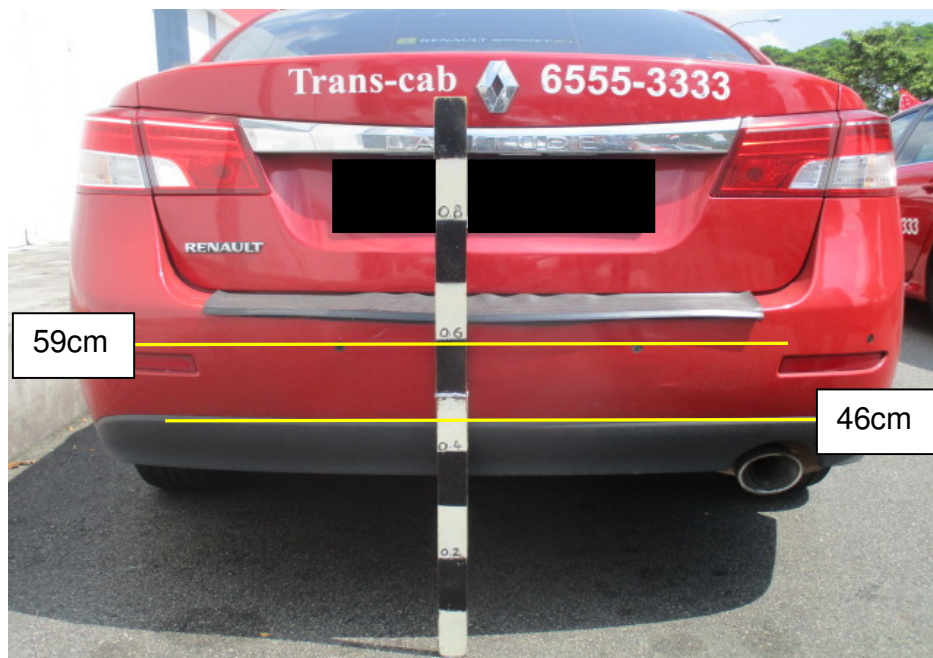
Photo 15 shows the height measurement being conducted on the rear portion of the Taxi (using a similar make and model). The height above ground level of the Taxi's lower rear bumper cover where the dislodgement was found was measured to be approximately 46cm. The height above ground level of the Taxi's rear bumper where the paint graze marks were found was measured to be approximately 59cm.

- a) the height above ground level of the Taxi's lower rear bumper cover where the dislodgement was found was measured to be approximately 46cm;
- b) the height above ground level of the Taxi's rear bumper where the paint graze marks were found was measured to be approximately 59cm;
- c) the height above ground level of the Nissan's front bumper where the paint graze marks were found was measured to be approximately 55cm;
- d) the height measurements appear to not support the findings of possible contact between the rear portion of the Taxi and the frontal portion of the Nissan. The damage observed on the rear portion of the Taxi was not a result of this contact and did not correspond to the damage observed on the frontal portion of the Nissan.

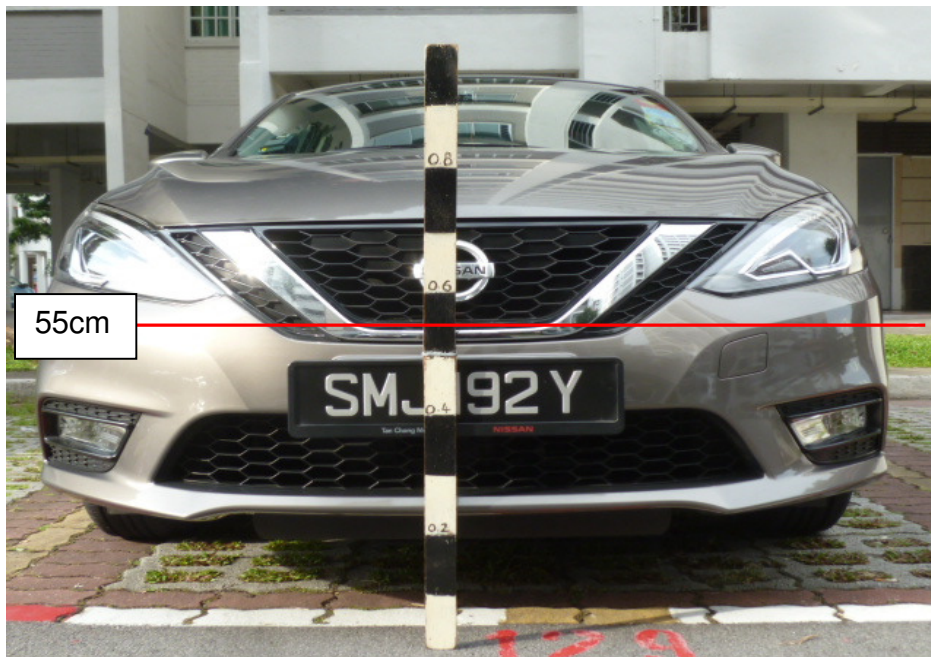
Photo 16 shows the height measurement being conducted on the frontal portion of the Nissan. The height above ground level of the Nissan's front bumper where the paint graze marks were found was measured to be approximately 55cm.
