# Smart Diagnosis

KNAD6817VN6623814 STONIC(YB CUV)/2022/G 1.0 T-GDI KAPPA PE

All DTC(0 System, 7 DTCs)

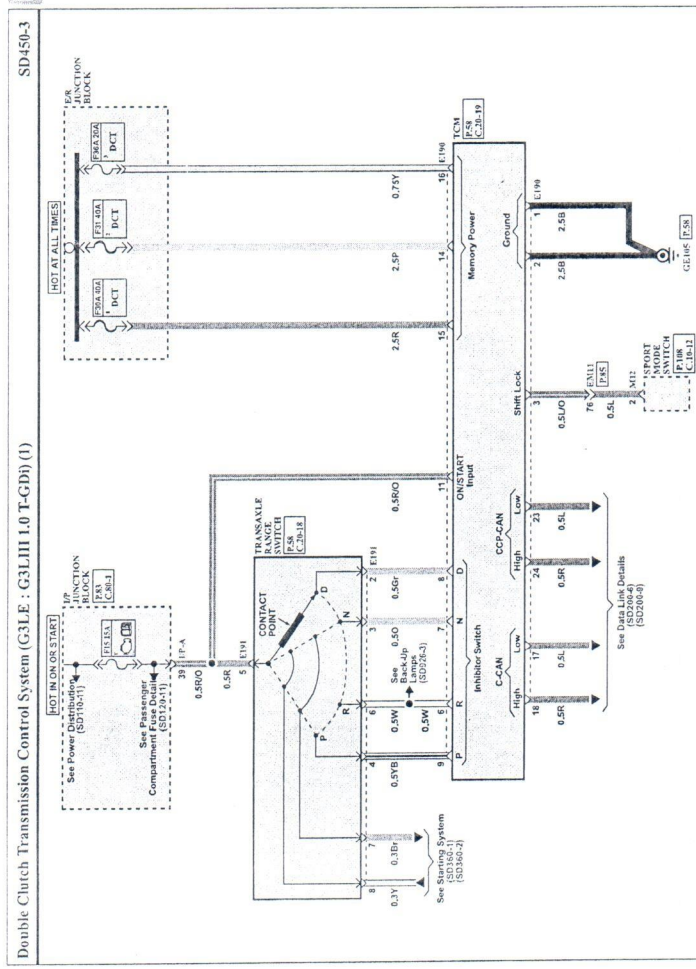
2022 > G 1.0 T-GDI KAPPA PE(MHEV) > Transmission > Double Clutch Transmission > P08801C TCM Power Input > Wiring Inspection

First you need to separate male connector about checking area and check the female connector to terminal insertion contact condition, then you need to install the pin to the right position after separate it.

| Good | ▲ Go to "Circuit Inspection" procedure. |
| No Good | ▲ Repair as necessary and then go to "Verification of Repair" procedure. |
