Your Ref: Lamborghini Huracan LP 580  
(chassis number ZHWEC2ZF6GLA04959)  
Our Ref : CI/TP21012506/D

**INSPECTION REPORT OF AN UNREGISTERED LAMBORGHINI HURACAN LP 580 MOTOR CAR WITH CHASSIS NUMBER ZHWEC2ZF6GLA04959**

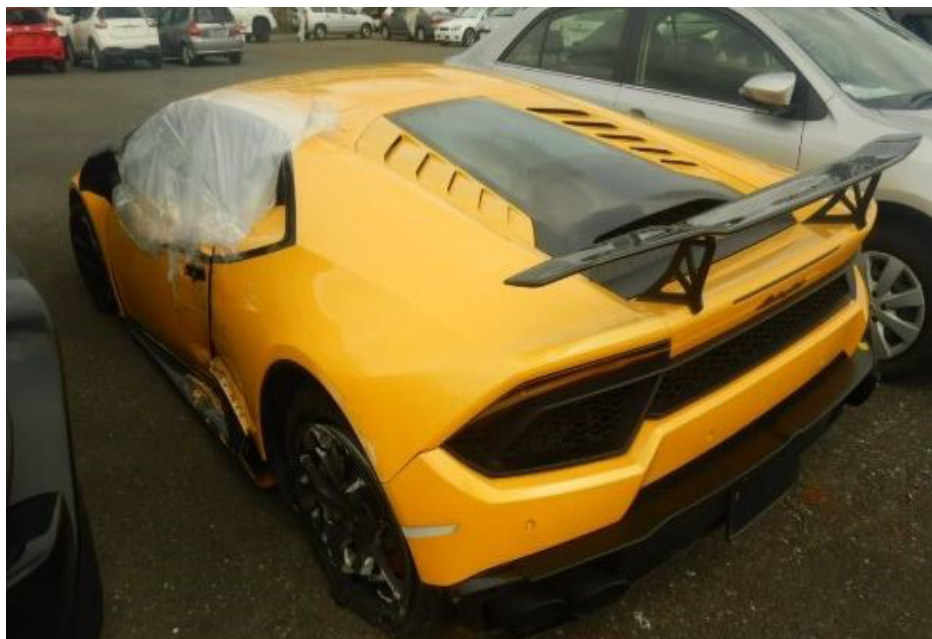
3. The photographs provided to me had showed damage to the Motor Car's left side portion. Body parts damaged include the front left wheel rim, front left door, front left door outer handle, front left door glass, rear left fender, rear left fender inner shield, rear left wheel rim, rear left tyre and left side lower skirting amongst others.
4. The orientation of the Motor Car's rear left wheel indicates damage to its rear left undercarriage parts. Undercarriage parts that may possible be damaged include the rear left lower arm, rear left upper arm, rear left shock absorber and rear left knuckle arm amongst others.
5. No physical damage was observed to other areas of the Motor Car. The airbag(s) was not deployed as seen from the photographs that were provided. See photo 1 – 6 below.

**Photo 1** shows the rear left body of the Motor Car (photograph provided to me). The photographs provided to me had showed damage to the left side portion of the Motor Car. Body parts damaged include the front left wheel rim, front left door, front left door outer handle, front left door glass, rear left fender, rear left fender inner shield, rear left wheel rim, rear left tyre and left side lower skirting amongst others.

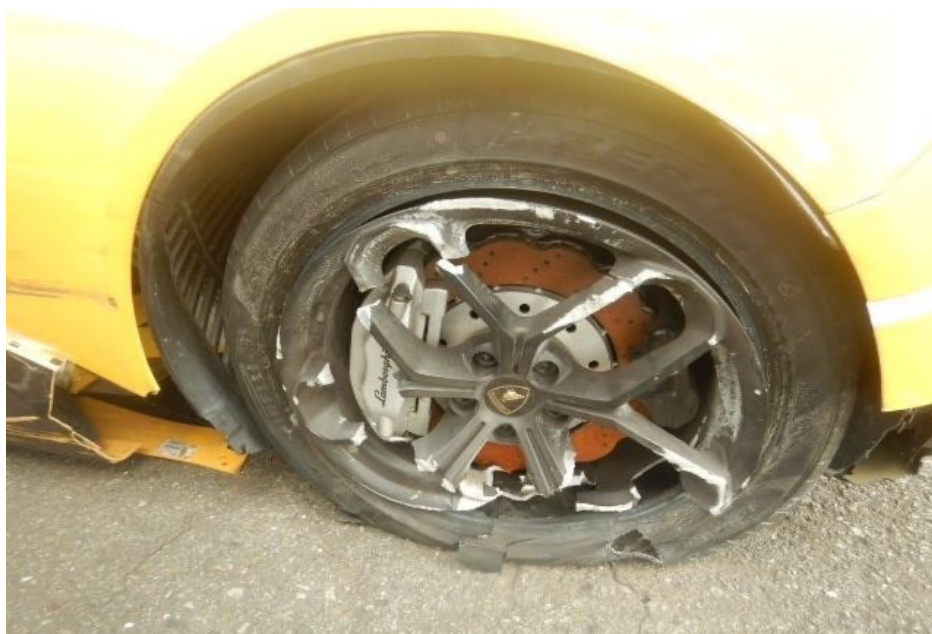
**Photo 2** shows a closer view of the damage to the Motor Car's rear left wheel rim, rear left tyre and rear left fender inner shield (photograph provided to me). The orientation of the Motor Car's rear left wheel indicates damage to its rear left undercarriage parts. Undercarriage parts that may possibly be damaged include the rear left lower arm, rear left upper arm, rear left shock absorber and rear left knuckle arm amongst others.

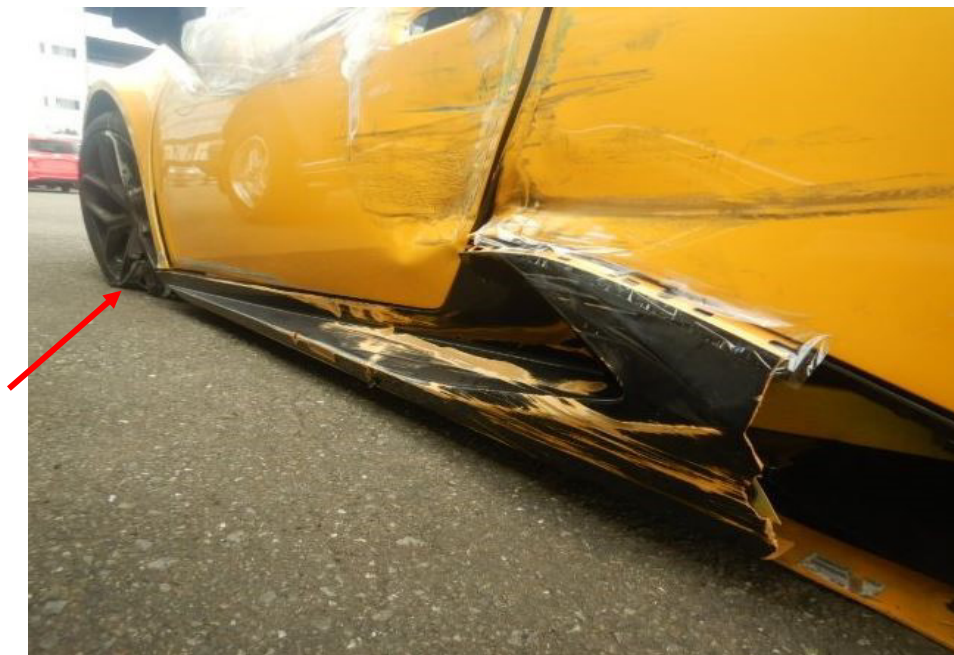
**Photo 3** shows a closer view of the damage to the Motor Car's rear left fender, front left door, front left wheel rim (arrowed) and left side lower skirting (photograph provided to me).

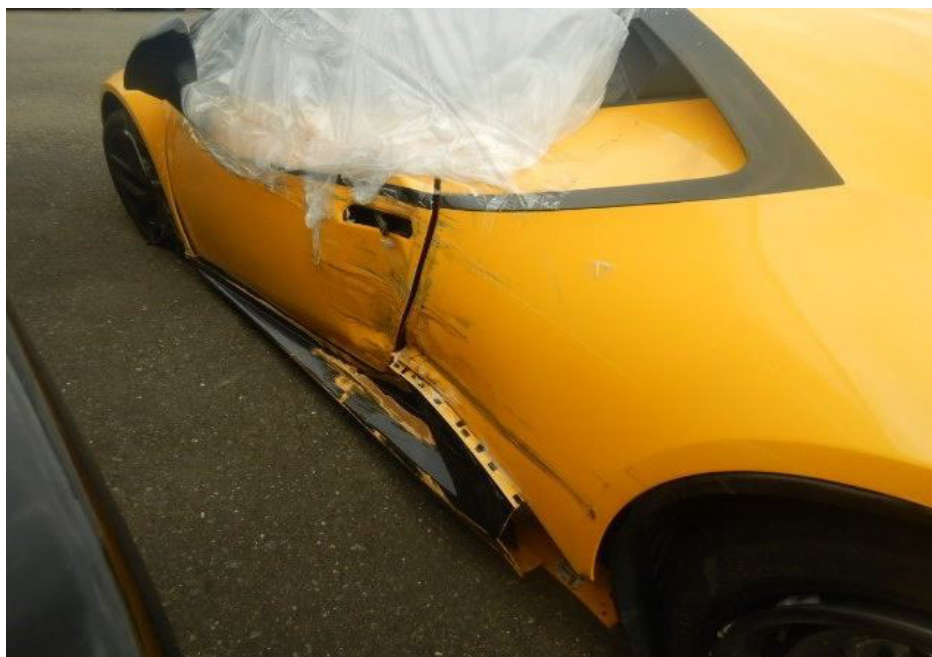
**Photo 4** shows a closer view of the damage to the Motor Car's rear left fender, front left door, front left door outer handle and left side lower skirting (photograph provided to me).

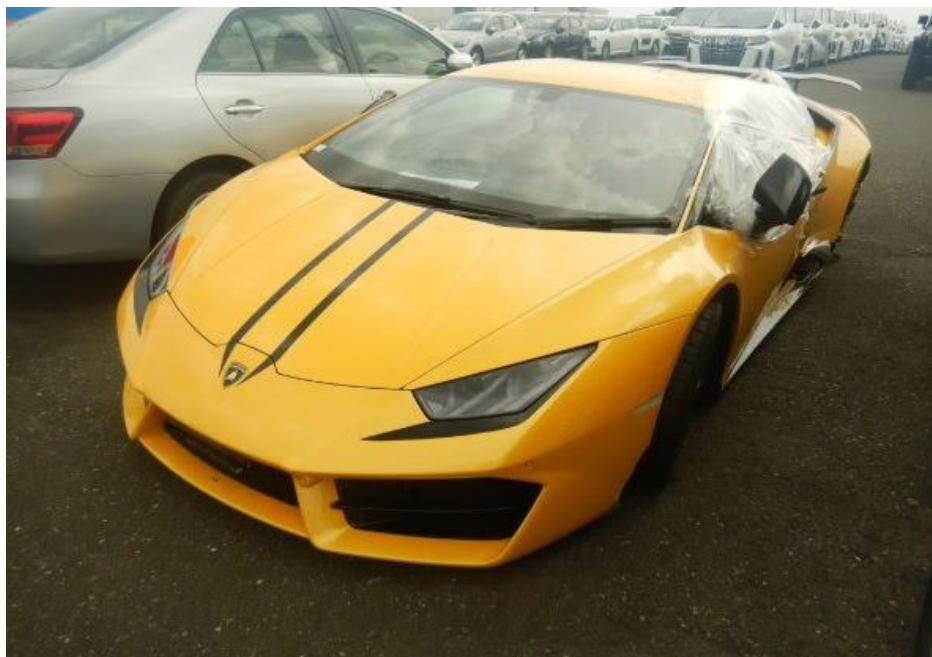
**Photo 5** shows the front left body of the Motor Car (photograph provided to me). No physical damage was observed to the frontal portion of the Motor Car. The airbag(s) was not deployed as seen from the photographs that were provided to me.

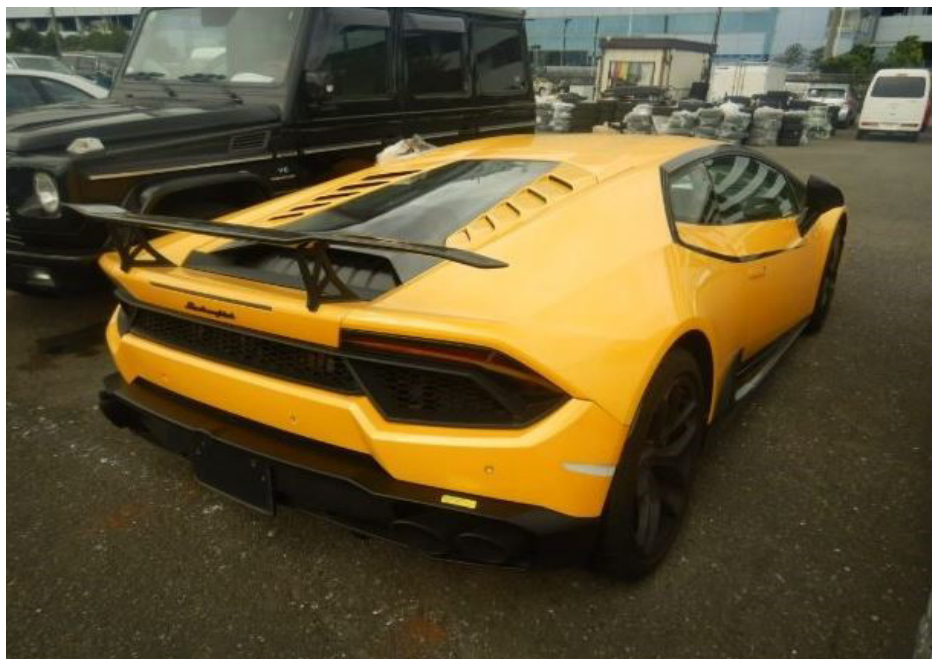
**Photo 6** shows the rear right body of the Motor Car (photograph provided to me). Apart for the left side portion, there was no physical damage observed to other areas of the Motor Car. The airbag(s) was not deployed as seen from the photographs that were provided to me.

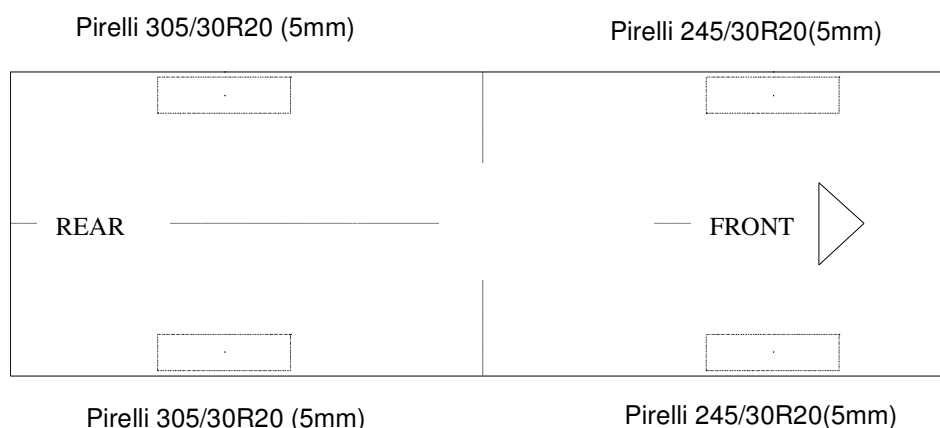
9. It was fitted with 20inch sport wheel rims that were wrapped with tyres that were observed to be of serviceable condition. The tyres were also sufficiently inflated for vehicular operation. The tyre brand, tyre size and approximate remaining tread depth of the 4 tyres of the Motor Car were recorded as follows: -

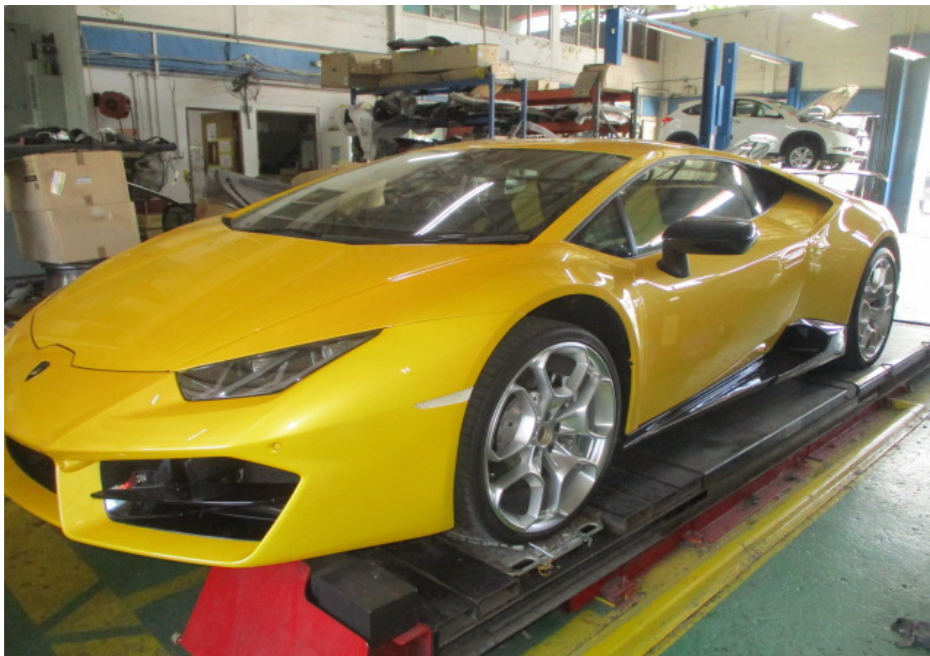
**Photo 7** shows a general view of the front left body of the Motor Car at the time of my inspection. The Motor Car was observed to be in a relatively good general condition with no loose exterior fittings observed. The body parts at the left side portion of the Motor Car were visually examined and it was observed that the repair/restoration works carried out to the damaged area of the Motor Car (refer to photograph 1 – 4 above) were reasonably adequate and in order.

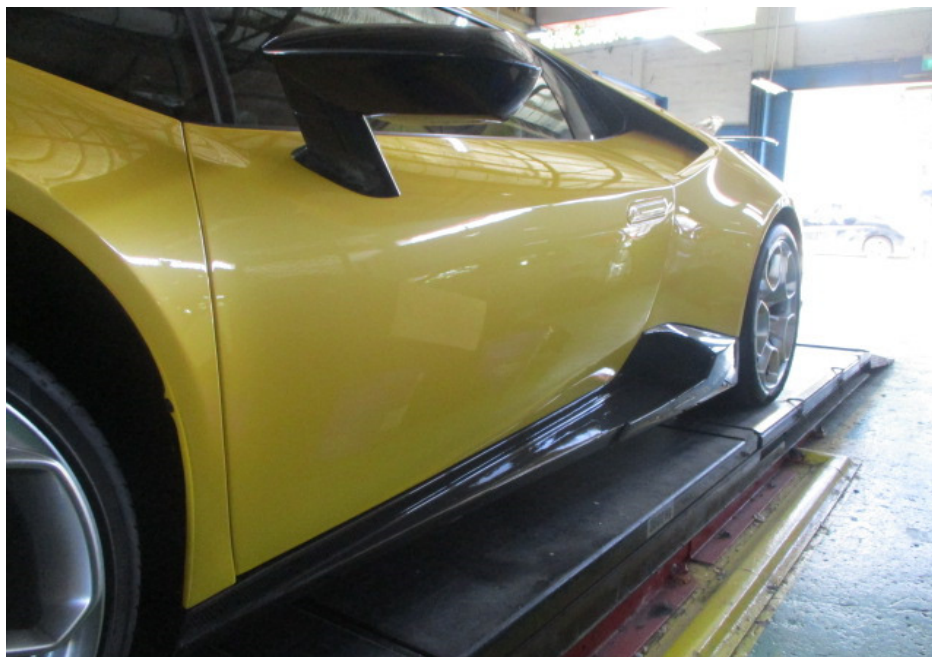
**Photo 8** shows a closer view of the Motor Car's front left door, left wing mirror and left side lower skirting at the time of my inspection. The body parts at the left side portion of the Motor Car were visually examined and it was observed that the repair/restoration works carried out to the damaged area of the Motor Car (refer to photograph 1 – 4 above) were reasonably adequate and in order.

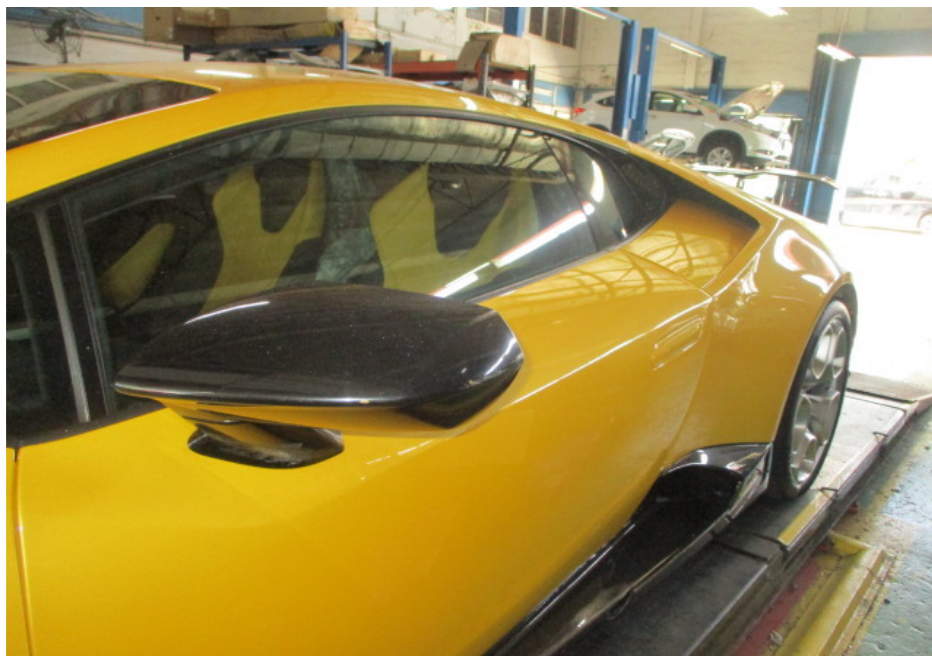
**Photo 9** shows a closer view of the Motor Car's left wing mirror, front left door, front left door glass and rear left fender. The body parts at the left side portion of the Motor Car were visually examined and it was observed that the repair/restoration works carried out to the damaged area of the Motor Car (refer to photograph 1 – 4 above) were reasonably adequate and in order.

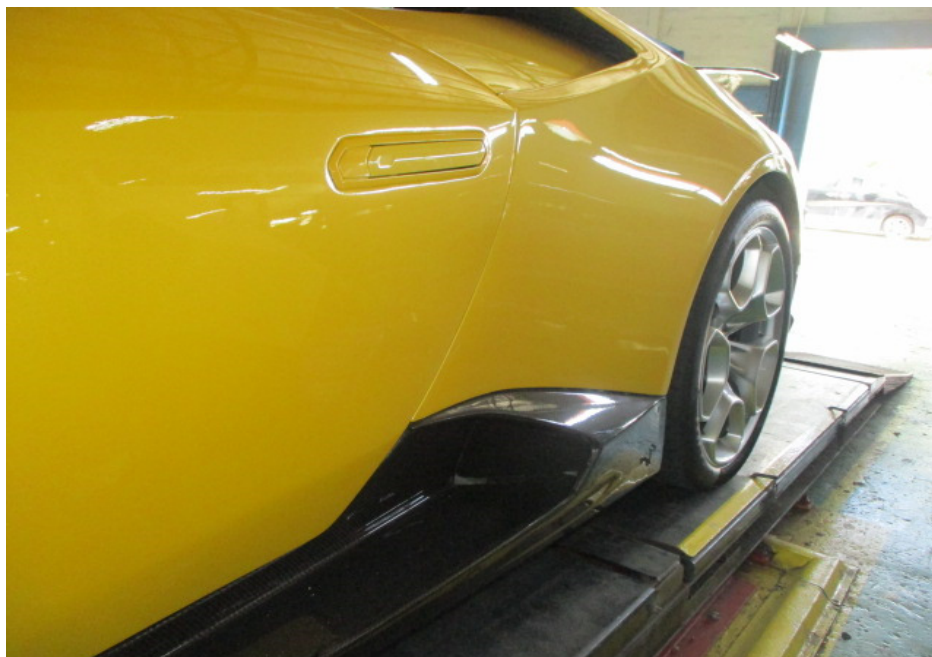
**Photo 10** shows a closer view of the Motor Car's front left door, front left door outer handle, rear left fender and left side lower skirting. The body parts at the left side portion of the Motor Car were visually examined and it was observed that the repair/restoration works carried out to the damaged area of the Motor Car (refer to photograph 1 – 4 above) were reasonably adequate and in order.

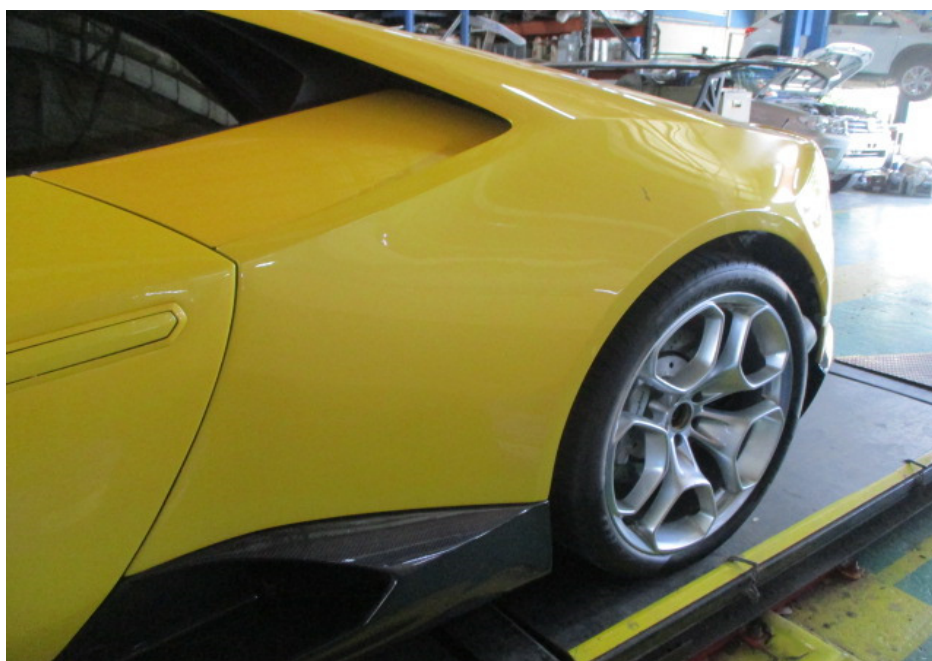
**Photo 11** shows a closer view of the Motor Car's rear left fender, rear left wheel rim and left side lower skirting. The body parts at the left side portion of the Motor Car were visually examined and it was observed that the repair/restoration works carried out to the damaged area of the Motor Car (refer to photograph 1 – 4 above) were reasonably adequate and in order.

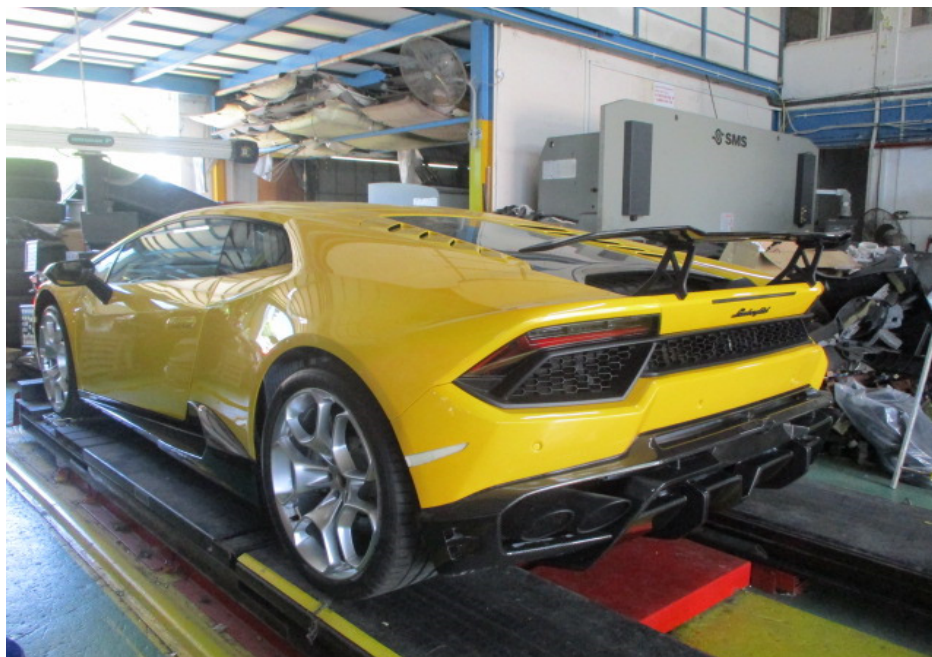
**Photo 12** shows a general view of the rear left body of the Motor Car at the time of my inspection. The Motor Car was observed to be in a relatively good general condition with no loose exterior fittings observed. The body parts at the left side portion of the Motor Car were visually examined and it was observed that the repair/restoration works carried out to the damaged area of the Motor Car (refer to photograph 1 – 4 above) were reasonably adequate and in order.

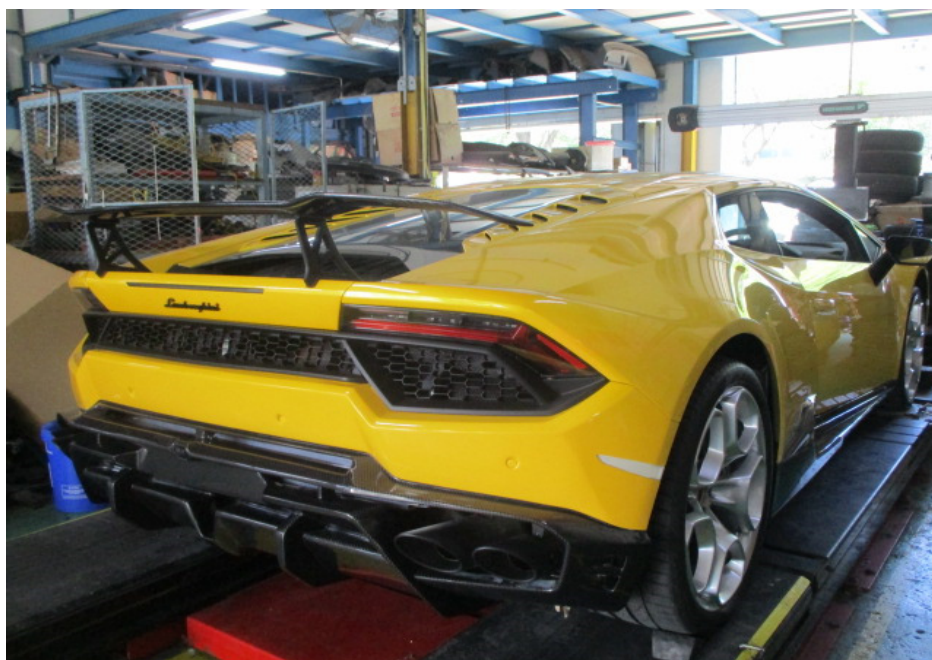
**Photo 13** shows a general view of the rear right body of the Motor Car at the time of my inspection. The Motor Car was observed to be in a relatively good general condition with no loose exterior fittings observed. The mileage of the Motor Car recorded at the time of my inspection was 3,498km.

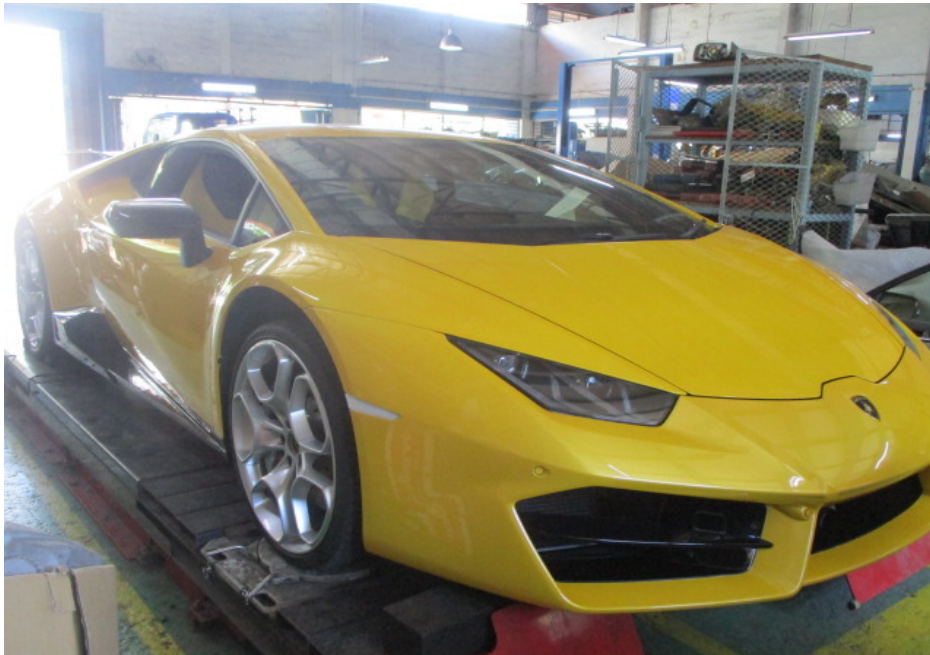
**Photo 14** shows a general view of the front right body of the Motor Car at the time of my inspection. The Motor Car was observed to be in a relatively good general condition with no loose exterior fittings observed. The mileage of the Motor Car recorded at the time of my inspection was 3,498km.

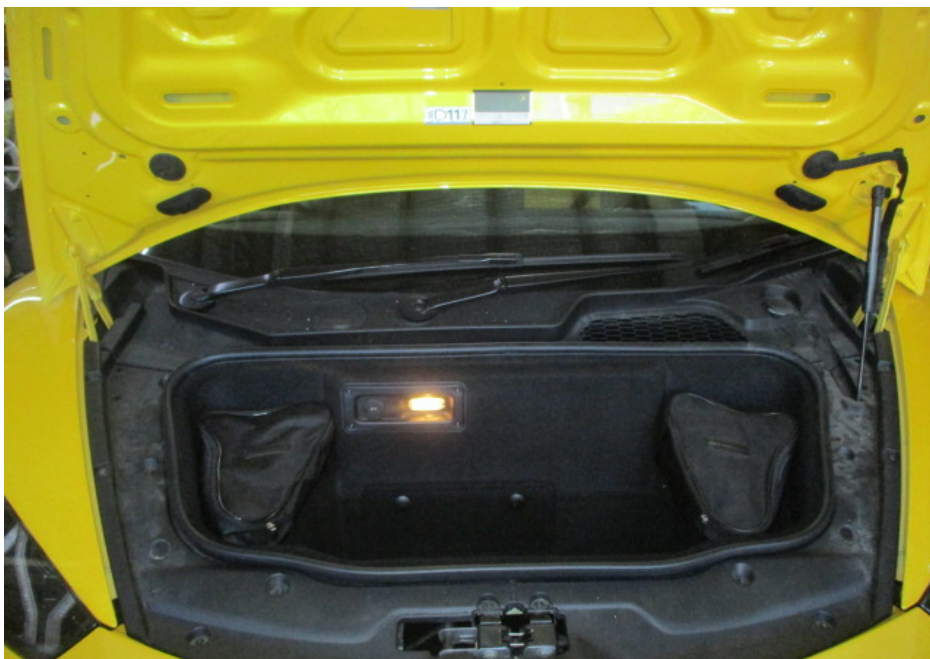
**Photo 15** shows a general view of the Motor Car's front bonnet compartment at the time of my inspection. All inner trims, garnishes and upholstery etc were observed to be properly fitted.

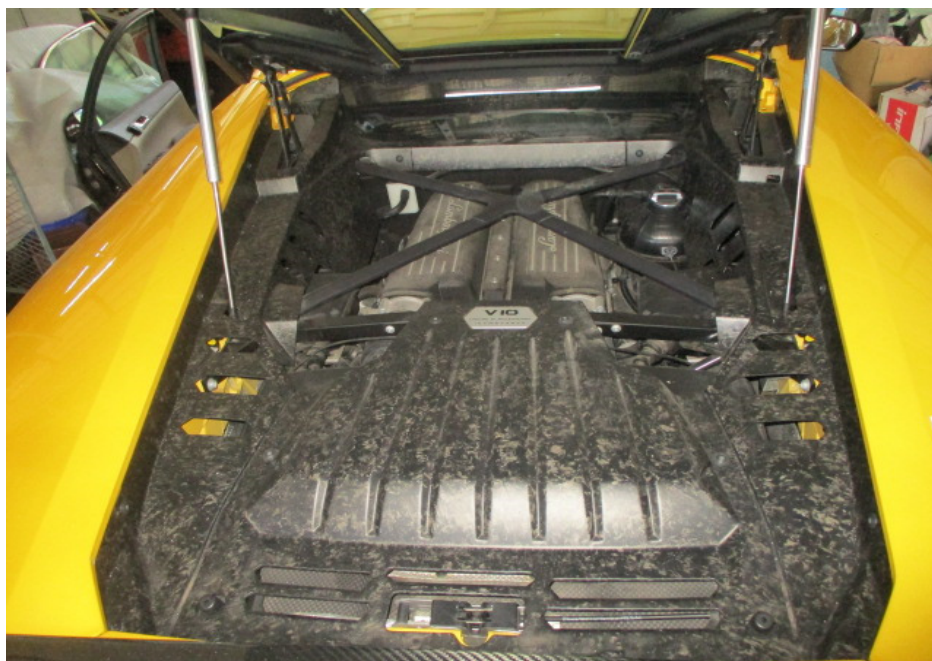
**Photo 17** shows a general view of the engine compartment of the Motor Car at the time of my inspection. The various parts and components inside the engine compartment were all observed to be intact and properly fitted. There was also no sign(s) or indication(s) of fluid leak and/or fluid stain found inside the engine compartment.

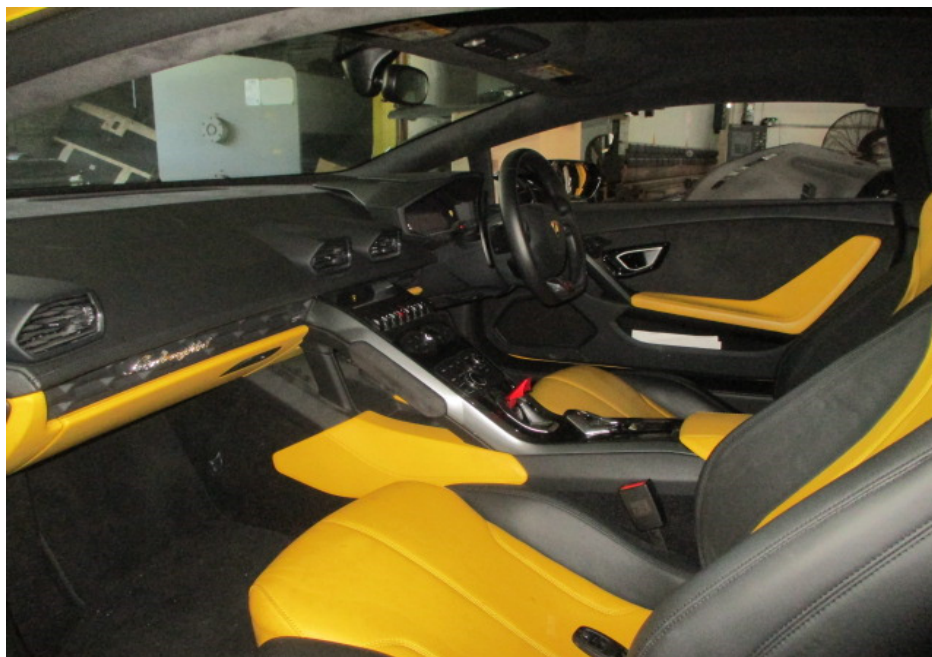
**Photo 18** shows the interior compartment of the Motor Car at the time of my inspection. The various parts and components, seats, trims, carpet, and upholstery inside the interior compartment were all observed to be intact and properly fitted.

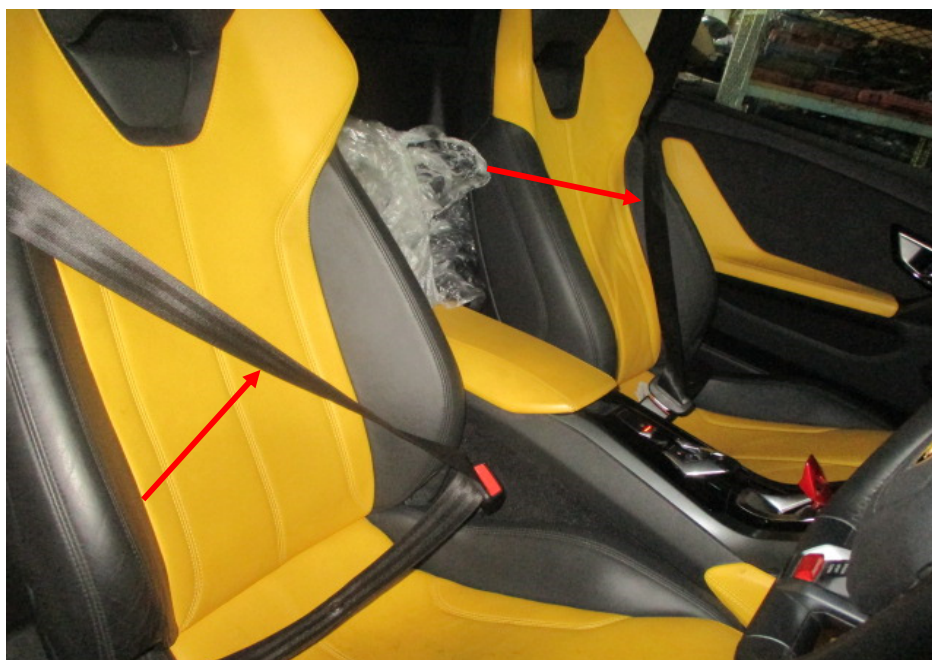
**Photo 19** shows the seats of the Motor Car. All the seats of the Motor Car were secured via seat rails to the floorboard. They were also fitted with a retractable seat belt reel and a pre-tensioner. The seat belts (arrowed) were tested and were able to be fastened into the respective pre-tensions that were fitted on the side of each individual seat.

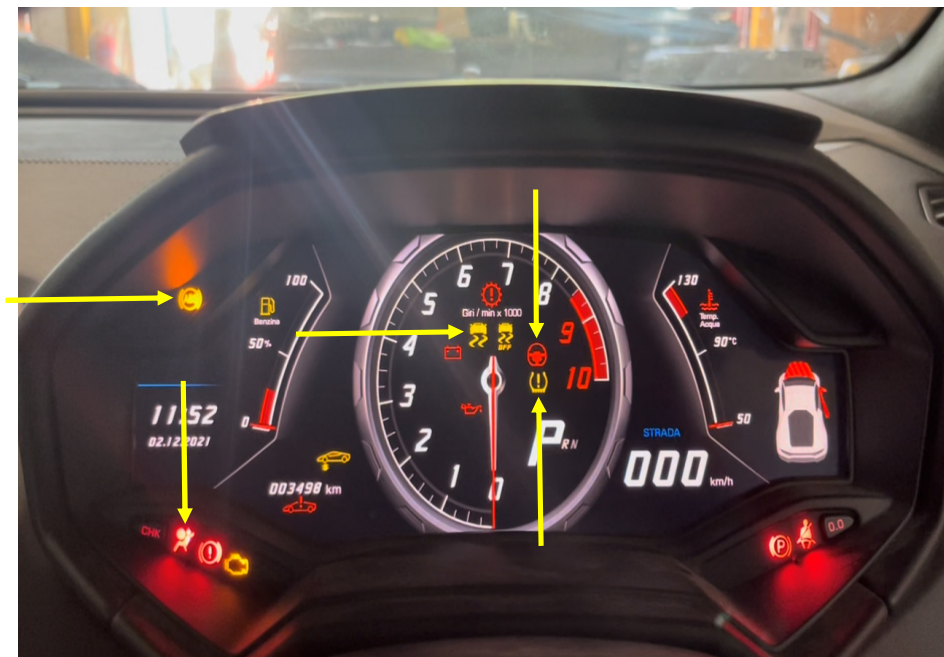
**Photo 20** shows the warning lights for the various electronic safety features appearing on the instrument panel of the Motor Car during its self-test when the engine is cranked, in particular the ABS, SRS, EPAS, TPM and TCS lights (arrowed).

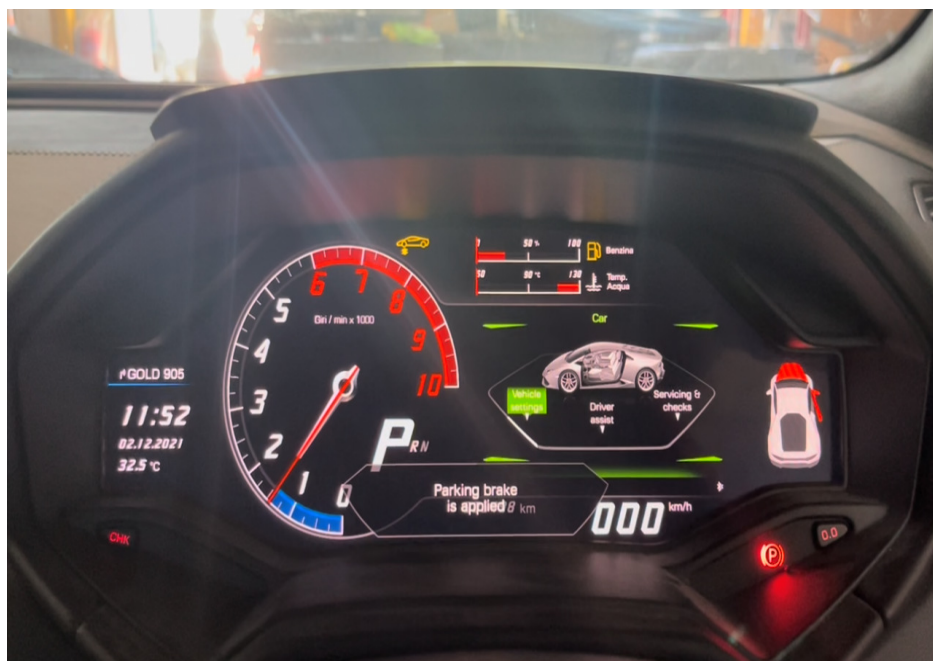
**Photo 21** shows the respective warning lights no longer illuminated, indicating that there is no fault detected to the ABS, SRS, EPAS, TPM and TCS systems of the Motor Car during the self-test. These electronic systems were hence in working condition at the time of my inspection.

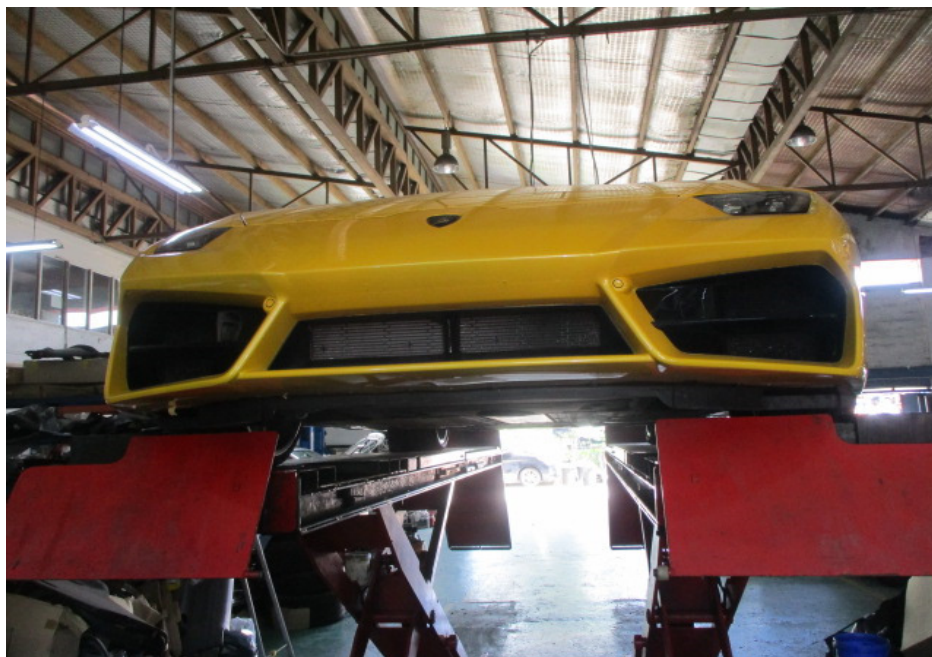
**Photo 22** shows the Motor Car hoisted up for checks on its undercarriage. There was no sign(s) or indication(s) of fluid leakage and/or fluid stain(s) on the underside of the Motor Car. The undercarriage components of the Motor Car were also all observed to be intact and secured in an appropriate manner.

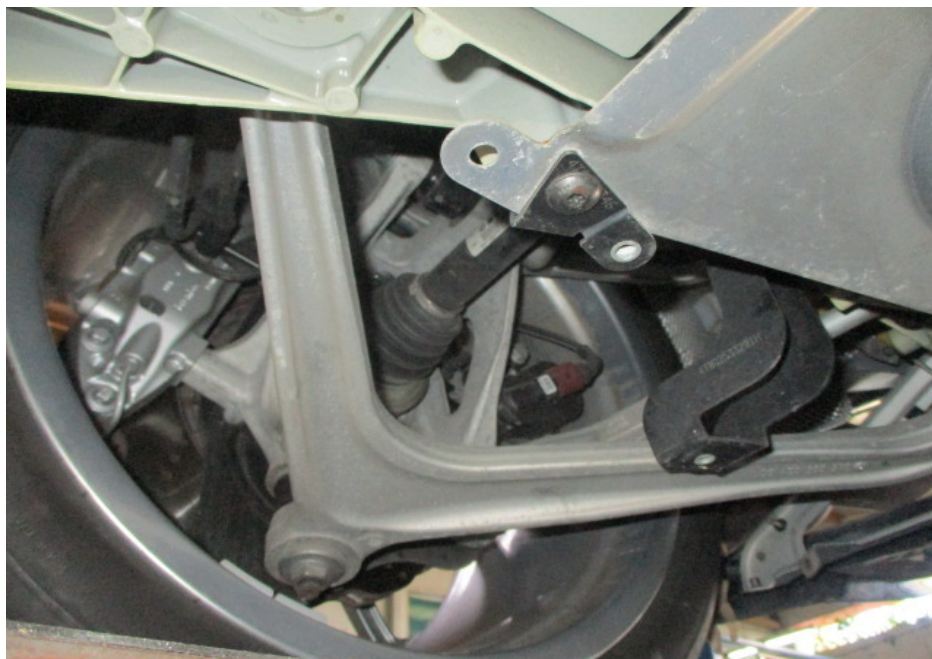
**Photo 23** shows a general view of the control arms and linkages at the rear right wheel of the Motor Car. I did not observe any fluid leak and/or fluid stain on the underside of the Motor Car. All of the Motor Car's undercarriage components were observed to be intact and secured in an appropriate manner.

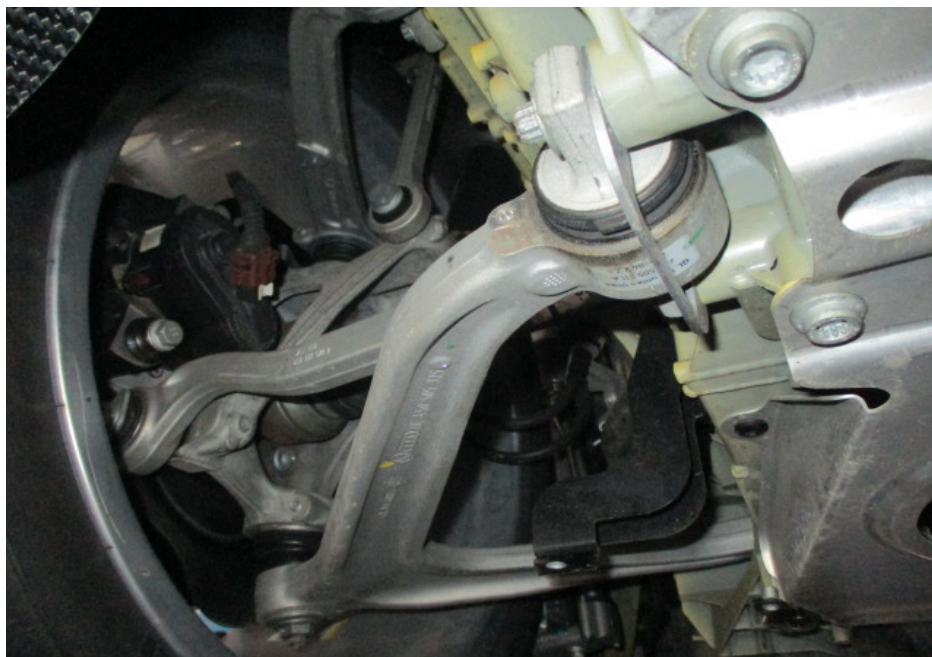
**Photo 24** shows a general view of the control arms and linkages at the rear left wheel of the Motor Car. I did not observe any fluid leak and/or fluid stain on the underside of the Motor Car. All of the Motor Car's undercarriage components were observed to be intact and secured in an appropriate manner.

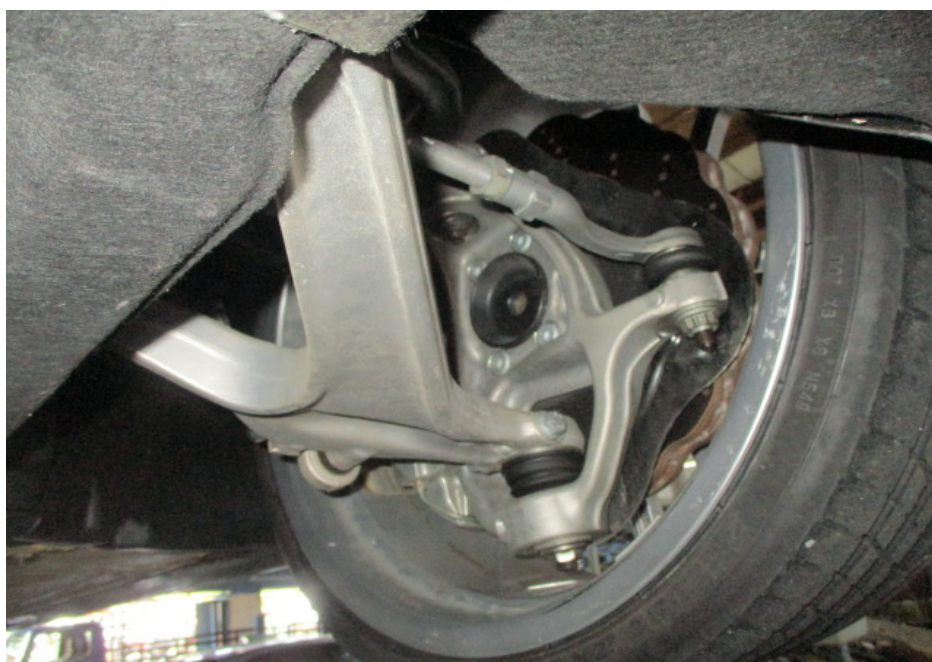
**Photo 25** shows the various undercarriage components at the front left wheel of the Motor Car. The mechanical components, control arms and linkages were all found to be intact and secured in an appropriate manner.

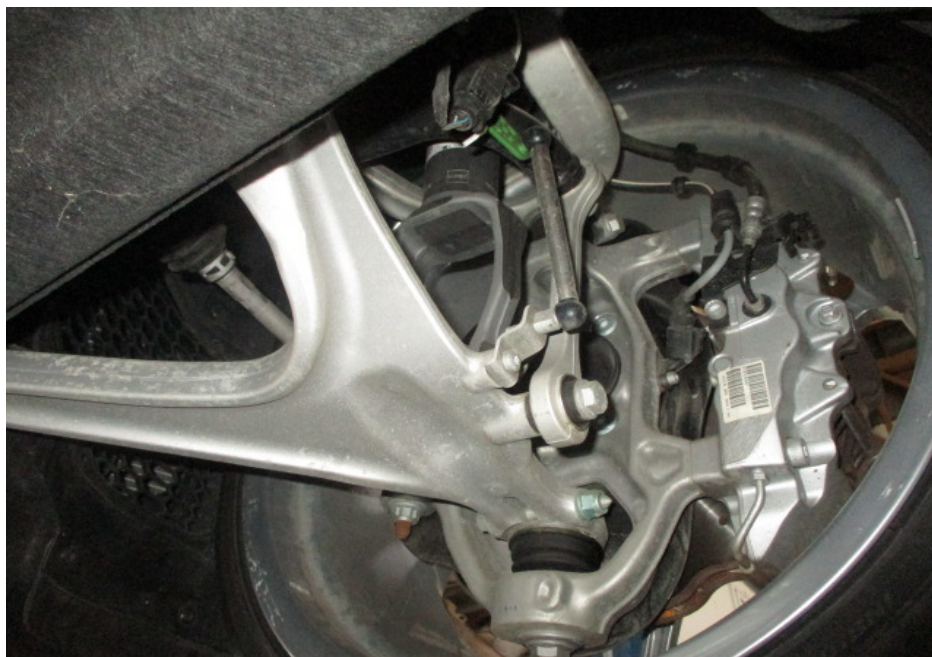
**Photo 26** shows the various undercarriage components at the front right wheel of the Motor Car. The mechanical components, control arms and linkages were all found to be intact and secured in an appropriate manner. I also did not observe any fluid leak and/or fluid stain on the underside of the Motor Car.

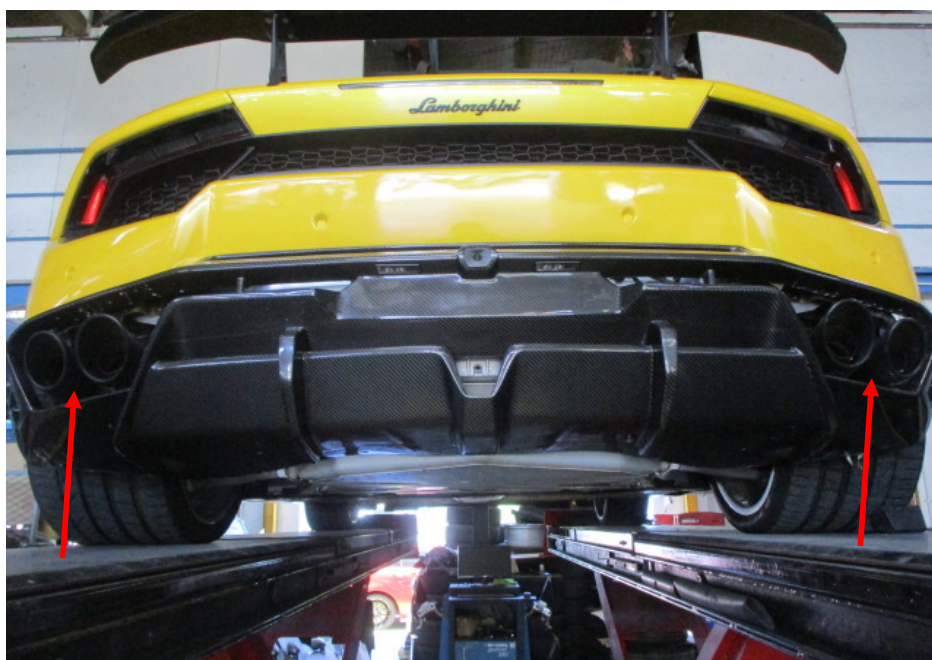
**Photo 27** shows the rear exhaust tips (arrowed) of the Motor Car. The Motor Car's exhaust system could not be examined as the exhaust pipes, rear mufflers and catalytic converters were all hidden from view.

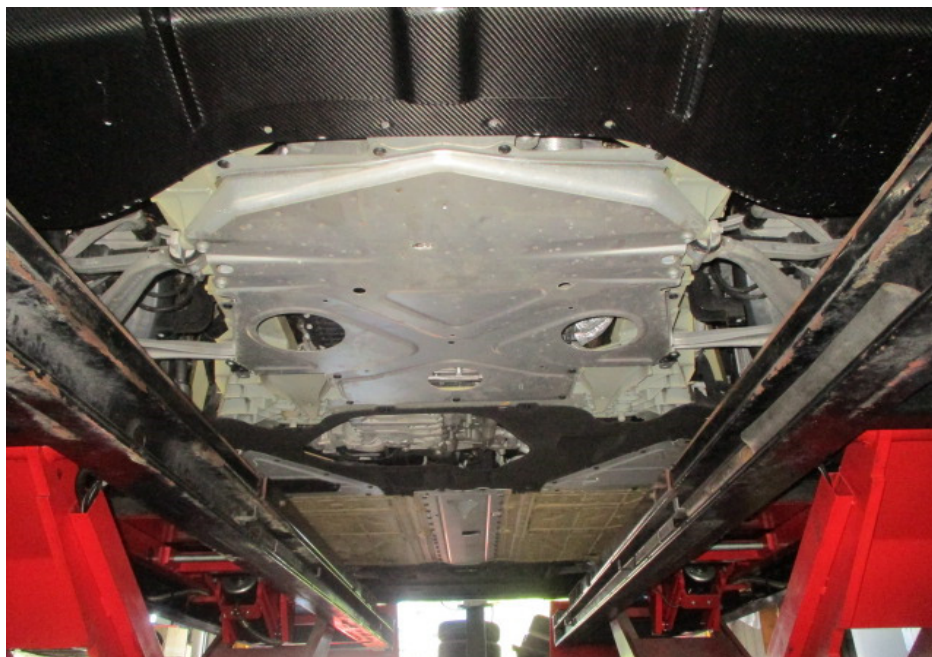
**Photo 28** shows a general view of the Motor Car's underside. The Motor Car's exhaust system could not be examined as the exhaust pipes, rear mufflers and catalytic converters were all hidden from view.

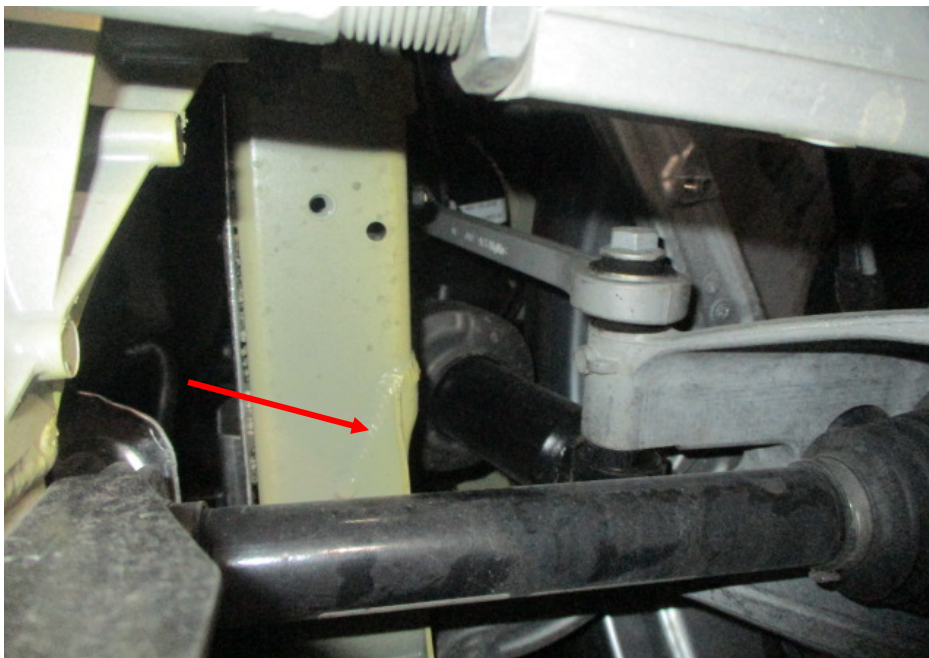
**Photo 29** shows the chassis/structural body at the underside rear right of the Motor Car. I did not find any weld marks other than original spot weld marks on the chassis/structural body of the Motor Car. The original factory sealant (arrowed) at the joints along the chassis/structural body was untouched, indicating no work was done on the chassis/structural body of the Motor Car and that the chassis/structural body was originally fitted.

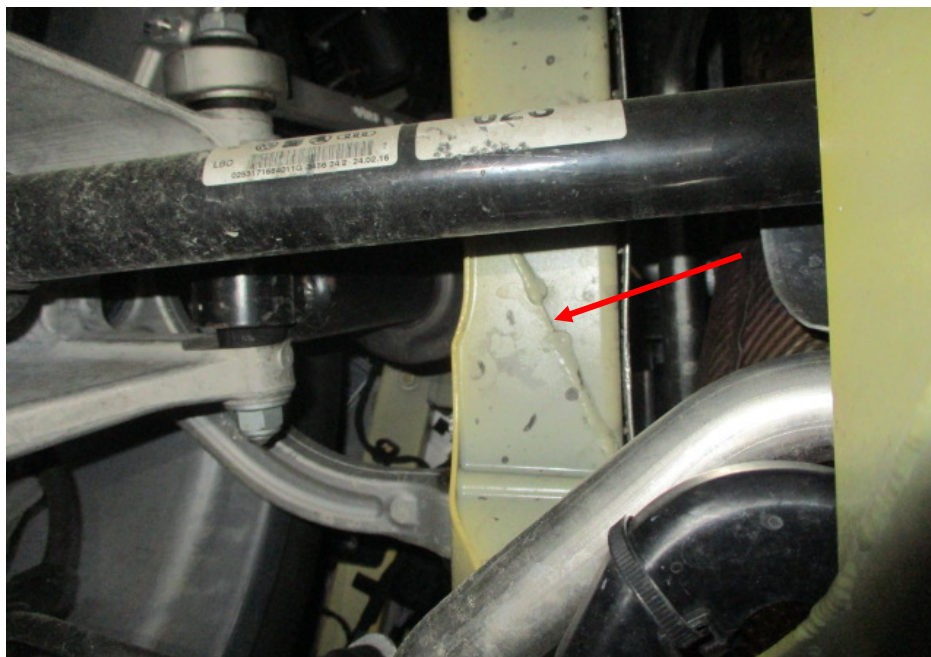
**Photo 30** shows the chassis/structural body at the underside rear left of the Motor Car. The original factory sealant (arrowed) at the joints along the chassis/structural body was observed to be untouched. In general, I had found no work was carried out on the chassis/structural body of the Motor Car. The chassis/structural body of the Motor Car was originally fitted.

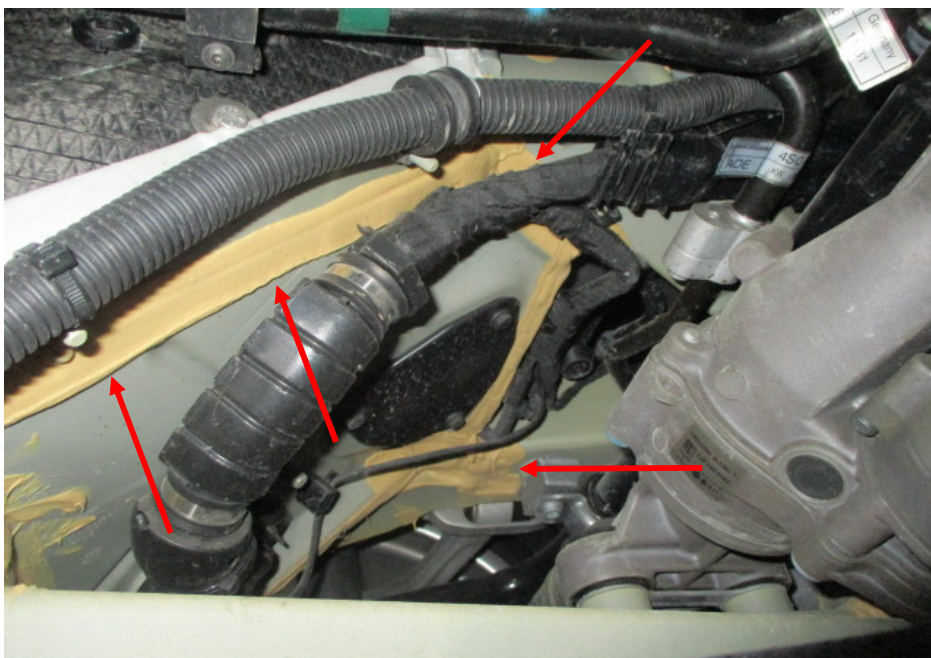
**Photo 31** shows the chassis/structural body at the underside front left of the Motor Car. I did not find any weld marks other than original spot weld marks on the chassis/structural body of the Motor Car. The original factory sealant (arrowed) at the joints along the chassis/structural body was untouched, indicating no work was done on the chassis/structural body of the Motor Car and that the chassis/structural body was originally fitted.

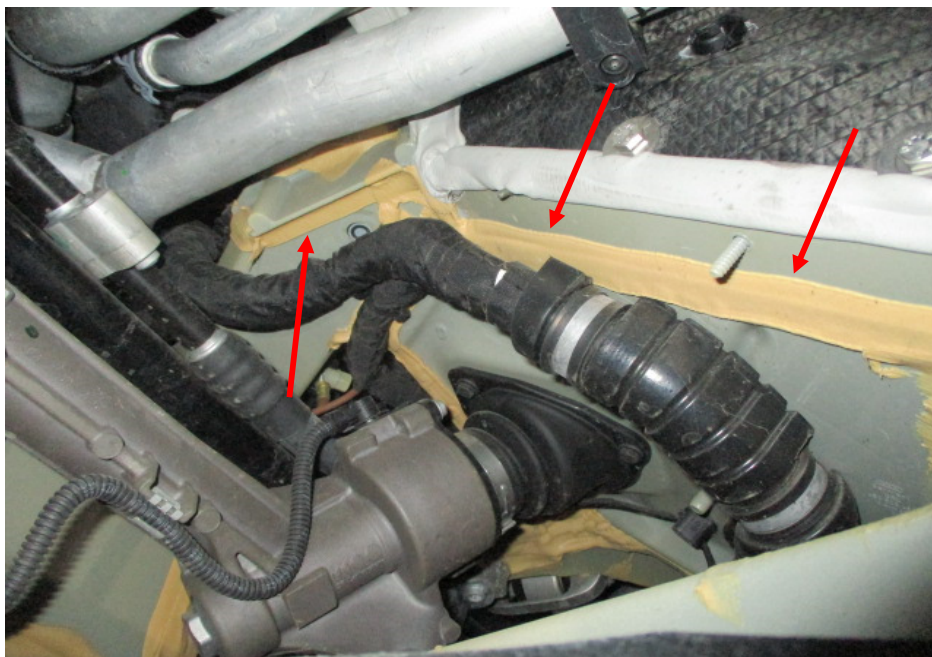
**Photo 32** shows the chassis/structural body at the underside front right of the Motor Car. The original factory sealant (arrowed) at the joints along the chassis/structural body was observed to be untouched. In general, I had found no work was carried out on the chassis/structural body of the Motor Car. The chassis/structural body of the Motor Car was originally fitted.
