Your Ref: Mercedes Benz CLA 180
(chassis number W1K1183842N117614)
Our Ref : CI/TP21012529/D

10 December 2021

**INSPECTION REPORT OF AN UNREGISTERED MERCEDES BENZ CLA 180
MOTOR CAR WITH CHASSIS NUMBER W1K1183842N117614**

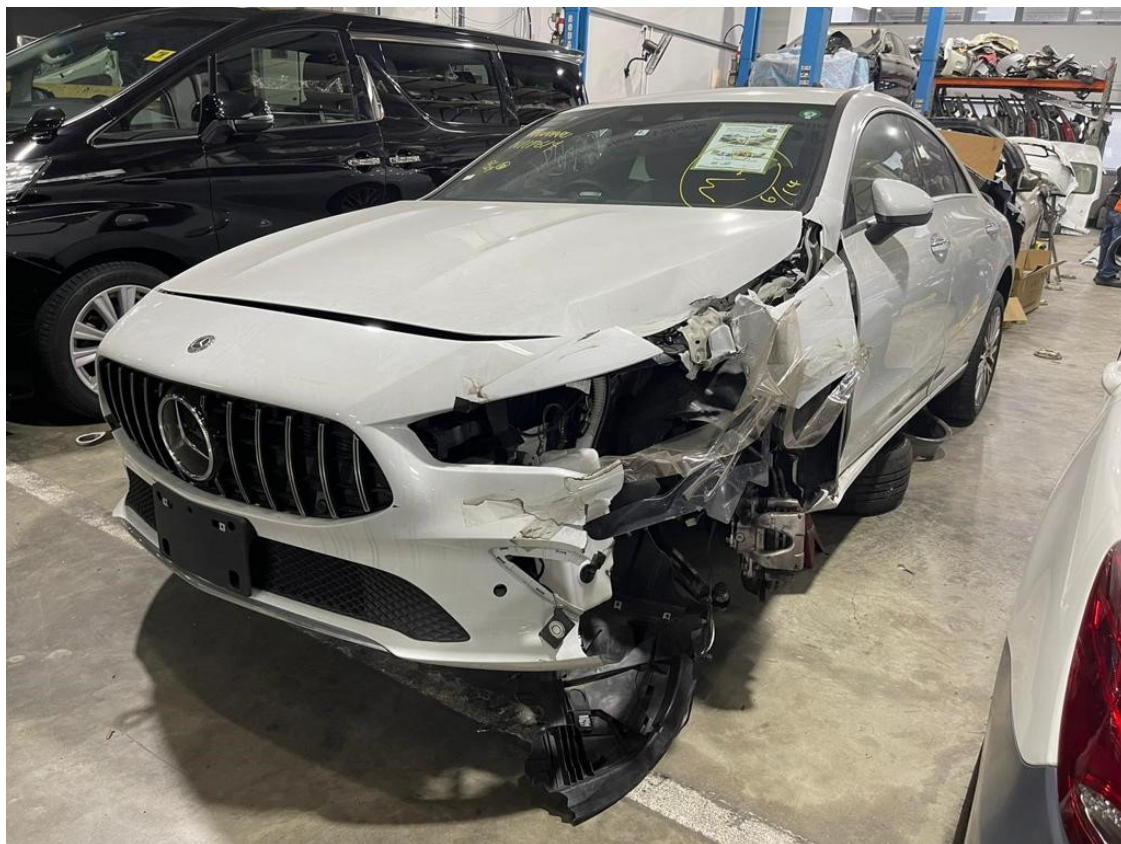
3. The photographs provided to me had showed damage to the Motor Car's front left portion. Body parts damaged include the front bumper, front bumper sponge, front bumper reinforcement, front bumper undercover, front bumper left lower grille, front bumper left sensors, front bonnet, front bonnet left hinge, front left headlamp, front left fender, front left fender inner shield, front left wheel rim, front left tyre, front support panel, front windscreen washer tank and left side rocker panel garnish amongst others.

4. Damage was also seen to the undercarriage parts at the front left wheel of the Motor Car. Undercarriage parts affected and/or possible affected include the front left lower arm, front left shock absorber, front left knuckle arm, front left drive shaft and front left steering tie rod amongst others.

Photo 1 shows the front left body of the Motor Car (photograph provided to me). The Motor Car was observed to have sustained damage at its front left portion. The front bumper, front bumper sponge, front bumper reinforcement, front bumper undercover, front bumper left lower grille, front bumper left sensors, front bonnet, front bonnet left hinge, front left headlamp, front left fender, front left fender inner shield, front left wheel rim, front left tyre and left side rocker panel garnish were amongst the body parts that were observed to have been damaged. In addition, damage was also seen to the undercarriage parts at the front left wheel of the Motor Car. Undercarriage parts affected and/or possible affected include the front left lower arm, front left shock absorber, front left knuckle arm, front left drive shaft and front left steering tie rod amongst others.

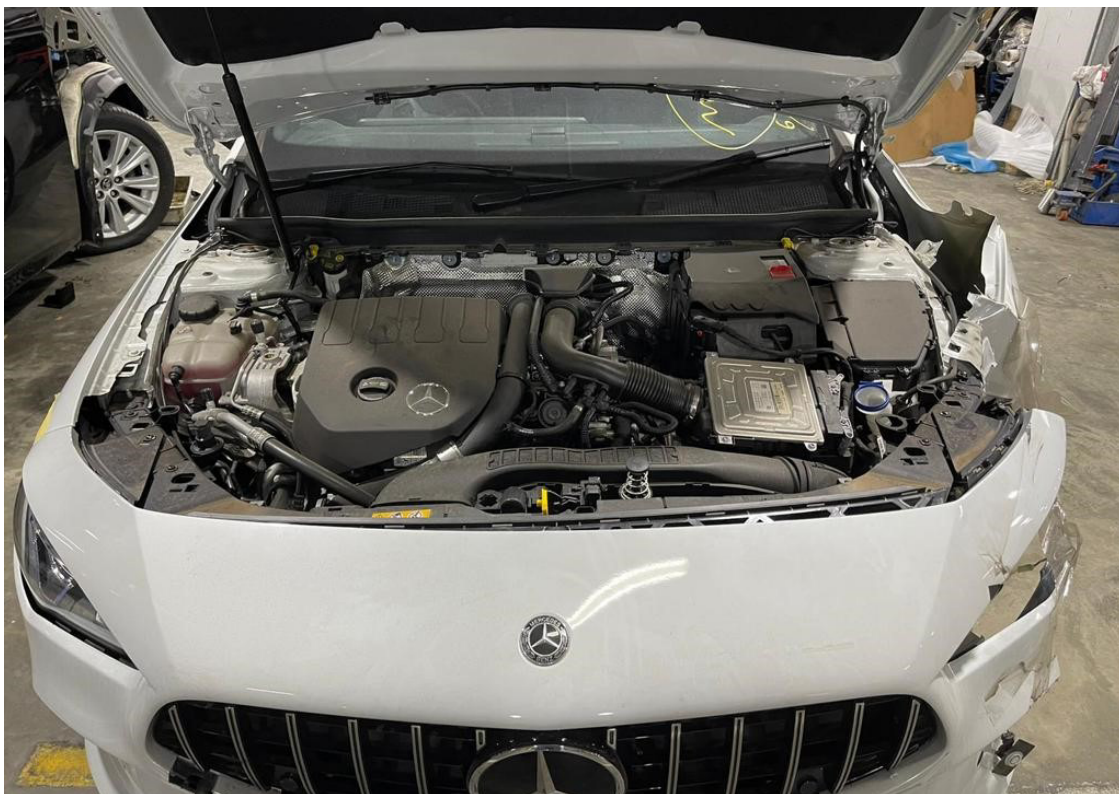
Photo 2 shows a general view of the Motor Car's engine compartment (photograph provided to me). The various parts and components within the engine compartment were observed to be largely unaffected except for the front support panel and front windscreen washer tank.

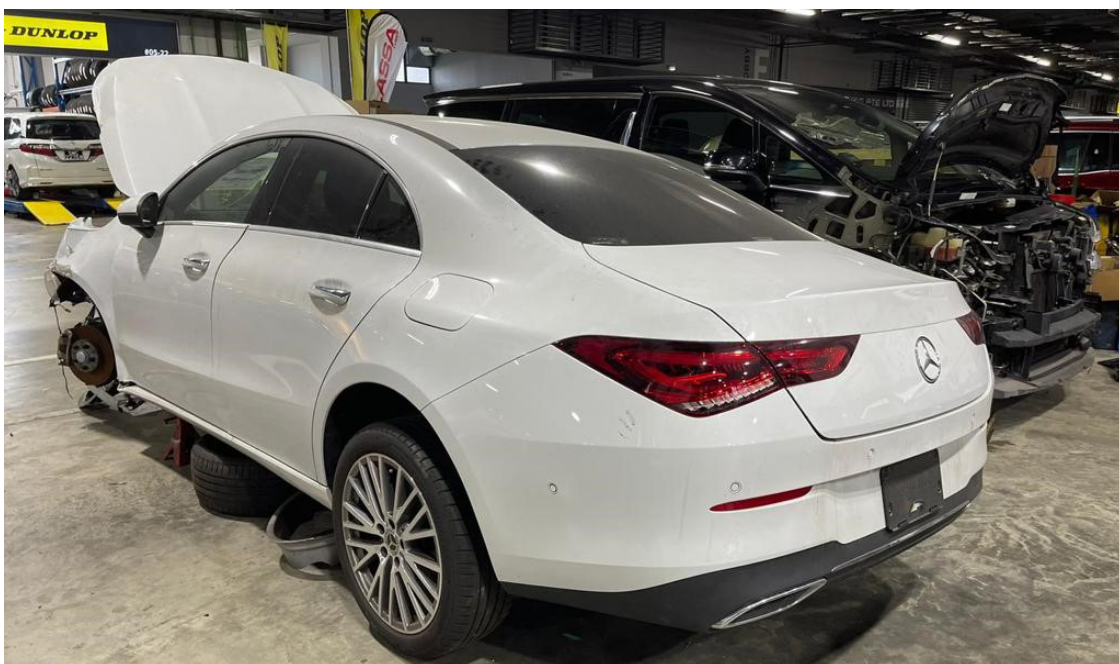
Photo 3 shows the rear left body of the Motor Car (photograph provided to me). Apart for the front left portion, there was no physical damage observed to other areas of the Motor Car. The airbag(s) of the Motor Car was not deployed as seen from the photographs that were provided.

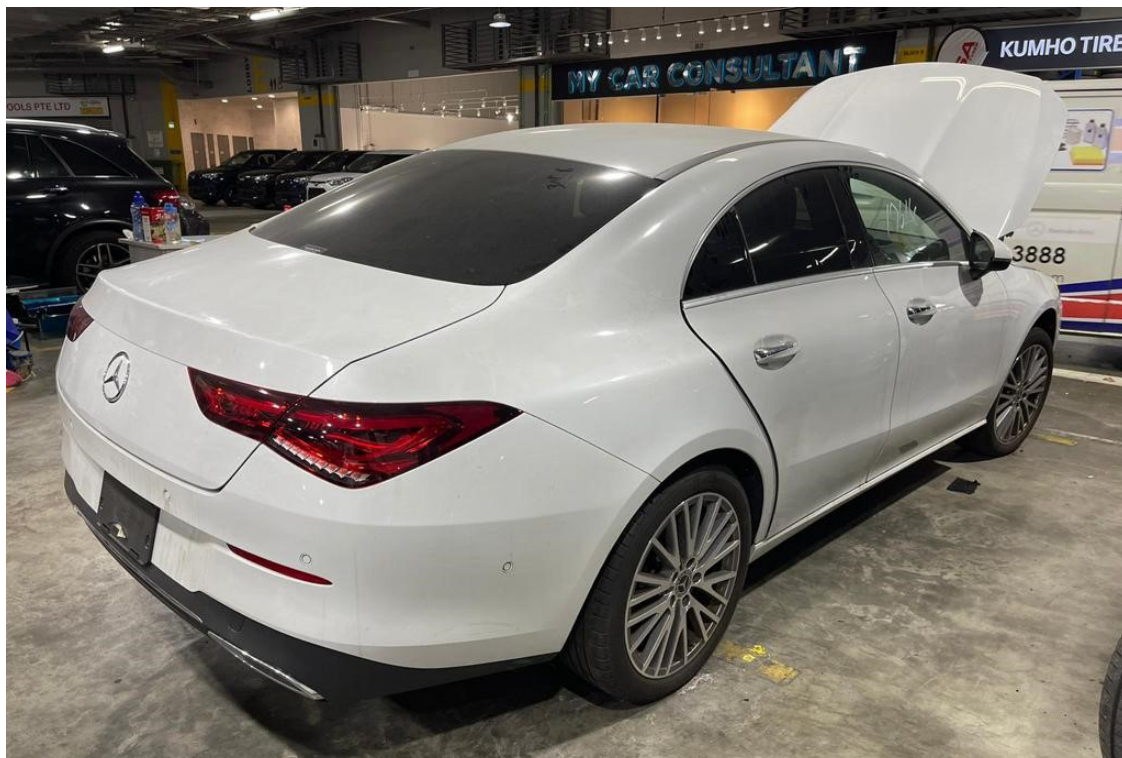
Photo 4 shows the rear right body of the Motor Car (photograph provided to me). Apart for the front left portion, there was no physical damage observed to other areas of the Motor Car. The airbag(s) of the Motor Car was not deployed as seen from the photographs that were provided.

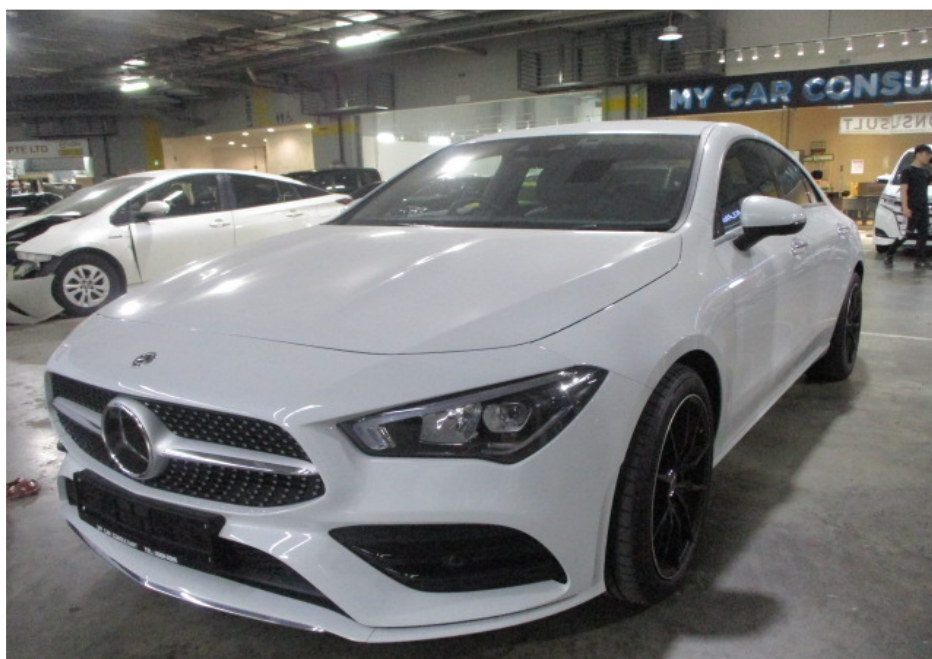
Photo 5 shows a general view of the front left body of the Motor Car at the time of my inspection. The Motor Car was observed to be in a relatively good general condition with no loose exterior fittings observed. The body parts at the front left portion of the Motor Car were visually examined and it was observed that the repair/restoration works carried out to the damaged area of the Motor Car (refer to photograph 1 & 2 above) were reasonably adequate and in order.

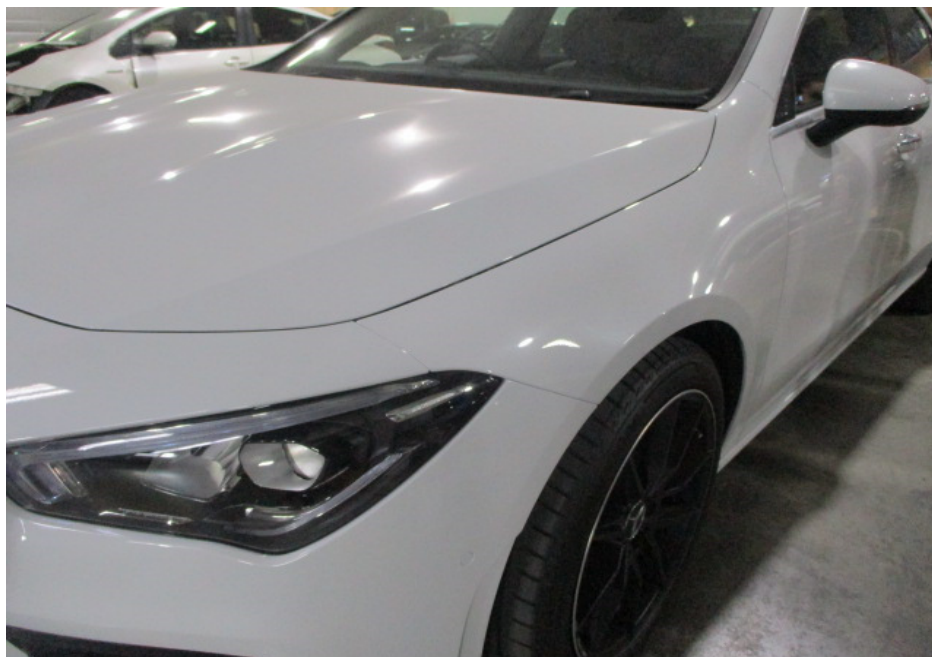
Photo 6 shows a closer view of the Motor Car's front bumper, front bonnet, front left headlamp and front left fender. The body parts at the front left portion of the Motor Car were visually examined and it was observed that the repair/restoration works carried out to the damaged area of the Motor Car (refer to photograph 1 & 2 above) were reasonably adequate and in order.

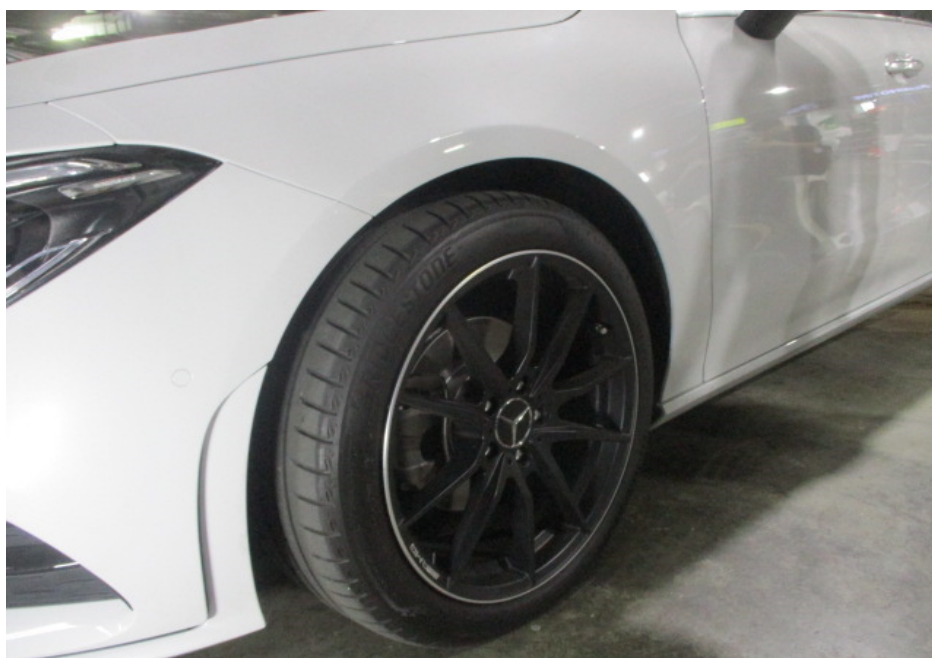
Photo 7 shows a closer view of the Motor Car's front left fender, front left wheel rim, front left tyre and left side rocker panel garnish. The body parts at the front left portion of the Motor Car were visually examined and it was observed that the repair/restoration works carried out to the damaged area of the Motor Car (refer to photograph 1 & 2 above) were reasonably adequate and in order.

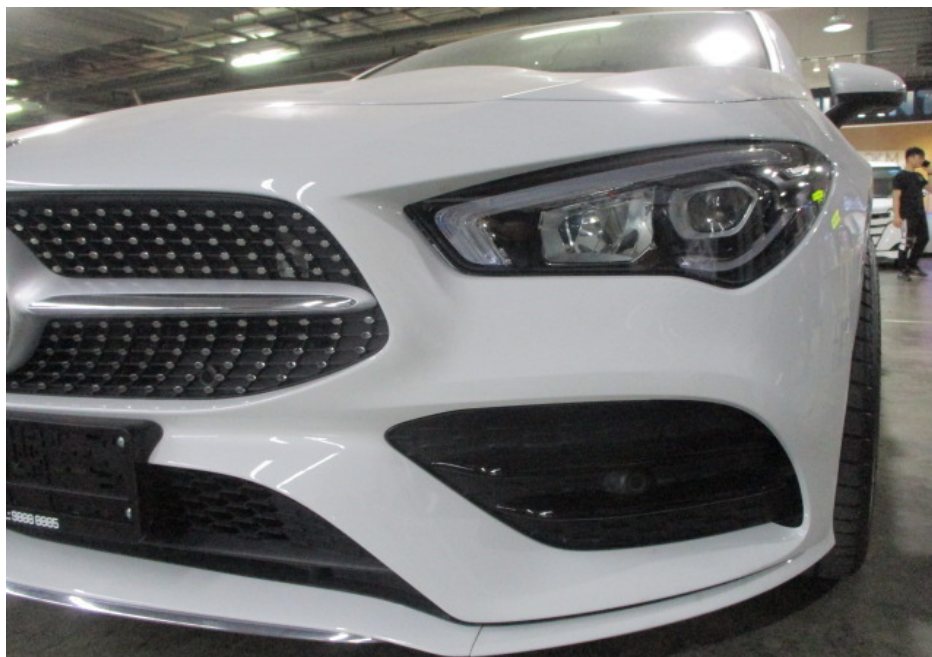
Photo 8 shows a closer view of the Motor Car's front bumper, front bumper left lower grille, front left headlamp and radiator grille. The body parts at the front left portion of the Motor Car were visually examined and it was observed that the repair/restoration works carried out to the damaged area of the Motor Car (refer to photograph 1 & 2 above) were reasonably adequate and in order.

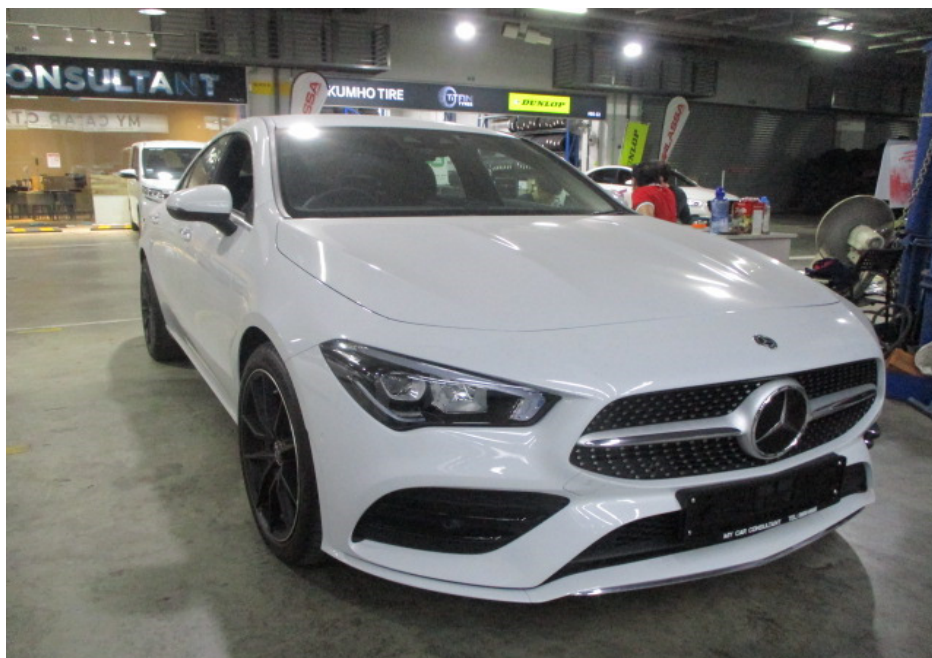
Photo 9 shows a general view of the front right body of the Motor Car at the time of my inspection. The Motor Car was observed to be in a relatively good general condition with no loose exterior fittings observed. The body parts at the front left portion of the Motor Car were visually examined and it was observed that the repair/restoration works carried out to the damaged area of the Motor Car (refer to photograph 1 & 2 above) were reasonably adequate and in order.

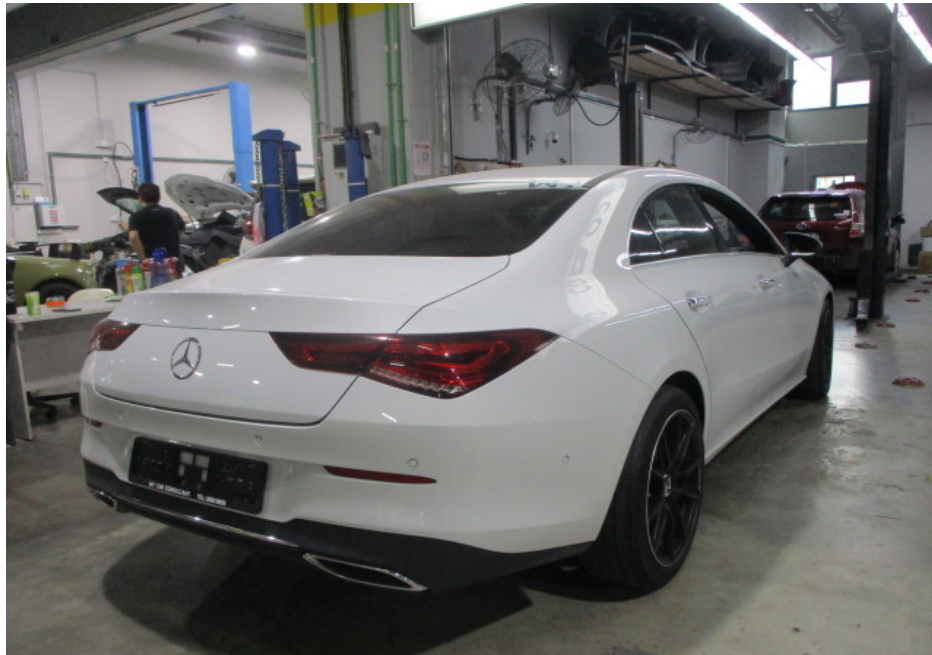
Photo 10 shows a general view of the rear right body of the Motor Car at the time of my inspection. The Motor Car was observed to be in a relatively good general condition with no loose exterior fittings observed. The mileage of the Motor Car recorded at the time of my inspection was 10,966km.

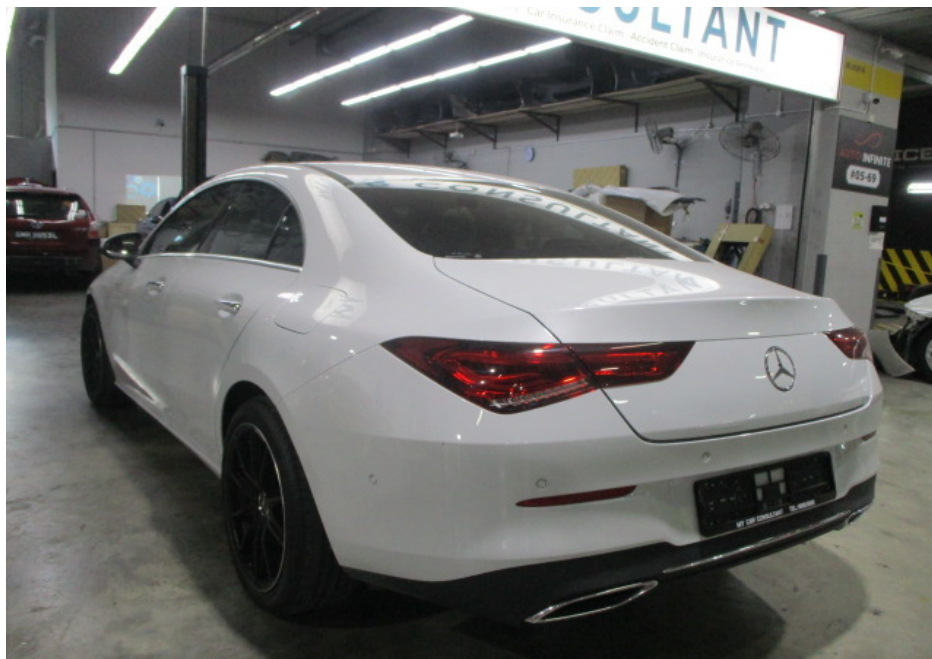
Photo 11 shows a general view of the rear left body of the Motor Car at the time of my inspection. The Motor Car was observed to be in a relatively good general condition with no loose exterior fittings observed. The mileage of the Motor Car recorded at the time of my inspection was 10,966km.

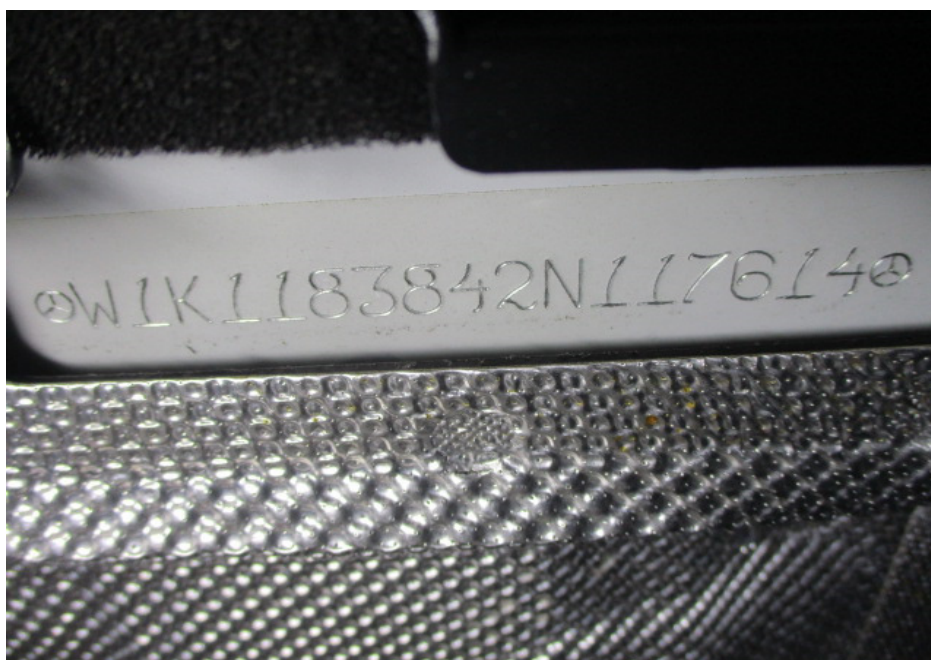
Photo 12 shows the chassis number of the Motor Car. The chassis number recorded was W1K1183842N117614.

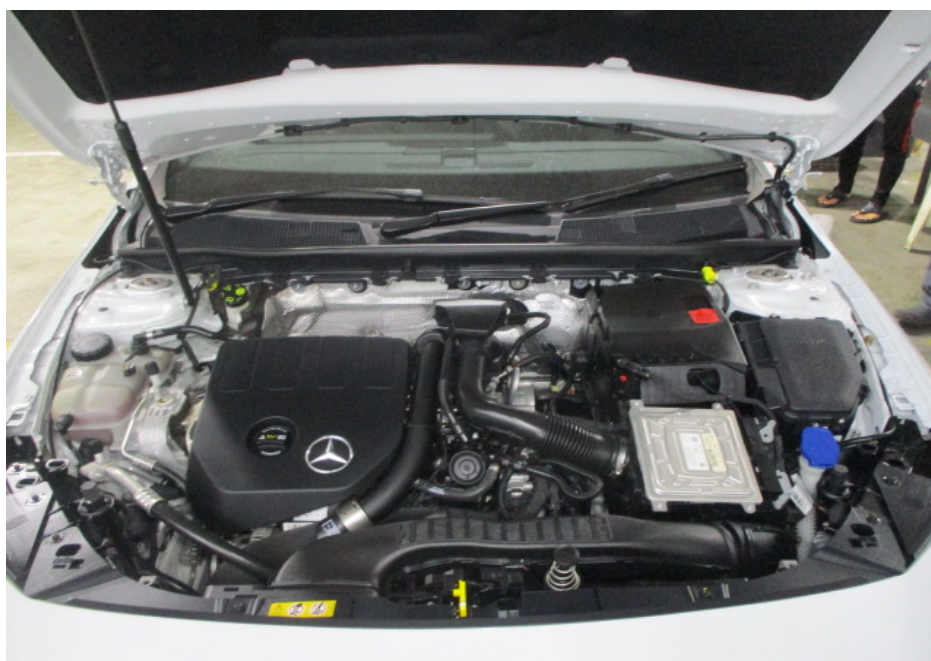
15. My examination of the engine compartment of the Motor Car revealed that the various parts and components inside the engine compartment were all intact and properly fitted. The engine oil, brake fluid and engine coolant were all found to be of sufficient level for operating purposes. Visually, there was also no contamination found to these fluids.
16. My checks on the underside of the Motor Car revealed no sign(s) or indication(s) of fluid leakage and/or fluid stain(s). The engine block and automatic transmission assembly were both secured properly. All undercarriage components of the Motor Car were also observed to be intact and secured in an appropriate manner.

Photo 13 shows a general view of the engine compartment of the Motor Car at the time of my inspection. The various parts and components inside the engine compartment were all observed to be intact and properly fitted. There was also no sign(s) or indication(s) of fluid leak and/or fluid stain found inside the engine compartment. The repair/restoration works carried out to the various parts within the engine compartment like the front support panel and front windscreen washer tank amongst others, were reasonably adequate and in order.

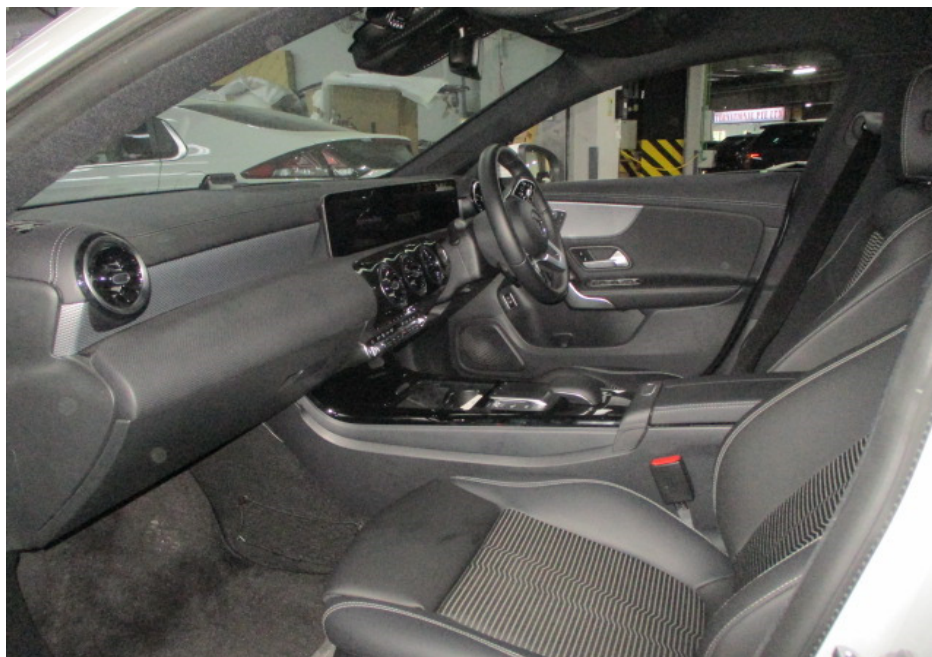
Photo 14 shows the interior compartment of the Motor Car. The front dashboard, steering wheel, seats, upholstery and trims etc were all observed to be intact and properly fitted.

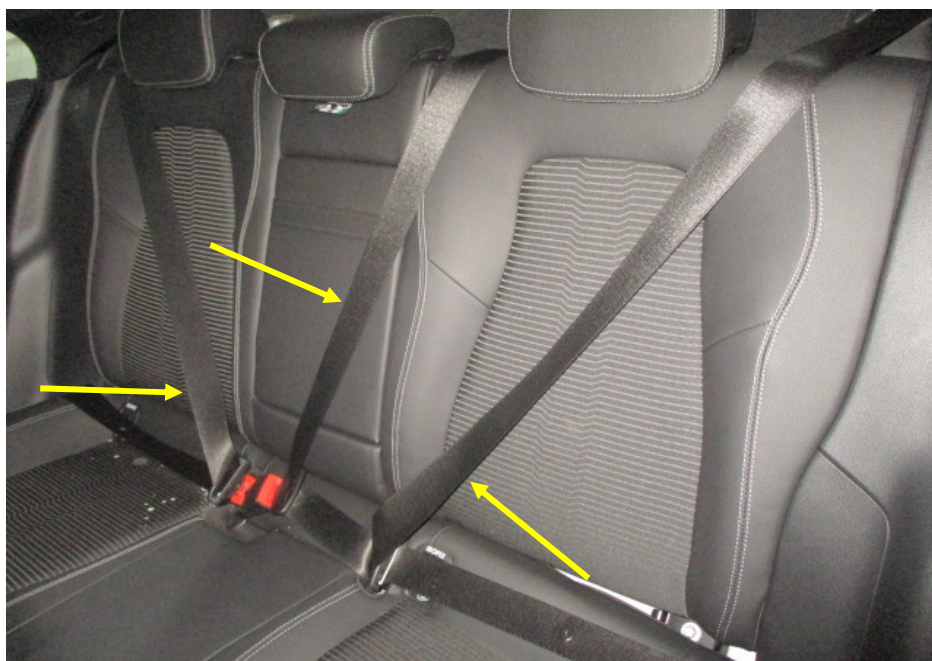
13. The seats of the Motor Car were found to be secured to the floorboard of the Motor Car via seat rails bolted onto the floorboard. Retractable seat belt reels and pre-tensioners were fitted on all seats of the Motor Car. The seat belts were tested and were able to be fastened securely into the respective pre-tensioners that were fixed to the side of all the seats.

Photo 15 shows the rear seats of the Motor Car. All the seats of the Motor Car were secured via seat rails to the floorboard. They were also fitted with a retractable seat belt reel and a pre-tensioner. The seat belts (arrowed) were tested and were able to be fastened into the respective pre-tensions that were fitted on the side of each individual seat.

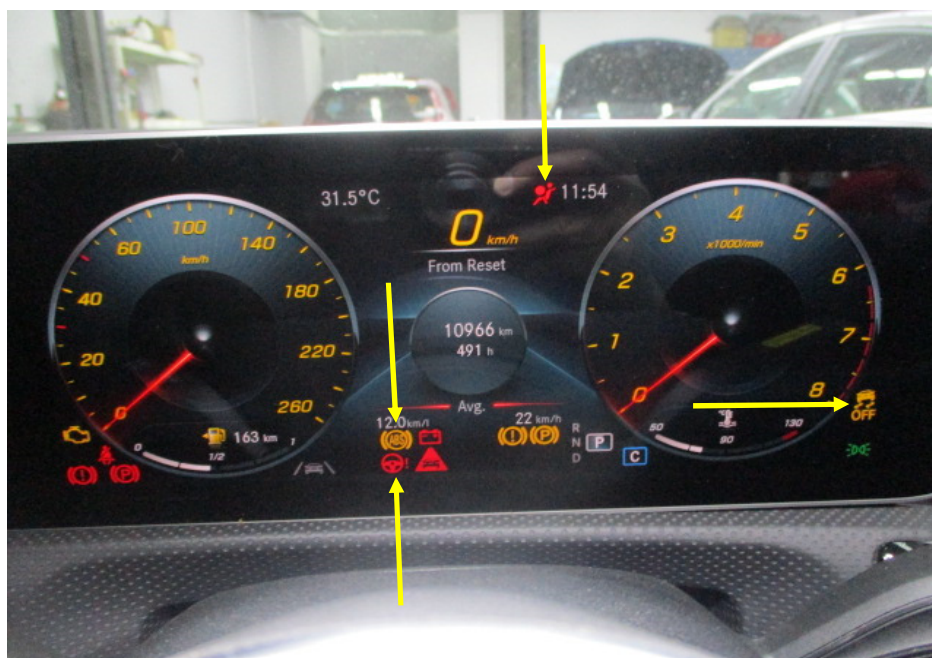
Photo 16 shows the warning lights for the various electronic safety features appearing on the instrument panel of the Motor Car during its self-test when the engine is cranked, in particular the ABS, SRS, EPS and TCS lights (arrowed).

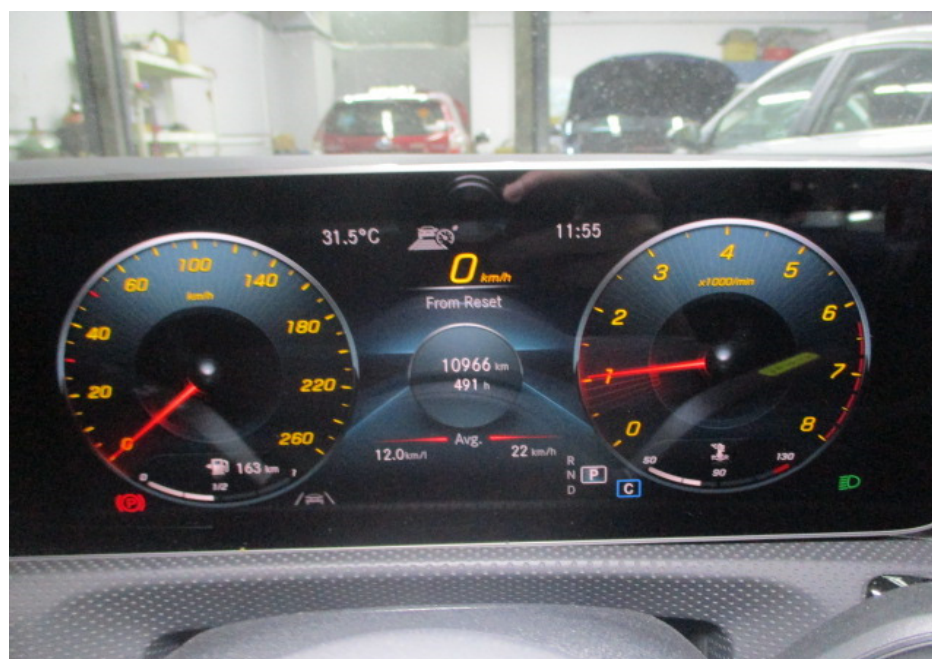
14. The Motor Car's automatic self-test of the functionality of its various electronic safety features like the Anti-Lock Brake System (ABS), Supplemental Restraint System (SRS), Electric Power Steering (EPS) and Traction Control System (TCS) during cranking of the engine had indicated that these electronic systems were in working condition. This was determined from the respective warning lights disappearing from the instrument panel after the self-test.

Photo 17 shows the respective warning lights no longer illuminated, indicating that there is no fault detected to the ABS, SRS, EPS and TCS systems of the Motor Car during the self-test. These electronic systems were hence in working condition at the time of my inspection.

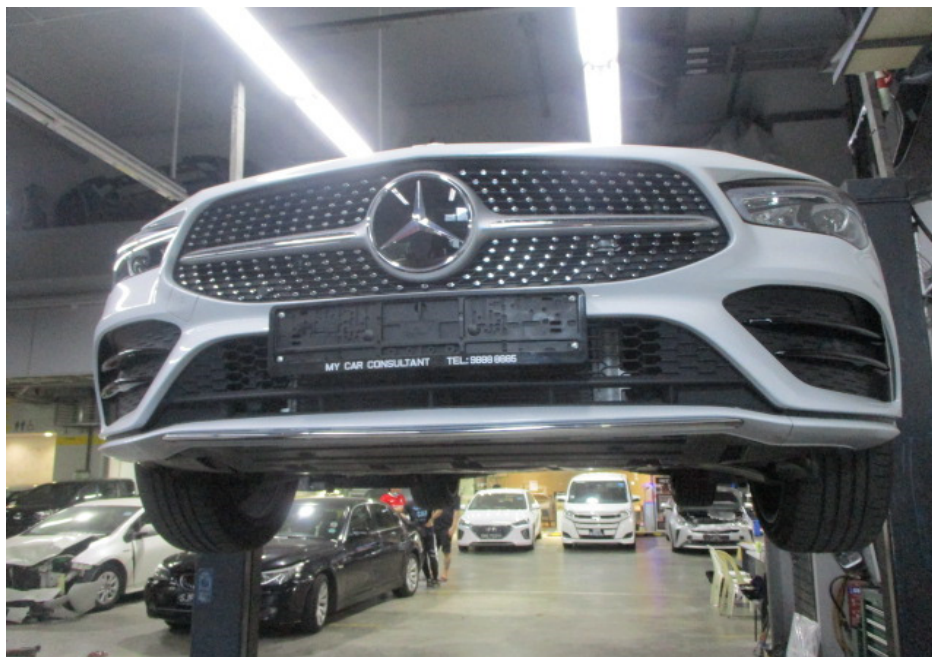
Photo 18 shows the Motor Car hoisted up for checks on its undercarriage. There was no sign(s) or indication(s) of fluid leakage and/or fluid stain(s) on the underside of the Motor Car. The undercarriage components of the Motor Car were also all observed to be intact and secured in an appropriate manner.

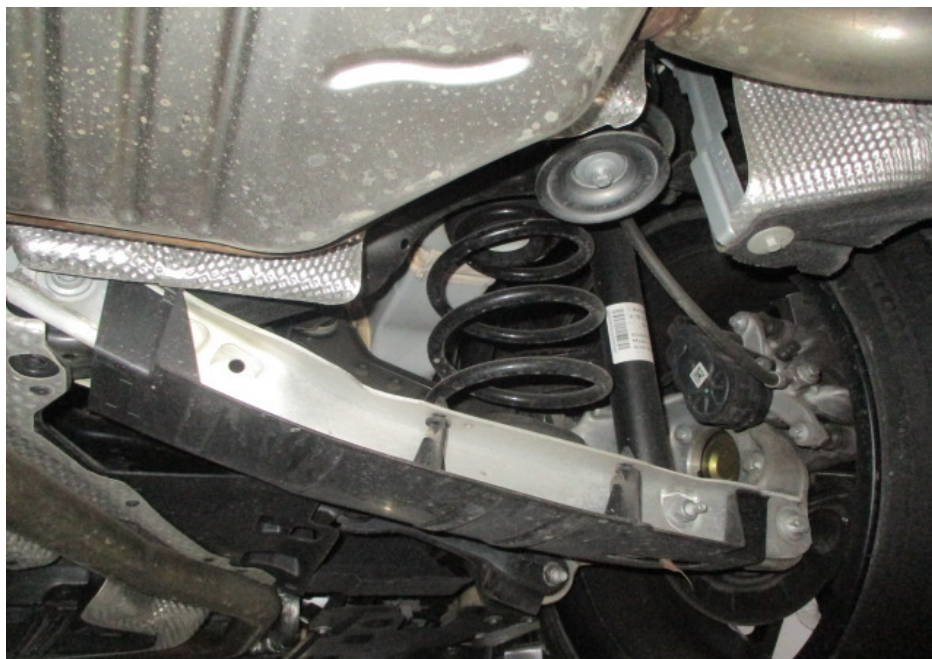
Photo 19 shows a general view of the control arms and linkages at the rear right wheel of the Motor Car. I did not observe any fluid leak and/or fluid stain on the underside of the Motor Car. All of the Motor Car's undercarriage components were observed to be intact and secured in an appropriate manner.

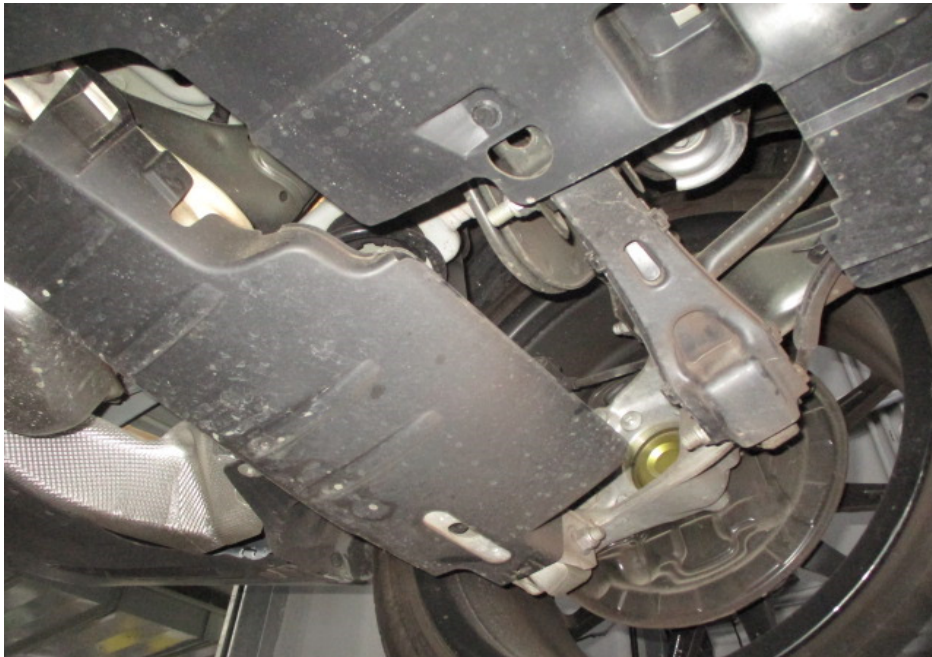
Photo 20 shows a general view of the control arms and linkages at the rear left wheel of the Motor Car. I did not observe any fluid leak and/or fluid stain on the underside of the Motor Car. All of the Motor Car's undercarriage components were observed to be intact and secured in an appropriate manner.

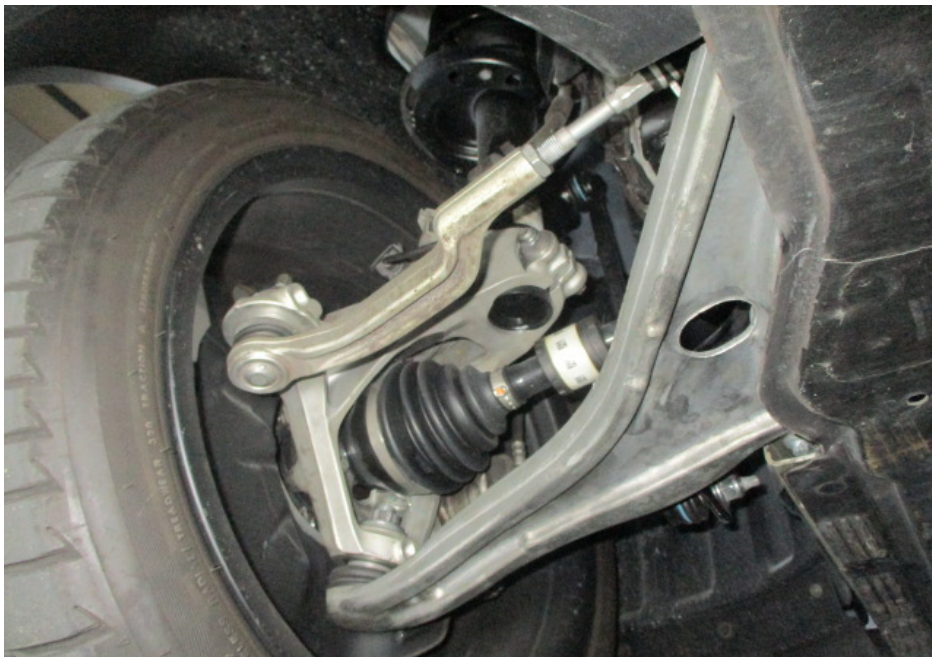
Photo 21 shows a general view of the control arms and linkages at the front left wheel of the Motor Car. I did not observe any fluid leak and/or fluid stain on the underside of the Motor Car. All of the Motor Car's undercarriage components were observed to be intact and secured in an appropriate manner.

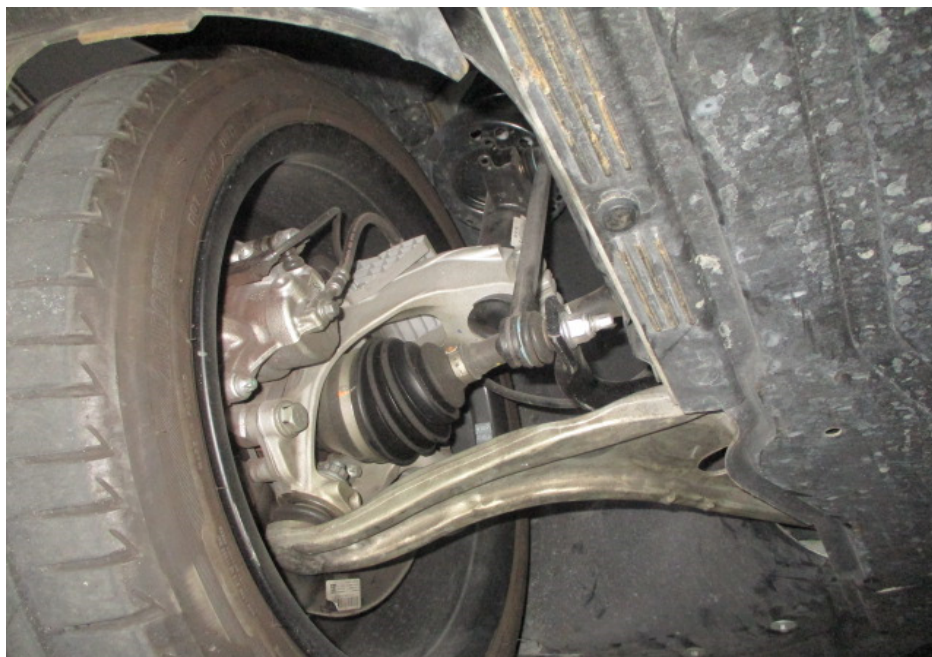
Photo 22 shows the various undercarriage components at the front right wheel of the Motor Car. The mechanical components, control arms and linkages were all found to be intact and secured in an appropriate manner. I also did not observe any fluid leak and/or fluid stain on the underside of the Motor Car.

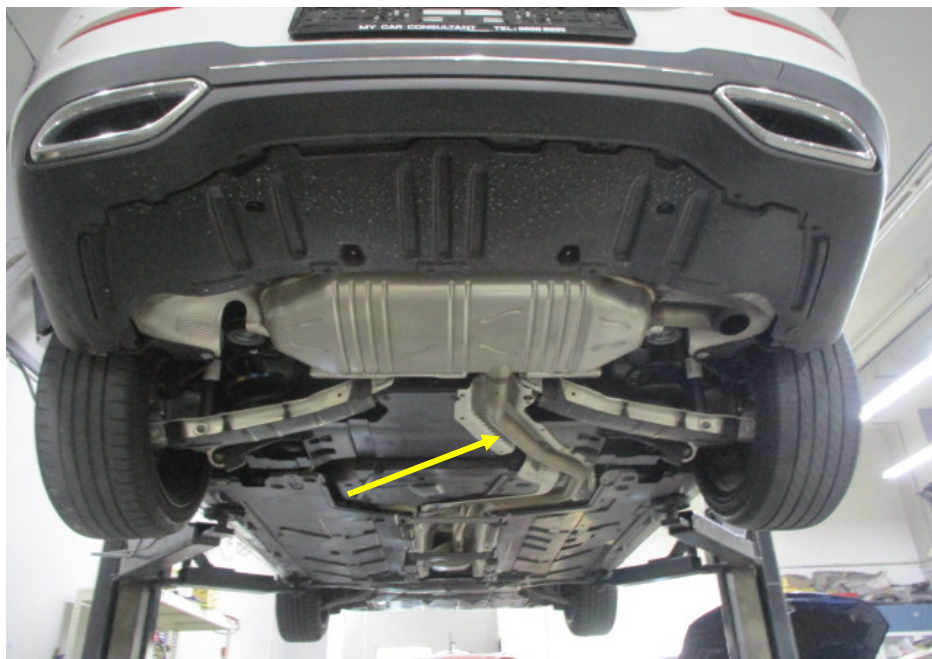
Photo 23 shows the rear section of the Motor Car's exhaust system. My examination of the Motor Car's exhaust system revealed no sign(s) or indication(s) of any cut or weld marks along its exhaust pipes (arrowed), on its rear muffler, on its centre resonator box and on its catalytic converter.

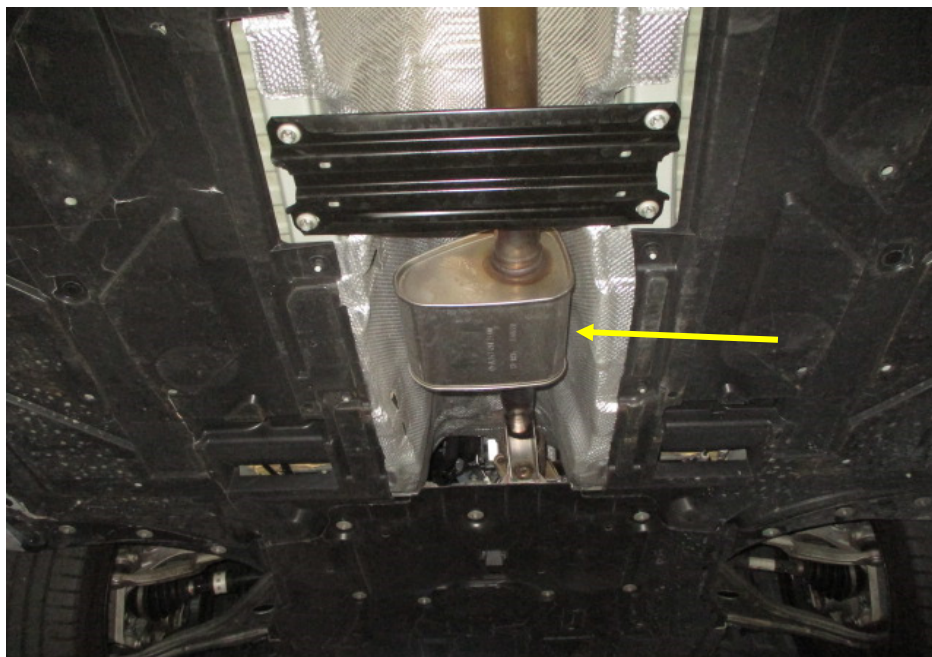
Photo 24 shows the front section of the Motor Car's exhaust system. My examination of the Motor Car's exhaust system revealed no sign(s) or indication(s) of any cut or weld marks along its exhaust pipes, on its rear muffler, on its centre resonator box (arrowed) and on its catalytic converter.

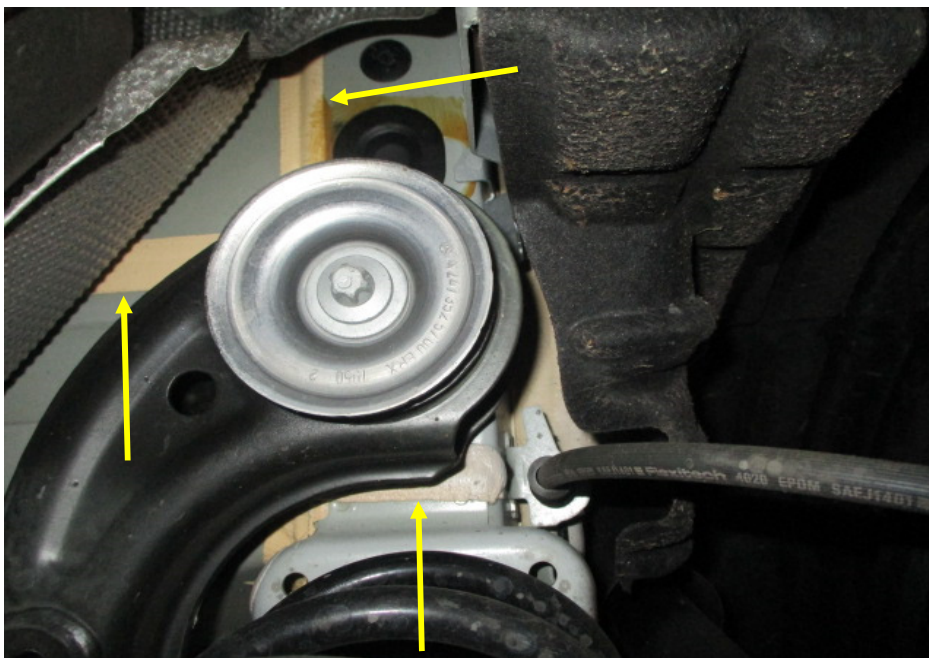
Photo 25 shows the chassis/structural body at the underside rear right of the Motor Car. I did not find any weld marks other than original spot weld marks on the chassis/structural body of the Motor Car. The original factory sealant (arrowed) at the joints along the chassis/structural body was also untouched, indicating no work was done on the chassis/structural body of the Motor Car and that the chassis/structural body was originally fitted.

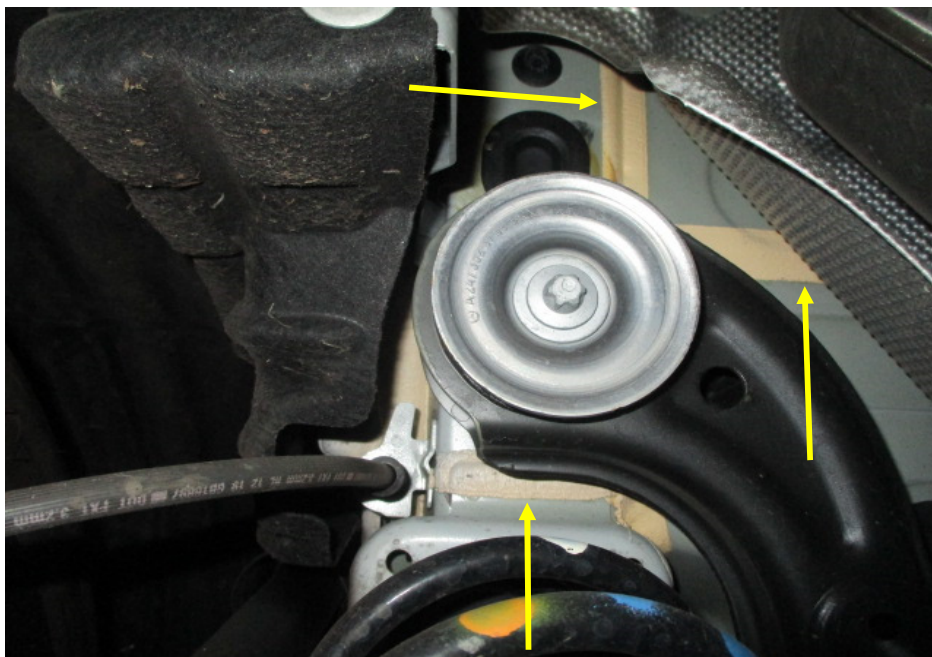
Photo 26 shows the chassis/structural body at the underside rear left of the Motor Car. The original factory sealant (arrowed) at the joints along the chassis/structural body was observed to be untouched. In general, I had found no work was carried out on the chassis/structural body of the Motor Car. The chassis/structural body of the Motor Car was originally fitted.

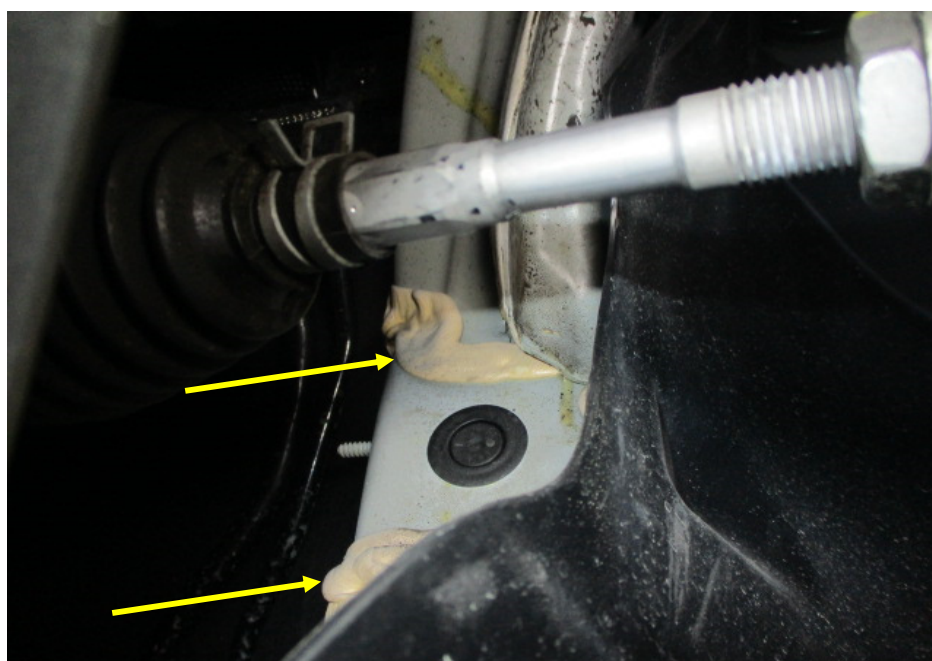
Photo 27 shows the chassis/structural body at the underside front left of the Motor Car. I did not find any weld marks other than original spot weld marks on the chassis/structural body of the Motor Car. The original factory sealant (arrowed) at the joints along the chassis/structural body was also untouched, indicating no work was done on the chassis/structural body of the Motor Car and that the chassis/structural body was originally fitted.

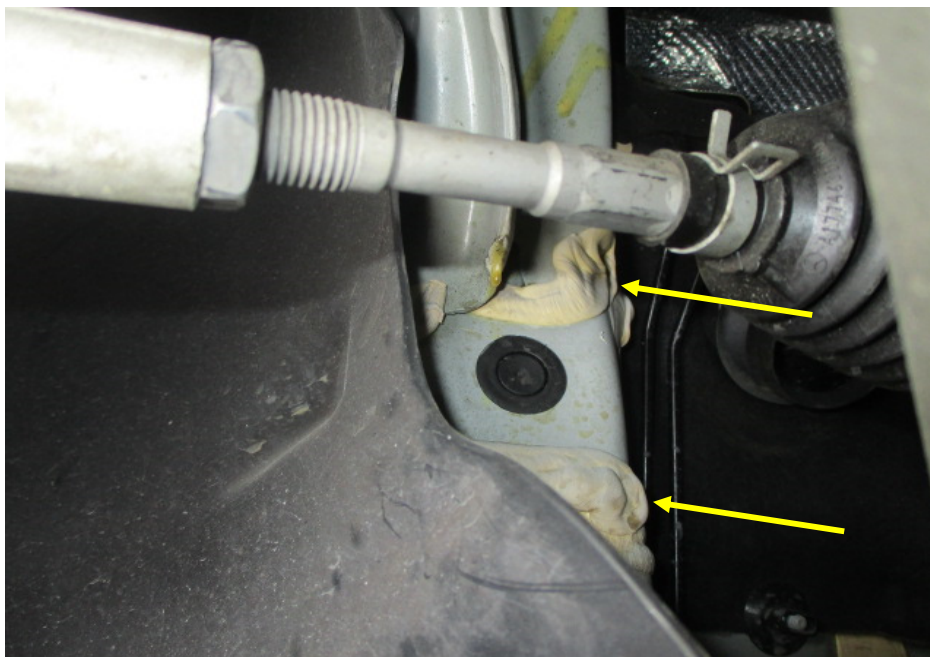
Photo 28 shows the chassis/structural body at the underside front right of the Motor Car. I did not find any weld marks other than original spot weld marks on the chassis/structural body of the Motor Car. The original factory sealant (arrowed) at the joints along the chassis/structural body was also untouched, indicating no work was done on the chassis/structural body of the Motor Car and that the chassis/structural body was originally fitted.

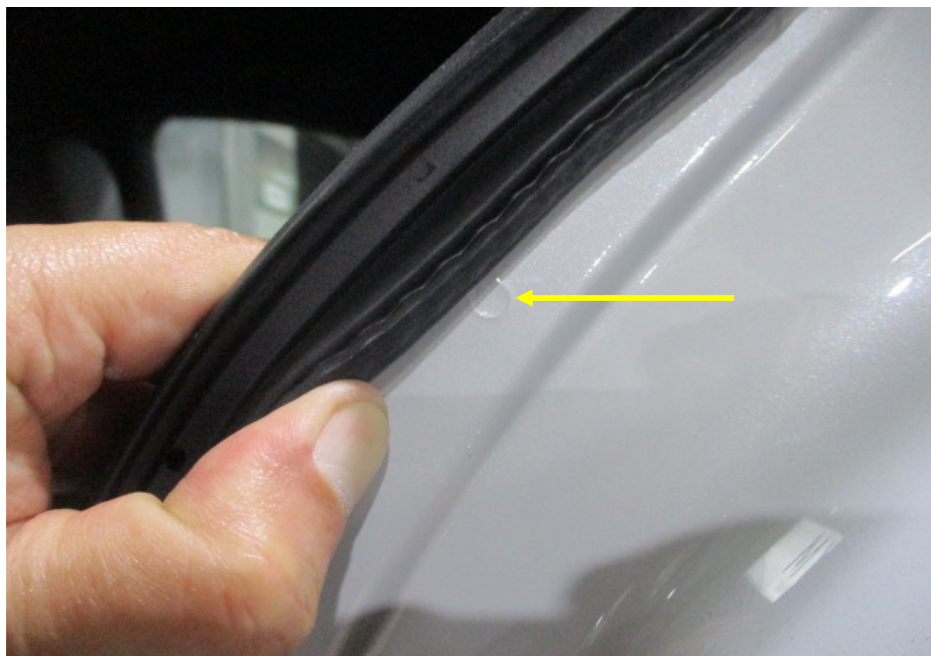
Photo 29 shows the left side "C" pillar of the Motor Car. I did not find any weld marks other than original spot weld marks (arrowed) on the left side "C" pillar of the Motor Car which, indicates that there was no re-welding works carried out. In general, I had found all the non-detachable body panels of the Motor Car to be originally fitted at the time of my inspection.
