Your Ref: Mercedes Benz CLA 180
(chassis number W1K1183842N117614)
Our Ref : CI/TP21012529/D

10 December 2021

**INSPECTION REPORT OF AN UNREGISTERED MERCEDES BENZ CLA 180
MOTOR CAR WITH CHASSIS NUMBER W1K1183842N117614**

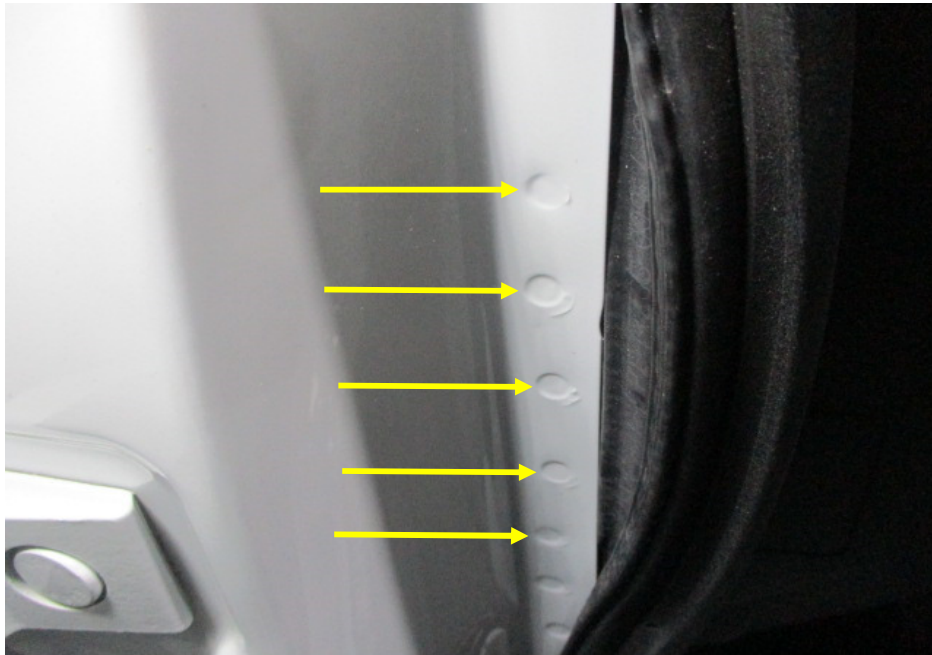
Photo 30 shows the left side "A" pillar of the Motor Car. I did not find any weld marks other than original spot weld marks (arrowed) on the left side "A" pillar of the Motor Car which, indicates that there was no re-welding works carried out. In general, I had found all the non-detachable body panels of the Motor Car to be originally fitted at the time of my inspection.
