Your Ref: Mercedes Benz E450 Coupe  
(chassis number WDD2383682F102579)

13 December 2021

Our Ref : CI/TP21012530/D

**INSPECTION REPORT OF AN UNREGISTERED MERCEDES BENZ E450  
COUPE MOTOR CAR WITH CHASSIS NUMBER WDD2383682F102579**

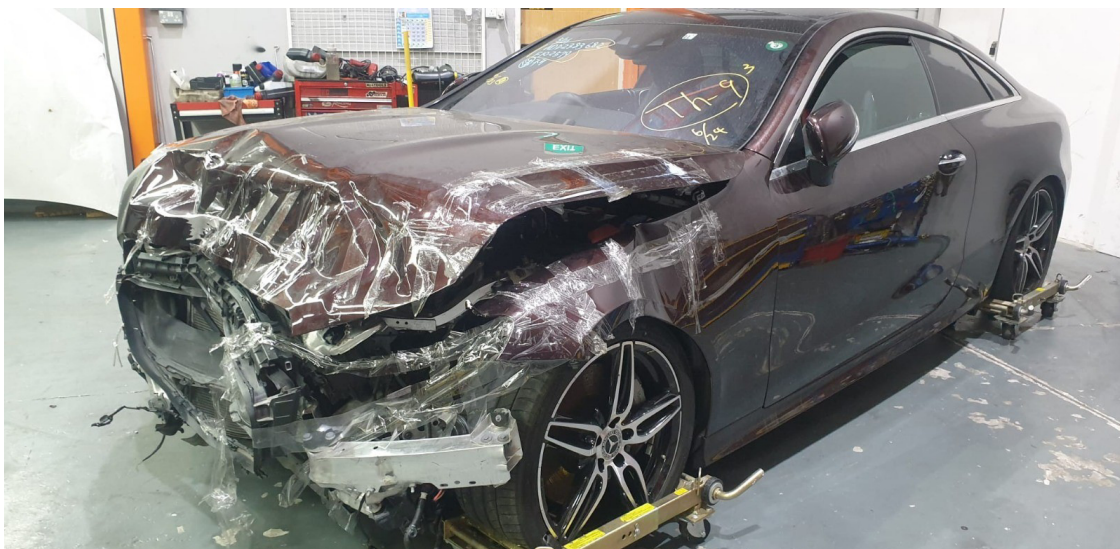
3. The photographs provided to me had showed damage to the Motor Car's frontal portion. Body parts damaged include the front bumper, front bumper under cover, front bumper lower chrome moulding, front bumper centre lower grille, front bumper sponge, front bumper reinforcement, front bumper left lower grille, front bumper right lower grille, front bumper sensors, radiator grille, front emblem, front bonnet, front bonnet locks, front bonnet hinges, front headlamps, front fenders, front support panel, front top air guide, front centre air guide, front left headlamp top panel, front right headlamp top panel, aircon condenser, radiator and cooling fan amongst others.

4. The photographs provided did not clearly show whether any airbag was deployed, however the extent of damage to the frontal portion of the Motor Car would suggest to me that either the driver airbag and/or the front left passenger airbag was possibly deployed.

**Photo 1** shows the front left body of the Motor Car (photograph provided to me). The Motor Car was observed to have sustained damage at its frontal portion. The front bumper, front bumper under cover, front bumper reinforcement, front bumper sponge, front bumper left lower grille, front bonnet, front bonnet left lock, front bonnet left hinge, front left headlamp, front left fender, front support panel, front left headlamp top panel, aircon condenser, radiator and cooling fan were amongst the body parts that were observed to have been damaged. The extent of damage to the frontal portion of the Motor Car would suggest to me that either the driver airbag and/or the front left passenger airbag was possibly deployed.

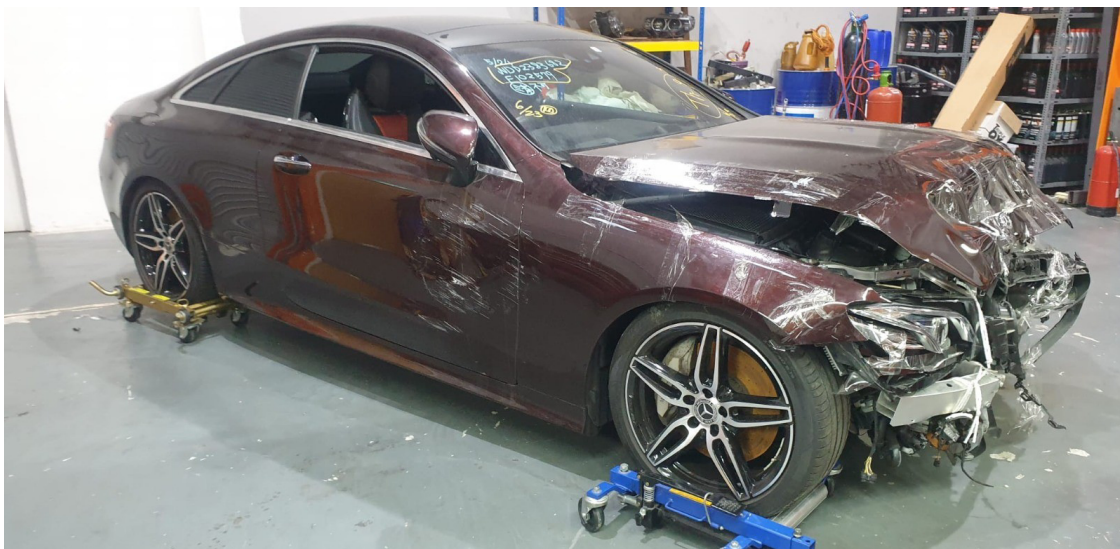
**Photo 2** shows the front right body of the Motor Car (photograph provided to me). The Motor Car was observed to have sustained damage at its frontal portion. The front bumper, front bumper reinforcement, front bumper sponge, front bumper right lower grille, radiator grille, front emblem, front bonnet, front bonnet right hinge, front right headlamp, front right fender, front right fender inner shield, front support panel, front right headlamp top panel, aircon condenser and radiator were amongst the body parts that were observed to have been damaged. The extent of damage to the frontal portion of the Motor Car would suggest to me that either the driver airbag and/or the front left passenger airbag was possibly deployed.

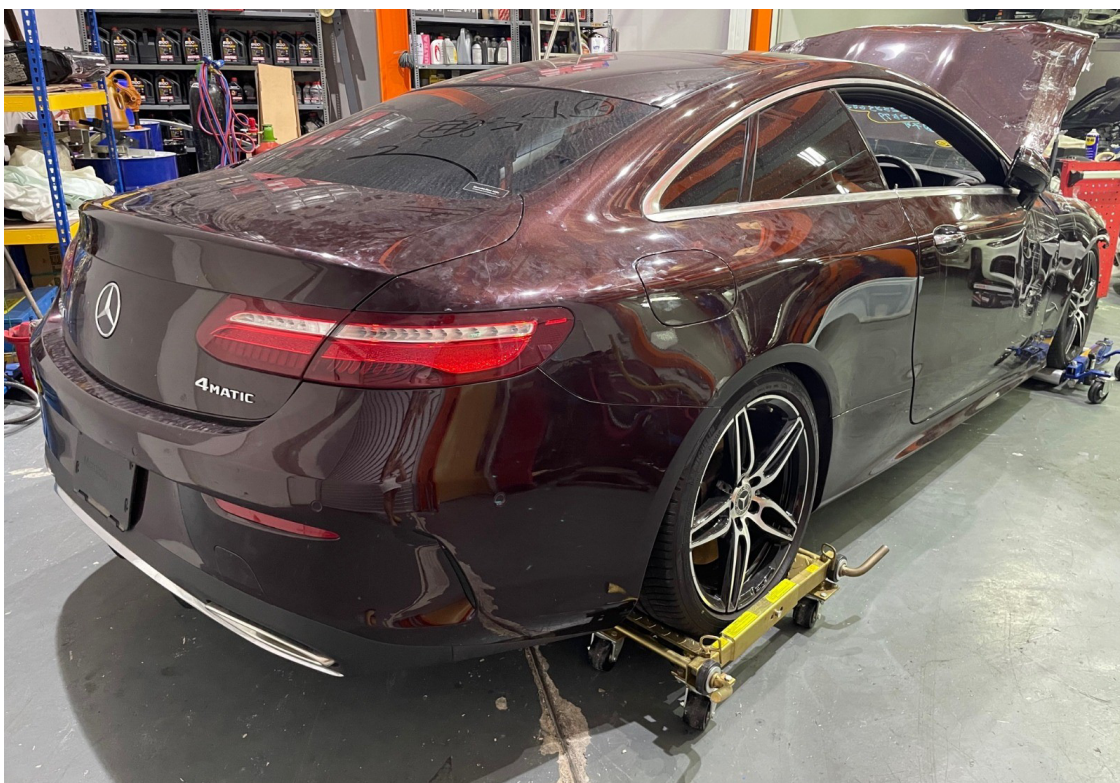
**Photo 3** shows the rear right body of the Motor Car (photograph provided to me). Apart for the frontal portion, there was no physical damage seen to other areas of the Motor Car.

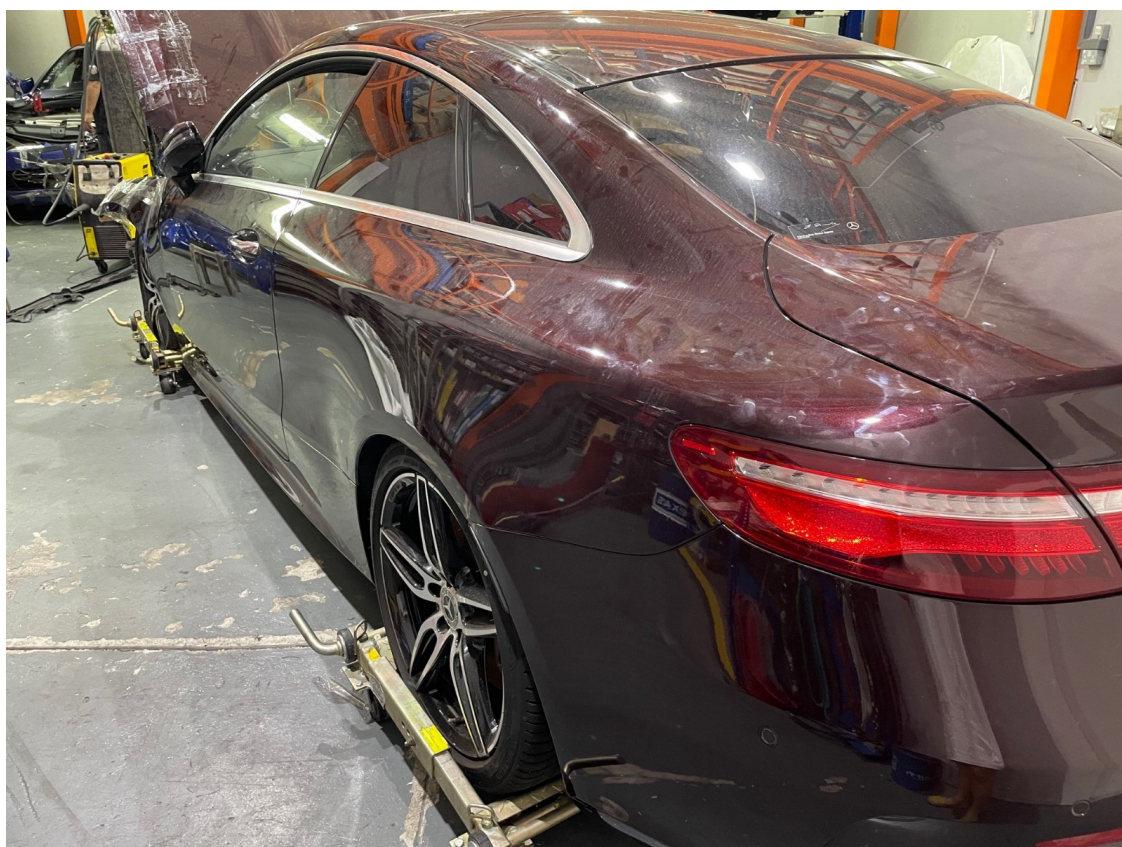
**Photo 4** shows the rear left body of the Motor Car (photograph provided to me). Apart for the frontal portion, there was no physical damage seen to other areas of the Motor Car.

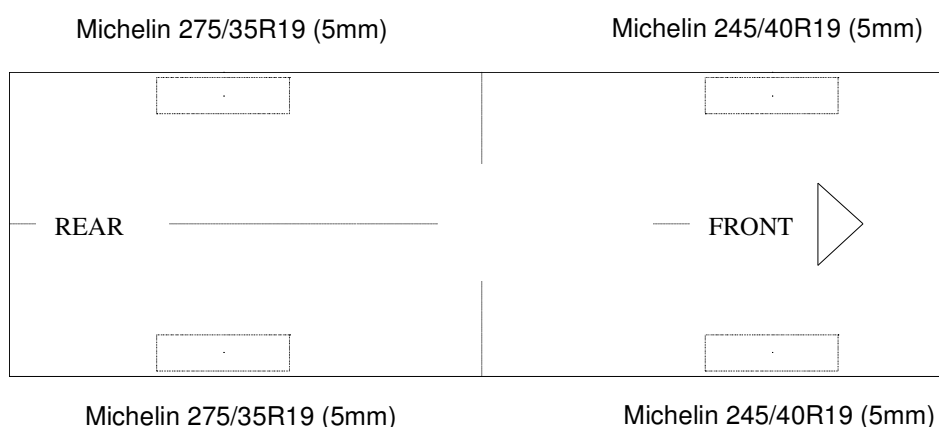
9. It was fitted with 19inch sport wheel rims that were wrapped with tyres that were observed to be of serviceable condition. The tyres were also sufficiently inflated for vehicular operation. The tyre brand, tyre size and approximate remaining tread depth of the 4 tyres of the Motor Car were recorded as follows: -

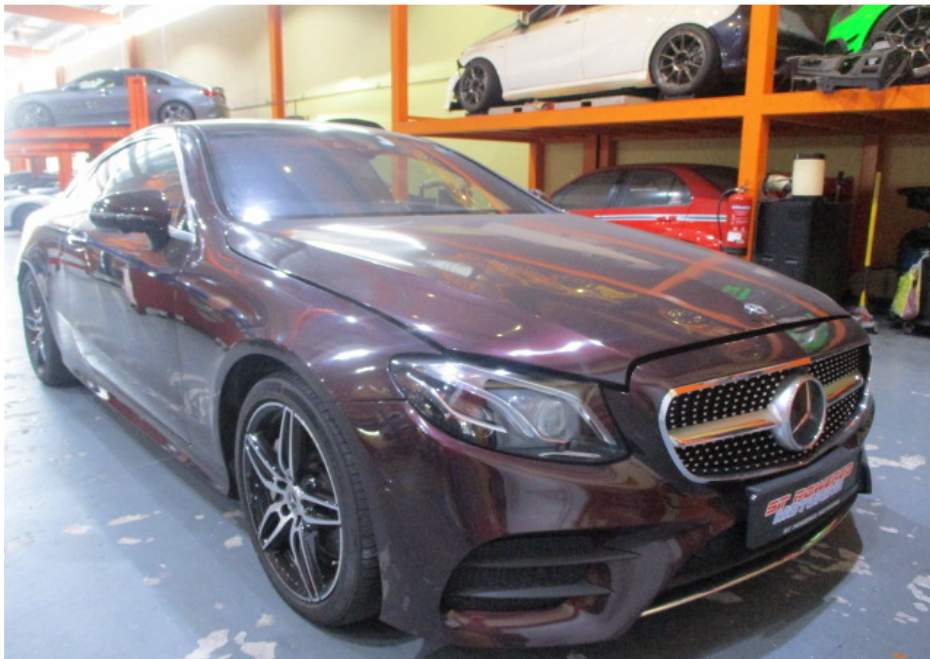
**Photo 5** shows a general view of the front right body of the Motor Car at the time of my inspection. The Motor Car was observed to be in a relatively good general condition with no loose exterior fittings observed. The body parts at the frontal portion of the Motor Car were visually examined and it was observed that the repair/restoration works carried out to the damaged area of the Motor Car (refer to photograph 1 & 2 above) were reasonably adequate and in order.

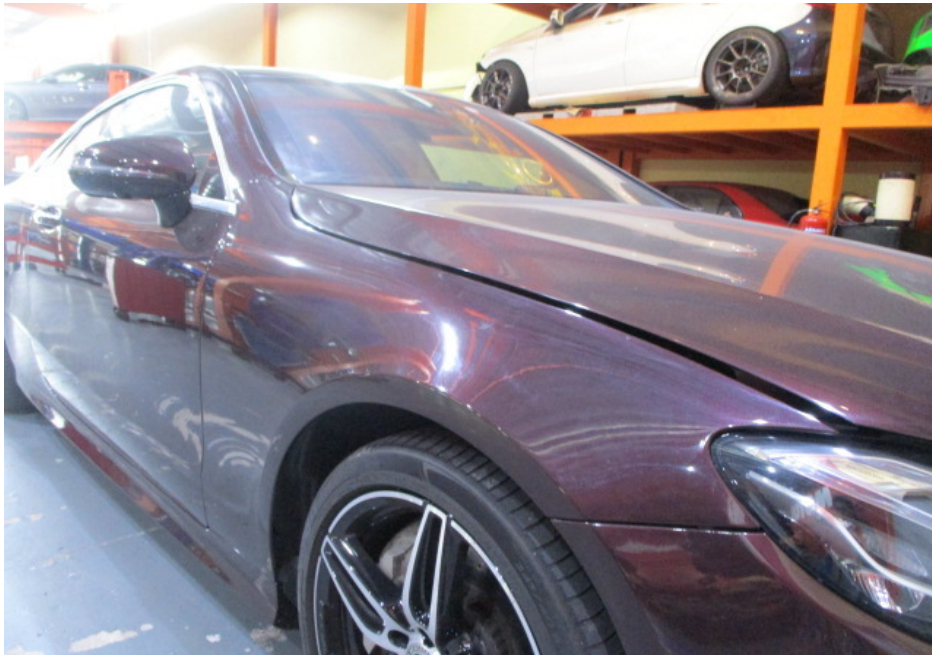
**Photo 6** shows a closer view of the Motor Car's front right headlamp, front right fender and front bonnet. The body parts at the frontal portion of the Motor Car were visually examined and it was observed that the repair/restoration works carried out to the damaged area of the Motor Car (refer to photograph 1 & 2 above) were reasonably adequate and in order.

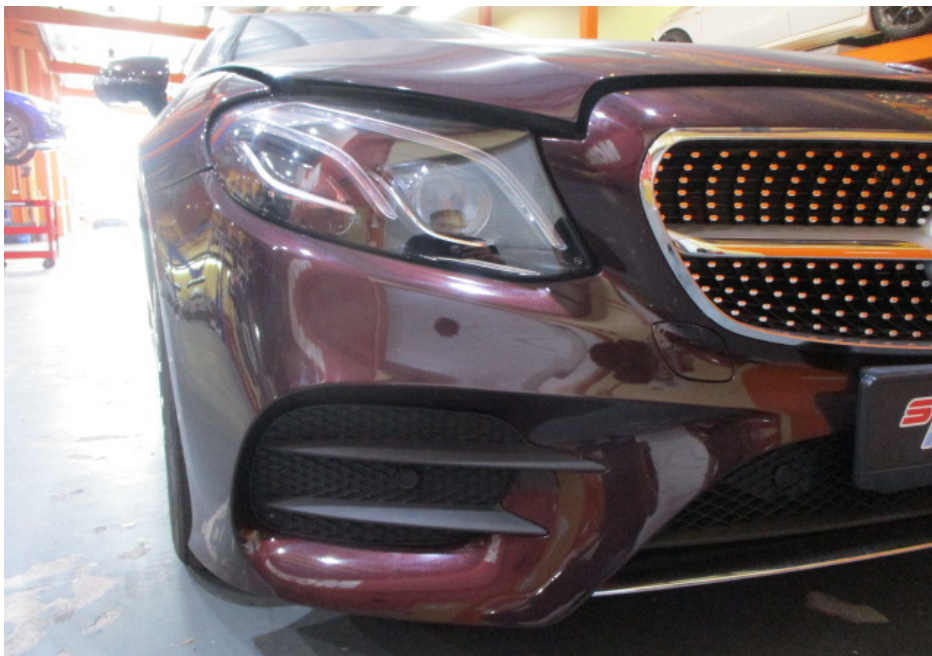
**Photo 7** shows a closer view of the Motor Car's front bumper, front bumper right lower grille, front bumper centre lower grille, front bumper lower chrome moulding and front right headlamp. The body parts at the frontal portion of the Motor Car were visually examined and it was observed that the repair/restoration works carried out to the damaged area of the Motor Car (refer to photograph 1 & 2 above) were reasonably adequate and in order.

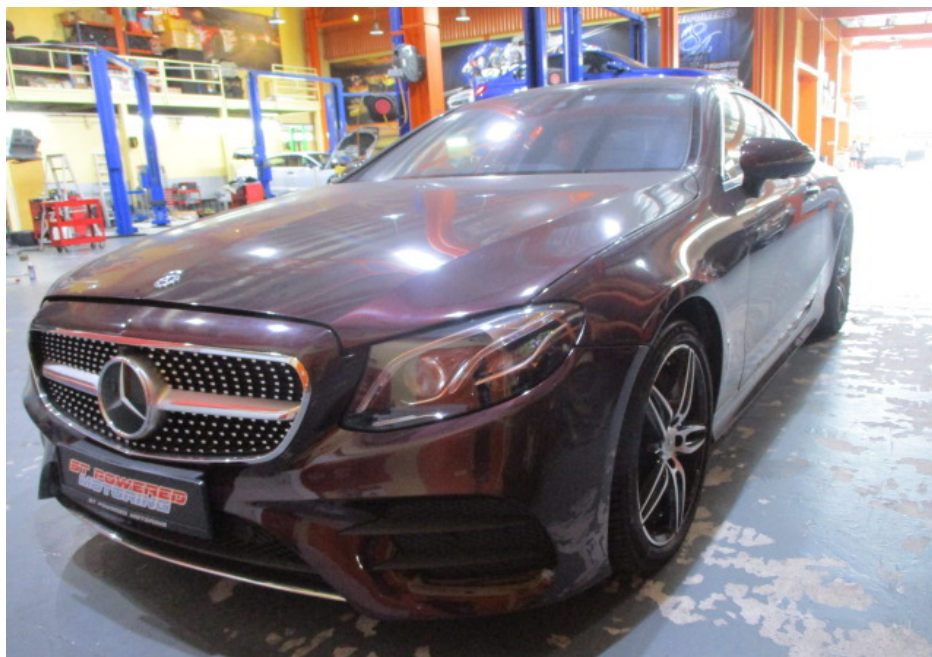
**Photo 8** shows a general view of the front left body of the Motor Car at the time of my inspection. The Motor Car was observed to be in a relatively good general condition with no loose exterior fittings observed. The body parts at the frontal portion of the Motor Car were visually examined and it was observed that the repair/restoration works carried out to the damaged area of the Motor Car (refer to photograph 1 & 2 above) were reasonably adequate and in order.

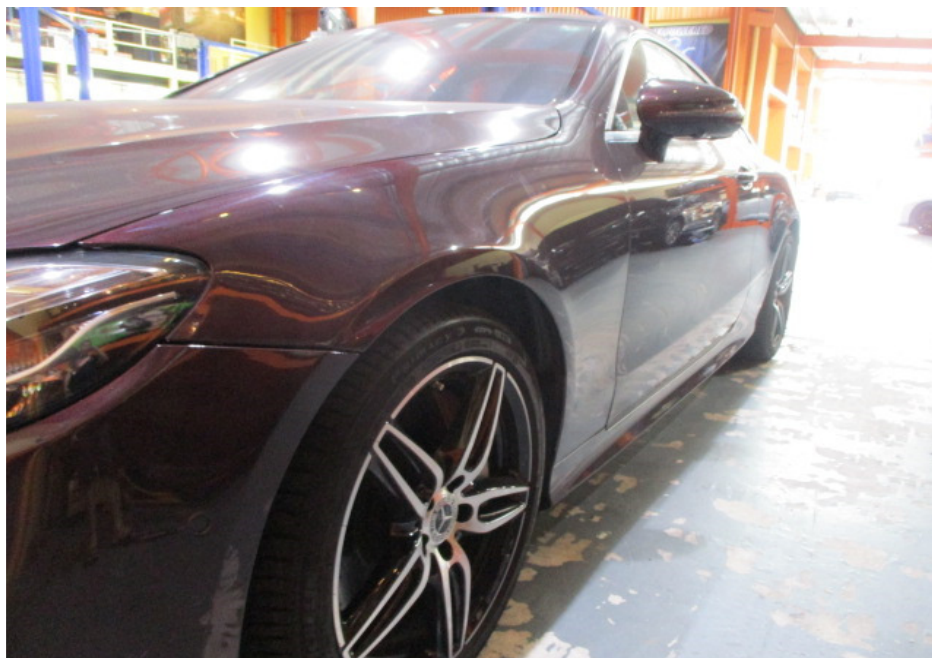
**Photo 9** shows a closer view of the Motor Car's front left fender and front bonnet. The body parts at the frontal portion of the Motor Car were visually examined and it was observed that the repair/restoration works carried out to the damaged area of the Motor Car (refer to photograph 1 & 2 above) were reasonably adequate and in order.

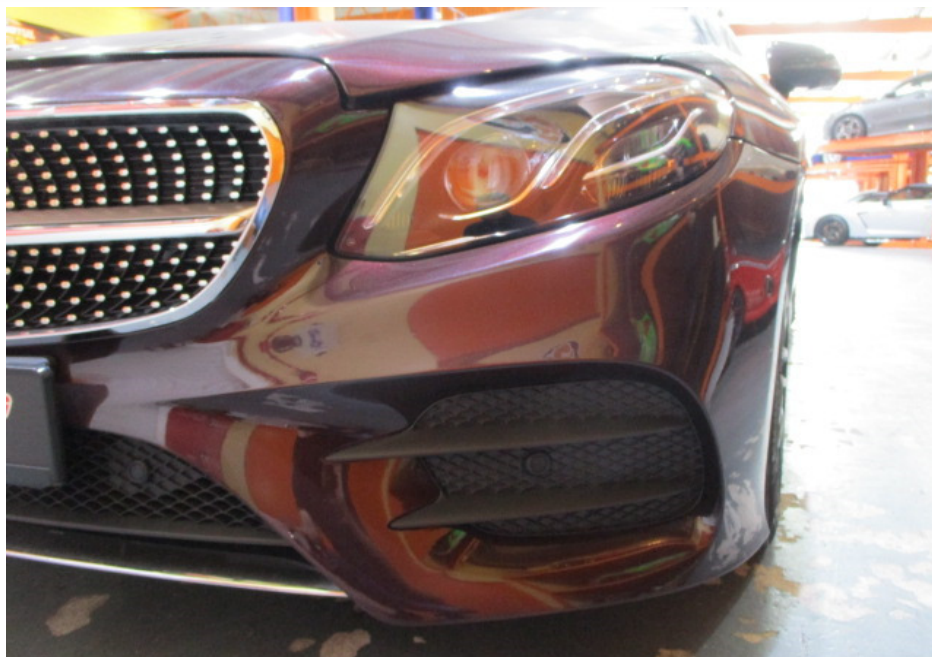
**Photo 10** shows a closer view of the Motor Car's front bumper, front bumper left lower grille and front left headlamp. The body parts at the frontal portion of the Motor Car were visually examined and it was observed that the repair/restoration works carried out to the damaged area of the Motor Car (refer to photograph 1 & 2 above) were reasonably adequate and in order.

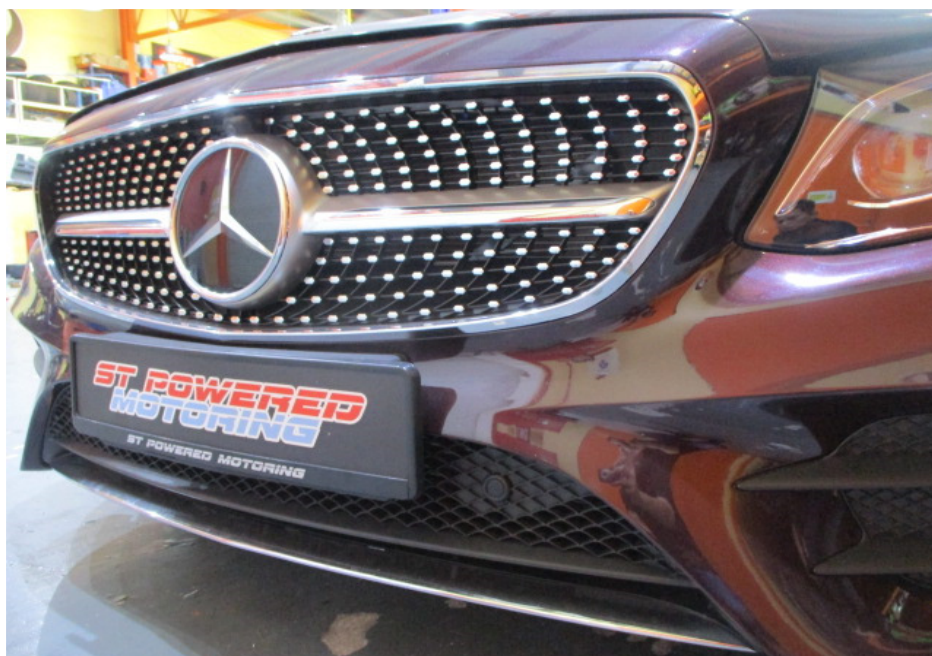
**Photo 11** shows a closer view of the Motor Car's front bumper, front bumper centre lower grille, front bumper lower chrome moulding, front emblem and radiator grille. The body parts at the frontal portion of the Motor Car were visually examined, and it was observed that the repair/restoration works carried out to the damaged area of the Motor Car (refer to photograph 1 & 2 above) were reasonably adequate and in order.

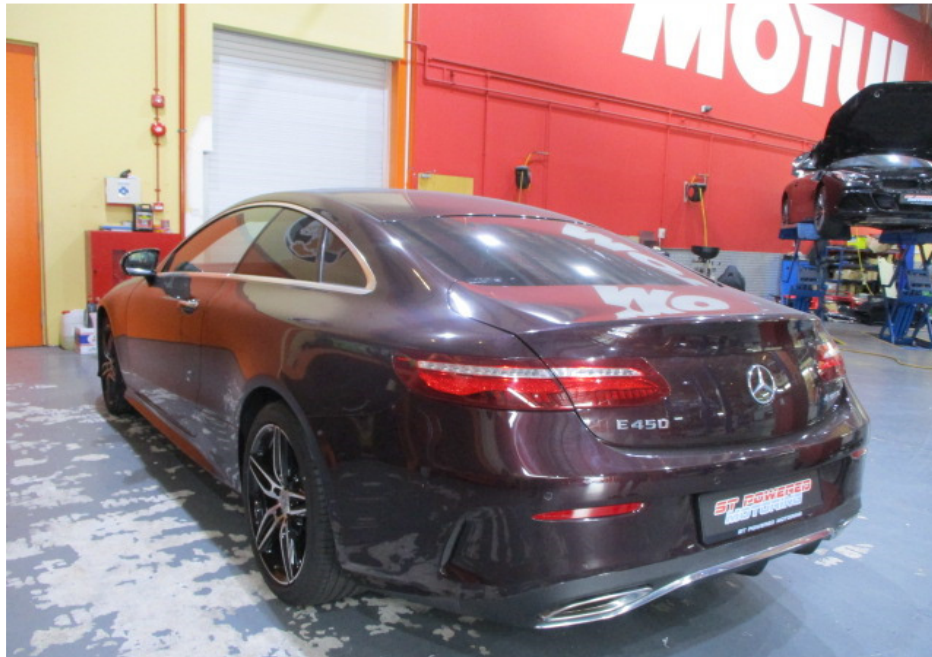
**Photo 12** shows a general view of the rear left body of the Motor Car at the time of my inspection. The Motor Car was observed to be in a relatively good general condition with no loose exterior fittings observed. The mileage of the Motor Car recorded at the time of my inspection was 13,218km.

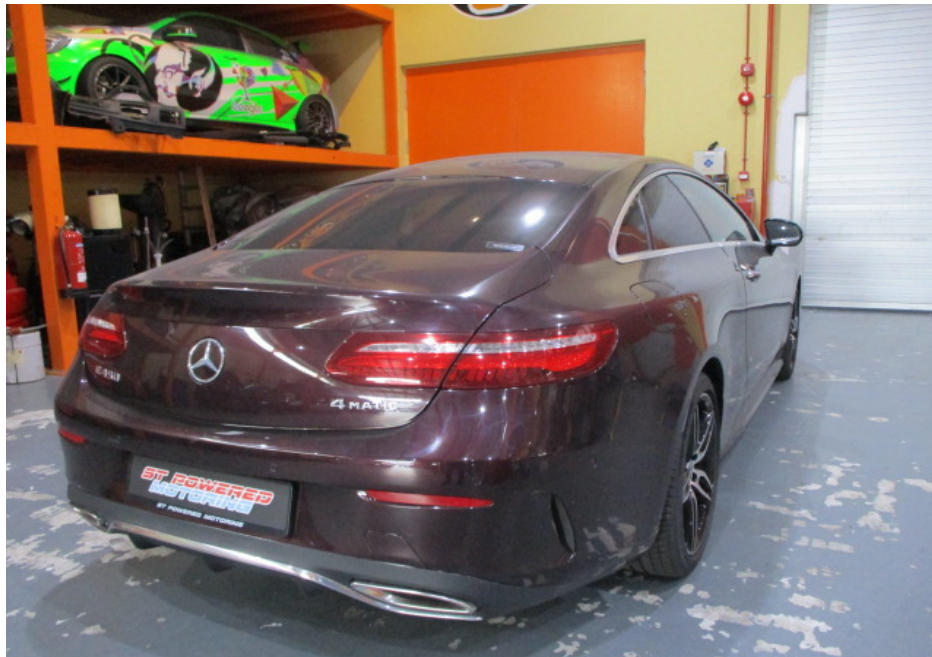
**Photo 13** shows a general view of the rear right body of the Motor Car at the time of my inspection. The Motor Car was observed to be in a relatively good general condition with no loose exterior fittings observed. The mileage of the Motor Car recorded at the time of my inspection was 13,218km.

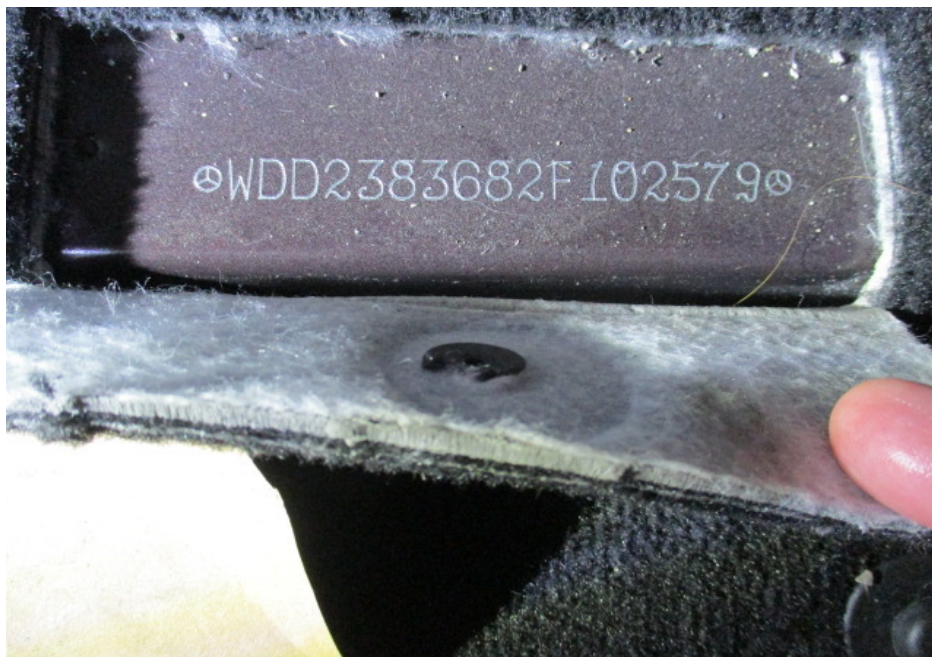
**Photo 14** shows the chassis number of the Motor Car. The chassis number recorded was WDD2383682F102579.

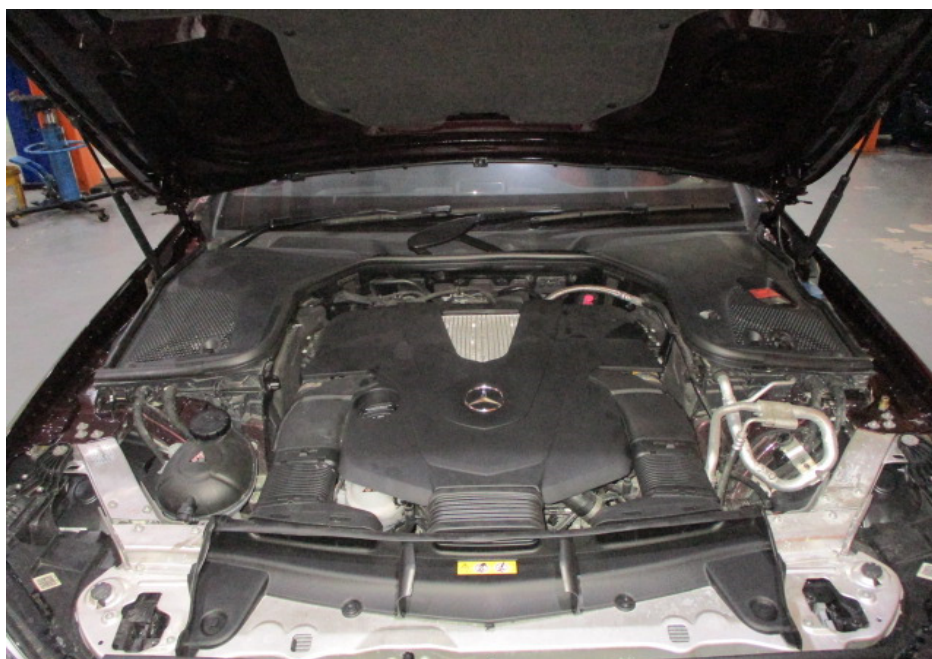
15. My examination of the engine compartment of the Motor Car revealed that the various parts and components inside the engine compartment were all intact and properly fitted. The engine oil, brake fluid and engine coolant were all found to be of sufficient level for operating purposes. Visually, there was also no contamination found to these fluids.
16. My checks on the underside of the Motor Car revealed no sign(s) or indication(s) of fluid leakage and/or fluid stain(s). The engine block and automatic transmission assembly were both secured properly. All undercarriage components of the Motor Car were also observed to be intact and secured in an appropriate manner.

**Photo 15** shows a general view of the engine compartment of the Motor Car at the time of my inspection. The various parts and components inside the engine compartment were all observed to be intact and properly fitted. There was also no sign(s) or indication(s) of fluid leak and/or fluid stain found inside the engine compartment. The repair/restoration works carried out to the various parts within the engine compartment like the front bonnet locks, front support panel, front top air guide, front left headlamp top panel, front right headlamp top panel, aircon condenser and radiator amongst others, were reasonably adequate and in order.

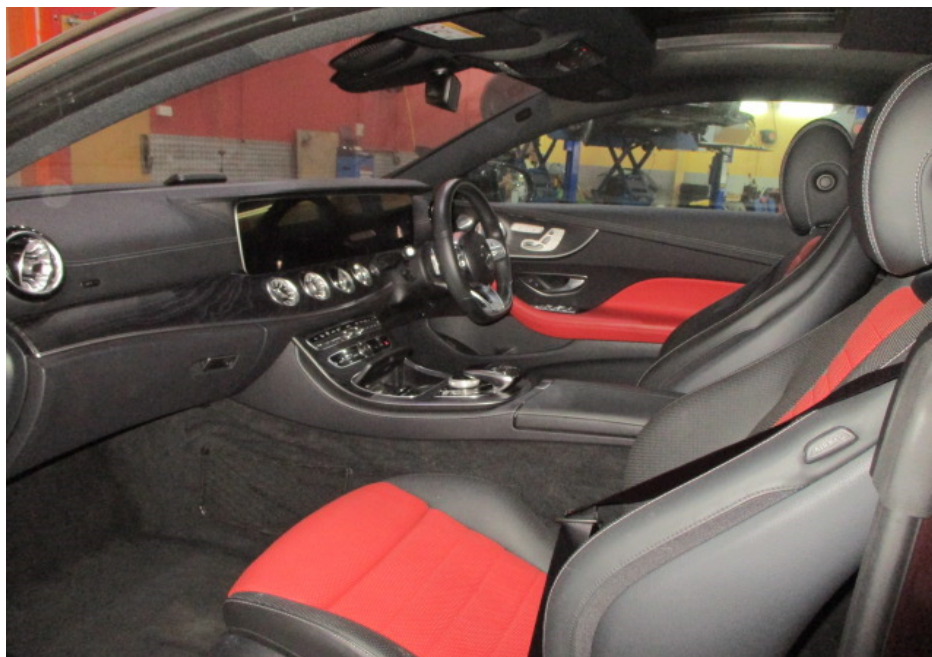
**Photo 16** shows the interior compartment of the Motor Car. The front dashboard, steering wheel, seats, upholstery and trims etc were all observed to be intact and properly fitted.

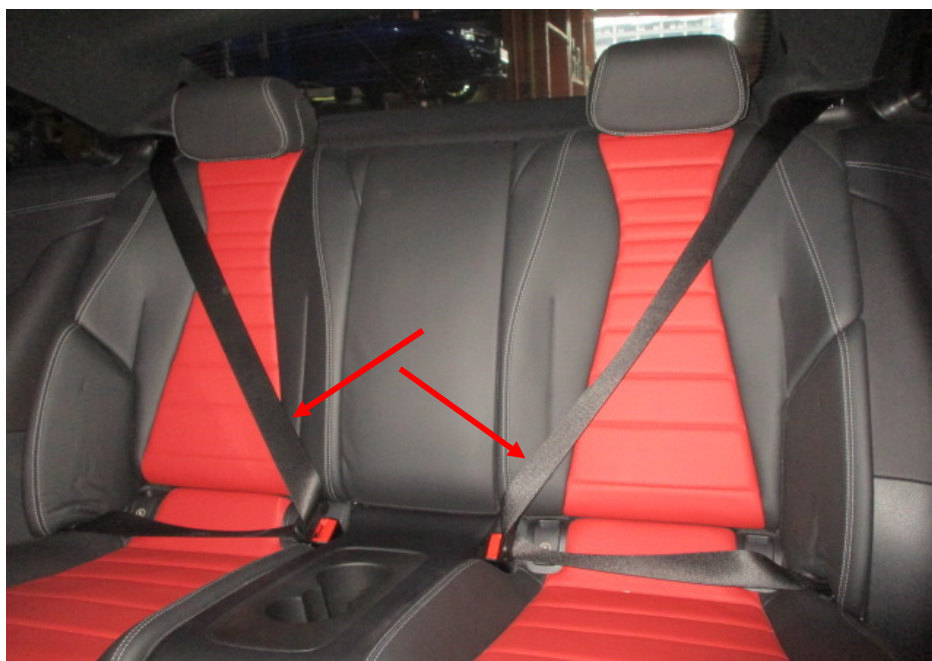
13. The seats of the Motor Car were found to be secured to the floorboard of the Motor Car via seat rails bolted onto the floorboard. Retractable seat belt reels and pre-tensioners were fitted on all seats of the Motor Car. The seat belts were tested and were able to be fastened securely into the respective pre-tensioners that were fixed to the side of all the seats.

**Photo 17** shows the rear seats of the Motor Car. All the seats of the Motor Car were secured via seat rails to the floorboard. They were also fitted with a retractable seat belt reel and a pre-tensioner. The seat belts (arrowed) were tested and were able to be fastened into the respective pre-tensions that were fitted on the side of each individual seat.

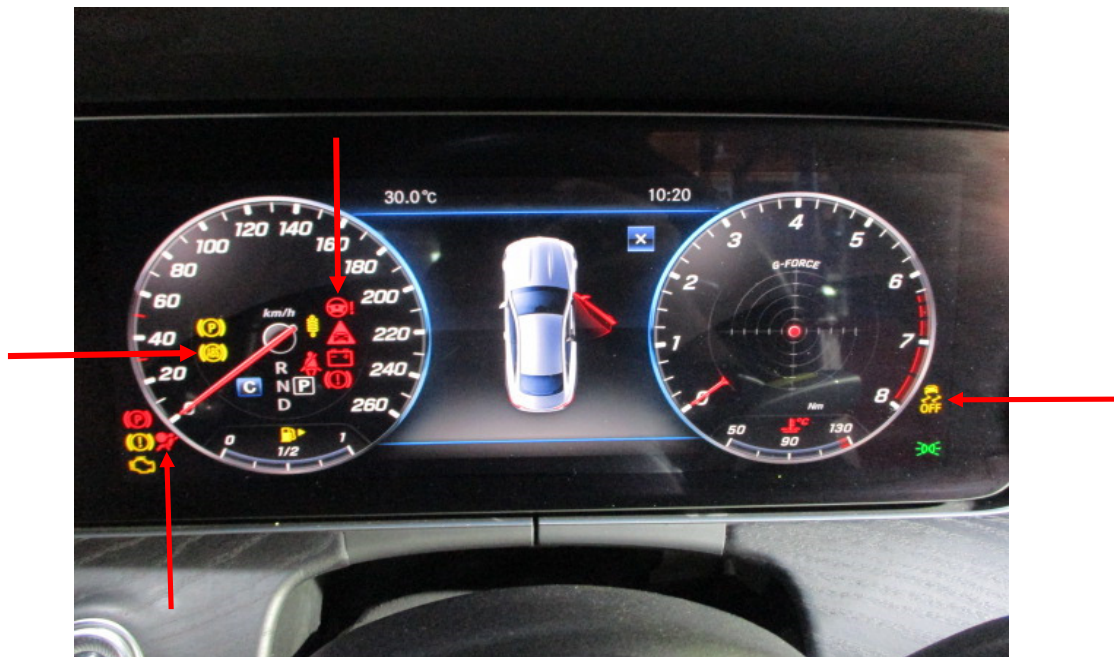
**Photo 18** shows the warning lights for the various electronic safety features appearing on the instrument panel of the Motor Car during its self-test when the engine is cranked, in particular the ABS, SRS, EPS and TCS lights (arrowed).

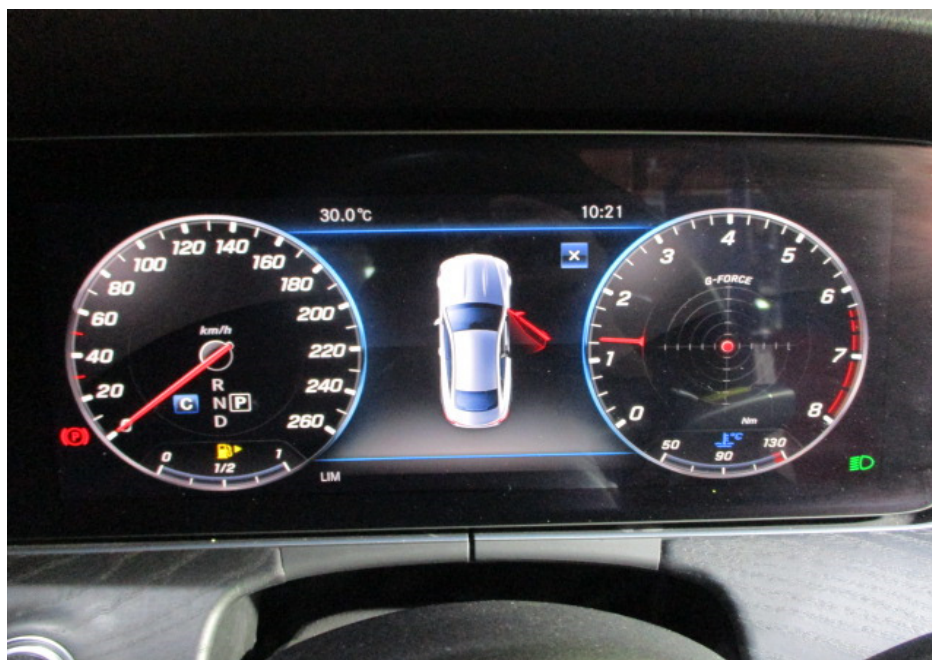
14. The Motor Car's automatic self-test of the functionality of its various electronic safety features like the Anti-Lock Brake System (ABS), Supplemental Restraint System (SRS), Electric Power Steering (EPS) and Traction Control System (TCS) during cranking of the engine had indicated that these electronic systems were in working condition. This was determined from the respective warning lights disappearing from the instrument panel after the self-test.

**Photo 19** shows the respective warning lights no longer illuminated, indicating that there is no fault detected to the ABS, SRS, EPS and TCS systems of the Motor Car during the self-test. These electronic systems were hence in working condition at the time of my inspection.

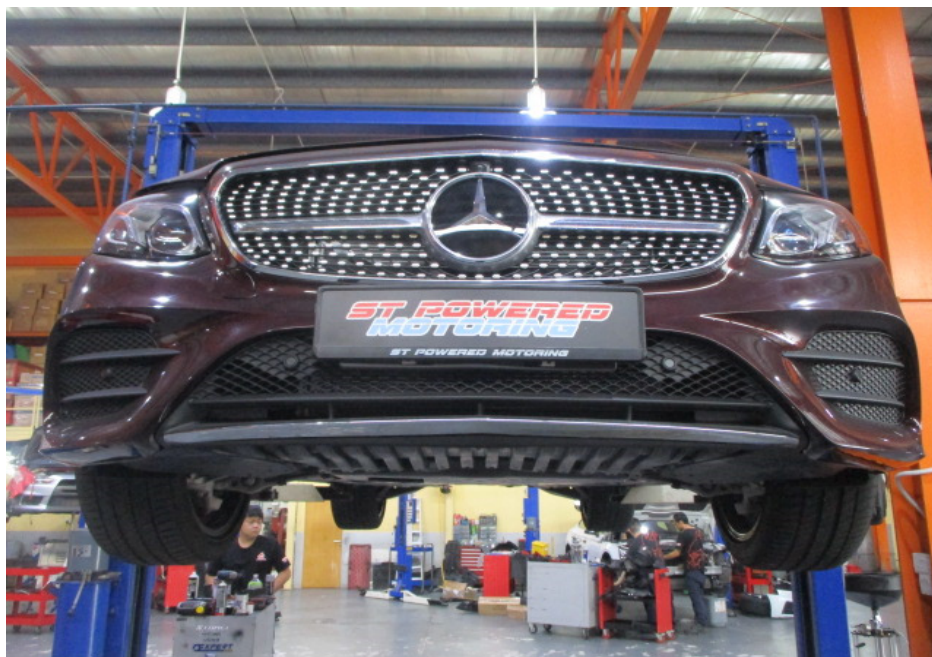
**Photo 20** shows the Motor Car hoisted up for checks on its undercarriage. There was no sign(s) or indication(s) of fluid leakage and/or fluid stain(s) on the underside of the Motor Car. The undercarriage components of the Motor Car were also all observed to be intact and secured in an appropriate manner.

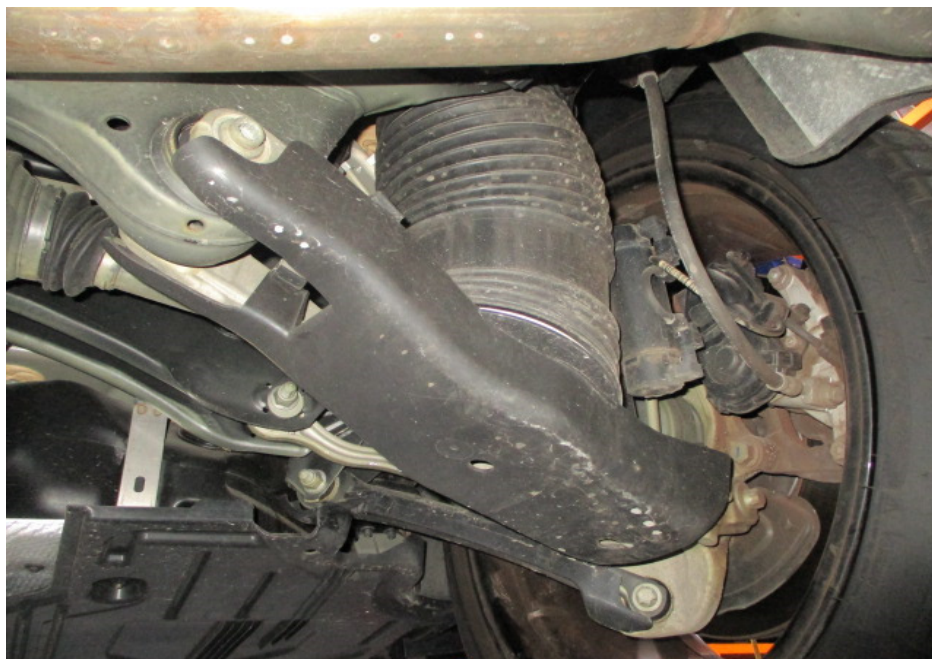
**Photo 21** shows a general view of the control arms and linkages at the rear right wheel of the Motor Car. I did not observe any fluid leak and/or fluid stain on the underside of the Motor Car. All of the Motor Car's undercarriage components were observed to be intact and secured in an appropriate manner.

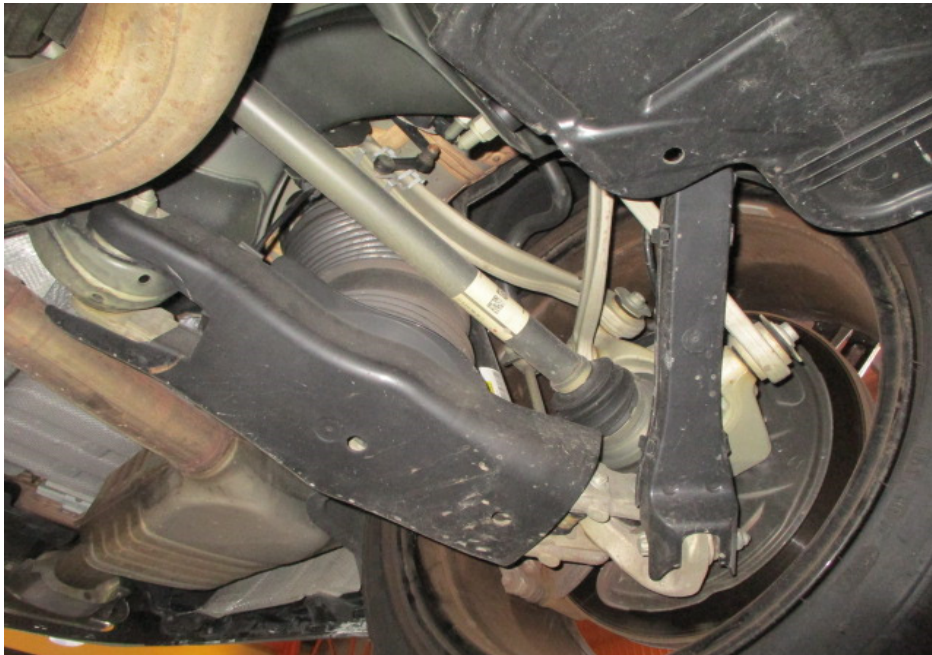
**Photo 22** shows a general view of the control arms and linkages at the rear left wheel of the Motor Car. I did not observe any fluid leak and/or fluid stain on the underside of the Motor Car. All of the Motor Car's undercarriage components were observed to be intact and secured in an appropriate manner.

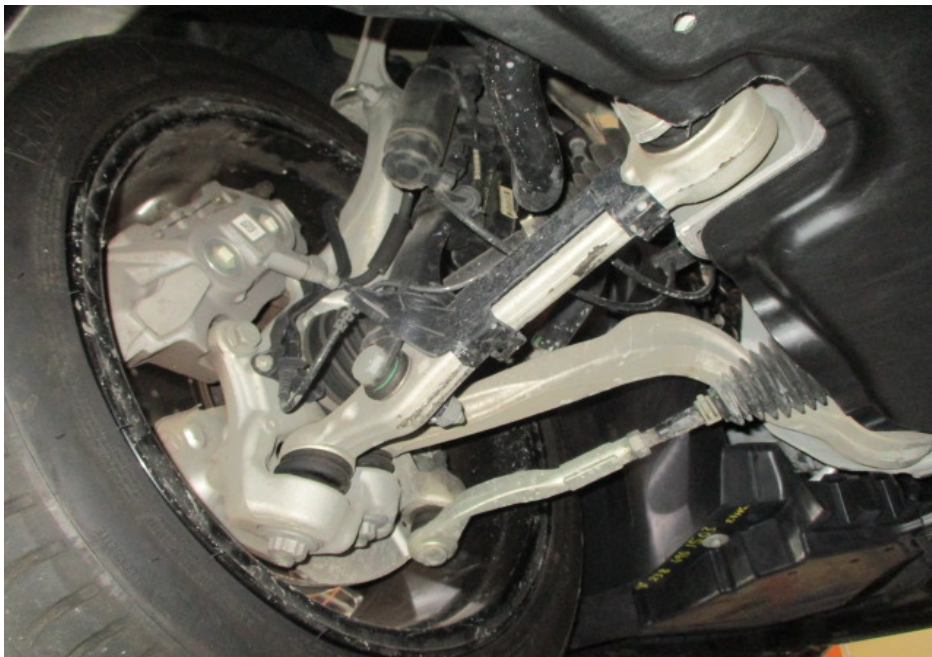
**Photo 23** shows the various undercarriage components at the front left wheel of the Motor Car. The mechanical components, control arms and linkages were all found to be intact and secured in an appropriate manner.

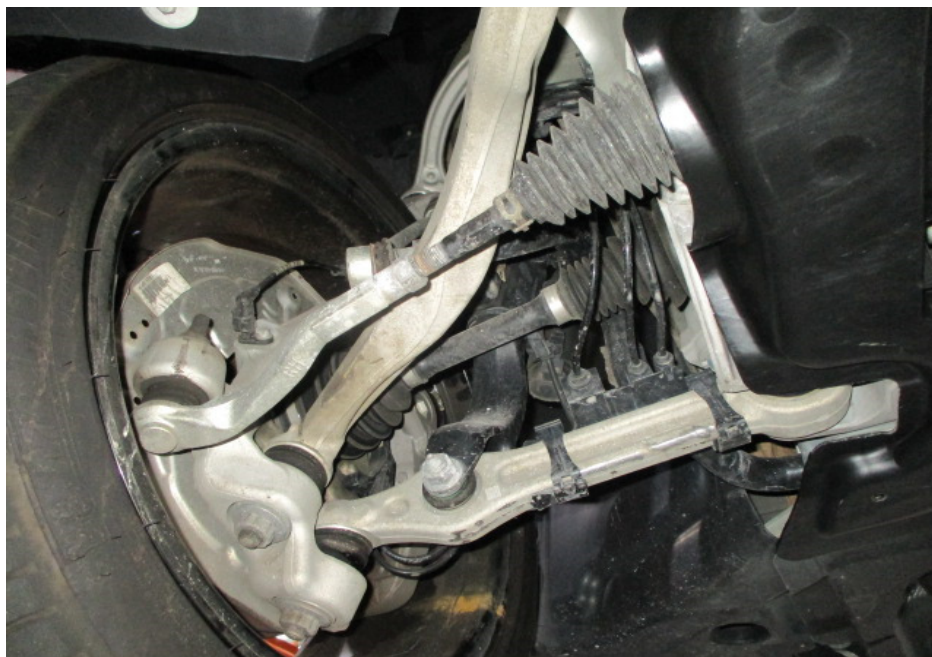
**Photo 24** shows the various undercarriage components at the front right wheel of the Motor Car. The mechanical components, control arms and linkages were all found to be intact and secured in an appropriate manner. I also did not observe any fluid leak and/or fluid stain on the underside of the Motor Car.

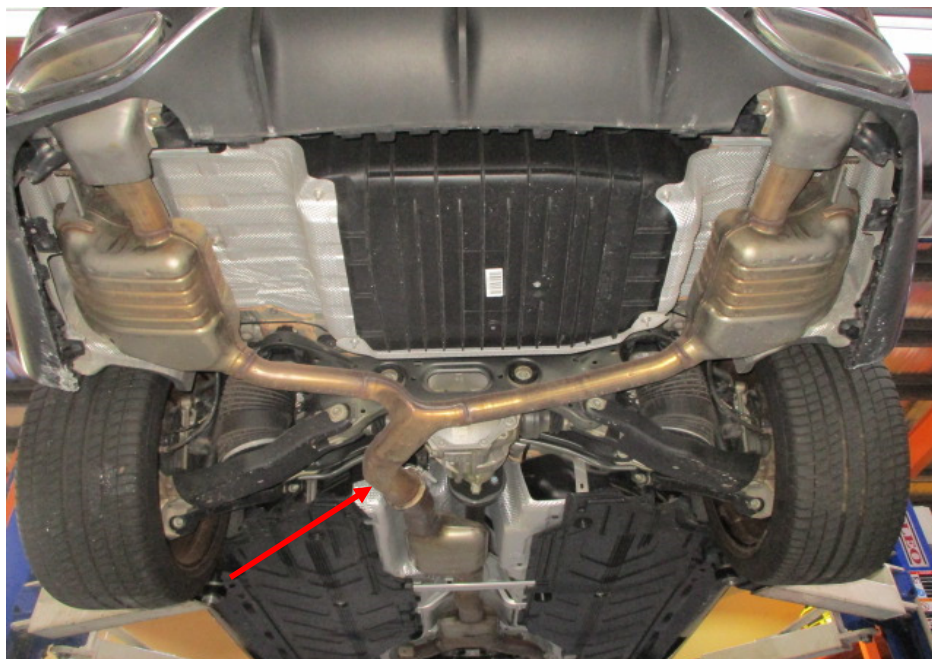
**Photo 25** shows the rear section of the Motor Car's exhaust system. My examination of the Motor Car's exhaust system revealed no sign(s) or indication(s) of any cut or weld marks along its exhaust pipes (arrowed), on its rear mufflers, on its centre resonator boxes and on its catalytic converters.

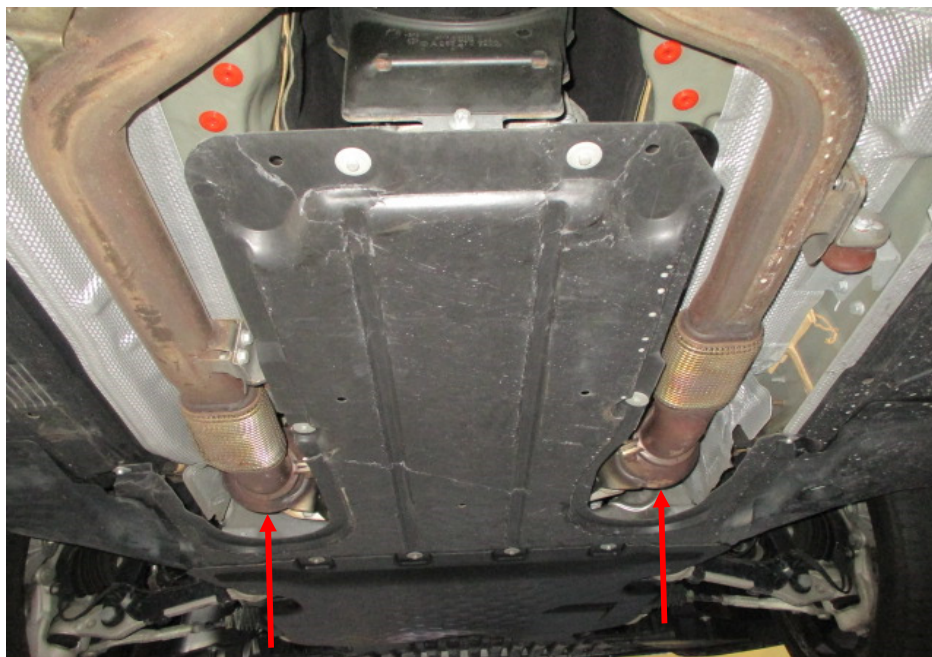
**Photo 26** shows the front section of the Motor Car's exhaust system. My examination of the Motor Car's exhaust system revealed no sign(s) or indication(s) of any cut or weld marks along its exhaust pipes, on its rear mufflers, on its centre resonator boxes and on its catalytic converters (arrowed).

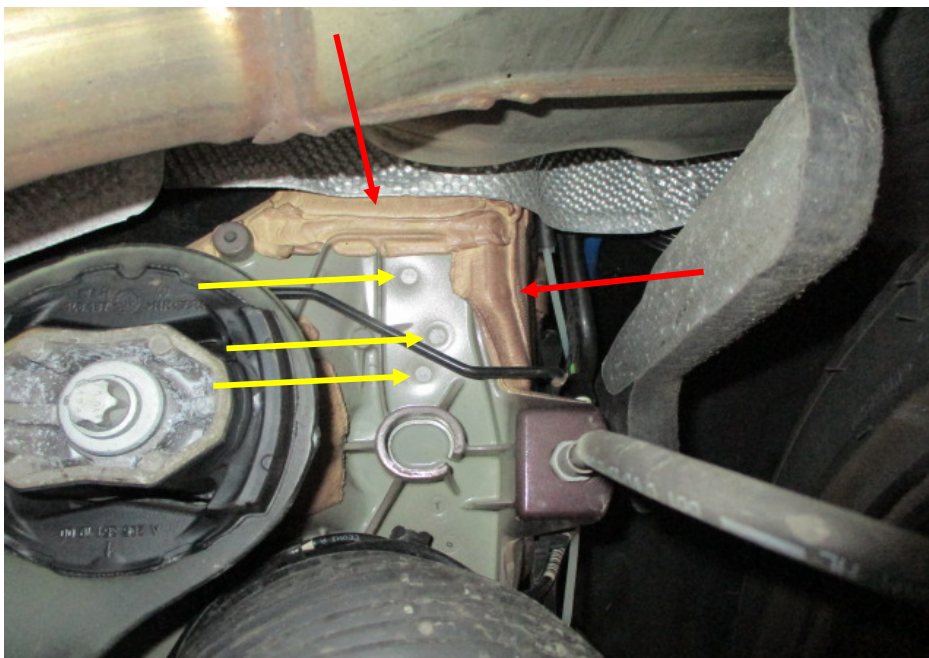
12. Visually, I did not find any weld marks, other than the original spot weld marks, on the chassis/structural body of the Motor Car. The original factory sealant at the joints along the chassis/structural body was also untouched, again indicating that no replacement of the chassis/structural body was carried out; and that the chassis/structural body was originally fitted.

**Photo 27** shows the chassis/structural body at the underside rear right of the Motor Car. I did not find any weld marks other than original spot weld marks (yellow arrow) on the chassis/structural body of the Motor Car. The original factory sealant (red arrow) at the joints along the chassis/structural body was also untouched, indicating no work was done on the chassis/structural body of the Motor Car and that the chassis/structural body was originally fitted.

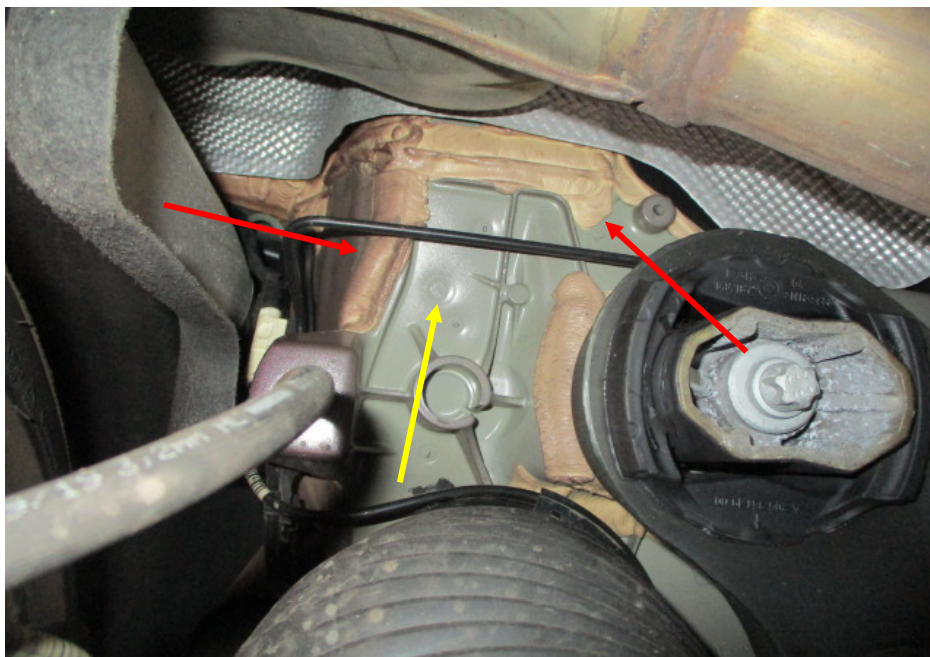
**Photo 28** shows the chassis/structural body at the underside rear left of the Motor Car. I did not find any weld marks other than original spot weld marks (yellow arrow) on the chassis/structural body of the Motor Car. The original factory sealant (red arrow) at the joints along the chassis/structural body was also untouched, indicating no work was done on the chassis/structural body of the Motor Car and that the chassis/structural body was originally fitted.

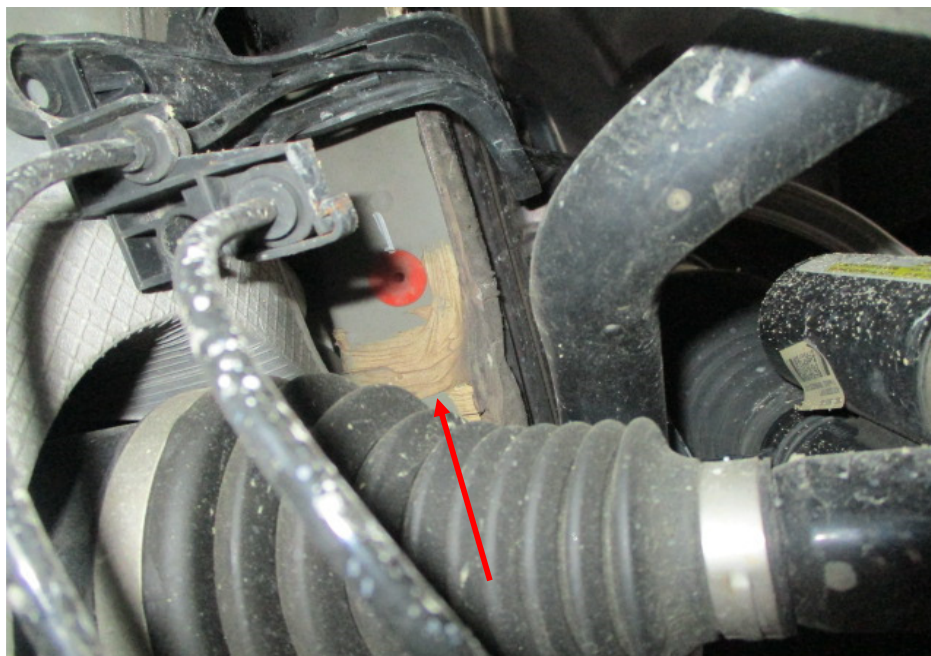
**Photo 29** shows the chassis/structural body at the underside front left of the Motor Car. The original factory sealant (arrowed) at the joints along the chassis/structural body was observed to be untouched. In general, I had found no work was carried out on the chassis/structural body of the Motor Car. The chassis/structural body of the Motor Car was originally fitted.
