Your Ref: Mercedes Benz E450 Coupe  
(chassis number WDD2383682F102579)

13 December 2021

Our Ref : CI/TP21012530/D

**INSPECTION REPORT OF AN UNREGISTERED MERCEDES BENZ E450  
COUPE MOTOR CAR WITH CHASSIS NUMBER WDD2383682F102579**

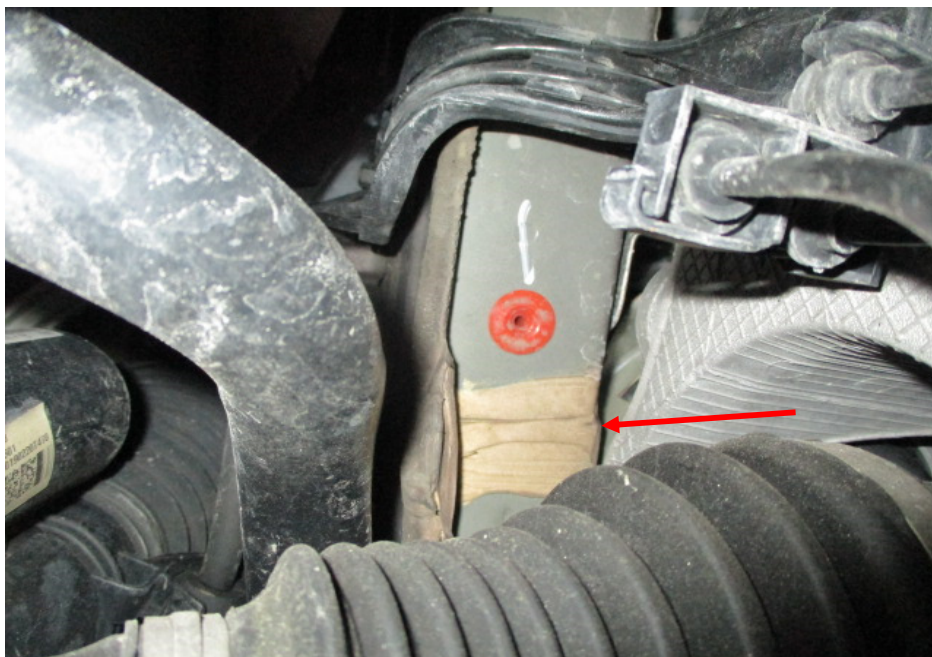
**Photo 30** shows the chassis/structural body at the underside front right of the Motor Car. The original factory sealant (arrowed) at the joints along the chassis/structural body was observed to be untouched. In general, I had found no work was carried out on the chassis/structural body of the Motor Car. The chassis/structural body of the Motor Car was originally fitted.

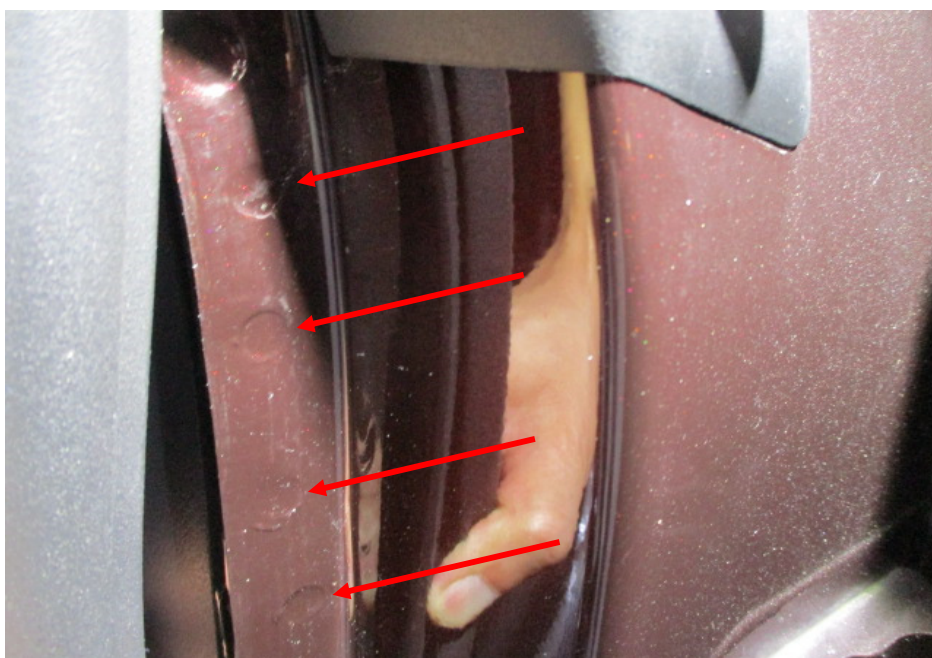
**Photo 31** shows the right side "A" pillar of the Motor Car. I did not find any weld marks other than original spot weld marks (arrowed) on the right side "A" pillar of the Motor Car which, indicates that there was no re-welding works carried out. In general, I had found all the non-detachable body panels of the Motor Car to be originally fitted at the time of my inspection.

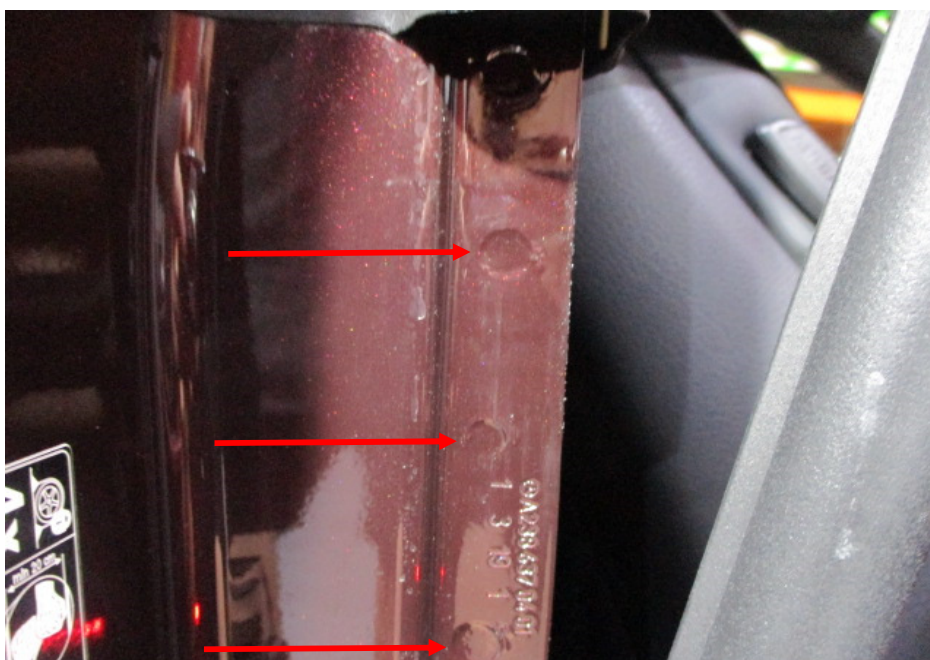
**Photo 32** shows the right side rear body panel of the Motor Car. I did not find any weld marks other than original spot weld marks (arrowed) on the right side rear body panel of the Motor Car which, indicates that there was no re-welding works carried out. In general, I had found all the non-detachable body panels of the Motor Car to be originally fitted at the time of my inspection.

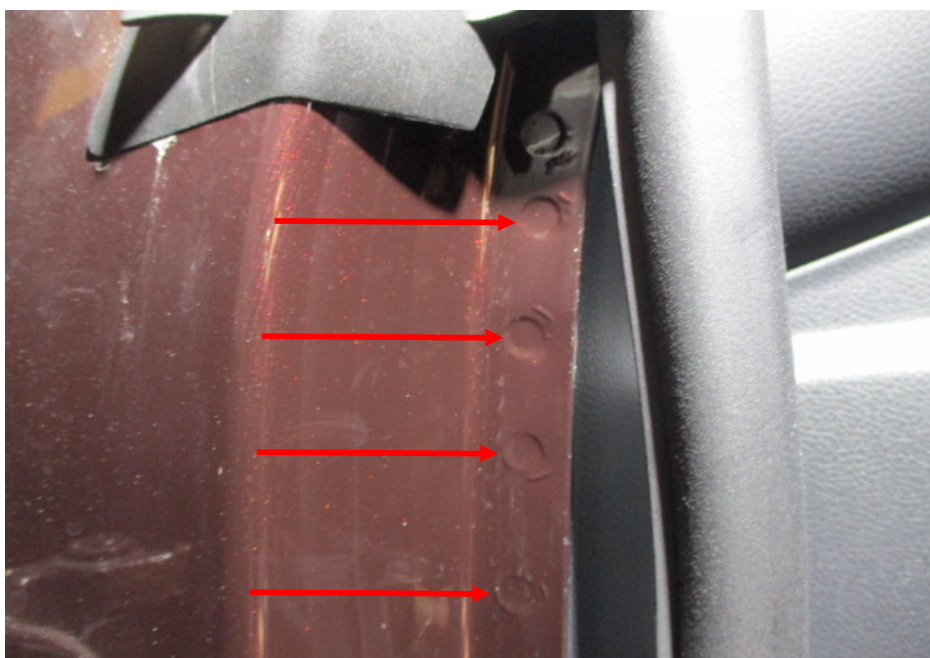
**Photo 33** shows the left side "A" pillar of the Motor Car. I did not find any weld marks other than original spot weld marks (arrowed) on the left side "A" pillar of the Motor Car which, indicates that there was no re-welding works carried out. In general, I had found all the non-detachable body panels of the Motor Car to be originally fitted at the time of my inspection.

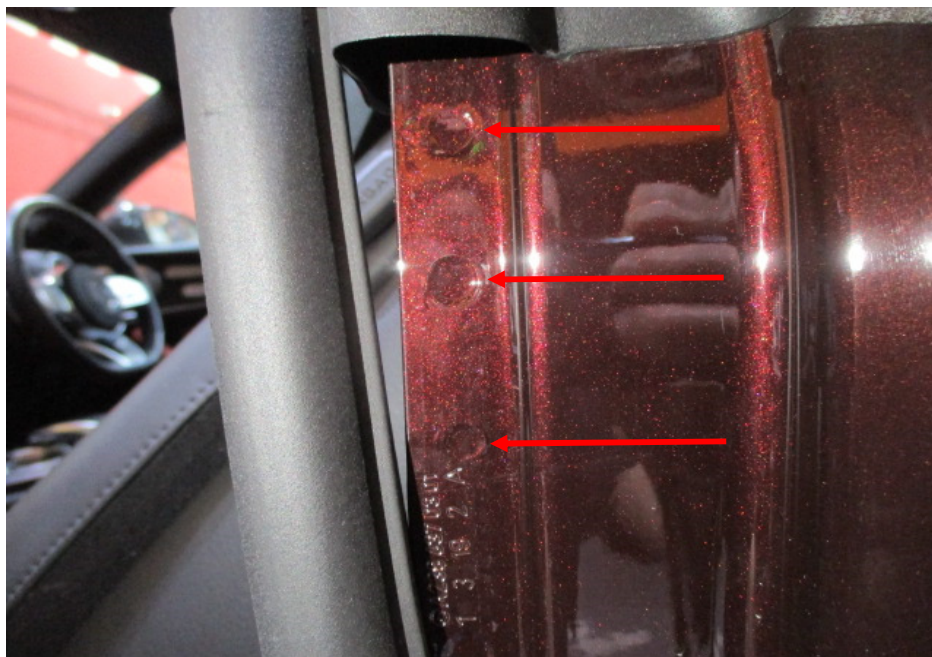
**Photo 34** shows the left side rear body panel of the Motor Car. I did not find any weld marks other than original spot weld marks (arrowed) on the left side rear body panel of the Motor Car which, indicates that there was no re-welding works carried out. In general, I had found all the non-detachable body panels of the Motor Car to be originally fitted at the time of my inspection.
