Your Ref: BMW 320i  
(chassis number WBA5F72000AE90203)  
Our Ref : CI/TP21012531/D

13 December 2021

**INSPECTION REPORT OF AN UNREGISTERED BMW 320i MOTOR CAR  
WITH CHASSIS NUMBER WBA5F72000AE90203**

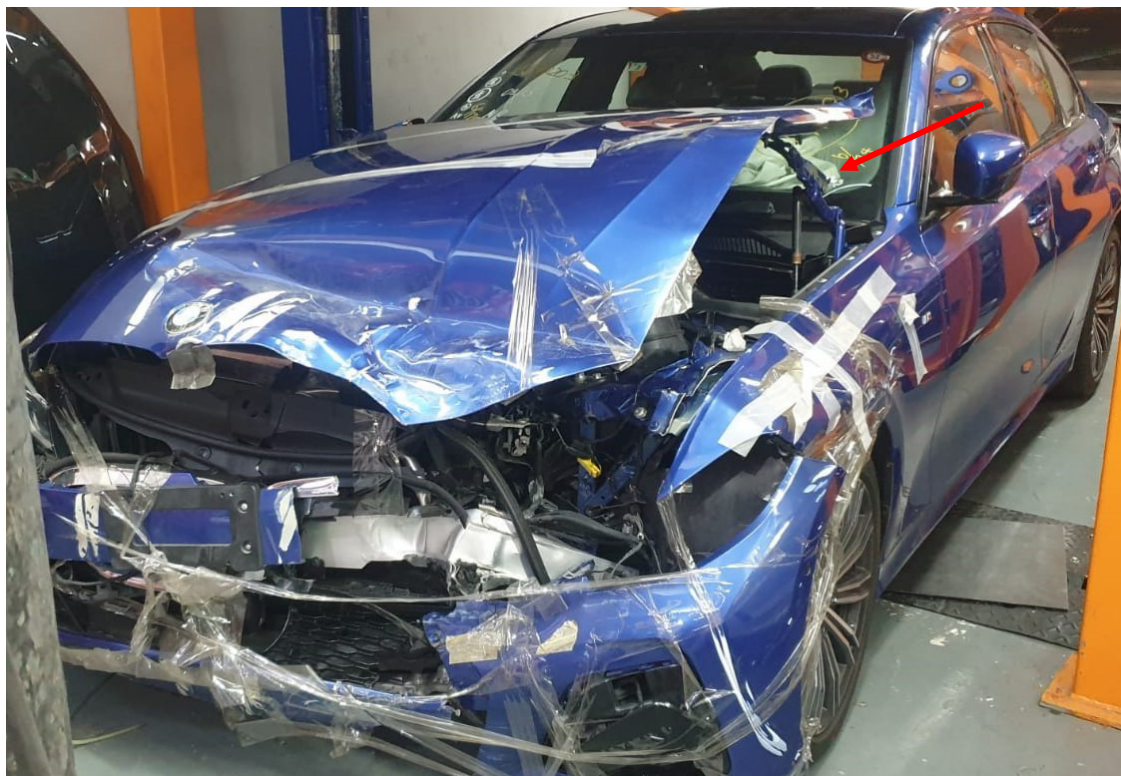
**Photo 1** shows the front left body of the Motor Car (photograph provided to me). The Motor Car was observed to have sustained damage at its frontal portion. The front bumper, front bumper reinforcement, front bumper sponge, front bumper centre lower grille, front bumper left lower grille, radar unit, front bonnet, front bonnet left lock, front bonnet left hinge, front left day light, front left headlamp, front left fender, front support panel, front left headlamp top panel, aircon condenser and radiator were amongst the body parts that were observed to have been damaged. The front left passenger airbag was deployed (arrowed).

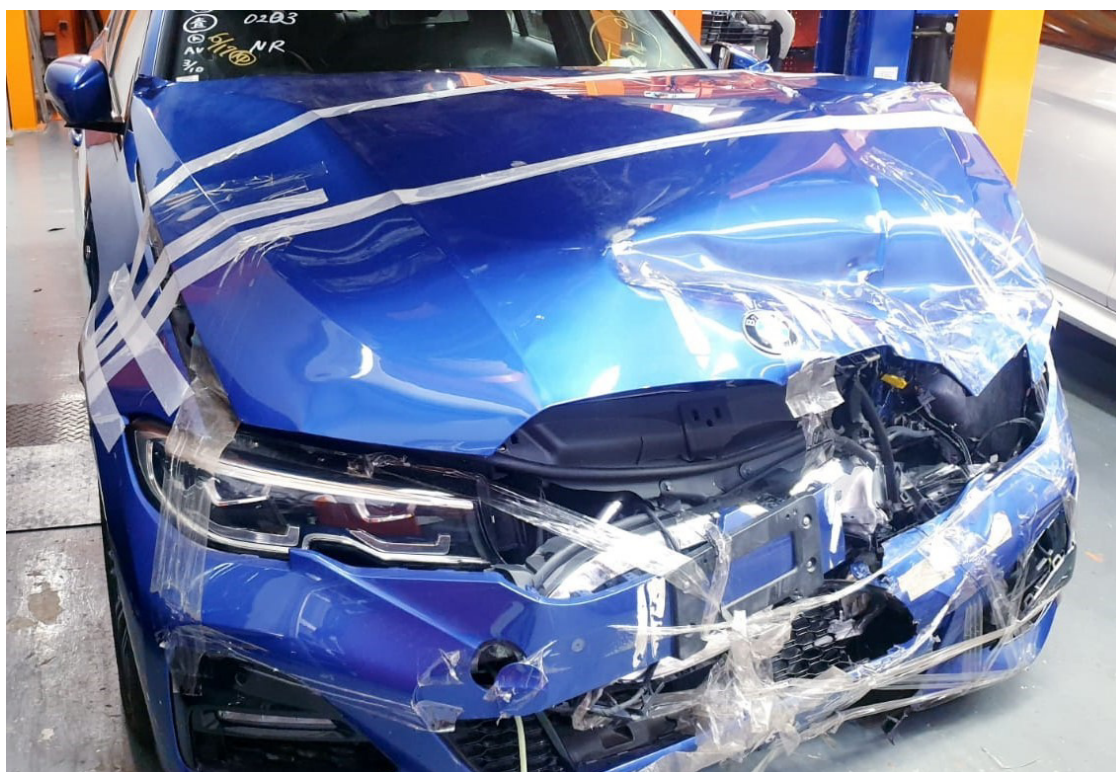
**Photo 2** shows the front right body of the Motor Car (photograph provided to me). The Motor Car was observed to have sustained damage at its frontal portion. The front bumper, front bumper reinforcement, front bumper sponge, front bumper centre lower grille, radiator grilles, front bonnet, front bonnet right hinge, front support panel and front centre air guide were amongst the body parts that were observed to have been damaged.

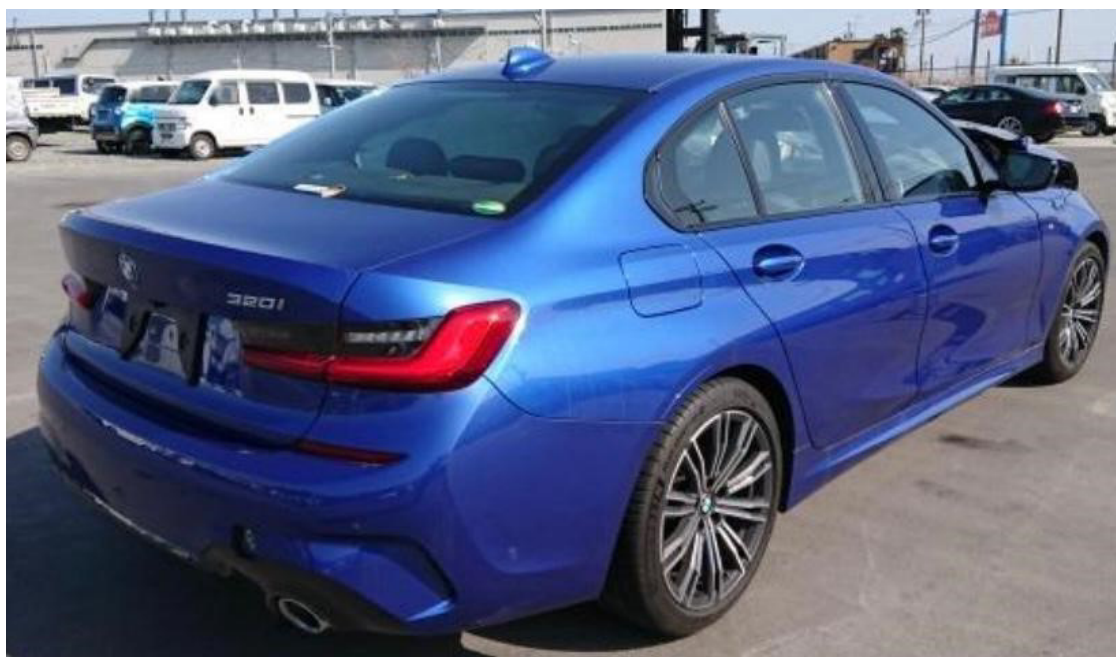
**Photo 3** shows the rear right body of the Motor Car (photograph provided to me). Apart for the frontal portion, there was no physical damage seen to other areas of the Motor Car.

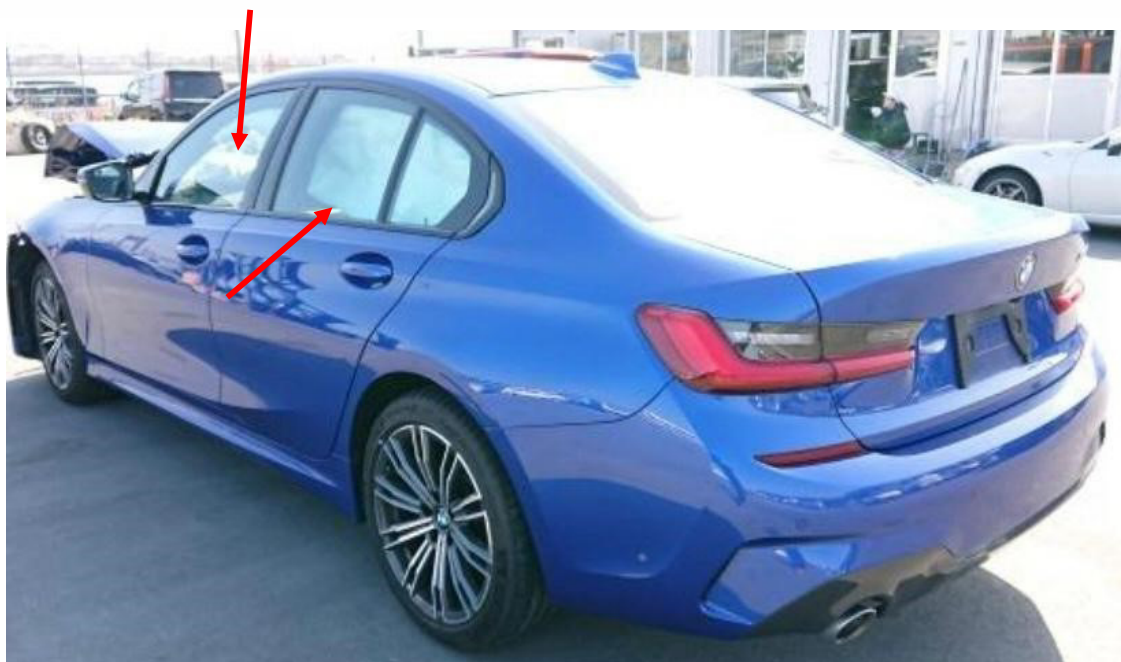
**Photo 4** shows the rear left body of the Motor Car (photograph provided to me). Apart for the frontal portion, there was no physical damage seen to other areas of the Motor Car. The left side curtain airbag and front left passenger airbag were seen to be deployed (arrowed).

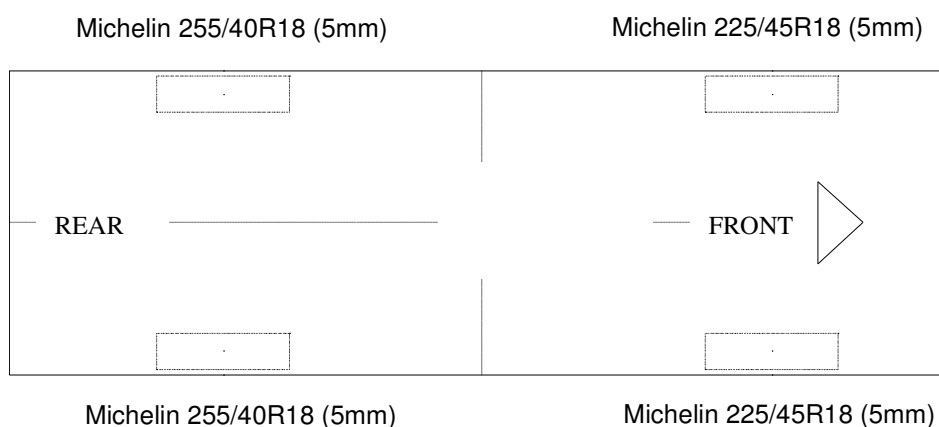
8. It was fitted with 18inch sport wheel rims that were wrapped with tyres that were observed to be of serviceable condition. The tyres were also sufficiently inflated for vehicular operation. The tyre brand, tyre size and approximate remaining tread depth of the 4 tyres of the Motor Car were recorded as follows: -

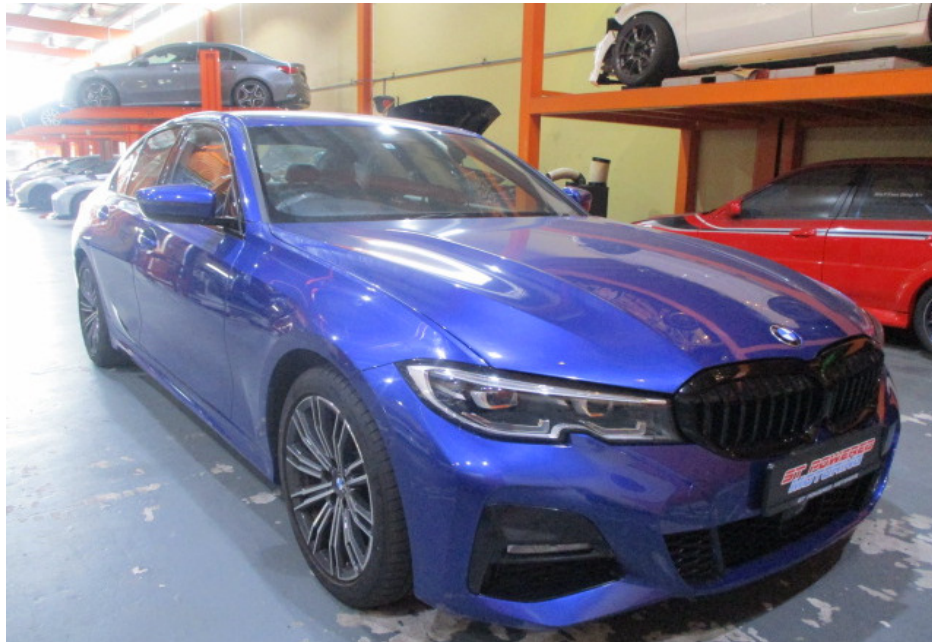
**Photo 5** shows a general view of the front right body of the Motor Car at the time of my inspection. The Motor Car was observed to be in a relatively good general condition with no loose exterior fittings observed. The body parts at the frontal portion of the Motor Car were visually examined and it was observed that the repair/restoration works carried out to the damaged area of the Motor Car (refer to photograph 1 & 2 above) were reasonably adequate and in order.

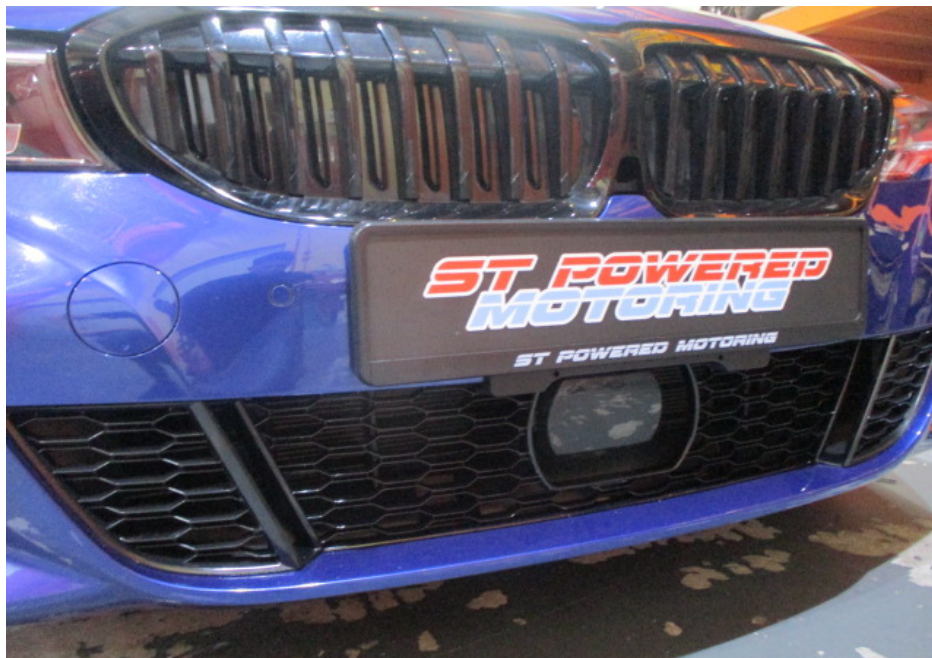
**Photo 6** shows a closer view of the Motor Car's front bumper, front bumper centre lower grille, radar unit and radiator grilles. The body parts at the frontal portion of the Motor Car were visually examined and it was observed that the repair/restoration works carried out to the damaged area of the Motor Car (refer to photograph 1 & 2 above) were reasonably adequate and in order.

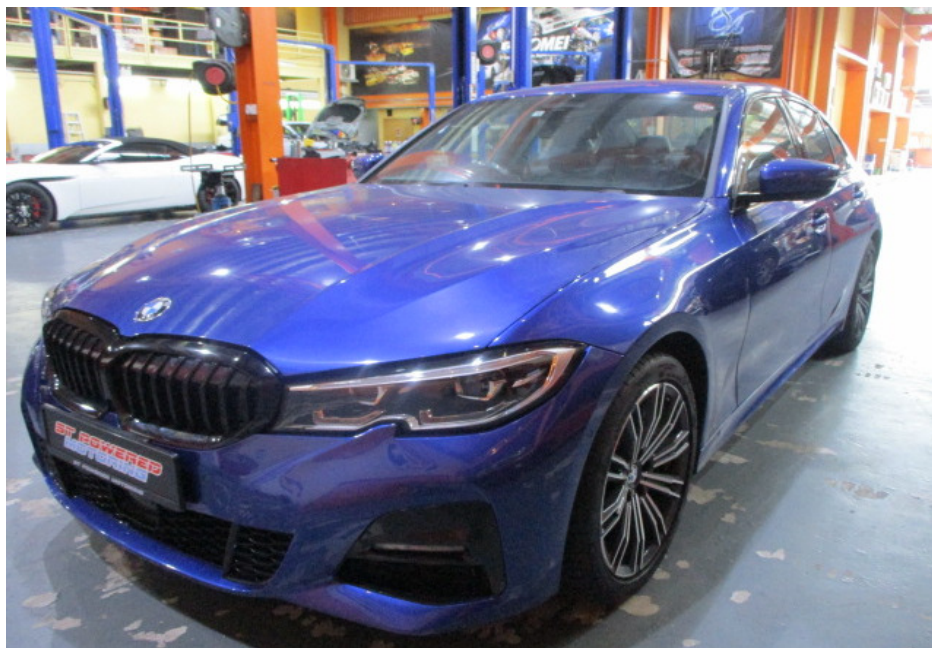
**Photo 7** shows a general view of the front left body of the Motor Car at the time of my inspection. The Motor Car was observed to be in a relatively good general condition with no loose exterior fittings observed. The body parts at the frontal portion of the Motor Car were visually examined and it was observed that the repair/restoration works carried out to the damaged area of the Motor Car (refer to photograph 1 & 2 above) were reasonably adequate and in order.

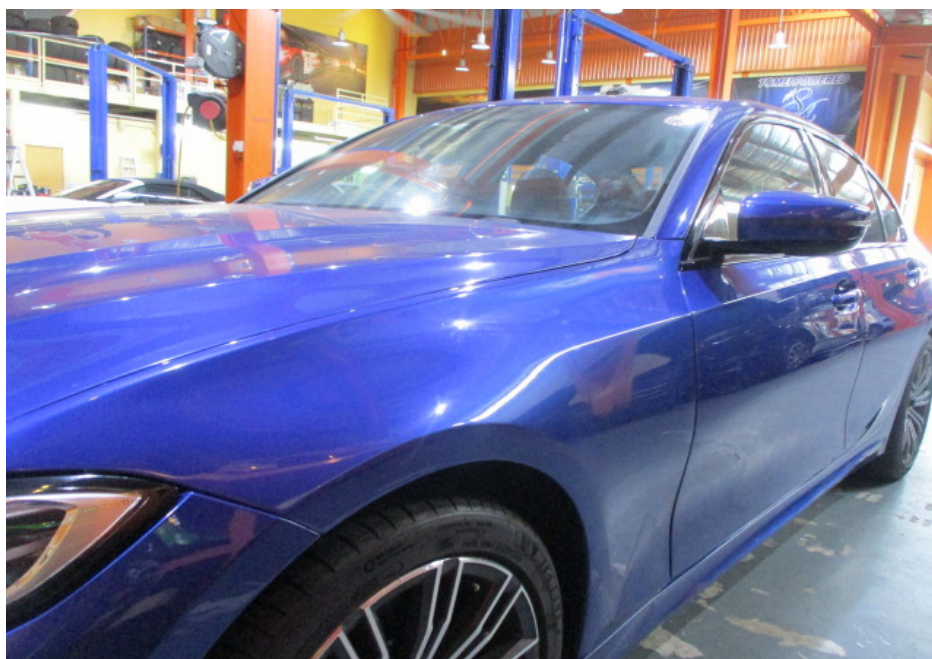
**Photo 8** shows a closer view of the Motor Car's front left fender, front left door and front bonnet. The body parts at the frontal portion of the Motor Car were visually examined and it was observed that the repair/restoration works carried out to the damaged area of the Motor Car (refer to photograph 1 & 2 above) were reasonably adequate and in order.

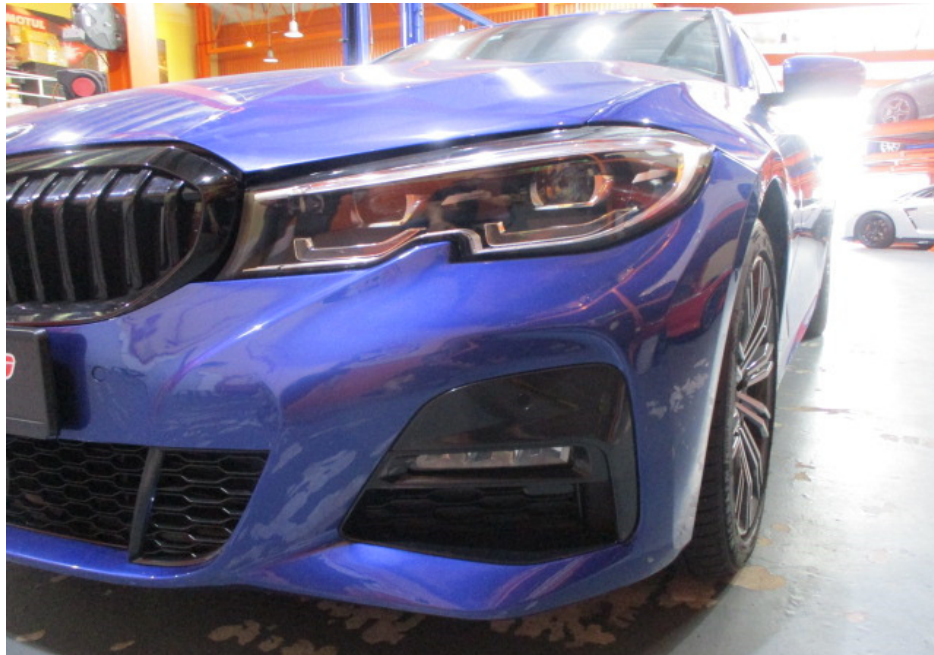
**Photo 9** shows a closer view of the Motor Car's front bumper, front bumper left lower grille, front bumper left day light and front left headlamp. The body parts at the frontal portion of the Motor Car were visually examined and it was observed that the repair/restoration works carried out to the damaged area of the Motor Car (refer to photograph 1 & 2 above) were reasonably adequate and in order.

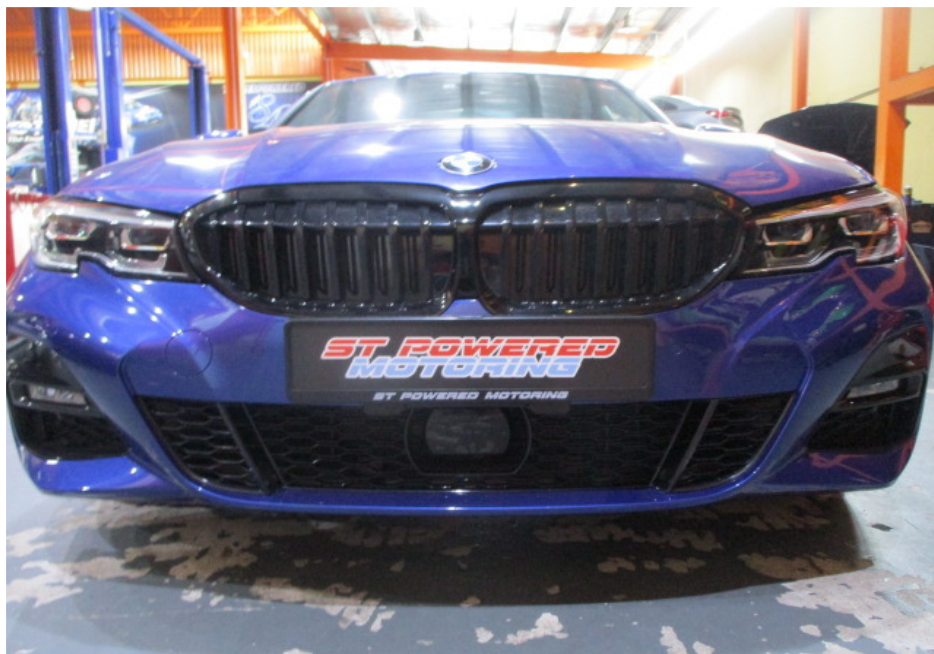
**Photo 10** shows a closer view of the Motor Car's front bumper, front bumper centre lower grille, front bonnet, front day lights, front headlamps, radar unit and radiator grilles. The body parts at the frontal portion of the Motor Car were visually examined, and it was observed that the repair/restoration works carried out to the damaged area of the Motor Car (refer to photograph 1 & 2 above) were reasonably adequate and in order.

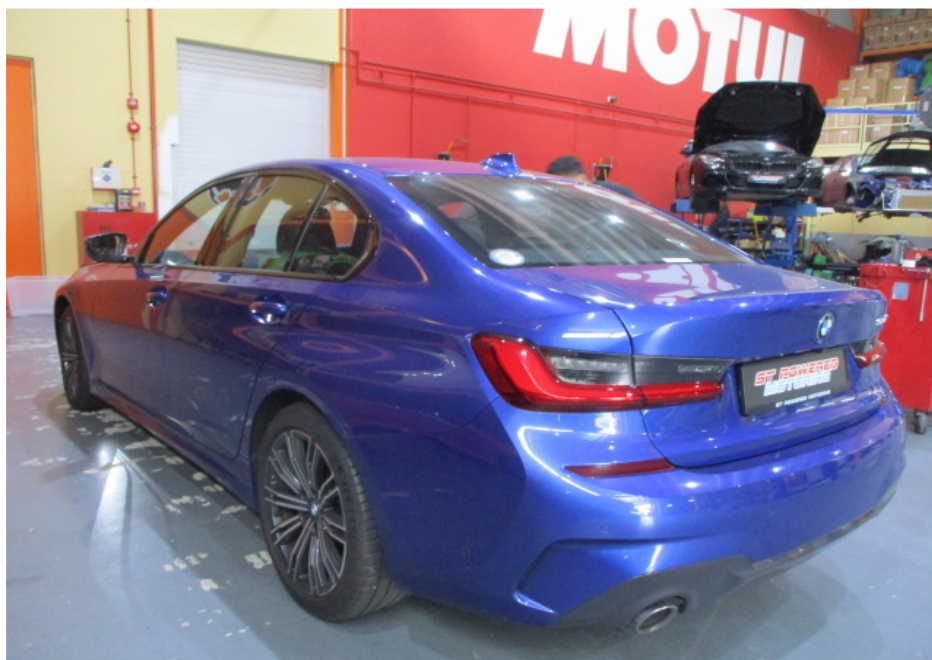
**Photo 11** shows a general view of the rear left body of the Motor Car at the time of my inspection. The Motor Car was observed to be in a relatively good general condition with no loose exterior fittings observed. The mileage of the Motor Car recorded at the time of my inspection was 19,687km.

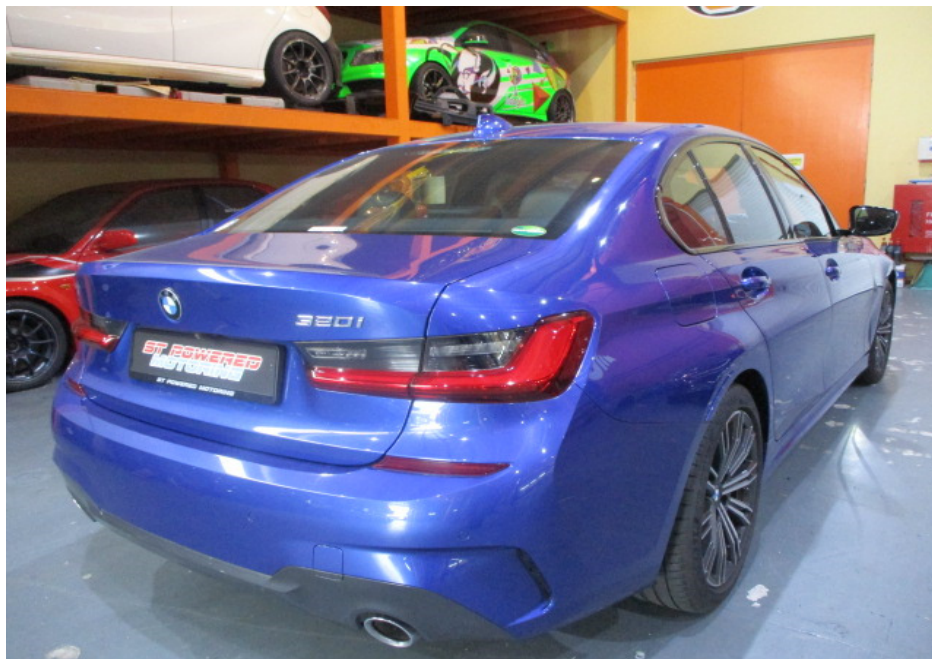
**Photo 12** shows a general view of the rear right body of the Motor Car at the time of my inspection. The Motor Car was observed to be in a relatively good general condition with no loose exterior fittings observed. The mileage of the Motor Car recorded at the time of my inspection was 19,687km.

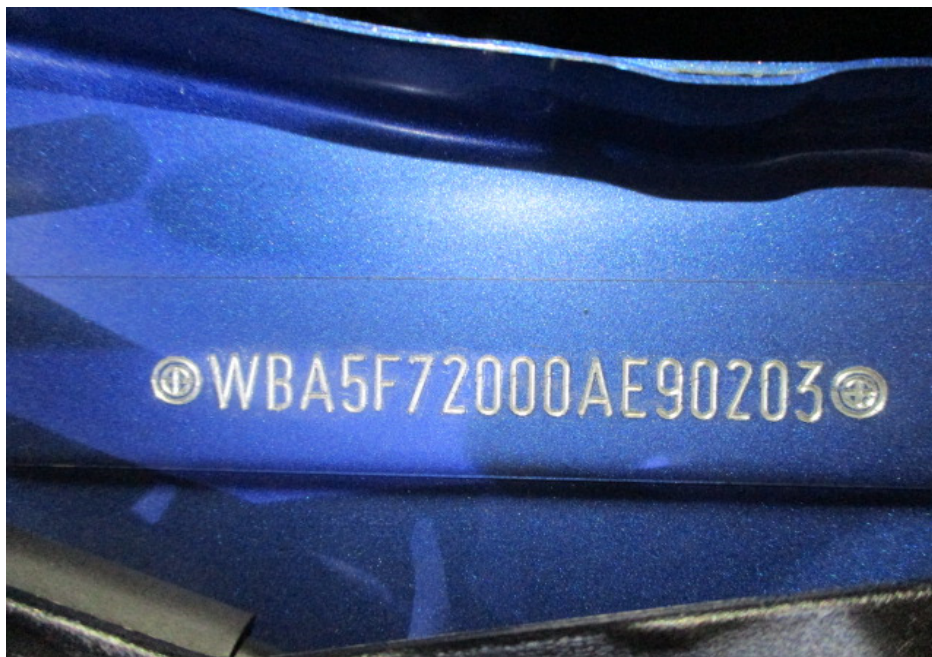
**Photo 13** shows the chassis number of the Motor Car. The chassis number recorded was WBA5F72000AE90203.

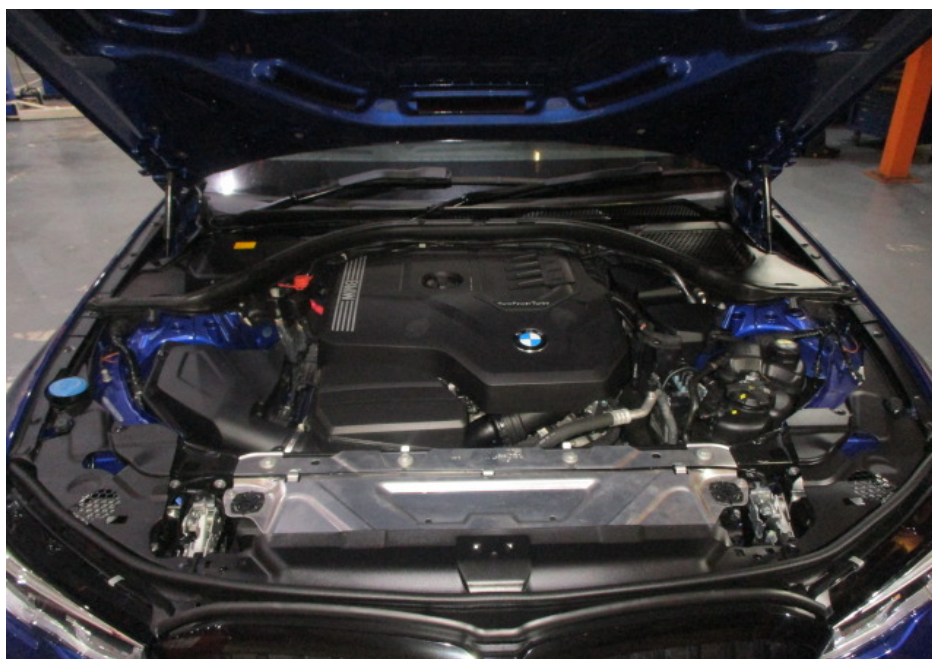
**Photo 14** shows a general view of the engine compartment of the Motor Car at the time of my inspection. The various parts and components inside the engine compartment were all observed to be intact and properly fitted. There was also no sign(s) or indication(s) of fluid leak and/or fluid stain found inside the engine compartment. The repair/restoration works carried out to the various parts within the engine compartment like the front bonnet locks, front support panel, front support panel top centre garnish, front left headlamp top panel, aircon condenser and radiator amongst others, were reasonably adequate and in order.

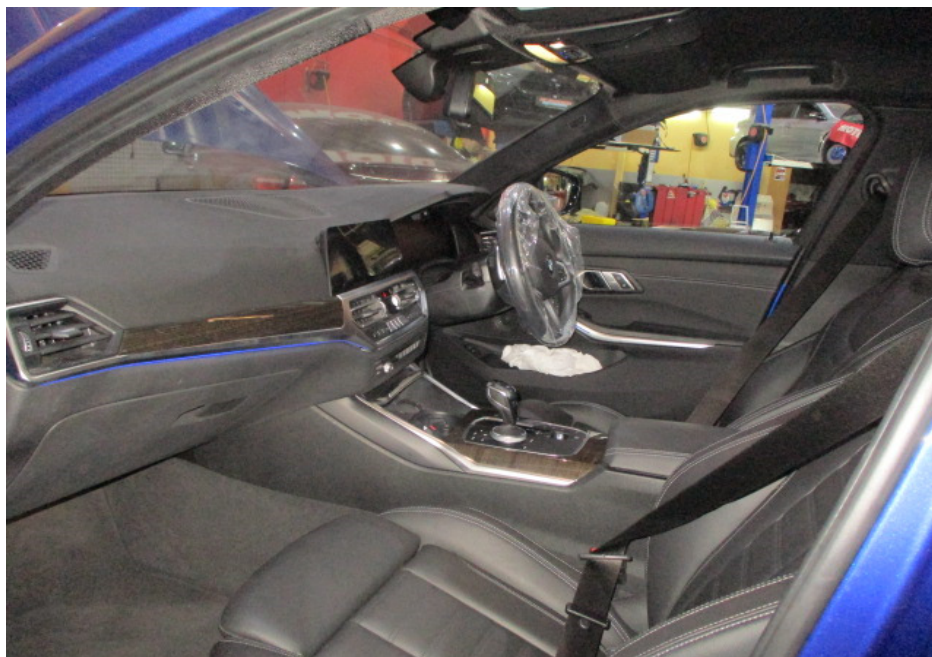
**Photo 15** shows the interior compartment of the Motor Car. The front dashboard, steering wheel, seats, upholstery and trims etc were all observed to be intact and properly fitted.

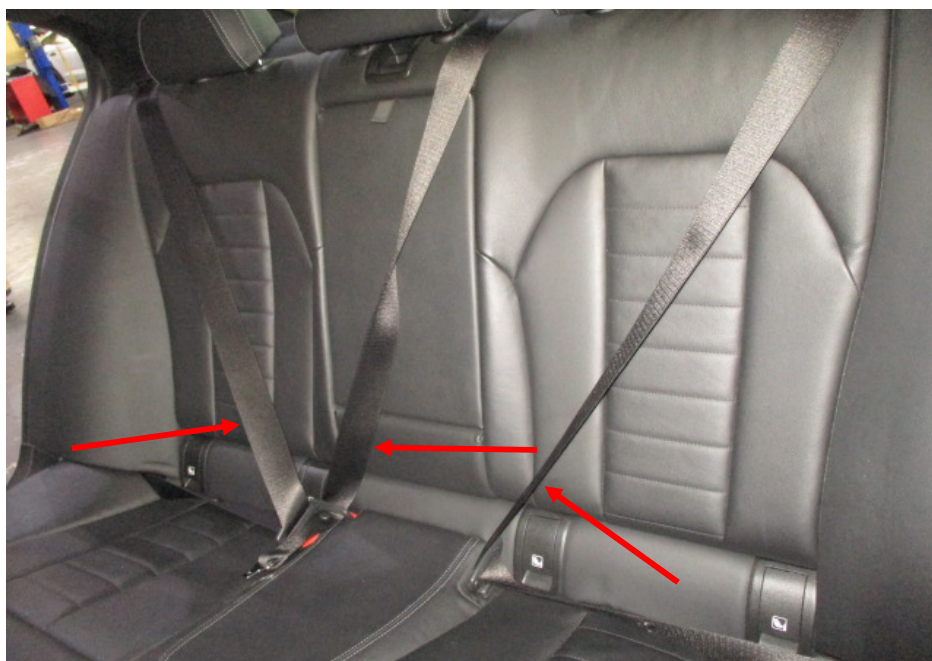
**Photo 16** shows the rear seats of the Motor Car. All the seats of the Motor Car were secured via seat rails to the floorboard. They were also fitted with a retractable seat belt reel and a pre-tensioner. The seat belts (arrowed) were tested and were able to be fastened into the respective pre-tensions that were fitted on the side of each individual seat.

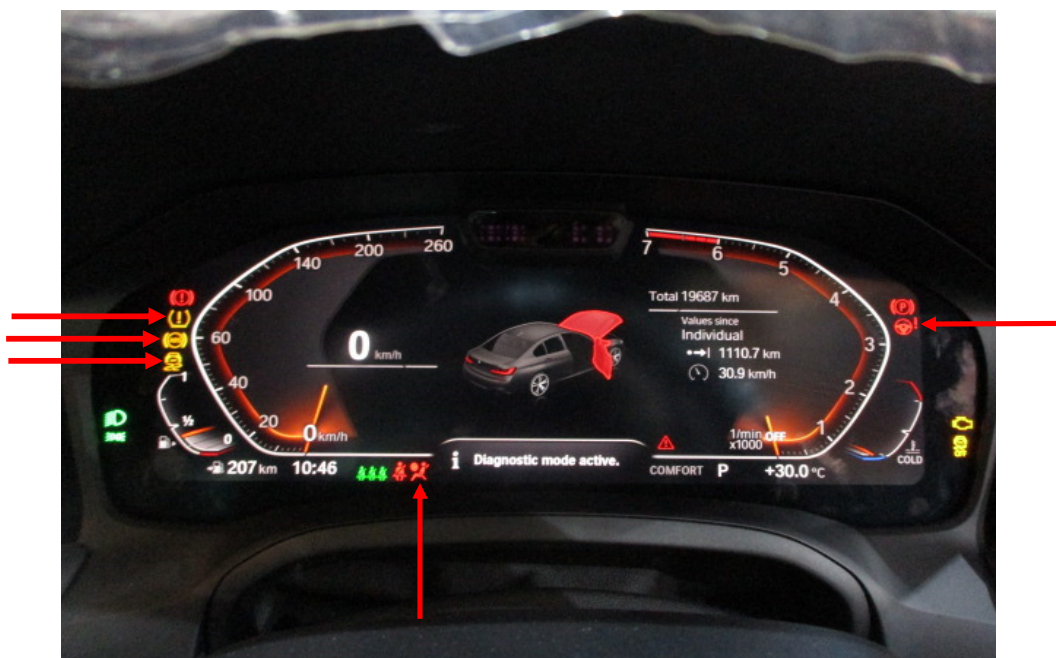
**Photo 17** shows the warning lights for the various electronic safety features appearing on the instrument panel of the Motor Car during its self-test when the engine is cranked, in particular the ABS, SRS, IAS, TPM and DSC lights (arrowed).

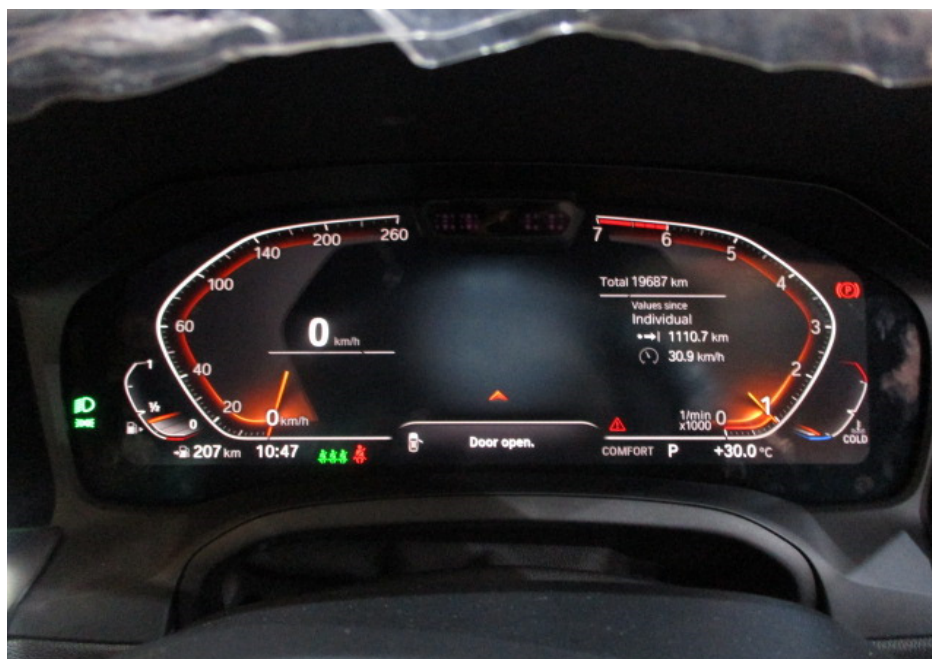
**Photo 18** shows the respective warning lights no longer illuminated, indicating that there is no fault detected to the ABS, SRS, IAS, TPM and DSC systems of the Motor Car during the self-test. These electronic systems were hence in working condition at the time of my inspection.

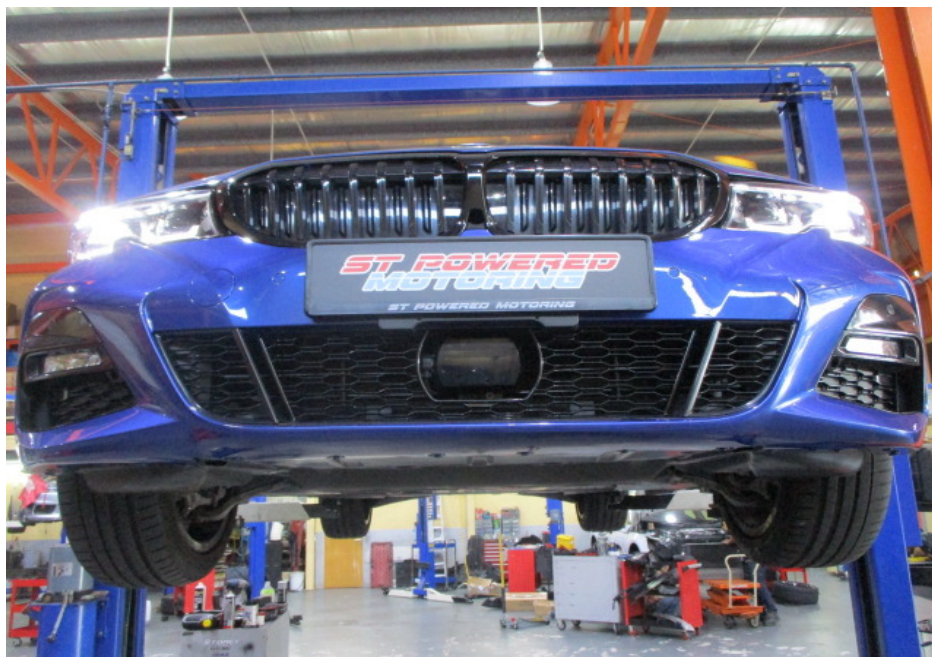
**Photo 19** shows the Motor Car hoisted up for checks on its undercarriage. There was no sign(s) or indication(s) of fluid leakage and/or fluid stain(s) on the underside of the Motor Car. The undercarriage components of the Motor Car were also all observed to be intact and secured in an appropriate manner.

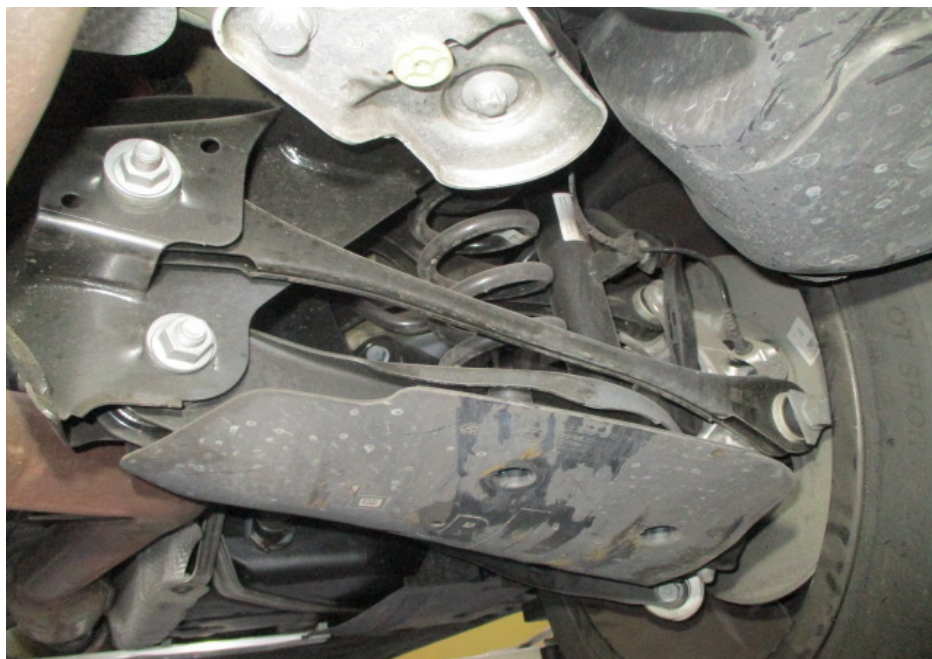
**Photo 20** shows a general view of the control arms and linkages at the rear right wheel of the Motor Car. I did not observe any fluid leak and/or fluid stain on the underside of the Motor Car. All of the Motor Car's undercarriage components were observed to be intact and secured in an appropriate manner.

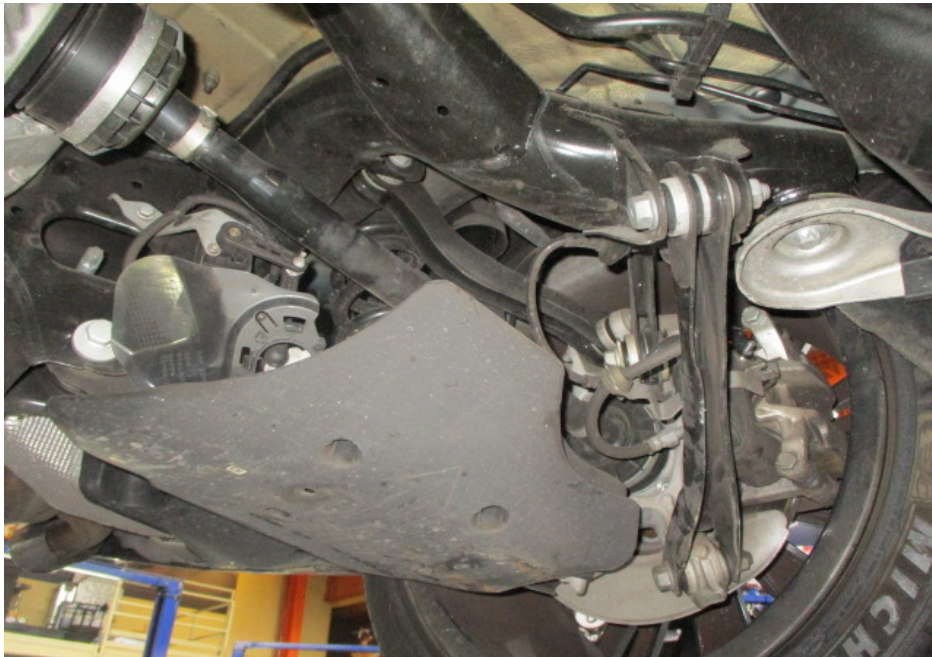
**Photo 21** shows a general view of the control arms and linkages at the rear left wheel of the Motor Car. I did not observe any fluid leak and/or fluid stain on the underside of the Motor Car. All of the Motor Car's undercarriage components were observed to be intact and secured in an appropriate manner.

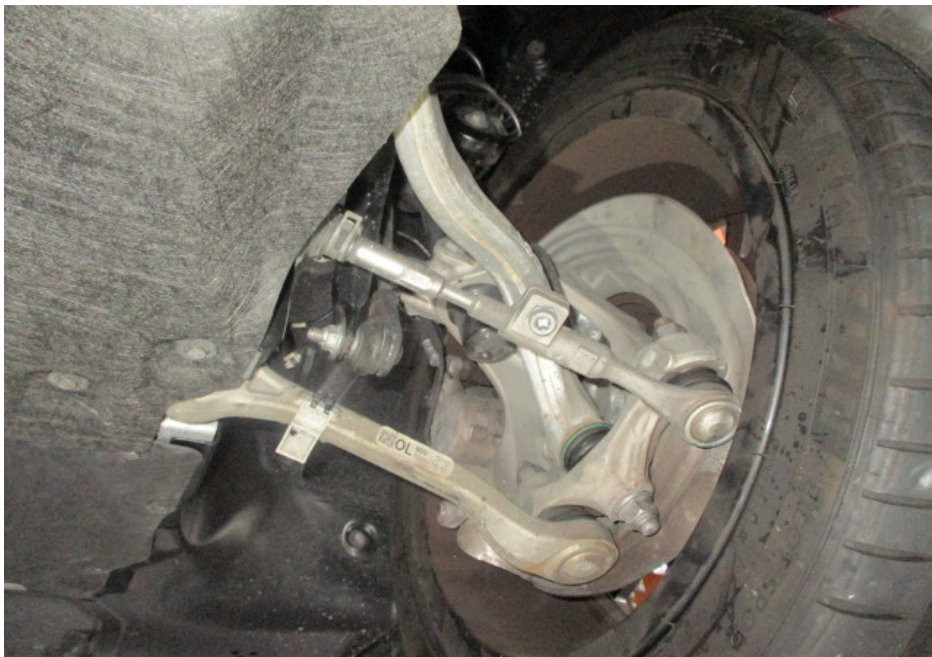
**Photo 22** shows the various undercarriage components at the front left wheel of the Motor Car. The mechanical components, control arms and linkages were all found to be intact and secured in an appropriate manner.

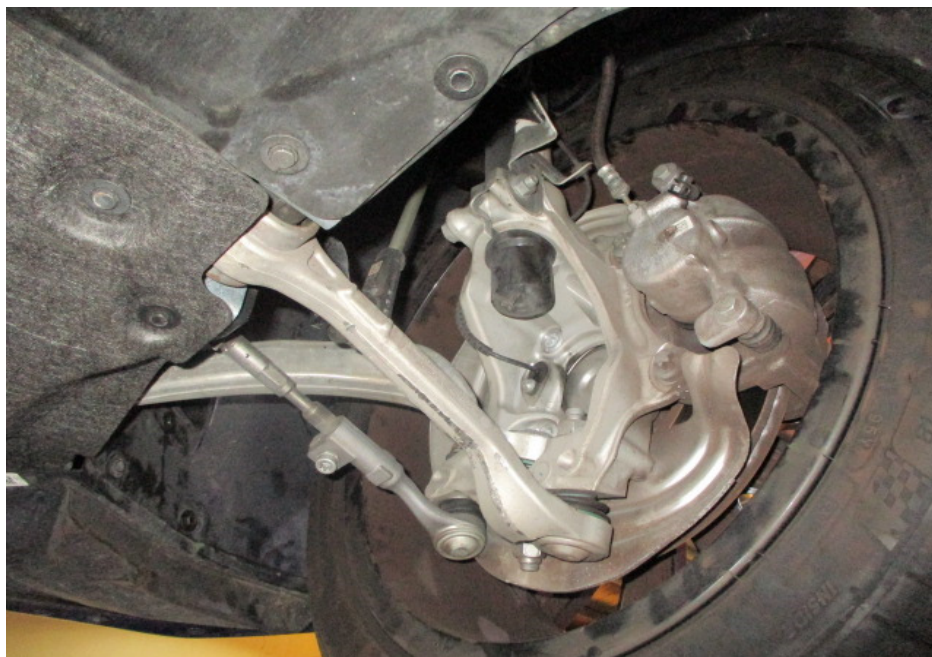
**Photo 23** shows the various undercarriage components at the front right wheel of the Motor Car. The mechanical components, control arms and linkages were all found to be intact and secured in an appropriate manner. I also did not observe any fluid leak and/or fluid stain on the underside of the Motor Car.

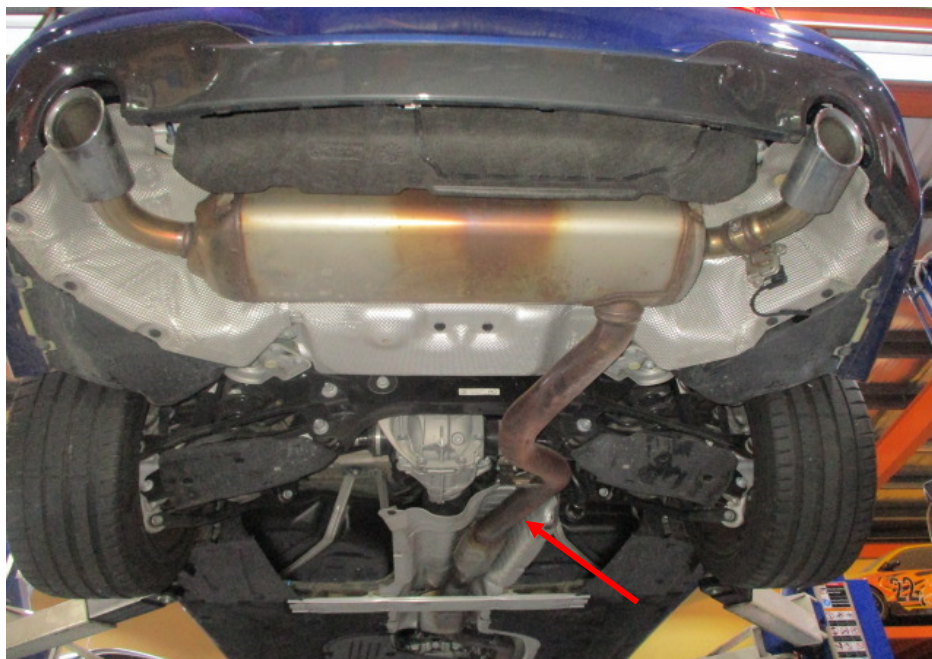
**Photo 24** shows the rear section of the Motor Car's exhaust system. My examination of the Motor Car's exhaust system revealed no sign(s) or indication(s) of any cut or weld marks along its exhaust pipes (arrowed), on its rear muffler, on its centre resonator boxes and on its catalytic converter.

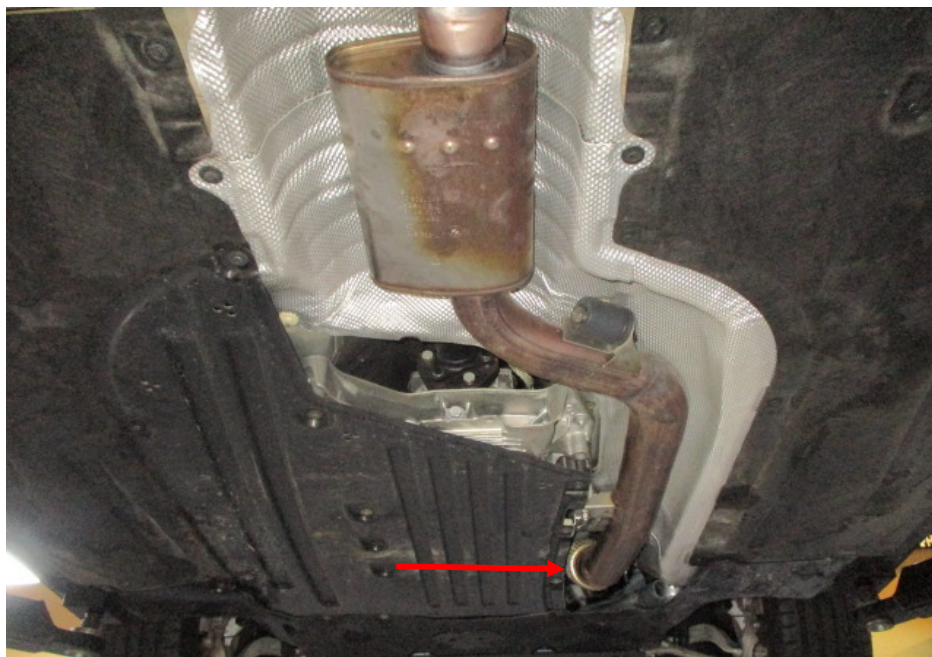
**Photo 25** shows the front section of the Motor Car's exhaust system. My examination of the Motor Car's exhaust system revealed no sign(s) or indication(s) of any cut or weld marks along its exhaust pipes, on its rear muffler, on its centre resonator boxes and on its catalytic converter (arrowed).

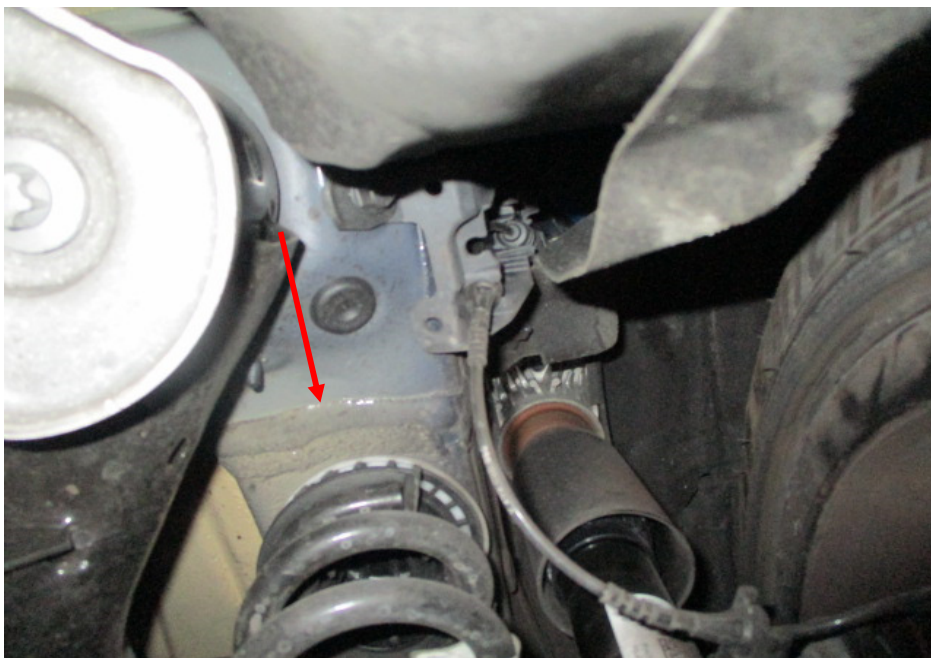
**Photo 26** shows the chassis/structural body at the underside rear right of the Motor Car. I did not find any weld marks other than original spot weld marks on the chassis/structural body of the Motor Car. The original factory sealant (arrowed) at the joints along the chassis/structural body was also untouched, indicating no work was done on the chassis/structural body of the Motor Car and that the chassis/structural body was originally fitted.

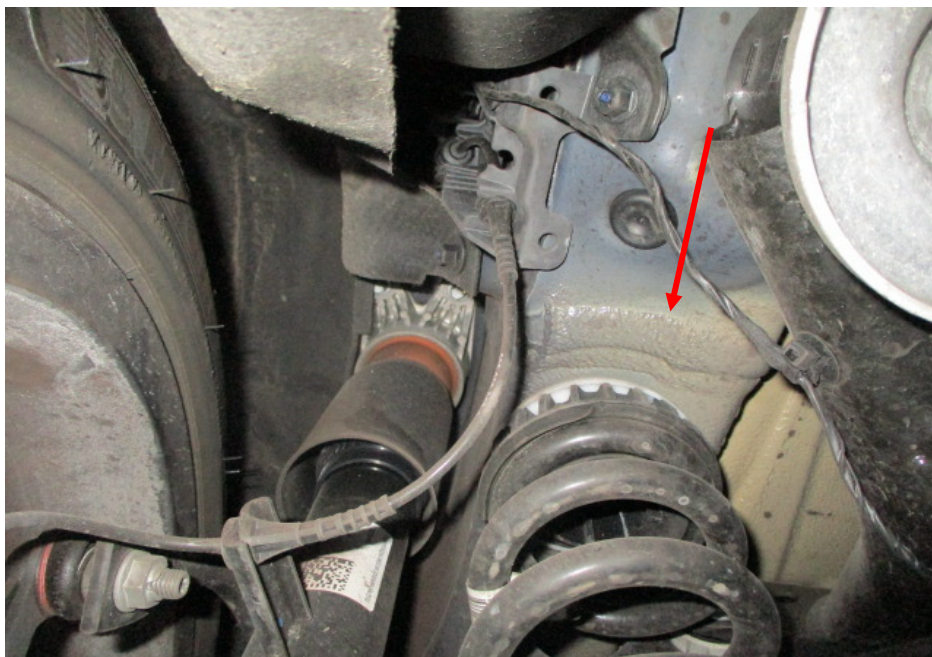
**Photo 27** shows the chassis/structural body at the underside rear left of the Motor Car. The original factory sealant (arrowed) at the joints along the chassis/structural body was observed to be untouched. In general, I had found no work was carried out on the chassis/structural body of the Motor Car. The chassis/structural body of the Motor Car was originally fitted.

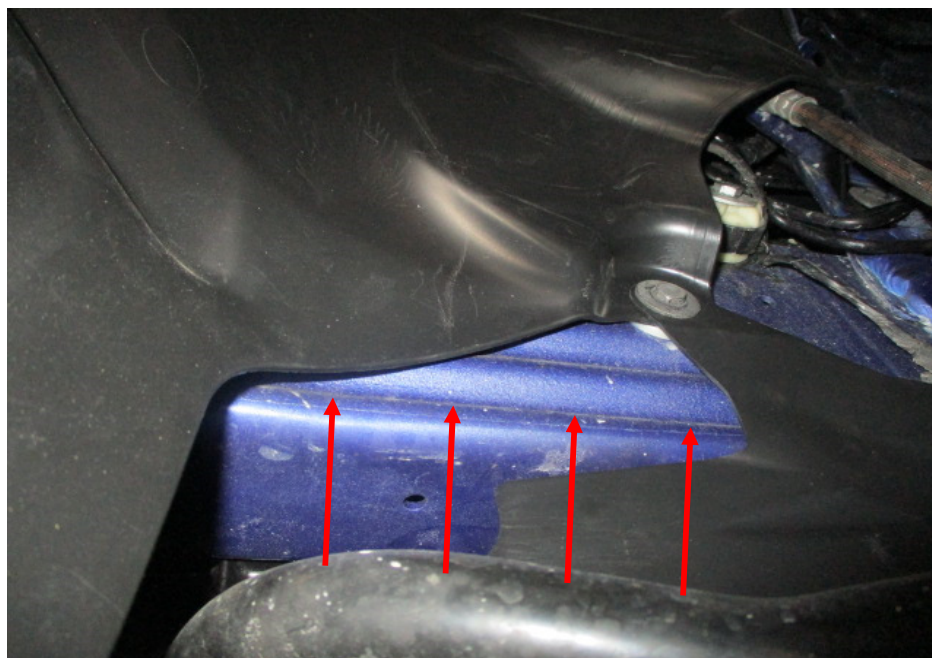
**Photo 28** shows the chassis/structural body at the underside front left of the Motor Car. I did not find any weld marks other than original spot weld marks on the chassis/structural body of the Motor Car. The original factory sealant (arrowed) at the joints along the chassis/structural body was also untouched, indicating no work was done on the chassis/structural body of the Motor Car and that the chassis/structural body was originally fitted.

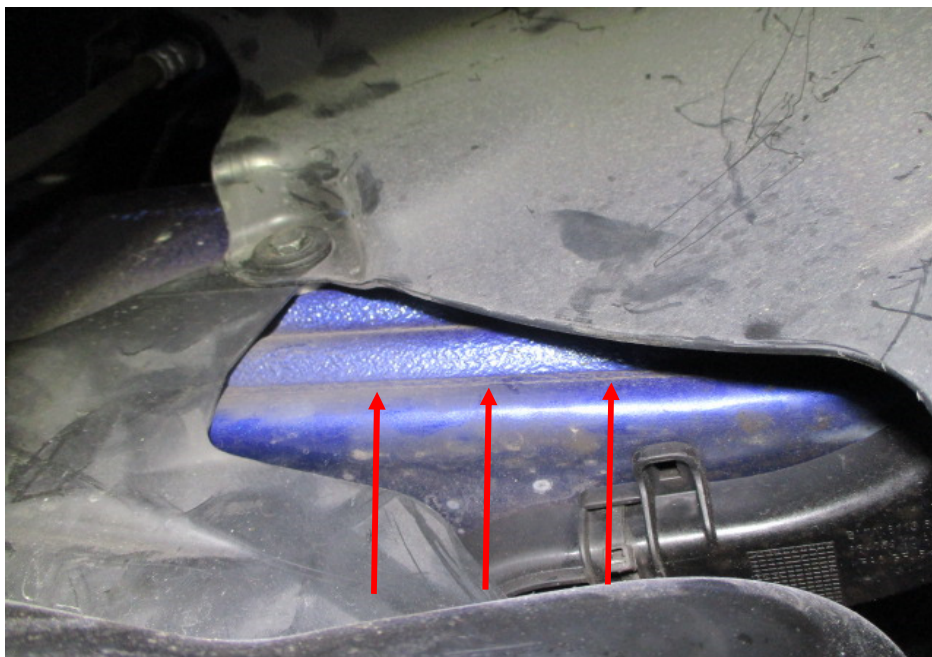
**Photo 29** shows the chassis/structural body at the underside front right of the Motor Car. The original factory sealant (arrowed) at the joints along the chassis/structural body was observed to be untouched. In general, I had found no work was carried out on the chassis/structural body of the Motor Car. The chassis/structural body of the Motor Car was originally fitted.

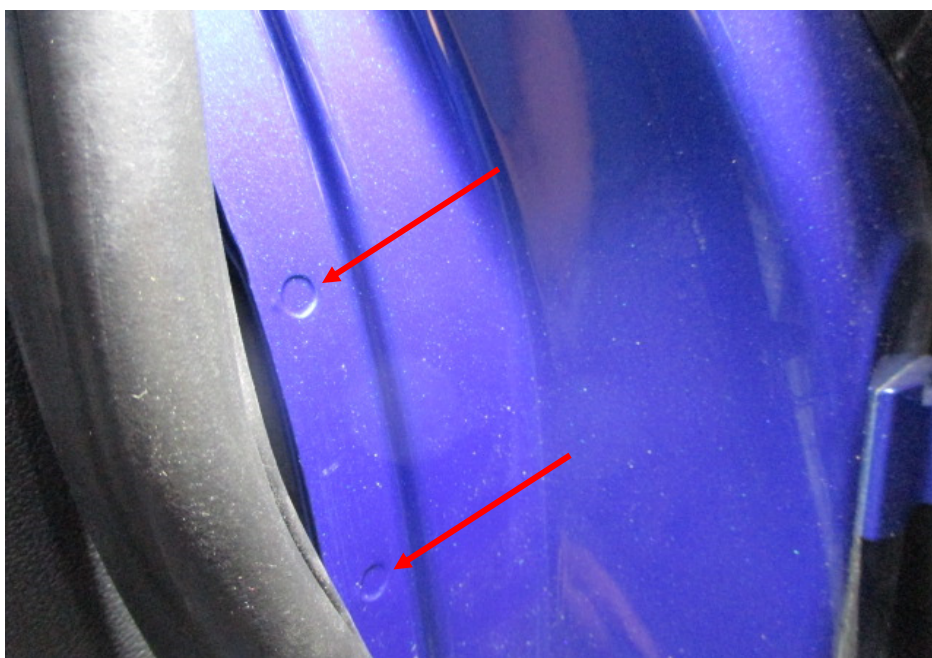
**Photo 30** shows the right side "A" pillar of the Motor Car. I did not find any weld marks other than original spot weld marks (arrowed) on the right side "A" pillar of the Motor Car which, indicates that there was no re-welding works carried out. In general, I had found all the non-detachable body panels of the Motor Car to be originally fitted at the time of my inspection.
