Your Ref: BMW 320i  
(chassis number WBA5F72000AE90203)  
Our Ref : CI/TP21012531/D

13 December 2021

**INSPECTION REPORT OF AN UNREGISTERED BMW 320i MOTOR CAR  
WITH CHASSIS NUMBER WBA5F72000AE90203**

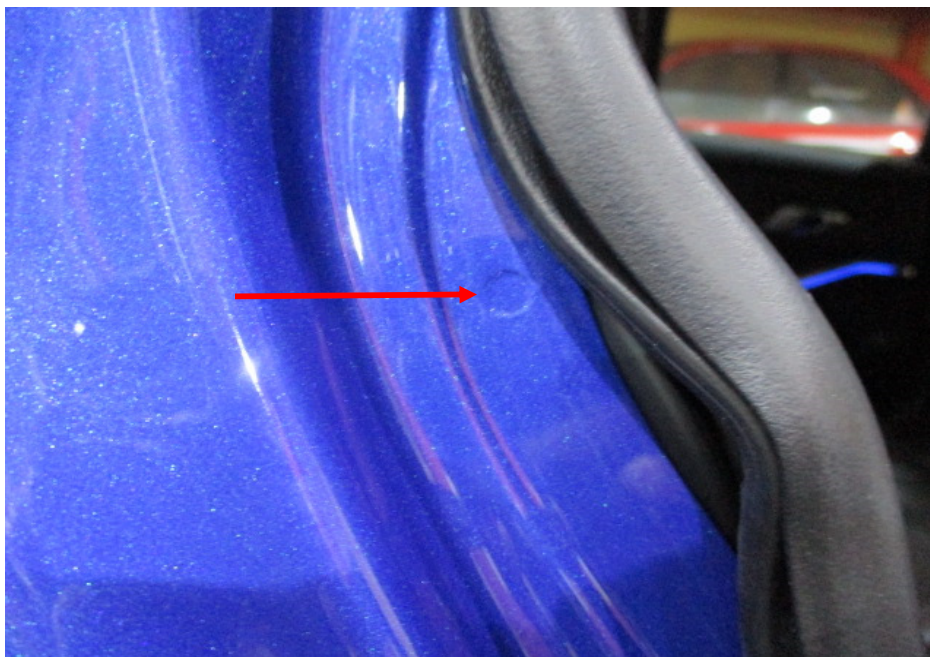
**Photo 31** shows the right side “C” pillar of the Motor Car. I did not find any weld marks other than original spot weld marks (arrowed) on the right side “C” pillar of the Motor Car which, indicates that there was no re-welding works carried out. In general, I had found all the non-detachable body panels of the Motor Car to be originally fitted at the time of my inspection.

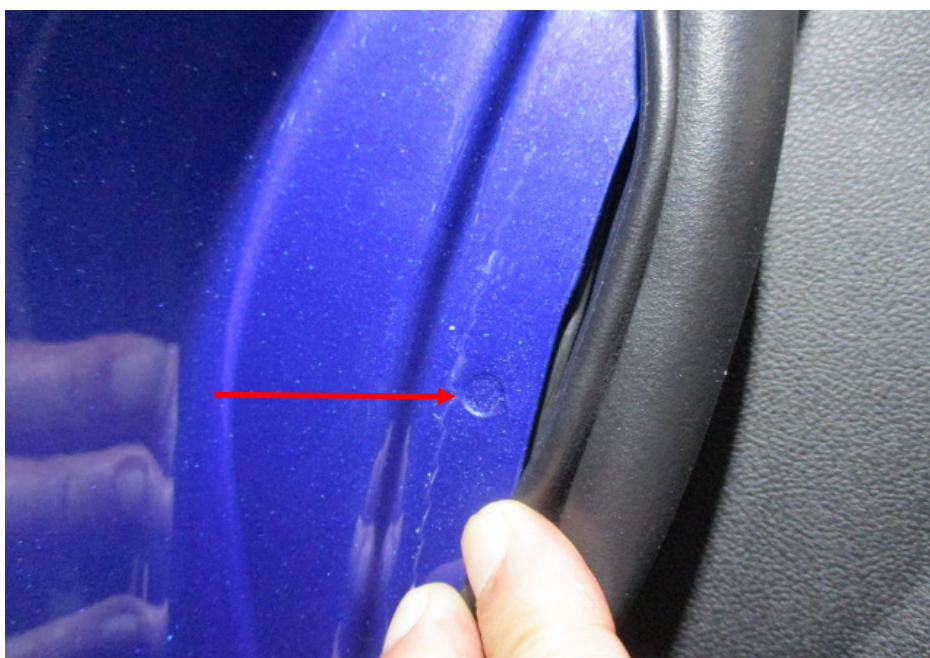
**Photo 32** shows the left side “A” pillar of the Motor Car. I did not find any weld marks other than original spot weld marks (arrowed) on the left side “A” pillar of the Motor Car which, indicates that there was no re-welding works carried out. In general, I had found all the non-detachable body panels of the Motor Car to be originally fitted at the time of my inspection.

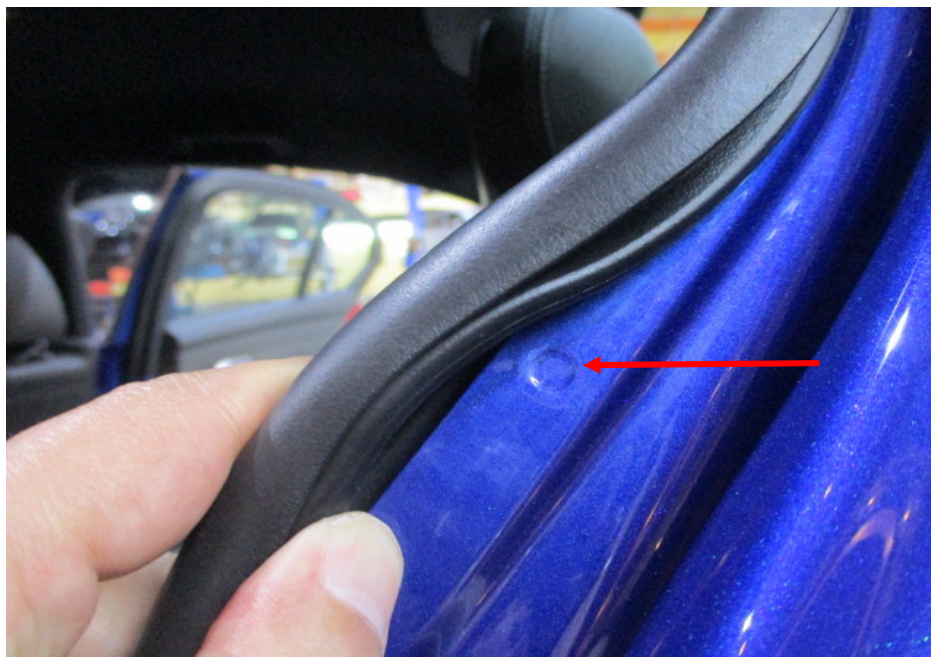
**Photo 33** shows the left side "C" pillar of the Motor Car. I did not find any weld marks other than original spot weld marks (arrowed) on the left side "C" pillar of the Motor Car which, indicates that there was no re-welding works carried out. In general, I had found all the non-detachable body panels of the Motor Car to be originally fitted at the time of my inspection.
