Your Ref: 6723766784SG
Our Ref : CS4/AIG21012722/D

21 December 2021

TECHNICAL INVESTIGATION REPORT OF FIRE INCIDENT INVOLVING THE INSURED VEHICLE SJG 2020Z ON 21 OCTOBER 2021

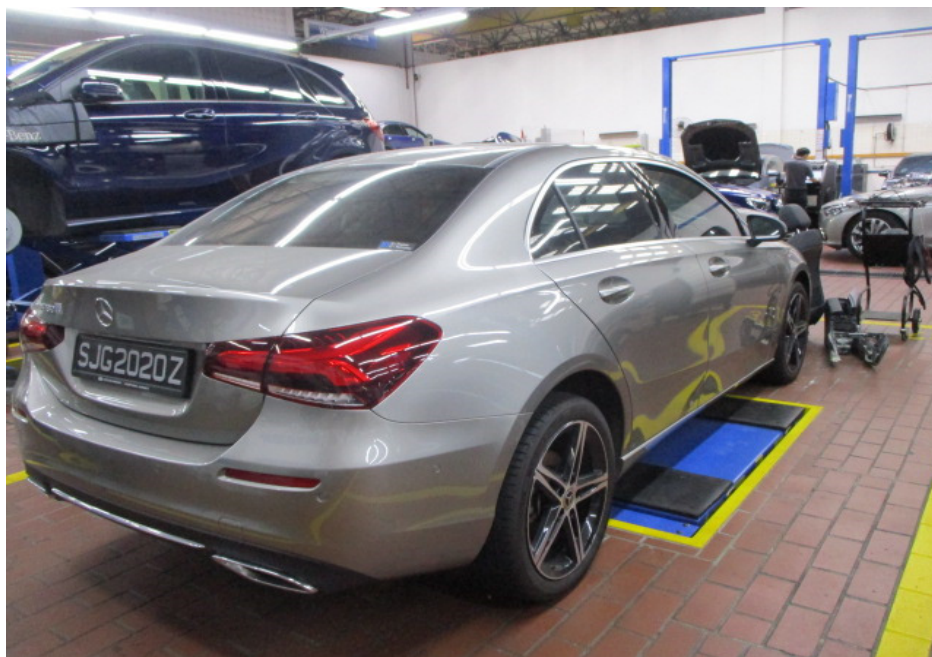
Photo 1 shows a general view of the rear right body of the Insured Vehicle at the time of my inspection. I did not observe any damage of fire nature to the exterior body of the Insured Vehicle. Its rear boot compartment and engine compartment were also found to be without any damage of fire nature.

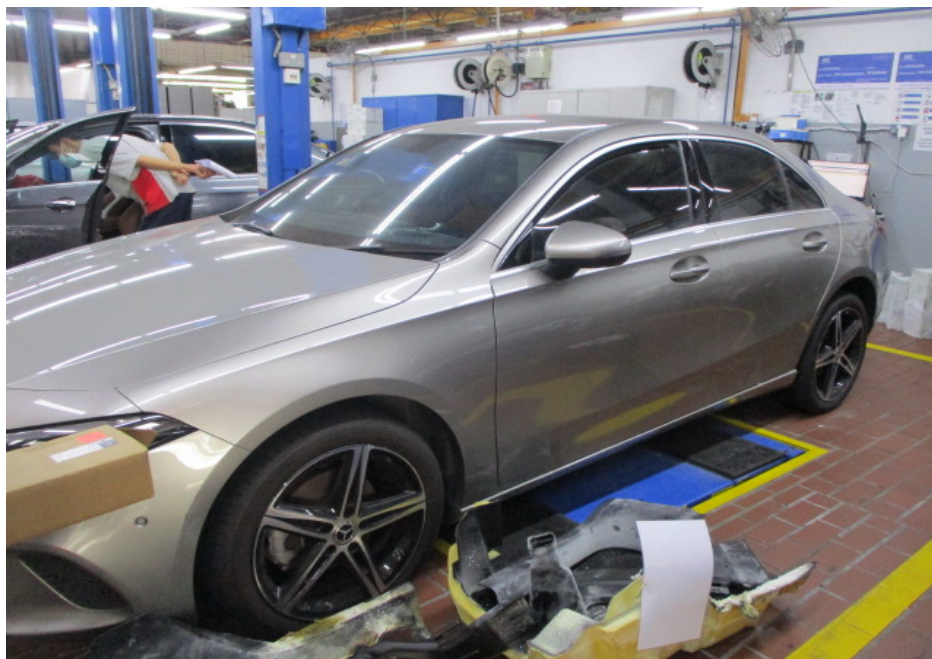
Photo 2 shows a general view of the left body of the Insured Vehicle at the time of my inspection. I did not observe any damage of fire nature to the exterior body of the Insured Vehicle. Its rear boot compartment and engine compartment were also found to be without any damage of fire nature.

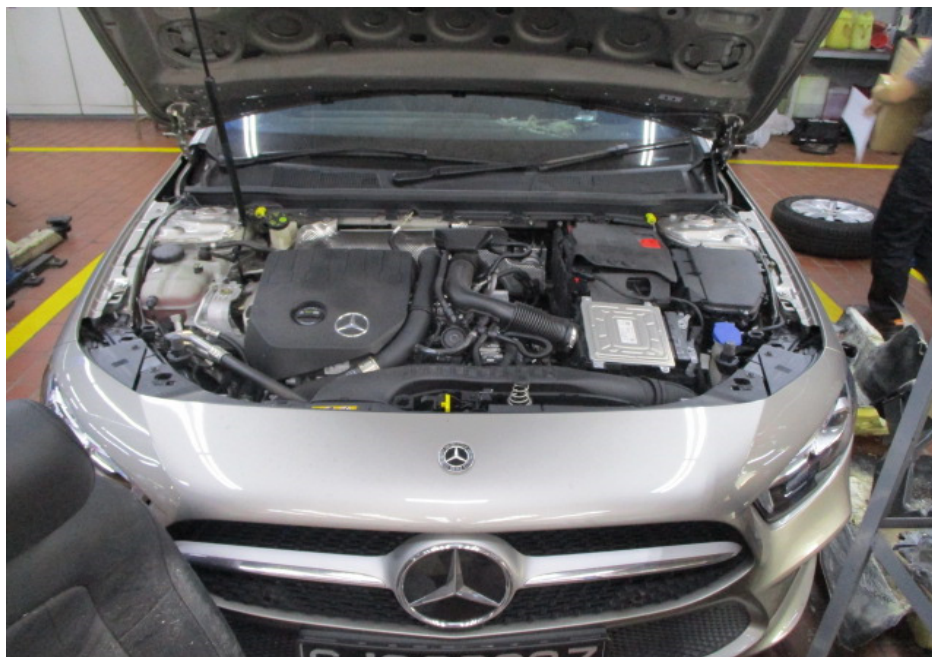
Photo 3 shows a general view of the frontal body and engine compartment of the Insured Vehicle at the time of my inspection. I did not observe any damage of fire nature to the exterior body of the Insured Vehicle. The engine compartment was also observed to be without any damage of fire nature.

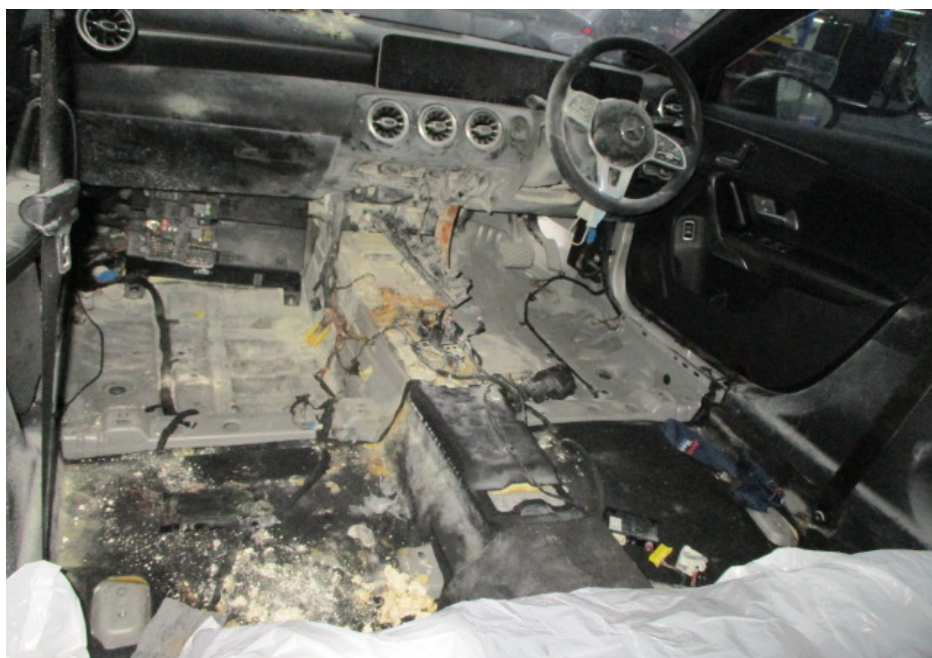
5. No visible damage of fire nature was observed to the exterior body of the Insured Vehicle. The rear boot compartment and engine compartment were also found to be without any fire damage.
6. Upon checking the interior compartment of the Insured Vehicle, I had found fire damage that was confined to the centre console area of the interior compartment. The dashboard, centre console, arm rest console, steering wheel, front left passenger seat, driver's seat, aircon ducts, aircon control panel, carpet, trims, upholstery, wirings, airbag control module and front windscreen were amongst the parts that were observed to be burnt and/or had sustained heat/smoke damage. See photo 1 – 6 below.

Photo 4 shows the interior compartment of the Insured Vehicle. Fire damage that was confined to the centre console area of the interior compartment was observed. The front dashboard, centre console, arm rest console, carpet, trims, upholstery, wirings and steering wheel were amongst the parts that were observed to be burnt and/or had sustained heat/smoke damage.

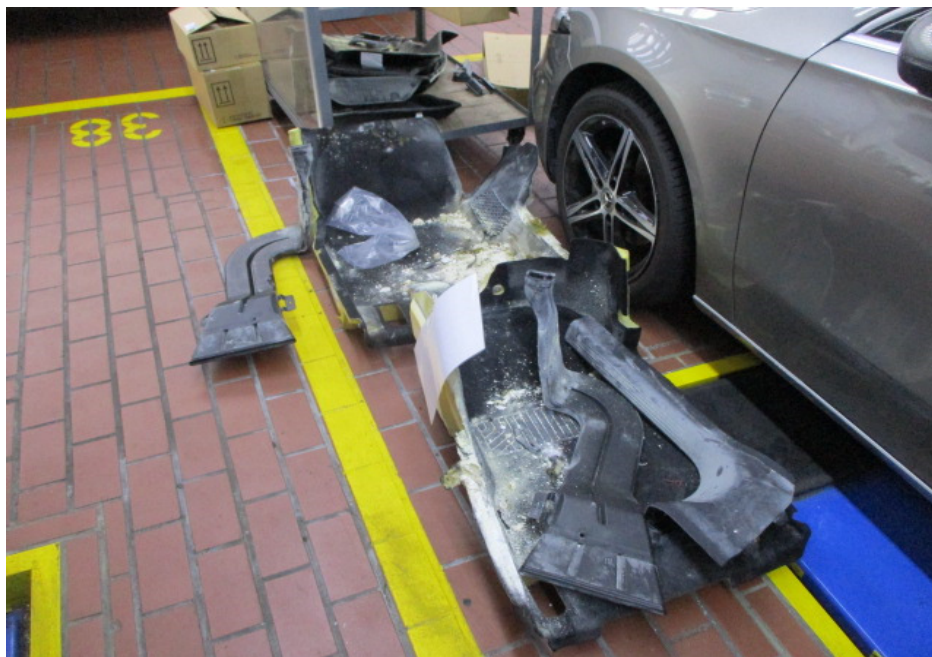
Photo 5 shows a general view of some of the burnt/damaged carpet, trims and aircon ducts that were removed from the interior compartment of the Insured Vehicle prior to my inspection.

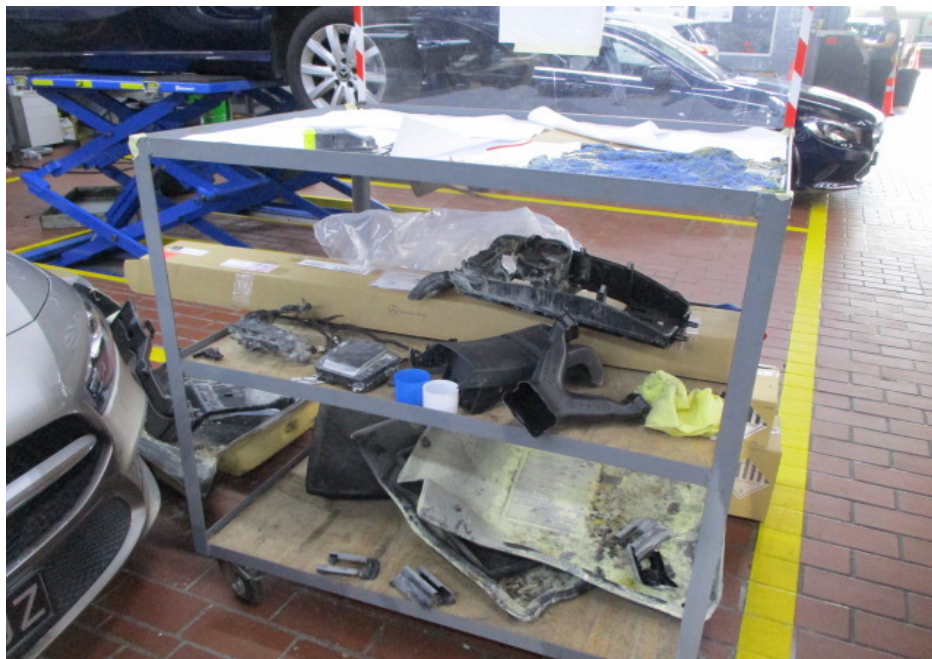
Photo 6 shows a general view of some of the burnt/damaged parts that were removed from the interior compartment of the Insured Vehicle prior to my inspection. These parts had included carpet, control panels, air ducts and trims amongst others.

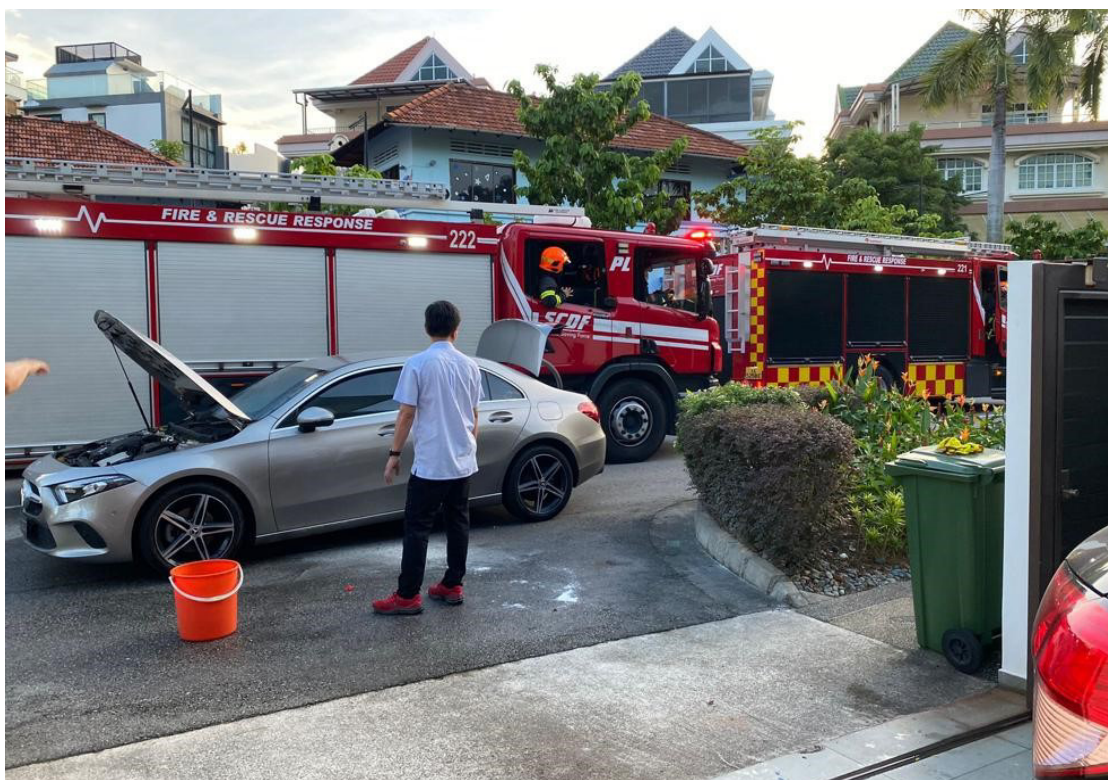
Photo 7 shows the Insured Vehicle at the incident scene, after the fire was extinguished (photograph provided to me by Mr Tan). The Insured Vehicle can be seen stopped outside the gate of a house with SCDF officers at scene.

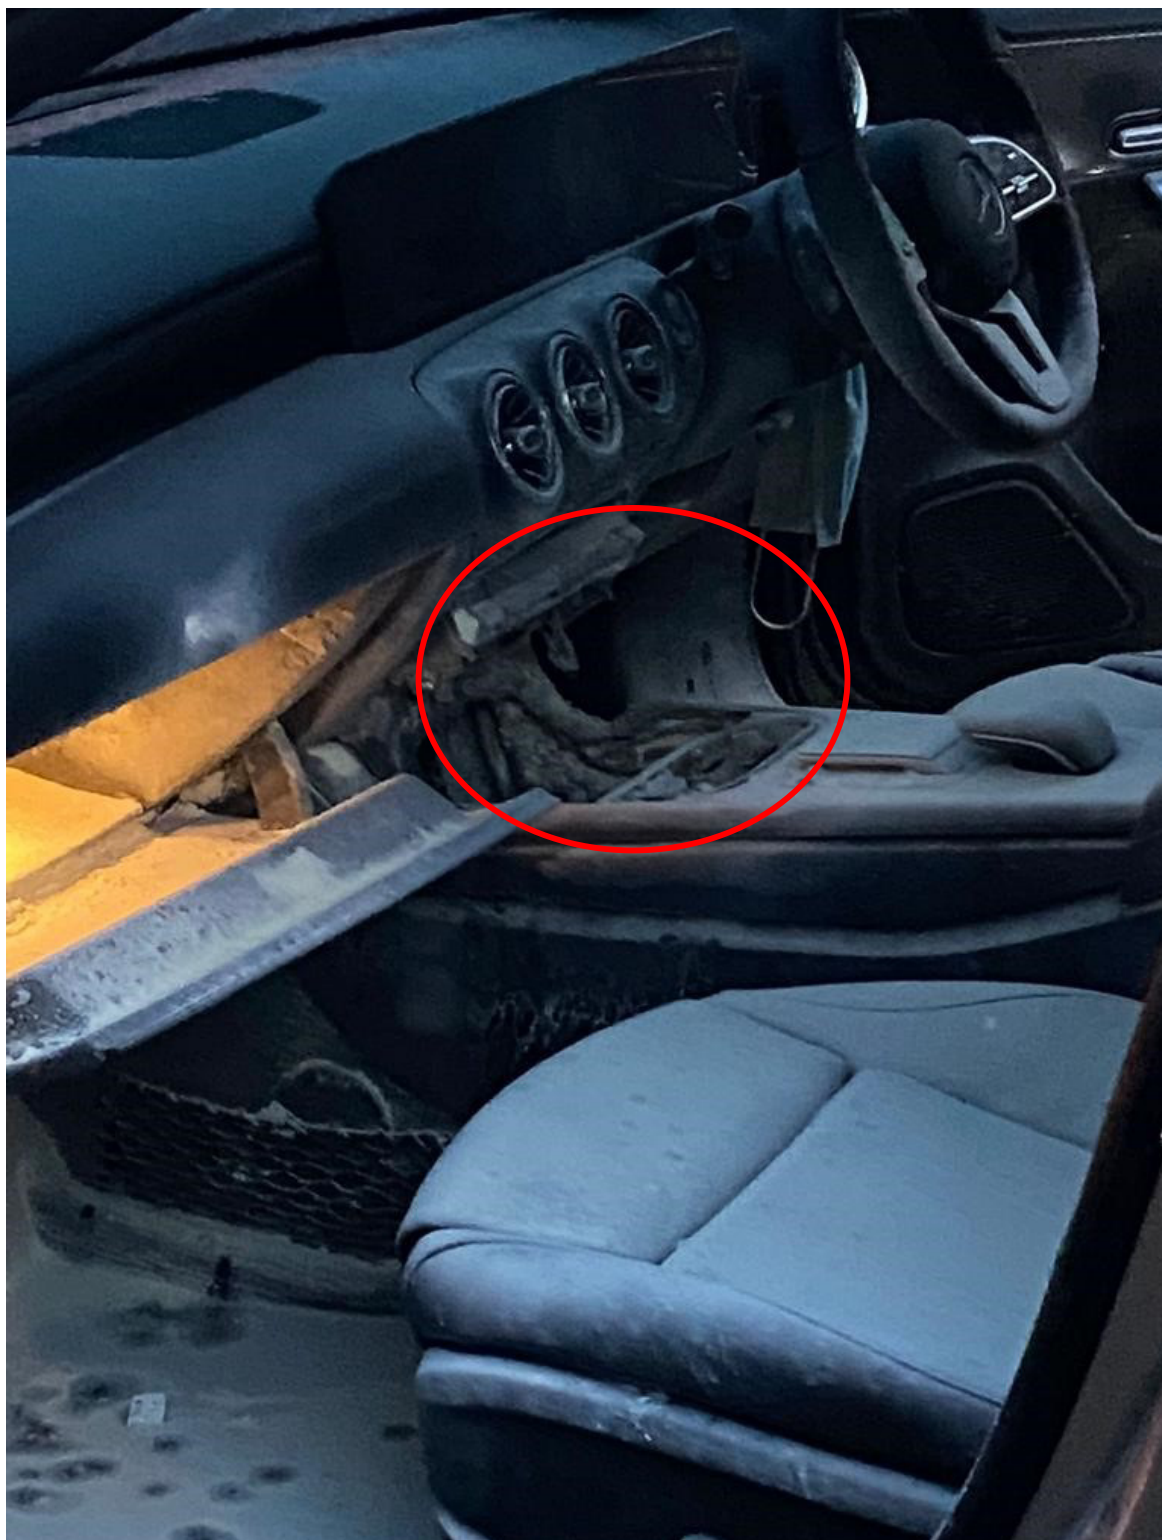
15. The photographs provided had showed the Insured Vehicle stopped outside the gate of a house with the fire extinguished. A section of the Insured Vehicle's centre console, within the interior compartment, was seen to be melted/burnt. Notable, I did not observe any electronic device(s) placed near the melted/burnt area. See photo 7 & 8 below.

Photo 8 shows the interior compartment of the Insured Vehicle at the incident scene, after the fire was extinguished (photograph provided to me by Mr Tan). A section of the Insured Vehicle's centre console (circled), within the interior compartment, was seen to be melted/burnt. Notable, I did not observe any electronic device(s) placed near the melted/burnt area.

16. For this case, it can clearly be established that the fire had originated within the interior compartment of the Insured Vehicle, at the centre console area highlighted by the red circle in photograph 8 above and also in photograph 9 below. This takes into consideration that there was no fire damage observed at other areas of the Insured Vehicle.

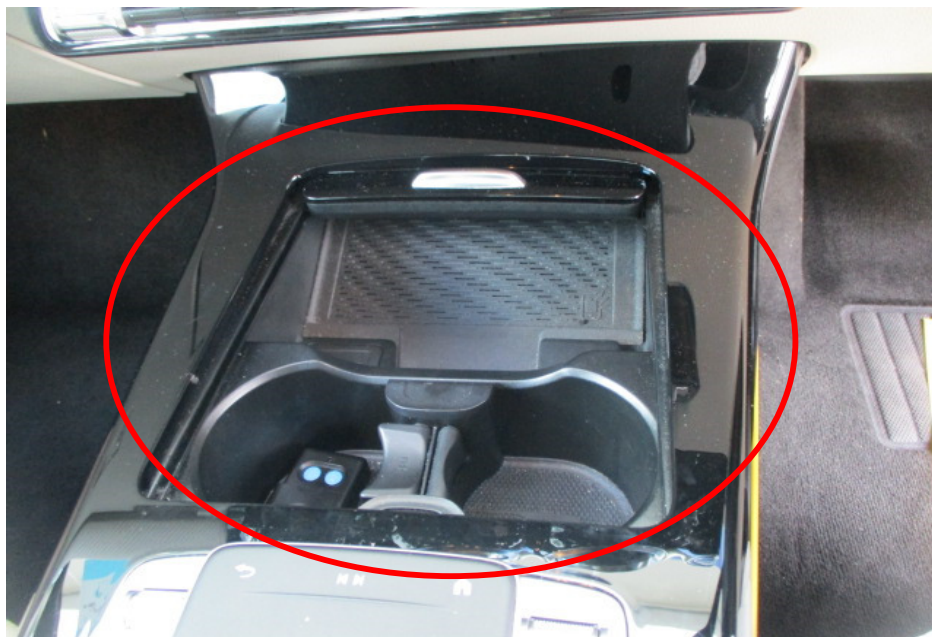
Photo 9 shows the centre console of a similar make and model vehicle as the Insured Vehicle. The fire to the Insured Vehicle had occurred at the area highlighted by the red circle. This takes into consideration that there was no fire damage observed at other areas of the Insured Vehicle apart for the fire damage seen at this same area of the Insured Vehicle immediately after the fire was extinguished, which is shown in photograph 8 above.

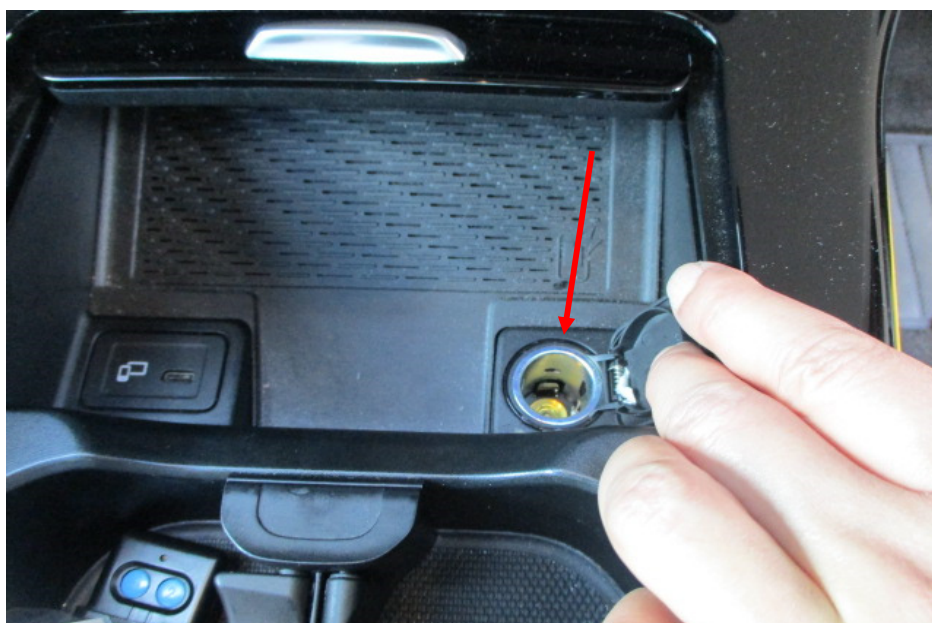
Photo 10 shows the auxiliary power outlet (arrowed) or more commonly referred to as cigarette lighter socket of a similar make and model vehicle as the Insured Vehicle. The auxiliary power outlet of the Insured Vehicle was found to be rusted (refer to photograph 11 & 12 below), which is a sign of prolonged exposure to high heat intensity. The auxiliary power outlet is also located towards the right of the centre console where the front dashboard reinforcement was correspondingly found to be rusted (refer to photograph 13 & 14 below).

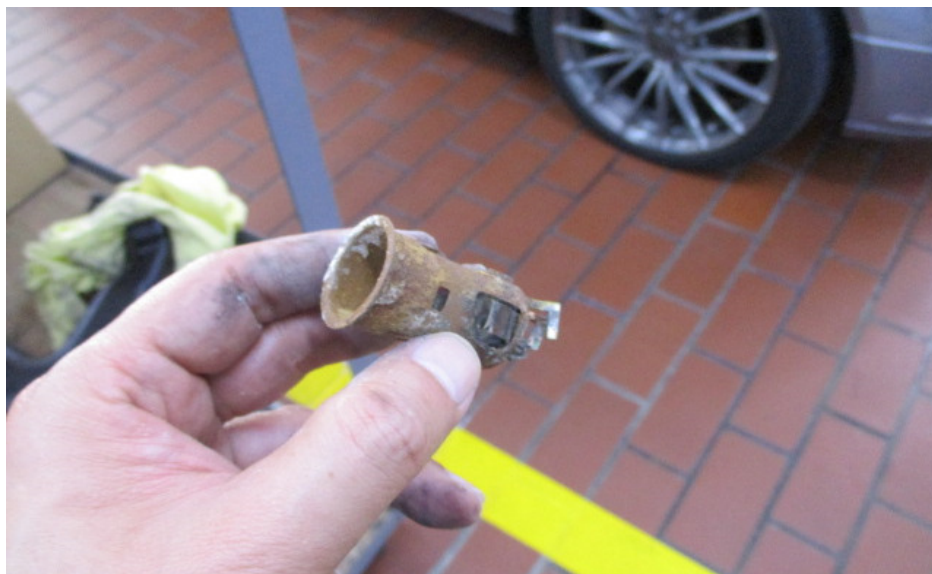
17. At the time of my inspection of the Insured Vehicle, I had found almost all the burnt/damaged parts surrounding the centre console within the interior compartment dismantled and removed for Mercedes Benz's own technical investigation into the cause of fire. Upon my close examination of the removed burnt/damaged parts, I had found the auxiliary power outlet or more commonly referred to as cigarette lighter socket to be rusted.

18. Typically, the presence of rust on a steel/metal material body part of a vehicle that was involved in a fire incident is a consequence of that body part being exposed to natural environmental condition after layers of paint and its related compounds were melted due to prolonged exposure of that particular body part to high heat intensity. Following the aforesaid, it would be reasonable to then determine that the auxiliary power outlet of the Insured Vehicle was exposed to prolonged high heat intensity.

Photo 11 shows the auxiliary power outlet of the Insured Vehicle, which was found to be rusted. The presence of rust on a steel/metal material body part of a vehicle that was involved in a fire incident is a consequence of that body part being exposed to natural environmental condition after layers of paint and its related compounds were melted due to prolonged exposure of that particular body part to high heat intensity. Following the aforesaid, it would be reasonable to determine that the auxiliary power outlet of the Insured Vehicle was exposed to prolonged high heat intensity.

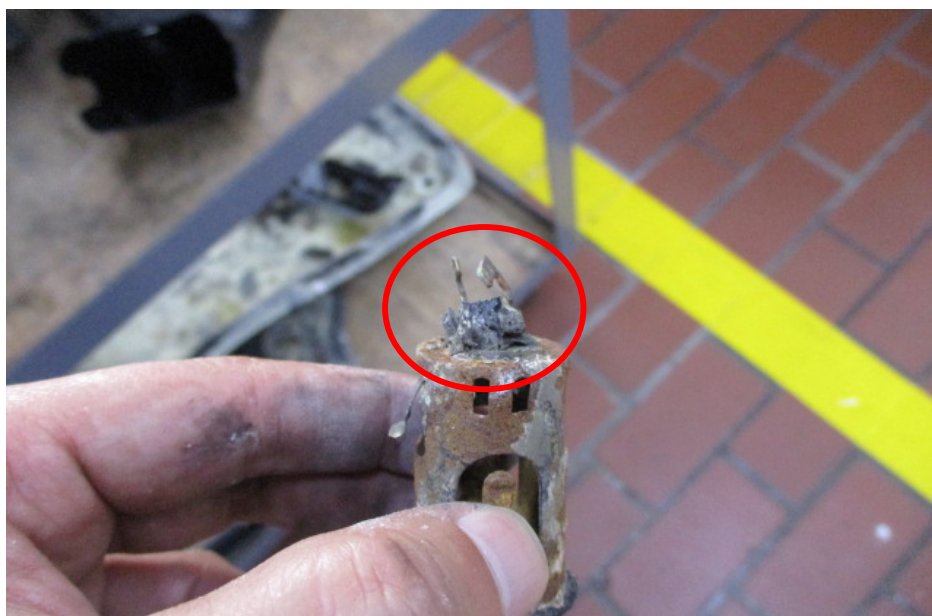
19. In modern day vehicles, the auxiliary power outlet is also a connector supplying electrical power (direct current) from the vehicle's electrical system. The auxiliary power outlet can be connected to provide the electrical current needed to power portable accessories that can be used in or near the vehicle. Since the auxiliary power outlet of the Insured Vehicle was exposed to prolonged high heat intensity and also given that the auxiliary power outlet is connected to the electrical system of the Insured Vehicle, it would appear to me that the fire to the Insured Vehicle had likely arisen due to abnormality of the electrical current at the auxiliary power outlet of the Insured Vehicle. In other words, the fire to the Insured Vehicle was of electrical nature to the wirings connecting to the pins of the auxiliary power outlet.

Photo 12 shows the auxiliary power outlet of the Insured Vehicle, which was found to be rusted. The auxiliary power outlet is also a connector supplying electrical power (direct current) from the vehicle's electrical system. The connecting pins are highlighted by the red circle. The fire to the Insured Vehicle had likely arisen due to abnormality of the electrical current at the auxiliary power outlet of the Insured Vehicle. In other words, the fire to the Insured Vehicle was of electrical nature to the wirings connecting to the pins of the auxiliary power outlet.

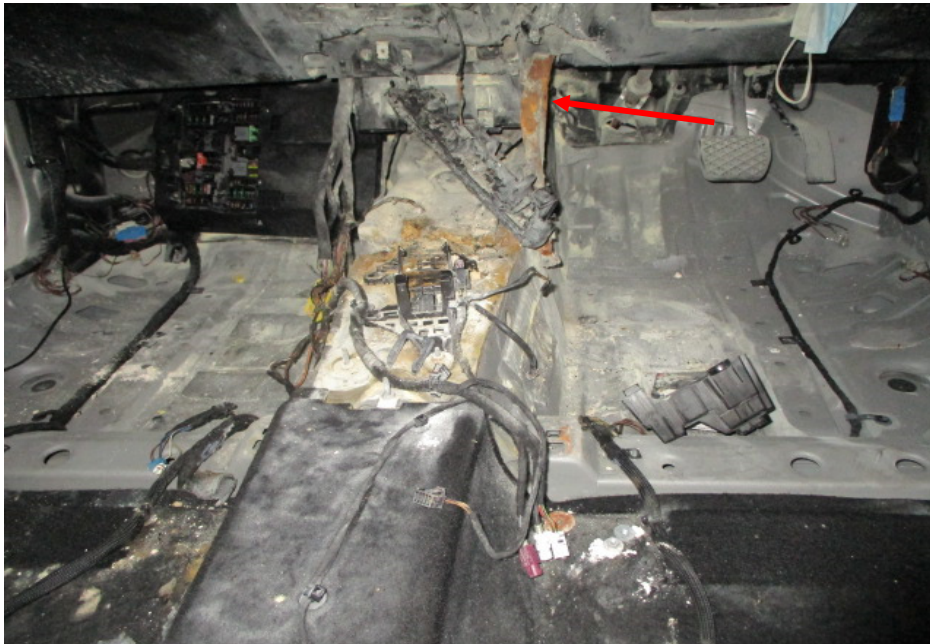
20. The fire occurring at the auxiliary power outlet of the Insured Vehicle is also supported by the rust observed on the front dashboard reinforcement, at the right side. This is the same side and in close proximity to where the auxiliary power outlet is located. The presence of rust seen on the front dashboard reinforcement is again an indication of prolonged exposure to high heat intensity at the right side area of the centre console. See photo 9 – 14 below.

Photo 13 shows a general view of the centre console area of the Insured Vehicle, after the burnt/damaged parts surrounding the centre console were dismantled and removed. Rust was observed on the front dashboard reinforcement, at the right side (arrowed). This is the same side and in close proximity to where the auxiliary power outlet is located. The presence of rust seen on the front dashboard reinforcement is again an indication of prolonged exposure to high heat intensity and hence supports the fire occurring at the auxiliary power outlet of the Insured Vehicle.

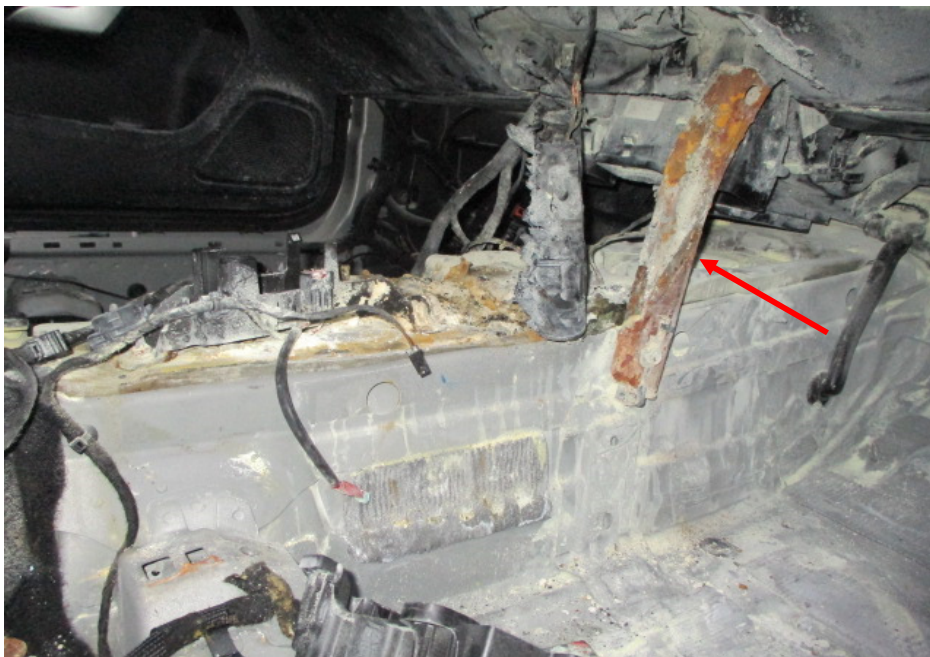
Photo 14 shows a closer view of the rust that had developed on the front dashboard reinforcement, at the right side (arrowed). This is the same side and in close proximity to where the auxiliary power outlet is located.
