Your Ref: 4595042732SG
Our Ref : CS4/AIG21012737/P

24th December 2021

**TECHNICAL INVESTIGATION REPORT OF ACCIDENT INCIDENT INVOLVING
THE INSURED VEHICLE SLV 2734U ON 6th December 2021**

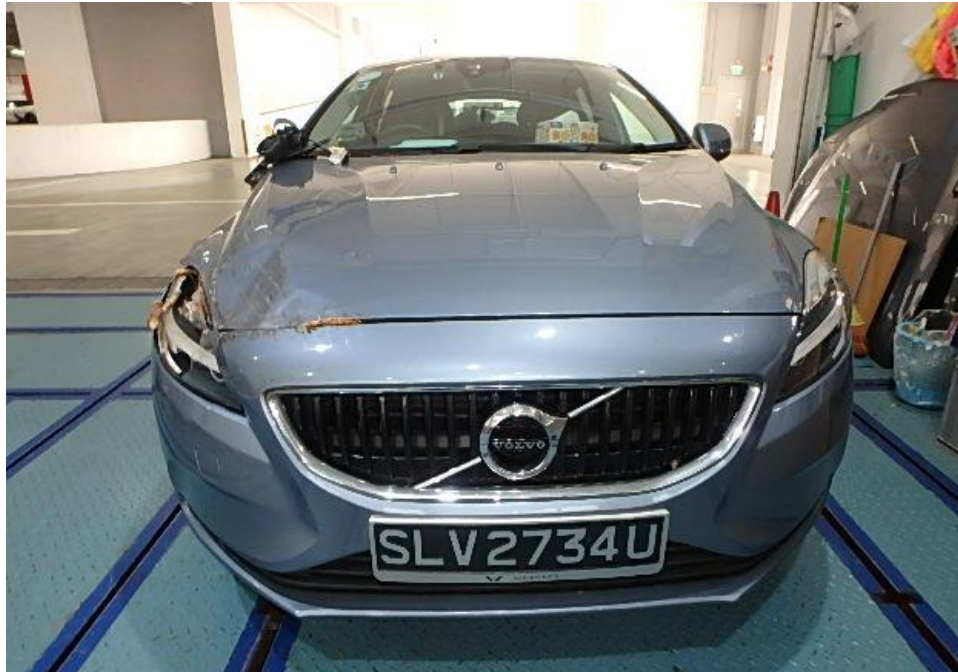
Photo 1 shows the general view of the front portion of the Insured Vehicle at the time of our inspection. Its front bonnet, front right headlamp, front bumper, front right fender and right side mirror was the body parts that were damaged as a result of the accident.

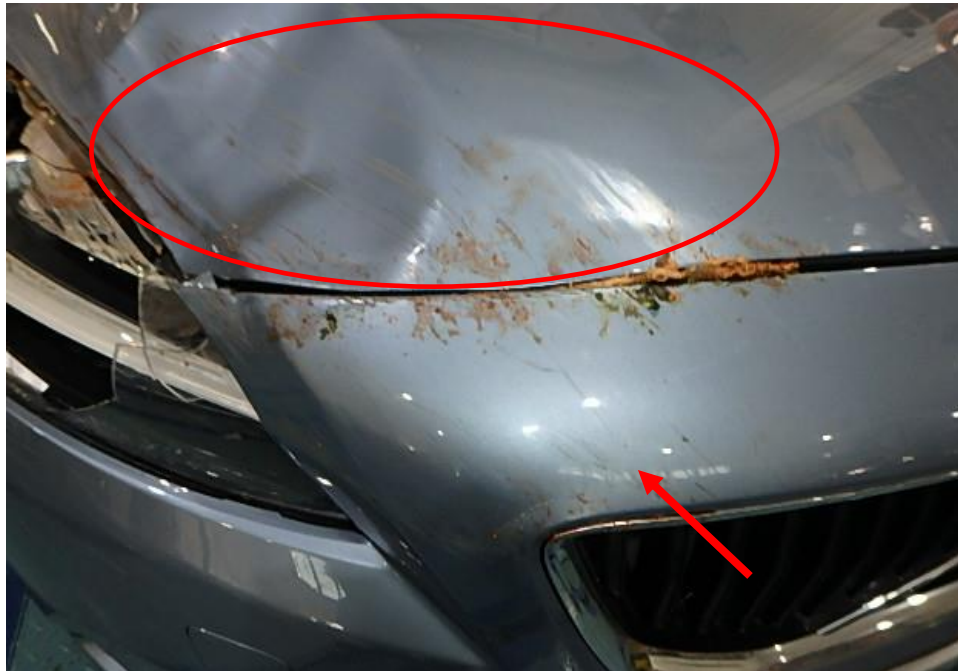
Photo 2 shows the close up view of the front portion of the Insured Vehicle at the time of our inspection. Its front bonnet (circled) and front bumper (arrowed), was the body parts that were damaged as a result of the accident.

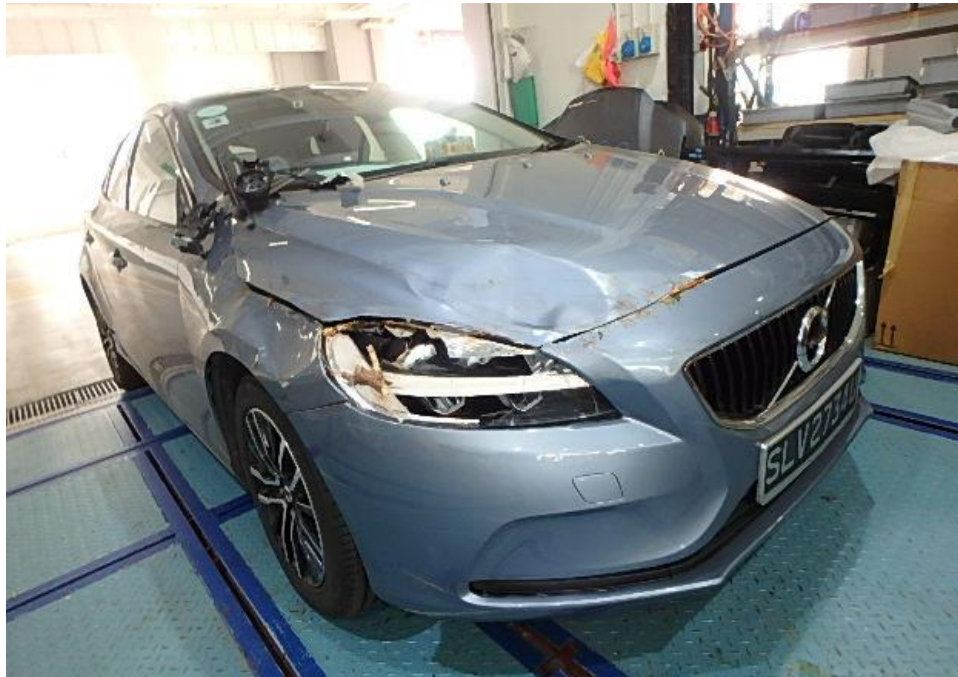
Photo 3 shows the general view of the right body of the Insured Vehicle at the time of our inspection. Its front right fender, front right headlamp, and right side rear view mirror was the body parts that were damaged as a result of the accident.

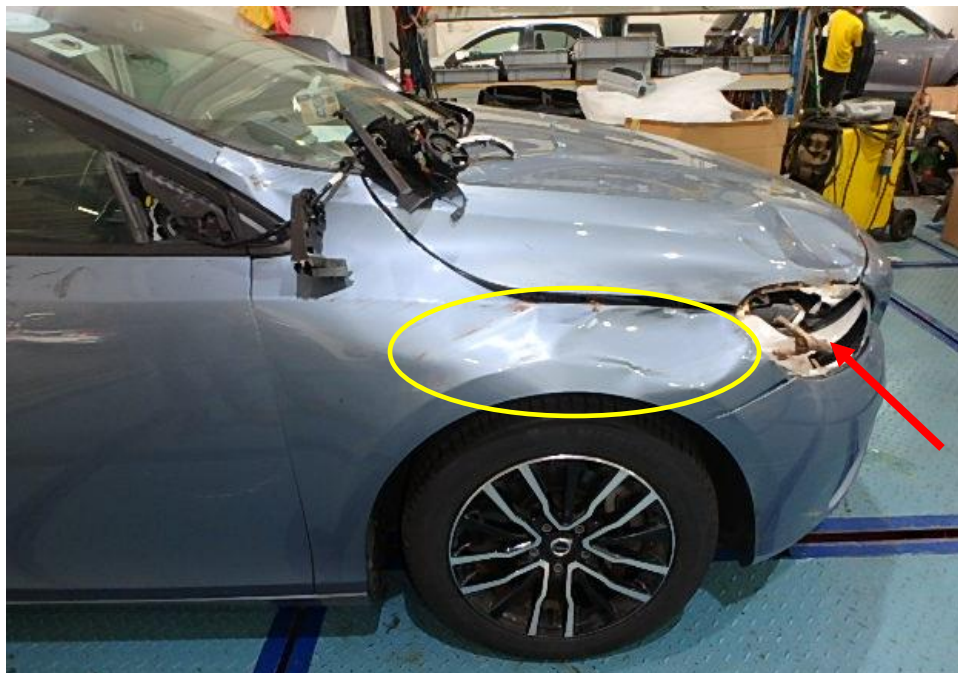
Photo 4 shows the close up view of the right body of the Insured Vehicle at the time of our inspection. Its front right fender (circled), and front right headlamp (red arrow) was the body parts that were damaged as a result of the accident.

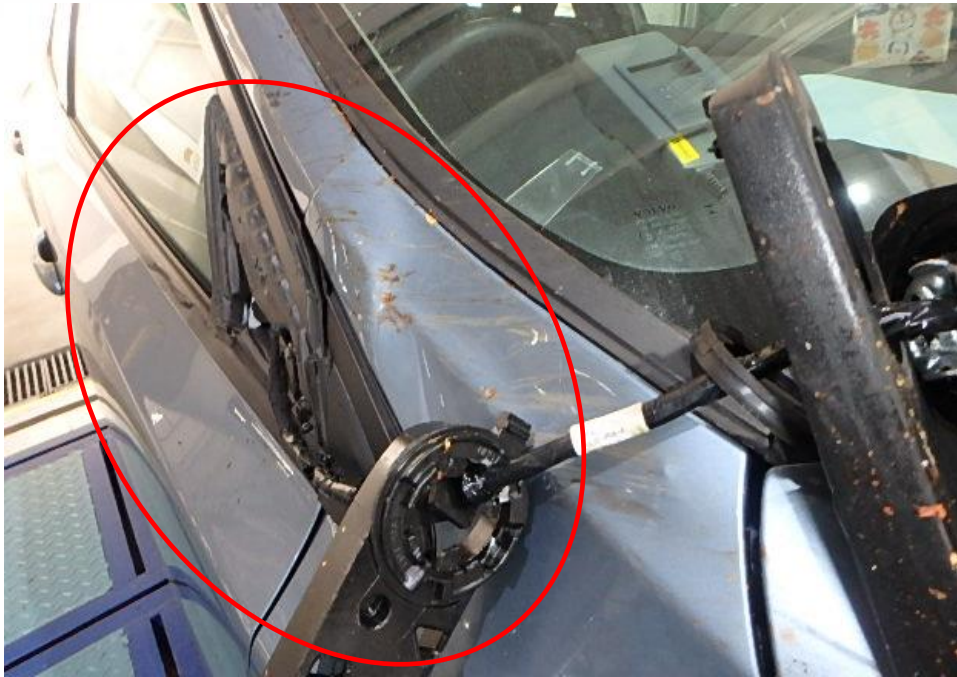
Photo 5 shows the close up view of the right body of the Insured Vehicle at the time of our inspection. Its right side rear view mirror (circled) was the body parts that were damaged as a result of the accident.

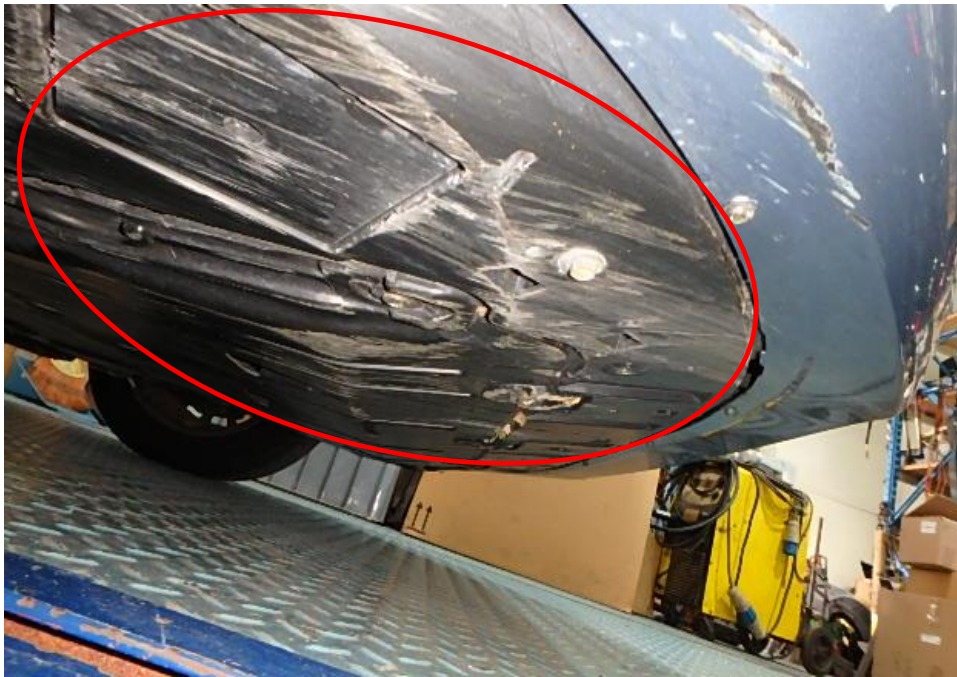
Photo 6 shows the close up view of the undercarriage portion of the Insured Vehicle at the time of our inspection. Its undercarriage panel (circled) was the body parts that were damaged as a result of the accident.

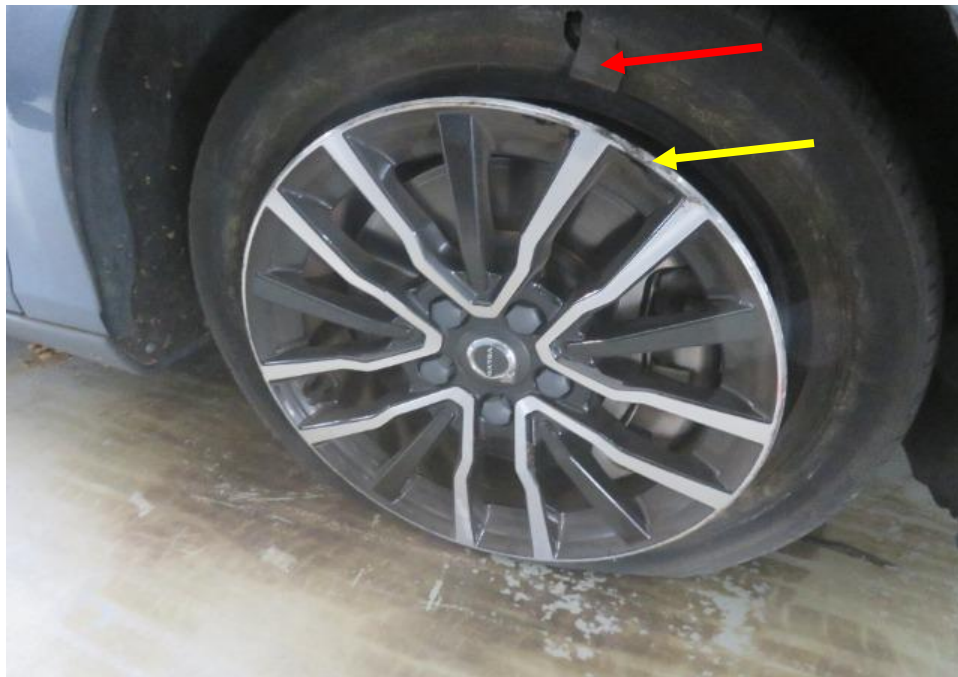
Photo 7 shows the general view of the front right tyre portion of the Insured Vehicle at the time of our inspection. Its front right tyre (red arrow) was observed to be cut and its wheel rim (yellow arrow) was observed to be scratched as a result of the accident.

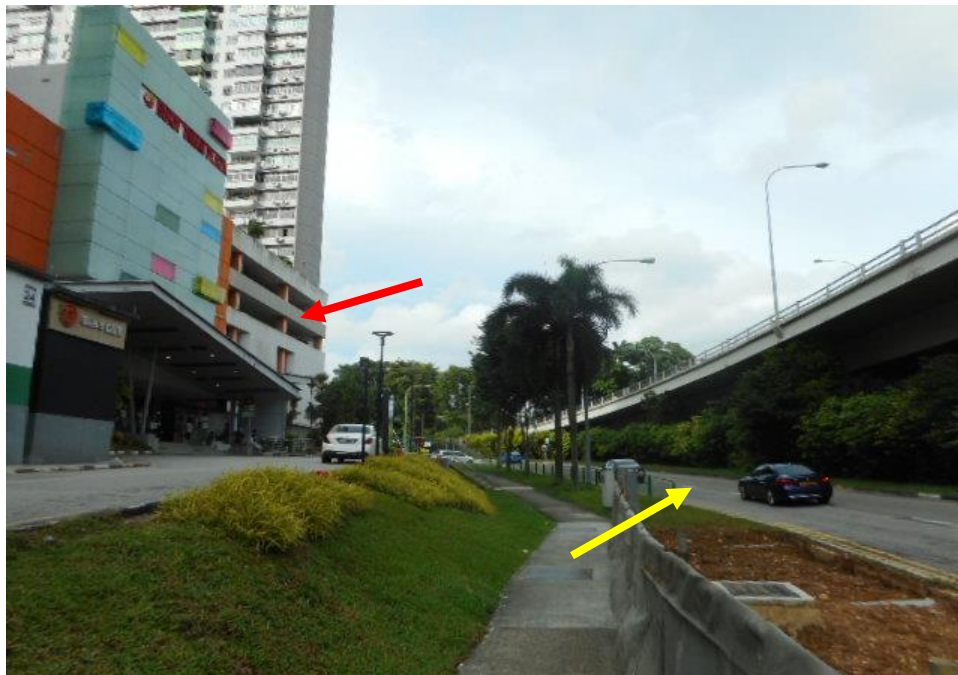
Photo 8 shows MSCP of Bukit Timah plaza on the left (red arrow) and Jln Anak Bukit Road on the right (yellow arrow). In general, the information that could be gathered from this photograph had corresponded to the events that were related to us by Mr Ong, location when the accident happened.

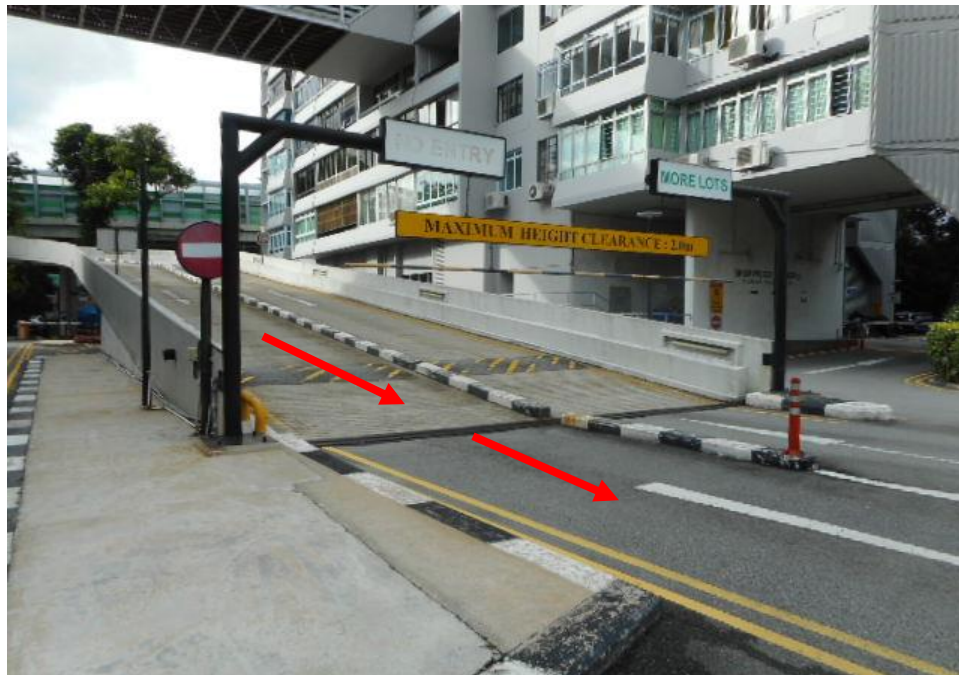
Photo 9 shows the MSCP exit from Bukit Timah Plaza (arrowed). In general, the information that could be gathered from this photograph had corresponded to the events that were related to us by Mr Ong, location when the accident happened.

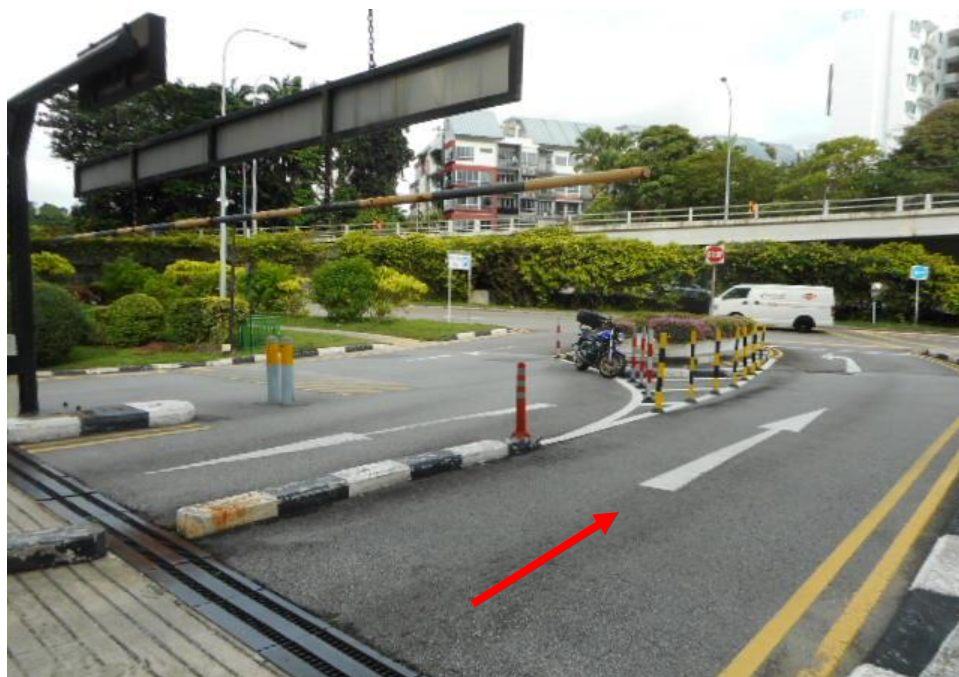
Photo 10 shows the MSCP exit junction from Bukit Timah Plaza. In general, the information that could be gathered from this photograph had corresponded to the events that were related to us by Mr Ong, location when the accident happened.

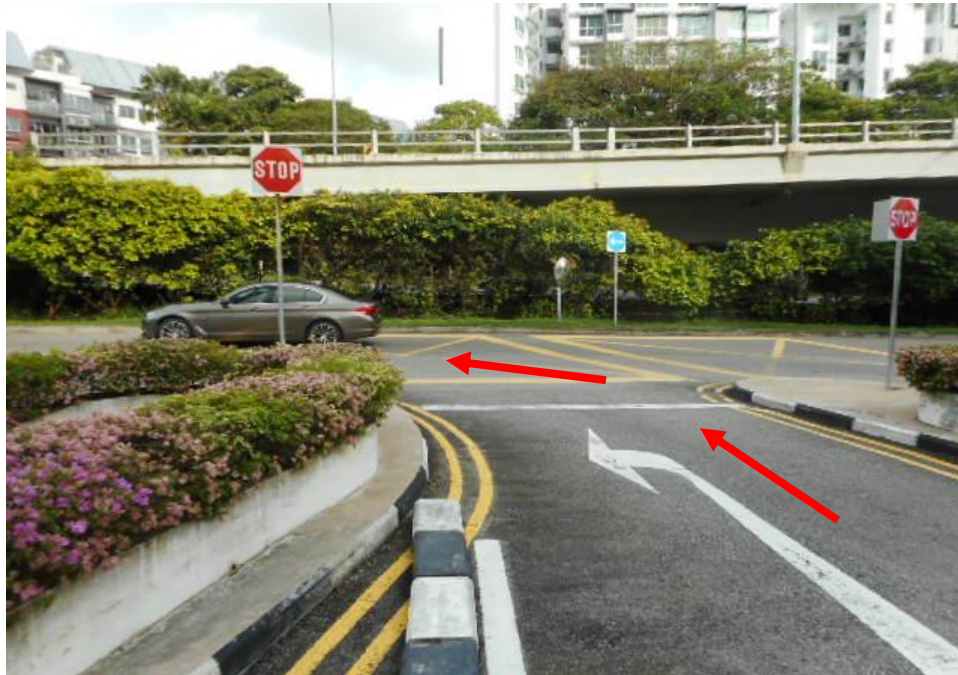
Photo 11 shows the left turn exit junction from Bukit Timah Plaza onto Jln Anak Bukit Road (arrowed). In general, the information that could be gathered from this photograph had corresponded to the events that were related to us by Mr Ong, location when the accident happened.

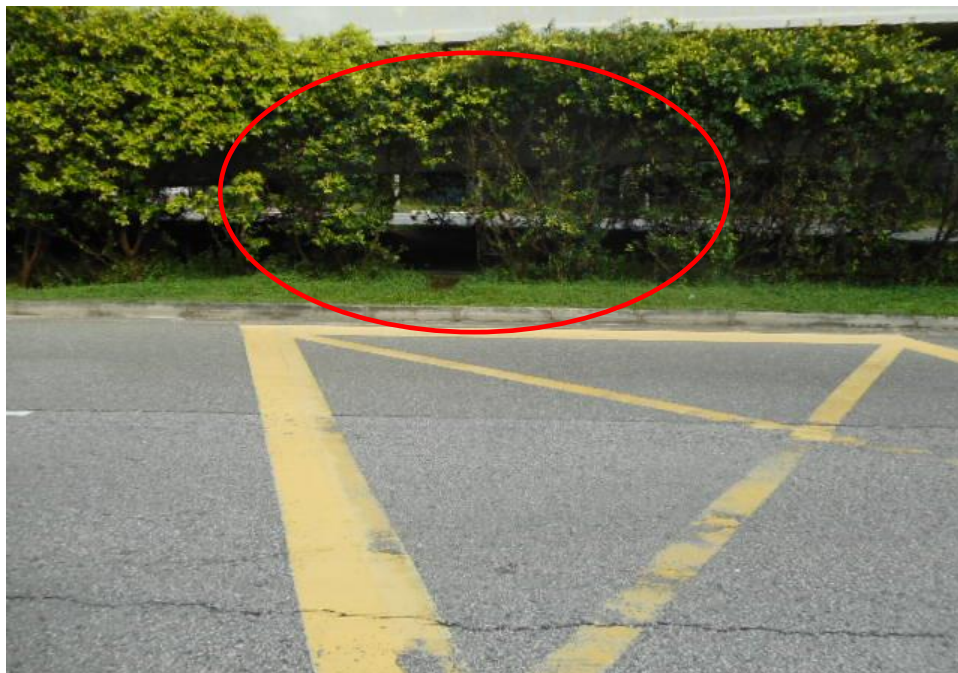
Photo 12 shows the area on the other side of the road from Bukit Timah Plaza onto Jln Anak Bukit Road we had observed a hole in between the tree shrubs and this is where the Insured Vehicle had mounted the curb and drove into (circled). In general, the information that could be gathered from this photograph had corresponded to the events that were related to us by Mr Ong, location when the accident happened.

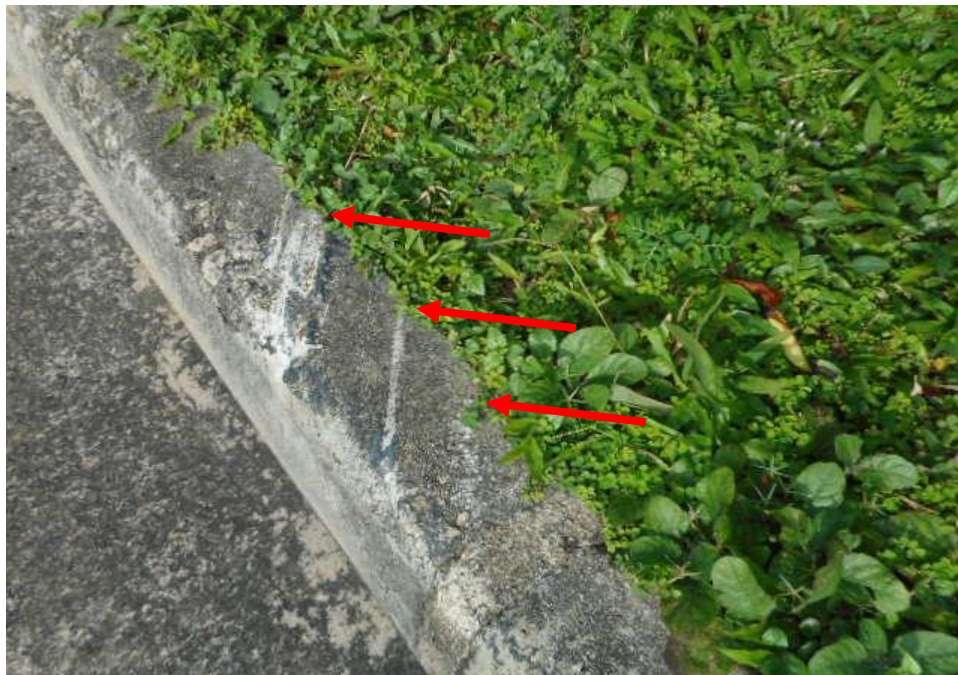
Photo 13 shows the curb side on Jln Anak Bukit Road, the curb had suffer damaged as a result of the Insured Vehicle mounting it (arrowed). In general, the information that could be gathered from this photograph had corresponded to the events that were related to us by Mr Ong, location when the accident happened.

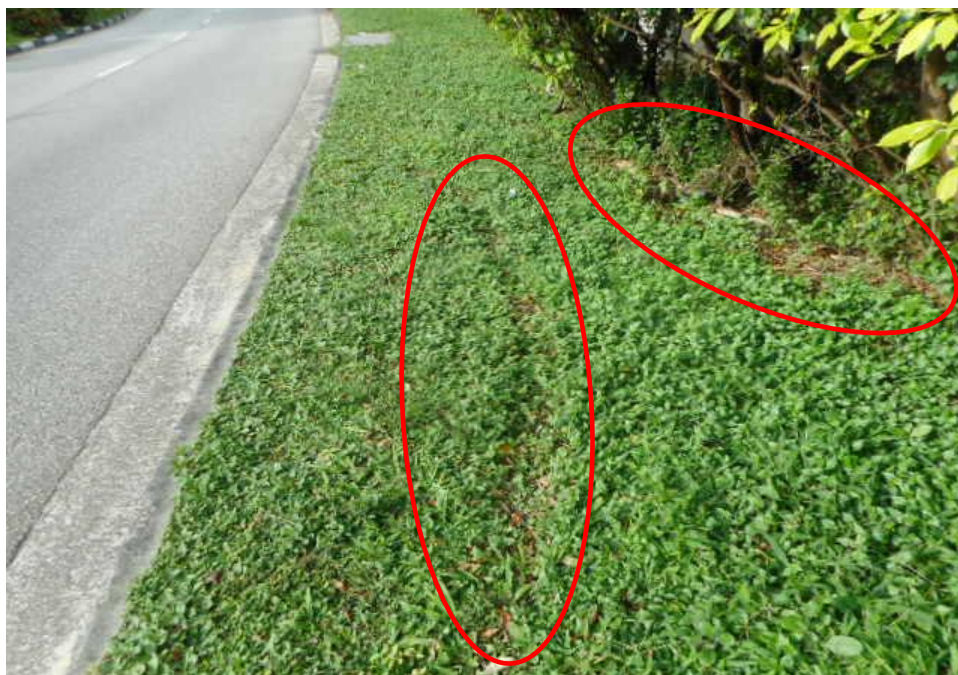
Photo 14 shows the grass patch on Jln Anak Bukit Road, the grass patch had signs of tyre track marks as a result of the Insured Vehicle mounting and driving over it (circled). In general, the information that could be gathered from this photograph had corresponded to the events that were related to us by Mr Ong, location when the accident happened.

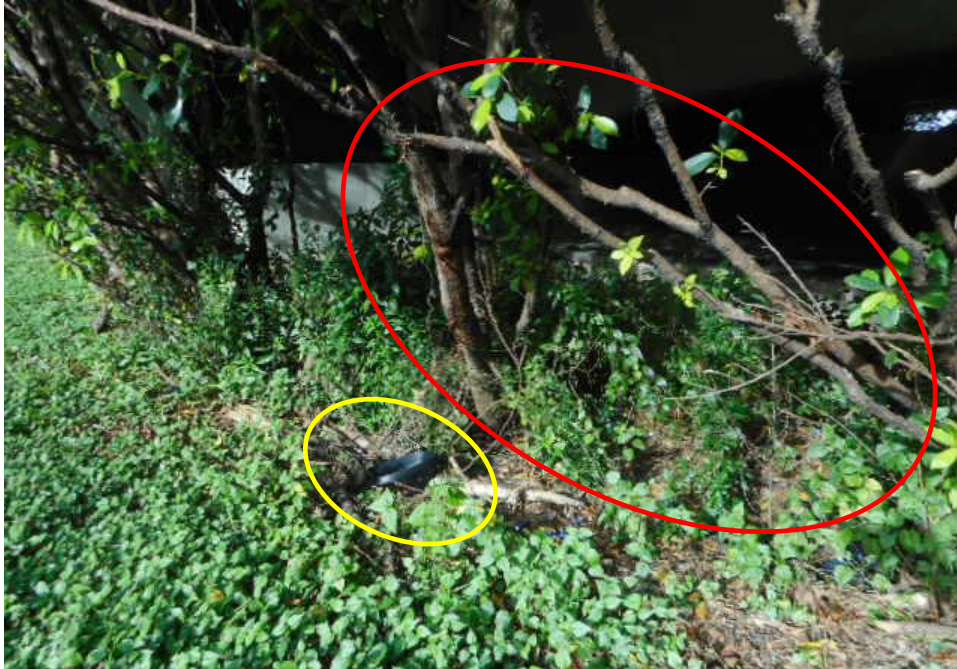
Photo 15 shows the general view of the tree shrubs on the grass patch of Jln Anak Bukit Road, the tree shrub and its branches had signs damaged marks as a result of the Insured Vehicle driving into (red circle) and we had observed multiple remains of the Insured Vehicle's right side rear view mirror (yellow circle) in that area. In general, the information that could be gathered from this photograph had corresponded to the events that were related to us by Mr Ong, location when the accident happened.

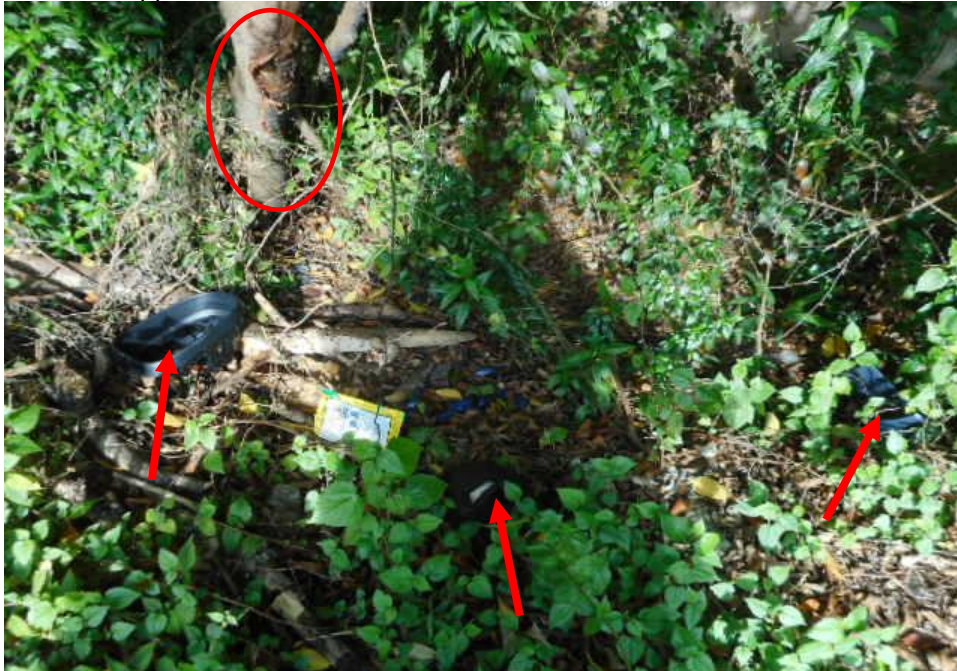
Photo 16 shows the close up view of the tree shrubs on the grass patch of Jln Anak Bukit Road, the tree shrub and its branches had signs damaged marks as a result of the Insured Vehicle driving into (red circle) and we had observed multiple remains of the Insured Vehicle's right side rear view mirror (arrowed) in that area. In general, the information that could be gathered from this photograph had corresponded to the events that were related to us by Mr Ong, location when the accident happened.

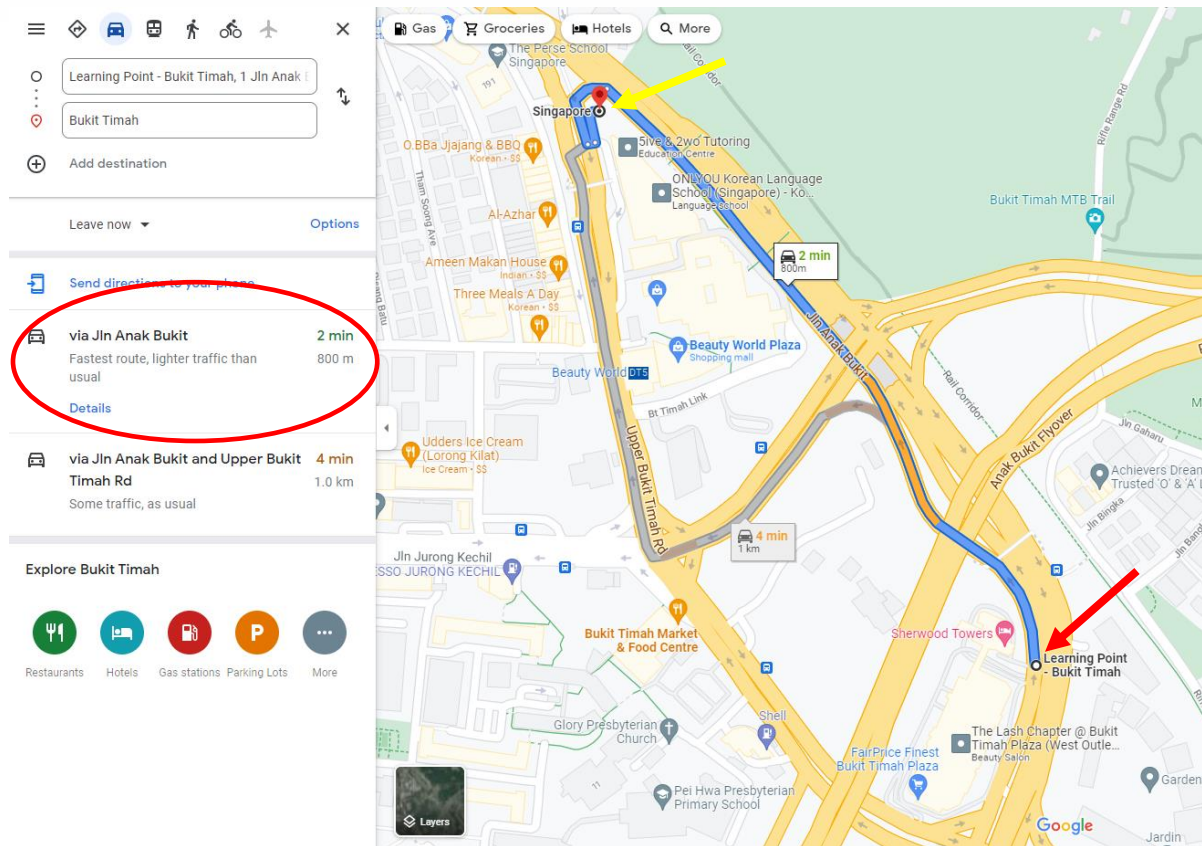
Photo 17 shows the routed route from Jln Anak Bukit Road (incident point) (red arrow) to mentioned car park (yellow) where Mr Ong drove to and inspected the Insured Vehicle was approximately 800m. (circled) In general, the information that could be gathered from this photograph had corresponded to the events that were related to us by Mr Ong, location when the accident happened.
