## INSPECTION CHECKLIST

Reference no: CS5/TP21012852/Cq

<b>Applicant</b>	<b>VENTURE CARS PTE LTD</b>
Date of Inspection	24/12/2021
Time of Inspection	13:30 HRS
Vehicle Make	HONDA
Vehicle Model	FIT 1.3 HOME
Vehicle Model Code	6BA-GR1
Engine Number	L13B1606532
Chassis Number	GR11104987
Motor Number (if any)	-
Odometer Reading	80 KM

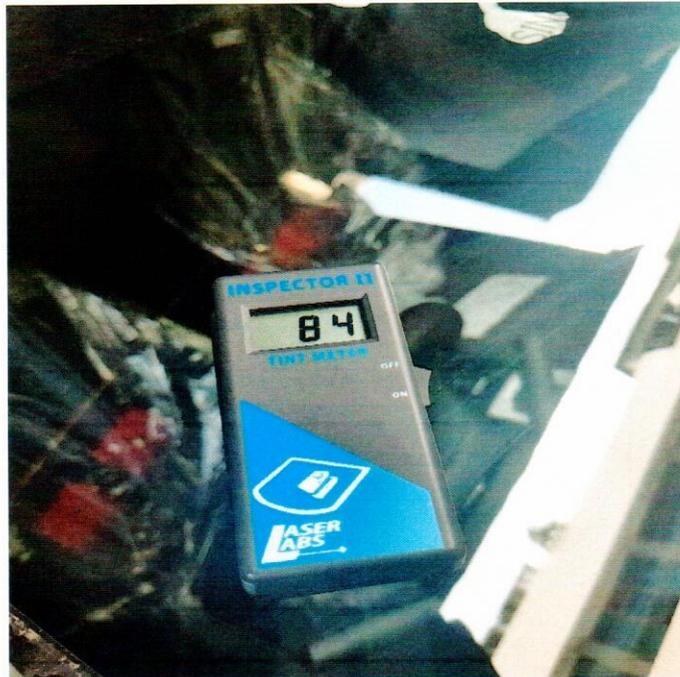
Windscreen VLT Reading: 84% (front)

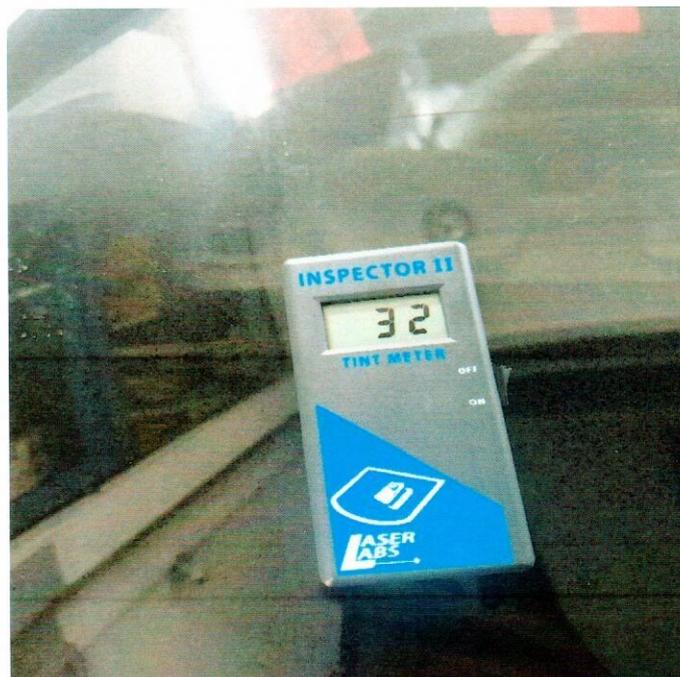
Windscreen VLT Reading: 32% (rear)

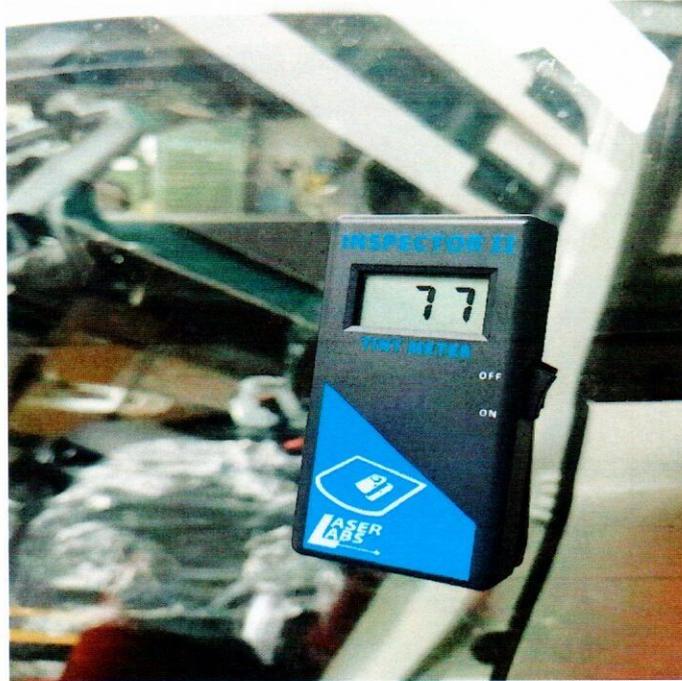
Front Windows VLT Reading: 77% (left)

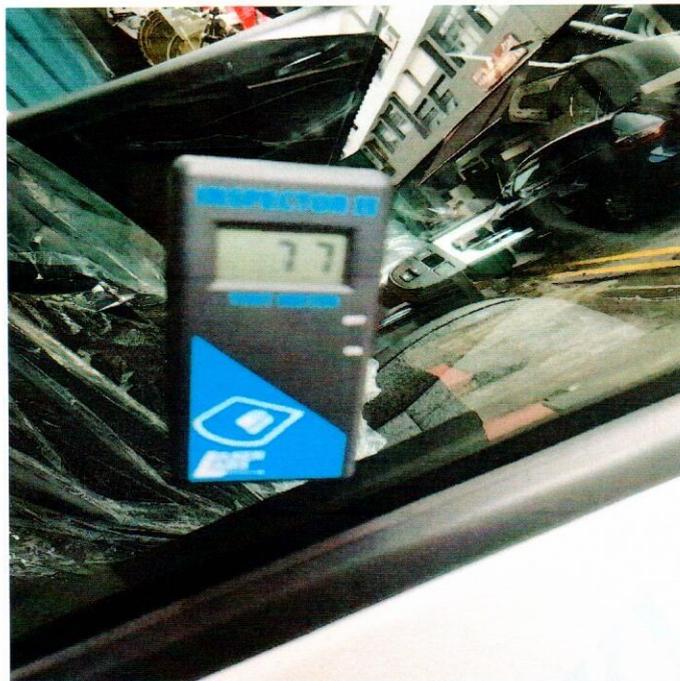
Front Windows VLT Reading: 77% (right)

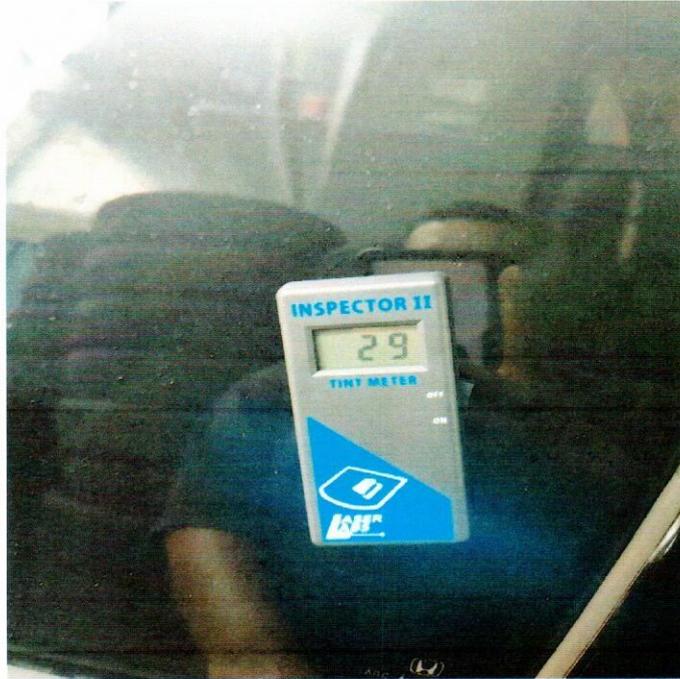
Rear Windows VLT Reading: 29% (left)

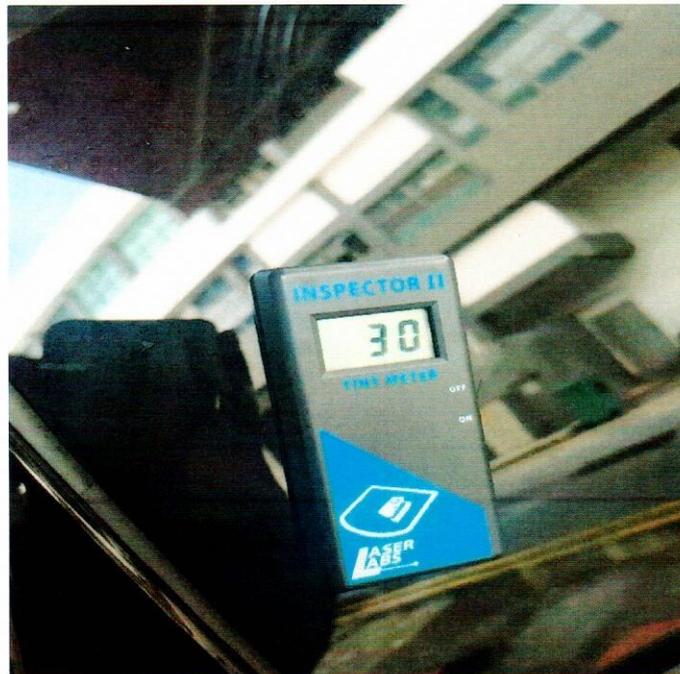
Rear Windows VLT Reading: 30% (right)

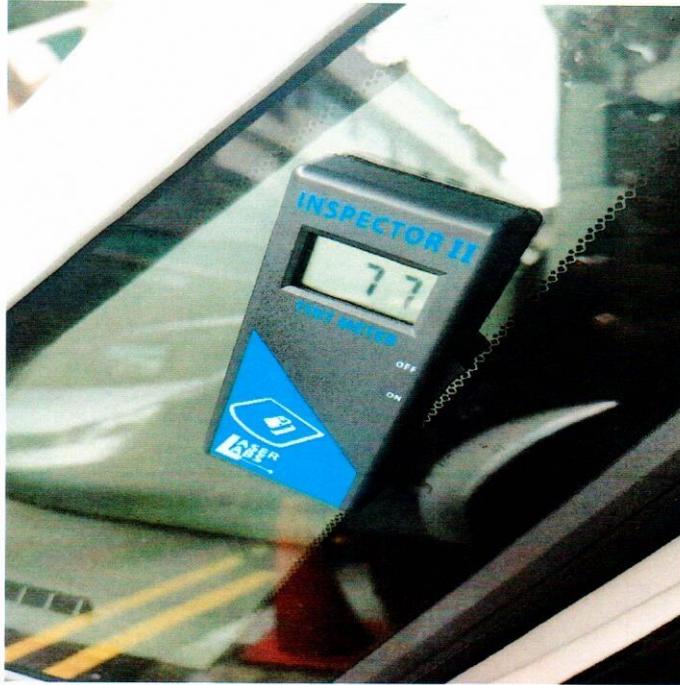
## Front Quarter Glass VLT Reading: 77 % (Left)

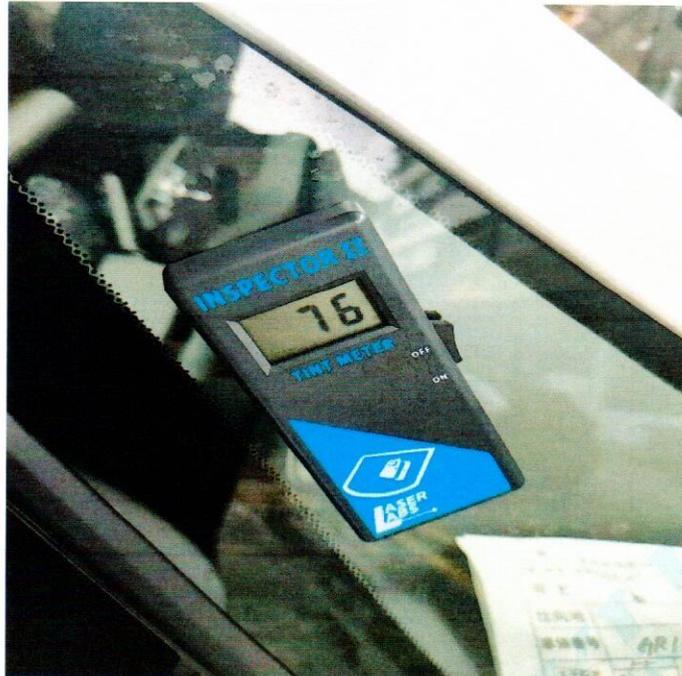
## Front Quarter Glass VLT Reading: 76% (Right)

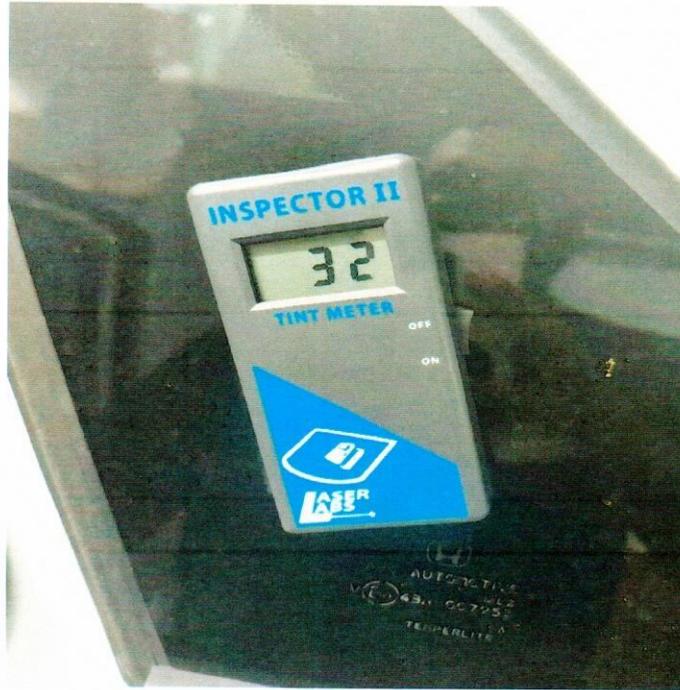
### Rear Quarter Glass VLT Reading: 32% (Left)

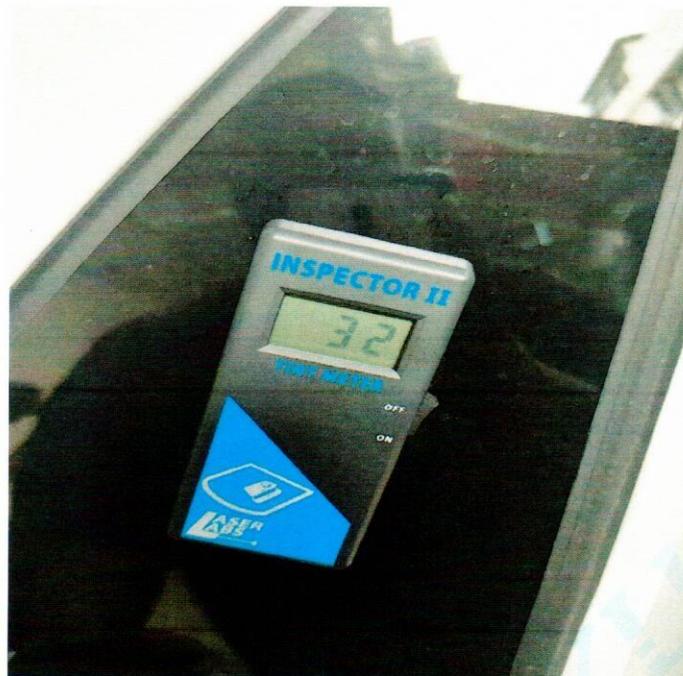
### Rear Quarter Glass VLT Reading: 32% (Right)
