Your Ref: TP/IP/53115/2021  
Our Ref: CI/TPD21013036/P

**Fatal Accident Investigation Team**

**MECHANICAL INSPECTION REPORT OF MOTOR LORRY GBE 447U**

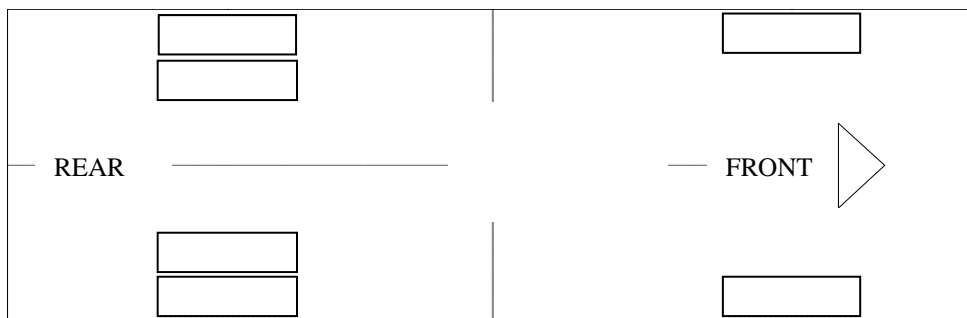
6. The 6 tyres of the Motor Lorry were observed to be in serviceable condition and sufficiently inflated for vehicular operation. I did not find any tear, cut or burst mark(s) on the outer and the inner sidewalls as well as across the tread of the 6 tyres. The tyre brand, tyre size and remaining tread depth of the 6 tyres of the Motor Lorry were recorded as follows:-

Lorrymax 155/R13 (1.9mm)

Triangle 195/R15 (4.7mm)

Lorrymax 155/R13 (1.6mm)

Dunlop 195/R15 (2.5mm)

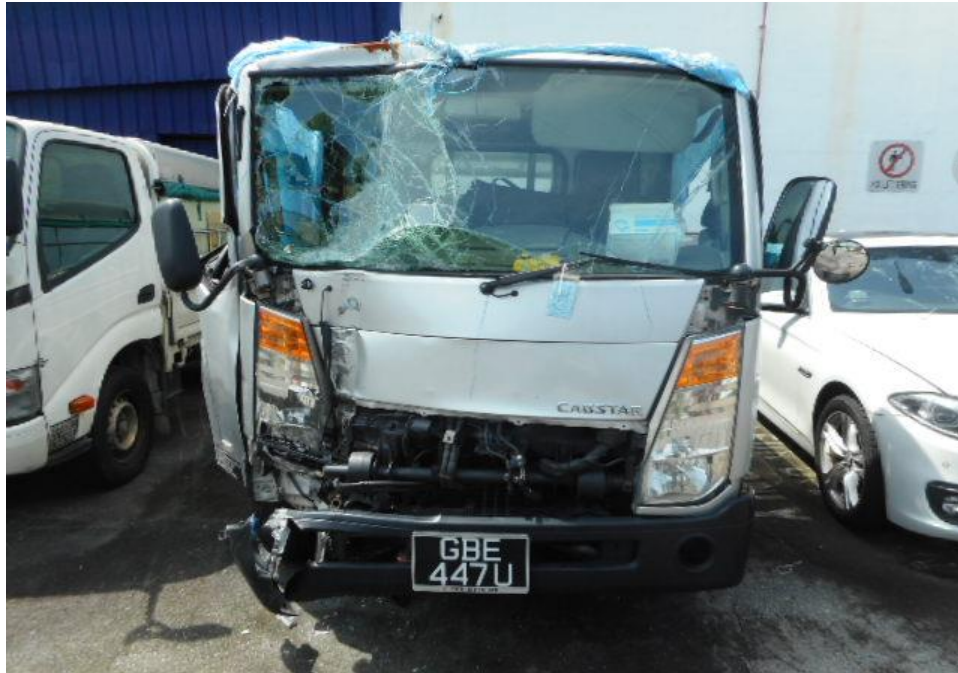
**Photo 1** shows a general view of the front portion of the Motor Lorry at the time of our inspection. The Motor Lorry was observed sustained major damages to its front cabin, front windscreen, front bumper and front body panel as well as its right door due to the accident.

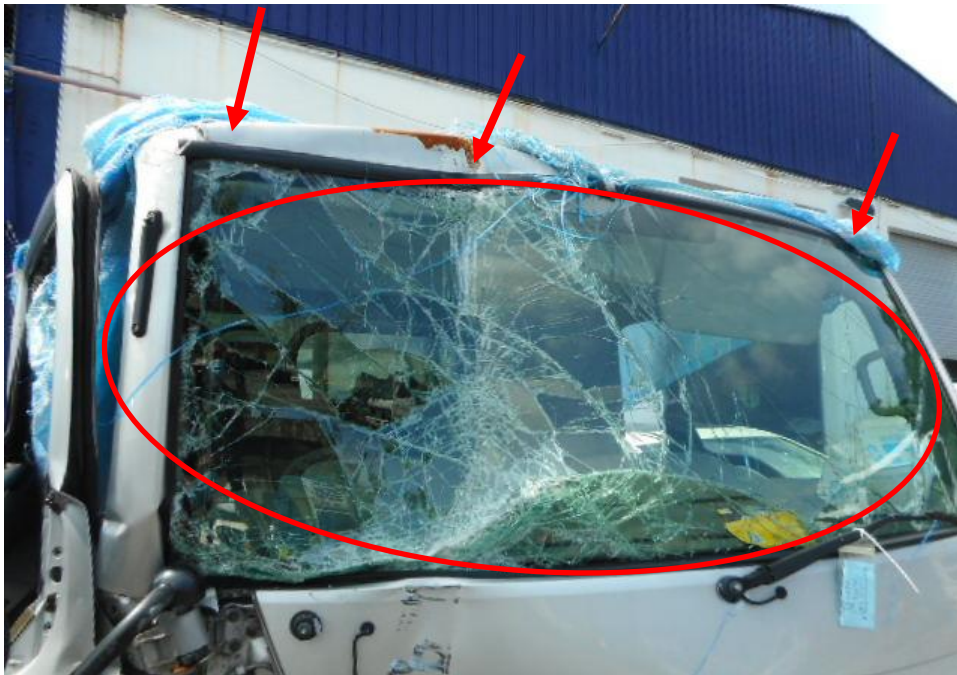
**Photo 2** shows the close up view of the front portion of the Motor Lorry at the time of our inspection. The Motor Lorry was observed to have sustained major damages to its front windscreen (circled) and its front cabin (arrowed) that was crushed due to the accident's impact.

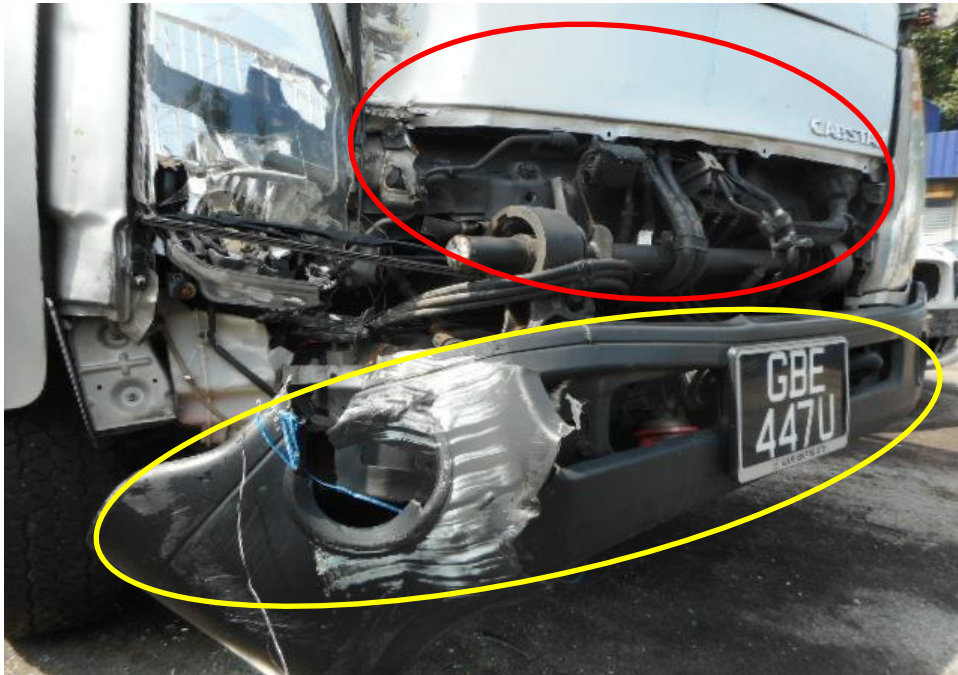
**Photo 3** shows the close up view of the front portion of the Motor Lorry at the time of our inspection. The Motor Lorry was observed to have sustained major damages to its front body panel (red circle) and front bumper (yellow circle) that was damaged as a result of the accident's impact.

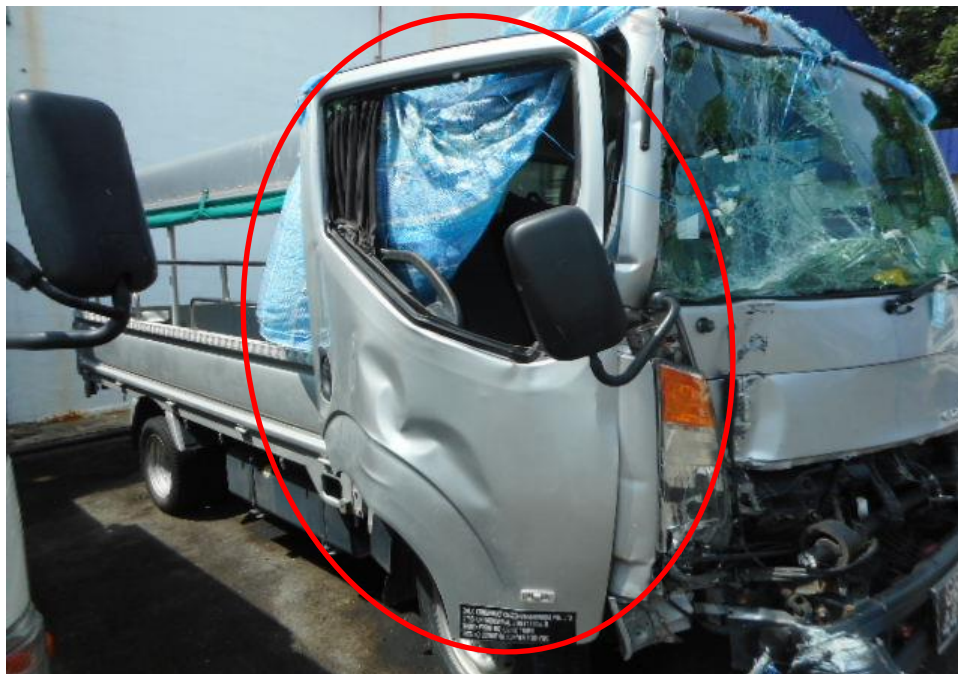
**Photo 4** shows the close up view of the right door of the Motor Lorry at the time of our inspection. The Motor Lorry was observed to have sustained damages to its right door (circled) as a result of the accident.

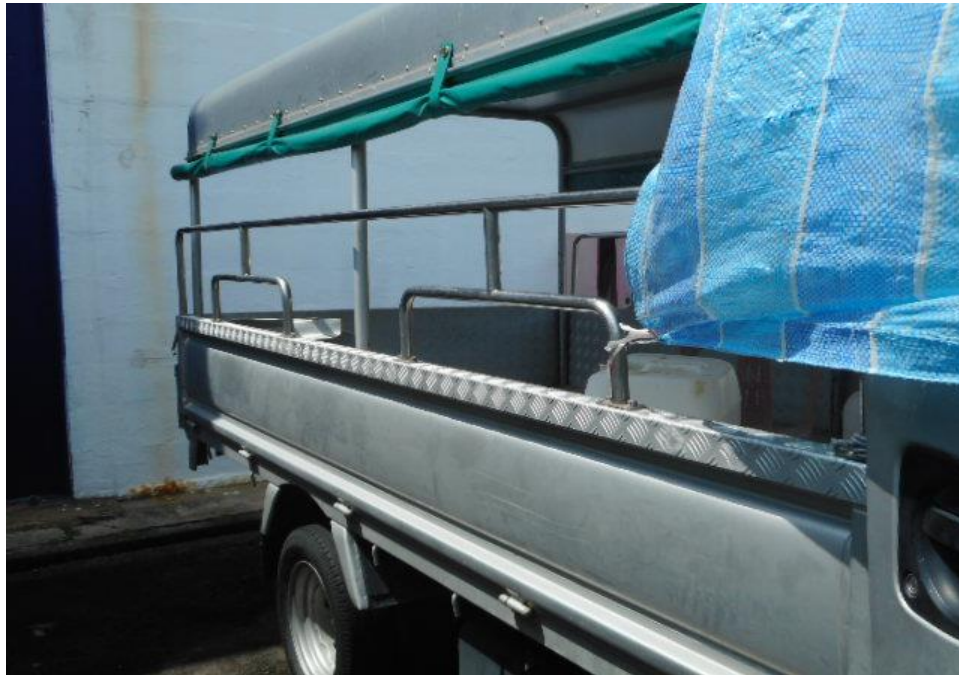
**Photo 5** shows a general view of the Motor Lorry's right body at the time of my inspection. The right portion of the Motor Lorry was observed to have been unaffected by the accident.

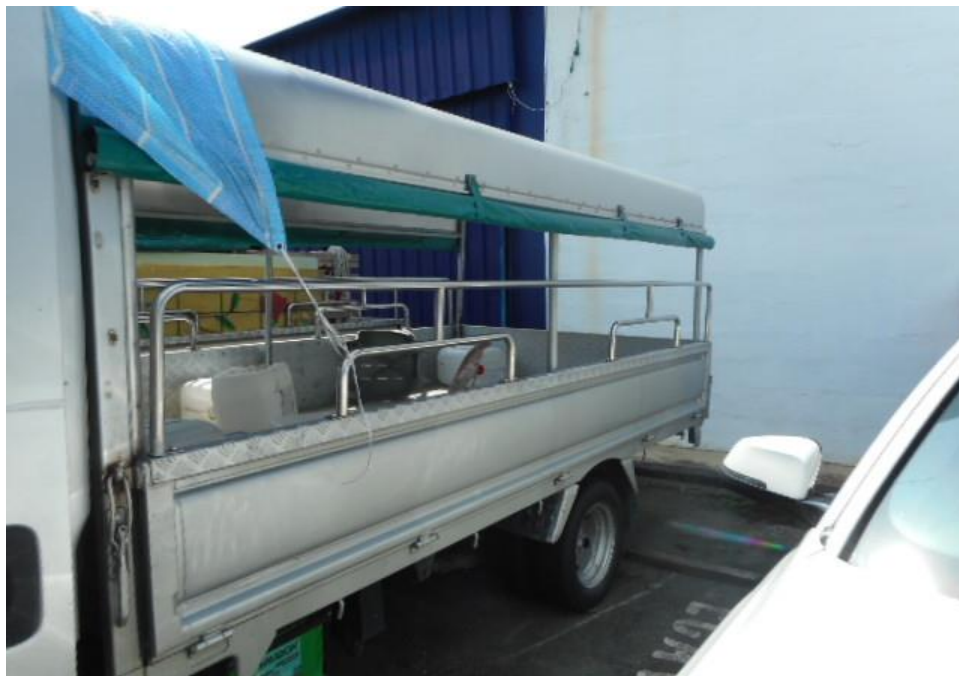
**Photo 6** shows a general view of the Motor Lorry's left body at the time of my inspection. The left portion of the Motor Lorry was observed to have been unaffected by the accident.

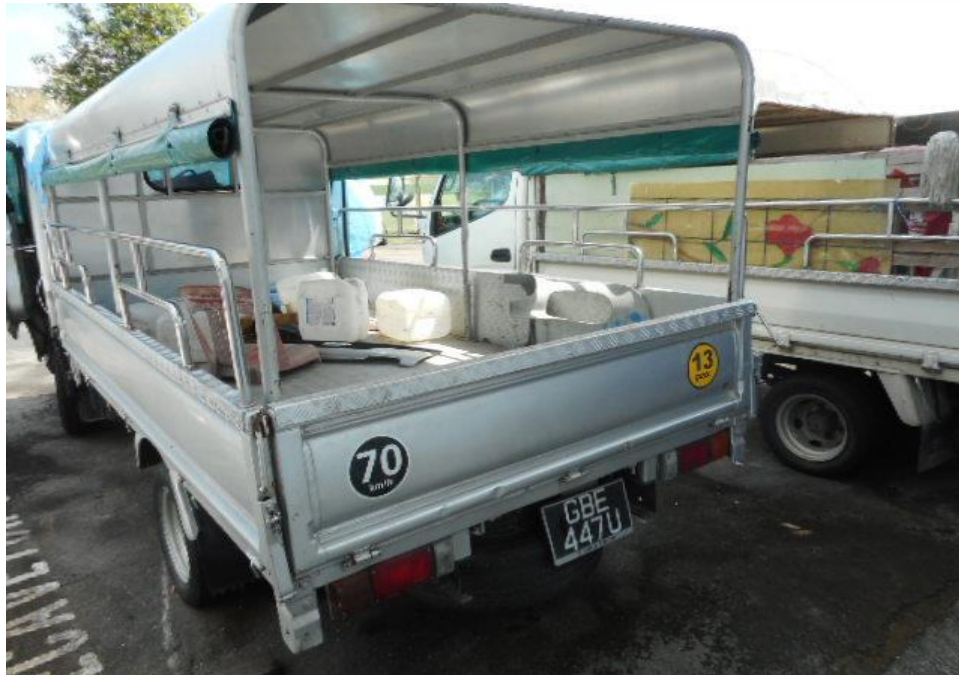
**Photo 7** shows the general view of the Motor Lorry's rear body at the time of my inspection. The Motor Lorry rear was observed to be unaffected by the accident.

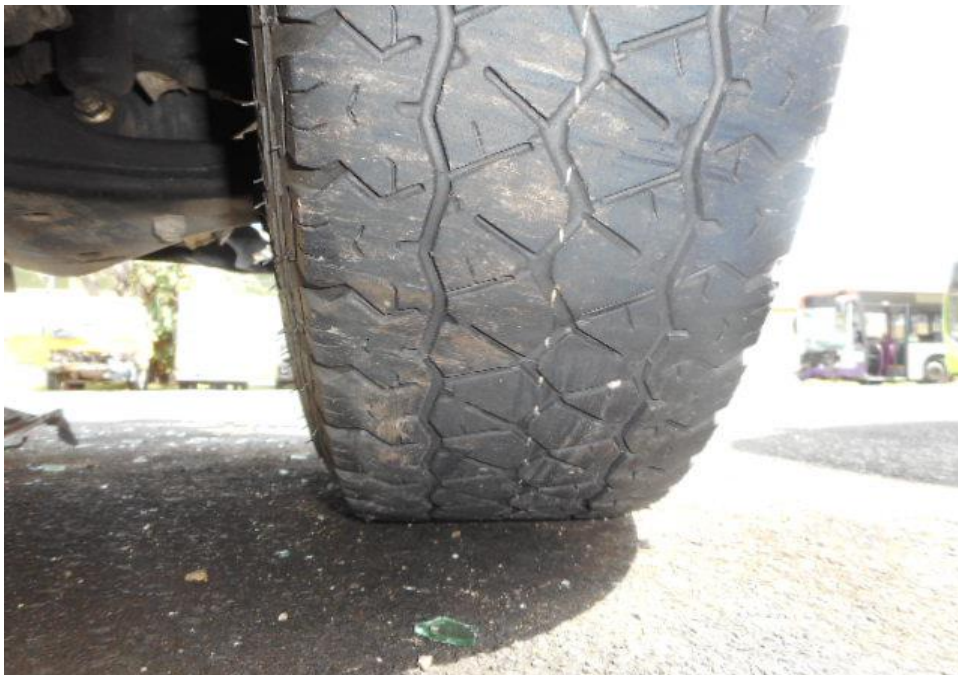
**Photo 8** shows the condition of the front right tyre of the Motor Lorry, which were observed to be in serviceable condition with remaining, tread depth of approximately 5.1mm. The tyre, which was wrapped around standard steel wheel rim, it was observed to be sufficiently inflated for vehicular operation.

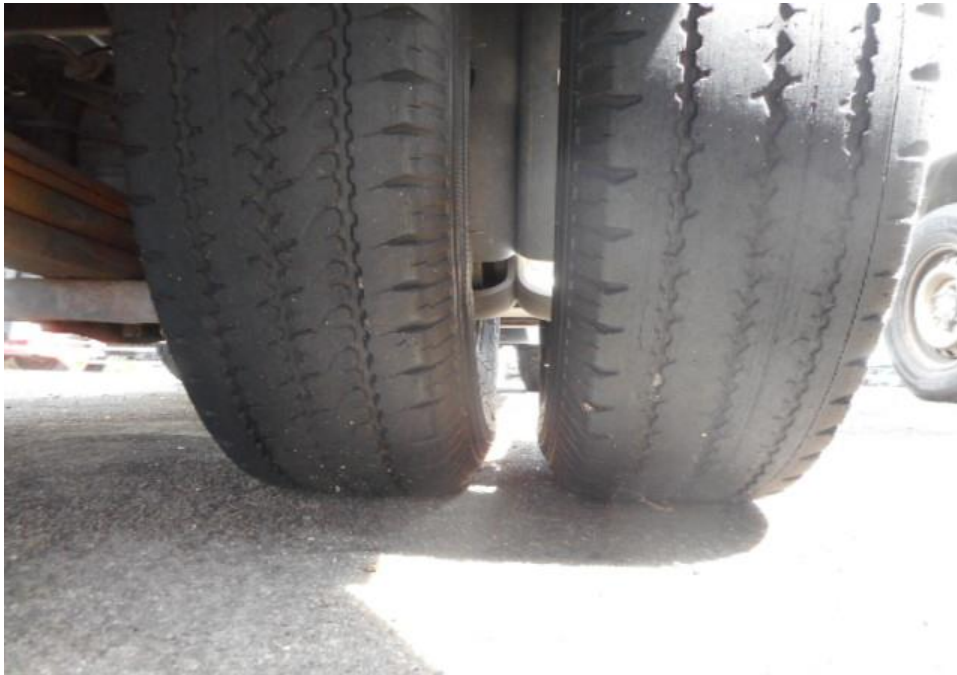
**Photo 9** shows the condition of the rear right tyres of the Motor Lorry, which were observed to be in serviceable condition with remaining, tread depth of approximately 1.6mm. The tyre, which was wrapped around standard steel wheel rim, it was observed to be sufficiently inflated for vehicular operation.

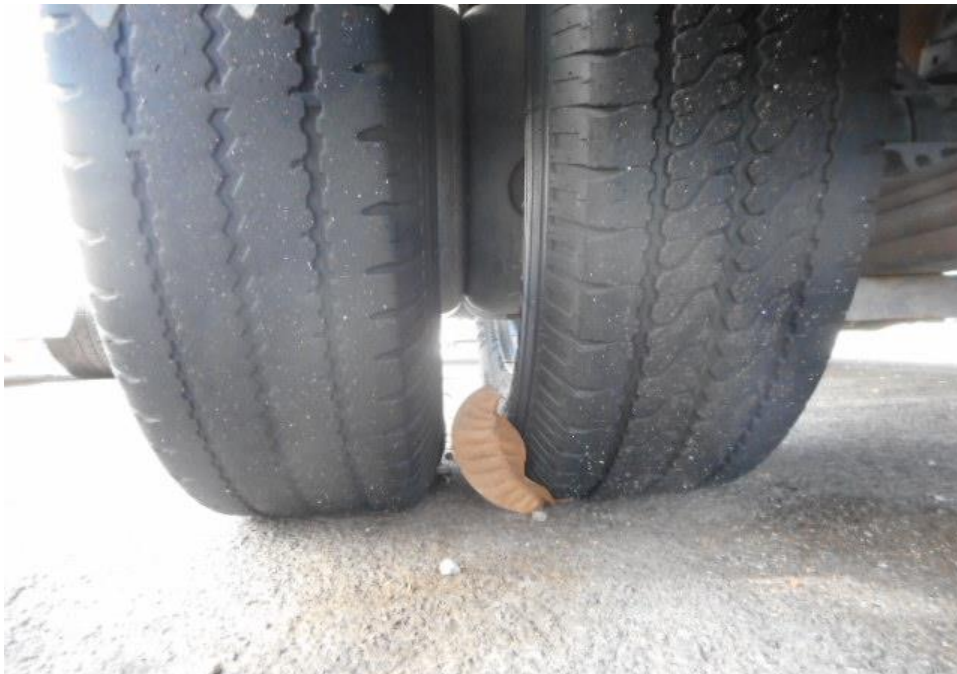
**Photo 10** shows the condition of the rear left tyres of the Motor Lorry, which were observed to be in serviceable condition with remaining, tread depth of approximately 1.9mm.

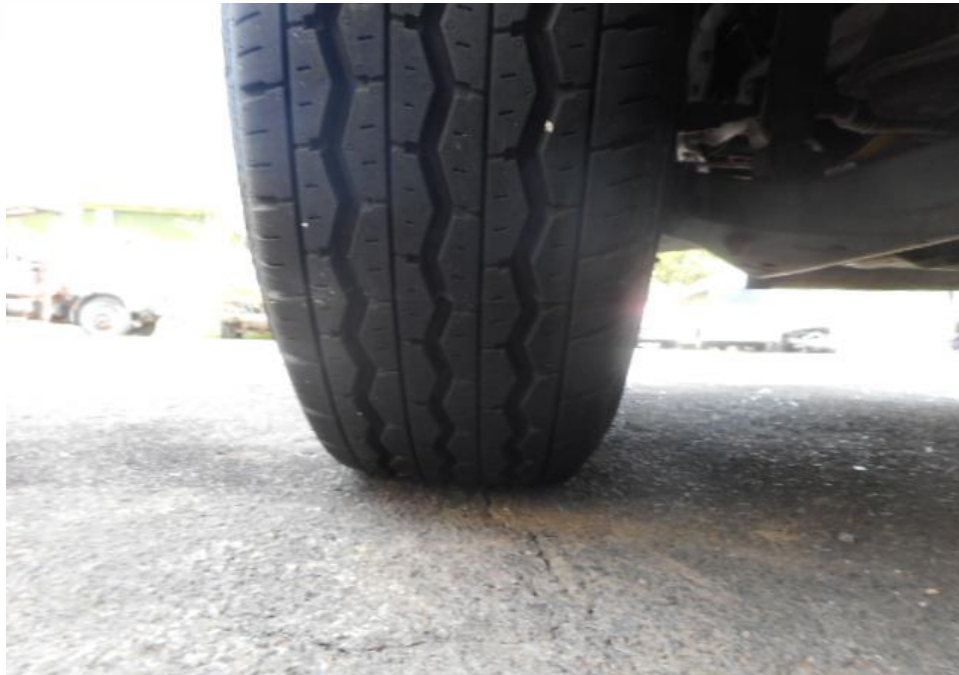
**Photo 11** shows the condition of the front left tyre of the Motor Lorry, which were observed to be in serviceable condition with remaining, tread depth of approximately 4.7mm. There was also no tear, cut or burst mark(s) on the outer and the inner sidewalls as well as across the tread of the 6 tyres that were fitted on the Motor Lorry.

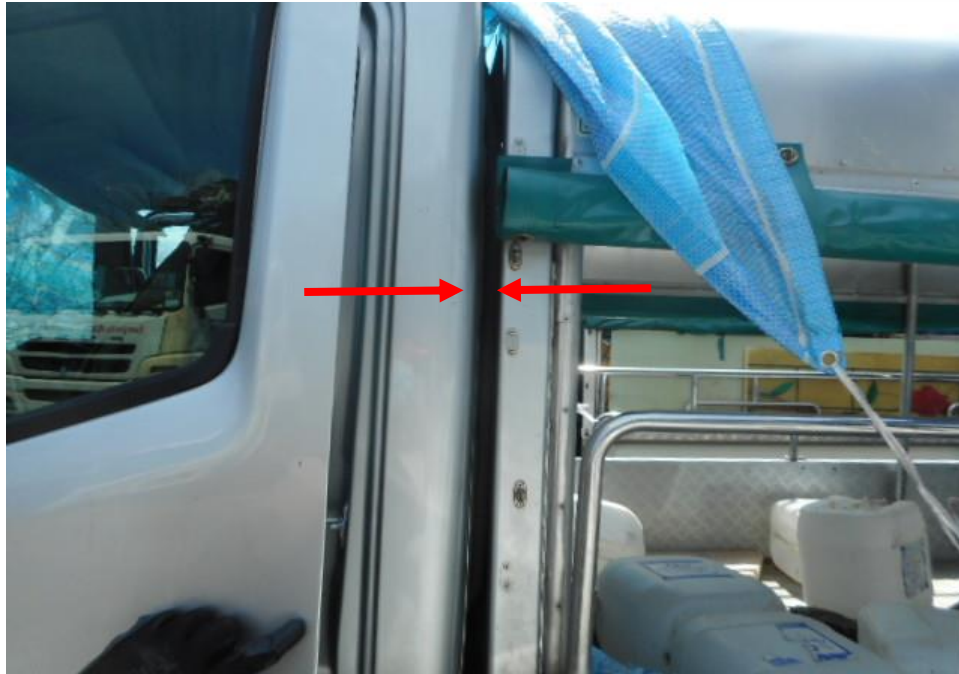
7. Upon examination of the Motor Lorry's engine compartment, we had observed that all the parts, components and fluids could not be inspection as due to the damage induced has crushed and deformed the cabin of the Motor Lorry which immobilized its opening and viewing. 12 below.

**Photo 12** shows the induced damage to the lifter of the front cabin (arrowed) of the Motor Lorry's which had immobilised the opening and viewing of the various parts and components inside the engine compartment a result of the accident.

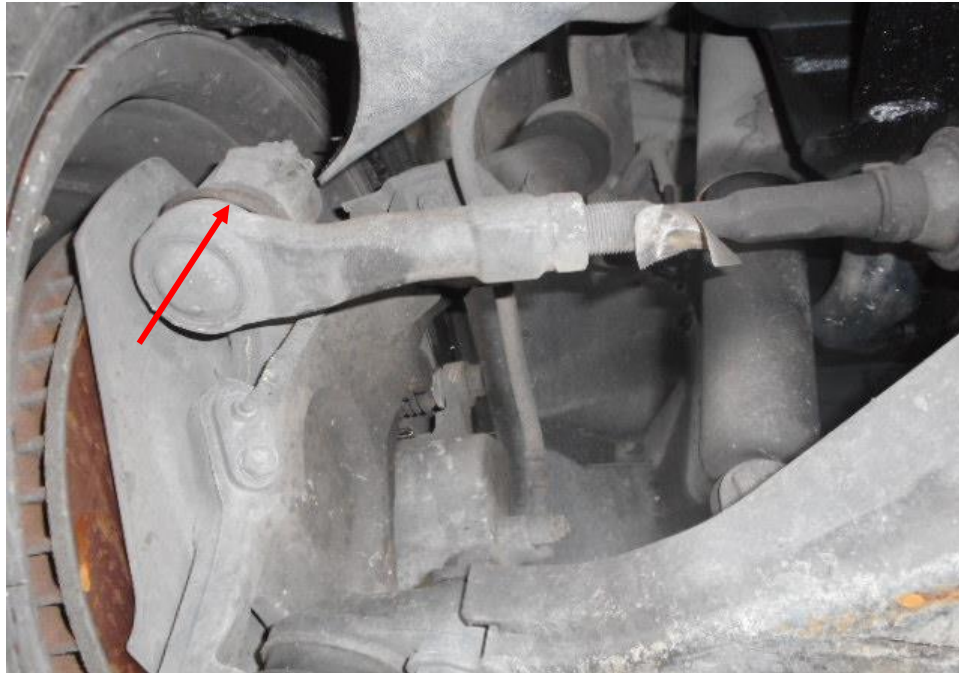
**Photo 13** shows the various undercarriage components at the front right wheel of the Motor Lorry, in particular the steering tie rod end (arrowed). The various steering components were all found to be intact, suggesting that the steering system of the Motor Lorry was likely to be in serviceable condition at the material time of accident. There was also no sign of fluid stain(s) observed on the various undercarriage components.

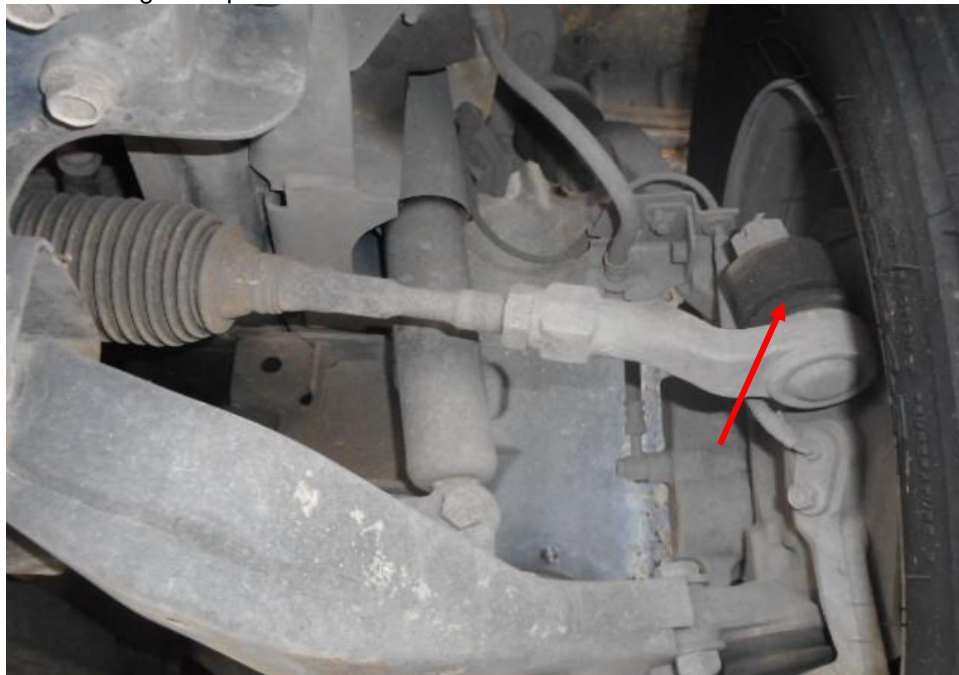
**Photo 14** shows the various undercarriage components at the front left wheel of the Motor Lorry, in particular the steering tie rod end (arrowed). The various undercarriage components of the Motor Lorry were all found to be intact without any visible damage. There was also no sign of fluid stain(s) observed on the various undercarriage components.

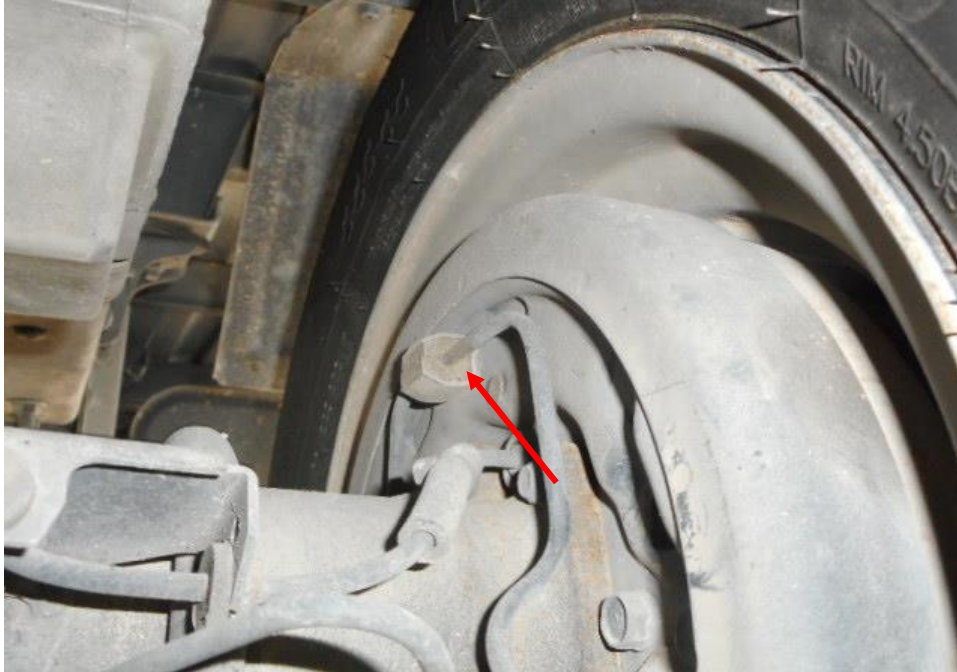
**Photo 15** shows the brake pipe (arrowed) at the rear right wheel of the Motor Lorry. I did not observe any leakage of brake fluid at the time of my inspection of the Motor Lorry. My static tests of the Motor Lorry's braking system, along with my visual examination of the various mechanical components in the braking system, had indicated that there was no internal leakage of pressure/vacuum.

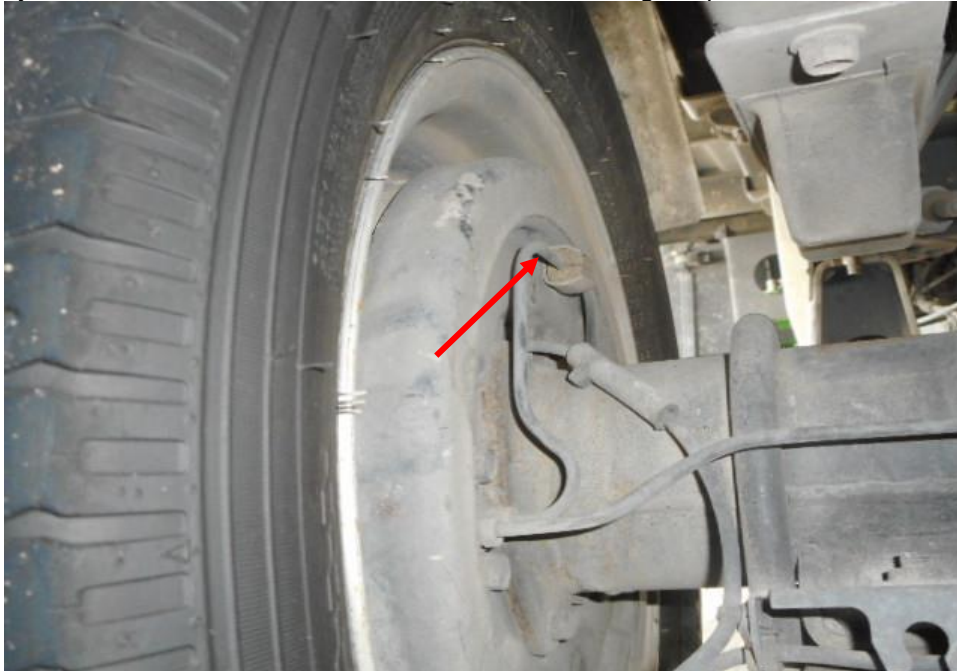
**Photo 16** shows the brake pipe (arrowed) at the rear left wheel of the Motor Lorry. I did not observe any leakage of brake fluid at the time of my inspection of the Motor Lorry. My static tests of the Motor Lorry's braking system, along with my visual examination of the various mechanical components in the braking system had indicated that there was no internal leakage of pressure/vacuum. Hence the braking system of the Motor Lorry was likely to be in serviceable condition at the material time of accident.

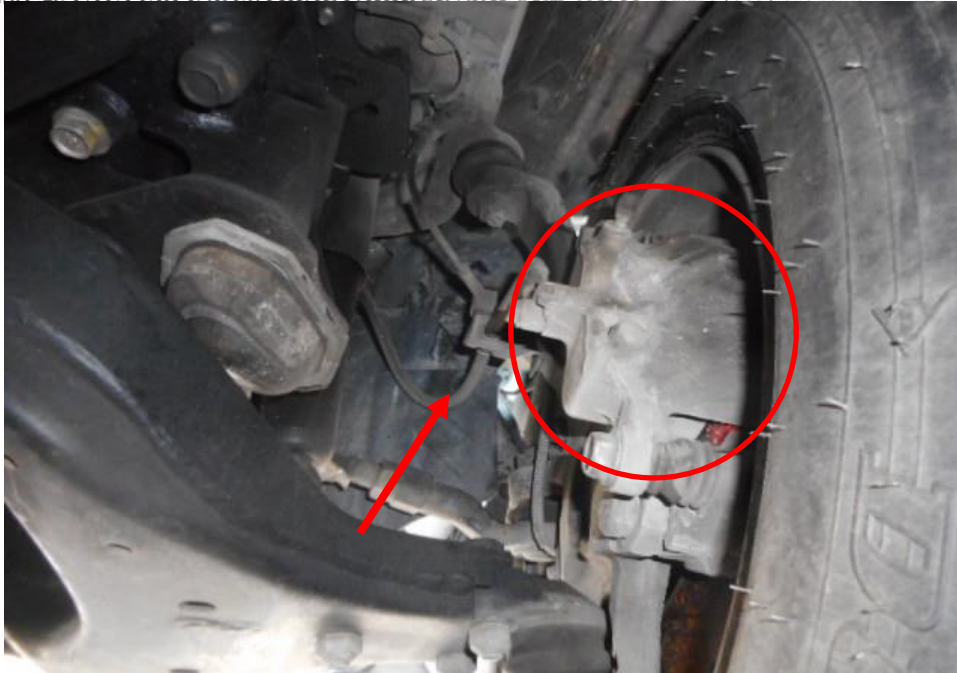
**Photo 17** shows the brake hose/pipe (arrowed) at the front right wheel of the Motor Lorry. No leakage of brake fluid was observed. Visual examination of the various components of the braking system like the brake caliper (circled), brake booster, brake pedal etc had revealed all to be intact and without visible damage at the time of accident. There was also no sign of fluid stain(s) observed on the various undercarriage components.

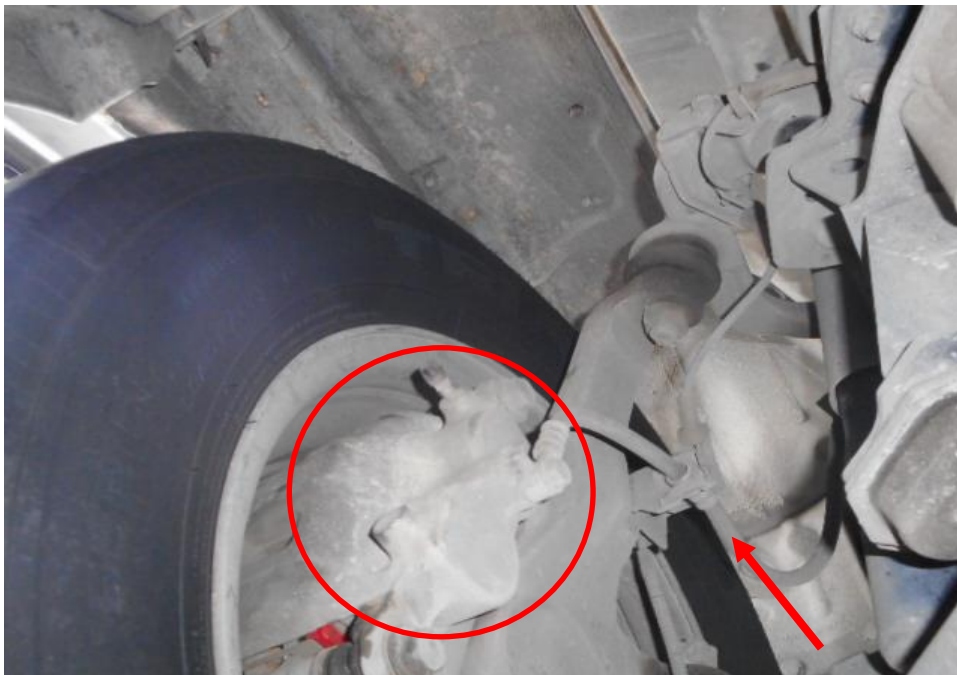
**Photo 18** shows the brake hose/pipe (arrowed) at the front left wheel of the Motor Lorry. No leakage of brake fluid was observed. Visual examination of the various components of the braking system like the brake caliper (circled), brake booster, brake pedal etc had revealed all to be intact and without visible damage at the time of accident. There was also no sign of fluid stain(s) observed on the various undercarriage components.

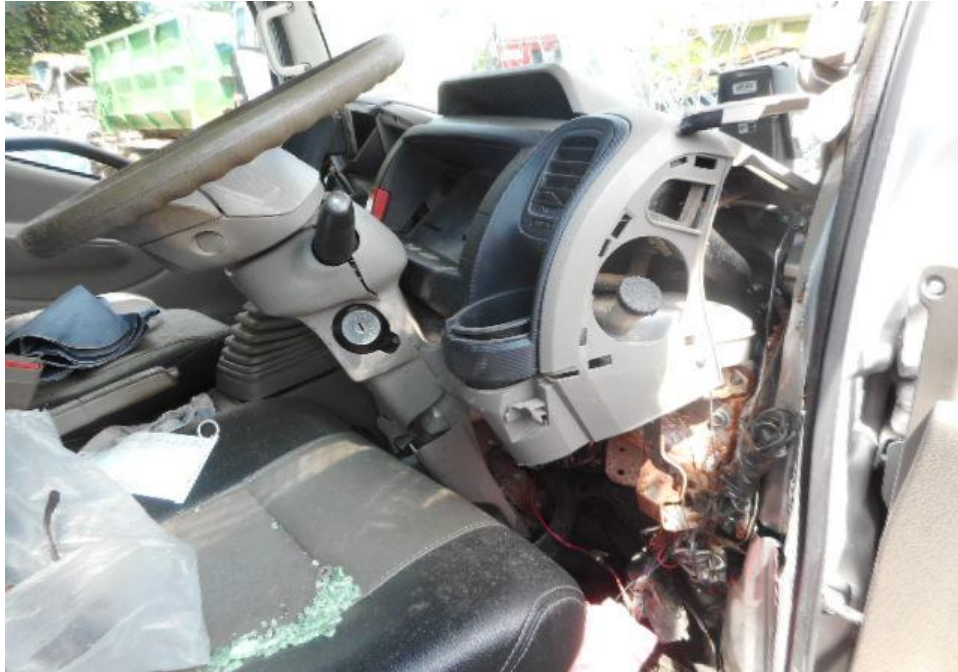
10. The static test of the Motor Lorry electronic safety system could not be inspected as the instrument cluster was damaged due to the induce impact from the accident. See photo 19 below

**Photo 19** shows instrument cluster and dashboard of the Motor Lorry at the time of our inspection. The instrument cluster was observed to be damaged as a result of the accident.
