Your Ref: TP/IP/56107/2021
Our Ref : CI/TPD21013037/P

27th December 2021

MECHANICAL INSPECTION REPORT OF MOTOR TIPPER, XD 6191L

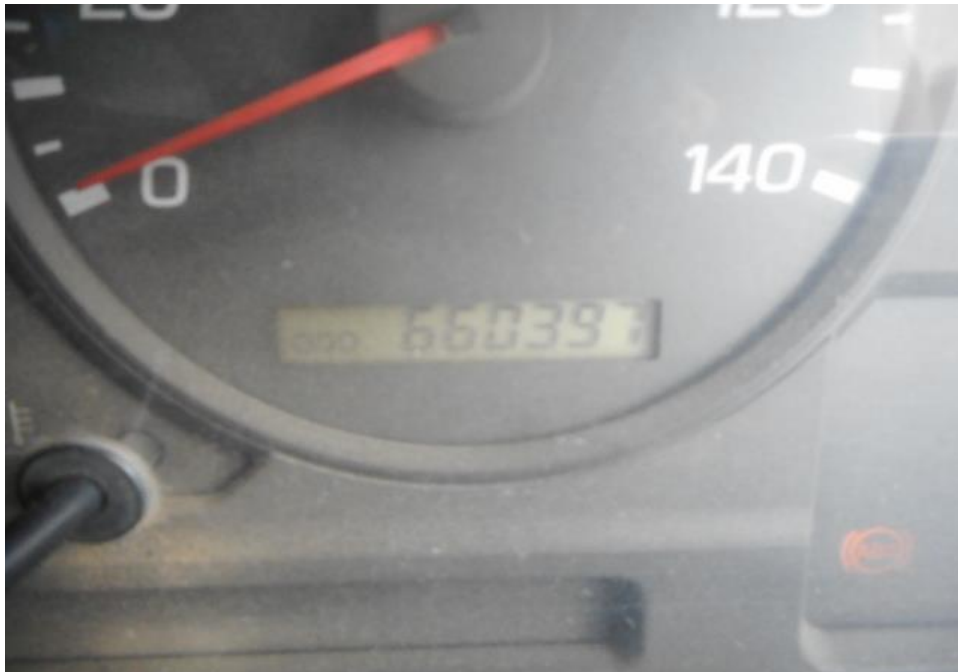
Photo 1 shows a general view of the instrument cluster of the Motor Tipper at the time of my inspection. The mileage of the Motor Tipper was 660,397km

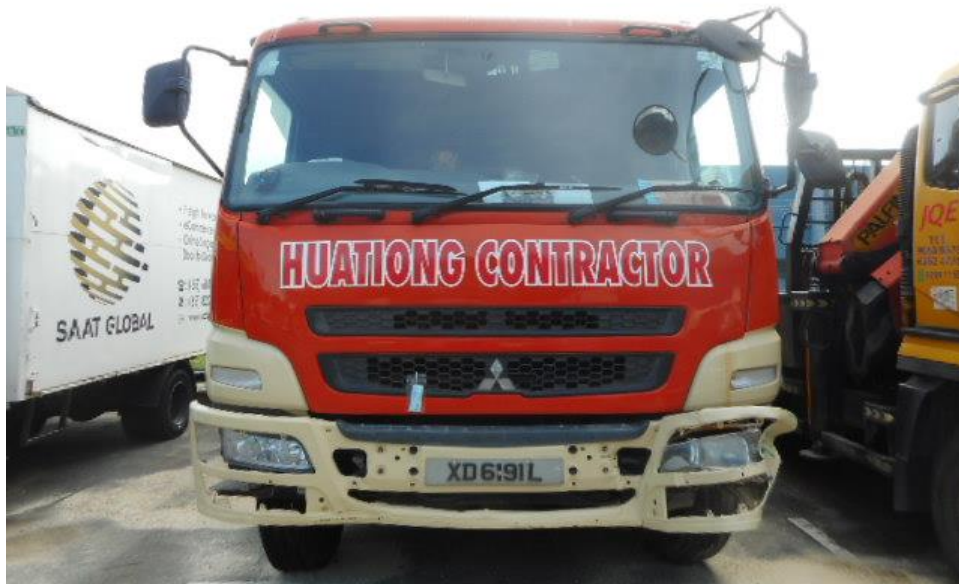
4. The mileage of the Motor Tipper at the time of my inspection was 660,397km.
5. The Motor Tipper was observed to sustained damage at its front and rear portion. Its front bumper and rear tipper body panel were damage at the time of my inspection as a result of the accident.

Photo 2 shows a general view of the front body of the Motor Tipper at the time of my inspection. The Motor Tipper was observed to sustained damage at its front portion. Its front bumper were damage at the time of my inspection as a result of the accident.

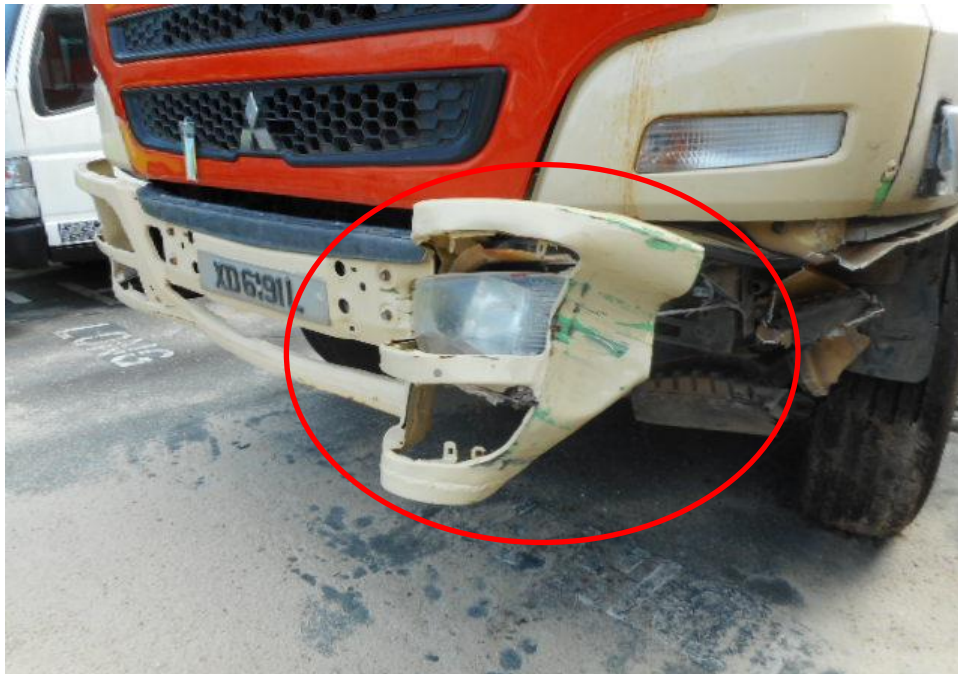
Photo 3 shows a close up view of the front body of the Motor Tipper at the time of my inspection. The Motor Tipper was observed to sustained damage at its front portion. Its front bumper (circled) were damage at the time of my inspection as a result of the accident.

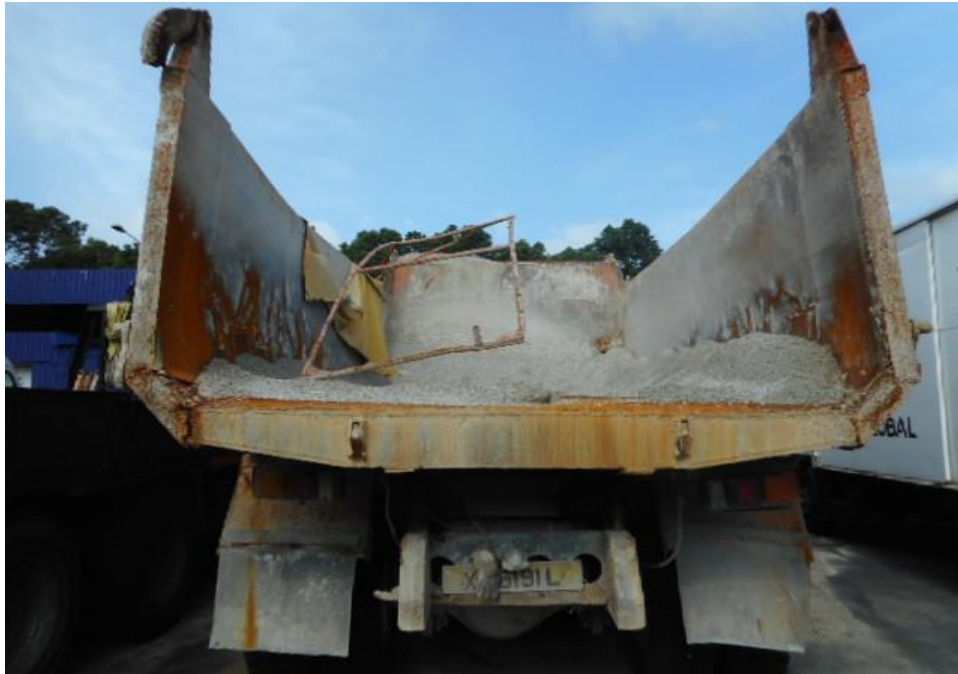
Photo 4 shows a general view of the Motor Tipper's rear body at the time of my inspection. The Motor Tipper was observed to sustained damage at its rear portion. Its rear tipper body panel were damage at the time of my inspection as a result of the accident.

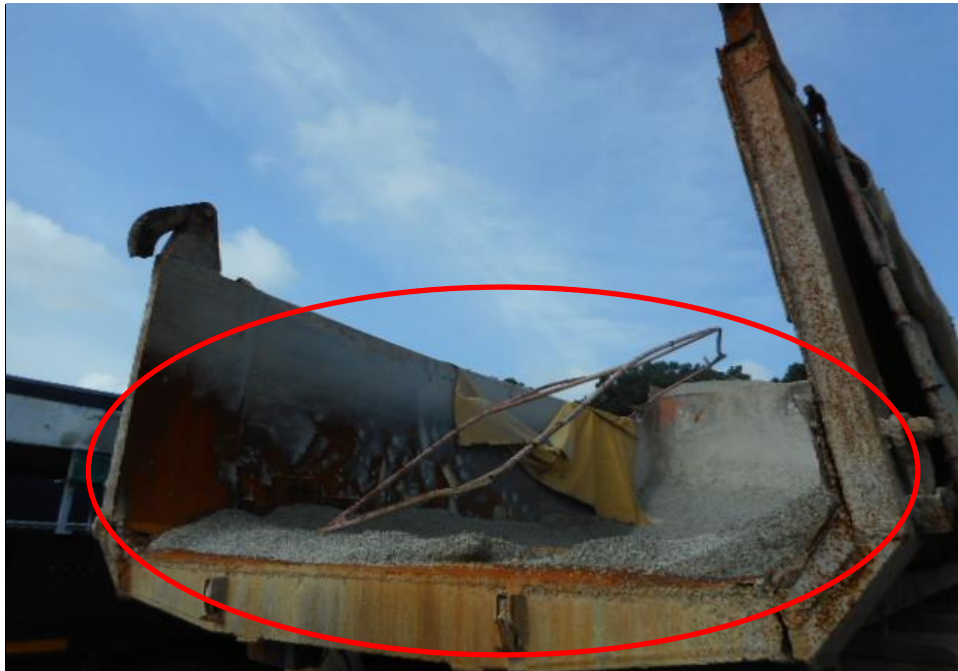
Photo 5 shows a close up view of the Motor Tipper's rear body at the time of my inspection. The Motor Tipper was observed to sustained damage at its rear portion. Its rear tipper body panel (circled) were damage at the time of my inspection as a result of the accident.

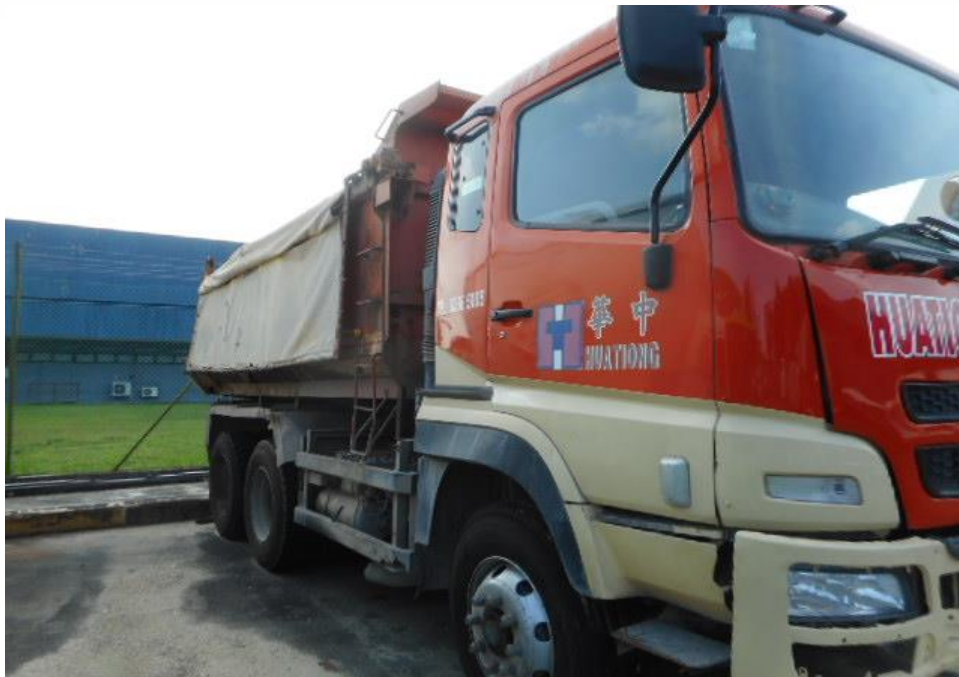
Photo 6 shows a general view of the right body of the Motor Tipper at the time of my inspection. The Motor Tipper was observed to be intact and unaffected by the accident.

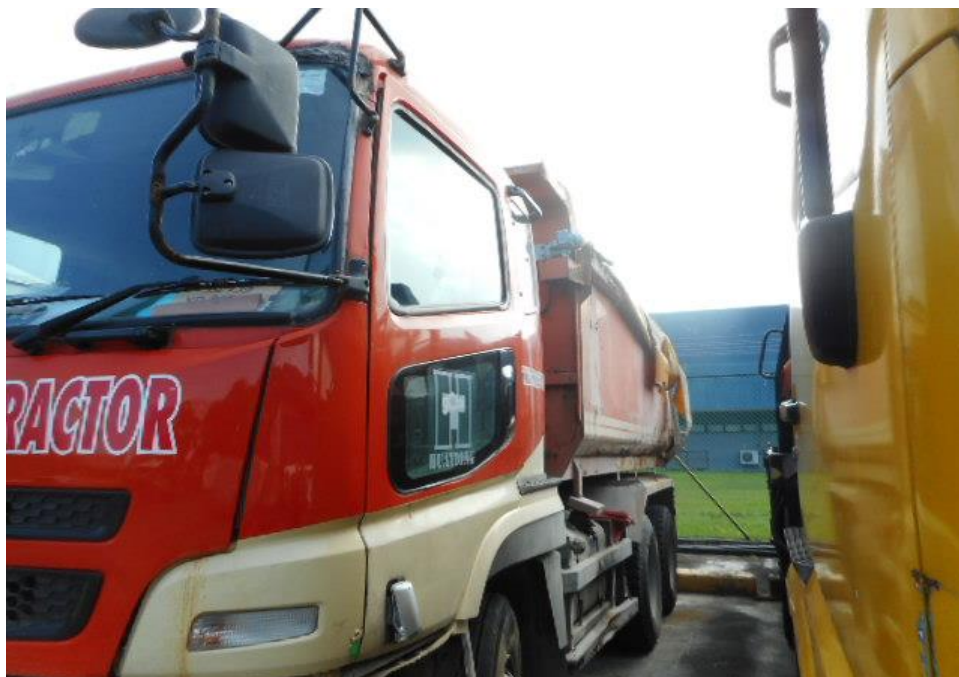
Photo 7 shows a general view of the left body of the Motor Tipper at the time of my inspection. The Motor Tipper was observed to be intact and unaffected by the accident.

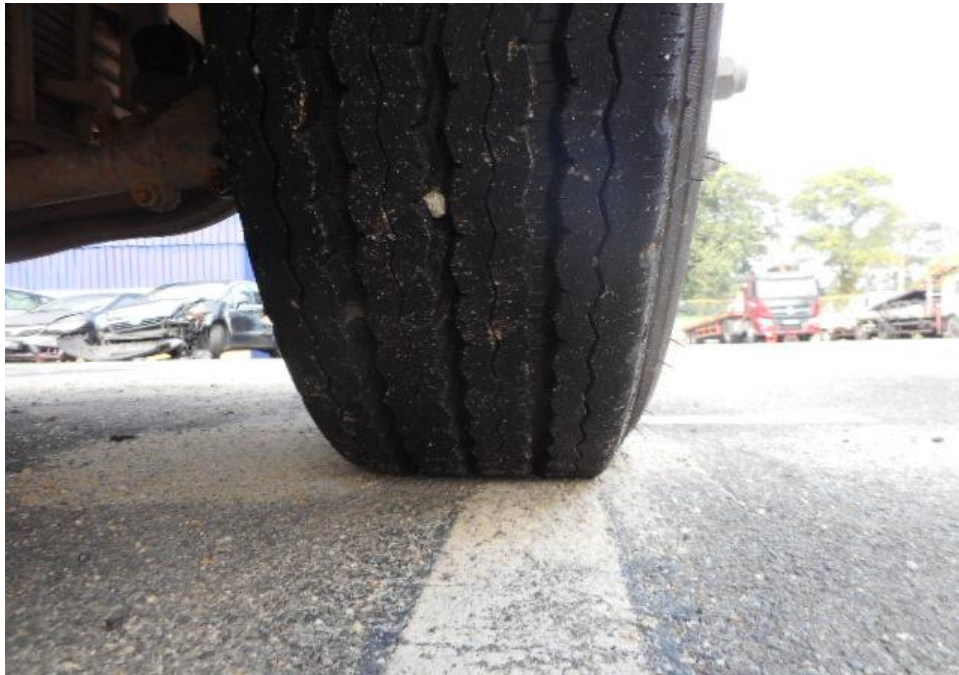
Photo 8 shows the condition of the front right tyre of the Motor Tipper, which was observed to be in serviceable condition with remaining tread depth of approximately 14.5mm. The tyre, which was wrapped around standard steel wheel rim, was also observed to be sufficiently inflated for vehicular operation. There was no tear, cut or burst mark(s) on the outer and the inner sidewalls as well as across the tread of the 10 tyres that were fitted on the Motor Tipper.

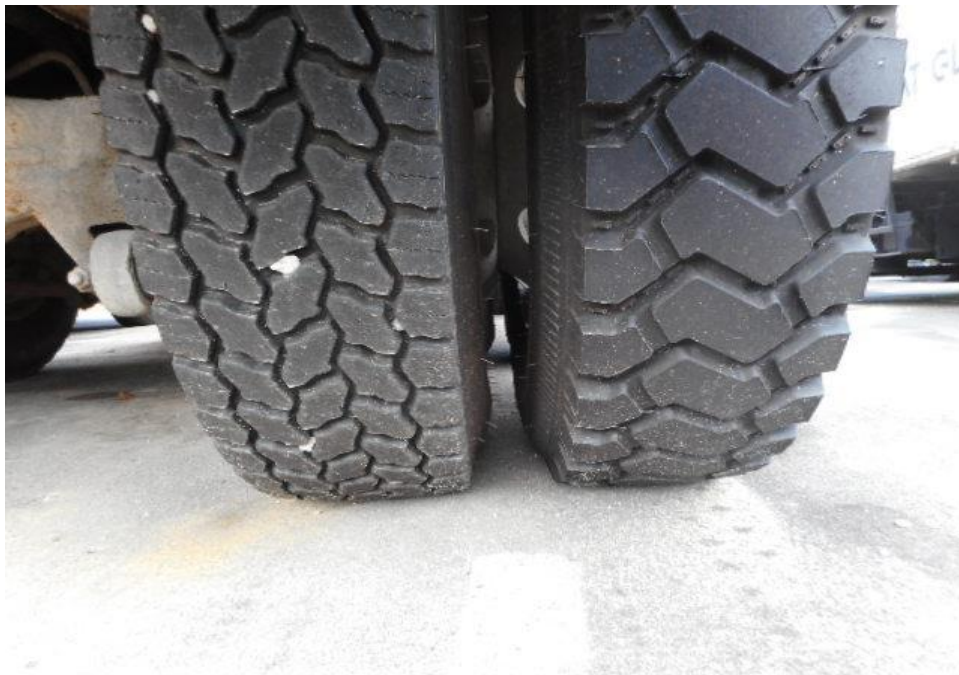
Photo 9 shows the condition of the rear right tyre of the Motor Tipper, which was observed to be in serviceable condition with remaining tread depth of approximately 14.3mm. The tyre, which was wrapped around standard steel wheel rim, was also observed to be sufficiently inflated for vehicular operation.

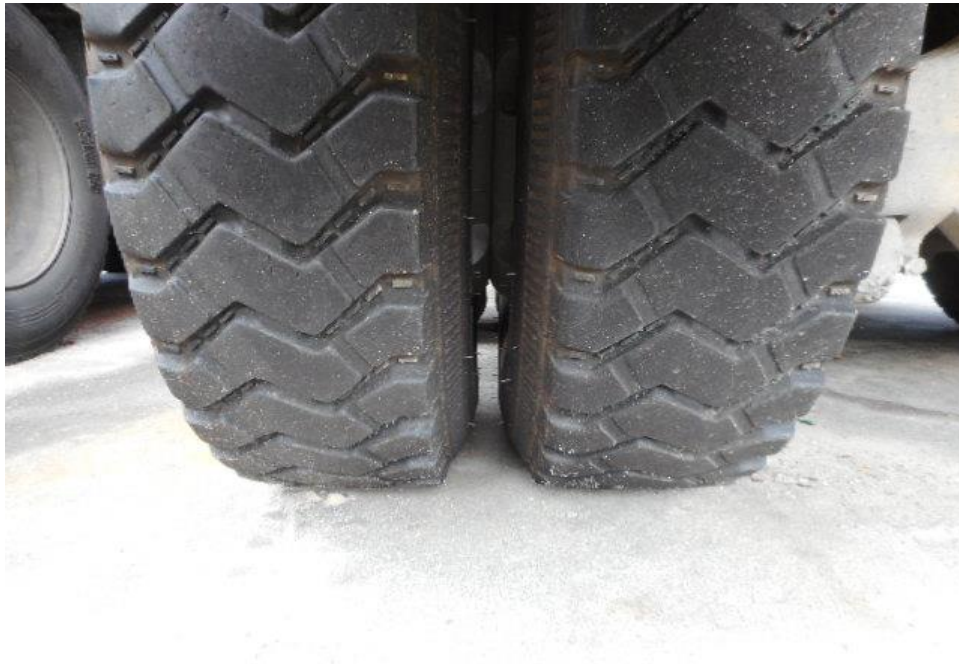
Photo 10 shows the condition of the rear left tyre of the Motor Tipper, which was observed to be in serviceable condition with remaining tread depth of approximately 12.6mm. The tyre, which was wrapped around standard steel wheel rim, was also observed to be sufficiently inflated for vehicular operation.

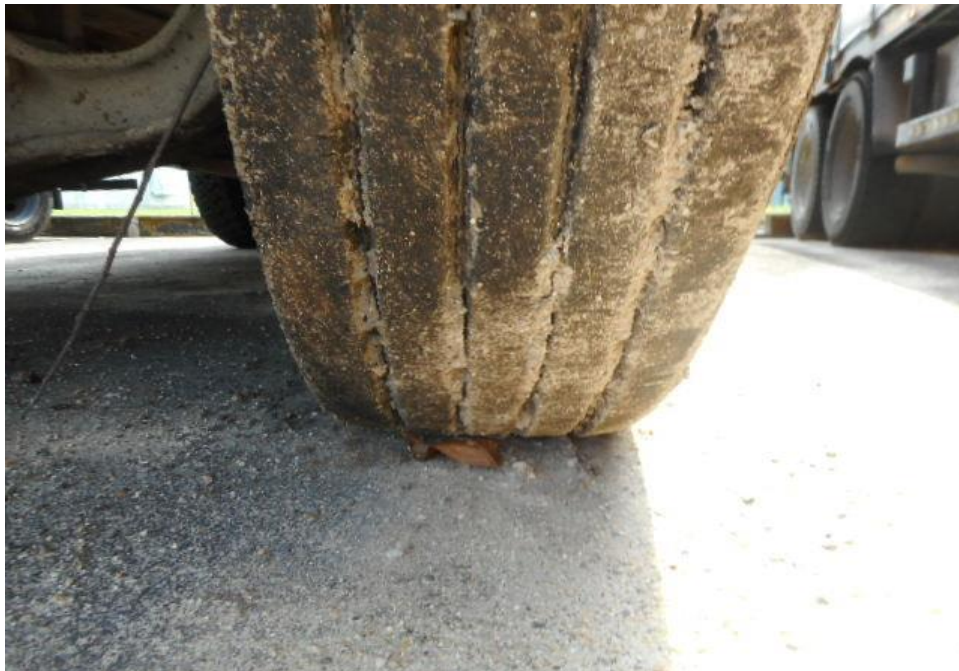
Photo 11 condition of the front left tyre of the Motor Tipper, which was observed to be in serviceable condition with remaining tread depth of approximately 10.6mm. The tyre, which was wrapped around standard steel wheel rim, was also observed to be sufficiently inflated for vehicular operation.

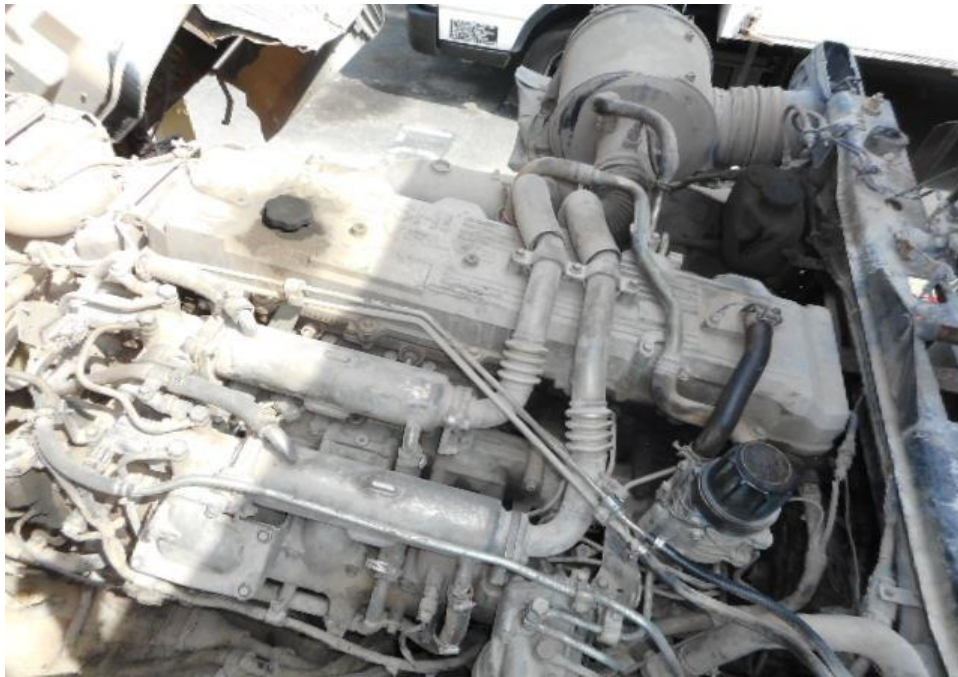
Photo 12 shows a general view of the Motor Tipper's engine compartment, which was accessed by lifting the front cabin of the Motor Tipper. The various parts and components inside the engine compartment were unaffected by the accident. There was also no sign(s) or indication(s) of fresh fluid leakage and/or fluid stain within the engine compartment

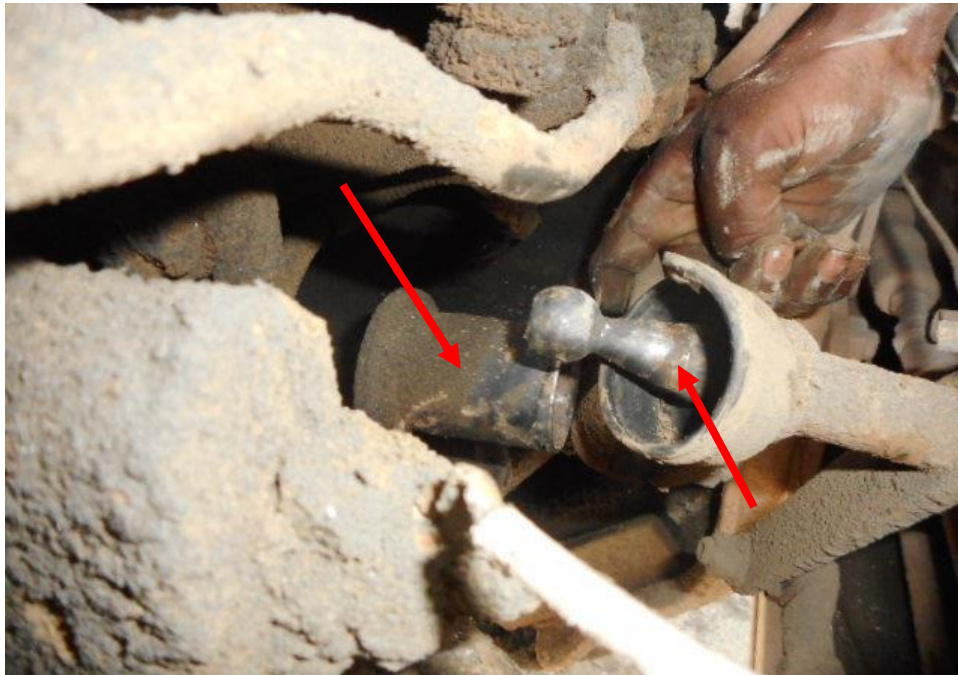
9. Further examination of the engine compartment revealed, there was no sign(s) or indication(s) of fresh fluid leakage and/or fluid stain within the engine compartment of the Motor Tipper. However, we observed the gearbox shifter cable linkage to be damaged and detached as a result of the accident.

Photo 13 shows a close up view of the Motor Tipper's engine compartment, which was accessed by lifting the front cabin of the Motor Tipper. The gearbox shifter cable linkage (arrowed) was observed to be damaged and detached as a result of the accident.

14. A short operational test of the Motor Tipper, to primarily determine whether there was any abnormality to its various operating systems was not conducted as the gearbox could not be engaged as the gear shifter linkage was damaged and detached as a result of the accident.

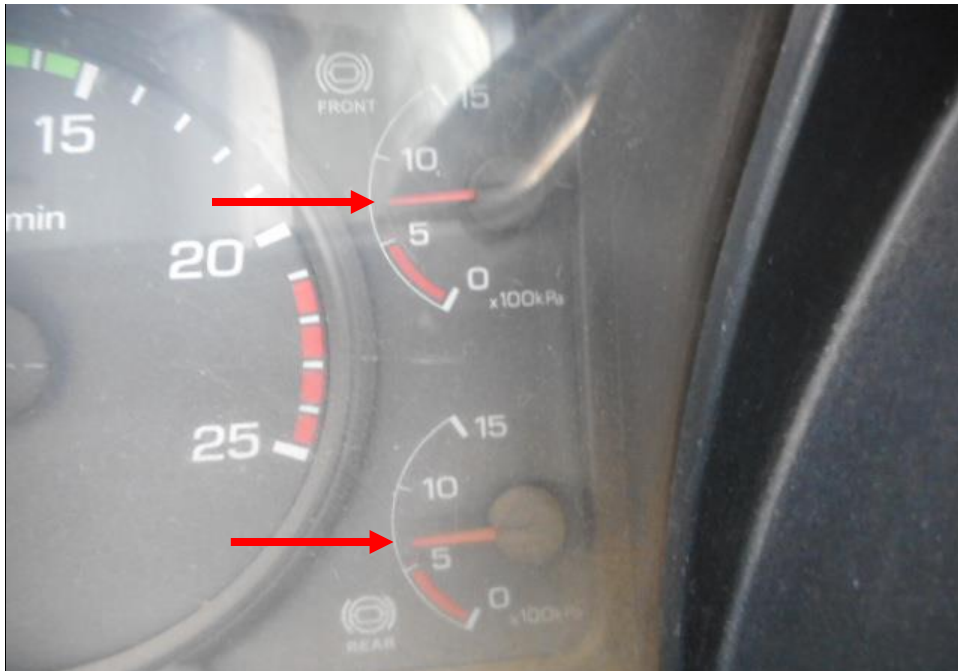
Photo 14 shows the air in the air brake cylinders of the Prime Mover at the time of my inspection. The air in the cylinder was observed to be of sufficient level & serviceable at the time of the accident.

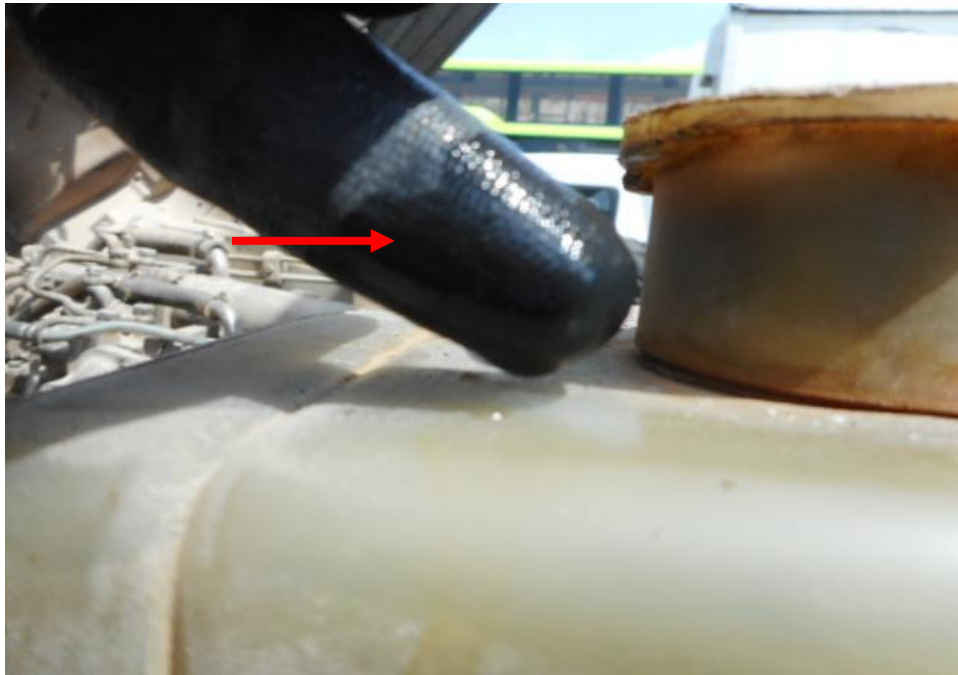
Photo 15 shows the engine coolant reservoir of the Motor Tipper at the time of my inspection. The engine coolant was observed to be of sufficient level (arrowed) and without any visible contamination.

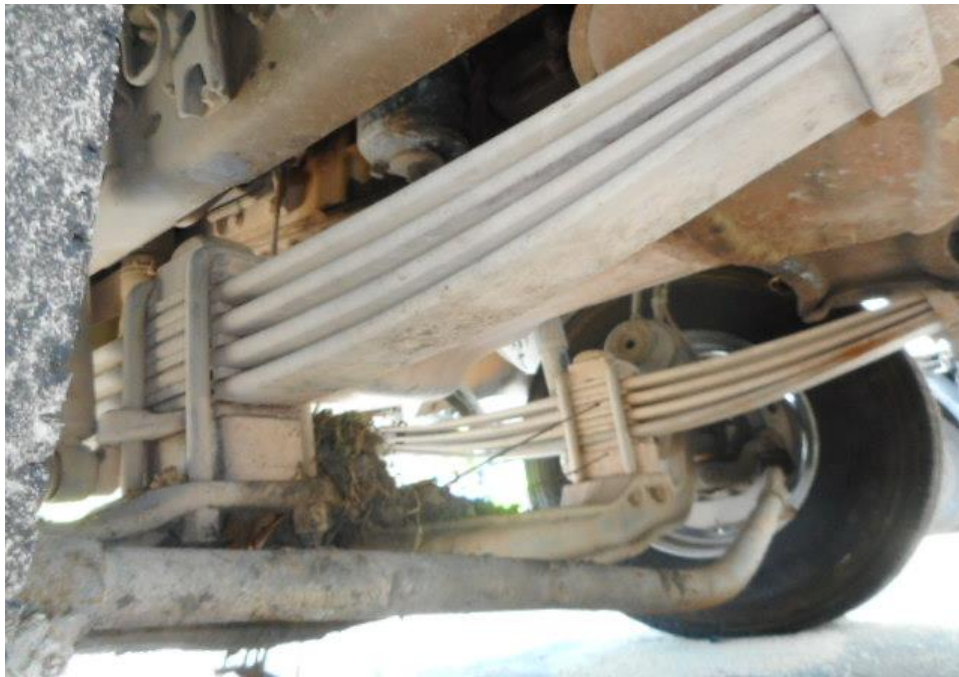
Photo 18 shows the undercarriage of the Motor Tipper, at the area where the engine housing and transmission housing are located. I did not find any sign(s) or indication(s) of fluid leak and/or fluid stain(s) on the underside of the Motor Tipper.

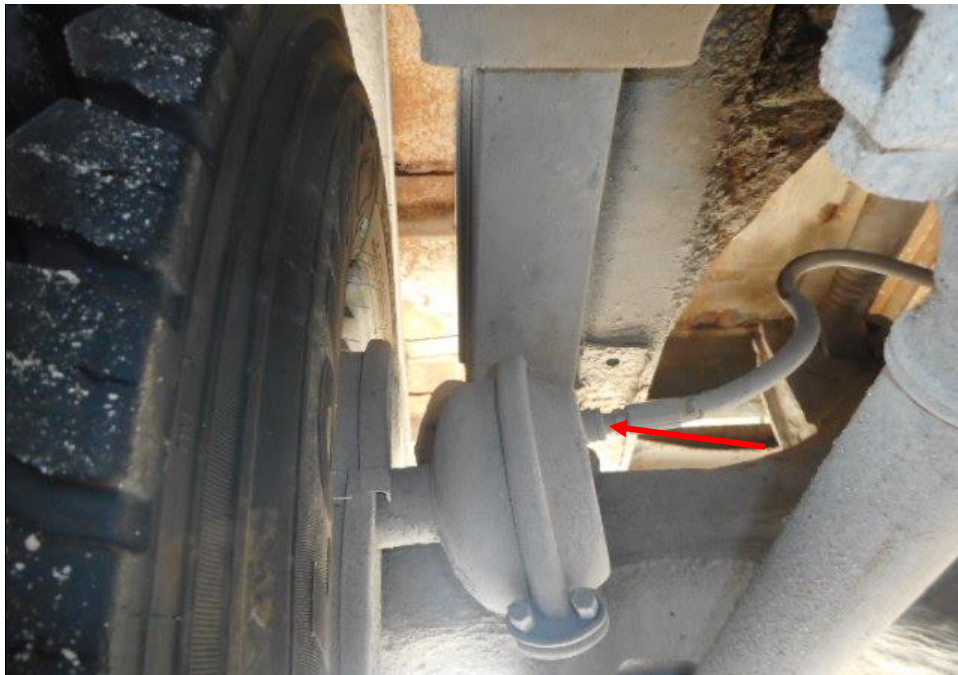
Photo 19 shows the brake pipe (arrowed) at the rear right wheel of the Motor Tipper. I did not observe any leakage of brake fluid at the time of my inspection of the Motor Tipper. My visual examination of the various mechanical components in the braking system, had indicated that there was no internal leakage of pressure/vacuum and these components were generally in good condition.

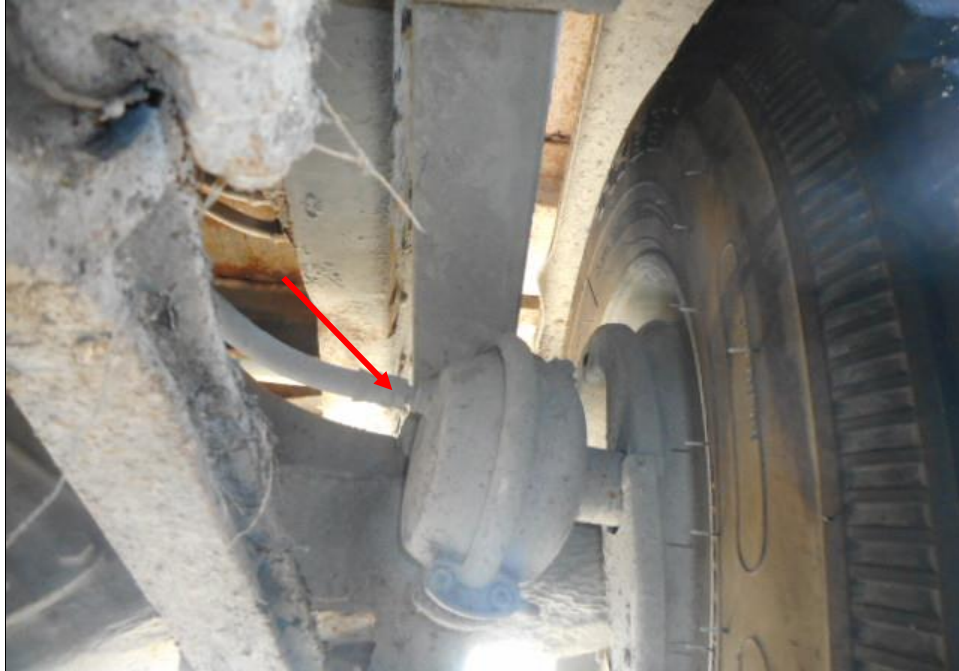
Photo 20 shows the brake pipe (arrowed) at the rear left wheel of the Motor Tipper. I did not observe any leakage of brake fluid at the time of my inspection of the Motor Tipper. My static tests of the Motor Tipper's braking system, along with my visual examination of the various mechanical components in the braking system, had indicated that there was no internal leakage of pressure/vacuum and these components were generally in good condition.

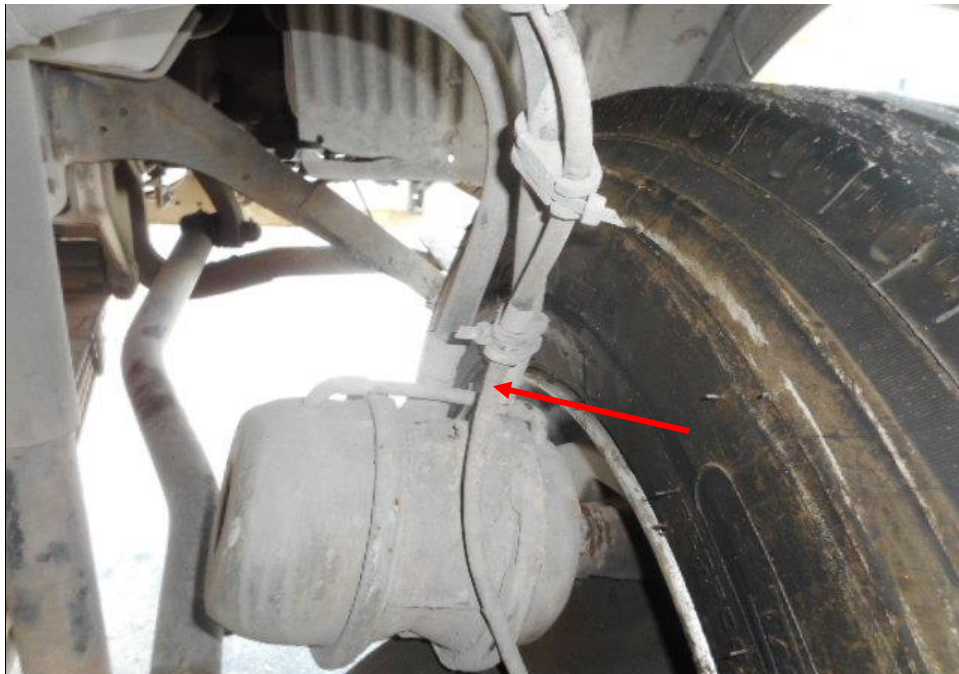
Photo 21 shows the brake pipe (arrowed) at the front right wheel of the Motor Tipper. I did not observe any leakage of brake fluid at the time of my inspection of the Motor Tipper. My static tests of the Motor Tipper's braking system, along with my visual examination of the various mechanical components in the braking system, had indicated that there was no internal leakage of pressure/vacuum and these components were generally in good condition.

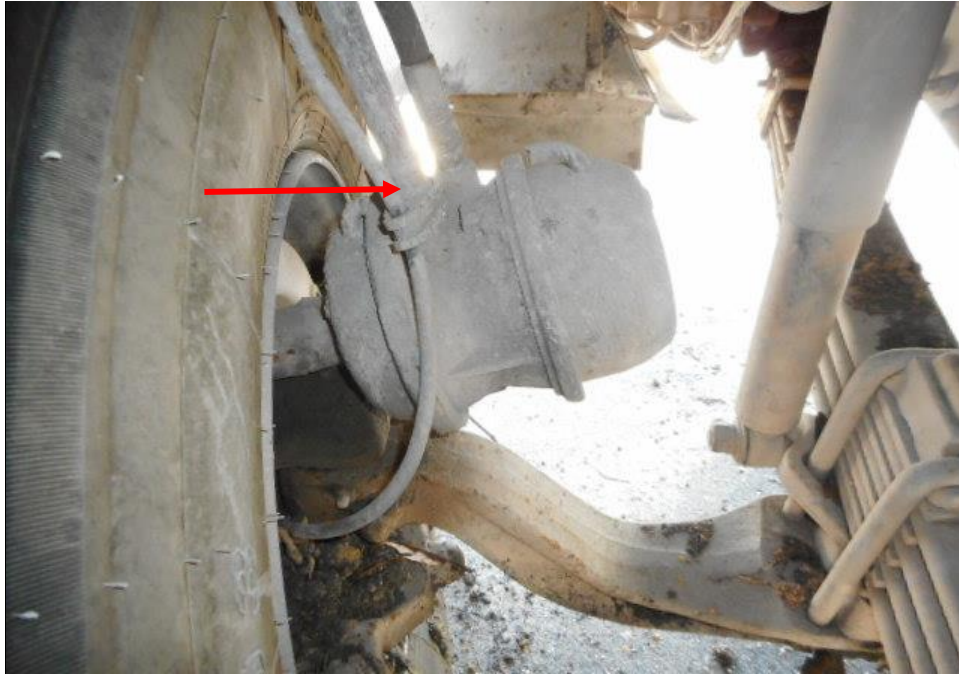
Photo 22 shows the brake pipe (arrowed) at the front left wheel of the Motor Tipper. I did not observe any leakage of brake fluid at the time of my inspection of the Motor Tipper. My visual examination of the various mechanical components in the braking system had indicated that these was no internal leakage of pressure/vacuum and these components were generally in good condition.

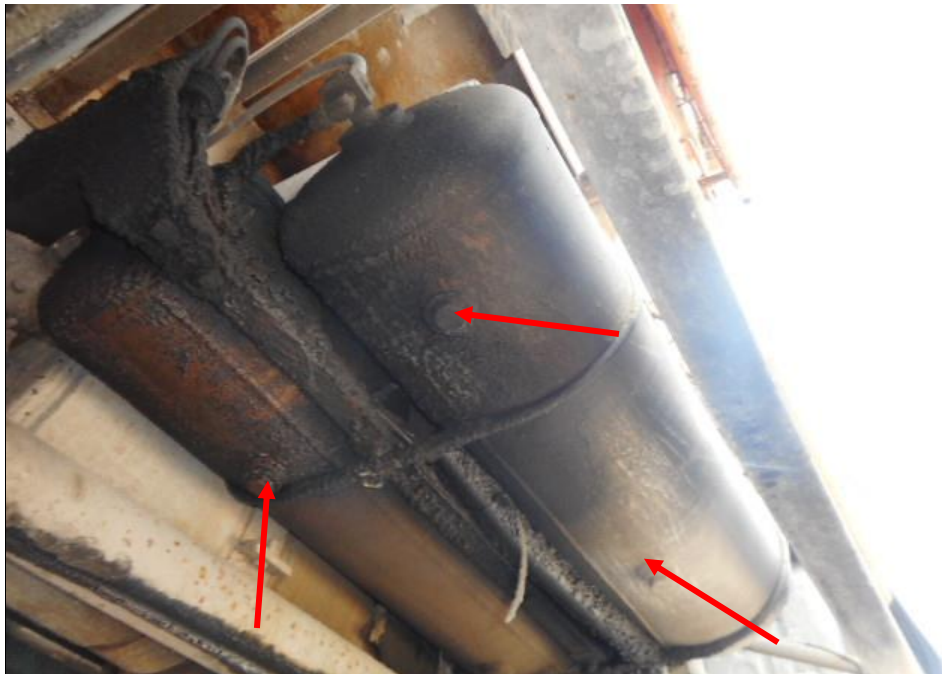
Photo 23 shows the air brake cylinders (arrowed) at the undercarriage of the Motor Tipper. I did not observe any leakage of air brake fluid at the time of my inspection of the Motor Tipper. My visual examination of the various mechanical components in the braking system had indicated that these was no internal leakage of pressure/vacuum and these components were generally in good condition.

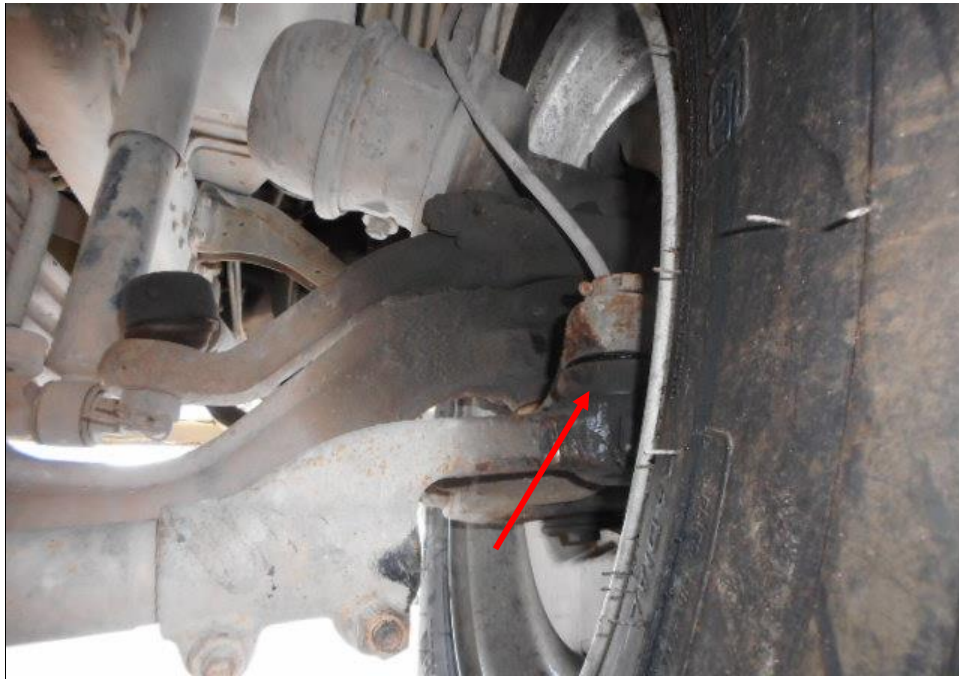
Photo 24 shows the various undercarriage components at the front right wheel of the Motor Tipper, in particular the steering tie rod end (arrowed) were found to be intact, there was also no sign of fluid stain(s) observed on the various undercarriage components.

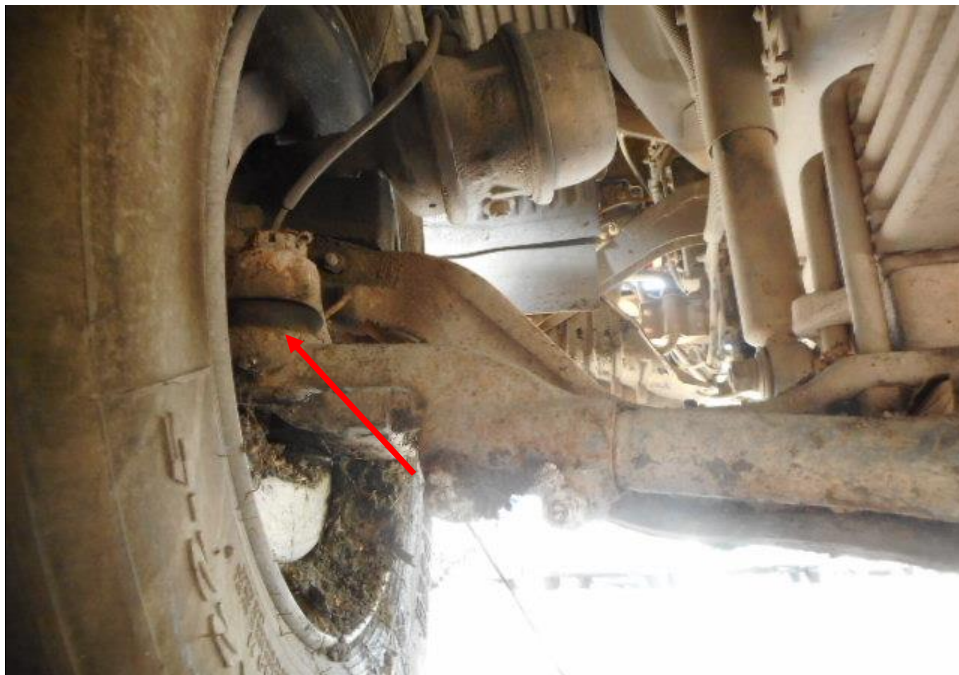
Photo 25 shows the various undercarriage components at the front left wheel of the Motor Tipper, in particular the steering tie rod end (arrowed). were found to be intact, there was also no sign of fluid stain(s) observed on the various undercarriage components.

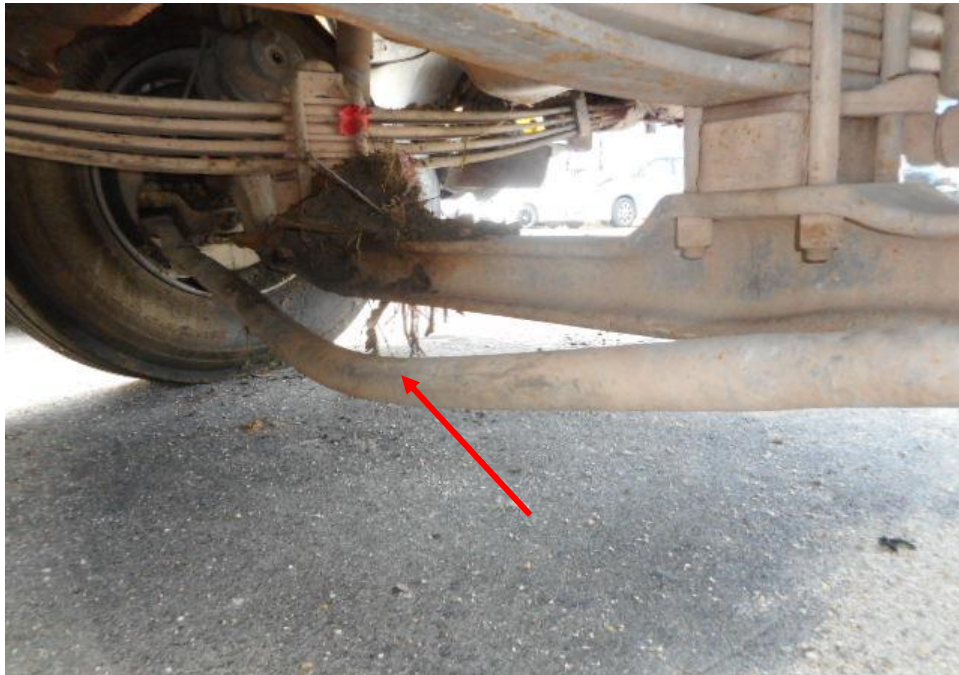
Photo 26 shows the steering tie rod end (arrowed) of the Motor Tipper. The steering tie rod was observed to sustained damage as a result of the accident.

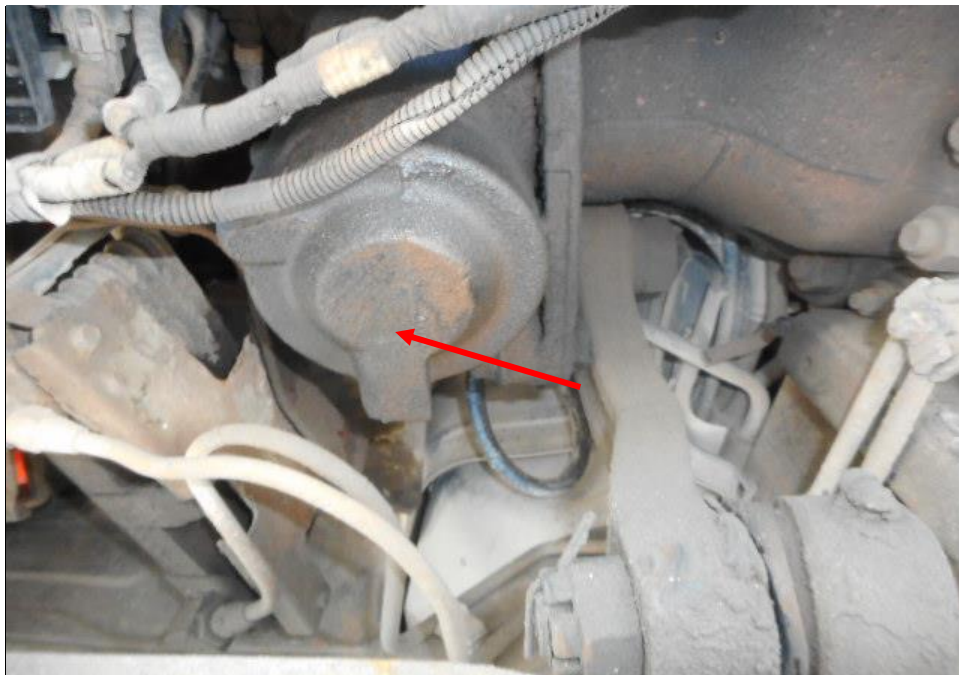
Photo 27 shows the steering box component (arrowed) at the undercarriage of the Motor Tipper was found to be intact without any visible damage. There was also no sign of fluid stain(s) observed on the various undercarriage components.
