You're Ref: TP/IP/55223/2021
Our Ref: CI/TPD21013038/P

13th January 2022

MECHANICAL INSPECTION REPORT OF MOTOR CAR SLU 5290T

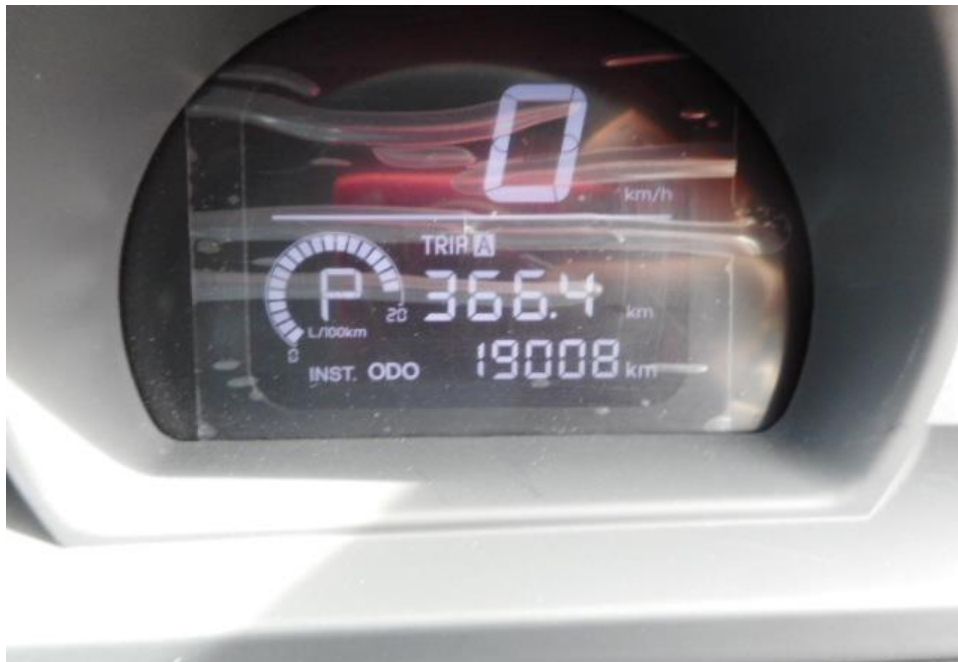
Photo 1 shows the mileage of the Motor Car at the time of my inspection. The mileage observed was 19,008km.

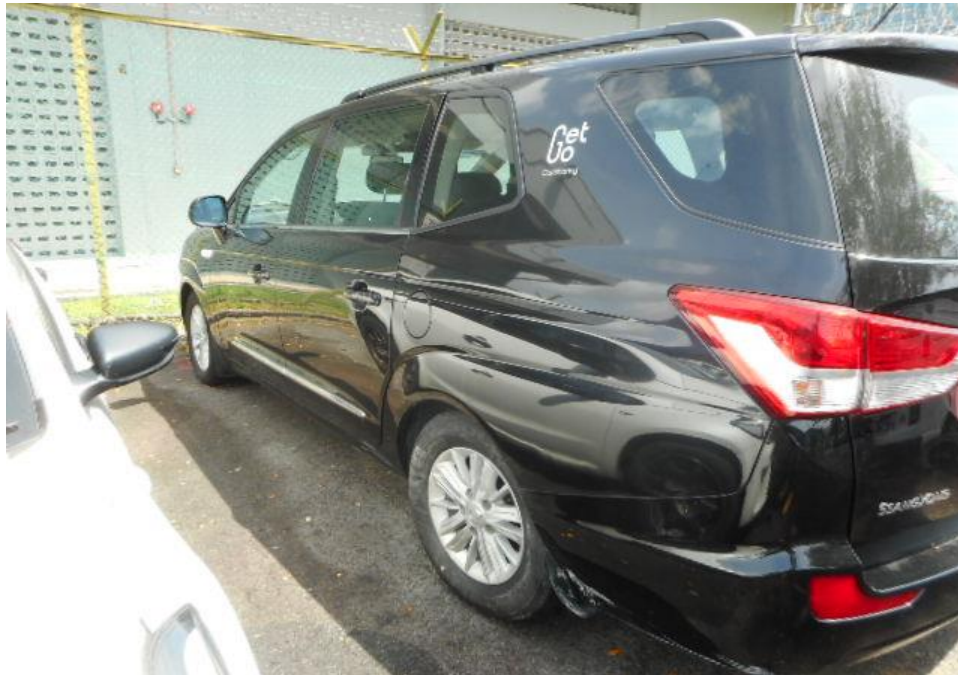
Photo 2 shows a general view of the Motor Car's left body at the time of my inspection. The Motor Car was observed to have sustained damage at its left and rear portion. Its left side skirt and its rear bumper were amongst the body parts that were damaged as a result of the accident.

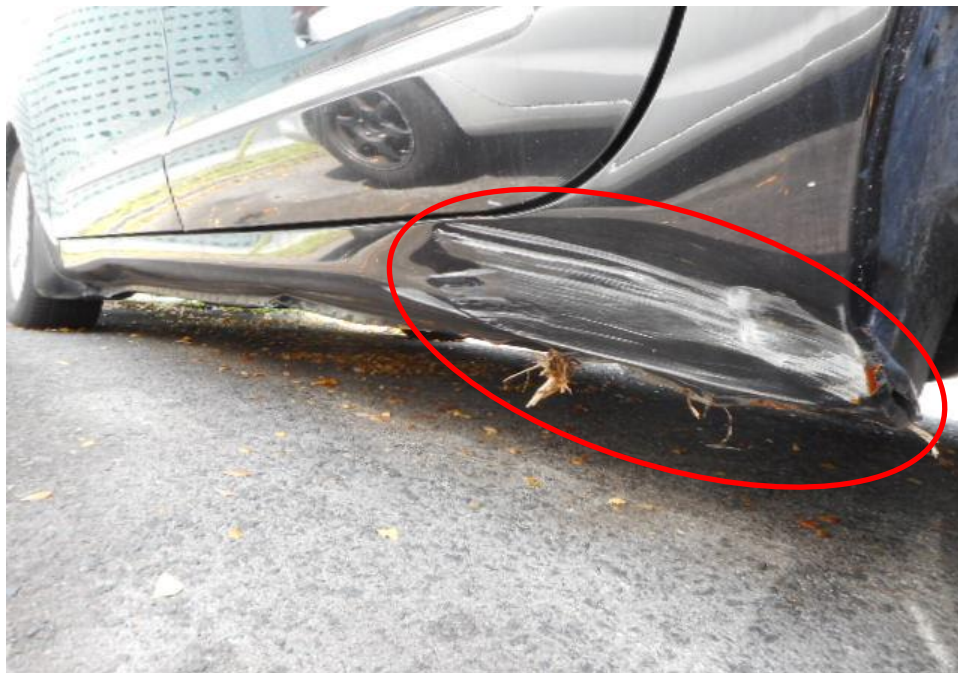
Photo 3 shows a close up view of the Motor Car's left body at the time of my inspection. The Motor Car was observed to have sustained damage at its left and rear portion. Its left side skirt (circled) were amongst the body parts that were damaged as a result of the accident.

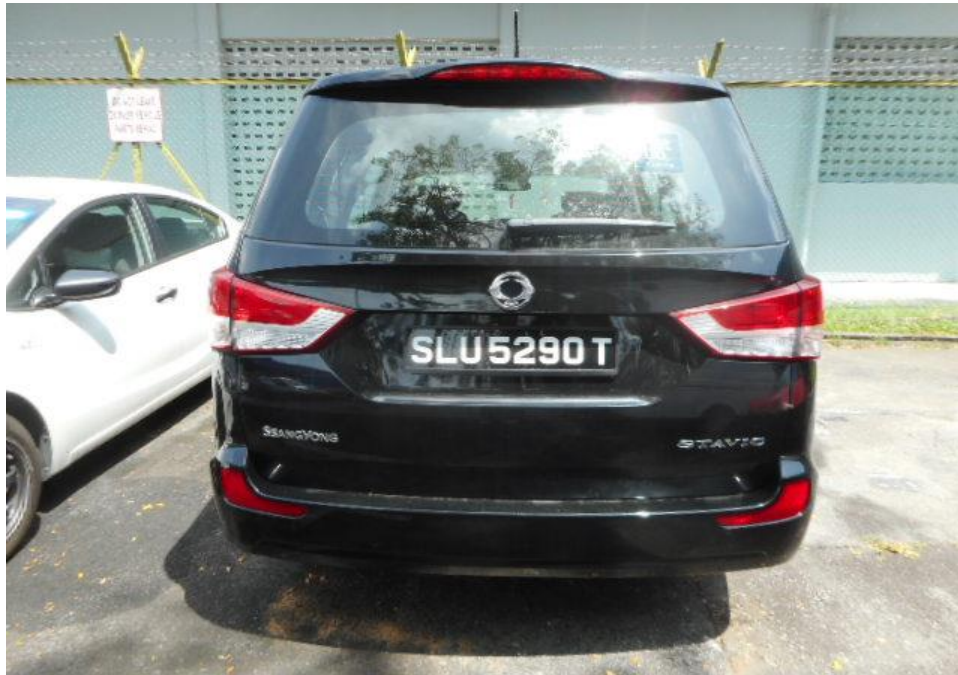
Photo 4 shows a general view of the Motor Car's rear body at the time of my inspection. The Motor Car was observed to have sustained damage at its left and rear portion. Its rear bumper were amongst the body parts that were damaged as a result of the accident.

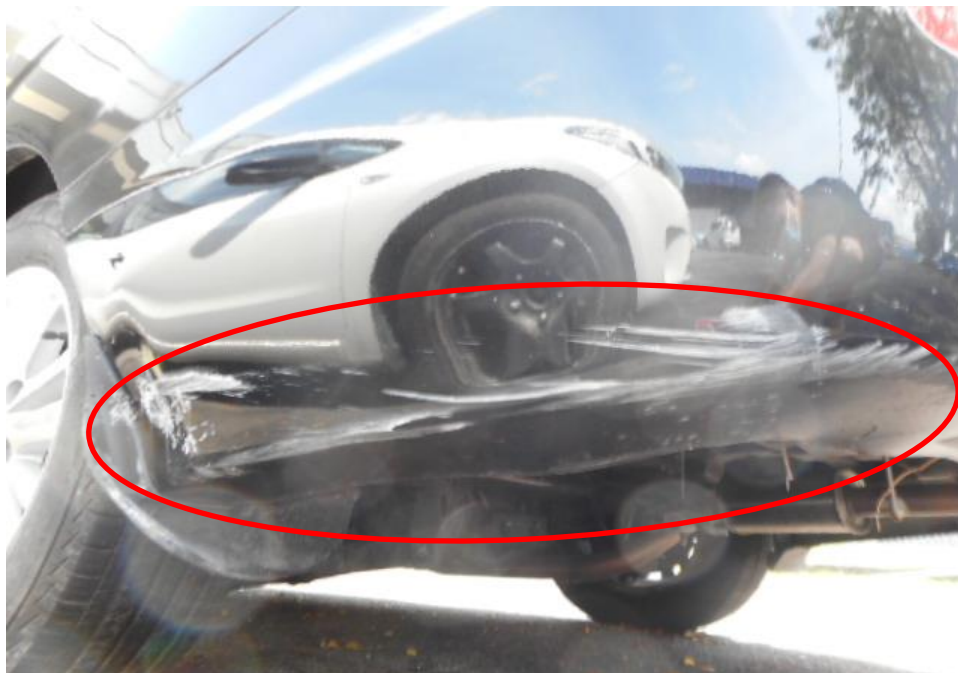
Photo 5 shows a close up view of the Motor Car's rear body at the time of my inspection. The Motor Car was observed to have sustained damage at its left and rear portion. Its rear bumper (circled) were amongst the body parts that were damaged as a result of the accident.

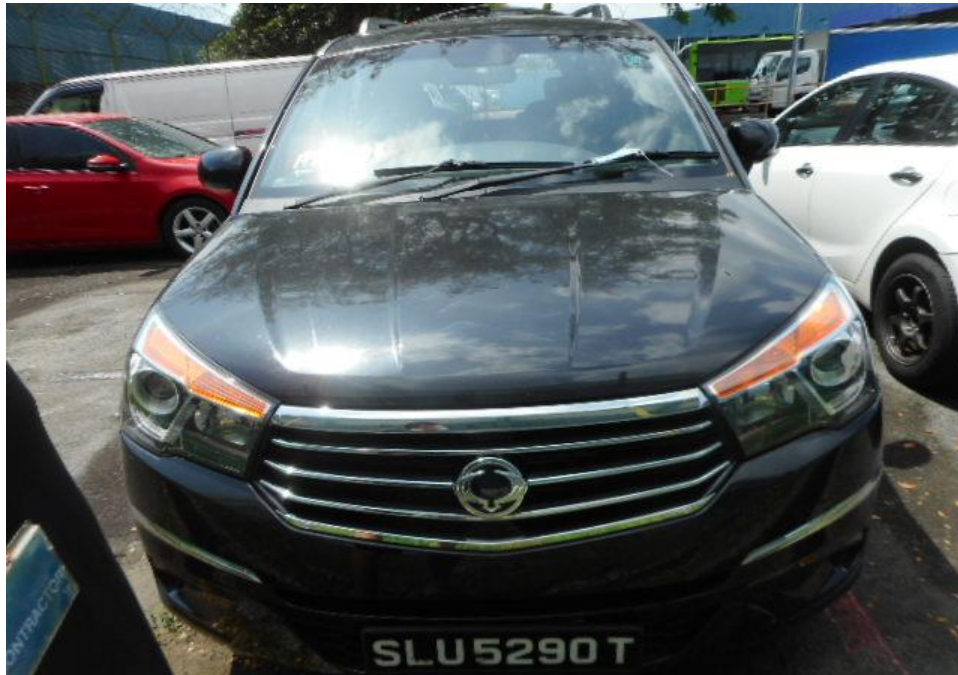
Photo 6 shows a general view of the Motor Car's front body at the time of my inspection. The front portion of the Motor Car was observed to have been unaffected by the accident.

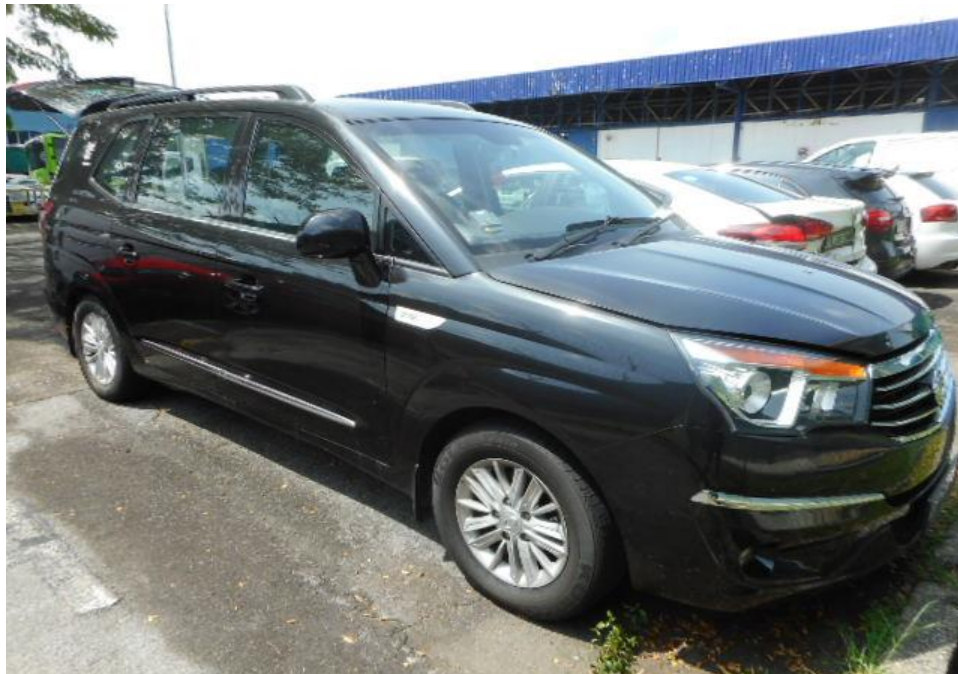
Photo 7 shows a general view of the Motor Car's right body at the time of my inspection. The right portion of the Motor Car was observed to have been unaffected by the accident.

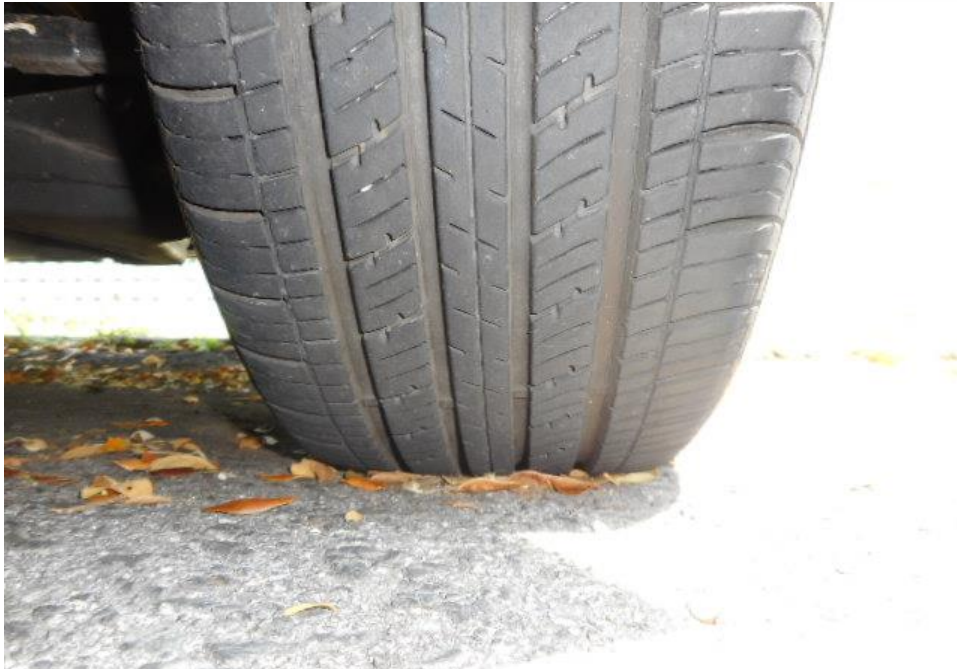
Photo 8 shows the condition of the front right tyre of the Motor Car, which was observed to be in serviceable condition with remaining tread depth of approximately 6.7mm. The tyre was sufficiently inflated for vehicular operation with no tear, cut or burst mark(s) on the outer and the inner sidewalls as well as across the tread. The 2 tyres of the Motor Car were wrapped around standard steel wheel rims without any damage.

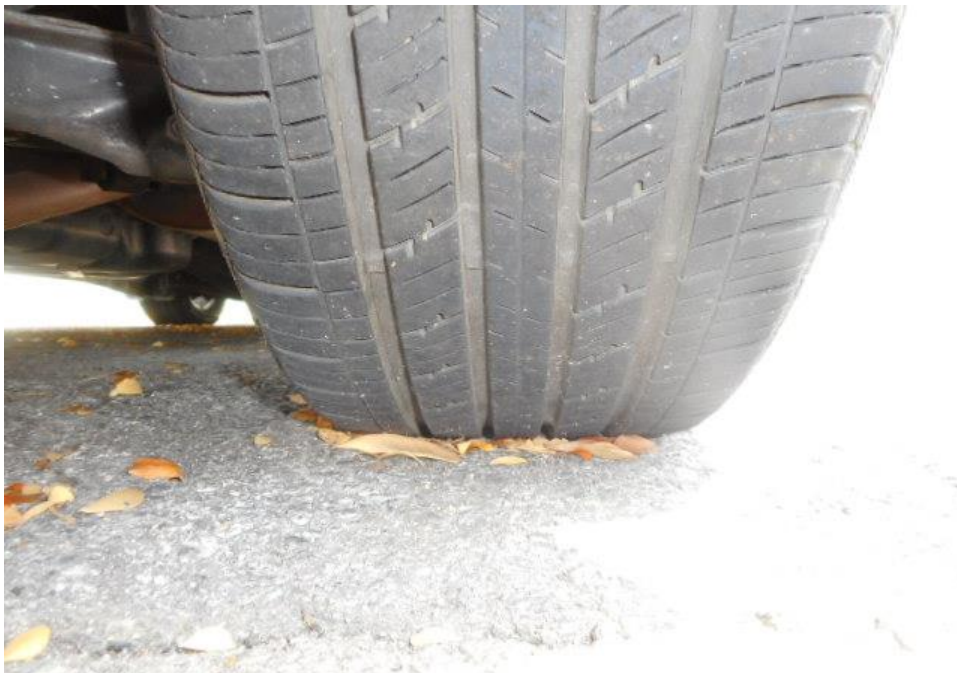
Photo 9 shows the condition of the rear right tyre of the Motor Car, which was observed to be in serviceable condition with remaining tread depth of approximately 5.7mm. The tyre was also observed to be sufficiently inflated for vehicular operation with no tear, cut or burst mark(s).

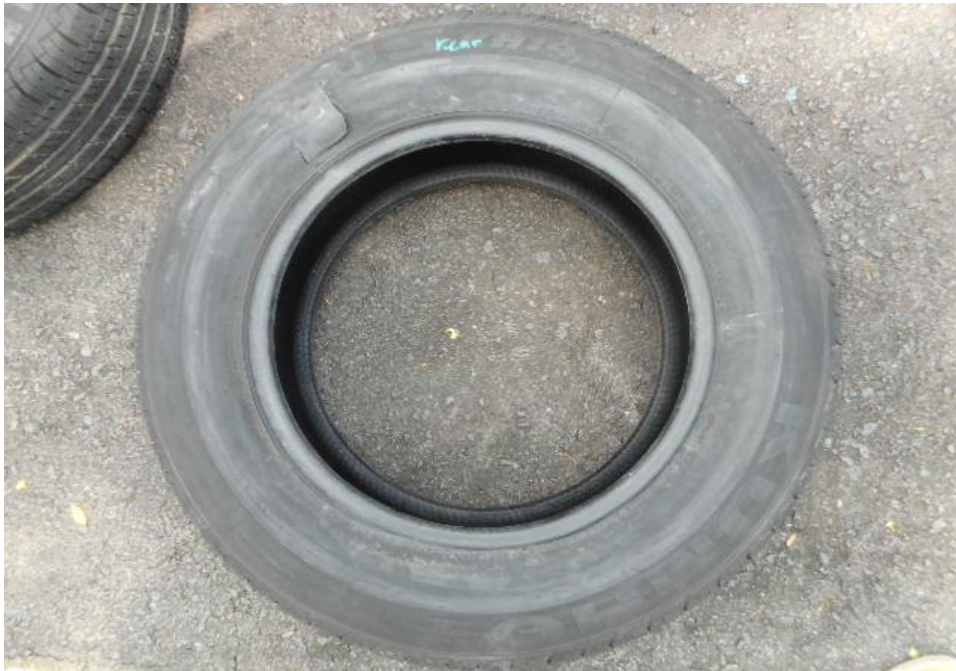
Photo 10 shows the general view and the condition of the rear left tyre of the Motor Car, which was observed to be in unserviceable condition with remaining tread depth of approximately 5.9mm. The tyre, was cut and deflated as a result of the accident.

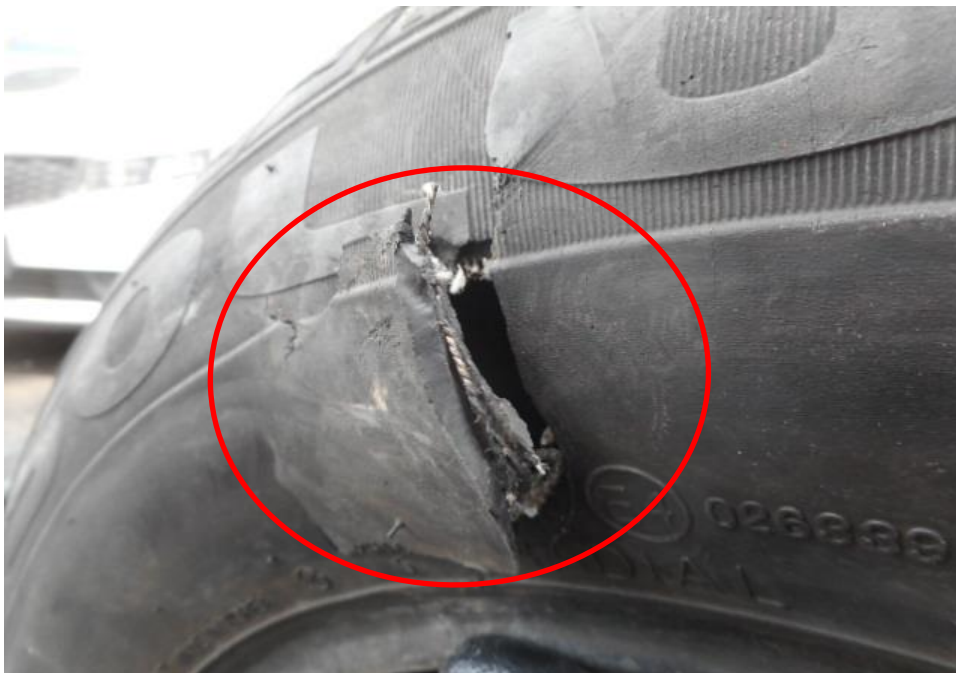
Photo 11 shows close up view and the condition of the rear left tyre of the Motor Car, which was observed to be in unserviceable condition with remaining tread depth of approximately 5.9mm. The tyre was cut and deflated (circled) as a result of the accident.

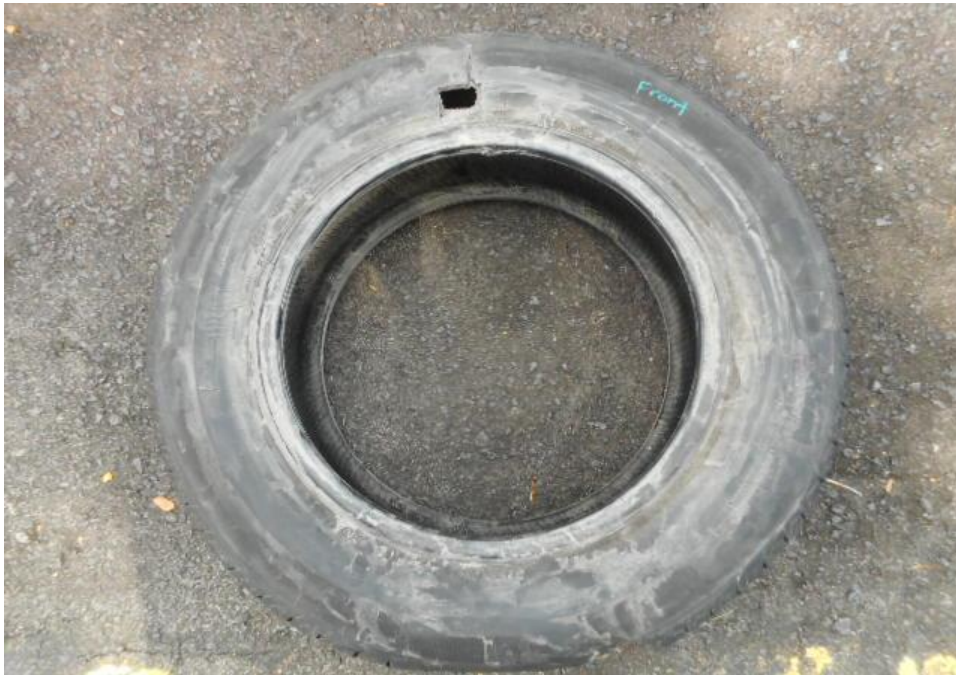
Photo 12 shows the general view and the condition of the front left tyre of the Motor Car, which was observed to be in serviceable condition with remaining tread depth of approximately 6mm. There was also no tear, cut or burst mark(s) on the outer and the inner sidewalls as well as across the tread of the Motor Car's 4 tyres.

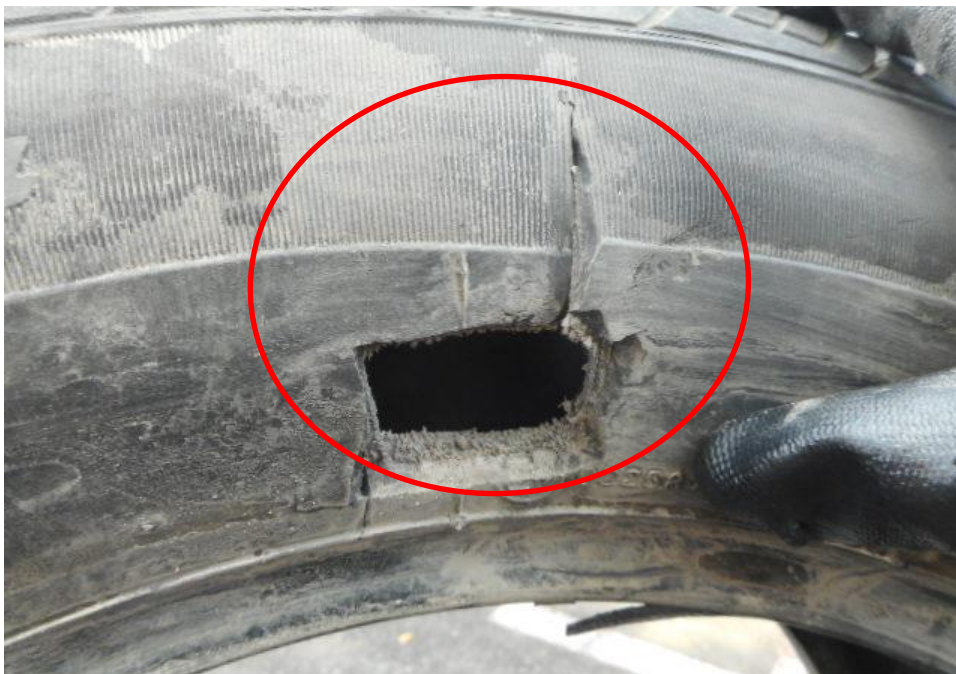
Photo 13 shows close up view and the condition of the rear left tyre of the Motor Car, which was observed to be in unserviceable condition with remaining tread depth of approximately 6mm. The tyre was cut and deflated (circled) as a result of the accident.

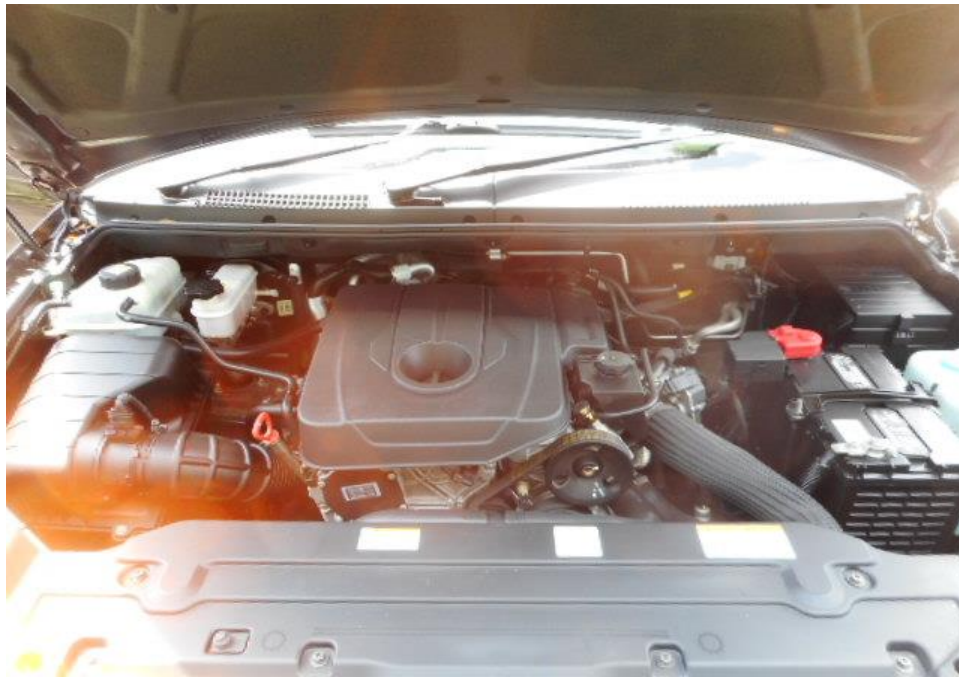
Photo 14 shows a general view of the Motor Car's engine compartment. The various parts and components inside the engine compartment were unaffected by the accident. There was also no sign(s) or indication(s) of fluid leakage and/or fluid stain within the engine compartment.

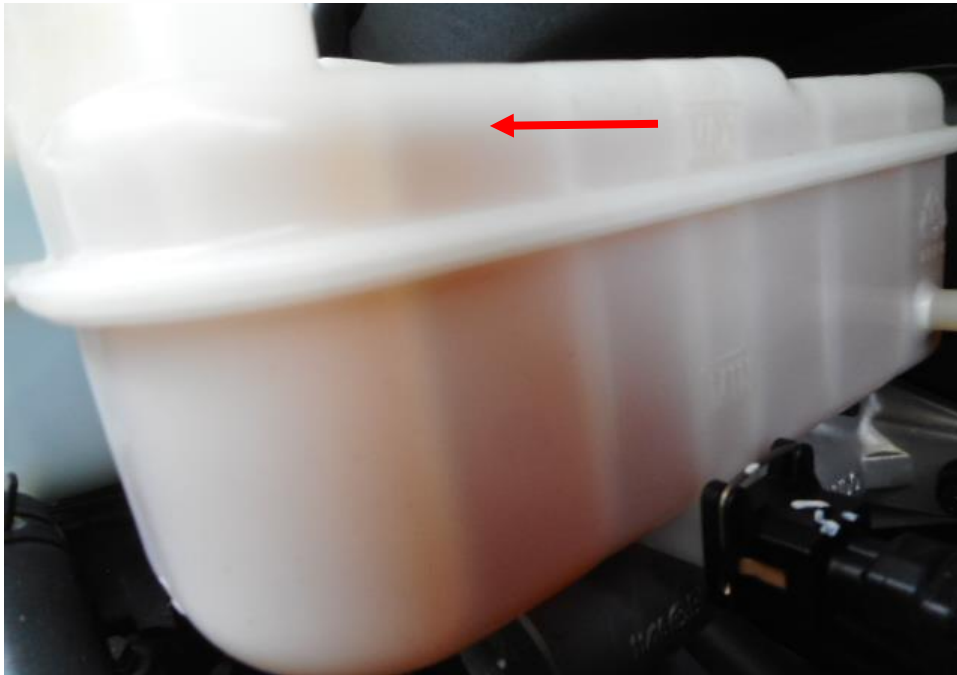
Photo 15 shows the brake fluid reservoir of the Motor Car at the time of my inspection. The brake fluid was observed to be of sufficient level (arrowed) and without any visible contamination.

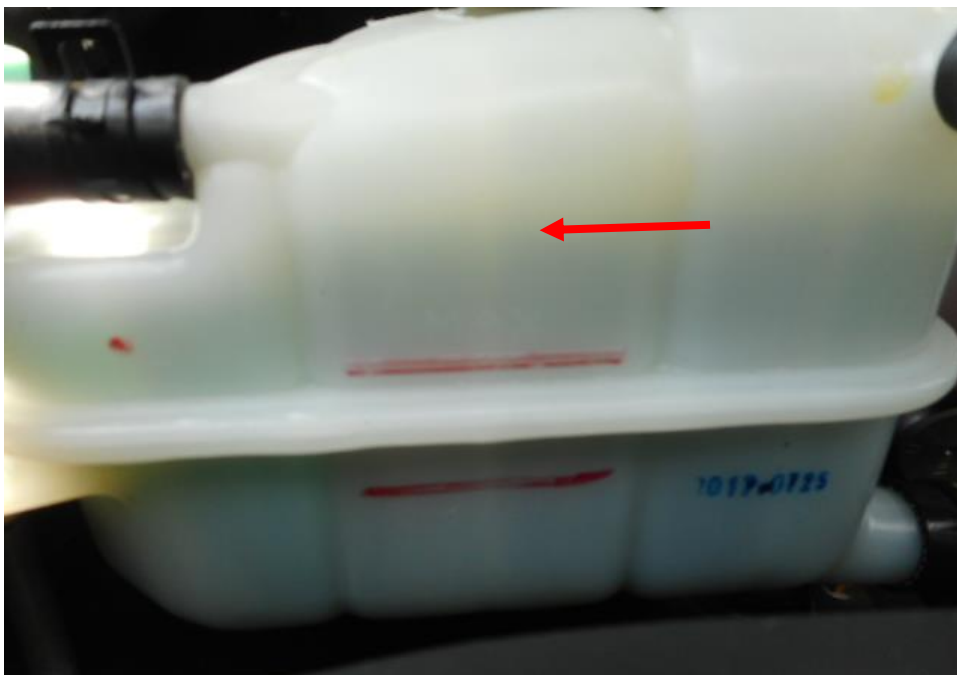
Photo 16 shows checks being carried out to the engine coolant of the Motor Car at the time of my inspection. The engine coolant was observed to be of sufficient level (arrowed) and without any visible contamination.

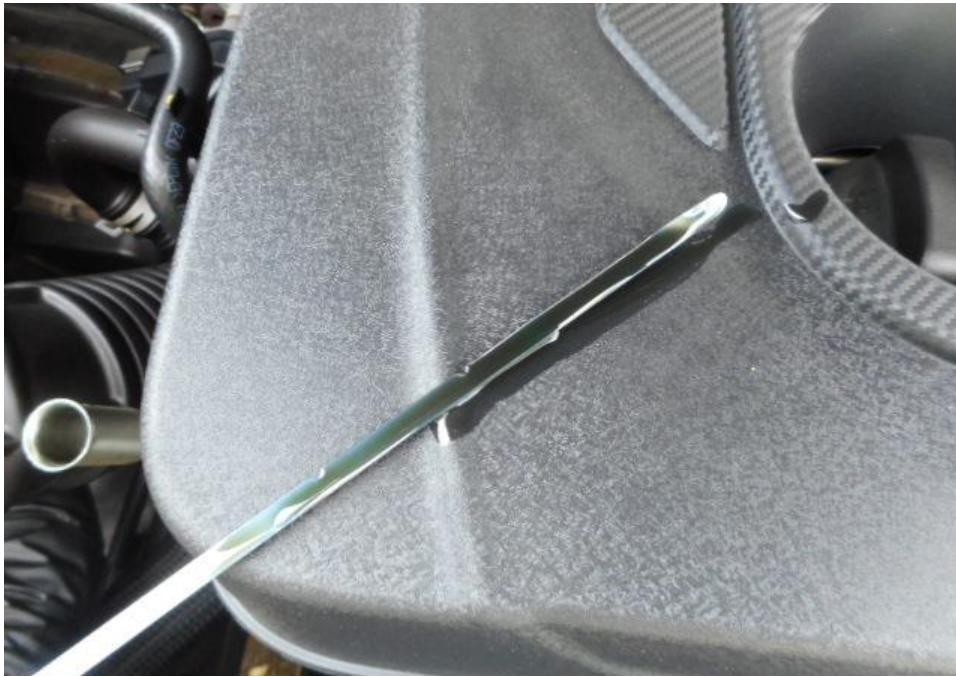
Photo 17 shows the engine oil dipstick of the Motor Car at the time of my inspection. The engine oil was observed to be of sufficient level and without any visible contamination.

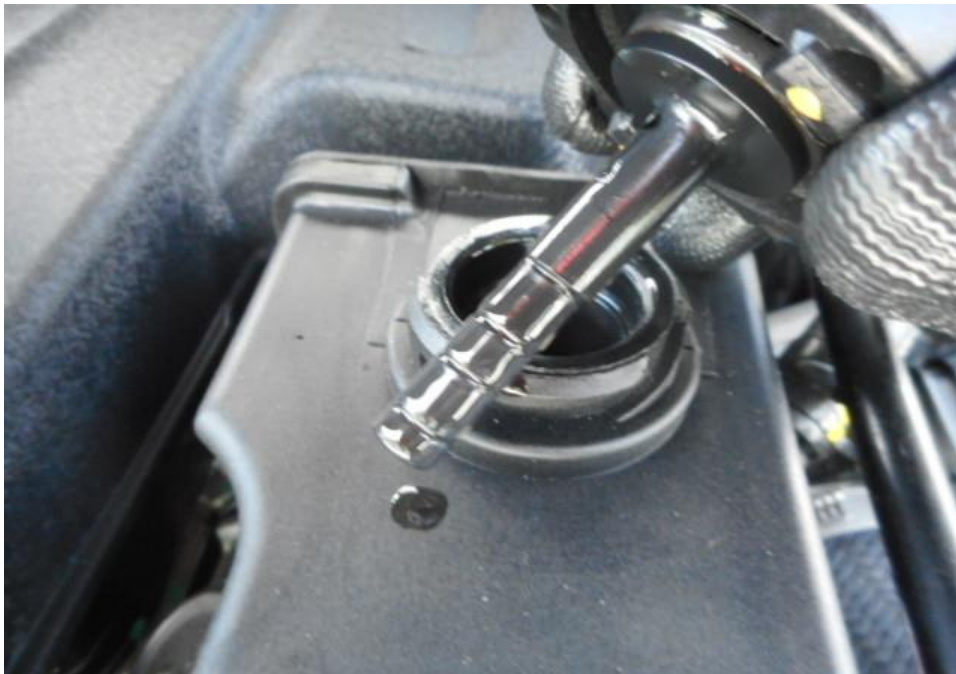
Photo 18 shows the power steering fluid dipstick of the Motor Car at the time of my inspection. The steering fluid was observed to be of sufficient level and without any visible contamination.

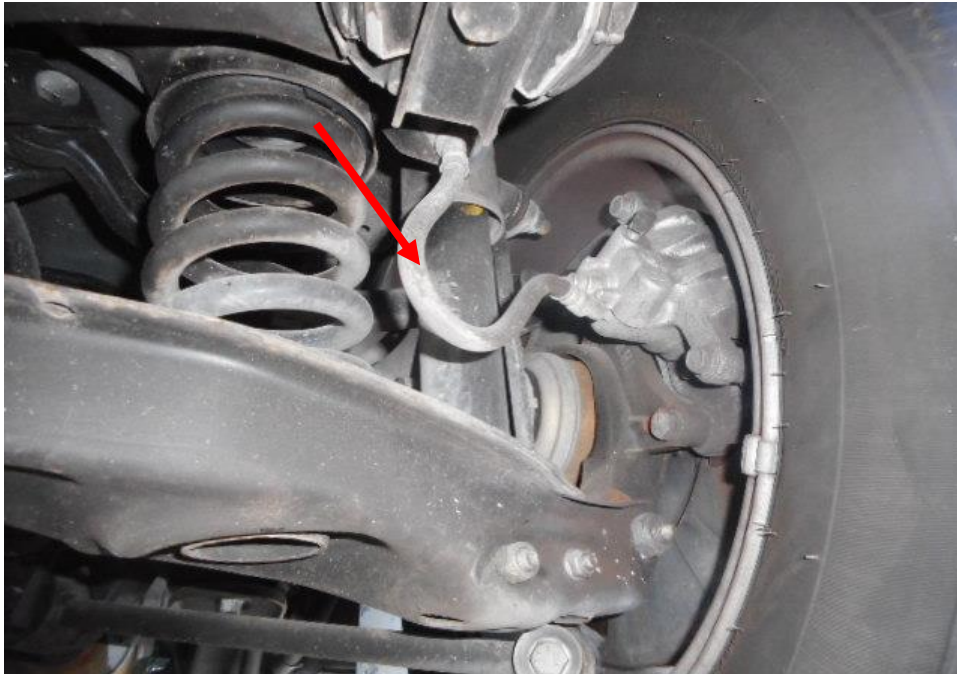
Photo 20 shows the brake hose/pipe (arrowed) at the rear right wheel of the Motor Car. No leakage of brake fluid was observed. Visual examination of the various components of the braking system like the drum brake, brake booster, brake pedal etc. had revealed all to be intact and without visible damage.

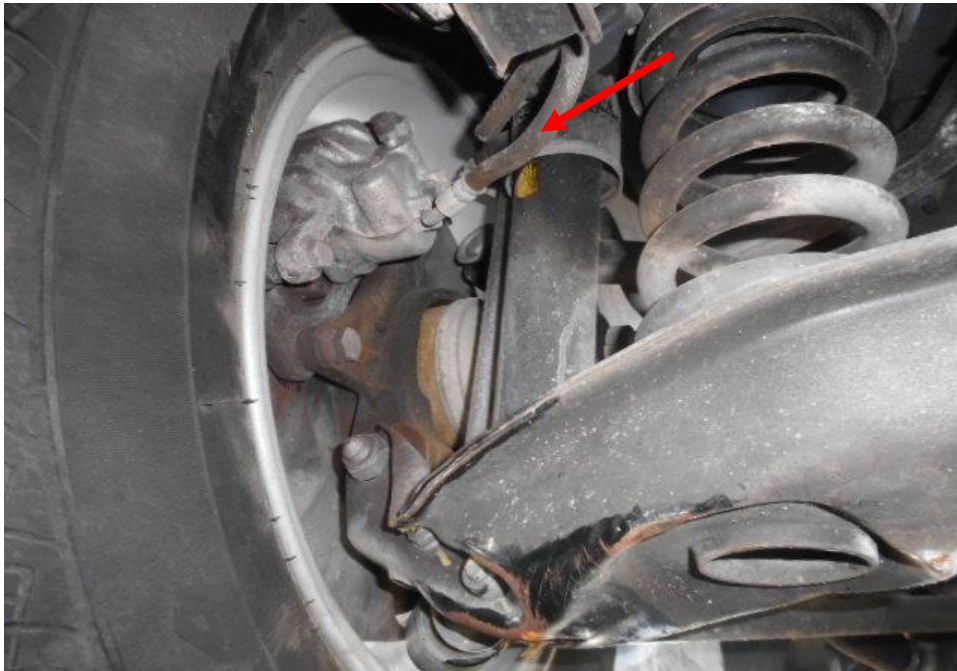
Photo 21 shows the brake hose/pipe (arrowed) at the rear left wheel of the Motor Car. I did not observe any leakage of brake fluid at the time of my inspection of the Motor Car. Static tests of the Motor Car's braking system had indicated that there was no internal leakage of pressure/vacuum. The undercarriage components of the Motor Car were also all found to be intact and without any visible damage.

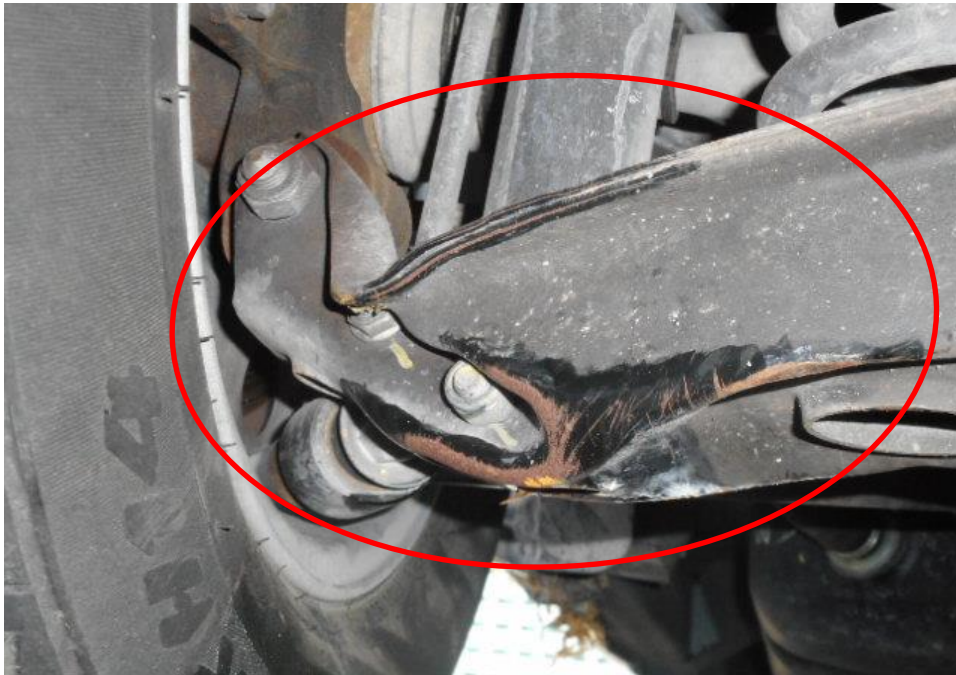
Photo 22 shows the lower arm (circled) at the rear left wheel of the Motor Car. It was observed to sustained damages as a result of the accident at the time of my inspection.

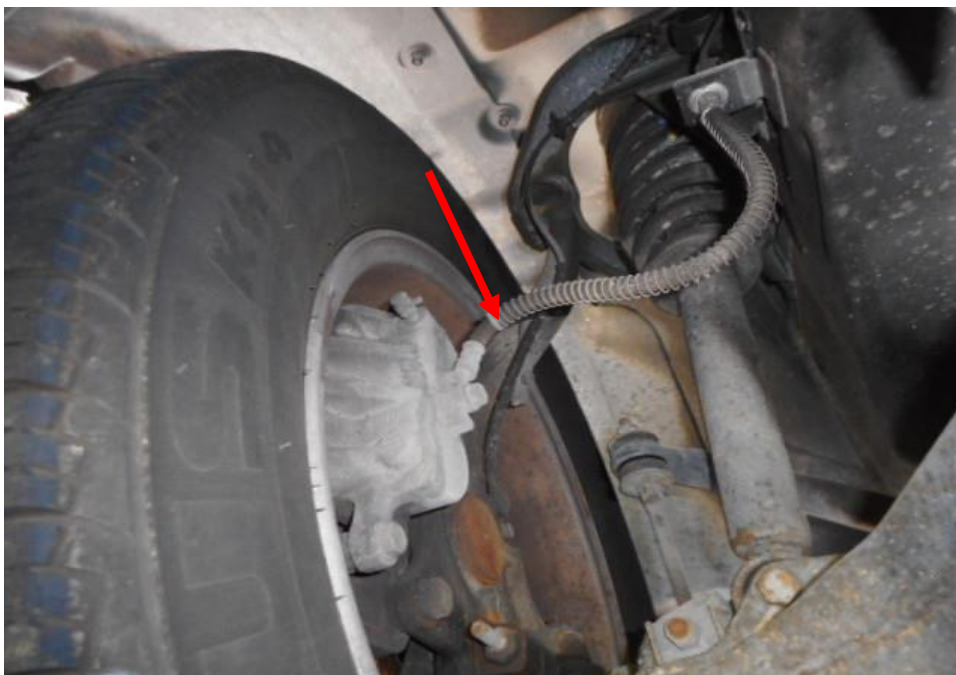
Photo 23 shows the brake hose/pipe (arrowed) at the front right wheel of the Motor Car. I did not observe any leakage of brake fluid at the time of my inspection of the Motor Car. Static tests of the Motor Car's braking system had indicated that there was no internal leakage of pressure/vacuum. The undercarriage components of the Motor Car were also all found to be intact and without any visible damage.

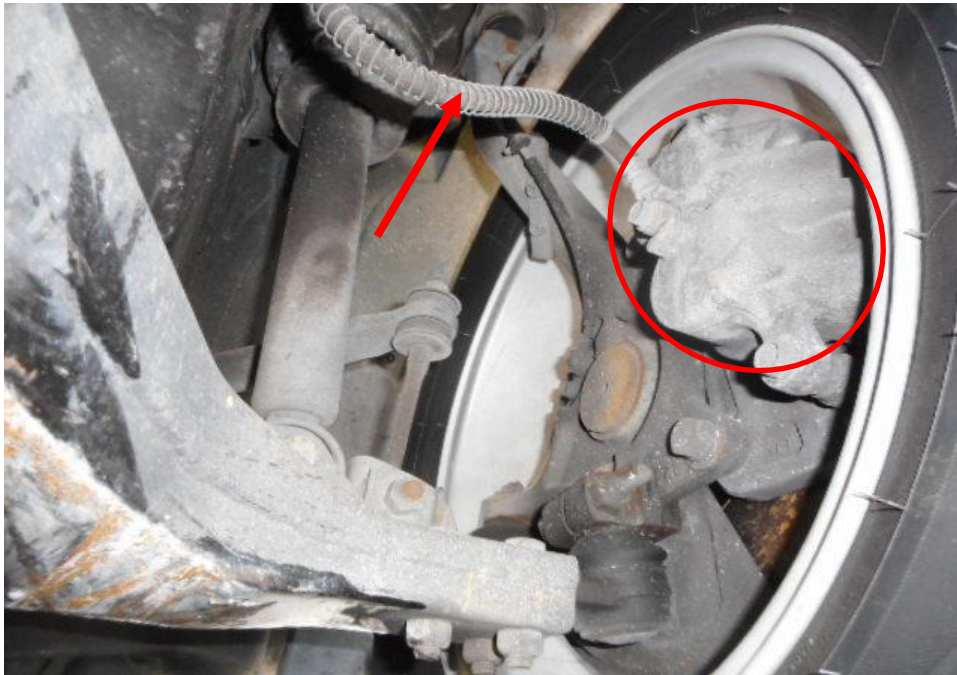
Photo 24 shows the brake hose/pipe (arrowed) at the front left wheel of the Motor Car. No leakage of brake fluid was observed. Visual examination of the various components of the braking system like the brake caliper (circled), brake booster, brake pedal etc had revealed all to be intact and without visible damage.

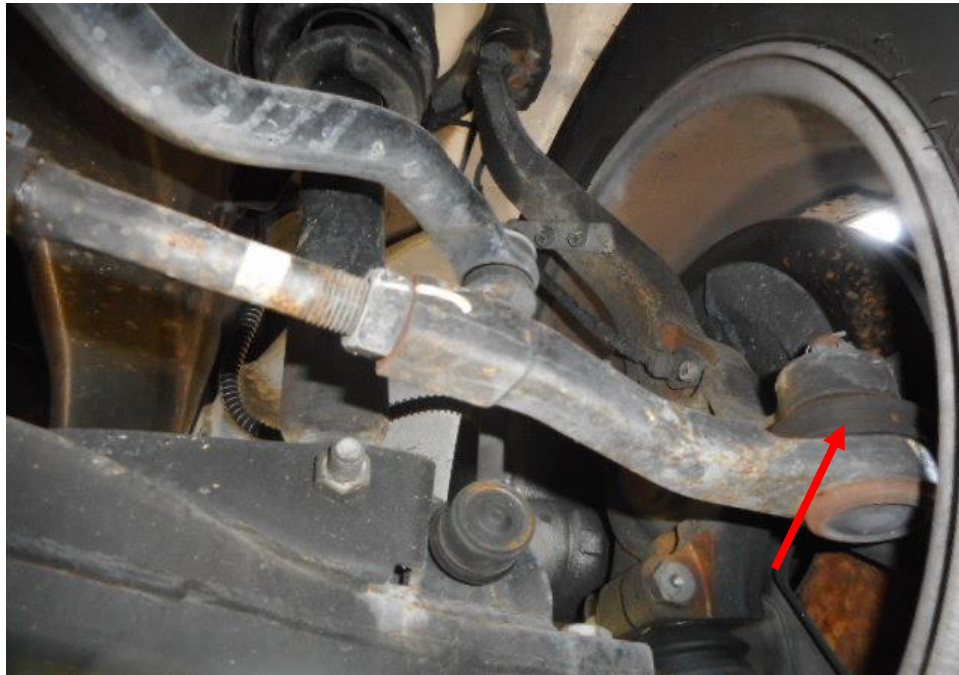
Photo 26 shows the various undercarriage components at the front right wheel of the Motor Car, in particular the steering tie rod (arrowed). The various steering components were all found to be intact, suggesting that the steering system of the Motor Car was likely to be in serviceable condition at the material time of accident. There was also no sign of fluid stain observed on the various undercarriage components at the front right wheel of the Motor Car.

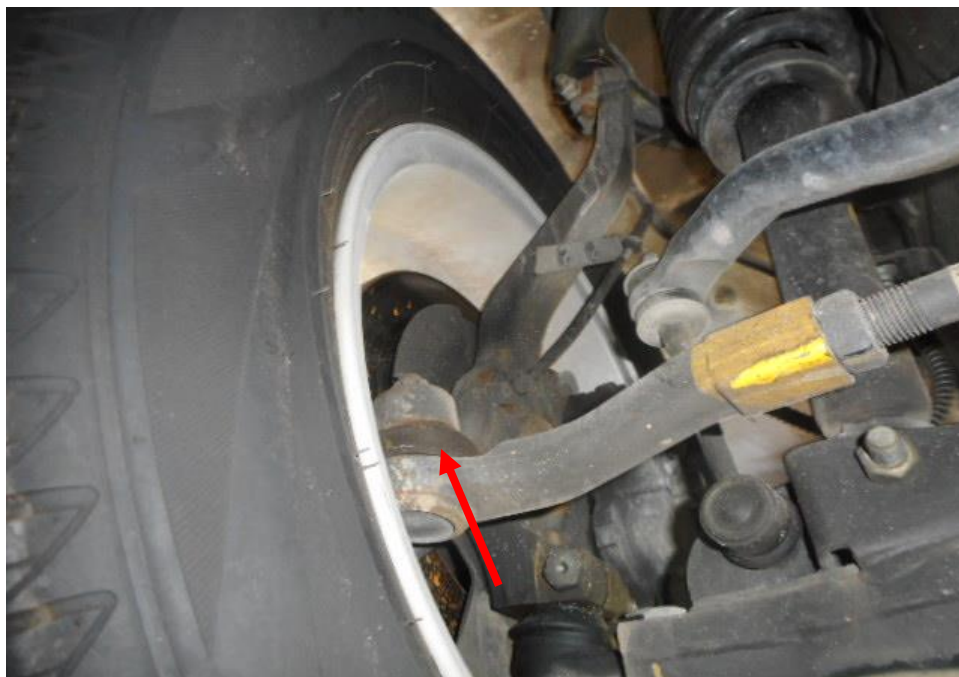
Photo 27 shows the various undercarriage components at the front left wheel of the Motor Car, which had included the steering tie rod (arrowed). The various undercarriage components of the Motor Car were all found to be intact without any visible damage.

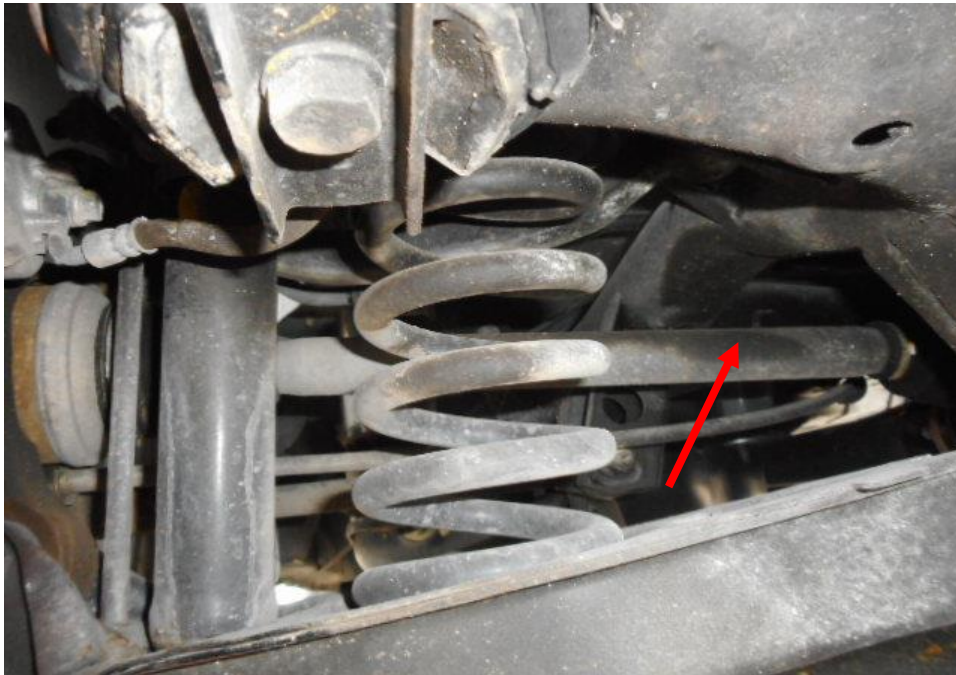
Photo 28 shows the various undercarriage components at the rear right wheel of the Motor Car, in particular the drive shaft (arrowed). The various steering components were all found to be intact, suggesting that the steering system of the Motor Car was likely to be in serviceable condition at the material time of accident. There was also no sign of fluid stain observed on the various undercarriage components at the rear right wheel of the Motor Car.

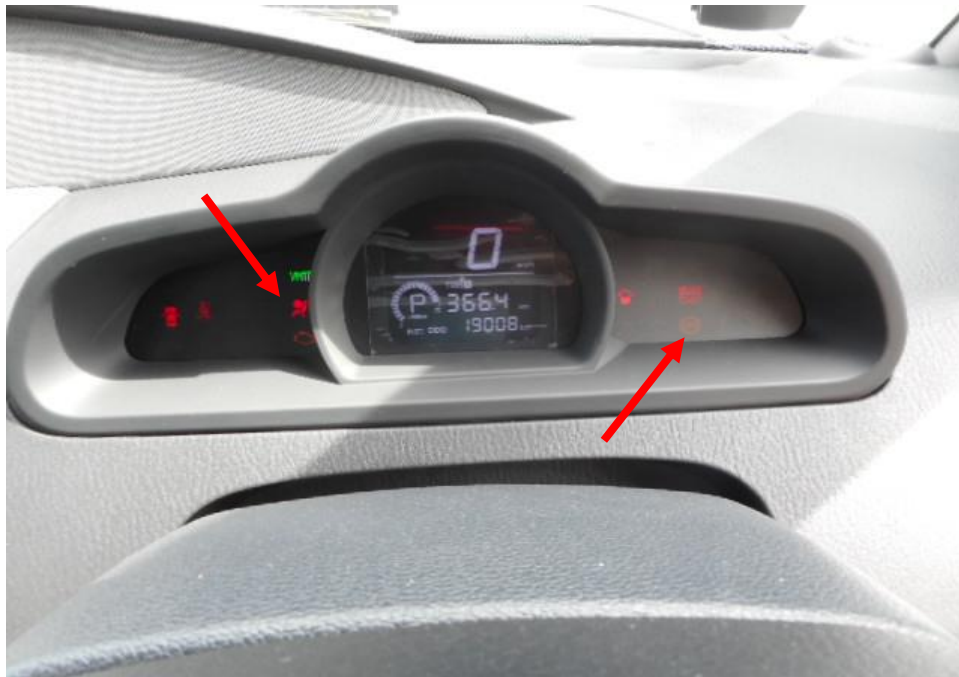
Photo 29 shows the warning light for Anti-Lock Brake System (ABS and Supplemental Restraint System (SRS) (arrowed) appearing on the instrument panel of the Motor Car during the self-test of its various electronic operating systems when its engine was cranked.

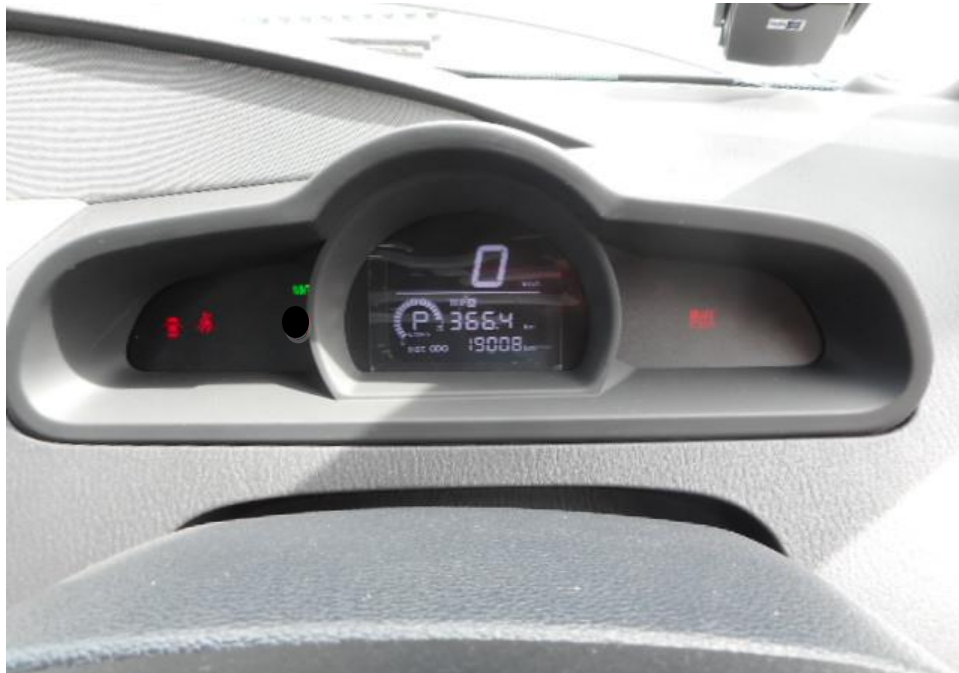
Photo 30 shows no warning lights illuminated on the instrument panel of the Motor Car after the engine was cranked. This would suggest that there was no abnormality to the electronic operating system of the Motor Car, like the ABS and SRS etc.
