You're Ref: TP/IP/52477/2021  
Our Ref: CI/TPD21013040/P

**Fatal Accident Investigation Team**

**MECHANICAL INSPECTION REPORT OF MOTOR CAR SMZ 8045C**

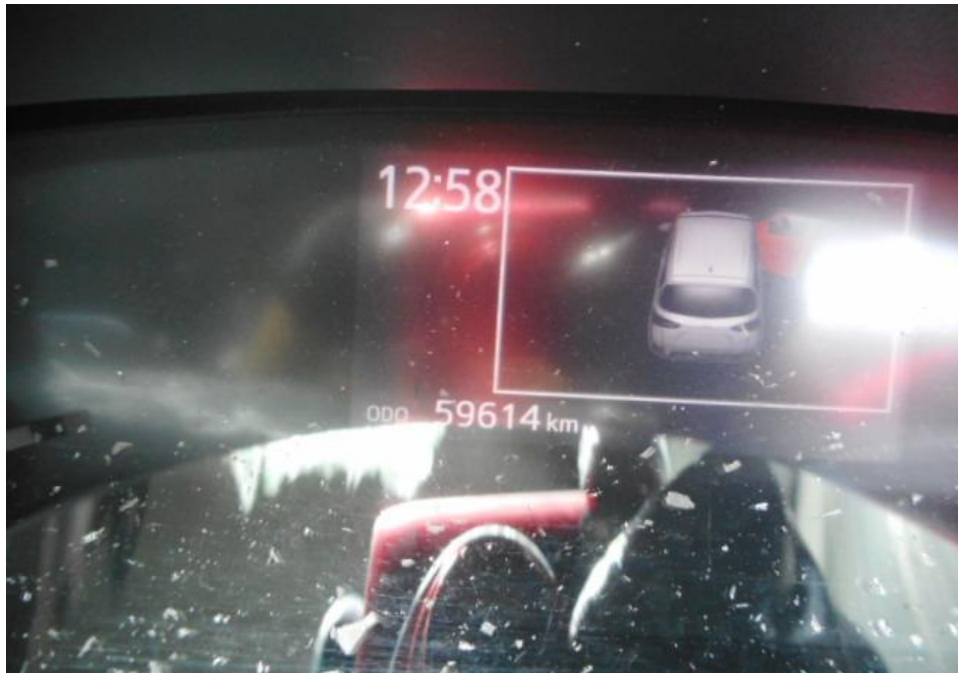
**Photo 1** shows the mileage of the Motor Car at the time of my inspection. The mileage observed was 59,614km.

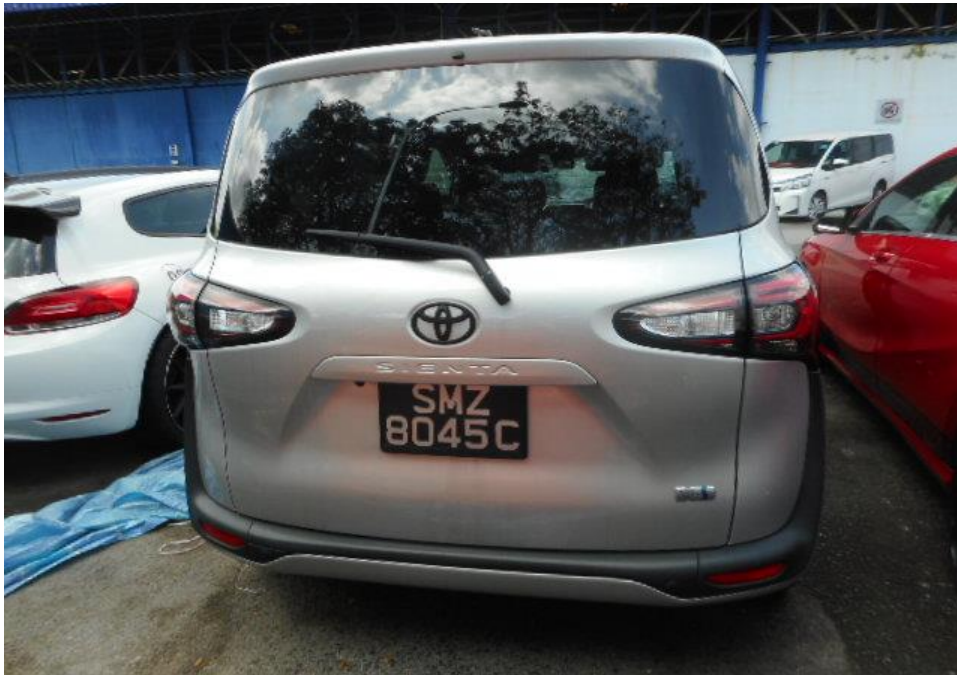
**Photo 2** shows the general view of the Motor Car's rear body at the time of my inspection. The Motor Car rear was observed to be unaffected by the accident.

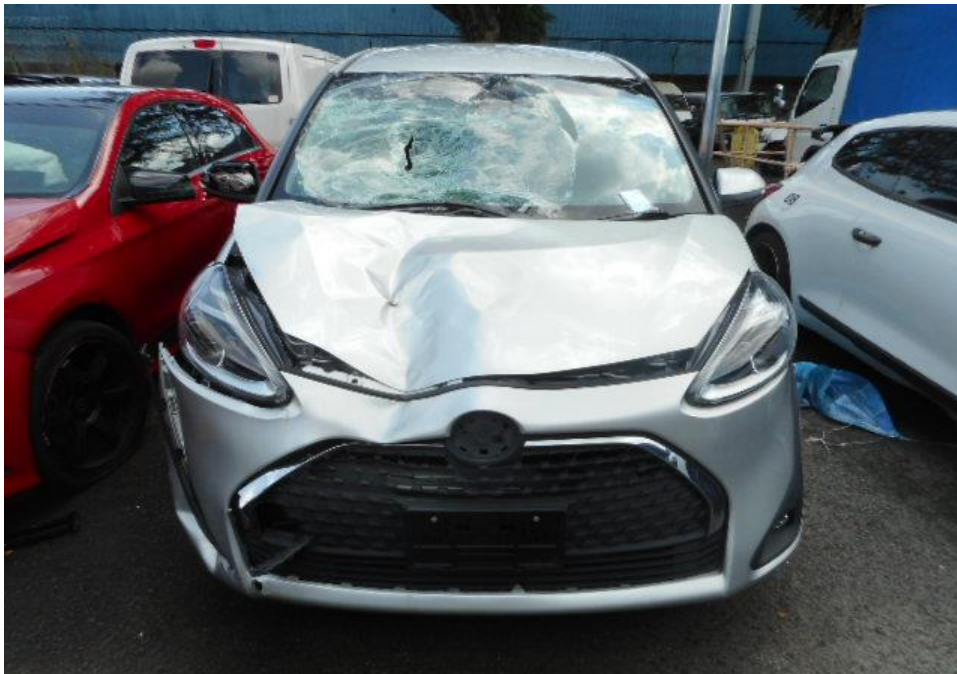
4. The mileage of the Motor Car at the time of my inspection was 59,614km.
5. The Motor Car was observed to have sustained damage at its front portion. Its front windscreen, front bonnet, front bumper and front right side view mirror was amongst the body parts that were damaged as a result of the accident.

**Photo 3** shows a general view of the Motor Car's front body at the time of my inspection. The front portion of the Motor Car was observed to have sustained damage. Its front windscreen, front bonnet, front bumper and front right side view mirror was amongst the body parts that were damaged as a result of the accident.

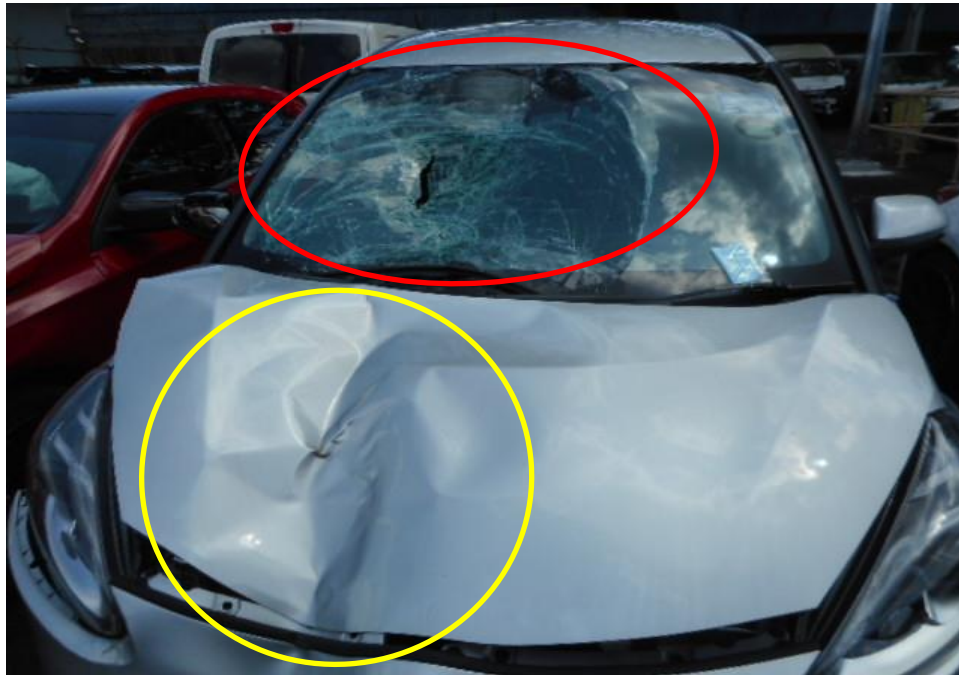
**Photo 4** shows a close up view of the Motor Car's front body at the time of my inspection. The front portion of the Motor Car was observed to have sustained damage. Its front windscreen (red circle) and front bumper (yellow circle) was the body parts that were damaged as a result of the accident.

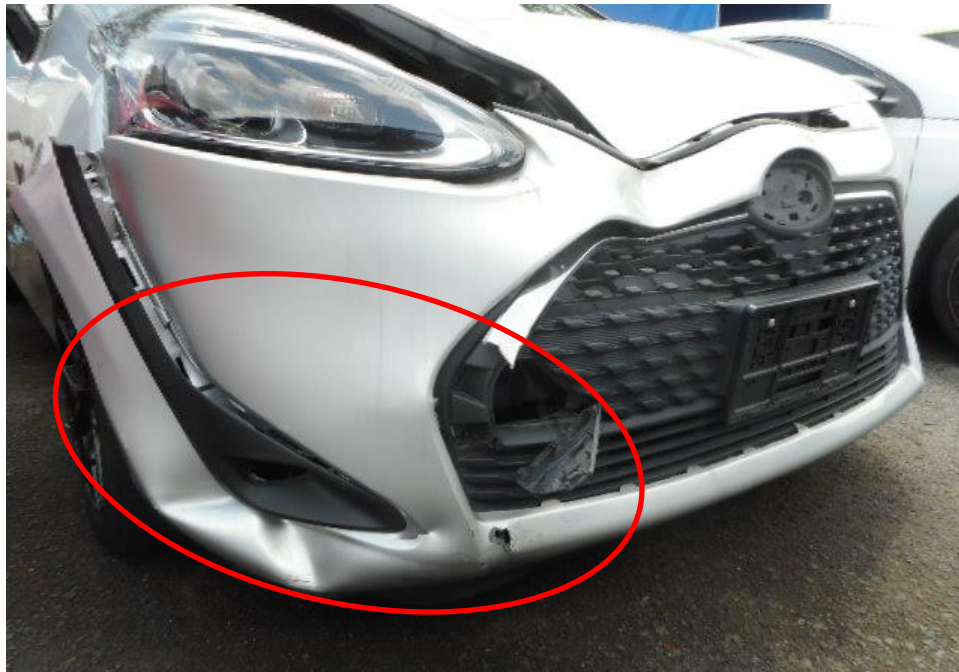
**Photo 5** shows a close up view of the Motor Car's front body at the time of my inspection. The front portion of the Motor Car was observed to have sustained damage. Its front bumper (circled) was the body parts that were damaged as a result of the accident.

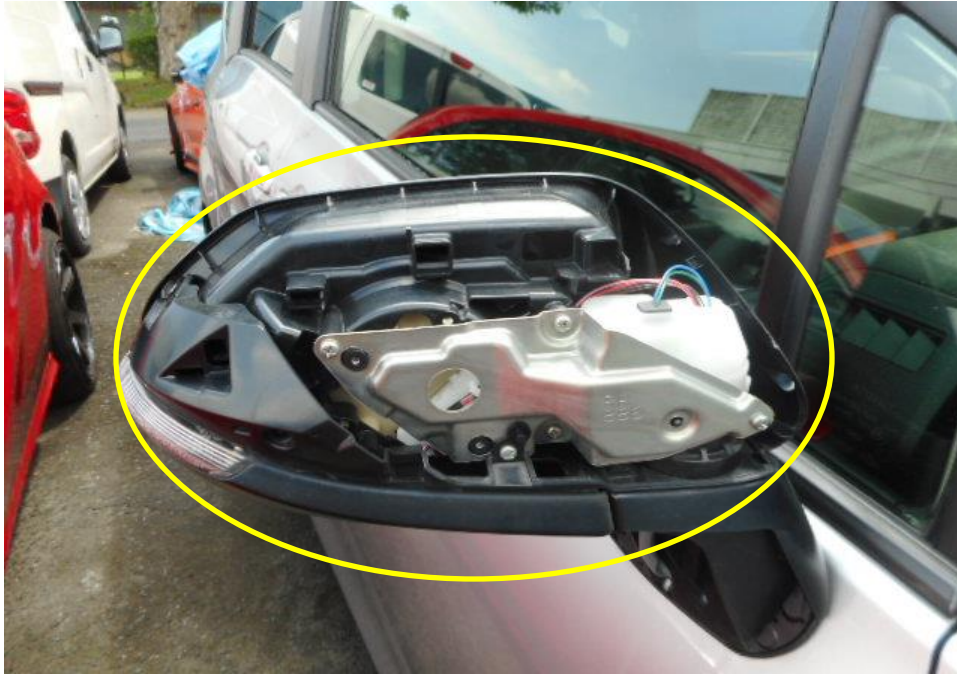
**Photo 6** shows a close up view of the Motor Car's front body at the time of my inspection. The front portion of the Motor Car was observed to have sustained damage. Its front right side view mirror (circled) was the body parts that were damaged as a result of the accident.

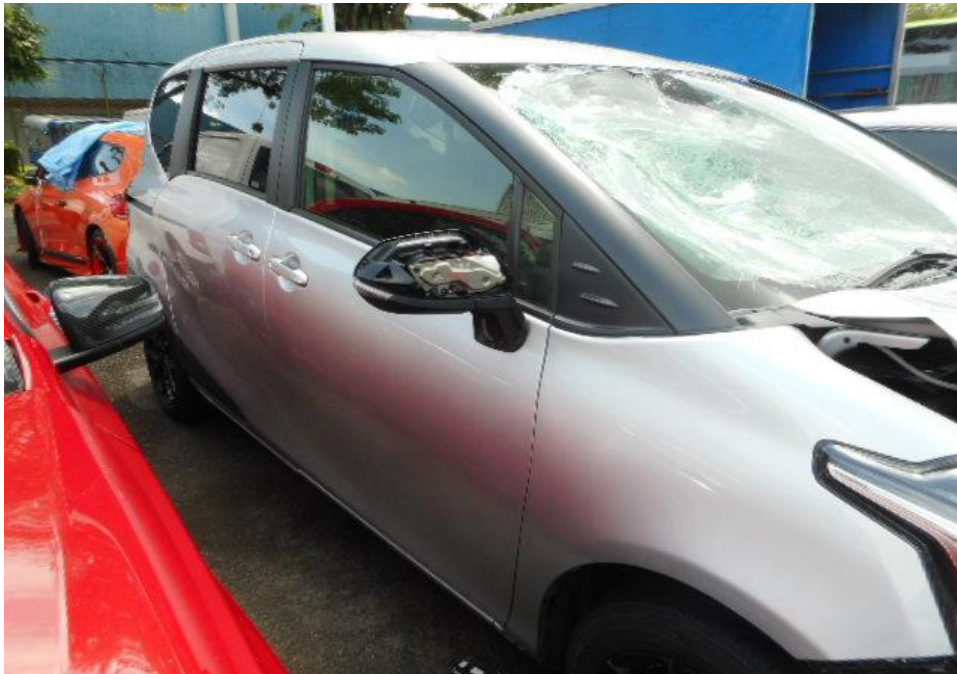
**Photo 7** shows a general view of the Motor Car's right body at the time of my inspection. The right portion of the Motor Car was observed to have been unaffected by the accident.

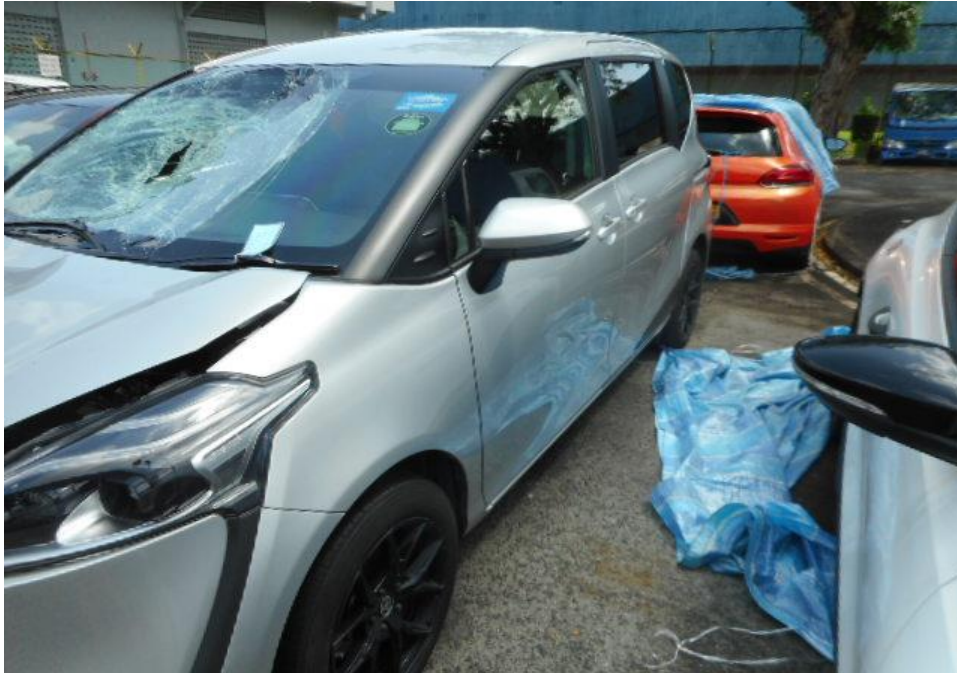
**Photo 8** shows a general view of the Motor Car's left body at the time of my inspection. The left portion of the Motor Car was observed to have been unaffected by the accident.

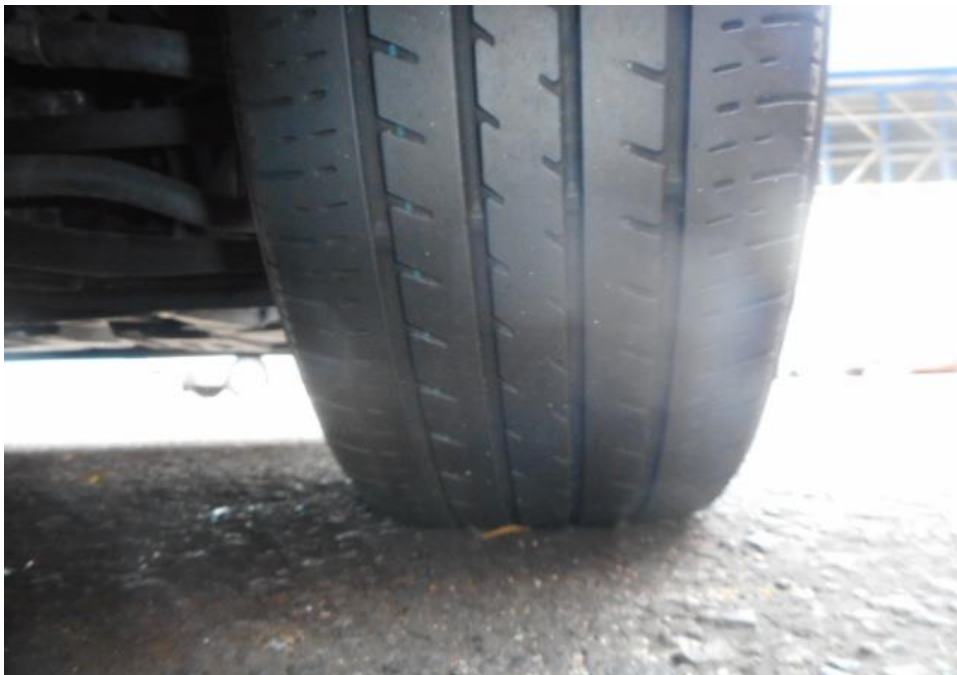
**Photo 9** shows the condition of the front right tyre of the Motor Car, which was observed to be in serviceable condition with remaining tread depth of approximately 4mm. The tyre was sufficiently inflated for vehicular operation with no tear, cut or burst mark(s) on the outer and the inner sidewalls as well as across the tread. The 4 tyres of the Motor Car were wrapped around standard steel wheel rims without any damage.

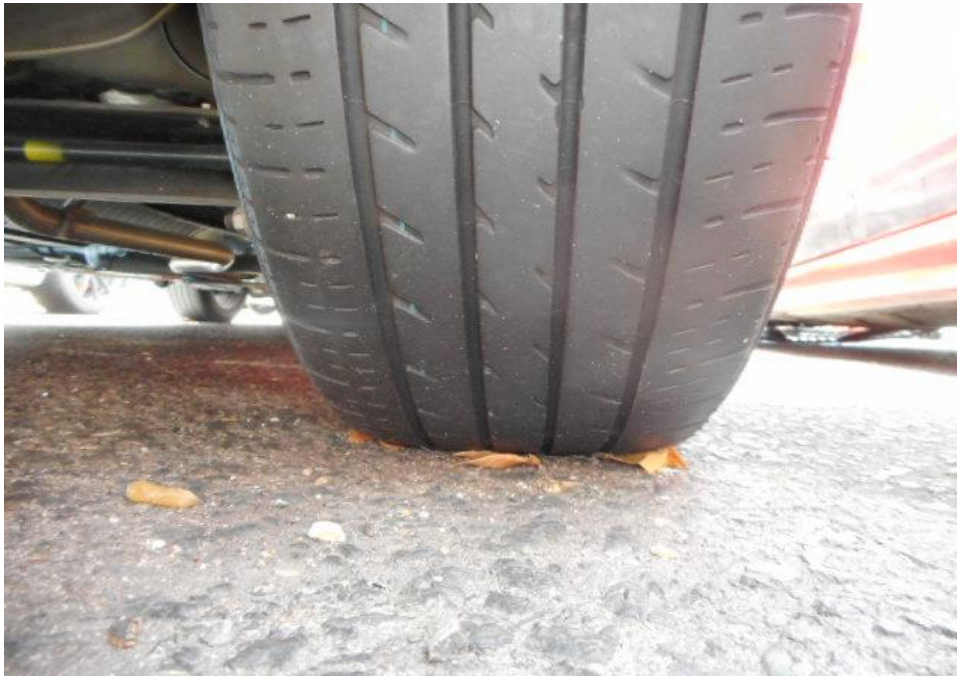
**Photo 10** shows the condition of the rear right tyre of the Motor Car, which was observed to be in serviceable condition with remaining tread depth of approximately 3.8mm. The tyre was also observed to be sufficiently inflated for vehicular operation with no tear, cut or burst mark(s).

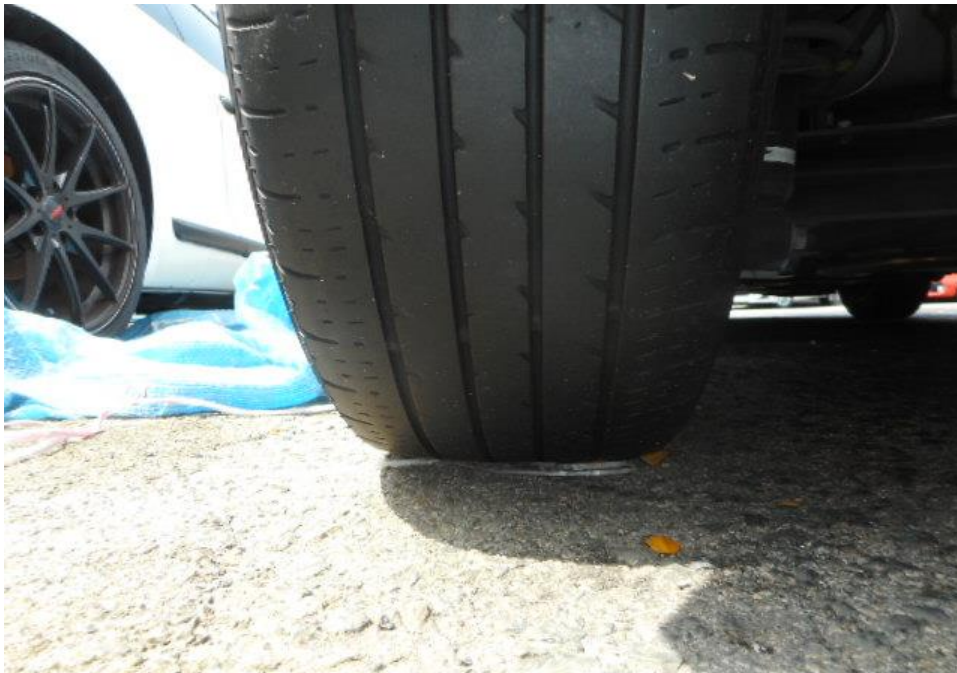
**Photo 11** shows the condition of the rear left tyre of the Motor Car, which was observed to be in serviceable condition with remaining tread depth of approximately 3.2mm. The tyre, which was wrapped around steel wheel rim, was also observed to be sufficiently inflated for vehicular operation. The 4 tyres of the Motor Car were wrapped around standard steel wheel rims.

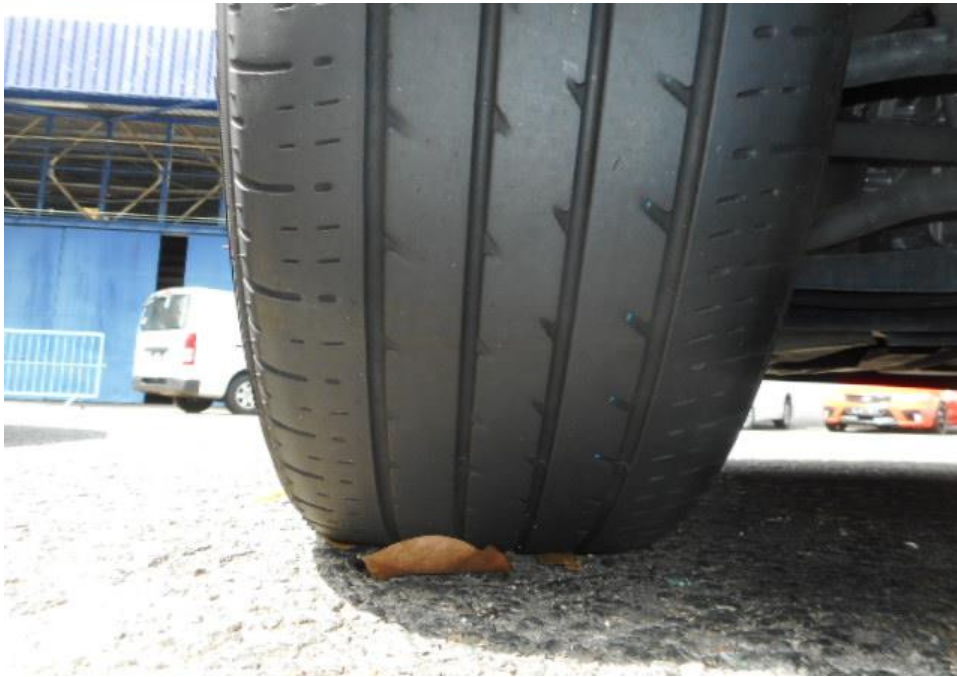
**Photo 12** shows the condition of the front left tyre of the Motor Car, which was observed to be in serviceable condition with remaining tread depth of approximately 3.2mm. There was also no tear, cut or burst mark(s) on the outer and the inner sidewalls as well as across the tread of the Motor Car's 4 tyres.

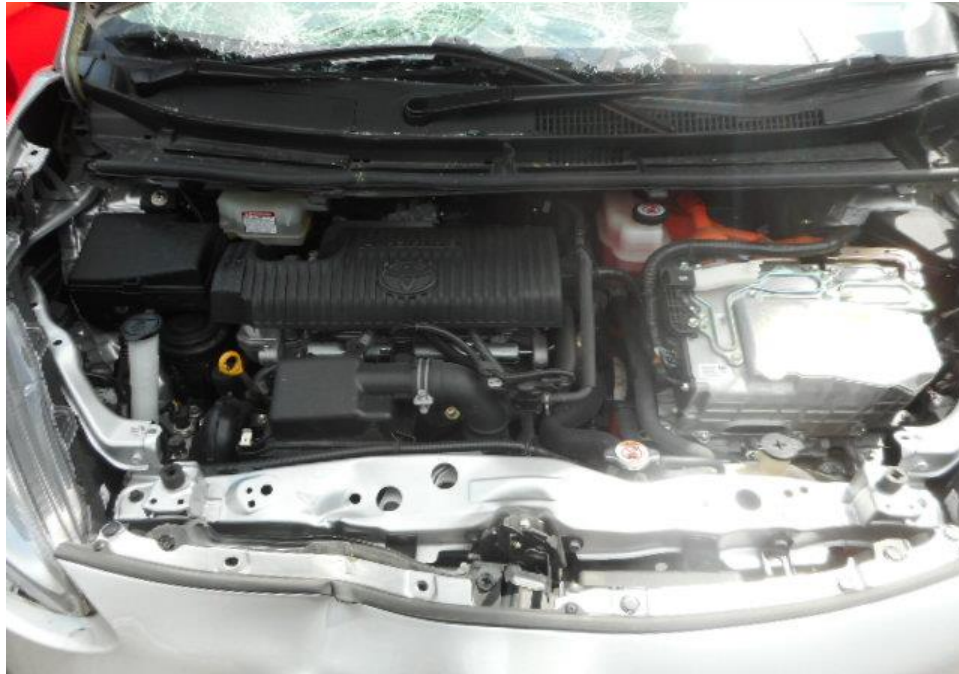
**Photo 13** shows a general view of the Motor Car's engine compartment. The various parts and components inside the engine compartment were unaffected by the accident. There was also no sign(s) or indication(s) of fluid leakage and/or fluid stain within the engine compartment.

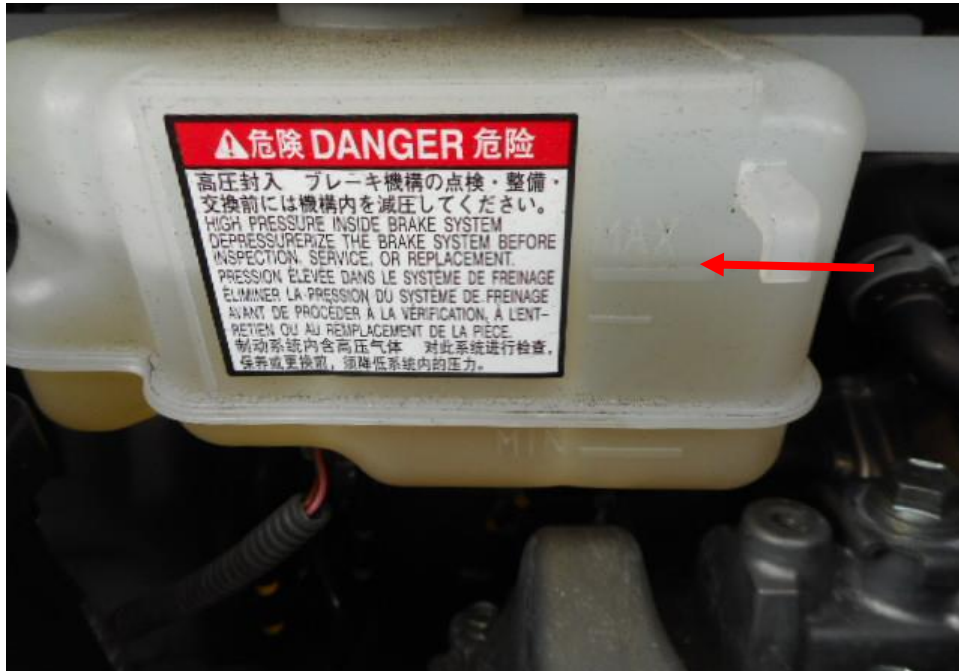
**Photo 14** shows the brake fluid reservoir of the Motor Car at the time of my inspection. The brake fluid was observed to be of sufficient level (arrowed) and without any visible contamination.

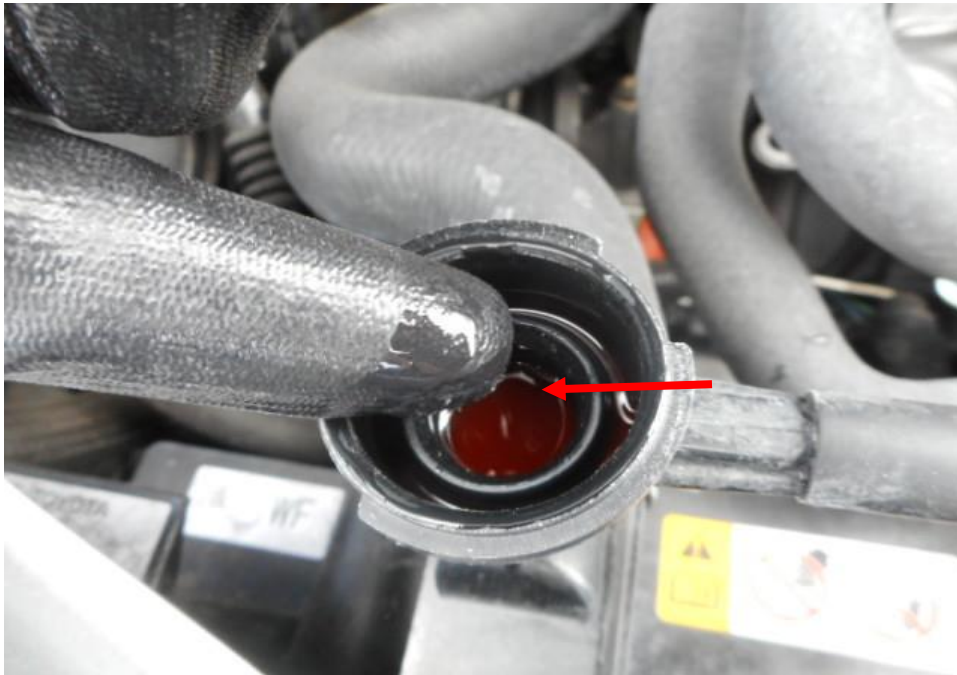
**Photo 15** shows checks being carried out to the engine coolant of the Motor Car at the time of my inspection. The engine coolant was observed to be of sufficient level (arrowed) and without any visible contamination.

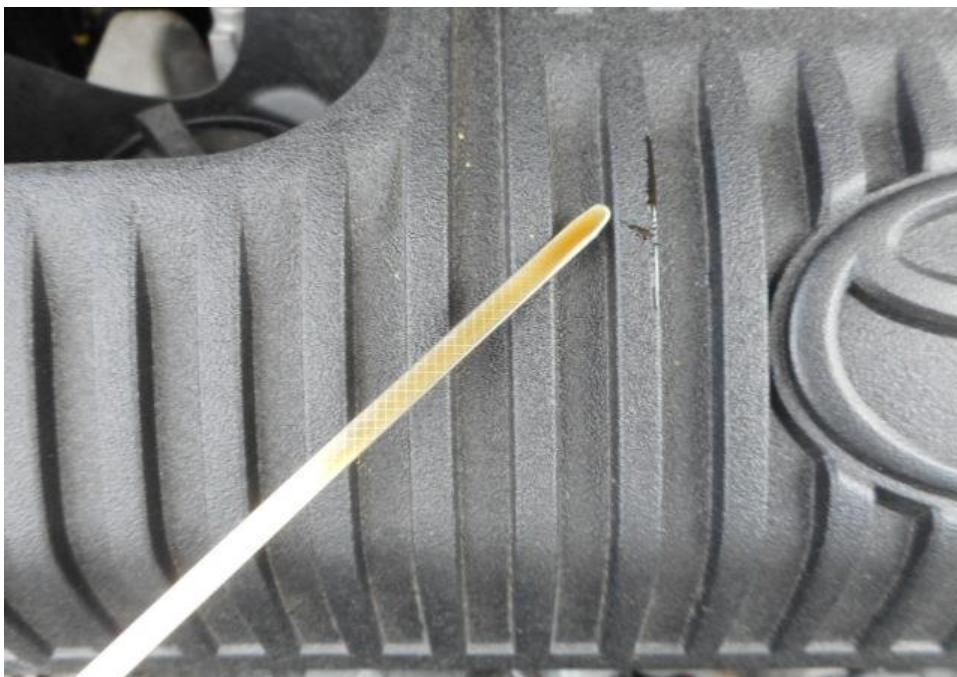
**Photo 16** shows the engine oil dipstick of the Motor Car at the time of my inspection. The engine oil was observed to be of sufficient level and without any visible contamination.

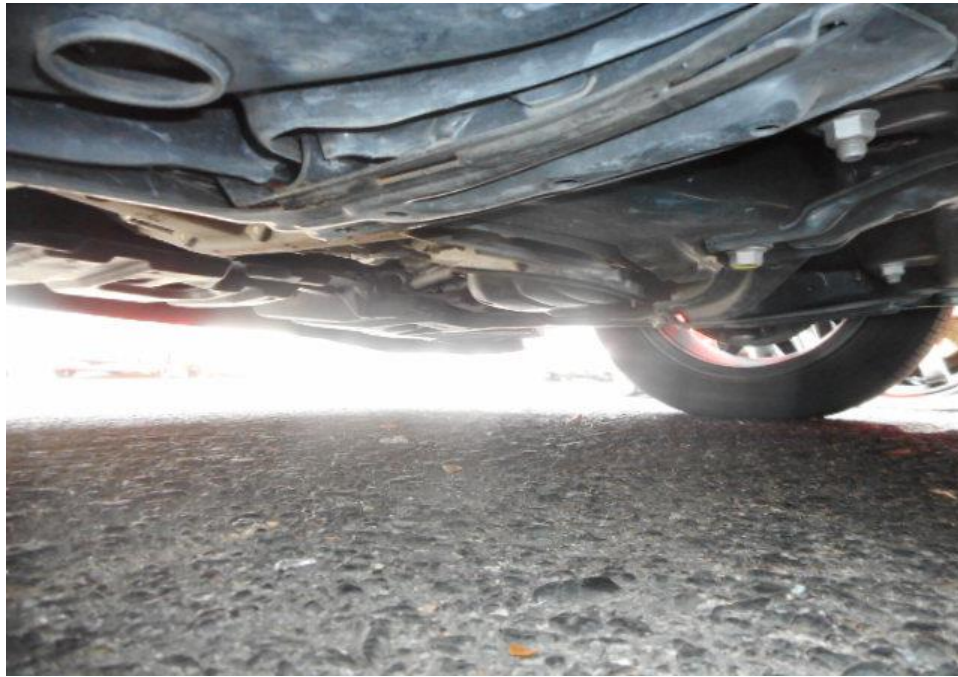
**Photo 17** shows the undercarriage of the Motor Car, at the area where the engine housing and transmission housing are located. I did not find any sign(s) or indication(s) of fluid leak and/or fluid stain(s) on the underside of the Motor Car.

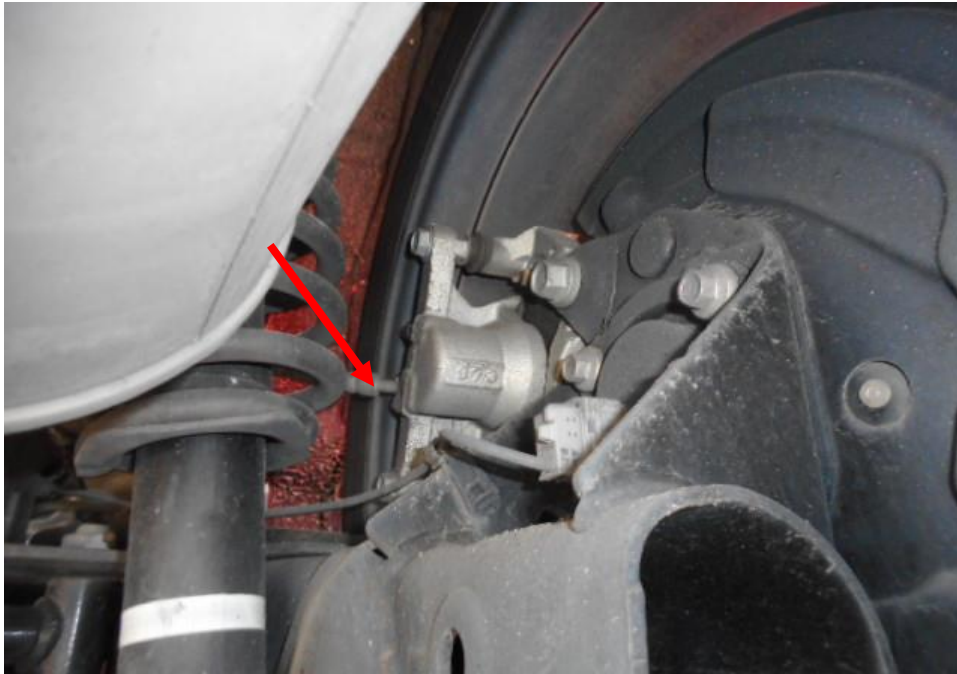
**Photo 18** shows the brake hose/pipe (arrowed) at the rear right wheel of the Motor Car. No leakage of brake fluid was observed. Visual examination of the various components of the braking system like the drum brake, brake booster, brake pedal etc. had revealed all to be intact and without visible damage.

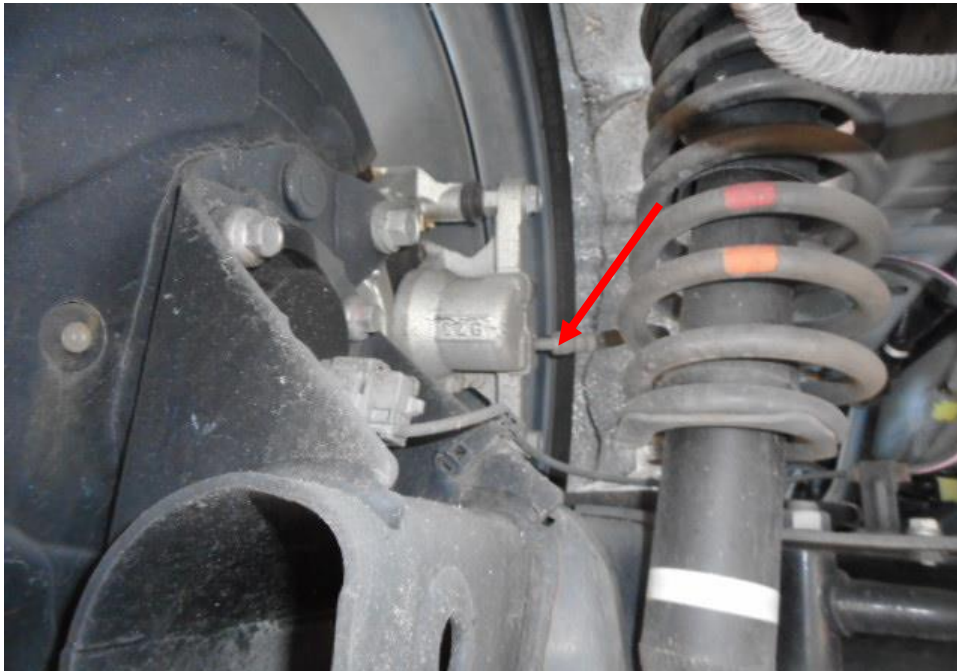
**Photo 19** shows the brake hose/pipe (arrowed) at the rear left wheel of the Motor Car. I did not observe any leakage of brake fluid at the time of my inspection of the Motor Car. Static tests of the Motor Car's braking system had indicated that there was no internal leakage of pressure/vacuum. The undercarriage components of the Motor Car were also all found to be intact and without any visible damage.

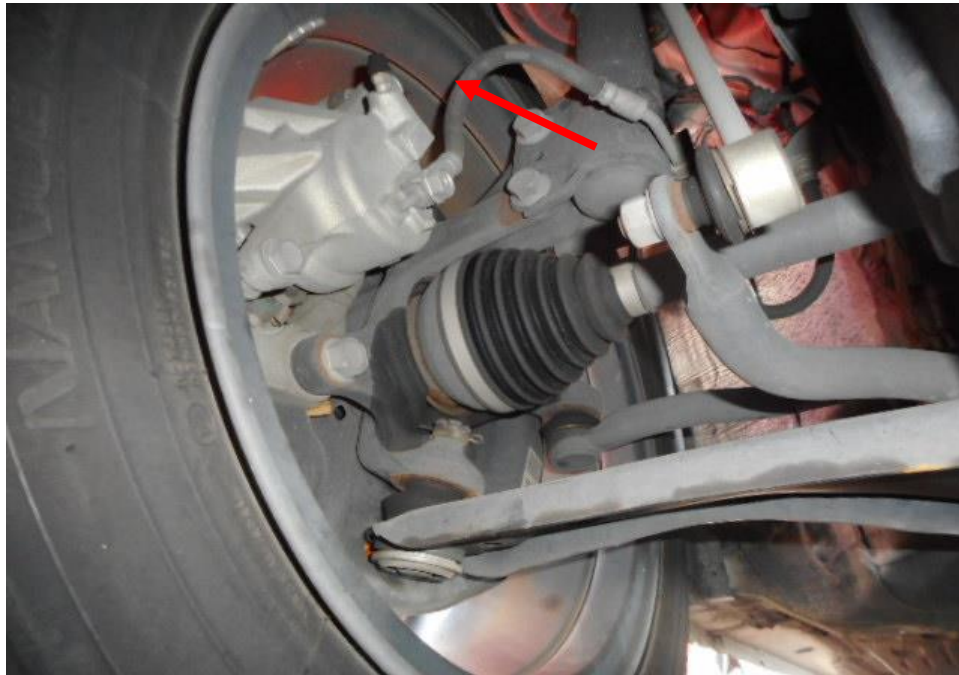
**Photo 20** shows the brake hose/pipe (arrowed) at the front right wheel of the Motor Car. I did not observe any leakage of brake fluid at the time of my inspection of the Motor Car. Static tests of the Motor Car's braking system had indicated that there was no internal leakage of pressure/vacuum. The undercarriage components of the Motor Car were also all found to be intact and without any visible damage.

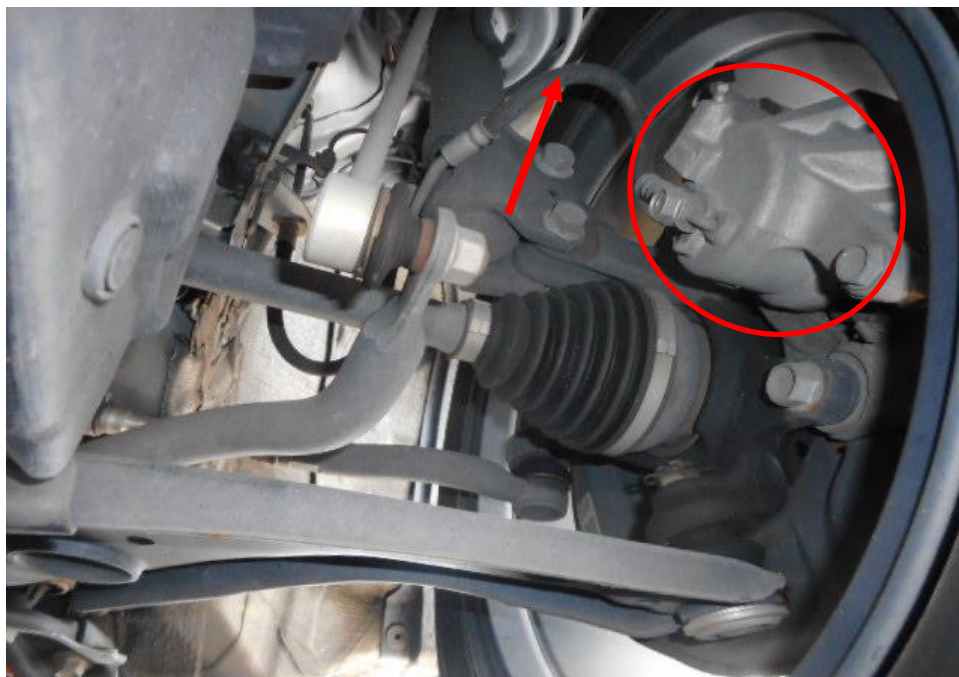
**Photo 21** shows the brake hose/pipe (arrowed) at the front left wheel of the Motor Car. No leakage of brake fluid was observed. Visual examination of the various components of the braking system like the brake caliper (circled), brake booster, brake pedal etc had revealed all to be intact and without visible damage.

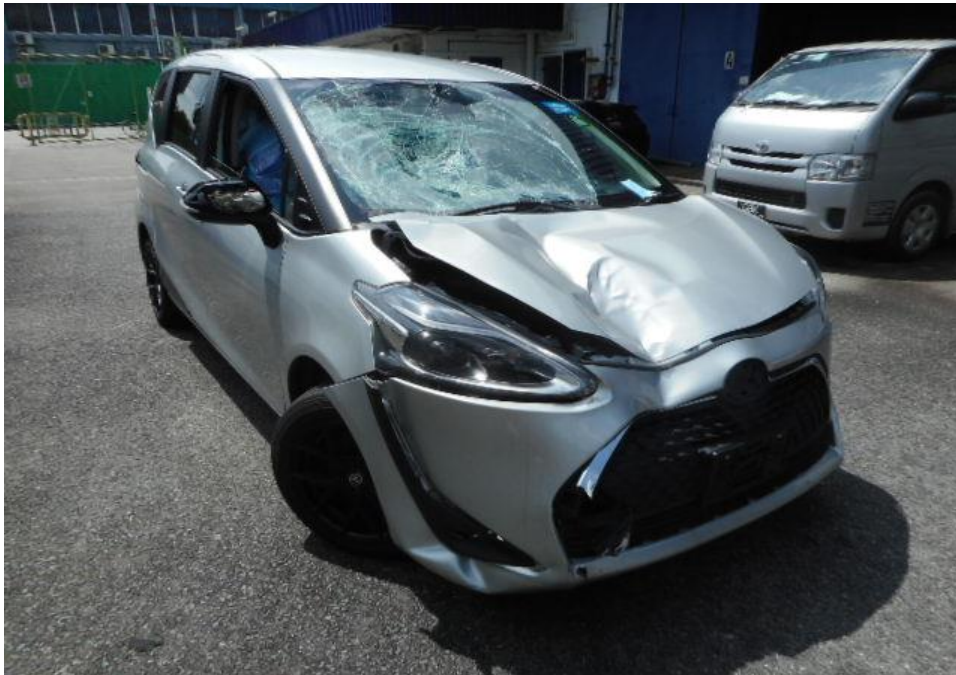
**Photo 22** shows the front right wheel of the Motor Car turned to its full left. During my steering system test, I did not experience any abnormal free play and/or resistance when I had turned the steering wheel towards the left and right. This would suggest that the steering system of the Motor Car was likely to be in serviceable condition at the material time of accident.

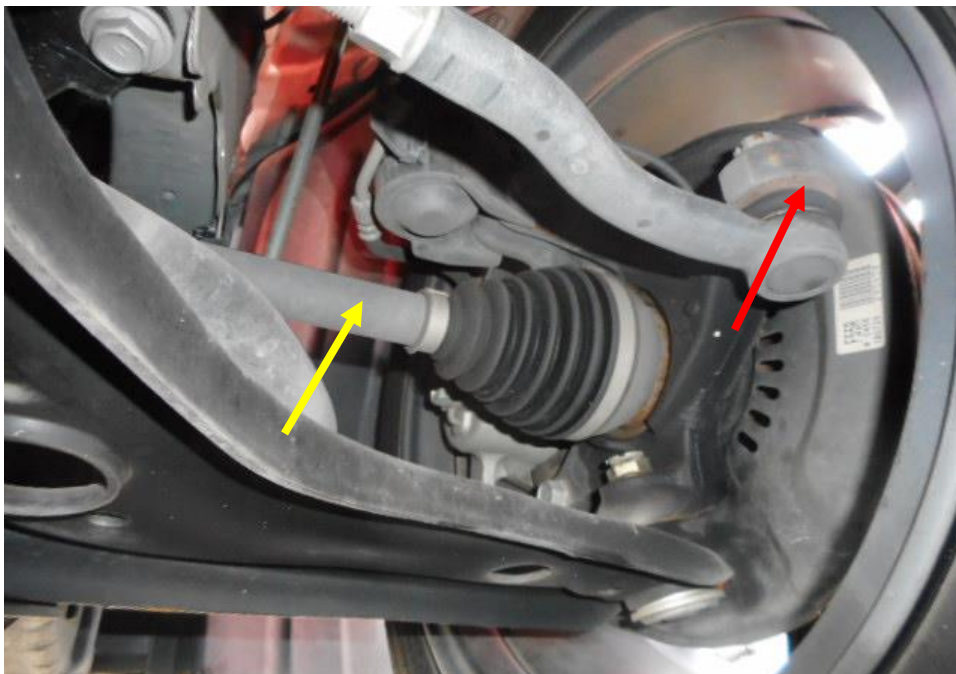
**Photo 23** shows the various undercarriage components at the front right wheel of the Motor Car, in particular the steering tie rod (red arrow) and drive shaft (yellow arrow). The various steering components were all found to be intact, suggesting that the steering system of the Motor Car was likely to be in serviceable condition at the material time of accident. There was also no sign of fluid stain observed on the various undercarriage components at the front right wheel of the Motor Car.

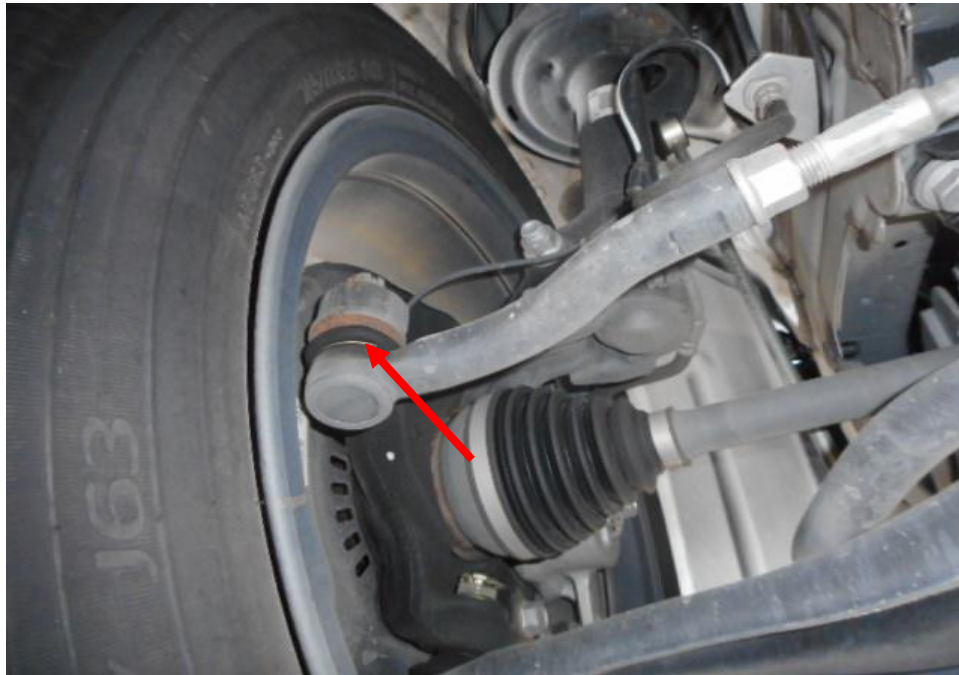
**Photo 24** shows the various undercarriage components at the front left wheel of the Motor Car, which had included the steering tie rod (red arrow). The various undercarriage components of the Motor Car were all found to be intact without any visible damage.

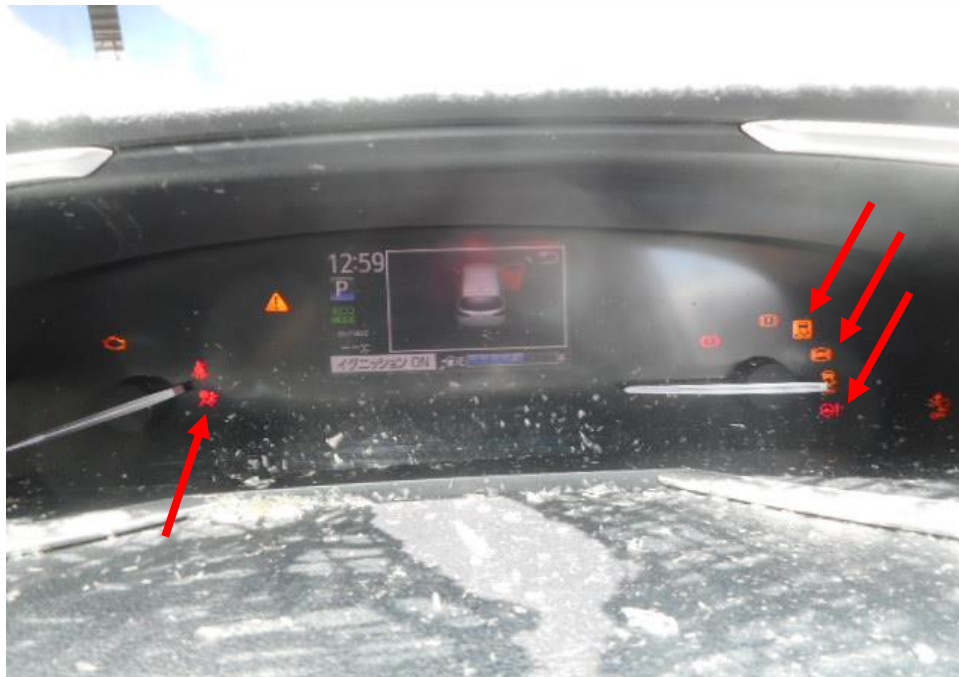
**Photo 25** shows the warning light for Anti-Lock Brake System (ABS), Electric Power Steering System (EPS), Traction Control System (TCS) and Supplemental Restraint System (SRS) (arrowed) appearing on the instrument panel of the Motor Car during the self-test of its various electronic operating systems when its engine was cranked.

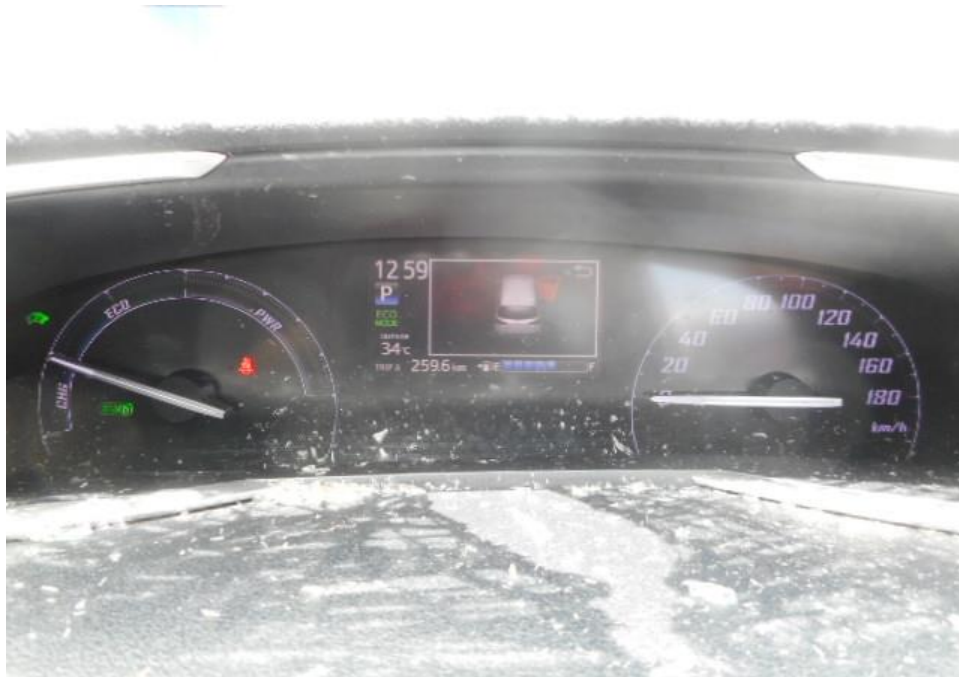
**Photo 26** shows no warning lights illuminated on the instrument panel of the Motor Car after the engine was cranked. This would suggest that there was no abnormality to the electronic operating system of the Motor Car, like the ABS, EPS, TCS and SRS etc.
