Vehicle No.	SDR 6638D
Insured Veh.	SMS 2352S
Claim No.	SNM21D207367
Policy No.	DMPCSNW00245092101
Accident Date	16/12/2021
Inspection Date	21/12/2021

2. Vehicle Particulars & Condition			
Make & Model	NISSAN QASHQAI (A)	c.c	1997
Engine No.	HIDDEN	Year of Reg.	2016
Chassis No.	SJNFBAJ11U1795383	Colour	METALLIC PEARL WHITE
Odometer	49328 KM	Steering	IN ORDER
Brakes	IN ORDER	Modification	STANDARD ALLOY RIM
General	GOOD

## ADJUSTMENT ON REPAIR COST FOR VEHICLE NO. SDR 6638D

## PHOTOGRAPHS FOR VEHICLE NO. SDR 6638D

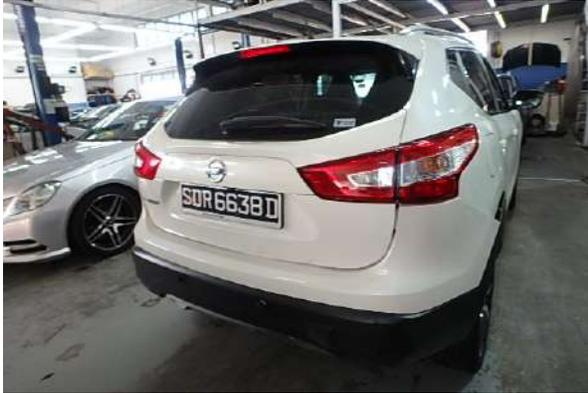
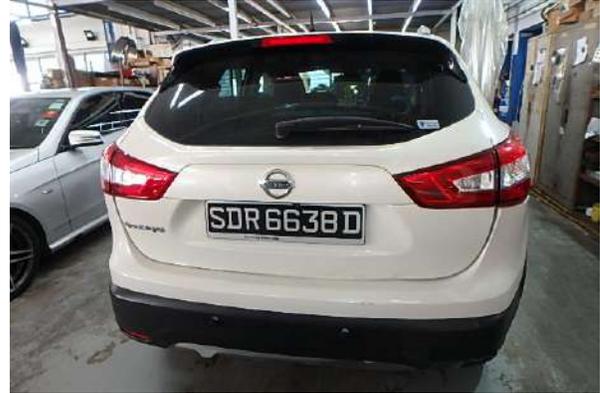
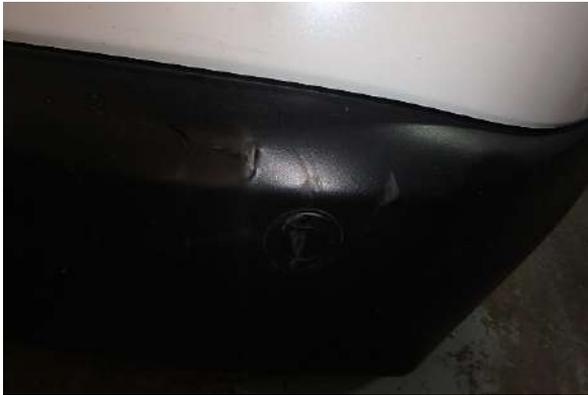
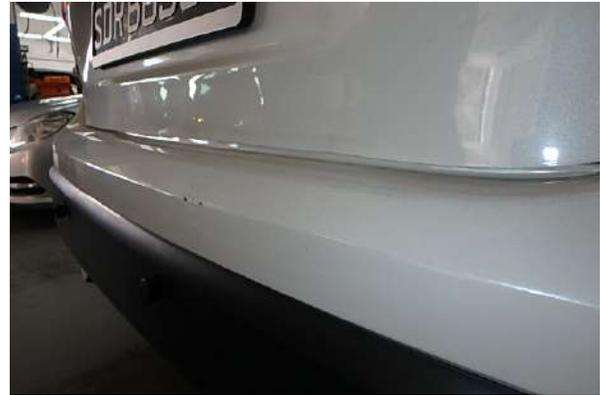
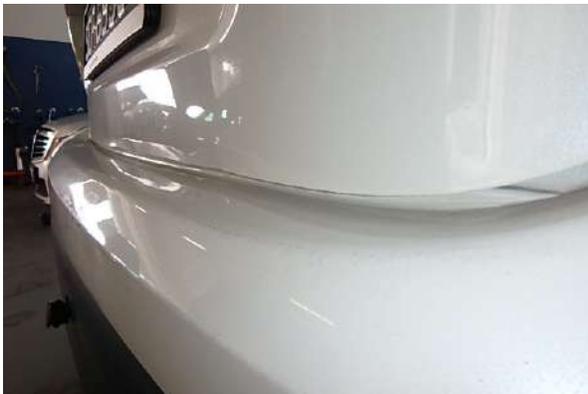
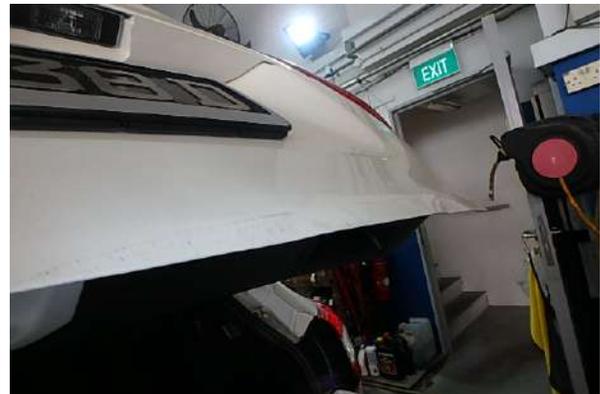
## INSPECTION

4. Description of Damages			
THE VEHICLE SUSTAINED DAMAGES AT THE REAR PORTION. DAMAGES SEE DETAILS.			
5. General Information			
Accident Date	16/12/2021	Inspection Date	21/12/2021
Survey held at	CITY AUTO PTE LTD BLK 8, SIN MING IND. ESTATE #01-60/62 Sector C SINGAPORE 575643.		
5a. Remarks			
A)THE INSPECTION WAS CONDUCTED ON A"WITHOUT PREJUDICE" BASIS. B)IN ACCORDANCE TO YOUR INSTRUCTIONS, WE HAVE NOT AUTHORISED REPAIRS.			
5b. Estimate Days of Repair			
ESTIMATED NORMAL PERIOD FOR REPAIR:		5 Working Days
