Your Ref: GBF 3319G
Our Ref : CI/TP21013055/D

26 December 2021

**TECHNICAL INVESTIGATION REPORT OF FIRE INCIDENT INVOLVING A
HYUNDAI STAREX POLICE VEHICLE GBF 3319G**

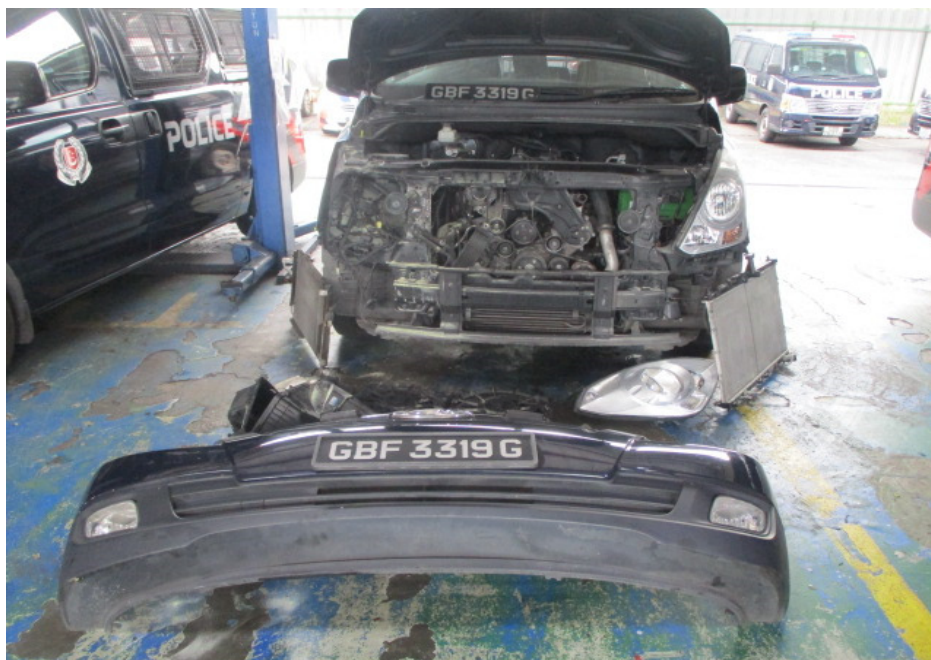
Photo 1 shows a general view of the frontal body of the vehicle at the time of my inspection. The parts at the frontal body of the vehicle were observed to have been dismantled prior to my inspection. This had included several parts within the engine compartment. No visible damage of fire nature was observed to the exterior body of the vehicle apart for some relatively minor melting of the radiator grille, at the front of the vehicle.

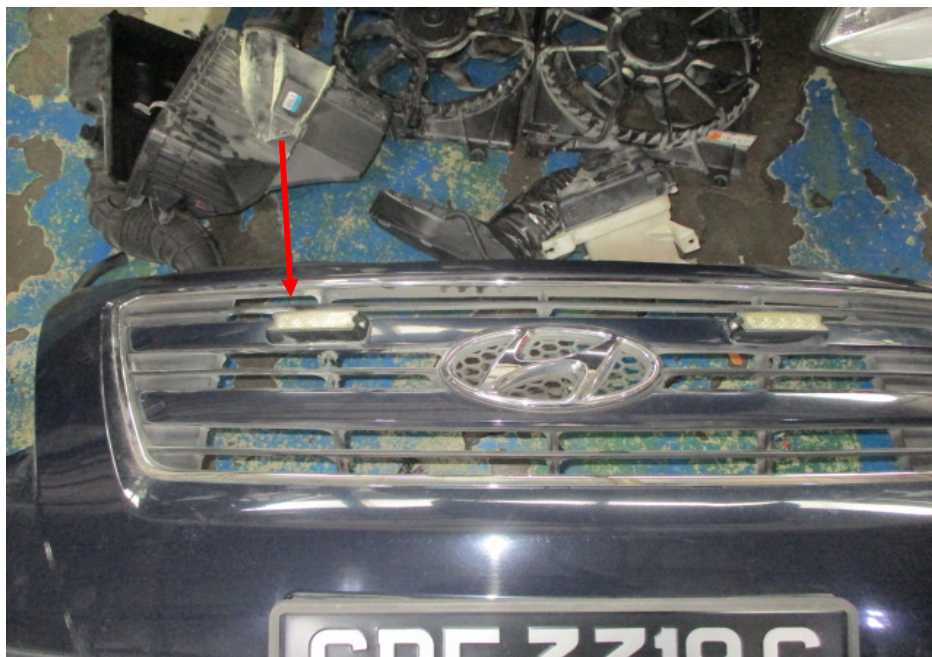
Photo 2 shows the radiator grille of the vehicle at the time of my inspection. I did not observe any damage of fire nature to the exterior body of the vehicle except for some relatively minor melting of the radiator grille (arrowed). The rear body, left side body, right side body and interior compartment of the vehicle were all found to be without any fire damage.

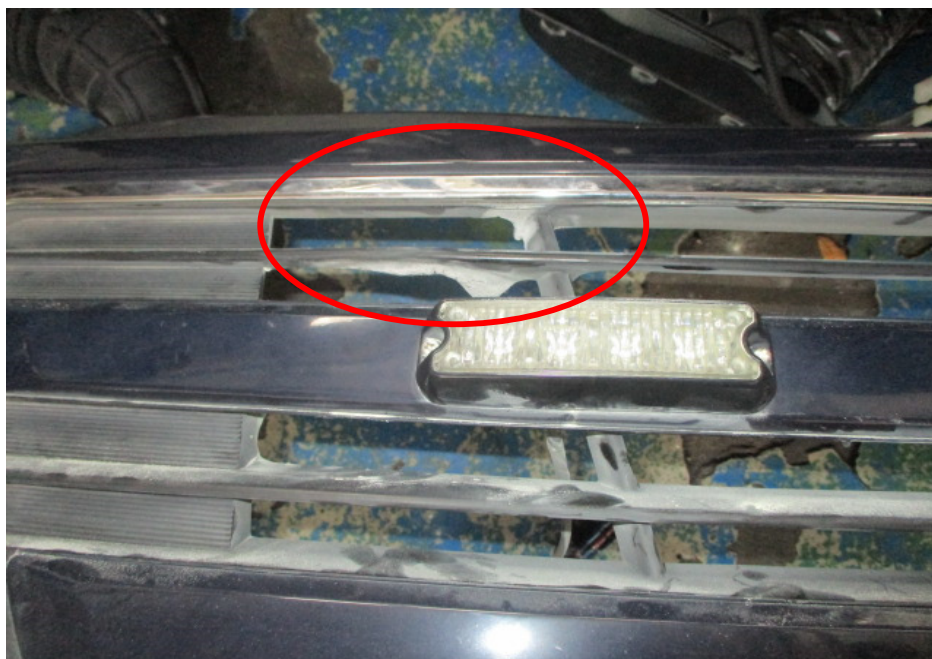
Photo 3 shows a closer view of the minor melting (circled) of the vehicle's radiator grille. Apart for this minor melting of the radiator grille, I did not observe any damage of fire nature to the exterior body of the vehicle.

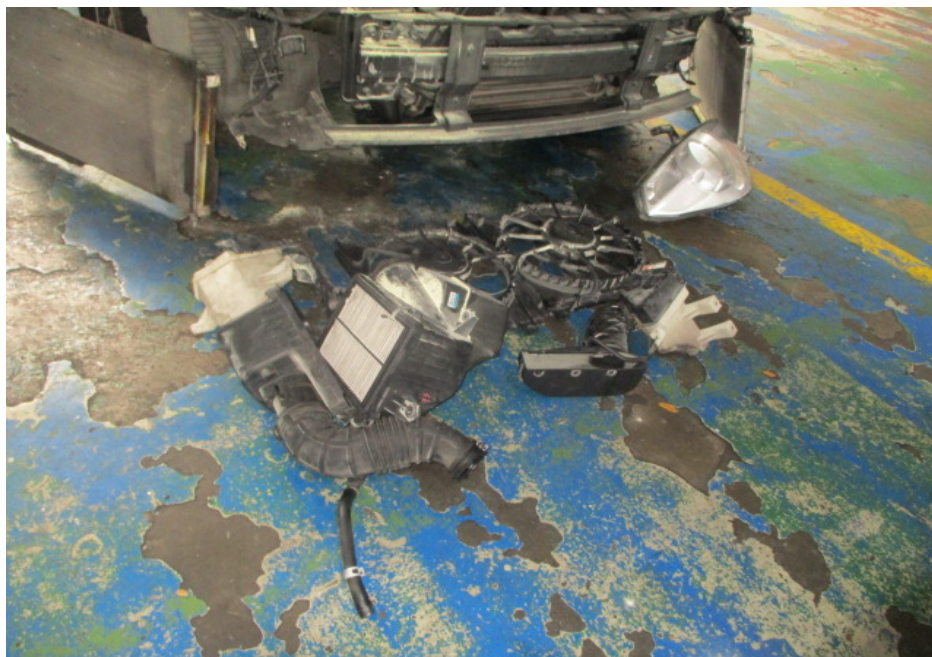
Photo 4 shows a general view of the parts that were dismantled prior to my inspection. The dismantled parts were mainly parts at the frontal body of the vehicle, including several parts within the engine compartment. Upon my examination of these parts, I had found some of these parts to be burnt and/or had sustained heat/smoke damage. The dismantling of these parts did not affect my findings as a similar make and model vehicle was made available for comparison in order for me to understand the positioning of the parts prior to dismantling.

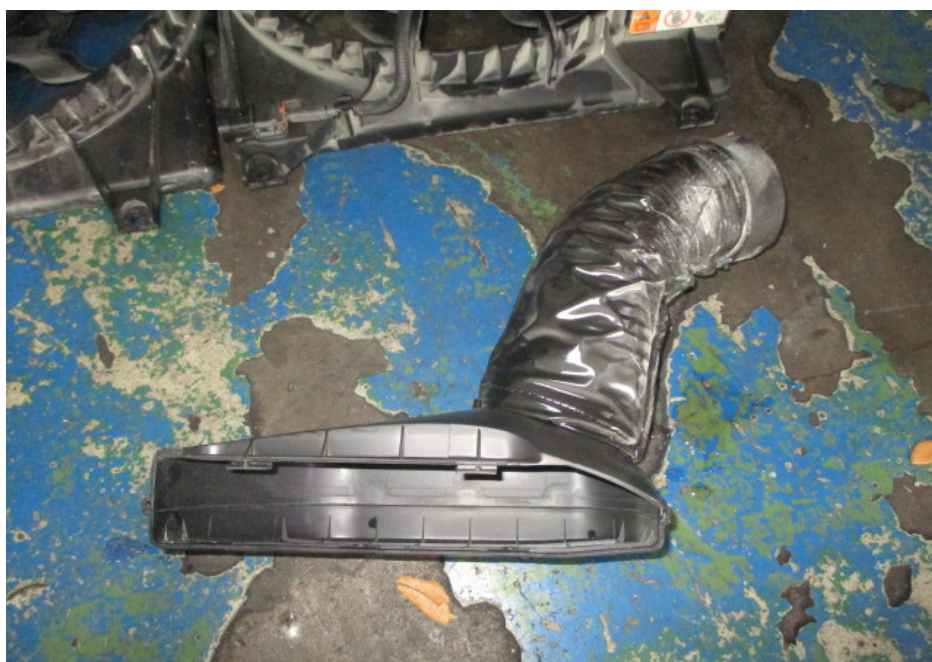
Photo 5 shows the partially melted air intake duct of the vehicle.

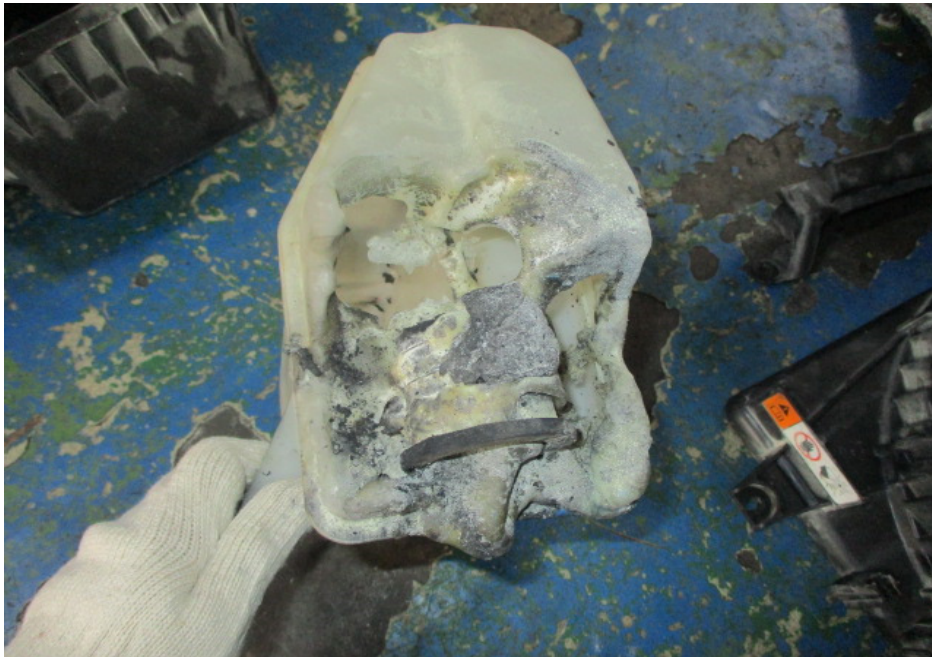
Photo 6 shows the partially melted wiper washer tank of the vehicle.

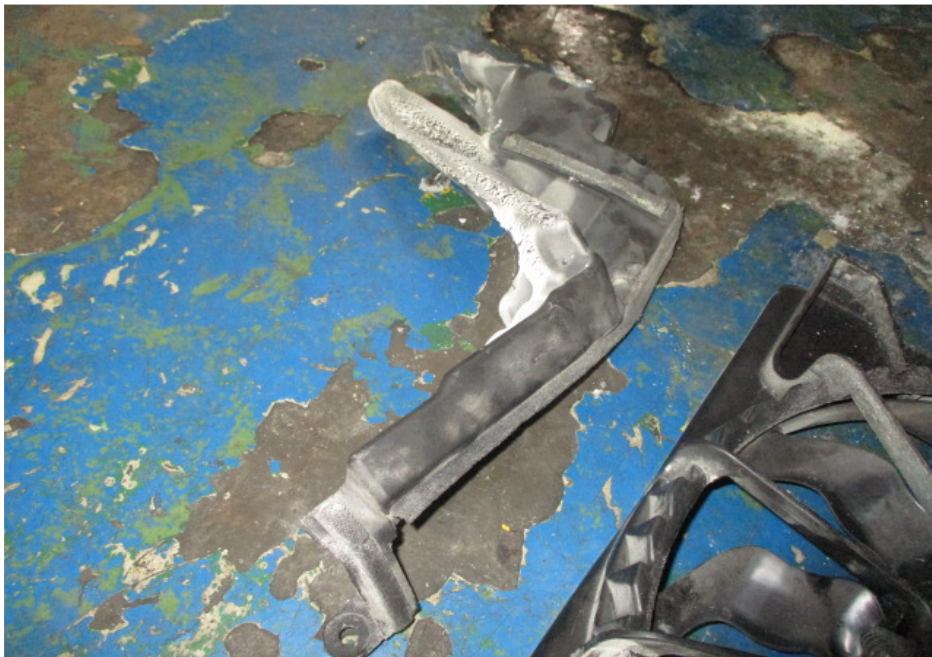
Photo 7 shows the partially melted air intake shield of the vehicle.

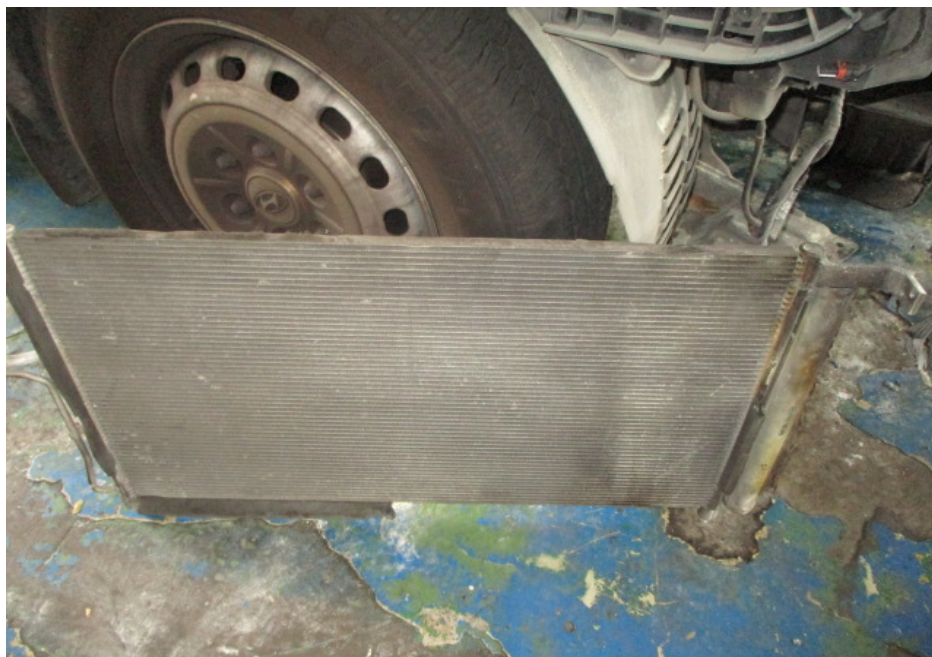
Photo 8 shows the aircon condenser of the vehicle, which was found to be burnt.

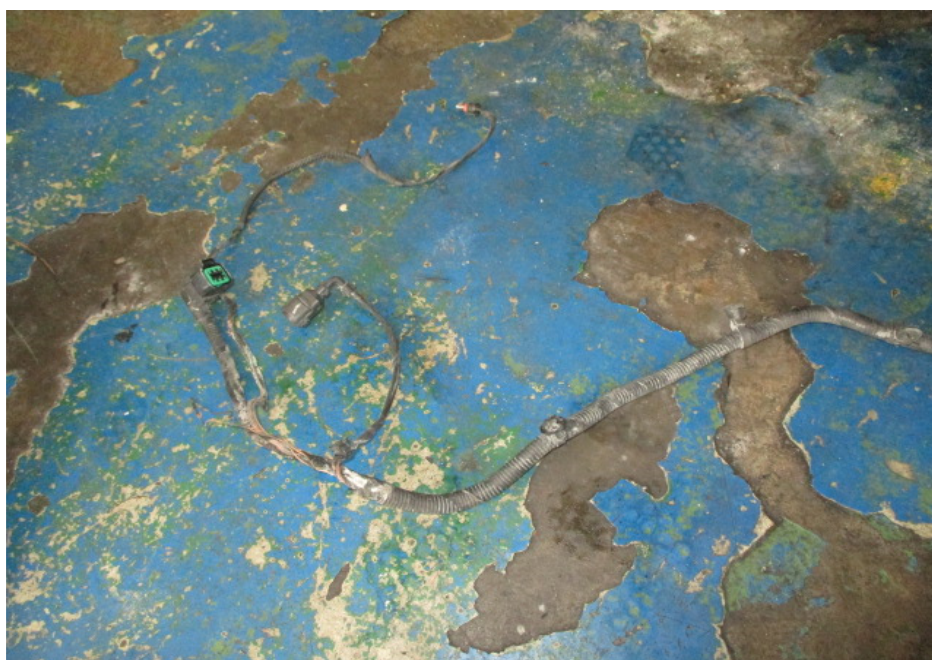
Photo 9 shows a general of the vehicle's front wire harness, which was found to be burnt.

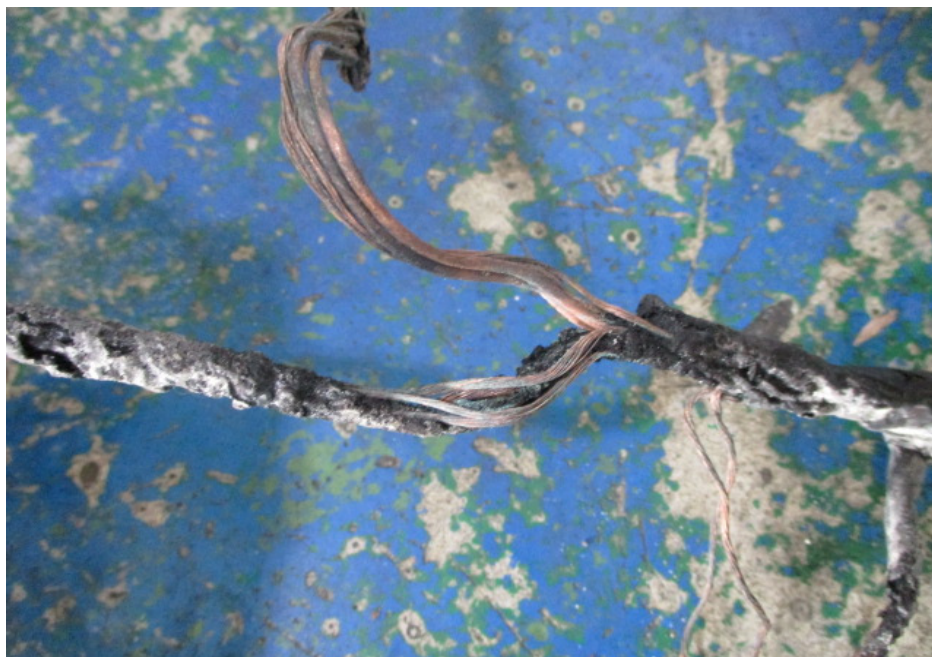
Photo 10 shows a closer view a stretch of burnt wirings from the vehicle's front wire harness.

10. One of the main causes of vehicular fire is abnormality of electrical current along its circuitry path. In this case, I had found greenish residue on a stretch of burnt wirings from the vehicle's front wire harness. This stretch of burnt wirings is located at the middle section area of the vehicle's front support panel.

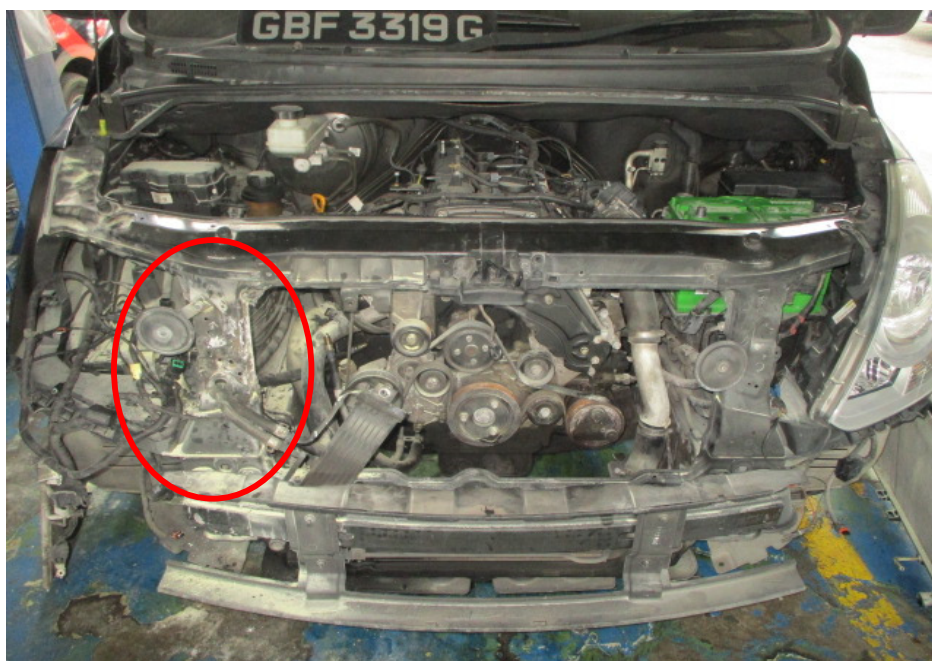
Photo 11 shows a general view of the vehicle's engine compartment. Several parts within the engine compartment were also dismantled prior to my inspection. The dismantling of the parts did not affect my findings as a similar make and model vehicle was made available for comparison in order for me to understand the positioning of the parts prior to dismantling. The front support panel was observed to be burnt, at the right side (circled). Overall, I had found all major parts beyond the support panel to be unaffected by the fire.

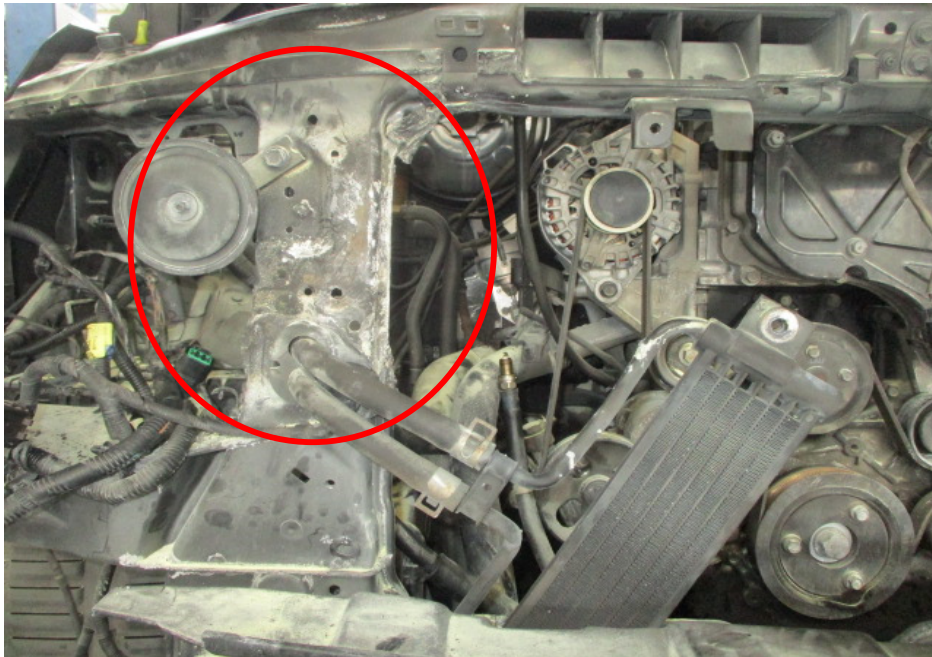
Photo 12 shows a closer view of the burnt front support panel (circled), at the right side of the vehicle.

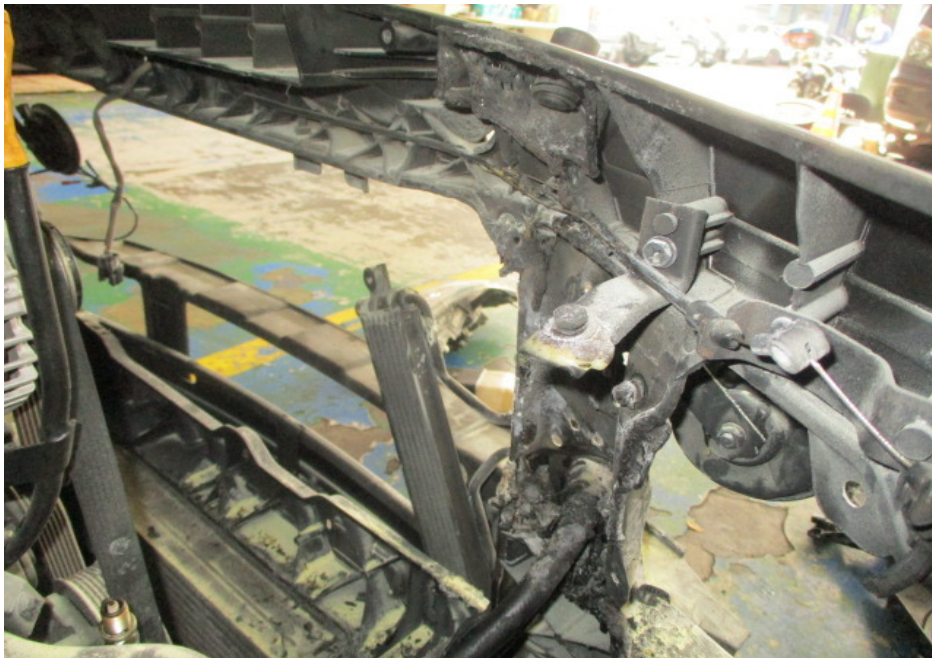
Photo 13 shows the area behind the burnt front support panel, at the right side of the vehicle. Parts surrounding this area were removed prior to my inspection. Some of these parts like the air duct, aircon condenser and radiator were burnt and/or had sustained heat/smoke damage. Refer to photograph 5 & 8 above.

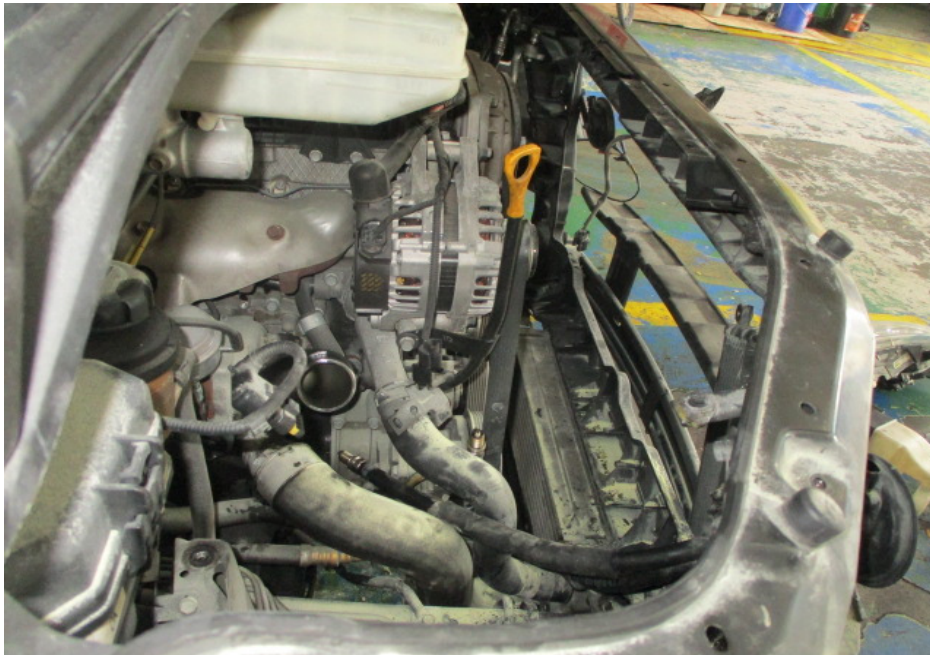
Photo 14 shows a general view of the vehicle's engine compartment. Several parts within the engine compartment were dismantled prior to my inspection. The dismantling of parts did not affect my findings as a similar make and model vehicle was made available for comparison in order for me to understand the positioning of the parts prior to dismantling. Overall, I had found all major parts beyond the support panel to be unaffected by the fire.

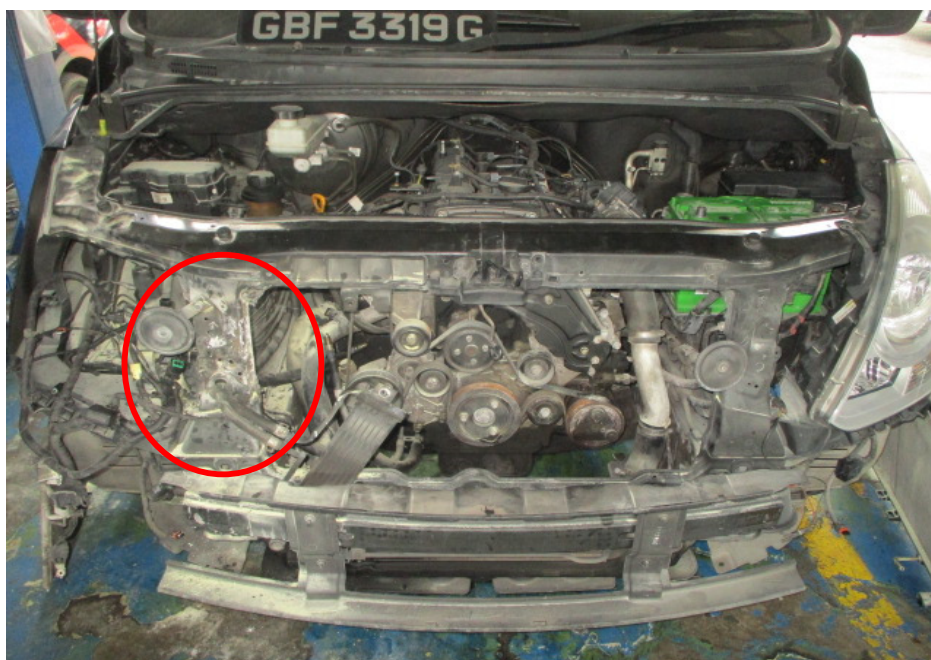
8. Using a similar make and model vehicle as comparison, I note that the parts that had sustained damage of fire nature were all confined to the front right portion of the vehicle. Since there were no other areas of fire damage, the fuel source of the fire or in other words where the fire had originated, would hence be at the front right portion of the vehicle.

Photo 15 shows a general view of the vehicle's frontal portion. By comparing the positioning of the parts that had sustained damage of fire nature (refer to photograph 16 below), I had noted that the parts that had sustained damage of fire nature were all confined to the front right portion of the vehicle. Since there were no other areas of fire damage to the vehicle, the fire to the vehicle can be established to have occurred at the front right portion (circled) of the vehicle.

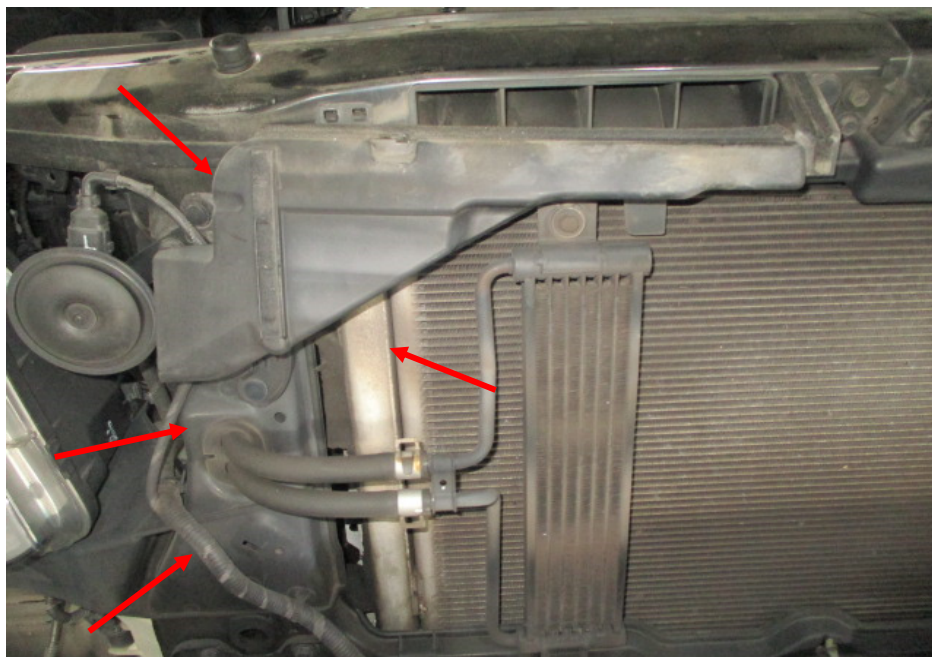
Photo 16 shows the front right portion of a similar make and model vehicle that was made available to me for comparison in order to understand the positioning of the parts that were dismantled from the vehicle prior to my inspection. Basing on the positioning, I note that the parts that had sustained damage of fire nature (highlighted by the red arrows) were all confined to the front right portion of the vehicle. The fire to the vehicle can then be established to have occurred at the front right portion of the vehicle (refer to photograph 15 above). Correspondingly, the fuel source of the fire would also be at the same front right portion of the vehicle.

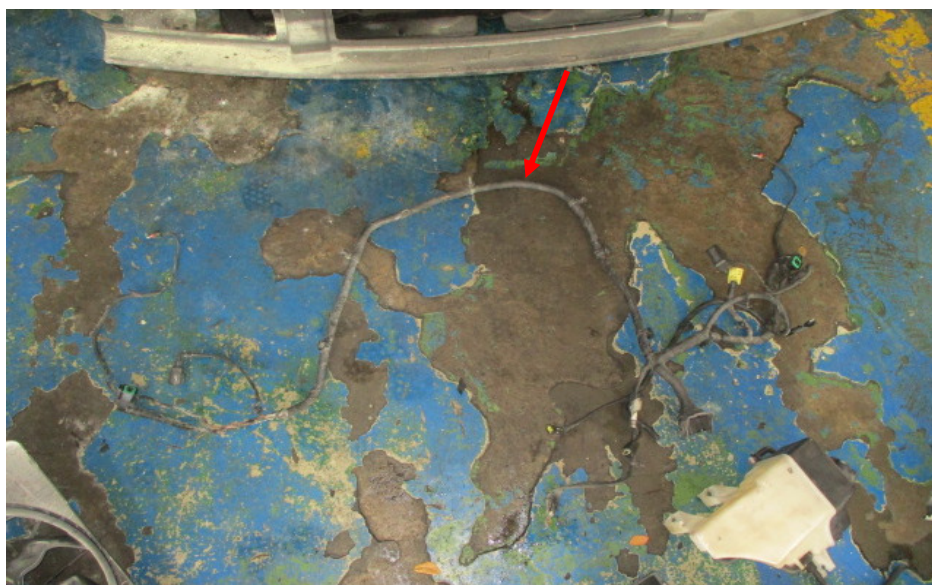
Photo 17 shows a general view of the front wire harness (arrowed) of the vehicle. Upon examination, I had found greenish residue on a stretch of burnt wirings of this front wire harness. Discoloration of one the wire connectors along this same front wire harness was also observed.

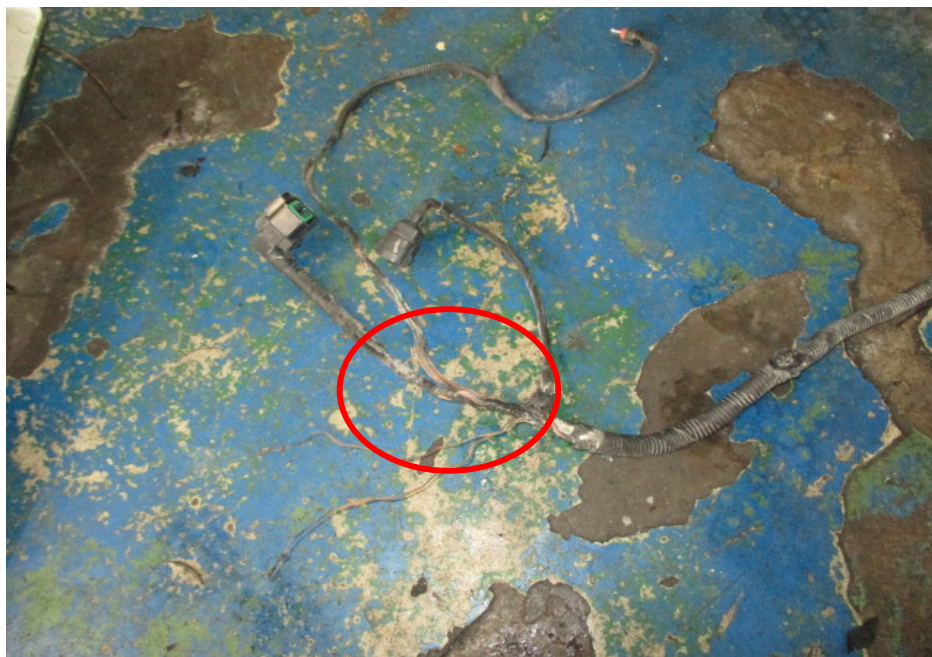
11. The presence of greenish residue indicates internal heating of copper wires, a sign of an electrical abnormality. Such greenish residue is normally left behind from oxidation as result of chemical reaction involving copper wires, heat and oxygen. Discoloration of wire connector(s) is also sometimes seen in an electrical abnormality situation. Hence, the greenish residue found on the stretch of burnt wirings from the vehicle's front wire harness would suggest to me that the cause of fire to the vehicle was of electrical in nature. This is further supported by discolouration found to one of the wire connectors along this same front wire harness. See photo 15 – 23 below.

Photo 18 shows a general view of the burnt wirings (circled) from the front wire harness of the vehicle. Upon closer examination, I had found greenish residue on a stretch of burnt wirings. The presence of greenish residue indicates internal heating of copper wires, a sign of an electrical abnormality occurring. Such greenish residue is normally left behind from oxidation as result of chemical reaction involving copper wires, heat and oxygen.

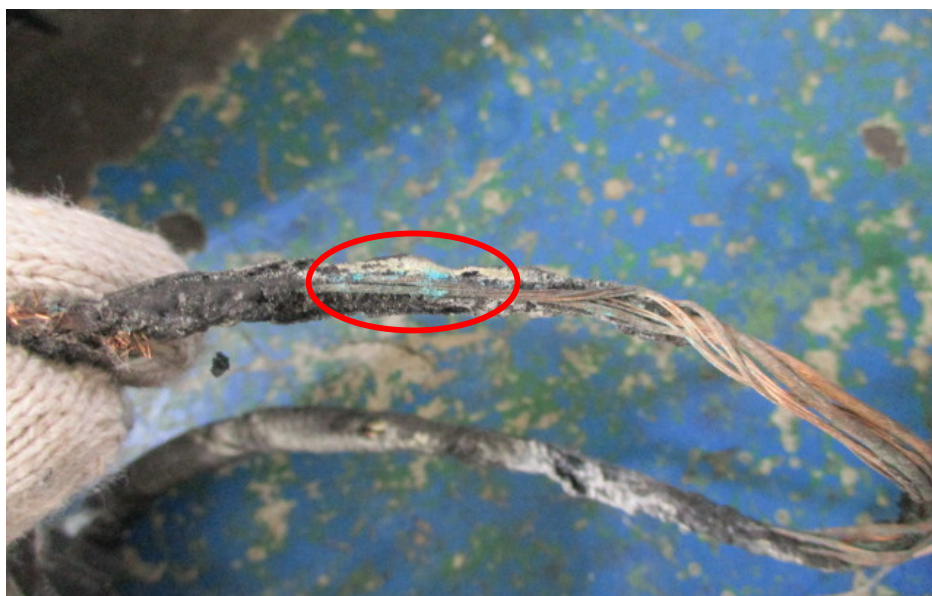
Photo 19 shows a closer view of the greenish residue (circled) that was found on a stretch of burnt wirings from the front wire harness of the vehicle. The presence of greenish residue indicates internal heating of copper wires, a sign of an electrical abnormality occurring. Such greenish residue is normally left behind from oxidation as result of chemical reaction involving copper wires, heat and oxygen. This stretch of burnt wirings is located at the middle section area of the vehicle's front support panel (refer to photograph 22 & 23 below).

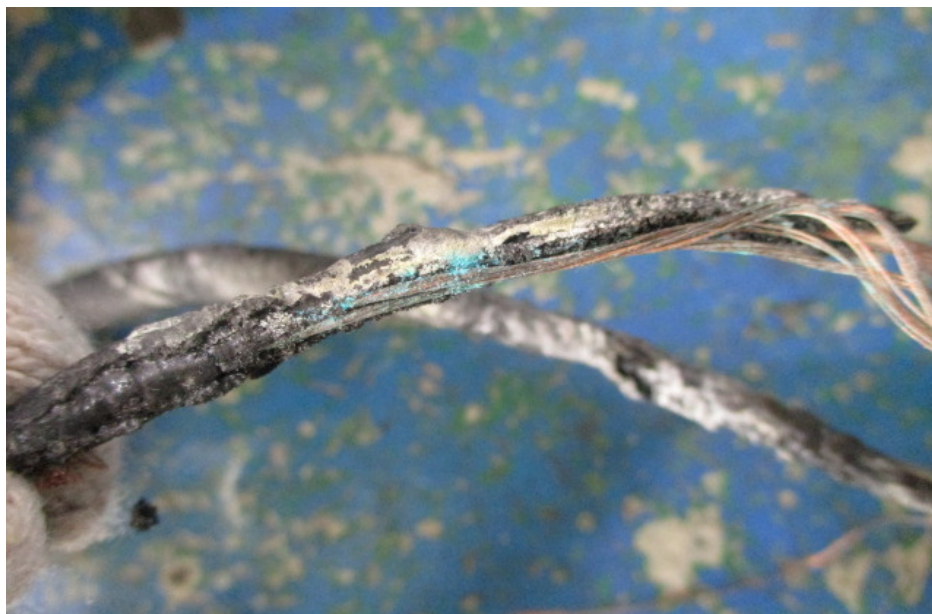
Photo 20 shows another view of the greenish residue that was found on a stretch of burnt wirings from the front wire harness of the vehicle. The presence of greenish residue indicates internal heating of copper wires, a sign of an electrical abnormality occurring. Such greenish residue is normally left behind from oxidation as result of chemical reaction involving copper wires, heat and oxygen. This stretch of burnt wirings is located at the middle section area of the vehicle's front support panel (refer to photograph 22 & 23 below).

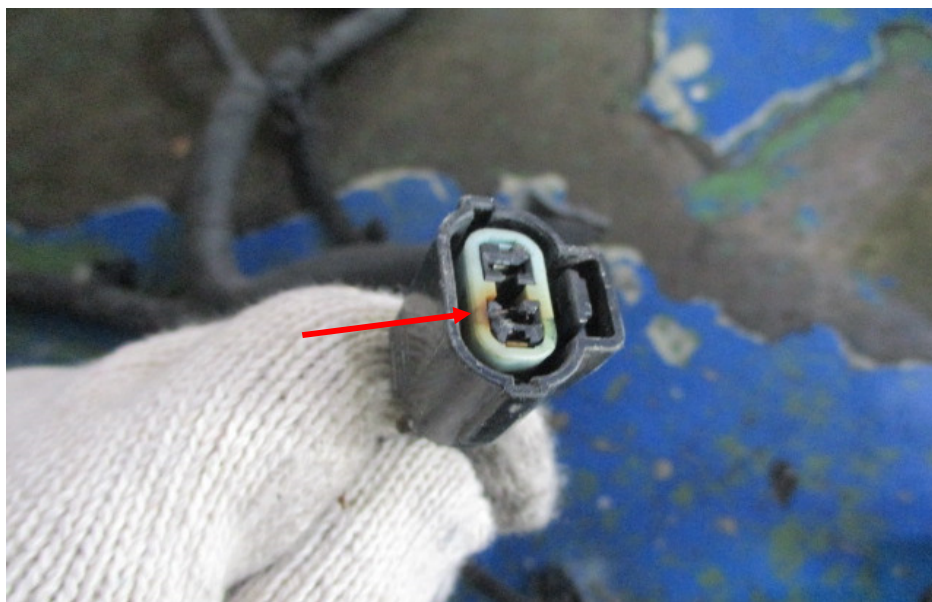
Photo 21 shows the discolouration that was observed on one of the wire connectors along the front wire harness of the vehicle. The greenish residue found on the stretch of burnt wirings from the vehicle's front wire harness (refer to photograph 19 & 20 above) and this discolouration to one of the wire connectors along the same front wire harness would suggest to me that there was an electrical abnormality to a stretch of wirings of the vehicle's front wire harness. This electrical abnormality was the cause of fire to the vehicle.

14. Having physically inspected and technically analysing the damages of burnt nature to the vehicle, I am of the view that the cause of fire to the vehicle was of electrical in nature. For this particular case, there was likely to be an abnormality of the electrical current and/or continuous electrical arcing to a stretch of wirings of the vehicle's front wire harness.

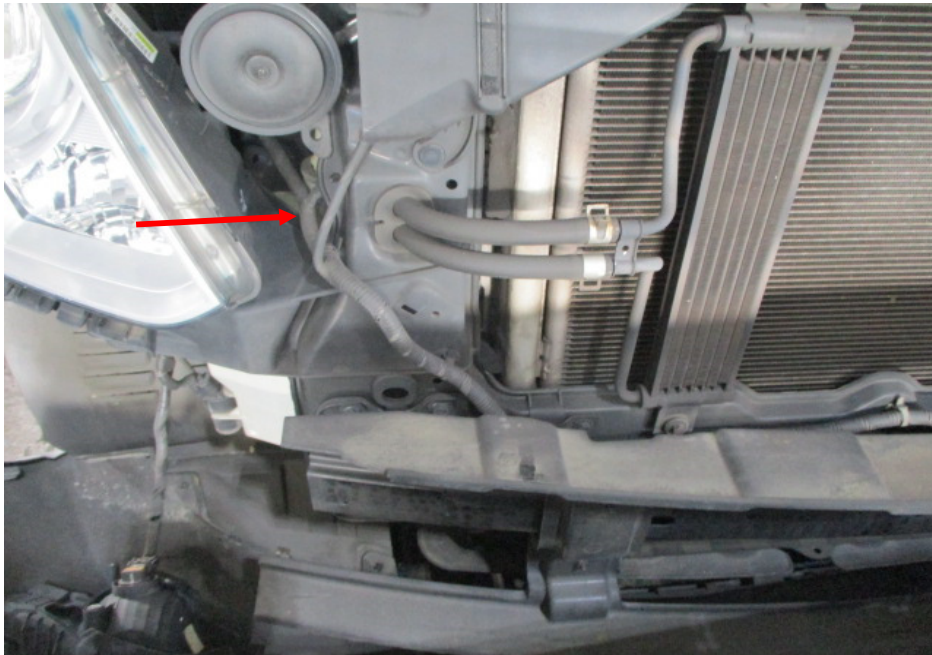
Photo 22 shows the front right portion of a similar make and model vehicle that was made available to me for comparison in order to understand the positioning of the parts that were dismantled from the vehicle prior to my inspection. The stretch of burnt wirings from the vehicle's front wire harness where greenish residue was found (refer to photograph 19 & 20 above) is highlighted by the red arrow. As seen in the photograph, the stretch of burnt wirings is located at the middle section area of the vehicle's front support panel. Note that most of the parts found to have been burnt and/or had sustained heat/smoke damage were all located in the immediate vicinity upwards of the burnt wirings.

12. The location of where the stretch of burnt wirings with green residue is located, as shown in photograph 22 & 23 above, also corresponds to the characteristic of heat rising upwards. Most of the parts that were found to have been burnt and/or had sustained heat/smoke damage were all located in the immediate vicinity upwards of the burnt wirings.
13. To put things into perspective, the burnt stretch of wirings of the vehicle's front wire harness had possibly experienced an abnormal spike in electrical current. This created excessive heat and/or continuous electrical arcing along the stretch of wirings leading to the melting of wire insulations. A fire then ignited when the surrounding air becomes energised by the exposed electrical arcing.

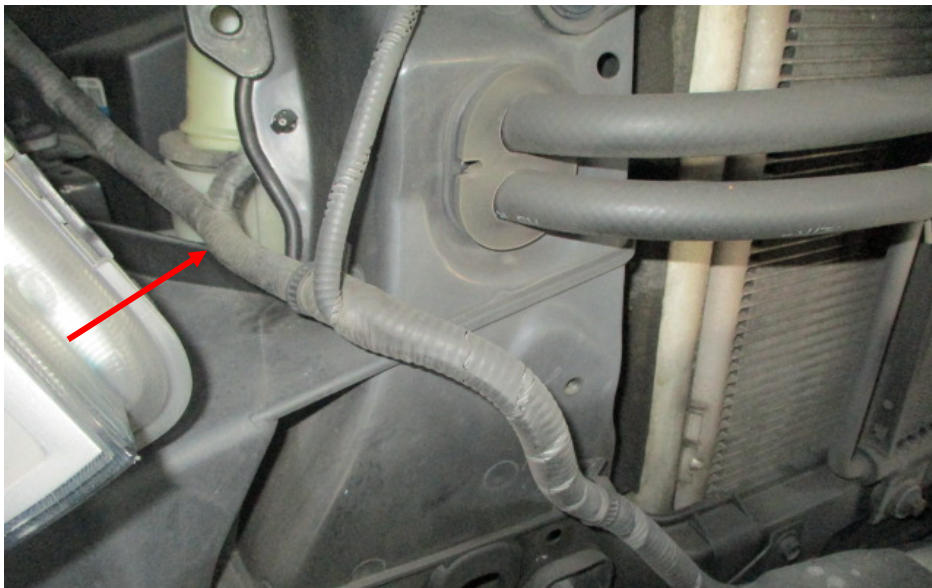
Photo 23 shows a closer view of where the stretch of burnt wirings with green residue (refer to photograph 19 & 20 above) was found. The stretch of burnt wirings is located at the middle section area of the vehicle's front support panel.
