LKK Auto Consultants Pte Ltd

ADJUSTMENT ON REPAIR COST FOR VEHICLE NO. SLR 8313H

PHOTOGRAPHS FOR VEHICLE NO. SLR 8313H

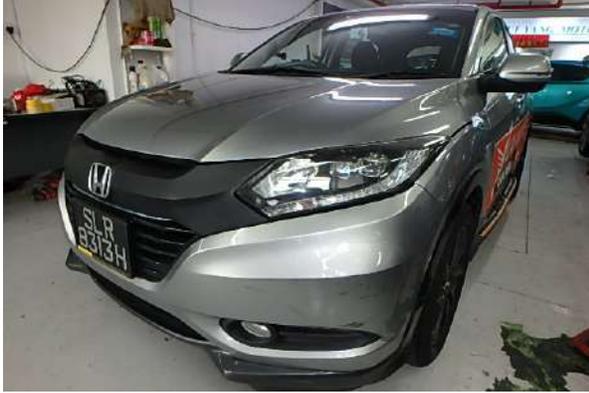
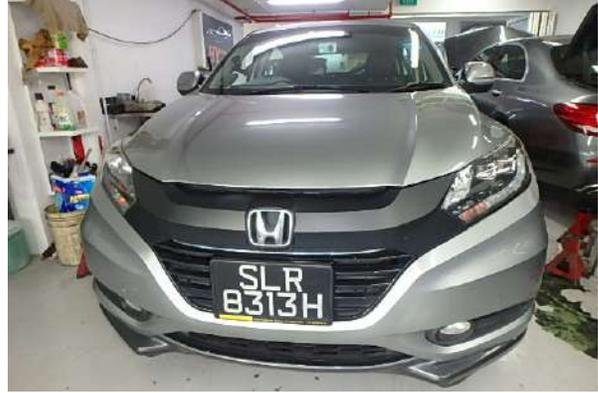
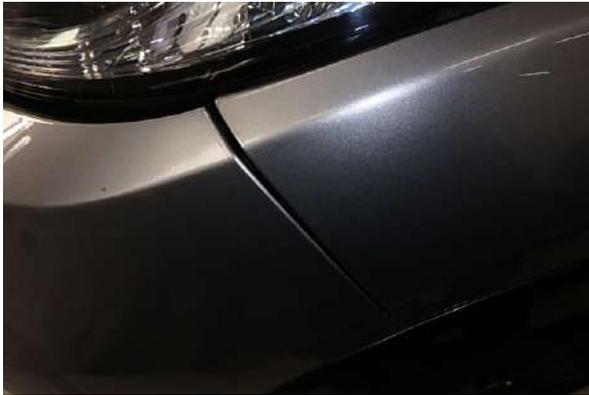
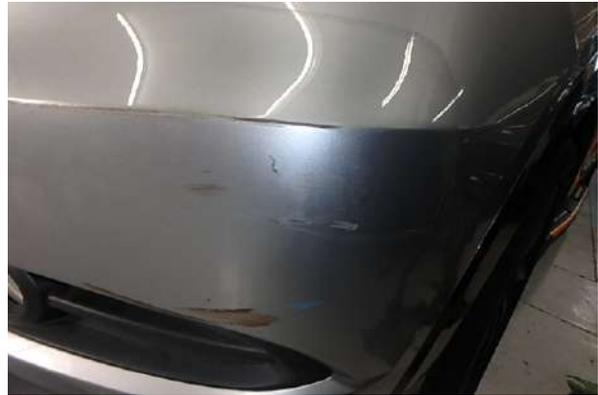
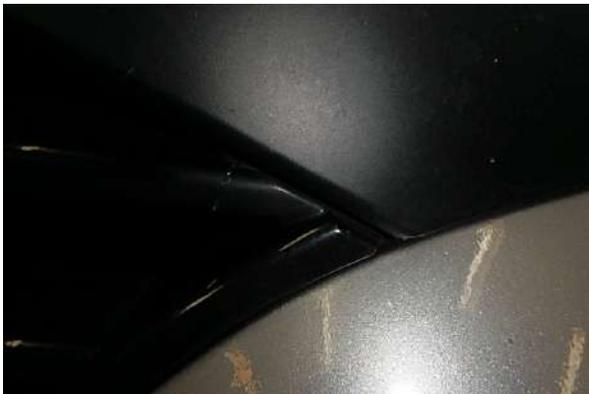
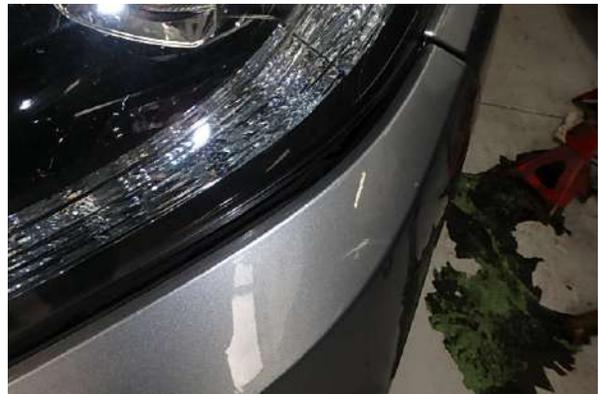
4. Description of Damages			
THE VEHICLE SUSTAINED DAMAGES AT THE FRONT N/S PORTION. DAMAGES SEE DETAILS.			
5. General Information			
Accident Date	25/12/2021	Inspection Date	04/01/2022
Survey held at	HUI YANG MOTOR PTE LTD BLOCK 176 SIN MING DRIVE #04-02 SIN MING AUTOCARE SINGAPORE 575721		
5a. Remarks			
A)THE INSPECTION WAS CONDUCTED ON A"WITHOUT PREJUDICE" BASIS. B)IN ACCORDANCE TO YOUR INSTRUCTIONS, WE HAVE NOT AUTHORISED REPAIRS.			
5b. Estimate Days of Repair			
ESTIMATED NORMAL PERIOD FOR REPAIR:		2 Working Days
