## LKK Auto Consultants Pte Ltd

Affiliated to Federation Internationale Des Experts En Automobile				
LONPAC INSURANCE BHD 300 BEACH ROAD #17-04/07 THE CONCOURSESINGAPORE 199555			Ref: CC4/LPC21013188/Kpa3q2	
			Date: 24/05/2022	
			Code: LPC2	
<b>1. Policy Particulars :- THIRD PARTY CLAIM</b>				
	<b>Insured Veh.</b>	GBK 668S	<b>Veh. Inspected</b>	SHD 9696S
	<b>Policy No.</b>	Z21VC05008228	<b>Coverage (\$)</b>	0.00
	<b>Claim No.</b>	21/21/22/VC05/025290	<b>Excess (\$)</b>	0.00
	<b>Assign From</b>	KENNY	<b>Assign Date</b>	28/12/2021
<b>2. Vehicle Particulars &amp; Condition</b>				
	<b>Make &amp; Model</b>	TOYOTA PRIUS (A)	<b>c.c</b>	1798
	<b>Engine No.</b>	HIDDEN	<b>Year of Reg.</b>	2019
	<b>Chassis No.</b>	JTDKB3FU503082627	<b>Colour</b>	M . P. WHITE / RED
	<b>Odometer</b>	277974 KM	<b>Steering</b>	IN ORDER
	<b>Brakes</b>	IN ORDER	<b>Modification</b>	STANDARD ALLOY RIM
	<b>General</b>	GOOD		
<b>3. Conditions of Tyres</b>				
		<b>Size</b>	<b>Make</b>	<b>Balance</b>

## ADJUSTMENT ON REPAIR COST FOR VEHICLE NO. SHD 9696S

### PHOTOGRAPHS FOR VEHICLE NO. SHD 9696S

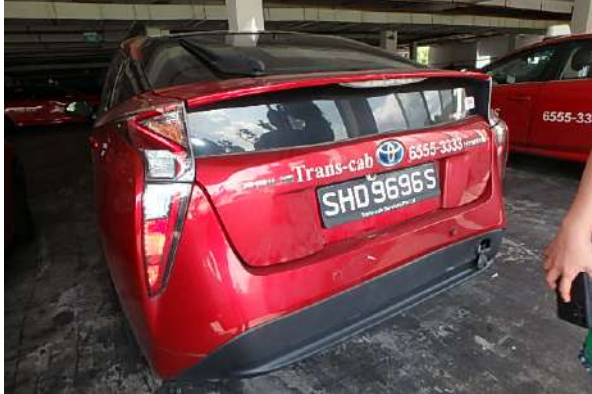
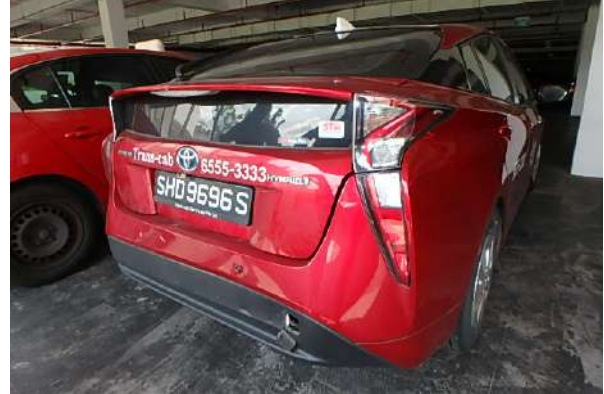
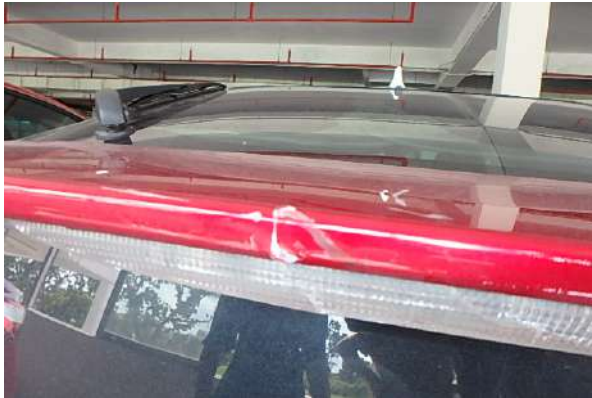
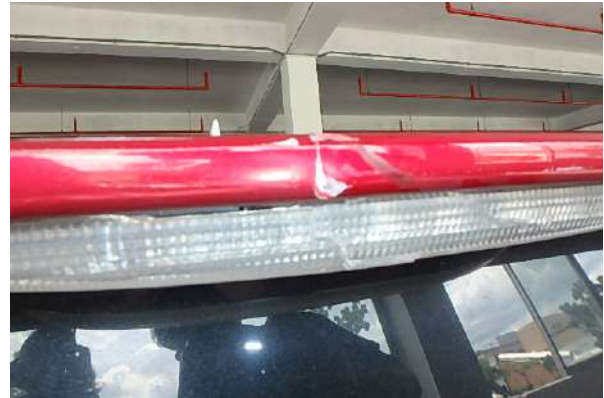
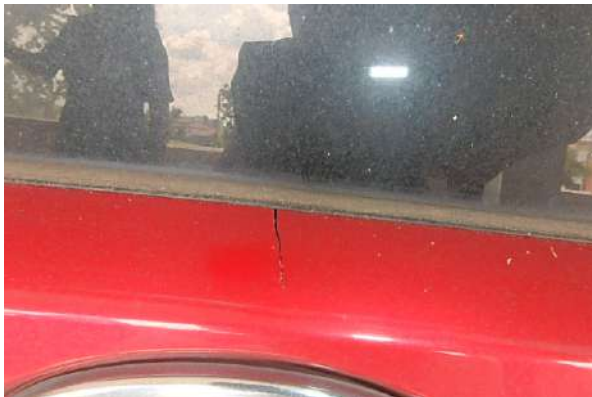
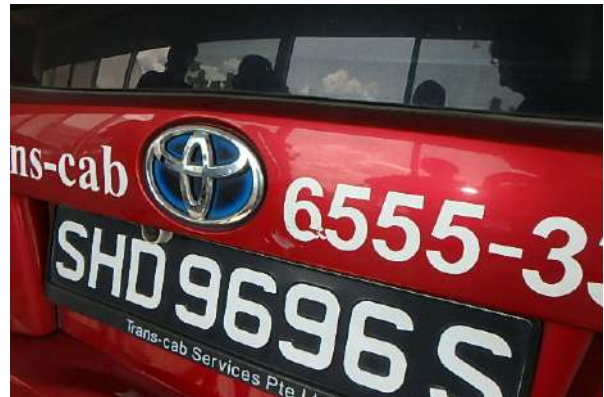
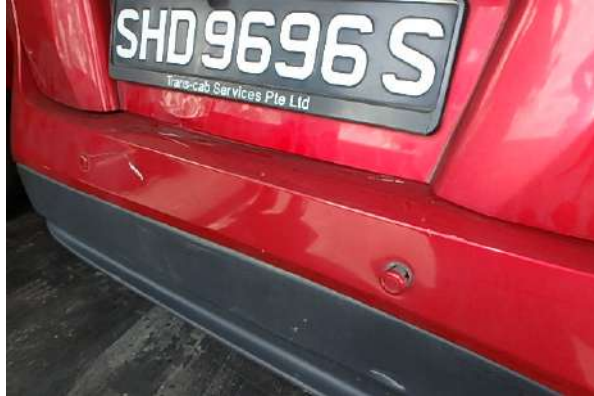
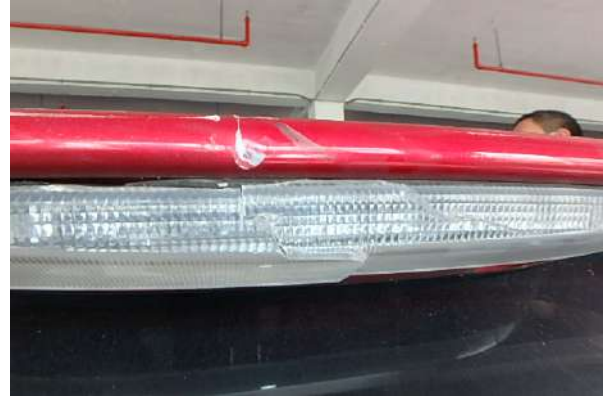
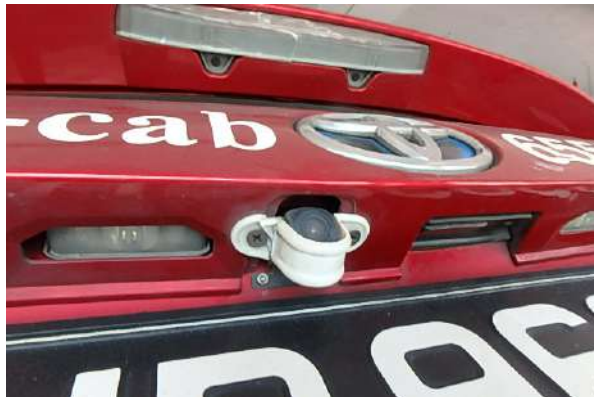
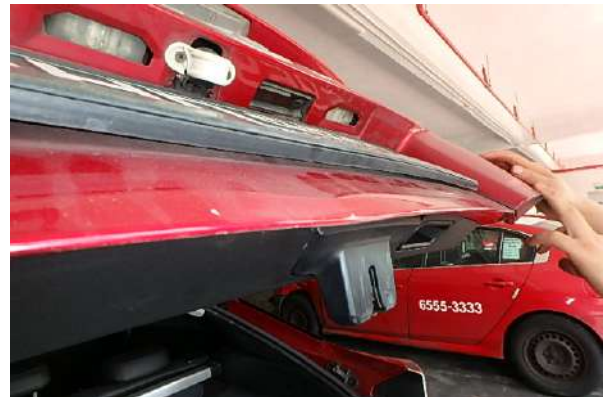
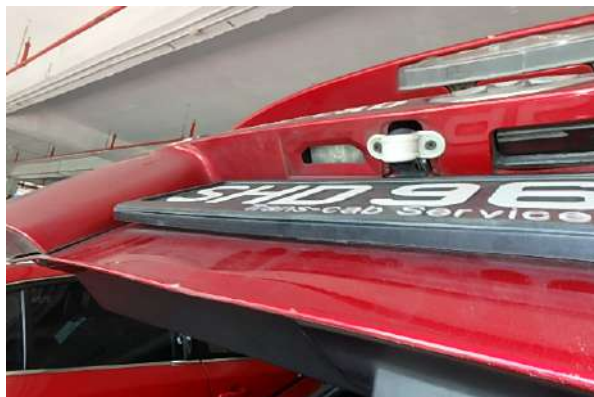
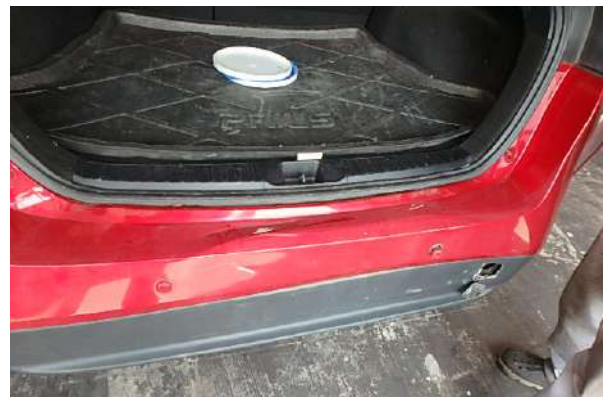
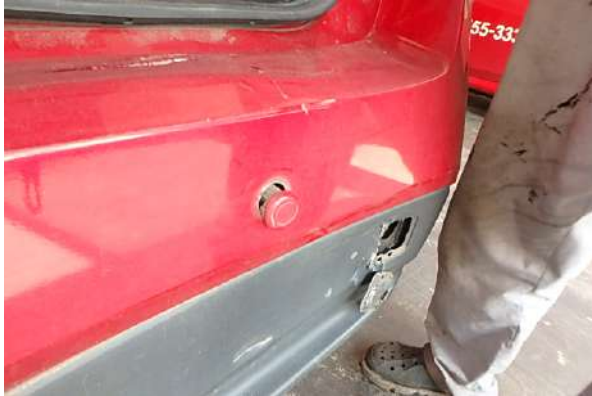
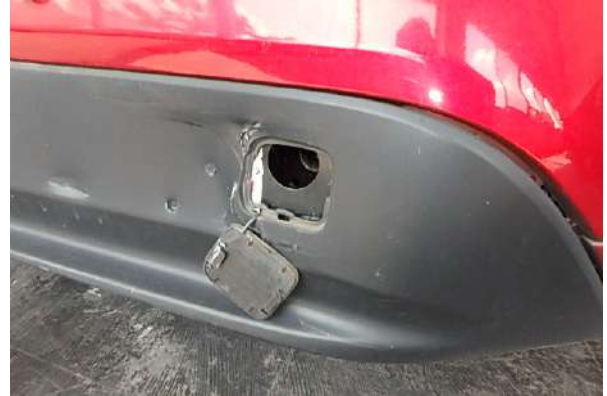
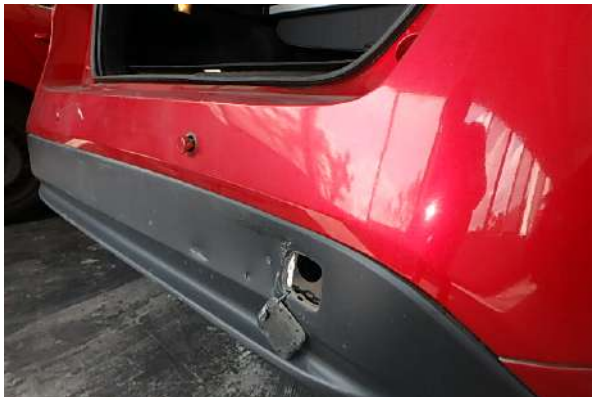
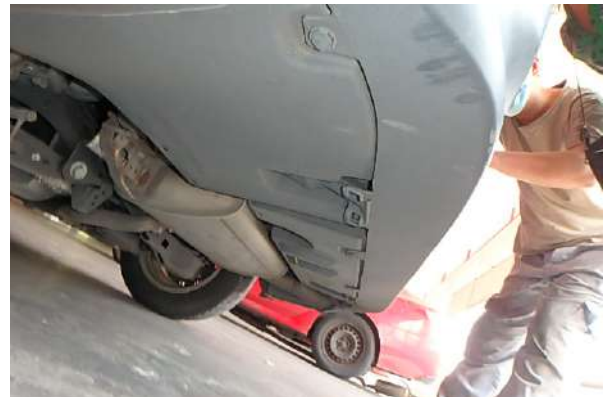
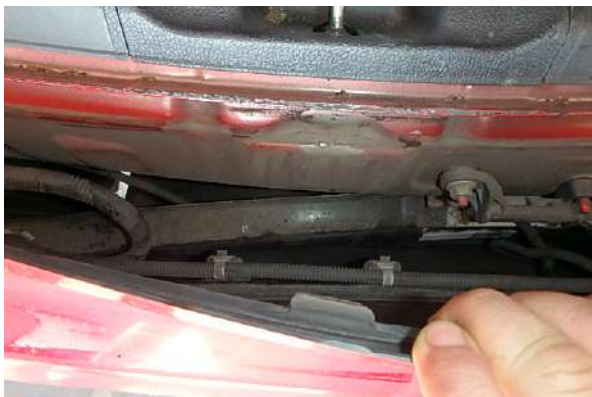
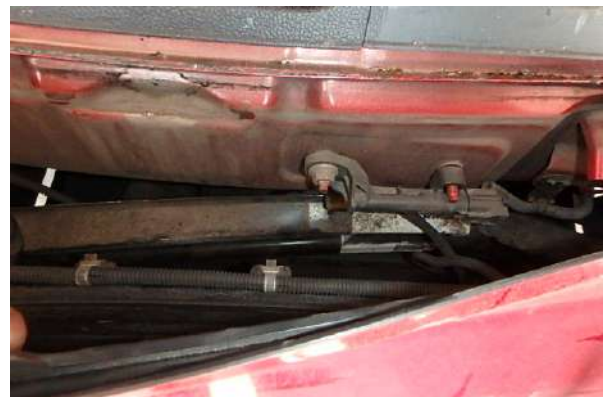
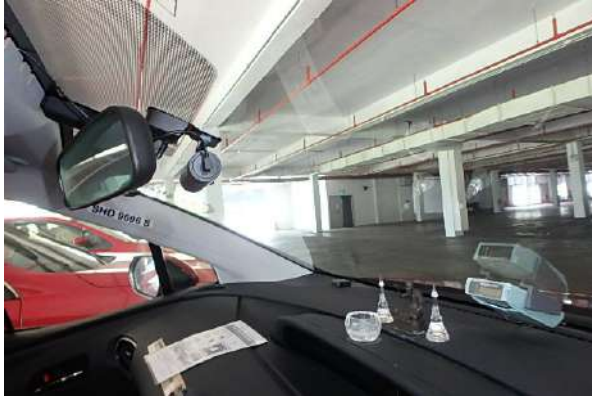
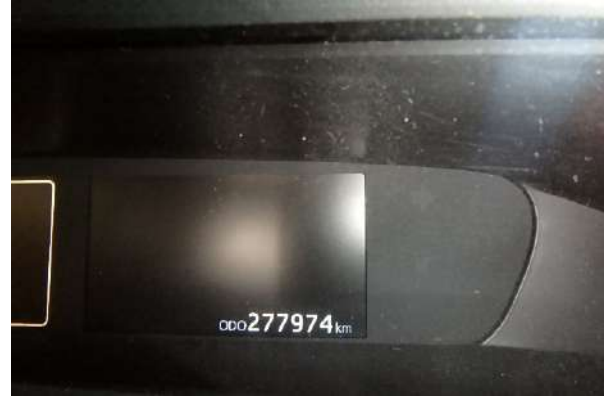
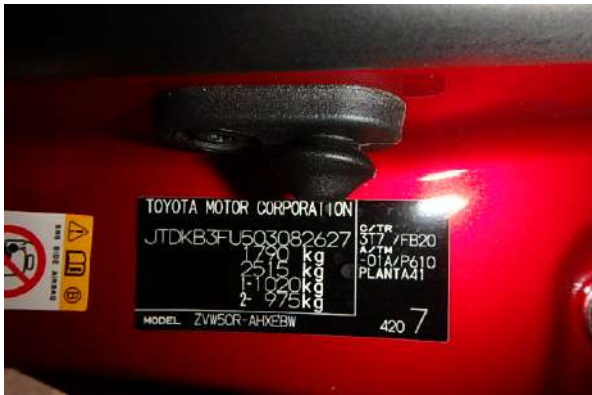
### INSPECTION

<b>R/H Front Tyre</b>	195/65 R15	SAILUN	9 mm
	<b>L/H Front Tyre</b>	195/65 R15	SAILUN	9 mm
	<b>R/H Rear Tyre</b>	195/65 R15	SAILUN	3 mm
	<b>L/H Rear Tyre</b>	195/65 R15	SAILUN	3 mm
<b>4. Description of Damages</b>				
	THE VEHICLE SUSTAINED DAMAGES AT THE REAR PORTION.  DAMAGES SEE DETAILS.			
<b>5. General Information</b>				
	<b>Accident Date</b>	27/12/2021	<b>Inspection Date</b>	28/12/2021
	<b>Survey held at</b>	TRANS-CAB AUTO SERVICES PTE LTD NO.2 ANG MO KIO ST 63 SINGAPORE 569111		
<b>5a. Remarks</b>				
	A)THE INSPECTION WAS CONDUCTED ON A"WITHOUT PREJUDICE" BASIS. B)IN ACCORDANCE TO YOUR INSTRUCTIONS, WE HAVE NOT AUTHORISED REPAIRS.			
<b>5b. Estimate Days of Repair</b>				
	ESTIMATED NORMAL PERIOD FOR REPAIR:		<b>3 Working Days</b>
