**SCHEMATIC DIAGRAM OF INCIDENT FOR MID 34780**

**ANNEX B****SCHEMATIC DIAGRAM OF INCIDENT**

**PHOTOGRAPHS OF ACCIDENT VEHICLE**

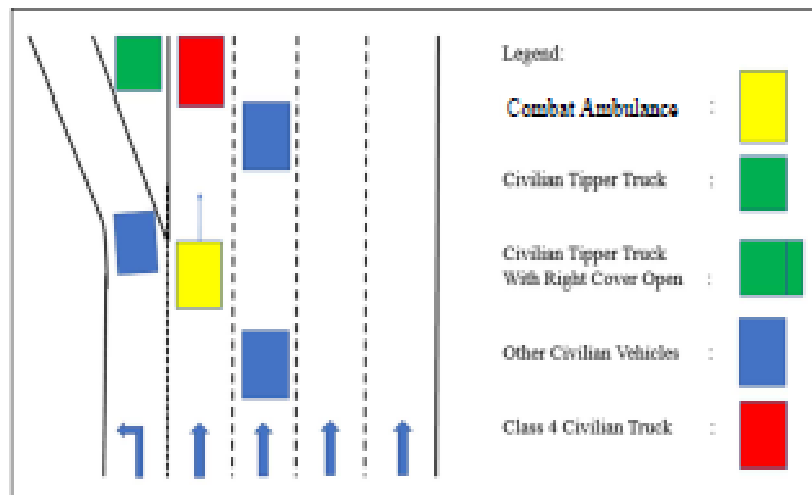
**Figure 1: Schematic diagram of incident**

A civilian tipper truck was stopped and parked at the chevrons on the left side while the combat ambulance is approaching from the right.

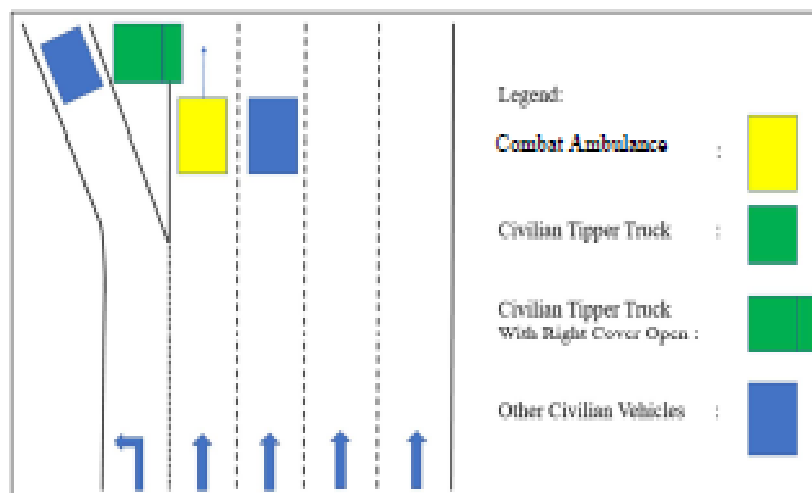
**Figure 2: Schematic diagram of Incident**

As combat ambulance moved past the stationary civilian tipper truck, the RHS top flap on the civilian tipper truck started to open up and protrude slightly into the travelling lane of combat ambulance.

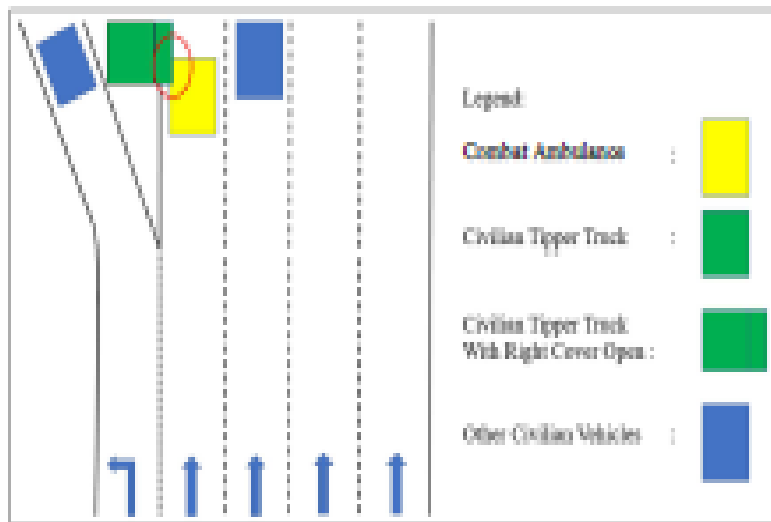
**Figure 3: Schematic diagram of Incident**

The combat ambulance did not see the RHS flap of the civilian tipper truck opening outwards and moved past the truck. Upon hearing a sudden "thump" sound, 39G Sean together with the trainer then realised that they may have grazed the opened flap on the civilian truck.

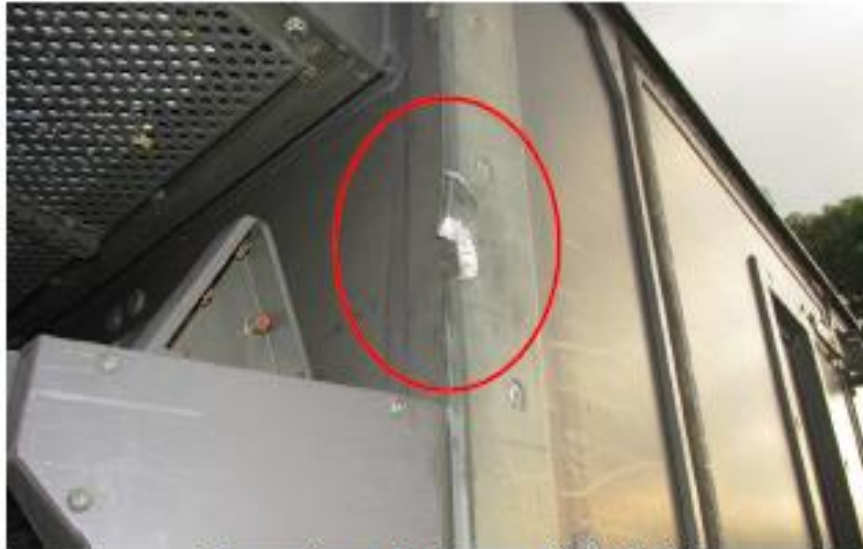
Close up view on the damages on MID 34780
