Your Ref: Porsche Marcan  
(chassis number WP1ZZZ95ZLLB04486)  
Our Ref : CI/TP21013284/D

30 December 2021

**INSPECTION REPORT OF AN UNREGISTERED PORSCHE MARCAN  
MOTOR CAR WITH CHASSIS NUMBER WP1ZZZ95ZLLB04486**

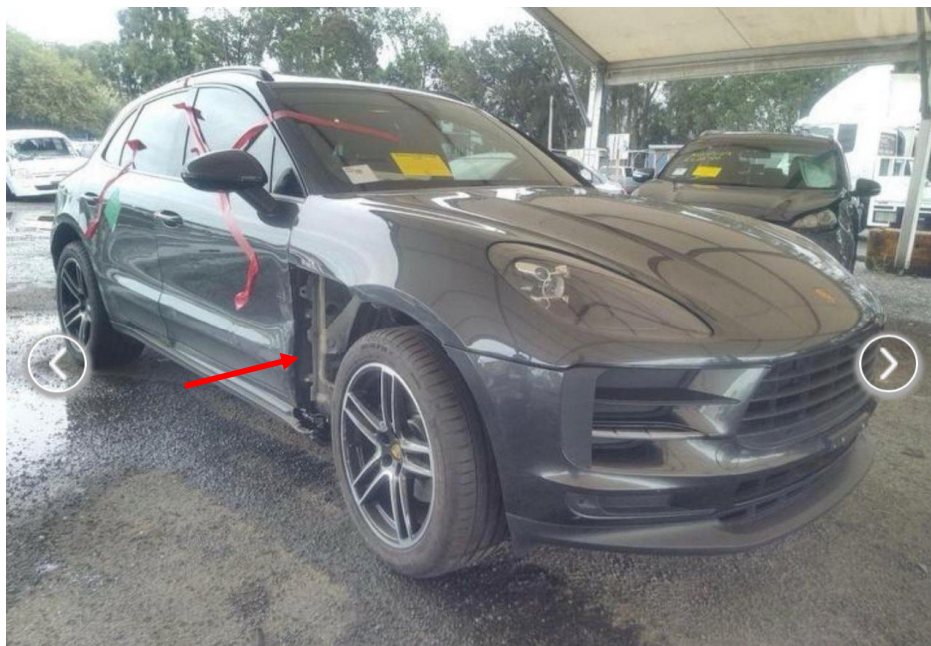
3. The photographs provided to me had showed the front right fender of the Motor Car dislodged/missing/damaged. No physical damage was observed to other areas of the Motor Car.
4. Parts and components within the engine compartment and interior compartment were intact and unaffected. The airbags were also not deployed as seen from the photographs that were provided to me. See photo 1 – 6 below.

**Photo 1** shows the front right body of the Motor Car (photograph provided to me). The photographs provided to me had showed the front right fender of the Motor Car dislodged/missing/damaged (arrowed). Apart for this, there was no physical damage observed to other areas of the Motor Car.

22. The body parts at the front right portion of the Motor Car were visually examined and it was noted that the repair/restoration works carried out to the damaged area of the Motor Car (refer to photograph 1 above) were reasonably adequate and in order.

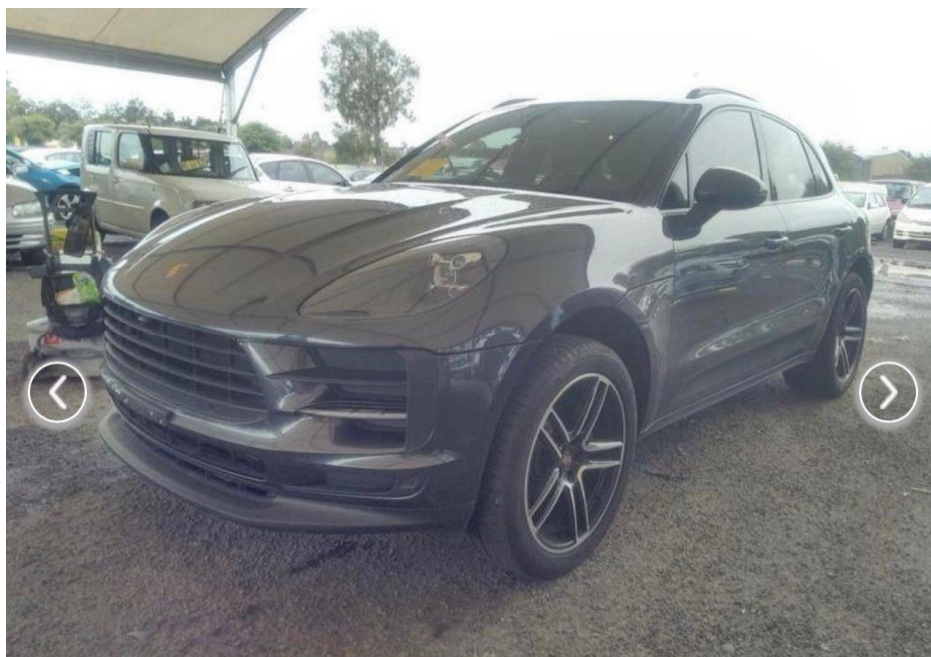
**Photo 2** shows the front left body of the Motor Car (photograph provided to me). Apart for the front right portion, there was no physical damage observed to other areas of the Motor Car. The airbags were also not deployed as seen from the photographs that were provided to me.

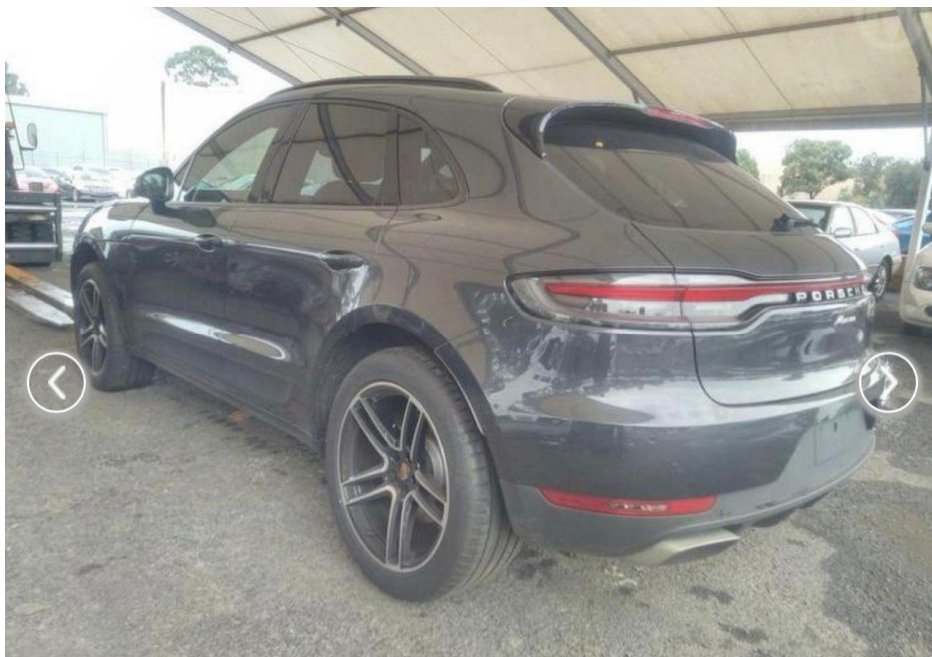
**Photo 3** shows the rear left body of the Motor Car (photograph provided to me). Apart for the front right portion, there was no physical damage observed to other areas of the Motor Car. The airbags were also not deployed as seen from the photographs that were provided to me.

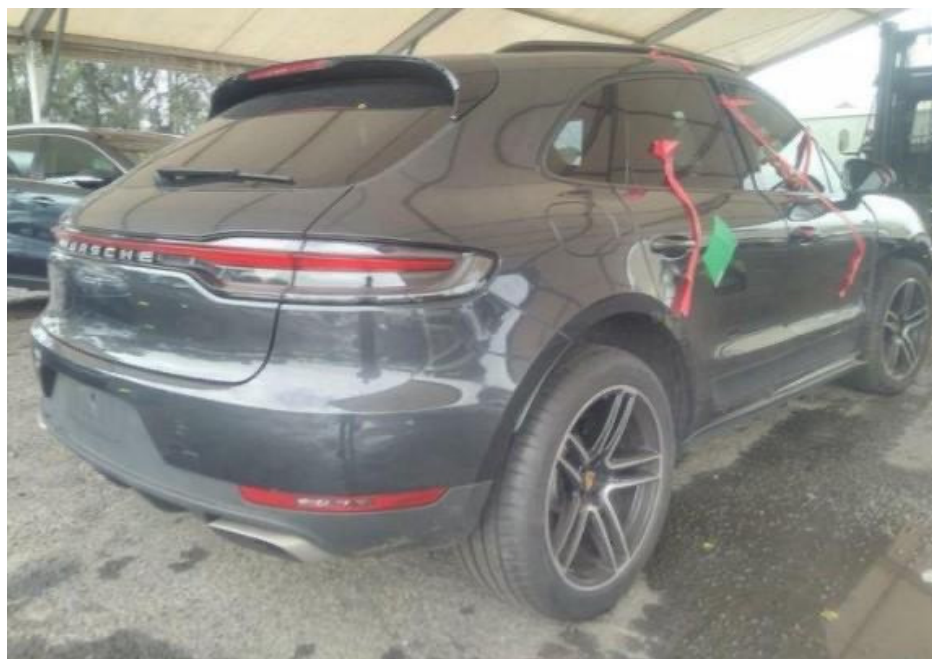
**Photo 4** shows the rear right body of the Motor Car (photograph provided to me). Apart for the front right portion, there was no physical damage observed to other areas of the Motor Car. The airbags were also not deployed as seen from the photographs that were provided to me.

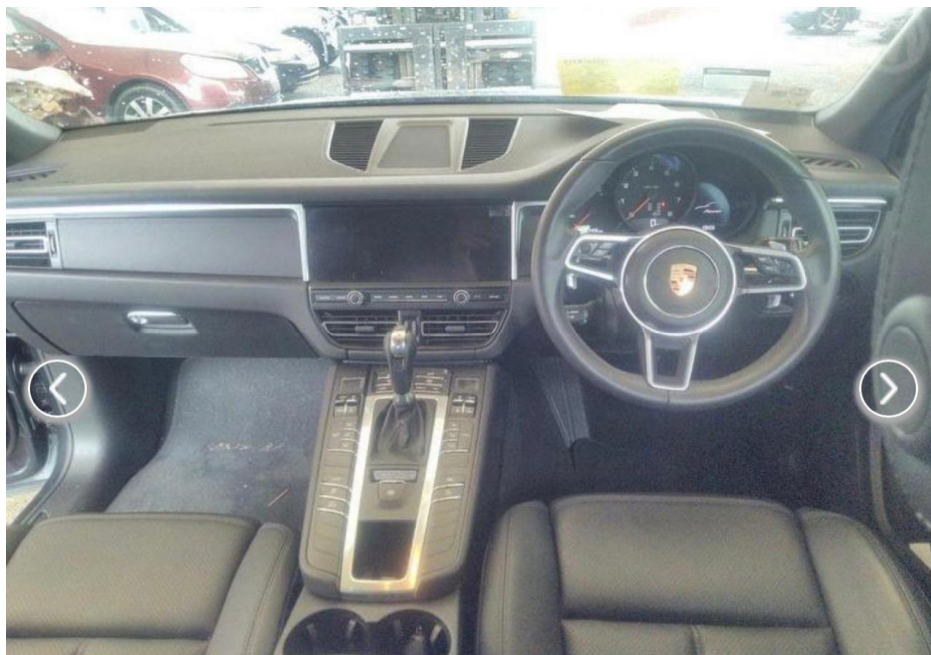
**Photo 5** shows the front dashboard of the Motor Car (photograph provided to me). Parts and components within the interior compartment were observed to be intact and unaffected. The airbags of the Motor Car were also not deployed as seen from the photographs that were provided to me.

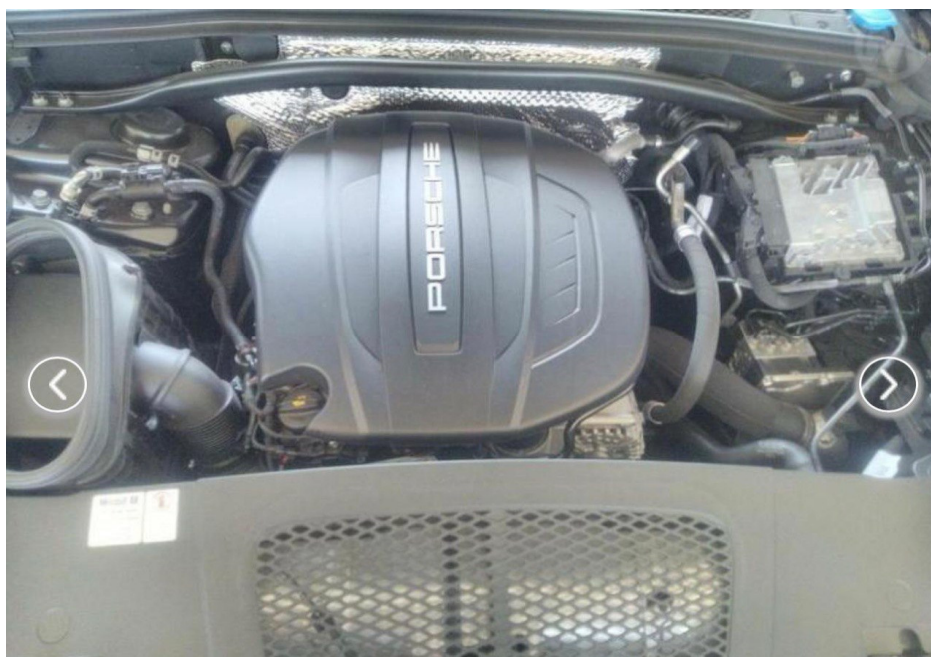
**Photo 6** shows the engine compartment of the Motor Car (photograph provided to me). Parts and components within the engine compartment were observed to be intact and unaffected.

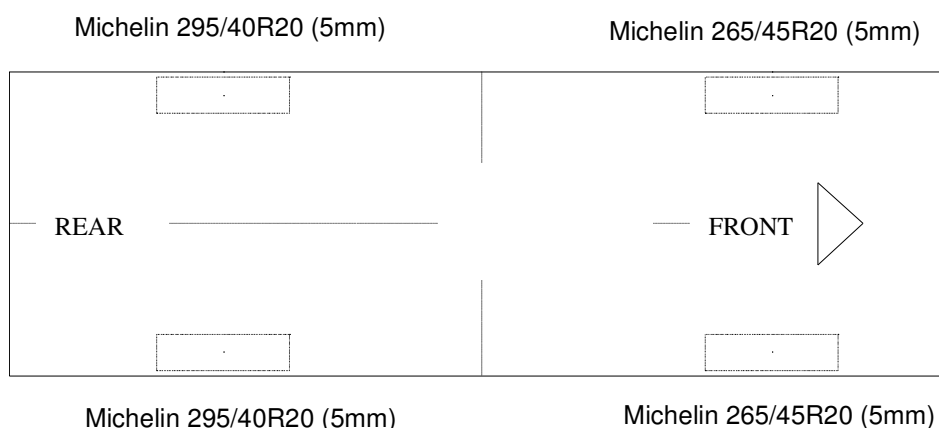
8. It was fitted with 20inch sport wheel rims that were wrapped with tyres that were observed to be of serviceable condition. The tyres were also sufficiently inflated for vehicular operation. The tyre brand, tyre size and approximate remaining tread depth of the 4 tyres of the Motor Car were recorded as follows: -

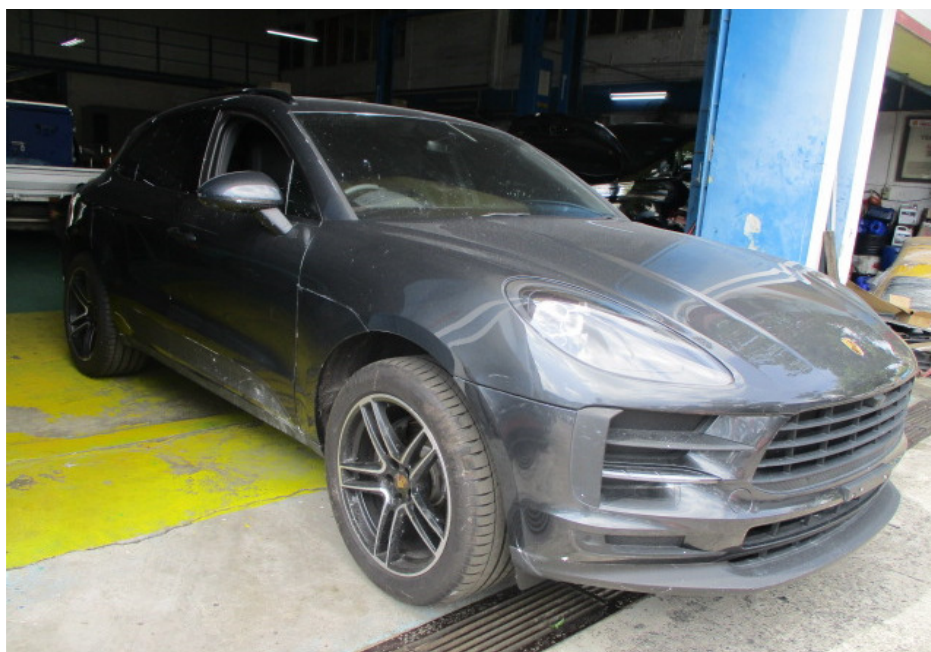
**Photo 7** shows a general view of the front right body of the Motor Car at the time of my inspection. The Motor Car was observed to be in a relatively good general condition with no loose exterior fittings observed. The body parts at the front right portion of the Motor Car were visually examined and it was observed that the repair/restoration works carried out to the damaged area of the Motor Car (refer to photograph 1 above) were reasonably adequate and in order.

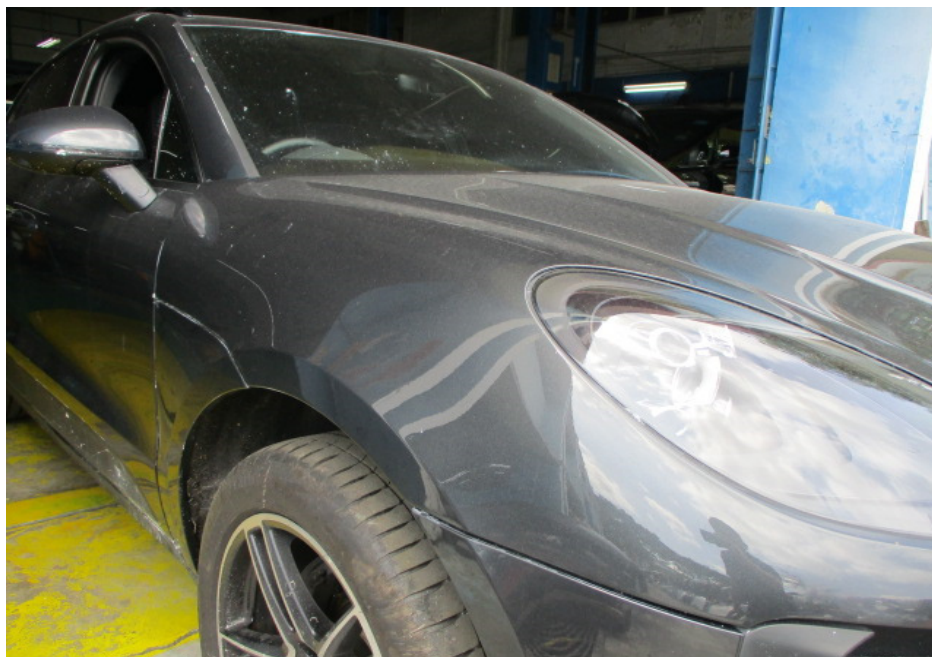
**Photo 8** shows a closer view of the Motor Car's front right headlamp, front right fender and front bonnet at the time of my inspection. The body parts at the front right portion of the Motor Car were visually examined and it was observed that the repair/restoration works carried out to the damaged area of the Motor Car (refer to photograph 1 above) were reasonably adequate and in order.

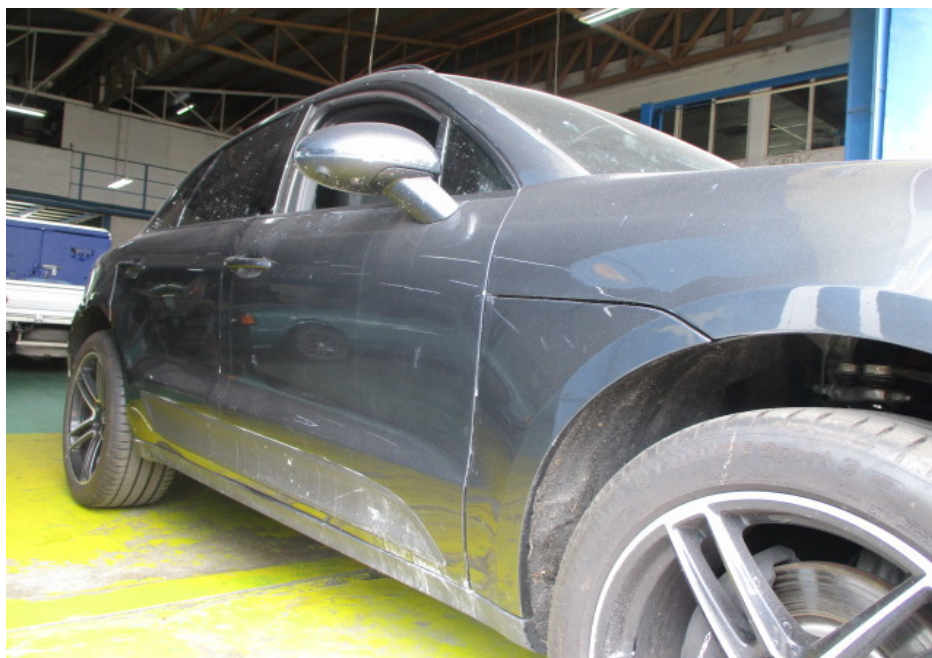
**Photo 9** shows a closer view of the Motor Car's front bonnet, front right fender, front right door and right side rocker panel garnish at the time of my inspection. The body parts at the front right portion of the Motor Car were visually examined and it was observed that the repair/restoration works carried out to the damaged area of the Motor Car (refer to photograph 1 above) were reasonably adequate and in order.

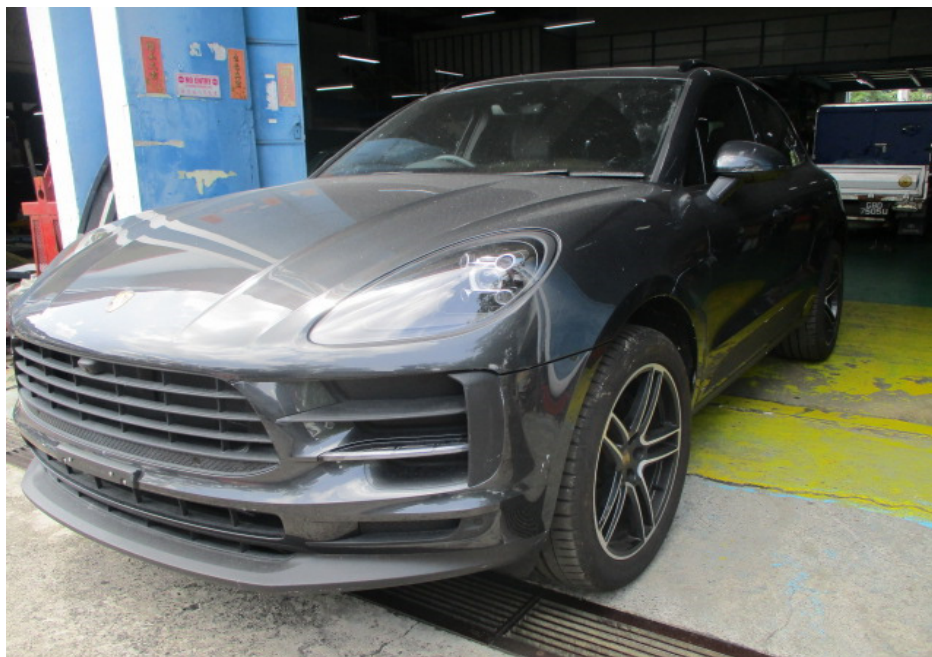
**Photo 10** shows a general view of the front left body of the Motor Car at the time of my inspection. The Motor Car was observed to be in a relatively good general condition with no loose exterior fittings observed. The body parts at the front right portion of the Motor Car were visually examined and it was observed that the repair/restoration works carried out to the damaged area of the Motor Car (refer to photograph 1 above) were reasonably adequate and in order.

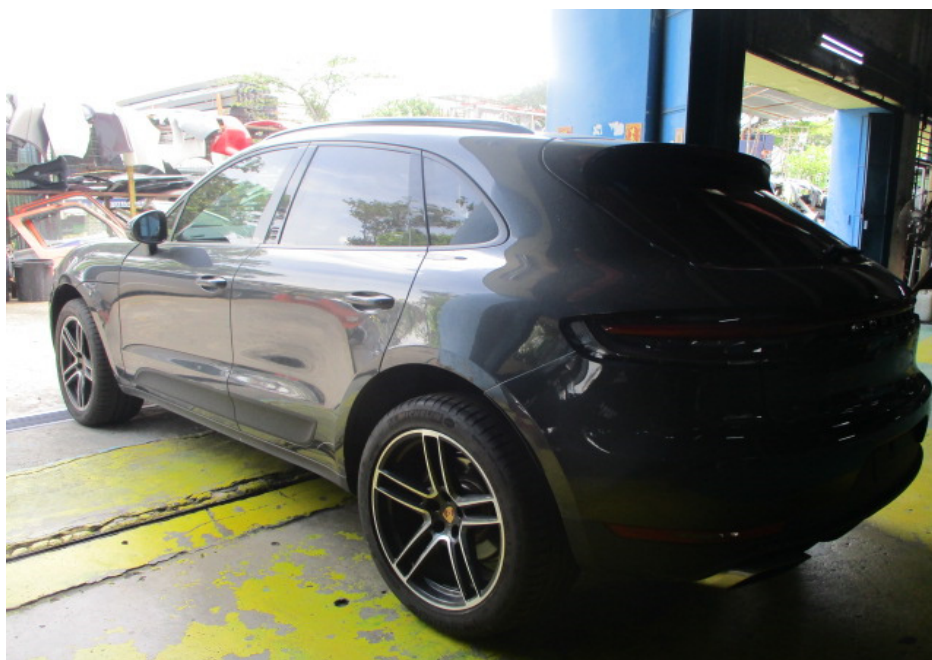
**Photo 11** shows a general view of the rear left body of the Motor Car at the time of my inspection. The Motor Car was observed to be in a relatively good general condition with no loose exterior fittings observed. The mileage of the Motor Car recorded at the time of my inspection was 9,626km.

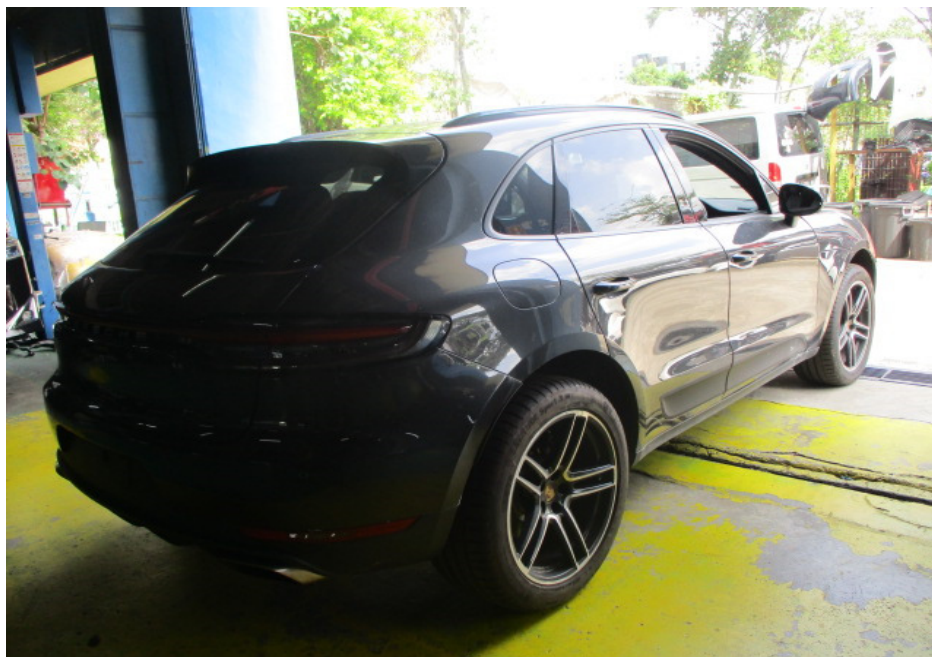
**Photo 12** shows a general view of the rear right body of the Motor Car at the time of my inspection. The Motor Car was observed to be in a relatively good general condition with no loose exterior fittings observed. The mileage of the Motor Car recorded at the time of my inspection was 9,626km.

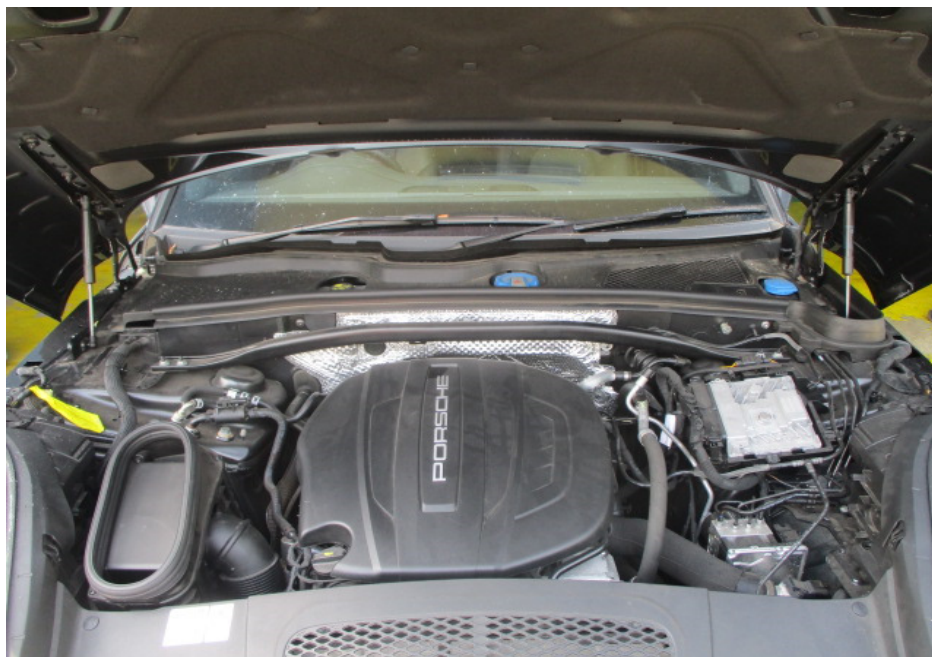
**Photo 14** shows a general view of the engine compartment of the Motor Car at the time of my inspection. The various parts and components inside the engine compartment were all observed to be intact and properly fitted. There was also no sign(s) or indication(s) of fluid leak and/or fluid stain found inside the engine compartment.

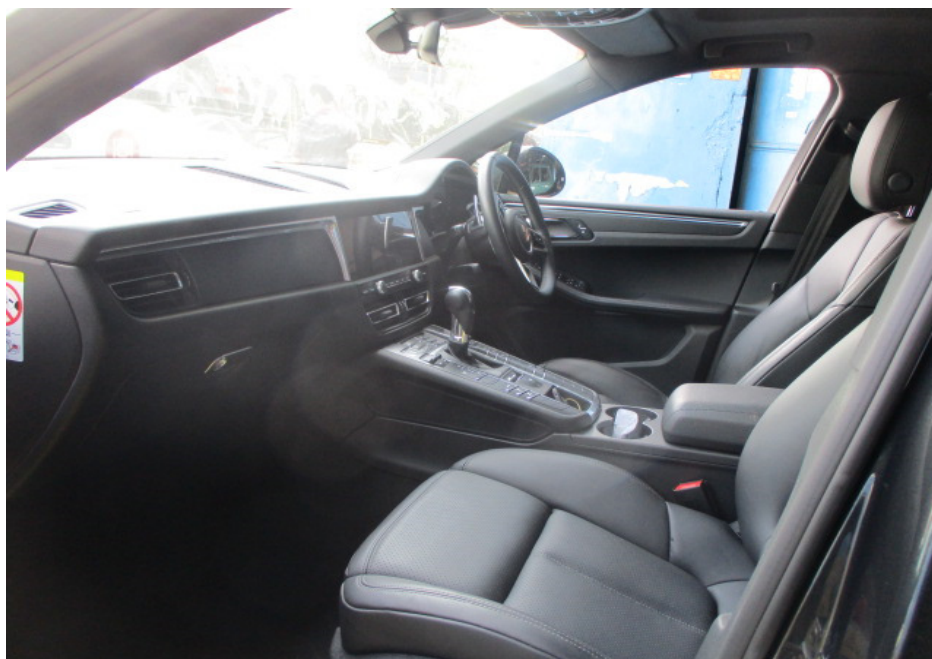
**Photo 15** shows the interior compartment of the Motor Car at the time of my inspection. The various parts and components, trims, carpet, and upholstery inside the interior compartment were all observed to be intact and properly fitted.

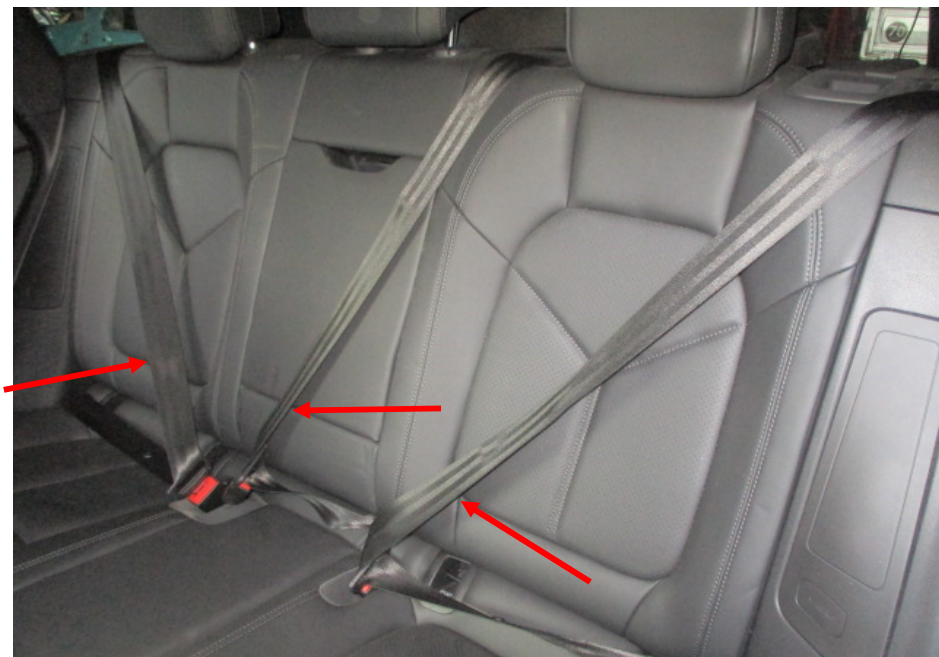
**Photo 16** shows the rear seats of the Motor Car. All the seats of the Motor Car were secured via seat rails to the floorboard. They were also fitted with a retractable seat belt reel and a pre-tensioner. The seat belts (arrowed) were tested and were able to be fastened into the respective pre-tensions that were fitted on the side of each individual seat.

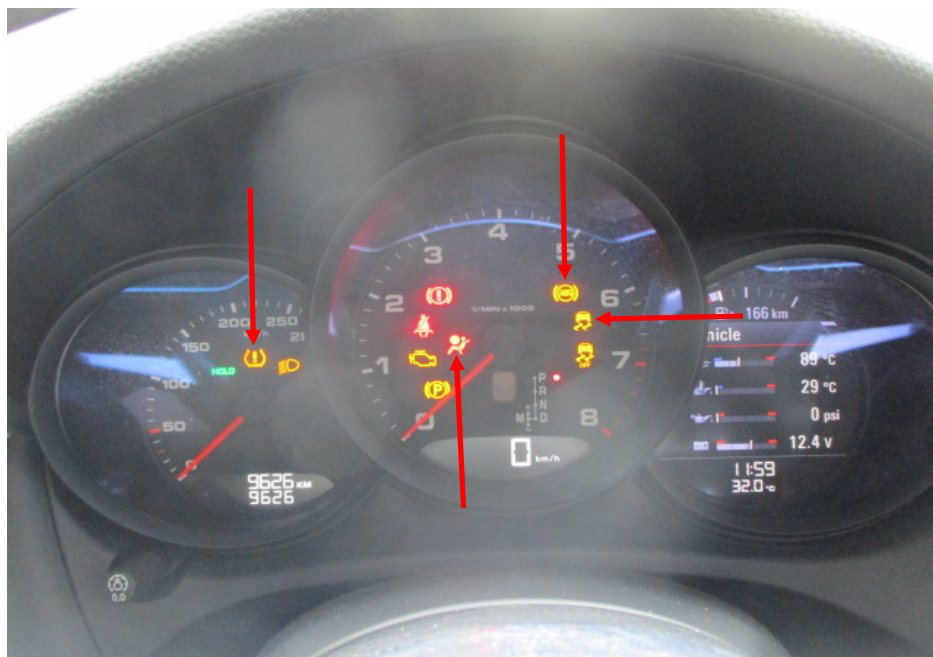
**Photo 17** shows the warning lights for the various electronic safety features appearing on the instrument panel of the Motor Car during its self-test when the engine is cranked, in particular the ABS, SRS, TPM and TCS lights (arrowed).

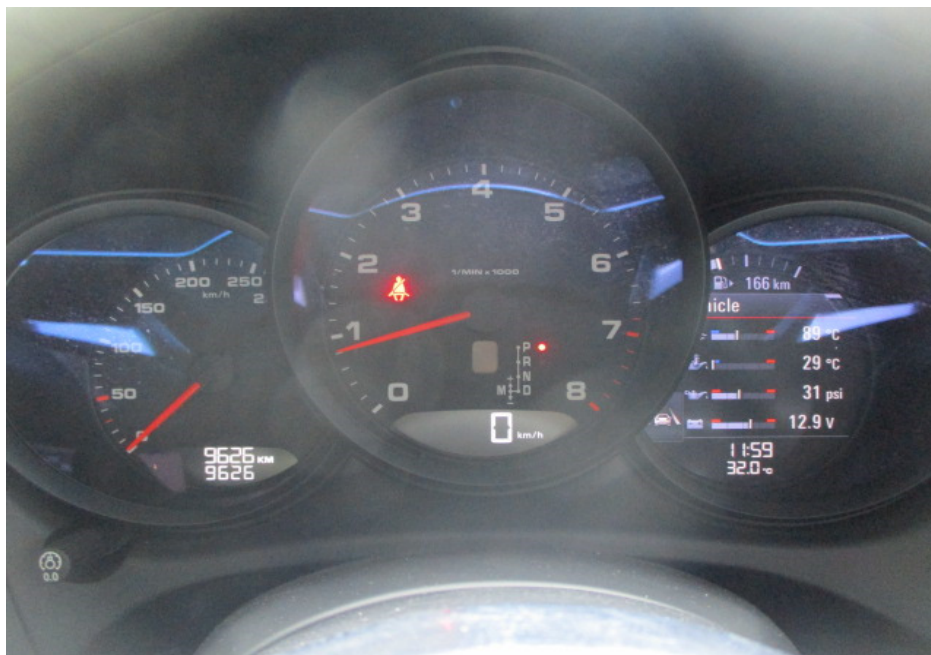
**Photo 18** shows the respective warning lights no longer illuminated, indicating that there is no fault detected to the ABS, SRS, TPM and TCS systems of the Motor Car during the self-test. These electronic systems were hence in working condition at the time of my inspection.

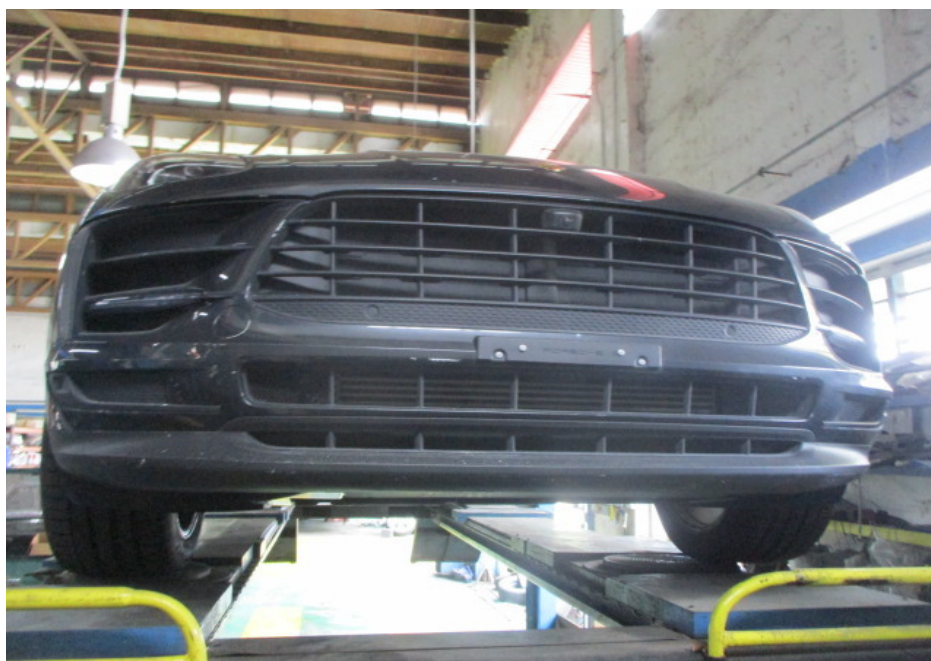
**Photo 19** shows the Motor Car hoisted up for checks on its undercarriage. There was no sign(s) or indication(s) of fluid leakage and/or fluid stain(s) on the underside of the Motor Car. The undercarriage components of the Motor Car were also all observed to be intact and secured in an appropriate manner.

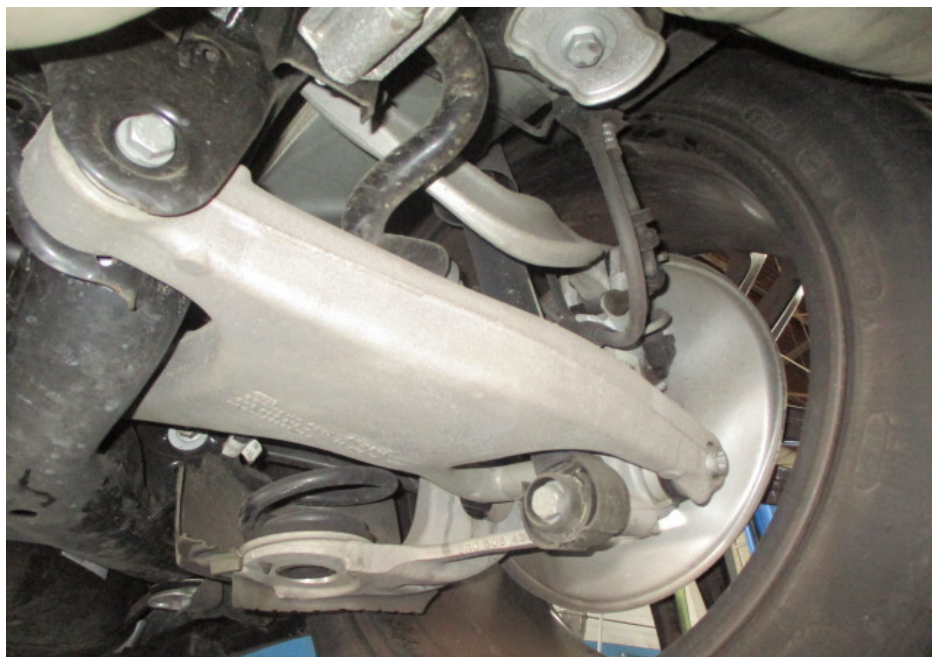
**Photo 20** shows a general view of the control arms and linkages at the rear right wheel of the Motor Car. I did not observe any fluid leak and/or fluid stain on the underside of the Motor Car. All of the Motor Car's undercarriage components were observed to be intact and secured in an appropriate manner.

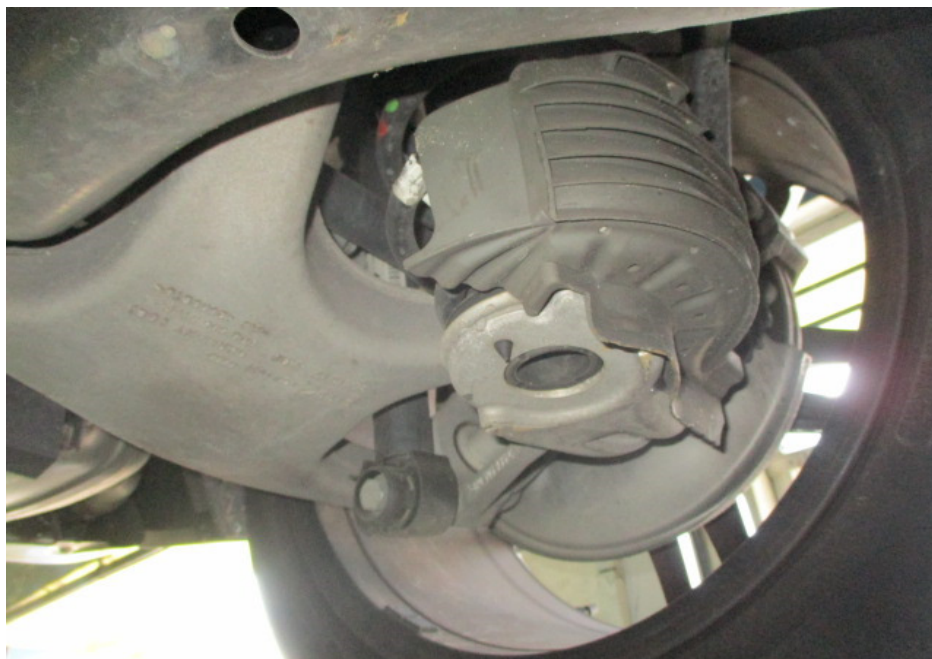
**Photo 21** shows a general view of the control arms and linkages at the rear left wheel of the Motor Car. I did not observe any fluid leak and/or fluid stain on the underside of the Motor Car. All of the Motor Car's undercarriage components were observed to be intact and secured in an appropriate manner.

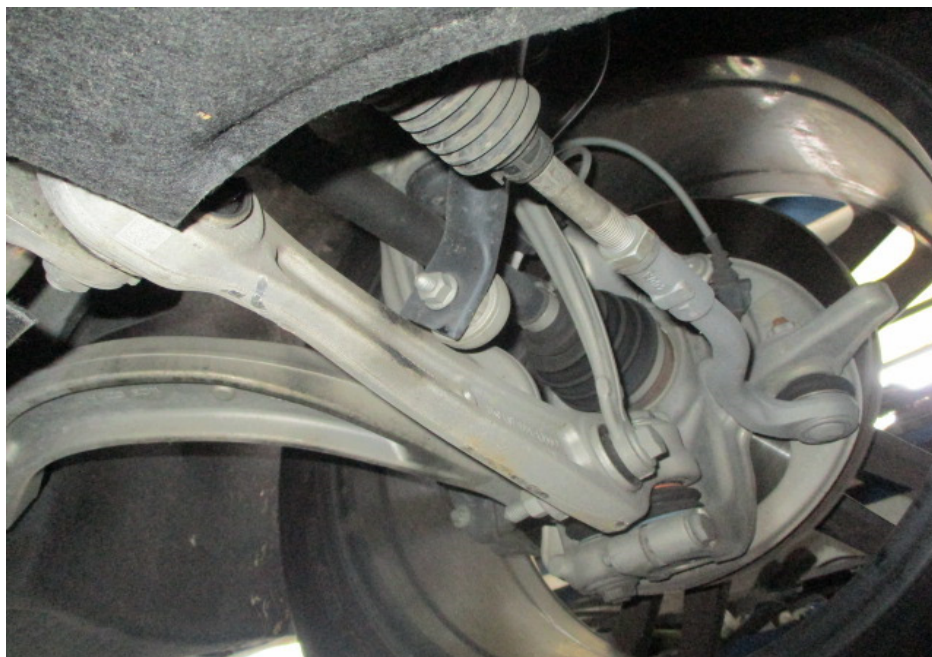
**Photo 22** shows the various undercarriage components at the front left wheel of the Motor Car. The mechanical components, control arms and linkages were all found to be intact and secured in an appropriate manner.

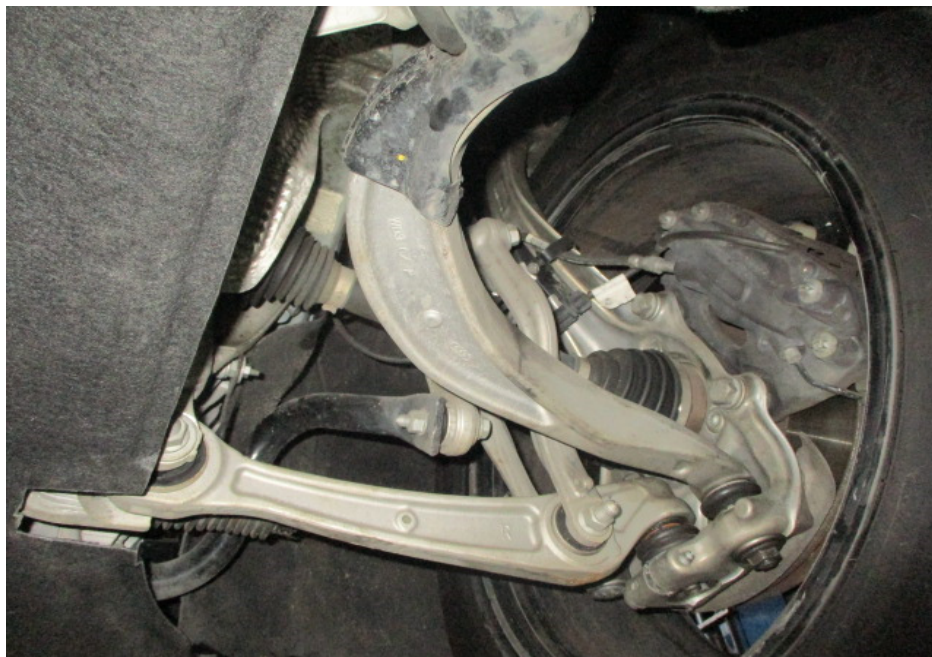
**Photo 23** shows the various undercarriage components at the front right wheel of the Motor Car. The mechanical components, control arms and linkages were all found to be intact and secured in an appropriate manner. I also did not observe any fluid leak and/or fluid stain on the underside of the Motor Car.

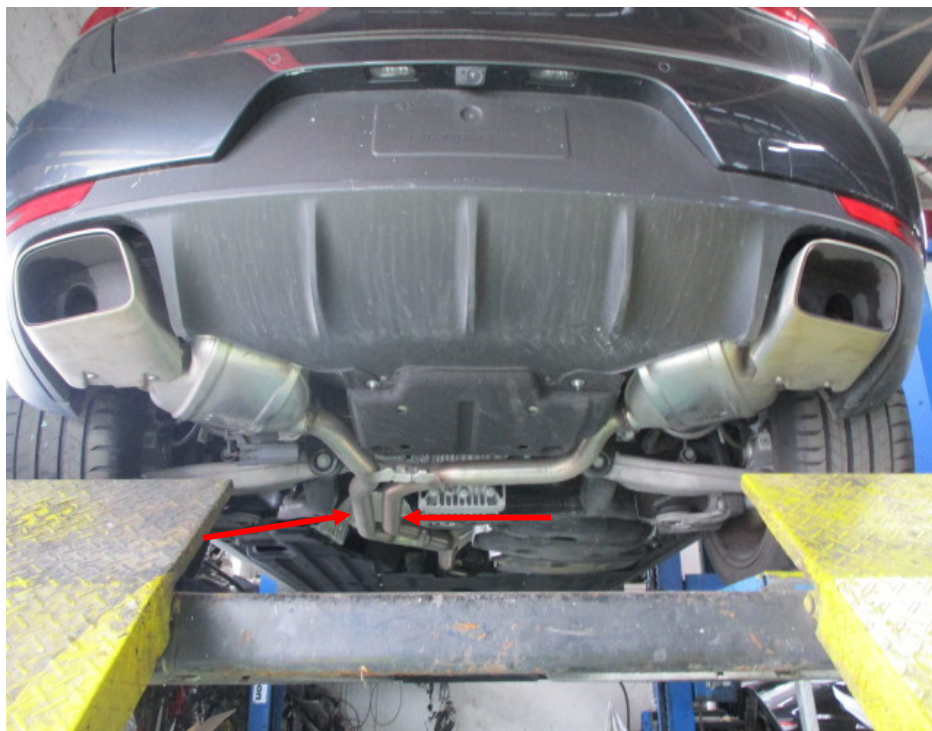
**Photo 24** shows the rear section of the Motor Car's exhaust system. My examination of the Motor Car's exhaust system revealed no sign(s) or indication(s) of any cut or weld marks along its exhaust pipes (arrowed), on its rear mufflers and on its catalytic converter.

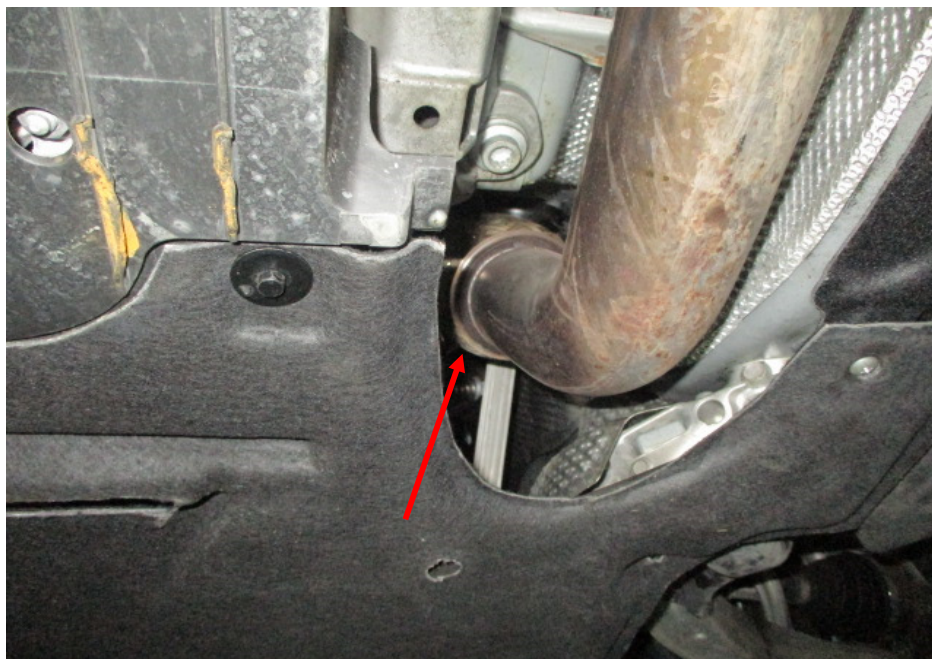
**Photo 25** shows the front section of the Motor Car's exhaust system. My examination of the Motor Car's exhaust system revealed no sign(s) or indication(s) of any cut or weld marks along its exhaust pipes, on its rear mufflers and on its catalytic converter (arrowed).

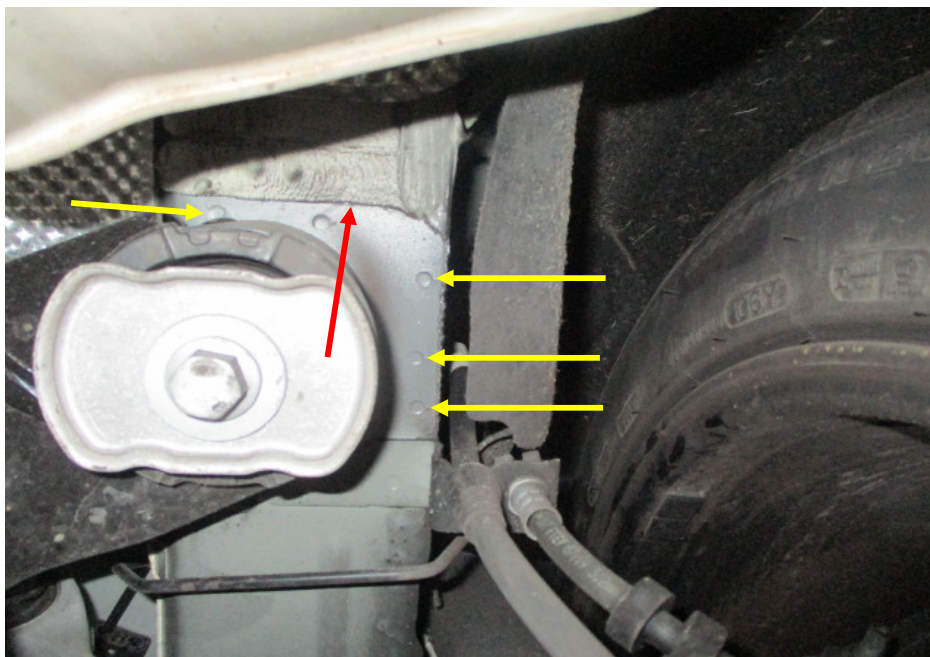
**Photo 26** shows the chassis/structural body at the underside rear right of the Motor Car. I did not find any weld marks other than original spot weld marks (yellow arrow) on the chassis/structural body of the Motor Car. The original factory sealant (red arrow) at the joints along the chassis/structural body was untouched, indicating no work was done on the chassis/structural body of the Motor Car and that the chassis/structural body was originally fitted.

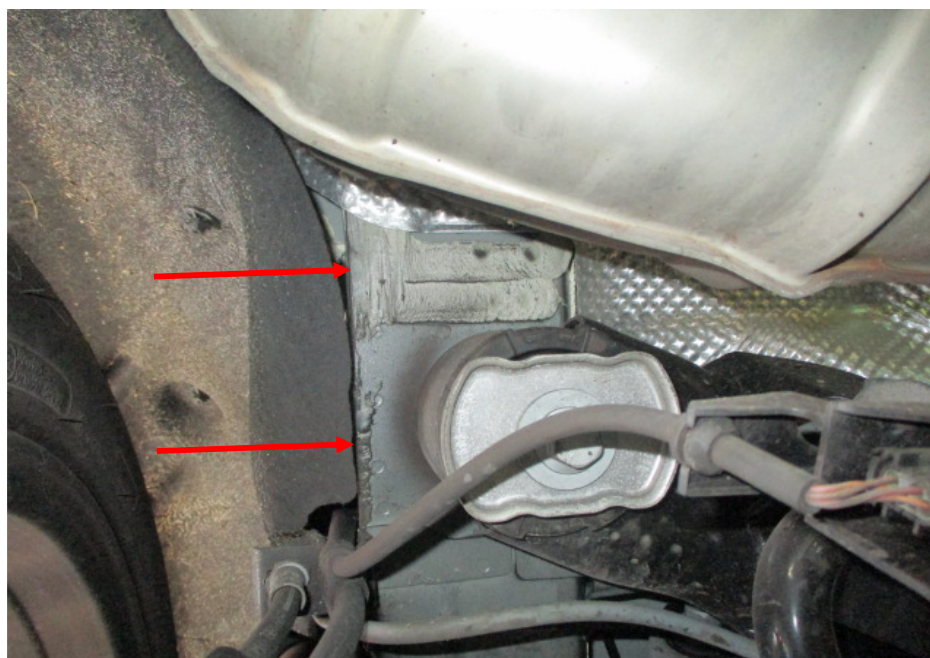
**Photo 27** shows the chassis/structural body at the underside rear left of the Motor Car. The original factory sealant (arrowed) at the joints along the chassis/structural body was observed to be untouched. In general, I had found no work was carried out on the chassis/structural body of the Motor Car. The chassis/structural body of the Motor Car was originally fitted.

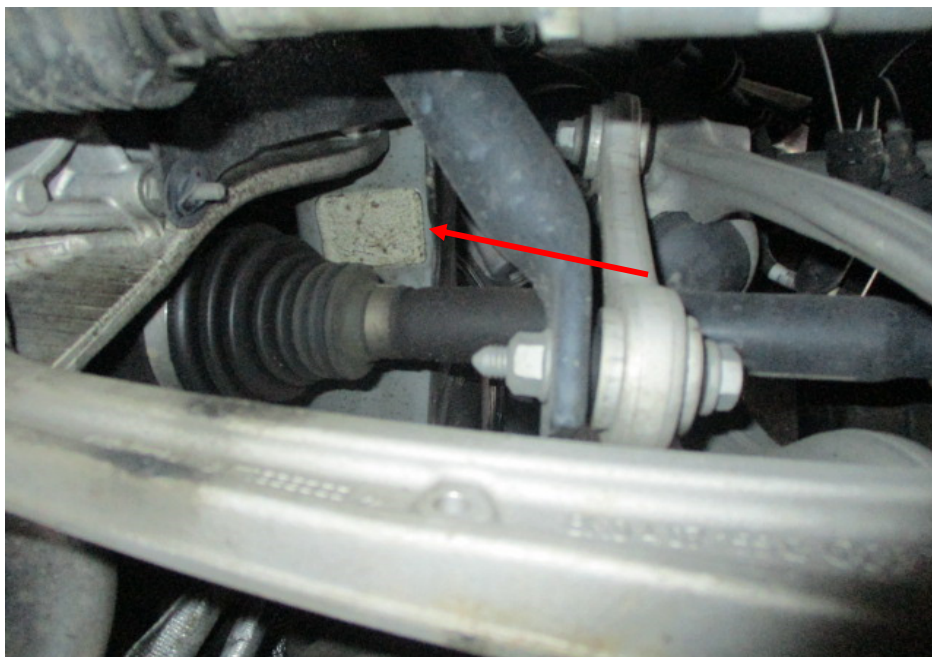
**Photo 28** shows the chassis/structural body at the underside front left of the Motor Car. I did not find any weld marks other than original spot weld marks on the chassis/structural body of the Motor Car. The original factory sealant (arrowed) at the joints along the chassis/structural body was untouched, indicating no work was done on the chassis/structural body of the Motor Car and that the chassis/structural body was originally fitted.

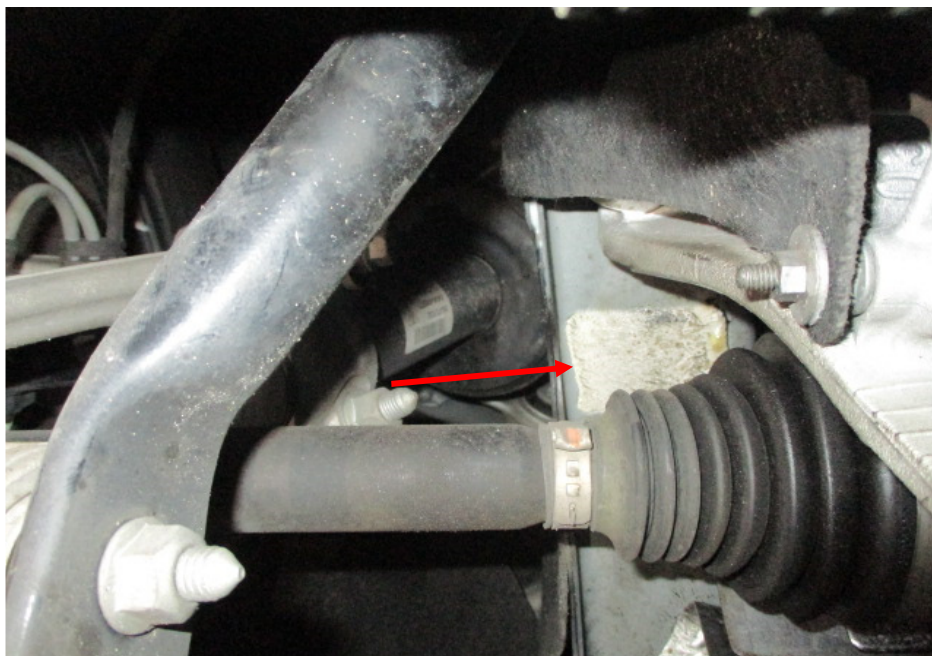
**Photo 29** shows the chassis/structural body at the underside front right of the Motor Car. The original factory sealant (arrowed) at the joints along the chassis/structural body was observed to be untouched. In general, I had found no work was carried out on the chassis/structural body of the Motor Car. The chassis/structural body of the Motor Car was originally fitted.

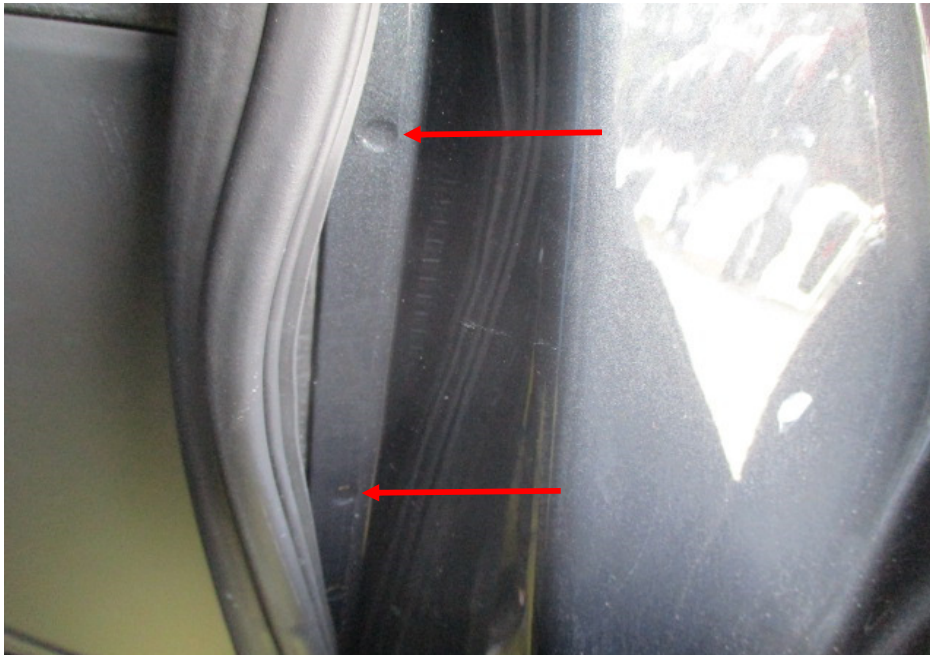
**Photo 30** shows the right side "A" pillar of the Motor Car. I did not find any weld marks other than original spot weld marks (arrowed) on the right side "A" pillar of the Motor Car which, indicates that there was no re-welding works carried out. In general, I had found all the non-detachable body panels of the Motor Car to be originally fitted at the time of my inspection.

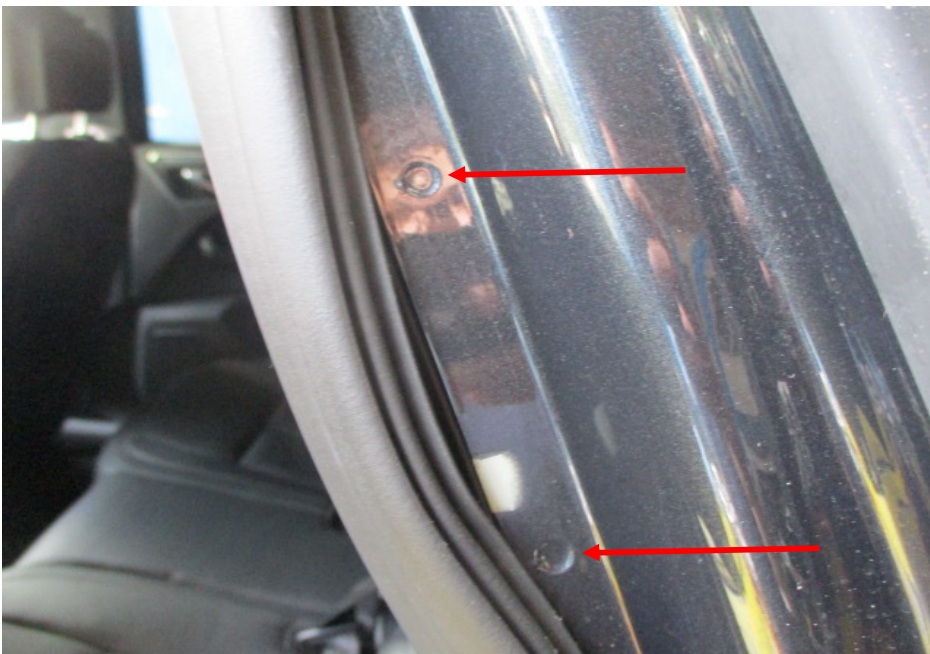
**Photo 31** shows the left side "C" pillar of the Motor Car. I did not find any weld marks other than original spot weld marks (arrowed) on the left side "C" pillar of the Motor Car which, indicates that there was no re-welding works carried out. In general, I had found all the non-detachable body panels of the Motor Car to be originally fitted at the time of my inspection.

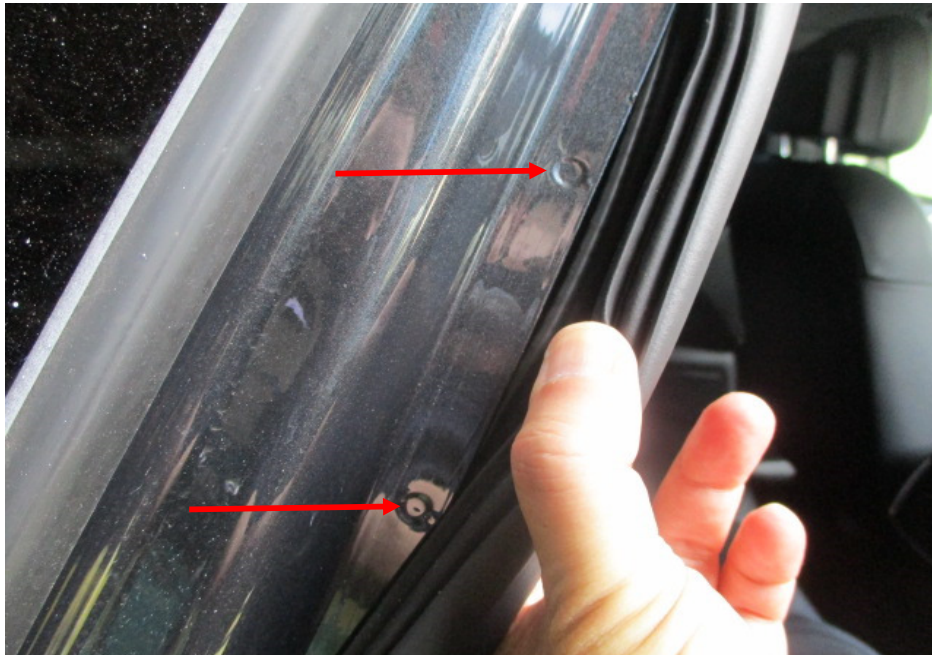
**Photo 32** shows the right side "C" pillar of the Motor Car. I did not find any weld marks other than original spot weld marks (arrowed) on the right side "C" pillar of the Motor Car which, indicates that there was no re-welding works carried out. In general, I had found all the non-detachable body panels of the Motor Car to be originally fitted at the time of my inspection.
