Your Ref : SNM22D204925
Our Ref : CS/CTI21013325/N

**AUTOMOBILE TECHNICAL INVESTIGATION REPORT OF ACCIDENT
INVOLVING SJR 9017E AND GBG 214P ON 14 DECEMBER 2021**

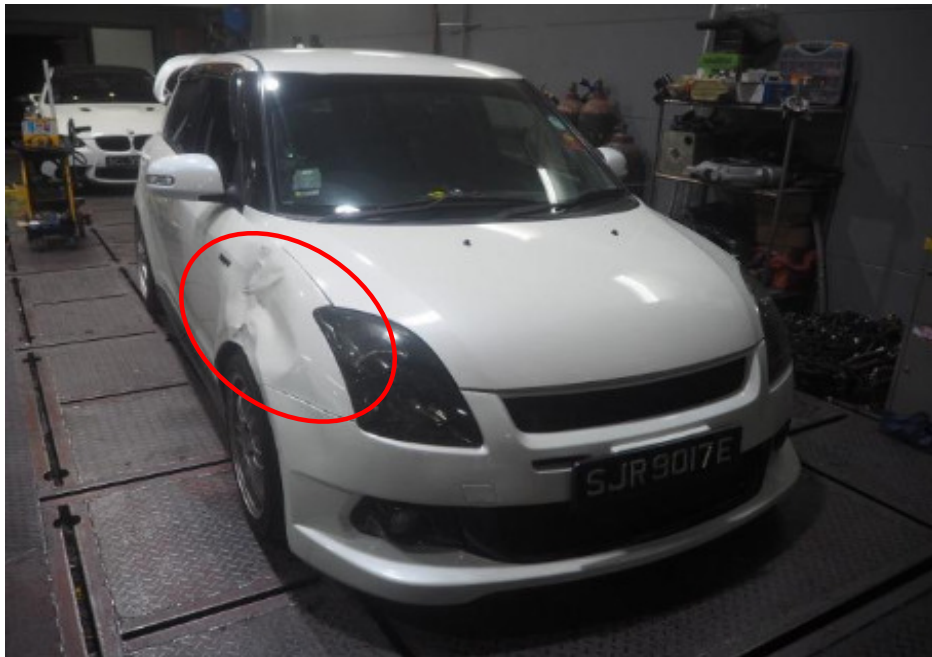
Photo 1 shows the general view of the frontal portion of the Suzuki at the time of the Pre- Repair Survey conducted by LKK Auto Consultants Pte. Ltd. which was taken about 2 weeks after the accident. The damage to the Suzuki was observed to be confined to the right front fender and front bumper (circled).

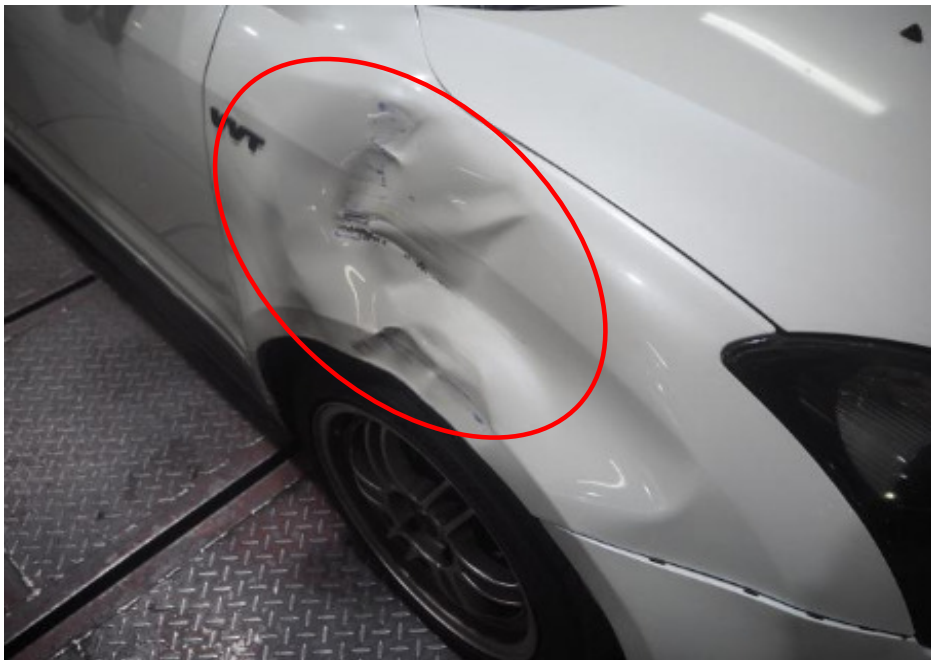
Photo 2 shows the dents (circled) found on the right front fender of the Suzuki.

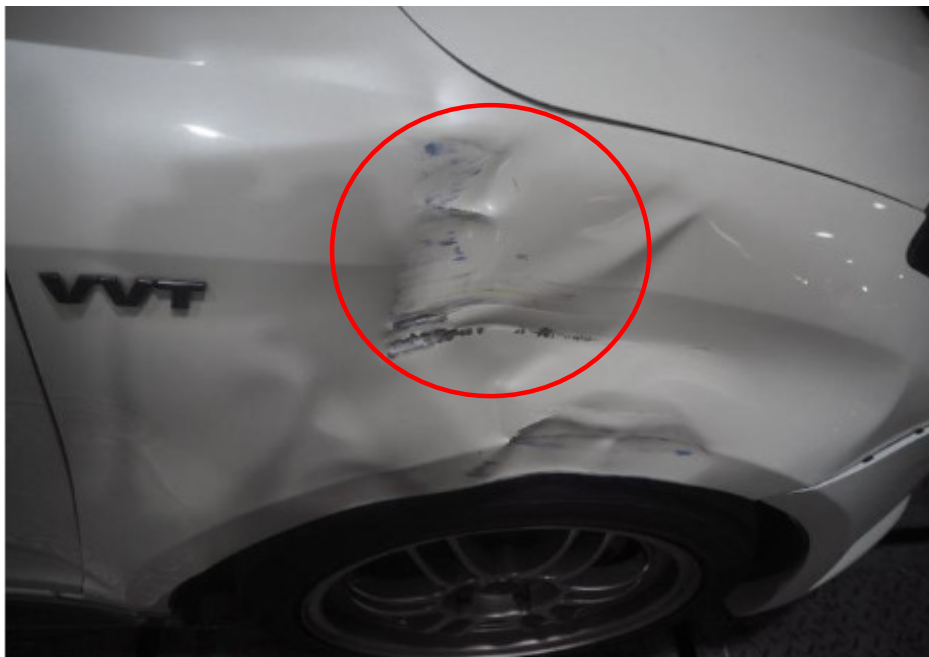
Photo 3 shows a closer view of the dents (circled) found on the right front fender of the Suzuki.

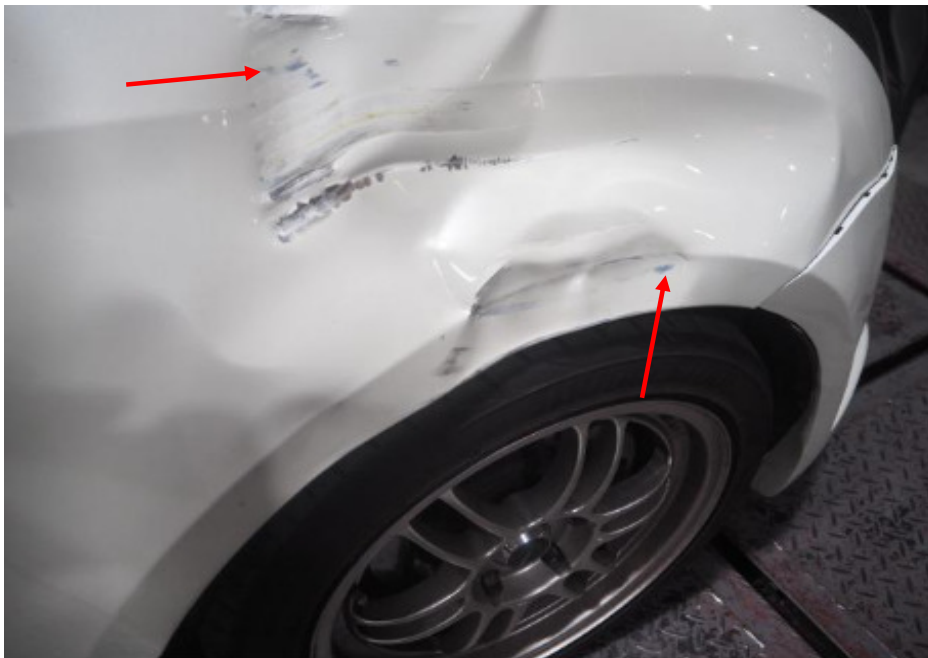
Photo 4 shows a closer view of the blue paint transfer marks found on the right front fender of the Suzuki (arrowed).

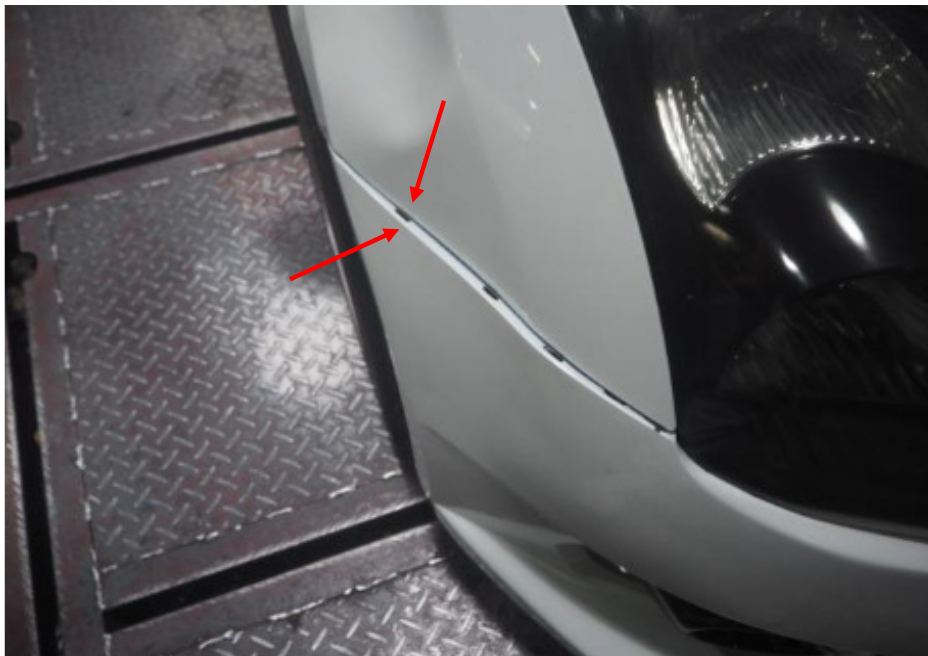
Photo 5 shows a closer view of the right corner edge of the front bumper of the Suzuki. We observed that the front bumper was misaligned at its corner edges (arrowed).

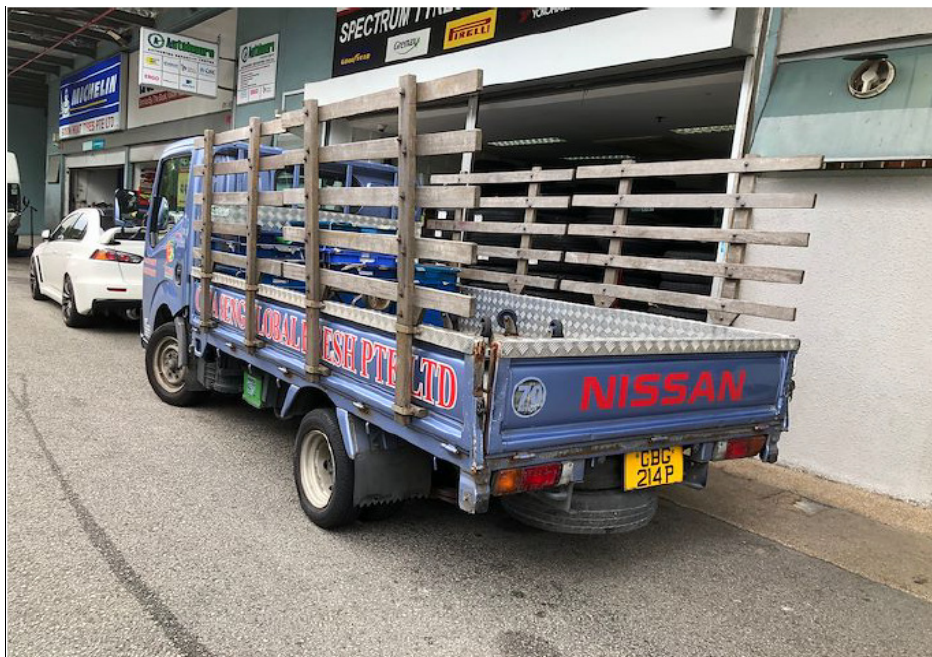
Photo 6 shows the general view of the left rear portion of the Nissan at the time of reporting. The examination had primarily focused on the left rear portion of the Nissan, in particular its left side gate as the accident was reported to be of a left to right nature.

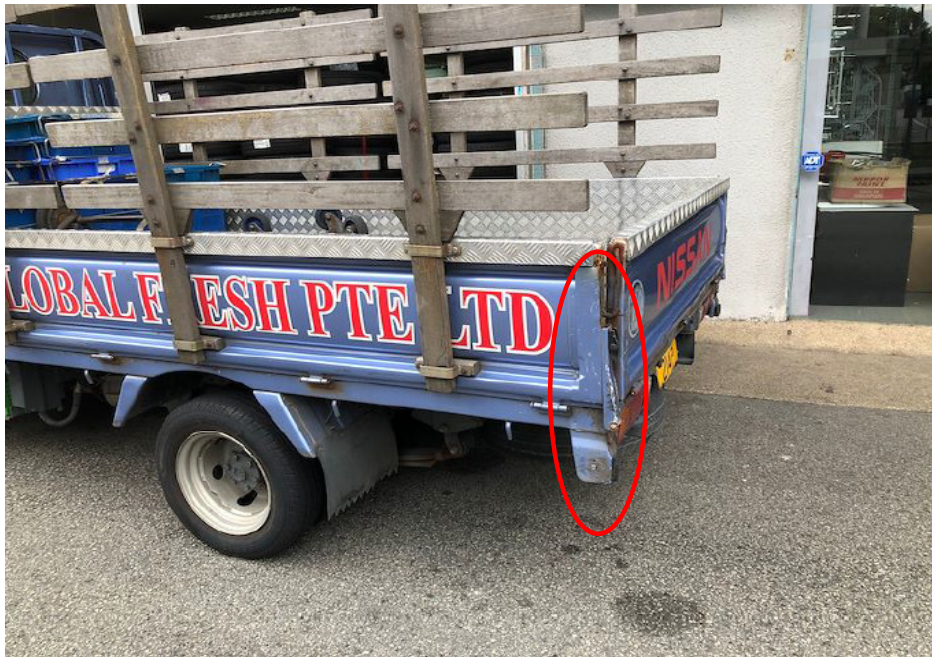
Photo 7 shows the white paint transfer marks found on the rear portion of the Nissan's left side gate (circled).

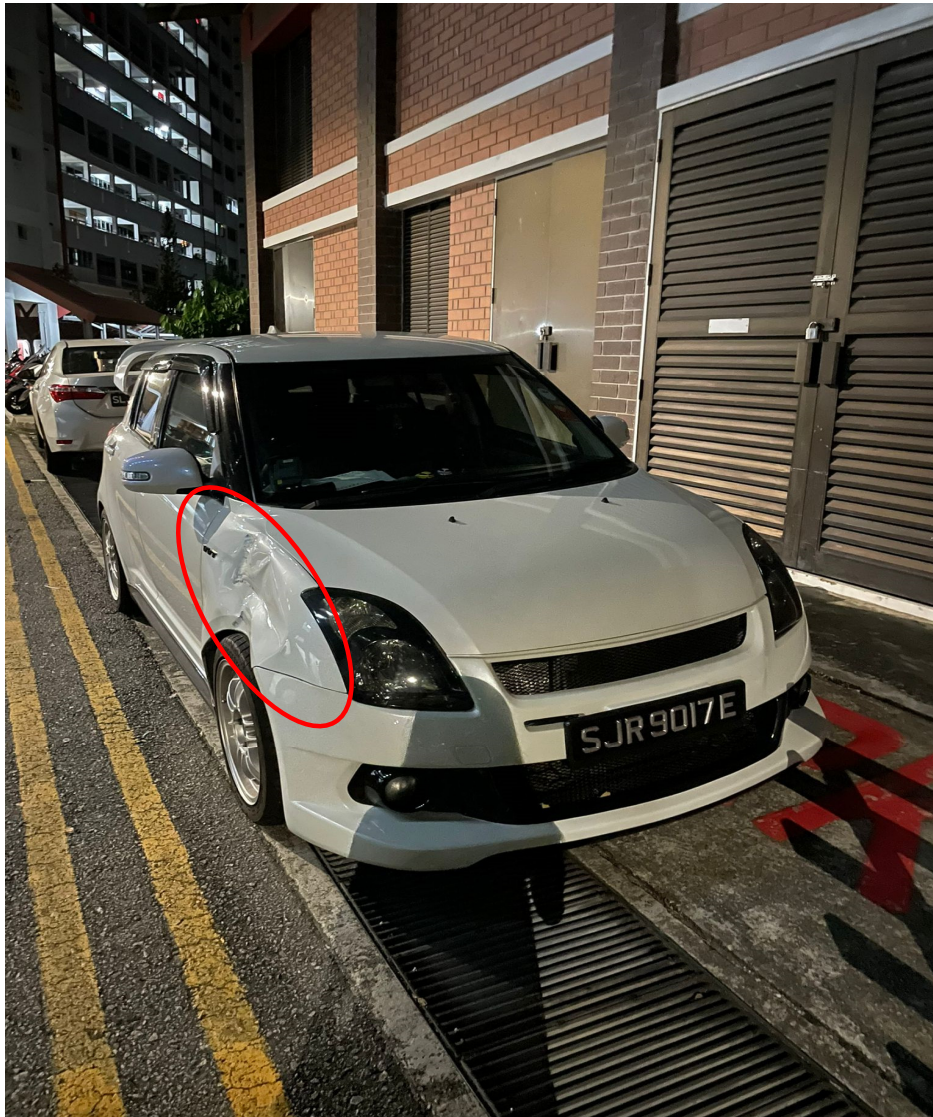
Photo 8 shows the position of the Suzuki at the accident location provided by Mr Tan. The Suzuki had sustained damages at the right front fender as a result of the accident (circled).

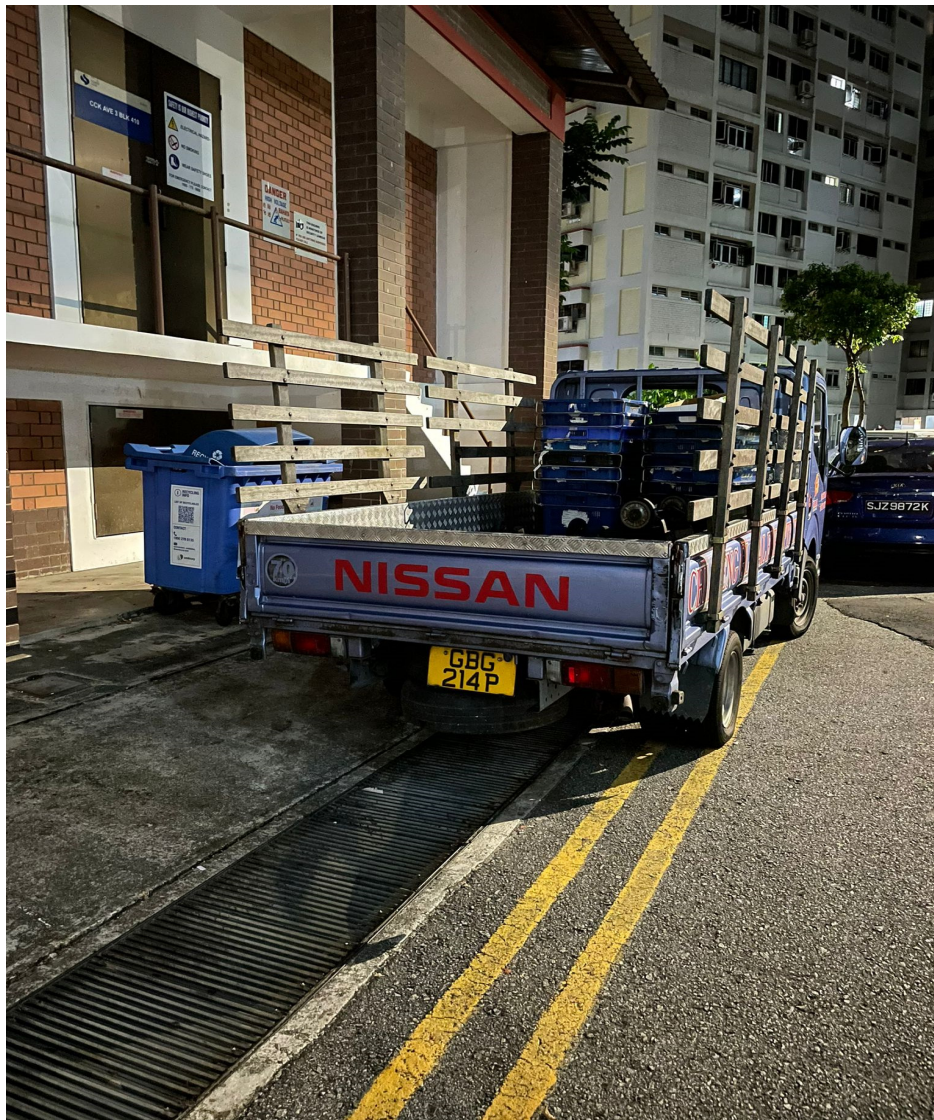
Photo 9 shows the position of the Nissan at the accident location provided by Mr Tan. The position of the Nissan appeared to be in front of the Suzuki.

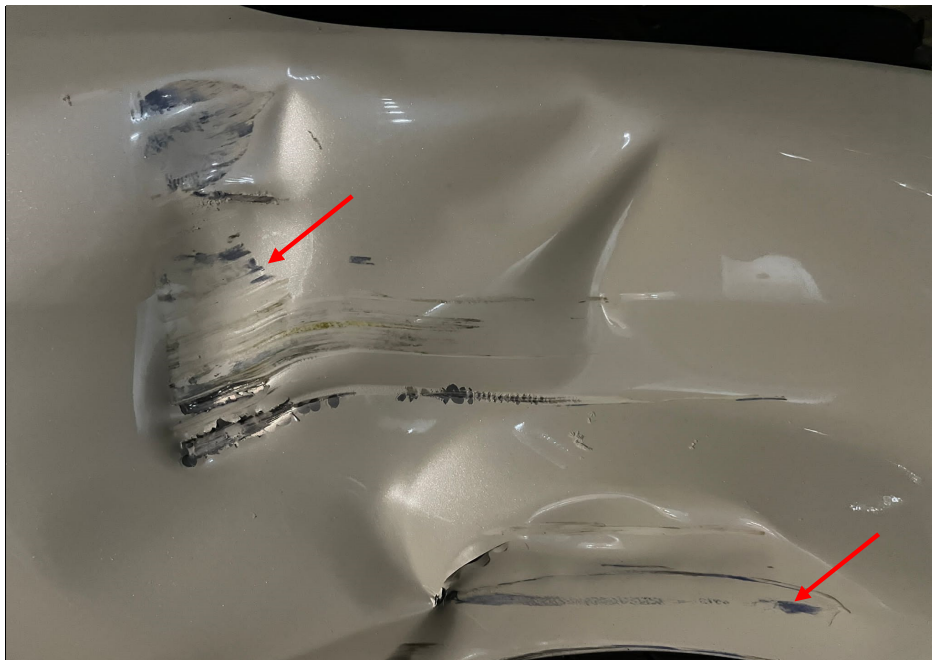
Photo 10 shows a close up view of the right front fender of the Suzuki at the accident location provided by Mr Tan. Blue paint transfer marks can be seen on the right front fender of the Suzuki post- accident (arrowed).

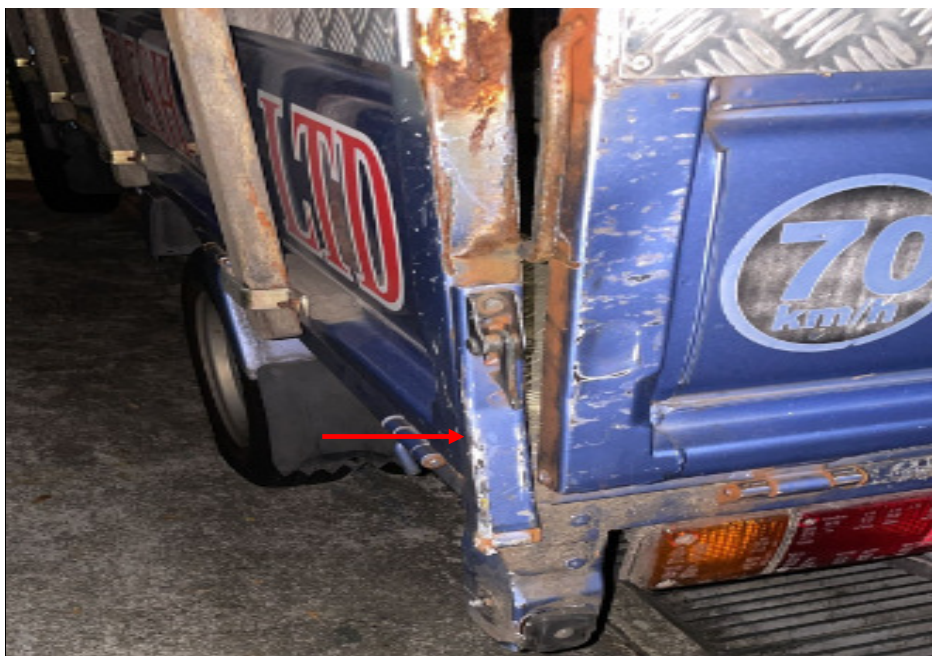
Photo 11 shows a close up view of the left rear portion of the Nissan at the accident location provided by Mr Tan. White paint transfer marks can be seen on the rear portion of the left side gate of the Nissan post- accident (arrowed).

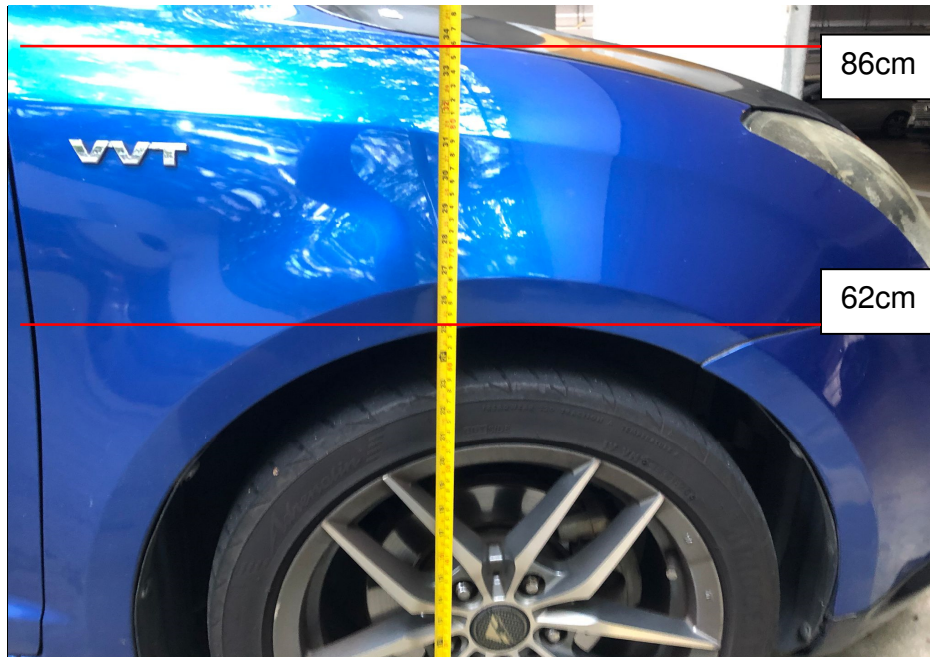
Photo 12 shows the height measurement being conducted on the right frontal portion of the Suzuki (using a similar make and model). The height range above ground level of the right front fender of the Suzuki, at the area where the damages were found, was measured to be approximately between 62cm to 86cm.

- a) the height range above ground level of the right front fender of the Suzuki, at the area where the damages were found, was measured to be approximately between 62cm to 86cm;

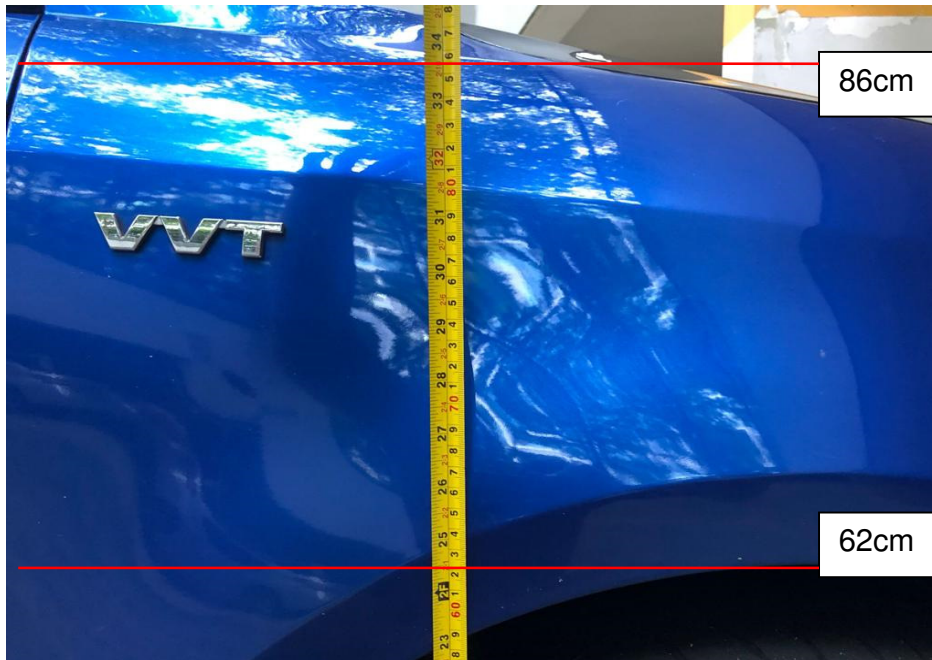
Photo 13 shows a closer view of the height measurement being conducted on the right frontal portion of the Suzuki (using a similar make and model). The height range above ground level of the right front fender of the Suzuki, at the area where the damages were found, was measured to be approximately between 62cm to 86cm.

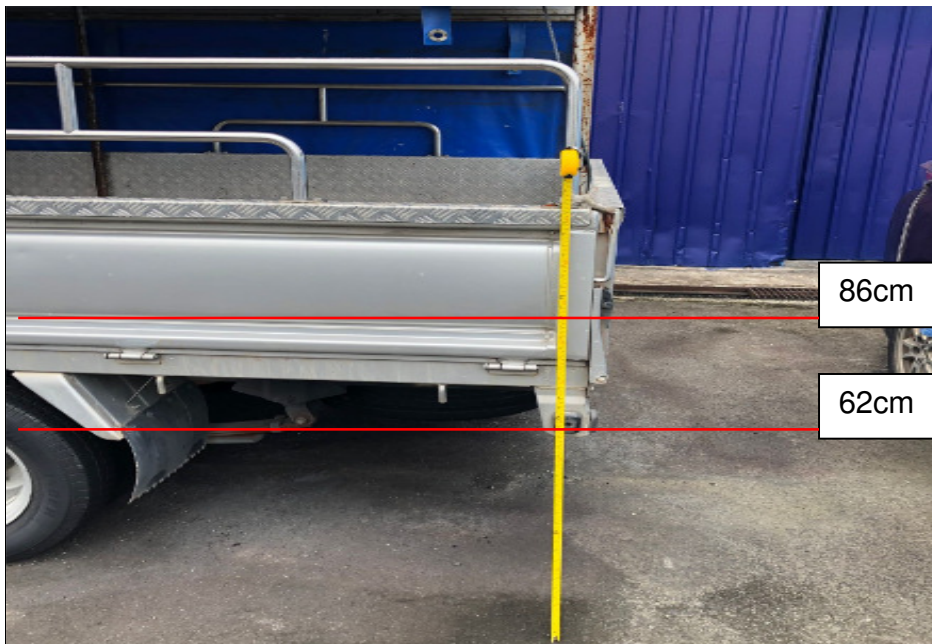
Photo 14 shows the height measurement being conducted on the left rear portion of the Nissan (using a similar make and model). The body part at the height range of between 62cm to 86cm above ground level was the rear portion of the left side gate of the Nissan where the white paint transfer marks were observed.

- b) the body part at the height range of between 62cm to 86cm above ground level was the rear portion of the left side gate of the Nissan where the white paint transfer marks were observed;
- c) the height measurements appear to support the findings of possible contact between the left rear portion of the Nissan and the right frontal portion of the Suzuki. The damage observed on the left rear portion of the Nissan was a result of this contact and corresponds to the damage observed on the right front fender of the Suzuki. In other words, the damage observed on the right front fender of the Suzuki is consistent to the damage observed on the left rear portion of the Nissan.

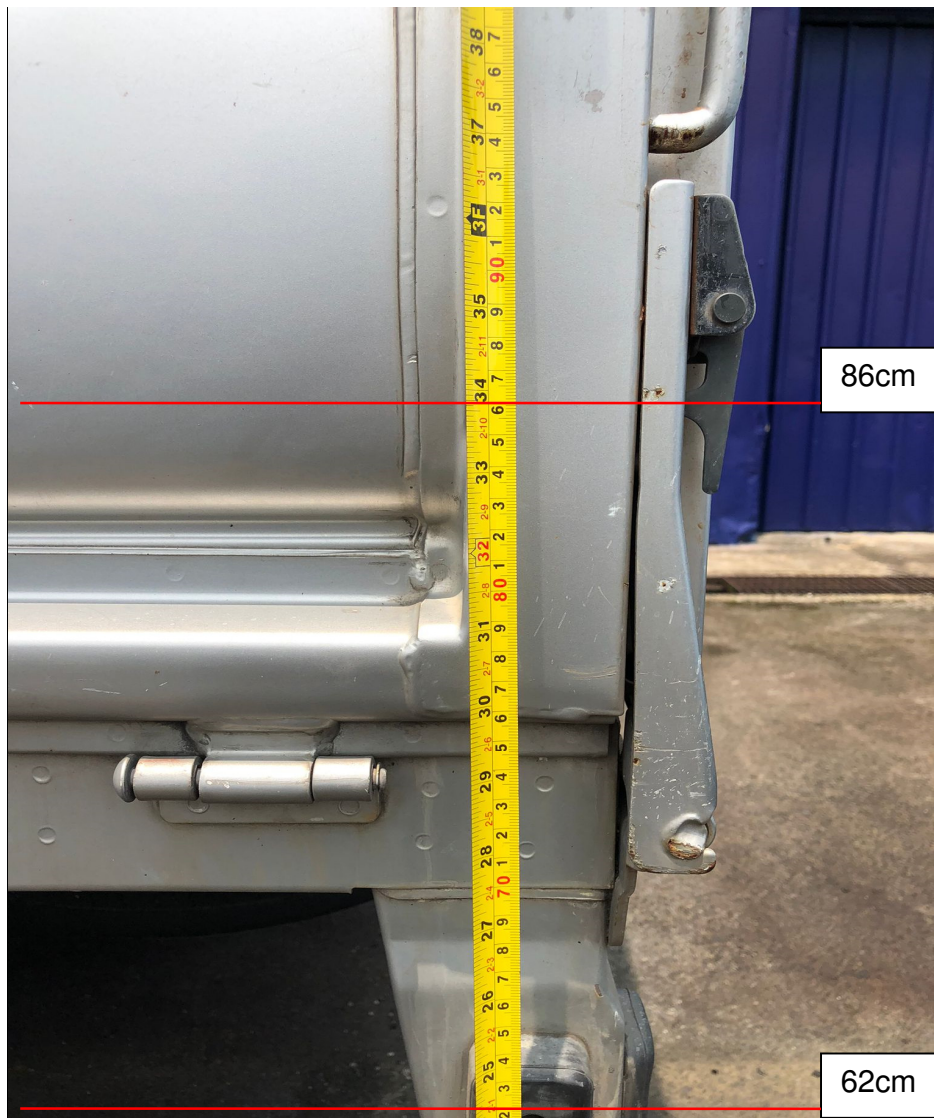
Photo 15 shows a closer view of the height measurement being conducted on the left rear portion of the Nissan (using a similar make and model). The body part at the height range of between 62cm to 86cm above ground level was the rear portion of the left side gate of the Nissan where the white paint transfer marks were observed.
