Your Ref: SNM21D207649/C01/TANKW
Our Ref : CS4/CTI22000190/N

11 January 2022

**TECHNICAL INVESTIGATION REPORT OF FIRE INCIDENT INVOLVING THE
INSURED VEHICLE SJY 8264C ON 23 DECEMBER 2021**

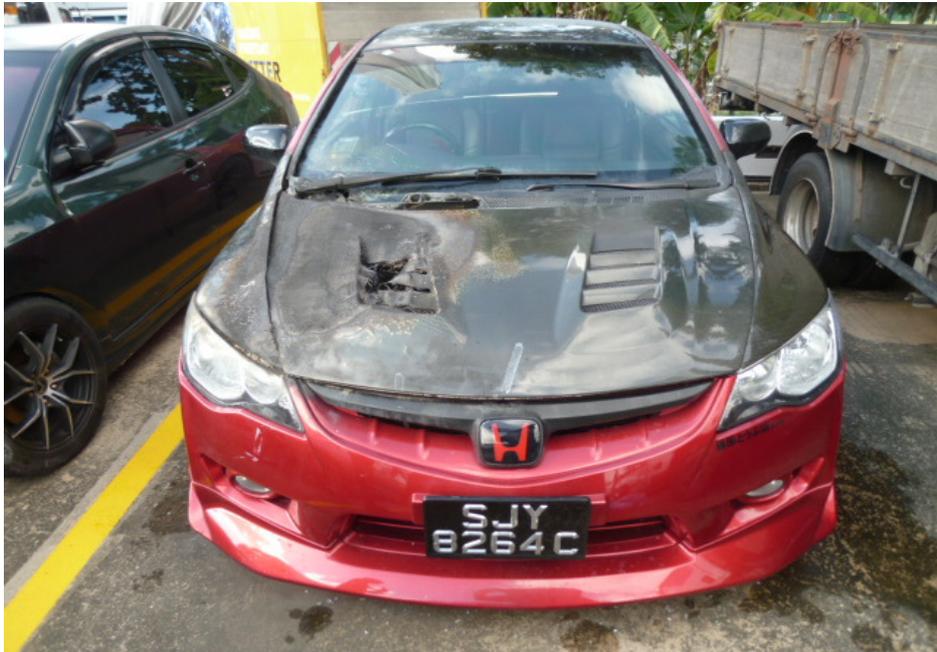
Photo 1 shows the general view of the frontal portion of the Insured Vehicle at the time of our inspection. The exterior body of the Insured Vehicle had sustained visible fire damage. This included its front windscreen, front bonnet, headlights, front bumper, side panels, front rims and front tyres.

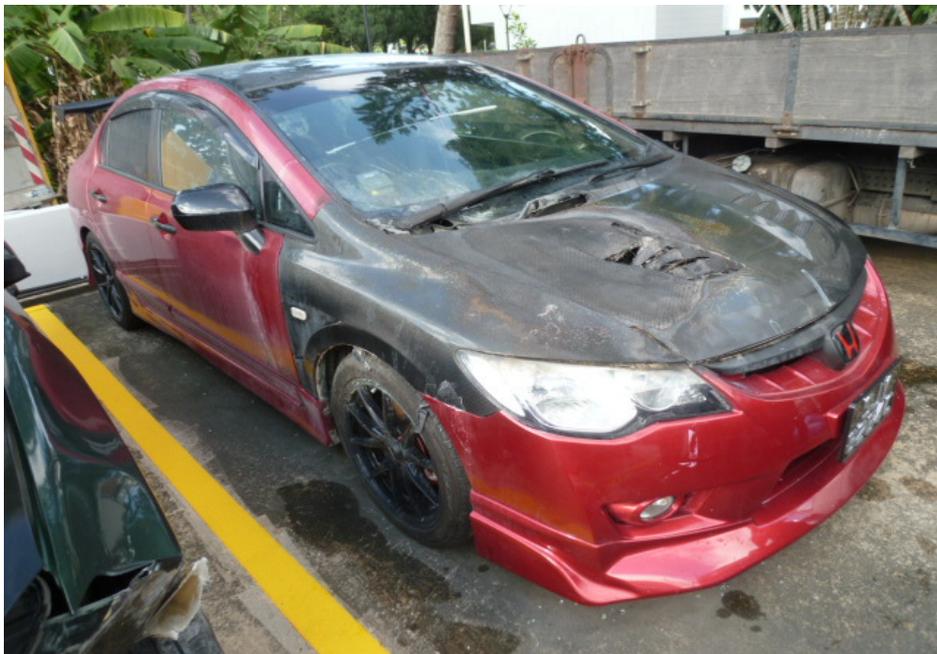
Photo 2 shows the general view of the right portion of the Insured Vehicle at the time of our inspection. The exterior body of the Insured Vehicle had sustained visible fire damage. This included its front windscreen, front bonnet, headlights, front bumper, right front fender, right front rim and right front tyre.

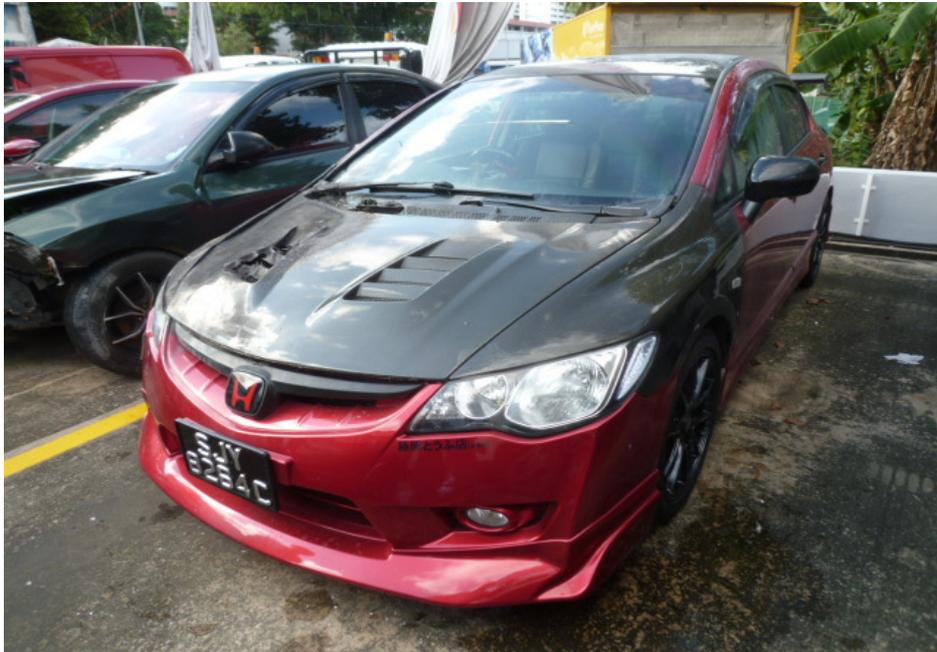
Photo 3 shows the general view of the left portion of the Insured Vehicle at the time of our inspection. The exterior body of the Insured Vehicle had sustained visible fire damage. This included its front windscreen, front bonnet, headlights, front bumper, left front fender, left front rim and left front tyre.

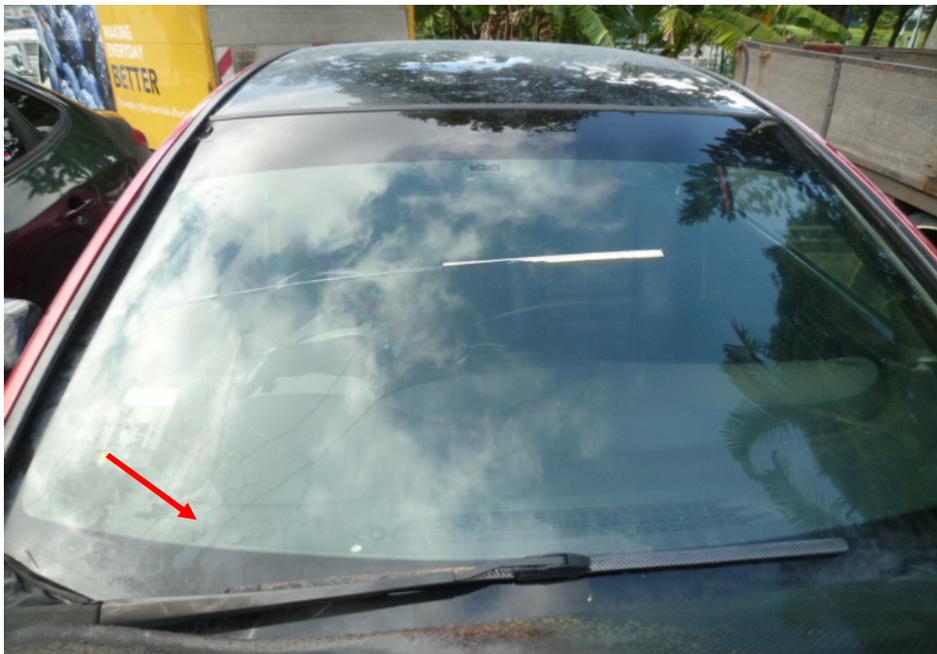
Photo 4 shows a closer view of the front windscreen of the Insured Vehicle at the time of our inspection. The front windscreen had sustained minimal fire damage (arrowed).

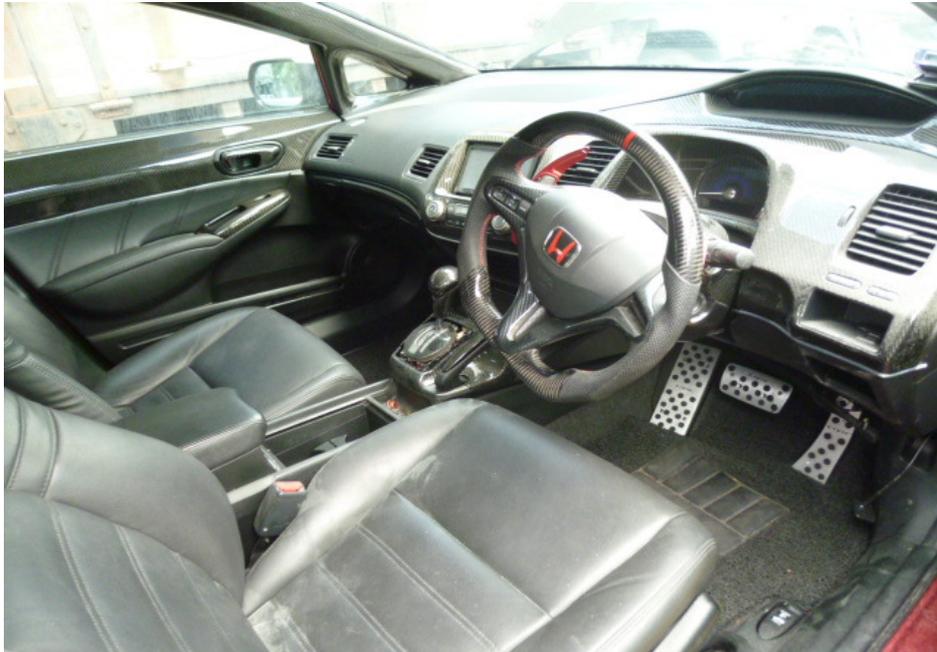
Photo 5 shows the interior compartment of the Insured Vehicle at the time of our inspection. The interior compartment of the Insured Vehicle was observed to be relatively unaffected by the fire.

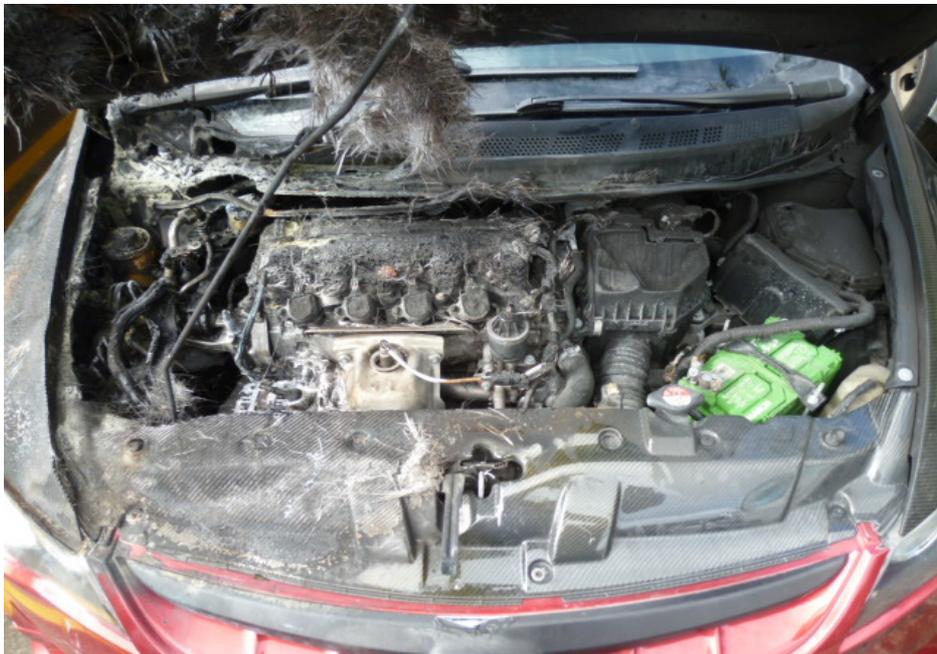
Photo 6 shows a general view of the engine compartment of the Insured Vehicle at the time of our inspection. Most of the components inside the engine compartment were found to be severely burnt and/or melted as a result of the fire.

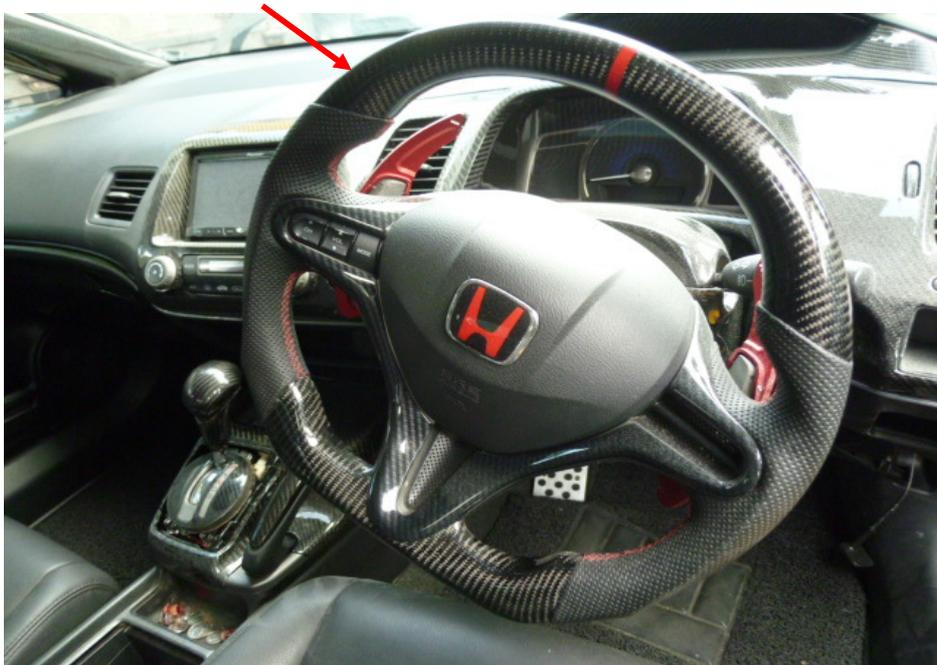
Photo 7 shows the aftermarket steering wheel that was fitted onto the Insured Vehicle upon our inspection (arrowed).

33. Although the aftermarket steering wheel, alloy rims, undercarriage brace, mid pipe and rear exhaust muffler fitted on the Insured Vehicle were not the standard type for the Insured Vehicle, we are of the view that these parts did not cause and/or contribute to the fire incident.

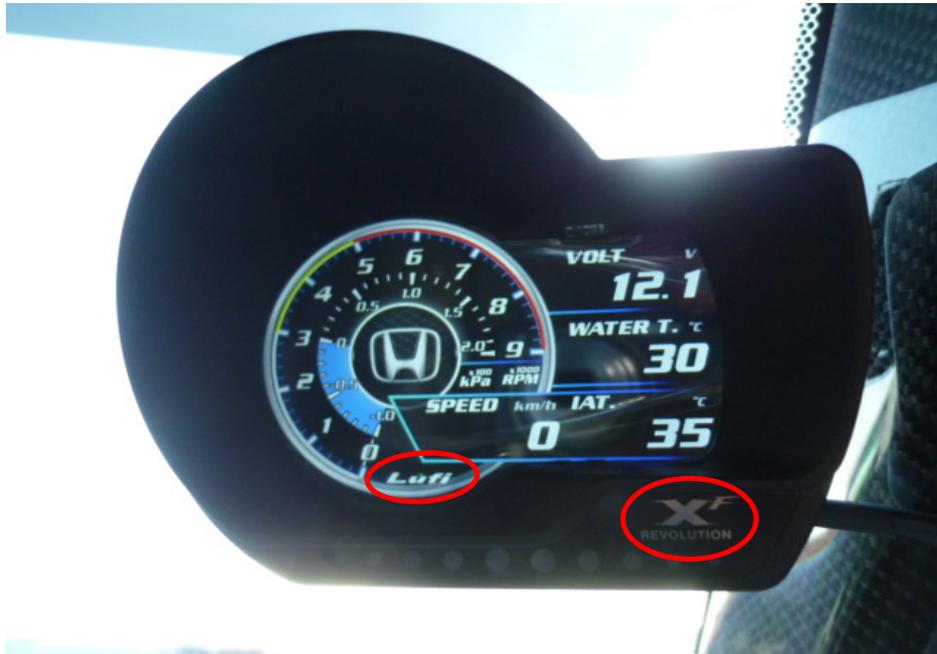
Photo 8 shows the on-board diagnostic (OBD) gauge that was fixed on the right 'A' pillar of the Insured Vehicle. The brand of the gauge was 'LUFI XF REVOLUTION' (circled).

32. We are further of the opinion that the additionally fitted electrical/electronic components found on the Insured Vehicle could have possibly caused overloading to the electrical system of the Insured Vehicle. However considering that the installation was carried out shortly after the Insured Vehicle was purchased which was approximately more than a year prior to the fire incident, the overloading was likely to be minimal.

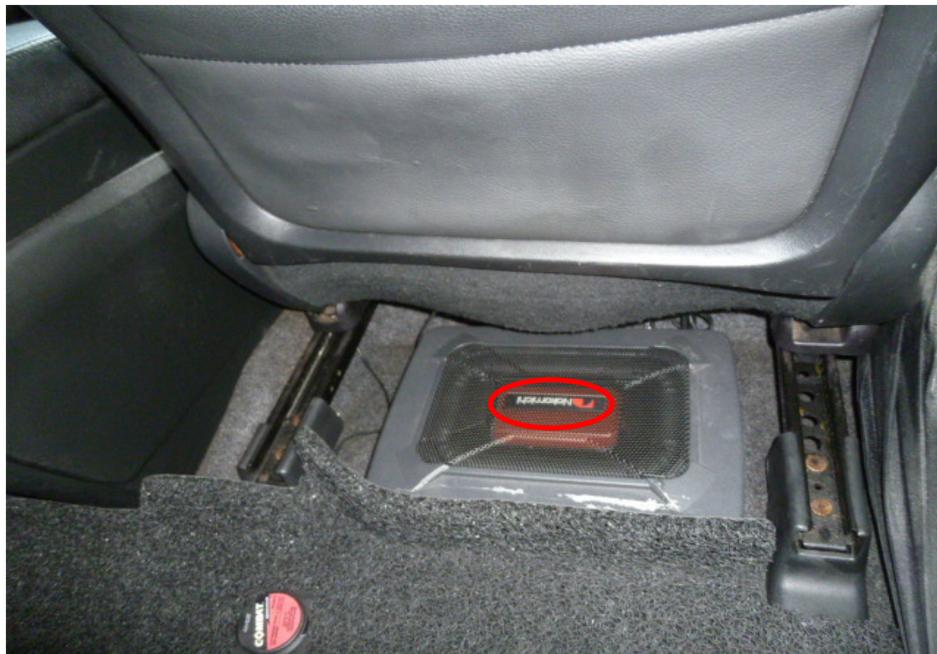
Photo 9 shows the aftermarket amplifier fitted underneath the driver seat of the Insured Vehicle upon our inspection. The brand of the amplifier was 'Nakamichi' (circled).

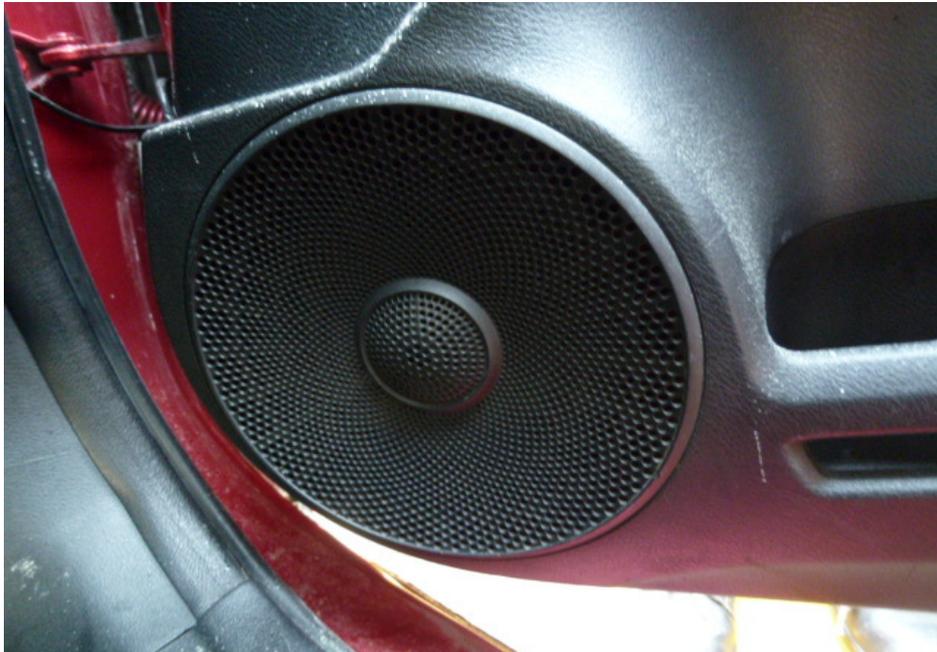
Photo 10 shows the 1st aftermarket speaker fitted onto the driver door of the Insured Vehicle upon our inspection.

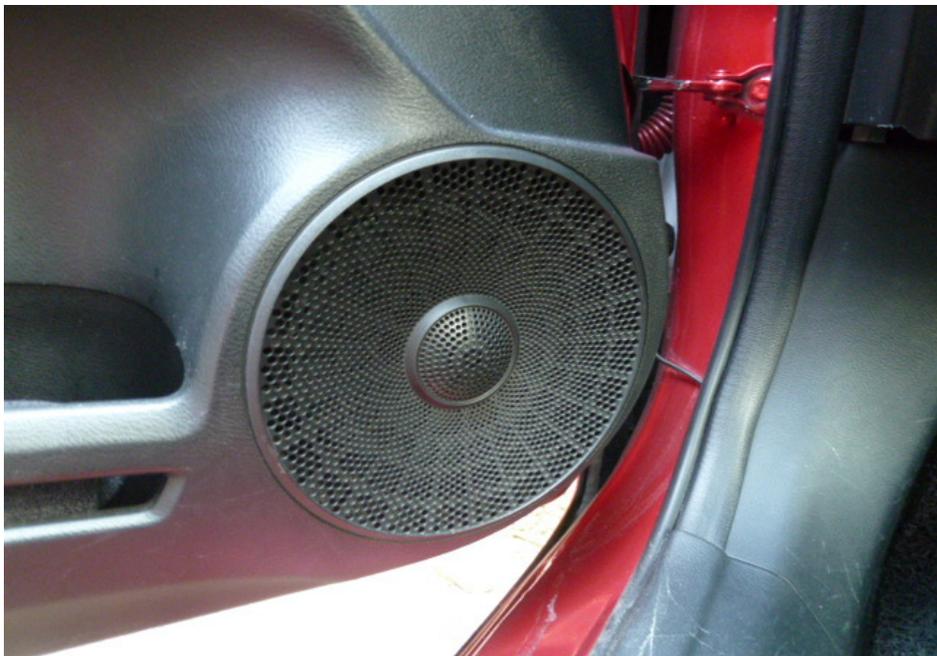
Photo 11 shows the 2nd aftermarket speaker fitted onto the left front passenger door of the Insured Vehicle upon our inspection.

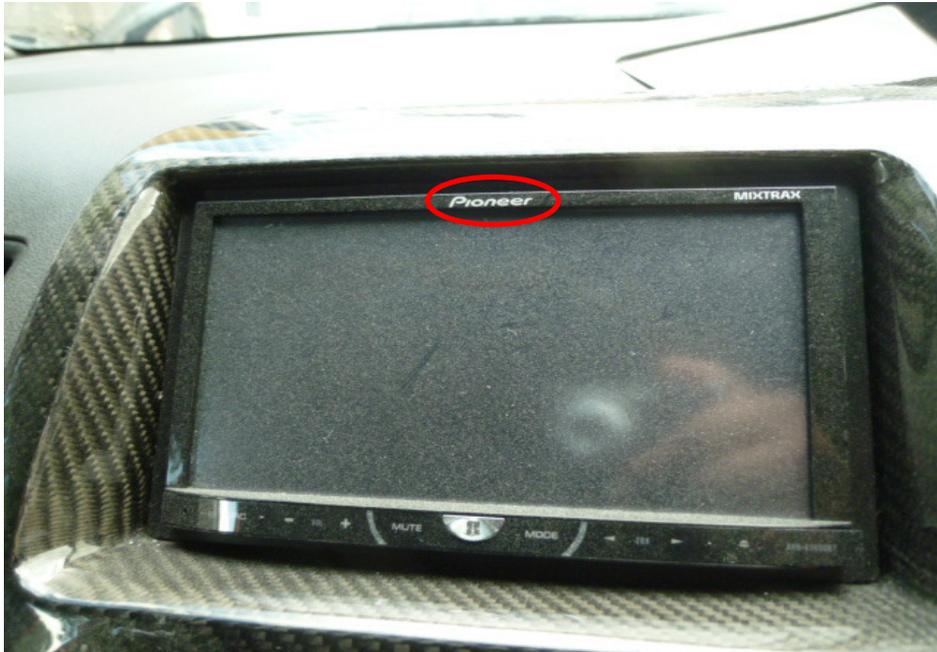
Photo 12 shows the in-car DVD player that was fitted at the centre portion of the front dashboard of the Insured Vehicle upon our inspection. The brand of the DVD player was 'Pioneer' (circled).

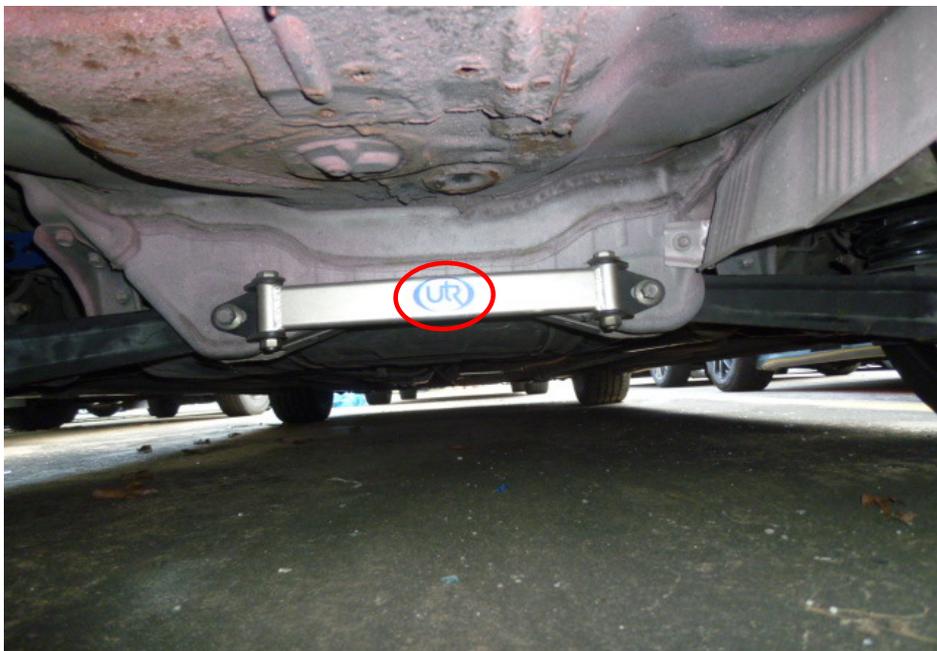
Photo 13 shows the undercarriage brace found to be fitted on the Insured Vehicle at the time of our inspection. The brand of the brace was 'Ultra Racing' (circled).

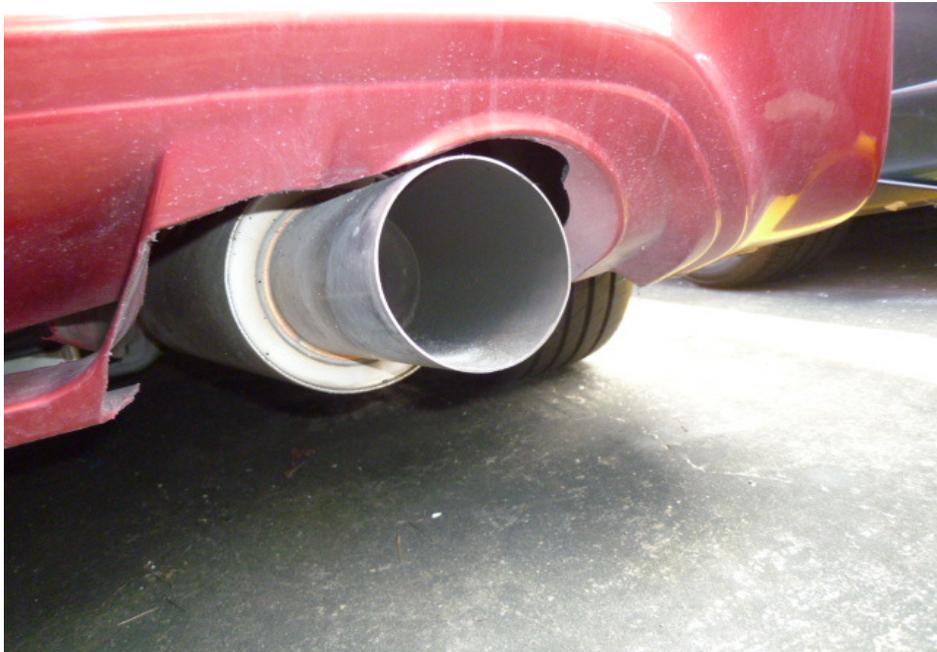
Photo 14 shows a front view of the non-standard rear exhaust muffler that was found to be fitted on the Insured Vehicle at the time of our inspection.

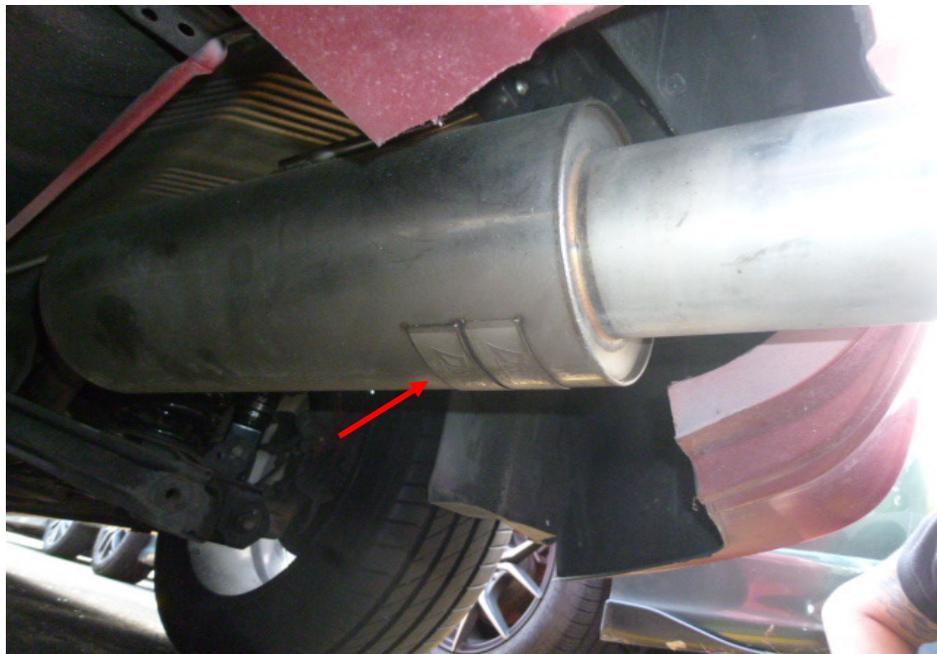
Photo 15 shows a closer left side view of the non-standard rear exhaust muffler that was found to be fitted on the Insured Vehicle at the time of our inspection. The brand of the rear exhaust muffler was 'DRIFT RACING' (arrowed).

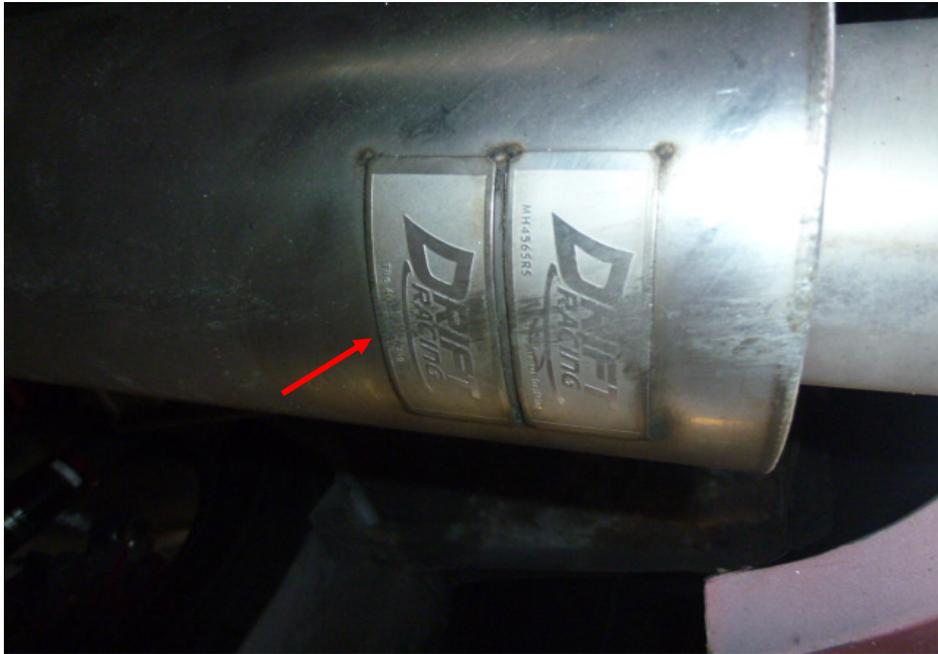
Photo 16 shows a close up view of the non-standard rear exhaust muffler that was found to be fitted on the Insured Vehicle at the time of our inspection. The brand of the rear exhaust muffler was 'DRIFT RACING' (arrowed).

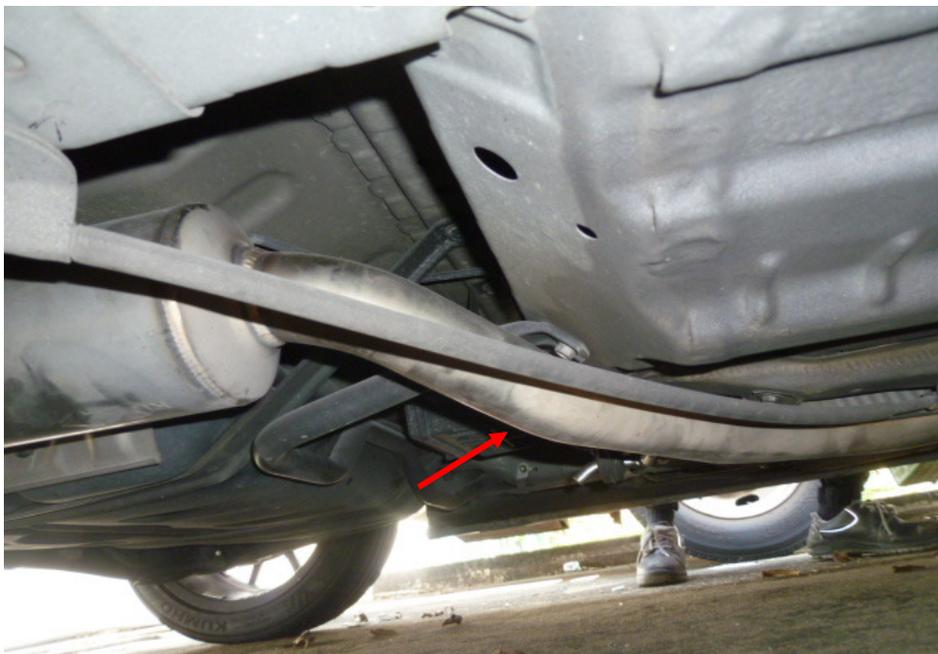
Photo 17 shows a close up view of the non-standard mid pipe that was found to be fitted on the Insured Vehicle at the time of our inspection (arrowed). The brand of the rear exhaust muffler was 'DRIFT RACING'.

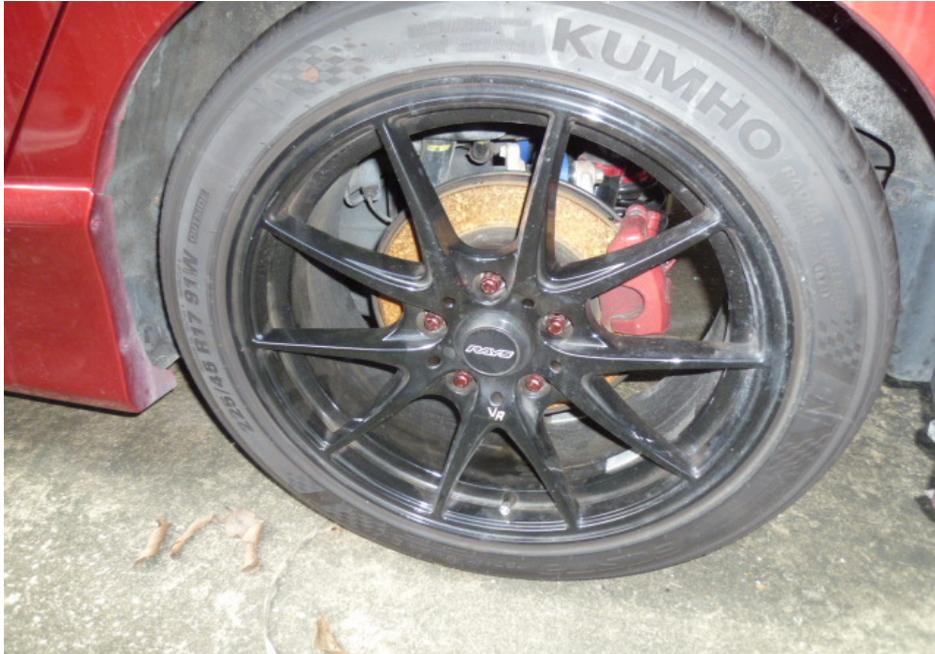
Photo 18 shows the non-standard rim found to be fitted on the Insured Vehicle at the time of our inspection. The 17- inch alloy rims fitted on the Insured Vehicle were not the standard type for the Insured Vehicle.

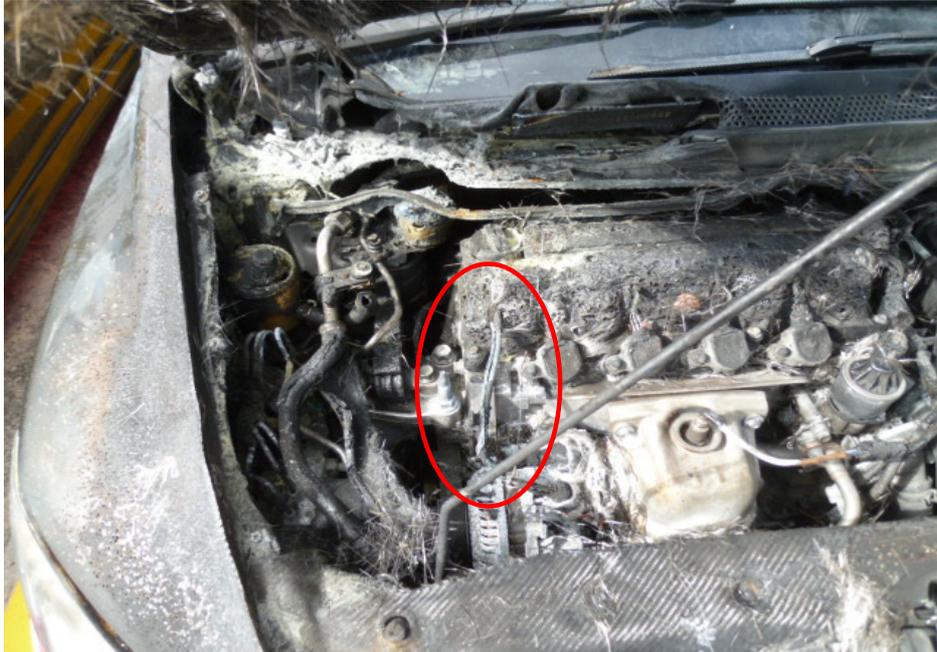
8. For this particular case, the fire appears to have originated within the engine compartment of the Insured Vehicle, somewhere around the right portion of the engine compartment. This can be determined from the greenish residue that was found on several stretches of burnt original factory fitted wirings mainly around the right portion of the engine compartment. The presence of greenish residue indicates internal heating of copper wires, a sign of an electrical short circuit occurring. The greenish residue is normally left behind from oxidation as a result of chemical reaction involving the copper wires. These physical evidences would appear to suggest that the cause of fire to the Insured Vehicle could have possibly been due to electrical in nature. See photos 19 – 23 below.

Photo 19 shows the burnt wirings around the right portion of the engine compartment which is near to the vicinity where the fire to the Insured Vehicle had likely started (circled).

29. Having investigated and technically analysed the damages of burnt nature to the Insured Vehicle, we are of the view that the cause of fire to the Insured Vehicle was of electrical in nature. For this particular case, the fire had originated along the wirings inside the engine compartment, somewhere around the right portion of the engine compartment. The wirings were original factory fitted wirings of the Insured Vehicle.

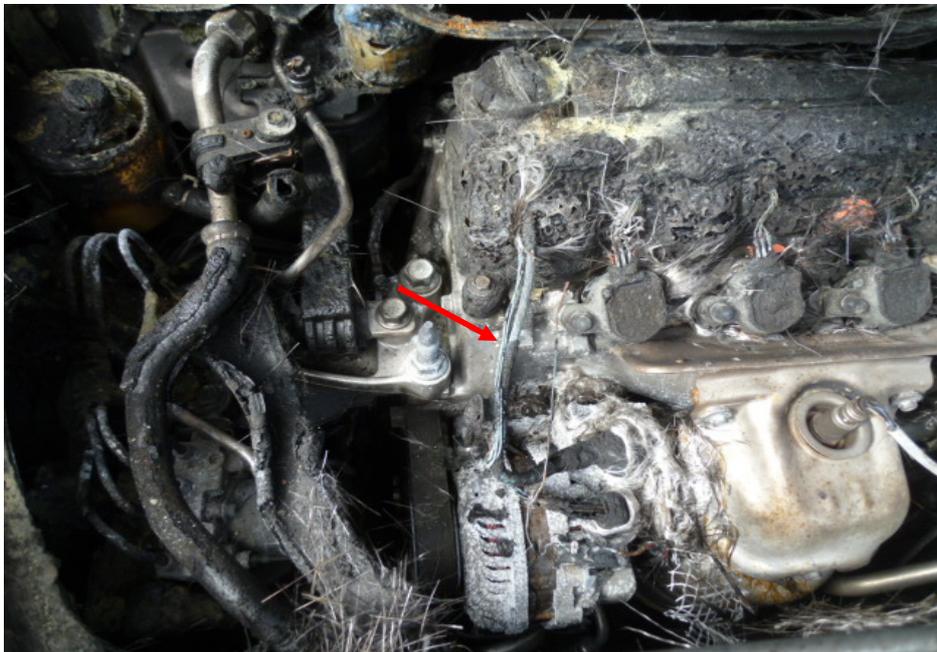
Photo 20 shows a closer view the greenish residue on several stretches of burnt wirings at the right portion of the engine compartment (red arrows). The presence of greenish residue indicates internal heating of copper wires, a sign of an electrical short circuit occurring. The greenish residue is normally left behind from oxidation as a result of chemical reaction involving the copper wires.

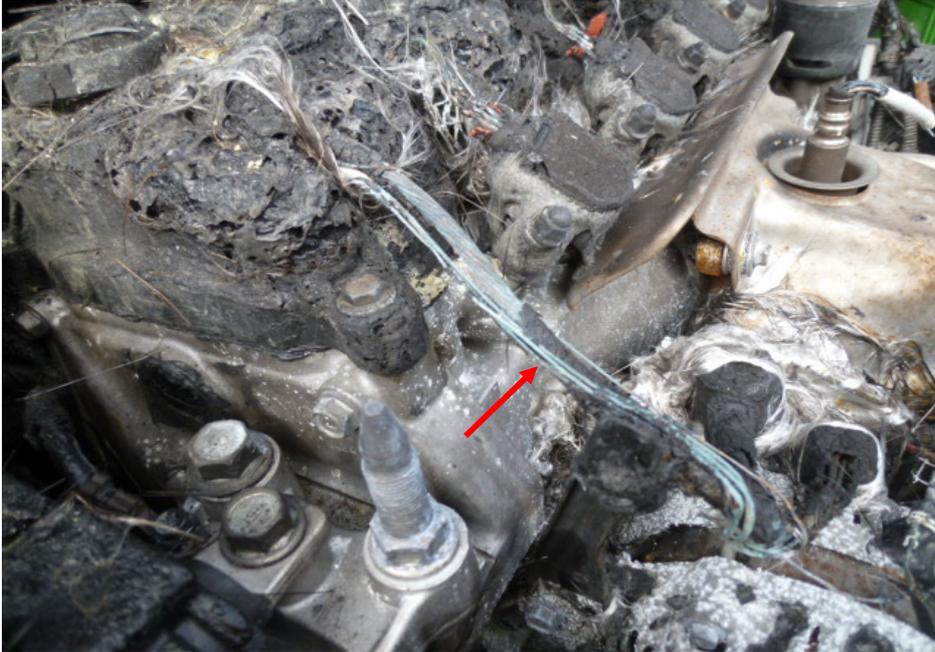
Photo 21 shows a closer view the greenish residue on several stretches of burnt wirings at the right portion of the engine compartment (red arrows). The presence of greenish residue indicates internal heating of copper wires, a sign of an electrical short circuit occurring. The greenish residue is normally left behind from oxidation as a result of chemical reaction involving the copper wires.

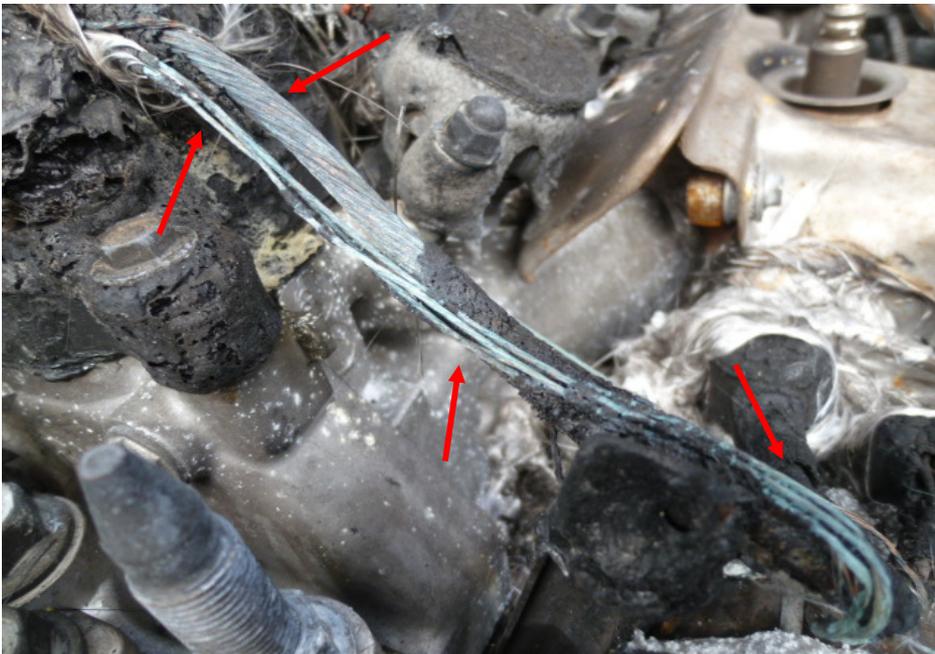
Photo 22 shows a close up view of the greenish residue on the wirings at the right portion of the engine compartment. The presence of such greenish residue suggests occurrence of an electrical short circuit.

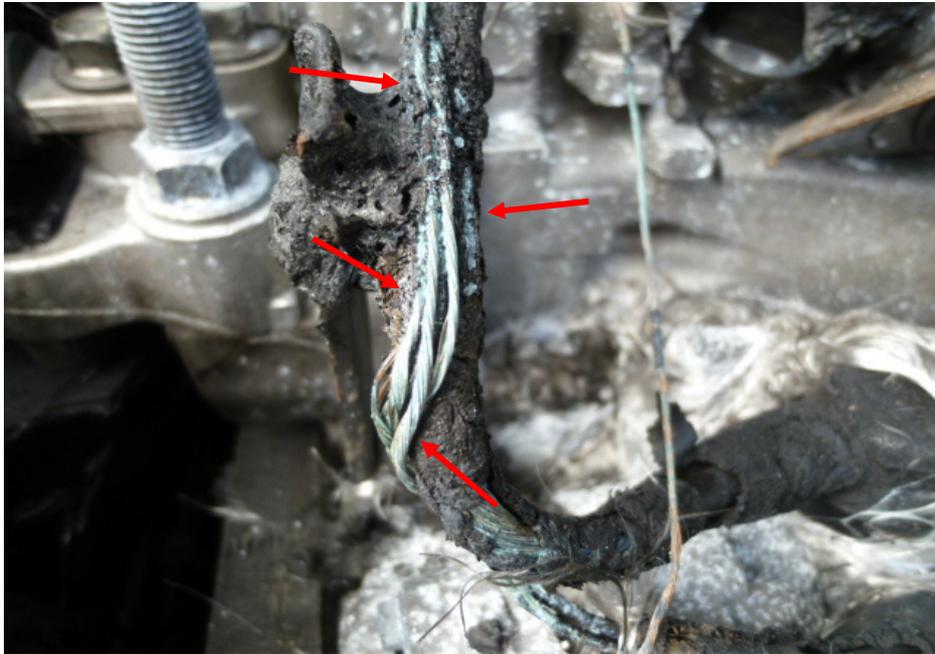
Photo 23 shows a close up view of the greenish residue on several burnt wirings at the right portion of the engine compartment (arrowed). The presence of such greenish residue suggests occurrence of an electrical short circuit.

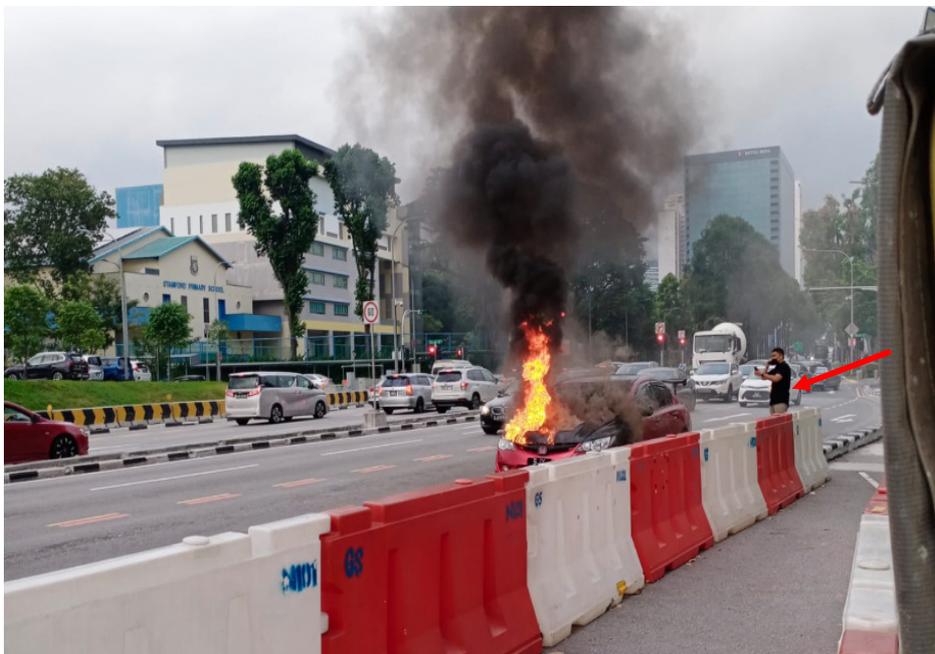
23. In general, the information that could be gathered from this photograph had corresponded to the events that were related to us by Mr Raihan. Our close examination of this photograph also showed no unusual foreign material(s) and/or object(s) found on the ground in the immediate area of the road along Victoria Street where the Insured Vehicle was positioned. See photo 27 below.

Photo 27 shows the Insured Vehicle on fire. In general, the information that could be gathered from this photograph had corresponded to the events that were related to us by Mr Raihan, which is he called 995 after exiting the Insured Vehicle (arrowed).
