Your Ref: SMW 3446C  
Our Ref : CI/III22000209/P

**TECHNICAL INVESTIGATION REPORT OF WARRARTY CLAIM INVOLVING  
THE INSURED VEHICLE SMW 3446C ON 8<sup>th</sup> November 2021**

Vehicle Registration No.	: SMW 3446C
Make / Model	: MERCEDES BENZ C200 AMG LINE M-HYBRID
AUTO	
Chassis No	: WDD2050772R465020
Year of Registration	: JUNE 2019
Mileage	: 35,834KM

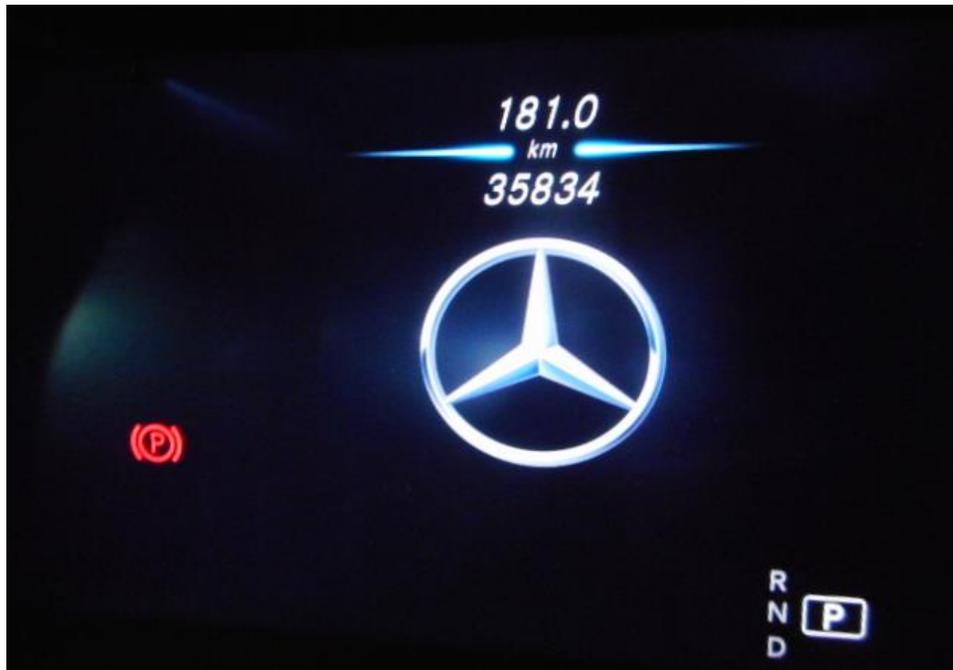
**Photo 1** shows the mileage of the Insured Vehicle recorded at the time inspection at 35,834KM

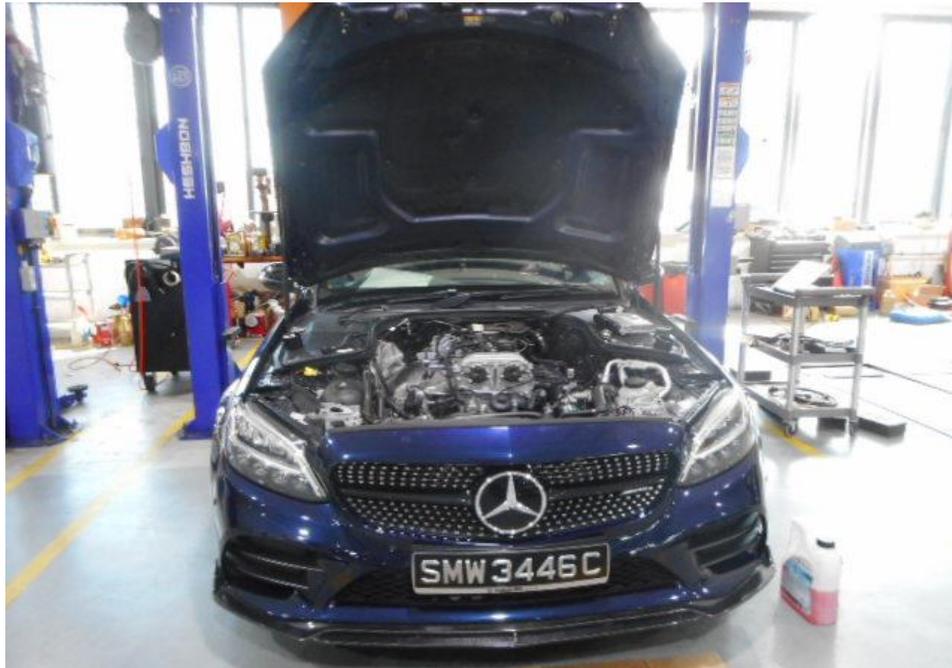
**Photo 2** shows the general view of the front portion of the Insured Vehicle at the time of our inspection. The Insured Vehicle is observed to be unaffected by any signs of accident.

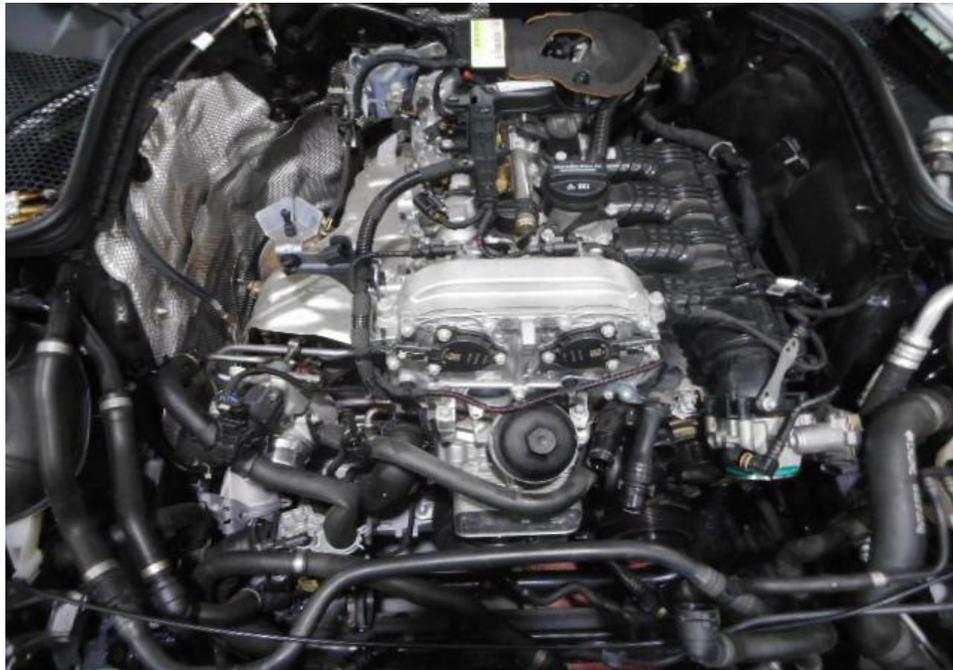
**Photo 3** shows the general view of the engine portion of the Insured Vehicle at the time of our inspection. The engine compartment is observed to be unaffected by any signs of accident.

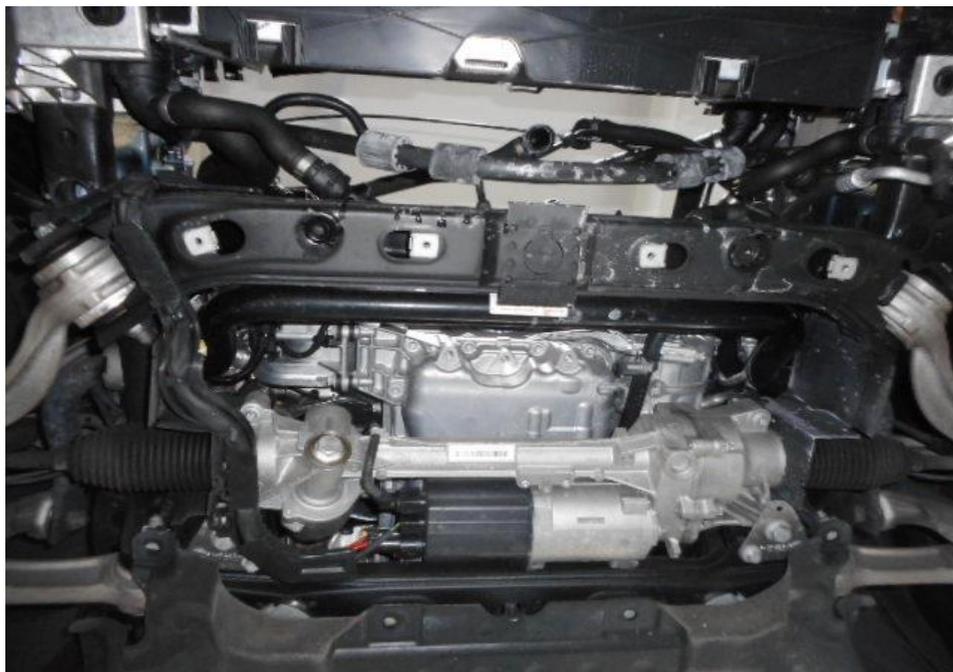
**Photo 4** shows the general view of the engine underside portion of the Insured Vehicle at the time of our inspection. The engine underside compartment is observed to be unaffected and by any signs of accident.

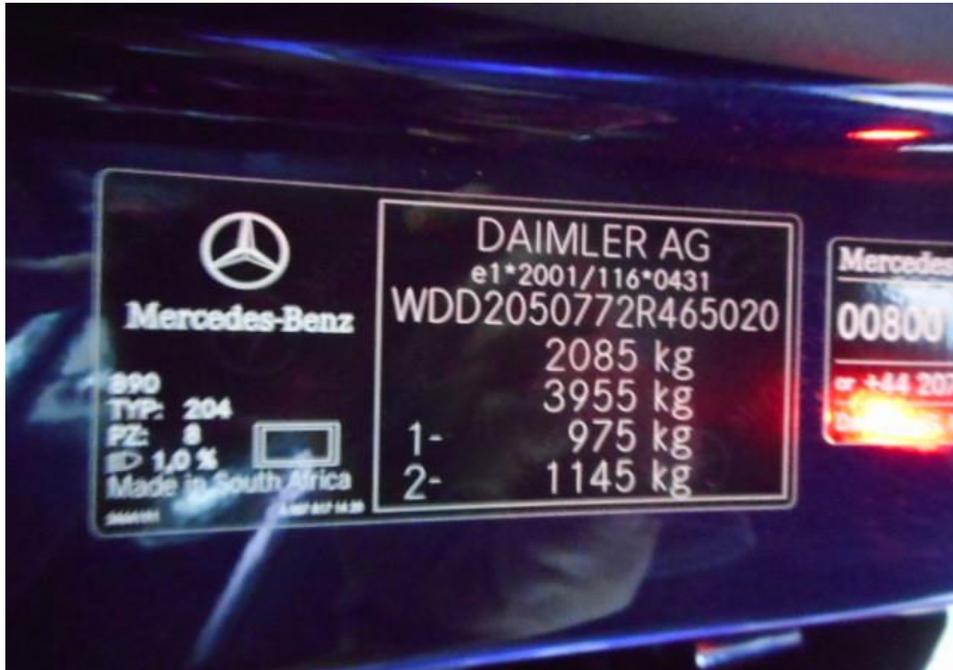
**Photo 5** shows the chassis number of the Insured Vehicle at the time of our inspection.

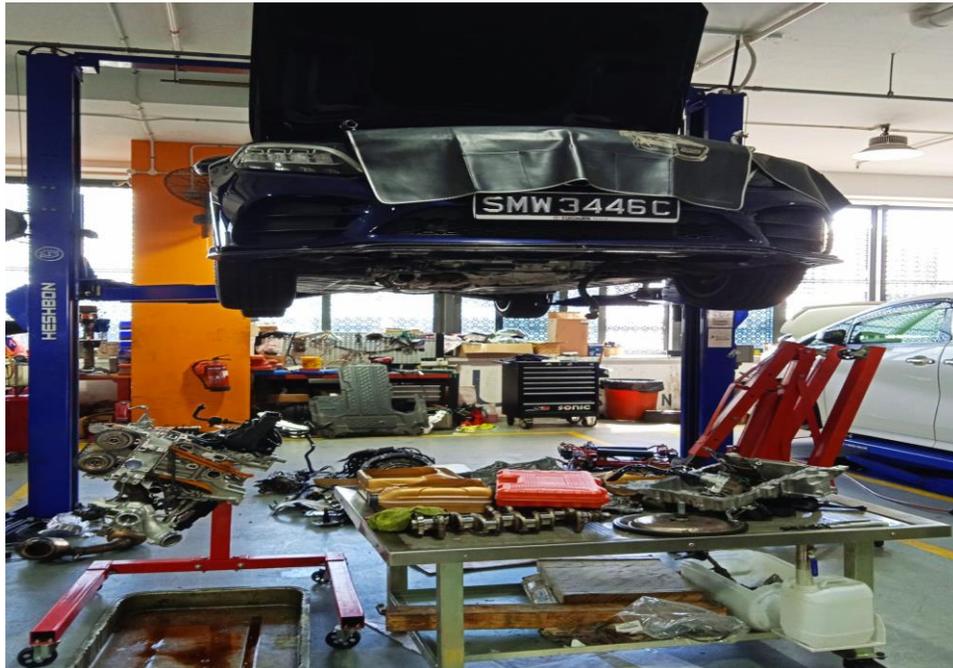
**Photo 6** shows the engine unit portion of the Insured Vehicle at the time of our inspection. The engine unit is observed to be taken out of the Insured Vehicle and dismantled.

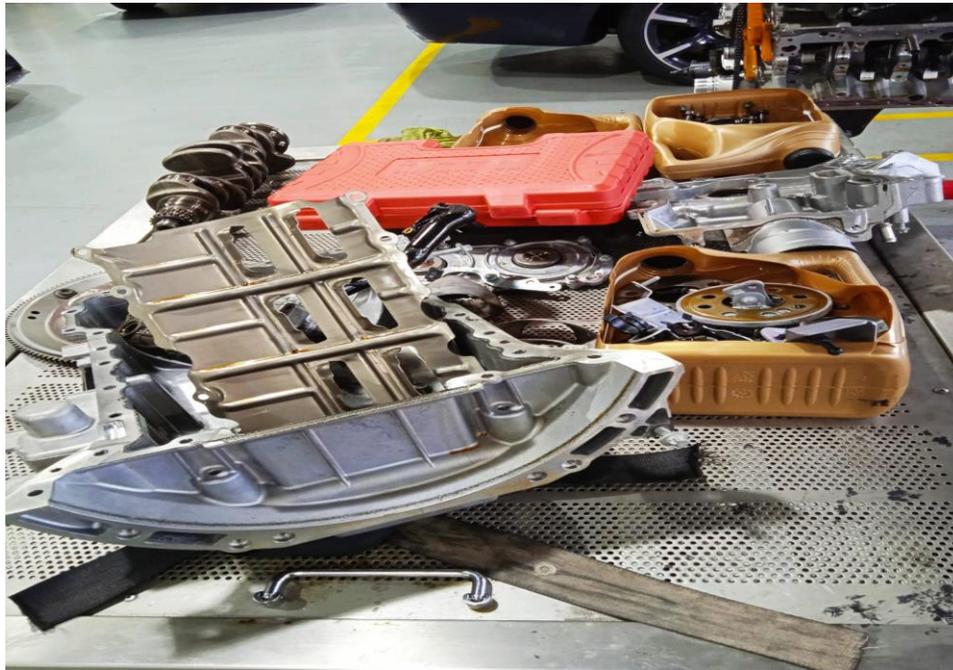
**Photo 7** shows the engine unit portion of the Insured Vehicle at the time of our inspection. The engine unit is observed to be taken out of the Insured Vehicle and dismantled.

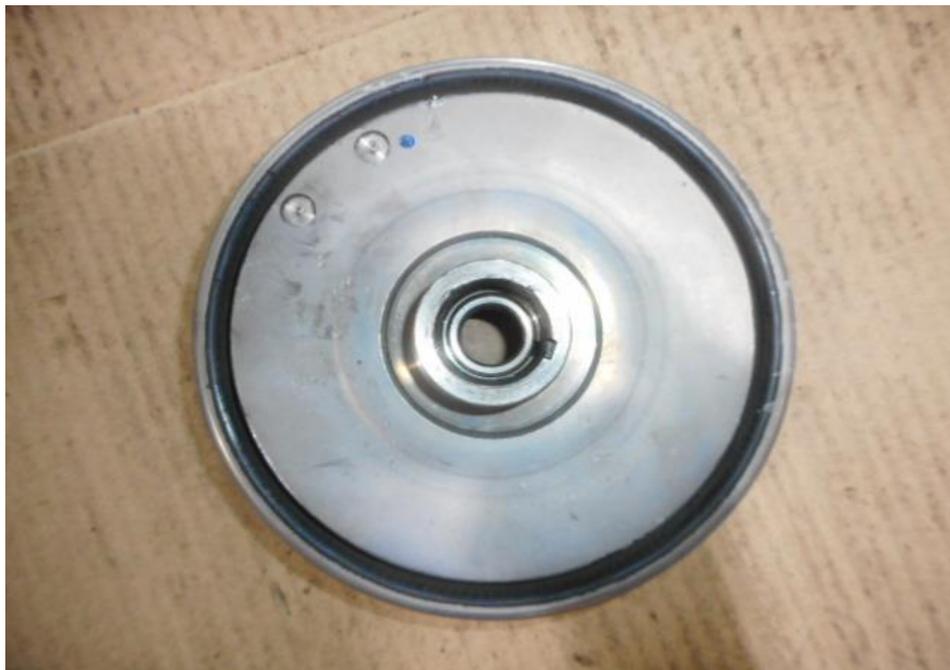
**Photo 8** shows the general view of the crankshaft pulley of the Insured Vehicle at the time of our inspection. The crankshaft pulley was observed to be damaged at the time of inspection.

7. We did not find any evidence which had suggested that the cause of abnormalities to the Insured Vehicle was due to poor maintenance and/or recurring problem. And the damaged to the crankshaft pulley locking pin was likely due to material stress which caused it to be broken and lodged in the crankshaft and resulting to the damages to the crankshaft and its components.
8. Our investigations had also revealed that at the time of writing this report, there is no manufacturer recall to similar make and model vehicle as the Insured Vehicle that may possibly be related to this incident.
9. The recommendation to replace the crankshaft pulley, crankshaft and its components at \$3,500 is justifiable as all the relevant checks has been conducted.

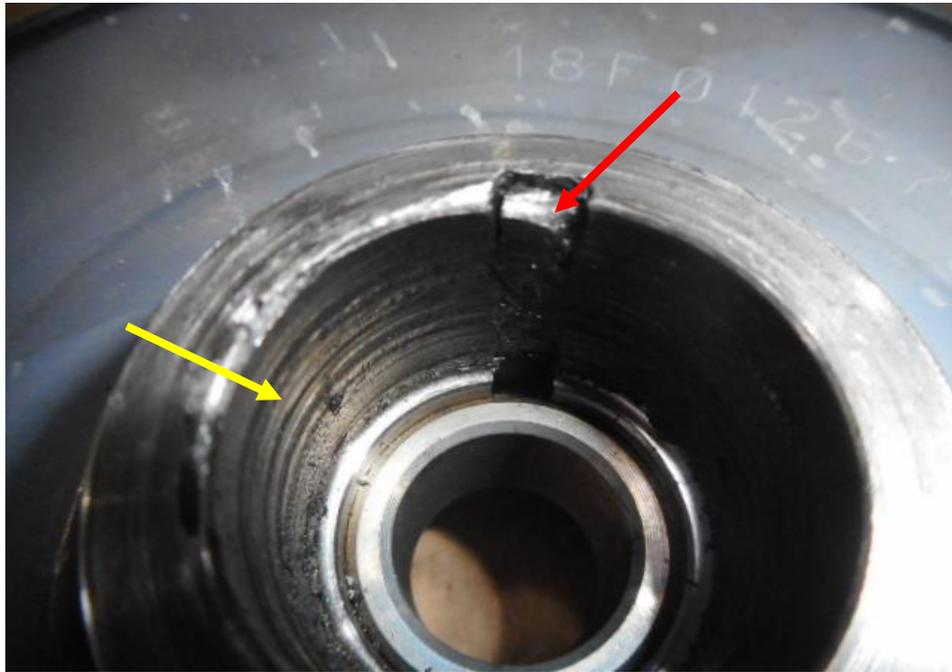
**Photo 9** shows the close up view of the crankshaft pulley of the Insured Vehicle at the time of our inspection. The crankshaft pulley locking pin (red arrow) was observed to be broken and there was damages to the surface (yellow arrow) of the pulley as well at the time of inspection.

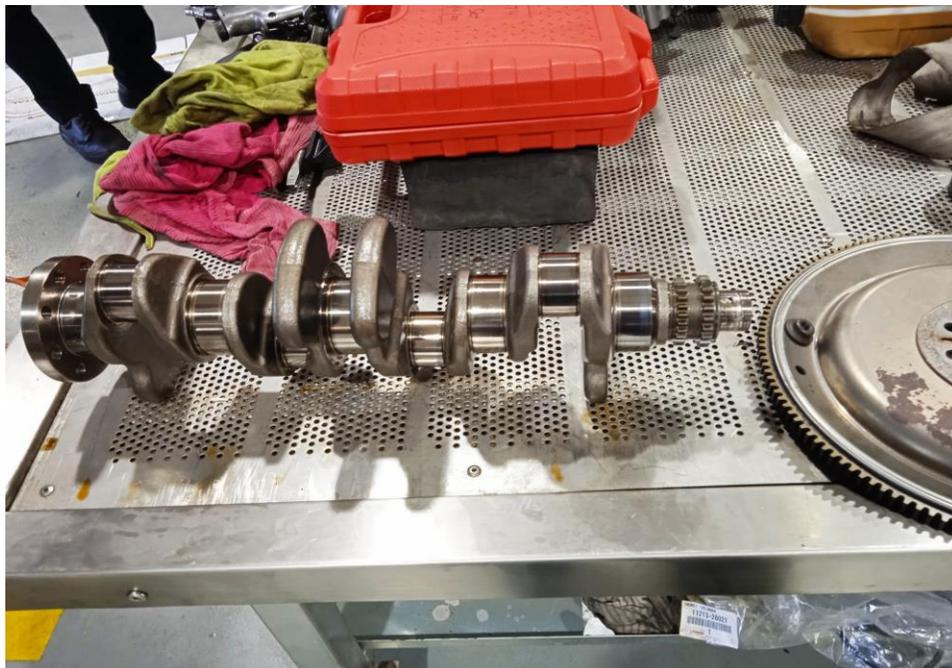
**Photo 10** shows the general view of the crankshaft of the Insured Vehicle at the time of our inspection. The crankshaft where the damaged crankshaft pulley was mounted on was also observed to be damaged at the time of inspection.

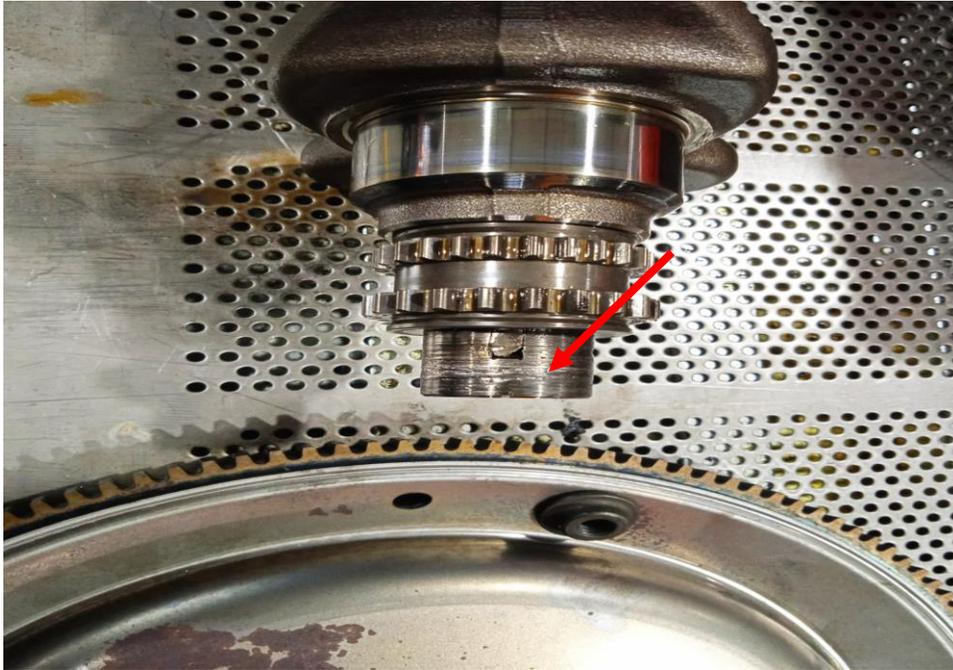
**Photo 11** shows the close up view of the crankshaft of the Insured Vehicle at the time of our inspection. The crankshaft where the damaged crankshaft pulley was mounted on was also observed to be damaged at the time of inspection.

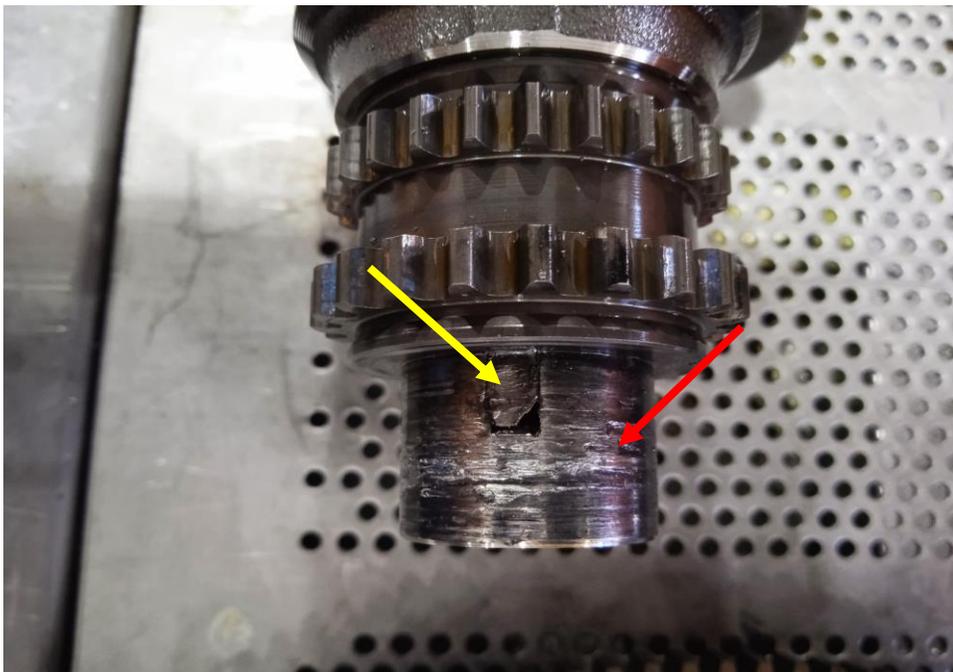
**Photo 12** shows the close up view of the crankshaft of the Insured Vehicle at the time of our inspection. On the crankshaft (red arrow) where the damaged crankshaft pulley was mounted on was also observed to be damaged and the other half of the broken locking pin (yellow arrow) was observed to be stuck on the crankshaft at the time of inspection.

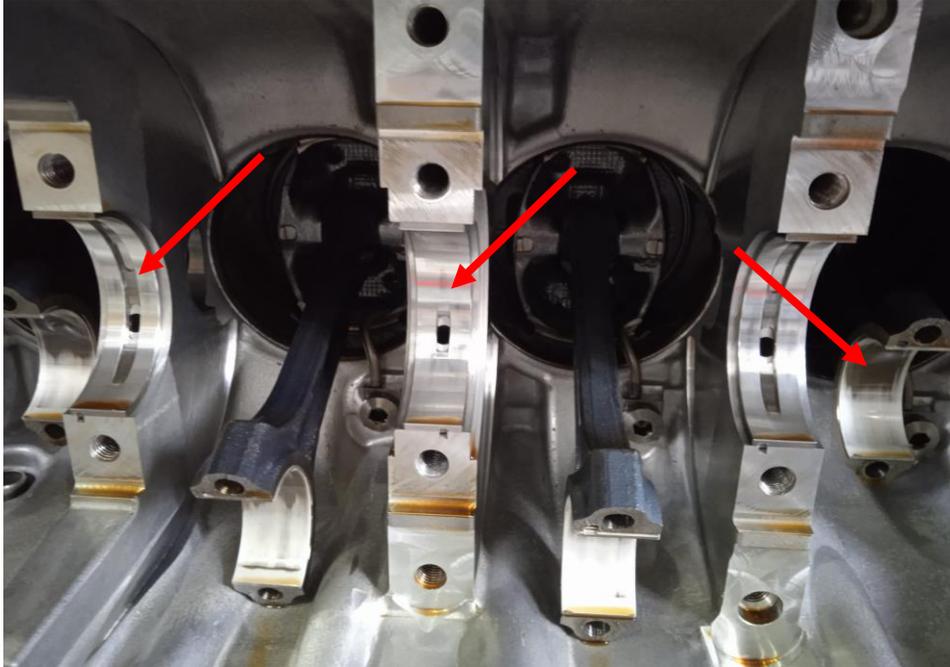
**Photo 13** shows the close up view of the crankshaft bearing of the Insured Vehicle at the time of our inspection. On the crankshaft bearing (arrowed) where the crankshaft was mounted on was also observed to be damaged as the damaged crankshaft pulley had caused the unbalanced crankshaft to move in the engine resulting to the damages to the crankshaft bearing at the time of inspection.
