Your Ref: CDMPG22000042-001
Our Ref : CS4/EGI22000288/P

22nd February 2022

TECHNICAL INVESTIGATION REPORT OF FIRE INCIDENT INVOLVING THE INSURED VEHICLE SLV 9795Y ON 7th January 2022

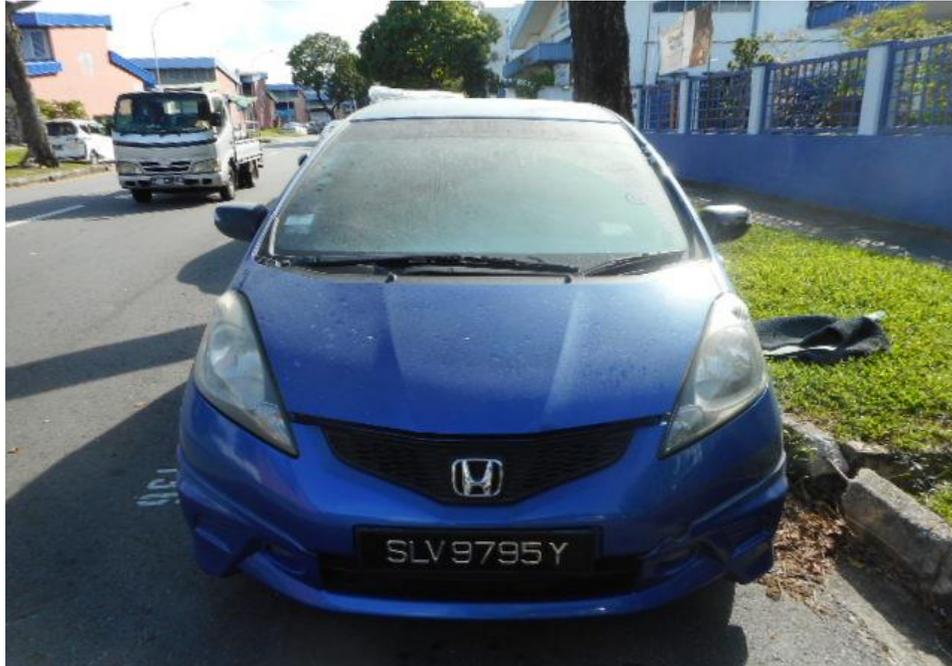
Photo 1 shows the general view of the front portion of the Insured Vehicle at the time of our inspection. The fire damage to the Insured Vehicle was confined to its interior portion. Its exterior is observed to be unaffected by the fire.

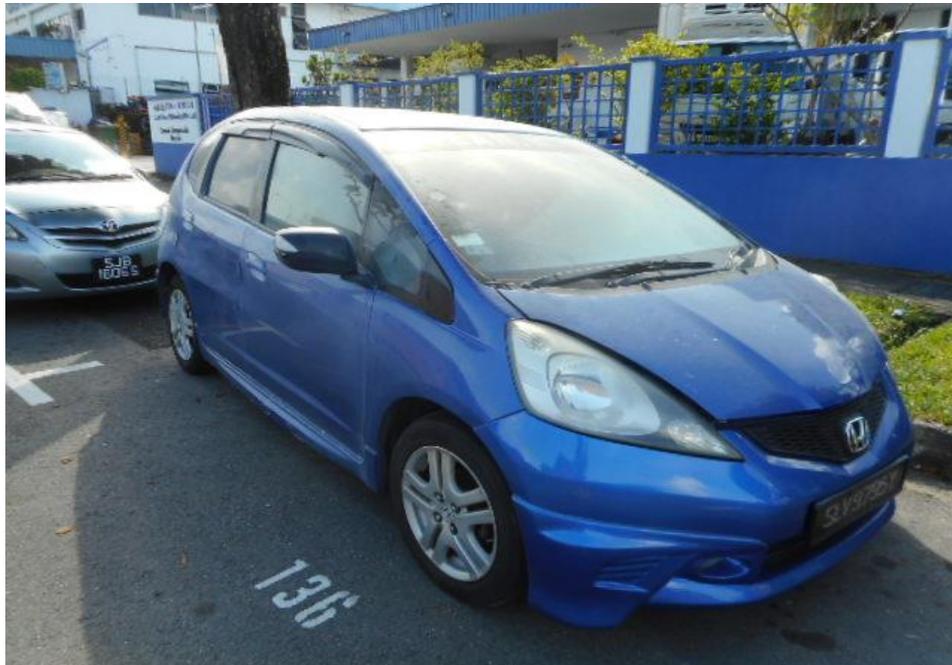
Photo 2 shows the general view of the right portion of the Insured Vehicle at the time of our inspection. The fire damage to the Insured Vehicle was confined to its interior portion. Its exterior is observed to be unaffected by the fire.

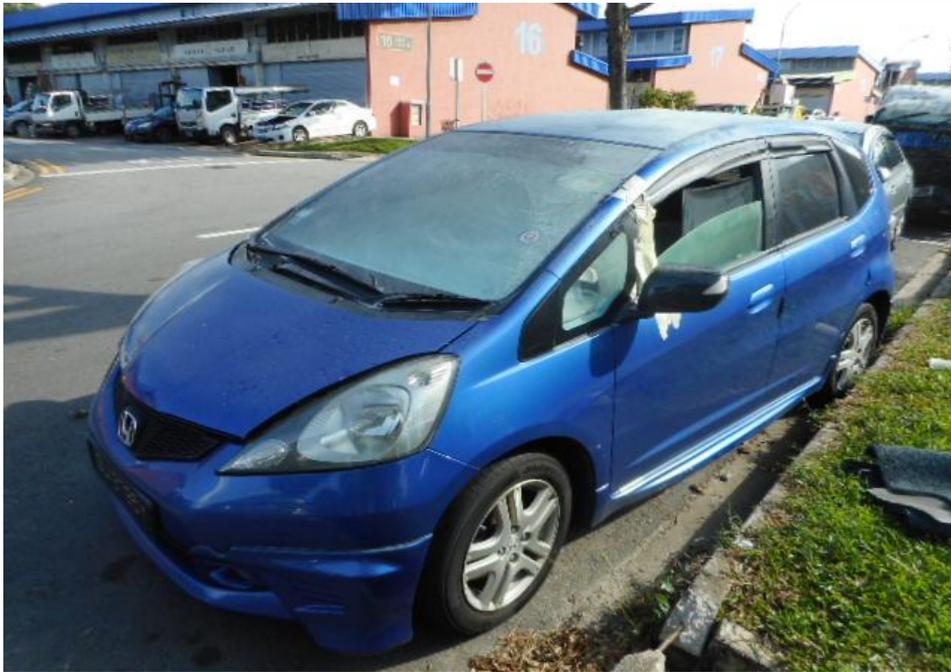
Photo 3 shows the general view of the left portion of the Insured Vehicle at the time of our inspection. The fire damage to the Insured Vehicle was confined to its interior portion. Its exterior is observed to be unaffected by the fire.

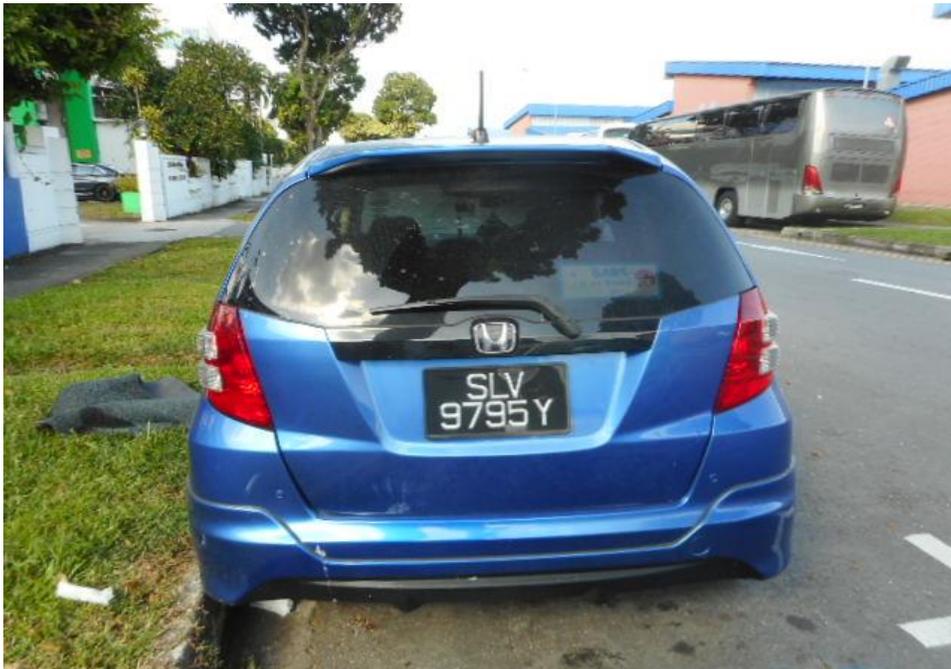
Photo 4 shows the general view of the rear portion of the Insured Vehicle at the time of our inspection. The fire damage to the Insured Vehicle was confined to its interior portion. Its exterior is observed to be unaffected by the fire.

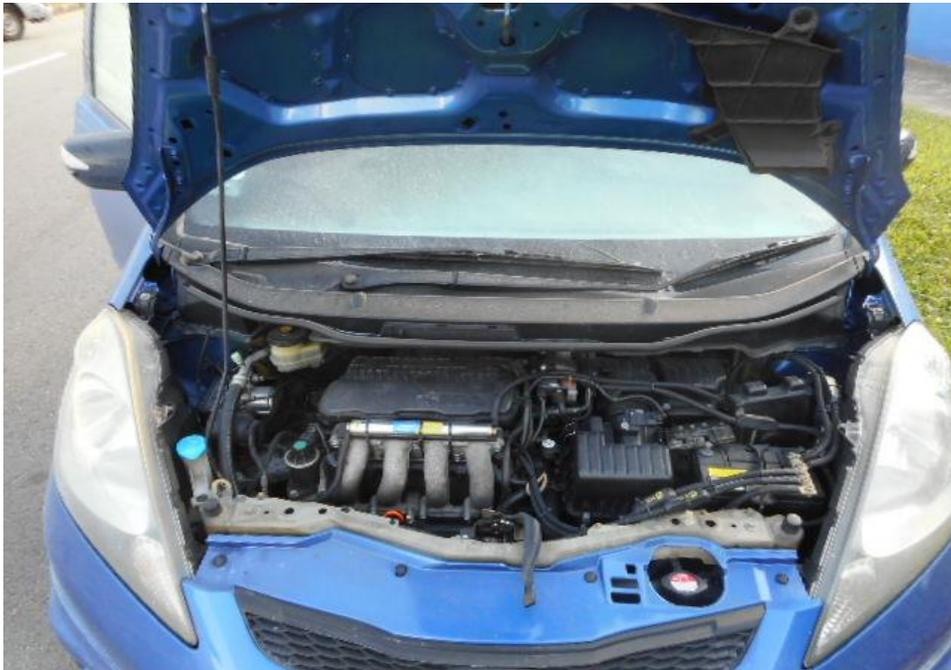
Photo 5 shows the general view of the engine portion of the Insured Vehicle at the time of our inspection. The fire damage to the Insured Vehicle was confined to its interior portion. Its engine compartment is observed to be unaffected by the fire.

21. Given the circumstances of the incident as reported, the possibility of the cause of fire to the Insured Vehicle being due to engine overheating would seem unlikely as Ms Lim had mentioned to us there were no indications of abnormally high temperatures when she was driving the Insured Vehicle on the day of the incident. Moreover, there was no damaged of fire nature in the engine compartment.

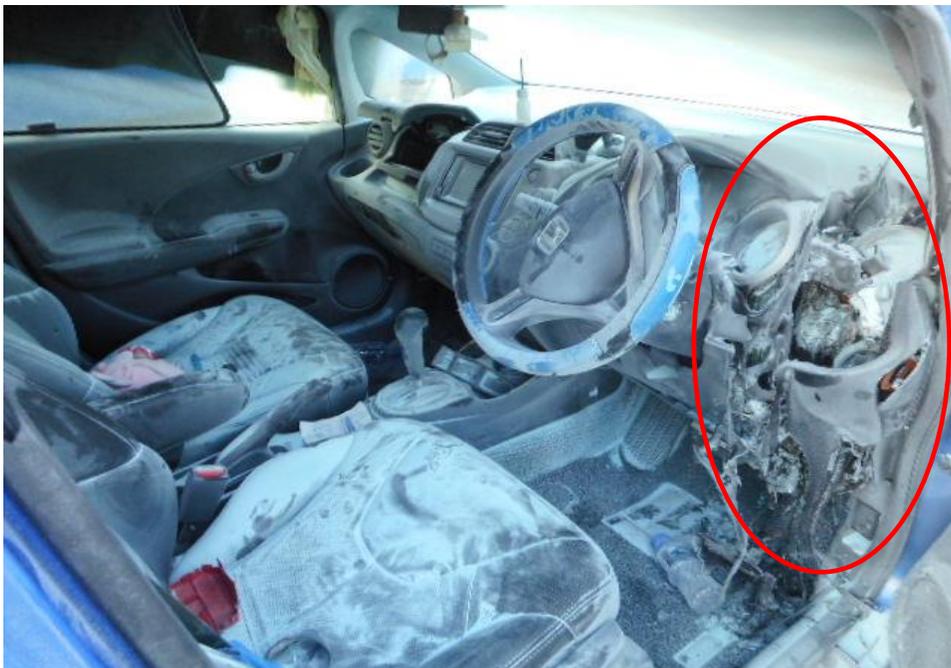
Photo 6 shows the general view of the interior compartment of the Insured Vehicle at the time of our inspection. The right portion of the dashboard had suffered heat and smoke damages (circled) as a result of the fire.

8. Based on the circumstances for this particular case, the fire appears to have originated from the interior portion of the Insured Vehicle, in the front right dashboard portion. This can be determined basing on the area where the extent of fire damage was most severe, the circumstances of the fires' origin at the material time of incident and also the burn marks and melting of material that were found at the front right dashboard portion.

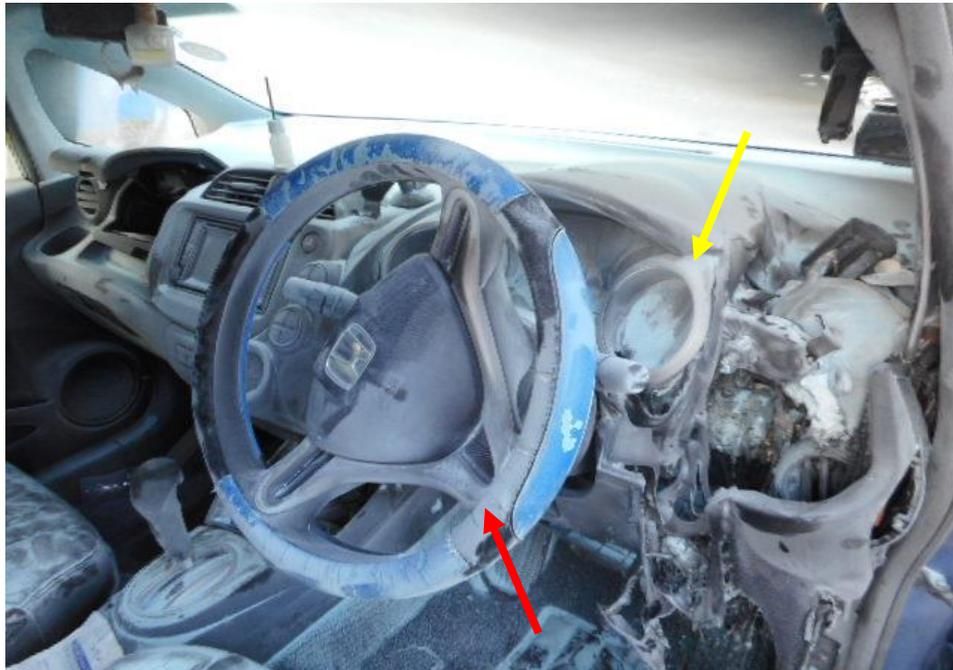
Photo 7 shows the close up view of the interior compartment of the Insured Vehicle at the time of our inspection. The steering wheel (red arrow) and its instrument panel (yellow arrow) had suffered heat and smoke damages (circled) as a result of the fire.

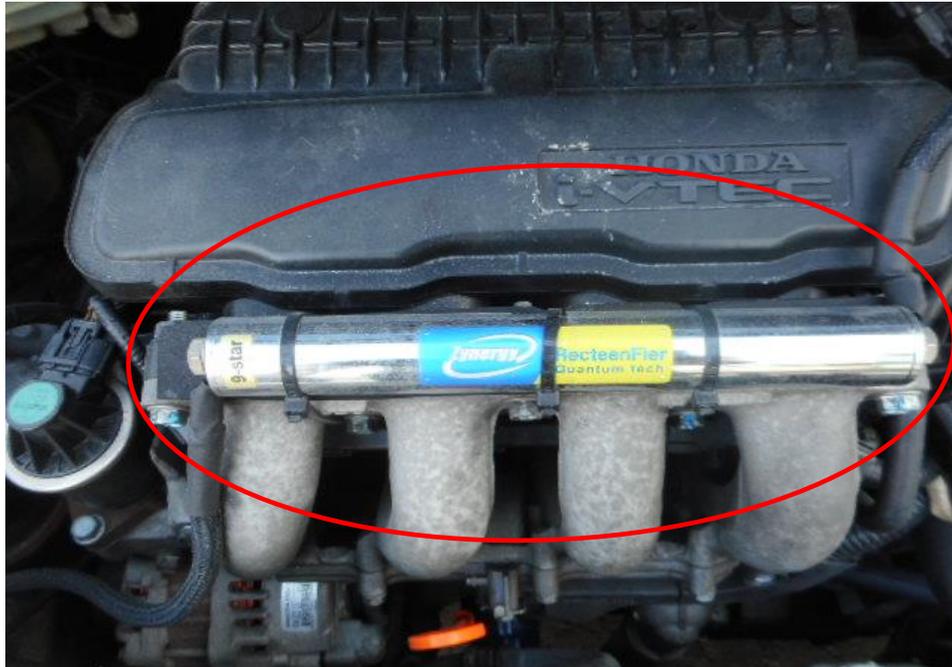
Photo 8 shows the front engine compartment of the Insured Vehicle an additionally fitted electrical grounding cables (circled) on the Insured Vehicle, which was observed to be unaffected by the fire.

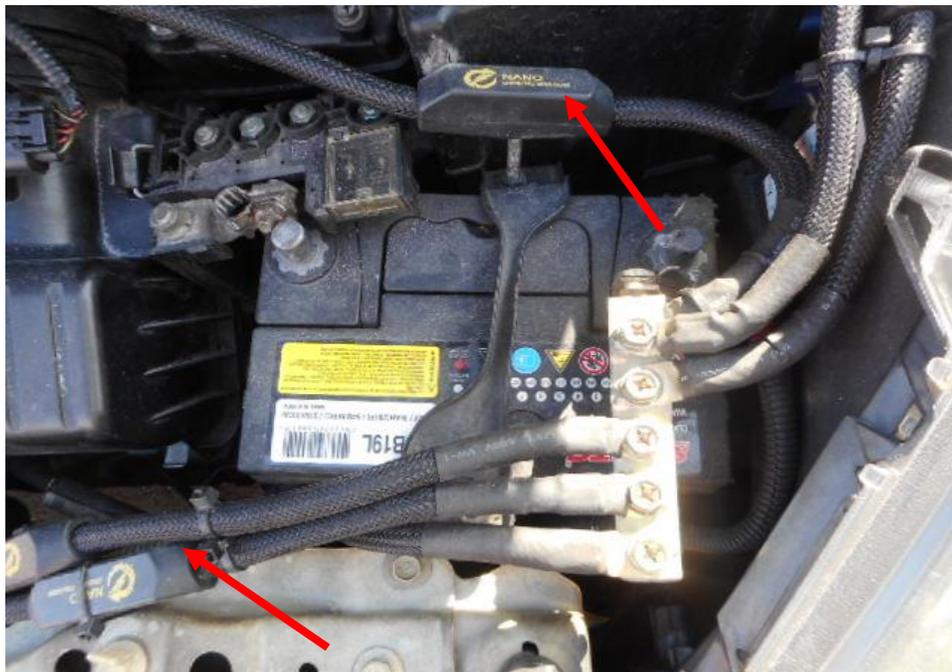
Photo 9 shows the front engine compartment of the Insured Vehicle an additionally fitted electrical grounding cables (arrowed) on the Insured Vehicle, which was observed to be unaffected by the fire.

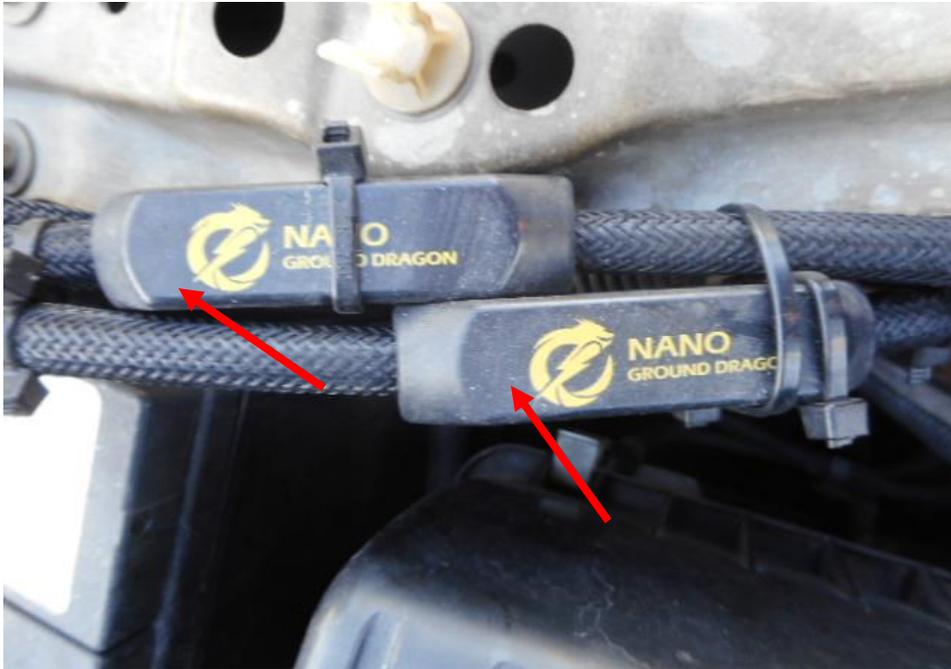
Photo 10 shows the front engine compartment of the Insured Vehicle an additionally fitted electrical grounding cables (arrowed) on the Insured Vehicle, which was observed to be affected by the fire.

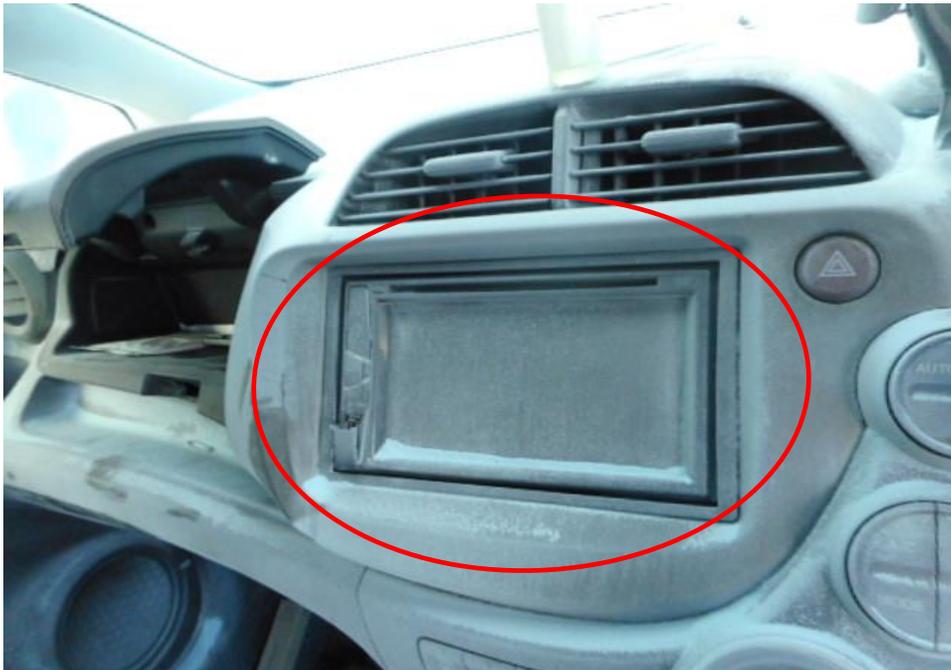
Photo 11 shows the interior dashboard of the Insured Vehicle an aftermarket audio head unit (arrowed) on the Insured Vehicle, which was observed to be affected by the fire.

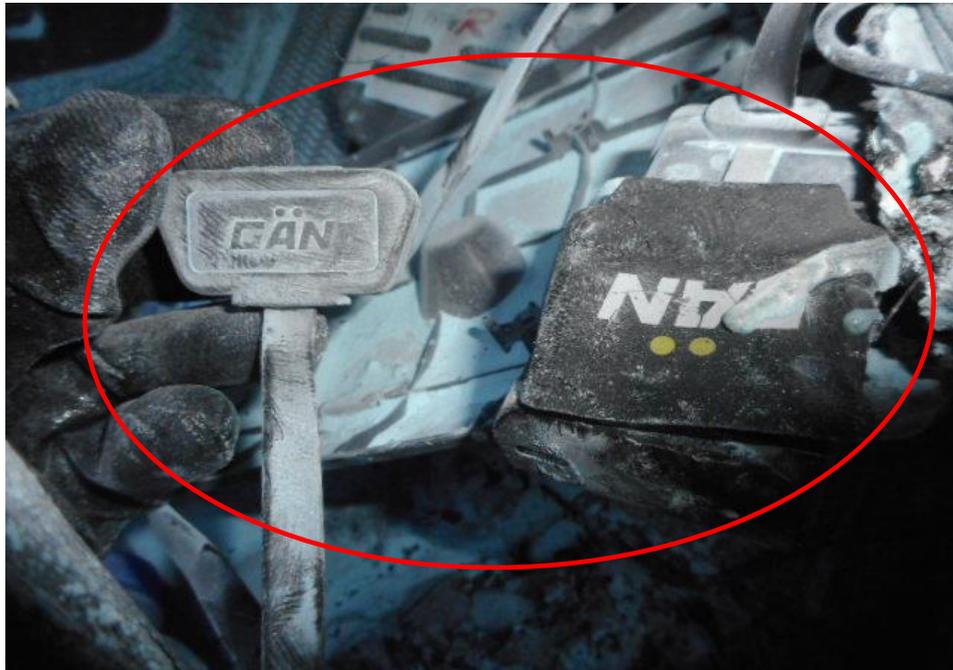
Photo 12 shows the interior driver foot well of the Insured Vehicle an additionally fitted OBD tuning module was found (arrowed) on the Insured Vehicle, which was observed to be affected by the fire.

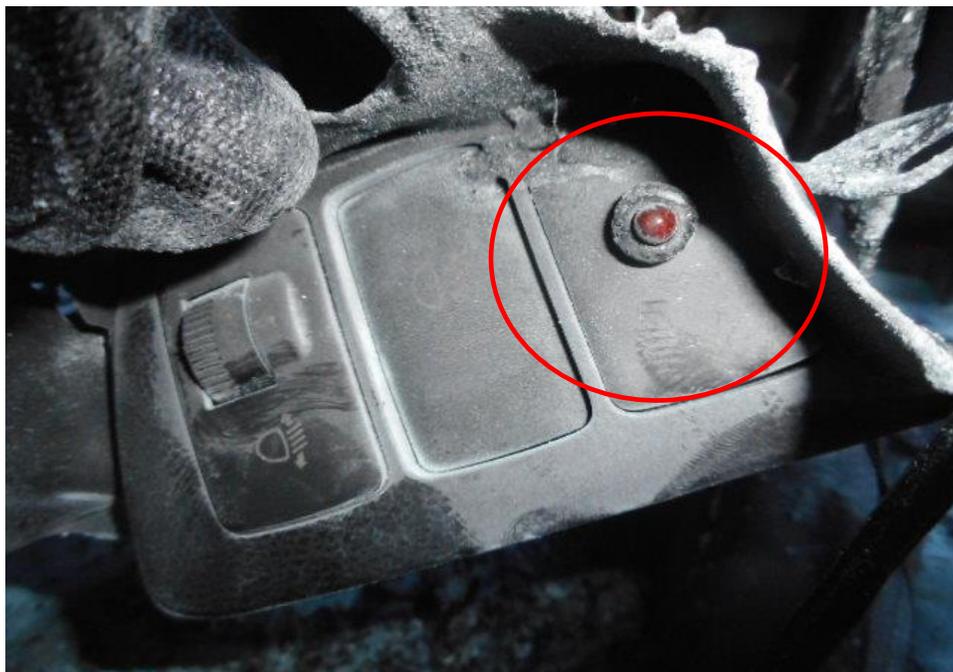
Photo 13 shows the interior dashboard of the Insured Vehicle, an additionally fitted alarm lighting and system was found (circled) on the Insured Vehicle, which was observed to be affected by the fire.

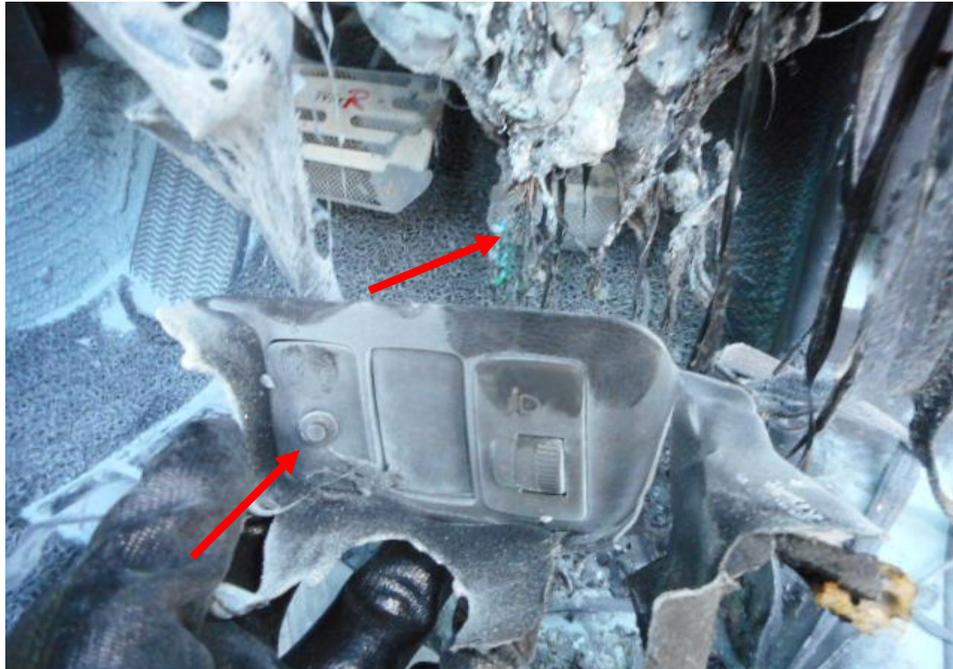
9. Upon closer observations, we have observed that its alarm lighting wirings in the right dashboard panel were observed to be where the fire had started, we had found traces of greenish residue on the wirings leading from the alarm lighting wirings to the fuse box panel. The alarm lighting wirings were not original wirings fitted from manufacturer and have been additionally fitted. The presence of greenish residue indicates internal heating of copper wires, a sign of an electrical short circuit occurring. The greenish residue is normally left behind from the oxidation as a result of chemical reaction involving the copper wires. This physical evidence would then appear to suggest that the cause of fire to the Insured Vehicle could have possibly been due to electrical in nature. See photo 14 -16 below.

Photo 14 shows the general view of the wirings in the front right dashboard of the Insured Vehicle at the time of our inspection. Observed where the fire had likely started from the wirings of the alarm lighting connecting to the fuse box panel (arrowed) as there was greenish residue on the surface. The presence of greenish residue indicates internal heating of copper wires, a sign of an electrical short circuit occurring. The greenish residue is normally left behind from oxidation as a result of chemical reaction involving the copper wires. The fire damage had also melted the electrical components that it was connected to. These alarm wirings and lighting components are not original wirings fitted from manufacturer and are additionally fitted.

23. The possibility of the fire being due to electrical in nature would then seem more likely given that engine overheating and external factors would both seem unlikely. The fire being due to electrical nature is also supported by the condition of the wirings that were found leading from the alarm lighting to its fuse box panel that was fitted in the front right dashboard of the Insured Vehicle. These wirings and electrical components were not original wirings and components fitted from manufacturer on the Insured Vehicle and was additionally fitted, which was earlier discussed in paragraph 9 above.

25. Having investigated and technically analysed the damages of burnt nature to the Insured Vehicle, we are of the view that the cause of fire to the Insured Vehicle was of electrical nature. For this particular case, the fire had originated from the wirings of the alarm lighting wiring to the fuse box panel which are installed at the front right dashboard, these are additionally fitted and not from the manufacturer.

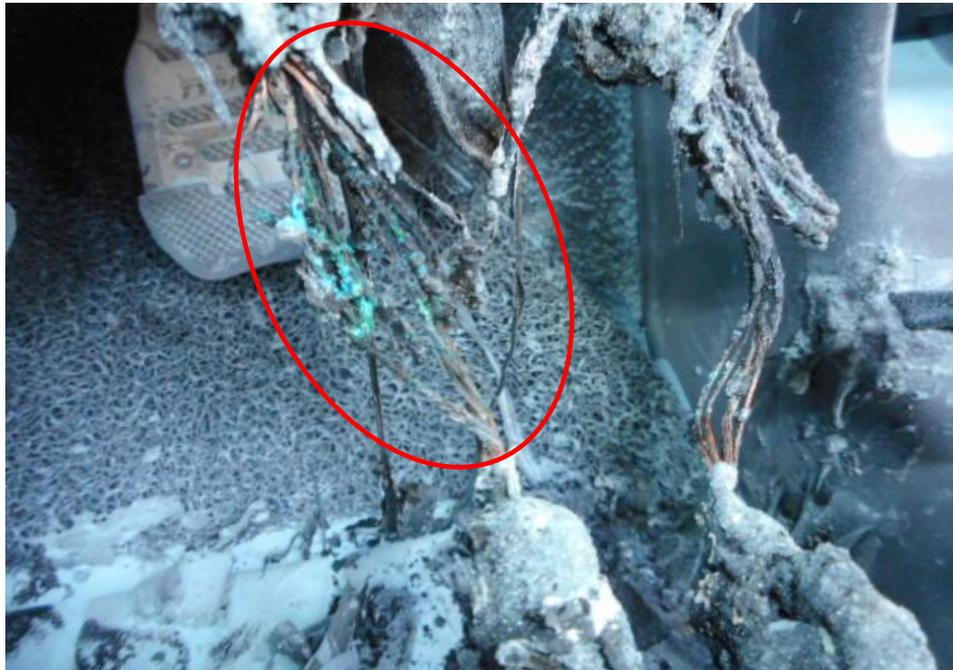
Photo 15 shows a close up view of the alarm lighting wiring harness connected to the fuse box panel (circled) as there was greenish residue on the surface. The presence of greenish residue indicates internal heating of copper wires, a sign of an electrical short circuit occurring. The greenish residue is normally left behind from oxidation as a result of chemical reaction involving the copper wires. The fire damage had also melted the electrical components that it was connected to. This is likely where the fire had started from. These alarm wirings and lighting components are not original wirings fitted from manufacturer and are additionally fitted.

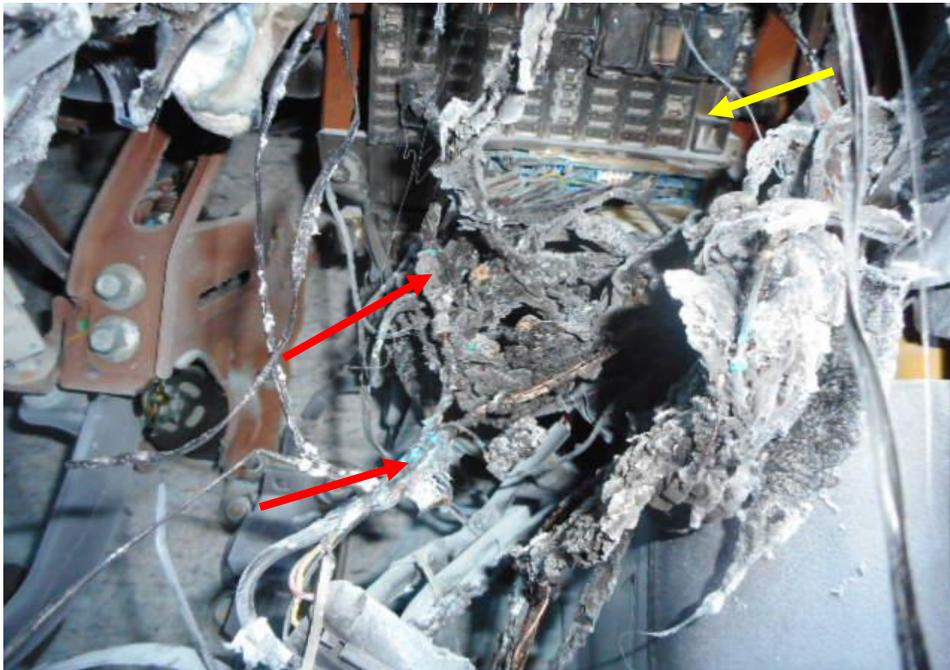
Photo 16 shows a close up view of the alarm lighting and wiring harness (red arrow) connected to the fuse box panel (yellow arrow) as there was greenish residue on the surface. The presence of greenish residue indicates internal heating of copper wires, a sign of an electrical short circuit occurring. The greenish residue is normally left behind from oxidation as a result of chemical reaction involving the copper wires. The fire damage had also melted the electrical components that it was connected to and the surrounding components. This is likely where the fire had started from. These alarm wirings and lighting components are not original wirings fitted from manufacturer and are additionally fitted.

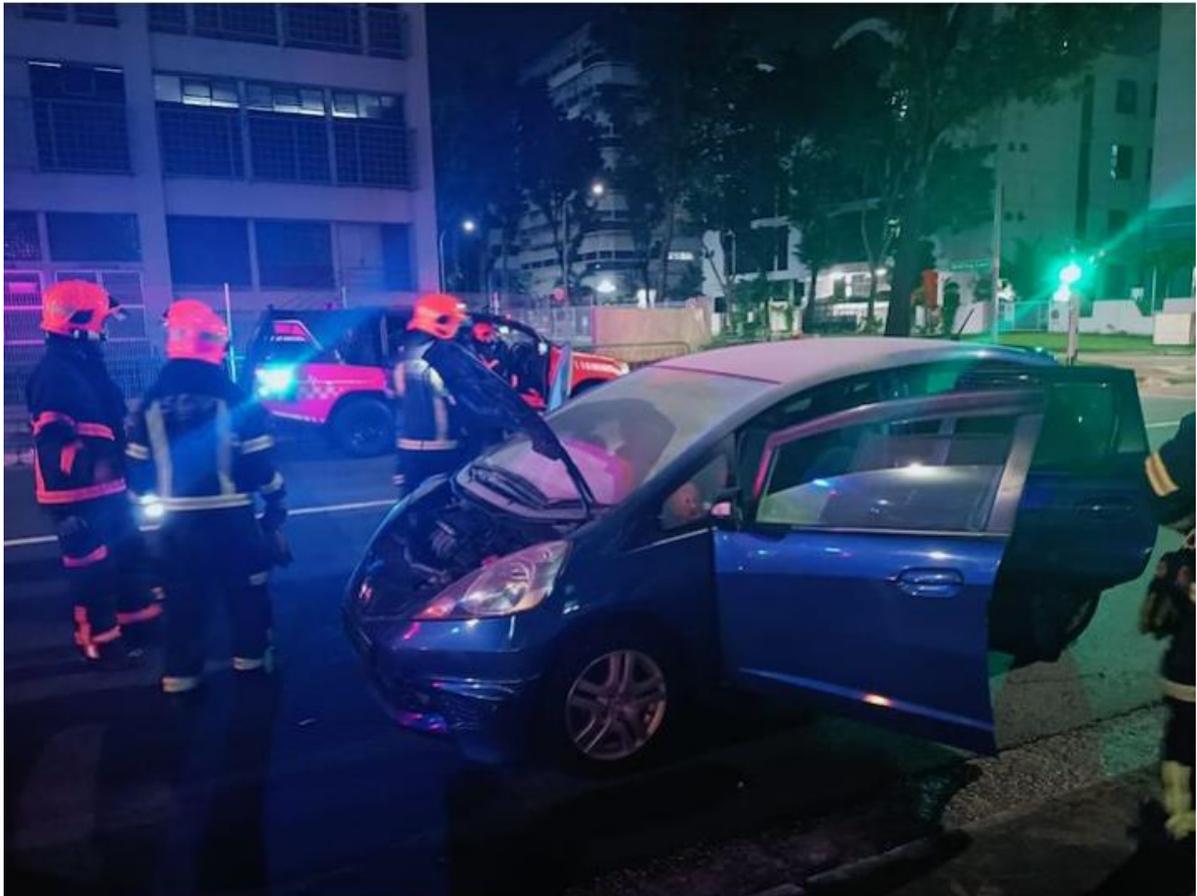
Photo 17 shows the SCDF officers at the scene inspecting the Insured Vehicle. In general, the information that could be gathered from this photograph had corresponded to the events that were related to us by Ms Lim, location when the fire broke out.

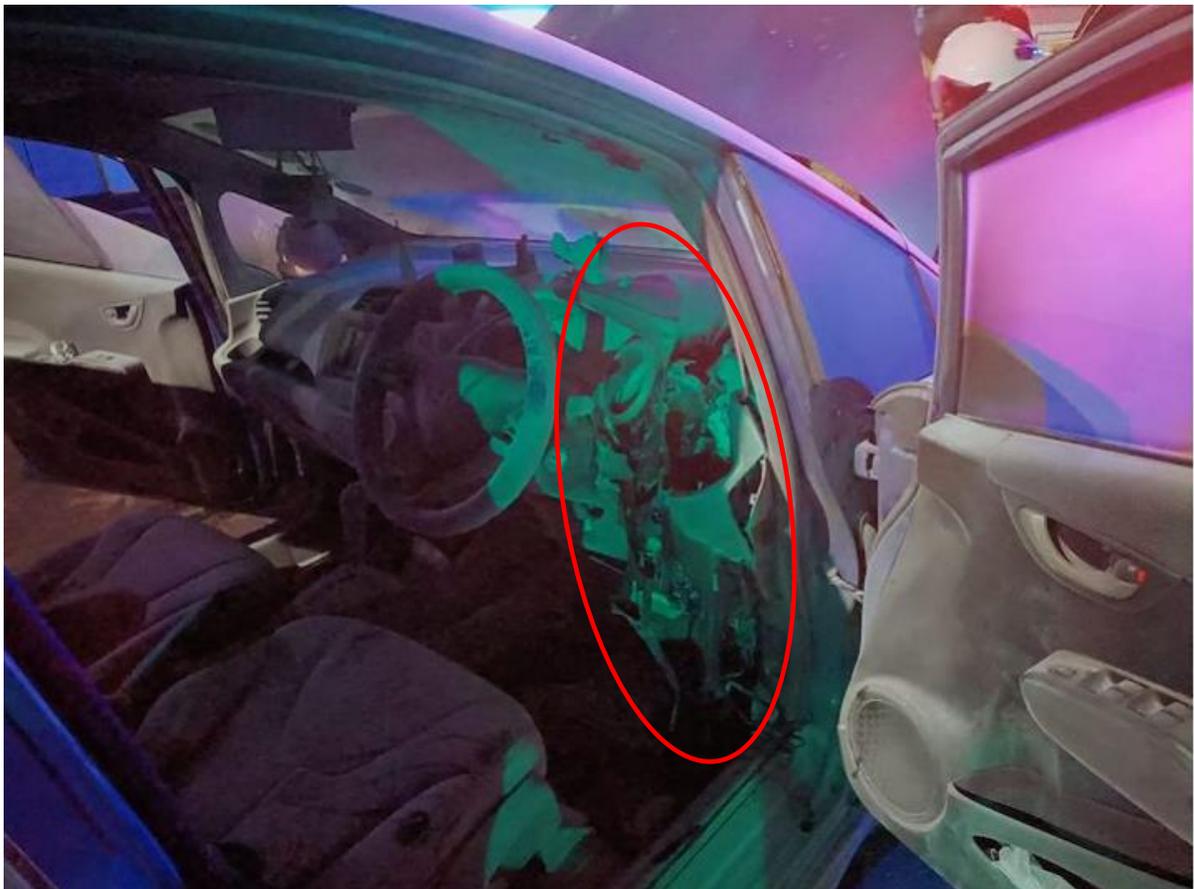
Photo 18 shows the interior front right dashboard portion (circled) that was damaged on the Insured Vehicle at a result of the fire. In general, the information that could be gathered from this photograph had corresponded to the events that were related to us by Ms Lim, location when the fire broke out.
