Your Ref: Porsche 718 Boxster
(chassis number WP0ZZZ98ZLS201298)
Our Ref : CI/TP22000313/D

10 January 2022

**INSPECTION REPORT OF AN UNREGISTERED PORSCHE 718 BOXSTER
MOTOR CAR WITH CHASSIS NUMBER WP0ZZZ98ZLS201298**

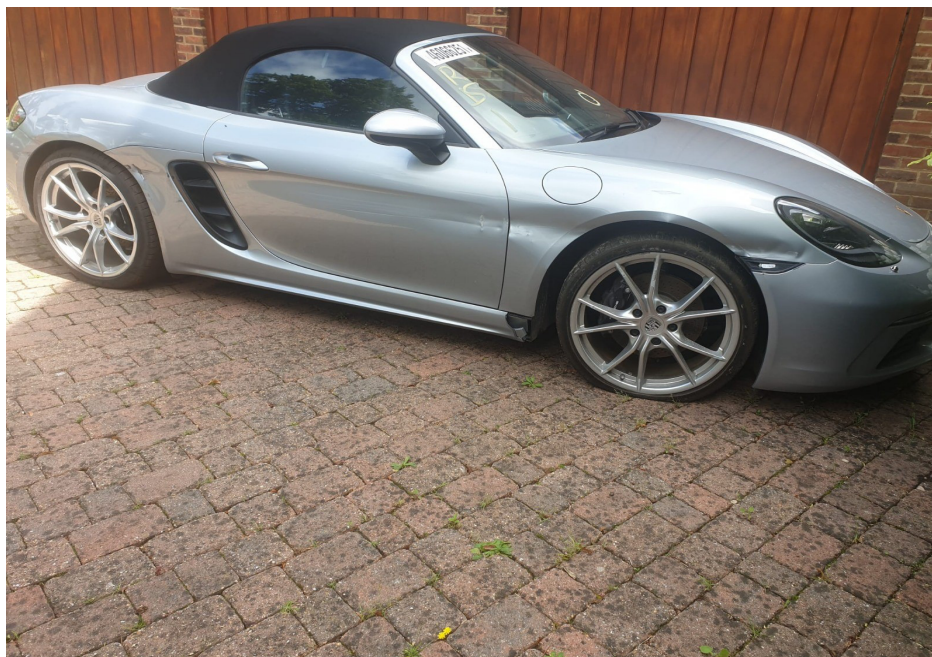
Photo 1 shows the right side body of the Motor Car (photograph provided to me). The photographs provided to me had showed relatively minor damage along the right side body of the Motor Car. The front bumper, front right fender, front right signal lamp, front right wheel rim, front right door, right side rocker panel garnish, right side air vent, rear right fender, rear right wheel rim and rear bumper were amongst the body parts that were observed to have been damaged.

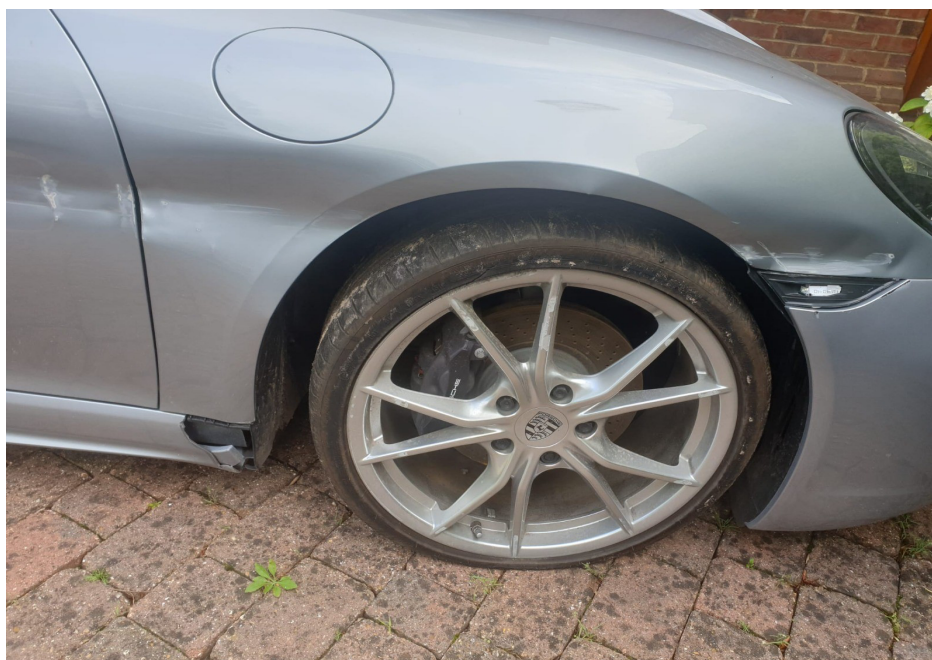
Photo 2 shows a closer view of the damaged front bumper, front right signal lamp, front right fender, front right wheel rim, front right door and right side rocker panel garnish of the Motor Car (photograph provided to me).

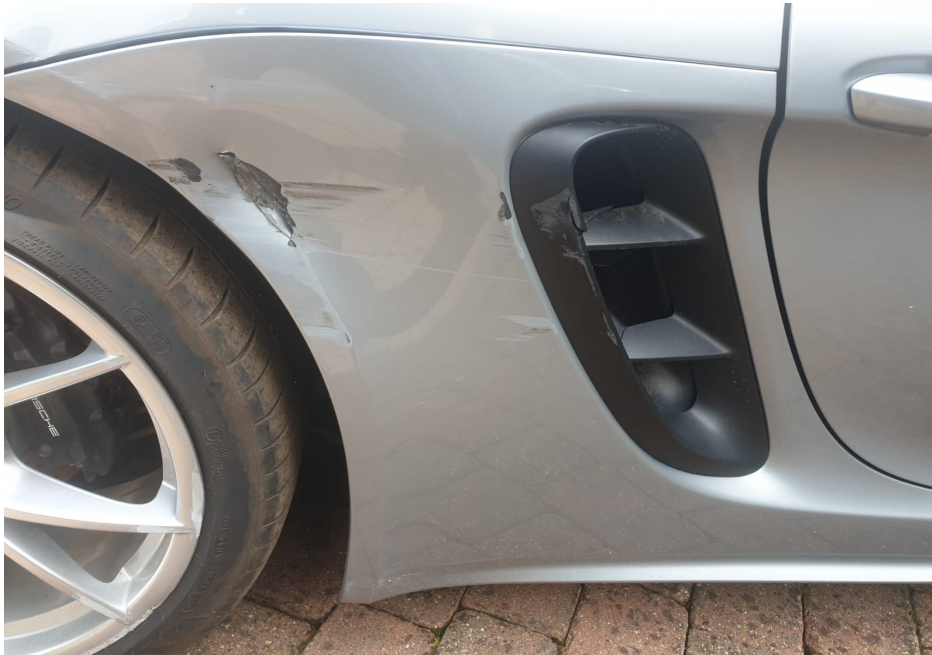
Photo 3 shows a closer view of the damaged right side rocker panel garnish and right side air vent of the Motor Car (photograph provided to me).

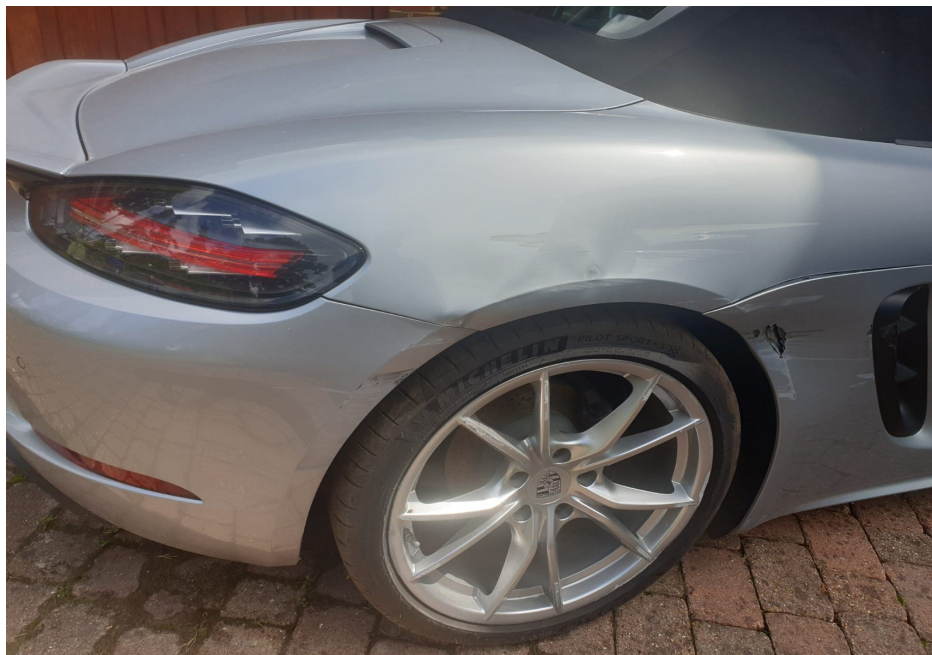
Photo 4 shows a closer view of the damaged right side rocker panel garnish, right side air vent, rear right fender, rear right wheel rim and rear bumper of the Motor Car (photograph provided to me).

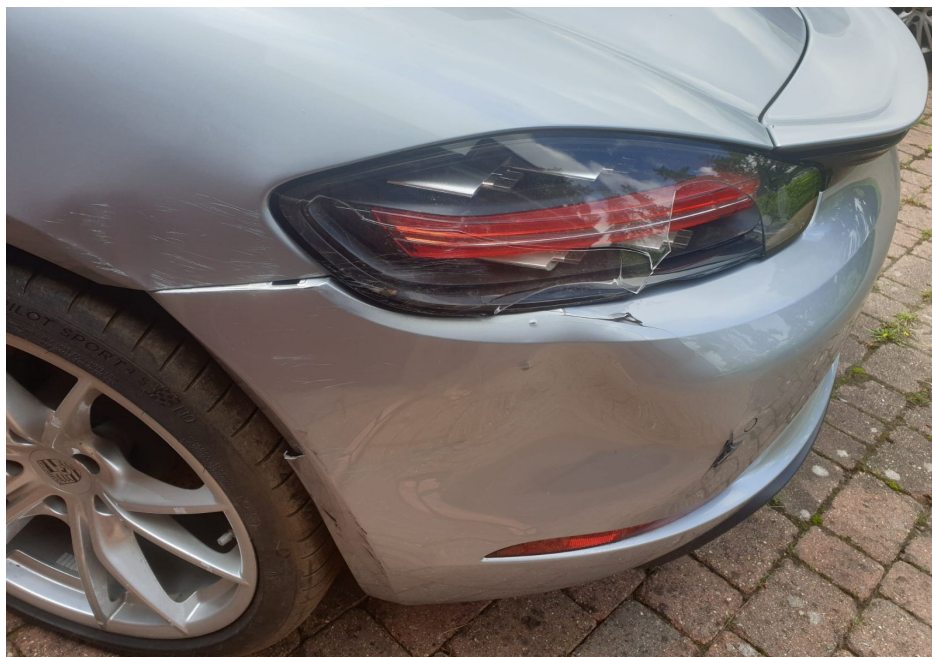
Photo 5 shows a closer view of the damaged rear bumper, rear left taillamp and rear left fender of the Motor Car (photograph provided to me). Apart for the right side body, the photographs provided had also showed relatively minor damage along the left side body of the Motor Car.

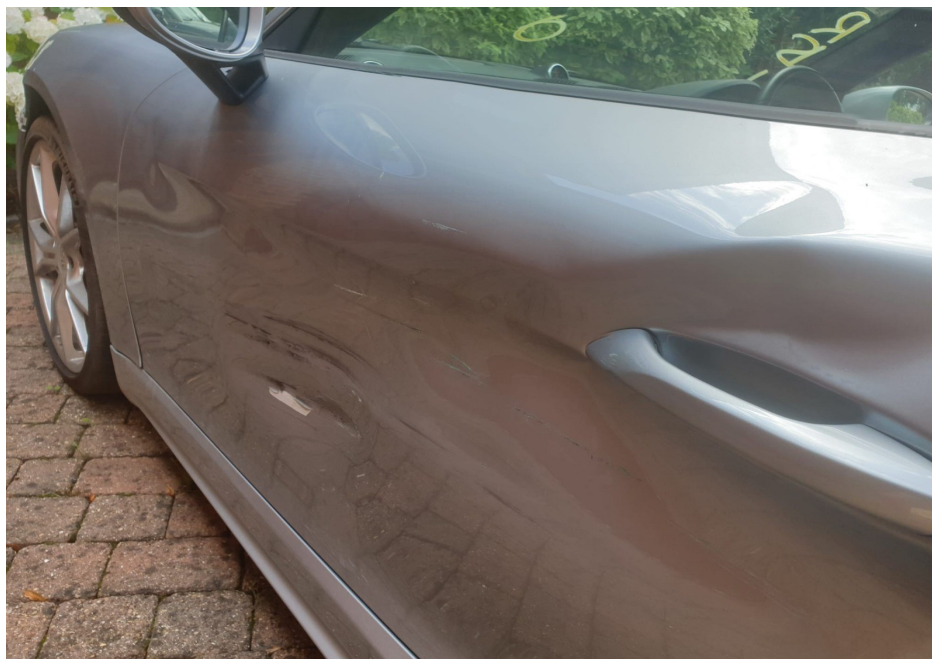
Photo 6 shows a closer view of the damaged front left door of the Motor Car (photograph provided to me). Apart for the right side body, the photographs provided had also showed relatively minor damage along the left side body of the Motor Car.

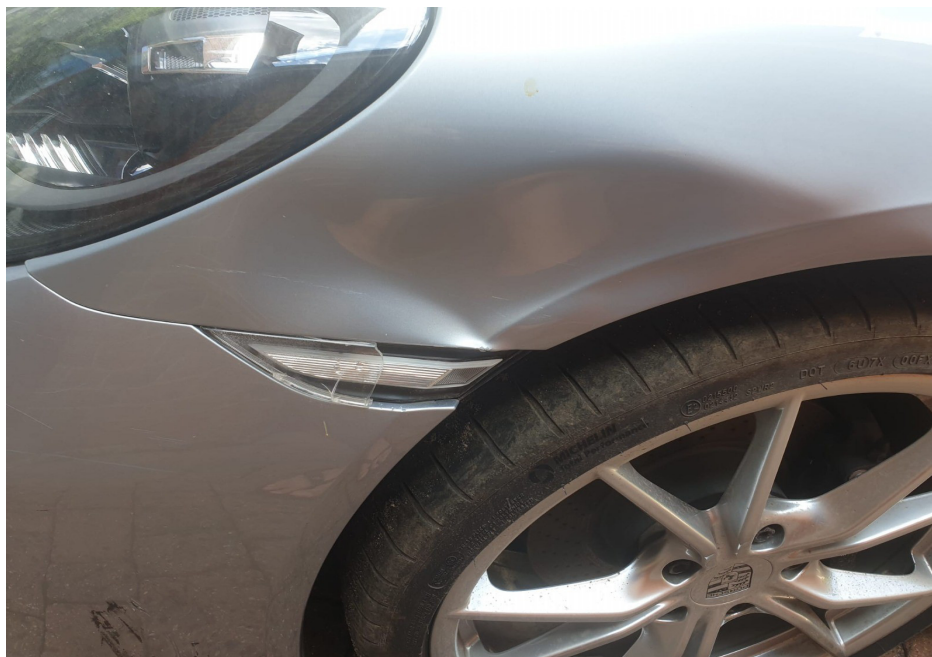
Photo 7 shows a closer view of the damaged front left fender, front left signal lamp and front bumper of the Motor Car (photograph provided to me). Apart for the right side body, the photographs provided had also showed relatively minor damage along the left side body of the Motor Car.

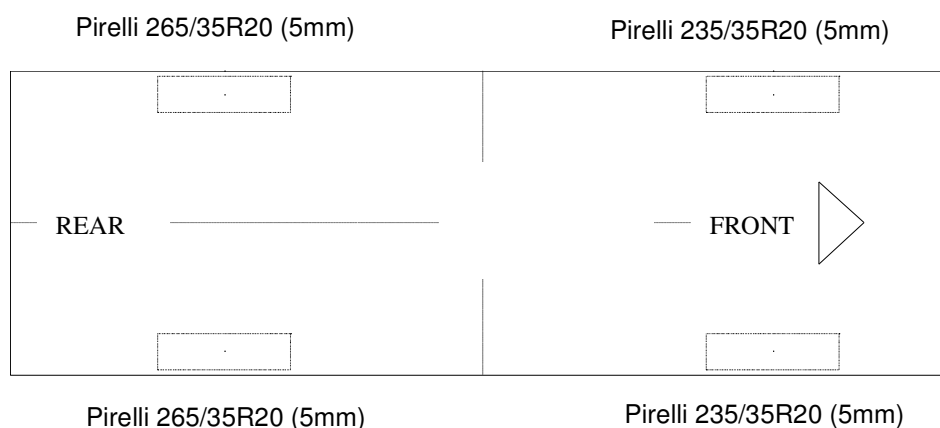
10. It was fitted with 20inch sport wheel rims that were wrapped with tyres that were observed to be of serviceable condition. The tyres were also sufficiently inflated for vehicular operation. The tyre brand, tyre size and approximate remaining tread depth of the 4 tyres of the Motor Car were recorded as follows: -

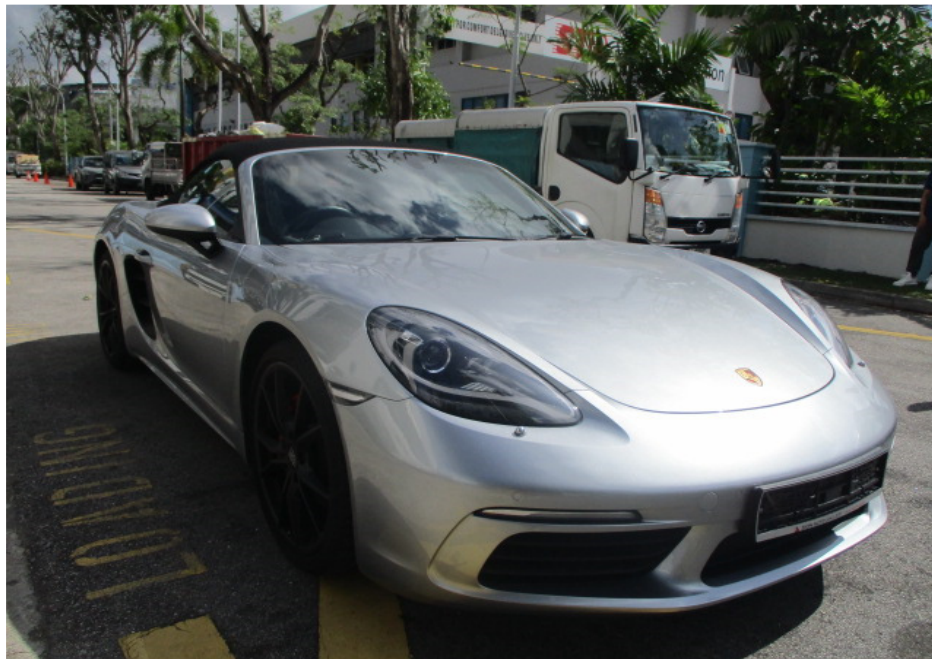
Photo 8 shows a general view of the front right body of the Motor Car at the time of my inspection. The Motor Car was observed to be in a relatively good general condition with no loose exterior fittings observed. The body parts along the right side body of the Motor Car were visually examined and it was observed that the repair/restoration works carried out to the damaged area of the Motor Car (refer to photograph 1 – 4 above) were reasonably adequate and in order.

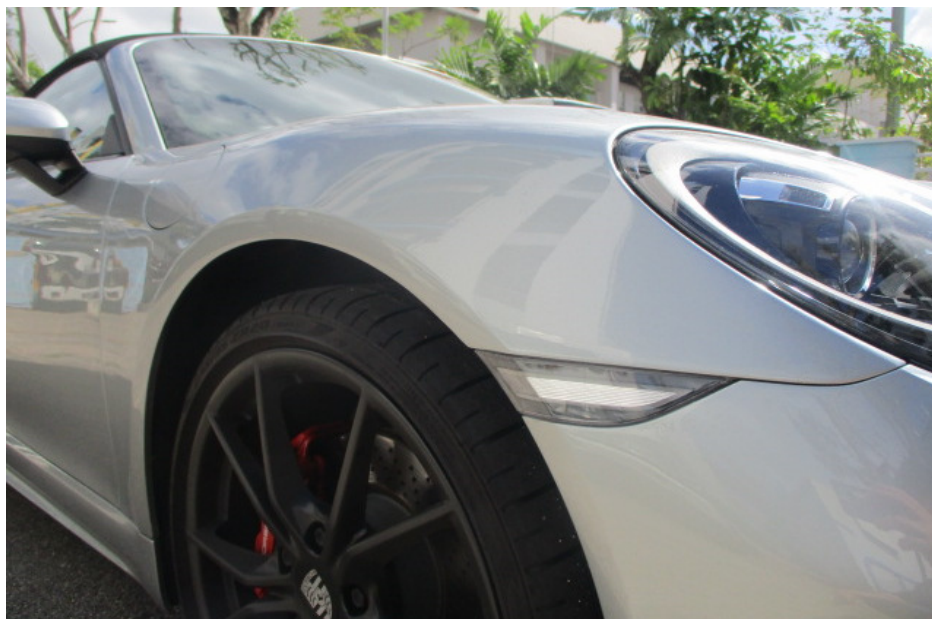
Photo 9 shows a closer view of the Motor Car's front bumper, front right signal lamp, front right fender and front right wheel rim at the time of my inspection. The body parts along the right side body of the Motor Car were visually examined and it was observed that the repair/restoration works carried out to the damaged area of the Motor Car (refer to photograph 1 – 4 above) were reasonably adequate and in order.

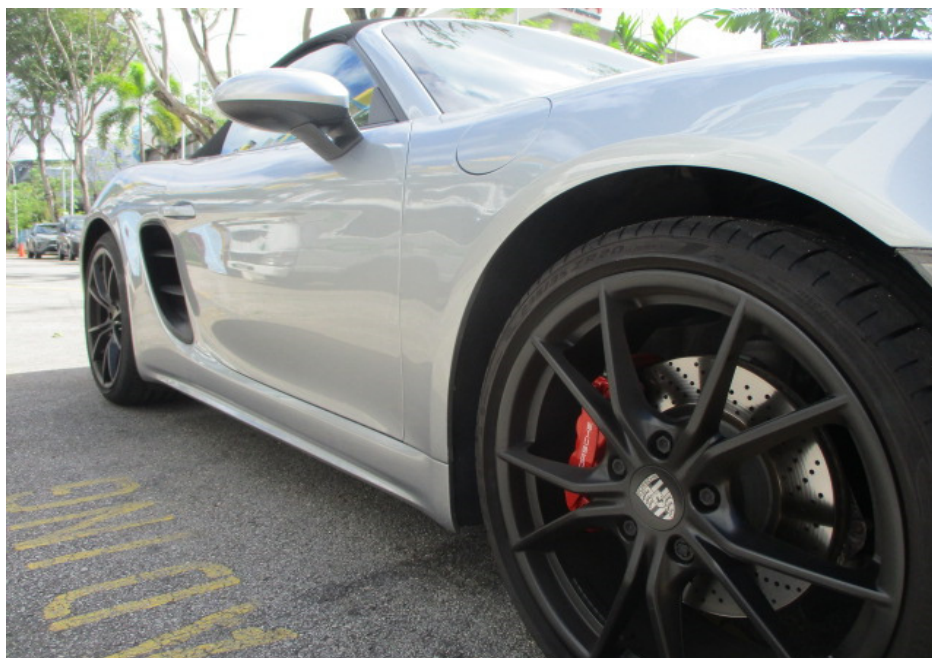
Photo 10 shows a closer view of the Motor Car's front right wheel rim, front right fender, front right door and right side rocker panel garnish at the time of my inspection. The body parts along the right side body of the Motor Car were visually examined and it was observed that the repair/restoration works carried out to the damaged area of the Motor Car (refer to photograph 1 – 4 above) were reasonably adequate and in order.

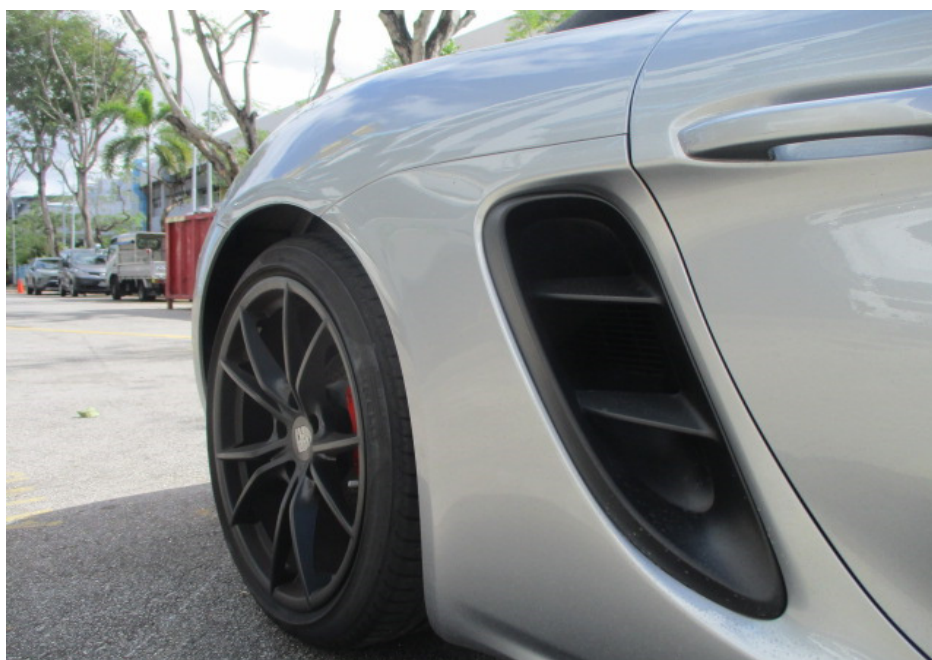
Photo 11 shows a closer view of the Motor Car's rear right wheel rim, rear right fender, right side air vent and right side rocker panel garnish at the time of my inspection. The body parts along the right side body of the Motor Car were visually examined and it was observed that the repair/restoration works carried out to the damaged area of the Motor Car (refer to photograph 1 – 4 above) were reasonably adequate and in order.

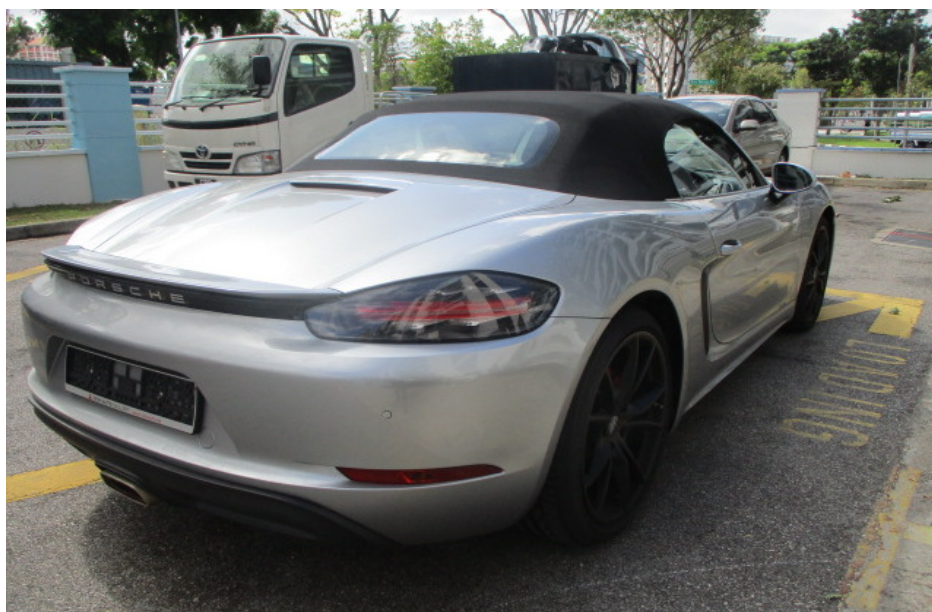
Photo 12 shows a general view of the rear right body of the Motor Car at the time of my inspection. The Motor Car was observed to be in a relatively good general condition with no loose exterior fittings observed. The body parts along the right side body of the Motor Car were visually examined and it was observed that the repair/restoration works carried out to the damaged area of the Motor Car (refer to photograph 1 – 4 above) were reasonably adequate and in order.

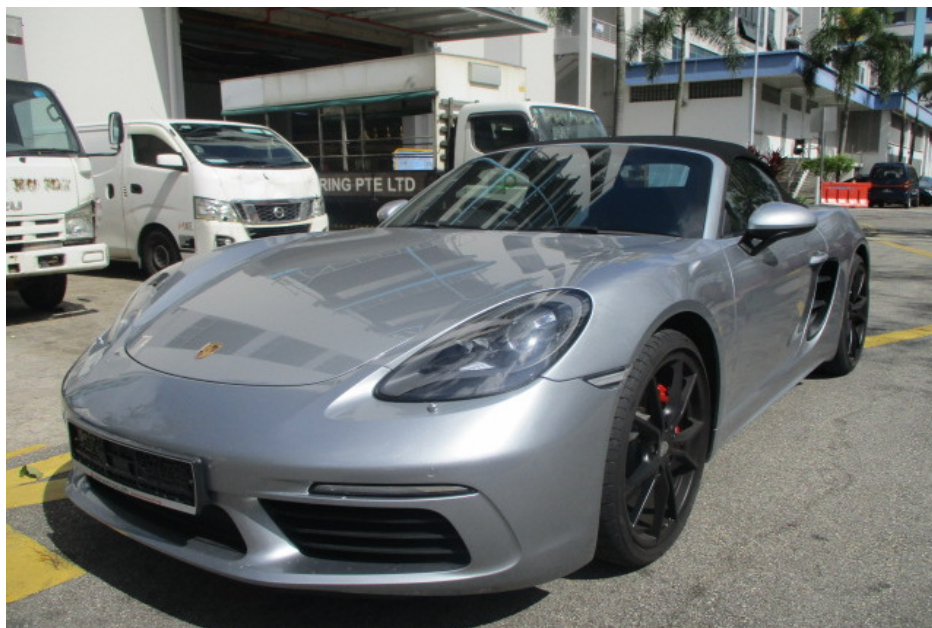
Photo 13 shows a general view of the front left body of the Motor Car at the time of my inspection. The Motor Car was observed to be in a relatively good general condition with no loose exterior fittings observed. The body parts along the left side body of the Motor Car were visually examined and it was observed that the repair/restoration works carried out to the damaged area of the Motor Car (refer to photograph 5 – 7 above) were reasonably adequate and in order.

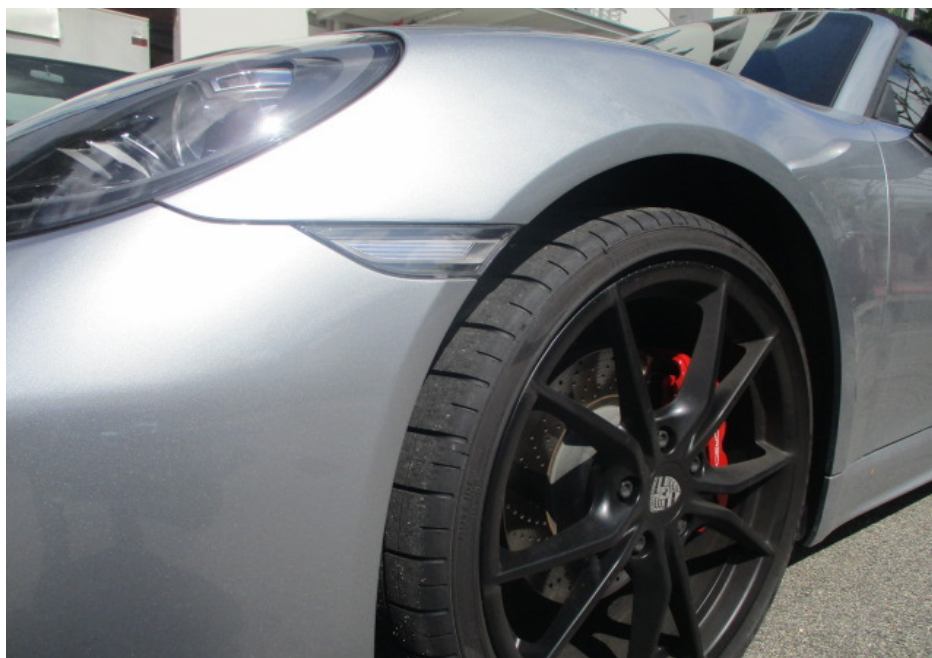
Photo 14 shows a closer view of the Motor Car's front bumper, front left signal lamp, front left fender and front left wheel rim at the time of my inspection. The body parts along the left side body of the Motor Car were visually examined and it was observed that the repair/restoration works carried out to the damaged area of the Motor Car (refer to photograph 5 – 7 above) were reasonably adequate and in order.

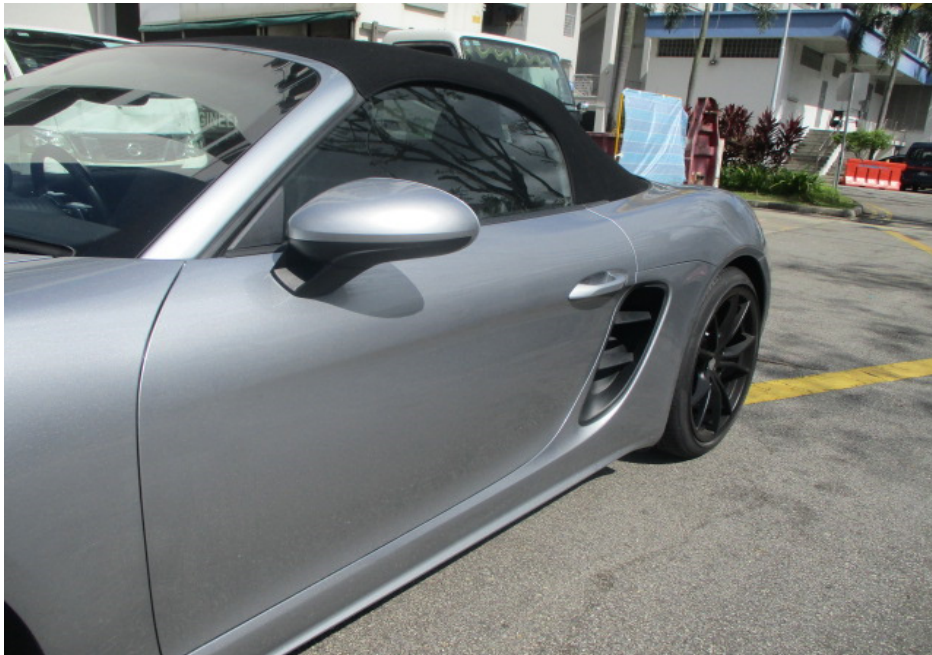
Photo 15 shows a closer view of the Motor Car's front left door and left side rocker panel garnish at the time of my inspection. The body parts along the left side body of the Motor Car were visually examined and it was observed that the repair/restoration works carried out to the damaged area of the Motor Car (refer to photograph 5 – 7 above) were reasonably adequate and in order.

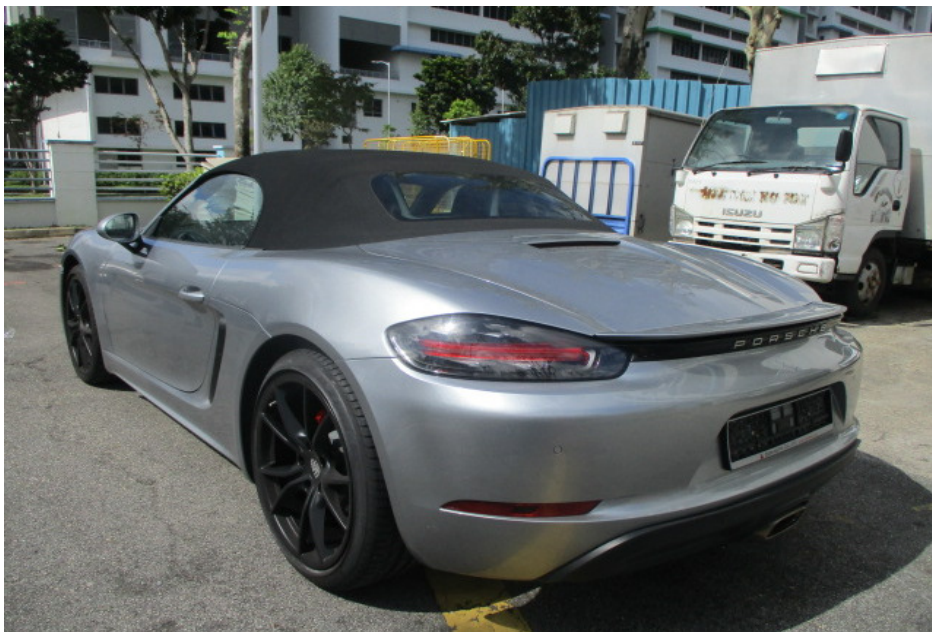
Photo 16 shows a general view of the rear left body of the Motor Car at the time of my inspection. The Motor Car was observed to be in a relatively good general condition with no loose exterior fittings observed. The body parts along the left side body of the Motor Car were visually examined and it was observed that the repair/restoration works carried out to the damaged area of the Motor Car (refer to photograph 5 – 7 above) were reasonably adequate and in order.

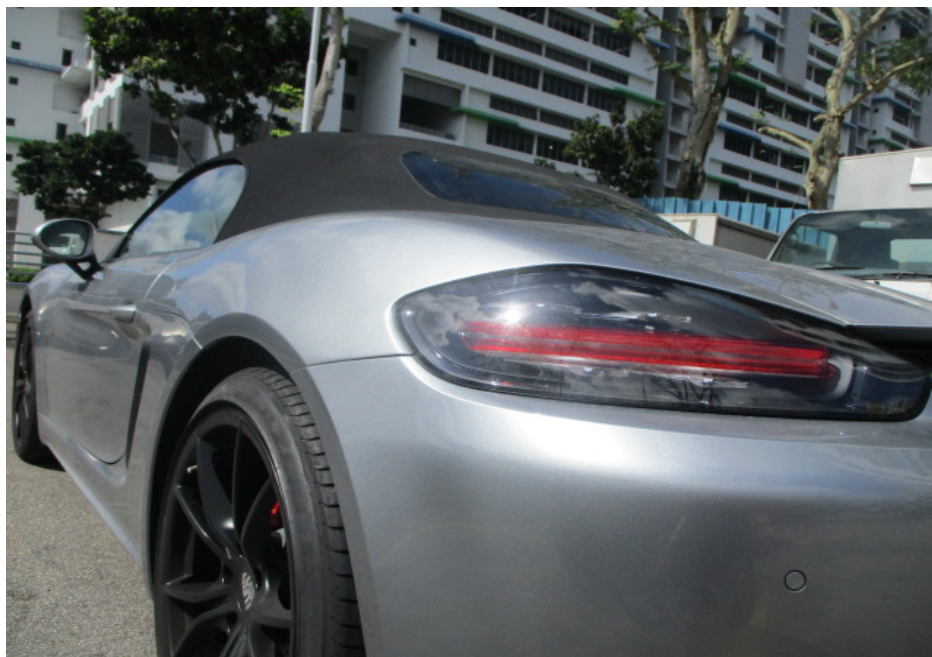
Photo 17 shows a closer view of the Motor Car's rear bumper, rear left taillamp and rear left fender at the time of my inspection. The body parts along the left side body of the Motor Car were visually examined and it was observed that the repair/restoration works carried out to the damaged area of the Motor Car (refer to photograph 5 – 7 above) were reasonably adequate and in order.

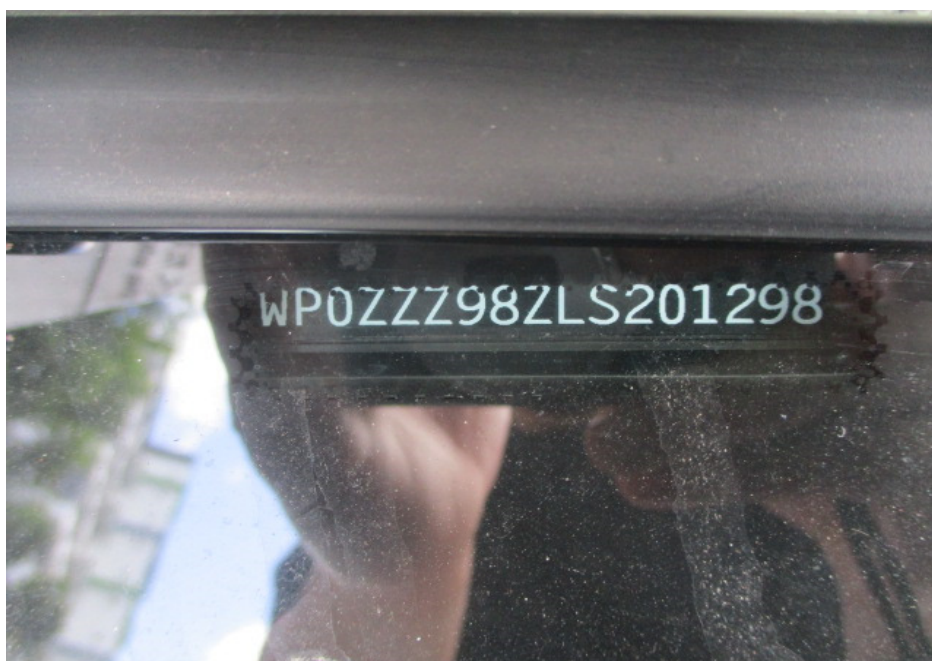
Photo 18 shows the chassis number of the Motor Car. The chassis number recorded was WP0ZZZ98ZLS201298.

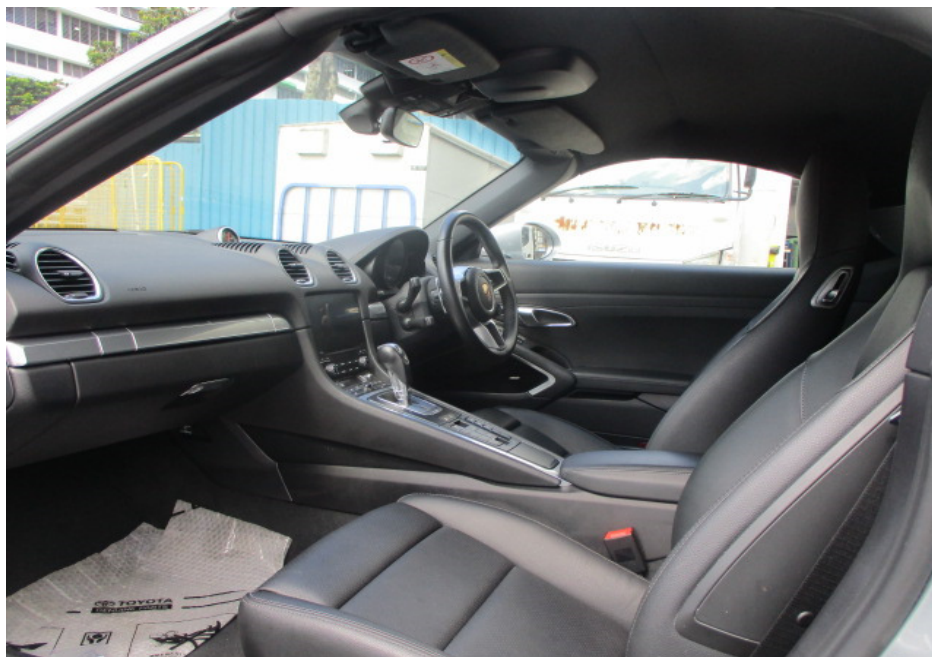
Photo 19 shows the interior compartment of the Motor Car at the time of my inspection. The various parts and components, trims, carpet, and upholstery inside the interior compartment were all observed to be intact and properly fitted.

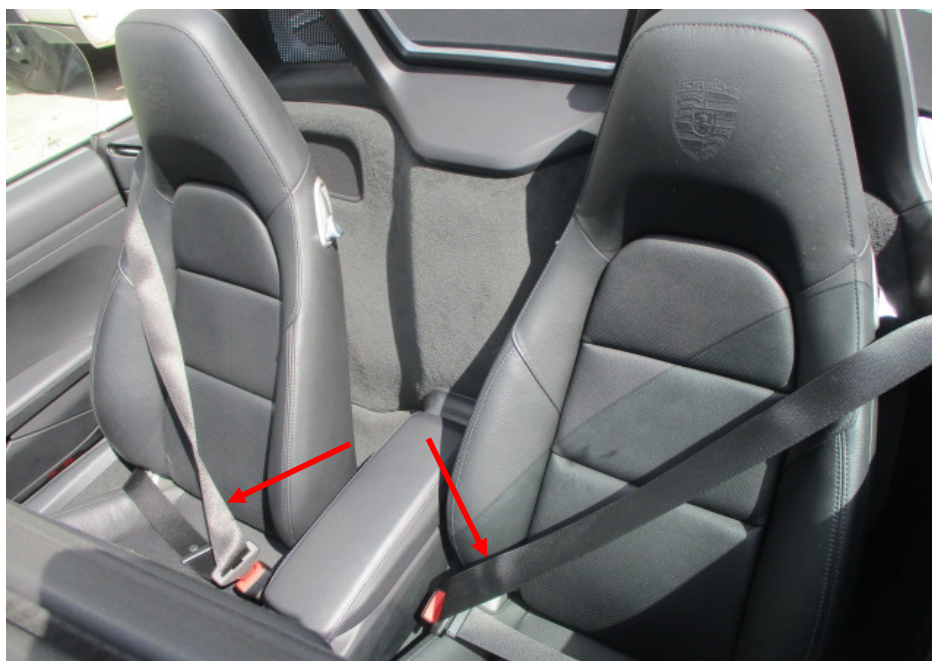
Photo 20 shows the seats of the Motor Car. All the seats of the Motor Car were secured via seat rails to the floorboard. They were also fitted with a retractable seat belt reel and a pre-tensioner. The seat belts (arrowed) were tested and were able to be fastened into the respective pre-tensions that were fitted on the side of each individual seat.

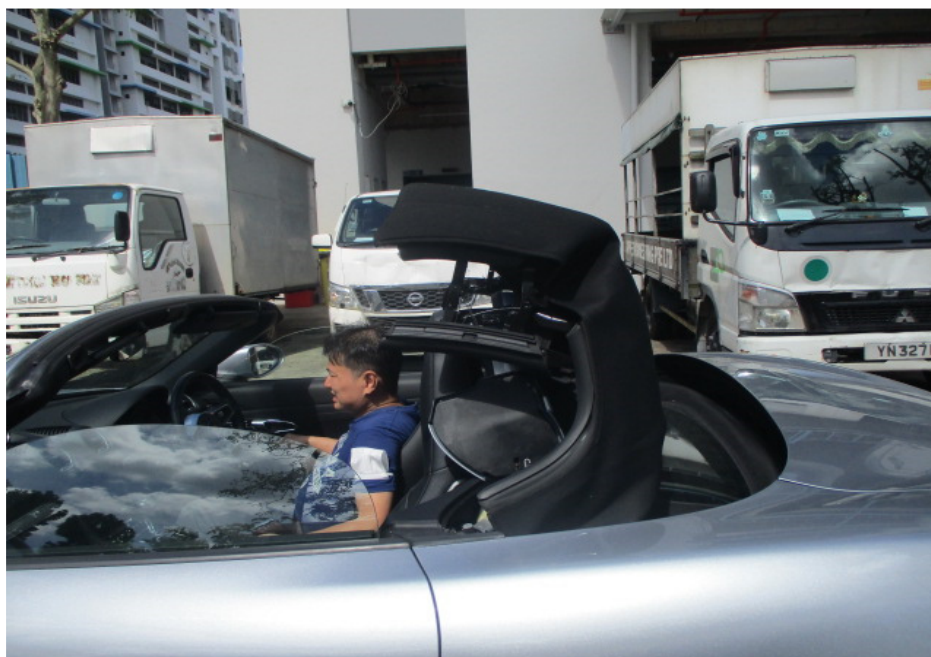
Photo 21 shows the Motor Car's soft top roof being tested. It was observed that as a safety feature, the soft top roof could only open and close when the Motor Car was in a stationary position. When opened, the soft top roof is completely folded into the rear compartment with no parts protruding out of the Motor Car's body. The soft top roof was also found adequately secured to the "A" pillar after closing.

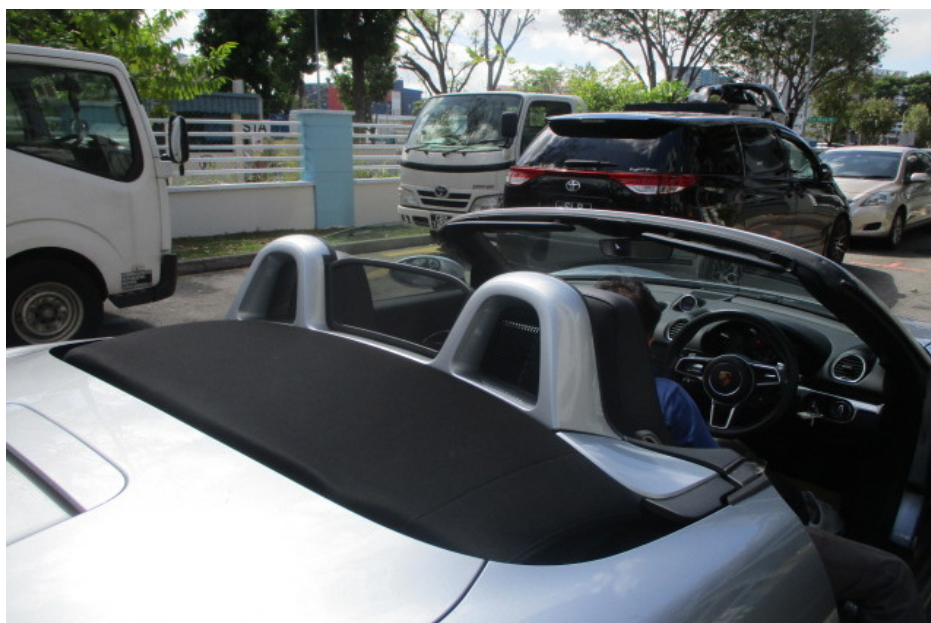
Photo 22 shows the Motor Car with its soft top roof completely folded. It was observed that as a safety feature, the soft top roof could only open and close when the Motor Car was in a stationary position. When opened, the soft top roof is completely folded into the rear compartment with no parts protruding out of the Motor Car's body. The soft top roof was also found adequately secured to the "A" pillar after closing.

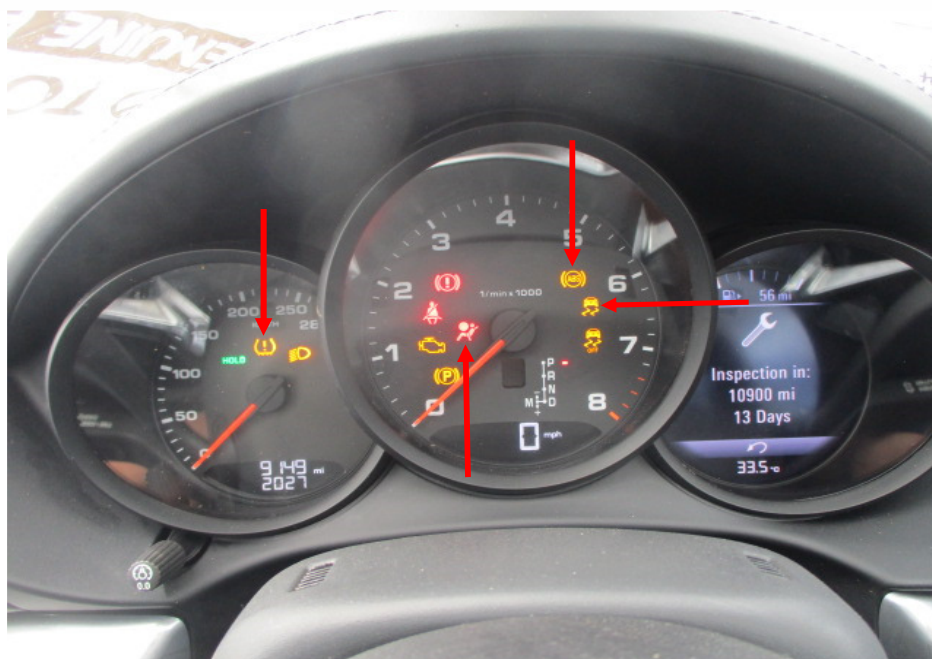
Photo 23 shows the warning lights for the various electronic safety features appearing on the instrument panel of the Motor Car during its self-test when the engine is cranked, in particular ABS, SRS, TPM and TCS lights (arrowed).

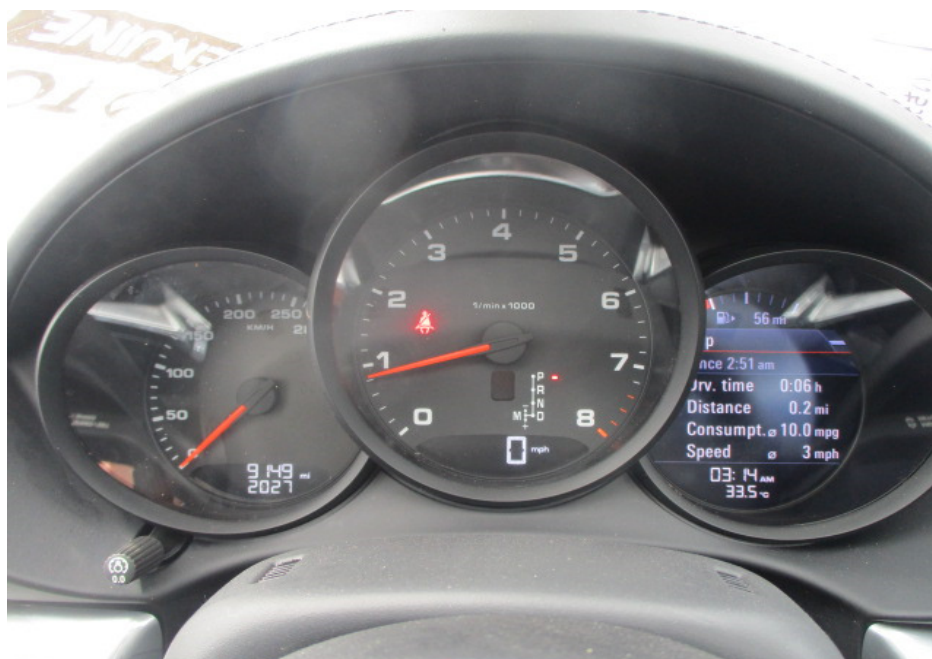
Photo 24 shows the respective warning lights no longer illuminated, indicating that there is no fault detected to ABS, SRS, TPM and TCS systems of the Motor Car during the self-test. These electronic systems were hence in working condition at the time of my inspection.

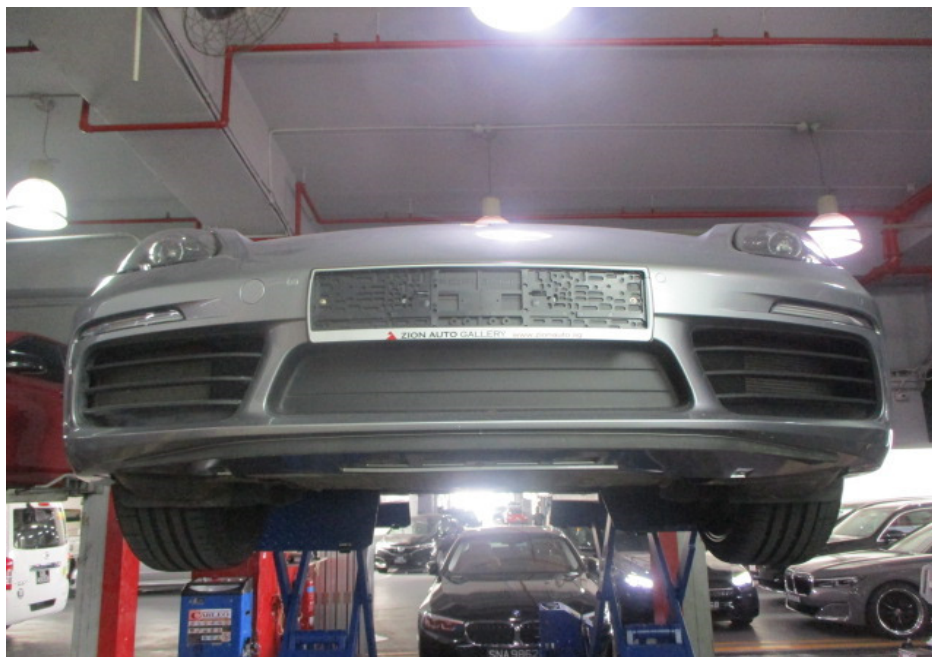
Photo 25 shows the Motor Car hoisted up for checks on its undercarriage. There was no sign(s) or indication(s) of fluid leakage and/or fluid stain(s) on the underside of the Motor Car. The undercarriage components of the Motor Car were also all observed to be intact and secured in an appropriate manner.

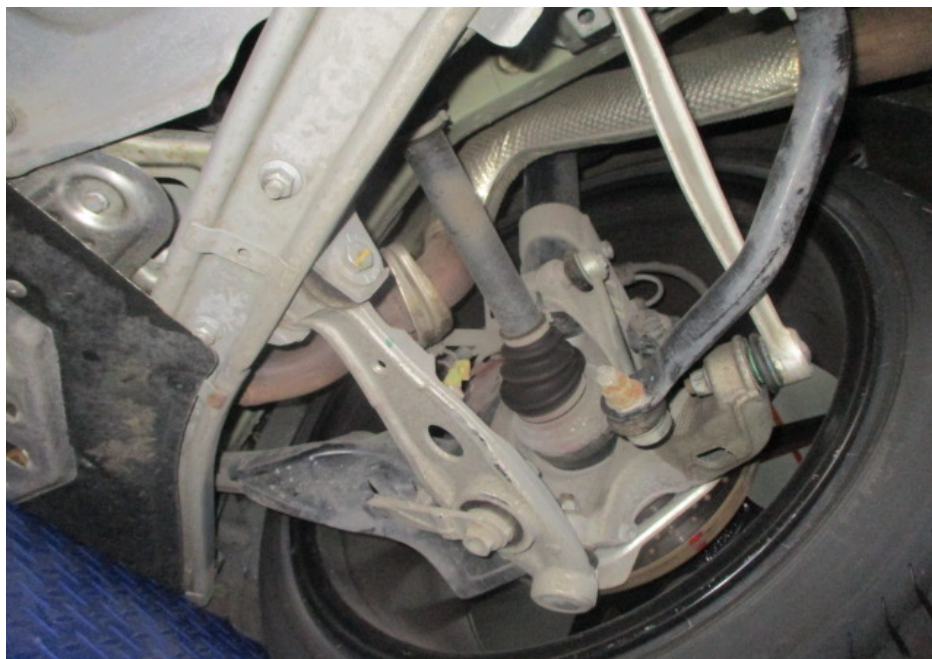
Photo 26 shows a general view of the control arms and linkages at the rear right wheel of the Motor Car. I did not observe any fluid leak and/or fluid stain on the underside of the Motor Car. All of the Motor Car's undercarriage components were observed to be intact and secured in an appropriate manner.

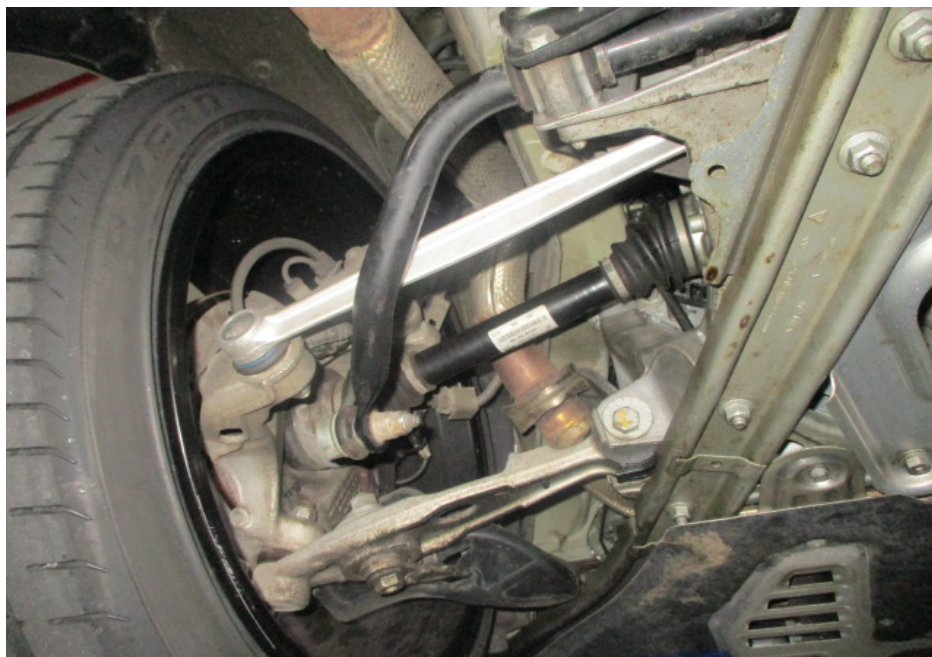
Photo 27 shows a general view of the control arms and linkages at the rear left wheel of the Motor Car. I did not observe any fluid leak and/or fluid stain on the underside of the Motor Car. All of the Motor Car's undercarriage components were observed to be intact and secured in an appropriate manner.

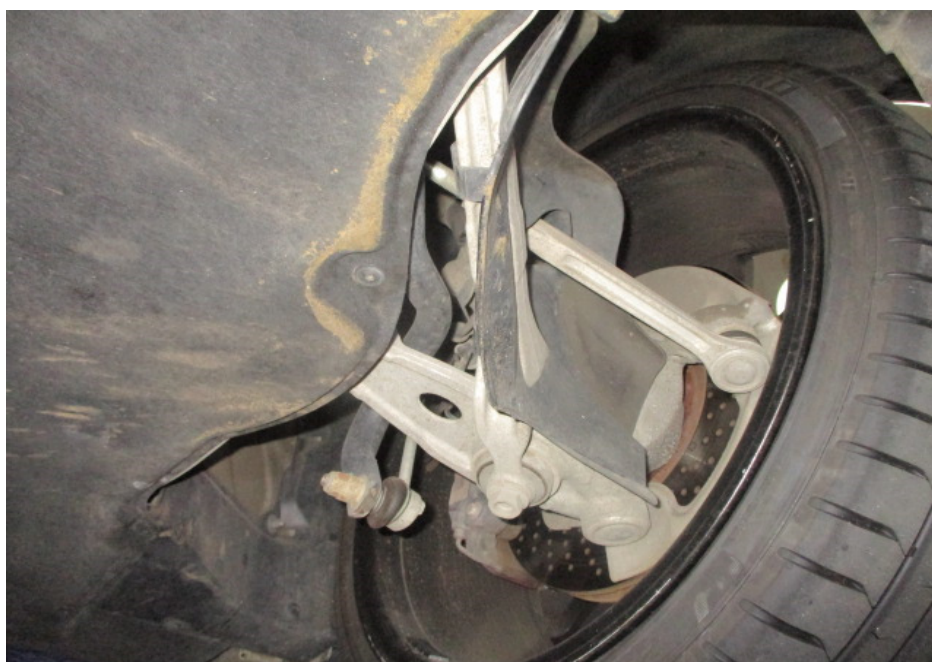
Photo 28 shows the various undercarriage components at the front left wheel of the Motor Car. The mechanical components, control arms and linkages were all found to be intact and secured in an appropriate manner.

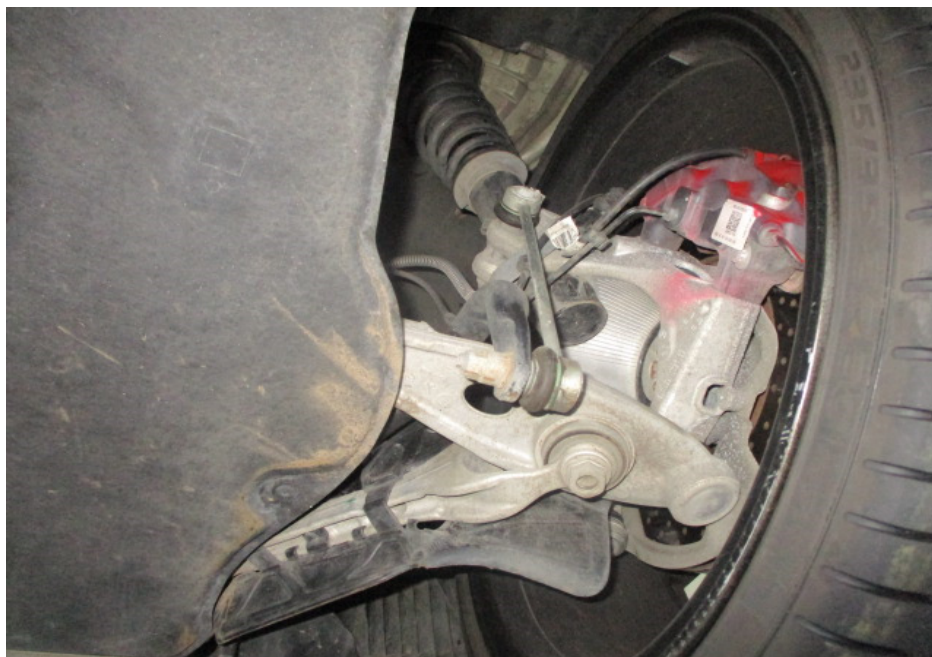
Photo 29 shows the various undercarriage components at the front right wheel of the Motor Car. The mechanical components, control arms and linkages were all found to be intact and secured in an appropriate manner. I also did not observe any fluid leak and/or fluid stain on the underside of the Motor Car.

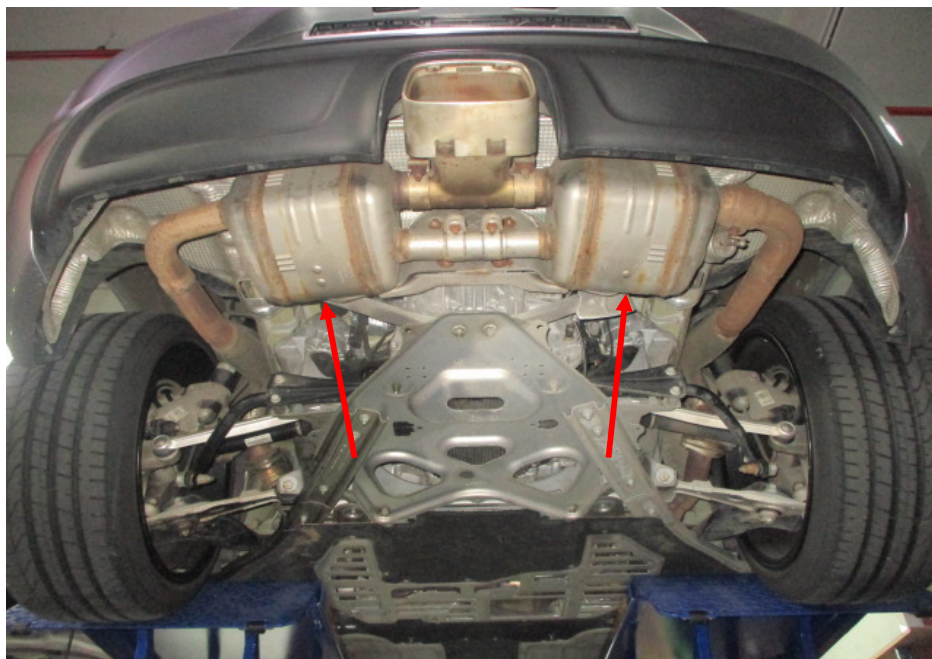
Photo 30 shows the Motor Car's rear mufflers (arrowed). My examination of the Motor Car's exhaust system revealed no sign(s) or indication(s) of any cut or weld marks along its exhaust pipes, on its catalytic converters and on its rear mufflers.

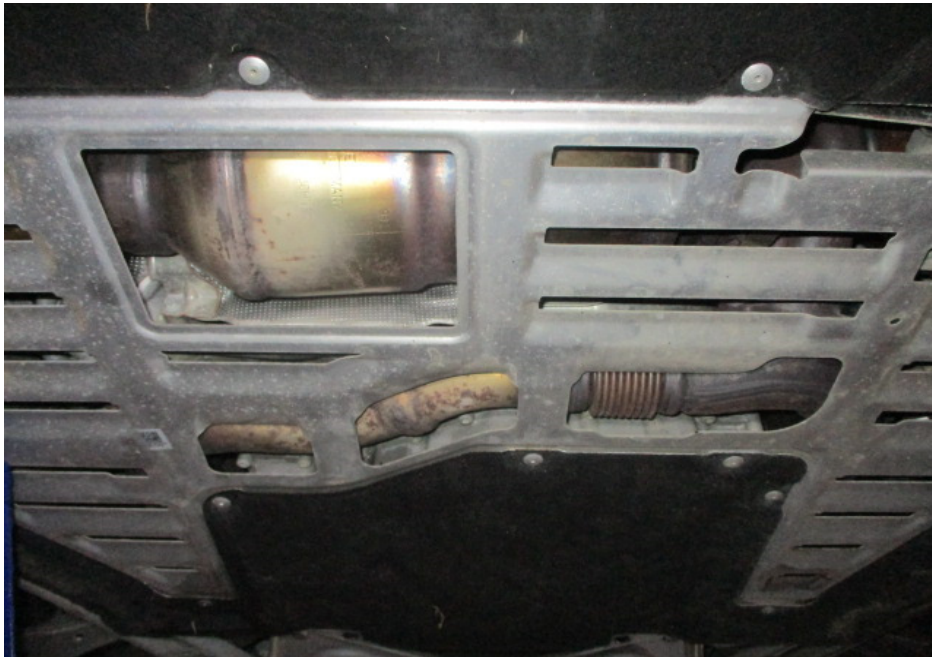
Photo 31 shows the Motor Car's catalytic converters. My examination of the Motor Car's exhaust system revealed no sign(s) or indication(s) of any cut or weld marks along its exhaust pipes, on its catalytic converters and on its rear mufflers.

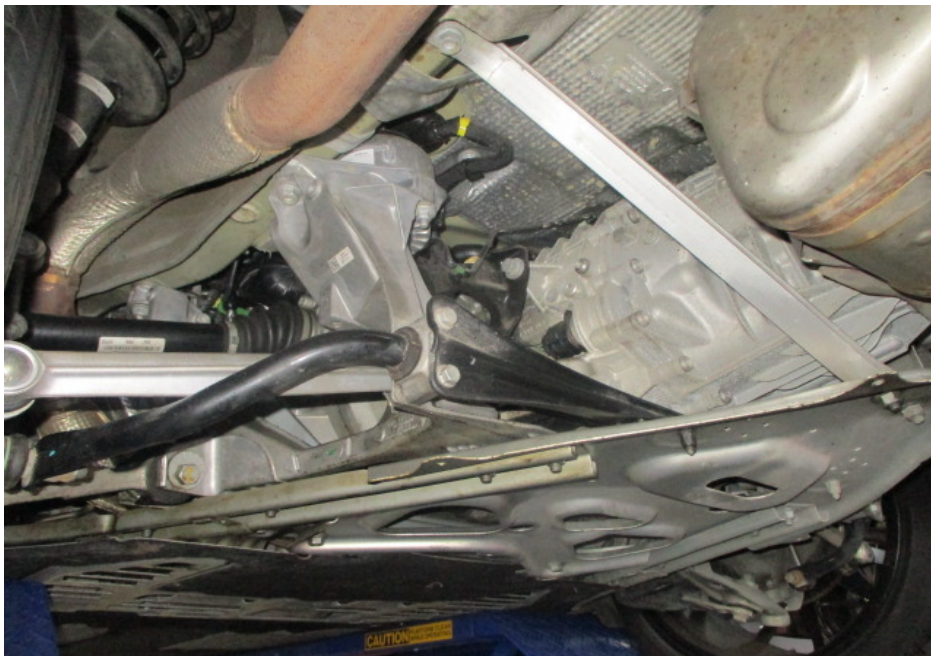
Photo 32 shows a general view of the Motor Car's engine compartment. The engine compartment was at the rear underside of the Motor Car. The various parts and components inside the engine compartment were all observed to be intact and properly fitted. There was also no sign(s) or indication(s) of fluid leak and/or fluid stain found inside the engine compartment.
