Your Ref: Porsche 718 Boxster
(chassis number WP0ZZZ98ZLS201298)
Our Ref : CI/TP22000313/D

10 January 2022

**INSPECTION REPORT OF AN UNREGISTERED PORSCHE 718 BOXSTER
MOTOR CAR WITH CHASSIS NUMBER WP0ZZZ98ZLS201298**

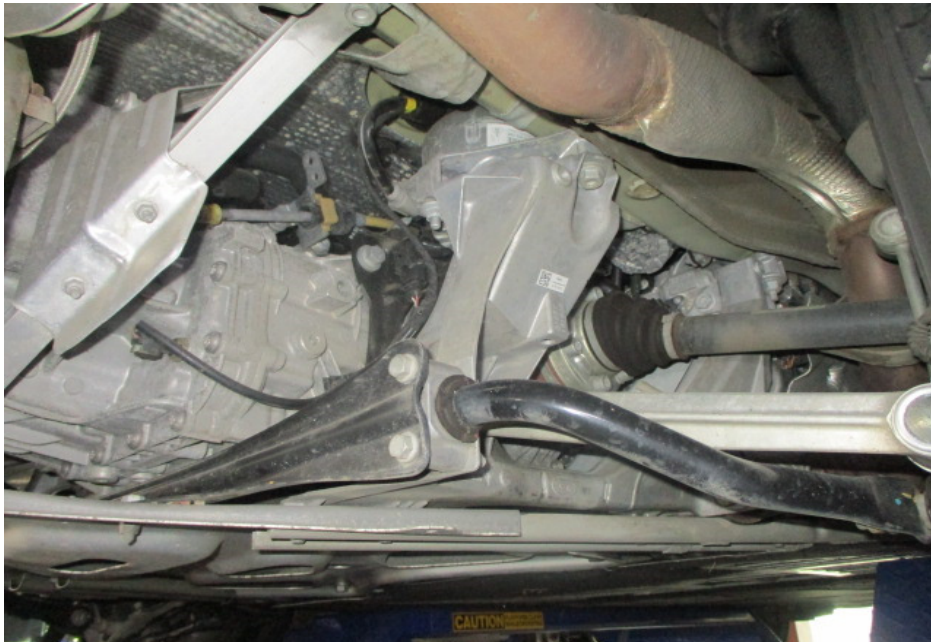
Photo 33 shows another view of the Motor Car's engine compartment. The engine compartment was at the rear underside of the Motor Car. The various parts and components inside the engine compartment were all observed to be intact and properly fitted. There was also no sign(s) or indication(s) of fluid leak and/or fluid stain found inside the engine compartment.

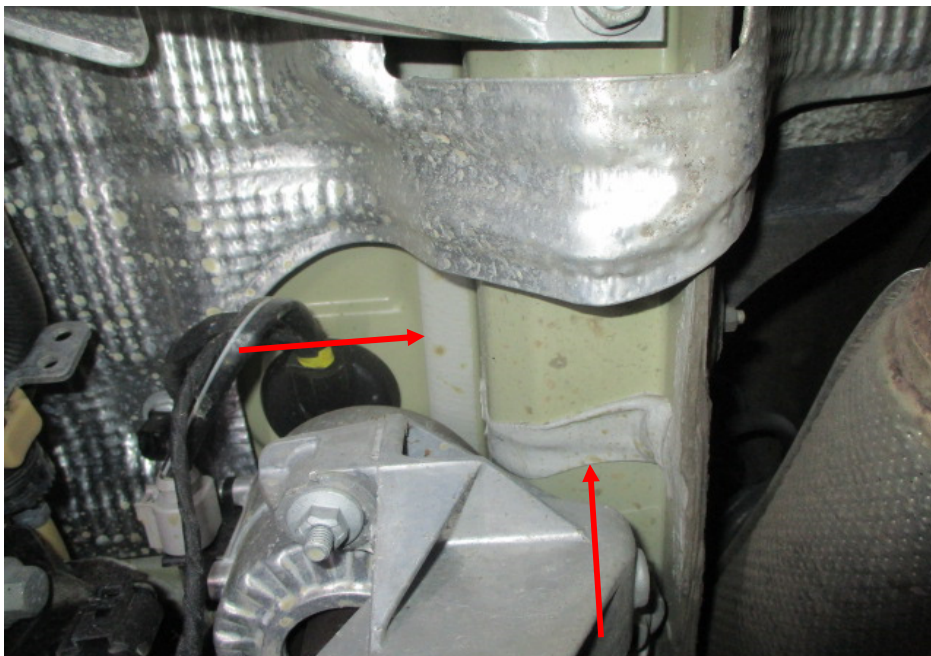
Photo 34 shows the chassis/structural body at the underside rear right of the Motor Car. I did not find any weld marks other than original spot weld marks on the chassis/structural body of the Motor Car. The original factory sealant (arrowed) at the joints along the chassis/structural body was untouched, indicating no work was done on the chassis/structural body of the Motor Car and that the chassis/structural body was originally fitted.

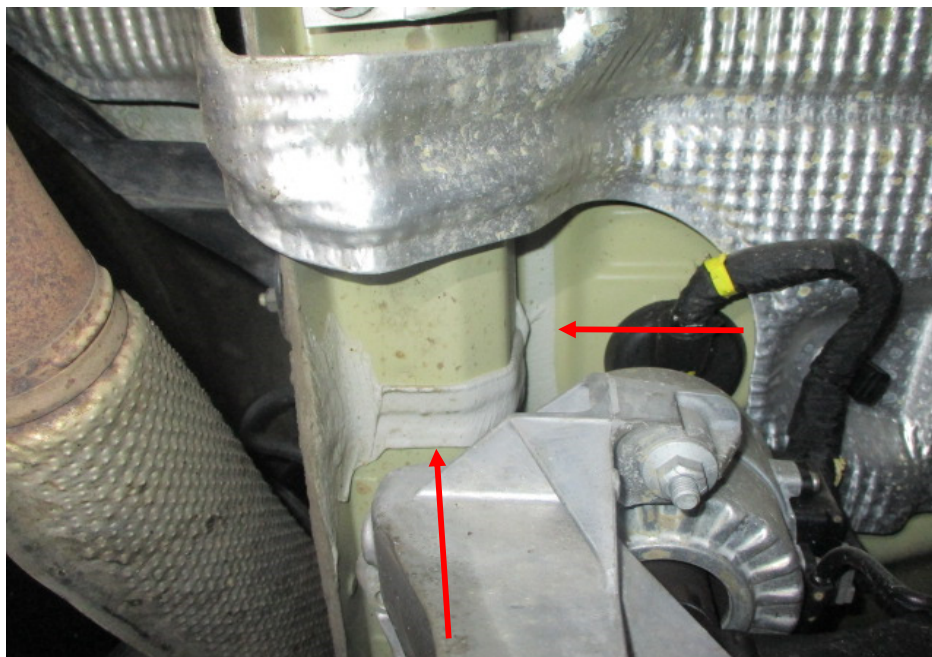
Photo 35 shows the chassis/structural body at the underside rear left of the Motor Car. The original factory sealant (arrowed) at the joints along the chassis/structural body was observed to be untouched. In general, I had found no work was carried out on the chassis/structural body of the Motor Car. The chassis/structural body of the Motor Car was originally fitted.

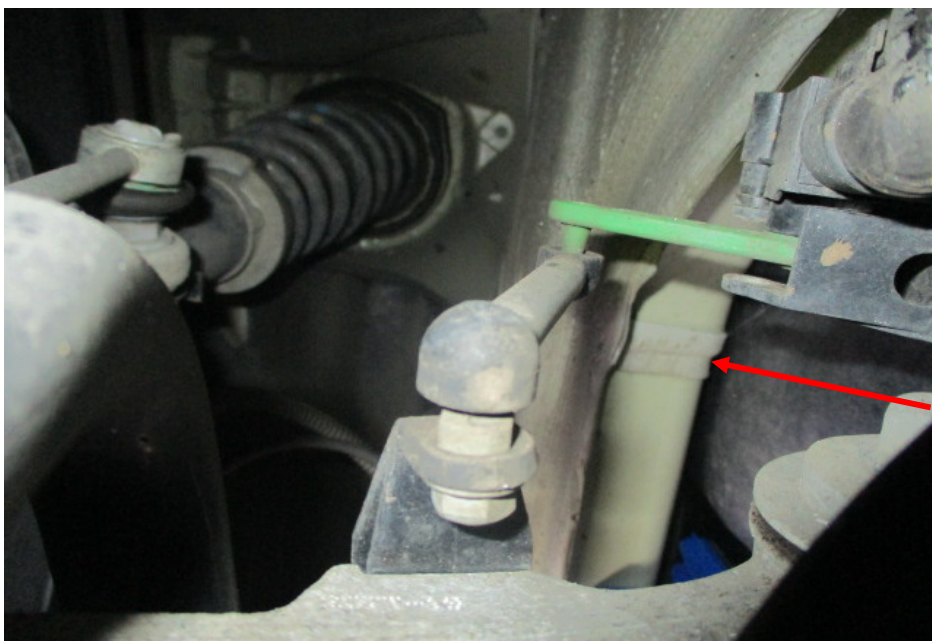
Photo 36 shows the chassis/structural body at the underside front left of the Motor Car. I did not find any weld marks other than original spot weld marks on the chassis/structural body of the Motor Car. The original factory sealant (arrowed) at the joints along the chassis/structural body was untouched, indicating no work was done on the chassis/structural body of the Motor Car and that the chassis/structural body was originally fitted.

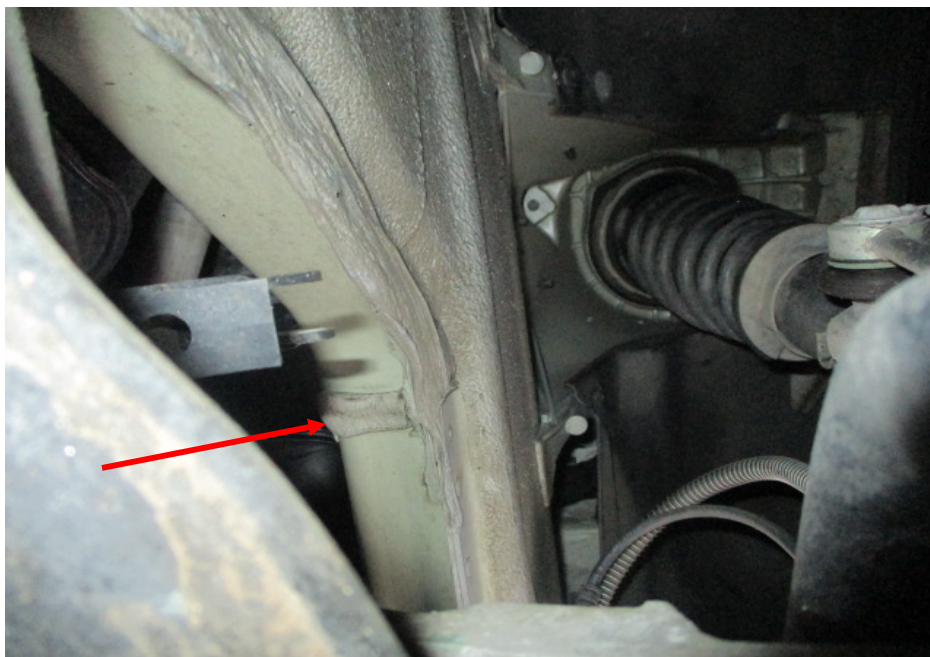
Photo 37 shows the chassis/structural body at the underside front right of the Motor Car. The original factory sealant (arrowed) at the joints along the chassis/structural body was observed to be untouched. In general, I had found no work was carried out on the chassis/structural body of the Motor Car. The chassis/structural body of the Motor Car was originally fitted.

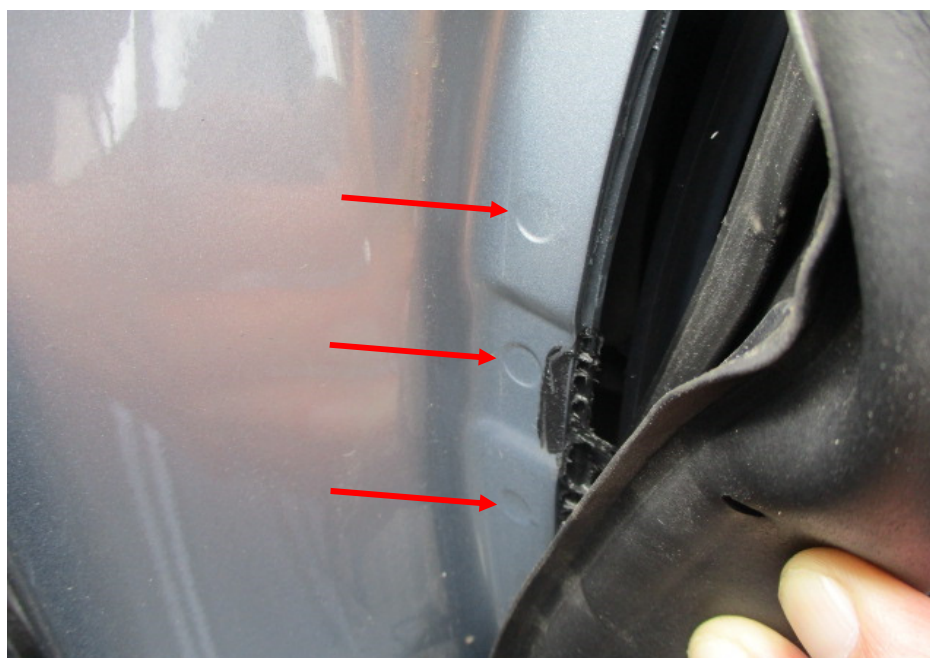
Photo 38 shows the left side "A" pillar of the Motor Car. I did not find any weld marks other than original spot weld marks (arrowed) on the left side "A" pillar of the Motor Car which, indicates that there was no re-welding works carried out. In general, I had found all the non-detachable body panels of the Motor Car to be originally fitted at the time of my inspection.

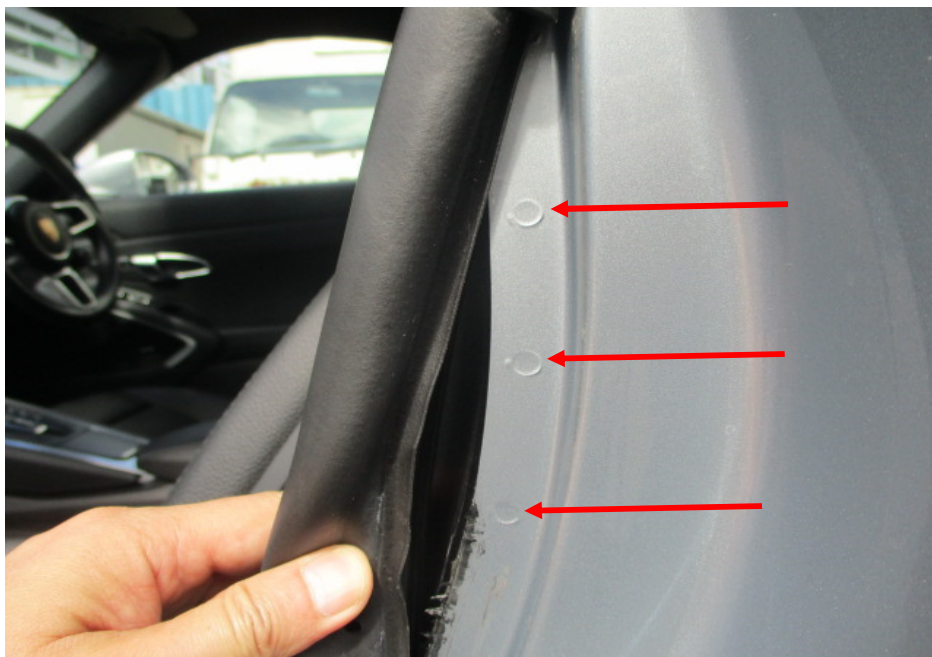
Photo 39 shows the rear left body panel of the Motor Car. I did not find any weld marks other than original spot weld marks (arrowed) on the rear left body panel of the Motor Car, which indicates that there was no re-welding works carried out. In general, I had found all the non-detachable body panels of the Motor Car to be originally fitted at the time of my inspection.

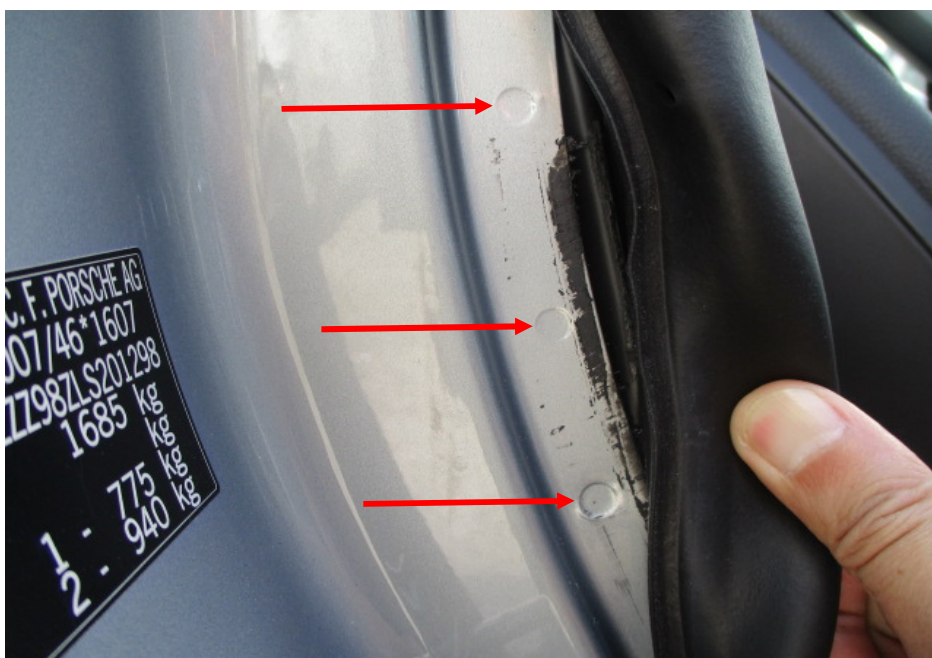
Photo 40 shows the rear right body panel of the Motor Car. I did not find any weld marks other than original spot weld marks (arrowed) on the rear right body panel of the Motor Car, which indicates that there was no re-welding works carried out. In general, I had found all the non-detachable body panels of the Motor Car to be originally fitted at the time of my inspection.

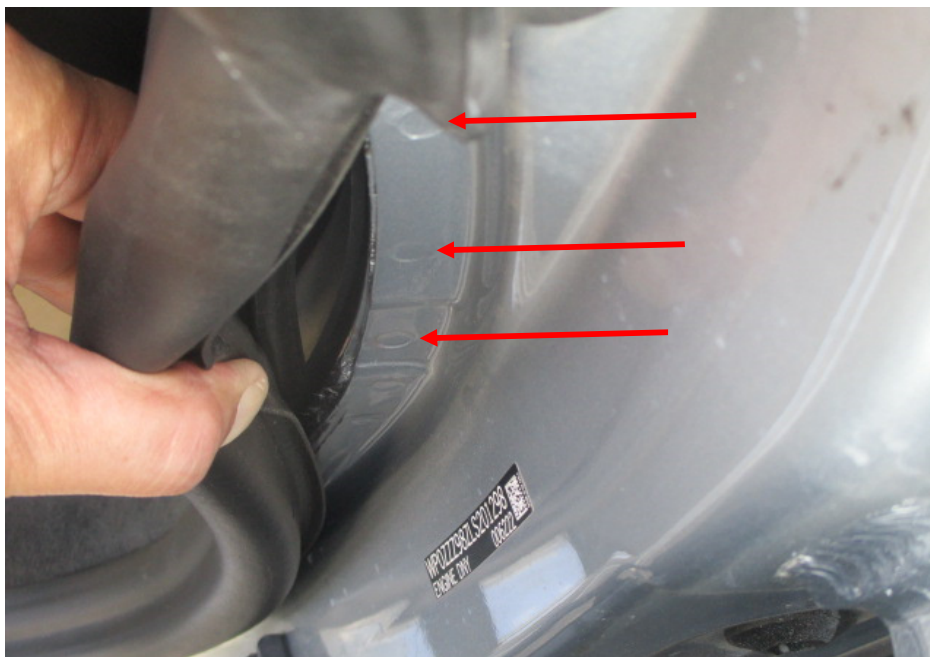
Photo 41 shows the right side “A” pillar of the Motor Car. I did not find any weld marks other than original spot weld marks (arrowed) on the right side “A” pillar of the Motor Car which, indicates that there was no re-welding works carried out. In general, I had found all the non-detachable body panels of the Motor Car to be originally fitted at the time of my inspection.
