Your Ref: BM M5
(chassis number WBSJF02090CE60106)
Our Ref : CI/TP22000314/D

08 January 2022

INSPECTION REPORT OF AN UNREGISTERED BMW M5 MOTOR CAR WITH CHASSIS NUMBER WBSJF02090CE60106

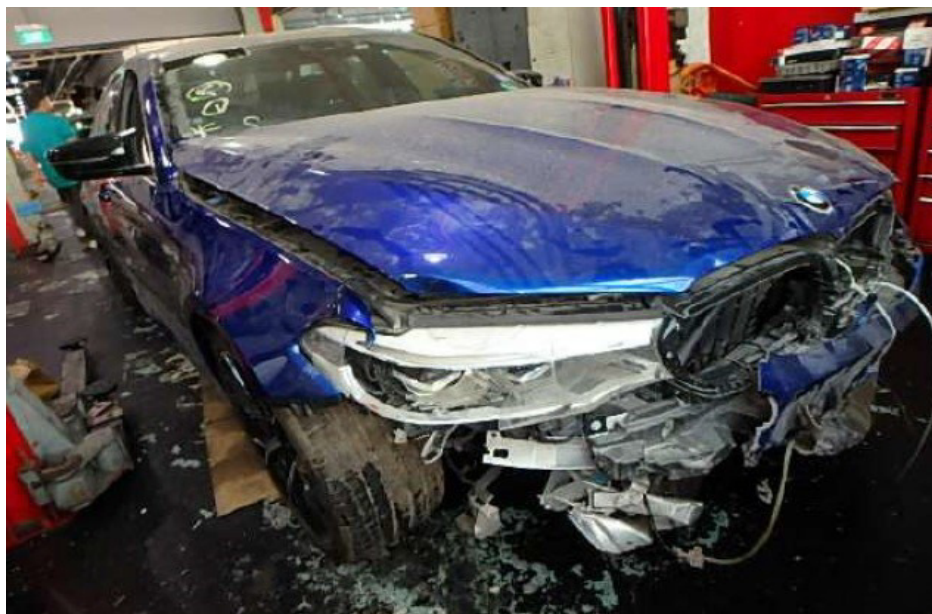
Photo 1 shows the front right body of the Motor Car (photograph provided to me). The photographs provided to me had showed damage to the frontal portion of the Motor Car. The front bumper, front bumper reinforcement, front bumper right lower grille, front bumper centre grille, radiator grilles, front bonnet, front right headlamp, front right fender, front right fender inner shield and front right radiator were amongst the body parts that were observed to have been damaged.

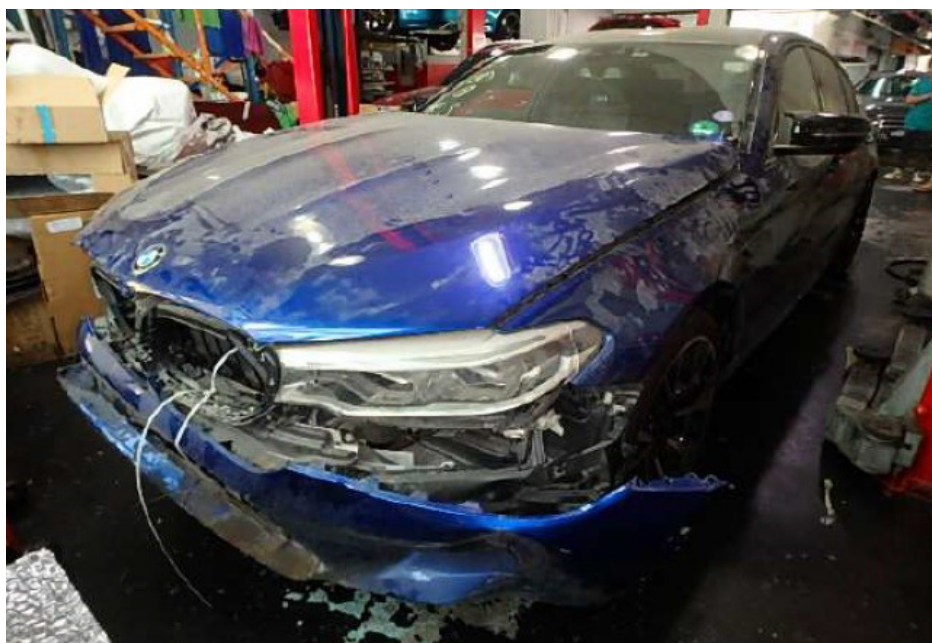
Photo 2 shows the front left body of the Motor Car (photograph provided to me). The photographs provided to me had showed damage to the frontal portion of the Motor Car. The front bumper, front bumper sponge, front bumper left lower grille, radiator grilles, front bonnet, front bonnet hinges and front left headlamp were amongst the body parts that were observed to have been damaged. The airbag(s) of the Motor Car appears to have been not deployed as seen from the photographs that were provided to me.

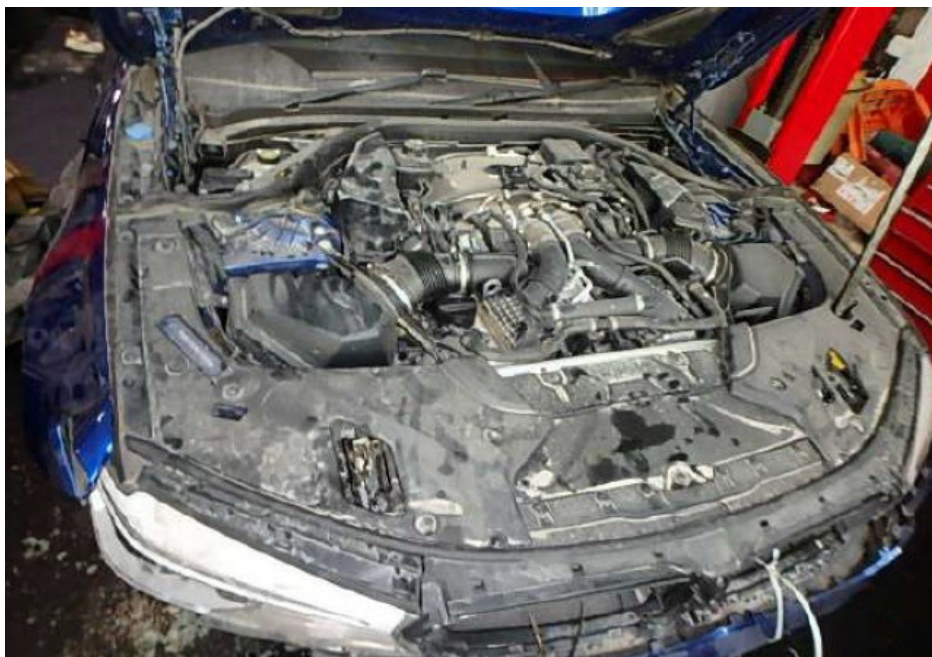
Photo 3 shows the engine compartment of the Motor Car (photograph provided to me). The various parts and components within the engine compartment were all intact and unaffected.

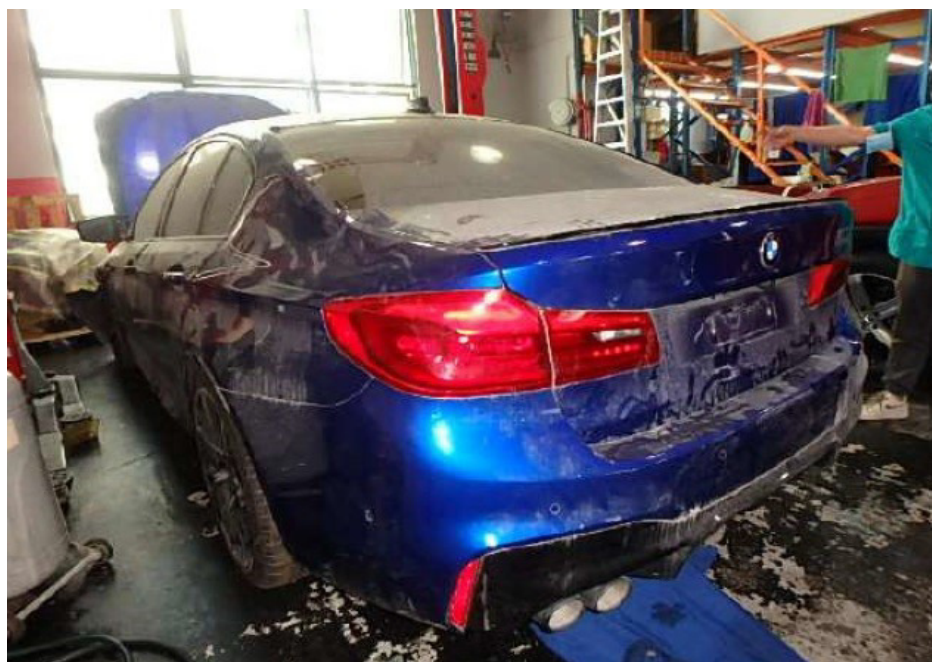
Photo 4 shows the rear left body of the Motor Car (photograph provided to me). Apart for the frontal portion, there was no physical damage observed to other areas of the Motor Car. The airbag(s) appears to have been not deployed as seen from the photographs that were provided to me.

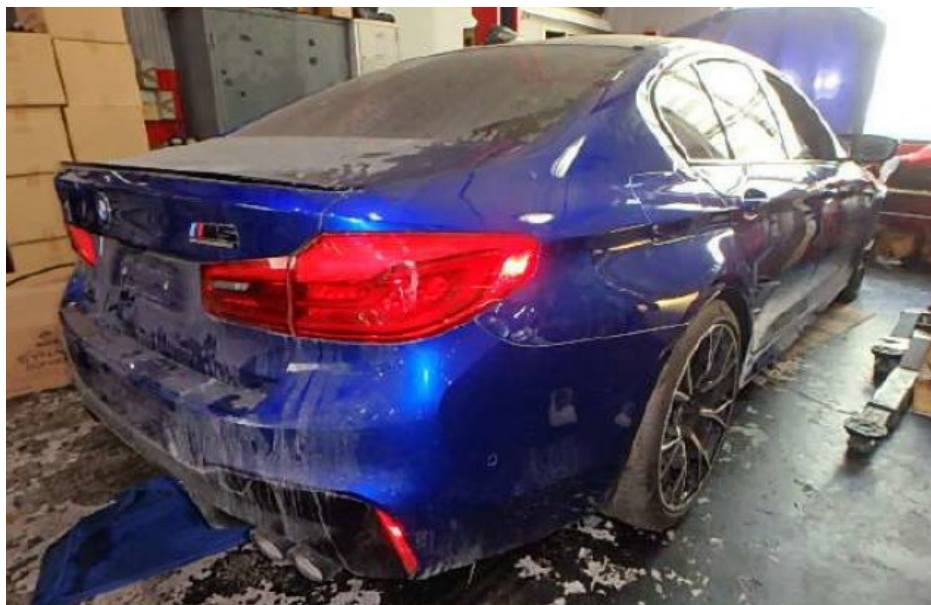
Photo 5 shows the rear right body of the Motor Car (photograph provided to me). Apart for the frontal portion, there was no physical damage observed to other areas of the Motor Car.

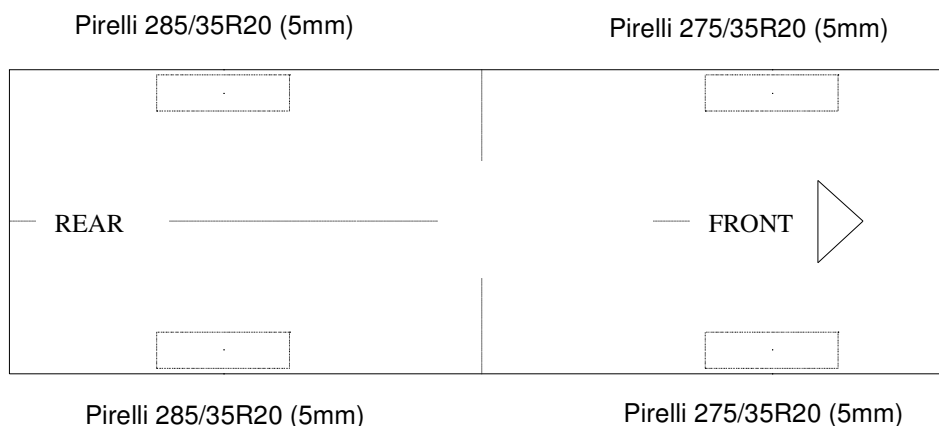
8. It was fitted with 20inch sport wheel rims that were wrapped with tyres that were observed to be of serviceable condition. The tyres were also sufficiently inflated for vehicular operation. The tyre brand, tyre size and approximate remaining tread depth of the 4 tyres of the Motor Car were recorded as follows: -

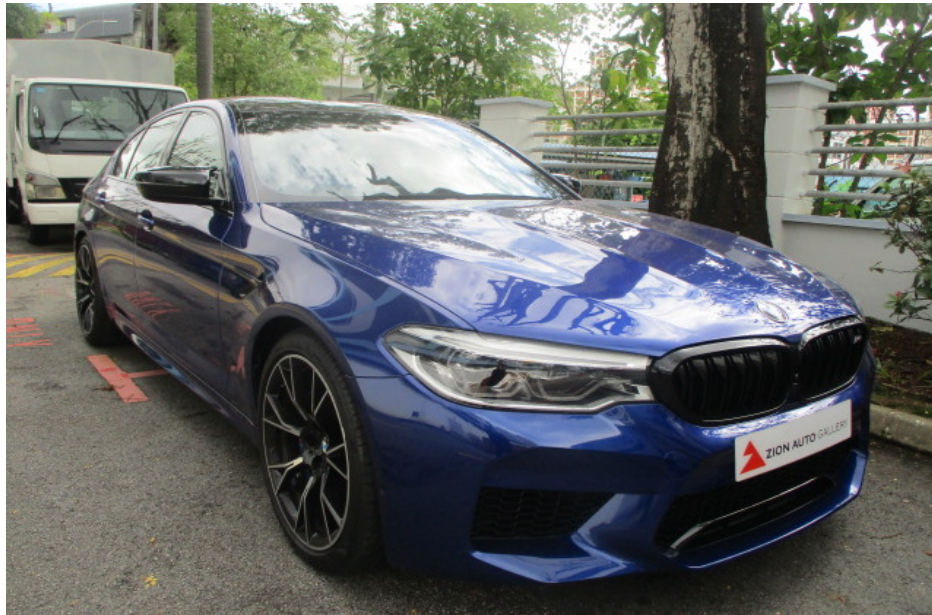
Photo 6 shows a general view of the front right body of the Motor Car at the time of my inspection. The Motor Car was observed to be in a relatively good general condition with no loose exterior fittings observed. The body parts at the frontal portion of the Motor Car were visually examined and it was observed that the repair/restoration works carried out to the damaged area of the Motor Car (refer to photograph 1 & 2 above) were reasonably adequate and in order.

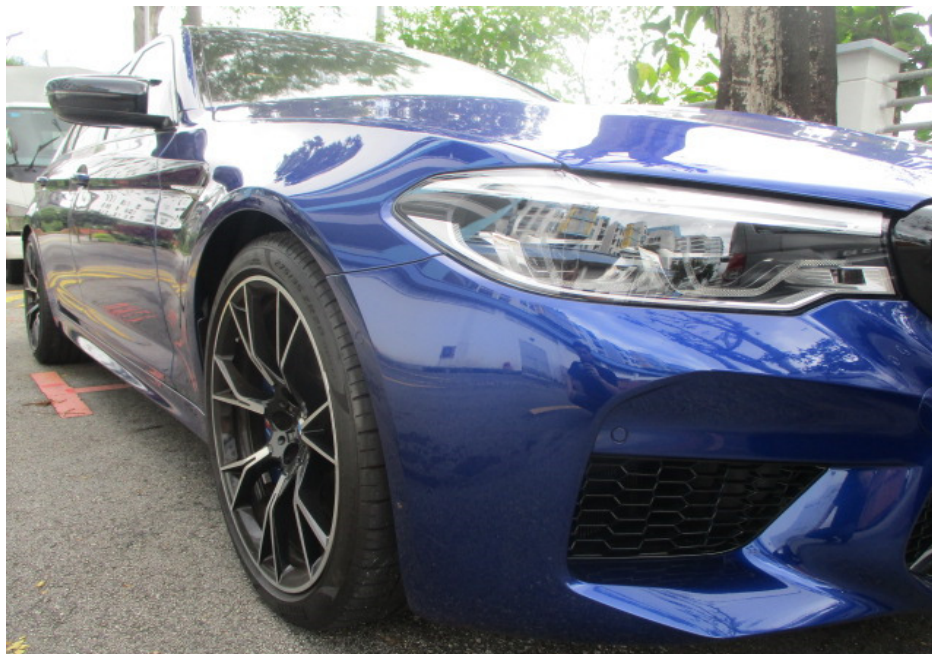
Photo 7 shows a closer view of the Motor Car's front bumper, front bumper right lower grille, front right headlamp and front right fender at the time of my inspection. The body parts at the frontal portion of the Motor Car were visually examined and it was observed that the repair/restoration works carried out to the damaged area of the Motor Car (refer to photograph 1 & 2 above) were reasonably adequate and in order.

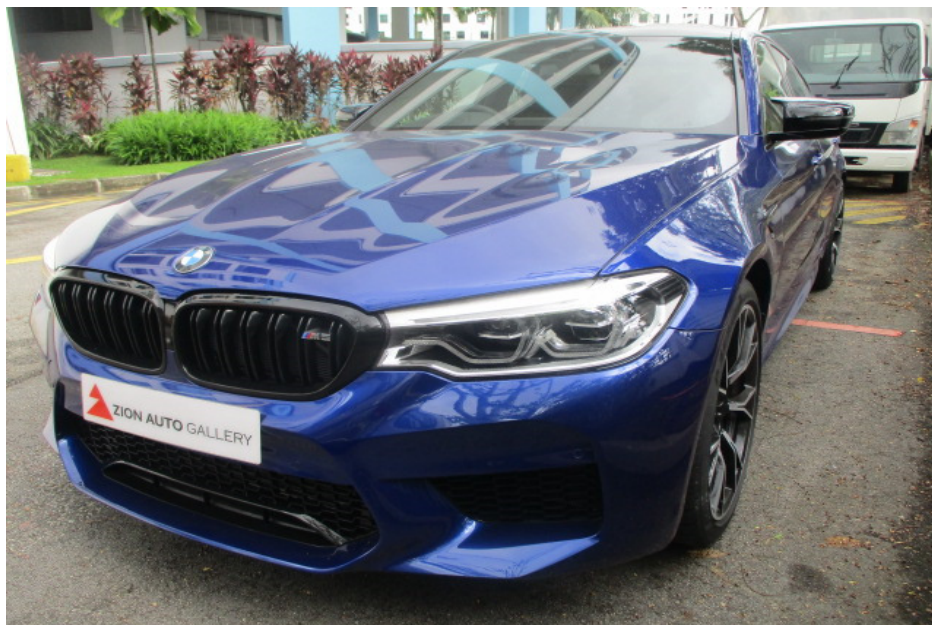
Photo 8 shows a general view of the front left body of the Motor Car at the time of my inspection. The Motor Car was observed to be in a relatively good general condition with no loose exterior fittings observed. The body parts at the frontal portion of the Motor Car were visually examined and it was observed that the repair/restoration works carried out to the damaged area of the Motor Car (refer to photograph 1 & 2 above) were reasonably adequate and in order.

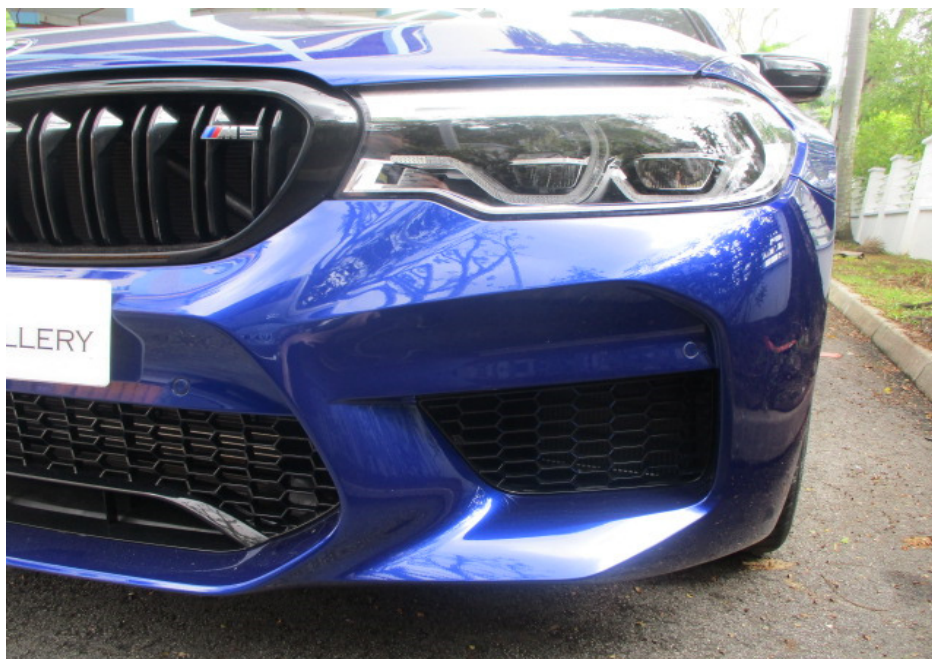
Photo 9 shows a closer view of the Motor Car's front bumper, front bumper left lower grille, front bumper sensors and front left headlamp at the time of my inspection. The body parts at the frontal portion of the Motor Car were visually examined and it was observed that the repair/restoration works carried out to the damaged area of the Motor Car (refer to photograph 1 & 2 above) were reasonably adequate and in order.

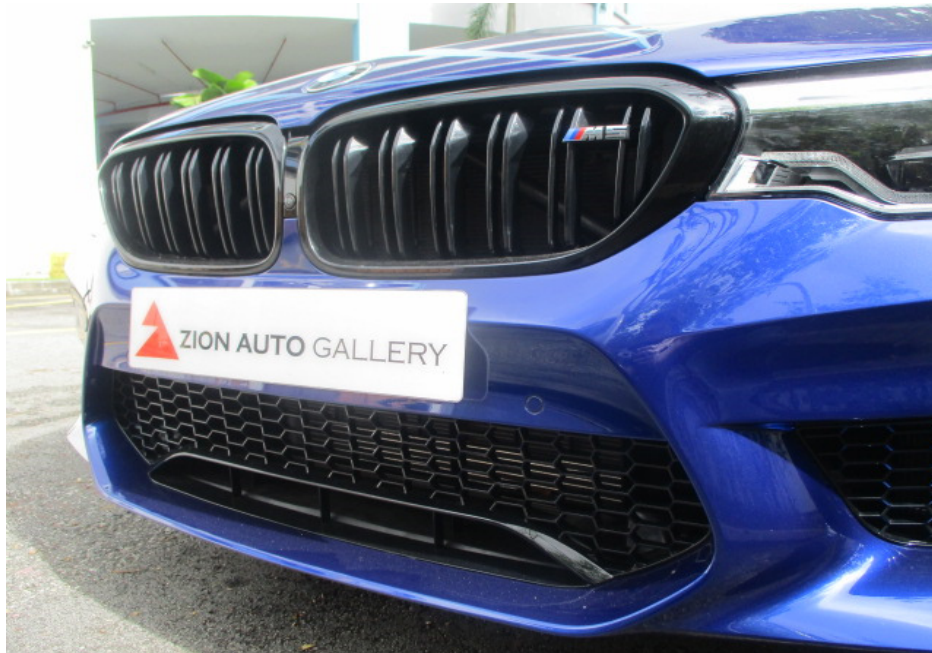
Photo 10 shows a closer view of the Motor Car's front bumper, front bumper centre lower grille, front bumper sensors and radiator grilles at the time of my inspection. The body parts at the frontal portion of the Motor Car were visually examined and it was observed that the repair/restoration works carried out to the damaged area of the Motor Car (refer to photograph 1 & 2 above) were reasonably adequate and in order.

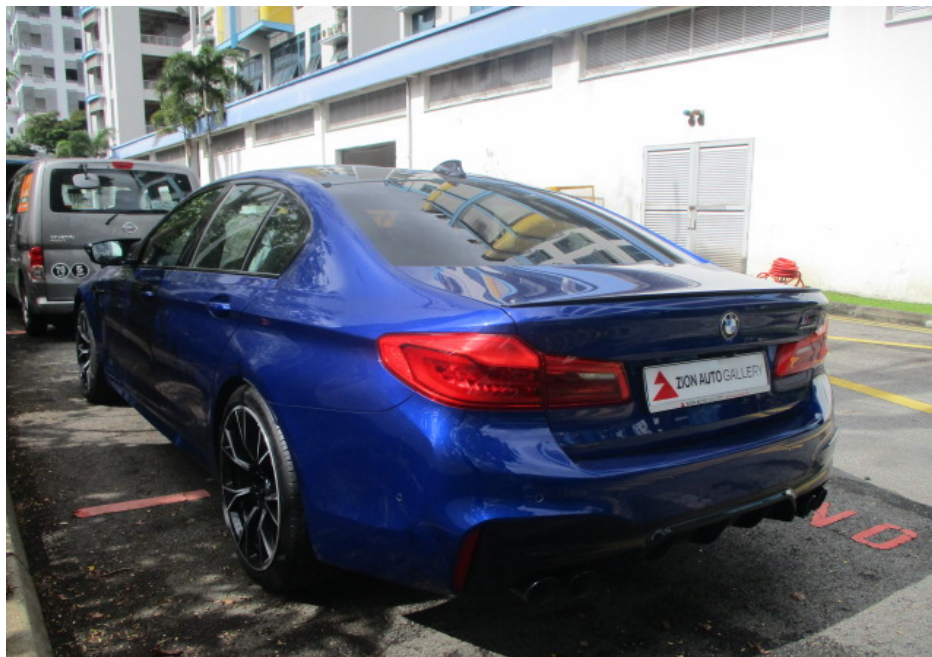
Photo 11 shows a general view of the rear left body of the Motor Car at the time of my inspection. The Motor Car was observed to be in a relatively good general condition with no loose exterior fittings observed. The mileage of the Motor Car recorded at the time of my inspection was 3,190km.

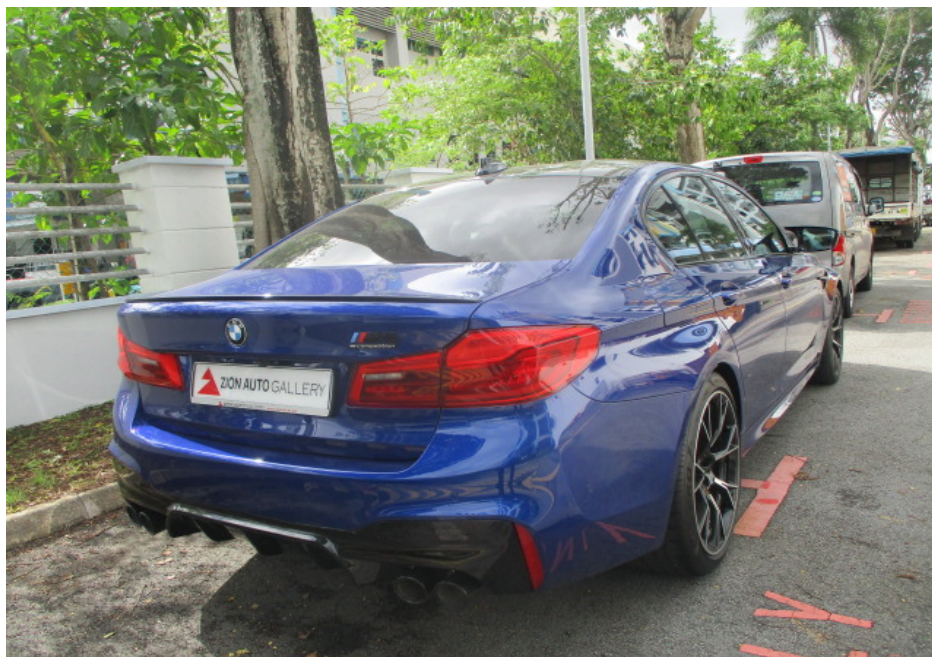
Photo 12 shows a general view of the rear right body of the Motor Car at the time of my inspection. The Motor Car was observed to be in a relatively good general condition with no loose exterior fittings observed. The mileage of the Motor Car recorded at the time of my inspection was 3,190km.

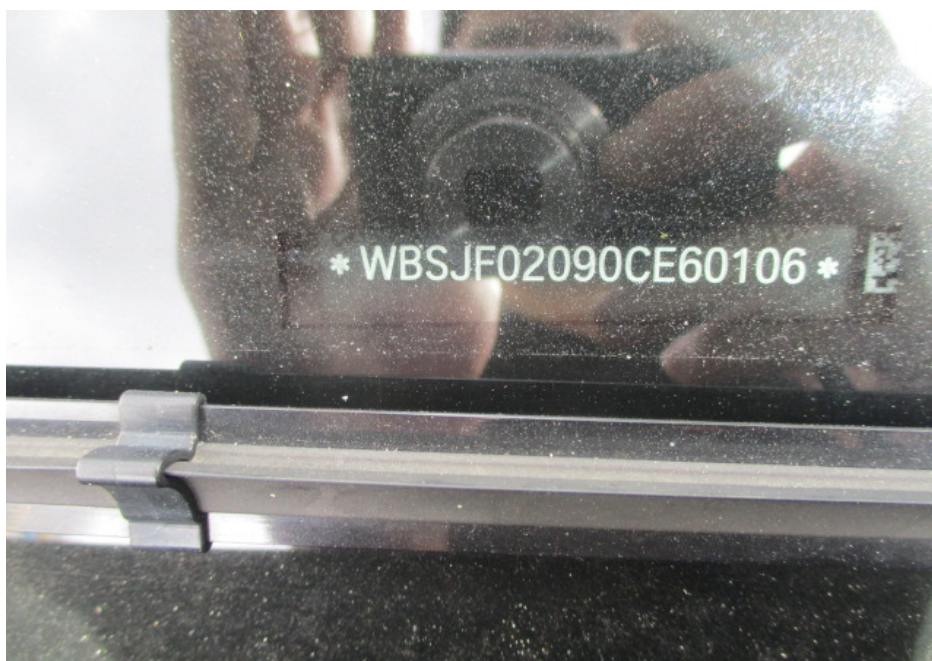
Photo 13 shows the chassis number of the Motor Car. The chassis number recorded was WBSJF02090CE60106.

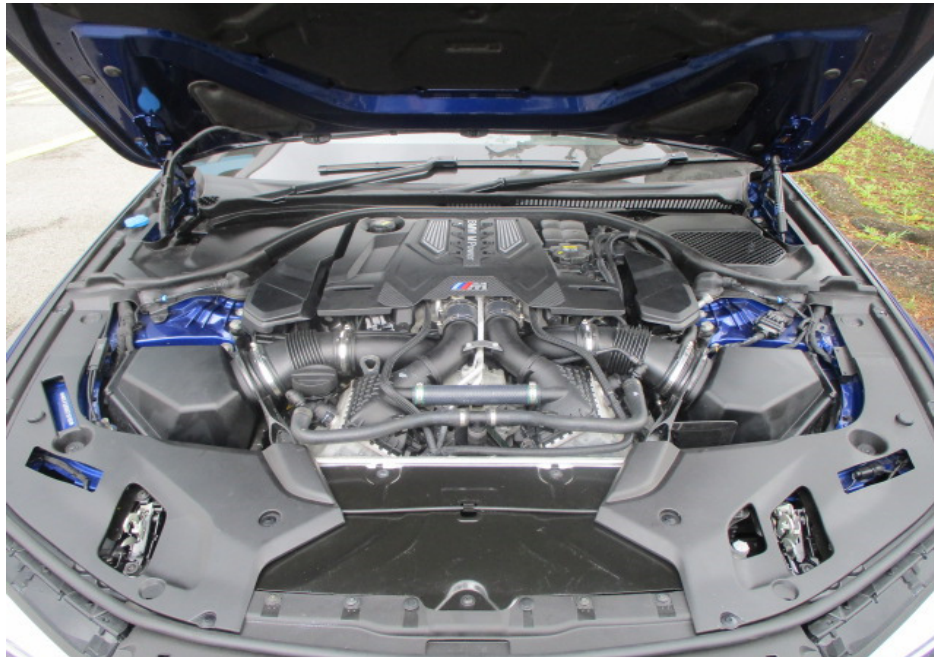
Photo 14 shows a general view of the engine compartment of the Motor Car at the time of my inspection. The various parts and components inside the engine compartment were all observed to be intact and properly fitted. There was also no sign(s) or indication(s) of fluid leak and/or fluid stain found inside the engine compartment.

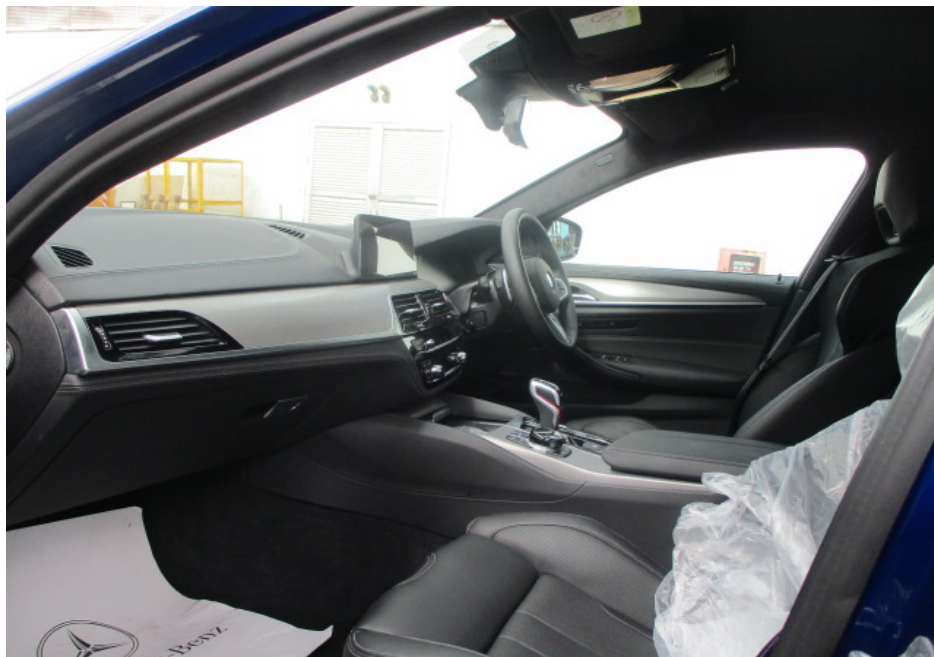
Photo 15 shows the interior compartment of the Motor Car at the time of my inspection. The various parts and components, trims, carpet, and upholstery inside the interior compartment were all observed to be intact and properly fitted.

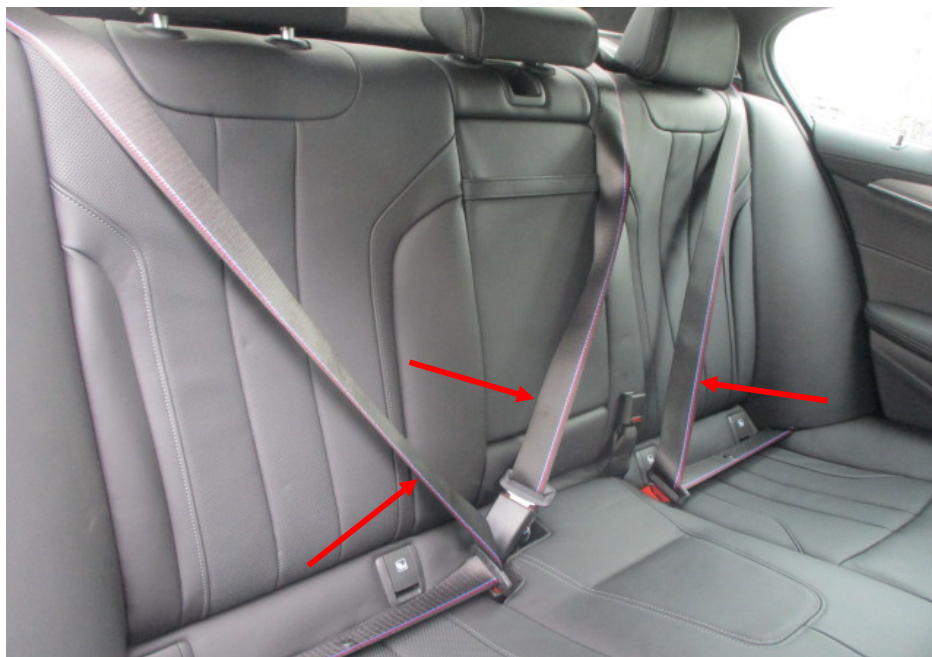
Photo 16 shows the rear seats of the Motor Car. All the seats of the Motor Car were secured via seat rails to the floorboard. They were also fitted with a retractable seat belt reel and a pre-tensioner. The seat belts (arrowed) were tested and were able to be fastened into the respective pre-tensions that were fitted on the side of each individual seat.

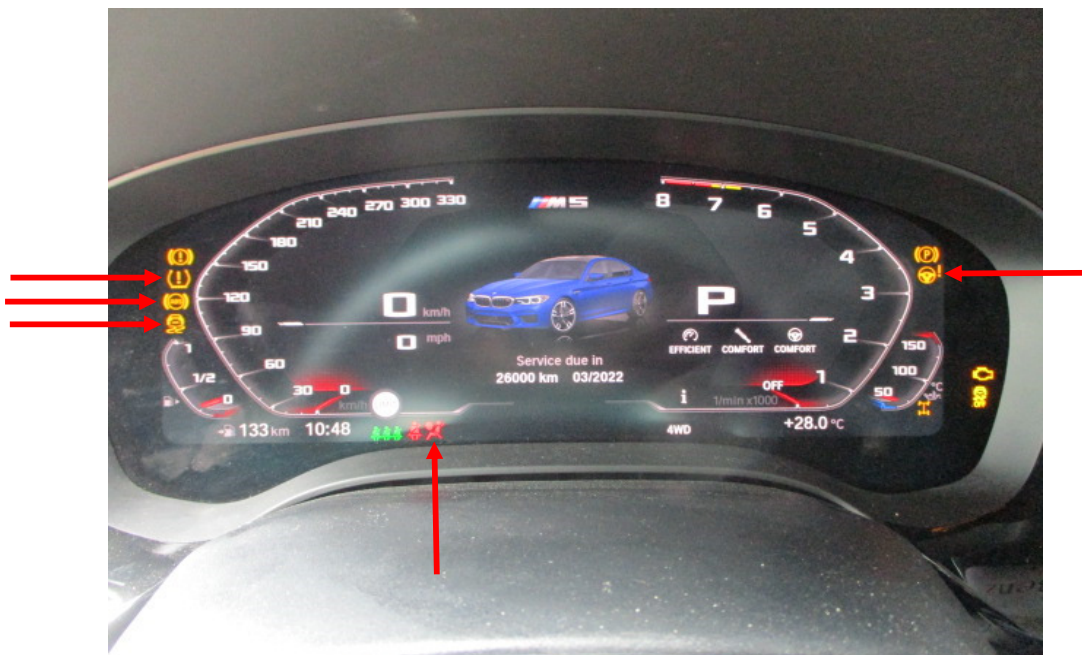
Photo 17 shows the warning lights for the various electronic safety features appearing on the instrument panel of the Motor Car during its self-test when the engine is cranked, in particular the ABS, SRS, IAS, TPM and DSC lights (arrowed).

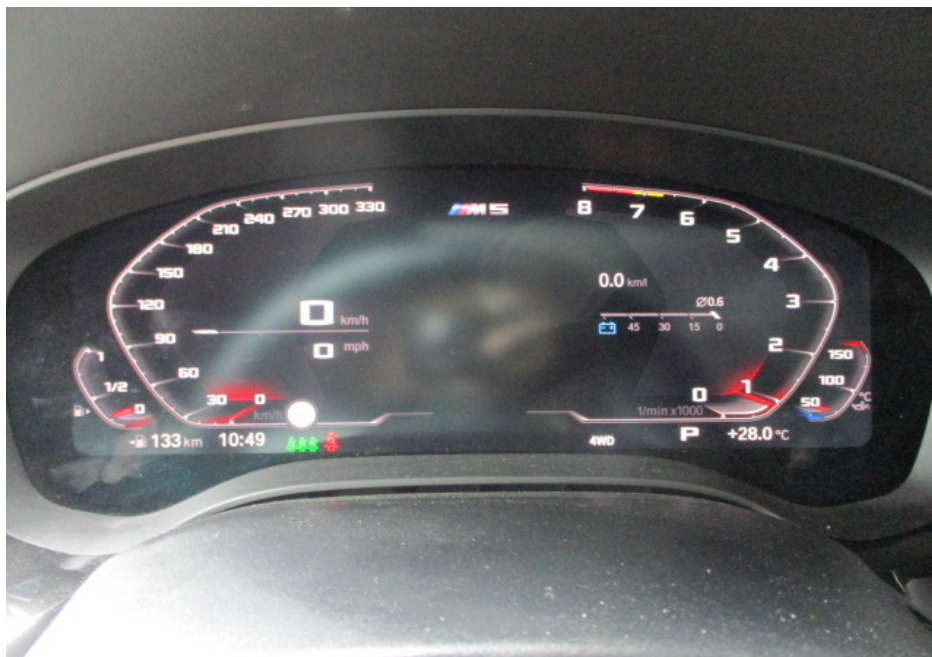
Photo 18 shows the respective warning lights no longer illuminated, indicating that there is no fault detected to the ABS, SRS, IAS, TPM and DSC systems of the Motor Car during the self-test. These electronic systems were hence in working condition at the time of my inspection.

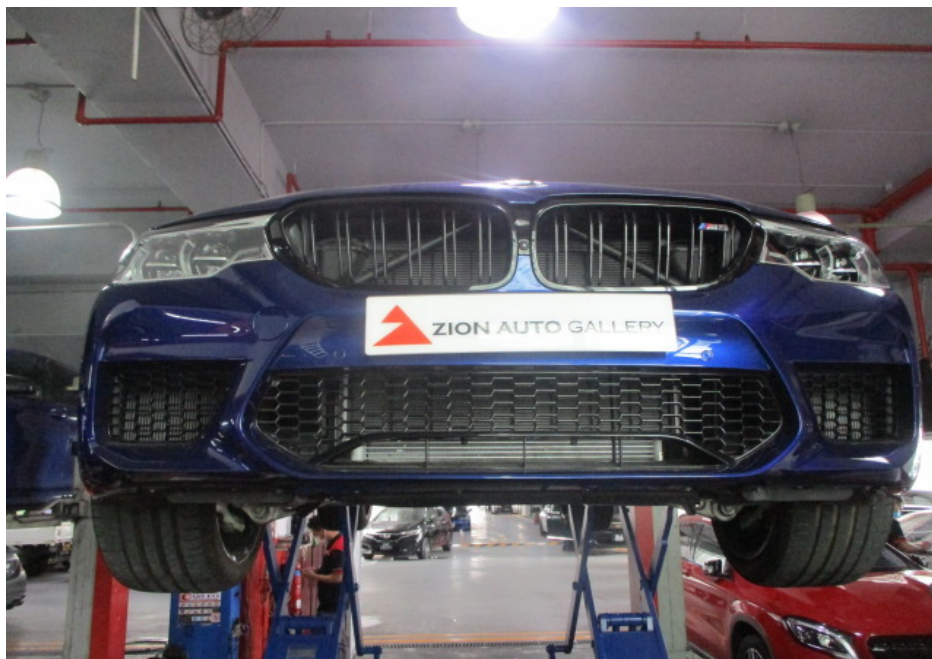
Photo 19 shows the Motor Car hoisted up for checks on its undercarriage. There was no sign(s) or indication(s) of fluid leakage and/or fluid stain(s) on the underside of the Motor Car. The undercarriage components of the Motor Car were also all observed to be intact and secured in an appropriate manner.

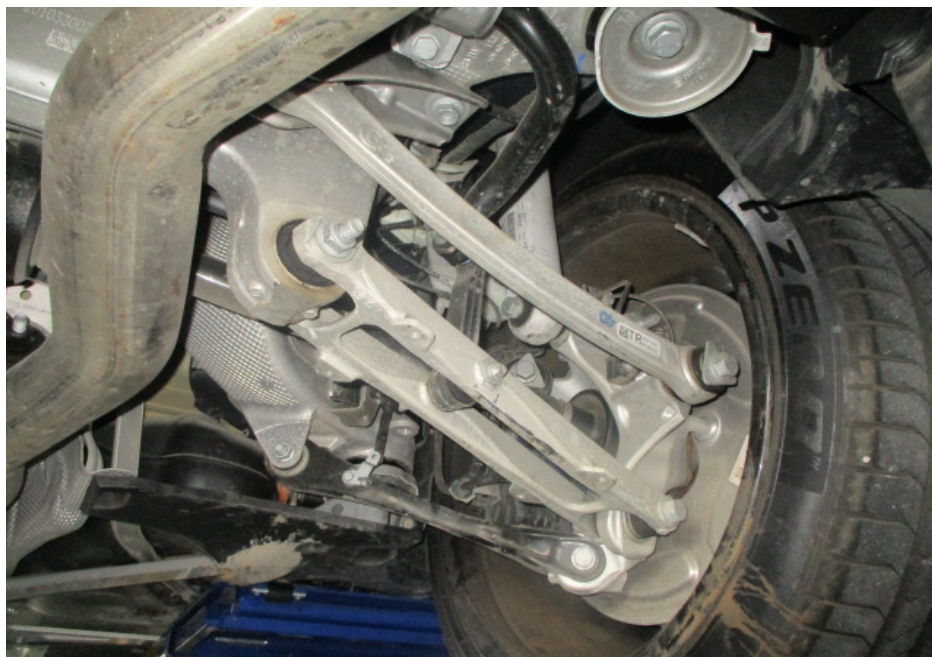
Photo 20 shows a general view of the control arms and linkages at the rear right wheel of the Motor Car. I did not observe any fluid leak and/or fluid stain on the underside of the Motor Car. All of the Motor Car's undercarriage components were observed to be intact and secured in an appropriate manner.

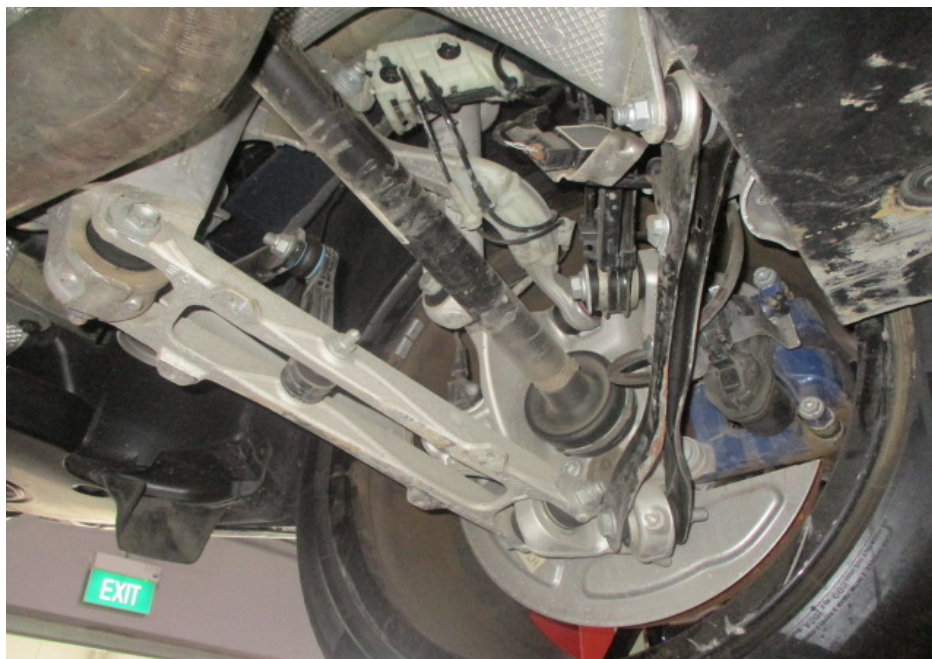
Photo 21 shows a general view of the control arms and linkages at the rear left wheel of the Motor Car. I did not observe any fluid leak and/or fluid stain on the underside of the Motor Car. All of the Motor Car's undercarriage components were observed to be intact and secured in an appropriate manner.

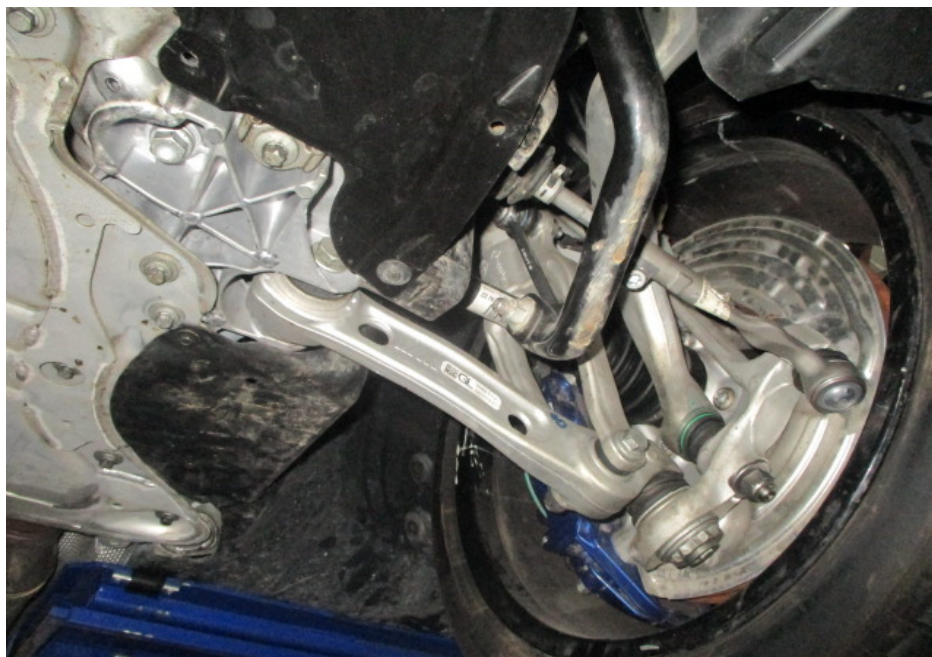
Photo 22 shows the various undercarriage components at the front left wheel of the Motor Car. The mechanical components, control arms and linkages were all found to be intact and secured in an appropriate manner.

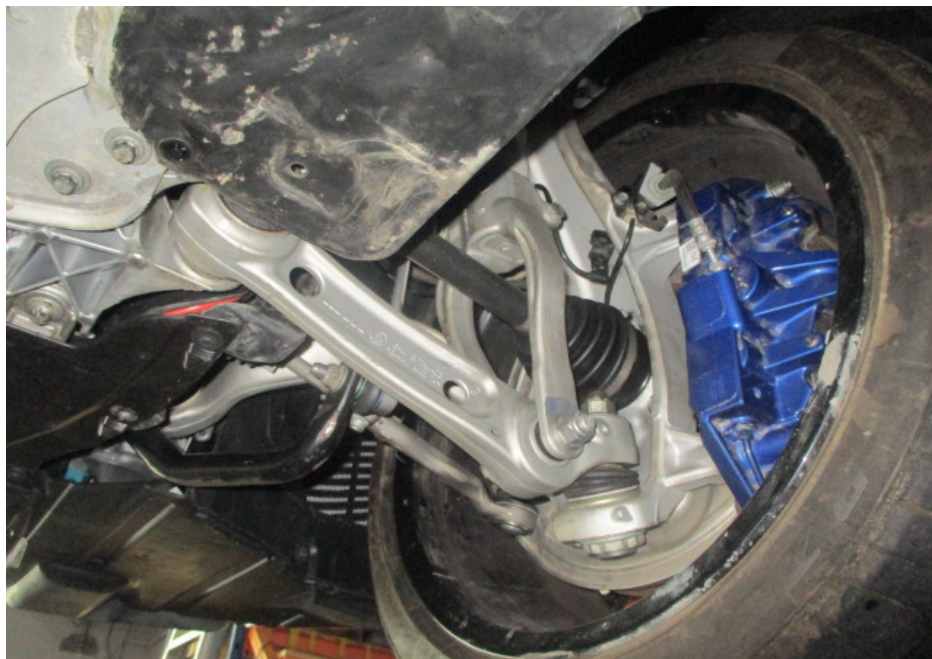
Photo 23 shows the various undercarriage components at the front right wheel of the Motor Car. The mechanical components, control arms and linkages were all found to be intact and secured in an appropriate manner. I also did not observe any fluid leak and/or fluid stain on the underside of the Motor Car.

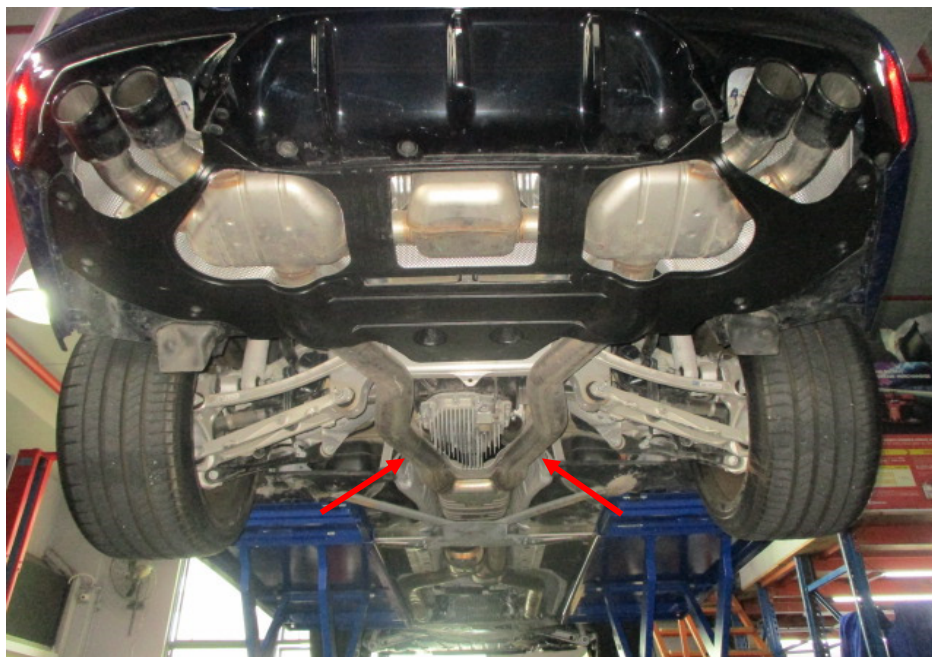
Photo 24 shows the rear section of the Motor Car's exhaust system. My examination of the Motor Car's exhaust system revealed no sign(s) or indication(s) of any cut or weld marks along its exhaust pipes (arrowed), on its rear mufflers, on its centre resonator boxes and on its catalytic converters.

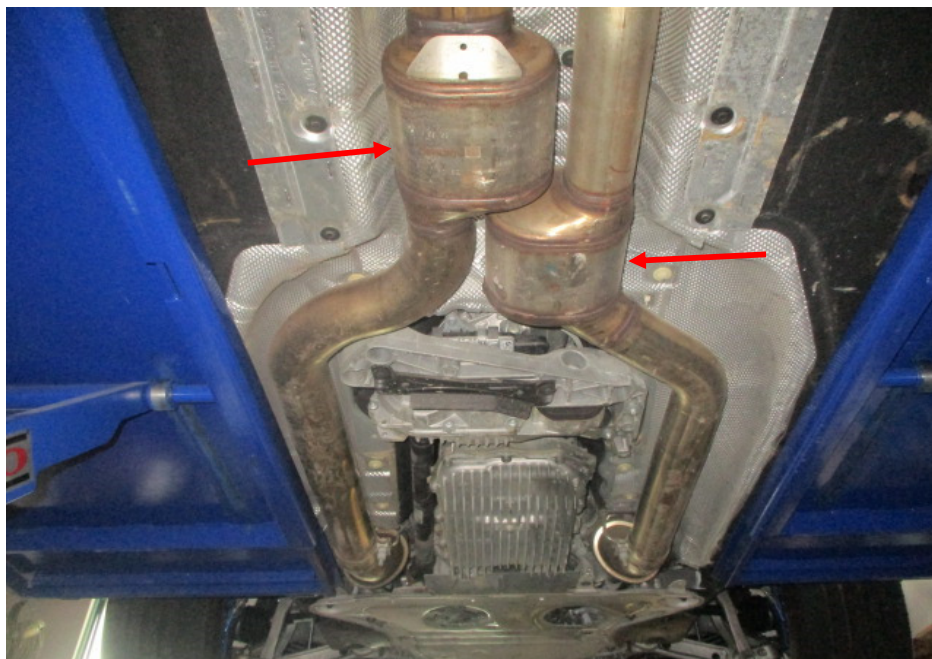
Photo 25 shows the front section of the Motor Car's exhaust system. My examination of the Motor Car's exhaust system revealed no sign(s) or indication(s) of any cut or weld marks along its exhaust pipes, on its rear mufflers, on its centre resonator boxes (arrowed) and on its catalytic converters.

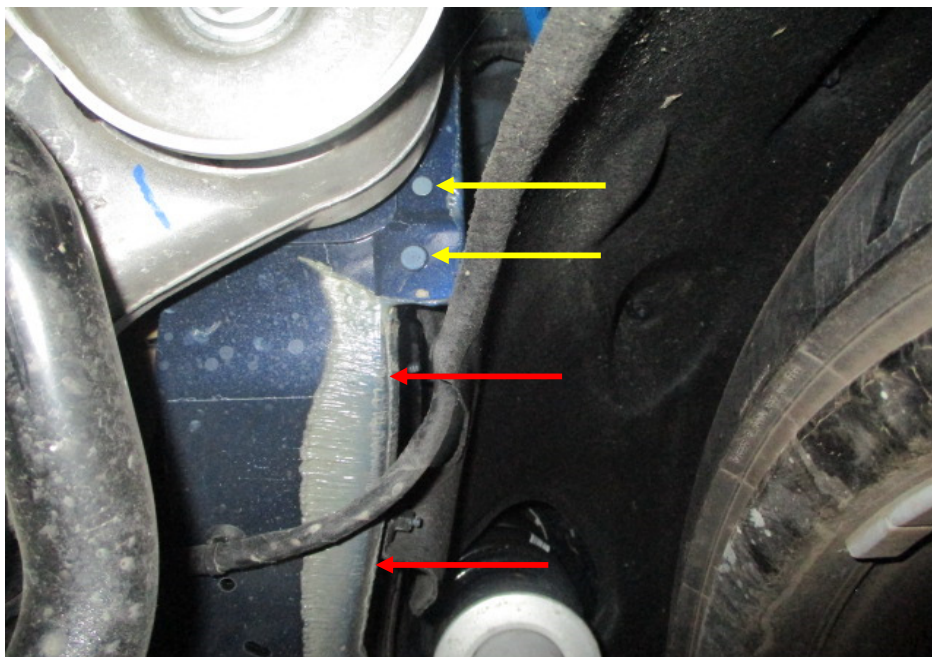
Photo 26 shows the chassis/structural body at the underside rear right of the Motor Car. I did not find any weld marks other than original spot weld marks (yellow arrow) on the chassis/structural body of the Motor Car. The original factory sealant (red arrow) at the joints along the chassis/structural body was untouched, indicating no work was done on the chassis/structural body of the Motor Car and that the chassis/structural body was originally fitted.

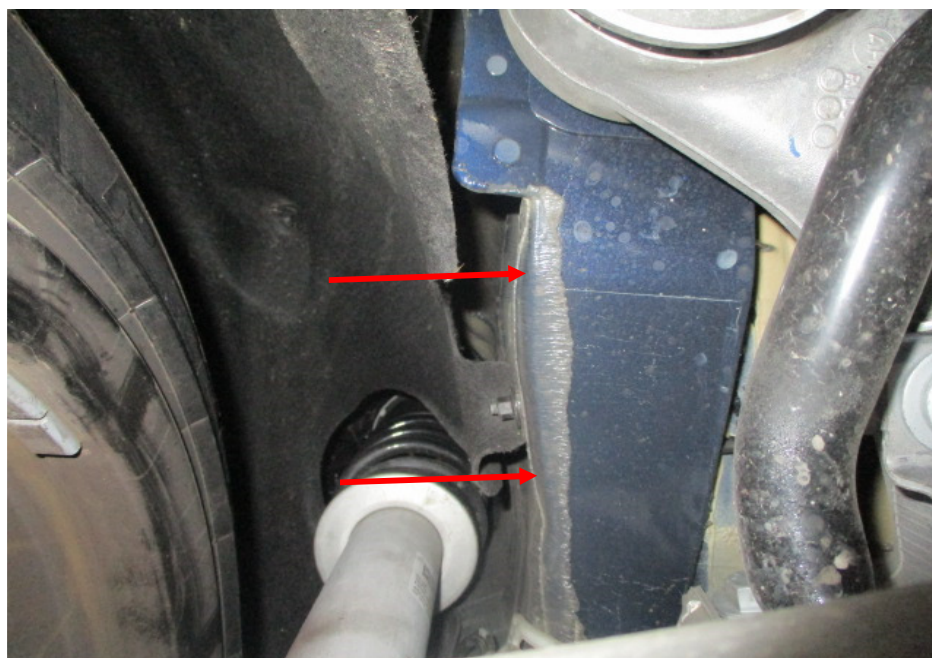
Photo 27 shows the chassis/structural body at the underside rear left of the Motor Car. The original factory sealant (arrowed) at the joints along the chassis/structural body was observed to be untouched. In general, I had found no work was carried out on the chassis/structural body of the Motor Car. The chassis/structural body of the Motor Car was originally fitted.

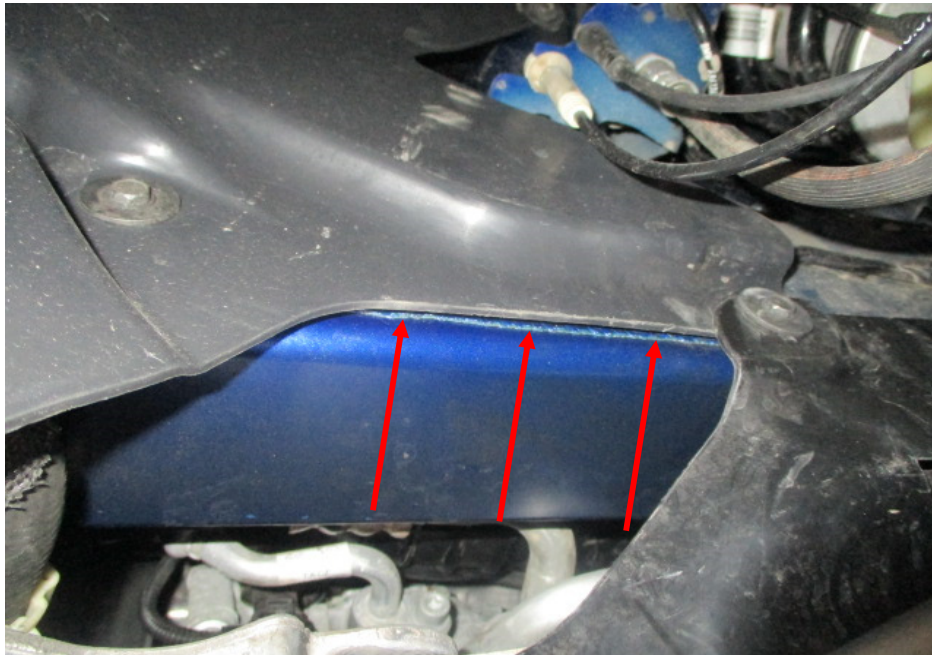
Photo 28 shows the chassis/structural body at the underside front left of the Motor Car. I did not find any weld marks other than original spot weld marks on the chassis/structural body of the Motor Car. The original factory sealant (arrowed) at the joints along the chassis/structural body was untouched, indicating no work was done on the chassis/structural body of the Motor Car and that the chassis/structural body was originally fitted.

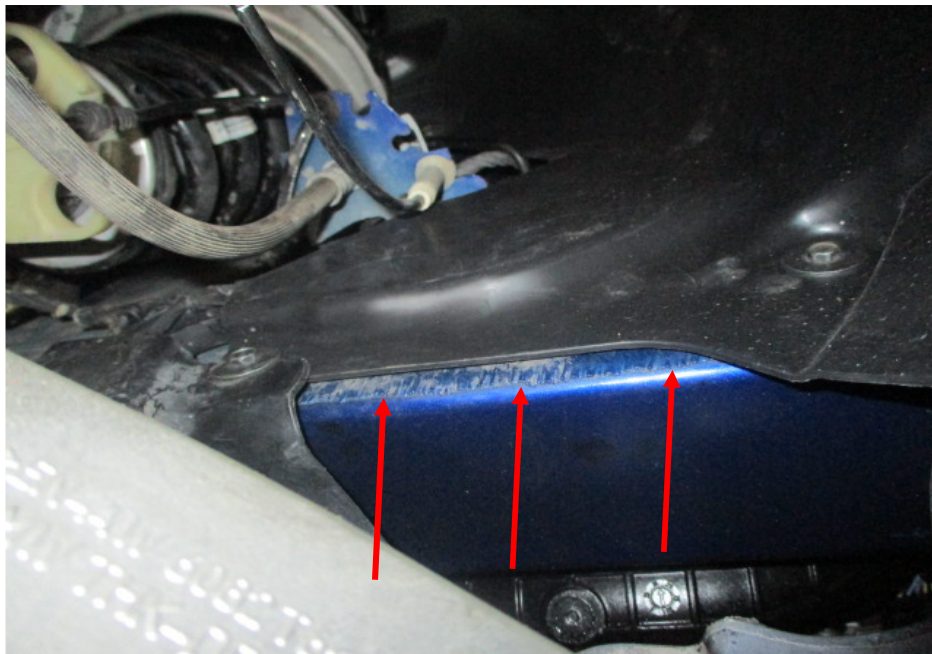
Photo 29 shows the chassis/structural body at the underside front right of the Motor Car. The original factory sealant (arrowed) at the joints along the chassis/structural body was observed to be untouched. In general, I had found no work was carried out on the chassis/structural body of the Motor Car. The chassis/structural body of the Motor Car was originally fitted.

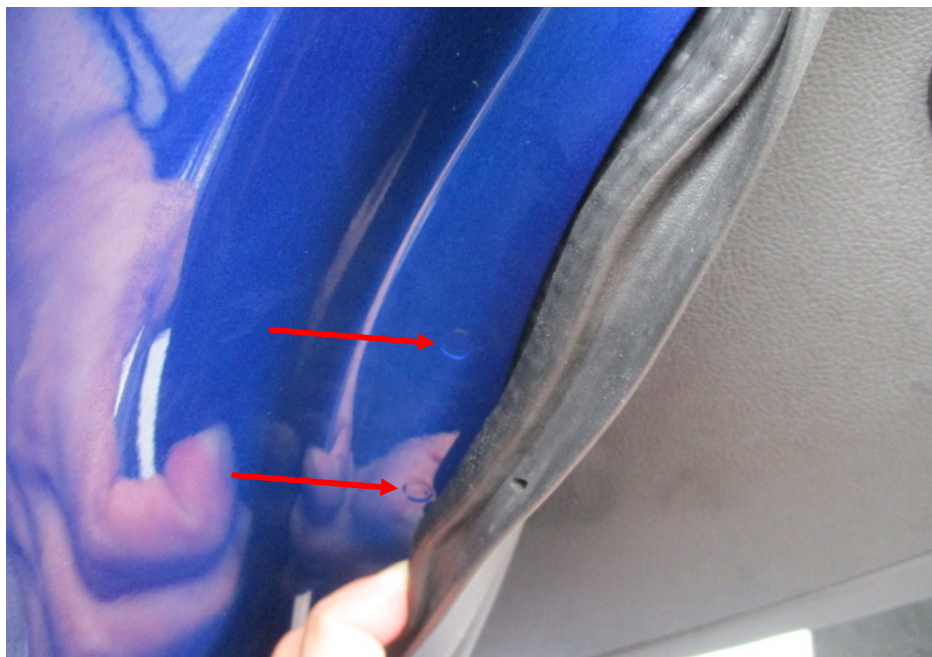
Photo 30 shows the left side "A" pillar of the Motor Car. I did not find any weld marks other than original spot weld marks (arrowed) on the left side "A" pillar of the Motor Car which, indicates that there was no re-welding works carried out. In general, I had found all the non-detachable body panels of the Motor Car to be originally fitted at the time of my inspection.

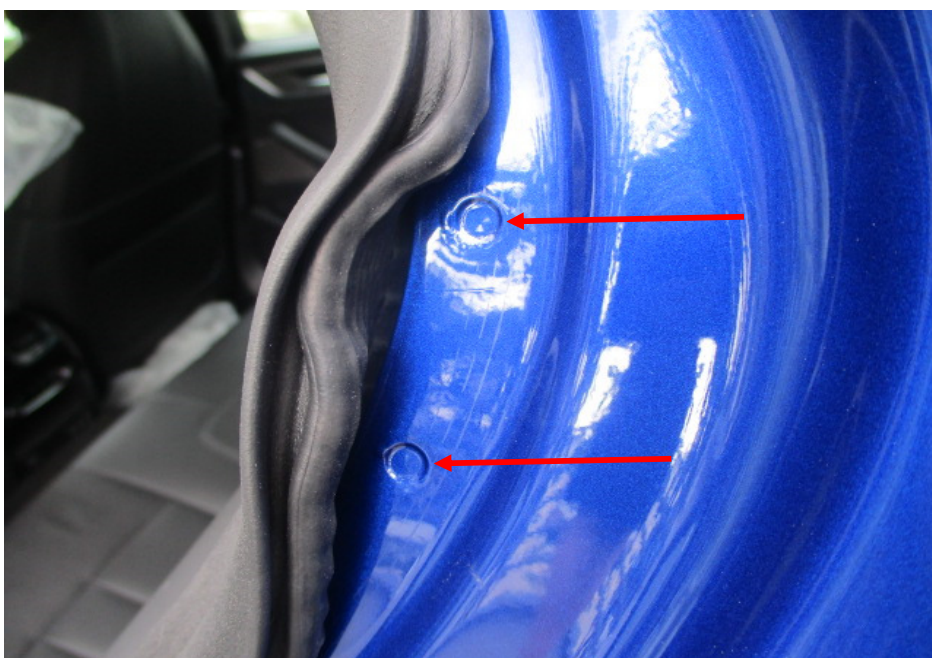
Photo 31 shows the left side "C" pillar of the Motor Car. I did not find any weld marks other than original spot weld marks (arrowed) on the left side "C" pillar of the Motor Car which, indicates that there was no re-welding works carried out. In general, I had found all the non-detachable body panels of the Motor Car to be originally fitted at the time of my inspection.

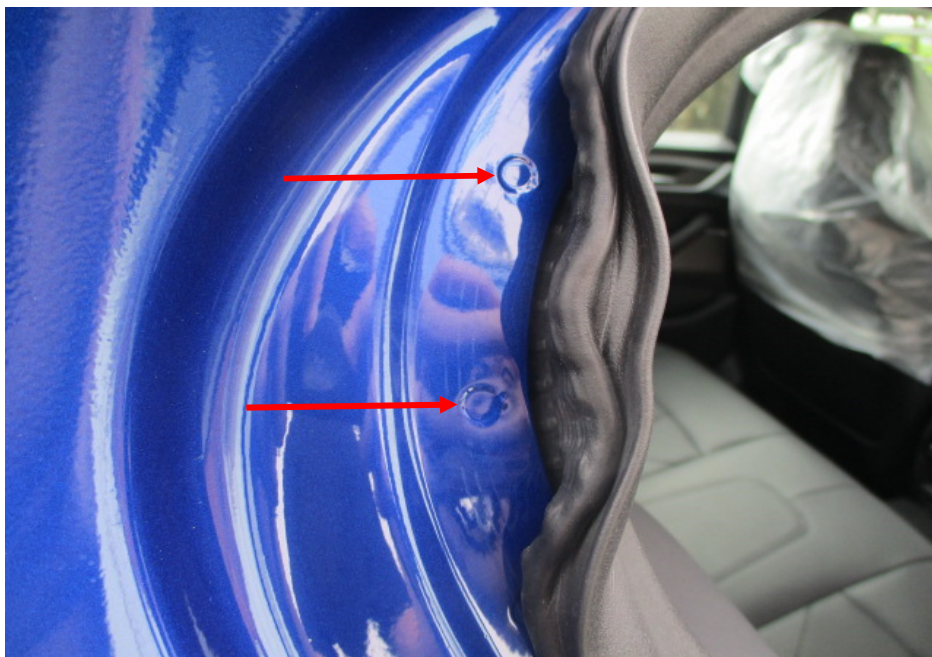
Photo 32 shows the right side "C" pillar of the Motor Car. I did not find any weld marks other than original spot weld marks (arrowed) on the right side "C" pillar of the Motor Car which, indicates that there was no re-welding works carried out. In general, I had found all the non-detachable body panels of the Motor Car to be originally fitted at the time of my inspection.
