Your Ref: TP/IP/55269/2021  
Our Ref: CI/TPD22000328/P

### **Fatal Accident Investigation Team**

### **MECHANICAL INSPECTION REPORT OF MOTOR VAN GW 4855U**

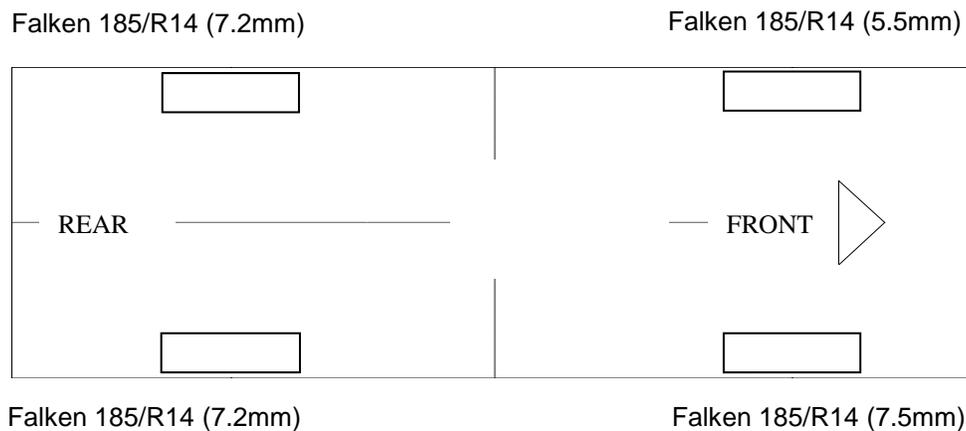
6. The 4 tyres of the Motor Van were observed to be in serviceable condition and sufficiently inflated for vehicular operation. I did not find any tear, cut or burst mark(s) on the outer and the inner sidewalls as well as across the tread of the 4 tyres. The tyre brand, tyre size and remaining tread depth of the 4 tyres of the Motor Van were recorded as follows:-

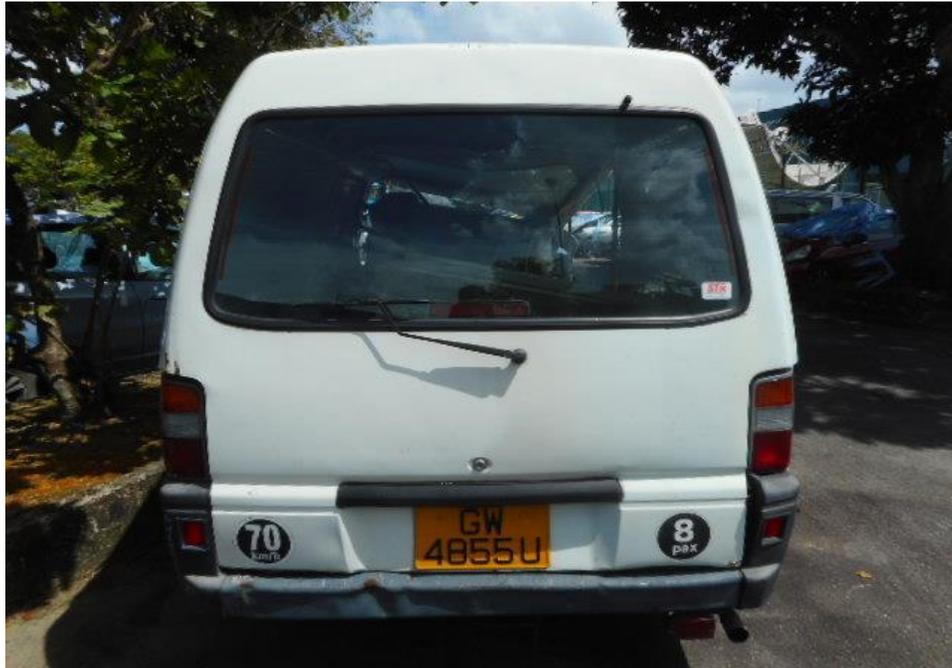
**Photo 1** shows the general view of the Motor Van's rear body at the time of my inspection. The Motor Van rear was observed to be unaffected by the accident.

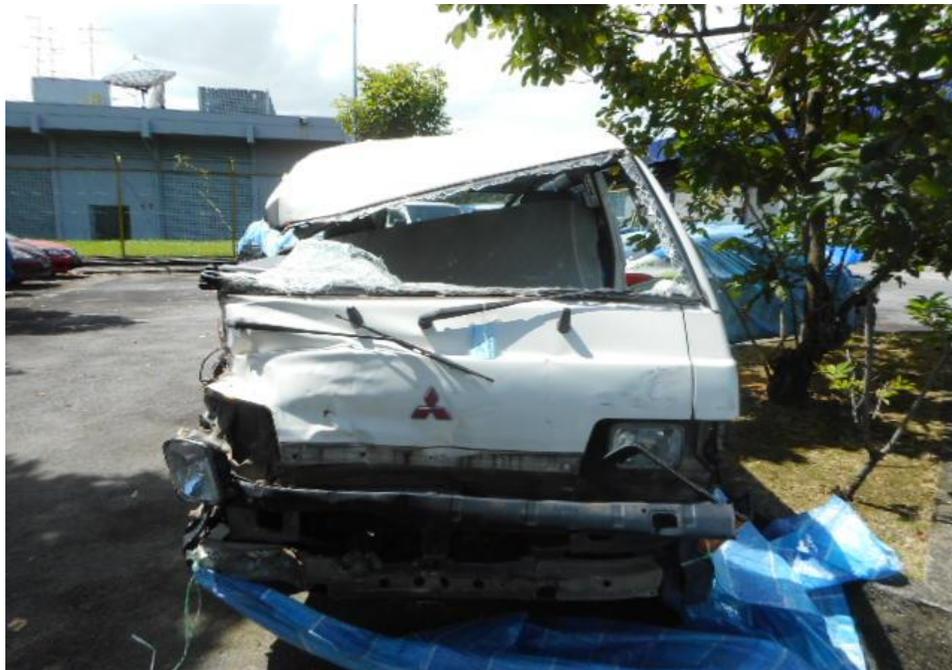
4. The mileage of the Motor Van at the time of my inspection was not recorded as the dashboard of the Motor Van was damaged as a result of the accident.
5. The Motor Van was observed to have sustained major damage at its front and right portion. Its front cabin, front windscreen, front bumper and front body panel portion as well as its right and left doors as a result of the accident.

**Photo 2** shows a general view of the front portion of the Motor Van at the time of our inspection. The Motor Van was observed sustained major damages to its front and right portion. Its front cabin, front windscreen, front bumper and front body panel portion as well as its right door as a result of the accident.

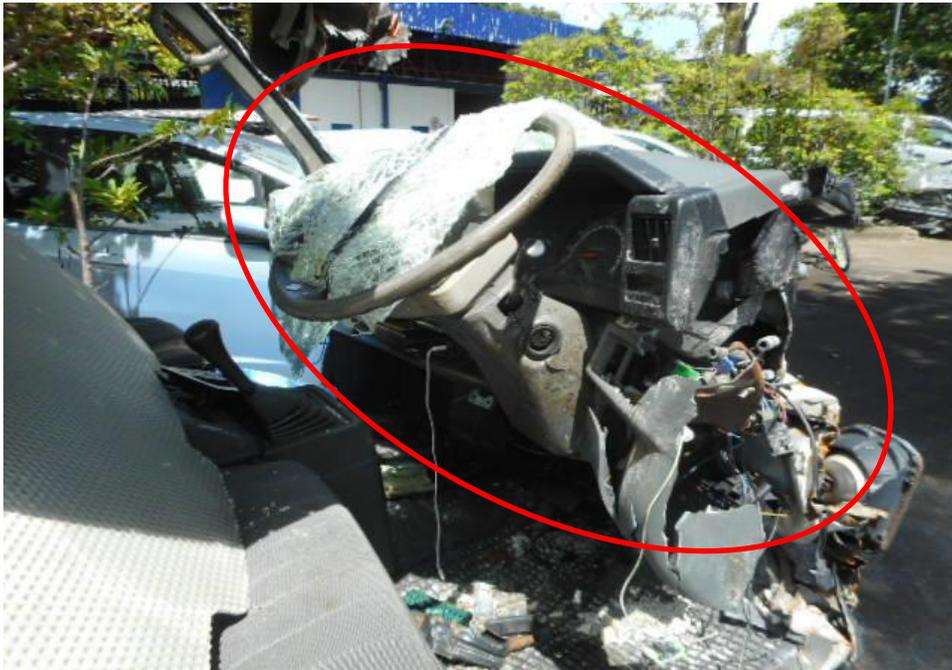
**Photo 3** shows the close up view of the front portion of the Motor Van at the time of our inspection. The Motor Van was observed to have sustained major damages to its dashboard (circled) that was crushed due to the accident's impact.

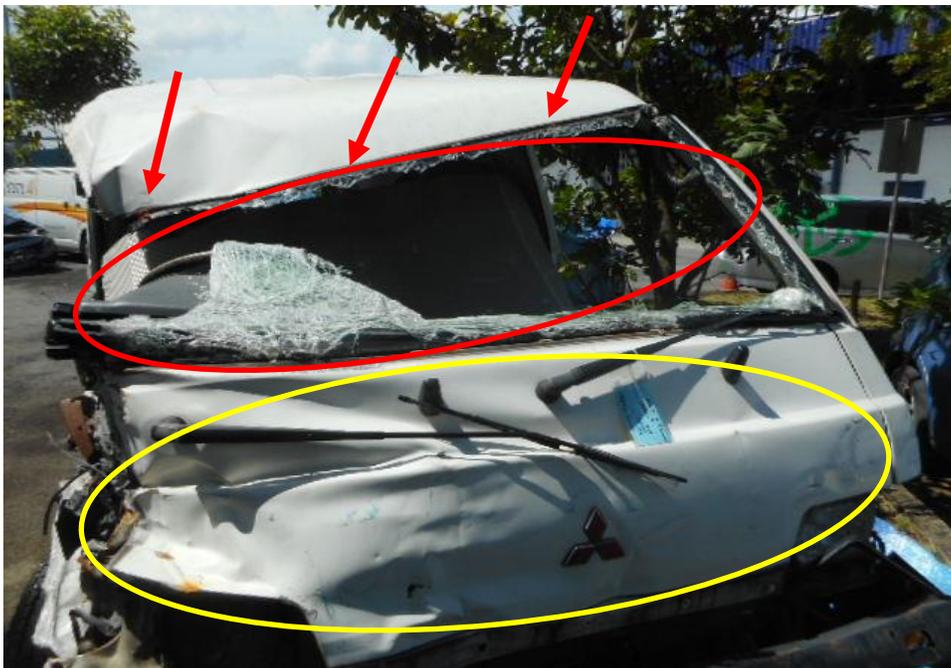
**Photo 4** shows the close up view of the front portion of the Motor Van at the time of our inspection. The Motor Van was observed to have sustained major damages to its front windscreen (circled), front body panel and its front cabin (arrowed) that was crushed due to the accident's impact.

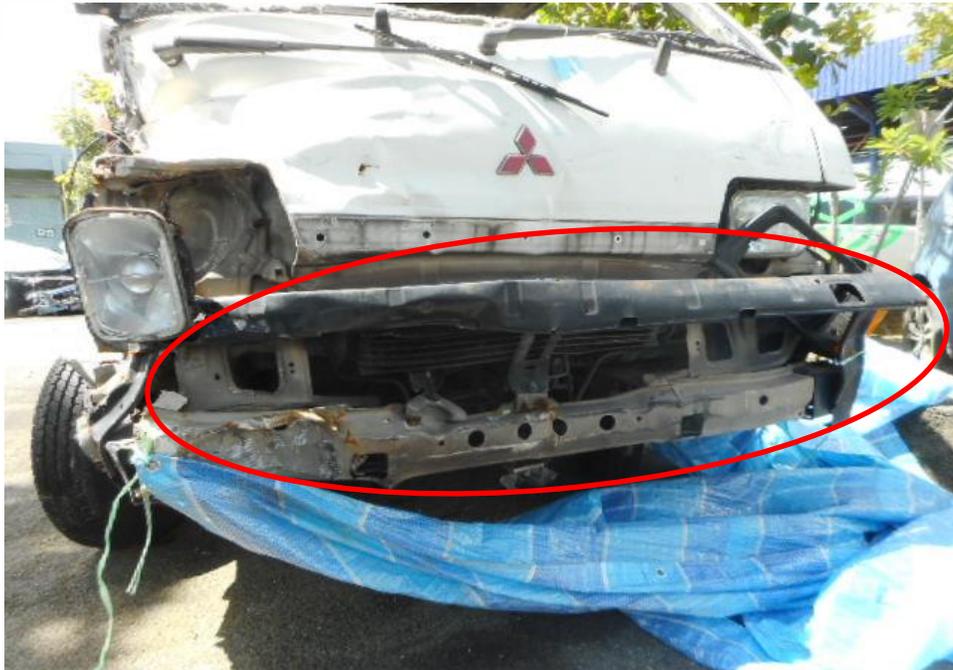
**Photo 5** shows the close up view of the front portion of the Motor Van at the time of our inspection. The Motor Van was observed to have sustained major damages to its front bumper (circled) that was damaged as a result of the accident's impact.

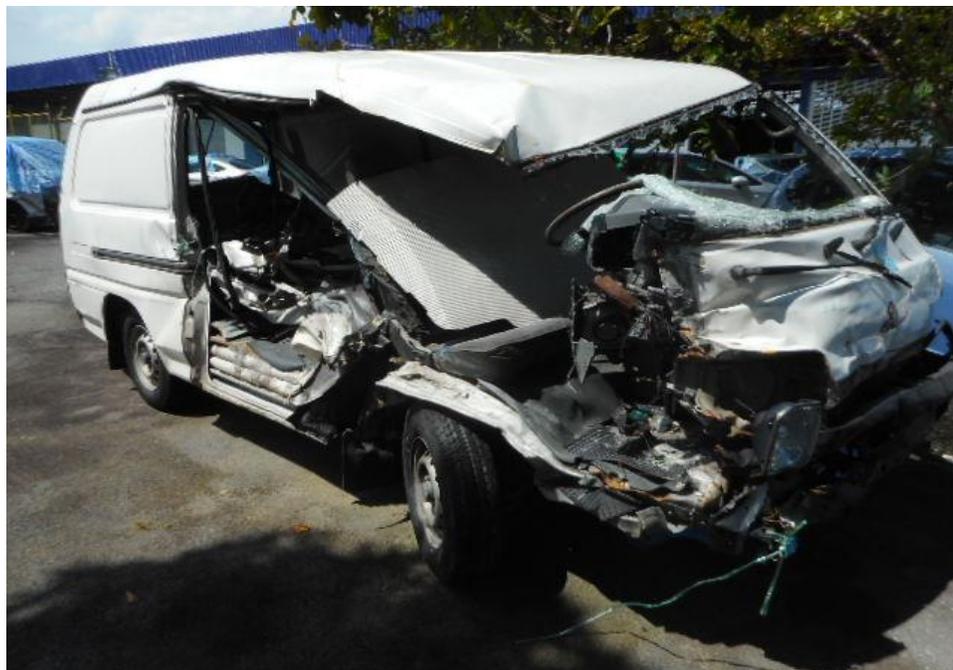
**Photo 6** shows the general view of the right body of the Motor Van at the time of our inspection. The Motor Van was observed to have sustained damages to its right doors as a result of the accident.

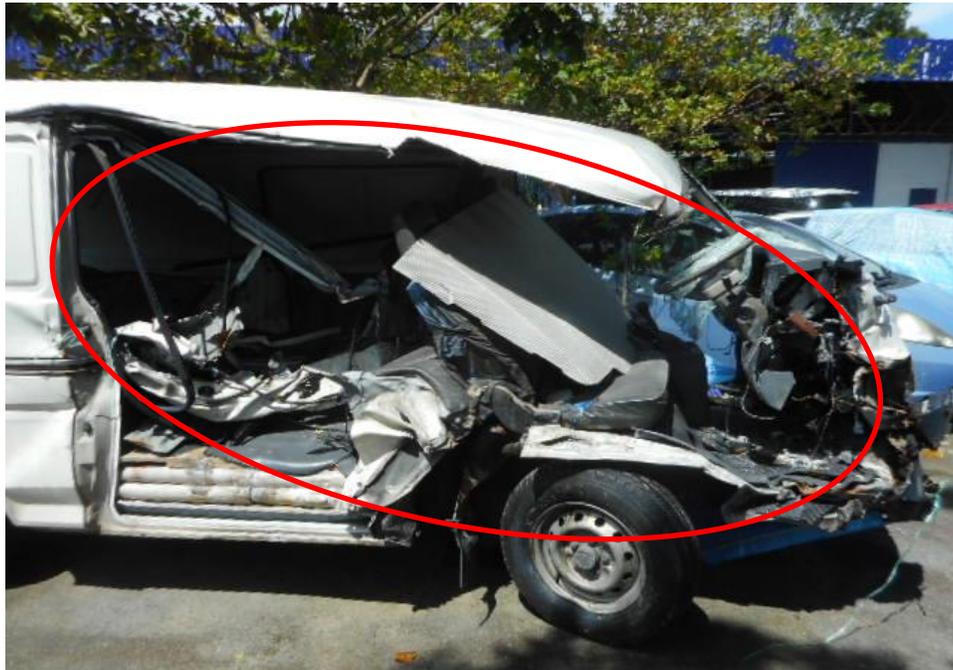
**Photo 7** shows the close up view of the right doors of the Motor Van at the time of our inspection. The Motor Van was observed to have sustained damages to its right doors (circled) as a result of the accident.

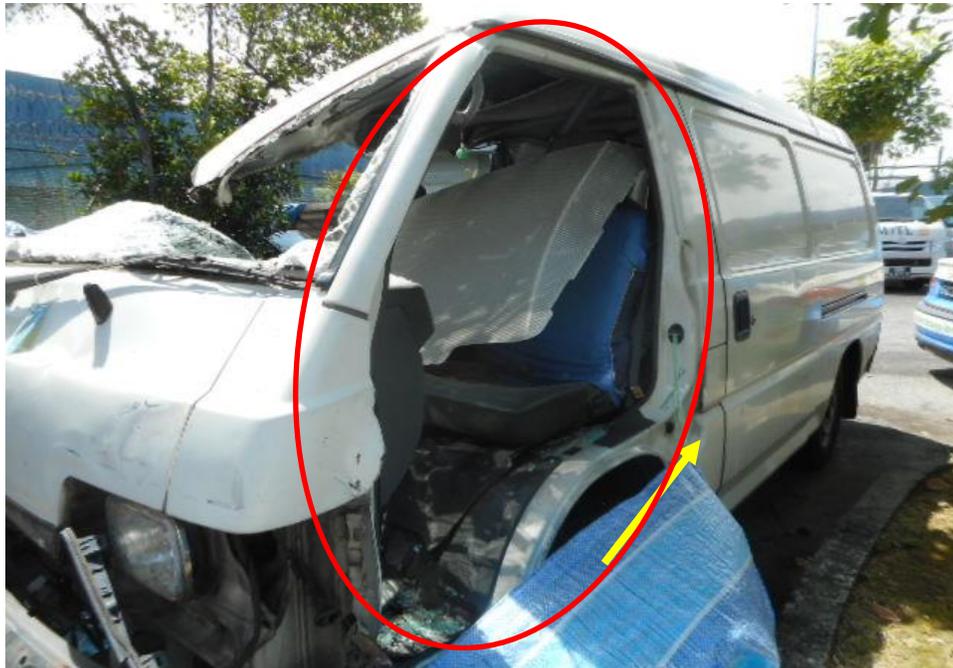
**Photo 8** shows the close up view of the left door of the Motor Van at the time of our inspection. The Motor Van was observed to have sustained damages to its left door (circled) as a result of the accident.

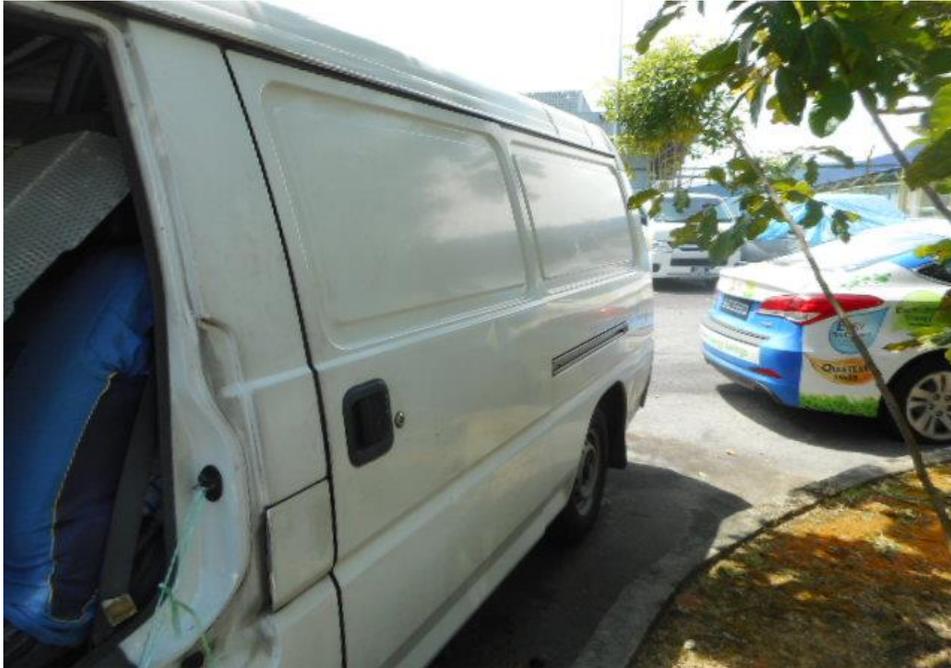
**Photo 9** shows a general view of the Motor Van's left body at the time of my inspection. The left portion of the Motor Van was observed to have been unaffected by the accident.

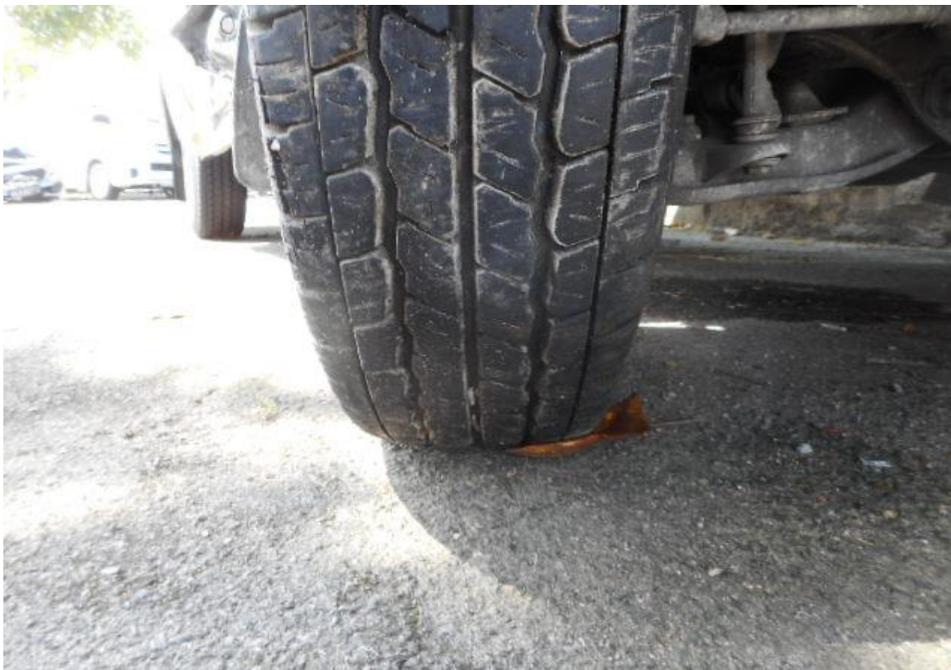
**Photo 10** shows the condition of the front right tyre of the Motor Van, which was observed to be in serviceable condition with remaining tread depth of approximately 7.5mm. The tyre, which was wrapped around standard steel wheel rim, was also observed to be sufficiently inflated for vehicular operation. There was no tear, cut or burst mark(s) on the outer and the inner sidewalls as well as across the tread of the 4 tyres that were fitted on the Motor Van.

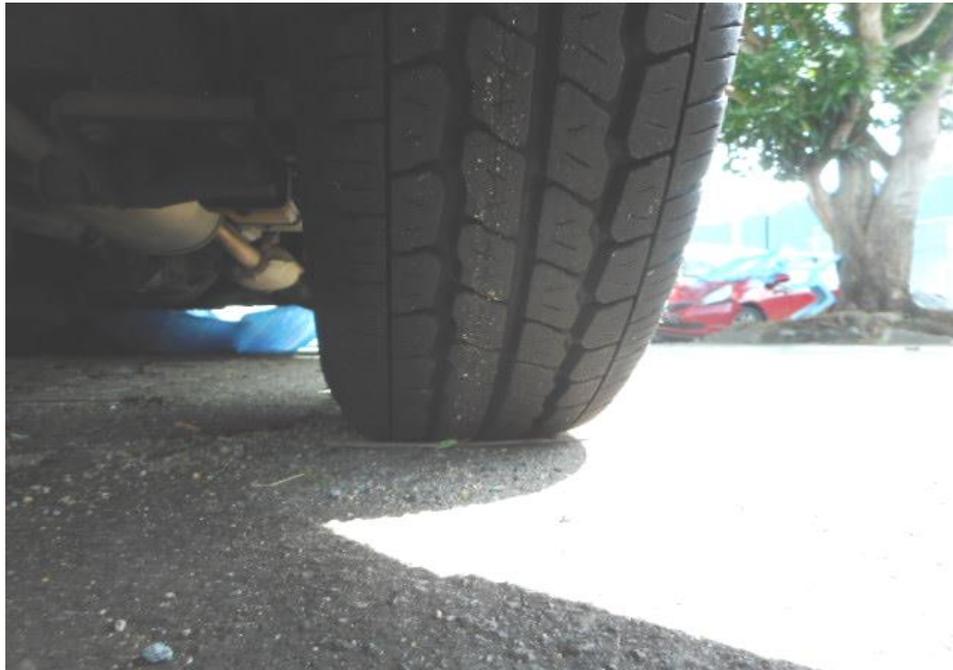
**Photo 11** shows the condition of the rear right tyre of the Motor Van, which were observed to be in serviceable condition with remaining, tread depth of approximately 7.2mm. See above.

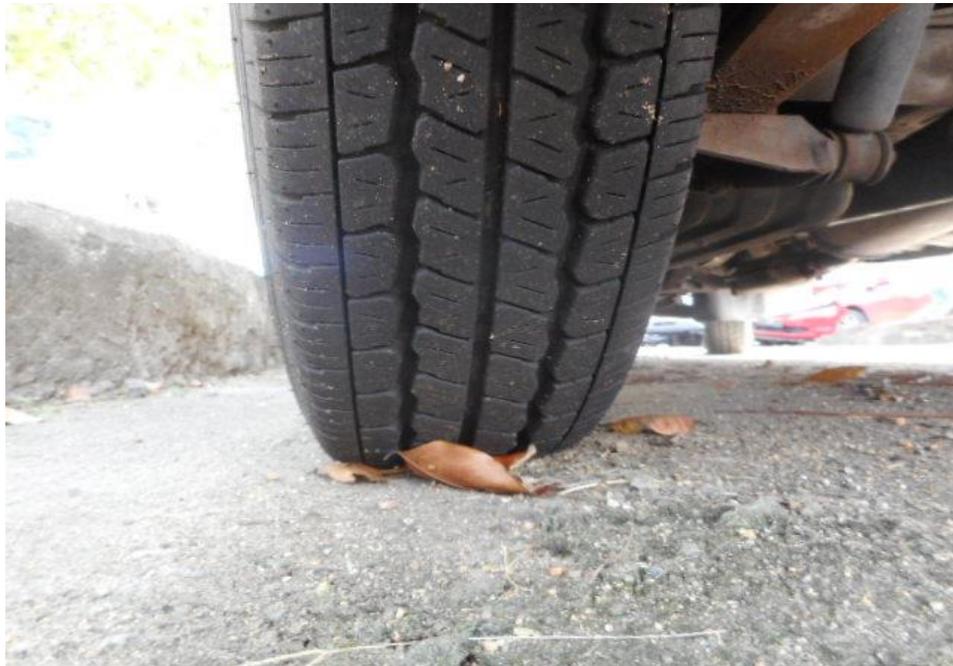
**Photo 12** shows the condition of the rear left tyre of the Motor Van, which were observed to be in serviceable condition with remaining, tread depth of approximately 7.2mm.

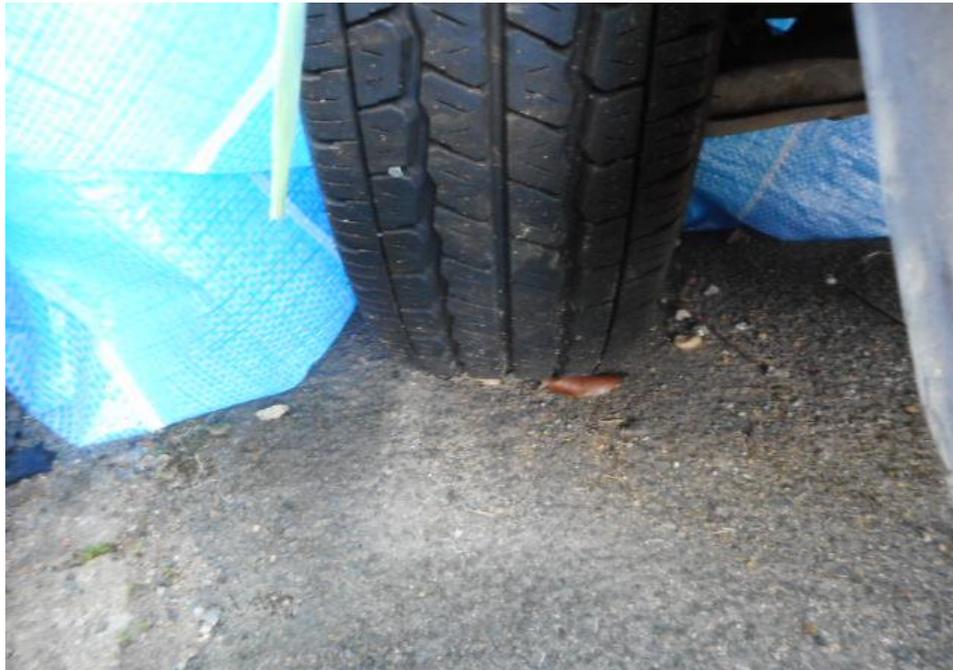
**Photo 13** shows the condition of the front left tyre of the Motor Van, which were observed to be in serviceable condition with remaining, tread depth of approximately 5.5mm.

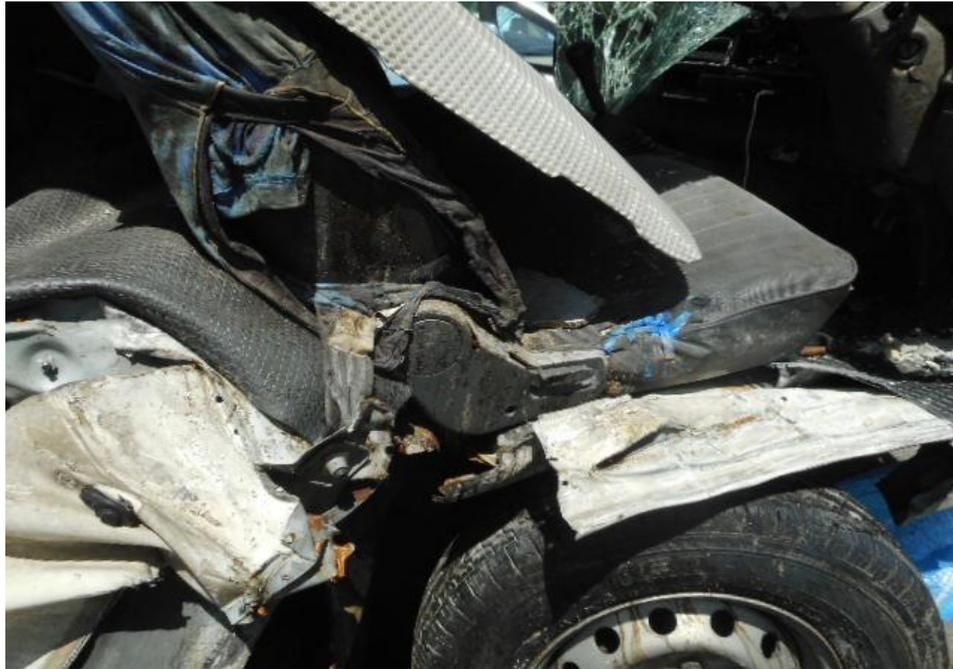
8. We were unable to examine the engine compartment of the Motor Van's due to the damage induced has crushed and deformed the cabin of the Motor Van which immobilized its opening and viewing as a result of the accident. See Photo 14 below.

**Photo 14** shows the induced damage to the front cabin engine compartment area of the Motor Van's which had immobilised the opening and viewing of the various parts and components inside the engine compartment a result of the accident.

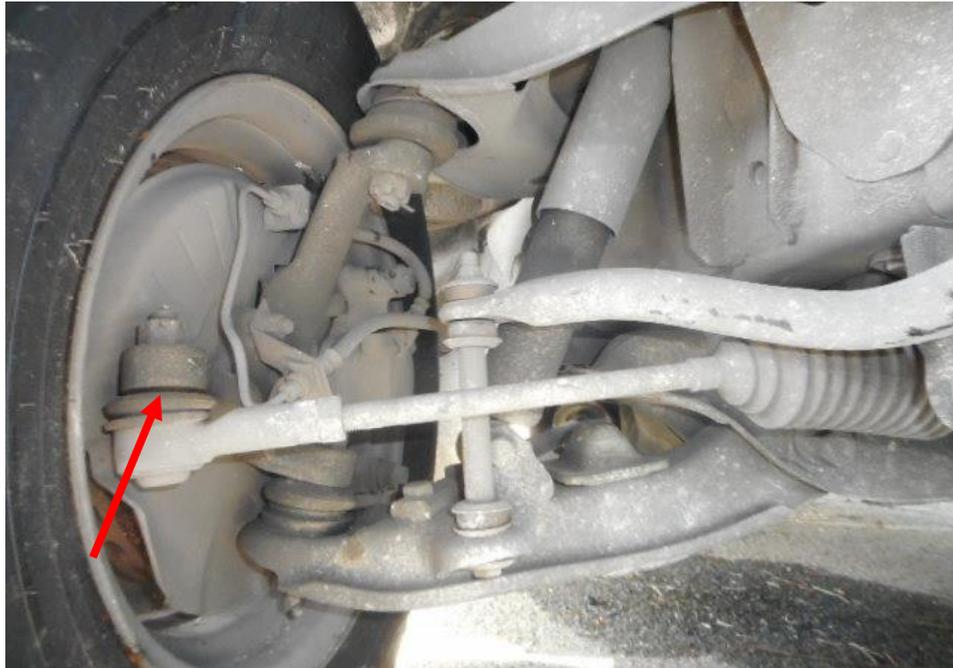
**Photo 15** shows the various undercarriage components at the front right wheel of the Motor Van, in particular the steering tie rod end and ball joints (arrowed) were observed to be intact. There was also no sign of fluid stain observed on the various undercarriage components at the front right wheel of the Motor Van.

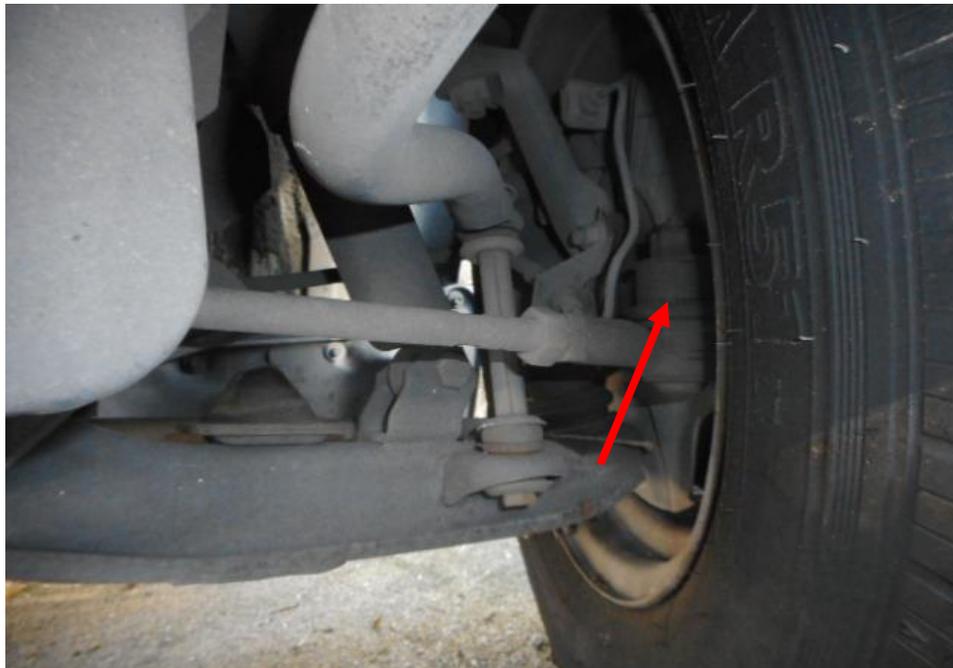
**Photo 16** shows the various undercarriage components at the front left wheel of the Motor Van, in particular the steering tie rod end and ball joints (arrowed) were observed to be intact. There was also no sign of fluid stain observed on the various undercarriage components at the front right wheel of the Motor Van.

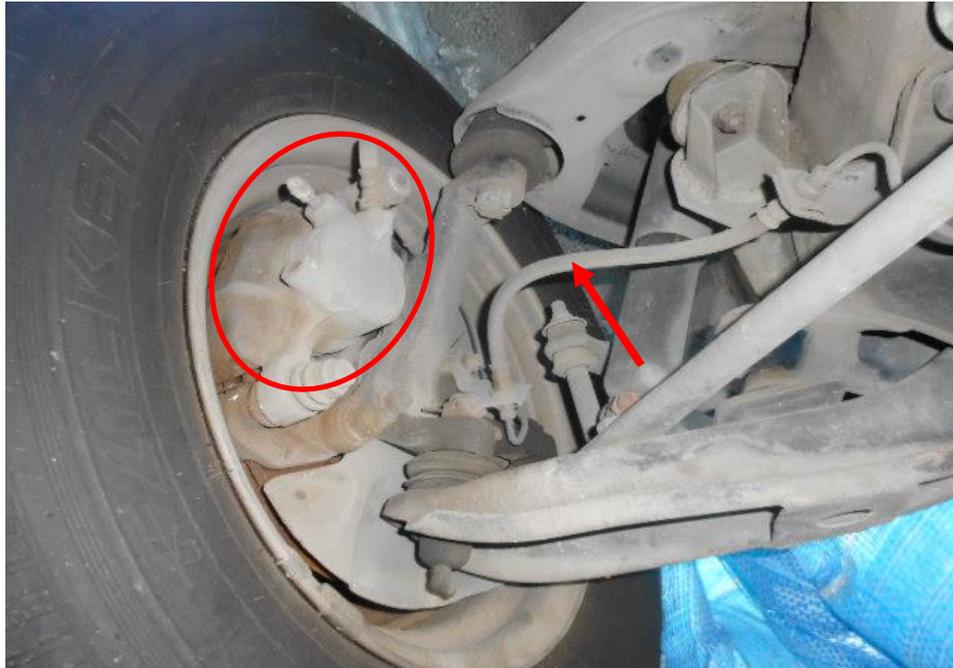
**Photo 17** shows the various undercarriage components at the front left wheel of the Motor Van, in particular the brake hose (arrowed) and callipers (circled). The various undercarriage components of the Motor Van were all found to be intact without any visible damage. There was also no sign of fluid stain(s) observed on the various undercarriage components.

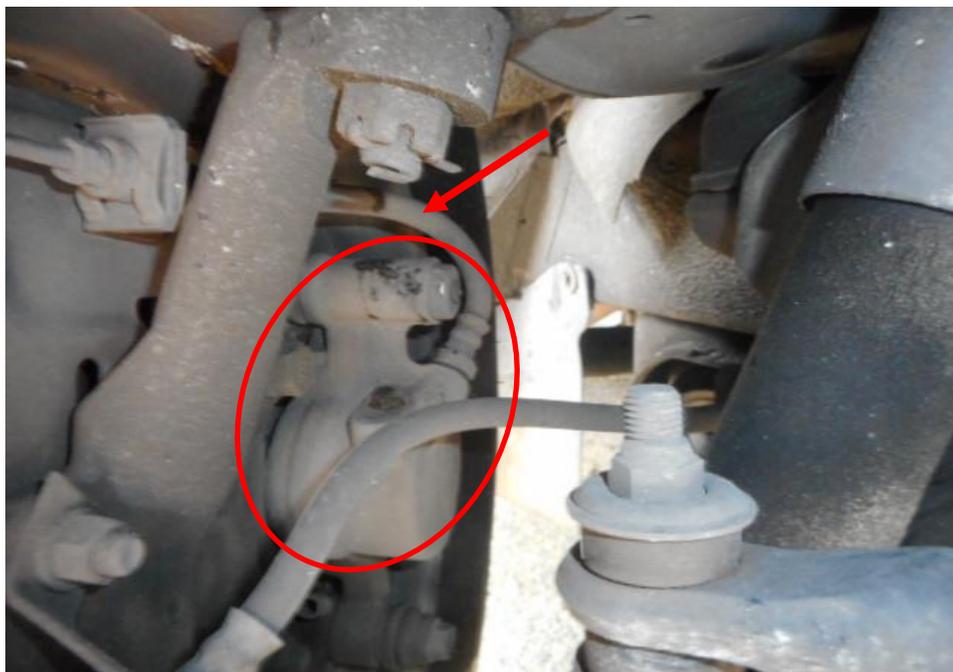
**Photo 18** shows the various undercarriage components at the front right wheel of the Motor Van, in particular the brake hose (arrowed) and callipers (circled). The various undercarriage components of the Motor Van were all found to be intact without any visible damage. There was also no sign of fluid stain(s) observed on the various undercarriage components.

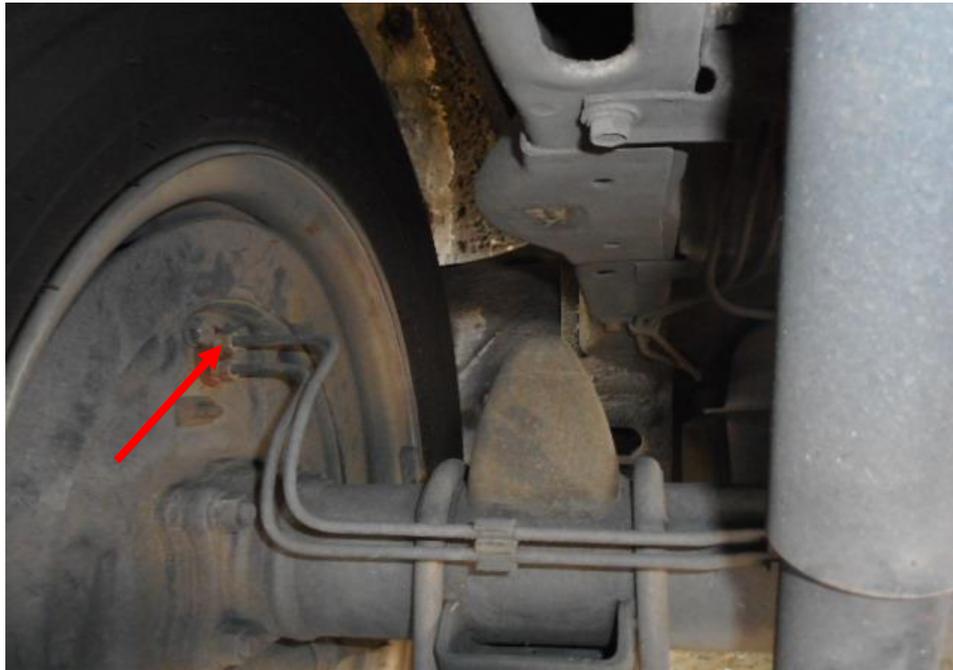
**Photo 19** shows the various undercarriage components at the rear left wheel of the Motor Van, in particular the brake hose and drum brake (arrowed). The various undercarriage components of the Motor Van were all found to be intact without any visible damage. There was also no sign of fluid stain(s) observed on the various undercarriage components.

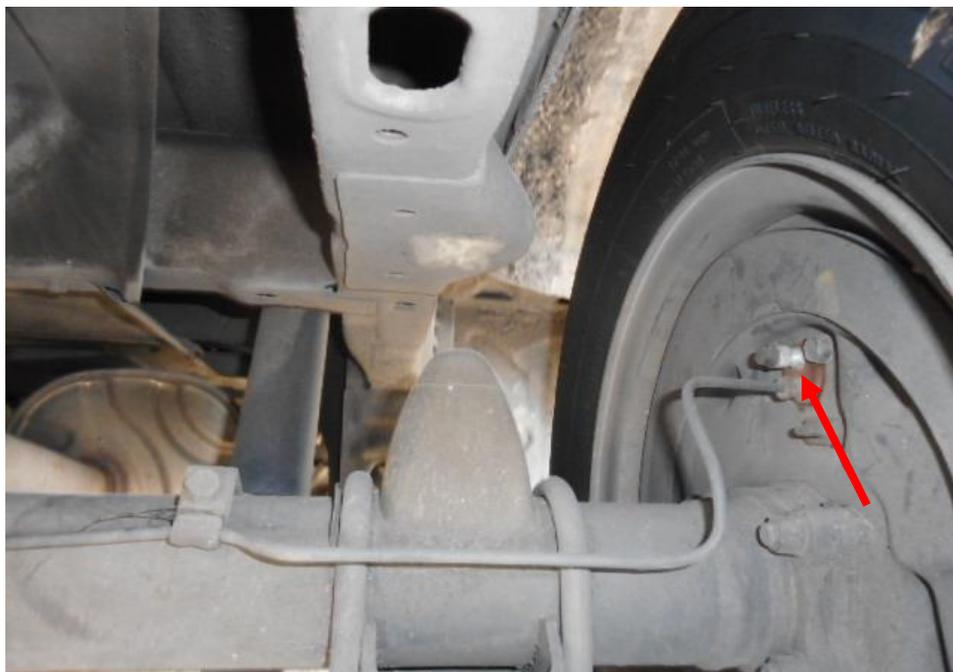
**Photo 20** shows the various undercarriage components at the rear right wheel of the Motor Van, in particular the brake hose and drum brake (arrowed). The various undercarriage components of the Motor Van were all found to be intact without any visible damage. There was also no sign of fluid stain(s) observed on the various undercarriage components.
